**FINAL REPORT FOR 2020
ON THE CONDITION OF THE MUNICIPAL OCEANFRONT BEACHES
BATHYMETRY OF TOWNSENDS INLET
THE BOROUGH OF AVALON, CAPE MAY COUNTY, NEW JERSEY**

**PREPARED FOR: THE BOROUGH OF AVALON
3100 DUNE DRIVE
AVALON, NJ 08202**

**PREPARED BY: THE STOCKTON UNIVERSITY COASTAL RESEARCH CENTER
30 WILSON AVENUE
PORT REPUBLIC, NEW JERSEY 08241**

February 17, 2021

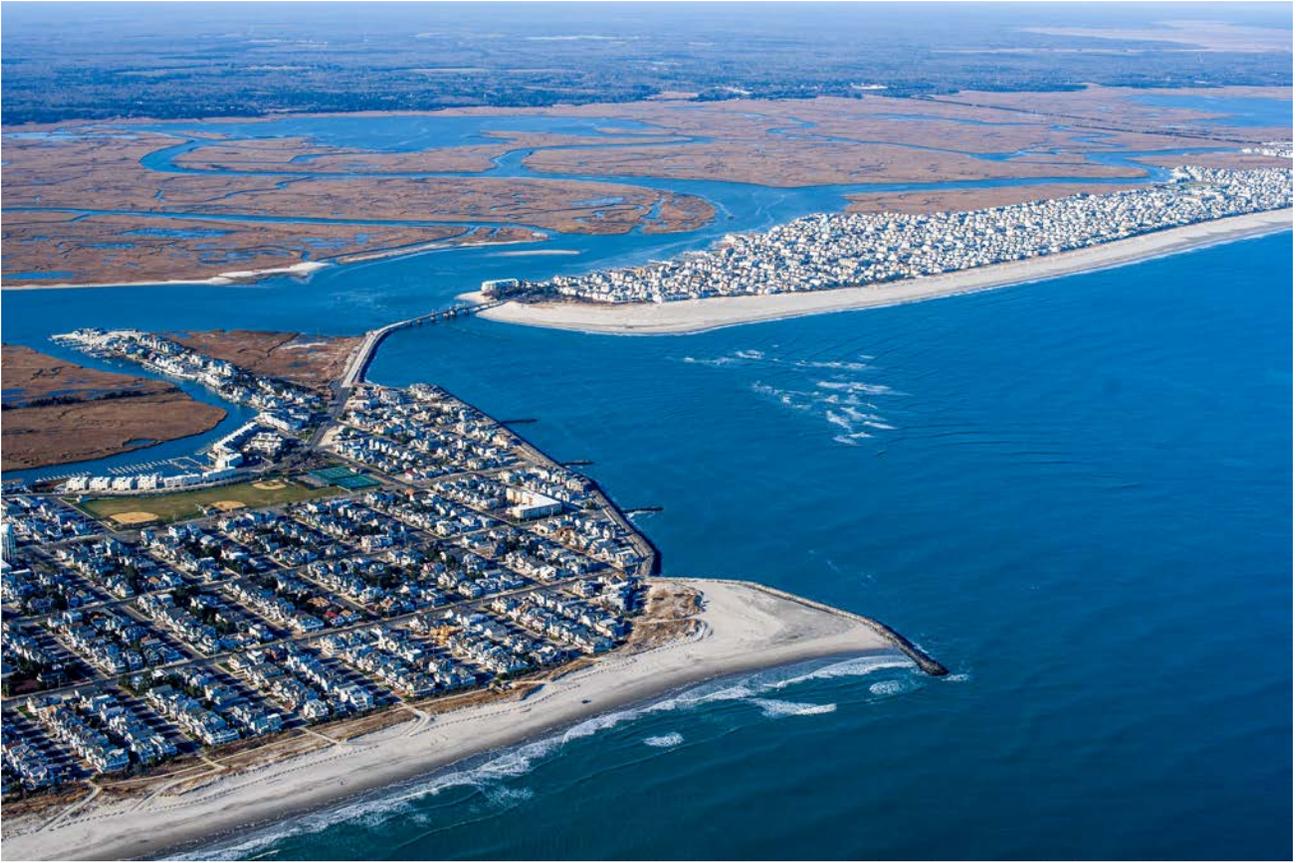
View of the Avalon oceanfront December 27, 2020 overlooking the northern engineered beach subject to the greatest erosion. The Townsends Inlet shoals appear as the zone of breaking waves off Sea Isle and as yet no breakers appear surrounding the 8th Street jetty in Avalon. As of the end of 2020 with two northeast storms at the end of December, the beach was in decent condition going into 2021. PHOTO by Ted Kingston.

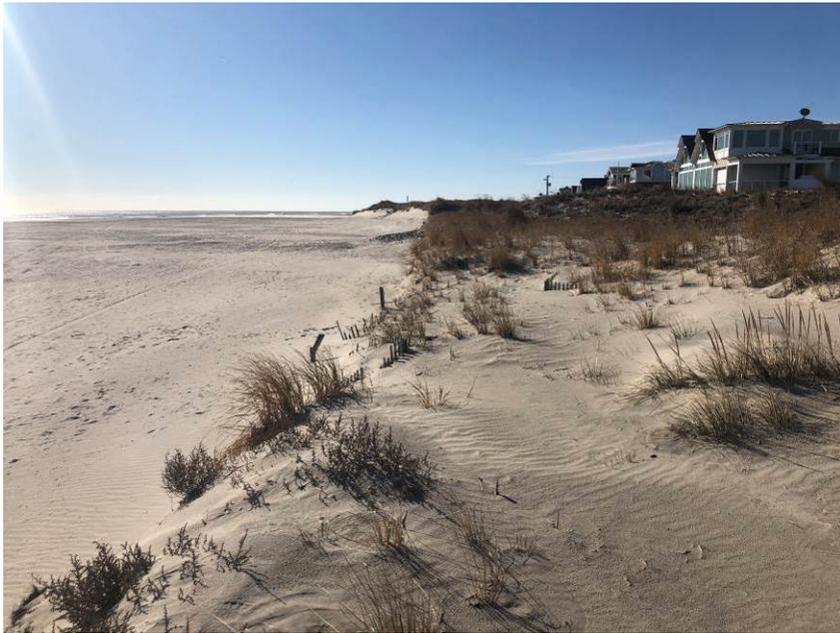
1a. December 3, 2019

Photographs 1a to 1c. 9th Street view to the south.

View 1a shows the foredune where sand has buried the newest row of fencing by Dec. 2019. The beach was at its widest extent after the USACE maintenance work.

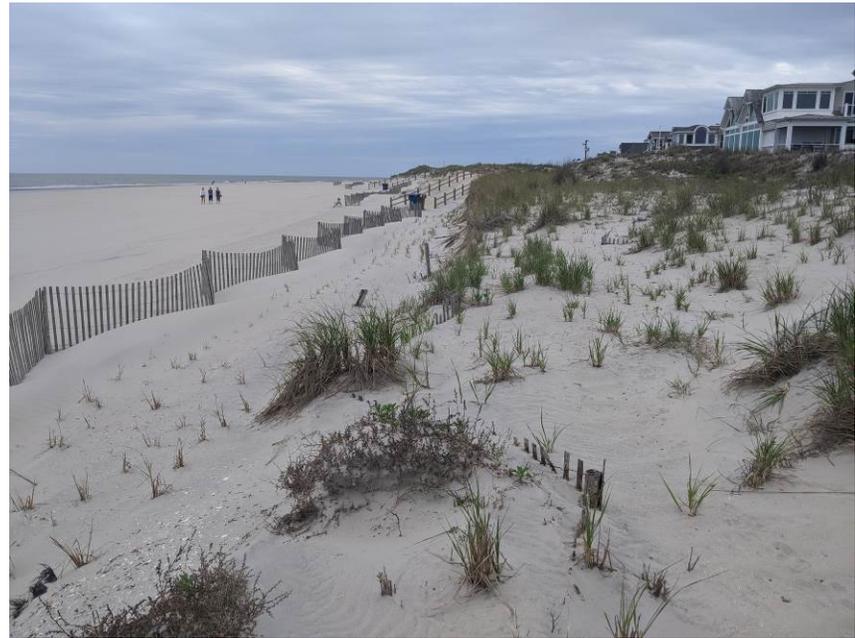
1b. June 3, 2020

View 1b was taken in June following addition of new fencing. Some beach retreat had occurred, but the site remains in good condition.

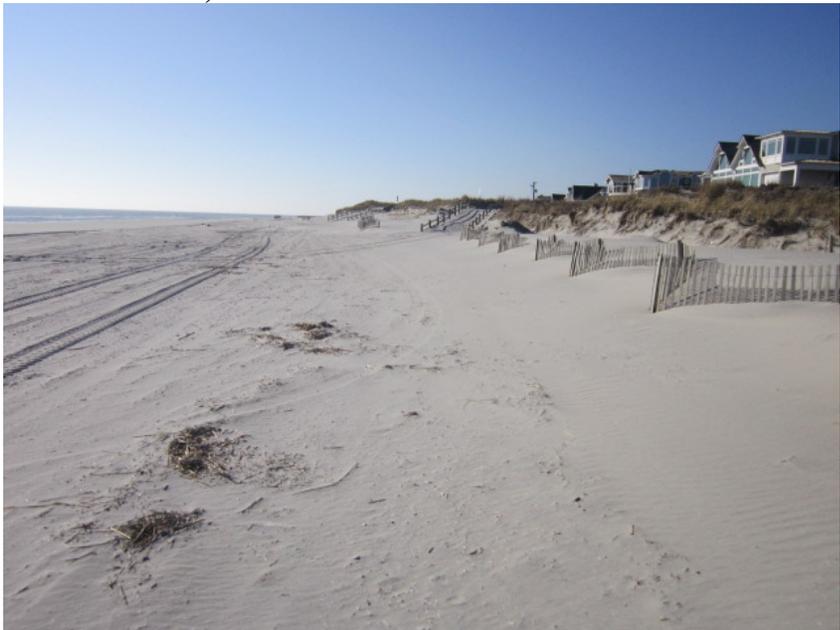
1c. December 11, 2020

View 1c This view from December 2020 and shows the remaining expanse added to the beach width by the USACE maintenance effort. Wind transport was actively burying the new fence line.

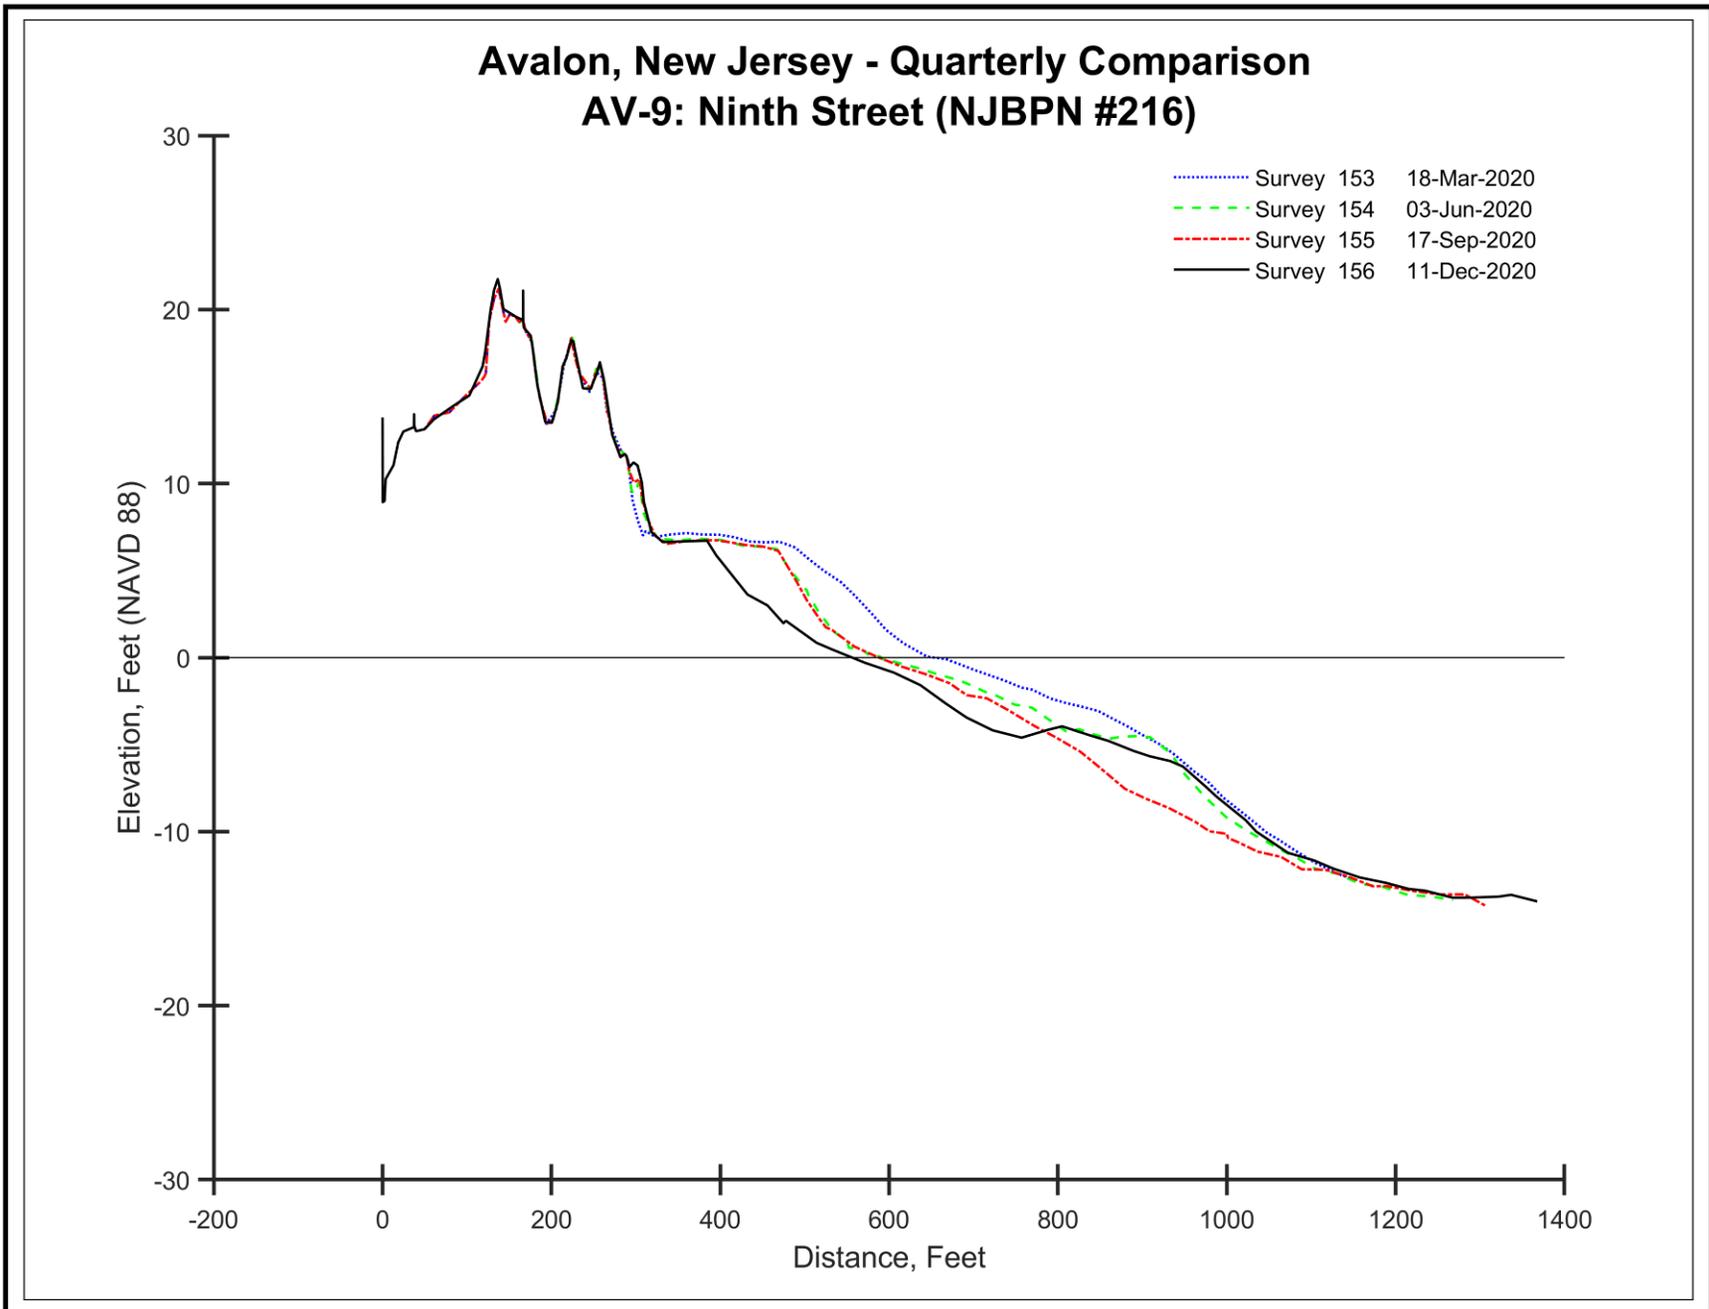
Figure 2. At 9th Street the beach retreated to the June position, remained stable through September, then retreated a lesser amount at the shoreline compared to that seen March to June (54 versus 32 feet). The sand volume lost by June was 8.65 yds³/ft. versus a gain of 0.24 yds³/ft. by December 2020 all due to deposition of a bar offshore as of the December 2020 profile.

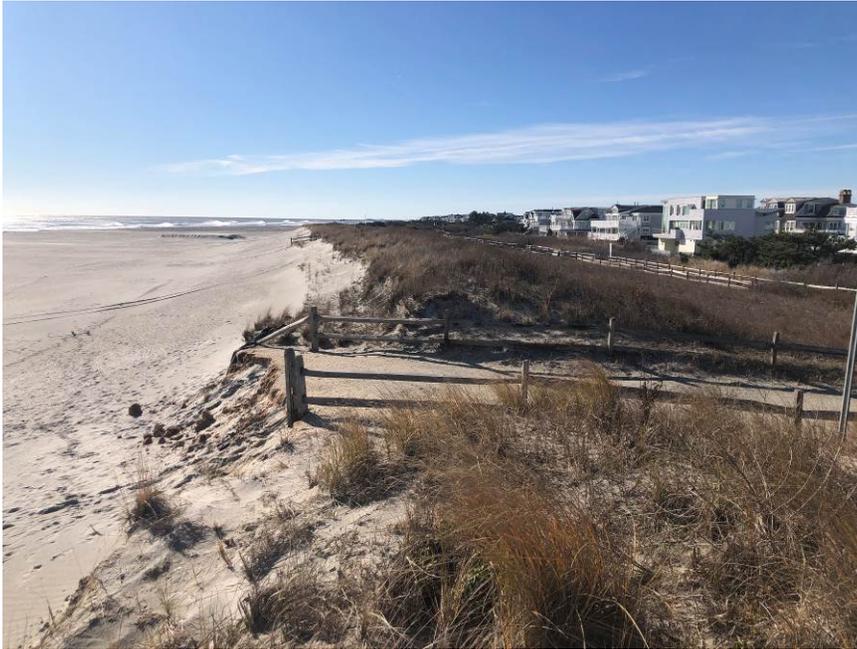
3a. December 3, 2019

Photographs 3a to 3c. 12th Street Views to the south.

View 3a was taken after the latest federal maintenance was complete, but the damage to the dune scarp had not been addressed by grading. The April 2017 work was augmented by the fall 2019 effort greatly expanding the beach width.

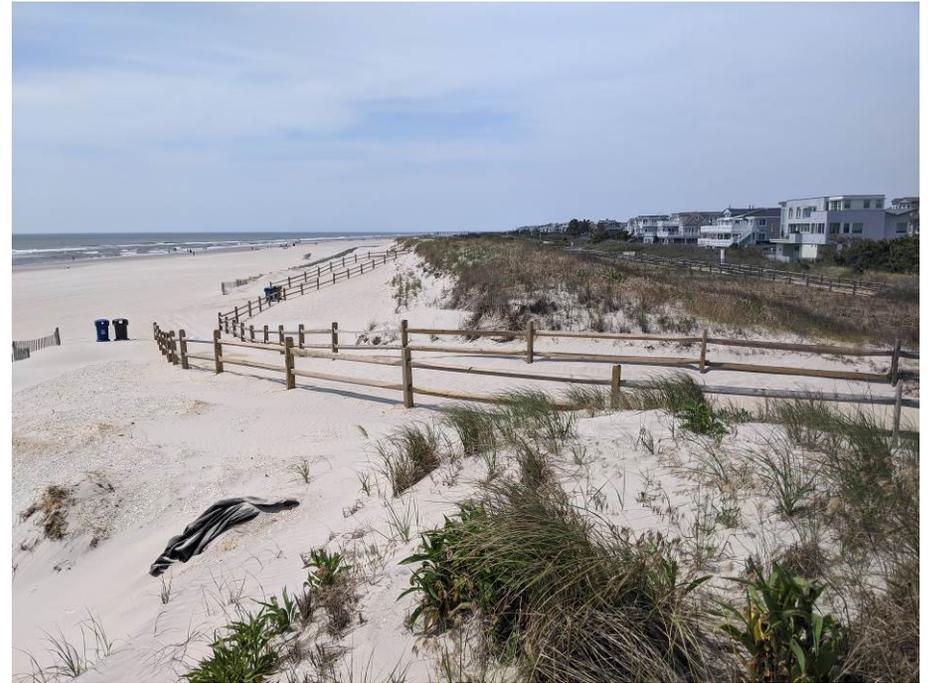
3b. June 3, 2020

View 3b was taken after Memorial Day following fencing and grading work. Some berm retreat had occurred

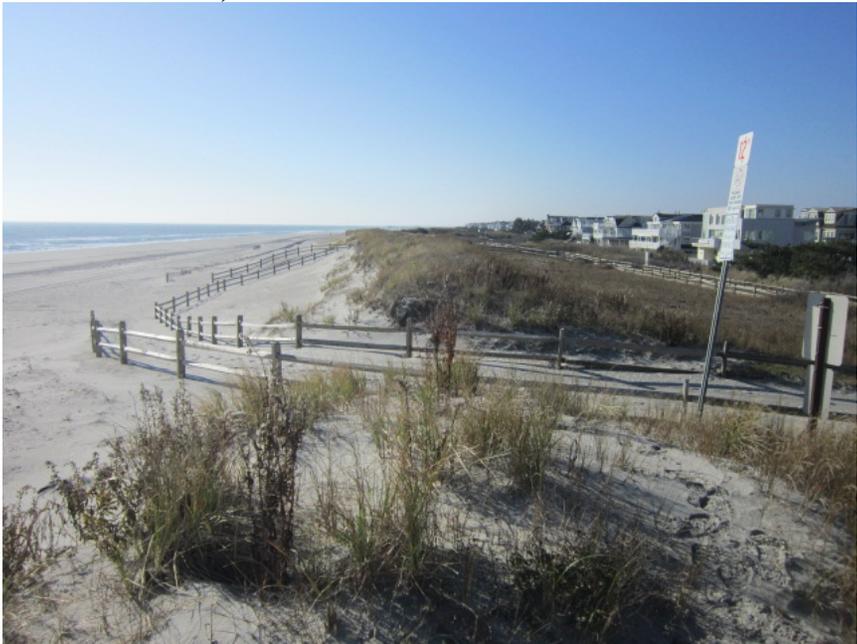
3c. December 11, 2020

View 3c. The December 2020 photograph shows the beach at the end of the year with some continued narrowing, but still in decent condition.

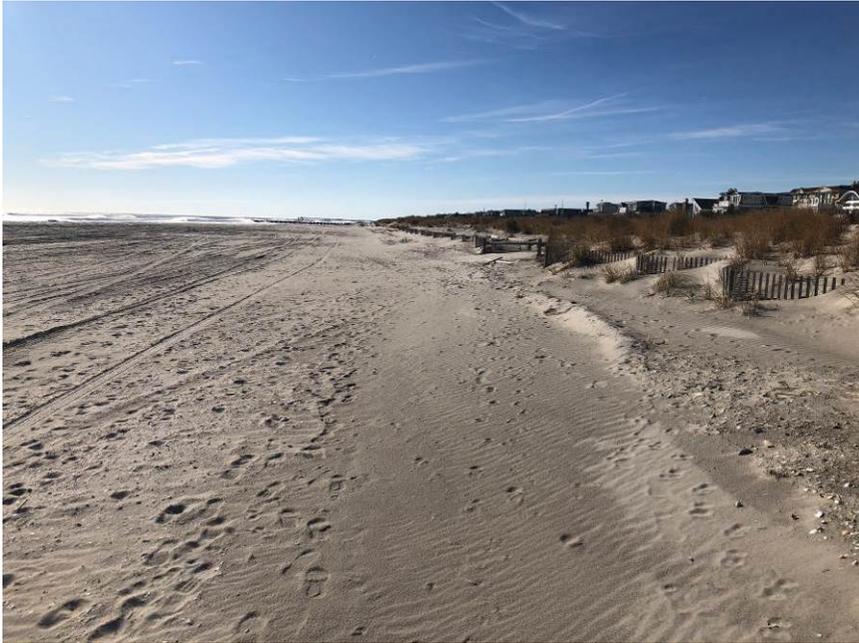
5a. December 3, 2019

Photographs 5a to 5c. 17th Street, view to the south.

View 5a By December 2019, the new beach width produced greater protection for this site following the US Army maintenance effort.

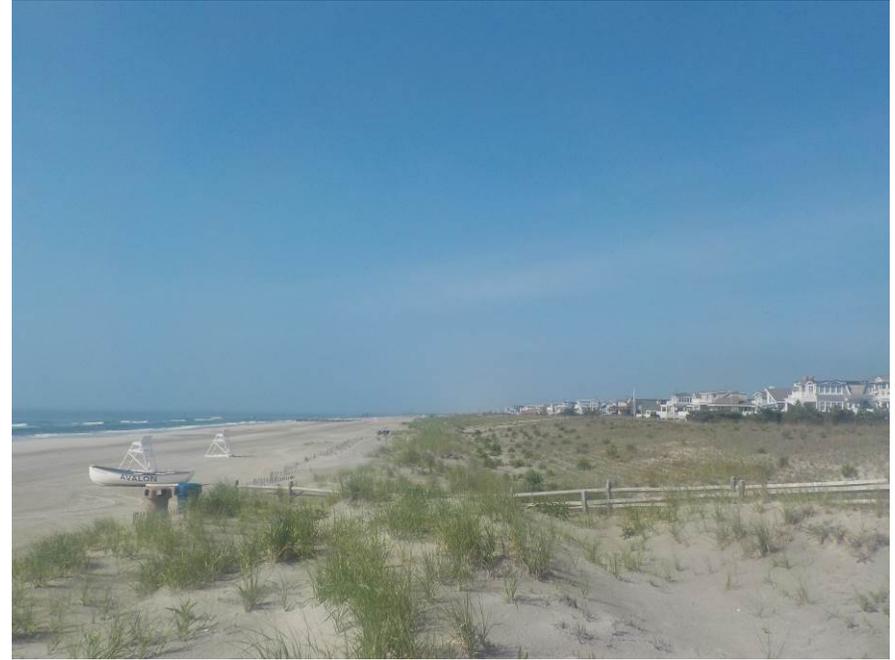
5b. May 30, 2020

View 5b By May 30th the grass had advanced into the ridge between the fences. The beach remained in decent condition as the new dune ridge continued to grow.

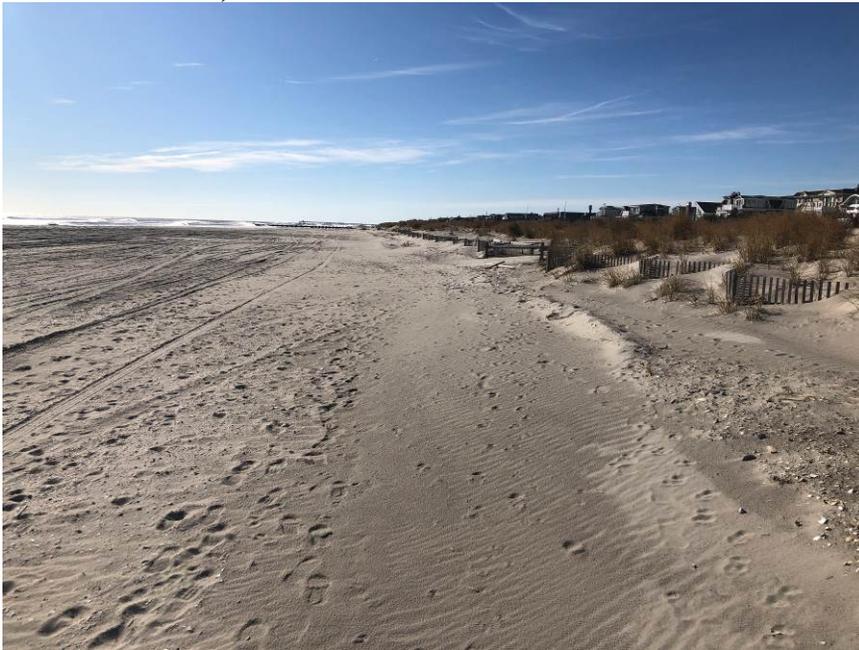
5c. December 11, 2020

View 5c shows the beach width reduced somewhat, but still an effective barrier to dune erosion as of the end of 2020.

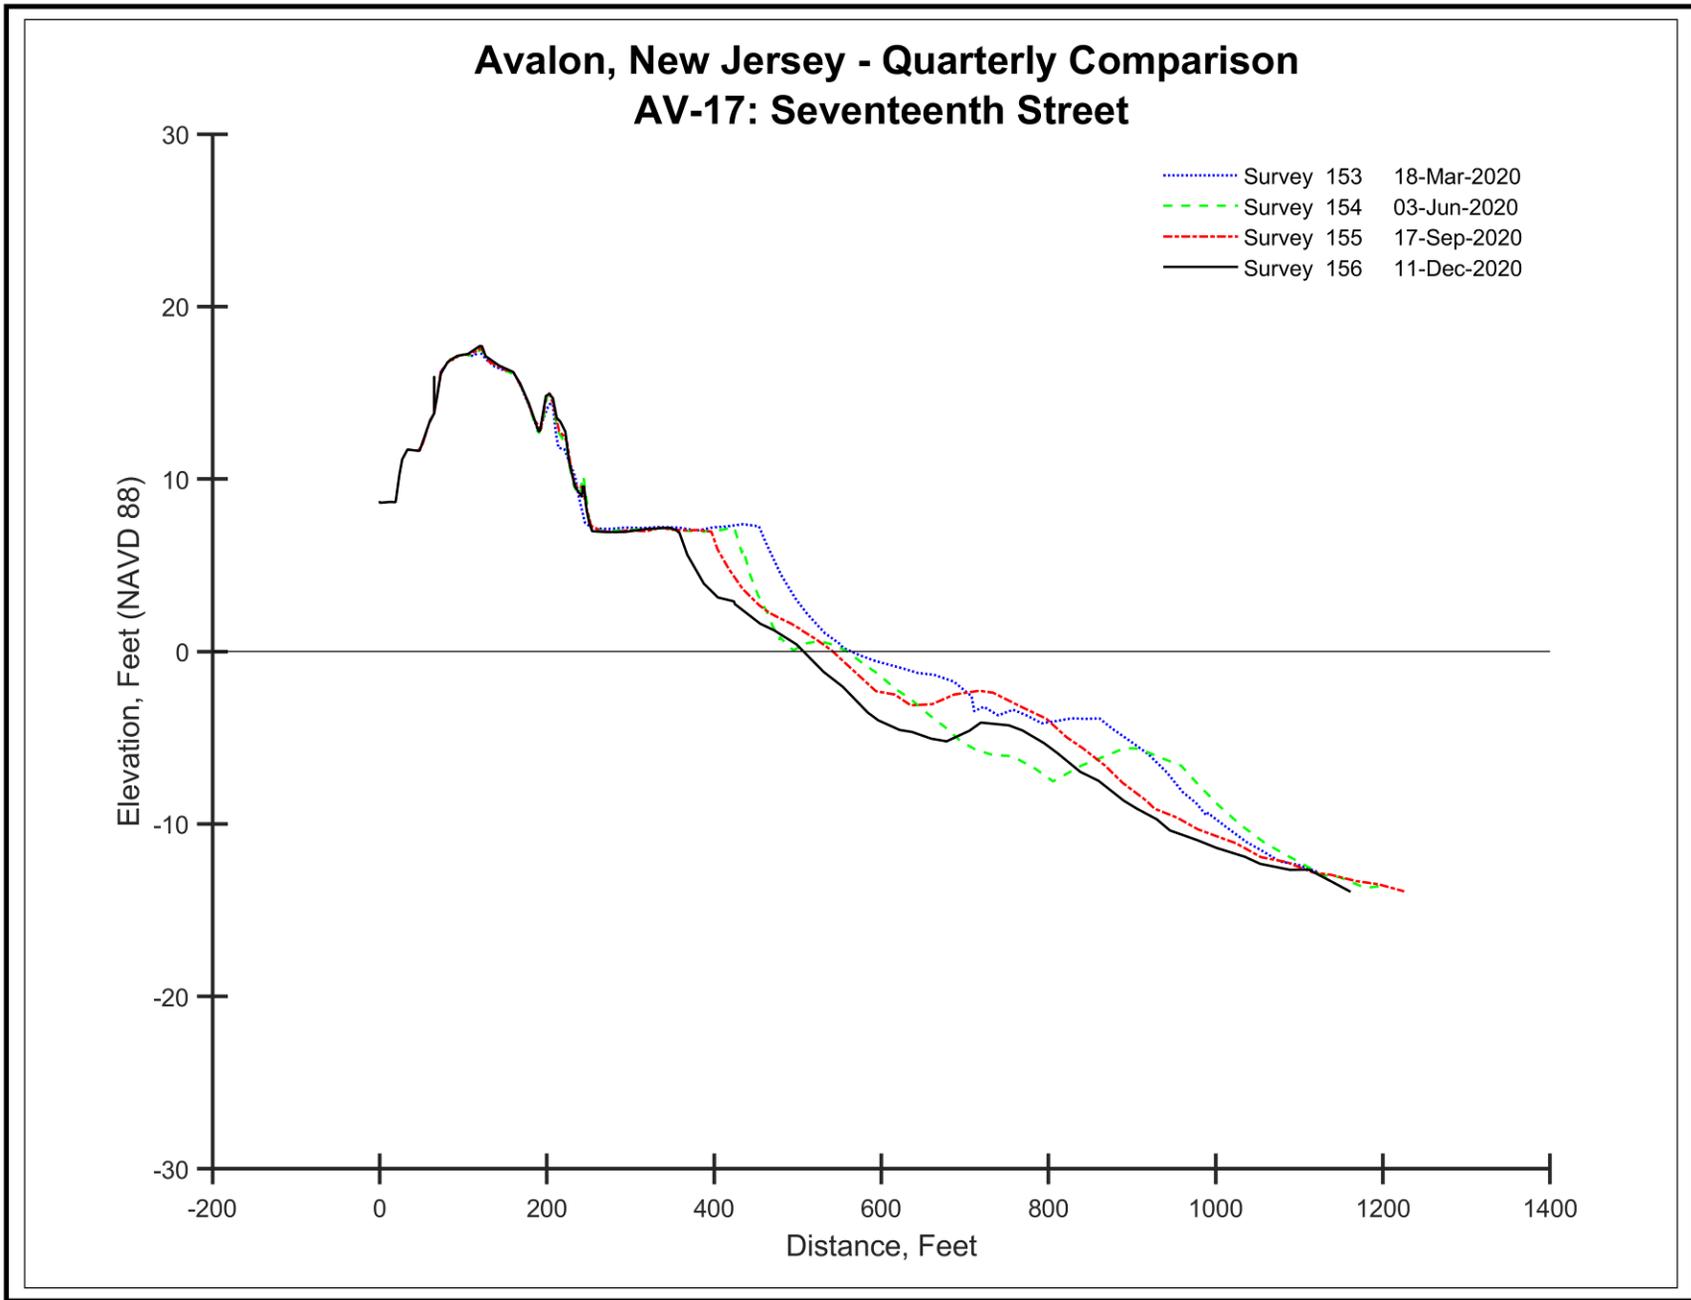
Figure 6. The first three quarters of 2019 saw minor beach retreat by September, but there was a sizable offshore bar about to attach to the beachface. The federal work added 118.12 yds³/ft. of sand moving the shoreline 185 ft. seaward. Berm retreat has definitely occurred.

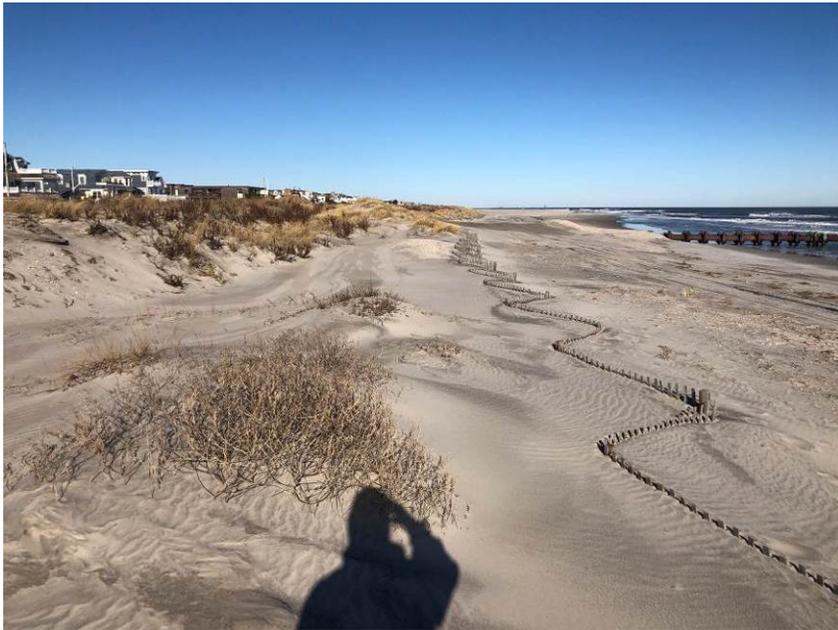
7a. December 3, 2019

Photographs 7a to 7c. 23rd Street, views to the north.

View 7a In December, just the tips of the 4-foot sand fence was showing, while the beach had narrowed considerably. The federal project did not directly place sand at this site, but material will migrate quickly into the region.

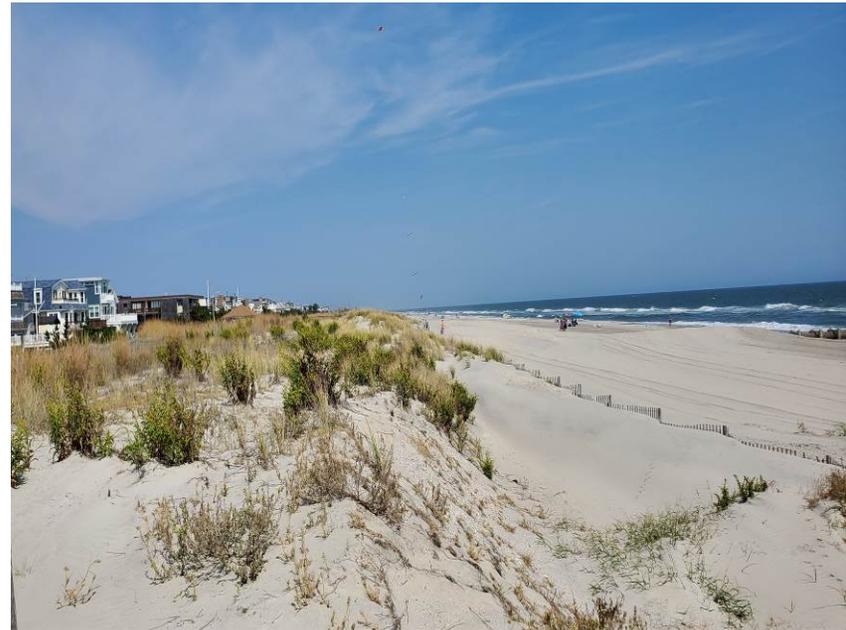
7b. September 18, 2020

View 7b By September the beach was somewhat wider as sand was transferred to the site from further north. Little additional fence burial occurred.

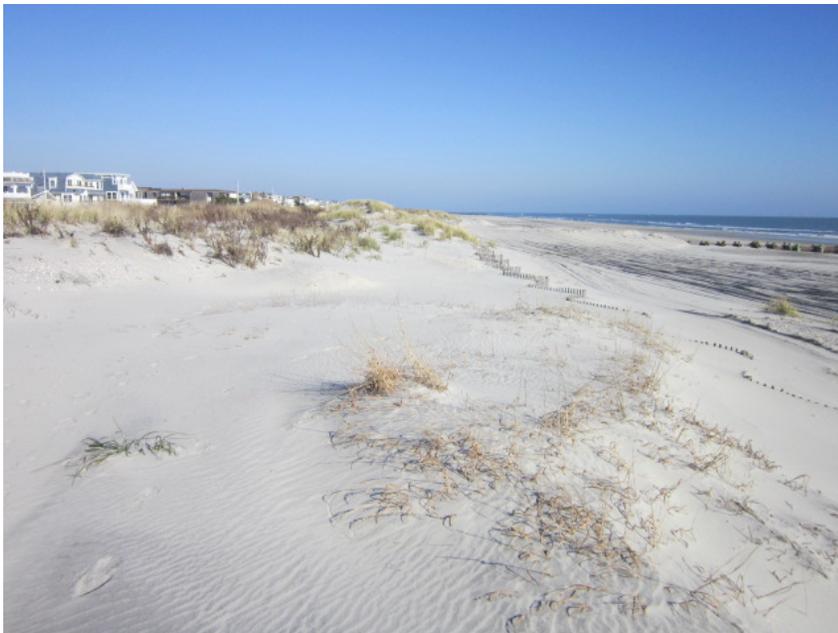
7c. December 11, 2020

View 7c By December 2020 the beach showed added wind deposition on the dune slope with added material at the stormwater pipeline in the distance.

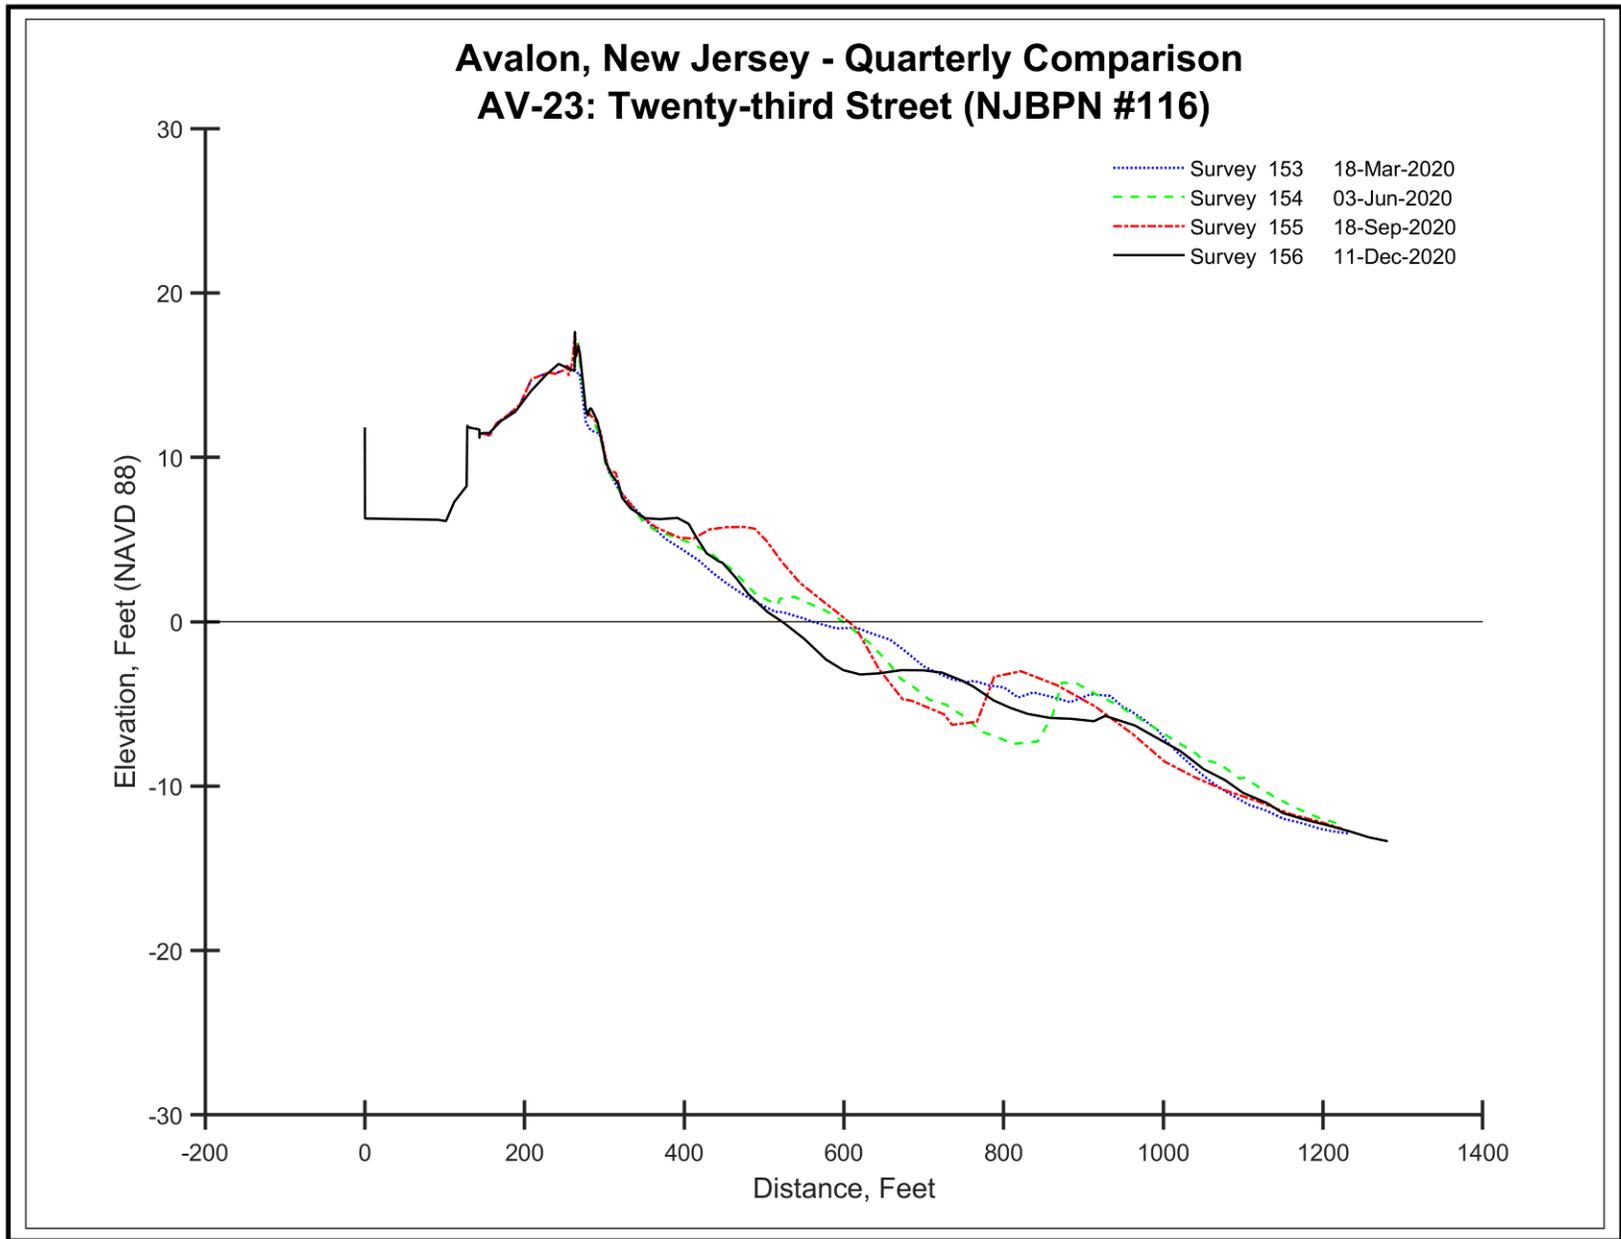
Figure 8. The widest beach was present in September as offshore bar material was moved onto the dry beach. This berm eroded significantly by December 2020, but sand appeared offshore as a broad bar feature.

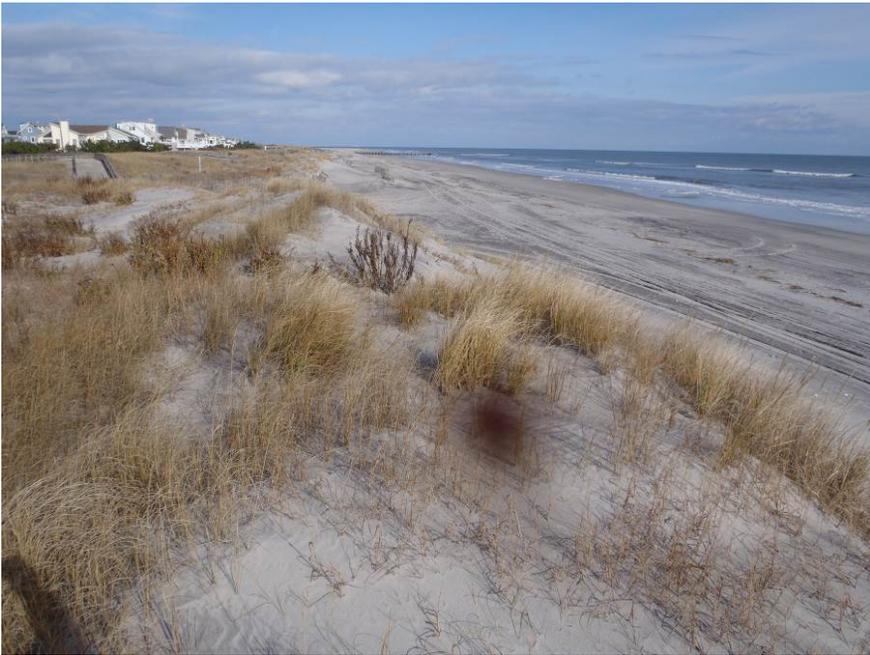
9a. December 4, 2019

Photographs 9a to 9c. 28th Street, views to the north.

View 9a. The sand fencing has been buried as the seaward dune slope accumulated wind transported material. The high tide line is only 50 feet from the dune toe despite the completion of the federal beach restoration project to the north.

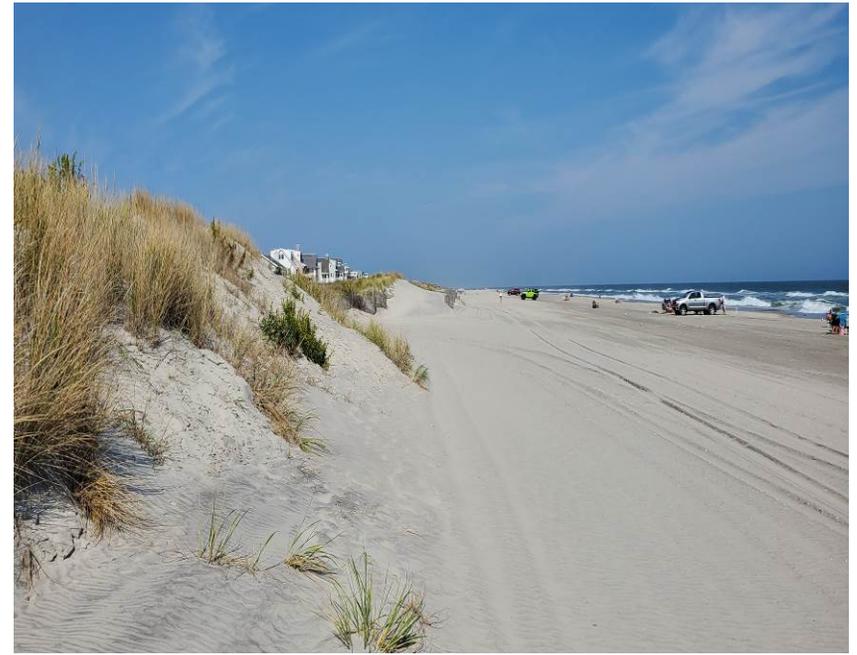
9b. September 18, 2020

View 9b shows the 28th Street beach following the summer season as the beach width improved in width due to sand deposition derived from northern beach sites.

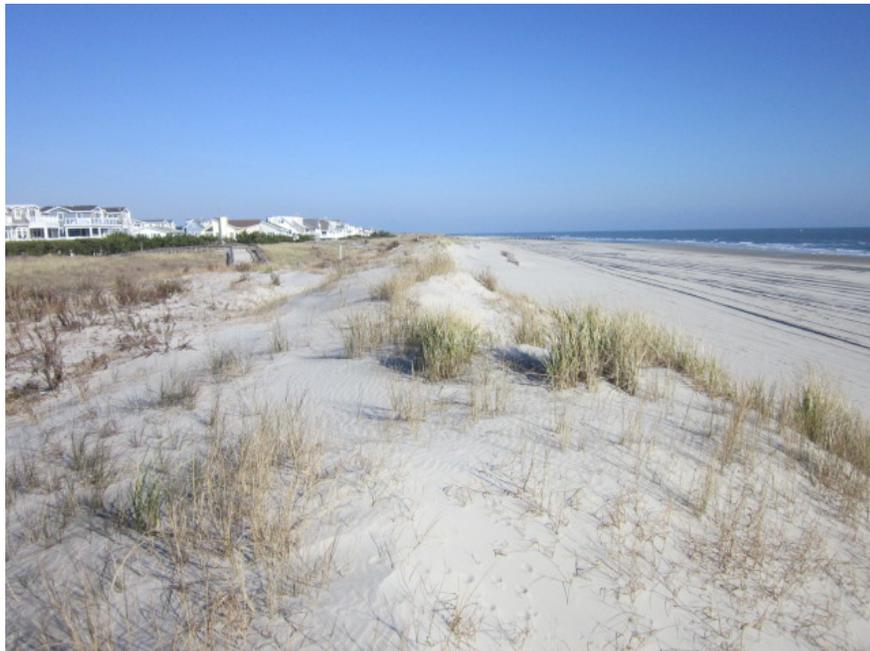
9c. December 11, 2020

View 9c shows the beach with wind deposition along the seaward dune slope and a generally higher beach elevation.

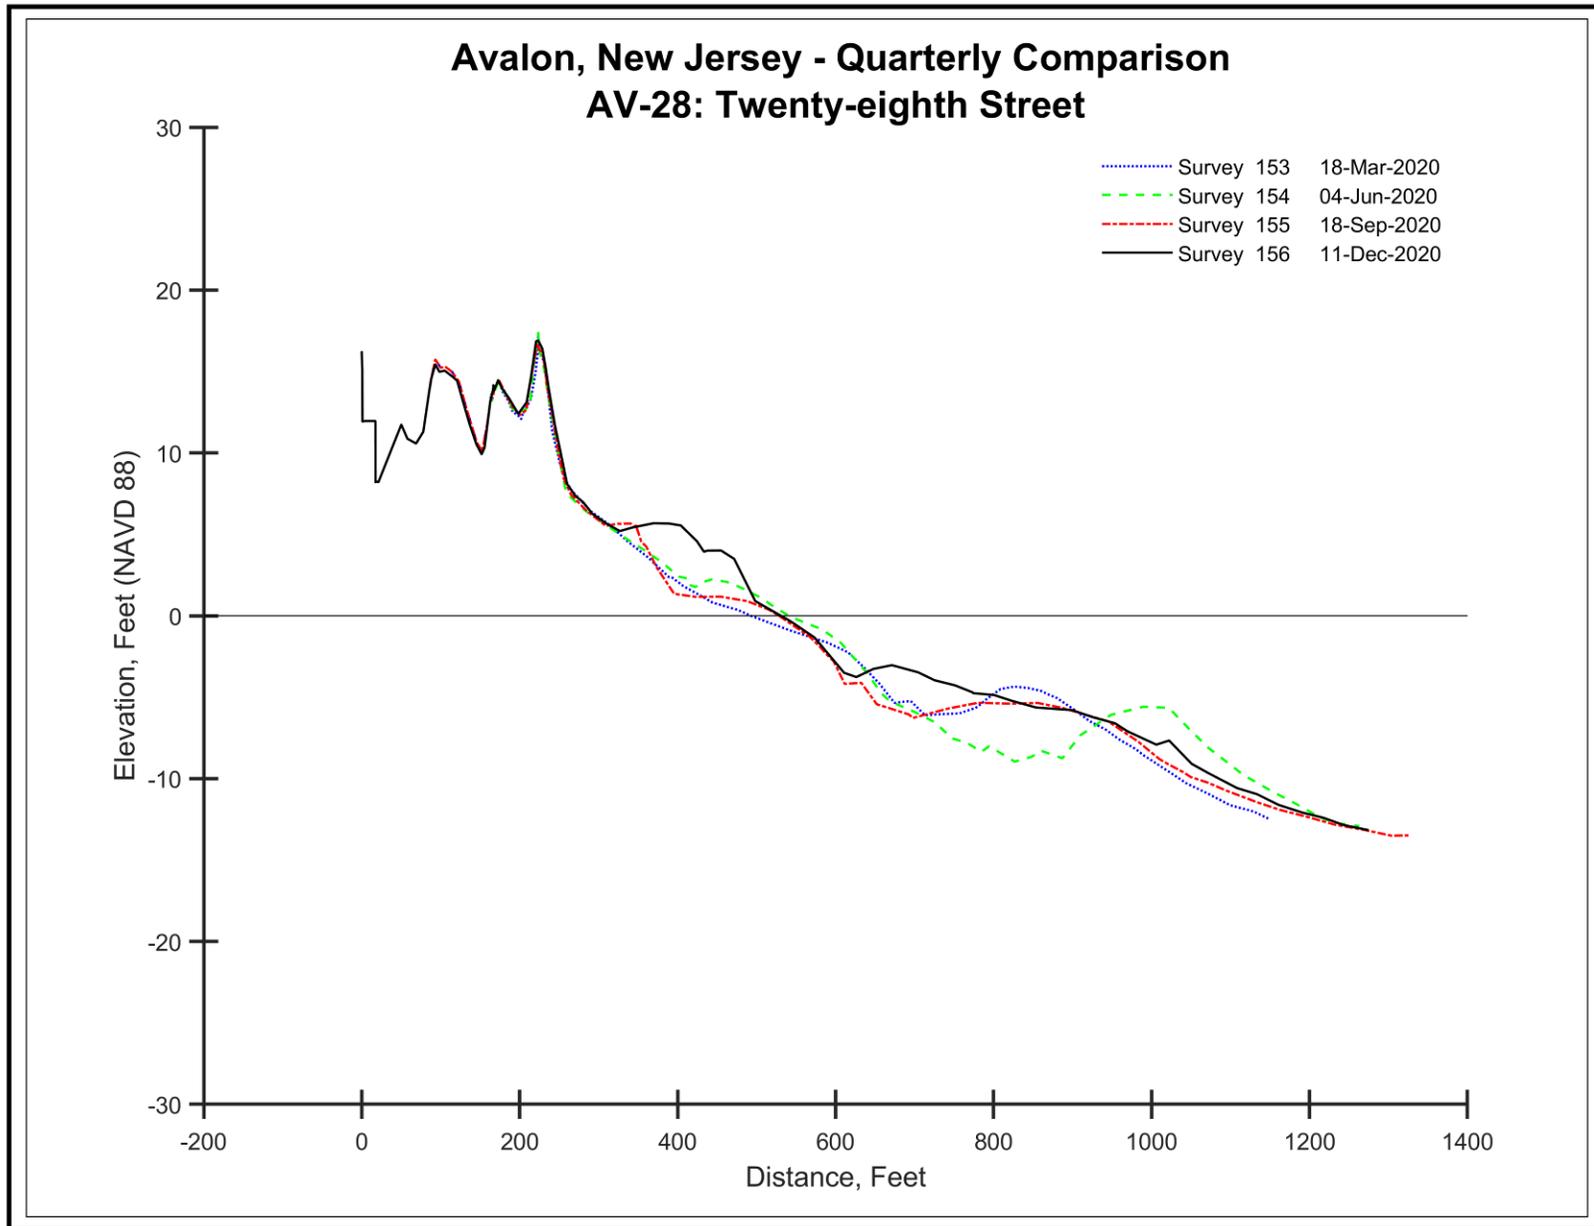
Figure 10. The 28th Street site was south of the USACE sand template for 2019. The first three quarters of 2020 produced limited changes while the December 2020 survey shows a very large berm deposit on the beach plus a wide, low amplitude bar system offshore.

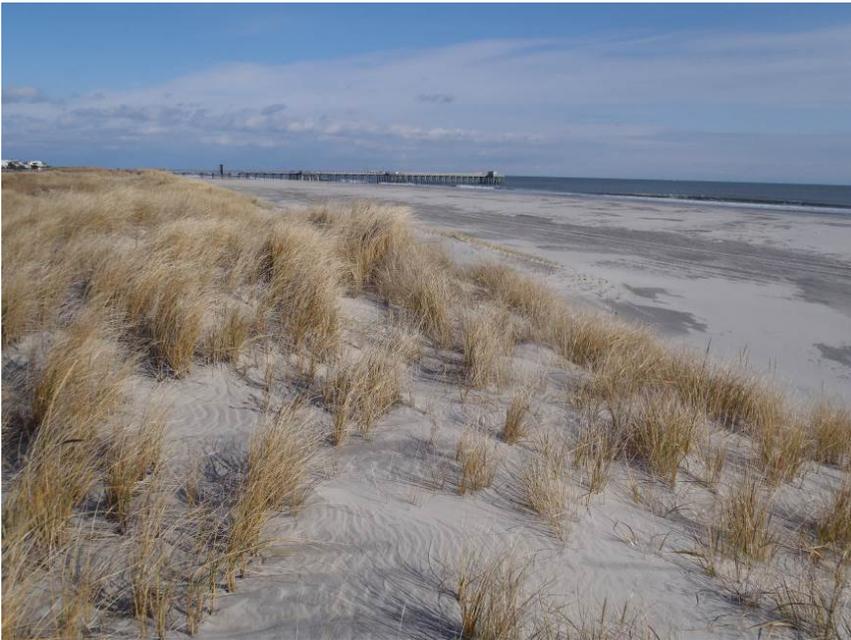
11a. December 4, 2019

Photographs 11a to 11c. 35th Street, views to the north.

View 11a. Sand continued to add to the foredune with a beach wide enough to provide a continuous supply.

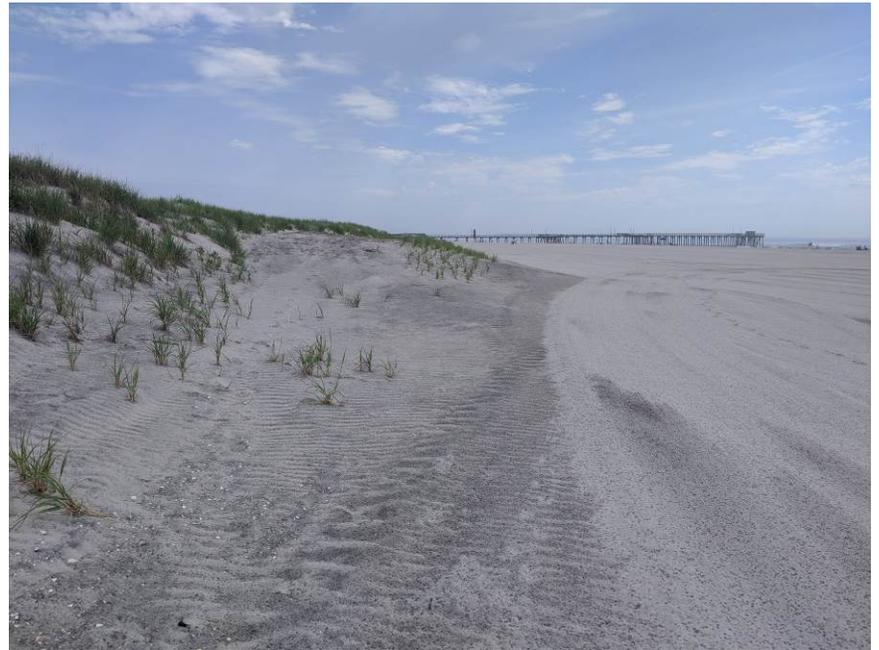
11b. June 4, 2020

View 11b. By June 2020 all traces of the raking had vanished and grass was moving downslope onto the beach.

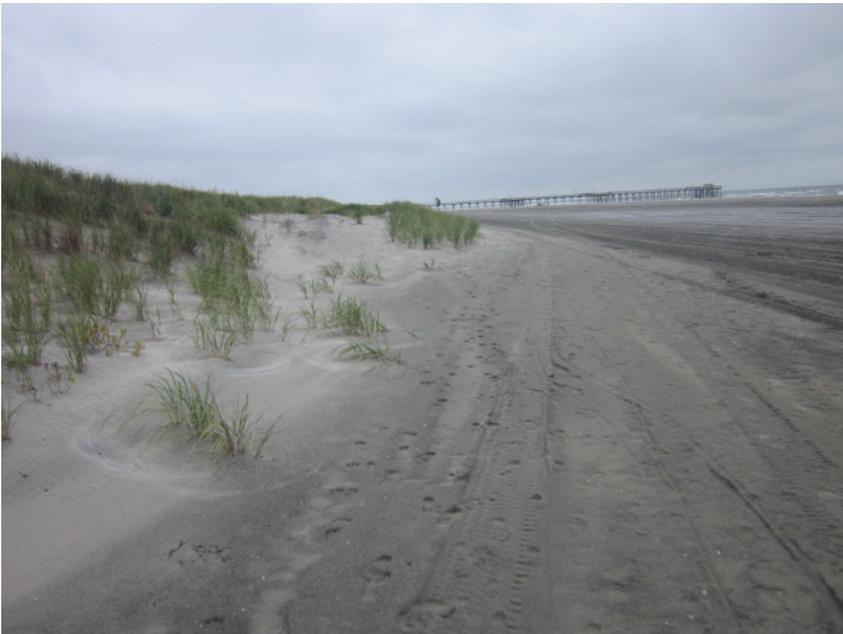
11c. September 23, 2020

View 11c. The September view along the toe of the dune slope shows continued grass growth, but little new wind transported sand added.

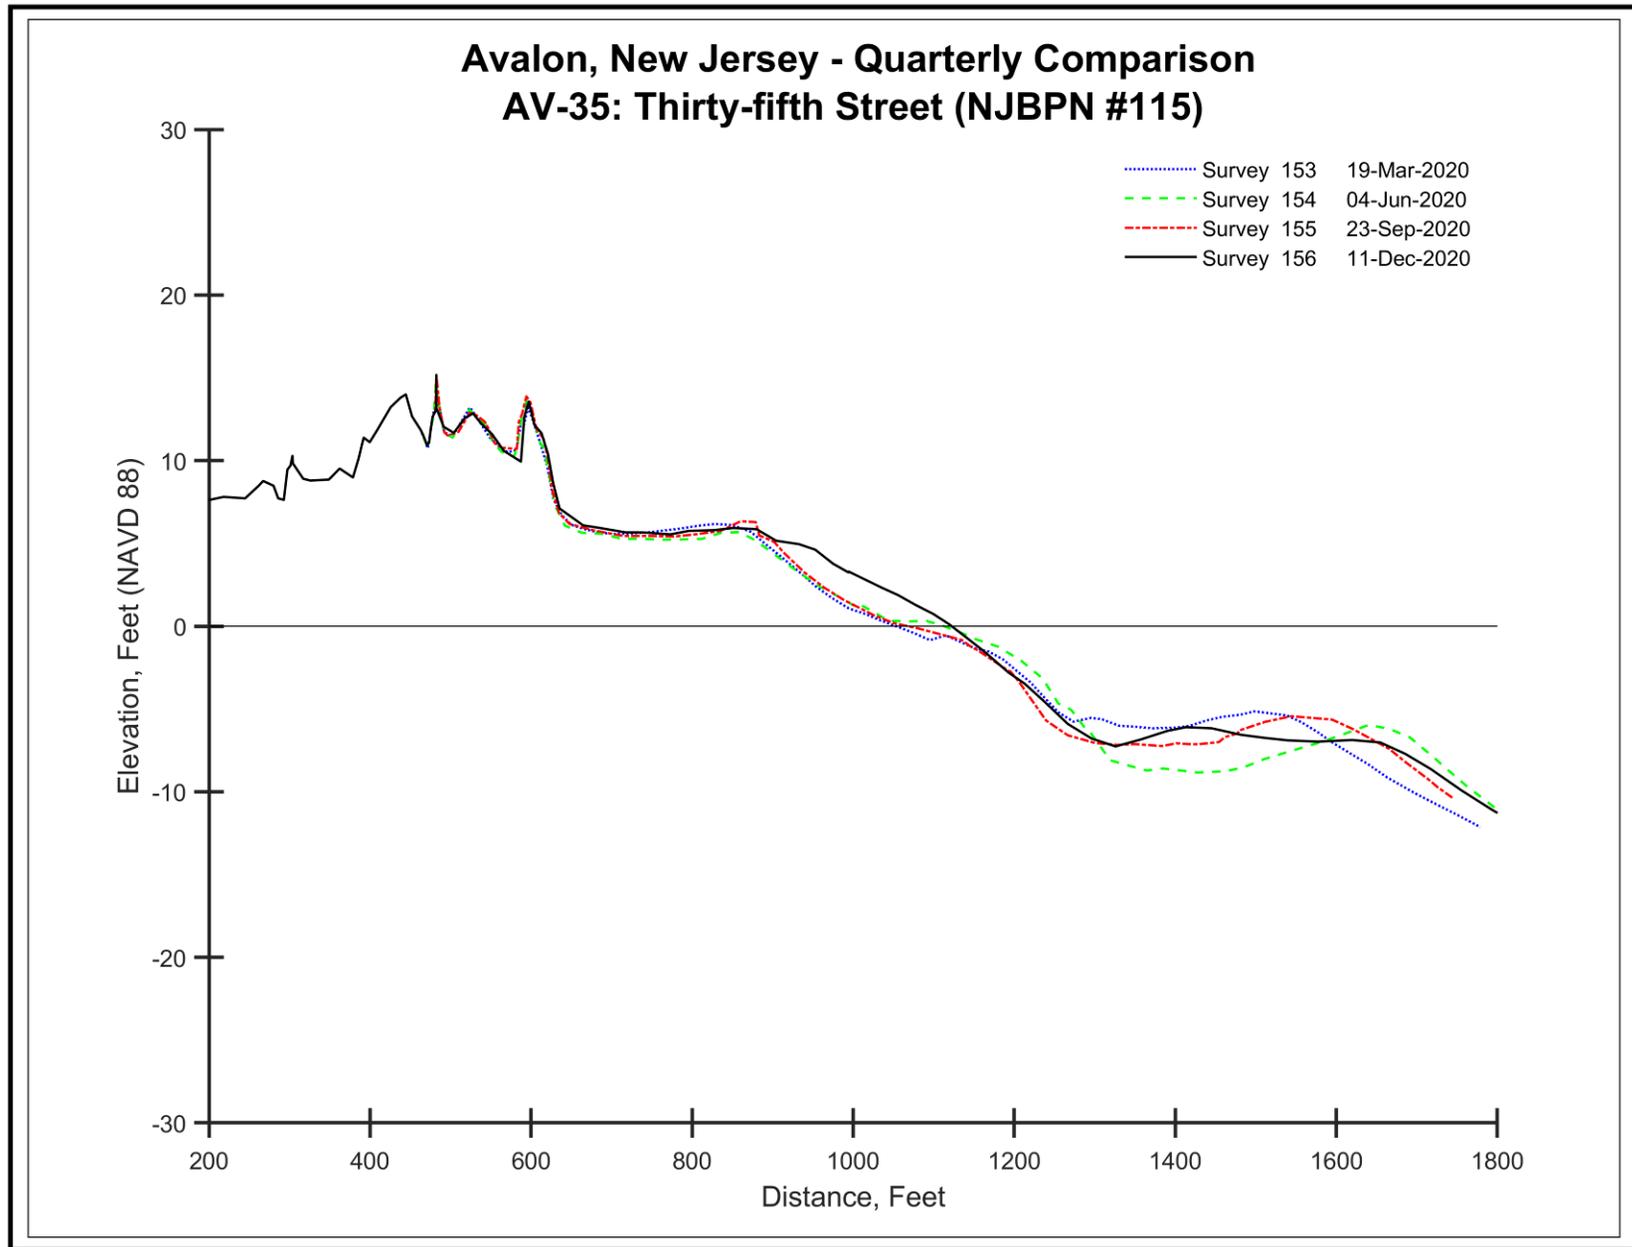
Figure 12. 35th Street location also saw an offshore bar shift positions allowing sand to migrate onto the beachface adding substantially in the final quarter survey adding half the annual 28 cubic yards per foot seen in that comparison.
