**FINAL REPORT FOR 2020
ON THE CONDITION OF THE MUNICIPAL OCEANFRONT BEACHES
BATHYMETRY OF TOWNSENDS INLET
THE BOROUGH OF AVALON, CAPE MAY COUNTY, NEW JERSEY**

**PREPARED FOR: THE BOROUGH OF AVALON
3100 DUNE DRIVE
AVALON, NJ 08202**

**PREPARED BY: THE STOCKTON UNIVERSITY COASTAL RESEARCH CENTER
30 WILSON AVENUE
PORT REPUBLIC, NEW JERSEY 08241**

February 17, 2021

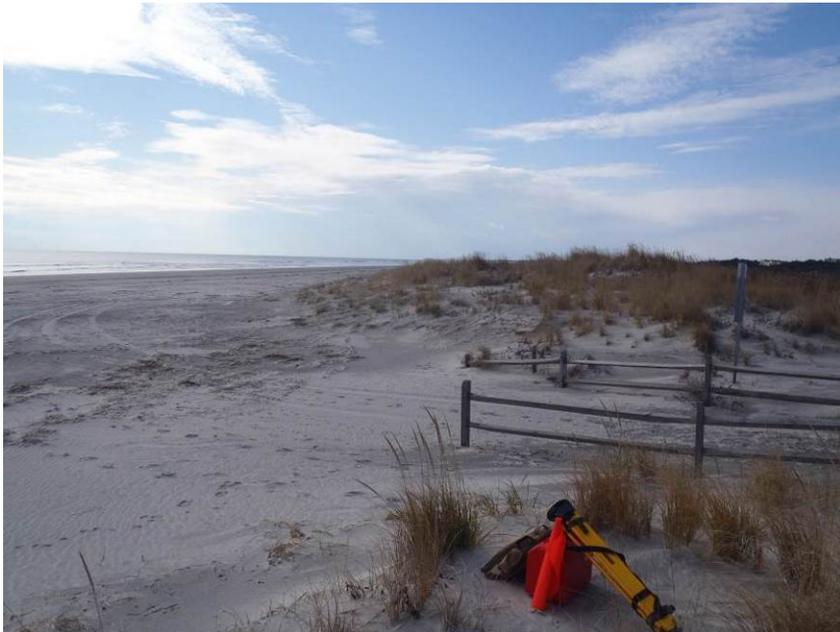
13a. March 18, 2019

Photographs 13a to 13c. 44th Street, views to the south.

View 13a shows the seaward dune toe slope with grass plants migrating down the slope. Beach widths have remained constant over time.

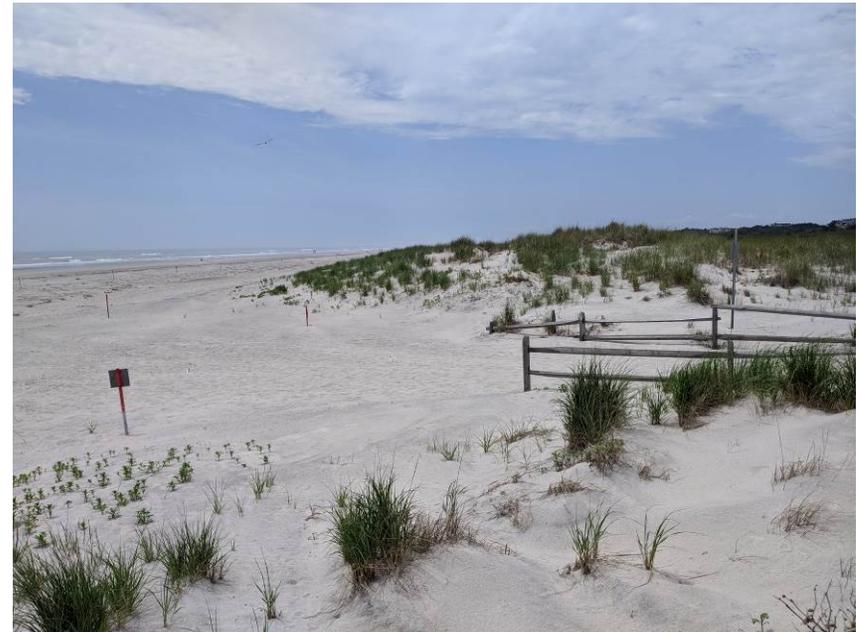
13b. June 4, 2020

View 13b is the same view in June showing grass growth and wind deposition in the dunes.

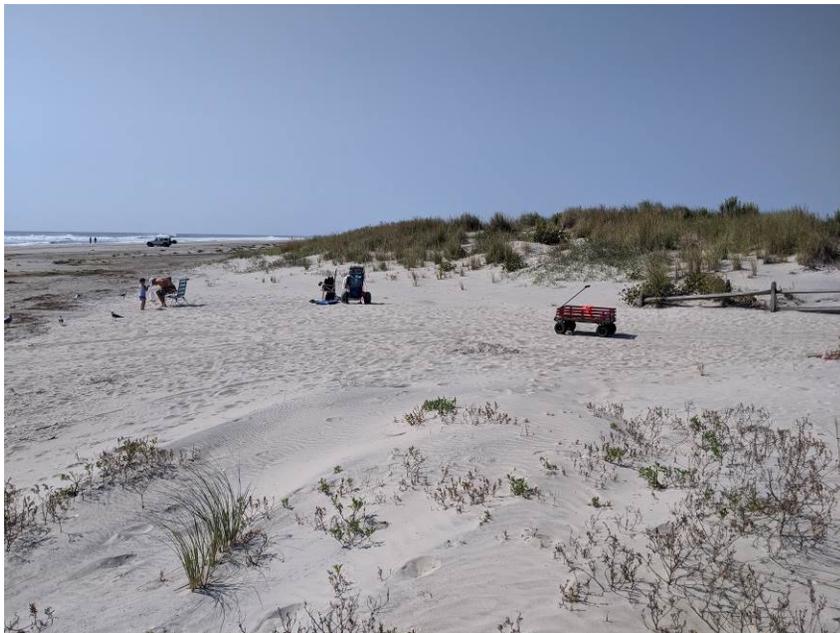
13c. September 23, 2020

View 13c is the September view to the south showing the dunes and beach where debris has been deposited near the dune toe recently.

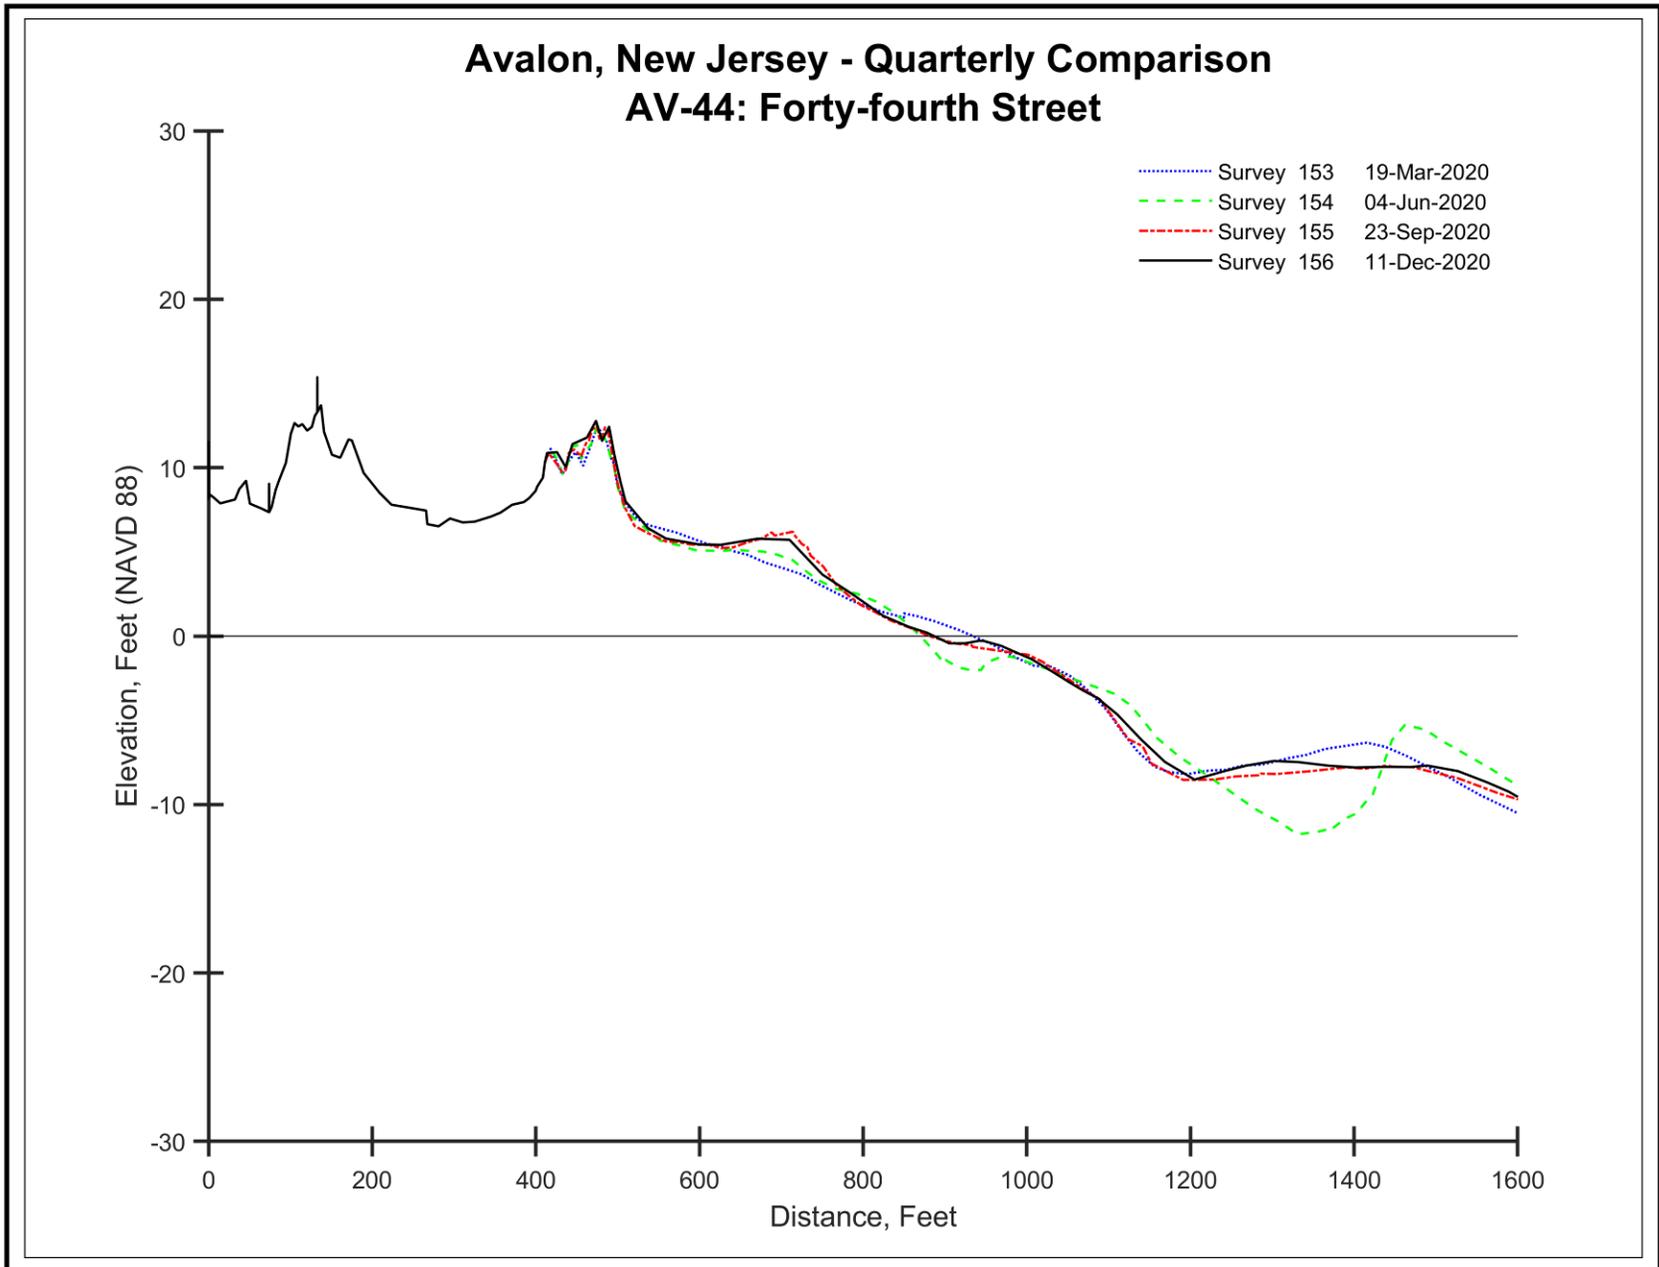
Figure 14. The beach accumulated a berm as of September 2020 while the June 2020 offshore bar system flattened out considerably with few subsequent changes seen.

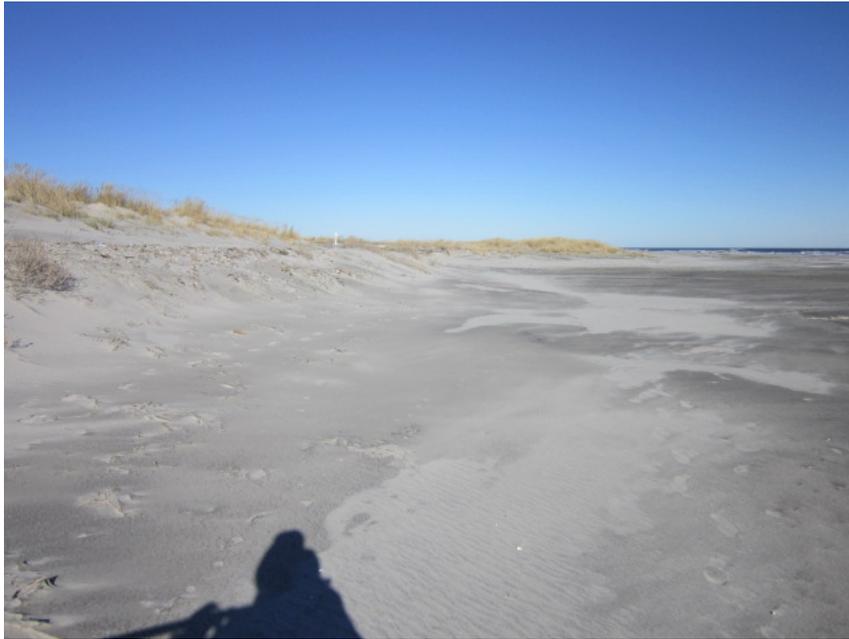
15a. December 3, 2019

Photographs 15a to 15c. 58th Street, views to the north along the seaward dune toe.

View 15a The December view is looking north along the seaward dune toe at the expanse of dry beach at this site.

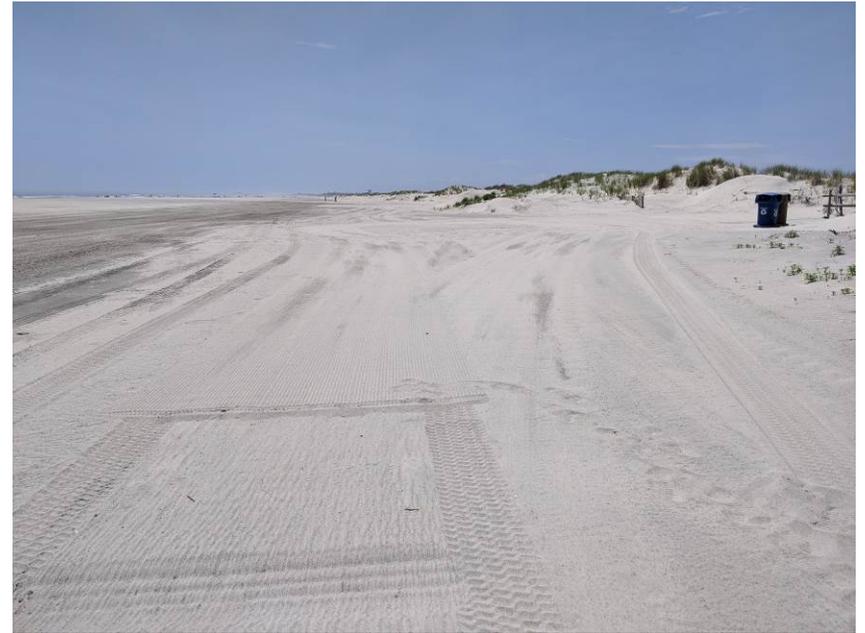
15b. June 4, 2020

View 15b This June view shows the impact of beach raking at the dune toe with the debris removed from the beach.

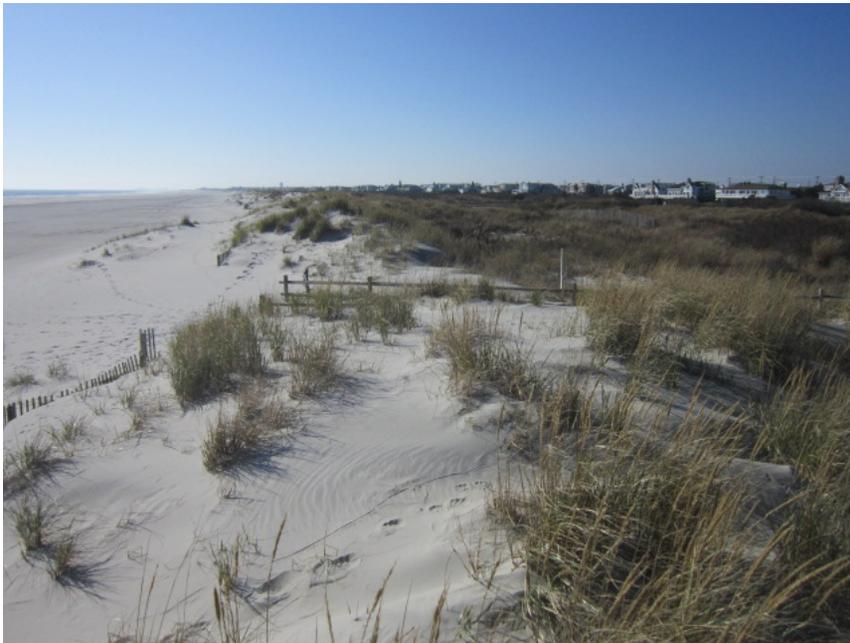
15c. December 11, 2020

View 15c The December 2020 view shows sand accumulation in the dunes at the site.

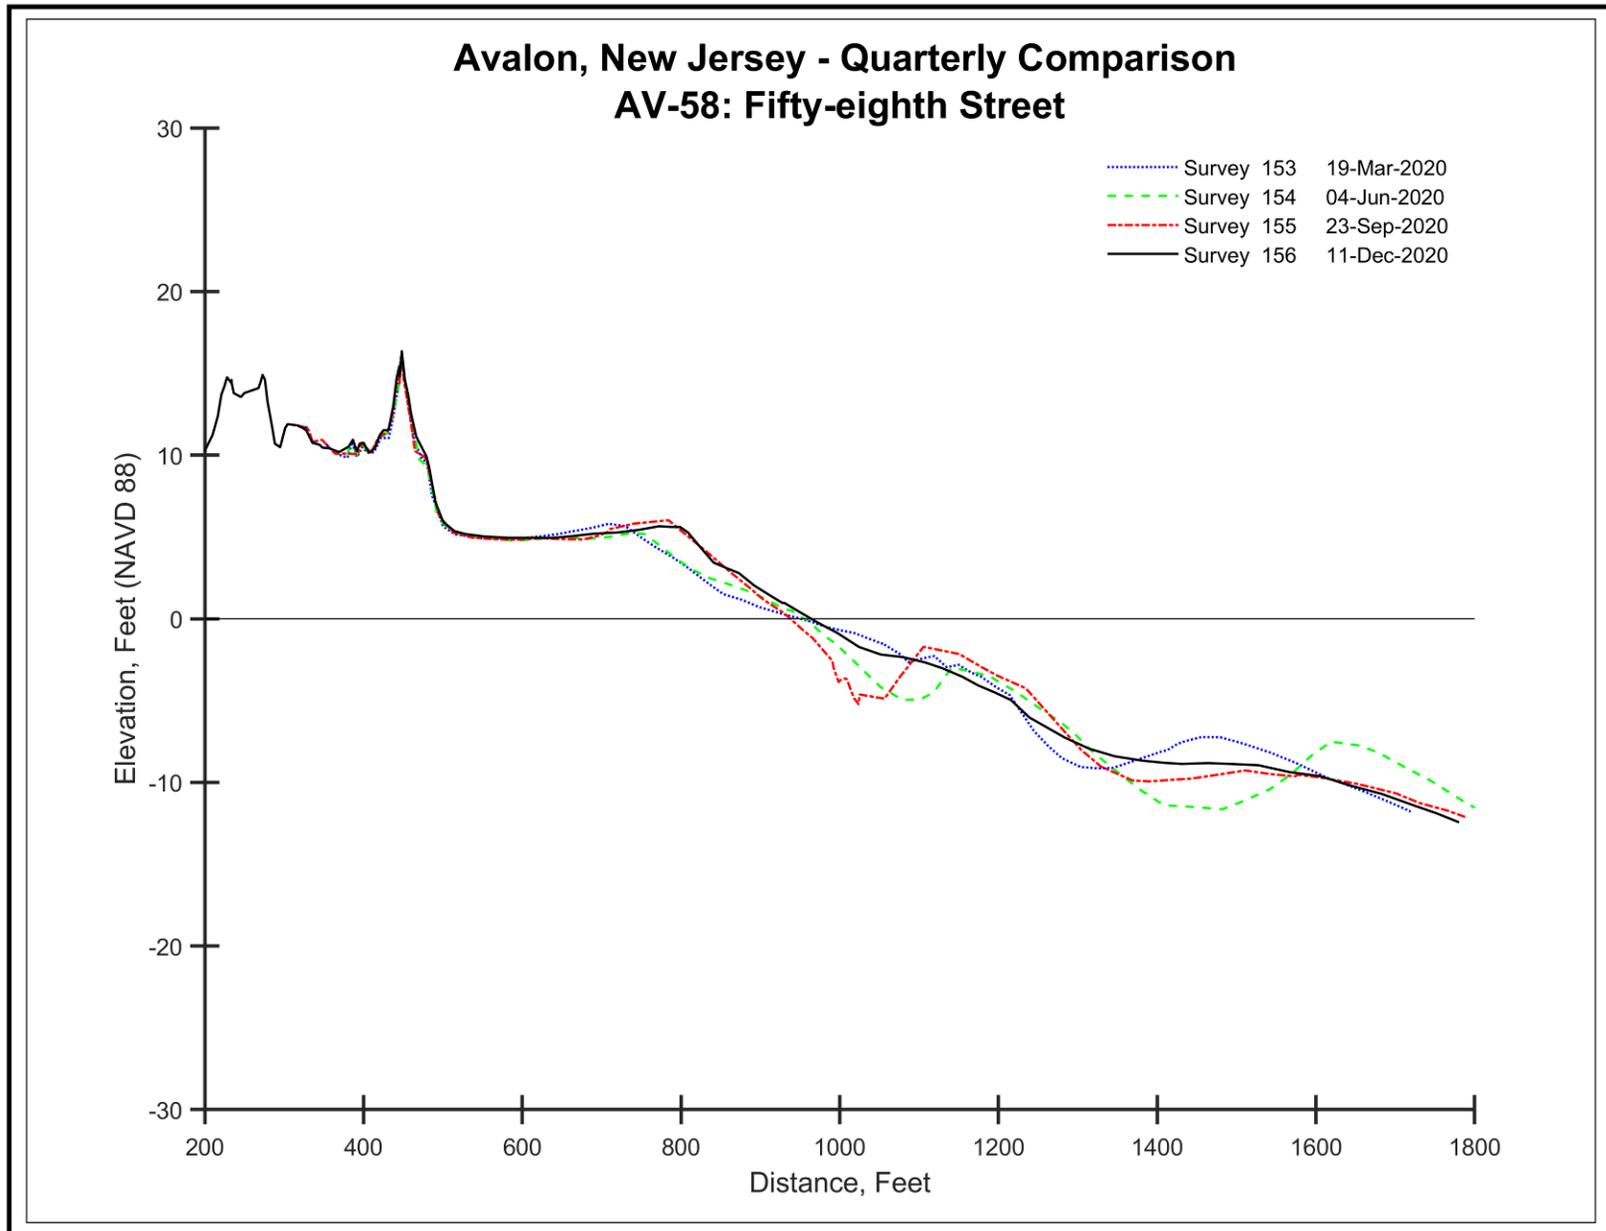
Figure 16. The upper beach and dune system changed relatively little over 2020. The offshore zone was active especially with the September cross section showing a large bar about to move onto the beach. If it did, the effect was short lived because the berm was essentially unchanged as of the December 2020 survey, but the nearshore trough was filled in.

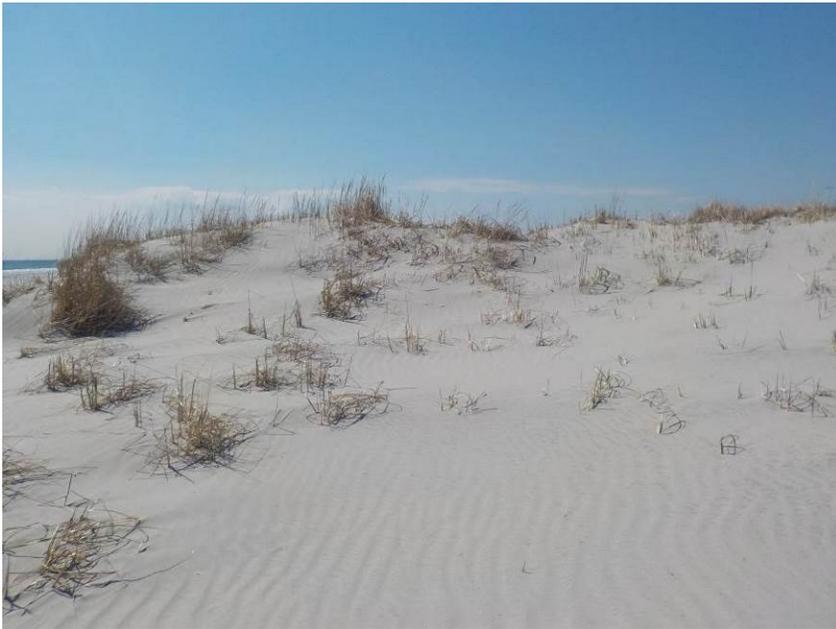
17a. December 3, 2019

Photographs 17a to 17c. 70th Street, views to the south along the dune toe.

View 17a illustrates the new foredune, blending into the primary dune to become part of the original feature.

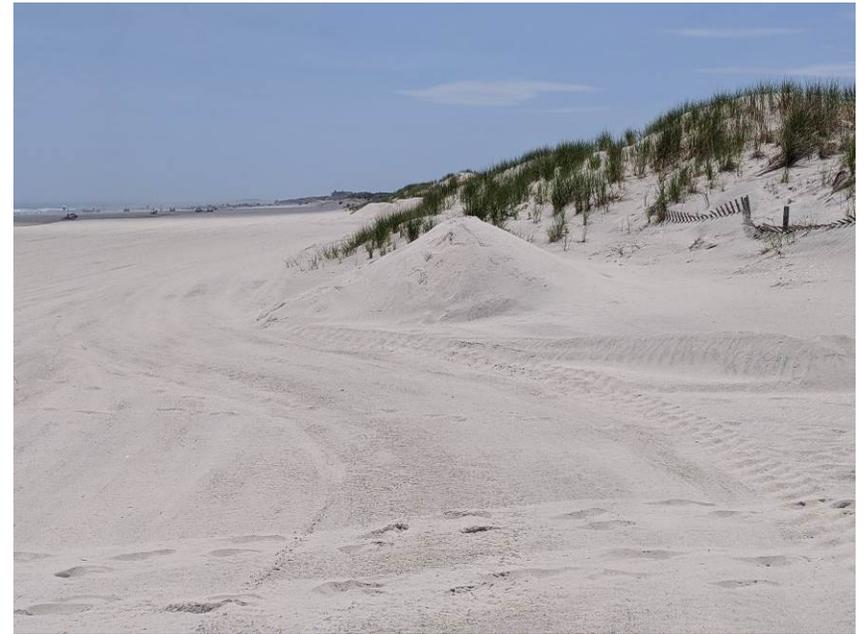
17b. September 23, 2019

View 17b is a view along the dune toe showing the expanse of dry beach and the foredune seaward slope.

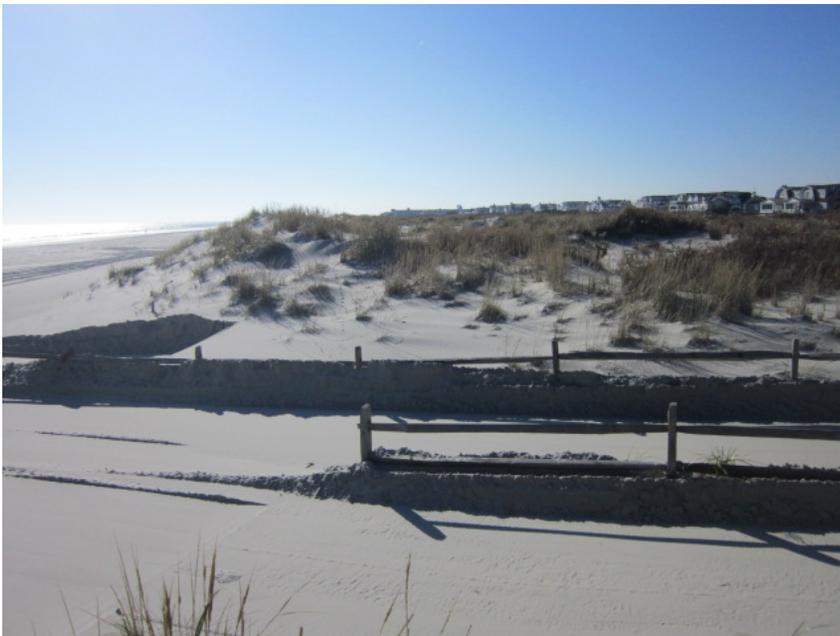
17c. December 11, 2020

View 17c This view from north of the access pathway shows the dunes and dry beach with some sand pushed up along the pathway.

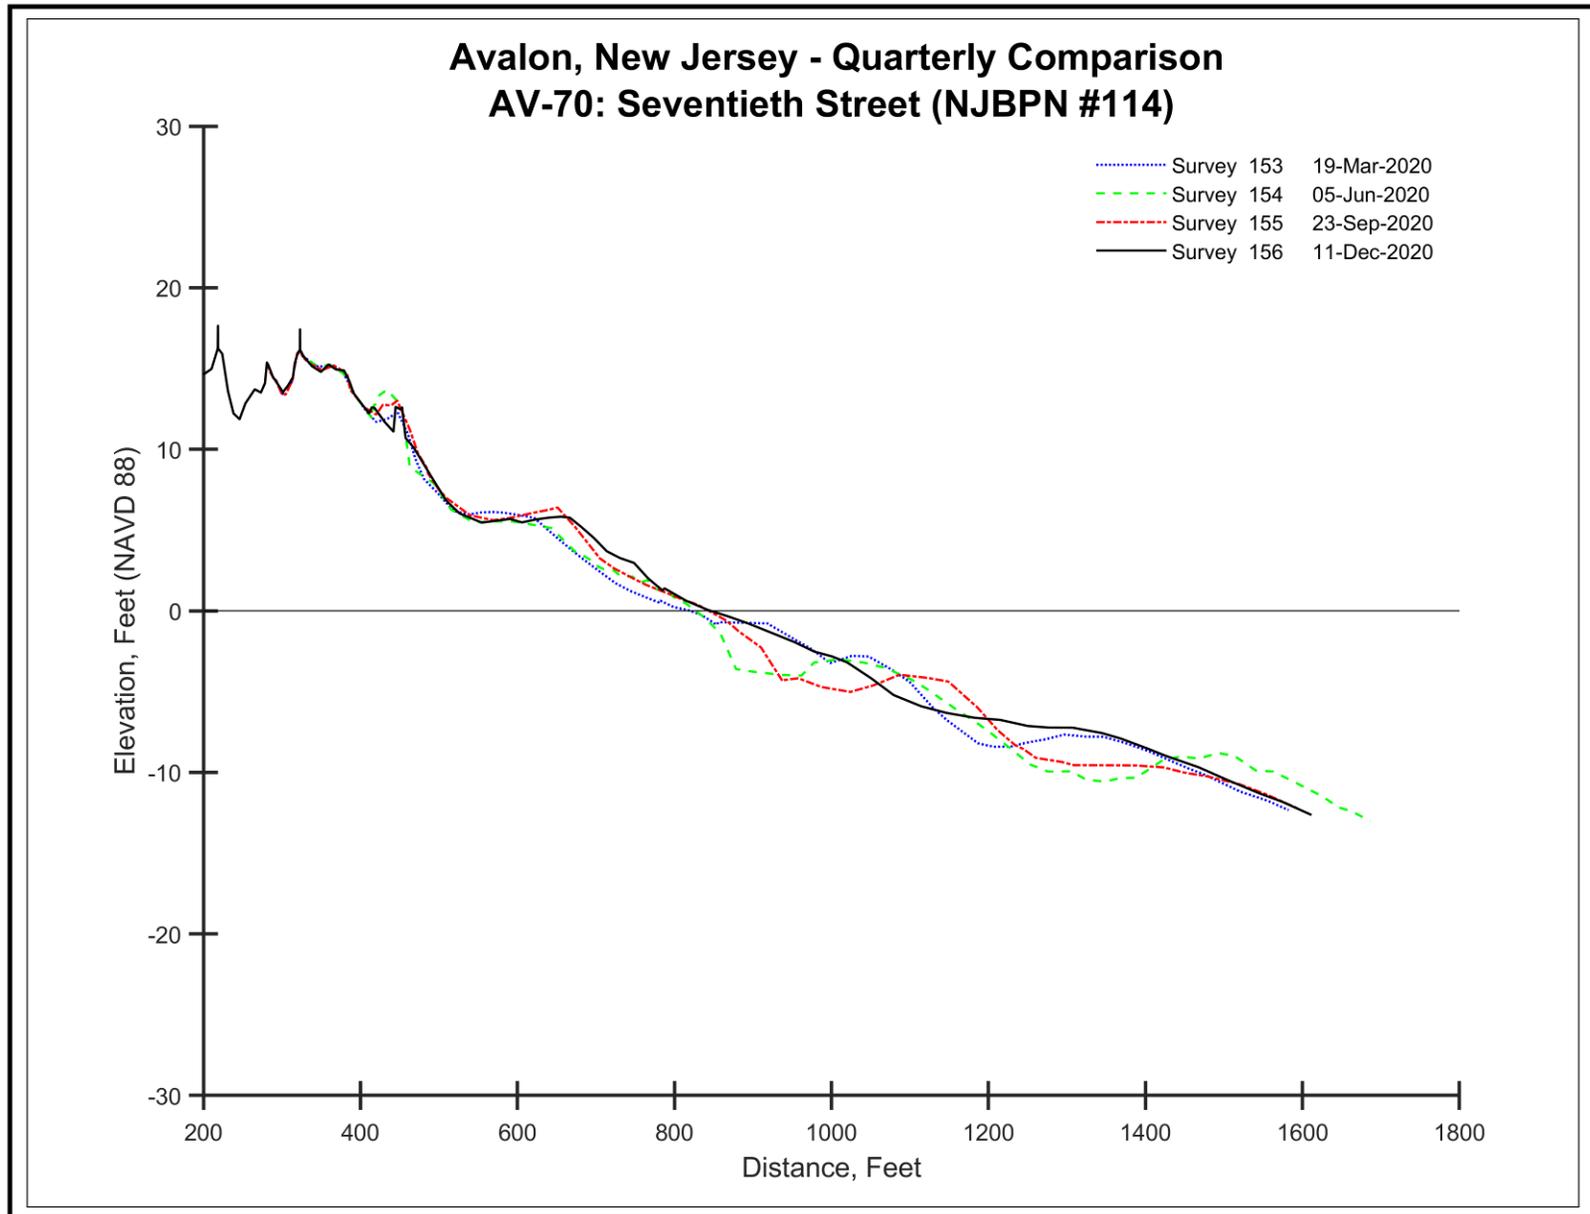
Figure 18. The growth in another in a series of foredunes is becoming a feature on the seaward slope. The beach and berm remain within normal limits. Offshore sand appears to have raised the seaward elevation considerably generating the large offshore volume addition seen.

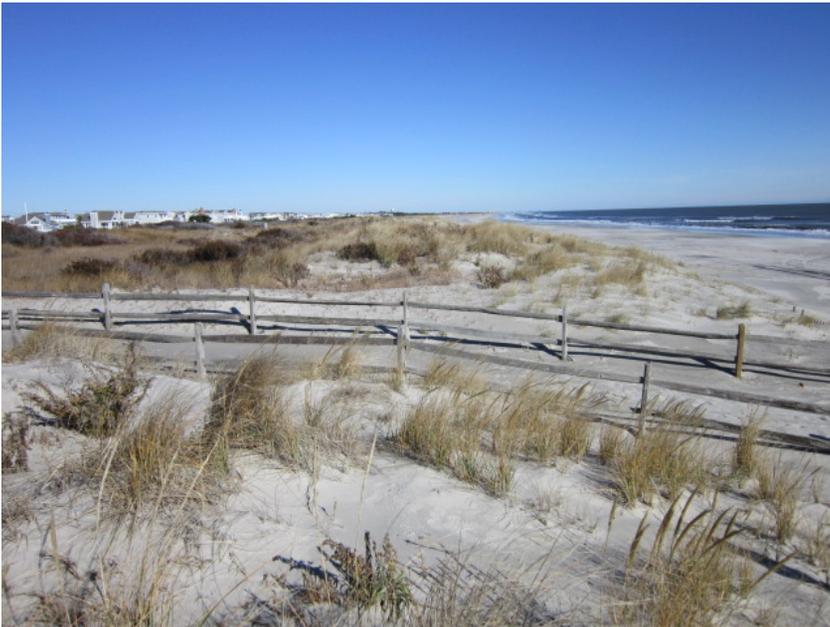
19a. December 3, 2019

Photographs 19a to 19c. 78th Street, views to the north.

View 19a This December view of the dunes, beach and oceanfront expanse shows the protection these extensive features provide Avalon residents.

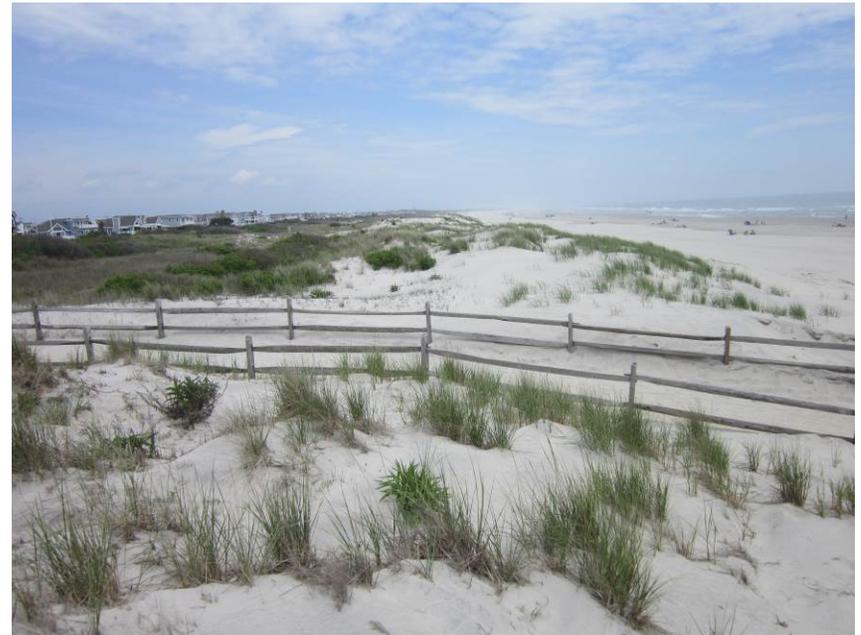
19b. June 5, 2020

View 19b The spring view shows grass growth in full swing as the season gets going.

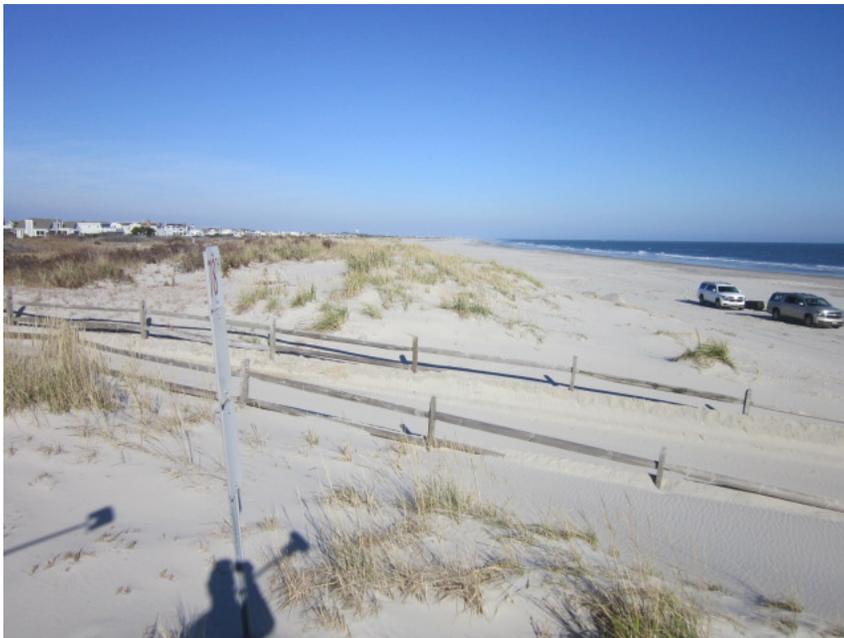
19c. December 11, 2020

View 19c This view along the foredune area shows continued stability at the site with added sand across the seaward dune slope.

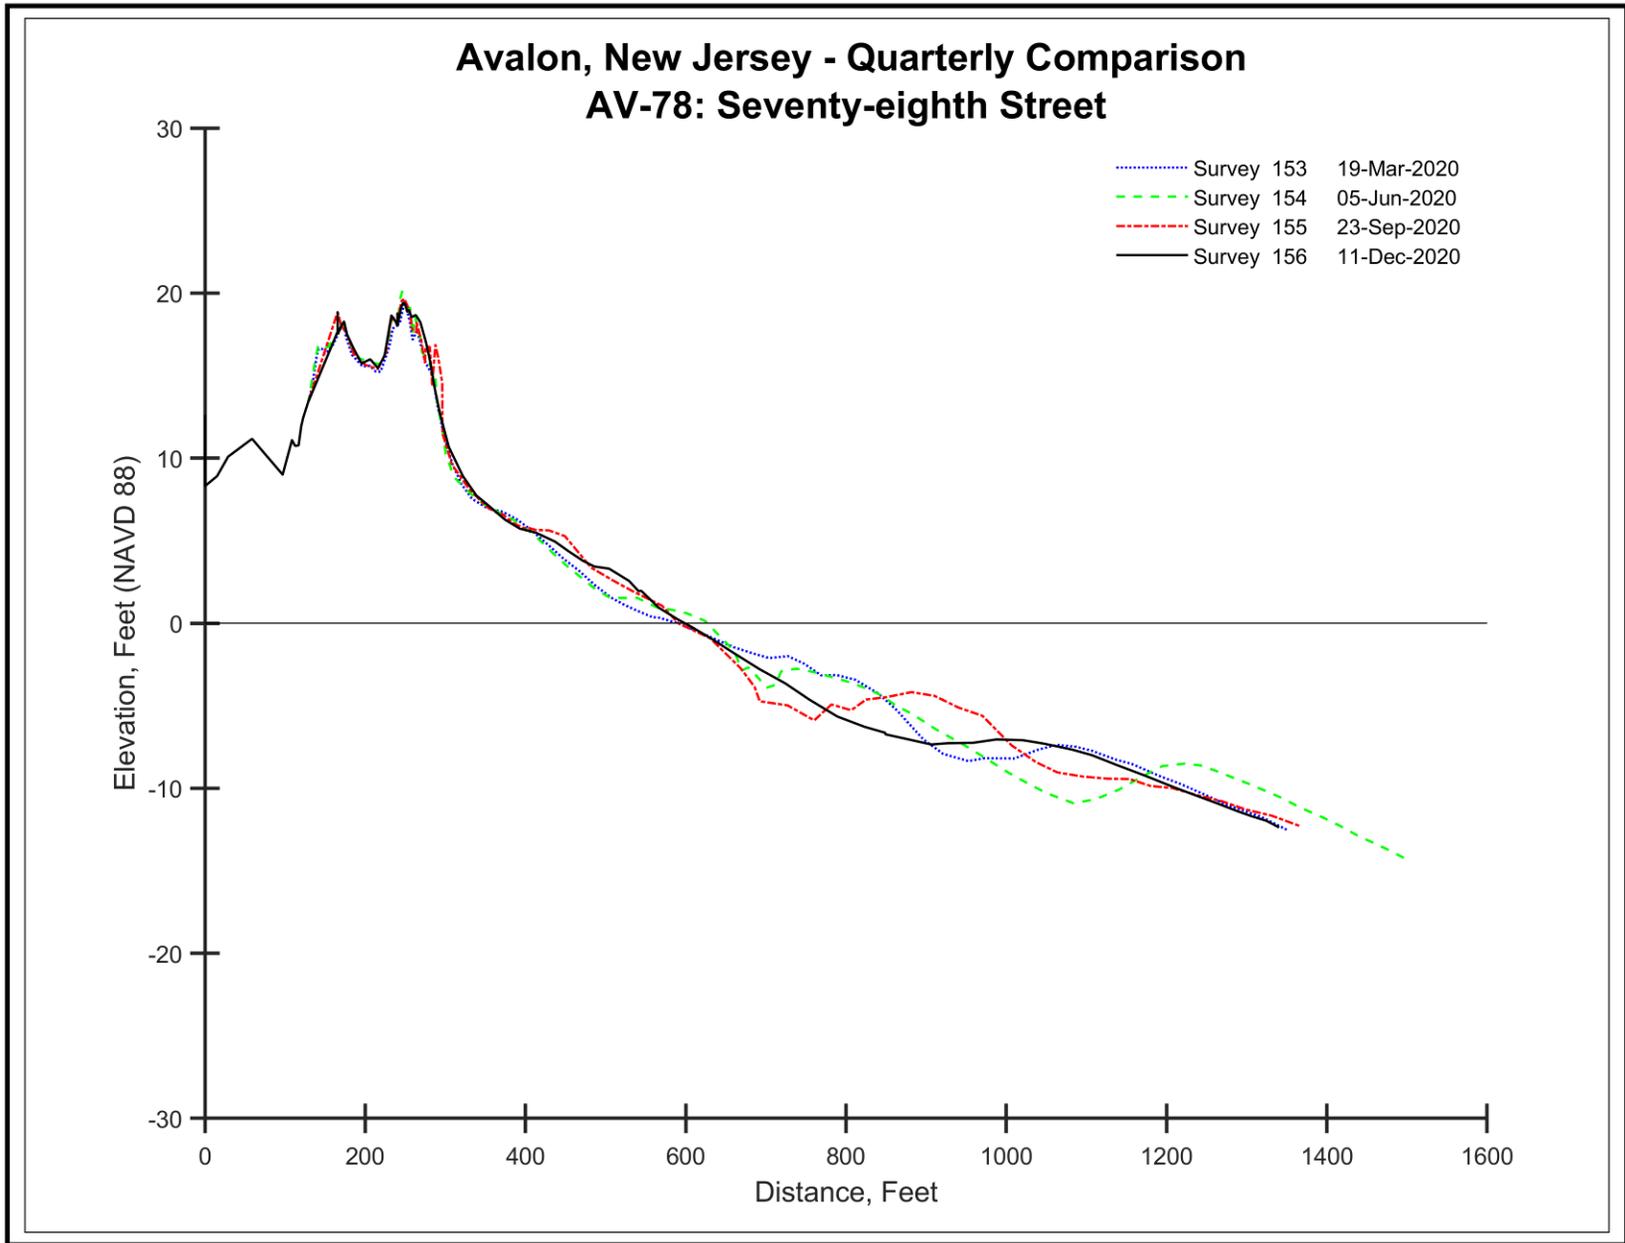
Figure 20. The primary dune is the dominant feature on the beach. The width of dry sand is smaller than other locations but appears sufficient to prevent dune damage. The beach changed very little in 2020, while the offshore region had bar locations vary between very close to the beach (Sept. survey) and quite distant (June survey). By Dec. 2020, the entire beach and bar profile had become quite uniform in slope.

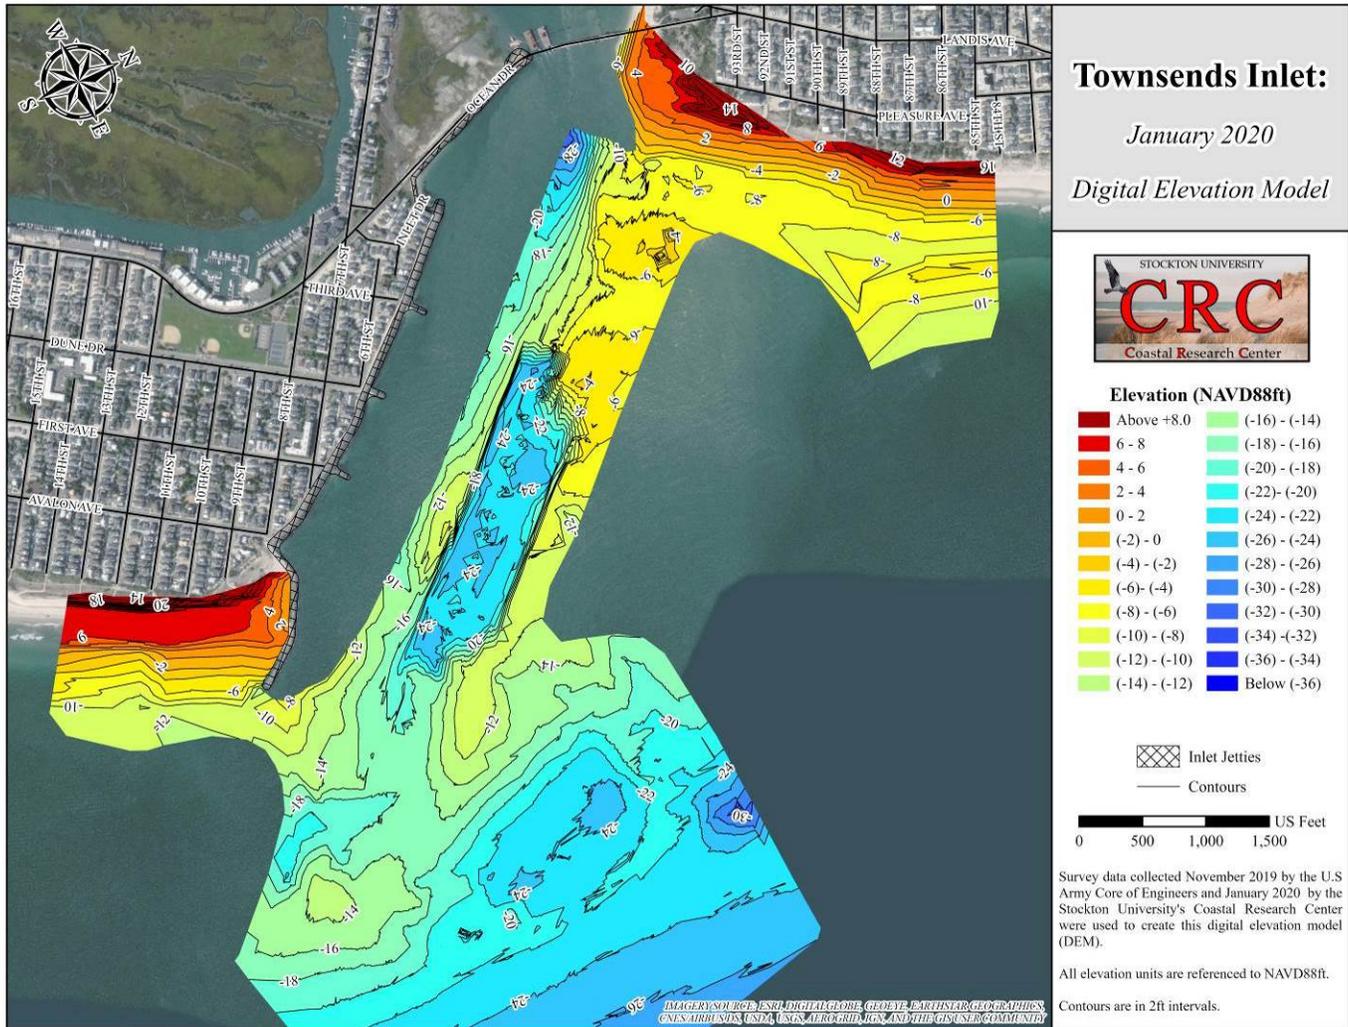
Figure 21 displays the inlet-adjacent beaches and the borrow zone and the immediate vicinity in Townsends Inlet. The excavation made into the sand deposited in the borrow area is easily visible in the figure. Dredging depths of -24 feet were recorded which removed as much as 22 feet of sand at the western end of the dredging cut. 569,210 cubic yards of sand were removed from the borrow zone for beach restoration, the actual project pay volume was given as 571,351 cubic yards. This was based on sand placed on the Avalon oceanfront beaches but compares quite well with the excavation volume indicated in the borrow zone comparison.

Figure 21. This Digital Elevation Model (DEM) combines post-dredging surveys by the contractor working on the USACE beach maintenance effort for the Avalon oceanfront completed by early December 2019, augmented by CRC shoreline surveys on both the Sea Isle City and northernmost Avalon beaches in January 2020. The dredging footprint is immediately evident in the center of the inlet channel. It is interesting that most of the ebb-shoals immediately seaward of Sea Isle City's beaches was not disturbed and the outer shoals of the ebb-delta were left intact.

The sand mining started inside the ebb-delta lobe which allowed sand accumulation to continue where it could assist Avalon's beach sediment supply naturally. The Sea Isle City side sand deposition was also not eliminated leaving material available to fill the excavation now at -24-foot elevations.

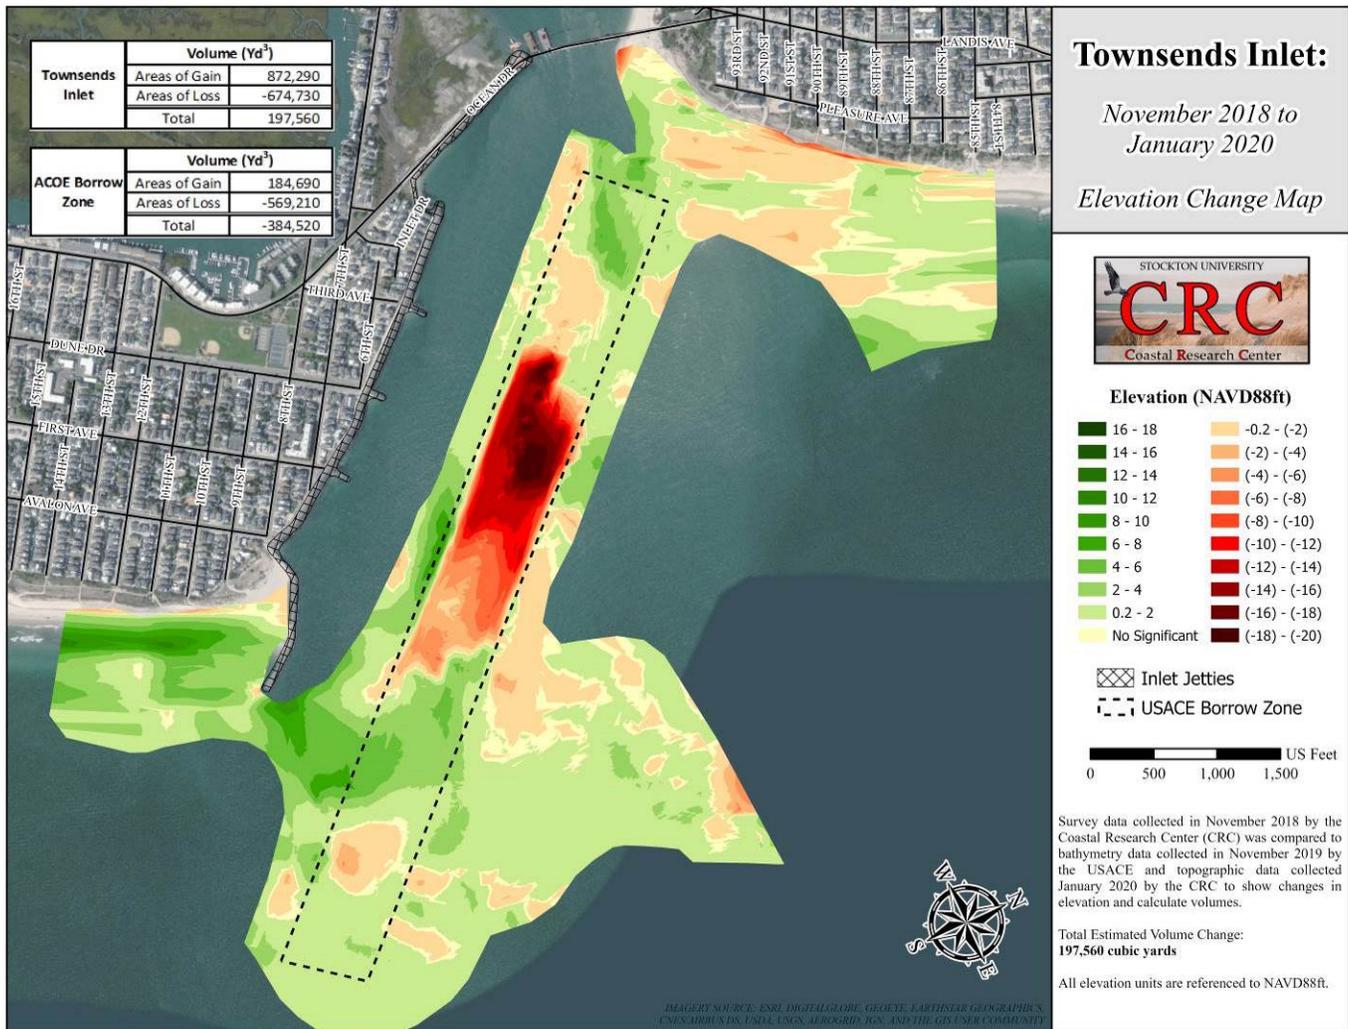
The 2019 combined bathymetric and topographic data was compared to similar November 2018 information obtained by the CRC as part of this inlet monitoring effort. The comparison only shows where the 2019 dataset overlapped with the 2018 information because that is the limit for direct comparison models. Areas of deposition greater than 0.2 feet vertically are in green, areas of plus or minus 0.2-foot vertical change are in yellow, while areas of greater than 0.2 feet of vertical erosion are in red shades (Figure 22).

Figure 22. Digital comparison between surveys completed in November 2018 with the 2019 data where overlap exists. Again, the excavation footprint is extremely clear with areas of deposition evident as well. The beachfront in Avalon displays the deposition of the inlet material with 10 to 12 feet of new material added at the maximum value for fill. However, sand accumulated naturally at the northeast of the tip of the Avalon jetty as well (+6 to 8 feet vertically in spots).

The USACE excavation for sand deposited on the Avalon oceanfront shows as deep red areas mirroring the DEM footprint above in Figure 21. Between Nov. 2018 and Dec. 2019 deposition of sand was extensive around the ebb-tidal delta seaward of the Avalon jetty tip. Up to 10 feet of vertical accretion took place directly to the northeast of the jetty itself. The 10 to 12 feet of deposition on the surveyed part of the Avalon beachfront is the result of sand placement by the federal maintenance project. The pattern of erosion and accretion on the Sea Isle City side of the inlet was the result of a year of sand bar accumulation and migration to the south toward the inlet. Some beach erosion occurred between 87th and 92nd Streets in Sea Isle.

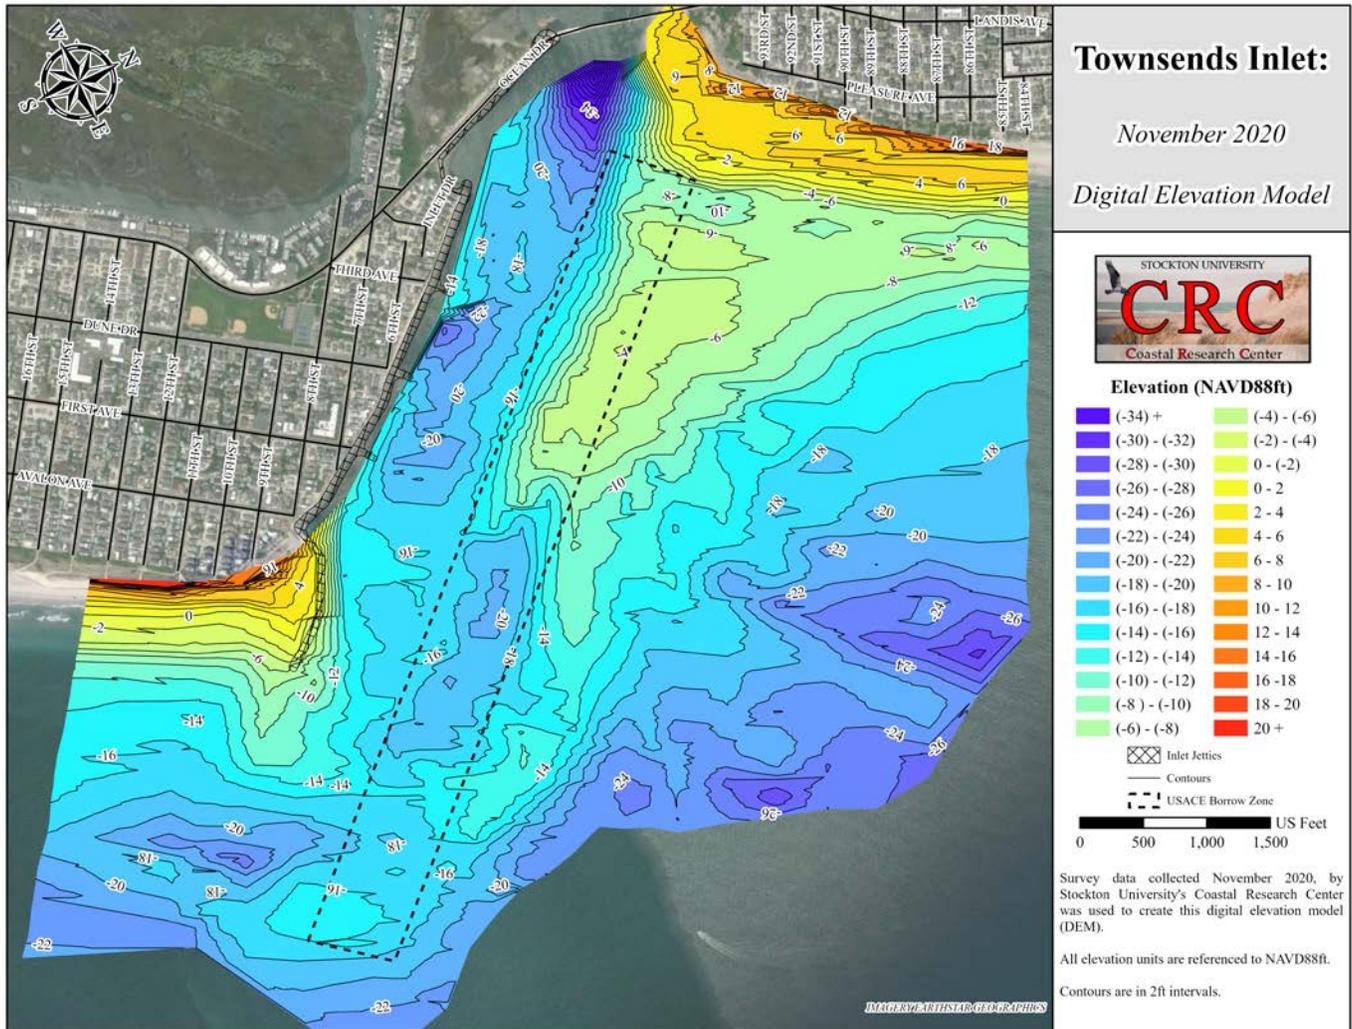
Figure 23 is the digital elevation map for December 2020 and shows that the maintenance dredging cut in figure 21 above has completely filled in. The deepest part of the borrow zone is located opposite the 8th Street jetty at -20 feet. The large northeast shoal attached to the Sea Isle City beach has a 1,500 by 2,500-foot scale of area above the -6-foot contour which is separated from the beach by a narrow exit channel along the base of the beachface with -10-foot depths.

Figure 23. November 2020 Townsends Inlet bathymetry showing the oceanfront beaches on both sides of the inlet and the ebb-tidal delta deposited seaward of the inlet opening. The main tidal channel axis has shifted further toward Avalon making the deepest passage under the inlet bridge at the second fixed span, not at the drawbridge span. The majority of the main channel extent has moved adjacent to the Avalon inlet revetment from the inlet bridge seaward to where the 8th Street jetty begins. This deeper area contrasts with that seen in the 2018 map (Figure 24). At the jetty sand has accumulated in considerable quantity around the jetty.

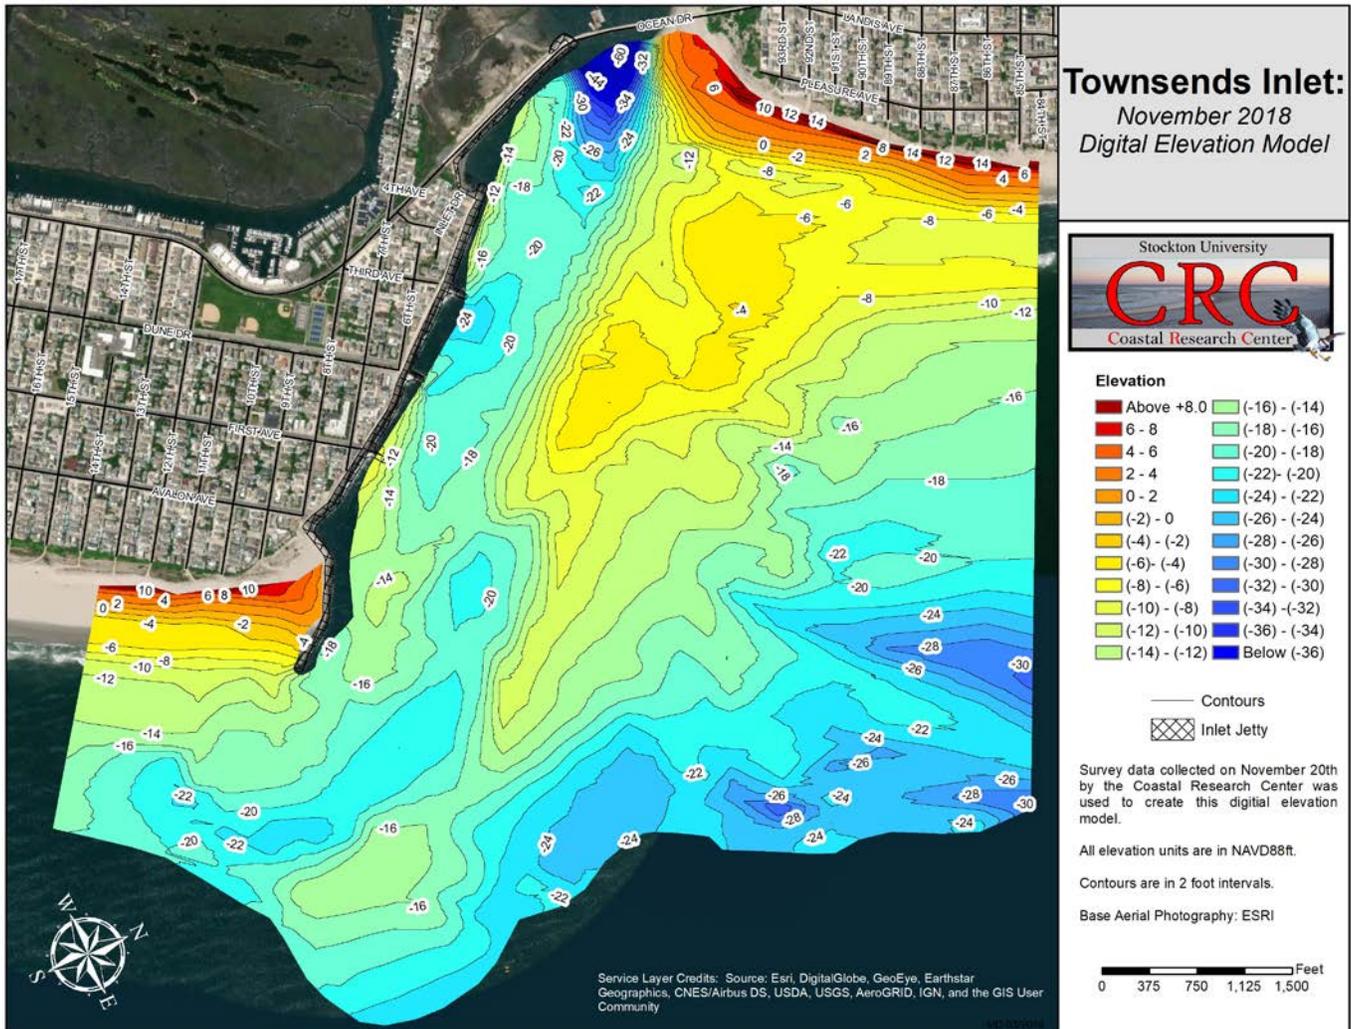
Figure 24. The 2018 Townsend's Inlet bathymetry shows the deepest area at the inlet bridge more centered under the bridge spans and with a zone of shallower channel margins along the Avalon inlet revetment. The water is over 18 feet deep at the inlet jetty as well, reduced to 6 feet by 2020. The Sea Isle shoals seaward of the City beaches were about the same in depth and extent but the exit into the Atlantic Ocean was reduced from -22 feet to -14 feet between 2018 and 2020.
