**FINAL REPORT FOR 2020
ON THE CONDITION OF THE MUNICIPAL OCEANFRONT BEACHES
BATHYMETRY OF TOWNSENDS INLET
THE BOROUGH OF AVALON, CAPE MAY COUNTY, NEW JERSEY**

**PREPARED FOR: THE BOROUGH OF AVALON
3100 DUNE DRIVE
AVALON, NJ 08202**

**PREPARED BY: THE STOCKTON UNIVERSITY COASTAL RESEARCH CENTER
30 WILSON AVENUE
PORT REPUBLIC, NEW JERSEY 08241**

February 17, 2021

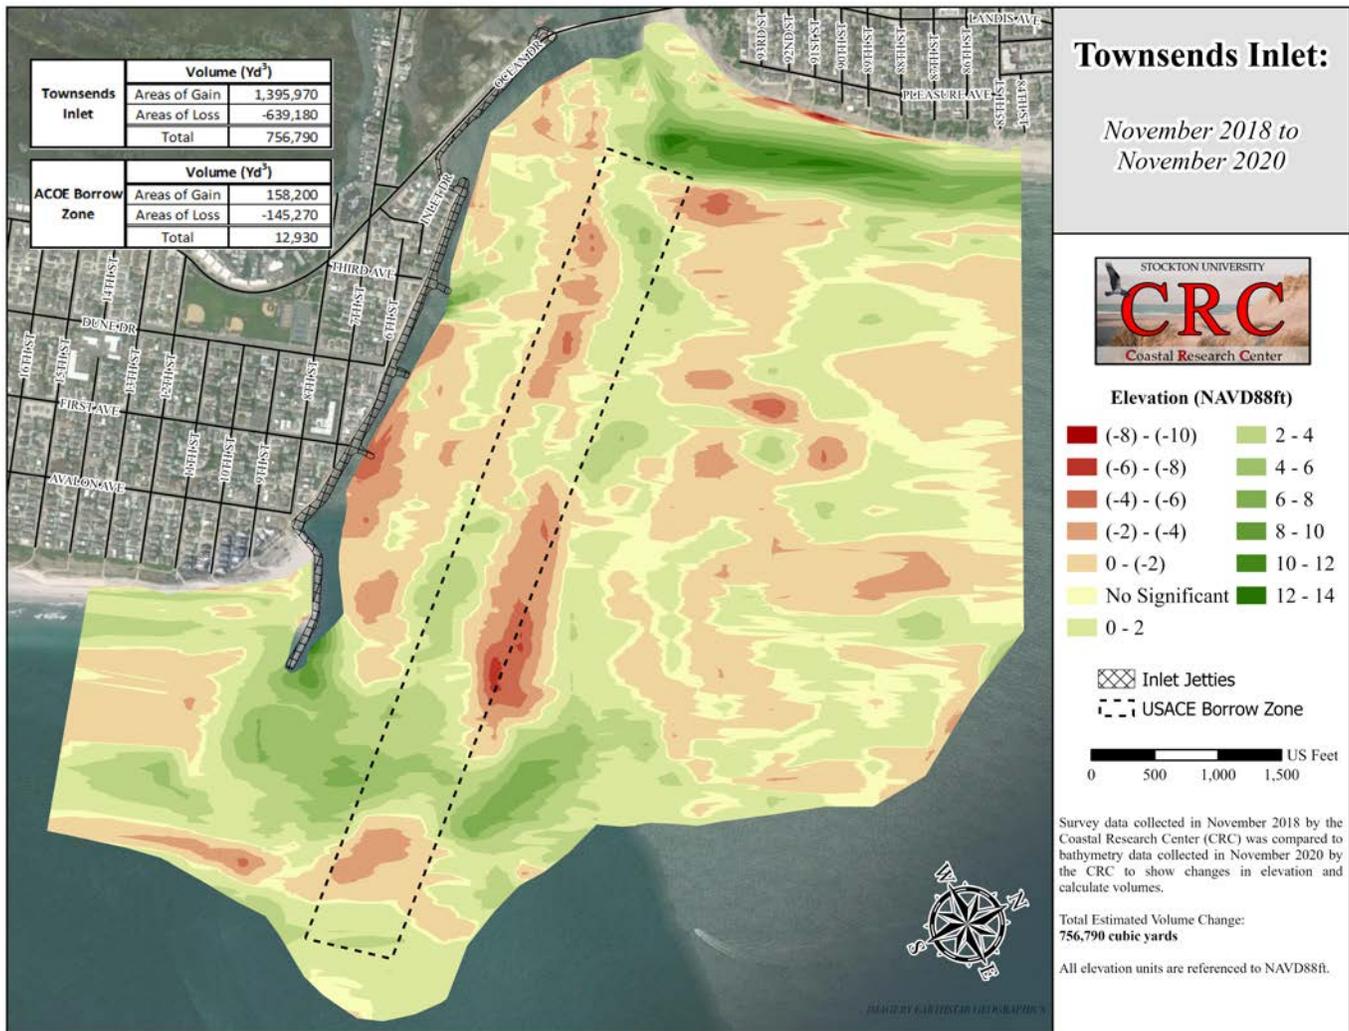
Figure 25. This comparison of the 2020 data with that taken in November 2018 allows the use of a complete area data set to show the regional changes around the inlet. There is one excavation at a maximum of 8 feet deeper in 2020 within the outline of the authorized borrow zone for the Avalon beach maintenance. The 2019 excavation sand volume was 569,210 cubic yards from the borrow zone. The contractor got paid for 571,351 cubic yards of sand. This comparison shows that since 2018 the borrow zone gained 12,930 cubic yards of sand meaning that the entire amount excavated in 2019 has been replaced as of November/December 2020.

The digital elevation comparison between 2018 before the 2019 maintenance dredging and the November/December 2020 data shows that the entire sand volume extracted for the Avalon beaches has been replaced within the borrow area leaving only one deep zone on the northeast edge about midway along the zone axis. The extensive multiple shades of green at the seaward end of the ebb-tidal delta that reach from the tip of the 8th Street inlet jetty around the borrow zone and toward the Sea Isle side of the inlet show a decrease in water depth of 6 to 8 feet creating a net sand volume gain of 756,790 cubic yards in two years. Little of this new sand lies within the borrow zone, but a total recovery from a 569,210 cubic yard removal from the borrow area in 2019 is significant nonetheless.
