**ANNUAL REVIEW FOR 2021
OF THE CAPE MAY POINT, NJ MUNICIPAL BEACHES**

PREPARED FOR: THE BOROUGH OF CAPE MAY POINT
215 LIGHTHOUSE AVENUE
CAPE MAY POINT, NJ 08212

PREPARED BY: STOCKTON UNIVERSITY COASTAL RESEARCH CENTER
30 WILSON AVENUE
PORT REPUBLIC, NJ 08241

May 12, 2021

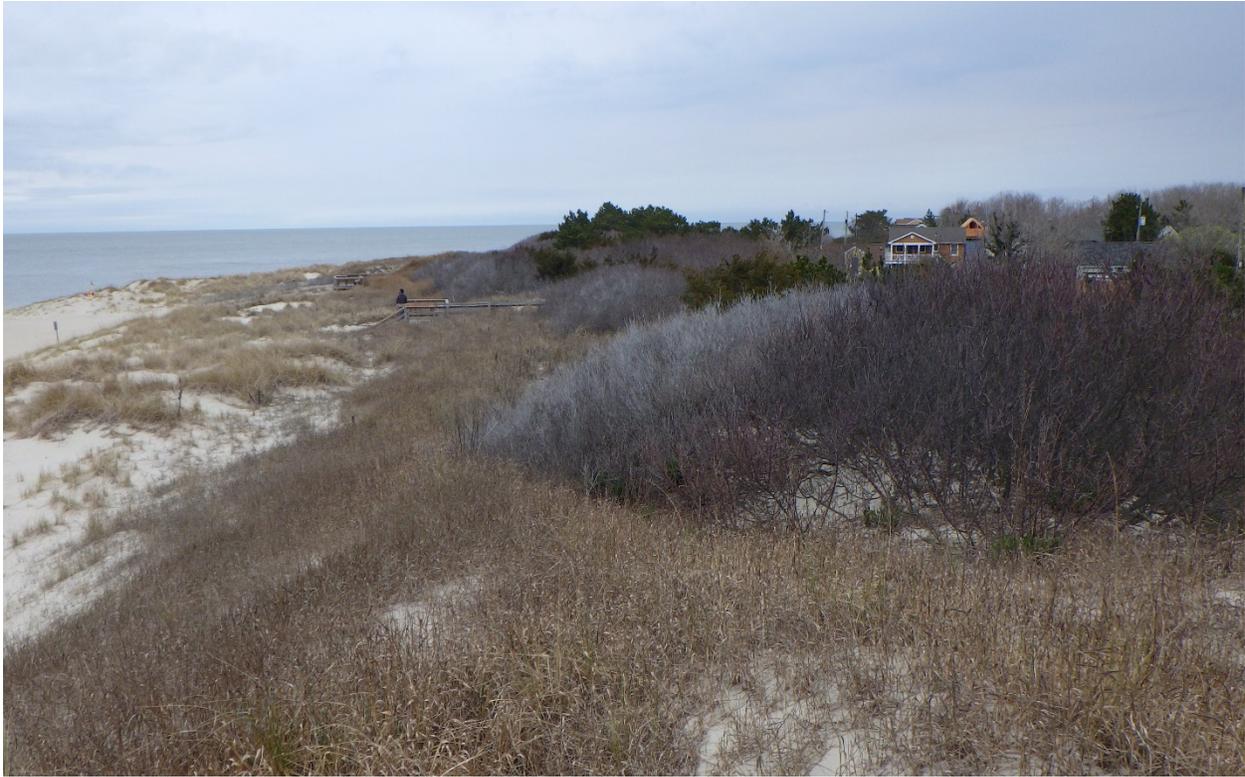
The photo above taken on April 9, 2021 from the survey reference location between Stites and Brainard Avenues in Cell CMP-7. This dune is the highest in Cape May Point exceeding 30 feet in elevation. The lower zone of sparser dune grass vegetation between the old growth and the beach has been transformed into a dune field by northwest winds since the initial USACE beach restoration in 2005. The dry beach is all new sand derived from this project.

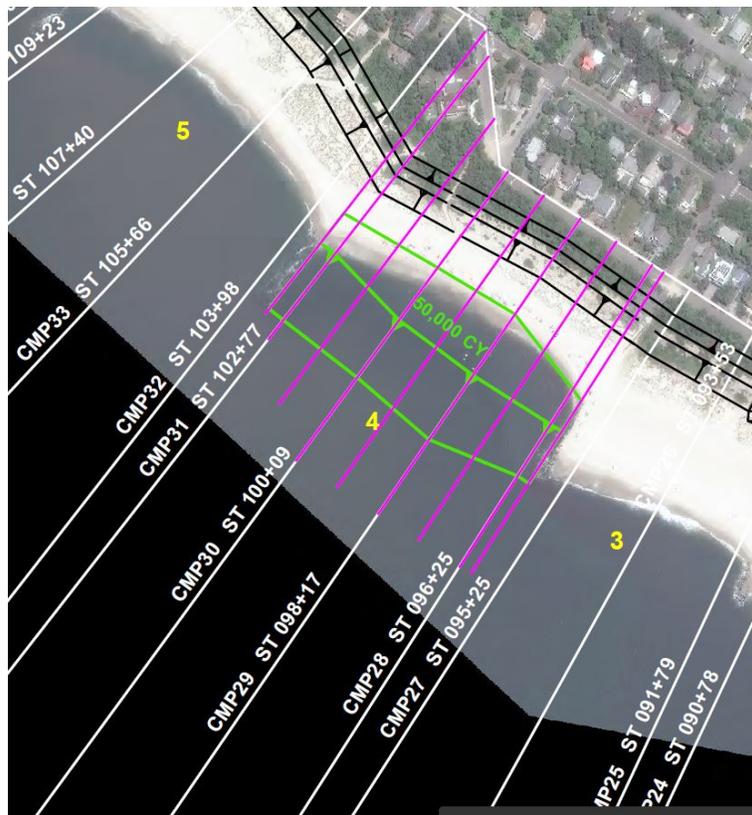
Figure 1. Site plan for the USACE beach maintenance completed at Lake Drive, Cape May Point as of February 2021 adding 50,000 cubic yards of sand derived from the NJ State Park beach and truck hauled to Lake Drive.

The past two years of successive retreat in the position of the beachface shifted dramatically by April 2021 with a 62.53 yds³/ft. sand volume increase and a shoreline advance of 109 feet seaward at the zero-elevation position. After reaching out to the US Army Corps of Engineers project manager (Dwight Packam) the response was presented that the Corps had transferred 50,000 cubic yards of beach sand derived from both the Nature Conservancy lands as well as from the NJ State park beach. Sand was truck-hauled to Lake Avenue as well as moved north to the “Cove” in Cape May City. Mr. Packam provided the map of the Cape May Point placement (Figure 1).

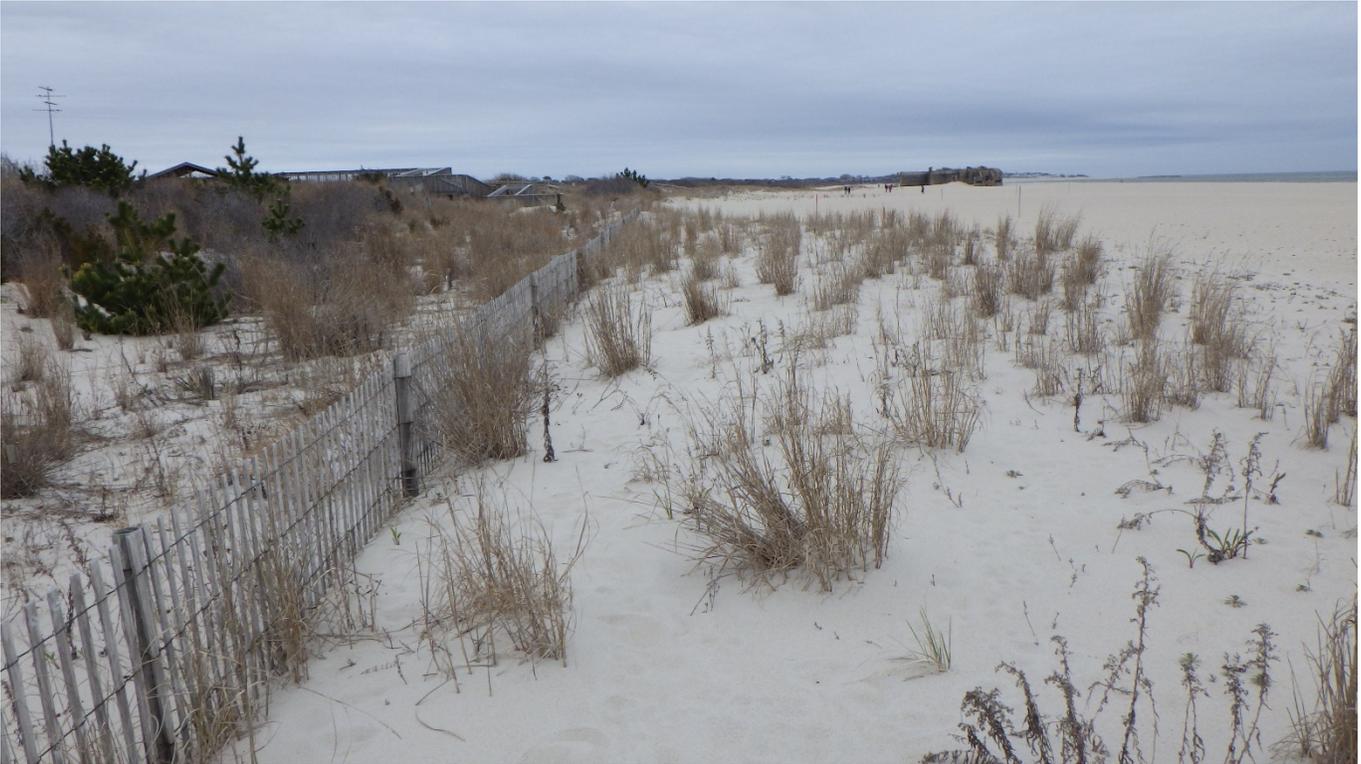
Figure 2. The view was taken April 9, 2021 showing the transition into the NJ State Park and with Cape May City in the far distance. This view is from the seaward toe of the dunes where grass has grown seaward beyond the fence. Prior to this project the concrete WW II control bunker was entirely in the ocean.

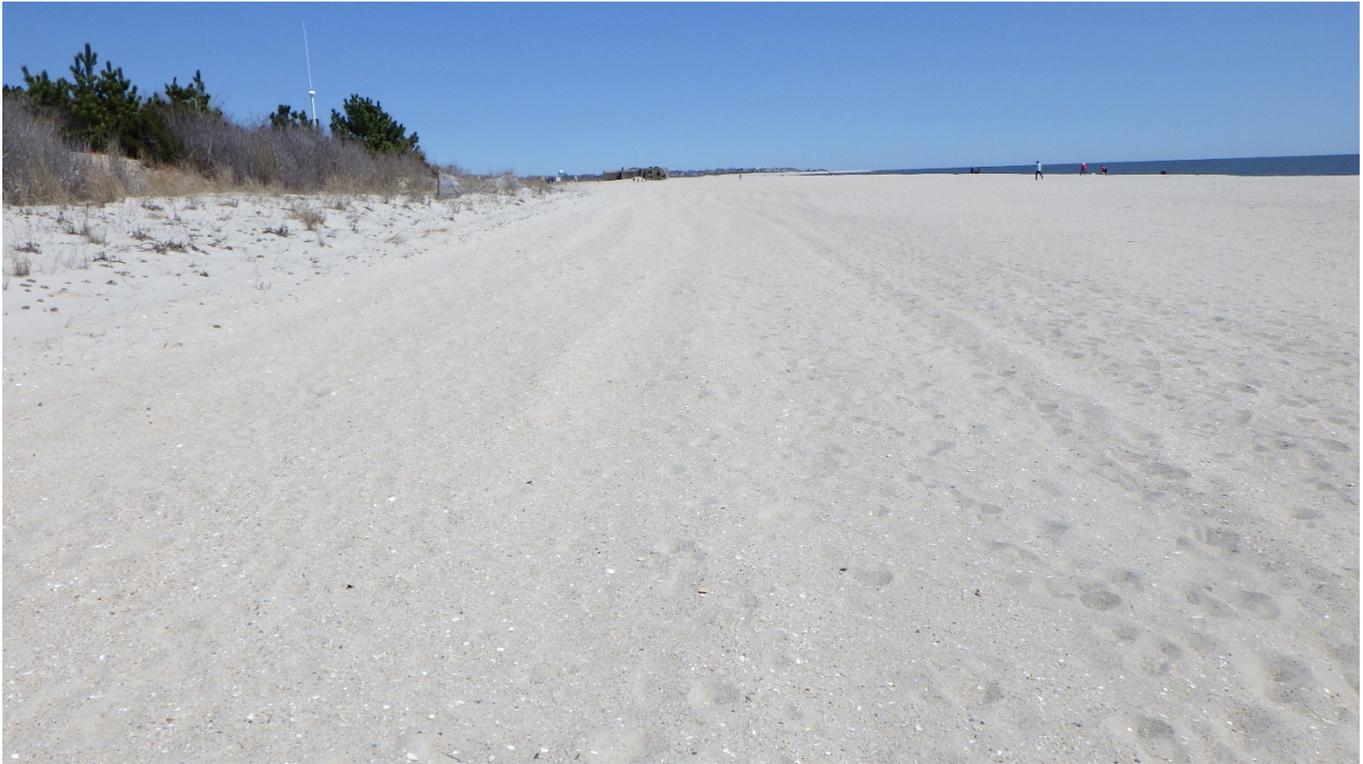
Figure 4. This view is to the northeast showing the beach width present as of April 8, 2021. The dune to the left side sits on top of the stone revetment and the beach is many times the pre-beach nourishment width creating an excellent storm barrier as well as a recreational resource enjoyed by the Borough citizens.

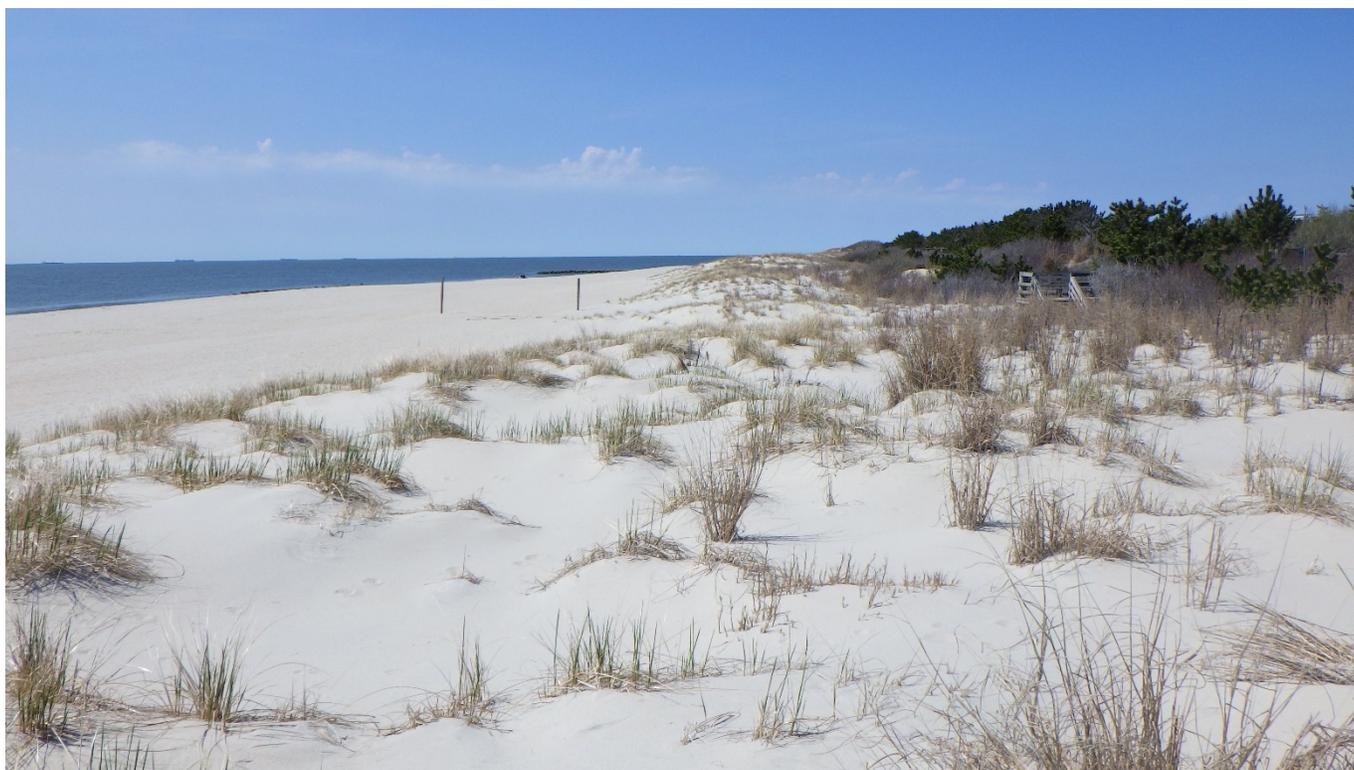
Figure 6. The April 8, 2021 view to the southwest shows an expanding foredune zone with large mounds of wind deposition around clumps of grass plants indicating continued dune enhancement. The beach width is recreationally sufficient and serves as an effective wave barrier too. The beach gained 29.0 yds³/ft. as the shoreline advanced 13 feet.

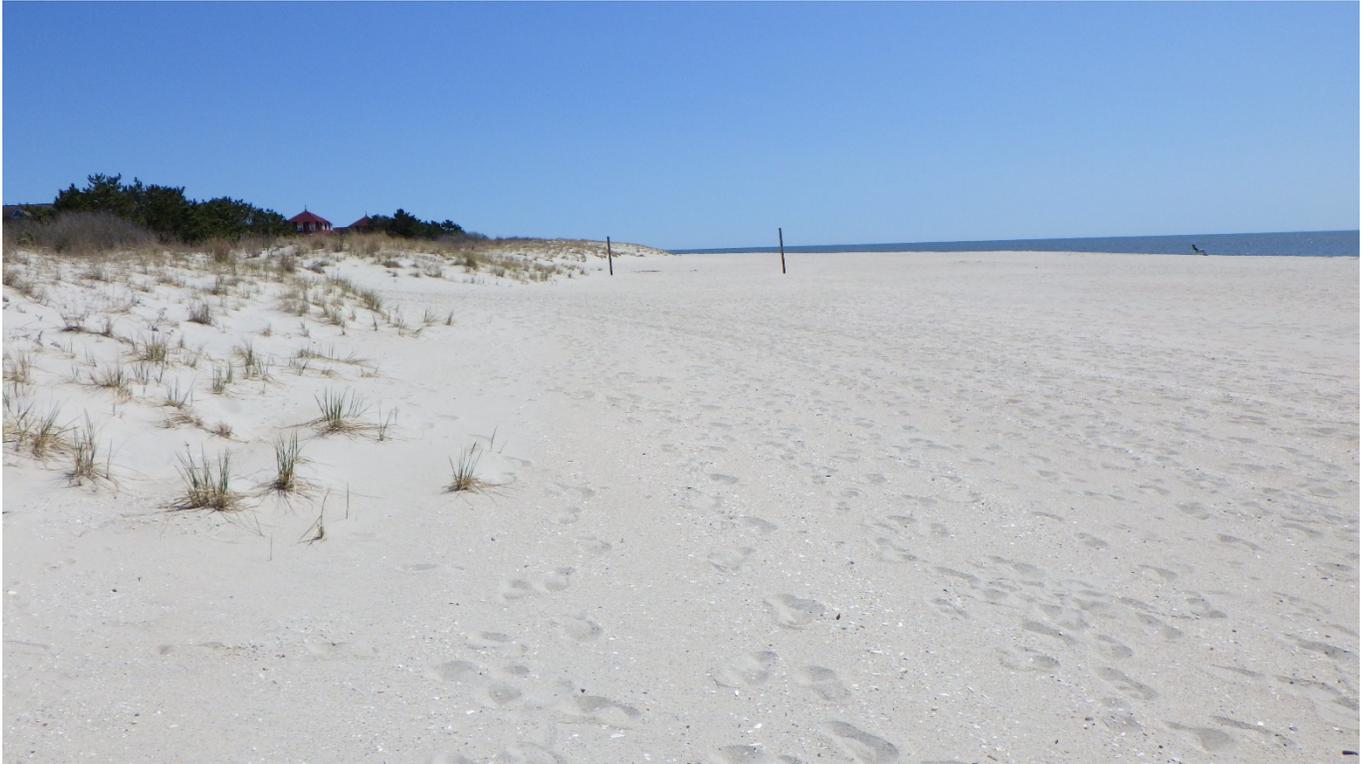
Figure 8. The view to the northeast along the foredune toe shows the grass creating the mounding of the added sand where root extensions have generated tufts of new growth expanding the dune’s width. The beach view is back toward CMP-2 with a wider beach present as of April 8, 2021.

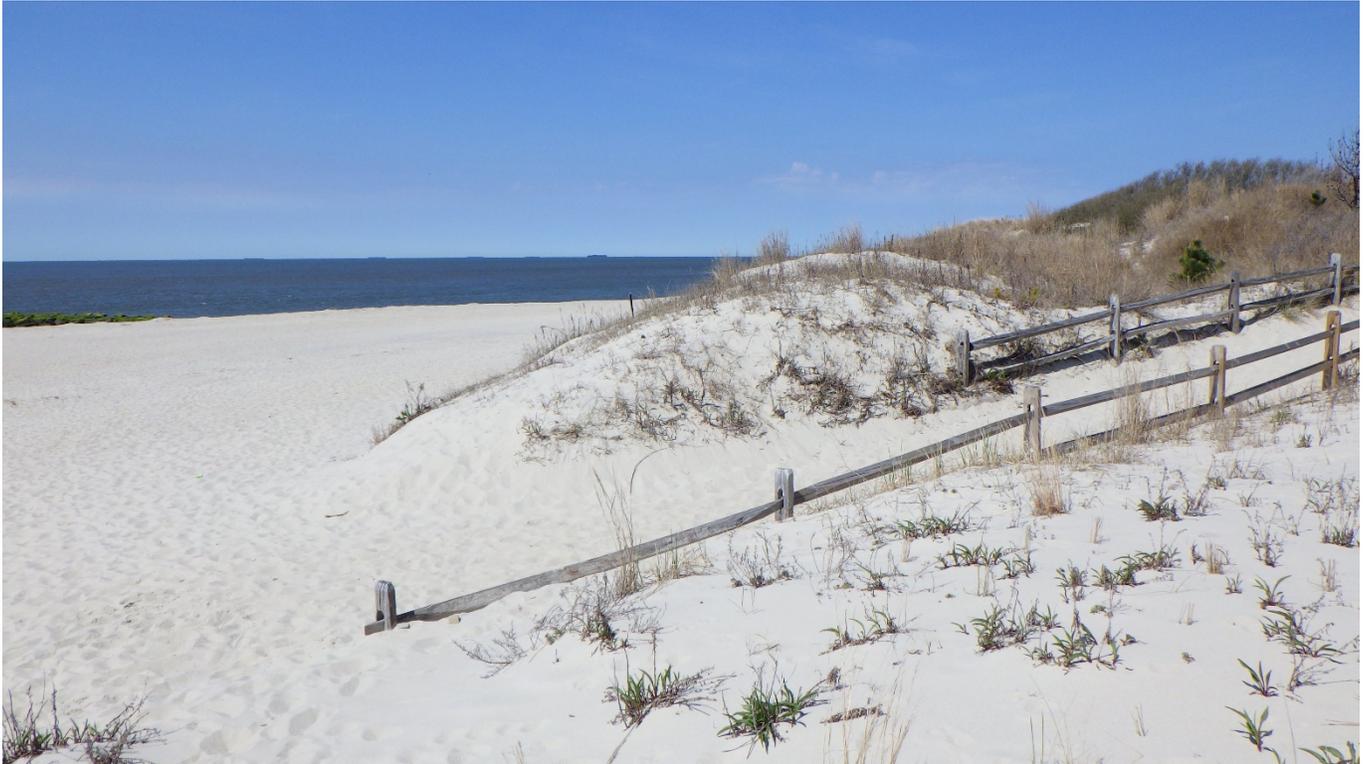
Figure 10. This April 8, 2021 view to the southwest shows the extensive foredune and a wider beach practically filling the rock groin cell extents.

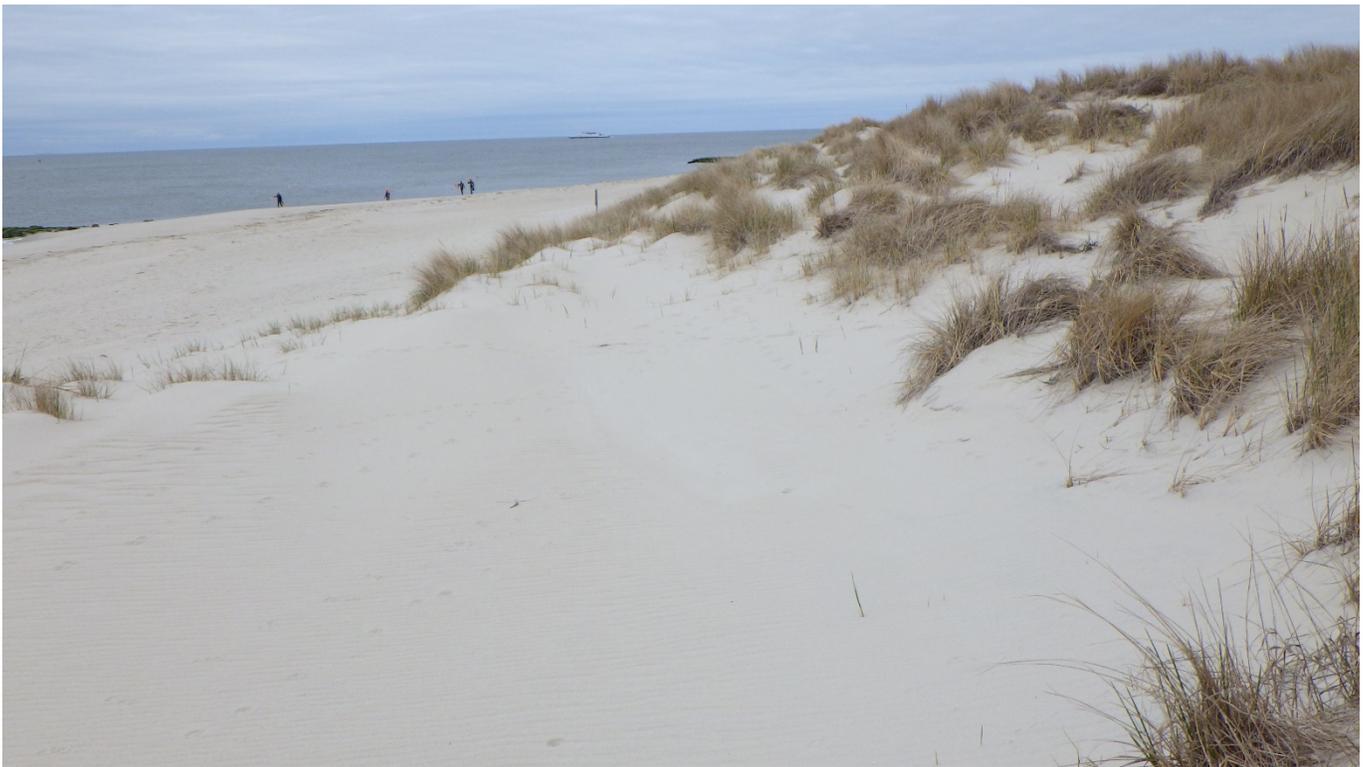
Figure 12. The April 9, 2021 view to the southwest shows the expanding dune toe plant growth and continued accumulation of additional dune sand. This site has experienced exceptional dune accumulation of new sand.

The wider beaches have provided a source of sand for the wind to move sand onto the seaward slope and crest of the dune. Since 2018 the primary dune and a foredune on the upper beach have grown considerably adding to the sand held in reserve putting more storm protection in place. The beach is wider by 33 feet. The “Beachsaver” reef system was detected, but with a higher sand elevation on the inside than offshore of the structures. Swimming areas are 210 feet wide from the zero-elevation position out to the reef alignment. The water would be over swimmers’ heads at the reef.

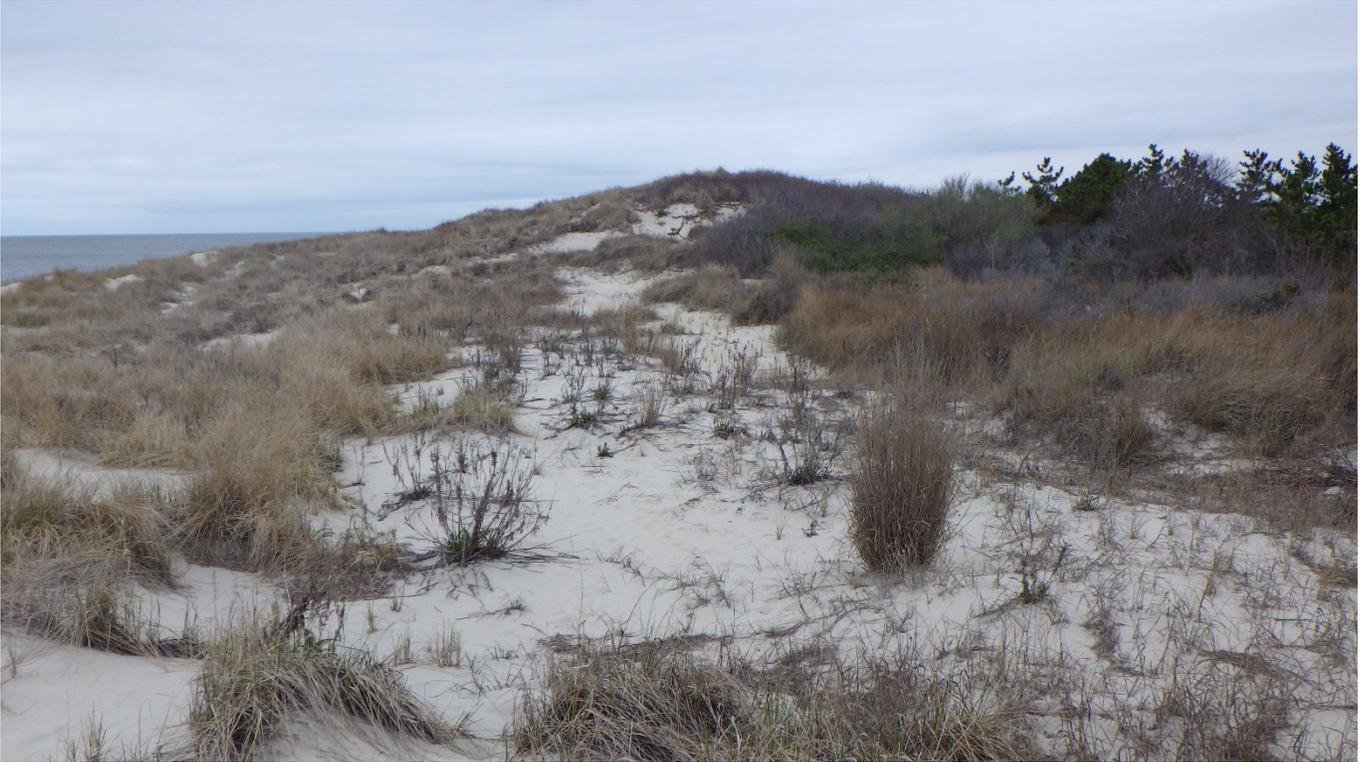
Figure 14. This view was taken April 9, 2021 at the instrument position in the dunes looking southwest into Delaware Bay. The dune toe defines the extent of dune growth leaving a modest dry beach widening toward the groin.

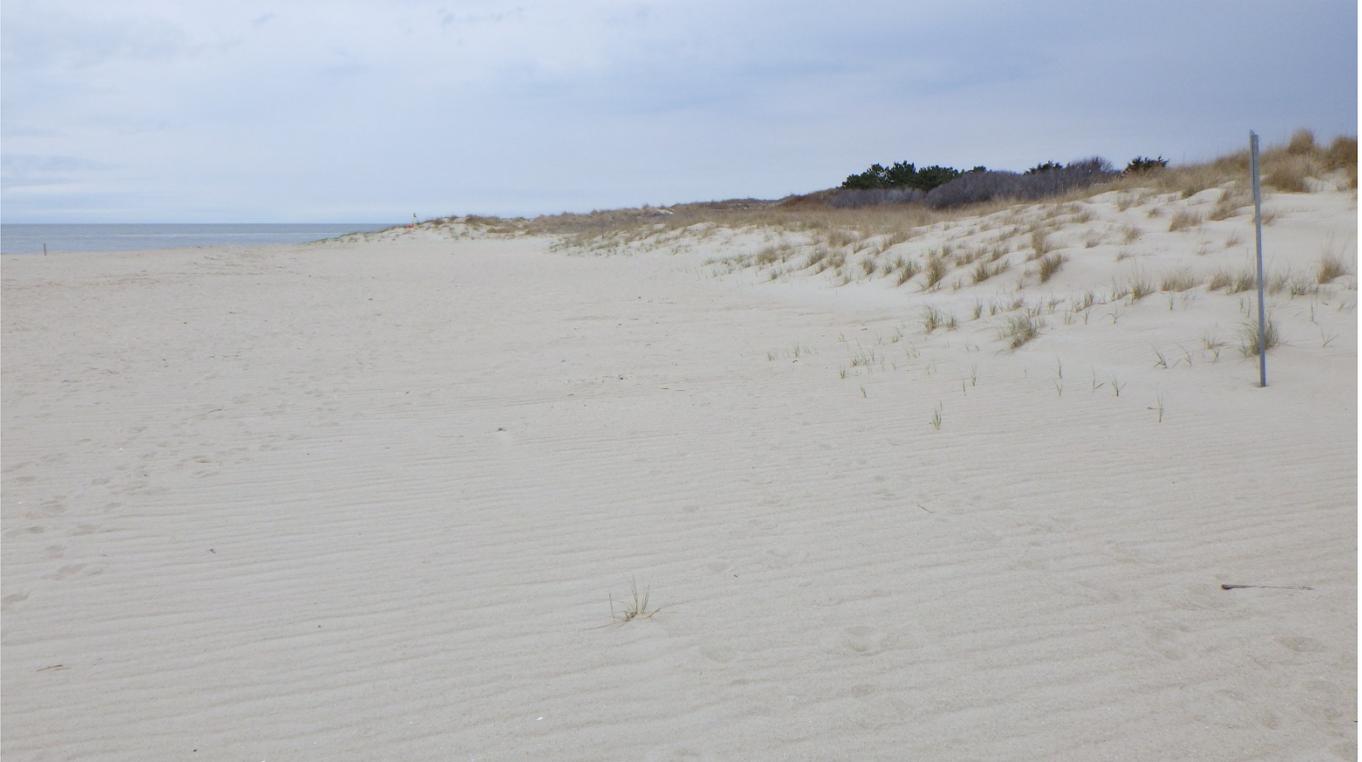
Figure 16. The April 9, 2021 view to the southwest on CMP-7 shows the expanse of foredune slope and its vegetation. The mass of accumulated dune sand remains the largest among the Cape May beach segments in both total elevation and width of the dunes. The beach provides excellent protection as well.

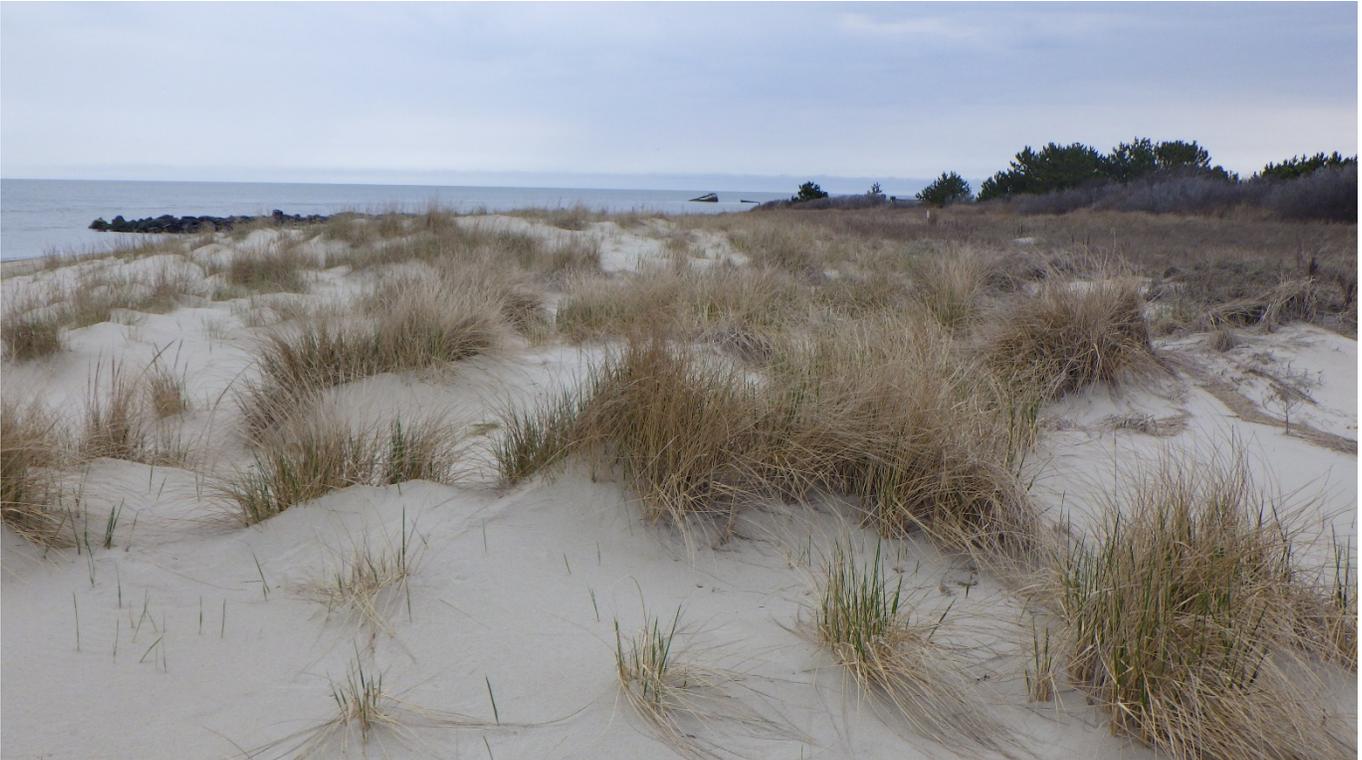
Figure 18. This westernmost cell ends at the groin in the distance. The view toward Delaware Bay was taken April 9, 2021. Lower Township is immediately adjacent to the structure. The hummocky dunes in the foreground all have appeared in the past 5-6 years as this beach has expanded.
