**2019 ANNUAL REPORT - TO THE CITY OF NORTH WILDWOOD
ON THE
CONDITION OF THE CITY BEACHES**

**PREPARED FOR: THE CITY OF NORTH WILDWOOD
901 ATLANTIC AVENUE
NORTH WILDWOOD, NJ 08260**

**PREPARED BY: THE STOCKTON UNIVERSITY COASTAL RESEARCH CENTER
30 WILSON AVENUE
PORT REPUBLIC, NJ 08241
February 26, 2020**

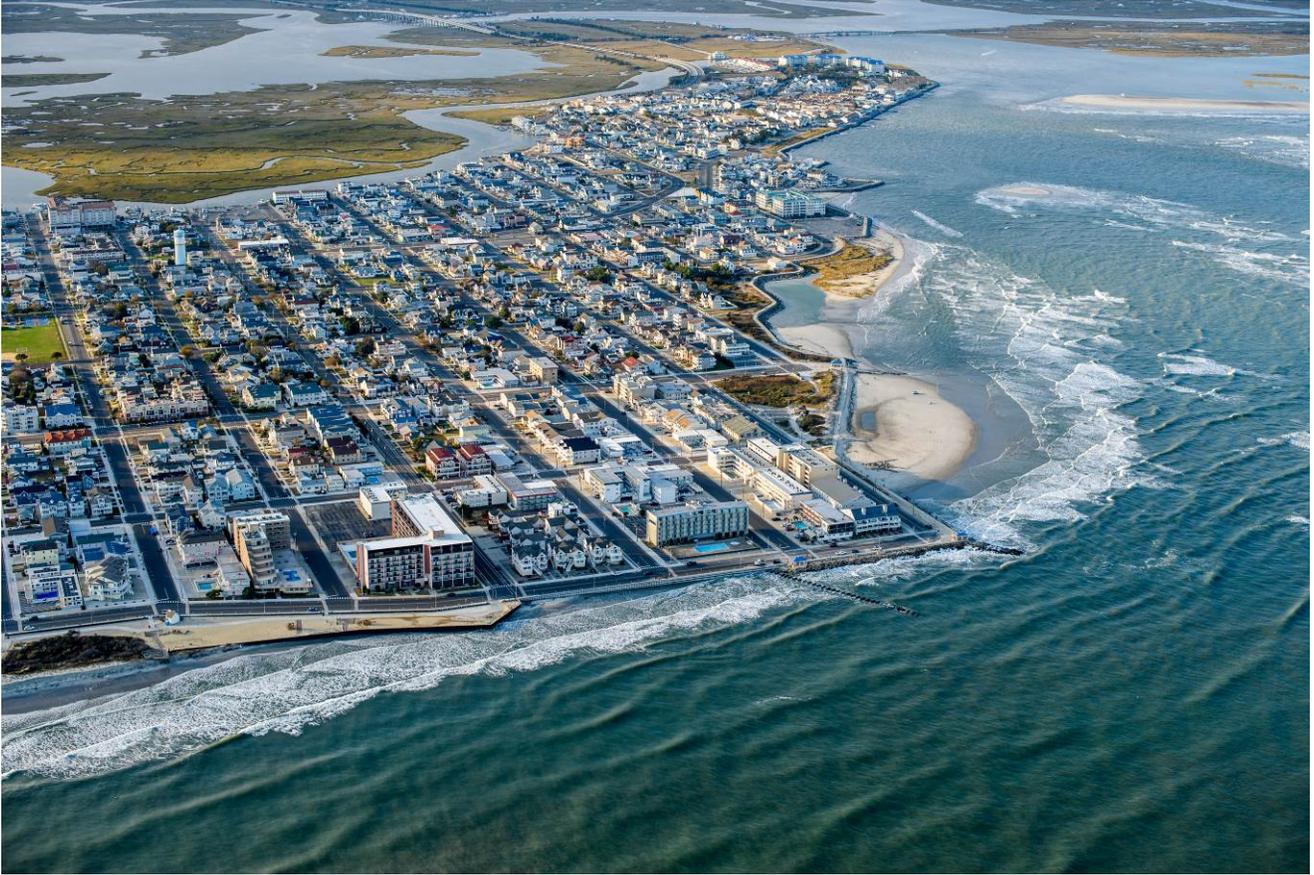
Aerial view of North Wildwood looking northwest into Hereford Inlet on October 12, 2019 showing high tide at the north end of the City. The new bulkhead is evident starting at 5th Avenue replacing the dune once present. The accumulation of shoal sand northeast of the inlet jetty is also evident with the expectation of greater accretion to come. The prior year's back pass sand lies partially in the pocket between the jetty and earlier spit growth into the inlet. (Aerial photo taken by Ted Kingston)

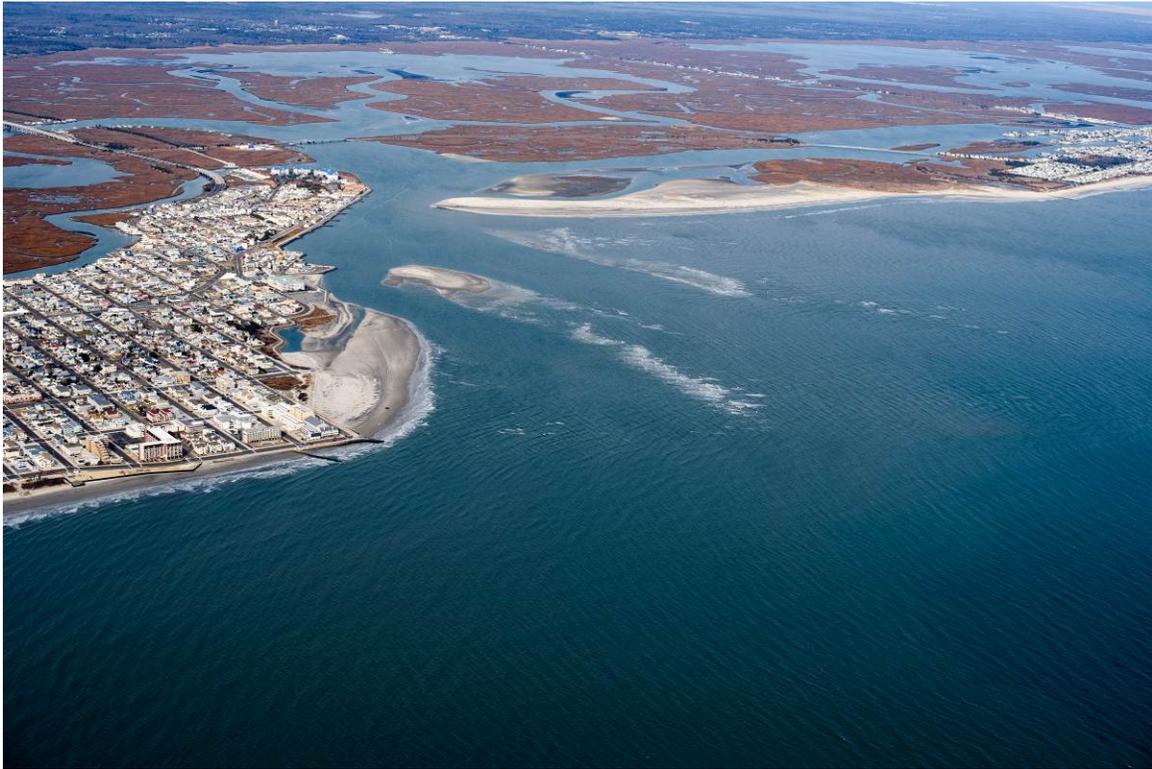
Figure 1. Aerial view from 12/7/2019 of Hereford Inlet and northern North Wildwood. There are three tidal channels exiting Hereford Inlet with the main channel positioned medially between two major shoals. Two smaller channels exist along the South Point shoreline close to the coast and the other hugs the North Wildwood shoreline southeast of New Jersey Avenue. The emerged shoal island has moved southeast over 1,500 feet since 2010, but to conform to the 1995 configuration (Figure 2), needs to move opposite the end of Surf Avenue. This would eventually permit the ebbing tidal flow to push the latest deposit of sand (derived from the 2019 transfer of sand stock from Wildwood) extending northwest from the 2nd Ave. jetty for four city blocks, back out to sea where it would accrete on the oceanfront beaches.

Figure 1, next page, shows the shoal island and the channel configurations as of December 7, 2019. The "tail" of white water extending toward the ocean from the shoal island is indicative of very shallow conditions. This configuration does not emphasize sand deposition around the northeast corner of North Wildwood as yet. Compare the 2019 view with that from 1995 to see that the shoal island needs to be closer to the jetty and with the tide channel close to the North Wildwood shoreline and not out into the inlet opening.

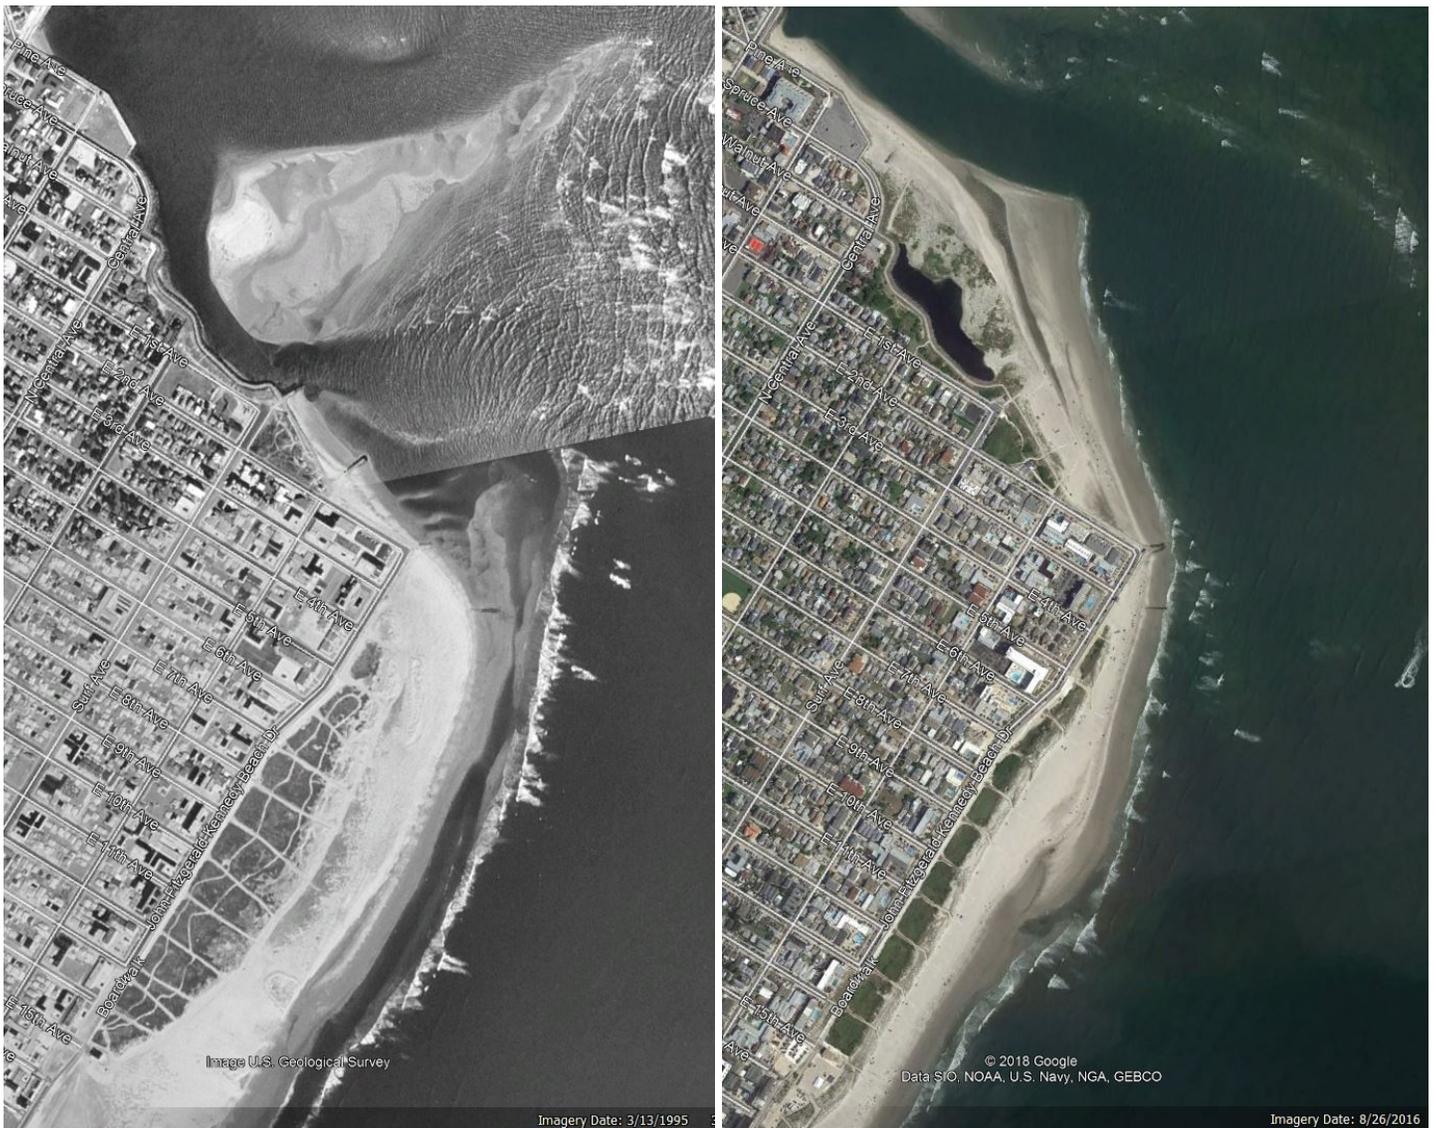
Figure 2. (Presented last year, but significant still). The northeast quadrant of the City of North Wildwood between March 1995 and August 2016 shows that oceanfront erosion appears related to large changes in shoal position and exposure at low tide in Hereford Inlet. In 1995, an exposed island sat between Central and Surf Avenues forcing a branch of the main tidal channel against the North Wildwood shoreline. There was no beach at the inlet shore until southeast of Surf Avenue. There was an extensive exposed sand flat system attached to the beach front bar system extending into the inlet. The ebb-tidal currents exited in proximity to the oceanfront beach and deposited sand in transport where wave action could easily move it to the beach bar system, and eventually onto the dry beach.

The two air photographs (Figure 2), were retained from last year's report to show the northeast corner of the City from March 1995 prior to major oceanfront changes and from August 2016 just prior to the most recent sand losses. In the 1995 view, the beach width at the north end of the City's oceanfront was close to 1,000 feet in width and when retreat commenced in that time frame, the loss rate did not appear to depend on storm frequency or seasonality for loss evaluation. The exact duplication of the 1995 configuration is not necessary, but the restriction of the flood-tidal flow direction by the island's location is important in forcing the sand to accumulate preferentially near the oceanfront beach. Waves then can move the shallow deposits onto the beach starting as offshore bars.

The 1995 shoal island was opposite the end of Surf Avenue, while the current shoal island lies two diameters to the northwest of the ideal position. The ebb currents move sand to the southeast, but the entire island mass is slow to follow individual tide cycles. Movement since 2011 has been in the range of 1,500 to 2,000 feet to the southeast in the direction of the ebb tidal flow. The constriction of the channel adjacent to North Wildwood needs to increase to cause the sand to deposit at or just east of the end of the 2nd Avenue jetty.

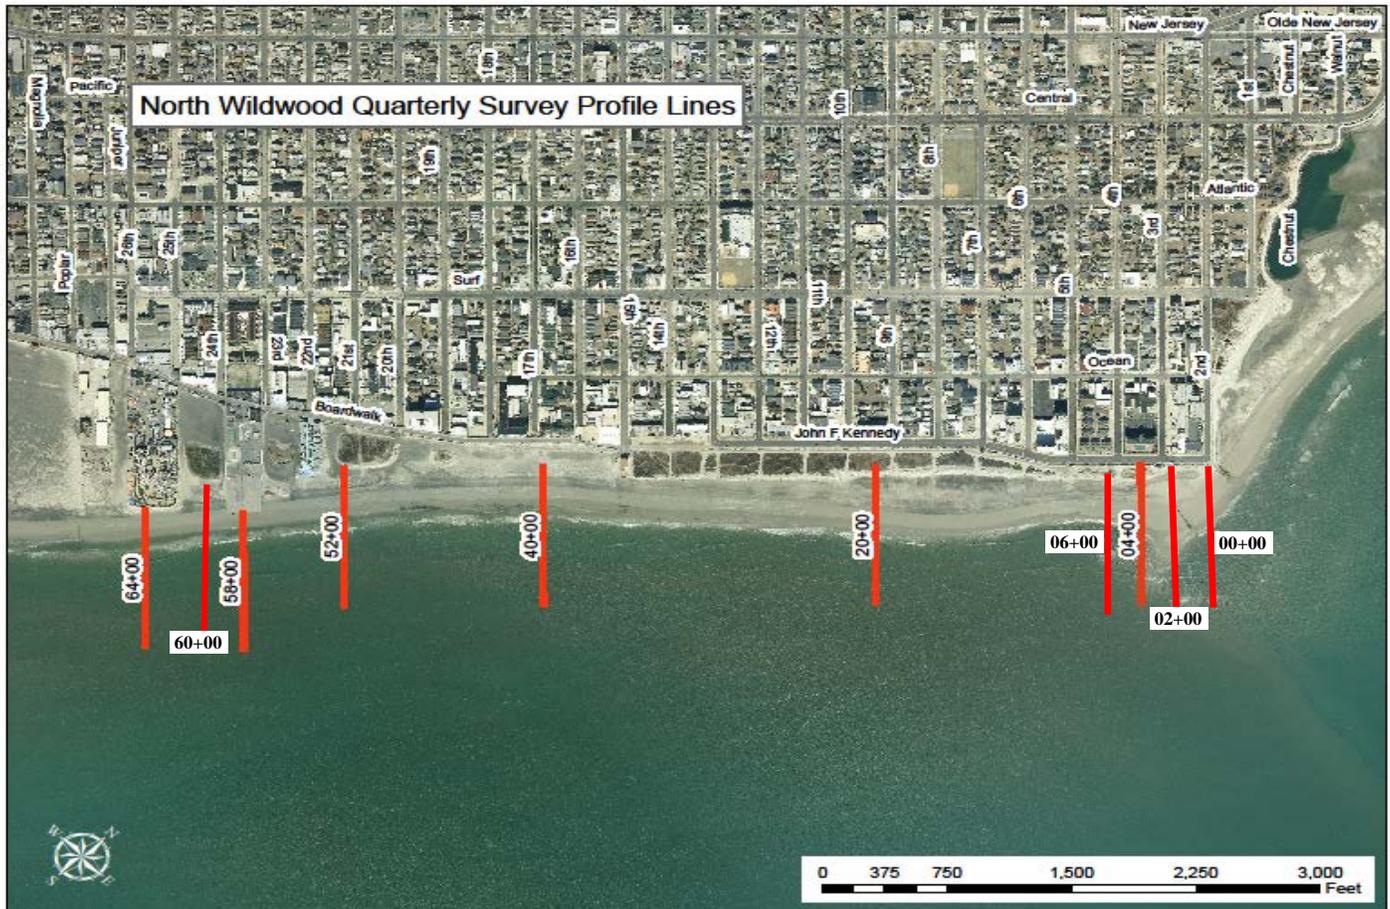
Figure 3. Shown above are locations of ten representative profile sites of the 54 profile stations where shoreline changes were measured on the City’s oceanfront from October 2018 to October 2019. For each of the ten profile stations descriptions and cross sections are provided to show typical changes over the year. This year surveys were included at the jetty, 200 feet, 400 feet, and 600 feet south of the jetty in the set of profiles. In addition, 6 survey lines are completed along the inlet beach in Hereford Inlet. They are spread non-uniformly from the 2nd Avenue jetty to Central Avenue northwest of the jetty. Four go at 200-foot spacing from the jetty to 600 feet northwest, another at 1,200 feet and the final survey line at 2,400 feet northwest at the end of Central Avenue.

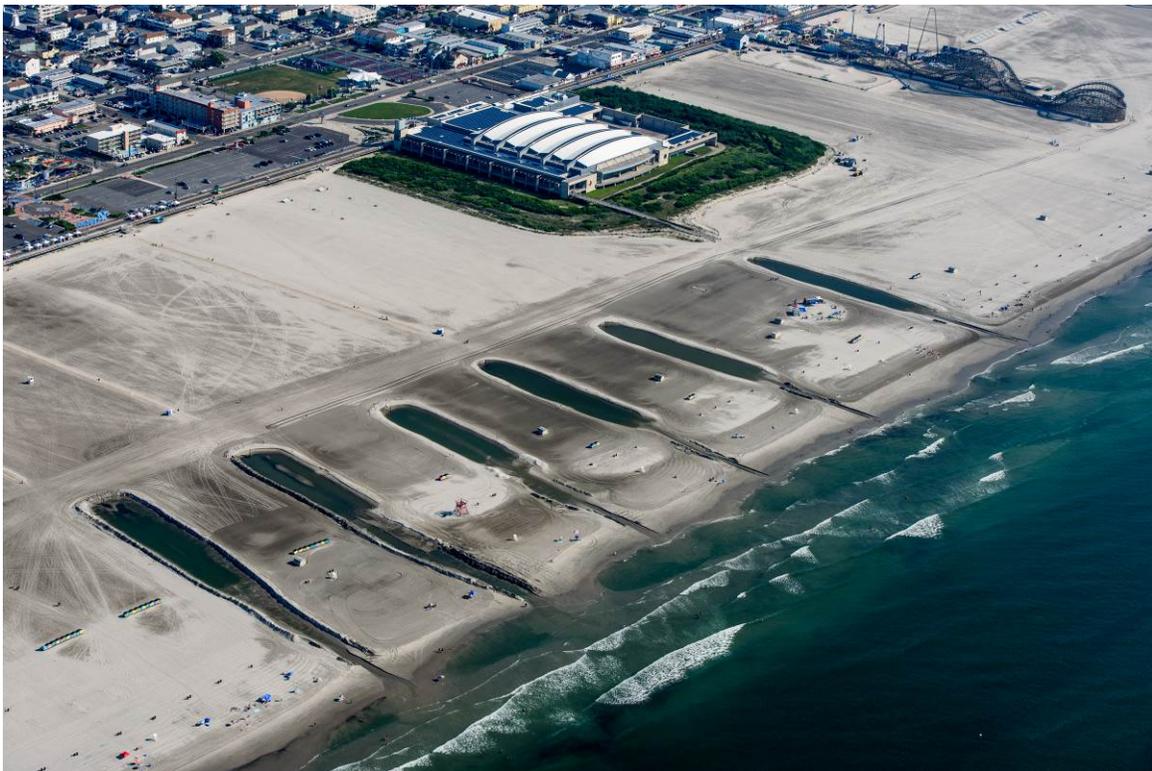
Figure 4. City of Wildwood oceanfront beach July 21, 2019 six weeks after conclusion of the 2019 back passing effort. The stormwater discharge points lie at the heads of each of the excavations at elevations well below the sand surface elevation. Burial means little effective stormwater discharge. They were originally built ending at the water's edge just past low tide. This view presents 20 – 25 years of evidence for shoreline accretion in the City of Wildwood.

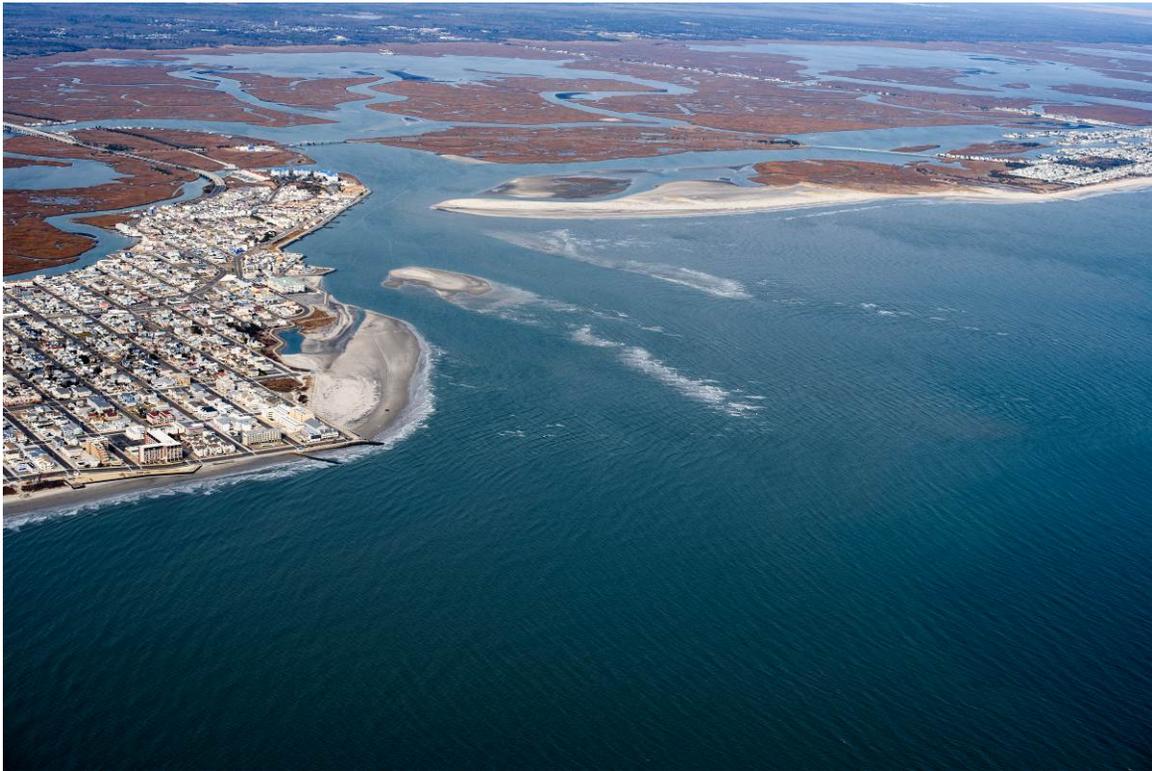
Figure 5. December 7, 2019 view into Hereford Inlet including the northern zone of the North Wildwood oceanfront. Note that new sand has been deposited from the jetty at 2nd Ave. toward the northwest to a point seaward of the prime bird nesting area west of Surf Avenue. The shoal island and its trailing sand bar lie between 500 and 1,000 feet seaward into the inlet from the City beaches.

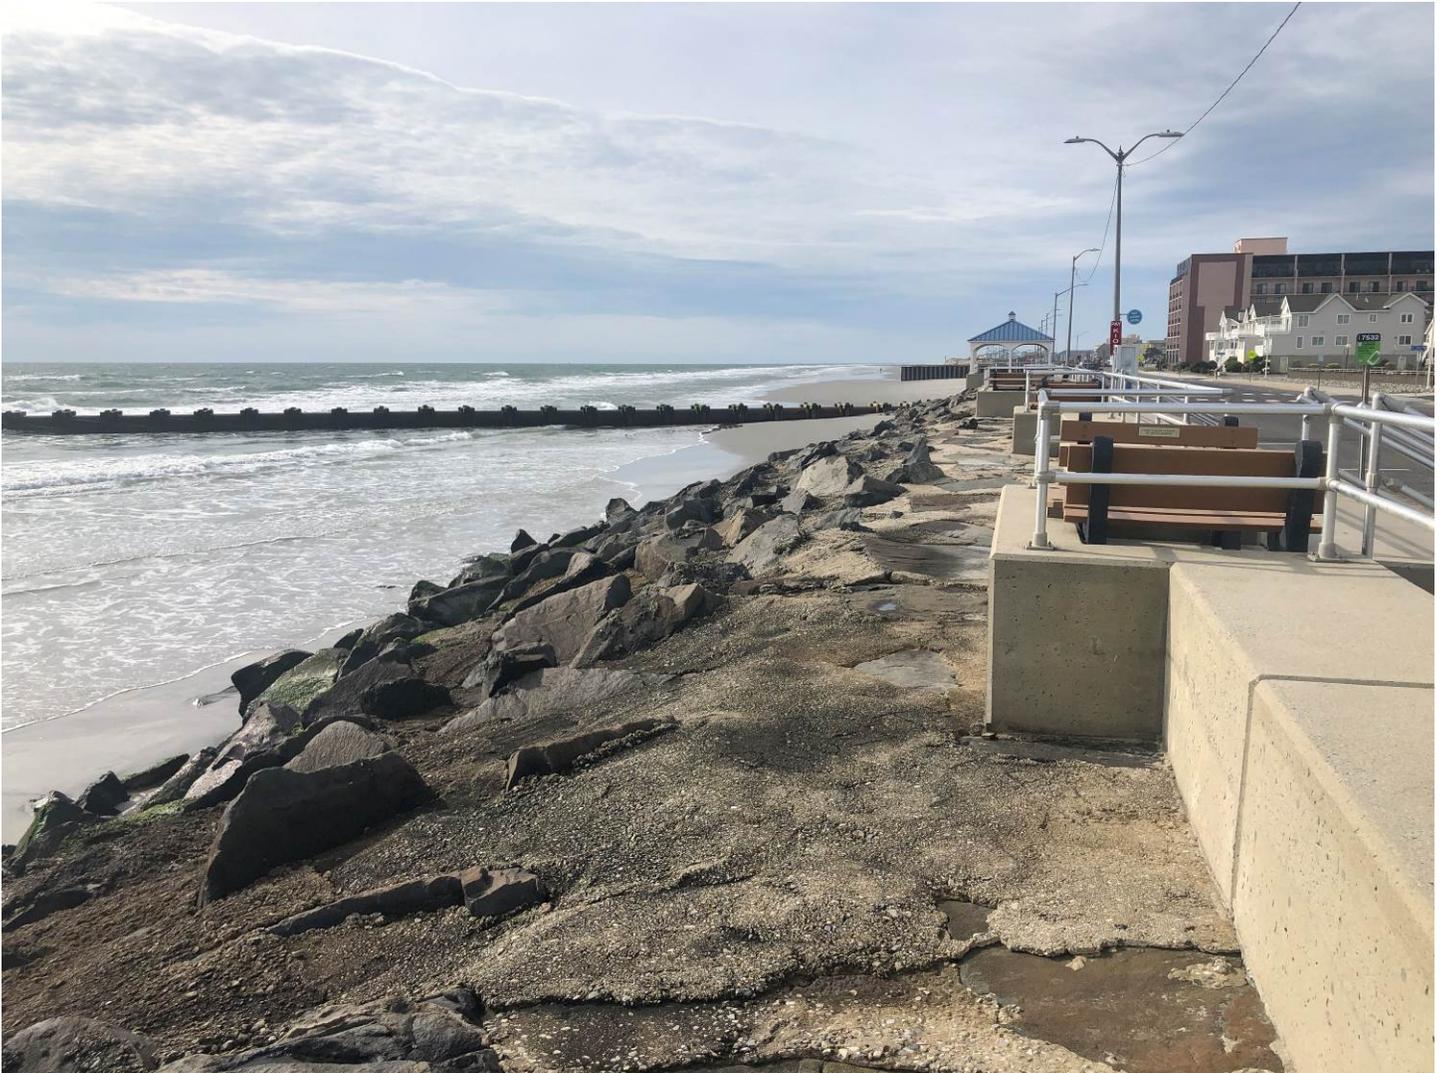
Figure 6. View to the south taken November 7, 2019 showing that the waves at low tide still reach the revetment. The slope offshore is relatively gentle, but not suitable for recreational use.

The site is currently not useable for recreational purposes other than watching the sea from the gazebo or fishing. Expected back passing of sand should provide a narrow dry beach for the coming summer season.

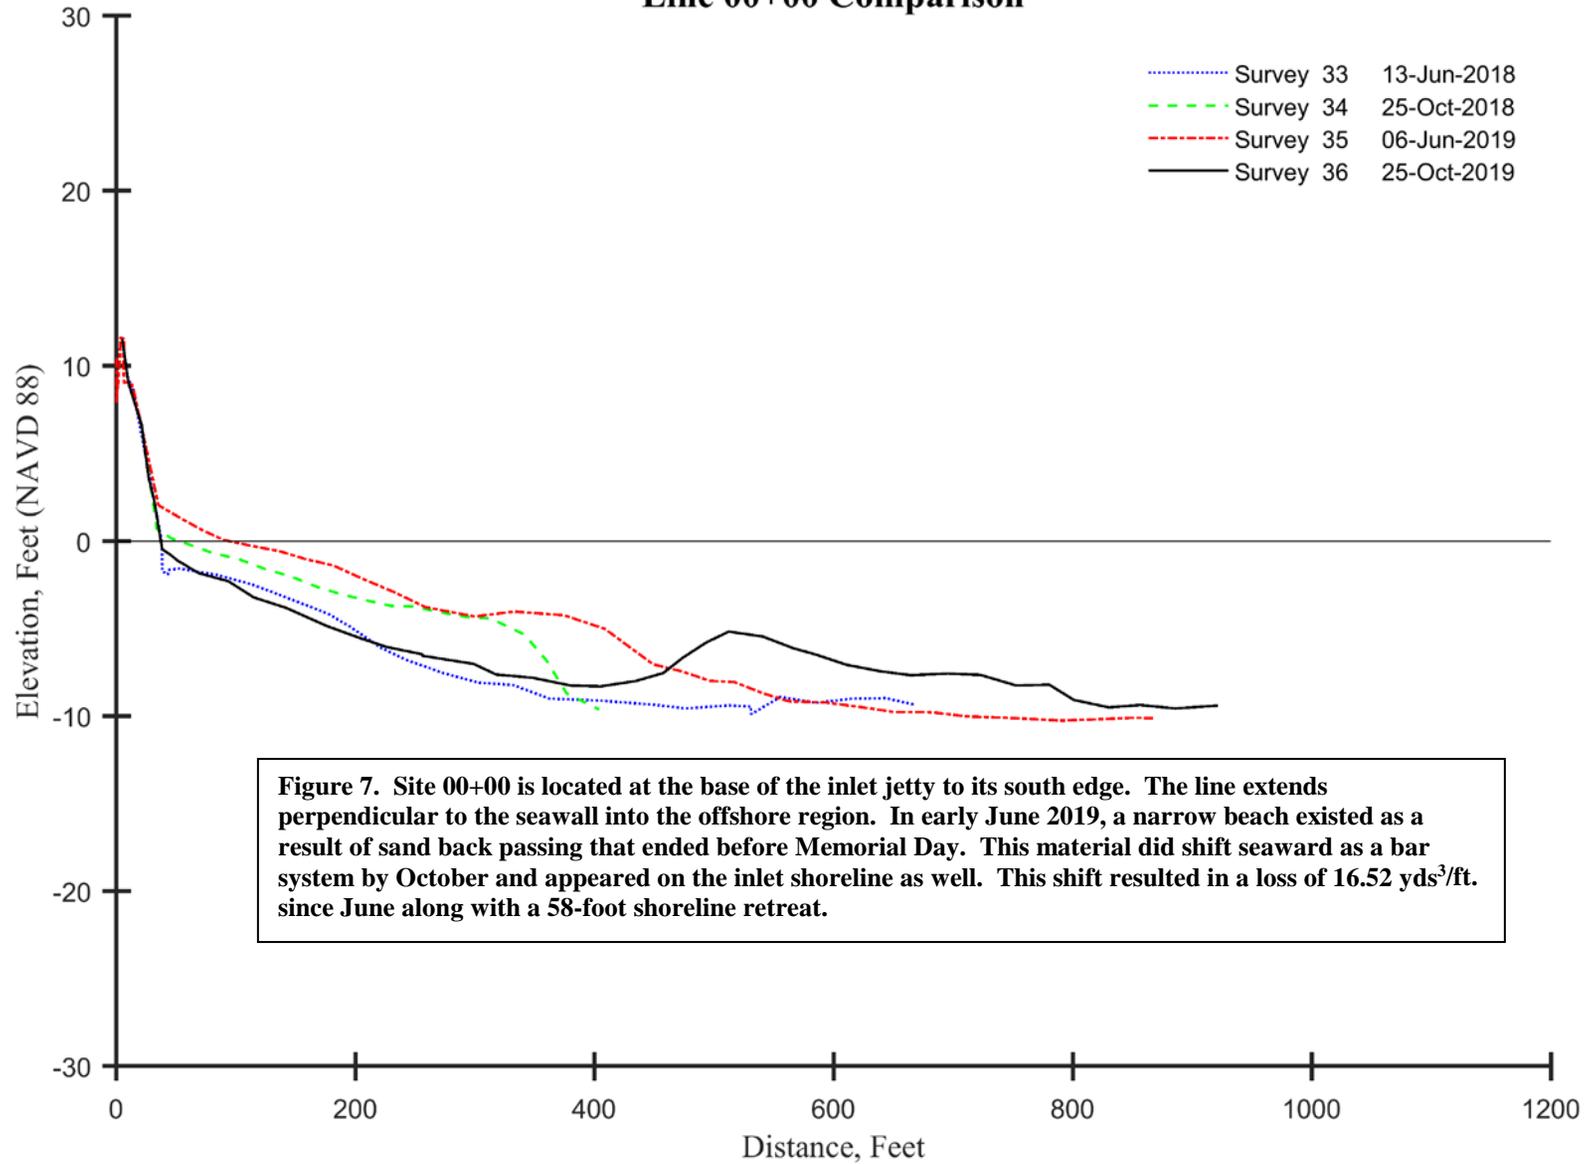
Line 00+00 Comparison

The first profile line was included to show the additions to the offshore region in the immediate vicinity of the Hereford Inlet jetty. This line starts at the oceanfront side of the jetty and extends perpendicular to the seawall into the ocean. There is no high tide beach present, with the first data points as of October 2019 presently just

below zero elevation NAVD 88. The best condition among the four surveys occurred in June 2019 when the starting beach elevation point was at 2.0 feet NAVD 88.

Figure 7. Site 00+00 is located at the base of the inlet jetty to its south edge. The line extends perpendicular to the seawall into the offshore region. In early June 2019, a narrow beach existed as a result of sand back passing that ended before Memorial Day. This material did shift seaward as a bar system by October and appeared on the inlet shoreline as well. This shift resulted in a loss of 16.52 yds³/ft. since June along with a 58-foot shoreline retreat.

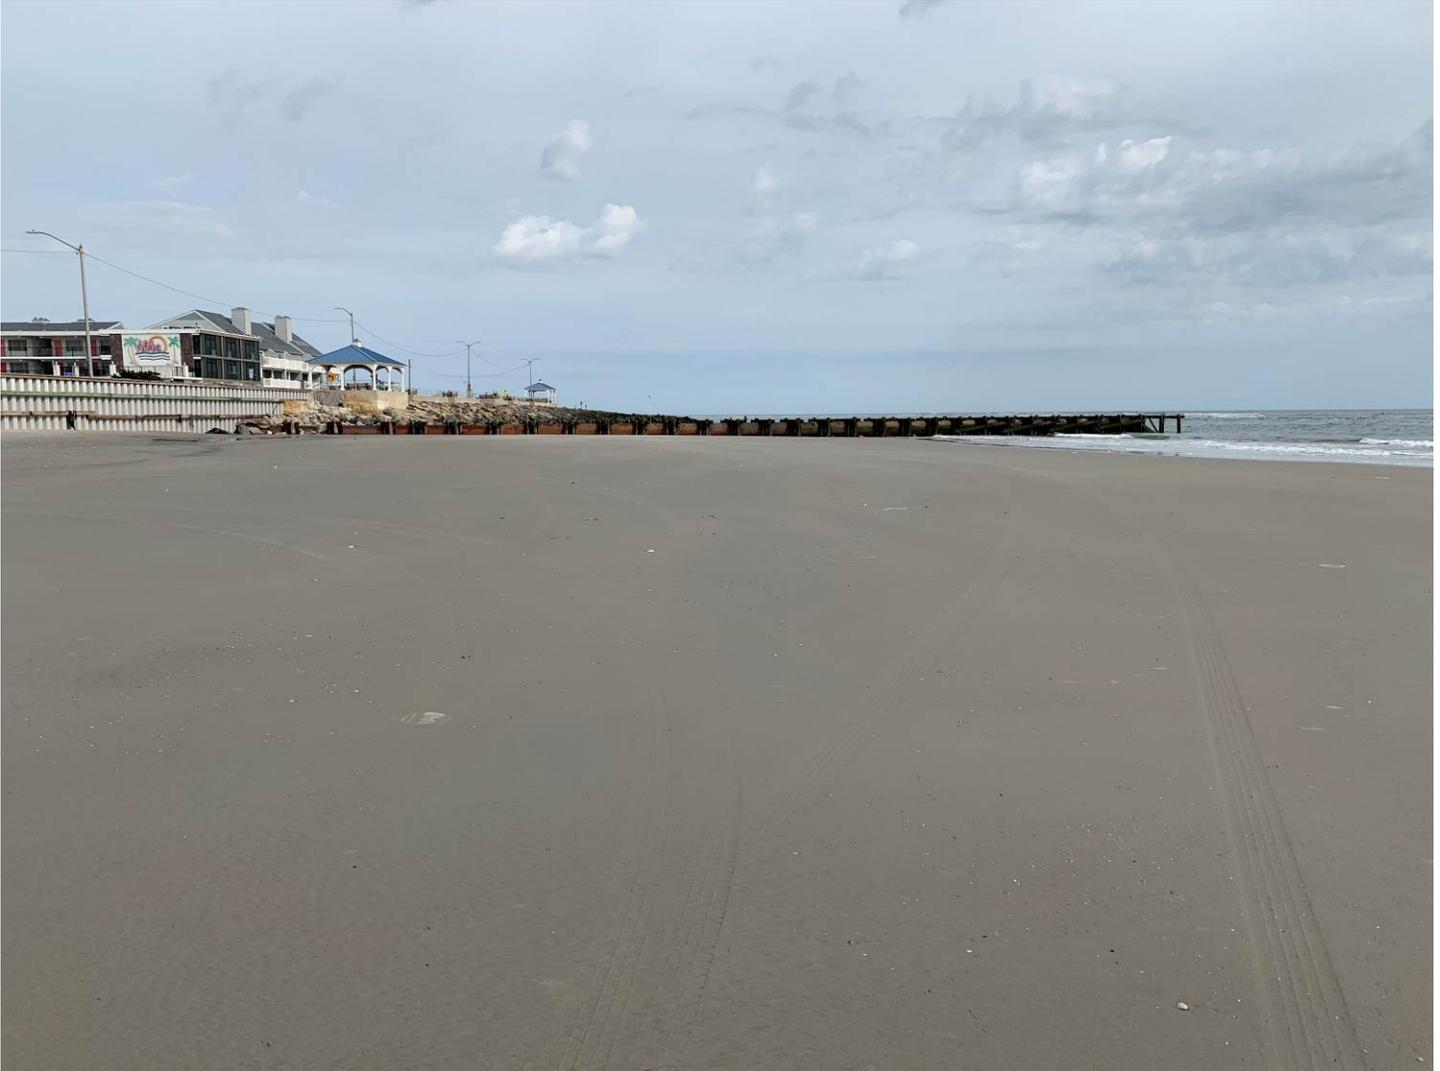
Located 200 feet south of the 2nd Ave. jetty, this site replicates conditions seen to the north. Sand placement by June 2019 had the effect of generating a dry sand beach along the bulkhead revetment that did not last until the fall survey in 2019. An 8-foot drop in elevation occurred at the revetment placing the October survey's starting point elevation just above zero.

Figure 8. The view toward the jetty from the lower beach near low tide shows that there is no dry beach as of October 2019.

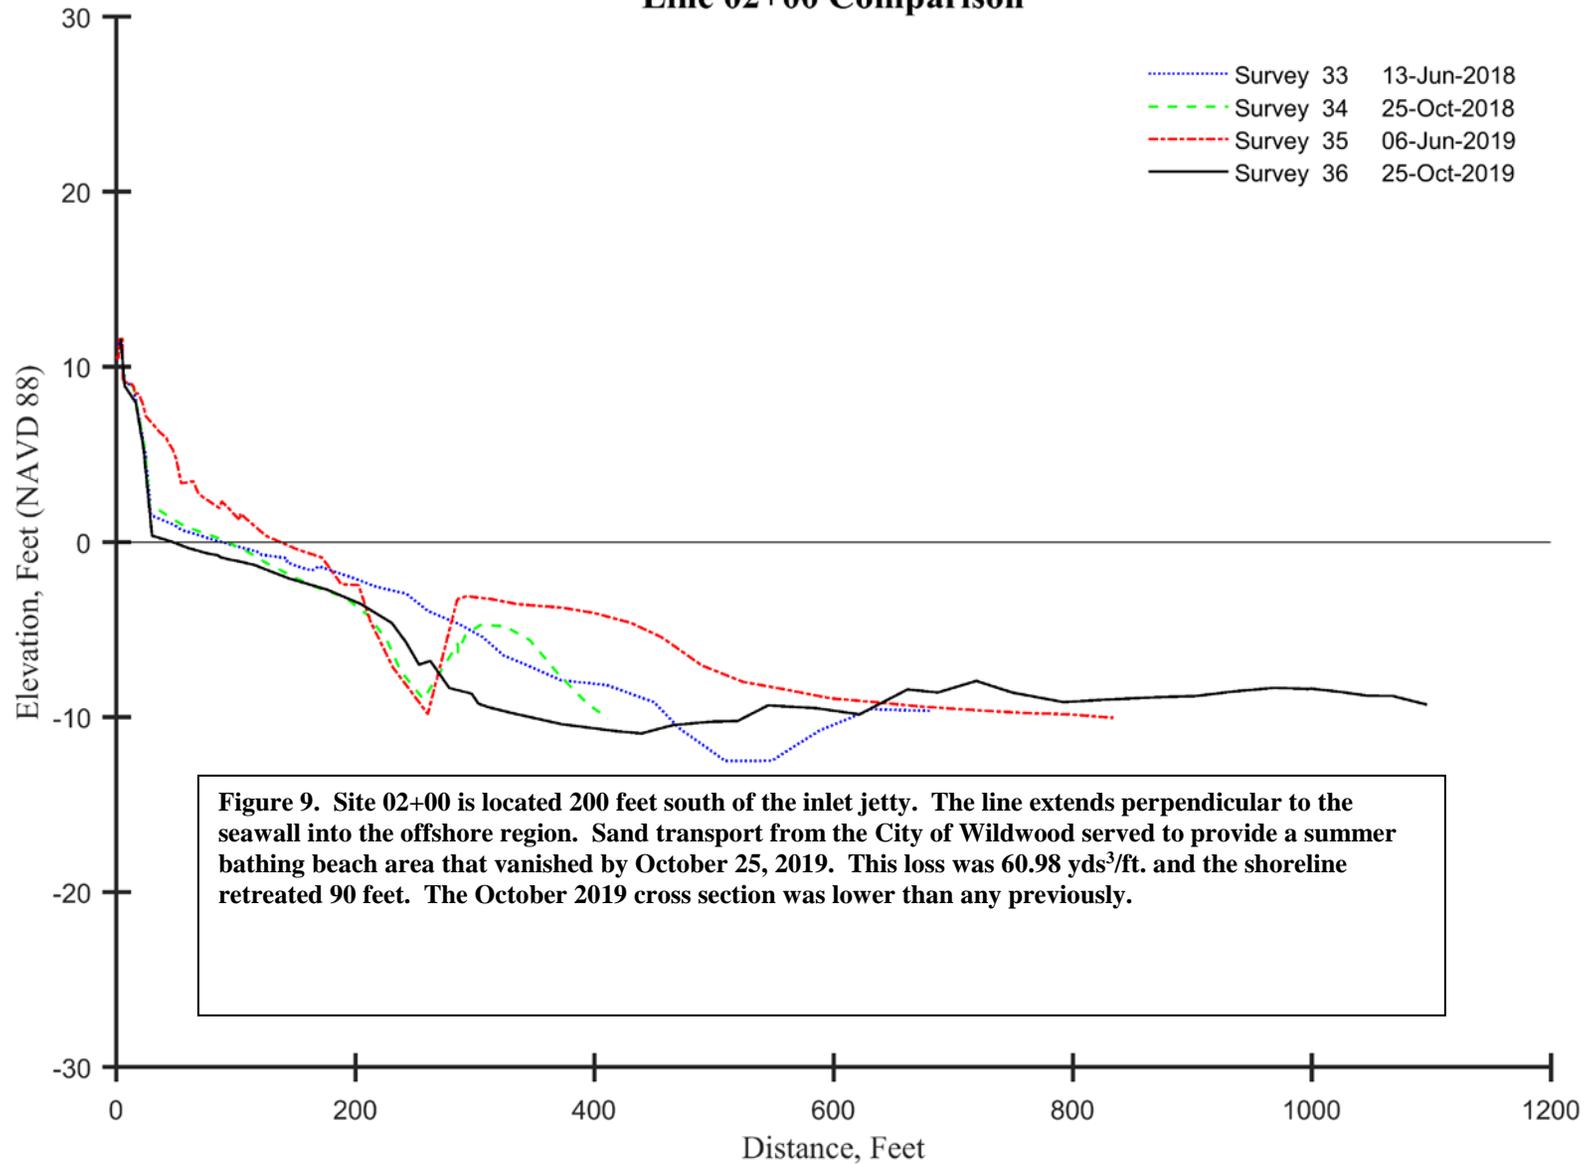
Line 02+00 Comparison

Figure 9. Site 02+00 is located 200 feet south of the inlet jetty. The line extends perpendicular to the seawall into the offshore region. Sand transport from the City of Wildwood served to provide a summer bathing beach area that vanished by October 25, 2019. This loss was 60.98 yds³/ft. and the shoreline retreated 90 feet. The October 2019 cross section was lower than any previously.

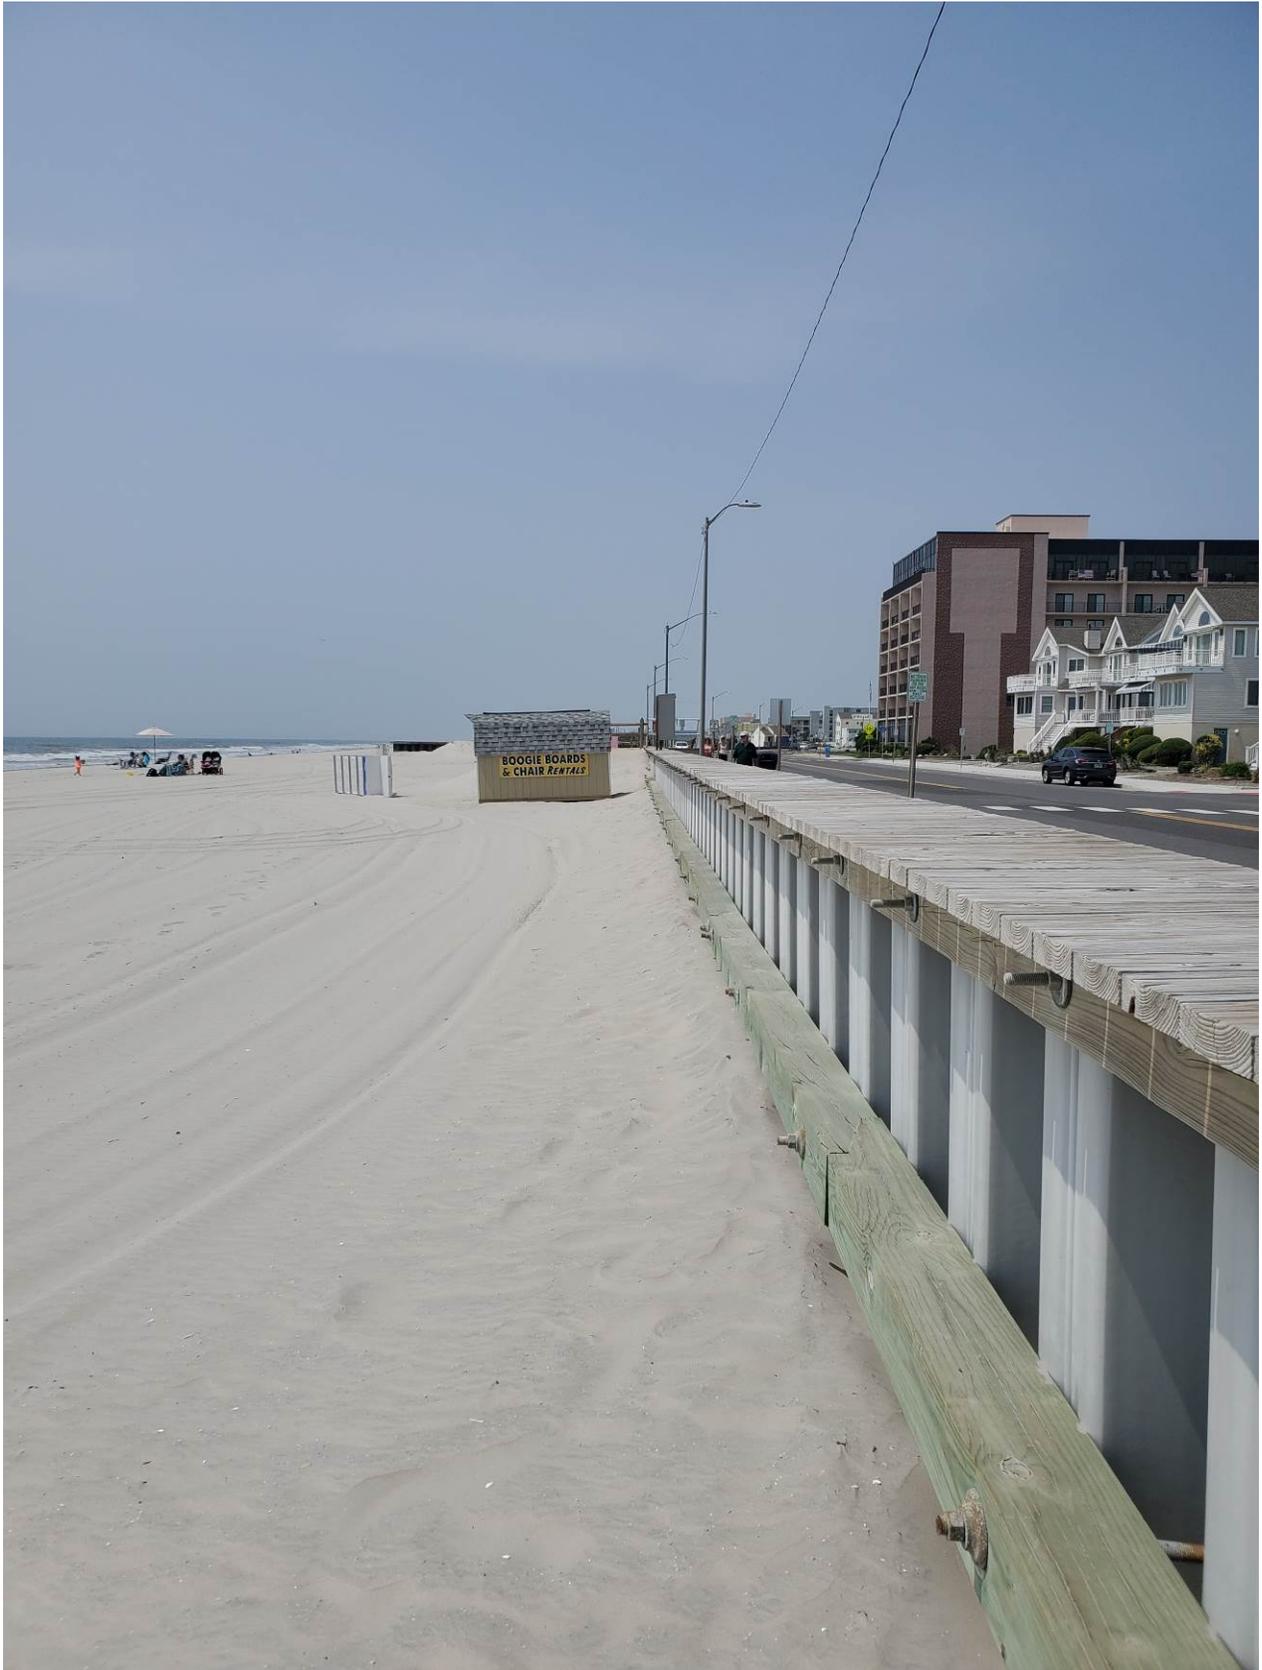
The site is located in the northern portion of the island adjacent to Hereford Inlet 400 feet south of the 2nd Avenue jetty. This area has typically been an erosional shoreline due to its proximity to the inlet and the direct impact from northeast storms. An offshore bar was present in the fall of 2018 indicating sand accumulation offshore related to inlet geomorphic changes which may prove positive to the north end beach. This beach received substantial sand placement during the spring 2019 back pass effort creating a decent-sized recreational beach during the summer. However, by late October the majority of that new material was gone, moved either into Hereford Inlet or transferred south along the remaining oceanfront. This process repeated the events recorded during 2018. *Sand placed here during episodes of back-passing show in the October 2017 and June 2018 survey data, but the beach was eroded to a narrow strip by October 2018.*

Figure 10. View to the south taken from directly in front of the cap on the new bulkhead that starts just south of the 3rd Avenue gazebo after conclusion of back passing on June 6, 2019. By October, the site was wet to the bulkhead with a complete loss of the bathing area.

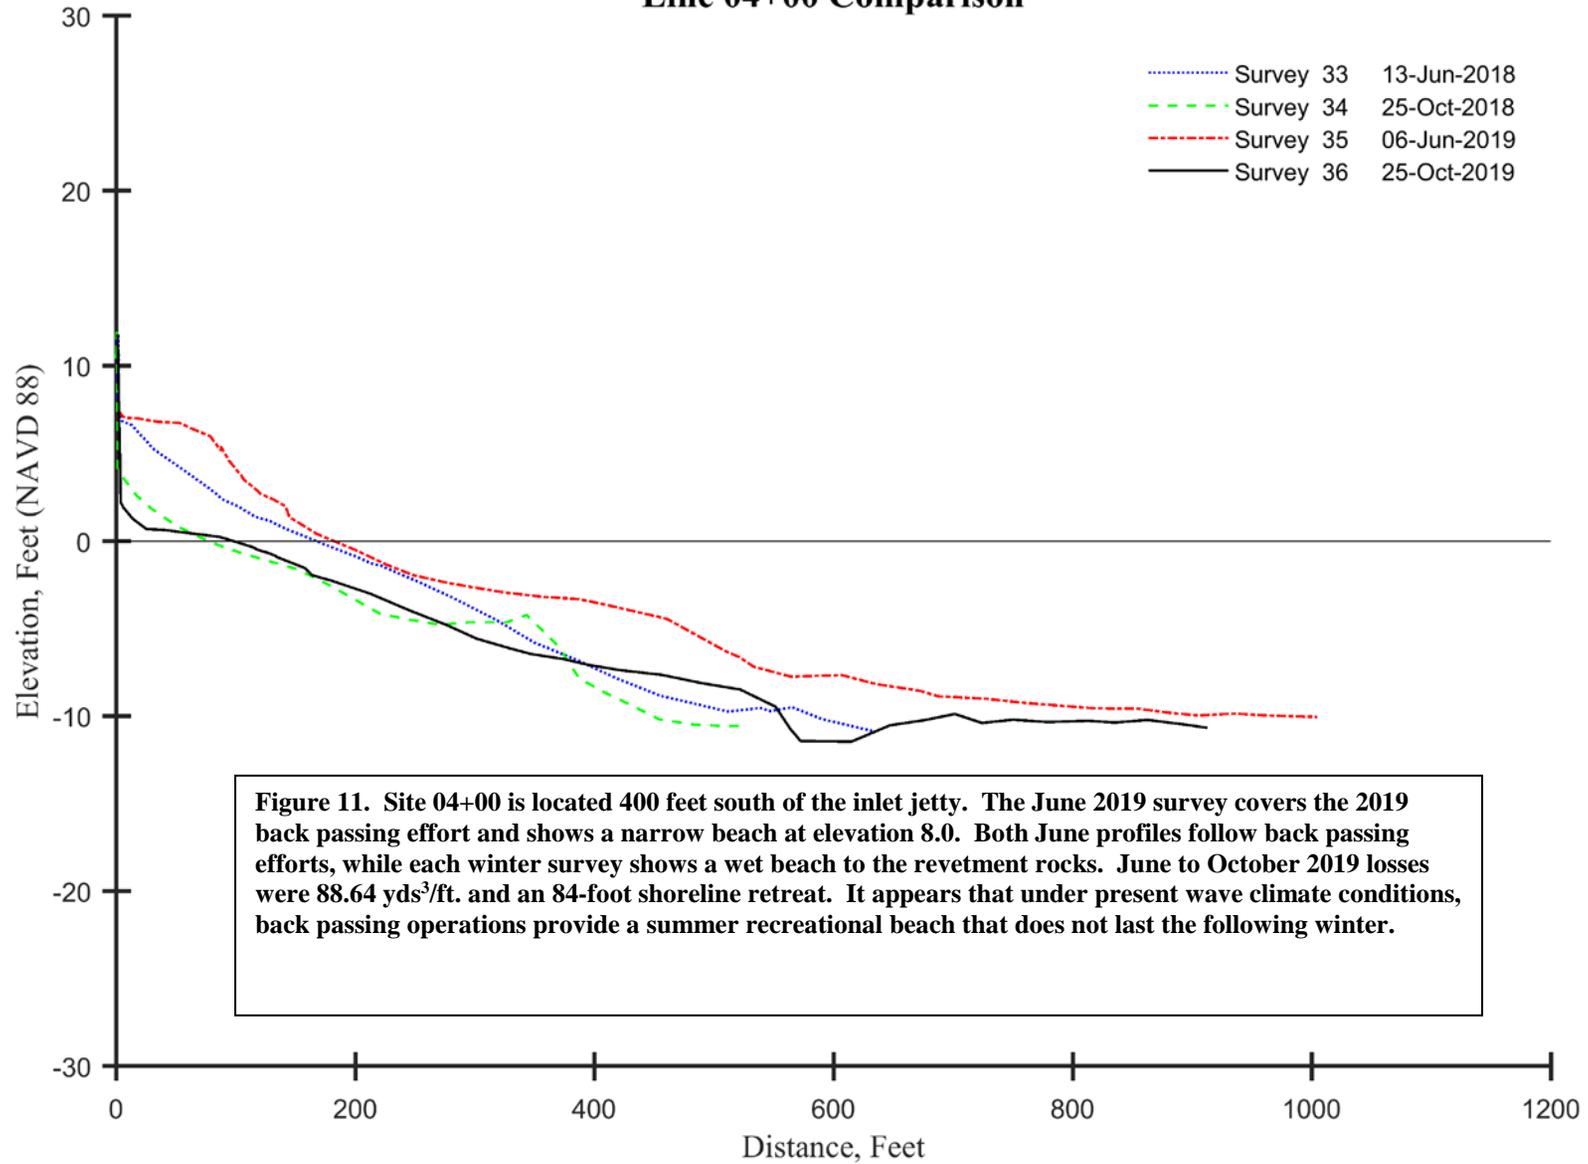
Line 04+00 Comparison

Figure 11. Site 04+00 is located 400 feet south of the inlet jetty. The June 2019 survey covers the 2019 back passing effort and shows a narrow beach at elevation 8.0. Both June profiles follow back passing efforts, while each winter survey shows a wet beach to the revetment rocks. June to October 2019 losses were 88.64 yds³/ft. and an 84-foot shoreline retreat. It appears that under present wave climate conditions, back passing operations provide a summer recreational beach that does not last the following winter.

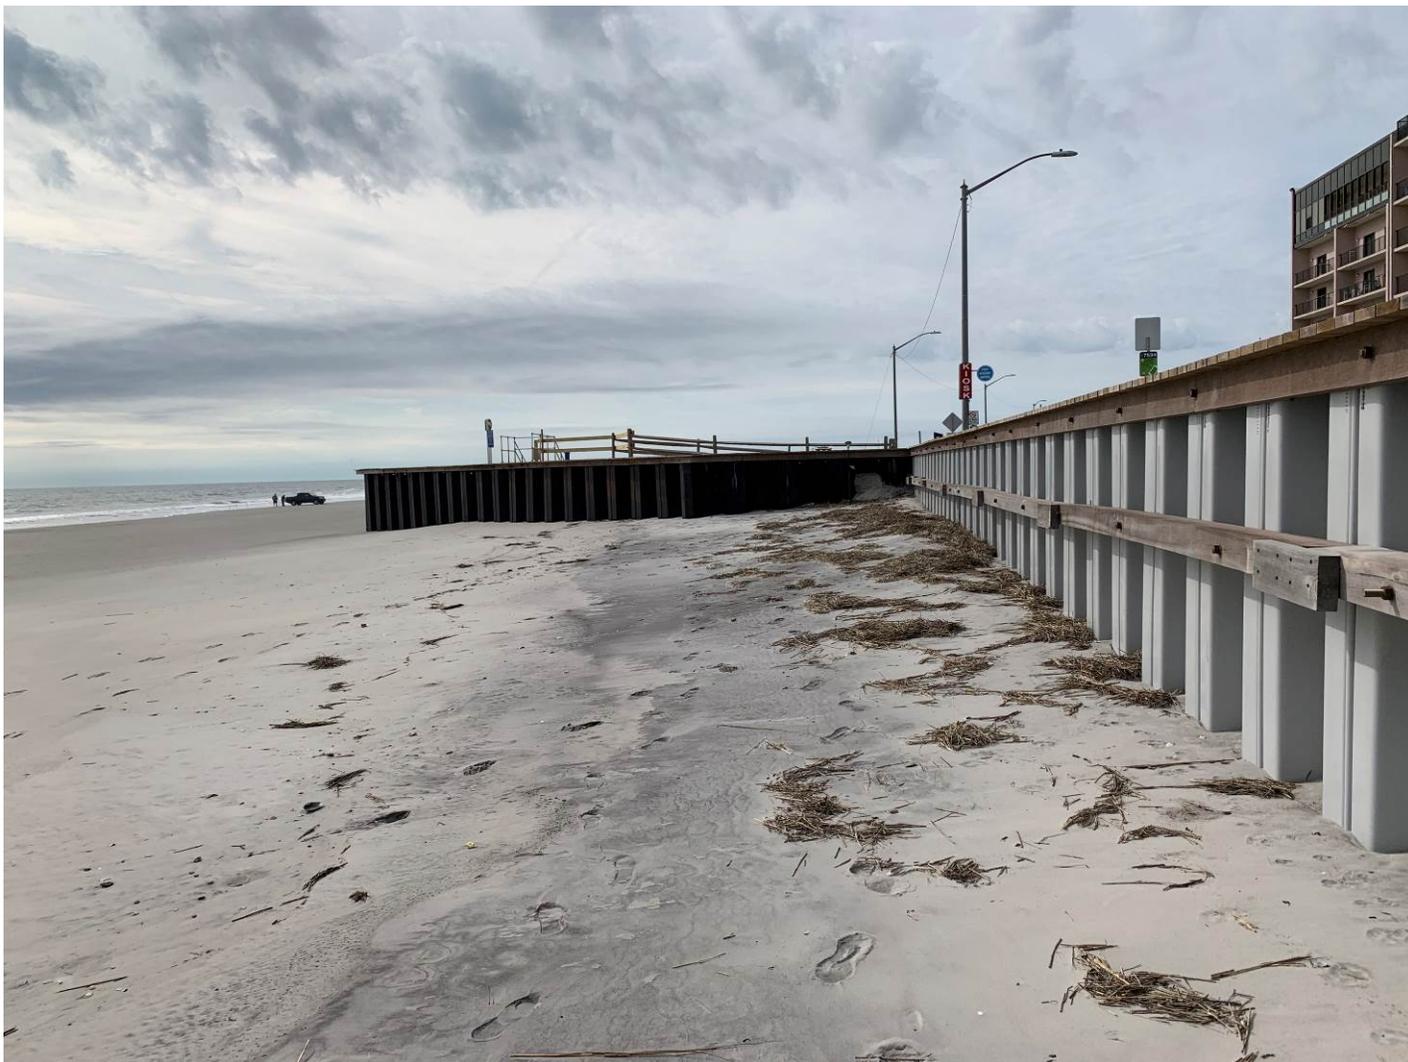
The third of the northern survey sites is located at the end of 4th Avenue where the new bulkhead was completed in early 2018. By 2018 all traces of the 2009 dune system had eroded away, replaced by material trucked in from Wildwood. The survey profiles (Figure 13) show the extreme contrast between the site with back passed sand present and after a storm season reduced the profile to a wet beach to the bulkhead. The same processes inflicted the same results at 06+00 as seen to the north and the prior year.

Figure 12. Site 06+00 is on the beach in proximity where the new bulkhead starts. The wrack material indicates that high tide just reaches the bulkhead at this location as of October 25, 2019. This is the contrast with the view of site 04+00 taken in June just after back pass operations for 2019 were complete.
