**2019 ANNUAL REPORT - TO THE CITY OF NORTH WILDWOOD
ON THE
CONDITION OF THE CITY BEACHES**

**PREPARED FOR: THE CITY OF NORTH WILDWOOD
901 ATLANTIC AVENUE
NORTH WILDWOOD, NJ 08260**

**PREPARED BY: THE STOCKTON UNIVERSITY COASTAL RESEARCH CENTER
30 WILSON AVENUE
PORT REPUBLIC, NJ 08241
February 26, 2020**

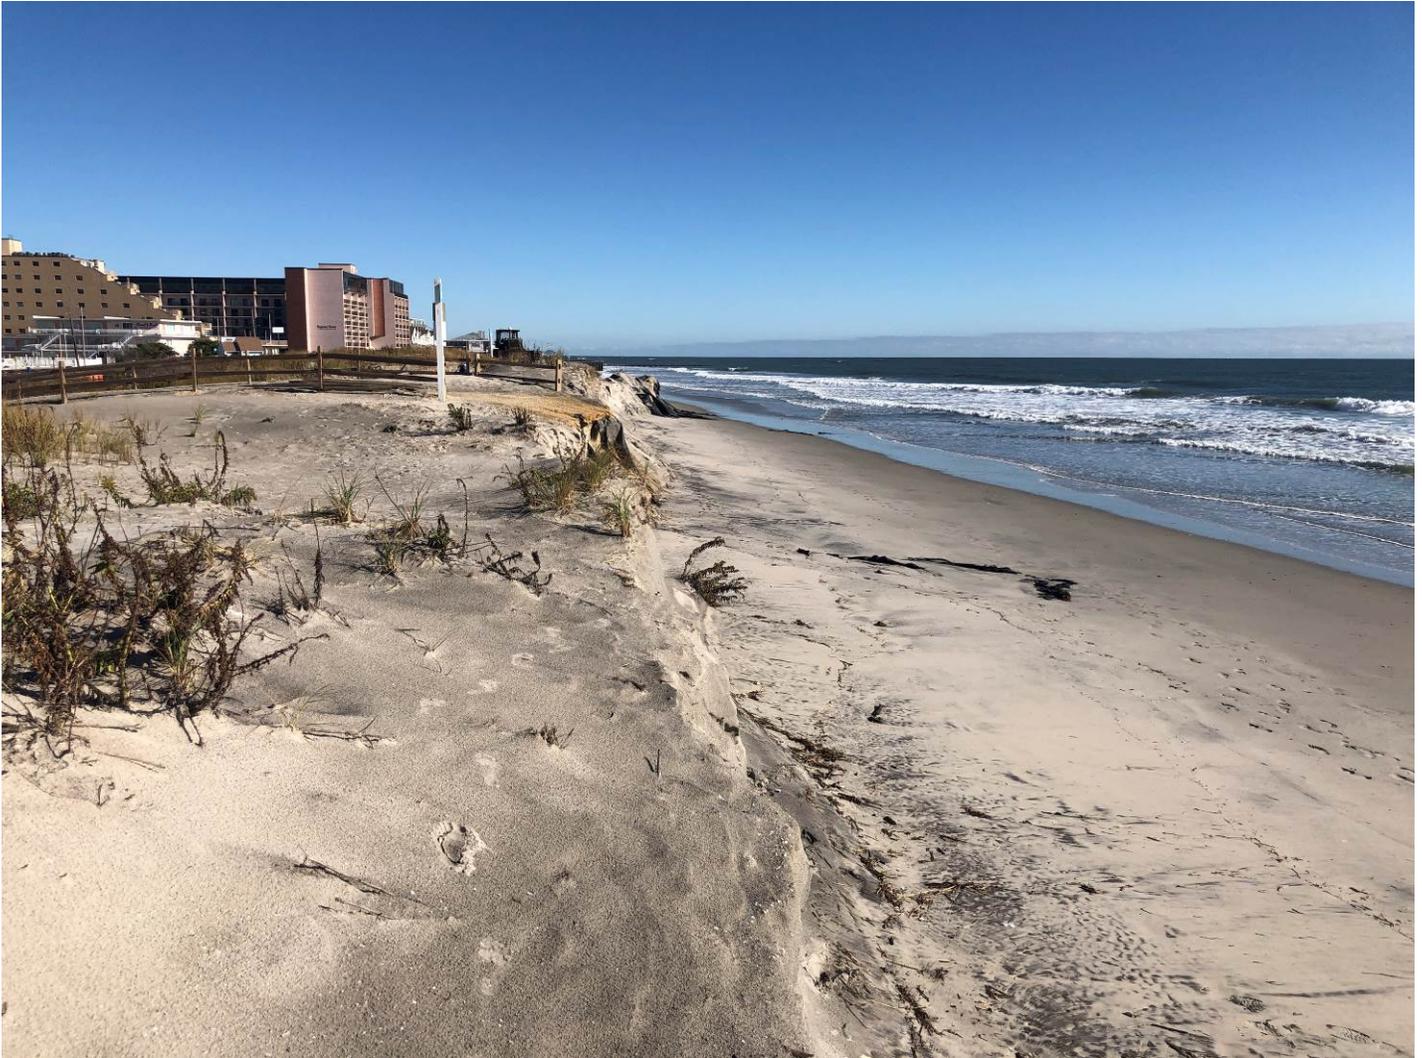
This site is located 2,000 feet south of the inlet jetty and is near the transition from erosion to stability and even accretion from time to time. Dune erosion has occurred here during storms, but frequently has resolved with wind transport and deposition after the storm event. Beach retreat was most dramatic between June and October 2018, after the spring series of northeast events had concluded with a minor event the day prior to Memorial Day 2018. The beach loss has an impact on both the dune stability and the available recreational space between 8th and 15th Streets. The pattern of beach retreat through 2019 indicates that the transport of sand south toward Wildwood has continued, but the appearance of sand offshore at the Hereford Inlet jetty might show changes at the inlet that could prove beneficial to the oceanfront beach in general.

Figure 14. Last fall's picture showed a low beach scarp seaward of the dunes, while this view demonstrates the severity of the entire dune losses since June 2019.

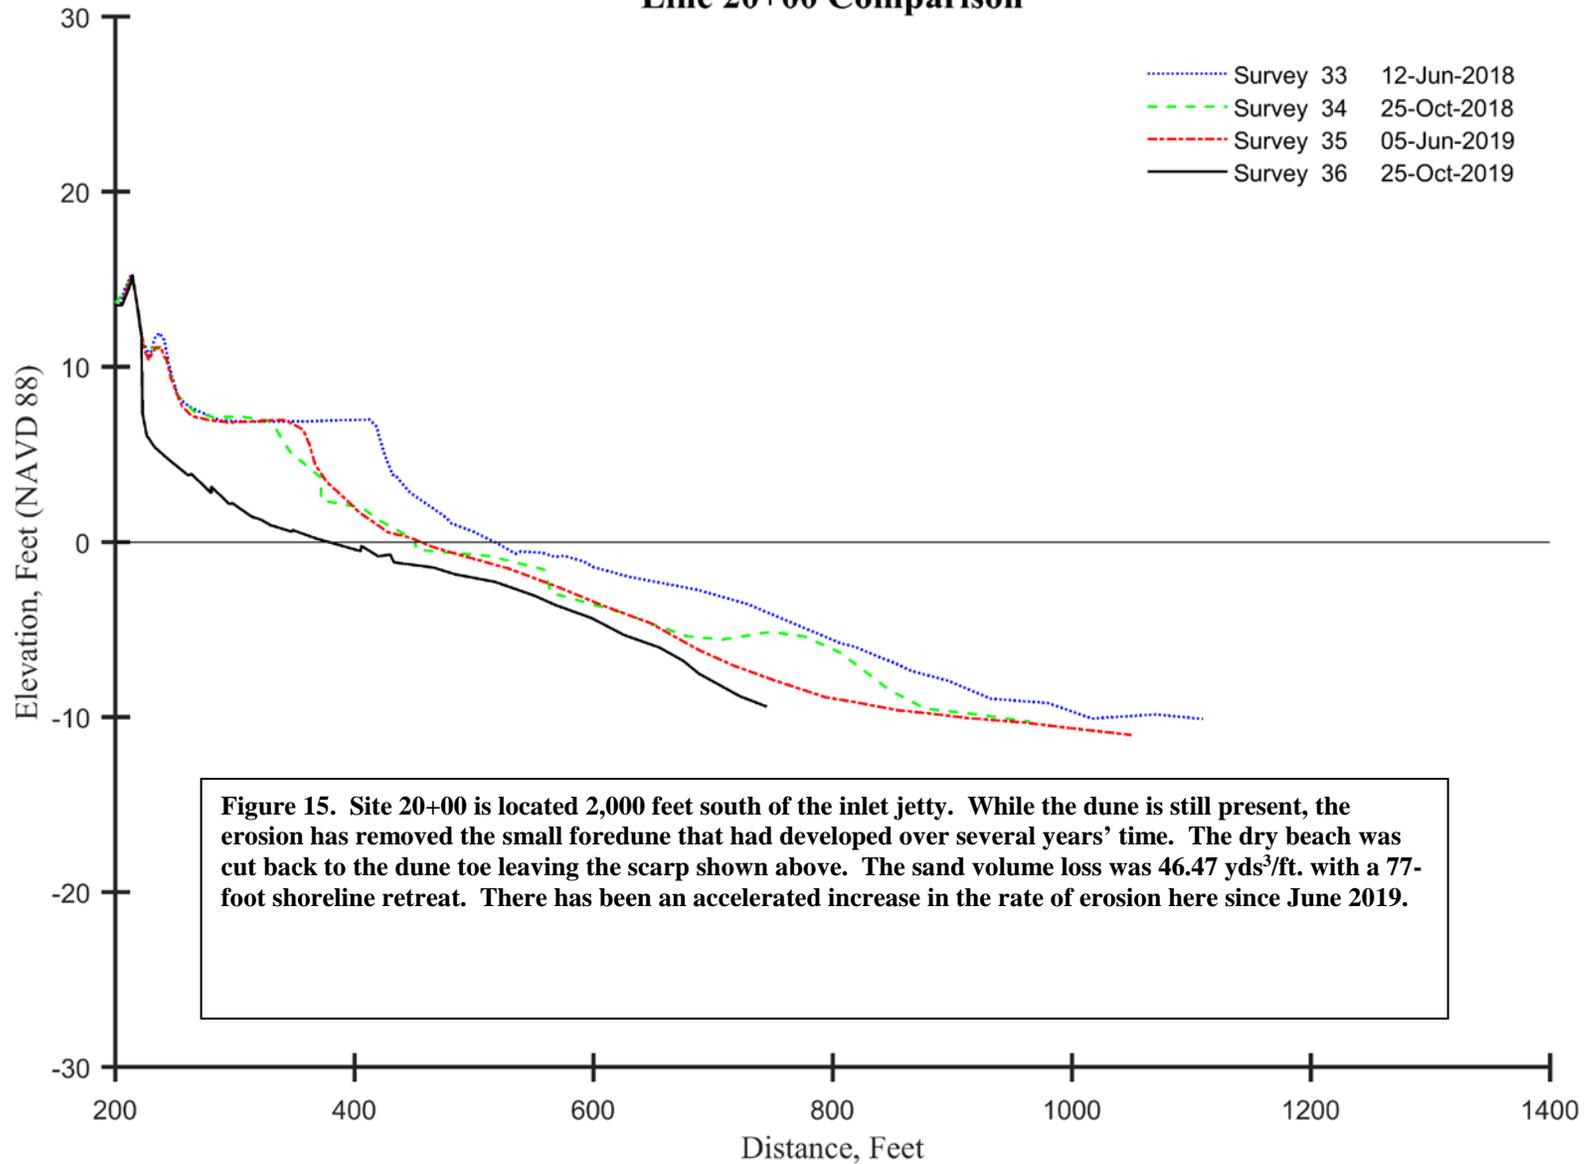
Line 20+00 Comparison

Figure 15. Site 20+00 is located 2,000 feet south of the inlet jetty. While the dune is still present, the erosion has removed the small foredune that had developed over several years' time. The dry beach was cut back to the dune toe leaving the scarp shown above. The sand volume loss was 46.47 yds³/ft. with a 77-foot shoreline retreat. There has been an accelerated increase in the rate of erosion here since June 2019.

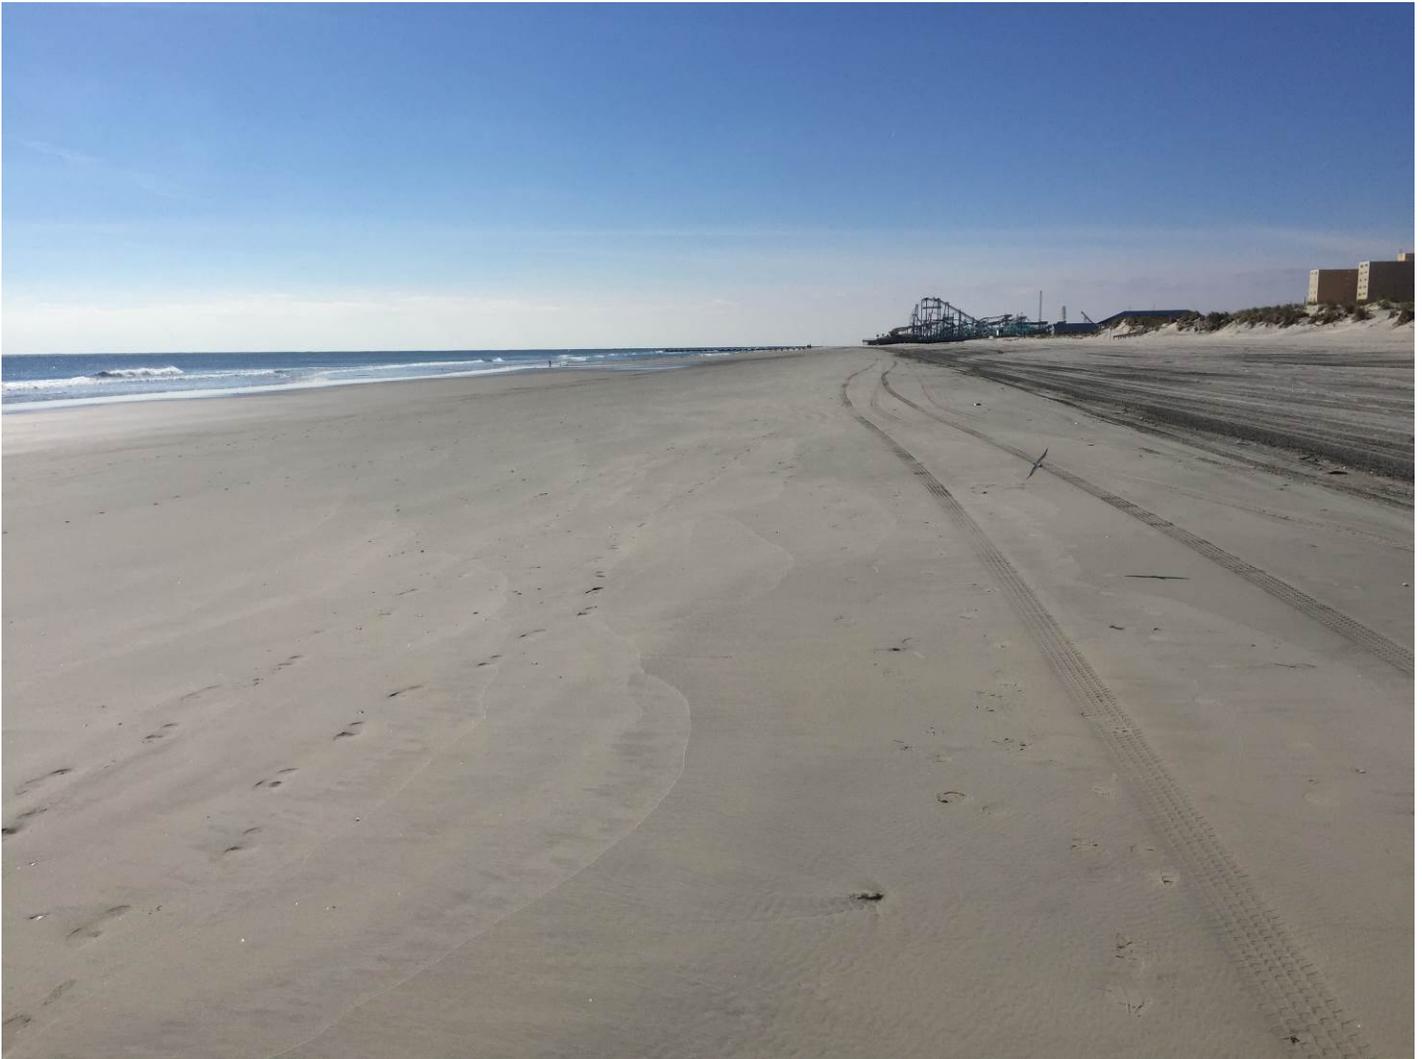
Positioned 4,000 feet south of the 2nd Avenue jetty, this site is located two blocks south of the lifeguard station in the mid-section of the City's oceanfront beaches. Following initial construction in 2009 this region has remained relatively stable. The dry sand expanse has diminished over the past decade, leaving the visitor's use area dependent on wave run-up conditions.

The beach narrowed over the past year with a flatter slope into the ocean. There was a modest offshore bar present these 12 months.

Figure 16. View to the south along the upper beach on October 25, 2019. Beach flattening has moved the wet/dry surf line close to the dunes. While no erosion of the dunes has occurred yet, the narrow beach where the most visitors tend to gather presents a space problem for the coming season.

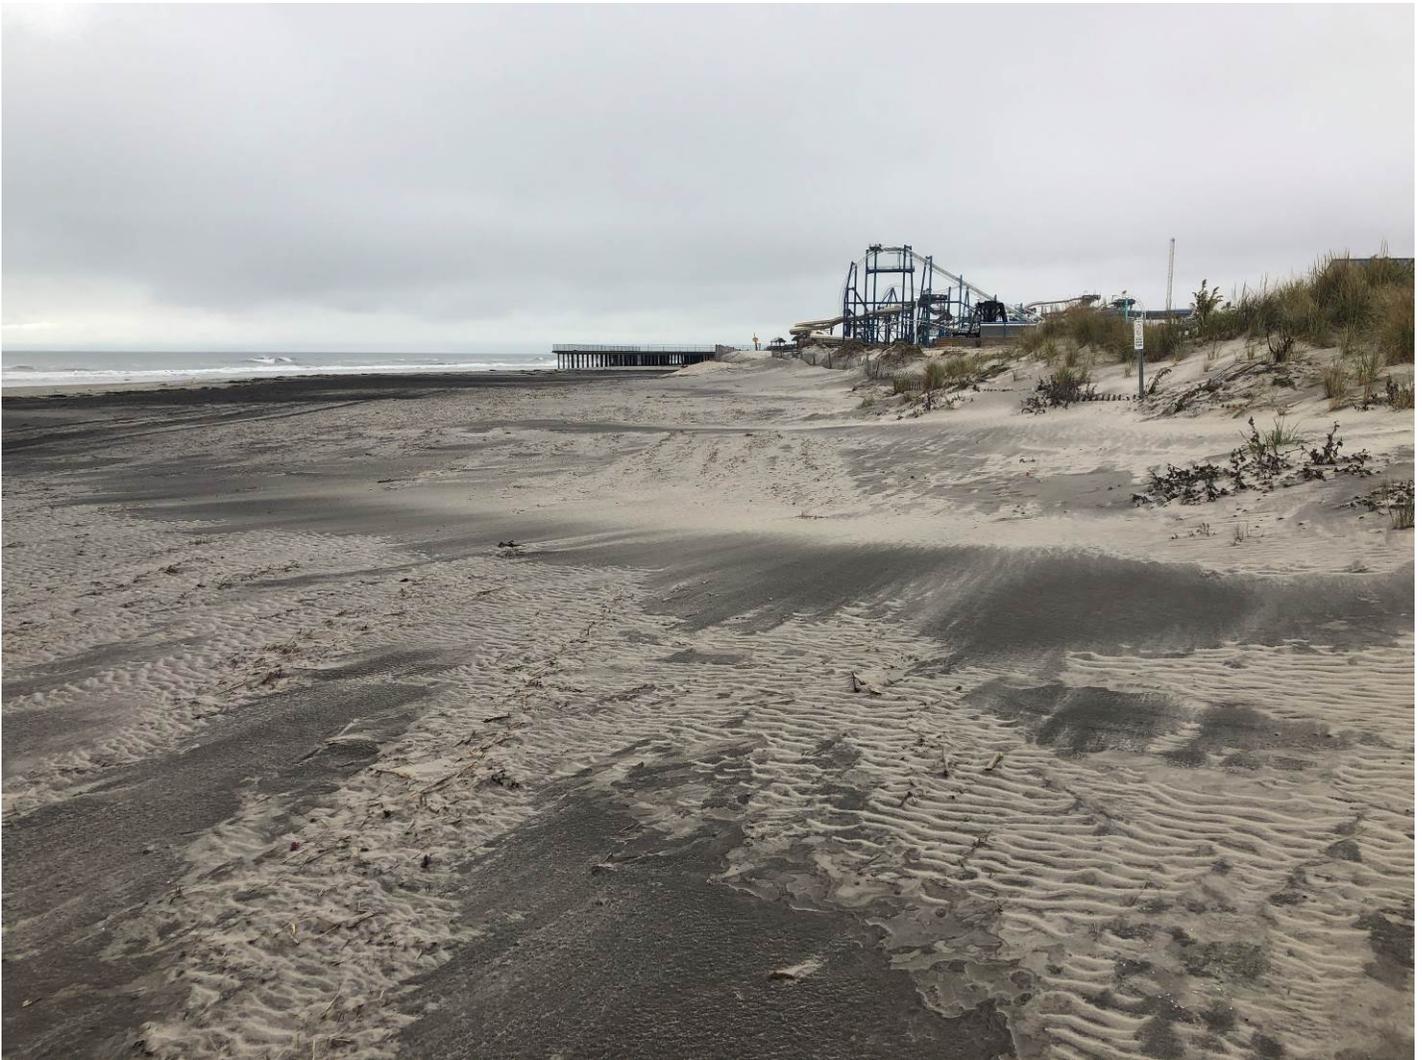
Several hundred feet of dry beach still protected the dune system at this location and to the north, to the south the beach width seaward of the dune was diminished significantly from the initial project design. Immediately south of this location, the engineered dune was initially built with a seaward jog in its alignment from just seaward of the boardwalk to run seaward of the eastern ends of the timber and Morey's piers in North Wildwood.

Figure 18. View to the south taken from the dune toe at 21st Avenue on October 28, 2019. The view along this part of the dune system shows a wider beach extending north and south from where the project design had the dune shift seaward in order to pass seaward of the three piers and the fourth structure at the Wildwood boundary. The start of the dune shift seaward commences just south of this survey line. The landward position has saved this dune from wave attack.

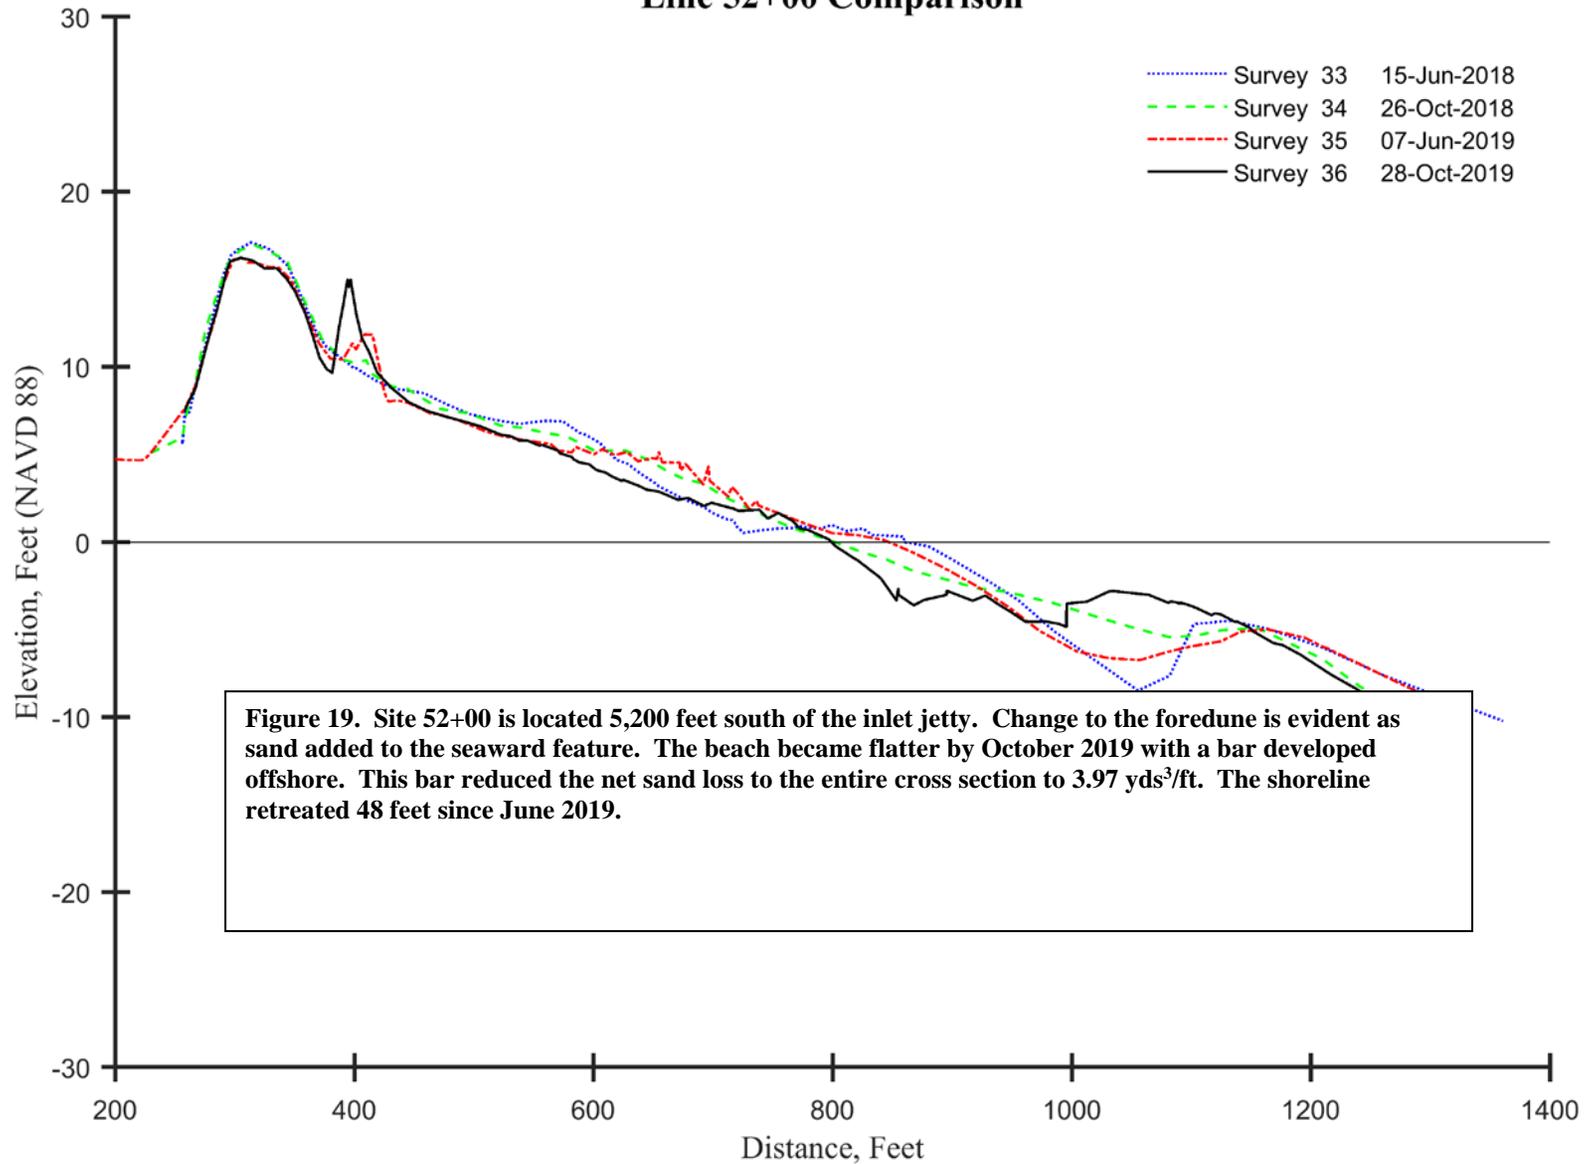
Line 52+00 Comparison

Figure 19. Site 52+00 is located 5,200 feet south of the inlet jetty. Change to the foredune is evident as sand added to the seaward feature. The beach became flatter by October 2019 with a bar developed offshore. This bar reduced the net sand loss to the entire cross section to 3.97 yds³/ft. The shoreline retreated 48 feet since June 2019.

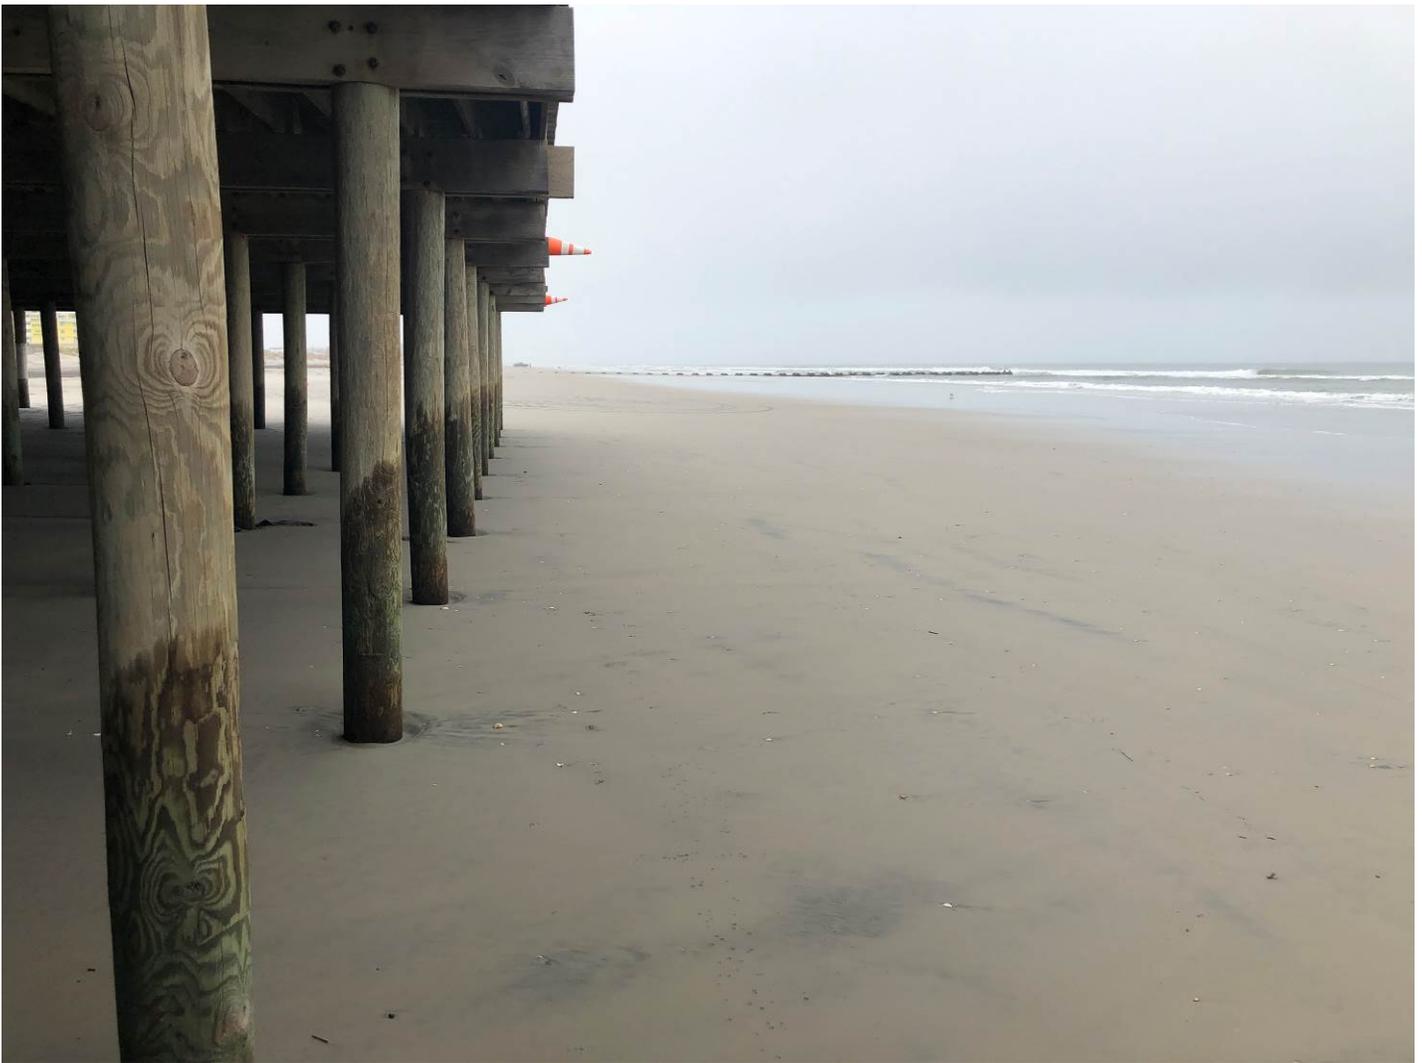
This site is located in the southern section of the City's oceanfront where the engineered dune system was originally constructed seaward of the piers. The original NJDEP project permits mandated a seaward jog in the dune system, which resulted in their vulnerability to the spate of frequent storms since 2009.

An effort was made in 2013 to restore the dune, but events in 2014 forced re-positioning the dune system landward between the piers and including a large vegetated island dune that had existed between Morey's Surfside Pier and the adjacent timber pier. The dune was merged with the landward end of the northeast side bulkhead wall put in for defense of the seaward end of the Surfside Pier. Sand was placed beside each timber pier as well to mitigate storm waves reaching boardwalk development. The view below documents the loss of beach elevation causing the pier ends to be positioned below normal high tide.

Figure 20. The northern timber pier lies in the surf zone after shoreline retreat. The flat beach is wide and would accumulate sand if it were available to move onto the shoreline. This view was taken October 30, 2019.

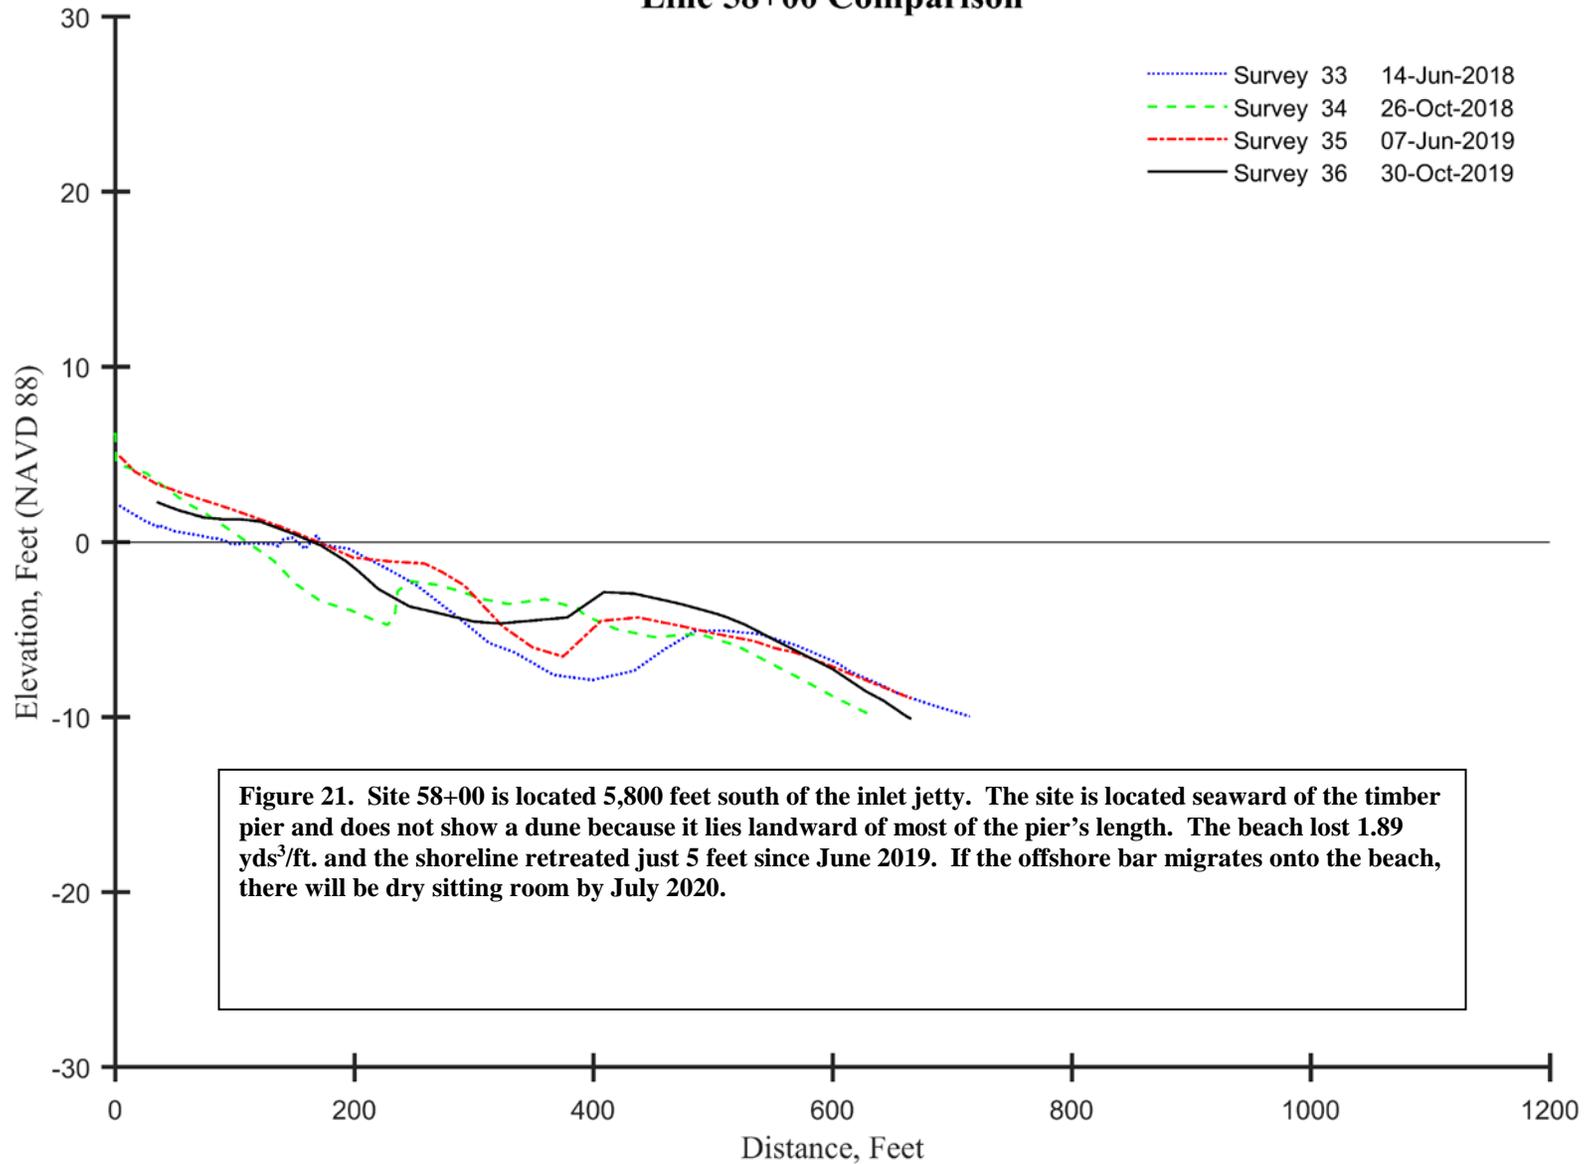
Line 58+00 Comparison

Figure 21. Site 58+00 is located 5,800 feet south of the inlet jetty. The site is located seaward of the timber pier and does not show a dune because it lies landward of most of the pier's length. The beach lost 1.89 yds³/ft. and the shoreline retreated just 5 feet since June 2019. If the offshore bar migrates onto the beach, there will be dry sitting room by July 2020.

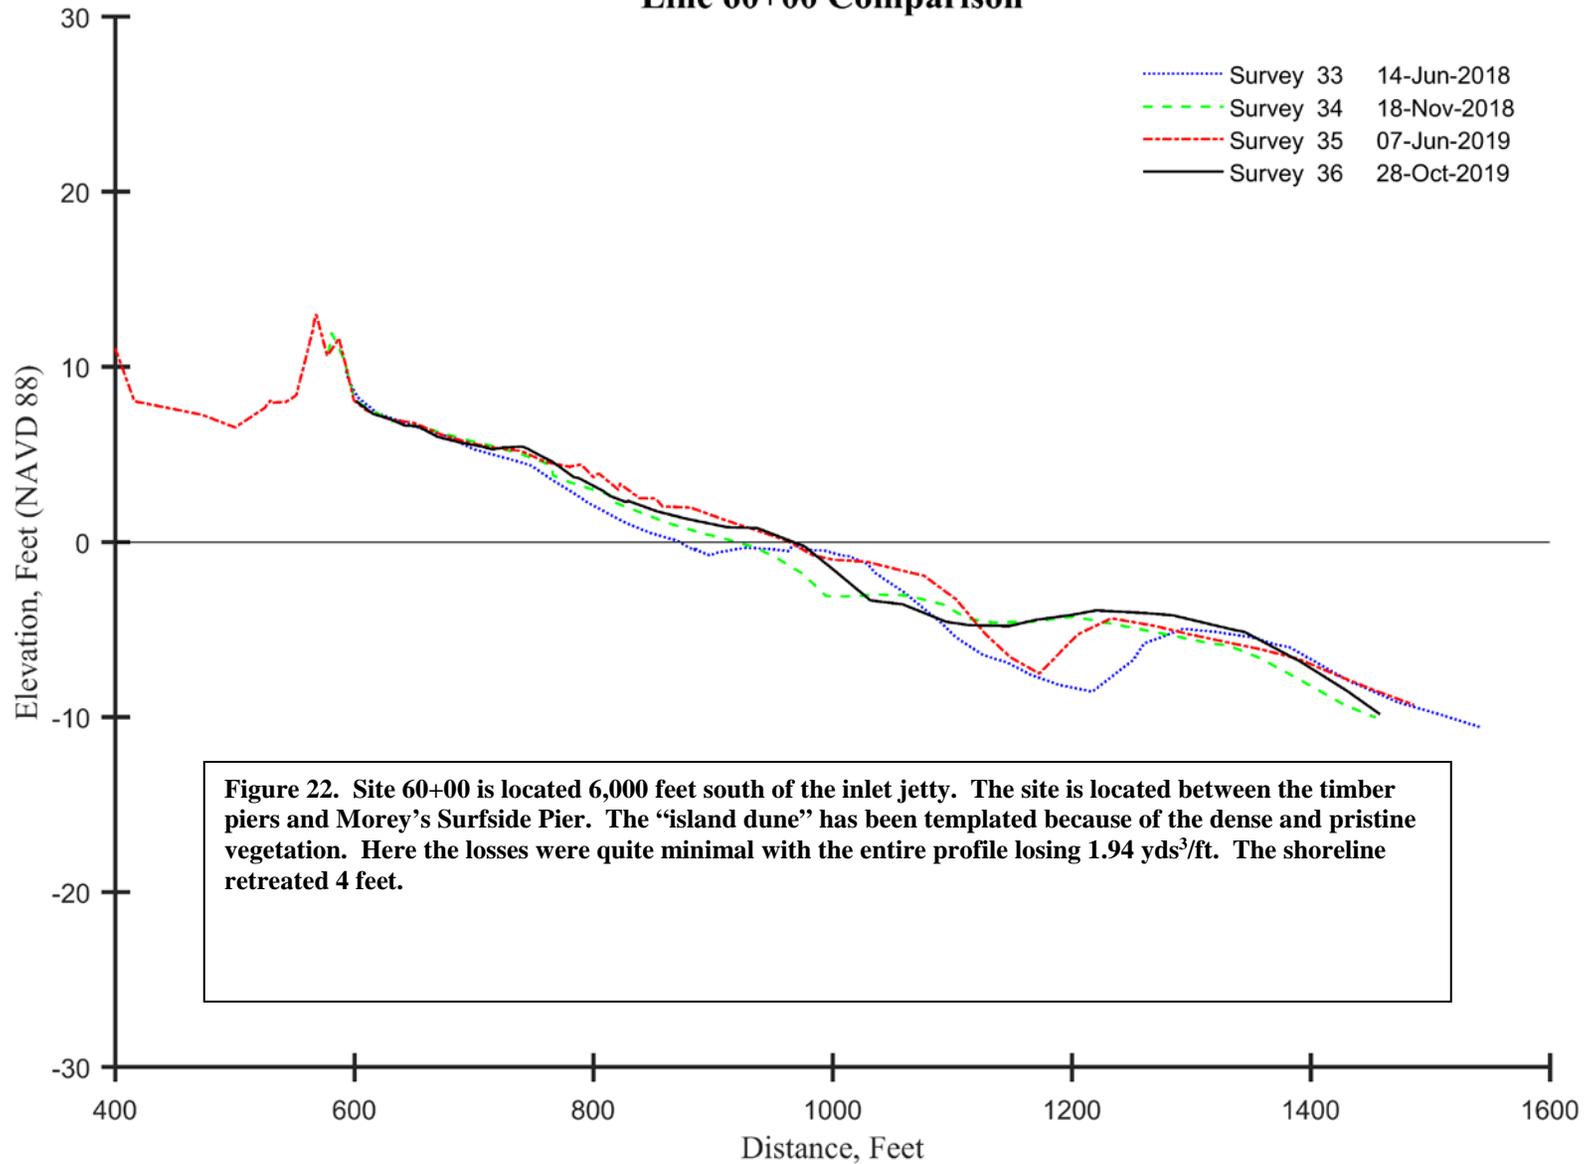
Line 60+00 Comparison

In an effort to better define the beach zone where piers dominate in North Wildwood, this site was included to show the changes to enhance dune protection since Hurricane Sandy. The main feature is an old dune island likely developed around beach raking debris left in a variety of places when the North Wildwood beach was much wider. In the 1990's multiple island dunes existed from 15th Avenue south to here because sand accumulated among the debris and plant seeds always accompanied the grass stems and other organics washed up onto the shoreline. These germinated, established and trapped more sand enhancing these features. The majority of these dune island features are long eroded away as the beachfront retreated between 1994 and 2009. During 2019 the beach elevation was at the minimum during the June 2018 survey. Elevations improved up to the June 2019 survey, then decreased slightly.

Figure 22. Site 60+00 is located 6,000 feet south of the inlet jetty. The site is located between the timber piers and Morey's Surfside Pier. The "island dune" has been templated because of the dense and pristine vegetation. Here the losses were quite minimal with the entire profile losing 1.94 yds³/ft. The shoreline retreated 4 feet.

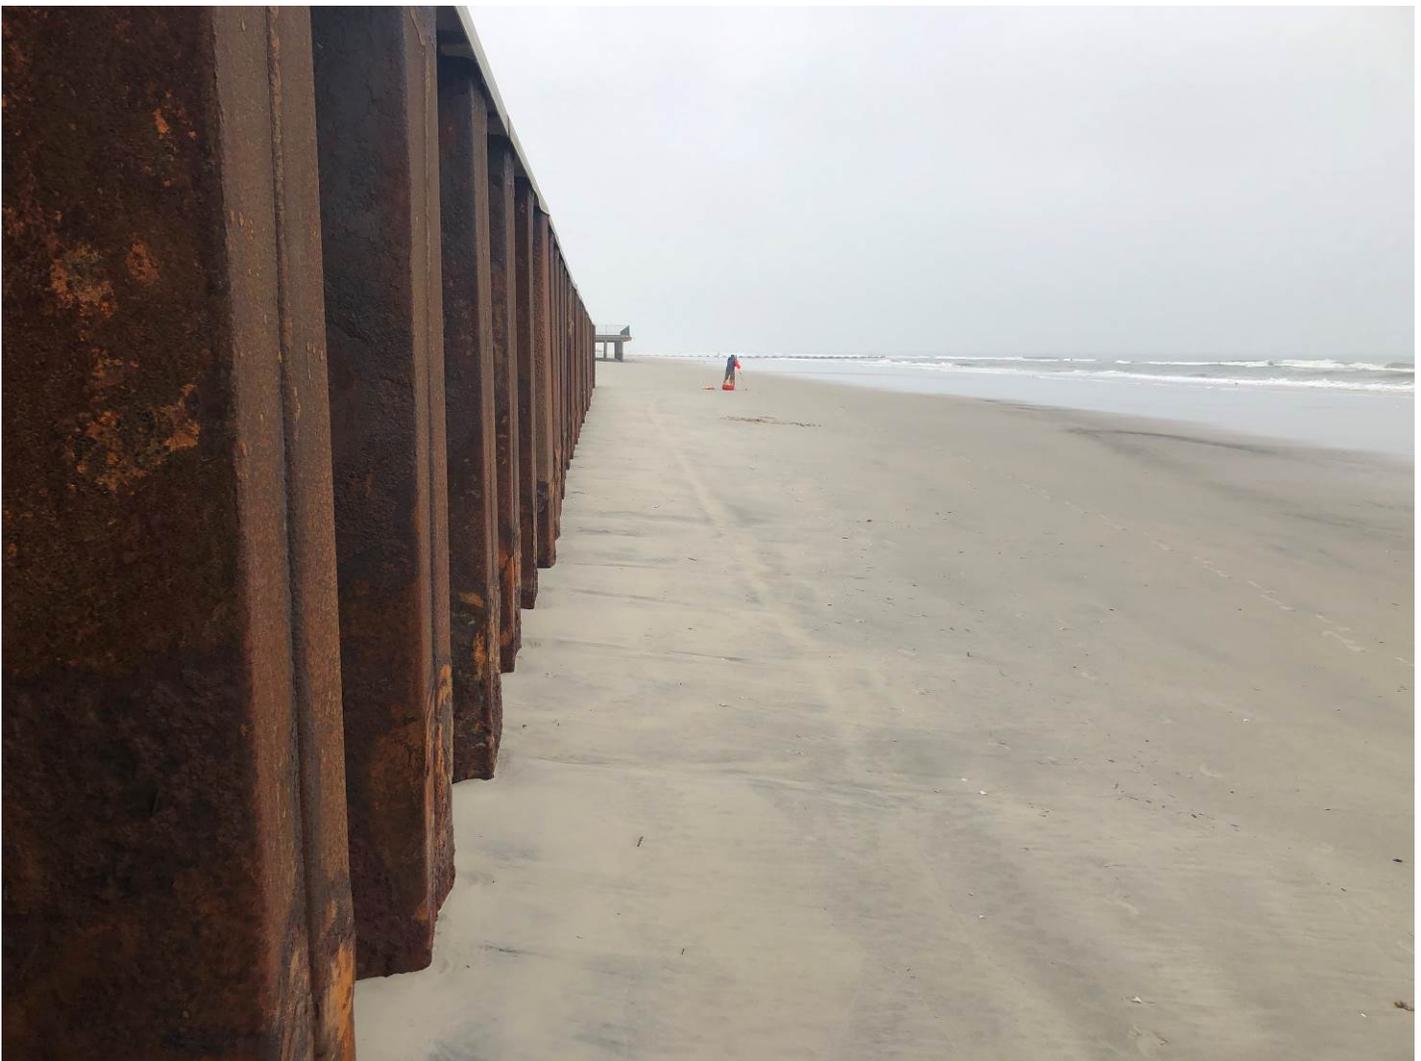
This is the southern-most cross section of the selected profiles within the larger database. Located seaward of the Surfside Pier and Ocean Oasis Water Park and Beach Club this site represents conditions at the south end engineered beach and its taper near the Wildwood and North Wildwood border. Initially the engineered beach design template placed the dune feature 30 feet seaward of the pier's steel bulkhead. A series of storm events that followed construction in 2009 resulted in multiple episodes of erosion followed by restoration efforts to maintain this section of dune. Following Hurricane Sandy this dune location was moved landward to connect between piers leaving this steel structure as the sole protection for the water park. The beach seaward of the feature is narrow and prone to storm erosion.

Like the profile at Line 58+00 located to the north of the piers, by the spring 2014 survey (April 25th), the beach and dune had eroded to a point where the City was forced to reposition this feature landward of the easternmost point of the piers. No dune was replaced south of Surfside Pier because the City of Wildwood declined to allow the original design to be re-established. The proximity to Ocean Oasis also mitigated against dune success due to the location in even mild storm wave activity.

Figure 23. View to the north taken on October 28, 2019 near 26th Avenue showing the beach at the Surfside Pier's seaward end steel bulkhead. Waves easily reach the bulkhead making a dry berm unlikely until the shoreline advances about 100 feet further seaward. Little change has occurred at the bulkhead in over a year with summer accumulations allowing minor beach use immediately seaward of the steel wall.

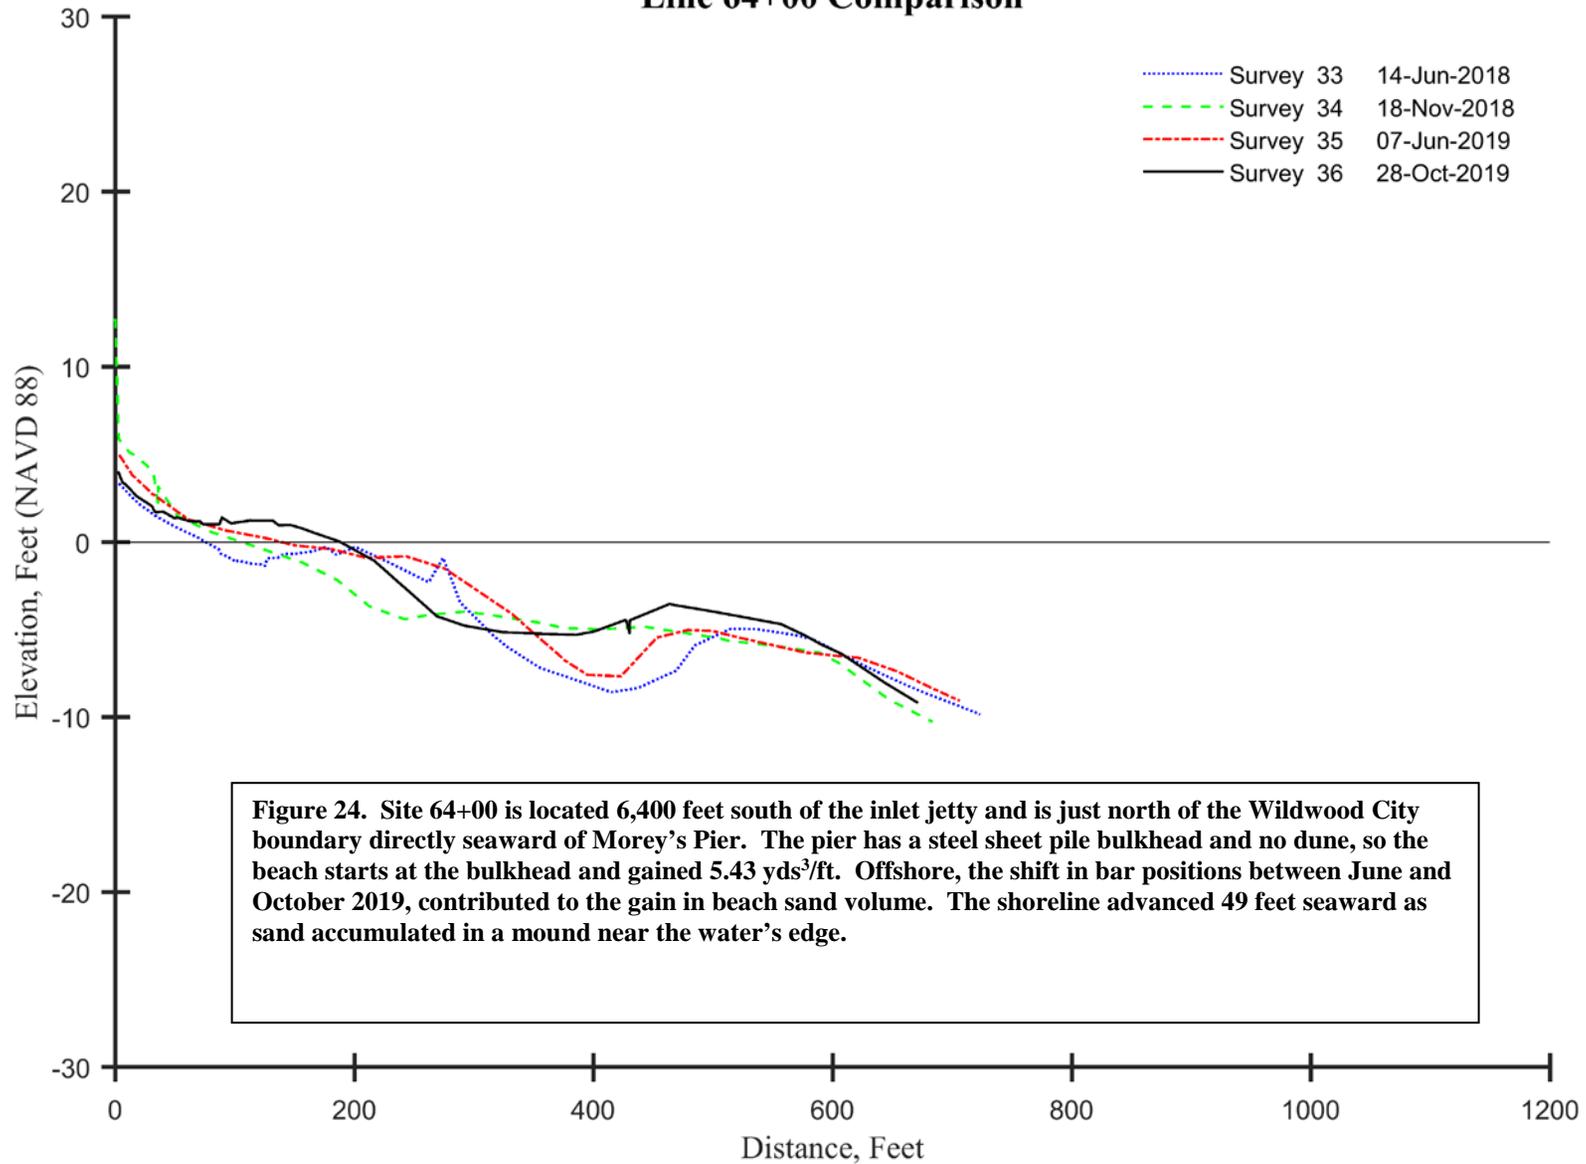
Line 64+00 Comparison

Figure 24. Site 64+00 is located 6,400 feet south of the inlet jetty and is just north of the Wildwood City boundary directly seaward of Morey's Pier. The pier has a steel sheet pile bulkhead and no dune, so the beach starts at the bulkhead and gained 5.43 yds³/ft. Offshore, the shift in bar positions between June and October 2019, contributed to the gain in beach sand volume. The shoreline advanced 49 feet seaward as sand accumulated in a mound near the water's edge.
