**FINAL REPORT FOR 2018  
ON THE CONDITION OF THE MUNICIPAL BEACHES  
IN  
THE TOWNSHIP OF UPPER, CAPE MAY COUNTY, NEW JERSEY**

**PREPARED FOR: THE TOWNSHIP OF UPPER  
PO BOX 205  
TUCKAHOE, NEW JERSEY 08250**

**PREPARED BY: THE STOCKTON UNIVERSITY COASTAL RESEARCH CENTER  
30 WILSON AVENUE  
PORT REPUBLIC, NJ 08241  
March 31, 2019**

# Annual Report for 2018 To The Township of Upper On the Condition of the Municipal Beaches in Strathmere

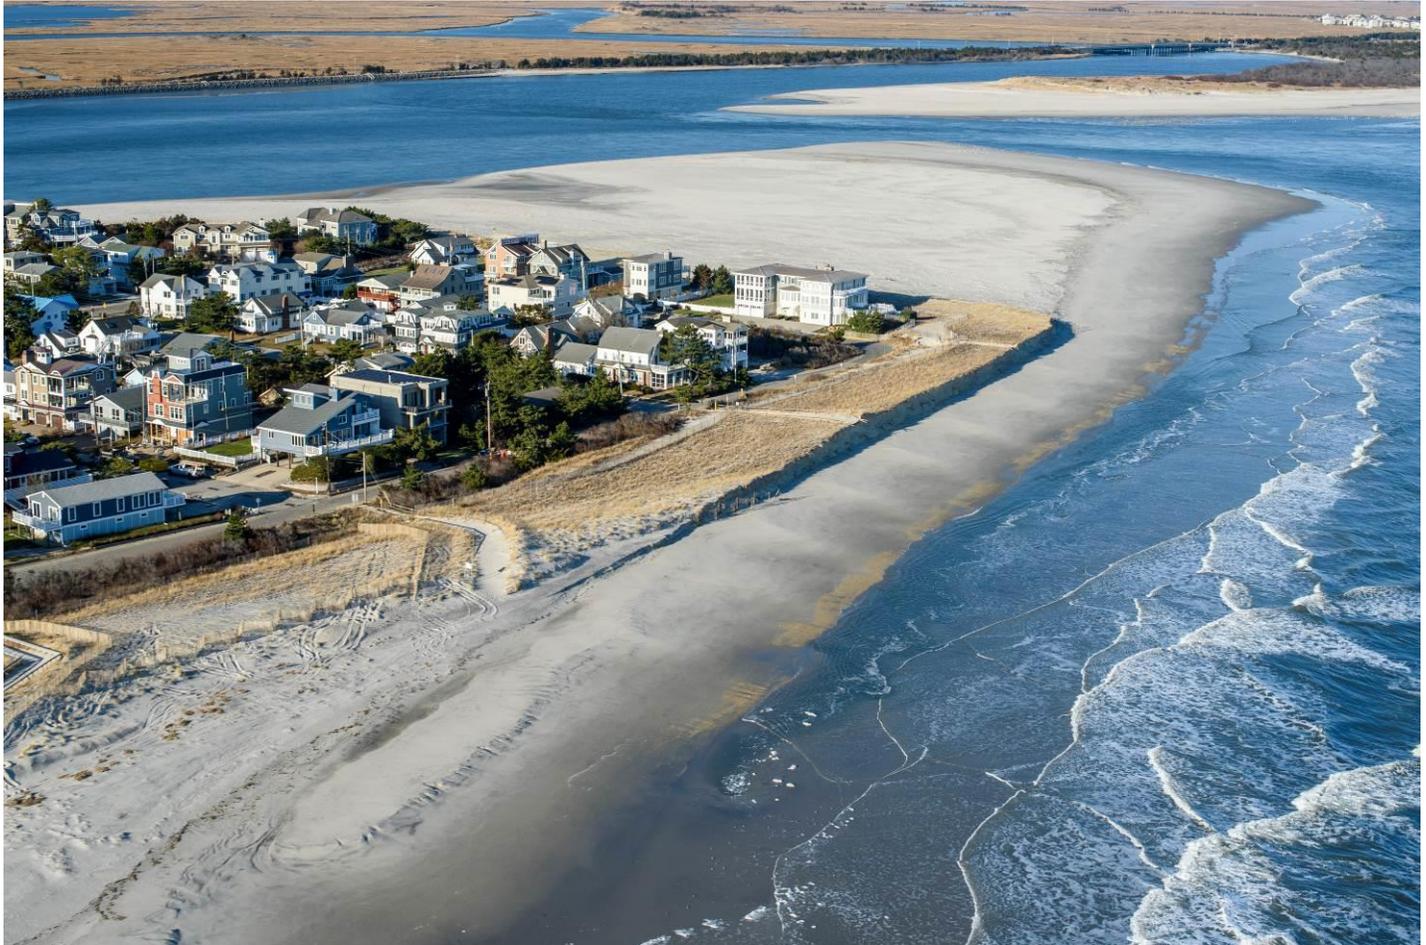
*Above is an aerial view of Strathmere, taken December 11, 2018, showing the relationship between the shoreline orientation between Williams Avenue and the tip of the sand spit in the inlet. This alignment is currently truncating the dune between its northern end and Seacliff Avenue. This time, there does not appear to be a subsidiary ebb-tidal channel causing this erosion. (Photo by Ted Kingston).*

Erosion along the Williams Avenue to the State Park oceanfront beach was apparent in December 2017, and got progressively worse during 2018 (cover photograph). Recently, the Upper Township public works commenced in harvesting sand from the berm near Jasper Avenue (UT-3) and truck hauling it north to place the piles at the toe of the dune scarp shown on the cover page. This inexpensive operation provides a buffer to normal to mild northeast waves from carving continuously into the near vertical sand cliff producing more collapse and dune loss. The process depends on larger quantities of inlet shoal sand accumulating closer to the beach where it can add to the beach system between Seaview and Williams Avenues widening the distance between the water's edge and the dune toe. Trucking enough sand north to dramatically alter the relationship between wave erosion and sand accumulation is not likely to be completely successful over time. The USACE is not scheduled to return for a maintenance operation for several years unless there is a Presidential Disaster Declaration for a serious storm.

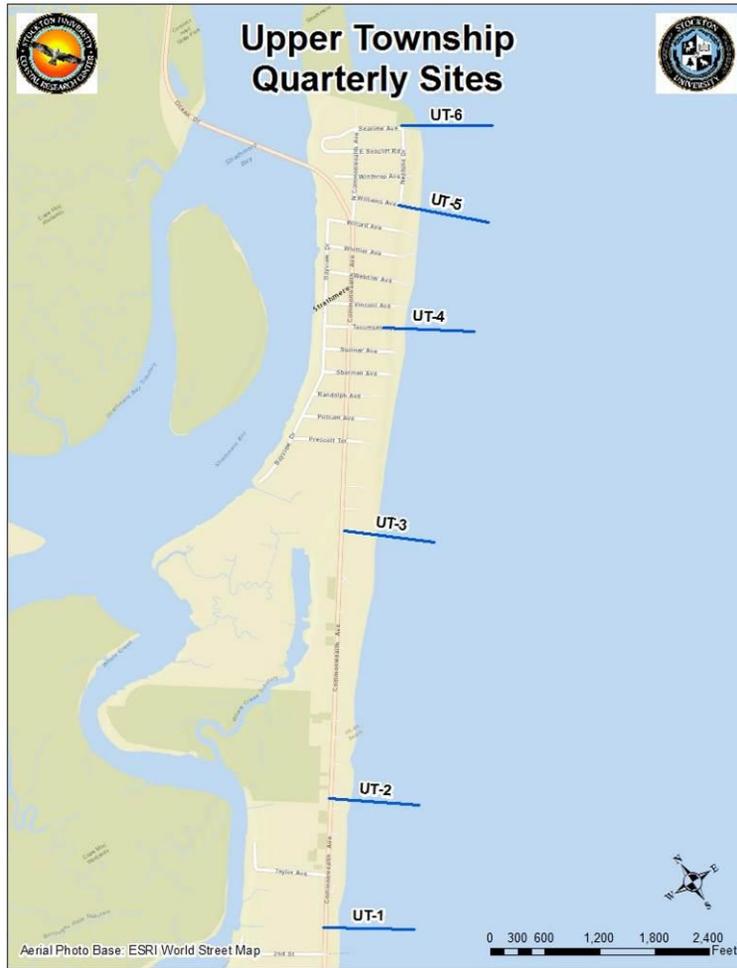
Figure 2 located below shows the locations of the 6 cross section locations used for this analysis.

Figure 2. Locations of the 6 beach profile stations for the engineered beach in Upper Township.

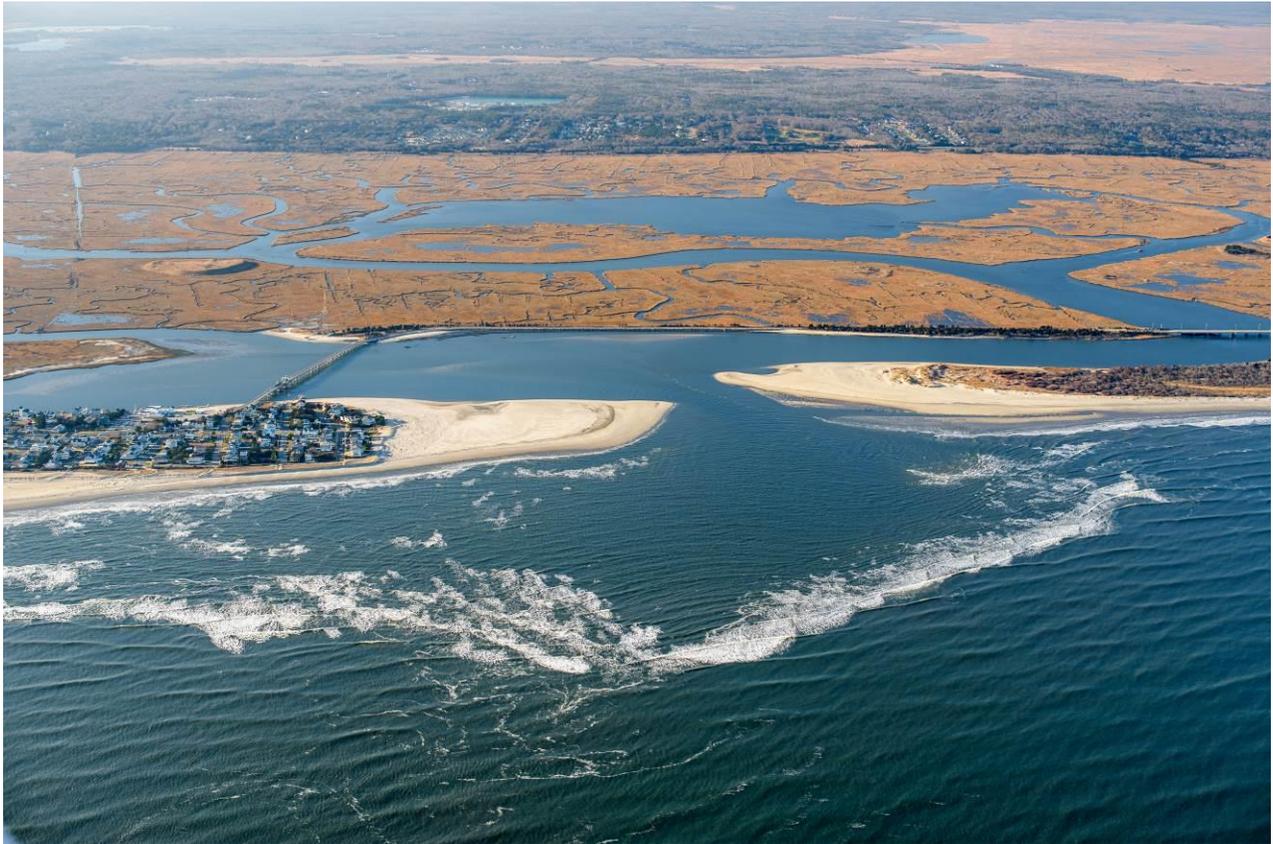
Figure 3. The entirety of the Corson's Inlet ebb-tidal delta shows in this December 11, 2018 aerial photograph with white water breaking from Peck's Beach in the State park around to Williams Avenue in Strathmere. As of this date, there was no main channel entrance into the inlet. Minor shoals appear between the Strathmere portion of the State Park land and almost to Williams Avenue, but these are still at a considerable distance offshore. (Photo by Ted Kingston)

The beach retreated as the offshore region became deeper by over a foot in large areas of the shoals associated with Corson's Inlet seaward of Strathmere. The latest aerial photography (December 11, 2018; Figure 3) seems to indicate that this sand has accumulated further seaward and as a continuous band of white water completely surrounding the inlet entrance at sea. This is called the ebb-tidal delta deposit and is controlled by the interaction of the ebb-tidal current flows and incoming waves over intervals of time measured in months.

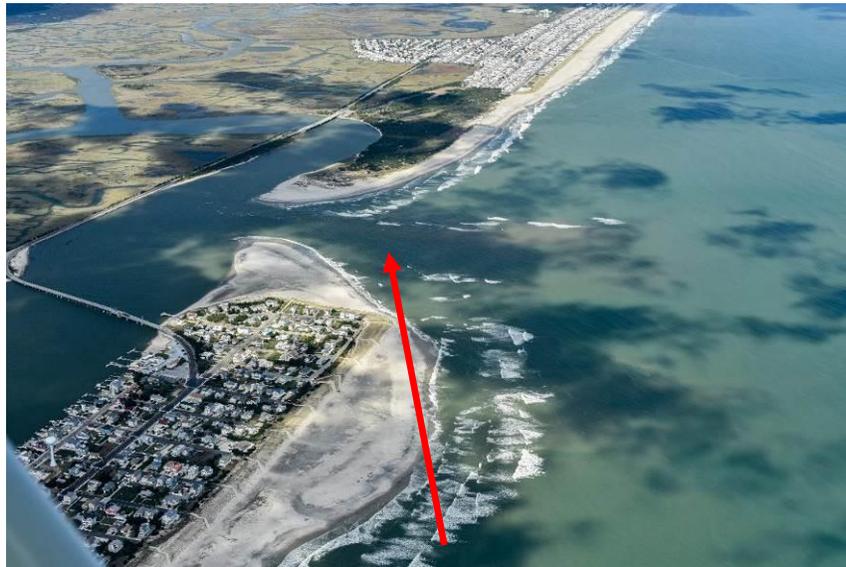
**Figure 4. View of Corson's Inlet Sept. 2017 looking along the northern oceanfront where the new dunes at Seaview Avenue are in close proximity to the water's edge over a year ago. This alignment has shifted landward to the point where the dune at Seaview has been affected along a considerable extent cut back in the worst areas to the dune crest.**

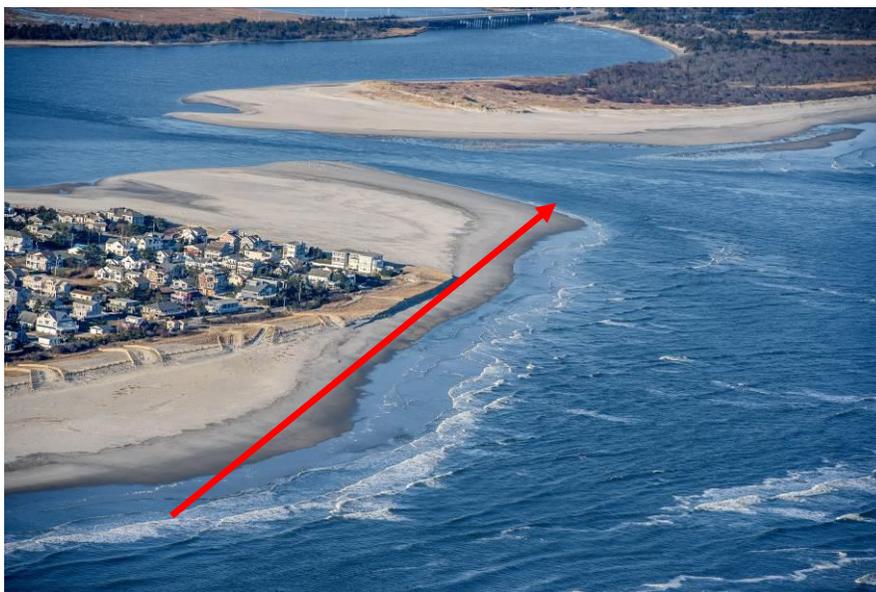
**Figure 5. View of Corson's Inlet on December 11, 2018 showing the extent of dune erosion along the same alignment which appeared in September 2017. The impact on the northeast corner municipal dune system is evident. This time there is no subsidiary tidal channel along the beach, but also the offshore bar system lies well seaward as seen in the breaking wave pattern.**

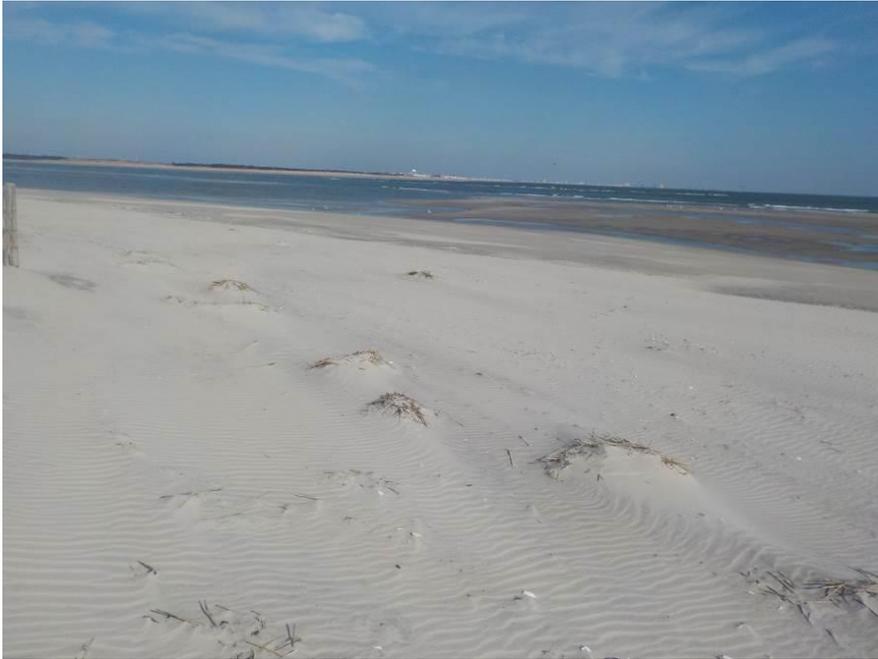
**6a. December 1, 2017**

**Photograph 6a On December 1<sup>st</sup>, the beach was still quite wide with exposed offshore sand flats showing at low tide.**

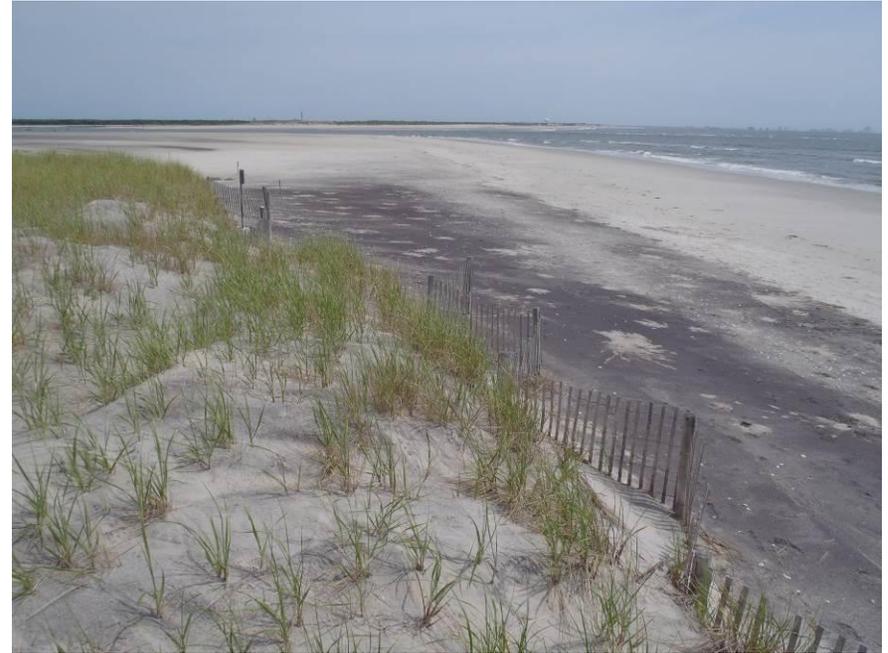
**6b. June 8, 2018**

**Photograph 6b shows the same perspective in June with a healthy crop of dune grass present, with the dune still undamaged**

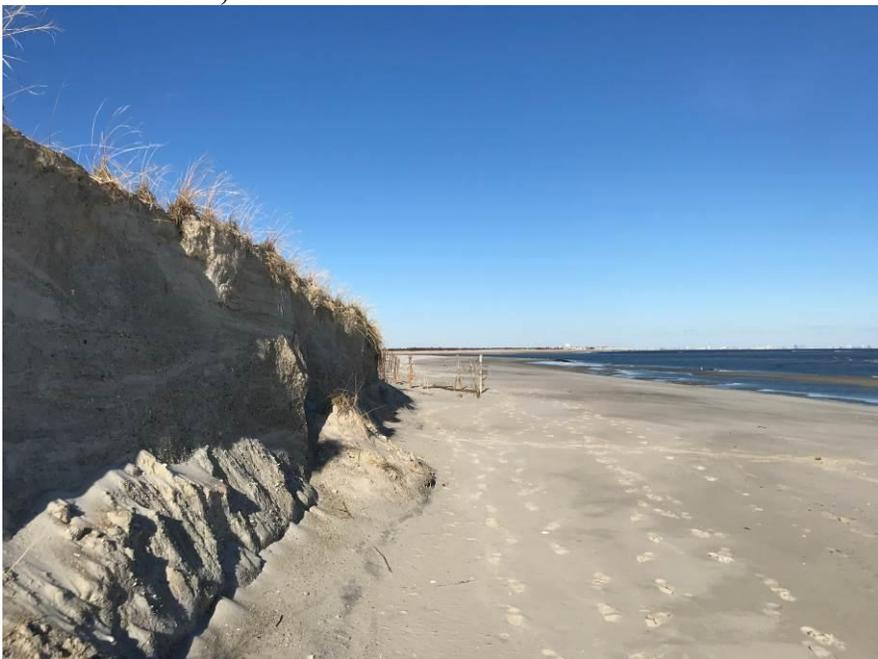
**6c. December 7, 2018**

**Photograph 6c was taken on December 7, 2018 with an extensive scarp cut into the dunes at Seaview Avenue and a wet beach to the dune toe. Sand transfer from the southern, wider beach is being used to retard the dune loss currently.**

Inlet tidal dynamics continue to play a significant role in shoreline stability in the vicinity of the Seaview Avenue site. Sand piles deposited at the dune scarp are at least a means to slow erosion rates in anticipation of improved sediment supplies reaching the location and in sufficient mass where the material efficiently blocks northeast waves and contribute to increasing the beachfront sand supply in excess of wave scouring.

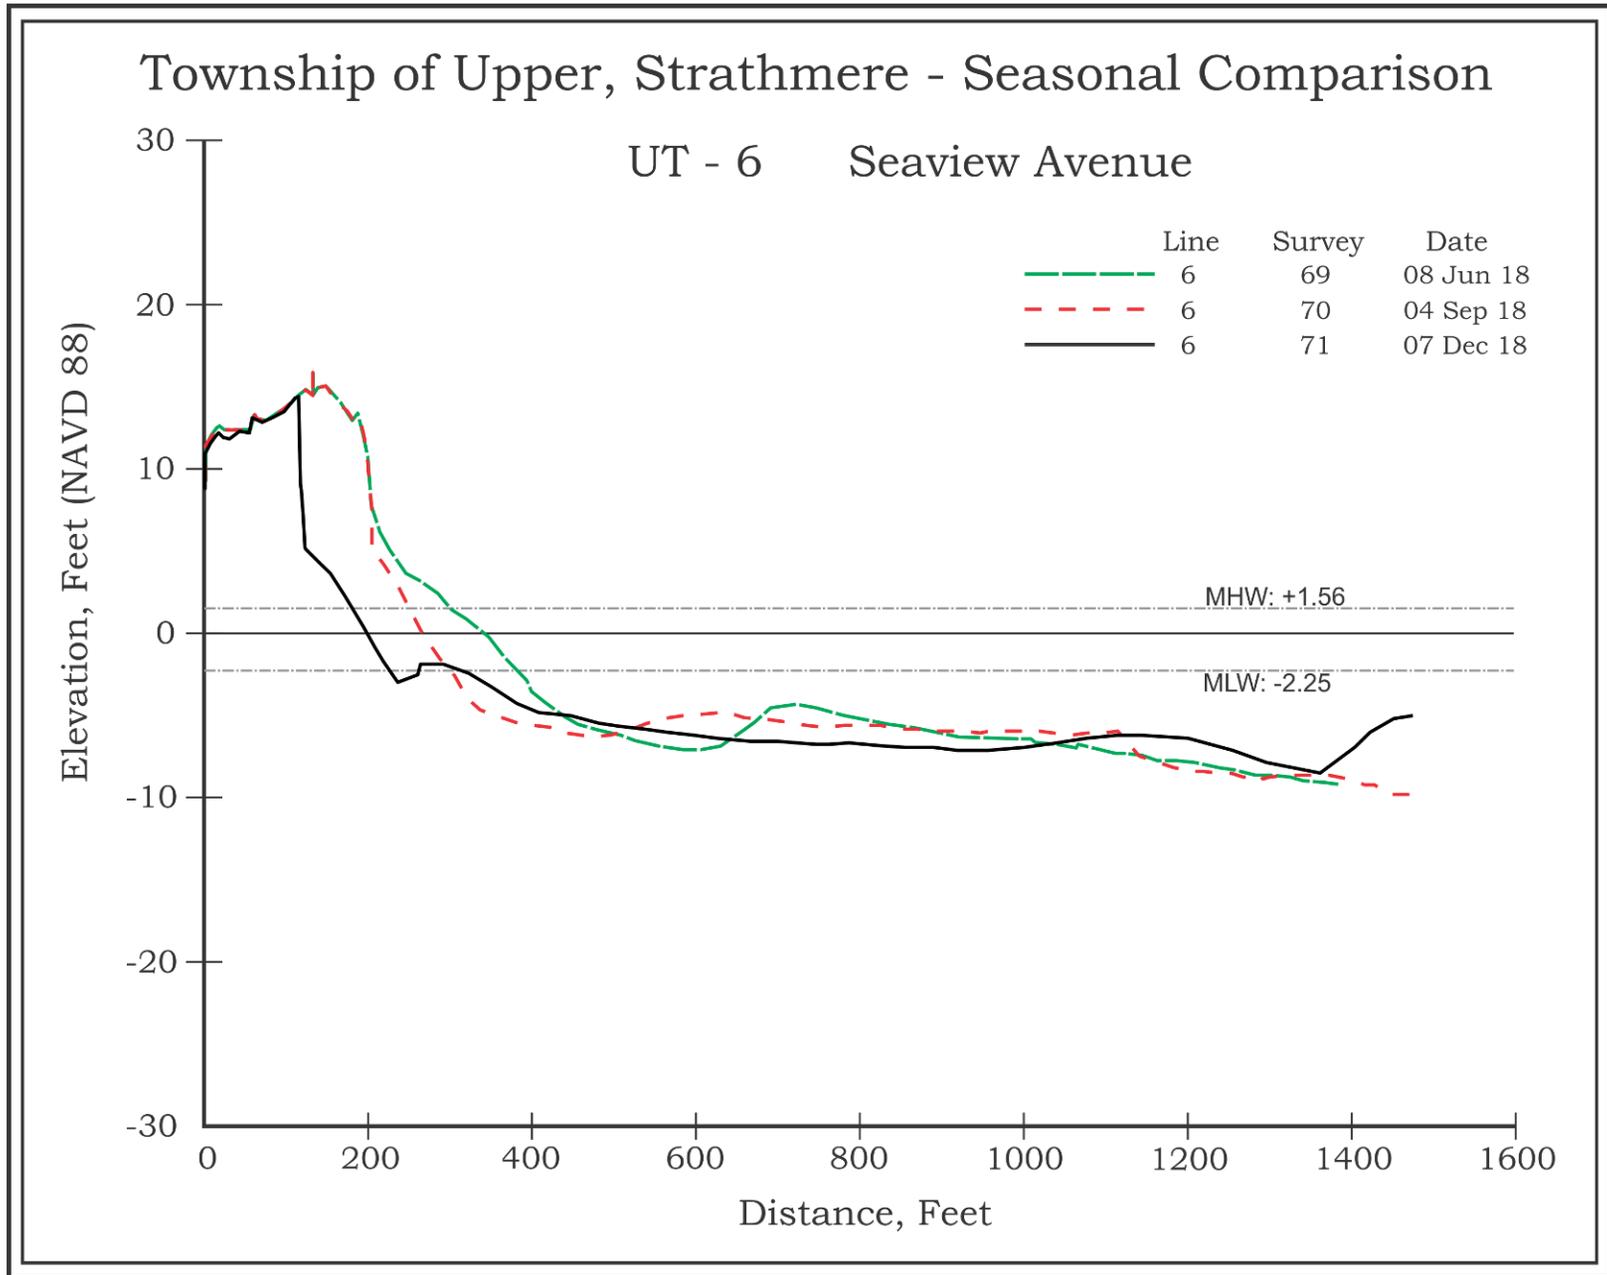
**Figure 7.** Between June and September the beach retreated nearly 70 feet and became much steeper in slope. The interval to December 7, 2018 produced continued retreat into the dune slope impacting the crest elevation. This problem usually involves a subsidiary tidal channel close to the water's edge that allows tidal flow to scour sand from the beach. There was a small bar at the base of the beachface and a larger feature a thousand feet further seaward that would not appear on the beach any time soon. Beach sand from the south is currently being added to the scarped areas of the dune toe to retard loss on a daily basis. This will not preclude storm attack, if moderate events occur during the spring of 2019.

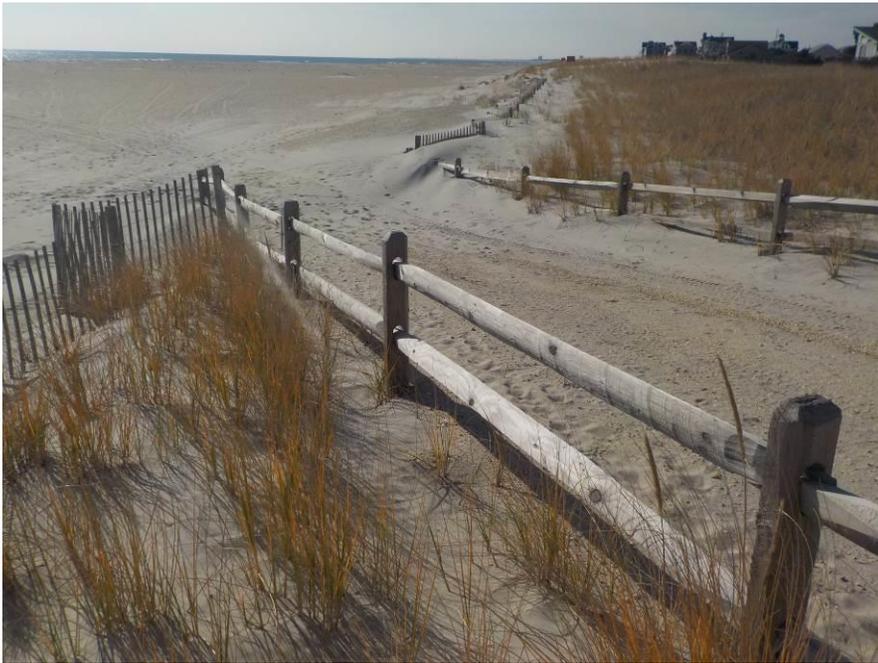
**8a. December 1, 2017**

**Figure 8a shows the winter beach from the pedestrian access pathway to the beach. Note the sand accumulation along the dune toe fencing plus a wide beach seaward.**

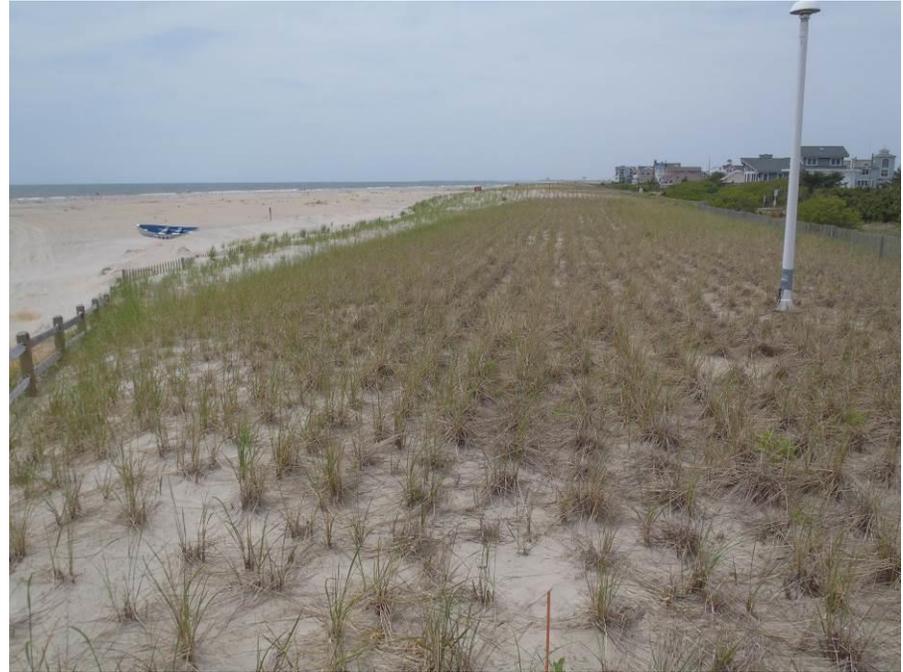
**8b. June 8, 2018**

**Figure 8b was taken in June looking south from the dune.**

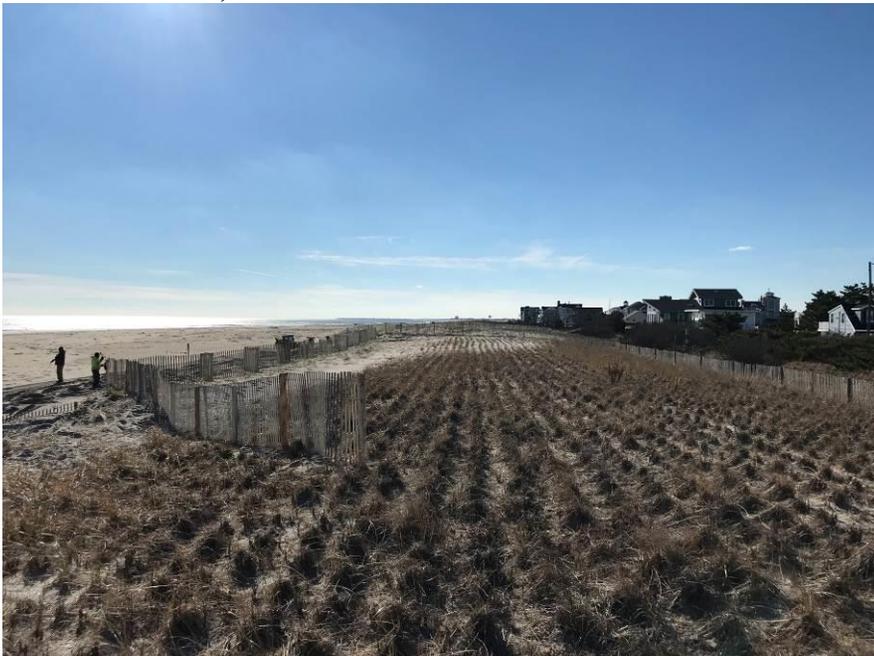
**8c. December 10, 2018**

**Figure 8c is a view of the beach following 200 feet of shoreline retreat since June 2018.**

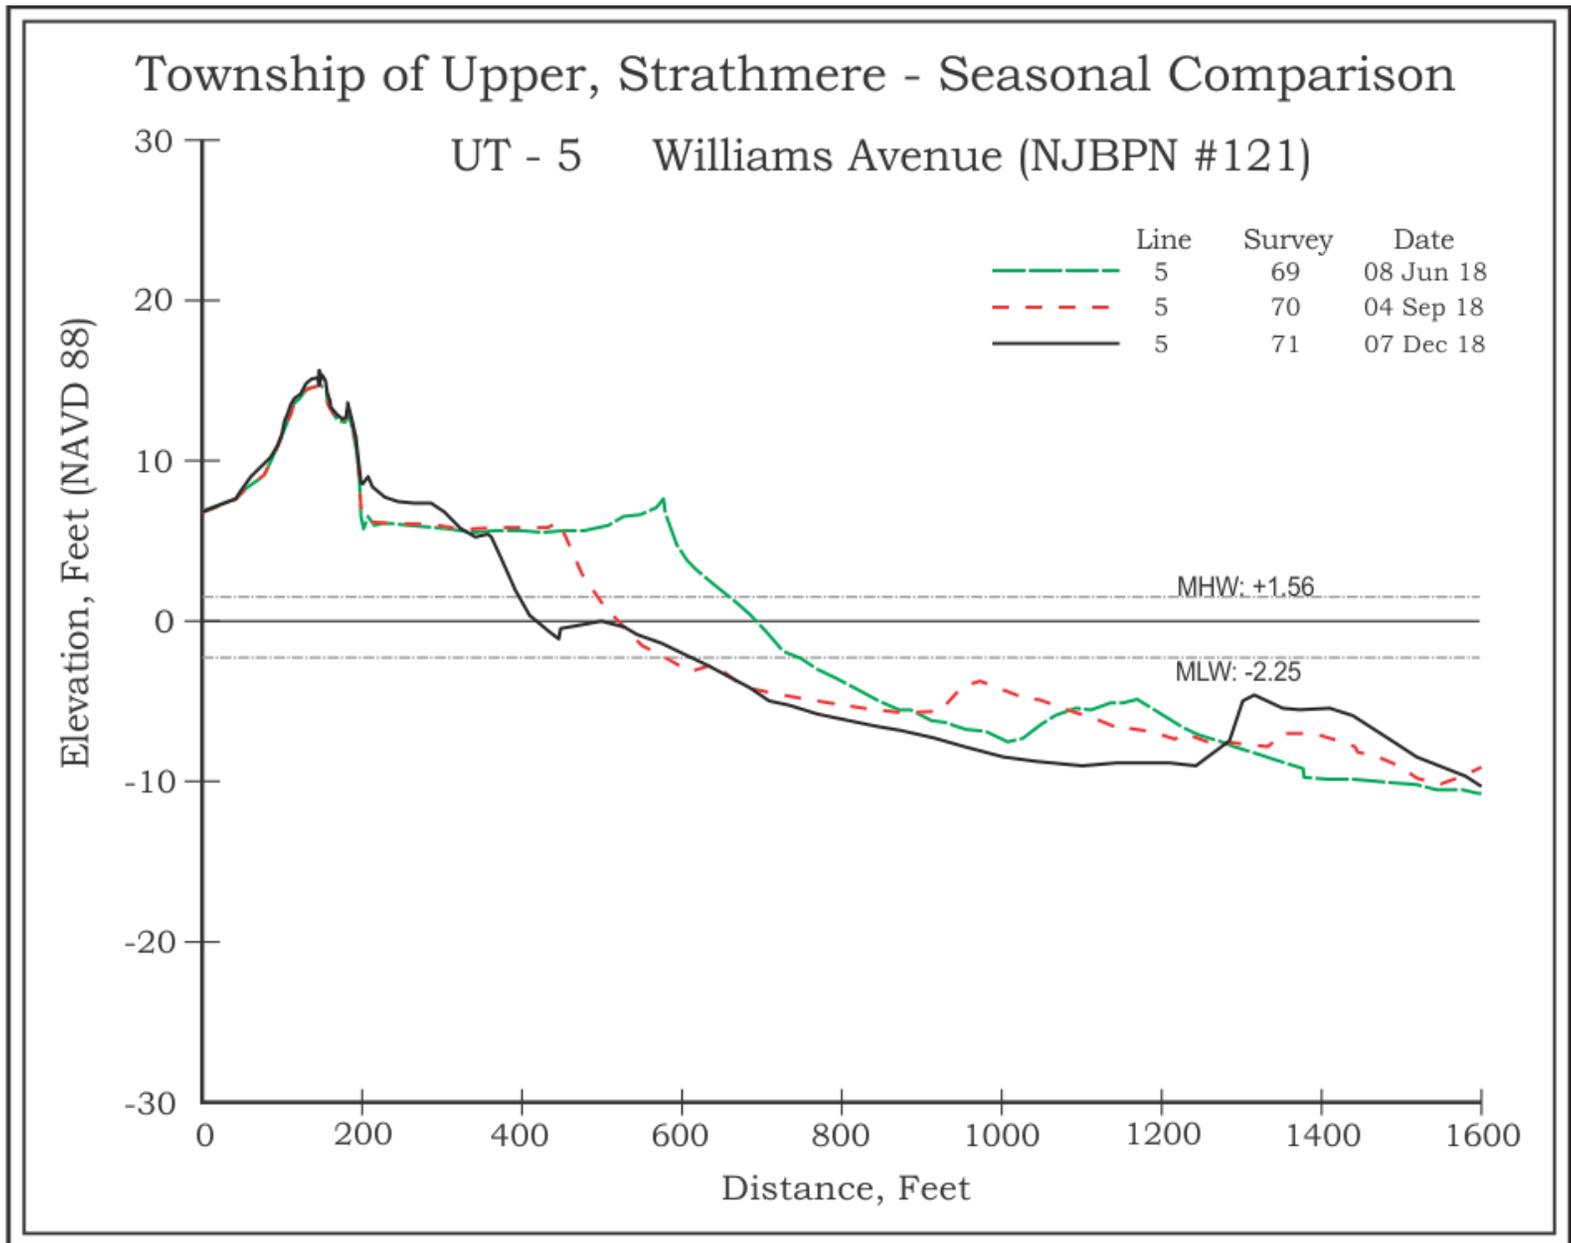
**Figure 9.** This site lies just south of the influence of the ebb-tidal delta for Corson’s Inlet, but not beyond the accretion generated by sand moving landward. The June to September retreat in the berm took a third of the dry beach width. The bar offshore moved 200 feet closer to land. The retreat continued into December with another 70 feet of retreat, a bar just off the beach and a large new bar present 1,200 feet from the dunes. Sand was deposited on the dry beach to the dune toe.

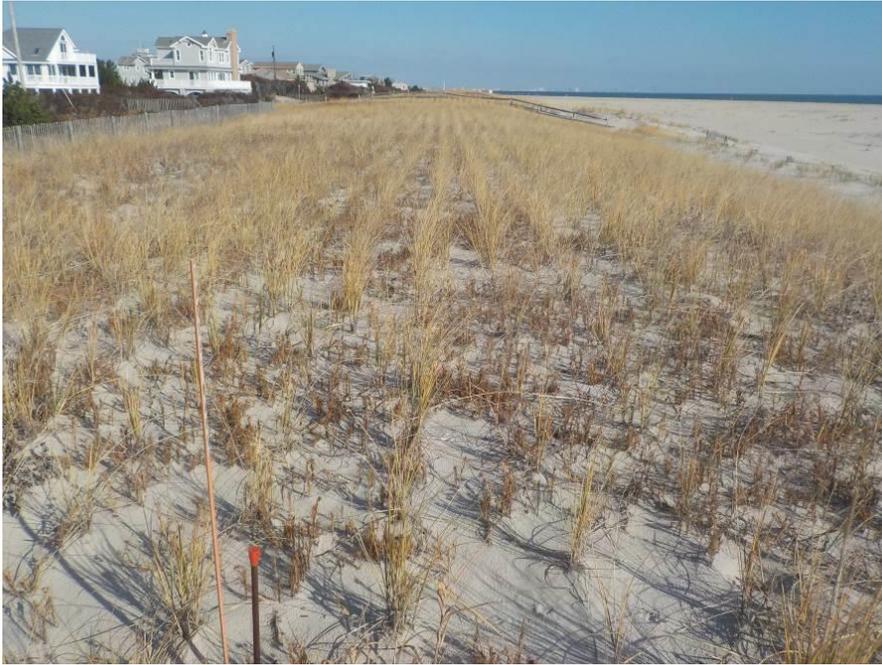
**Figure 10a. December 1, 2017**

**Figure 10a is a view to the north along the dune crest during the winter.**

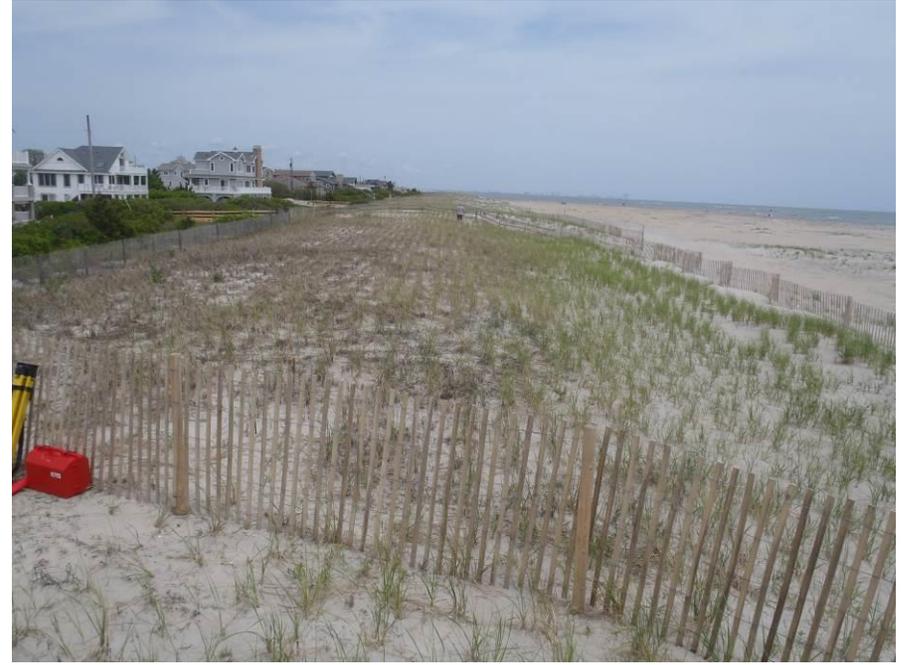
**Figure 10b. June 8, 2018**

**Figure 10b shows the planted dune grass and stable recreational beach during the summer of 2018.**

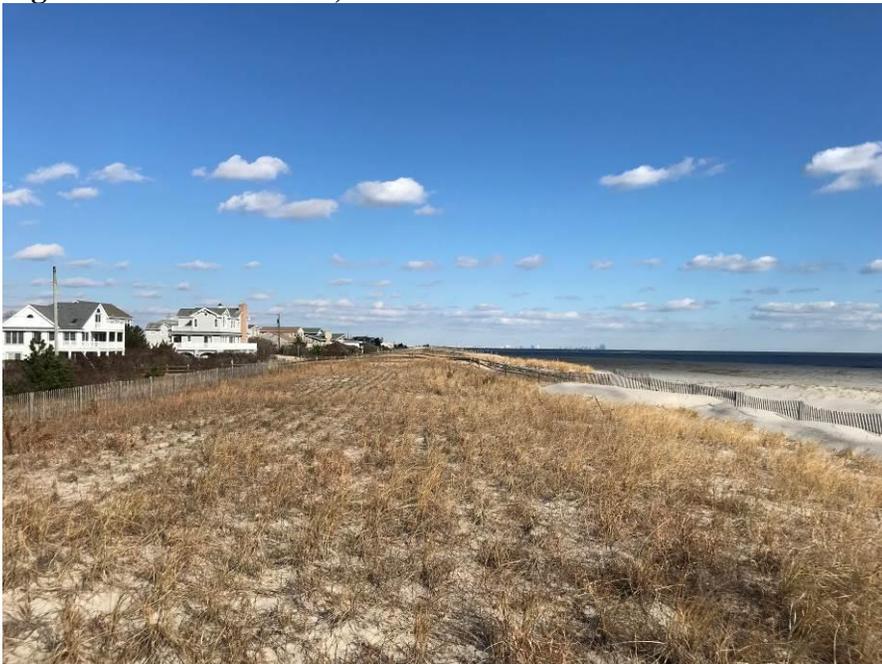
**Figure 10c. December 10, 2018**

**Figure 10c shows the same perspective by December 2018. The fencing along the dune toe was virtually completely buried by accretional sands. A large lobe appears landward beyond the fence line indicating significant local deposition.**

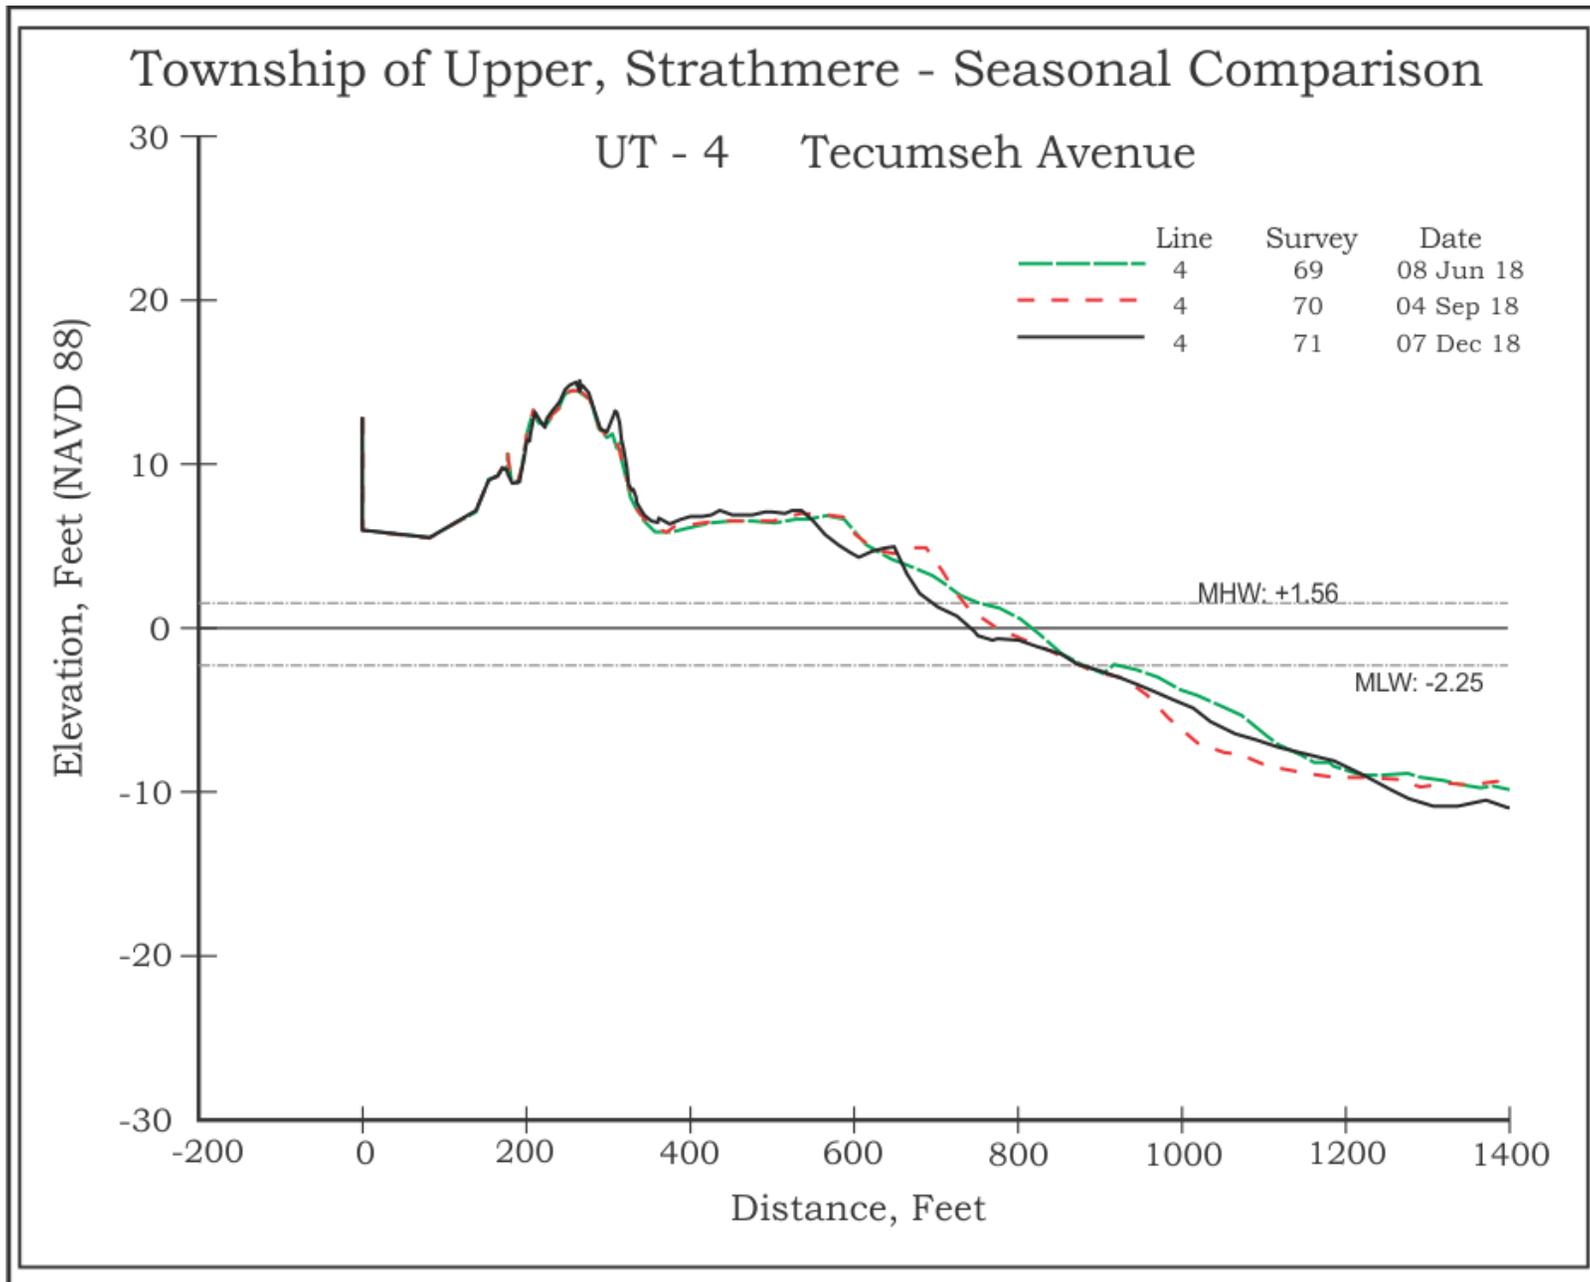
**Figure 11. The dune and recreational beaches remained relatively consistent over 2018 with modest alterations in the beachface and offshore slope. The dunes gained sand and the dry beach grew fractionally higher across the entire width seaward of the dunes.**

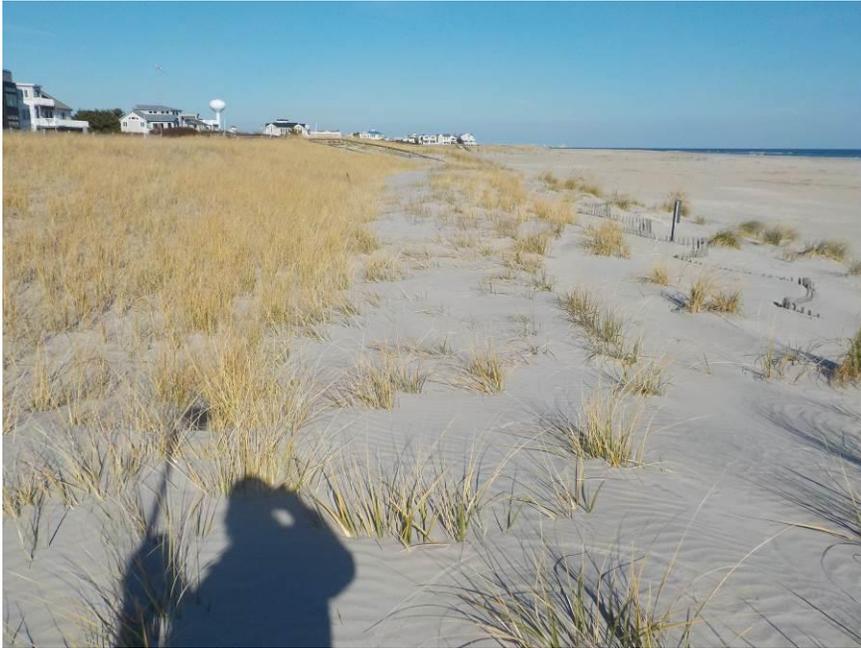
**12a. December 1, 2018**

**Photo 12a is a view to the north along the dune crest during the winter. The tops of the foredune fence are barely exposed at this time as a result of wind-generated sand transport into the dunes.**

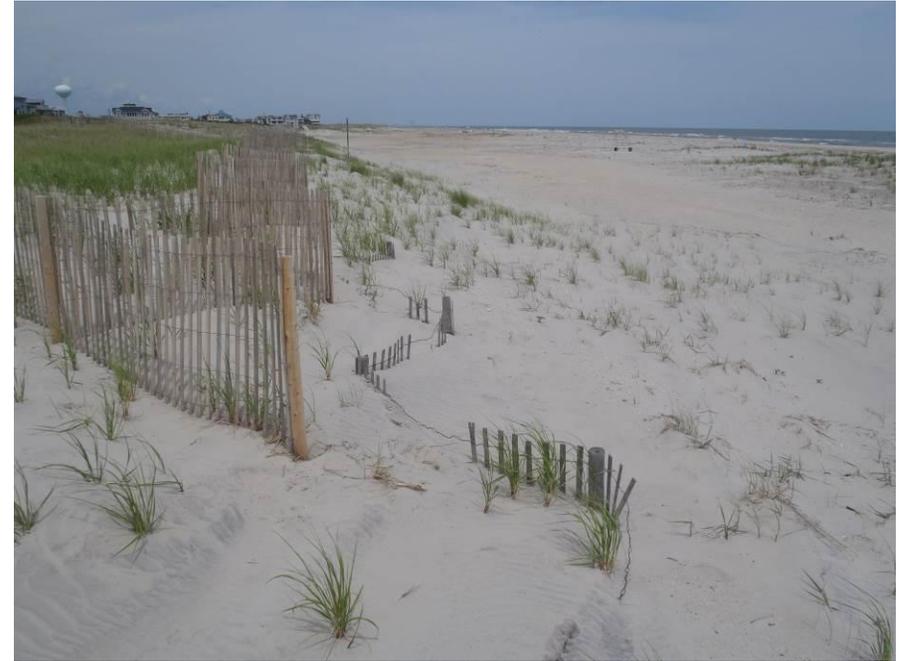
**12b. June 8, 2018**

**Photograph 12b shows the view to the north taken from the foredune perspective where a new fence line has been installed on top of the post-beach nourishment effort in 2016.**

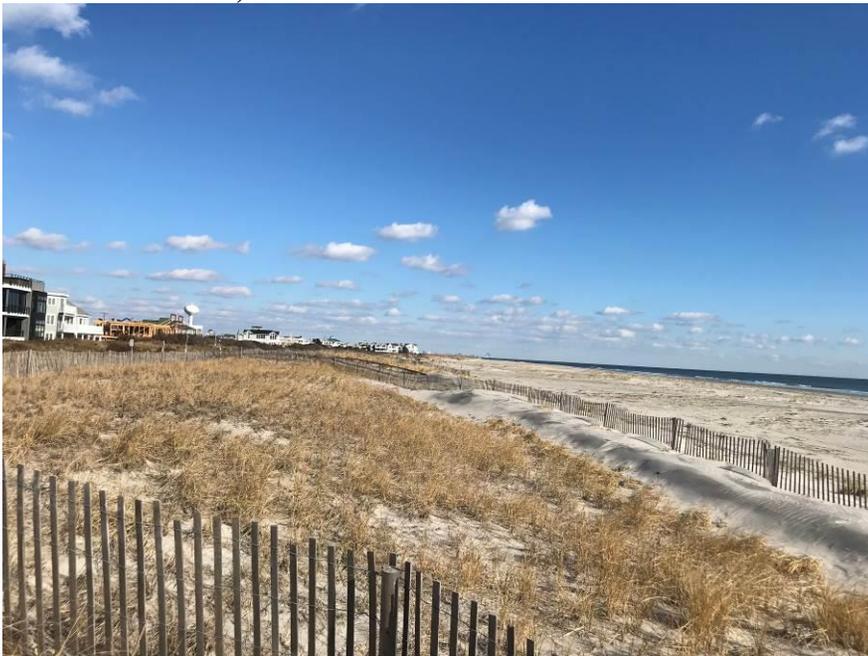
**12c. December 10, 2018**

**Photograph 12c shows the deposit at the new foredune fence in 5 months. A foredune has built up to the point where it shows below on the cross section.**

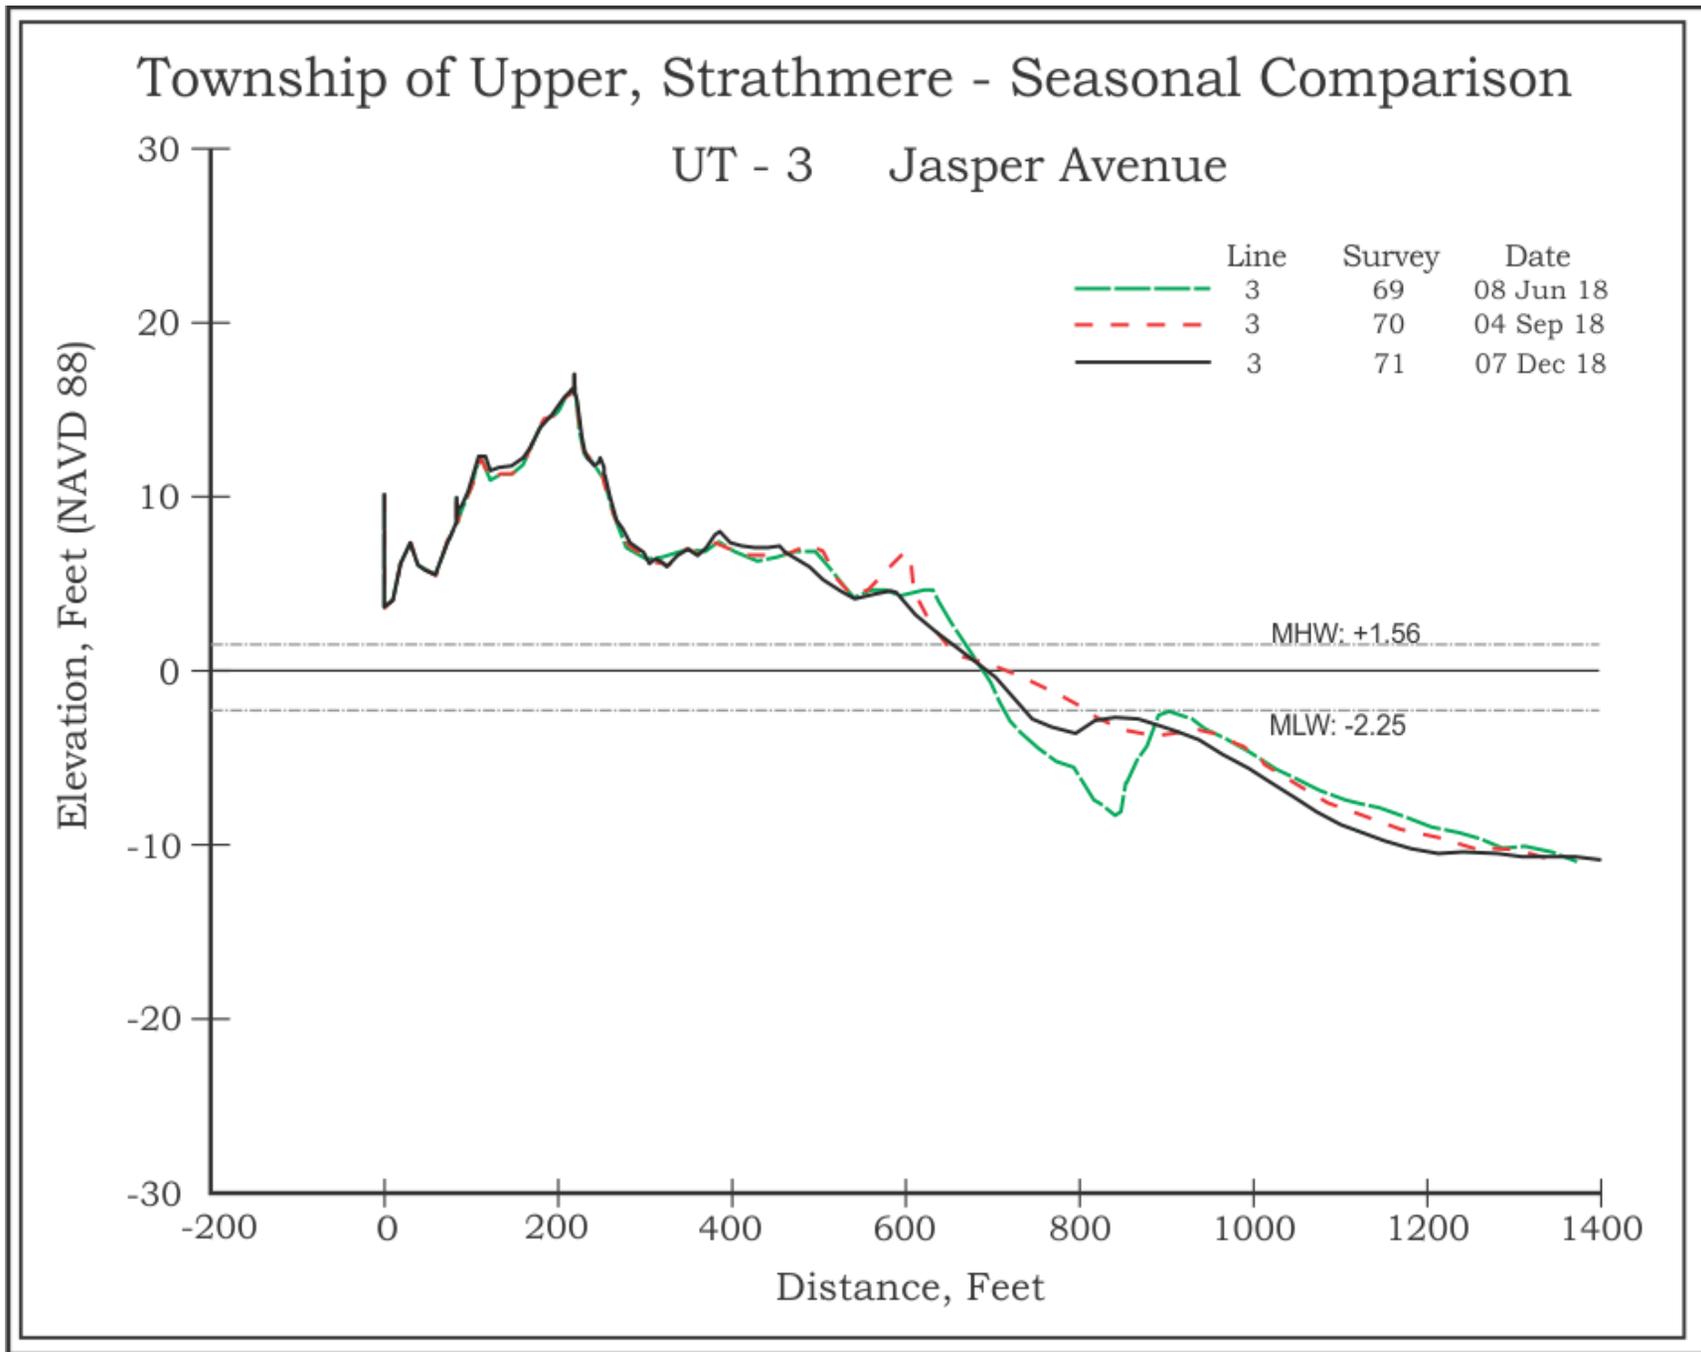
Figure 13. At Jasper Avenue the dunes and back beach areas did not change much over the past year, but major shifts in bar trough depth and position made for most of the sand volume changes observed.

The site displayed wild gyrations in berm elevations and offshore trough scouring during 2018. In June the offshore trough was nearly 10 feet deep with an 8-foot high offshore bar poised to move onto the beach. The bar’s sand mass appears to have completely filled in the trough by September and built a sharp peak of a berm on the beach. The December survey captured a cross section more medial between the two extremes with a small mound offshore and a more uniform beach slope. Little change occurred in the dunes or dry back beach zone. The sand volume change was  $-21.66 \text{ yds}^3/\text{ft.}$  during the fall 2018 season, while between June and December the sand volume decreased by just  $3.25 \text{ yds}^3/\text{ft.}$

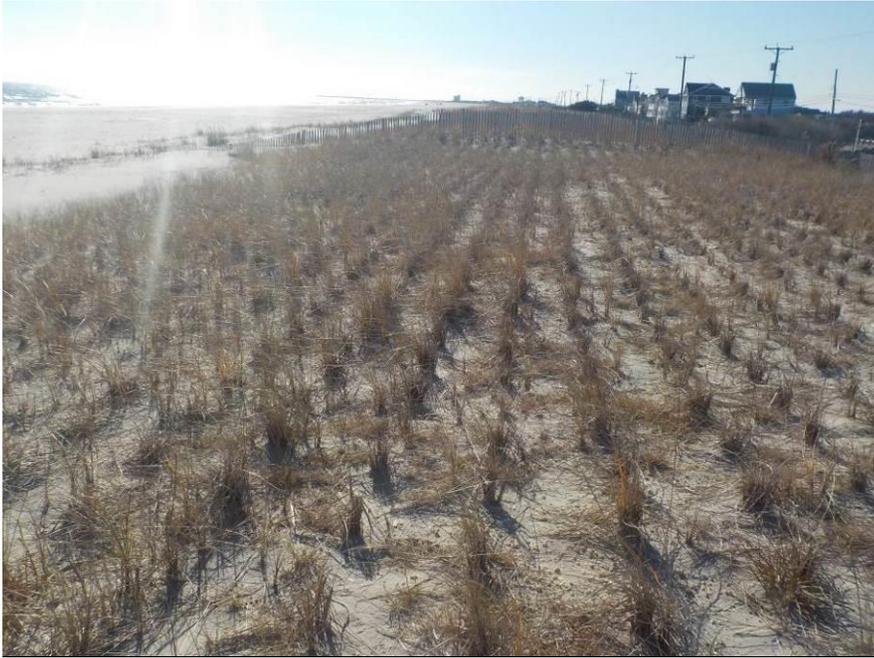
**14a. December 1, 2017**

**Figure 14a is a view to the south from the instrument position on the new foredune slope.**

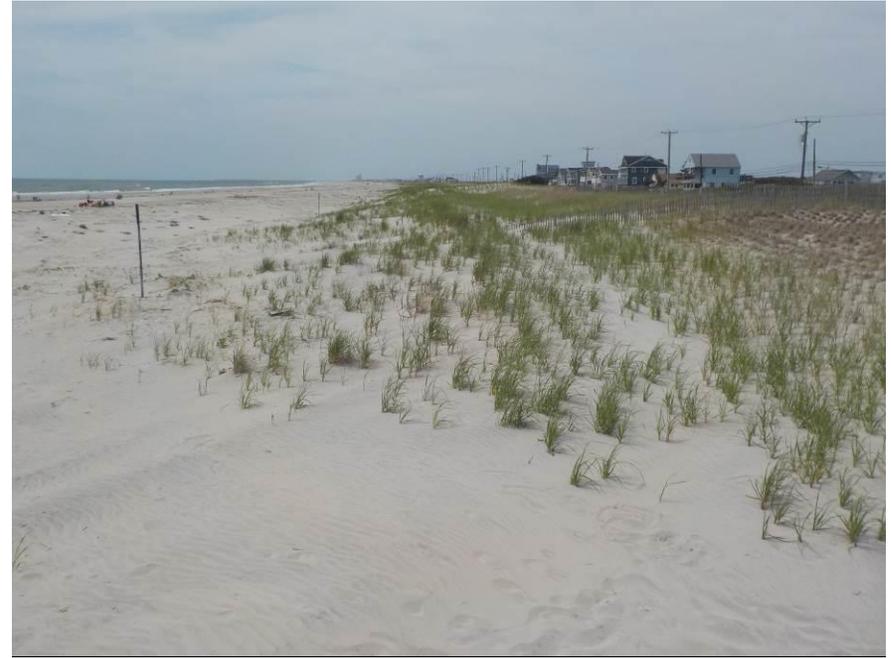
**Figure 14b. June 8, 2018**

**Photograph 14b shows the dune toe in June with a substantial deposit of wind transported sand completely burying the line of fence. The plants are doing well with root extensions migrating seaward.**
