**FINAL REPORT FOR 2018  
ON THE CONDITION OF THE MUNICIPAL BEACHES  
IN  
THE TOWNSHIP OF UPPER, CAPE MAY COUNTY, NEW JERSEY**

**PREPARED FOR: THE TOWNSHIP OF UPPER  
PO BOX 205  
TUCKAHOE, NEW JERSEY 08250**

**PREPARED BY: THE STOCKTON UNIVERSITY COASTAL RESEARCH CENTER  
30 WILSON AVENUE  
PORT REPUBLIC, NJ 08241  
March 31, 2019**

# Annual Report for 2018 To The Township of Upper On the Condition of the Municipal Beaches in Strathmere

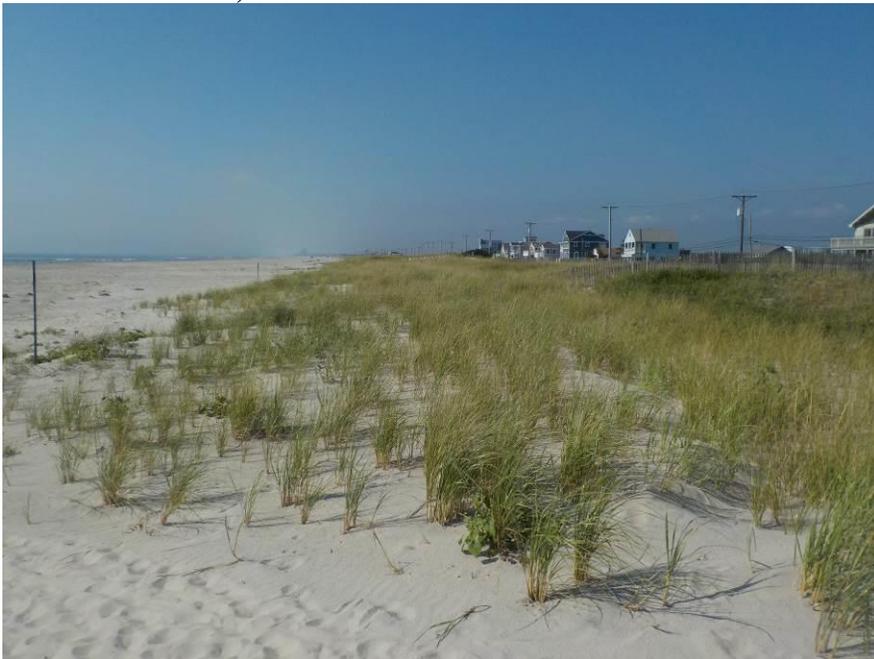
**14c. September 4, 2018**

**Photograph 14c is a view to the south along the seaward dune crest displaying the overall width of the healthy dune system. The foredune fence has enhanced this system by continuing to add wind transported sand. This is the September survey view.**

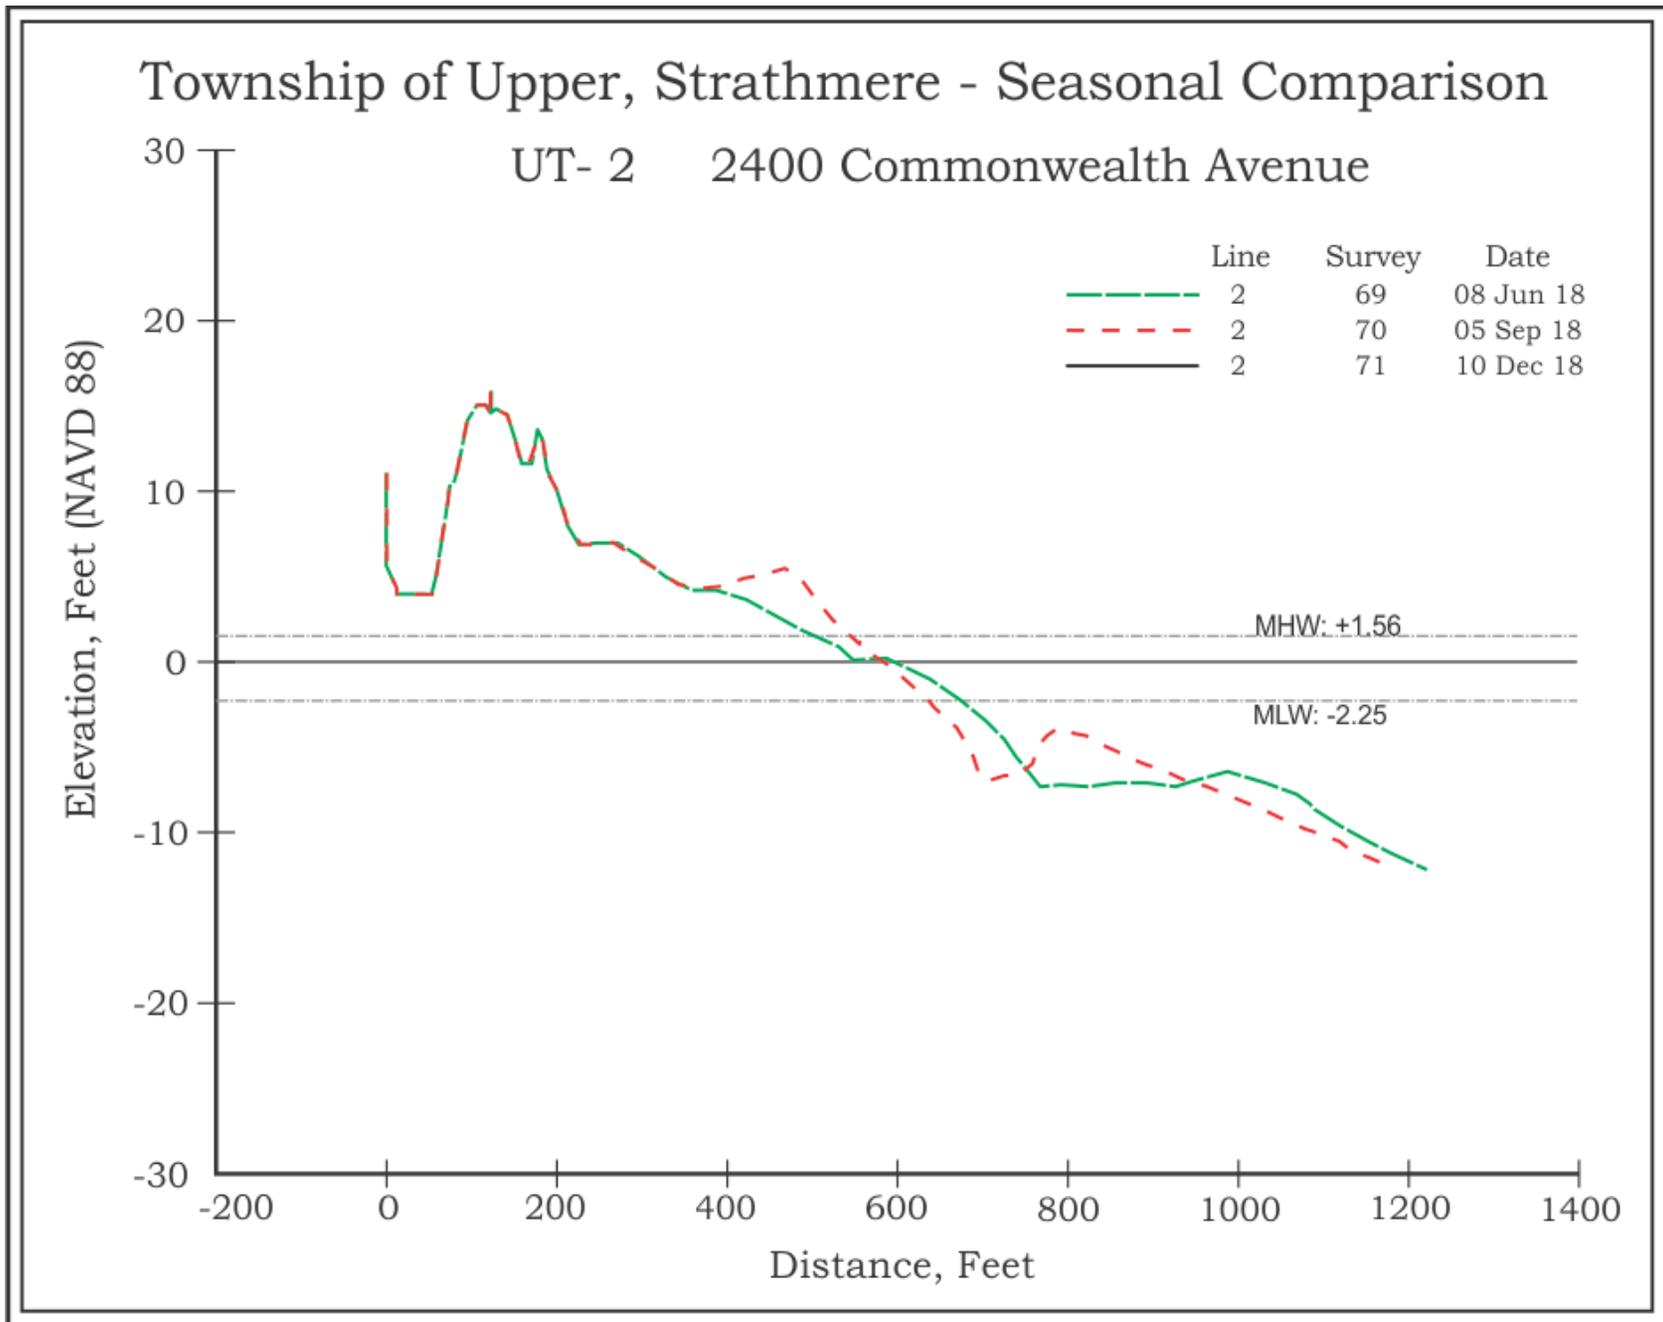
**Figure 15.** The cross sections display June to September conditions where sand was added to the berm building a classic summer feature. Sand to do this clearly came from just offshore as the bar migrated 200 feet closer to the beach. The December survey was overlooked at this site, so no data exists.

Between June and September 2018 the bar moved toward the shoreline and a classic summer berm developed on the beach. Unfortunately, no December survey exists due to bad weather coming in December 10<sup>th</sup> forcing the team off the beach without completing this profile. The return trip was forgotten in the crush to complete multiple other surveys. The seasonal changes were positive and the site has been very stable. The spring 2019 survey will be contrasted with the September 2018 profile.

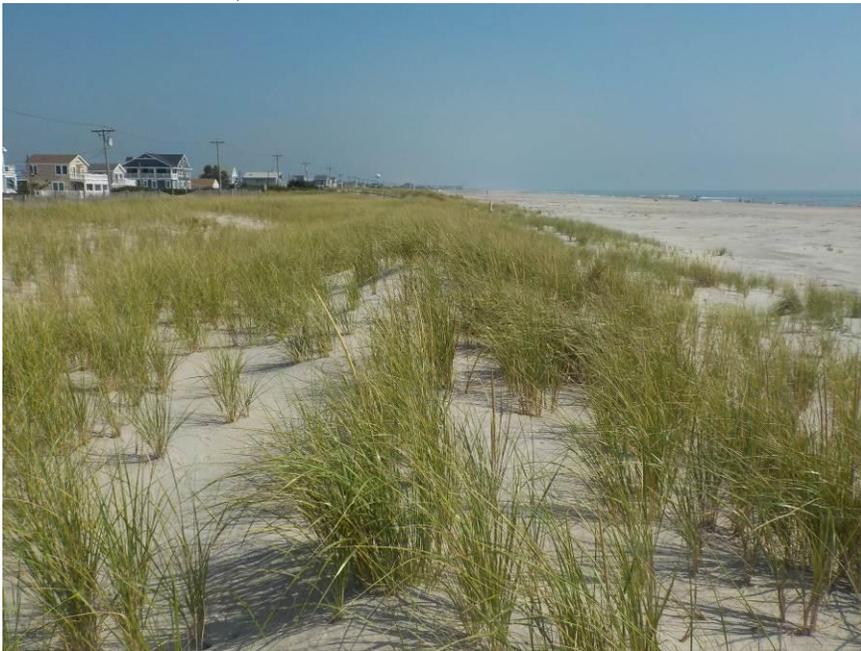
**16c. September 4, 2018**

**Photograph 16c provides the fall view to the north across the dune and onto the beach. The fence is fully buried in new sand added to the dune toe.**

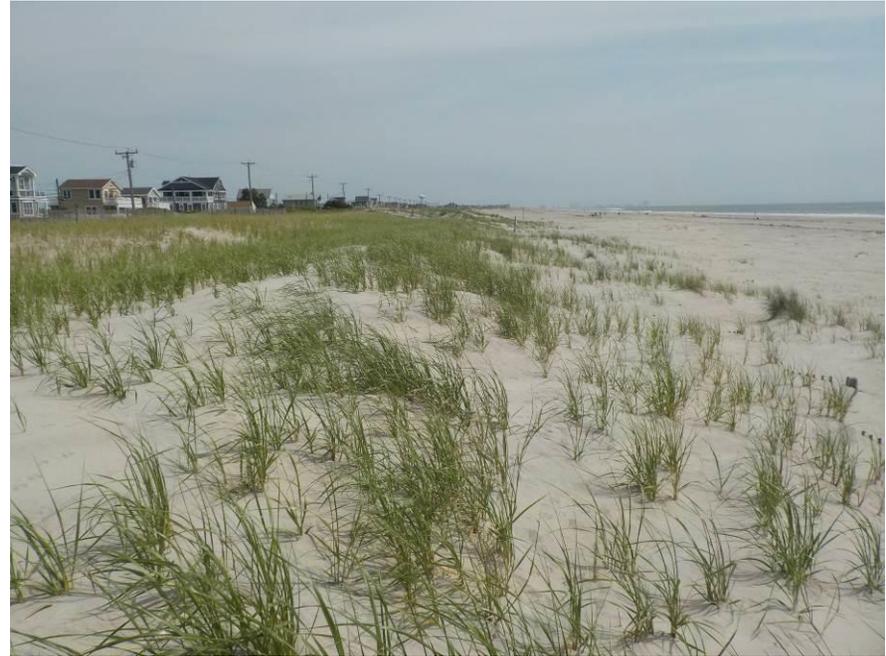
**16b. June 8, 2018**

**Photograph 16b shows the dune with grass plants and the deposition of wind transported sand covering the top of the 4-foot fence. Tiny bits of the original fence show along the right margin.**

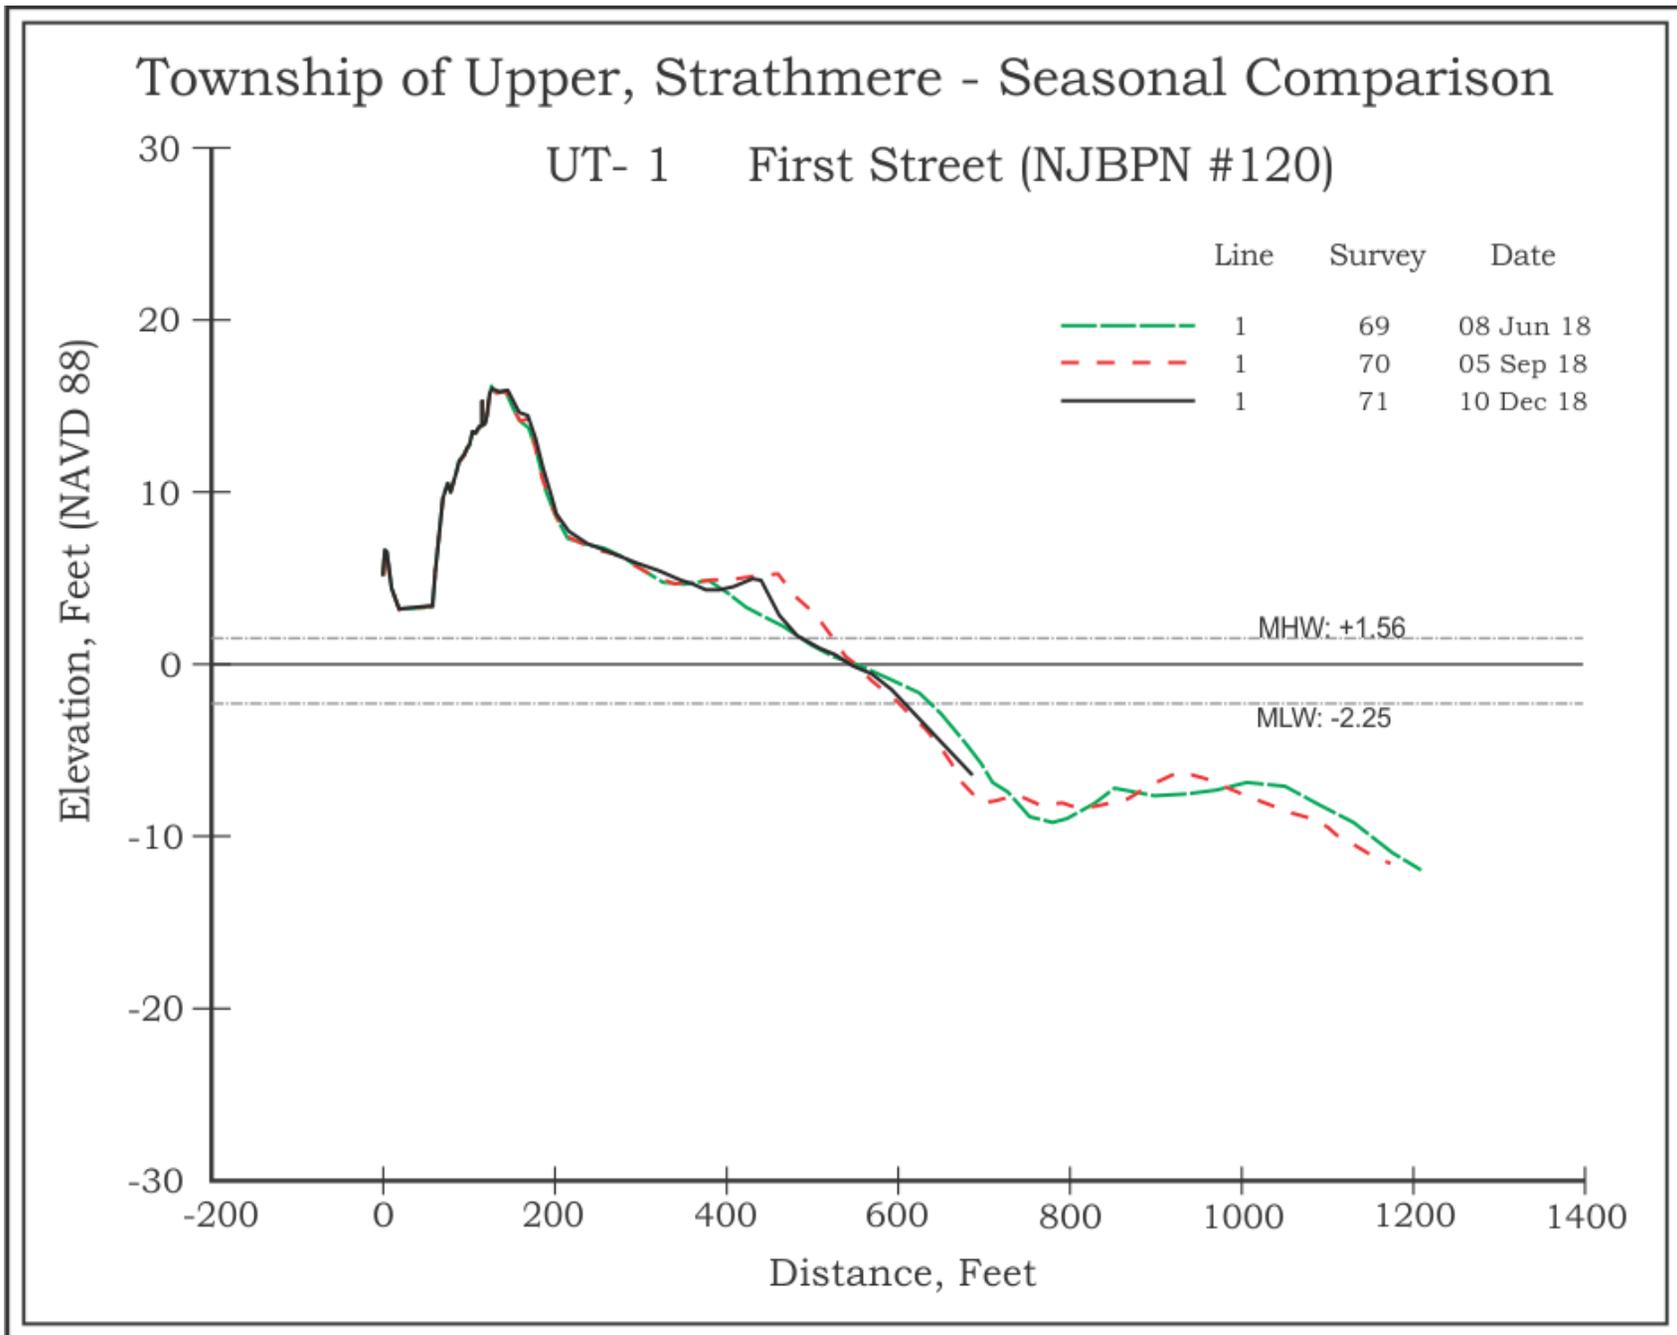
**Figure 17.** Overall, this site remained relatively stable throughout the 2018 survey year. A substantial summer berm developed by September, which did not entirely vanish by December. Minor sand addition was seen in the dunes.

A similar June to September berm development occurred here as seen at UT-2. Bar migration was less, but the bar was smaller in volume. The December cross section falls short of the bar system due to increasing wave intensity on the 10<sup>th</sup> of December ultimately forcing the crew to not attempt UT-2 that day. By December the berm had been reduced (-4.23 yds<sup>3</sup>/ft. above the zero datum), and sand was transported offshore (2.18 yds<sup>3</sup>/ft. added).

The June profile was still reflecting storm damage during the spring 2018 storm series, so the beach gained 5.30 yds<sup>3</sup>/ft. as offshore material moved onto the beach seasonally (-5.23 yds<sup>3</sup>/ft.) when the December profile is compared to the one done in June. The net change June to December was just 0.07 yds<sup>3</sup>/ft. with a 8-foot shoreline retreat.
