**FINAL REPORT FOR 2020
ON THE CONDITION OF THE MUNICIPAL BEACHES
IN
THE TOWNSHIP OF UPPER, CAPE MAY COUNTY, NEW JERSEY**

**PREPARED BY: THE STOCKTON UNIVERSITY COASTAL RESEARCH CENTER
30 WILSON AVENUE
PORT REPUBLIC, NJ 08241
JANUARY 28, 2021**

**Annual Report for 2020
To
The Township of Upper
On the Condition of the Municipal Beaches in Strathmere**

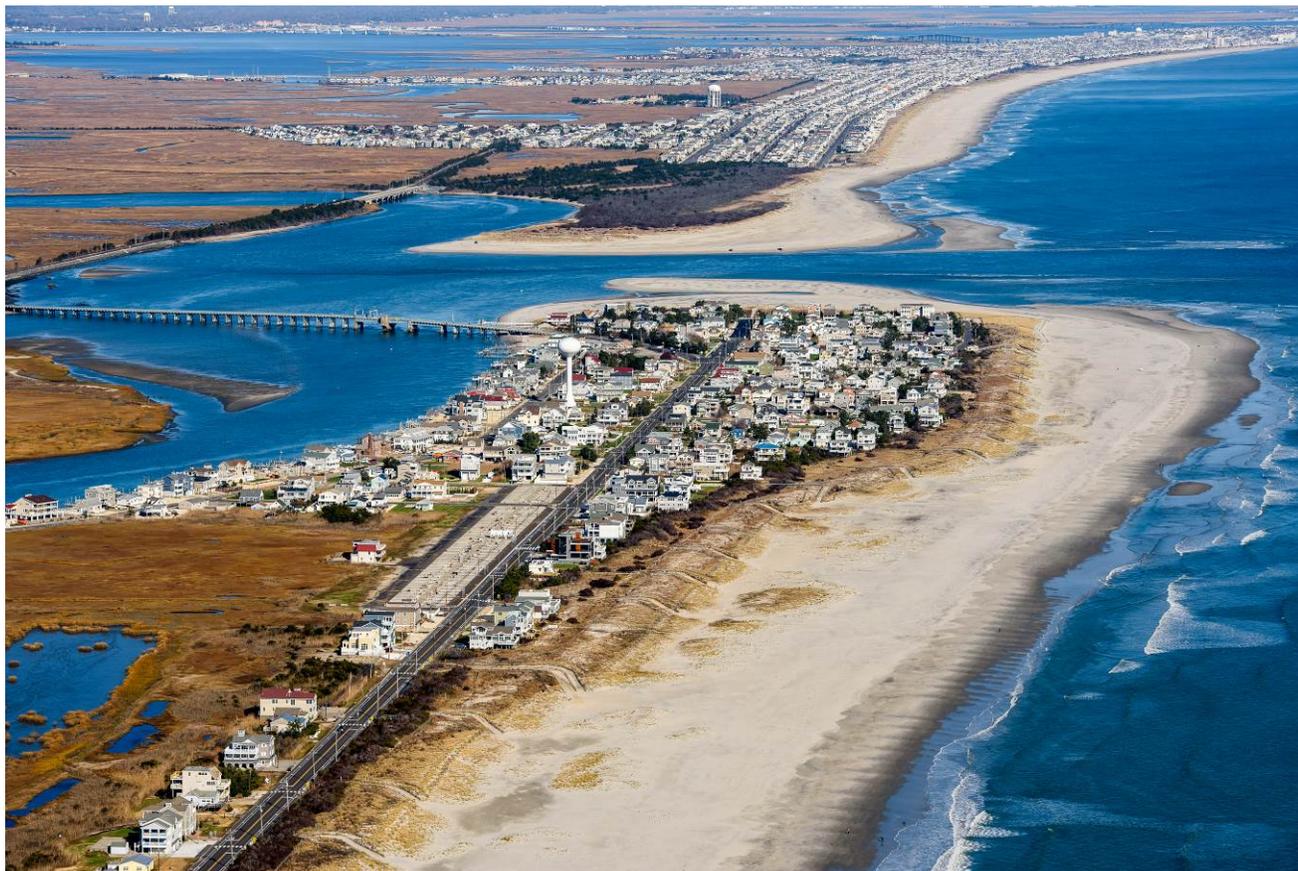
An aerial view of Strathmere, taken November 29, 2020, showing the majority of Strathmere as winter commenced. The beach widths appear quite sufficient to maintain a level of storm protection going forward. Offshore bar material resides along the northern oceanfront water's edge. (Photo by Ted Kingston).

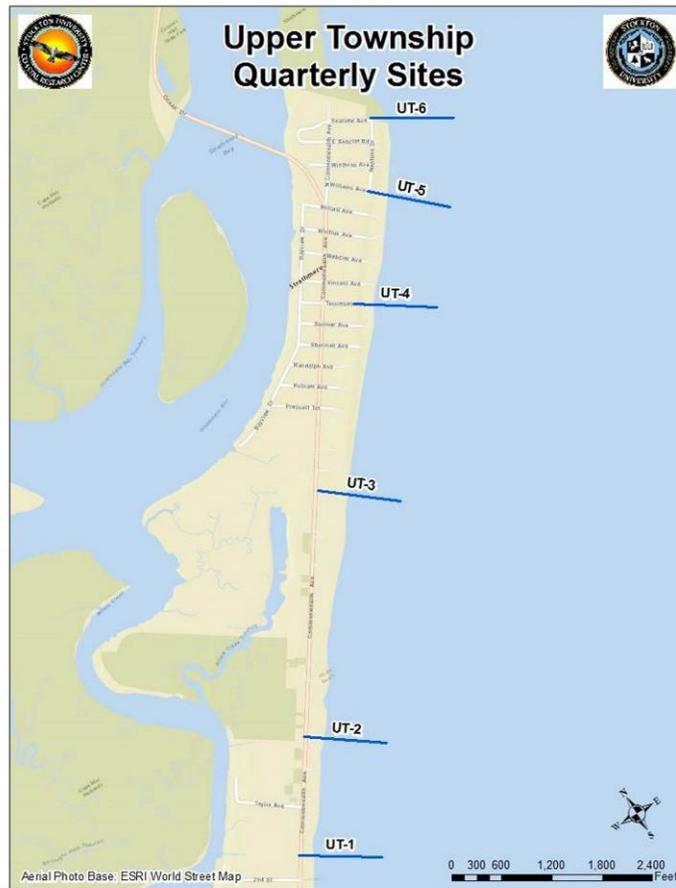
Figure 1 shows the locations of the 6 cross section locations used for this analysis.

Figure 1. Locations of the 6 beach profile stations for the engineered beach in Upper Township.

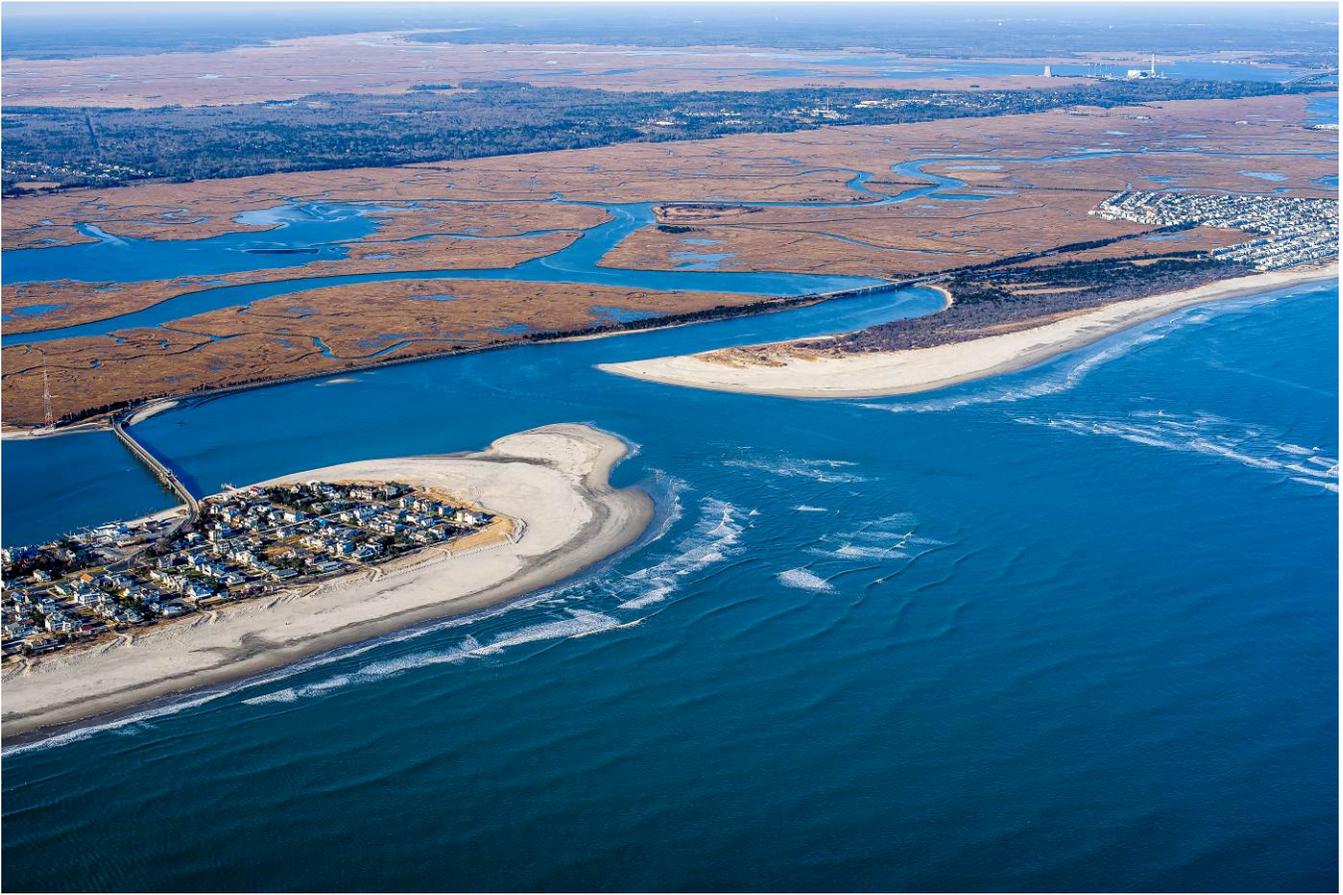
Figure 2. This December 27, 2020 view shows the entirety of Corson's Inlet with the offshore bar systems well defined by breaking waves near the beach and on the shoals off the north side of the inlet. The array of beach widths seems to reflect relative stability for the moment as do the survey transects. (Photo by Ted Kingston)

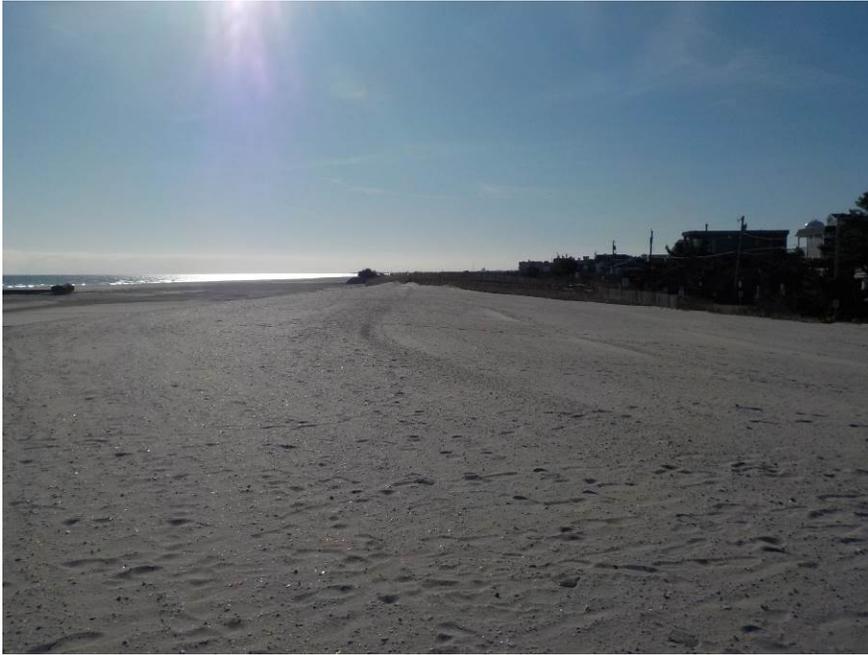
3a. December 12, 2019

Figures 3a to 3c. Seaview Avenue survey site. View to the south.

Photograph 3a was taken on December 12, 2019 following completion of project maintenance by the USACE. The restored dune was not vegetated or fenced, but the beach width has been restored to the design specifications.

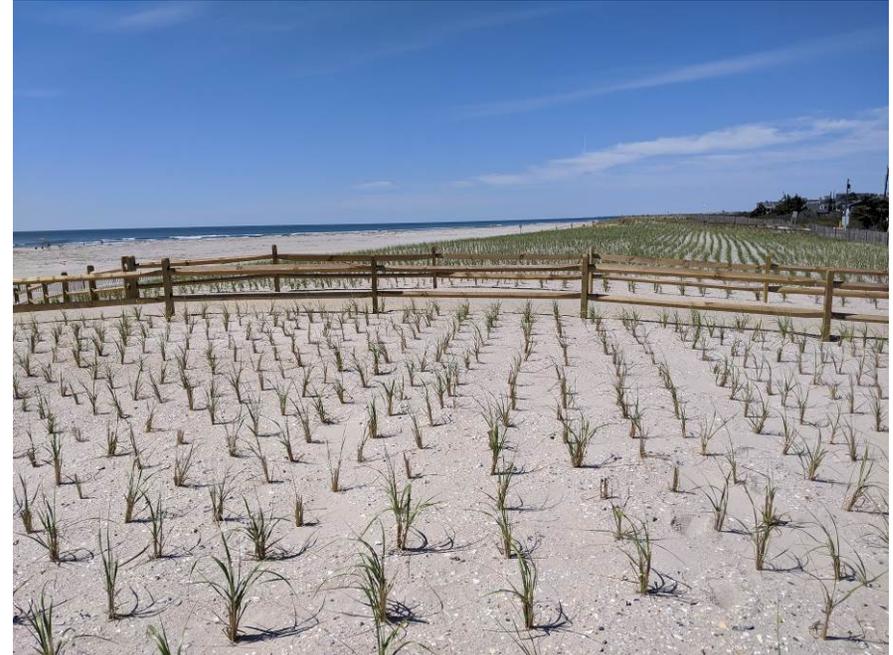
3b. June 1, 2020

Photograph 3b shows that by June 2020 grass had been planted on the restored dune with the pedestrian walking path to the beach defined by split rail fencing.

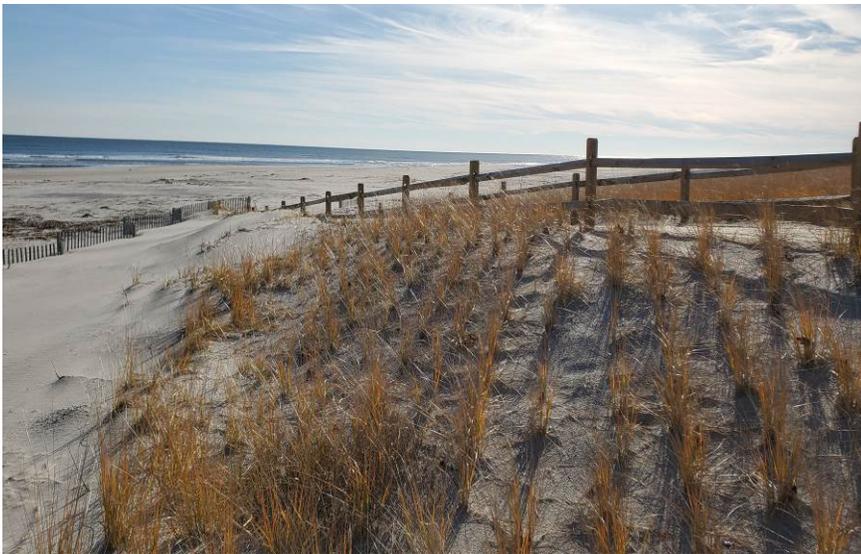
3c. December 15, 2020

Photograph 3c shows a view to the south a year following the last sand placement with wind deposition showing at the dune toe and a sufficiently wide beach remaining at the site.

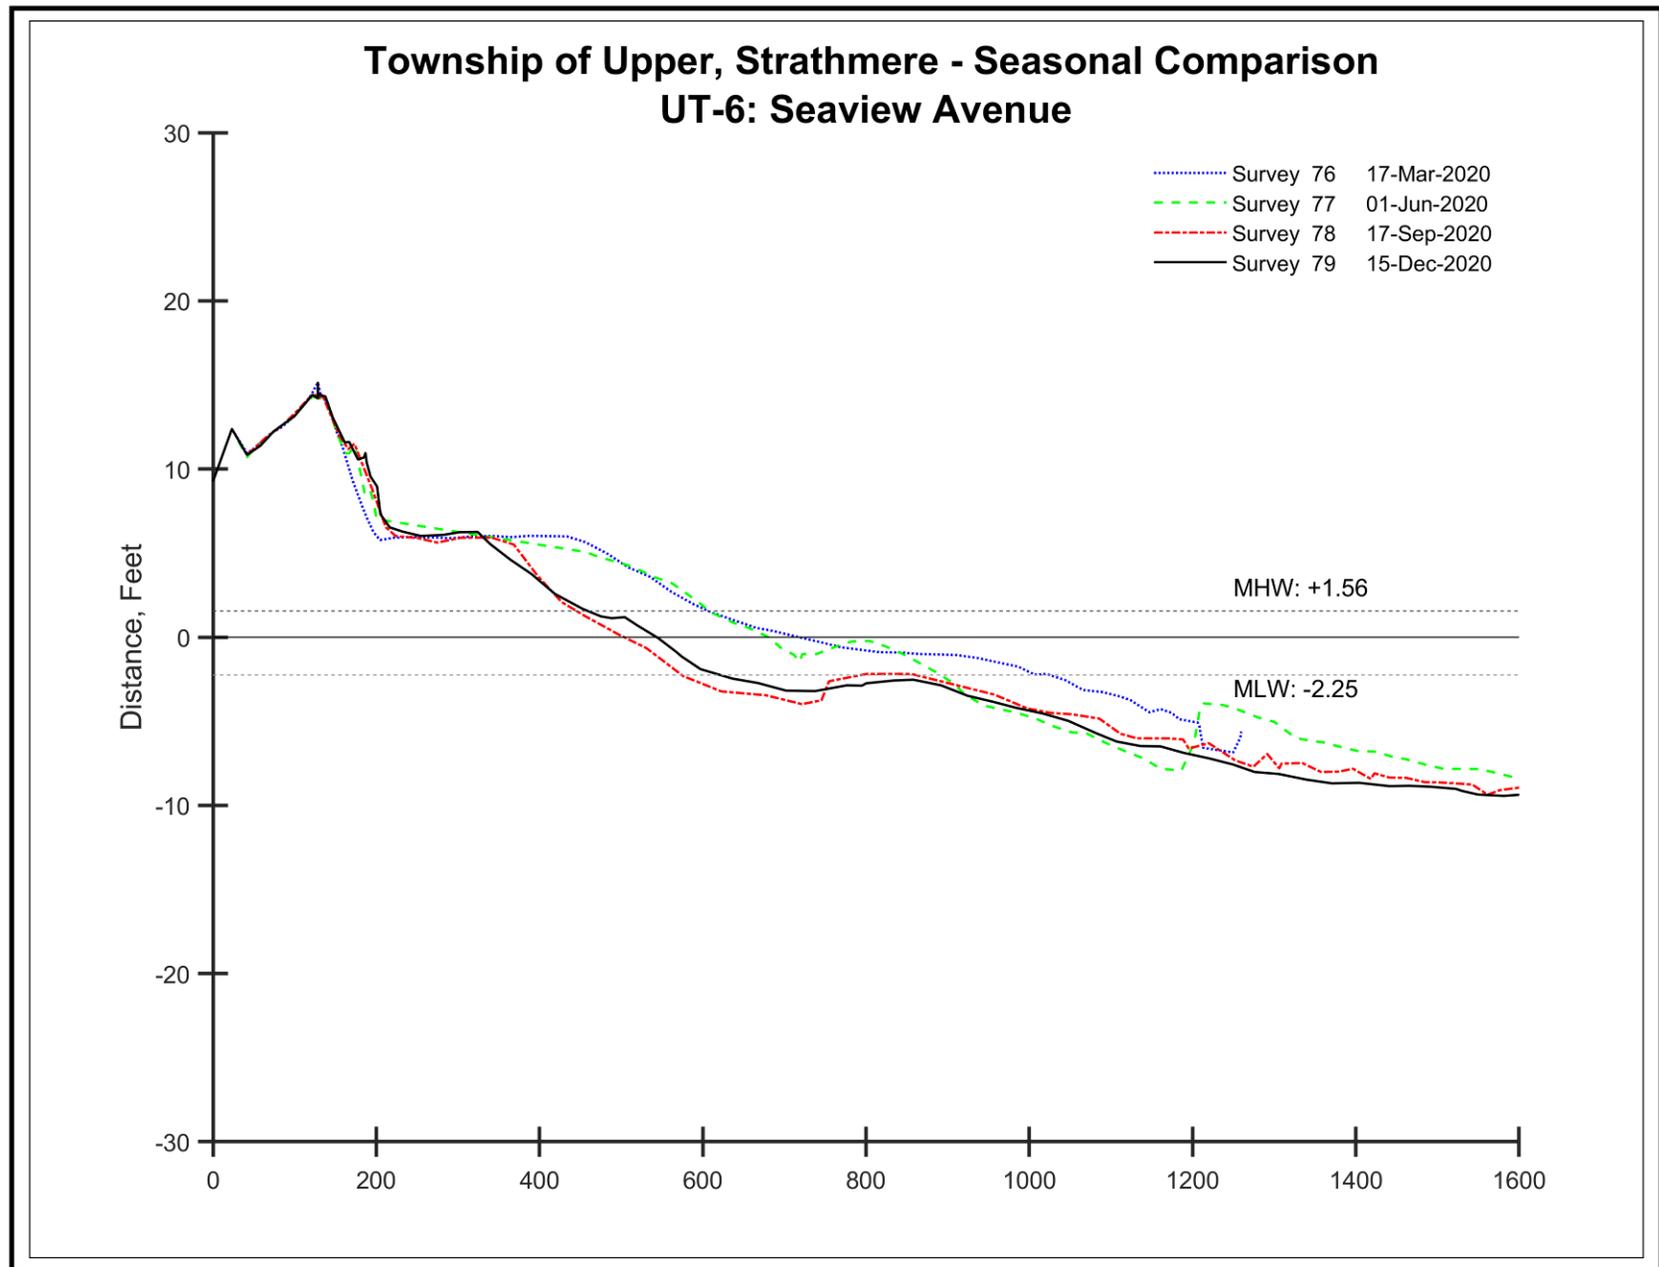
Figure 4. Sand readily accumulated at the seaward dune slope following the December 2019 dune and beach restoration by the USACOE. Between June and September substantial berm retreat occurred along with a substantial lowering of the offshore profile elevation. Minimal change occurred between the September and December surveys.

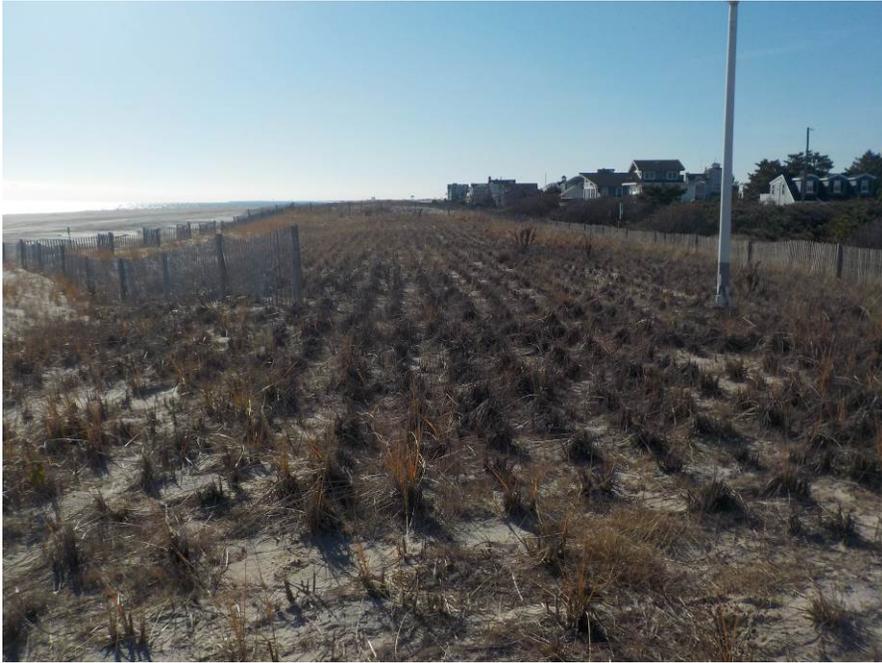
5a. December 12, 2019

Figures 5a to 5c. UT-5 survey site on Williams Avenue.

Figure 5a is a view of the beach after the federal maintenance widened the beach and added sand to the dune area seaward of the existing grass.

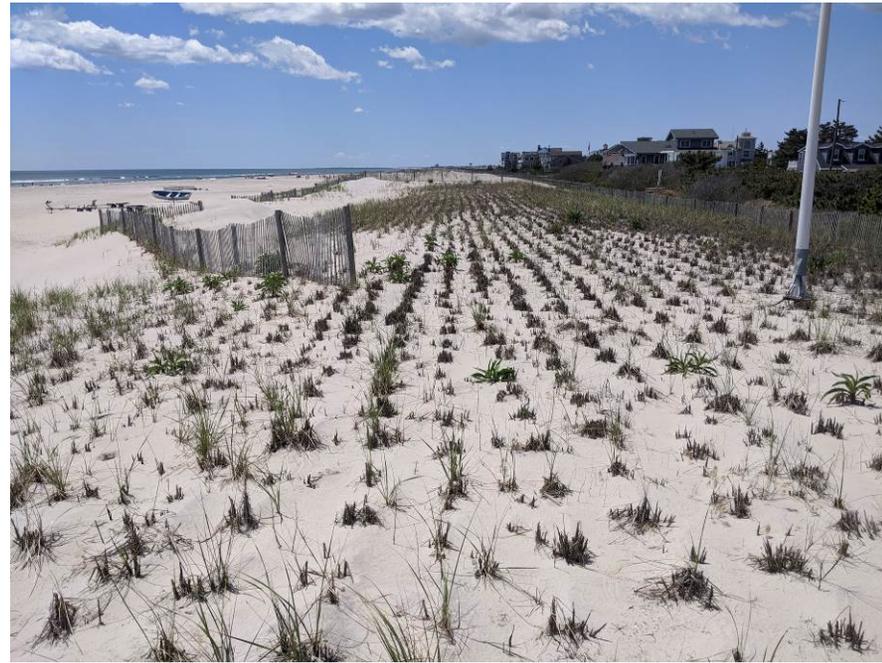
5b. June 1, 2020

Figure 5b was taken in June 2020 looking south from the dune showing a sizable grass mortality among plants installed following installation during the federal project. The satellite plants along the wind-generated fore dune ridge appear to have thrived.

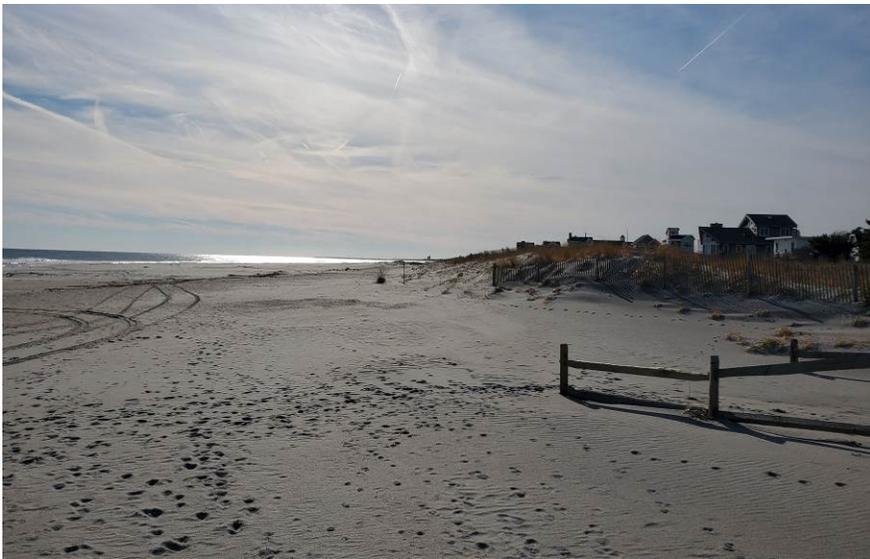
5c. December 15, 2020

Figure 5c shows the beach surface from the seaward dune toe to the water line as of the end of 2020.

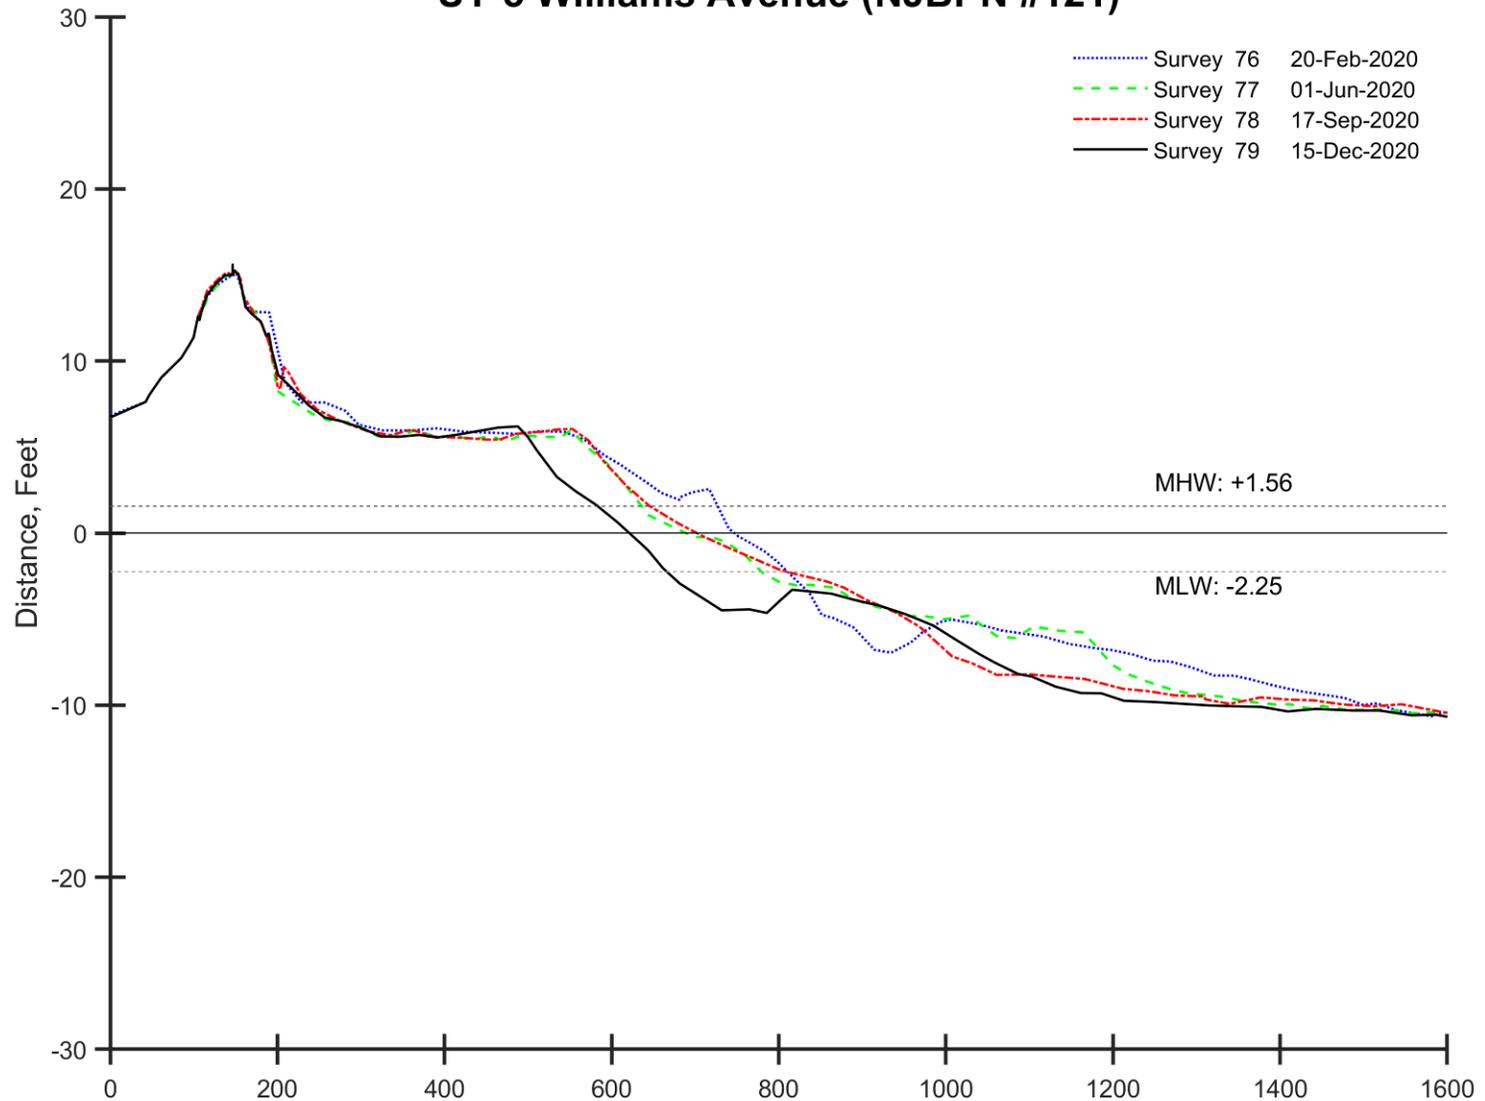
Township of Upper, Strathmere - Seasonal Comparison UT-5 Williams Avenue (NJBPN #121)

Figure 6. The site is still within influence derived from tidal currents associated with Corson’s Inlet. Sand deposited offshore forms into bars which migrate landward to attach to the beach. This occurred between June and September followed by a 75-foot berm retreat by December 2020 but with another bar poised to move onto the beach just offshore.

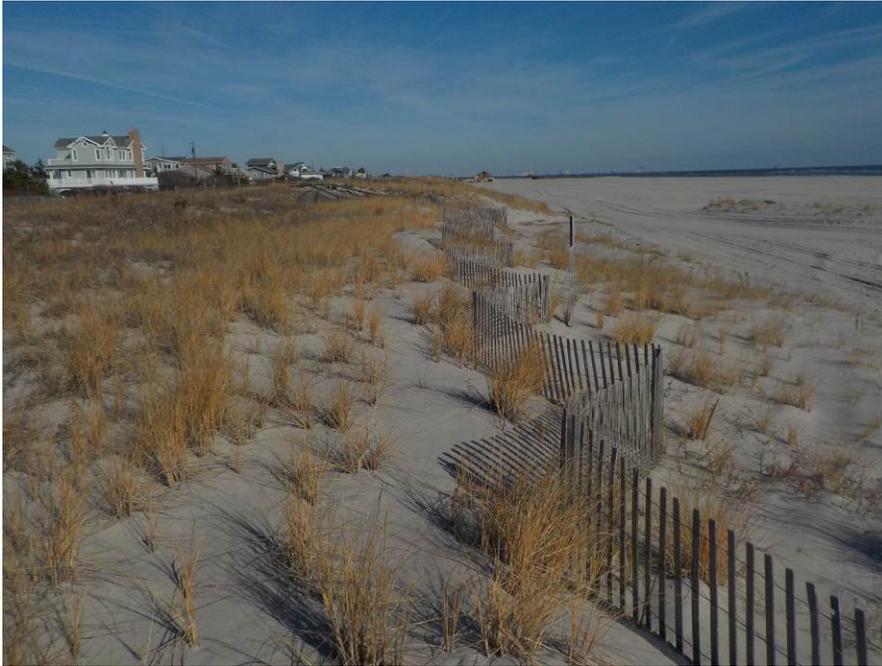
Figure 7a. December 12, 2019

Figure 7a shows the federal project was completed generating a wider beach, with some sand wind-transported into the dunes and onto the upper dry beach.

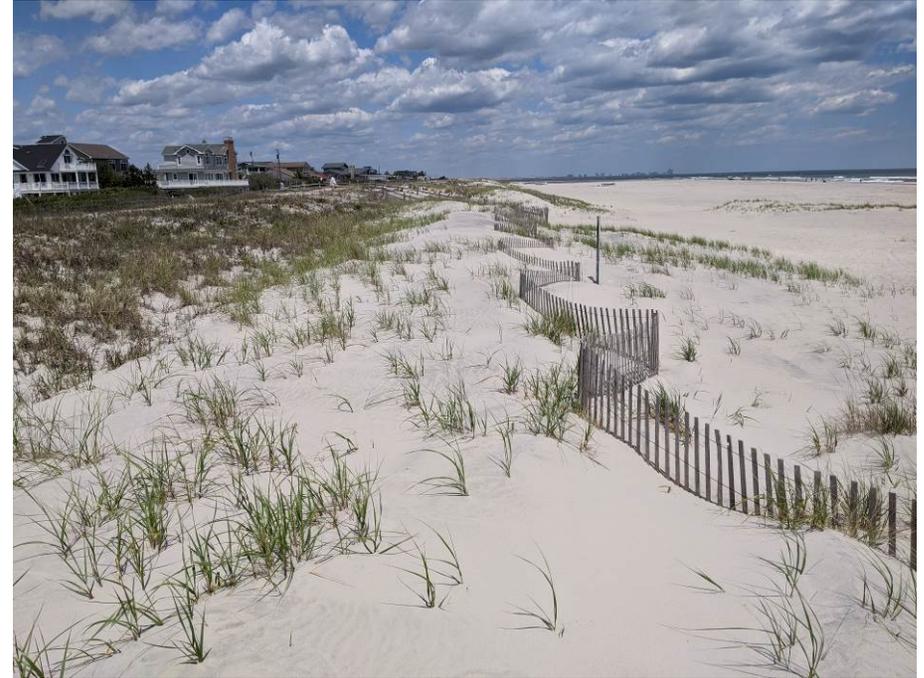
Figure 7b. June 1, 2020

Figure 7b shows the summer beach in June of 2020 with more wind deposition at the accreting foredune fencing enhanced with beach grass expanding onto its surface.

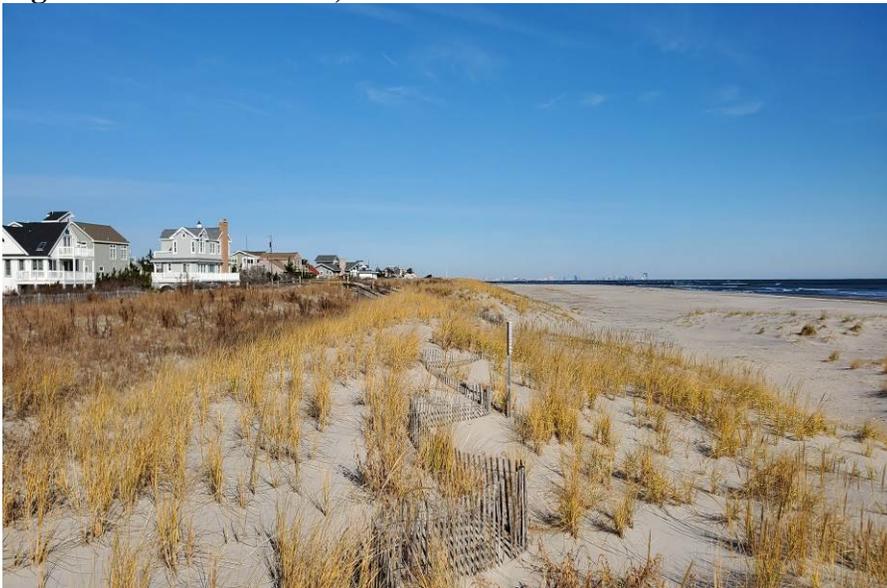
Figure 7c. December 15, 2020

Figure 7c is almost the exact perspective as figure 7a above and shows minimal change to the primary dune field as all the added material was deposited on the mid-beach foredune to the right side of the photograph.

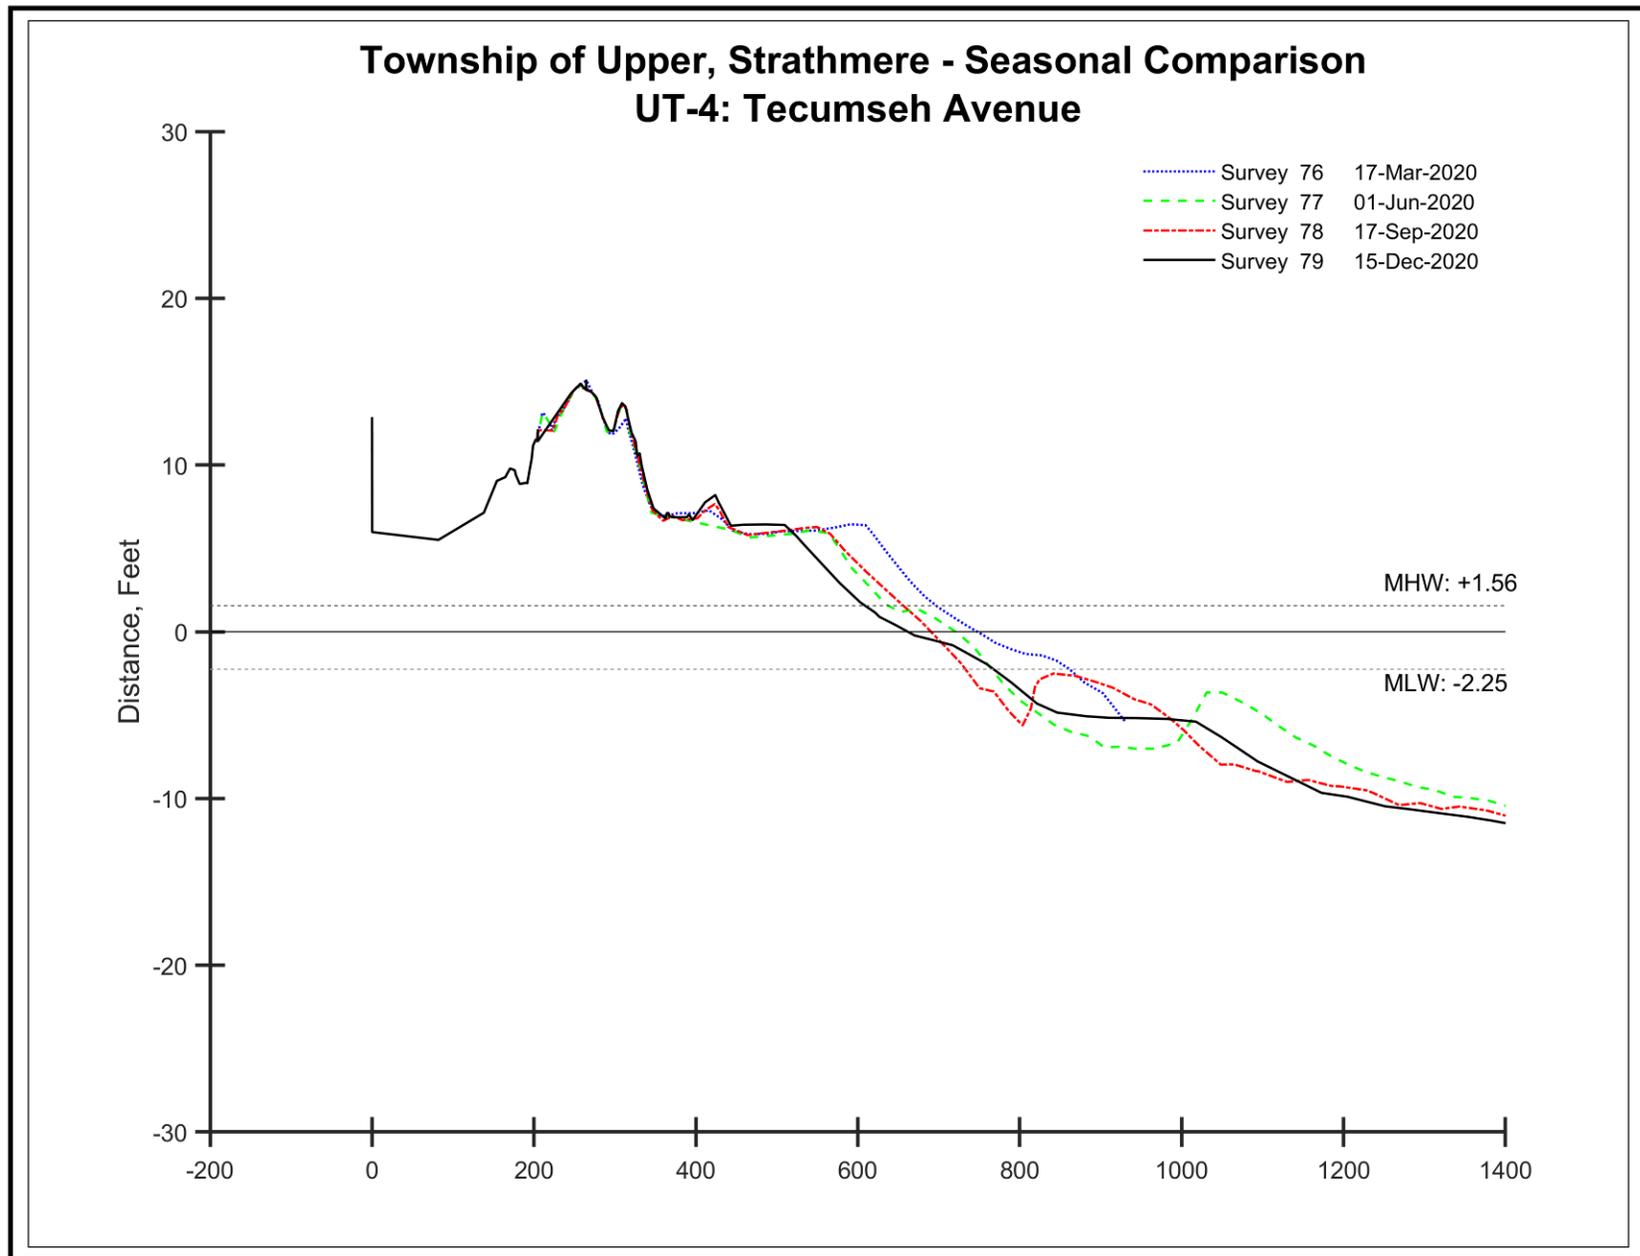
Figure 8. This location saw large offshore bars appear in the June survey and migrate over 200 feet closer to the beach by September. The berm retreated in two cycles between March and June and again between September and December where the offshore bar system decreased significantly in elevation but filled in the trough landward of the bar crest.

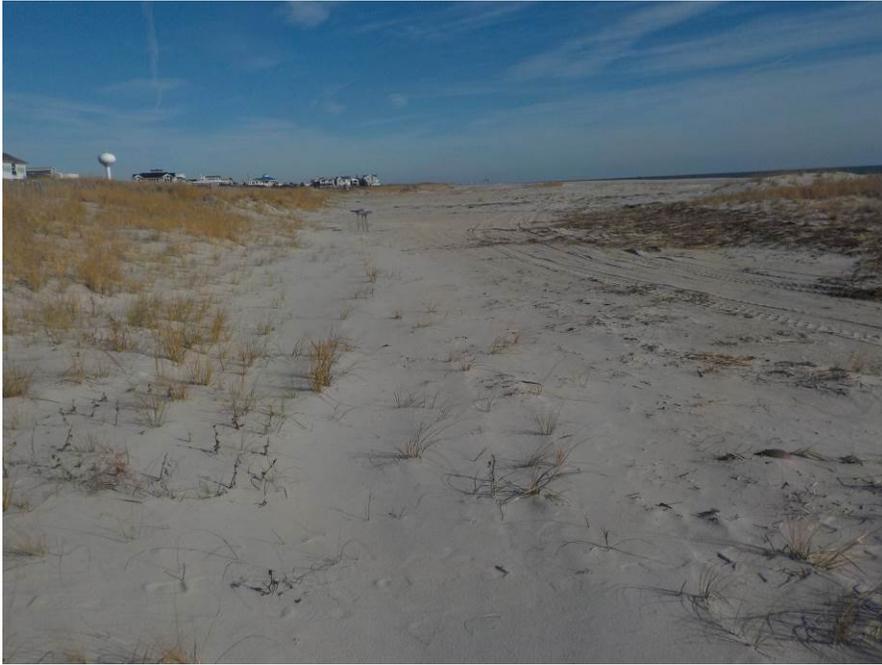
9a. December 12, 2019

Photo 9a shows the development of dune grass on the dry beach surface since the initial federal work was completed in 2016. Each summer this area expands and acts as a sand trap for wind transported material.

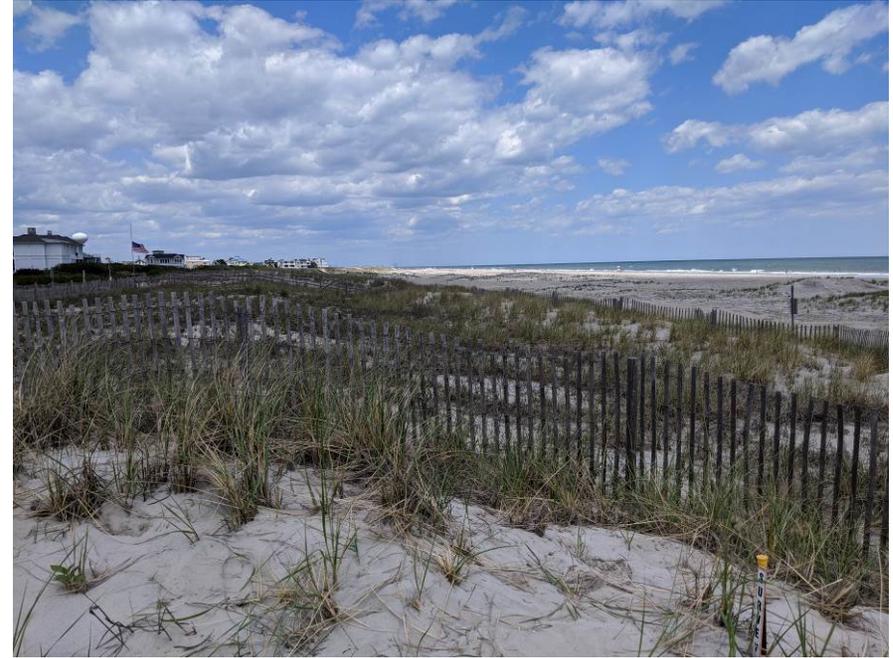
9b. June 1, 2020

Photograph 9b shows the view to the north taken from the primary dune crest across the new foredune to show the greatly expanded beach and dune system now present at UT-3.

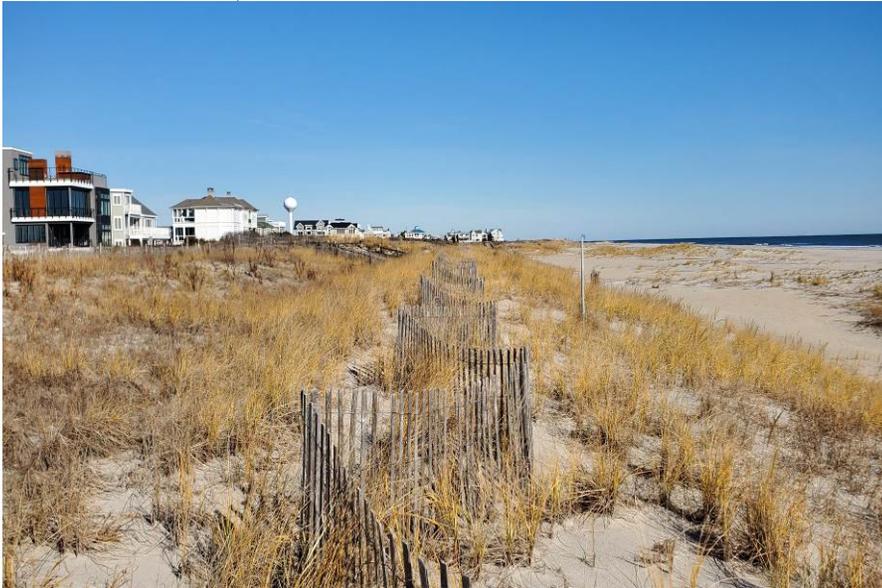
9c. December 15, 2020

Photograph 9c is a view along the sand fence to the north showing minimal sand accumulation at the fence, but additions in the foredune area on the dry beach surface.

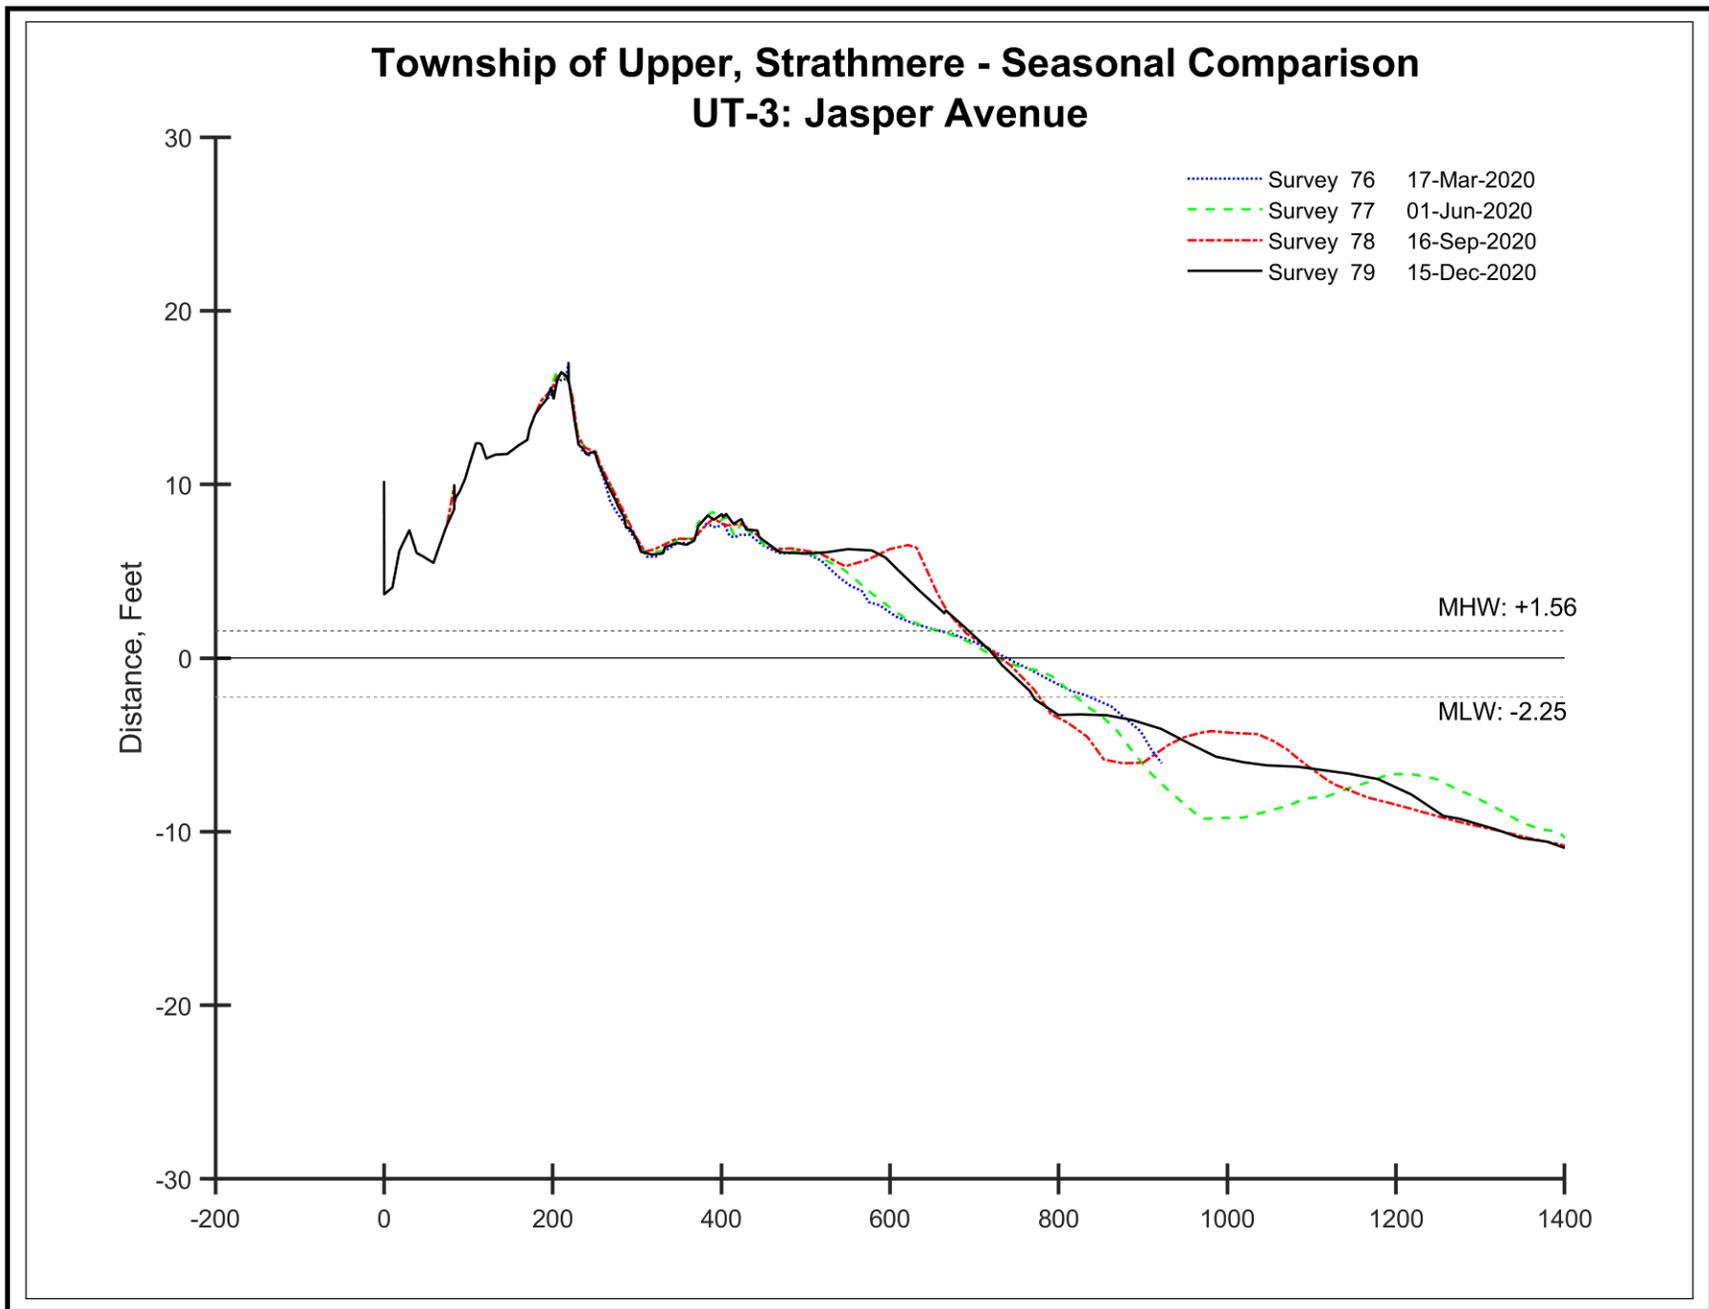
Figure 10. All the dune accretion took place on the emerging foredune seaward of the primary feature. The beach berm developed a major new crest position shown on the Sept. survey. This new crest retreated at the higher elevation as sand was washed further landward. The shoreline position did not change. The shortened March survey failed to collect data on the offshore bar conditions leading to a lower sand volume gain volume beyond 950 feet.

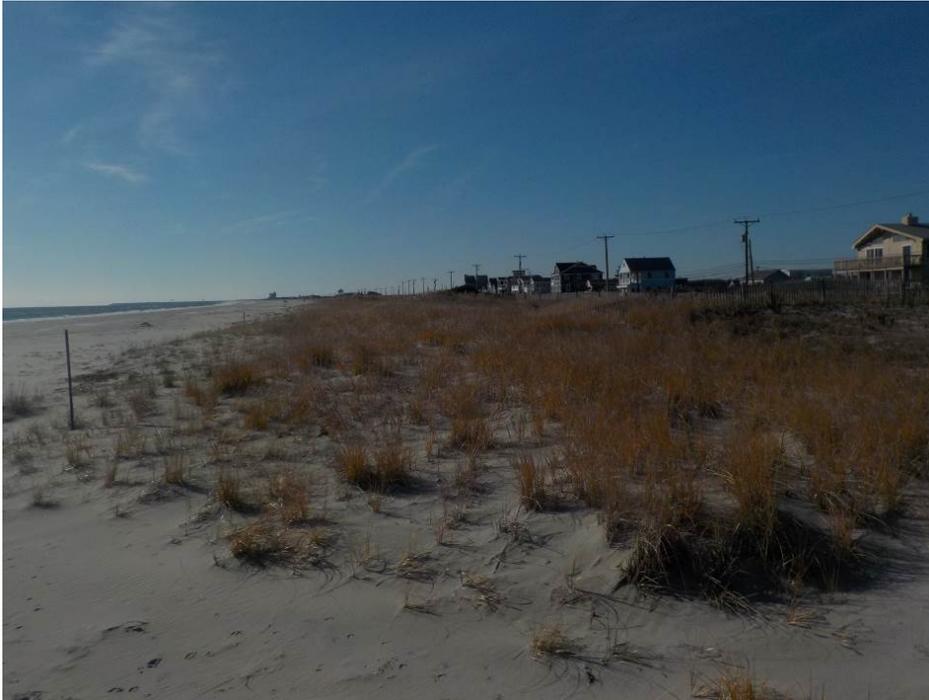
11a. December 12, 2019

Figure 11a shows a view from December 2019 where the grass became distributed more naturally as the planted plugs spread out and seaward onto the foredune area.

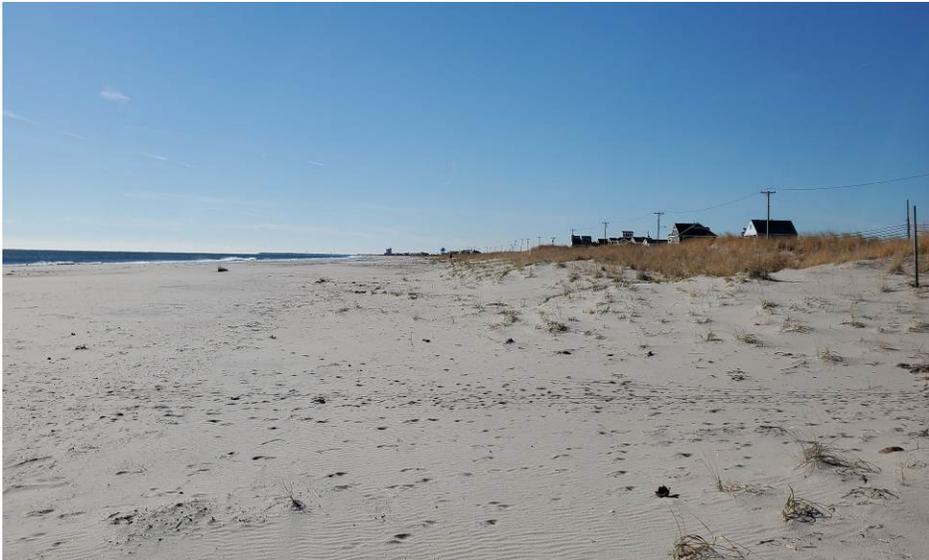
11c. December 15, 2020

Photograph 11c is a beach view at the toe of the dune across the open beach. The pattern of change is only one where the beach appears wider than it did in June 2020.

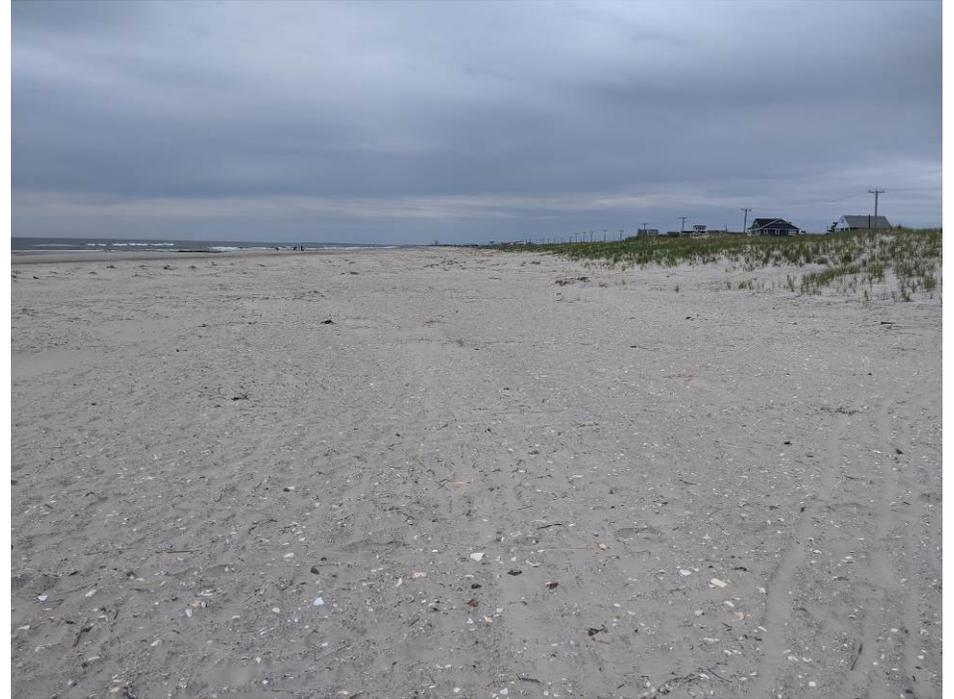
Figure 11b. June 2, 2020

Photograph 11b shows a wide dry beach leading up to the expanding seaward dune slope with grass migrating down slope onto the upper beach.
