**FINAL REPORT FOR 2020
ON THE CONDITION OF THE MUNICIPAL BEACHES
IN
THE TOWNSHIP OF UPPER, CAPE MAY COUNTY, NEW JERSEY**

**PREPARED BY: THE STOCKTON UNIVERSITY COASTAL RESEARCH CENTER
30 WILSON AVENUE
PORT REPUBLIC, NJ 08241
JANUARY 28, 2021**

**Annual Report for 2020
To
The Township of Upper
On the Condition of the Municipal Beaches in Strathmere**

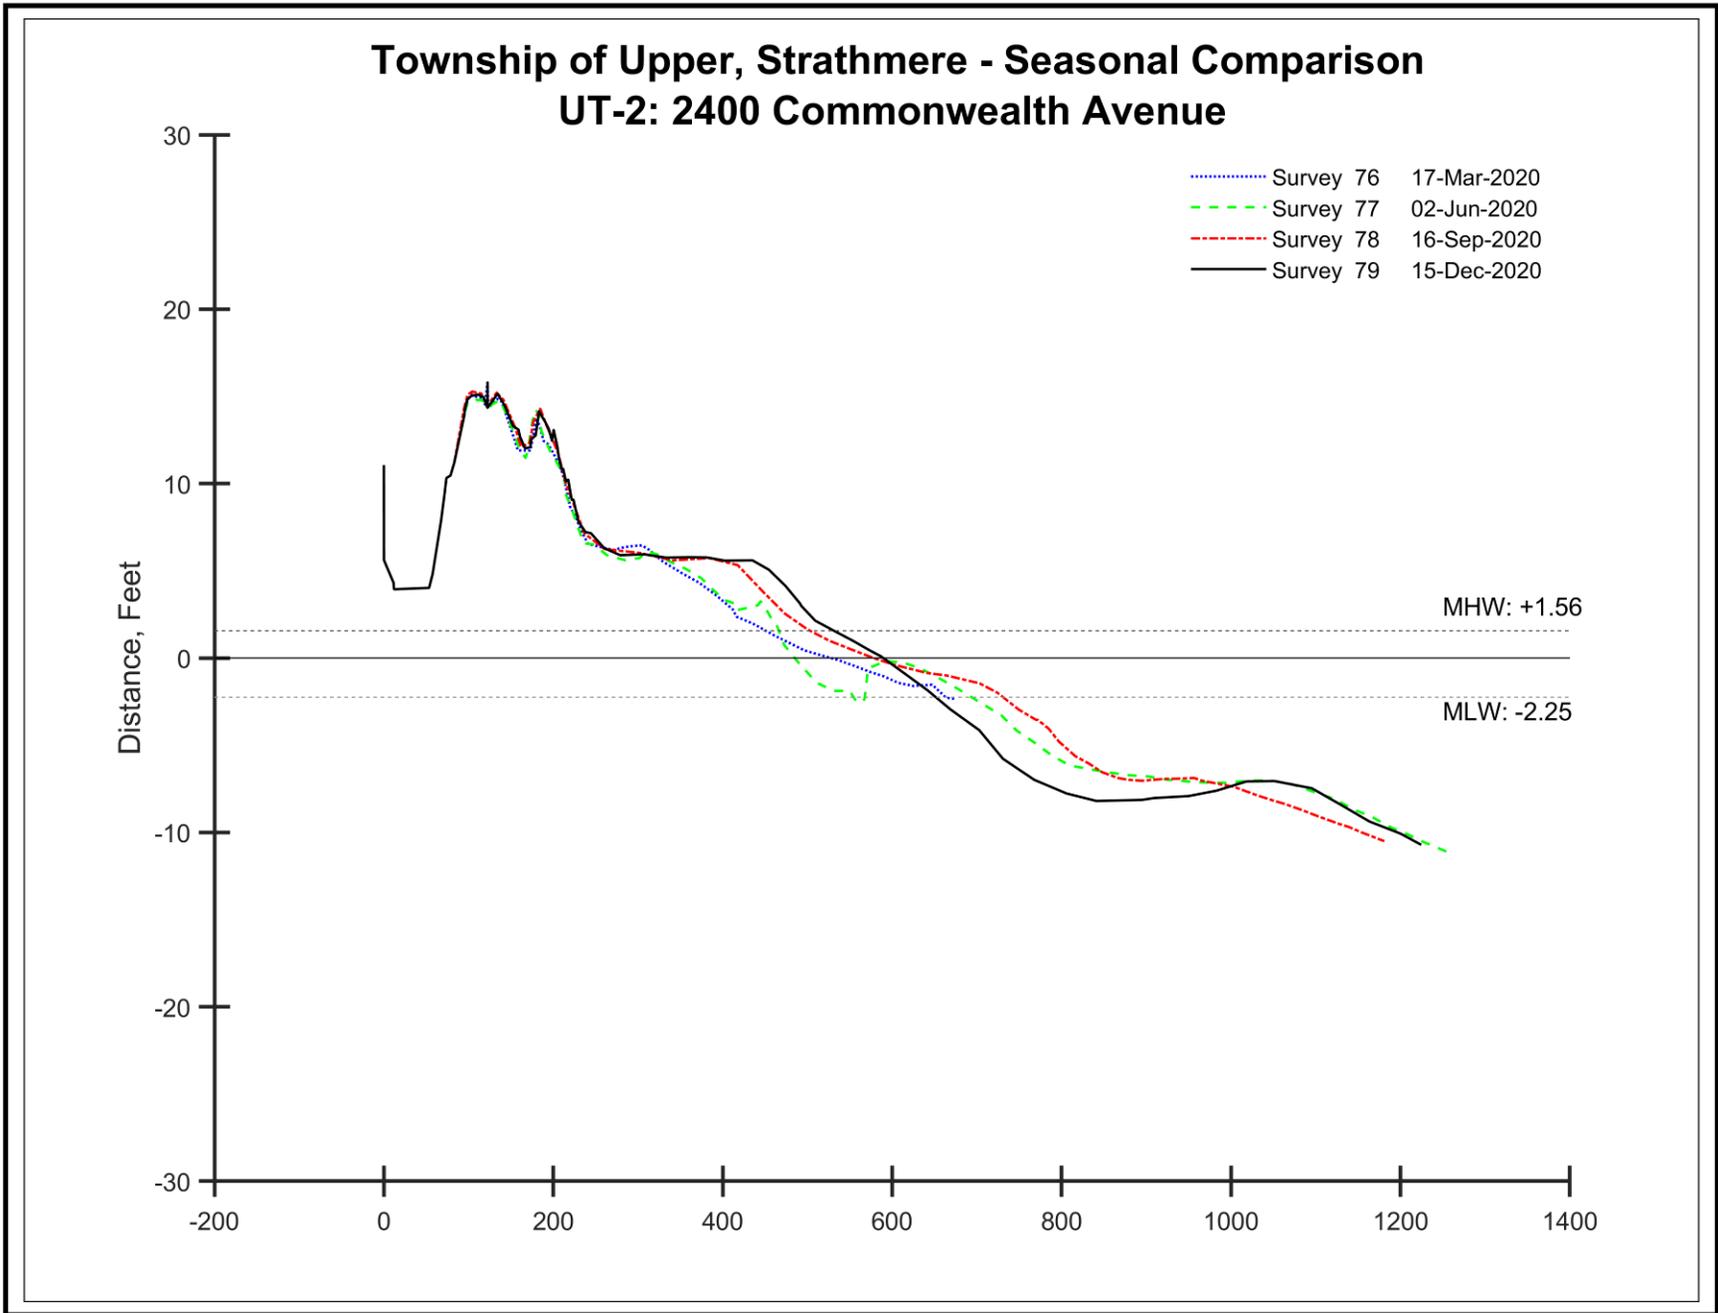
Figure 12. The past year saw sand added to the berm widening the beach by about 25 feet at the zero-elevation point and by over 100 feet at the berm crest elevation. Sand was transferred onto the beach between September and December 2020 specifically in the nearshore area.

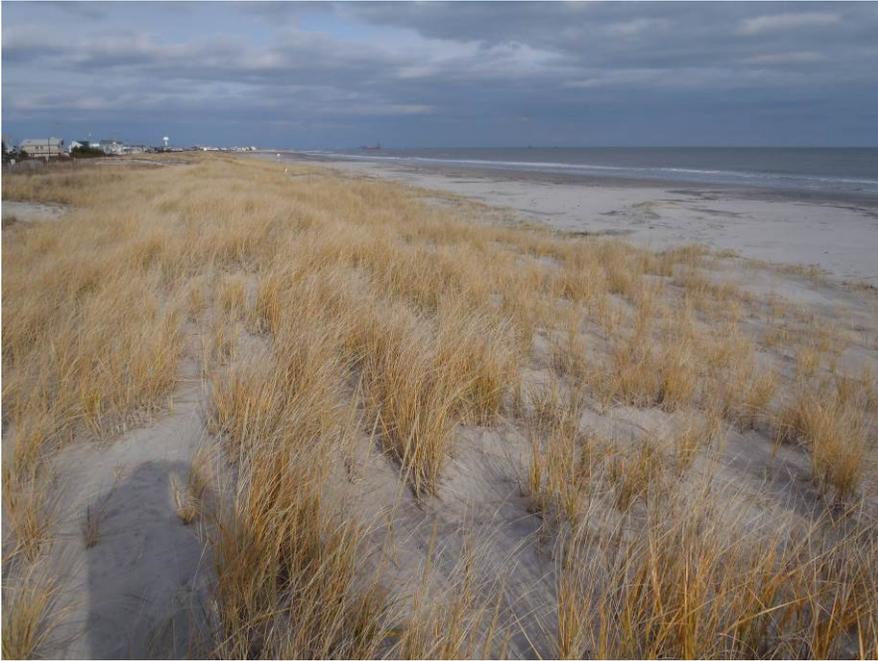
13a. December 12, 2019

Photograph 13a provides the winter view to the north across the dune and onto the beach. The decrease in beach berm width is evident in the picture.

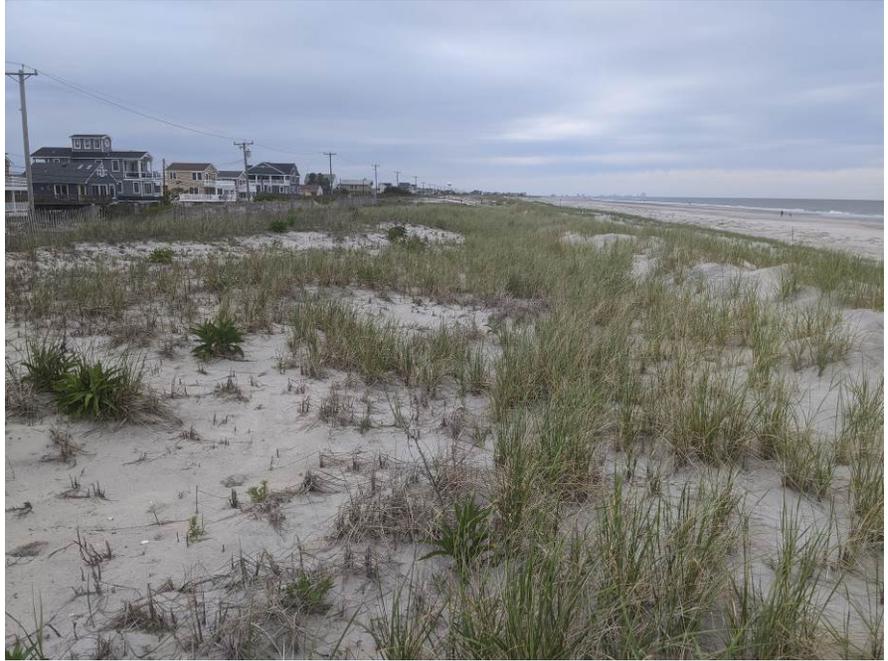
13b. June 2, 2020

Photograph 13b shows the beach six months later when sand had added to the berm increasing the beach width. Summer growth has added luxuriant vegetative cover to the dune.

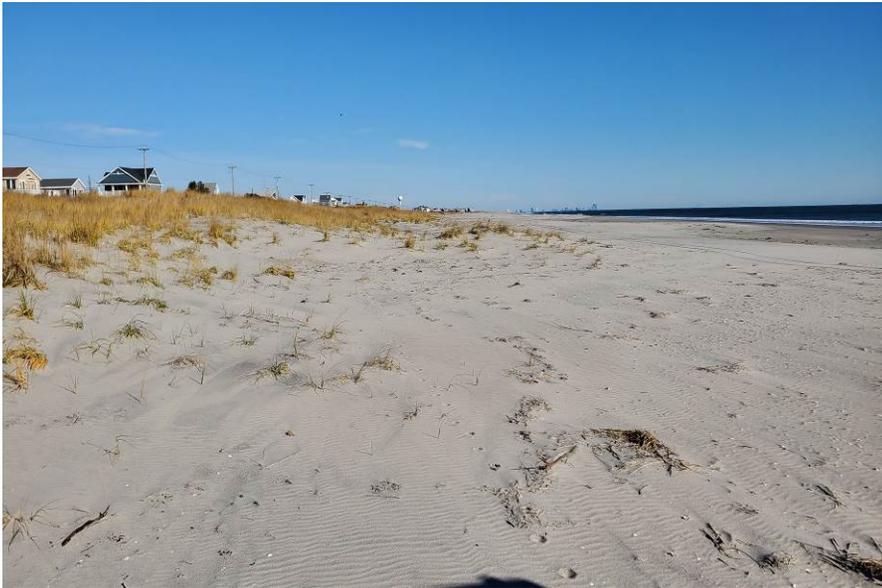
13c. December 15, 2020

Photograph 13c is a view to the north at the seaward toe of the dunes across the beach showing the extent of sand accumulation. These three views show far more sand present than was on the site prior to the federal project completion.

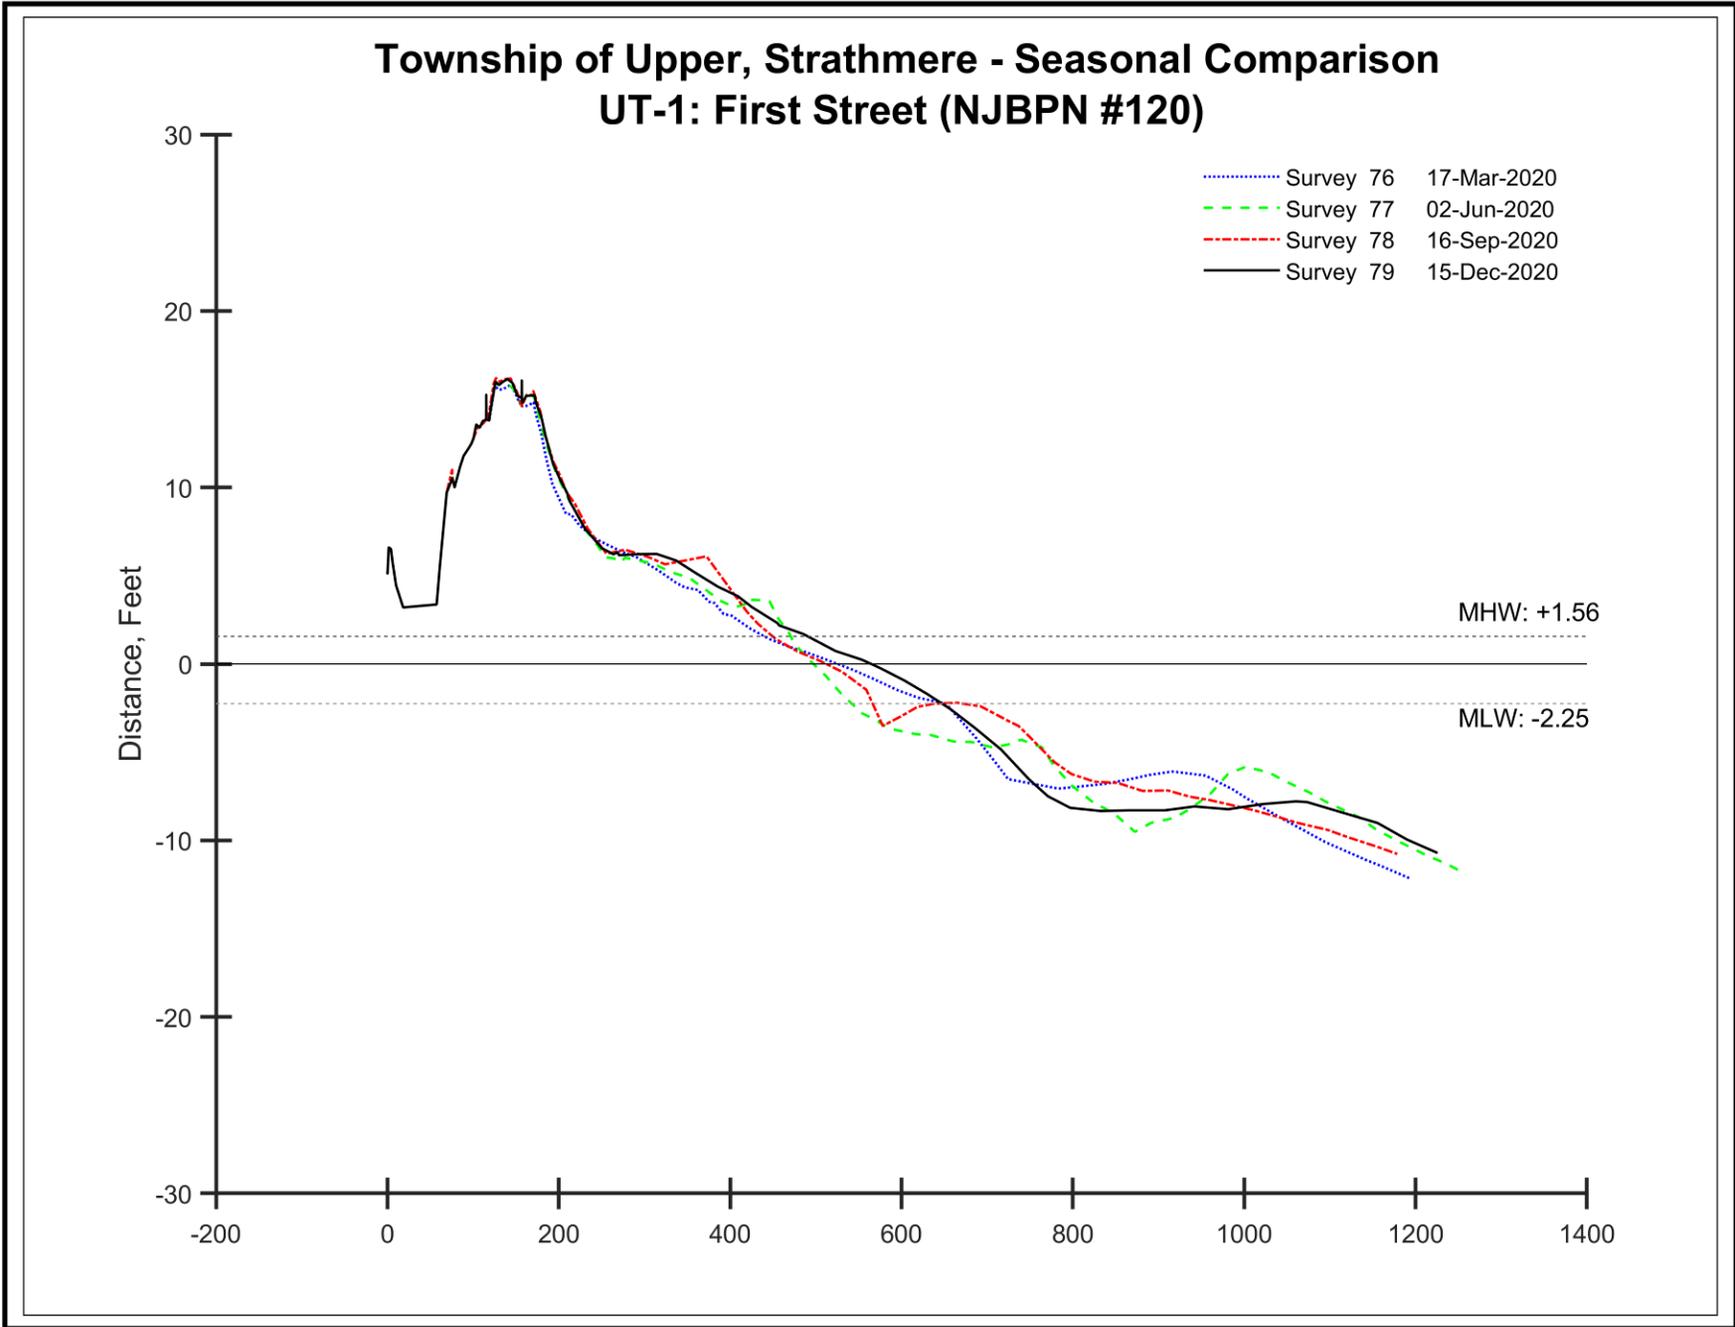
Figure 14. Sand was carried to the seaward primary dune slope this year while material appearing offshore migrated up onto the dry beach by December 2020. This is evidence that littoral transfer has moved sand from near the inlet south onto the mid-island beaches.
