New Jersey Beach Profile Network

Atlantic County

Little Egg Inlet
to Great Egg Harbor Inlet

NJBPN Profile #'s
134 - 126

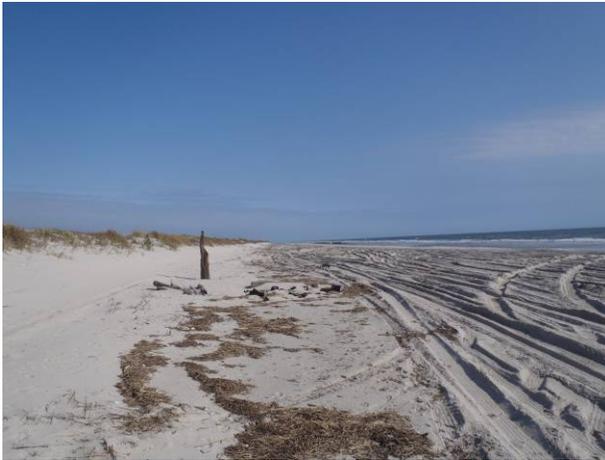
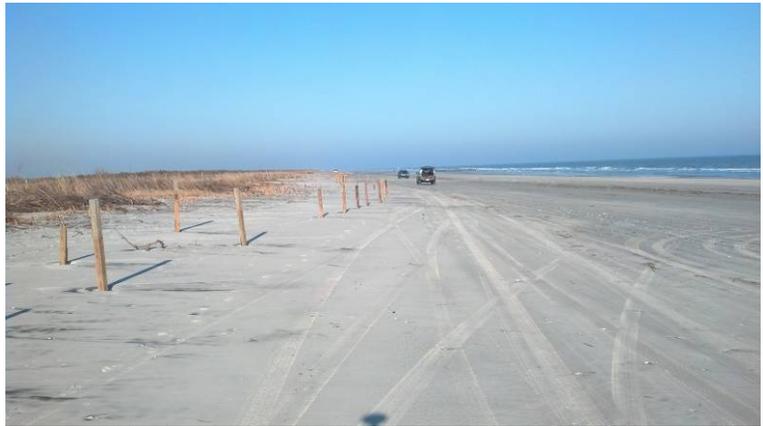
NJBPN 134 – Green Acres Area, Brigantine

The photographs above were taken on October 26, 2012 (left) and November 11, 2012 (right). The dune on the left started from nothing in January 1993, and was washed flat by Sandy (right). It is likely that the posts in the right picture date from the original 1992 post-storm effort to re-create the dune along this open-space beach.

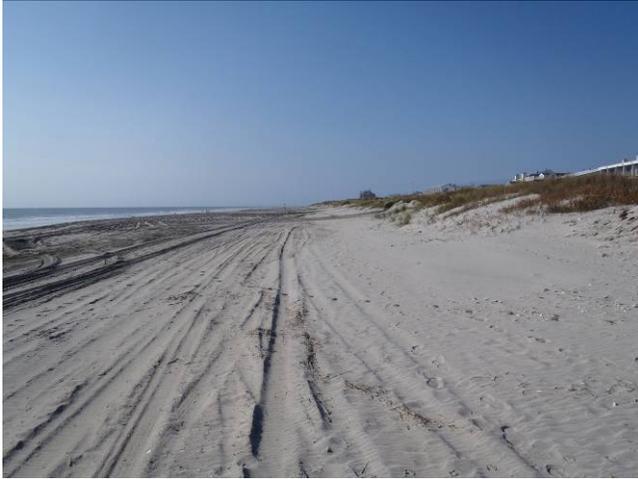
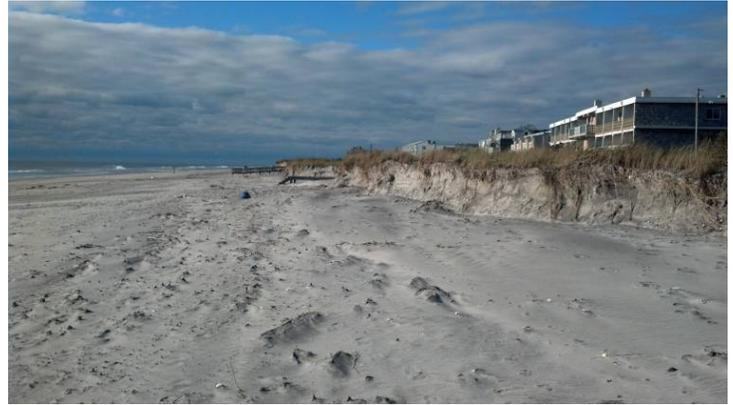
NJBPN 133 – 4th Street North, Brigantine

The photographs above were taken on October 26, 2012 (left) and November 3, 2012 (right). The seaward slope of the dunes was truncated by Sandy with sand moved seaward. Minor overwash at street ends occurred in places, but wholesale damage was absent.

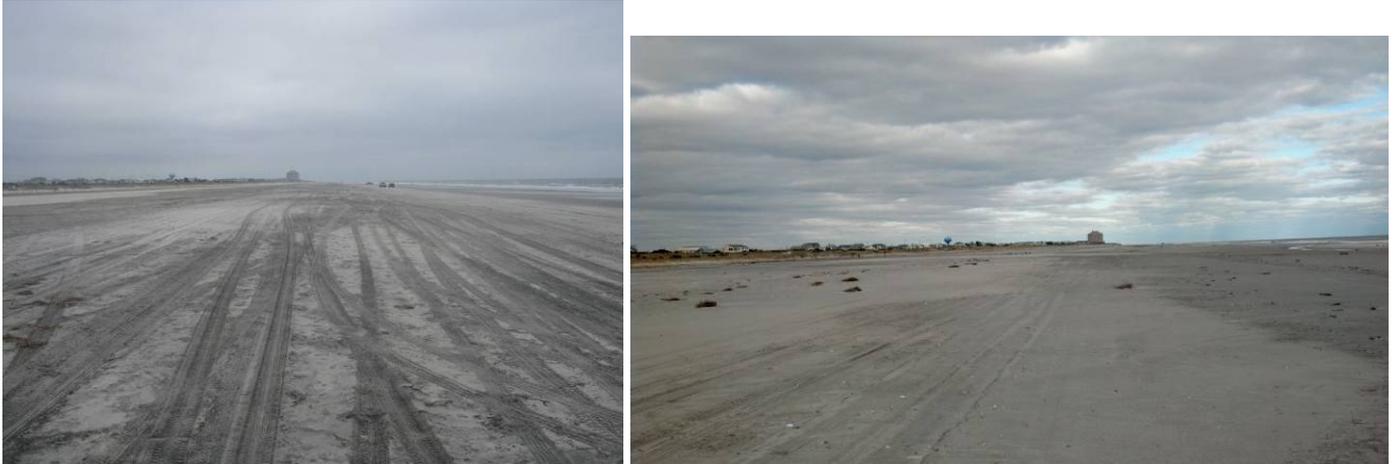
NJBPN 131 – 43rd Street South, Brigantine

The photographs above were taken on October 25, 2012 (left) and November 3, 2012 (right). The large building at 15th Street South shows in both pictures in the distance. From the large building at 15th Street, to a mile south of this site, the beach width is huge with multiple rows of vegetated dune ridges to the landward site. The storm surge and wave energy expended itself in the dunes closest to the back beach margin with no ill effect on the development.

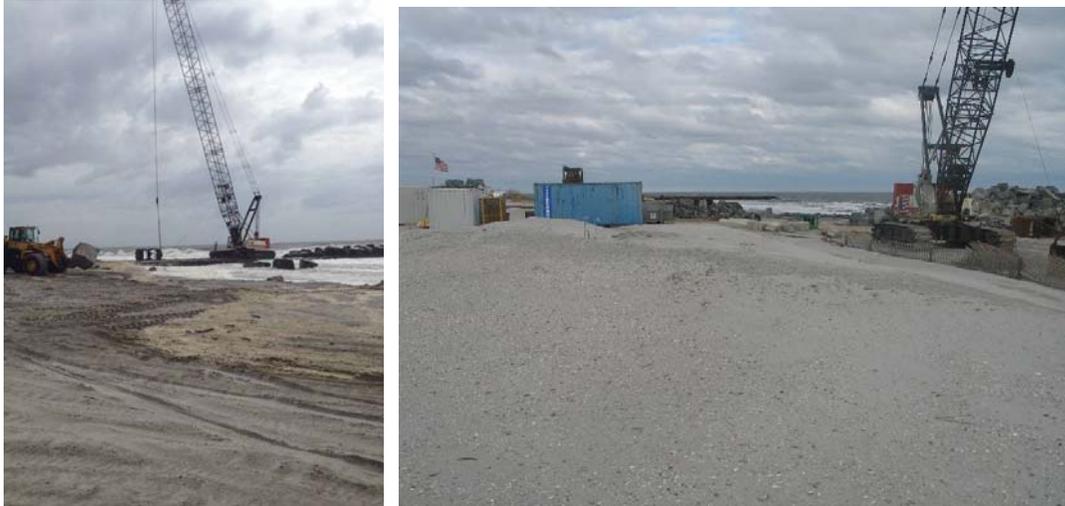
NJBPN 230 – Rhode Island Avenue, Atlantic City

The photographs were taken on September 18, 2012 (left) and November 6, 2012 (right). Work was continuing on the rock sill being placed between the Massachusetts and Vermont Avenue groins in northern Atlantic City. The new Revel Entertainment casino was built here and a submerged, shore-parallel rock sill between the two groins was built to trap sand as a “perched” beach for a longer time period between the maintenance interval for the Federal beach project. Since the maintenance was just completed following hurricane Irene in 2011, the dune/beach system resisted the storm damage from Sandy with about three quarters of the dune surviving.

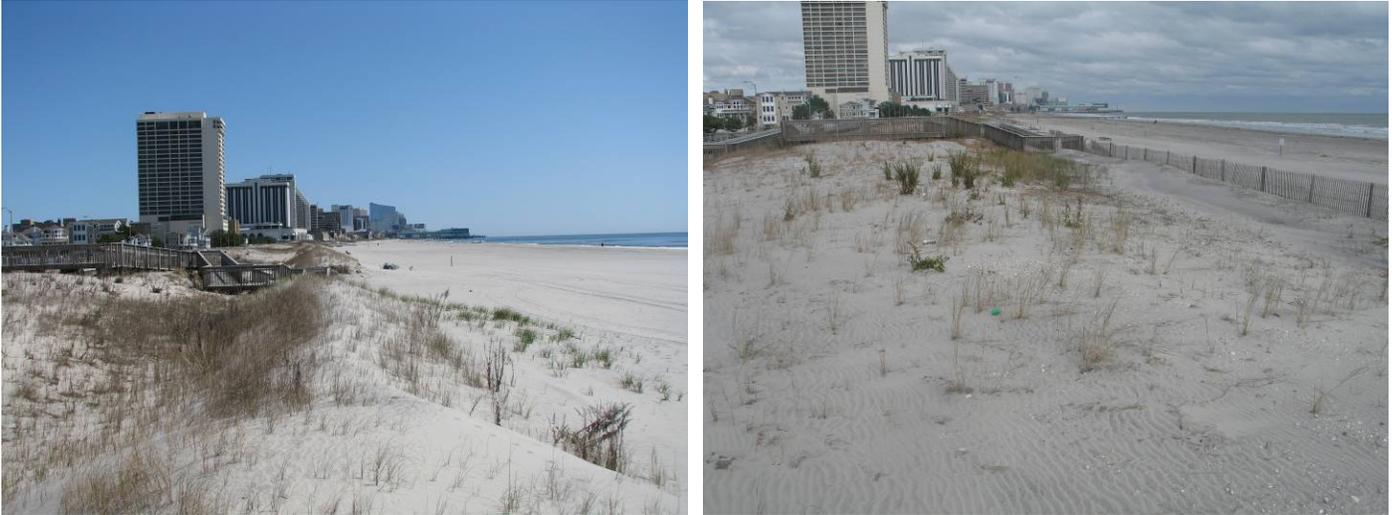
NJBPN 129 – Raleigh Avenue, Atlantic City

The photographs above were taken on April 13, 2012 (left) and November 6, 2012 (right). Raleigh Avenue lies in the middle of the Federal beach project and this meant that little damage was done. The dunes were invaded on the seaward slope depositing sand in the grass and knocking down an incipient foredune.

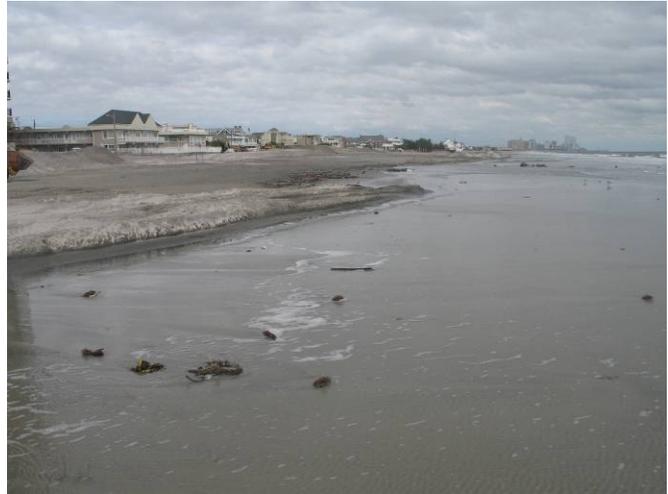
NJBPN 127 – Benson Avenue, Margate City

The photographs above were taken on April 13, 2012 (left) and November 6, 2012 (right). The relatively robust berm was cut down and pushed landward as a substantial deposit that included Benson Avenue and environs. The work was underway to excavate the sand at the sea-side of the bulkhead to keep water from simply running over it.

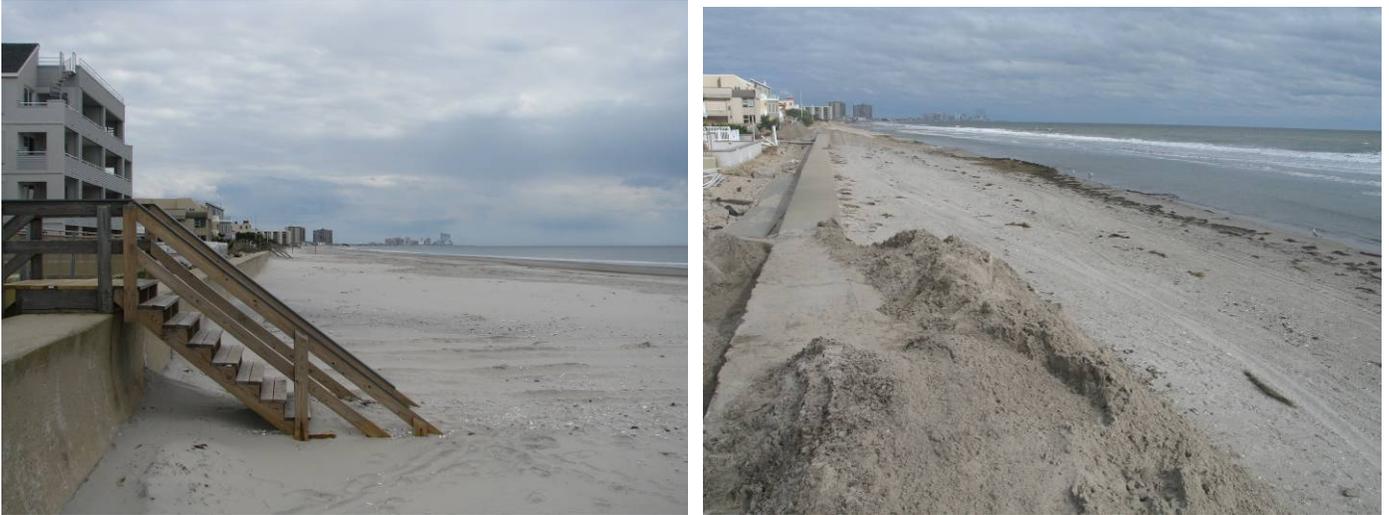
NJBPN 126 – 17th Street, Longport

The photographs above were taken on April 11, 2012 (left) and November 6, 2012 (right). The narrow beach allowed wave energy to explode on the seawall. The water bounced over it and crashed into the homes built at the base of the wall. Street end flooding, sand deposition to Atlantic Avenue and structural damage was spread along the shoreline.

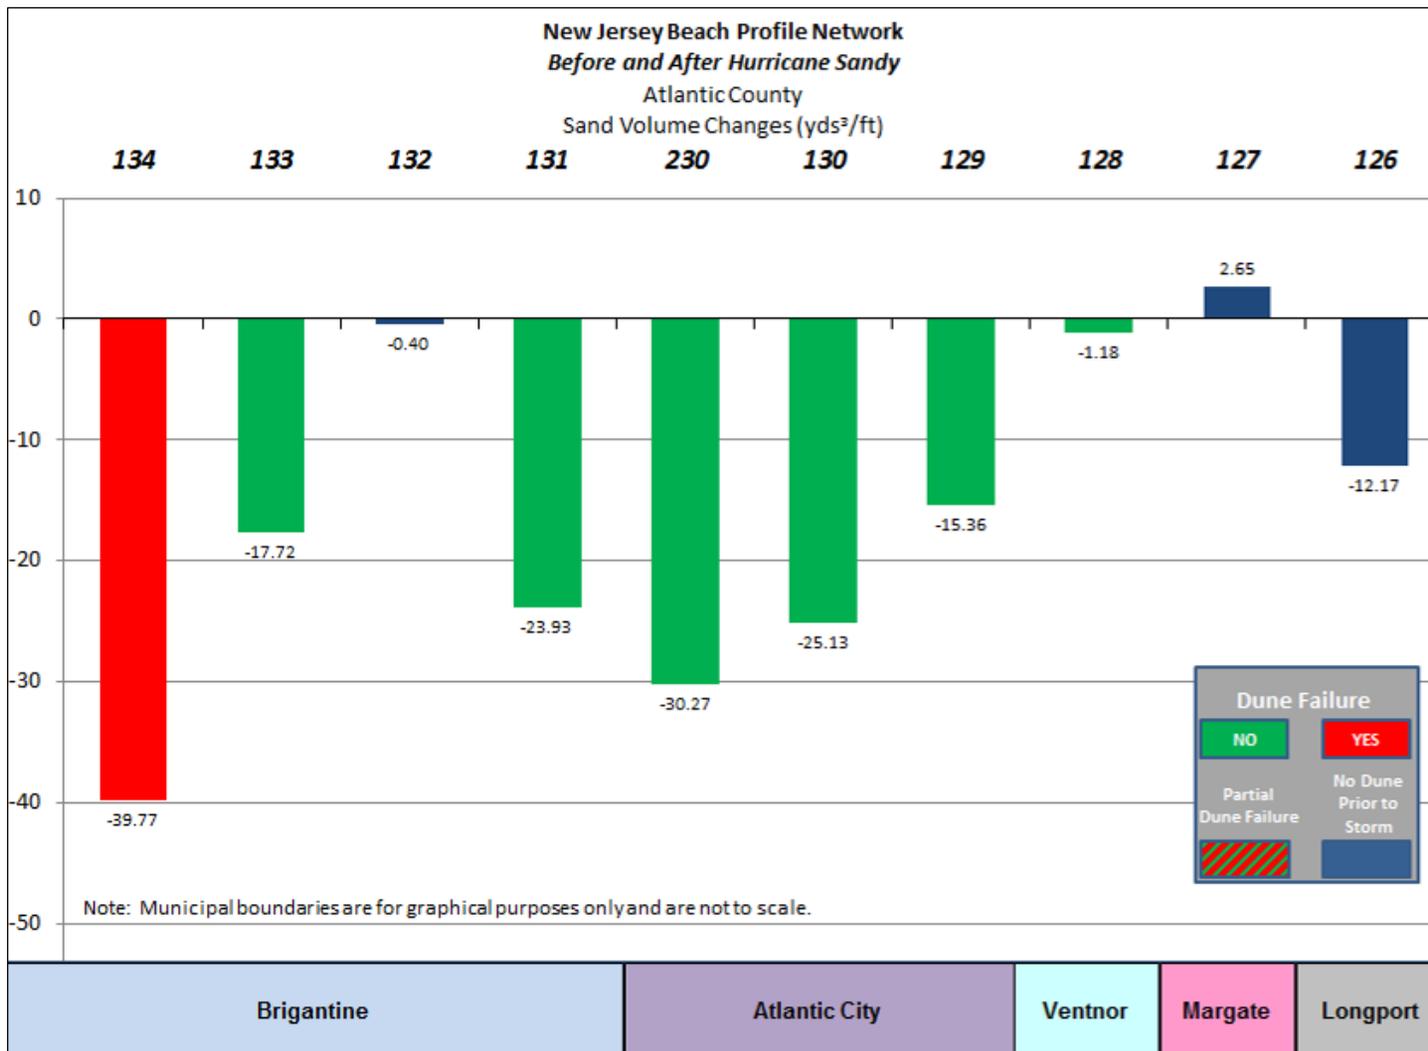
Figure 86. This graphic shows the sand volume loss figures for each of the communities within the developed sections of the Atlantic County shoreline. Federal shore protection projects have occurred along this portion of the New Jersey shoreline in Brigantine (northern portion), Atlantic City, and Ventnor. In Brigantine, prior to the storm the engineered had beach had been eroded away. Atlantic City and Ventnor’s engineered beach and dune systems have been maintained by the USACE recently and withheld the storm generated waves from breaching the dunes. All sites experienced berm erosion and dune losses except for site 127 in Margate, where sand had accumulated in front of the bulkhead adjacent to the street end (No dune at this location). The only true dune failure occurred in the national area on the north end of Brigantine (site 134), however sites 132 (Brigantine), 127 (Margate) and 126 (Longport) did not have dune systems in place prior to the storm and all experienced overwash of waves with sand being transported landward of the beach.
