New Jersey Beach Profile Network

Cape May County

Great Egg Harbor Inlet
to Stow Creek

NJBPN Profile #'s
225 - 100

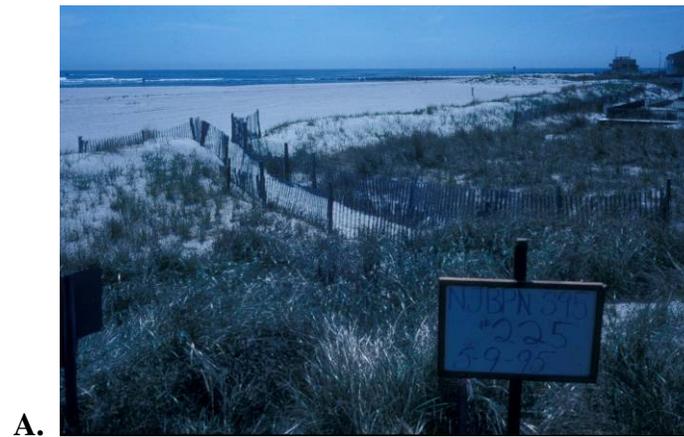
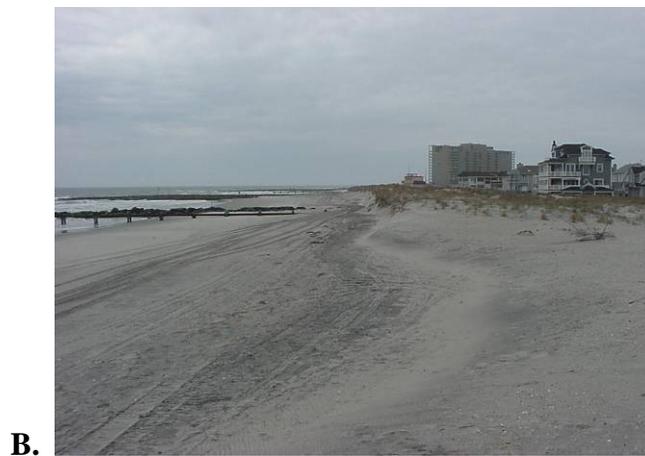
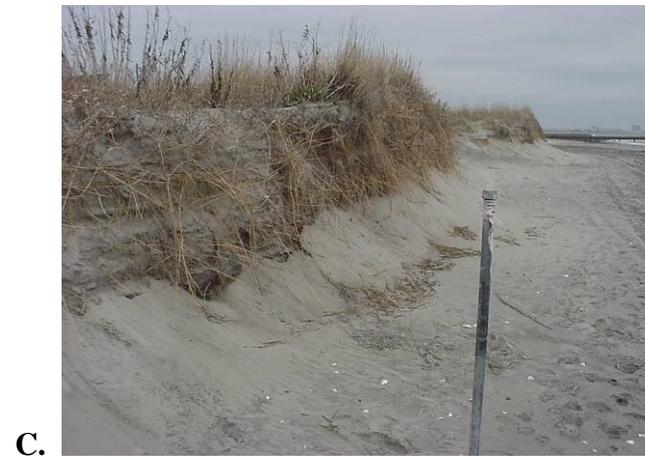
20-Year Comparison Photographs – Site 225, Gardens Road, Ocean City

The photograph taken in 1995 (top, A) shows the much larger beach and dune system that was present at that time. By 2006 (bottom, B and C), the shoreline retreated over 300 feet and significant erosion of the primary dune occurred.

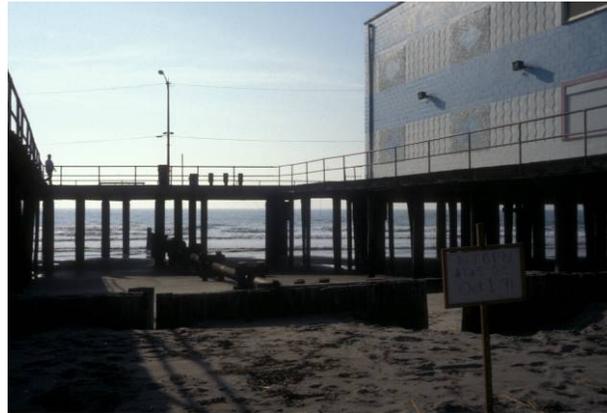
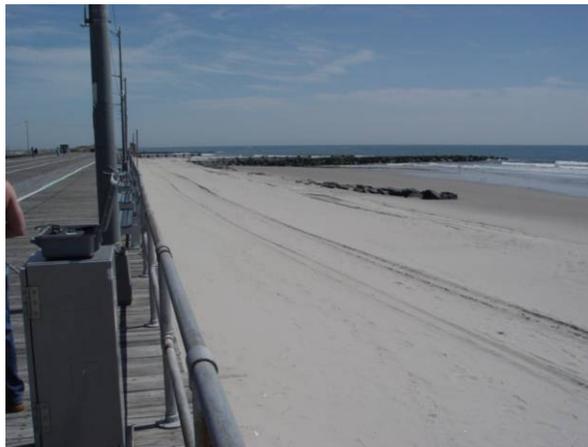
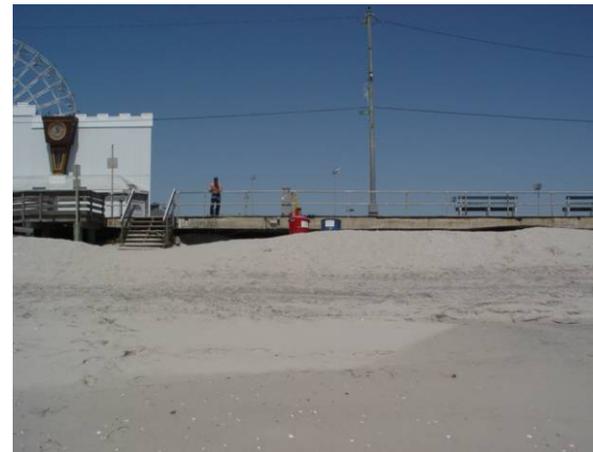
20-Year Comparison Photographs – Site 125, 6th Street, Ocean City

The photograph taken in 1991 (A) shows how the waves reached the boardwalk at that time. The erosion by 2006 had produced retreat to the point where waves had the potential to reach this structure once again (Photos B and C). The movement of sand to the north had slowed to the point where the Gardens Road site was also retreating badly. It now appears as if funding will allow the ACOE to return to Ocean City and continue the process of pumping sand back to this hot spot along the NJ coastline.

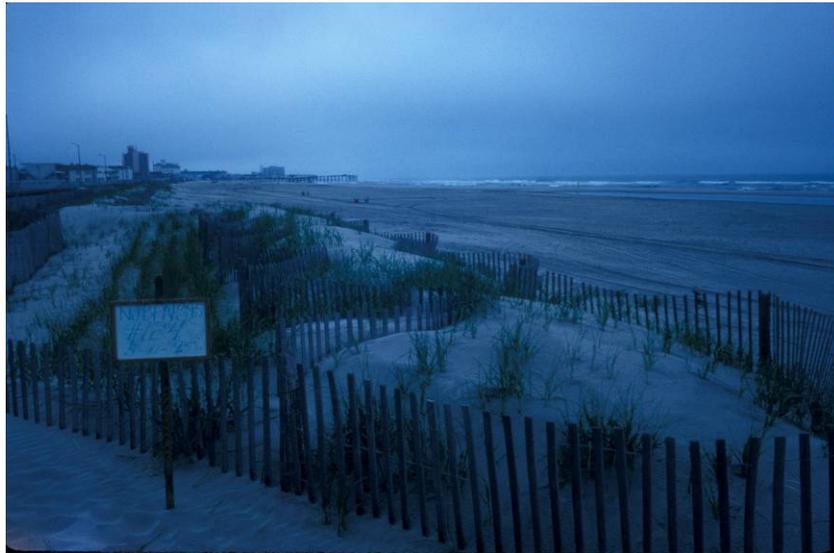
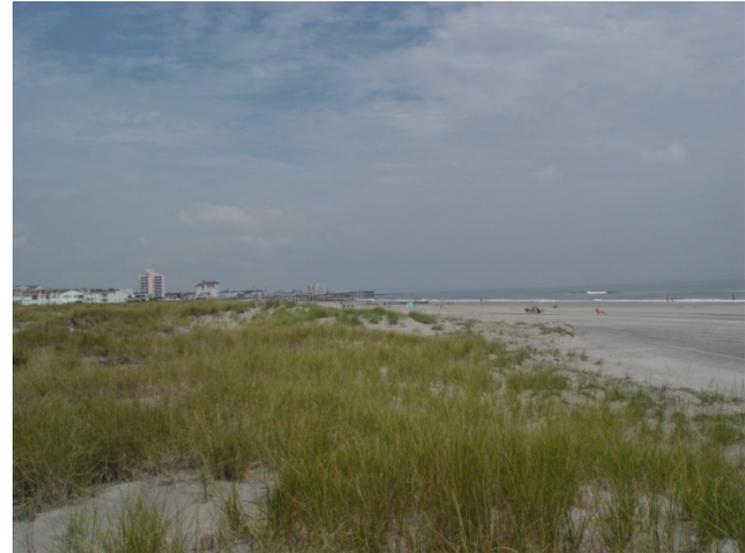
20-Year Comparison Photographs – Site 124, 20th Street, Ocean City

Photograph A, was taken Aug. 11, 1995 following the restoration of the erosion to the Ocean City beach restoration project produced by the December 1992 northeast storm. The dune was developed at the boardwalk on the reconstructed beach. Sand continued to accumulate along this mid-island shoreline until the dune field was 300 feet wider east of the boardwalk and then the beach remained about as wide as it was in 1995. Keep in mind that low tide came up under the boardwalk in 1986 as can be seen in the cross section below and the zero elevation shoreline has advanced over 450 feet seaward since then.

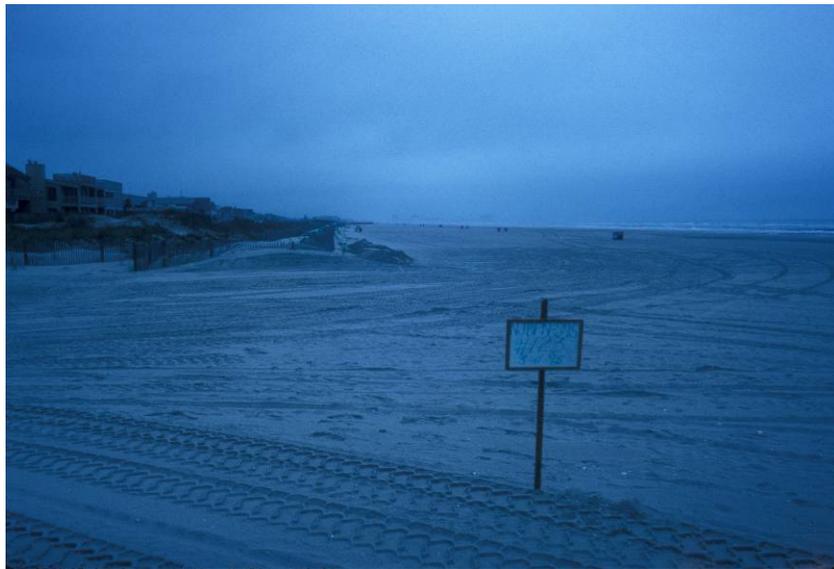
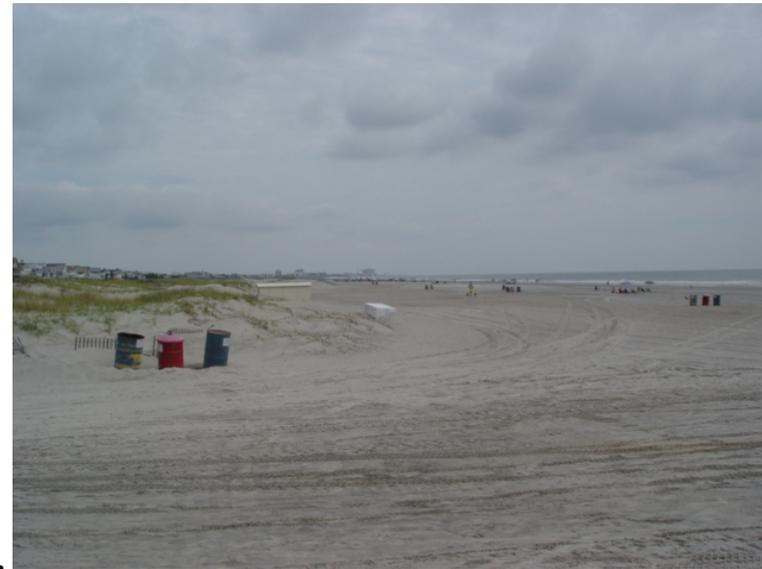
20-Year Comparison Photographs – Site 223, 34th Street, Ocean City

The 34th Street site has a major entrance from the street end for lifesaving vehicles and other beach maintenance activities. The 1995 photograph (A.) shows the wide gap in the dunes. As the dunes grew on either side it was decided to move the profile 40 feet south to cover these features. The 2006 photograph (B) shows the enhanced dune and the access gap still present at the street end.

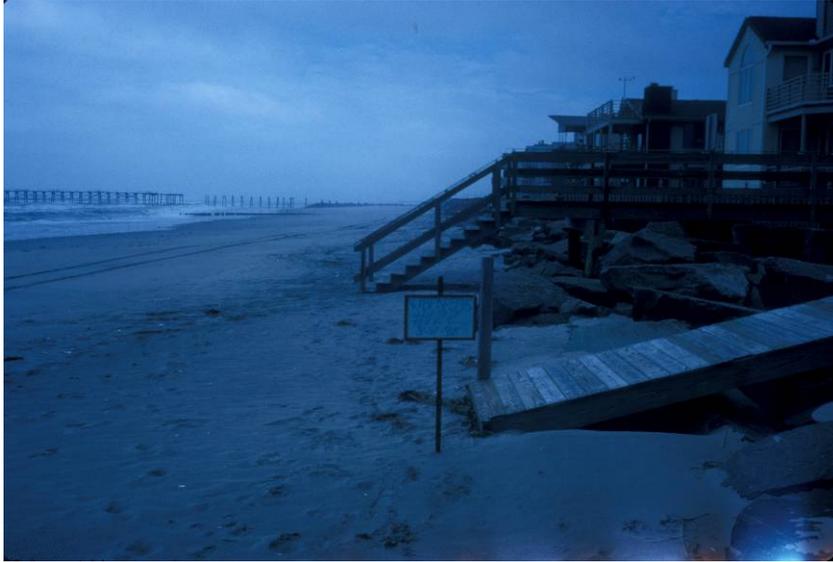
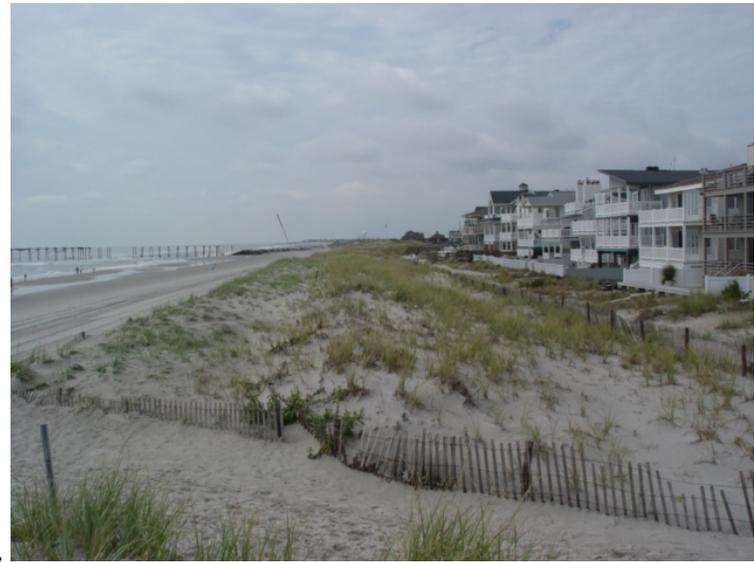
20-Year Comparison Photographs – Site 122, 56th Street, Ocean City

The southern end of the island was supplemented by a NJ State cooperative beach restoration effort in 1995. The left photo (A) shows the relative vulnerability to storm damage at the private home development along this reach. By 2006 dune growth has placed a substantial barrier between the homes and the shoreline leaving a beach of similar width seaward of the dunes. If you look at the groin and pilings in the far distance in both photographs the seaward advance in the low tide elevation is not great, but the dunes appear stable on the beach that has emerged a decade after the fill.

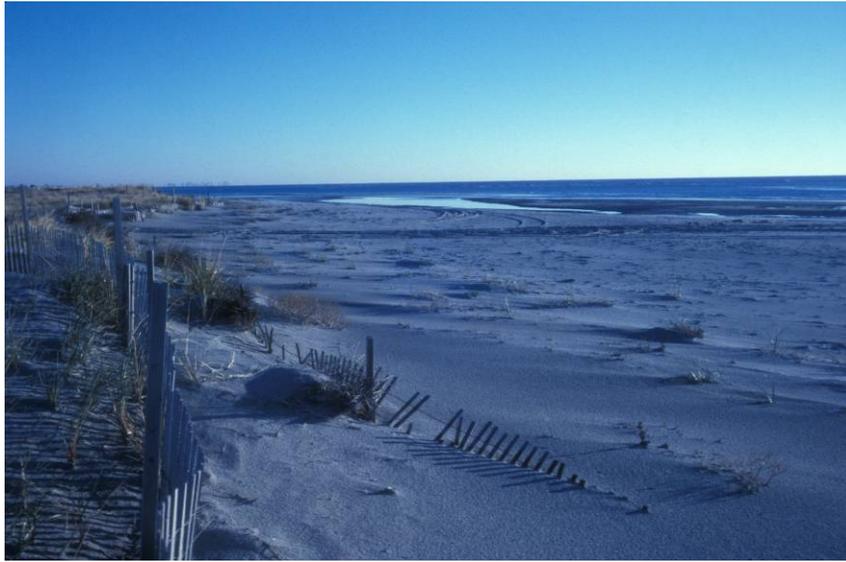
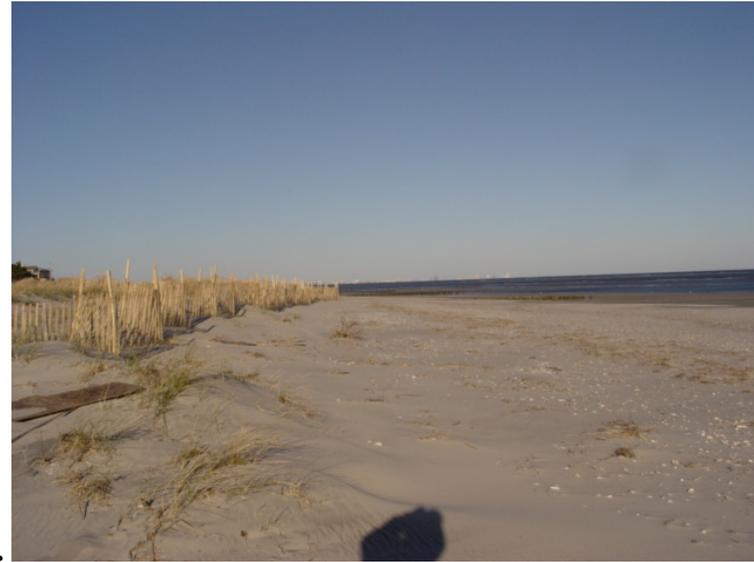
20-Year Comparison Photographs – Site 121, William Road, Strathmere

Positioned fairly near Corson's Inlet, site 121 often receives large volumes of sand as the inlet channel shifts around in its delta region. The influence of sand supplies added to Ocean City to the north has also impacted this site. Beach nourishment was completed here in 1984 and in 2001 by the State of NJ along with funding from the Township of Upper. In 1988 the beach was in a wide format following the fill and inlet configuration allowing large bars to migrate onto the shoreline as shown in photo A. The 2006 photo (B) shows a larger dune system and a similar beach, but there was additional sand pumped onto this beach in 2001.

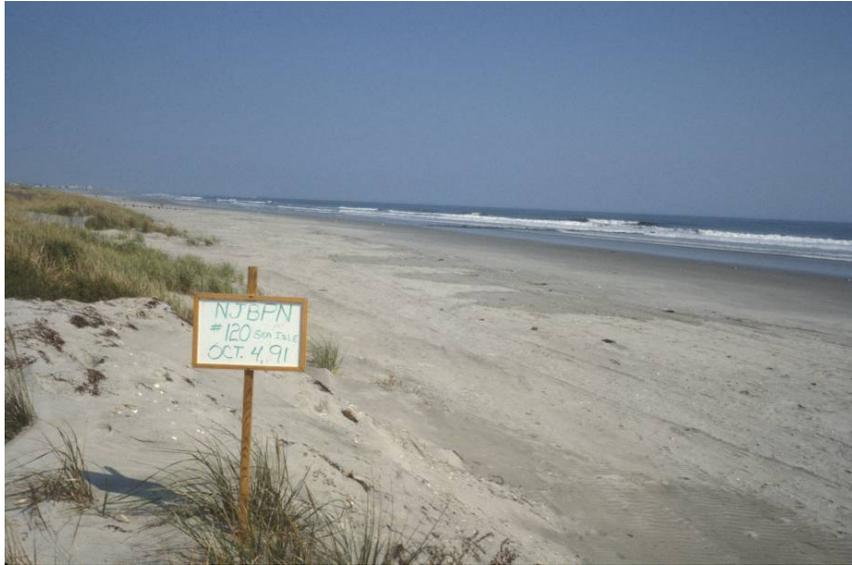
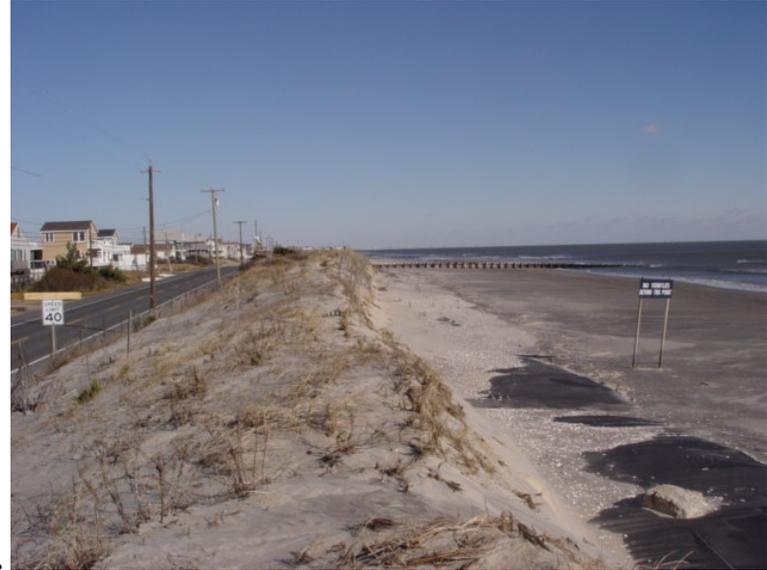
20-Year Comparison Photographs – Site 120, 1st Street, Sea Isle City

In spite of two significant nourishment efforts north of this site, very little new sand has arrived to widen this beach or improve the dunes. In 1991 the dune was all natural (A), but narrow and fairly low with a narrow low elevation beach seaward. Multiple storms breached this stretch and washed directly into the bay. In 1996 a 10-foot diameter geo-textile tube was installed along 2,000 feet of the northern Sea Isle City shoreline, filled with beach sand and covered with quarry sand hauled to the site. This feature has withstood storm events of low intensity since, but the beach is still narrow and of low elevation (B).

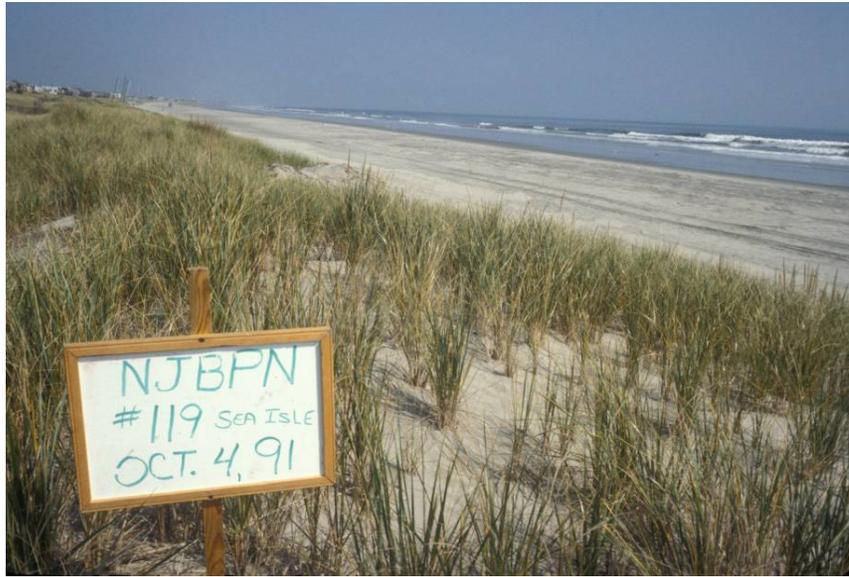
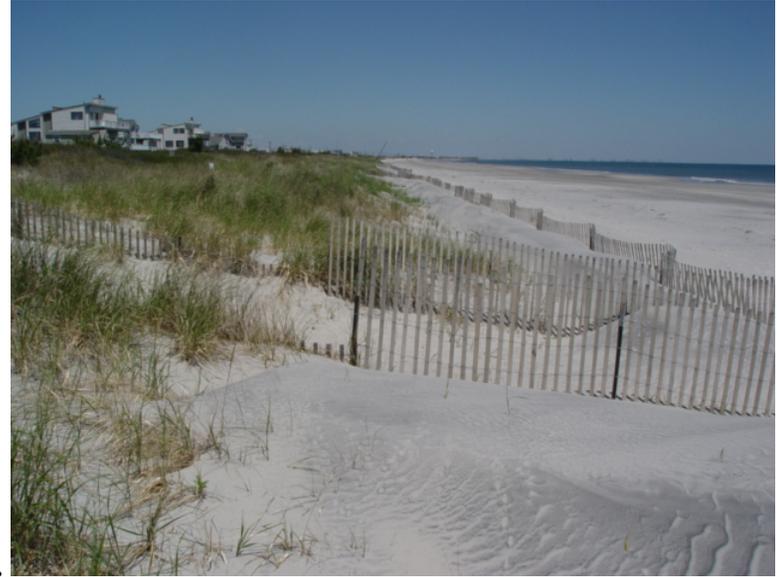
20-Year Comparison Photographs – Site 119, 25th Street, Sea Isle City

The 25th Street beach is south of the installed geo-textile dune core. In 1991 the view to the north shows the dune and beach (A). The addition of sand to the dune is substantial over the years and the beach widened at the same rate as the dune advanced seaward. Sand fencing shown in B. will continue the accretion to the seaward dune toe in the absence of storm activity.

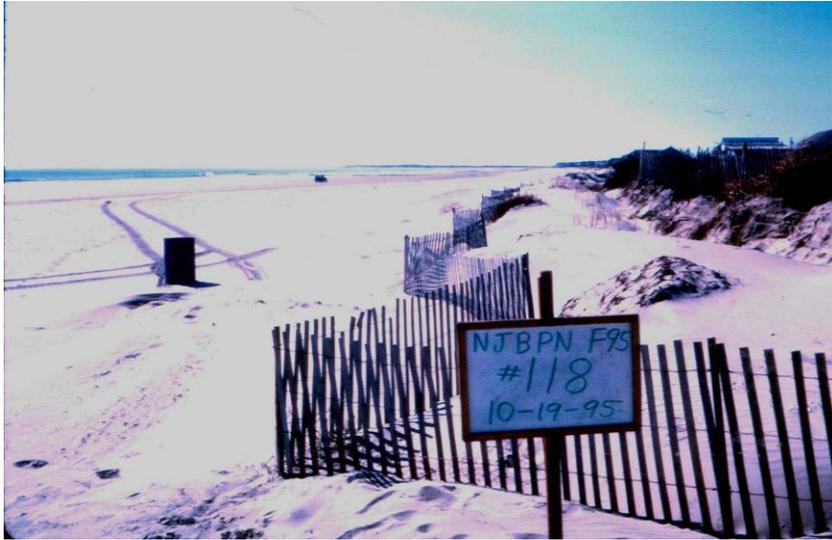
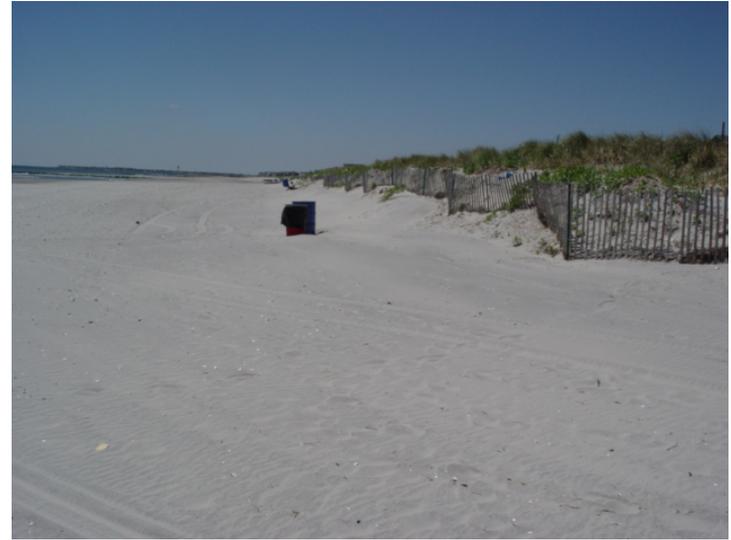
20-Year Comparison Photographs – Site 118, 57th Street, Sea Isle City

This beach is located in the heart of the Sea Isle City recreational district. There is an asphalt promenade landward of the dunes that forms a demarcation line for the dune system. The 1995 photo (A) shows a relatively wide beach with a dune scarp beginning to heal as sand accumulated at the dune fencing. By 2006 (B) the dune had grown higher, but not much wider as it is confined by the fencing in front and the promenade to the rear.

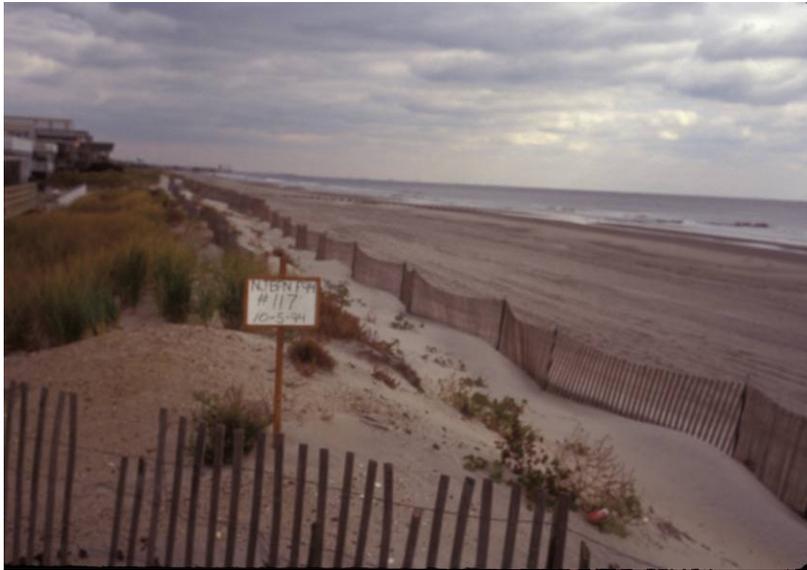
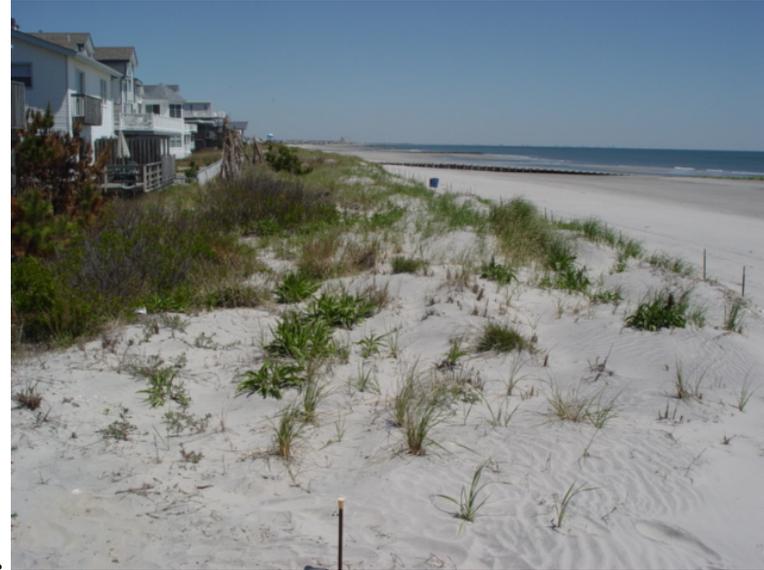
20-Year Comparison Photographs – Site 117, 80th Street, Sea Isle City

The left photo (A) was taken in 1994 following the 1992 beach nourishment that enhanced both the dune and beach width. Since then the dune has remained stable and the beach declined only modestly by 2006 (B).

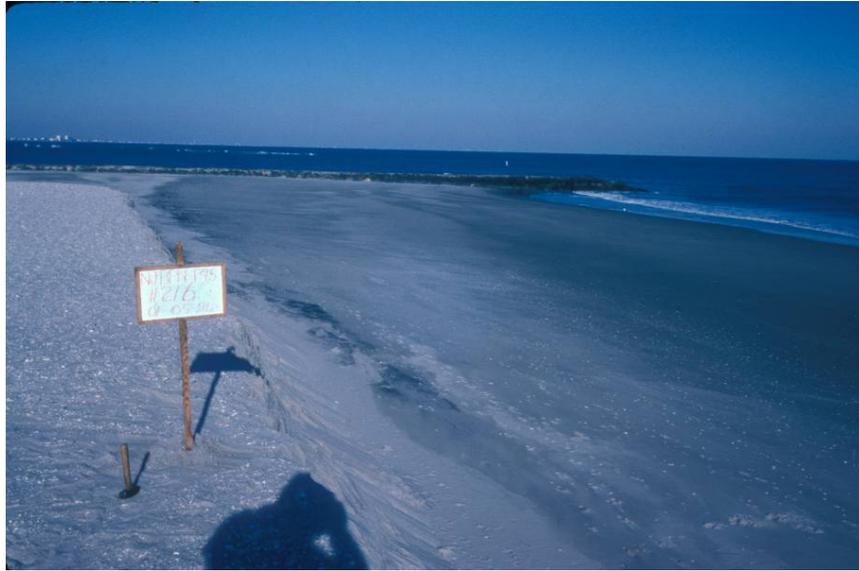
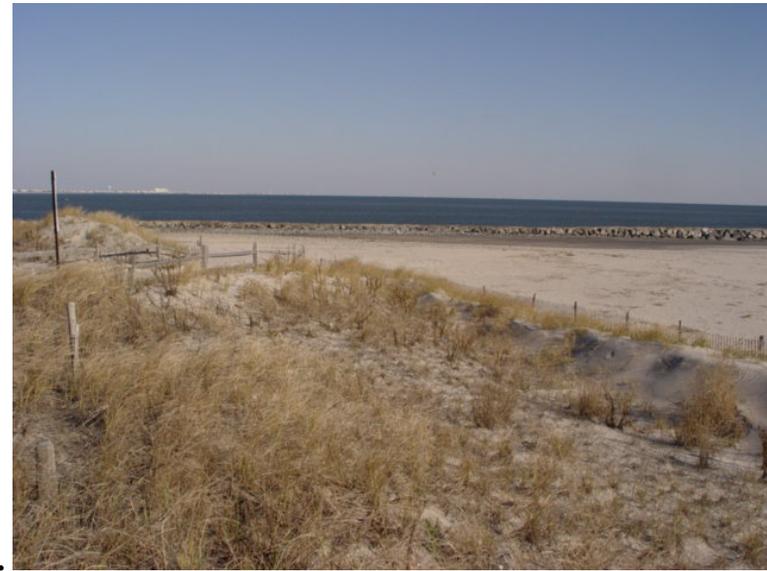
20-Year Comparison Photographs – Site 216, 9th Street, Avalon

Site 216 was added in 1994 to help define changes near Townsend's Inlet in Avalon. In 1996 (A) the beach was retained by the inlet jetty which was extended during 2001. This plus multiple nourishment events widened the beach as sand remained sheltered from northeast storm waves by the longer jetty (B). The dune grew both higher and wider as well.

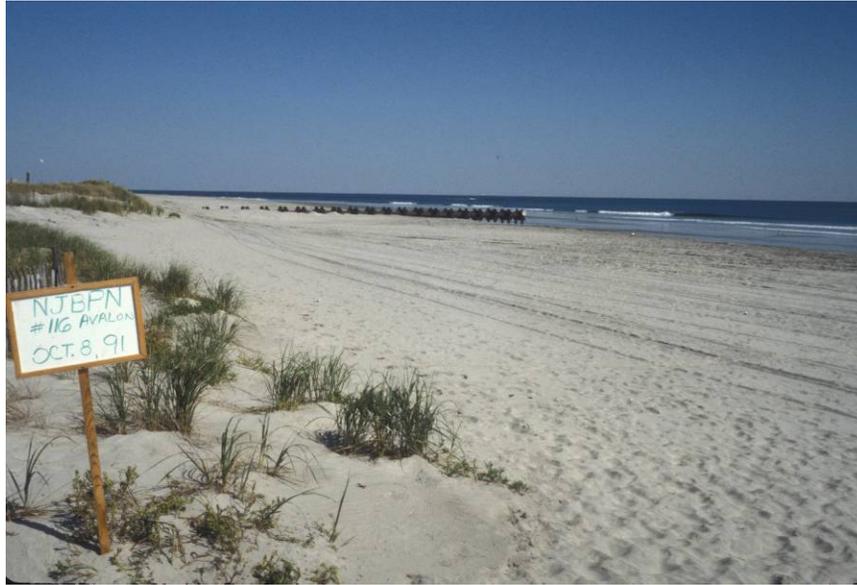
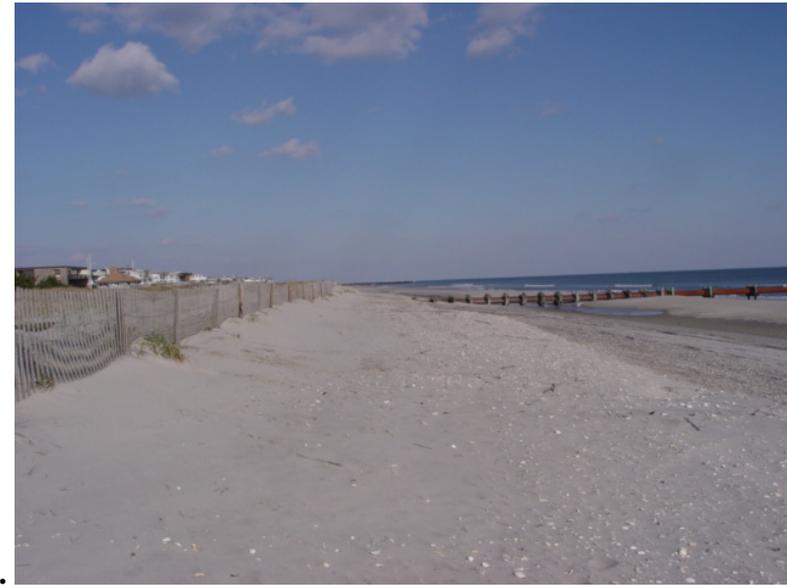
20-Year Comparison Photographs – Site 116, 23rd Street, Avalon

Beach nourishment commenced (A) in 1987 with over a million cubic yards of sand added between the jetty at 8th Street and the fishing pier at 31st Street. Prior to the initial project the high tide reached landward of the boardwalk into private property. By 1991 the beach and dune had received a renourishment in 1990. Multiple NJ State – locally funded projects continued until the Federal project started in 2002. By 2006 (B) the beach/dune system was wider and afforded considerable increase in protection when compared to the 1986 situation. The profile cross section below shows 1986, but that situation deteriorated further during the 1986 – 1987 winter season leading to the need for the initial nourishment project.

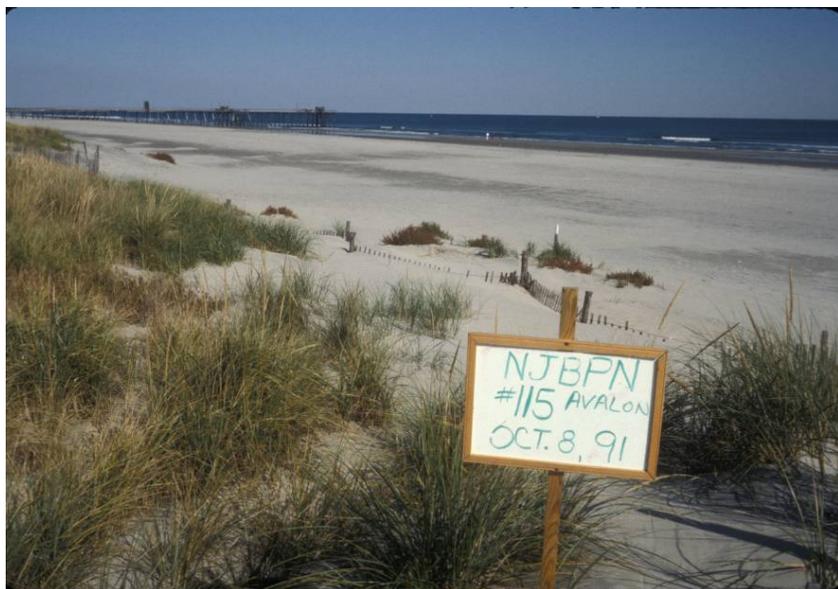
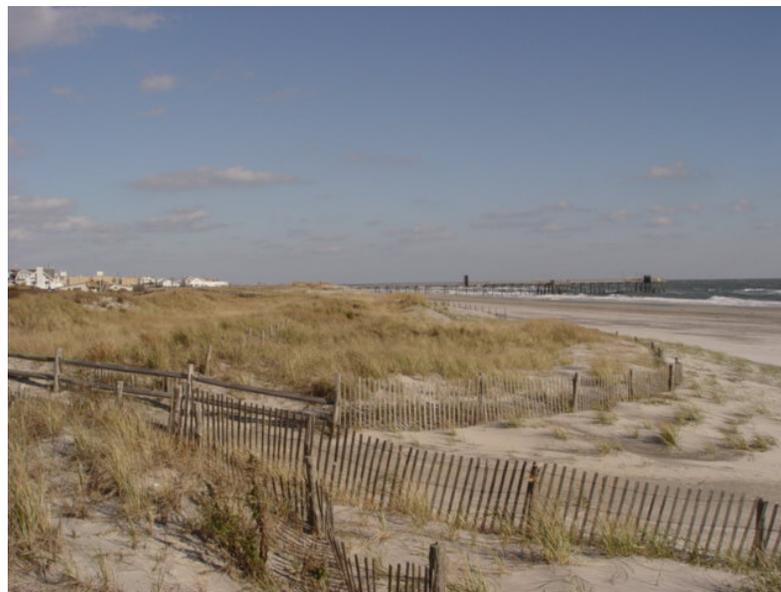
20-Year Comparison Photographs – Site 115, 35th Street, Avalon

35th Street has a wide dune “forest” between the development and the ocean beach. Termed the “High Dune Area” by the Borough of Avalon, this area is unique to the New Jersey developed coastline. Dunes rise to over 50-foot elevations 900 feet west of the seaward toe of dune development. This toe position has advanced seaward steadily as the management efforts added sand to the northern shoreline. 1991 Photo shows the instrument position that was moved seaward once since it was established in 1982 (A). The 2006 photograph shows the new dune toe location with the instrument position at the ridge located to the far left of photograph B. The cross sections below show the extent of dune growth.

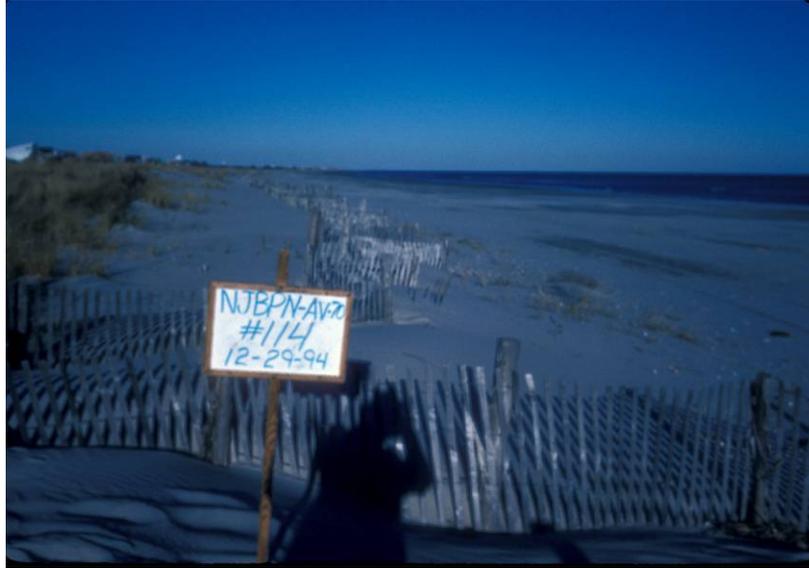
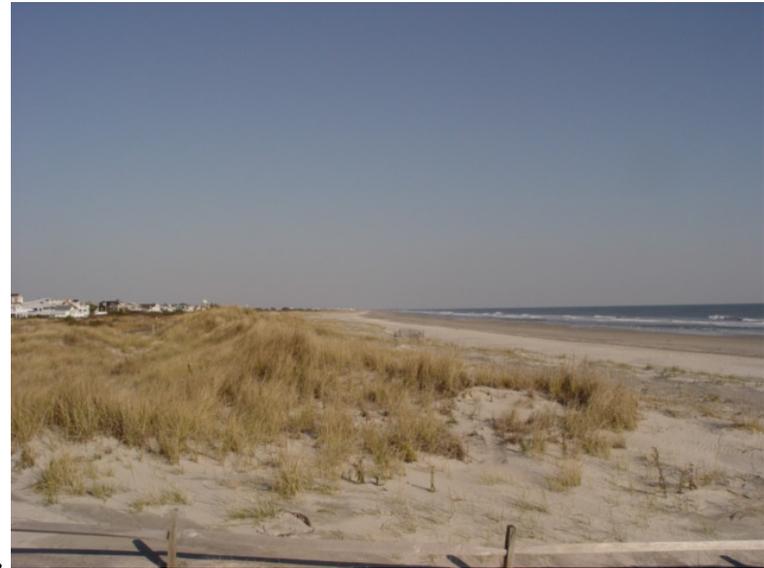
20-Year Comparison Photographs – Site 114, 70th Street, Avalon

70th Street represents the southern end of the wide expanse of dunes because development pushed seaward from Dune Drive toward the beach south of 56th Street. However, the municipality reserved a wide area for dunes and this foresight has paid off handsomely in the width of shore protection available even in 1994 (A). By 2006 (B) the dunes had widened by double their 1986 width with a corresponding widening at the beach creating a stable, formidable shore protection barrier along this segment of the Borough of Avalon.

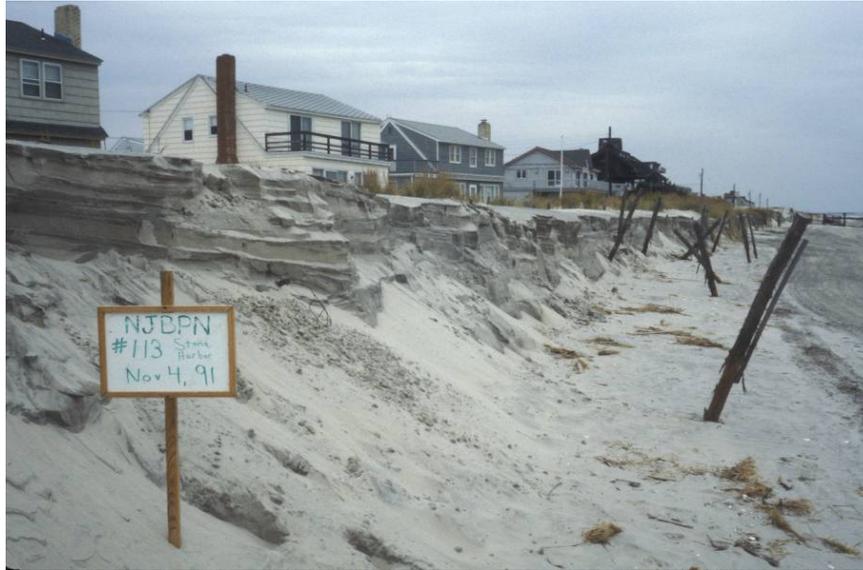
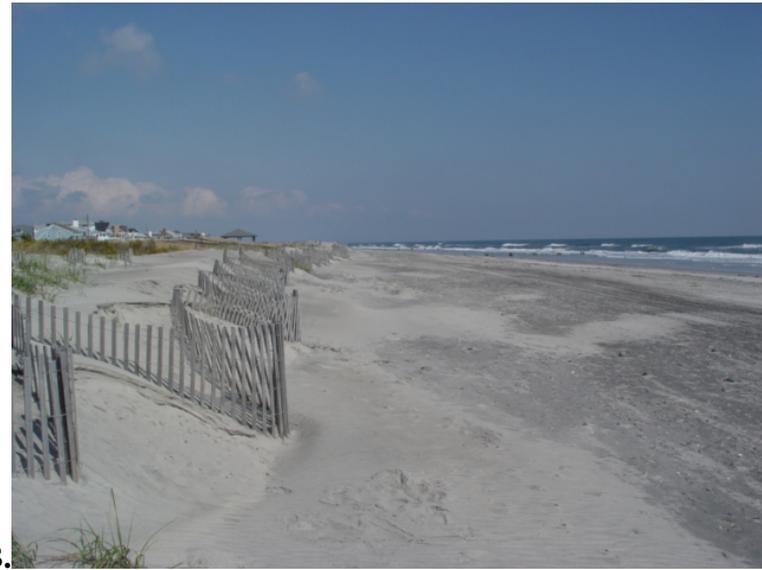
20-Year Comparison Photographs – Site 113, 90th Street, Stone Harbor

The view to the left was taken about a month following the October 1991 “Halloween Storm” that produced an extensive scarp taking about half the width of the dune system. The Borough of Stone Harbor conducted a cooperative fill in 1997 with the State of New Jersey, then participated in the 2003 Federal project that added a large volume of sand to the municipal shoreline. The 2006 photograph (B) shows the beach, new dune fencing and the wider dune field between the development and the sea.

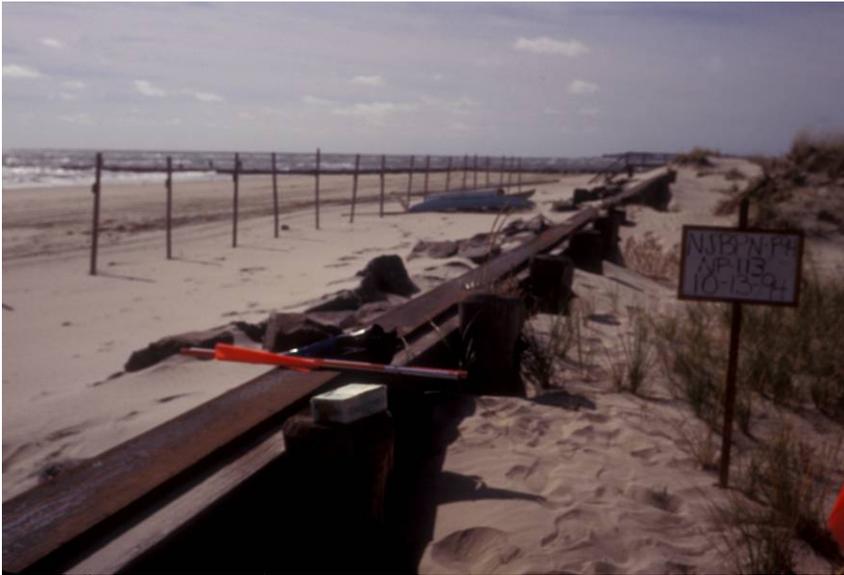
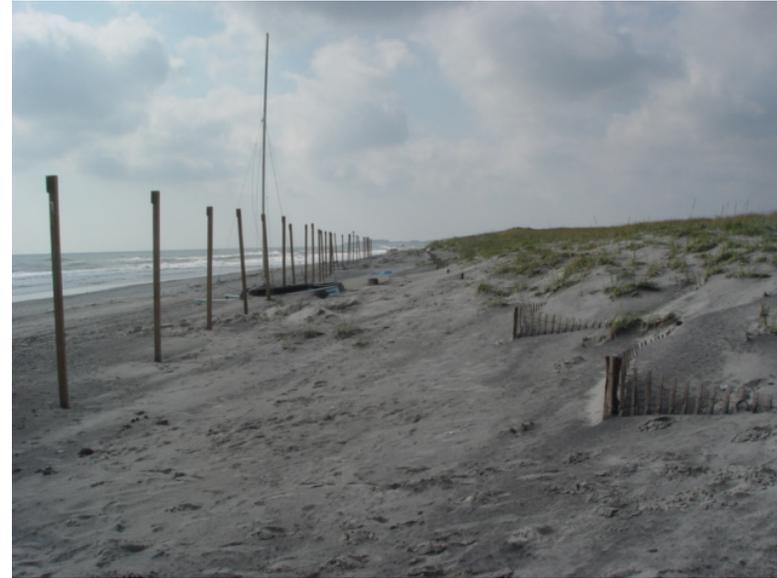
20-Year Comparison Photographs – Site 212, South End, Stone Harbor

This site was added in 1994 to have a replacement site for 112 that eroded out of existence in 1990. Hereford Inlet processes influenced that disappearance. This site is defended by the bulkhead and rock revetment and a terminal groin at its southern end. The 1994 photograph (A) was taken prior to beach nourishment and shows the initial configuration of the shoreline. By 2006 the Federal project was completed burying the revetment in the dune and widening the beach nearly to the seaward end of the terminal groin (B).

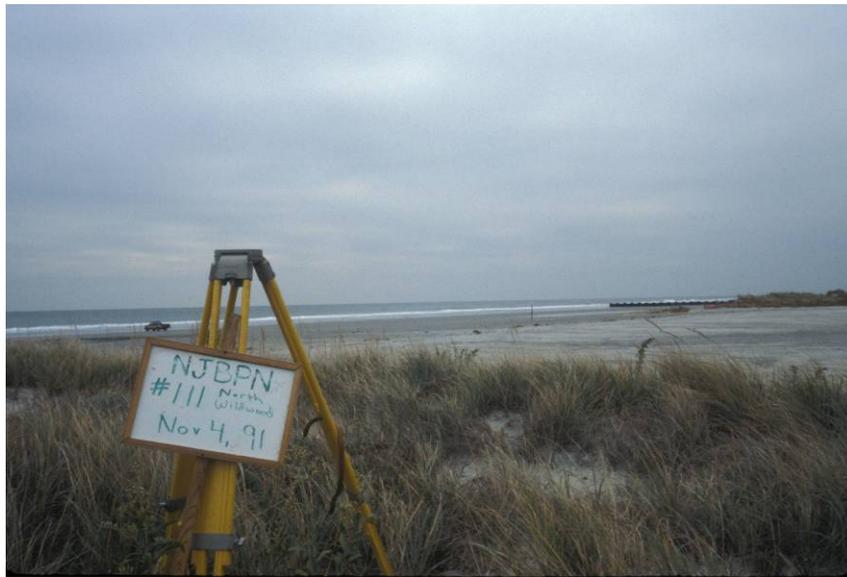
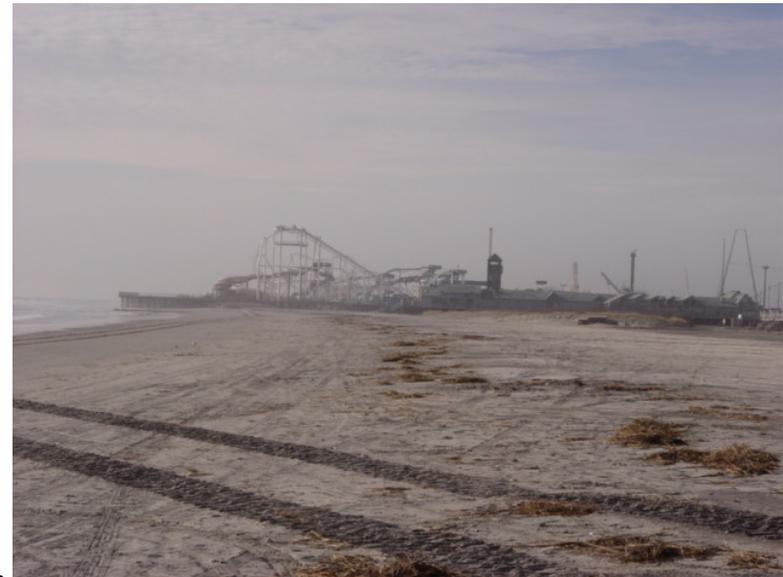
20-Year Comparison Photographs – Site 111, 15th Avenue, North Wildwood

This site lost more width to the beach than any other of the 100 sites in NJ. In 1991 (A) there were multiple “island” dunes located on the dry beach behind the high tide line. The rate of loss commenced in 1988 and accelerated until 2005. The loss removed about 70% of the huge beach width there in 1986. The right photograph (B) shows the view to the south and the presence of the amusement pier at the water’s edge in 2006.

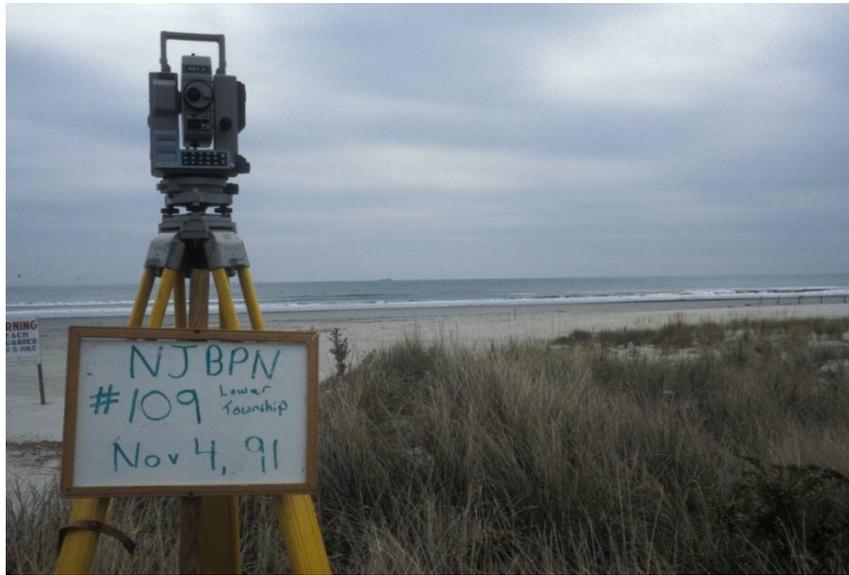
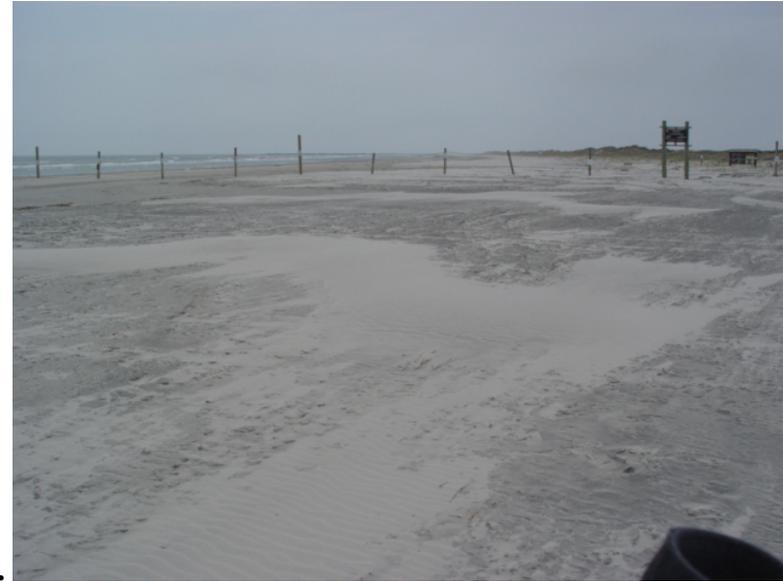
20-Year Comparison Photographs – Site 109, Raleigh Avenue, Lower Township

Further south along the Wildwood's shoreline sand accumulation produced incremental shoreline advances after the 1992 northeast storm. The 1991 photograph (A) shows the beach and dune field at Raleigh Avenue. The 2006 photograph (B) shows a wider beach seaward of the dunes developed as sand moved south and was trapped by the Cold Springs Inlet jetty.

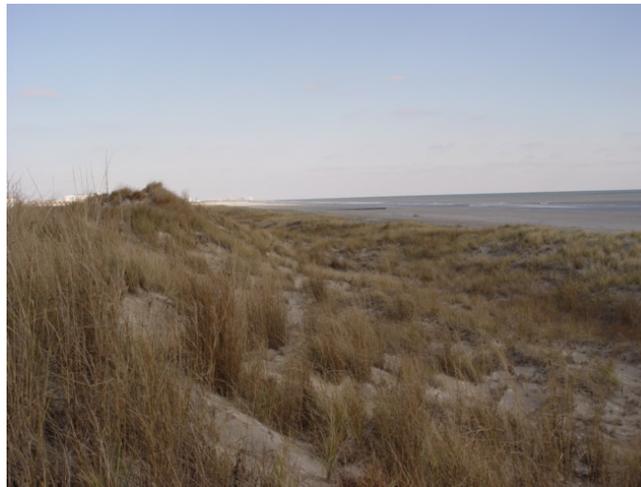
C.

20-Year Comparison Photographs – Site 208, Cape May National Wildlife Refuge, Lower Township

This site was added in the new wildlife refuge that was created from the military installation formerly using this southern segment of “2-Mile Island”. The 1994 photographs (A and B) show the dune ridge and the beach from the ridge as profiling commenced. The continued addition of sand has produced an advance in the dune position seaward following the shoreline accretion. The stone jetties are the dominant feature trapping the sand moving south since completion in 1911.

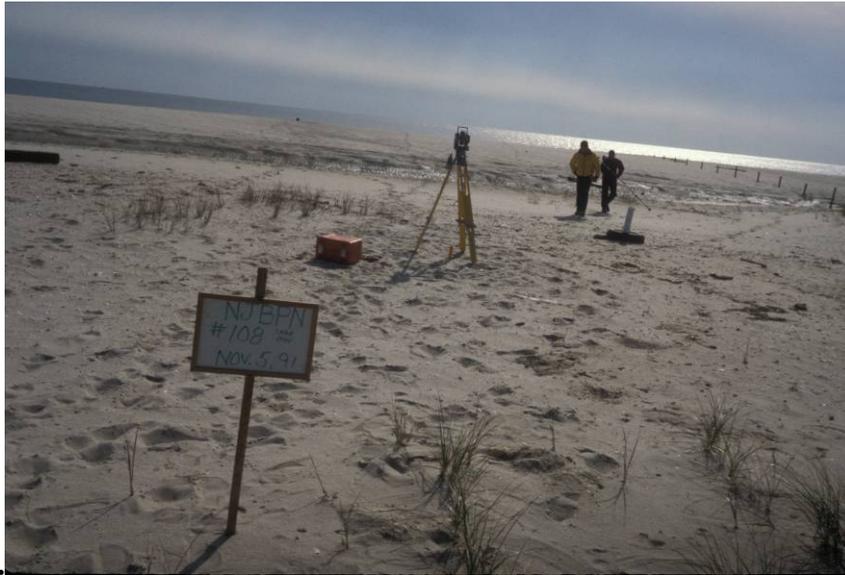
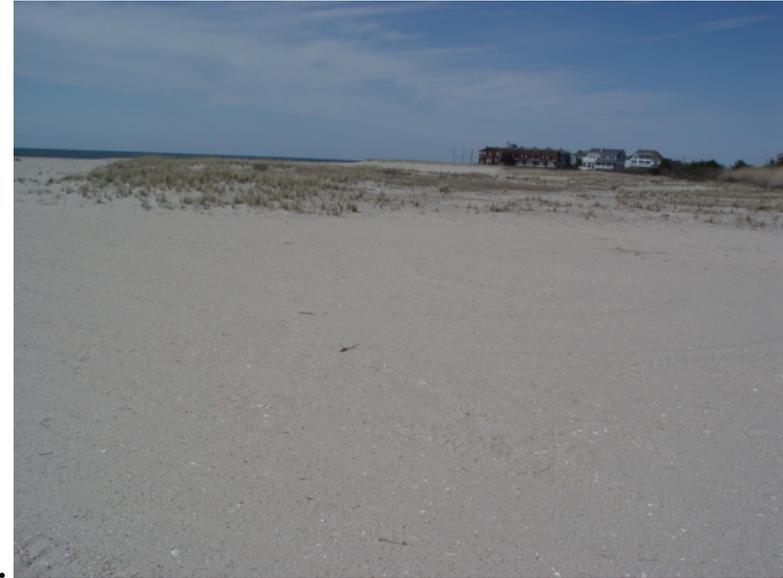
A. 20-Year Comparison Photographs – Site 108, Cape May Beach Club, Cape May

The 1991 photograph follows the 1989 addition of sand to the Cape May City shoreline as the initial New Jersey Federal beach restoration project got underway. The impact of the “Halloween Storm” in 1991 shows as overwash into the dune area with a large ridge developed seaward of the transit position. By 2006 the site (B) had grown seaward by an additional 250 feet from the 1991 situation. Several renourishment efforts have kept the beach in excellent condition.

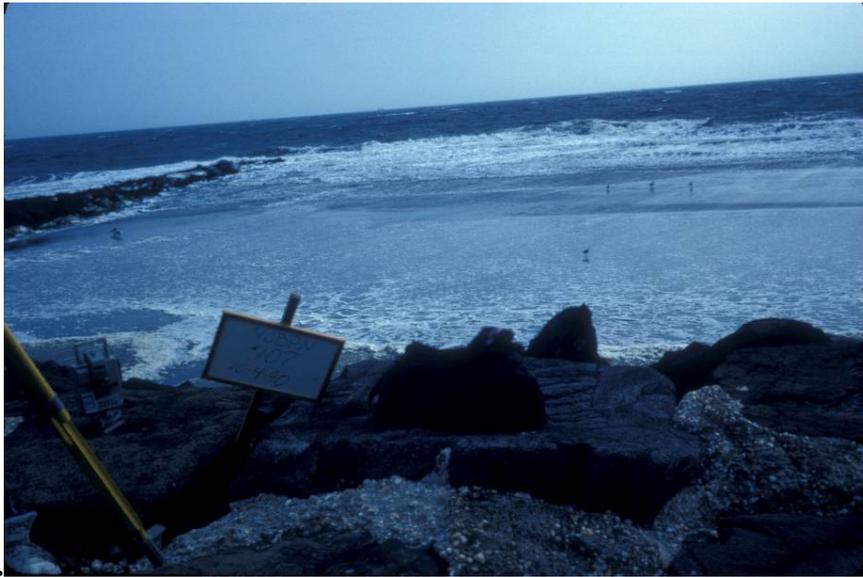
A.

20-Year Comparison Photographs – Site 107, Baltimore Avenue, Cape May

There was no dry beach at Baltimore Avenue in 1990 (A), but the development was protected by a series of rock groins and a rock revetment in front of a timber bulkhead. A little dry sand would appear each summer and quickly be moved back offshore each winter. The fill arrived in 1991 with a repair fill in 1993 following the December 1992 northeaster. The dune width extends further seaward (B) than the position of the 1990 zero elevation position. The 313-foot shoreline advance has produced a fine recreational beach and a tremendous increase in shore protection.

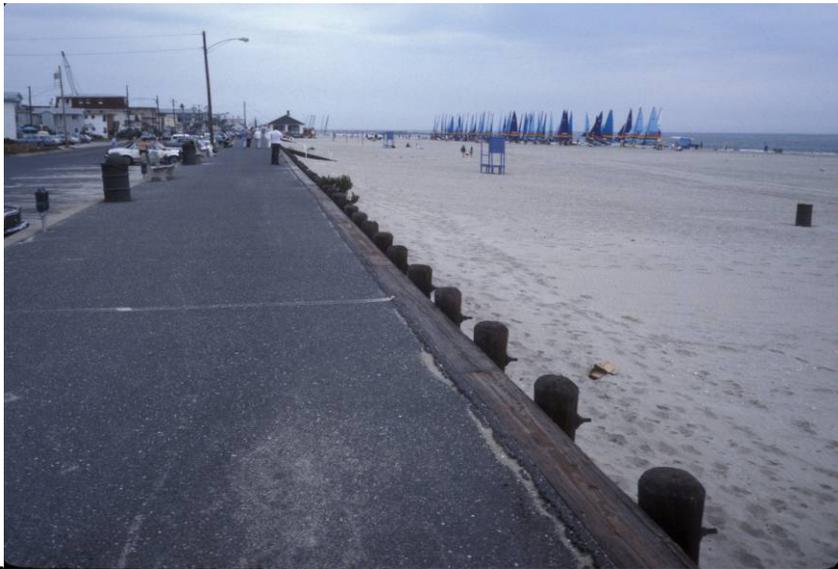
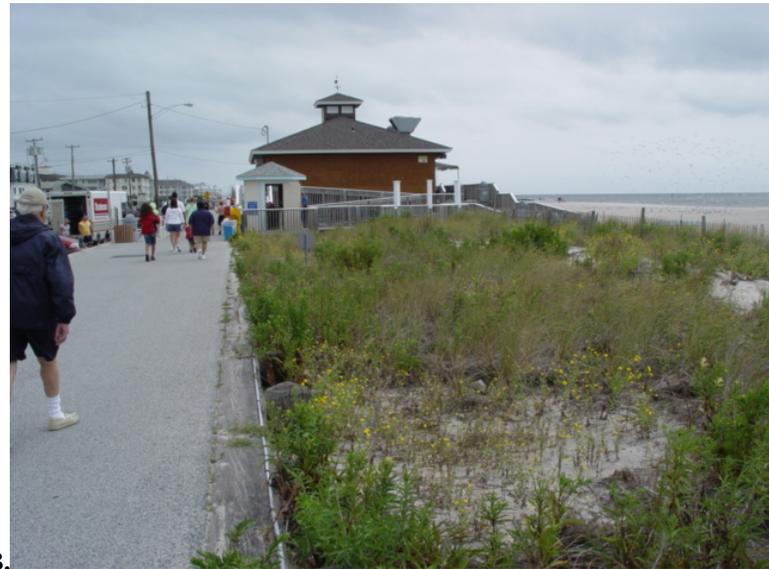
20-Year Comparison Photographs – Site 206, Broadway Avenue, Cape May

The southern extent of the Cape May City shoreline retained a beach in 1986 (A), but only because of a terminal groin at the southern edge of town. The promenade was the only “shore protection” afforded to an expensive array of hotel and restaurant development. The Federal project allowed enough space for a reasonable dune development seaward of the promenade as the added sand also widened the beach (B).
