New Jersey Beach Profile Network

Cape May County

Great Egg Harbor Inlet
to Stow Creek

NJBPN Profile #'s
225 - 100

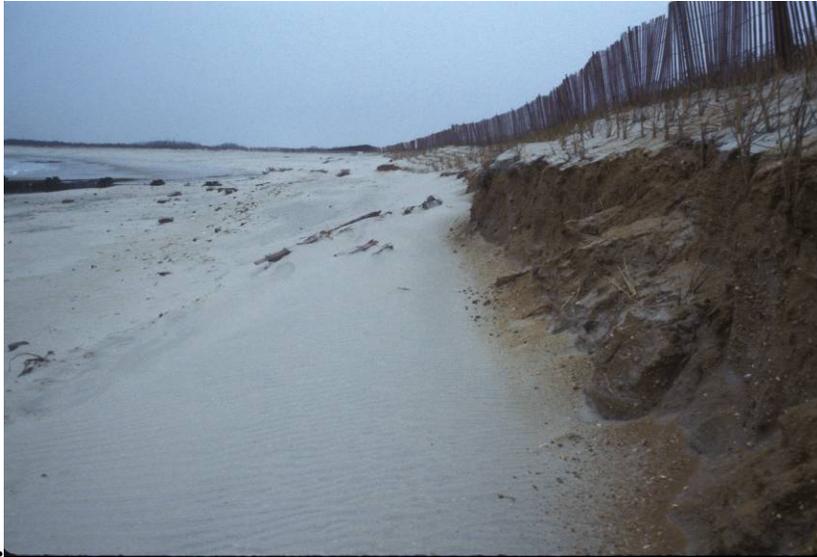
A.

20-Year Comparison Photographs – Site 105, Nature Conservancy, Cape May

This site was chosen to portray the natural beach existing south of Cape May City. In 1986 the State of NJ had just completed an I-5 gravel core to the dune to reduce storm flooding of the marshes and other development landward of the marsh along this beach segment. Erosion was cutting into this core as the initial survey was conducted. The Cape May City Federal beach restoration project generated a sand supply escaping the City’s southern terminal groin that tripled the width of this beach. The original dune just shows to the extreme right in the B photograph as a darker green vegetated ridge extending to the distance. All the dunes and sand in the photograph have been built where waves moved ashore in 1986.

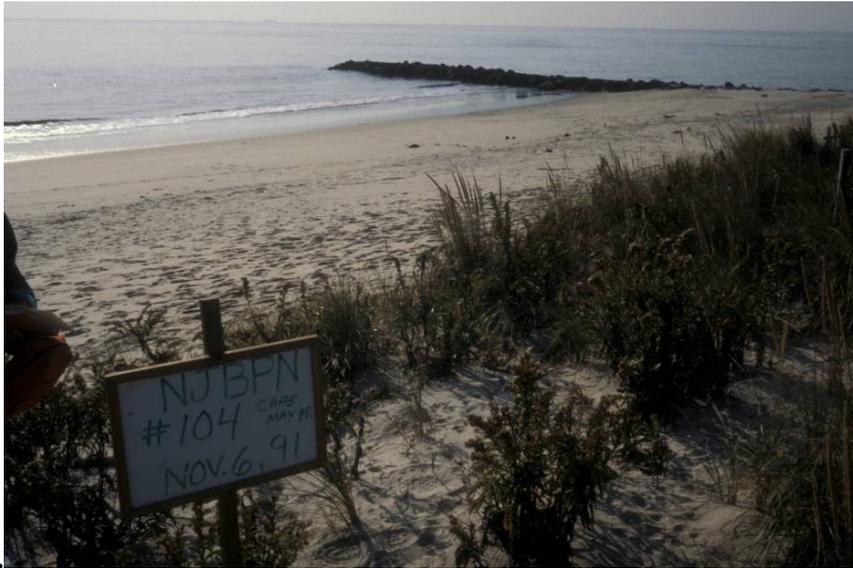
A.

20-Year Comparison Photographs – Site 104, Lake Drive, Cape May Point

Cape May Point has been the site of experiments in beach retention using submerged offshore breakwater units that were placed between groins in 1993, 1995 and by the ACOE in 2002. Four of the eight groin cells contain these structures and in 2004 a Federal beach nourishment project added sand in the first 6 of the 8 cells. The 1991 photo (A) shows the Lake Drive beach prior to any work. No structures were placed in this cell, but sand was added as shown in photo B to the right. The breakwater-protected beach cells appear to be resisting sand loss better than the unprotected shoreline segments.

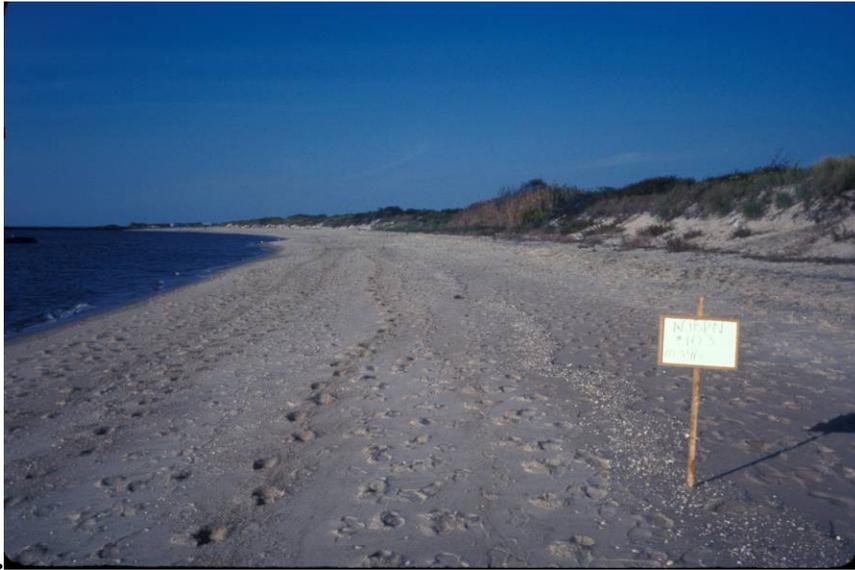
A.

20-Year Comparison Photographs – Site 103, Higbee Beach State Park

The western shoreline of Cape May County is exposed to strong westerly winds across Delaware Bay and a very limited sand supply that bleeds around Cape May Point and the nine groins. The 1990 photograph (A) shows the bluff and the beach curving north toward the Cape May Canal entrance. Slow bluff retreat related to strong winds during elevated water levels has produced about 50 feet of shoreline retreat since 1986 (B). Six of 20 surveys showed minor shoreline advance as sand taken from erosion of the bluff consolidated on the beach.

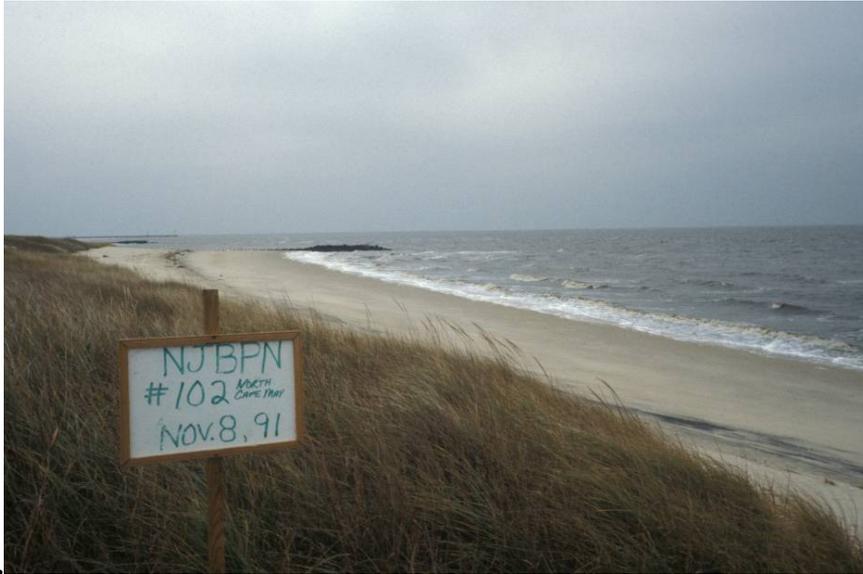
A.

20-Year Comparison Photographs – Site 102, Whittier Avenue, North Cape May

The beach further north into Delaware Bay was slightly more stable probably due to the presence of a wide tidal shelf that restricts wave approach at all by high tide. In 1991 the beach supported a dune with a narrow strip of sand between in and the low tide terrace offshore (A). This feature shows the best on the cross section below. The dune grew higher (B) as sand moved into the feature and the terrace supports low amplitude sand bars that migrate around as the wave pattern changes.

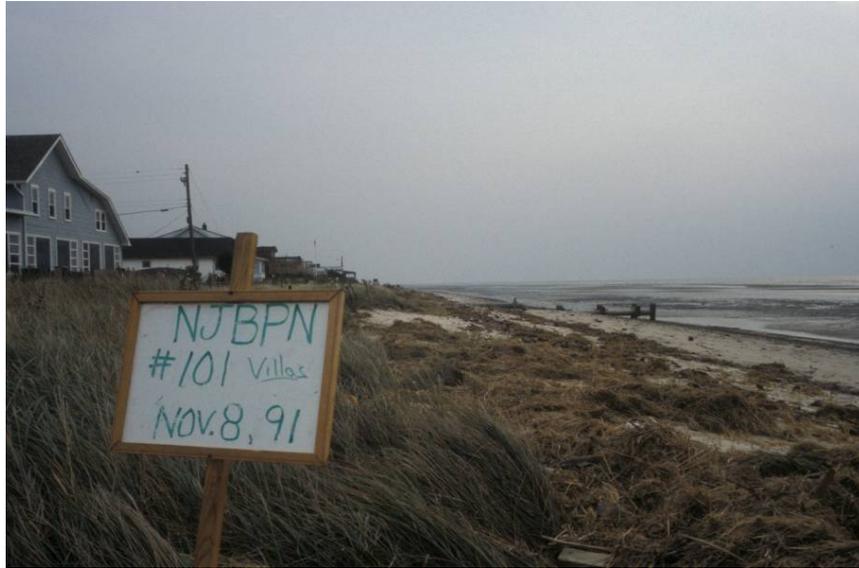
A.

20-Year Comparison Photographs – Site 101, Pacific Avenue, Villas

The exposed terrace shows in the 1991 photograph (A) along with piles of dead vegetation on the upper beach. This material decays but also captures sand to allow plant growth in some locations where waves don't come in a carry it away before it is established. The right photograph (B) shows the same dune and beach. Little erosion took place since the 2006 dune slope is seaward of that present in 1986.

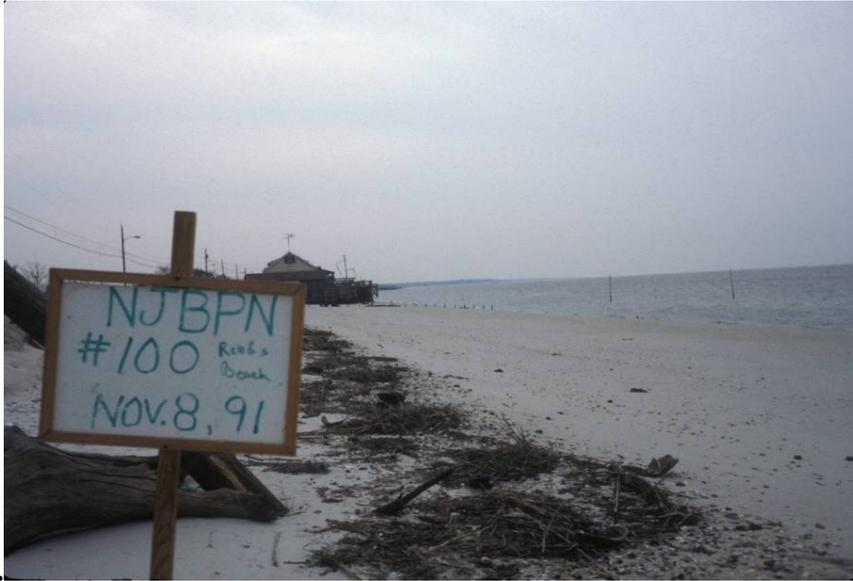
A.

20-Year Comparison Photographs – Site 100, Beach Avenue, Reeds Beach
