## **New Jersey Beach Profile Network**

# **Monmouth County**

**Raritan Bay and Sandy Hook  
to Manasquan Inlet**

**NJBPN Profile #'s  
187 - 256**

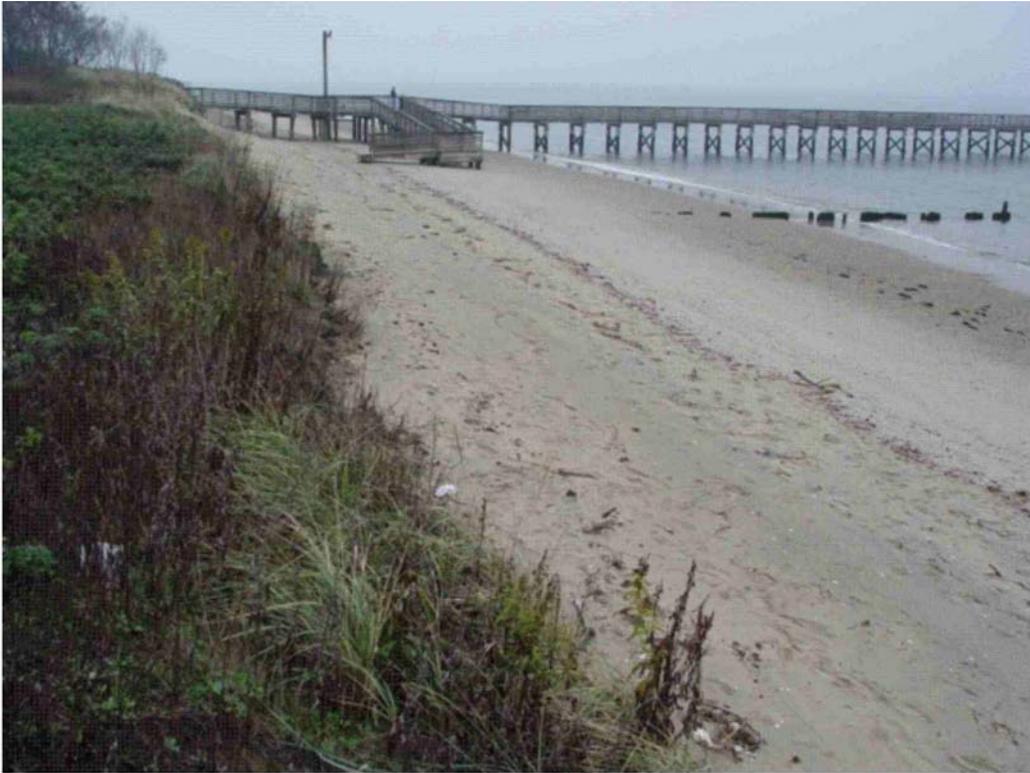
Photoplate 1a. This photo was taken on November 12, 2003 at NJBPN 185 (Raritan Bay at the Spy House Museum). The bay floor below -2.0 below low tide is seldom involved in changes, but the dune is easily cut by northeast storm waves on the bay.

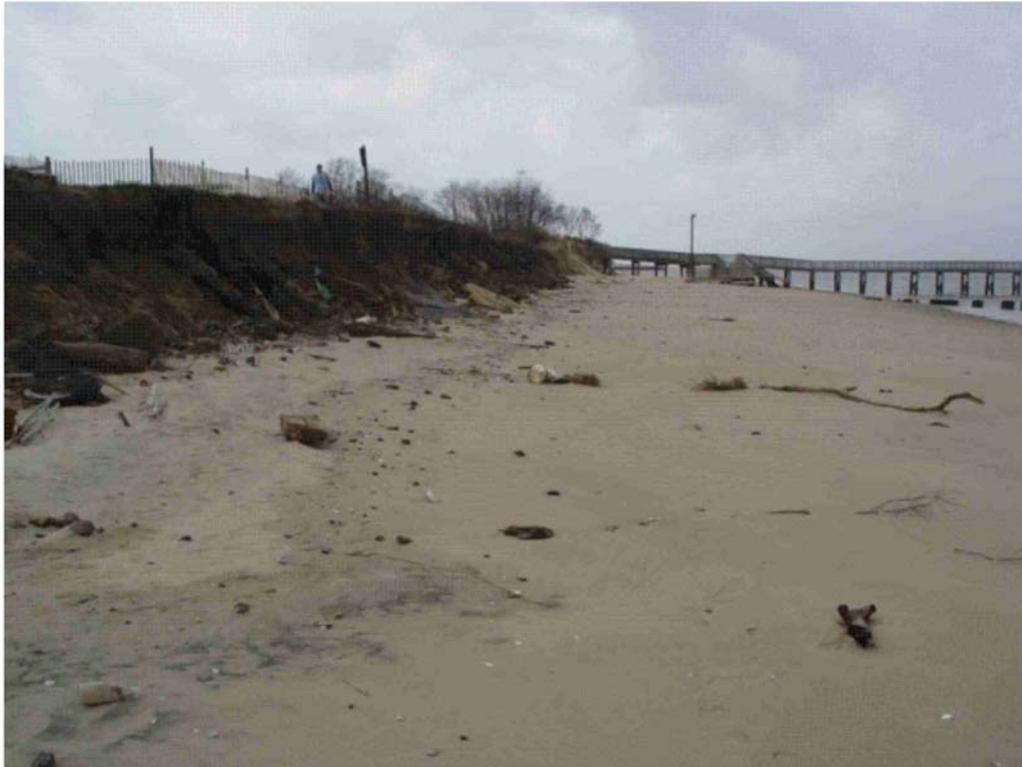
Photoplate 1b. By November 29, 2005 there had been substantial damage done by a pair of northeast storms in mid-October. Erosion destroyed the vegetation and exposed waste rubble used as dune core when the park was upgraded. The beach remained at nearly the same width.

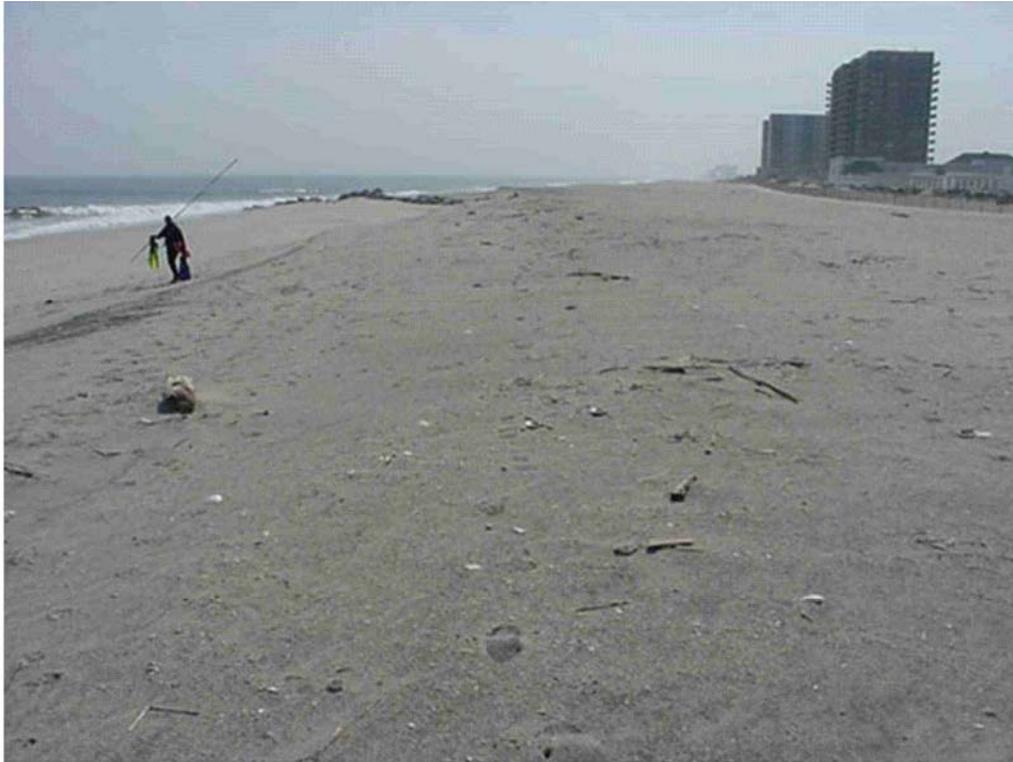
Photoplate 2a. Looking south from Cottage Road, Monmouth Beach in the Fall of 2003. The beach extended well seaward of the development south of the groin. The picture was taken April 2, 2003 and shows conditions about a year following maintenance sand placement.

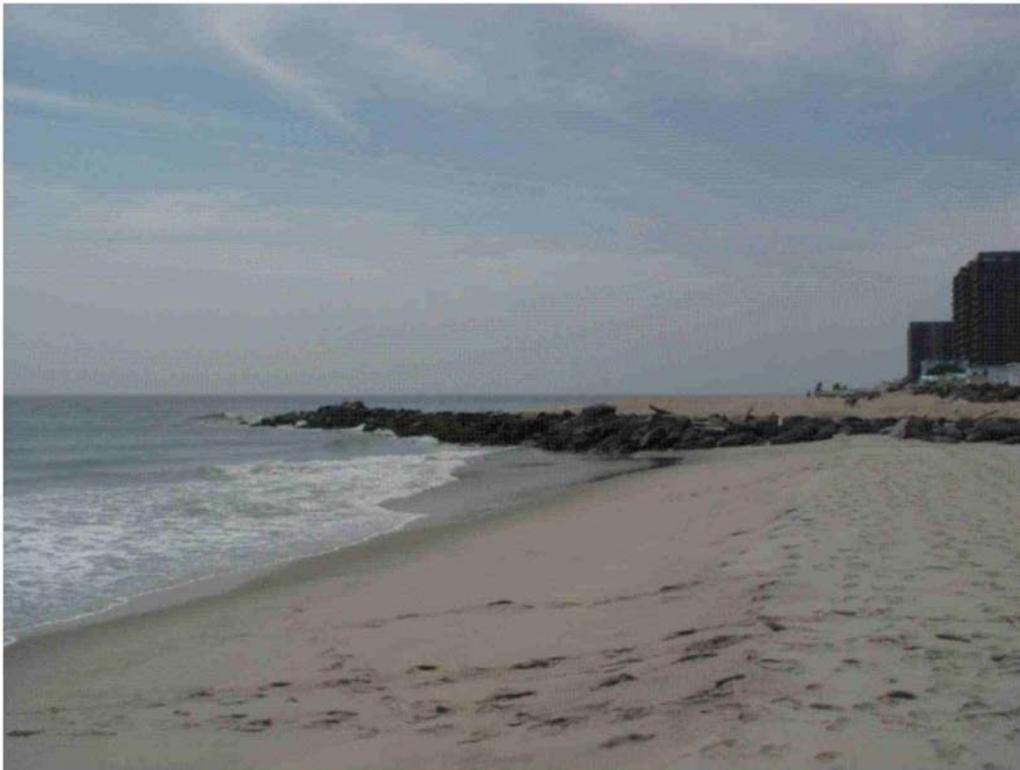
Photoplate 2b. By June 14, 2005 shoreline retreat had exposed the groin again and forced the high tide line back to the rocks south of the groin. The beach continued to erode so that by the summer's end there was a scarp cut into the toe of the dunes north of the groin and well landward of this photograph.

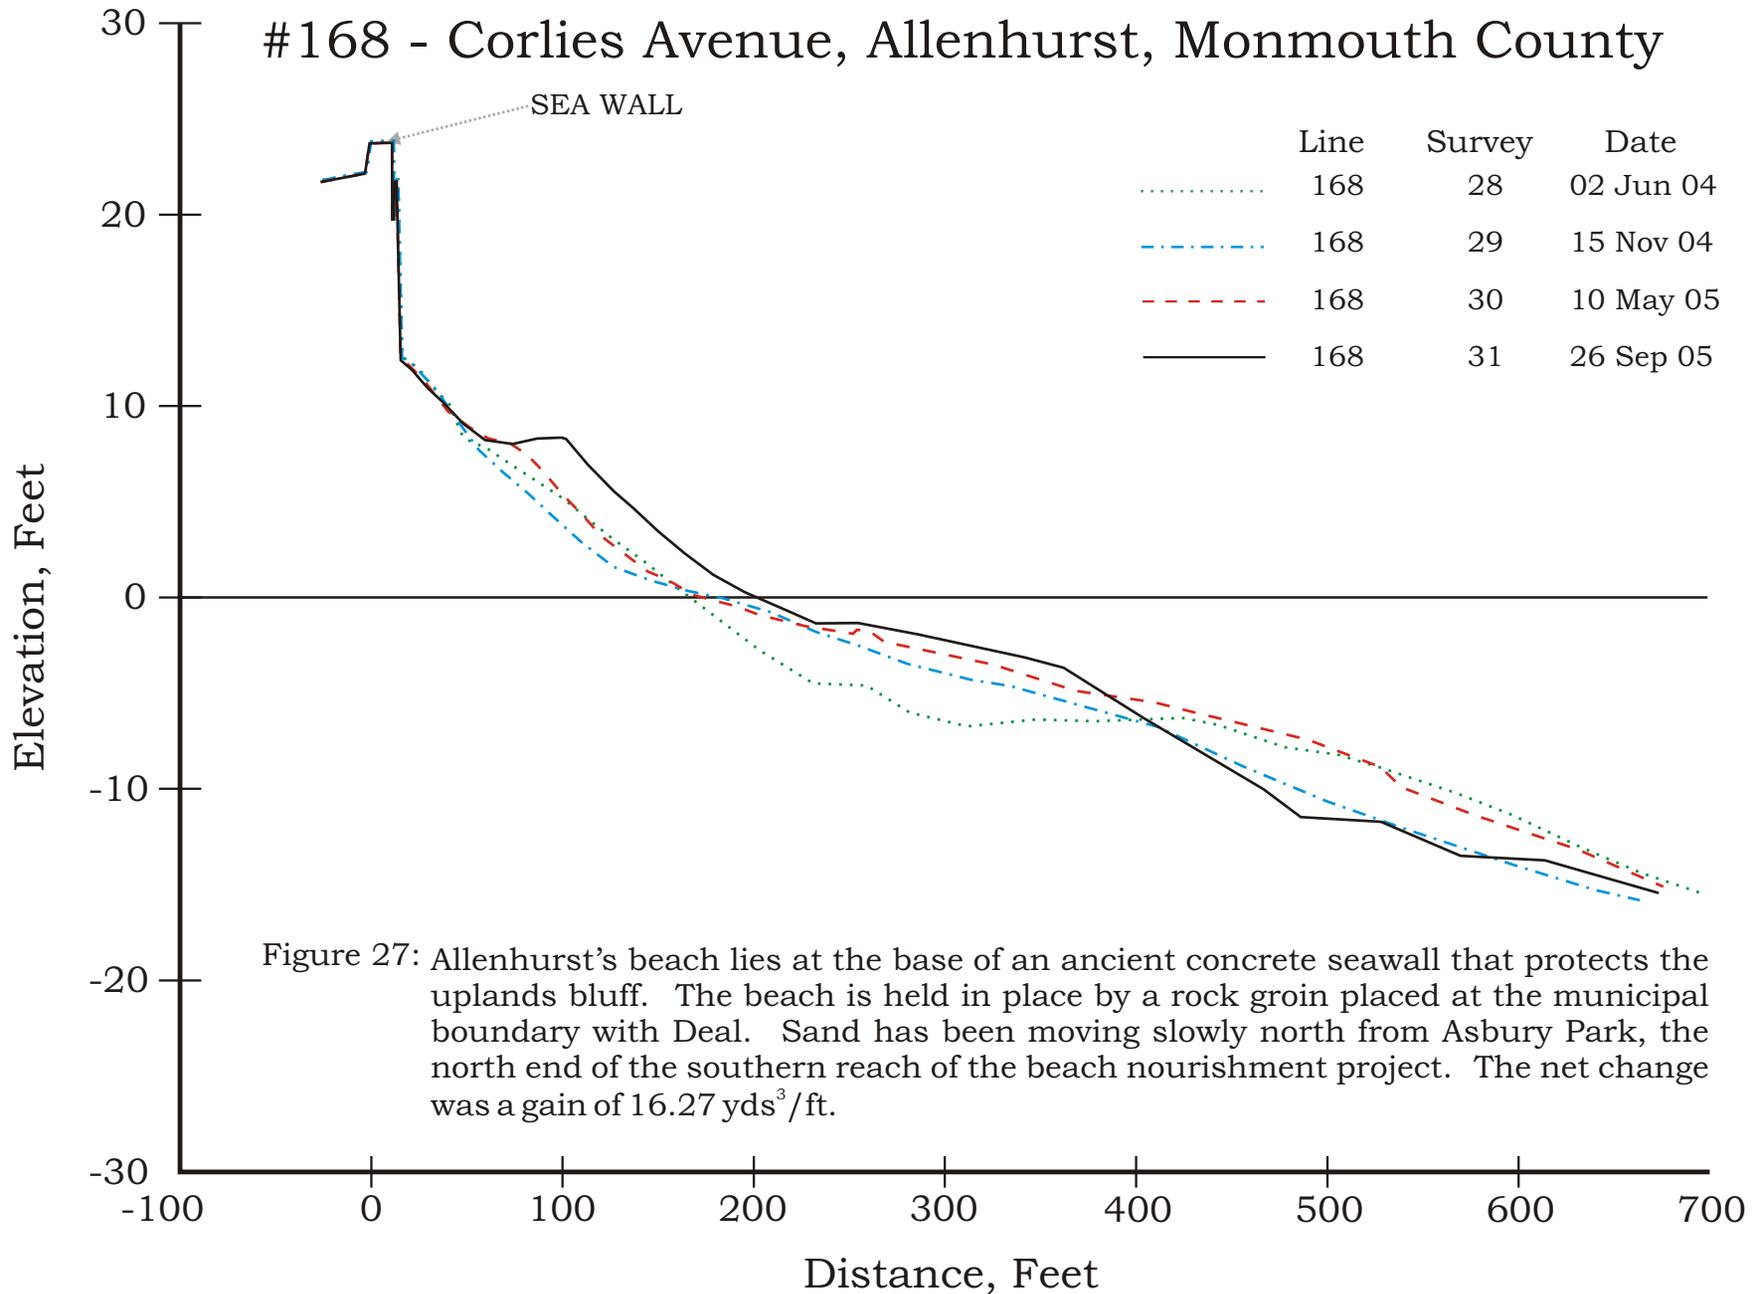
#168 - Corlies Avenue, Allenhurst, Monmouth County

Figure 27: Allenhurst's beach lies at the base of an ancient concrete seawall that protects the uplands bluff. The beach is held in place by a rock groin placed at the municipal boundary with Deal. Sand has been moving slowly north from Asbury Park, the north end of the southern reach of the beach nourishment project. The net change was a gain of 16.27 yds<sup>3</sup>/ft.
