## New Jersey Beach Profile Network 2012 Annual Report on Shoreline Changes in New Jersey's Four Coastal Counties Raritan Bay to Delaware Bay Spring of 2011 Through Fall of 2012

Prepared for:  
New Jersey Department of Environmental Protection  
Division of Construction and Engineering  
1510 Hooper Avenue, Toms River, New Jersey 08753

Prepared by:  
The Richard Stockton Coastal Research Center  
Richard Stockton College of New Jersey  
30 Wilson Avenue, Port Republic, NJ 08241

July 31, 2013

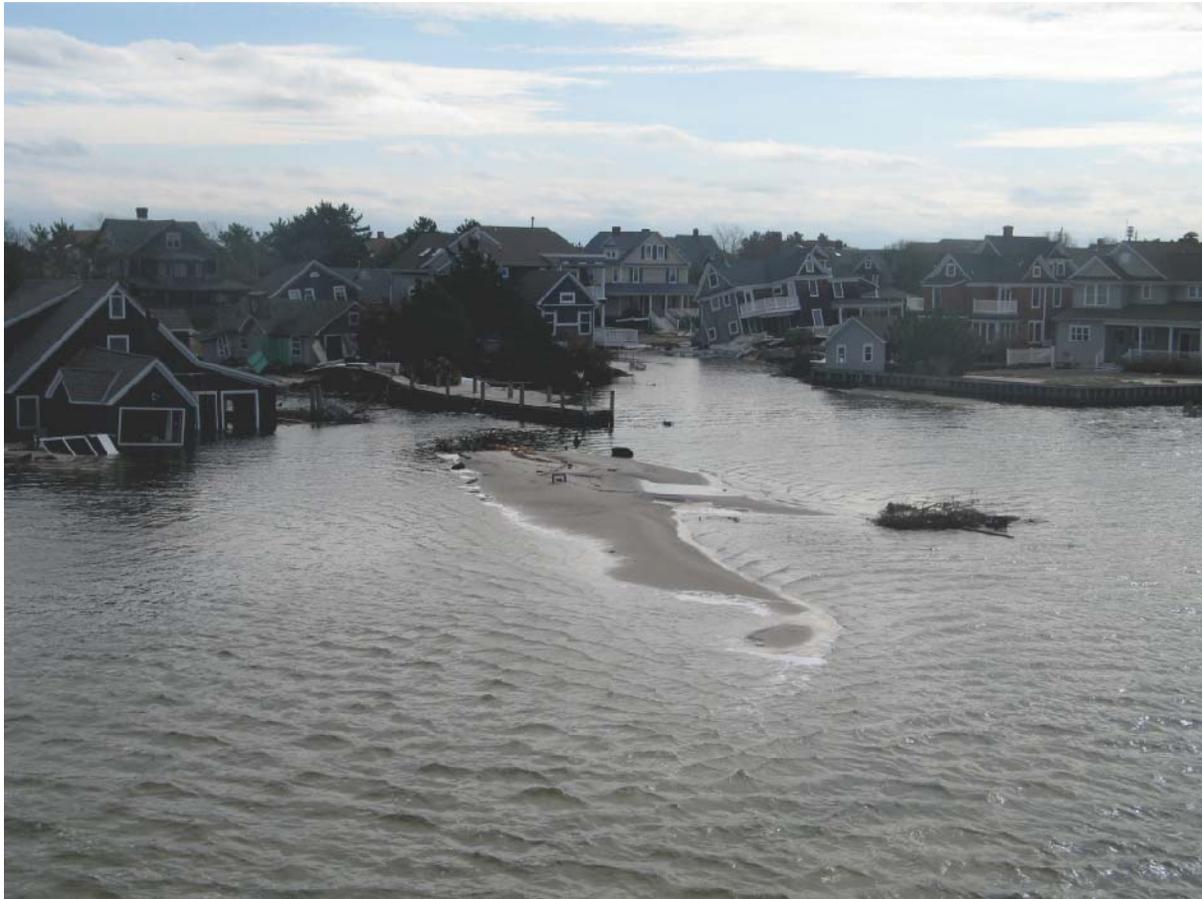
*Central Manaloking, NJ October 31, 2012 following Hurricane Sandy looking north from the bridge to the Borough. The former shoreline along Barnegat Bay ran through the center of the photograph. This is where the tidal inlet breached through the barrier spit entered the bay.*

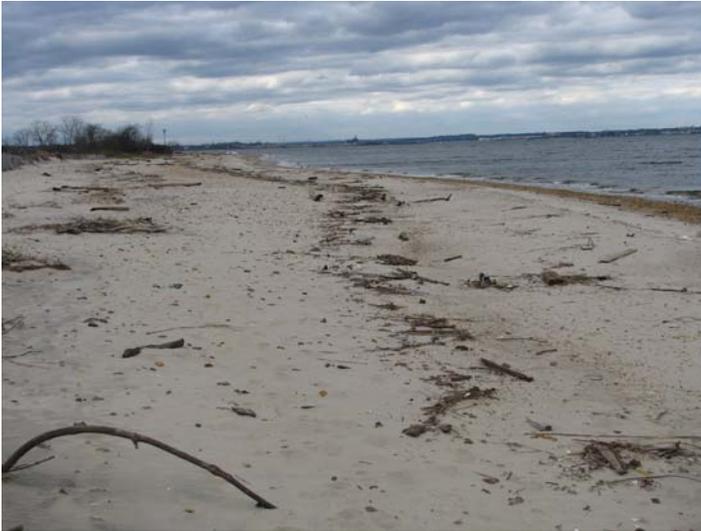
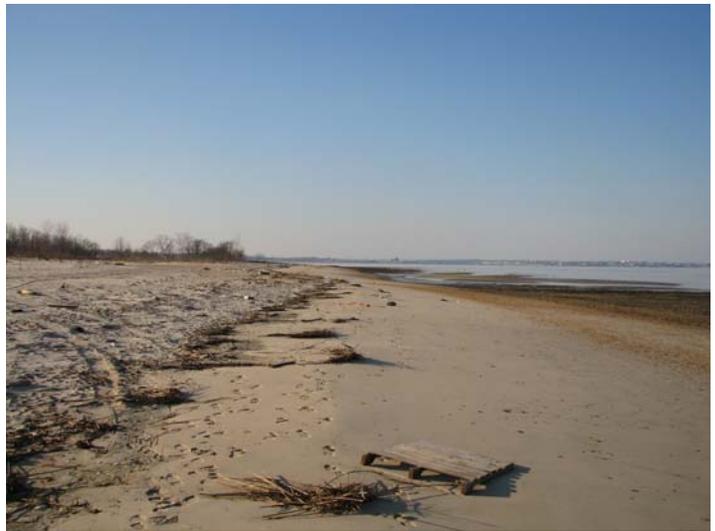
**NJBPN 187 – Beach Park, Cliffwood Beach**

This is the westernmost NJBPN site located on Raritan Bay. The photograph on the left shows the shoreline on November 30, 2011. The photo on the right, taken at low tide shows the lag deposits from Sandy (taken on December 13, 2012).

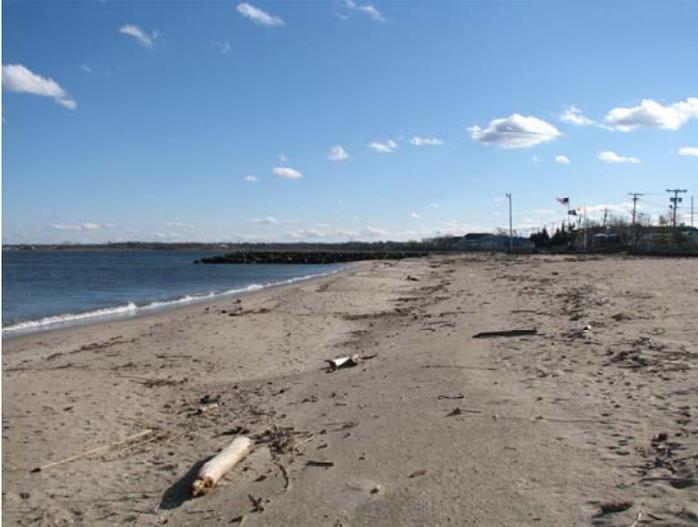
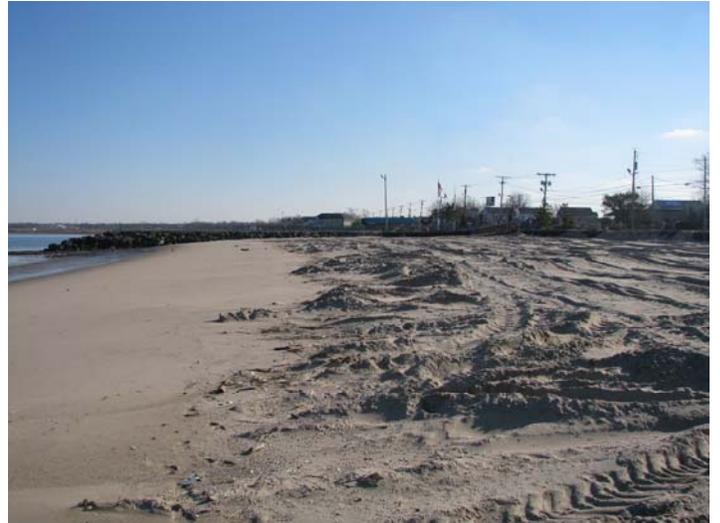
**NJBPN 286 – Beach Street, Union Beach**

This site is located at the public bathing beach and was established in 2009. The photograph on the left shows the shoreline on November 30, 2011. The photo on the right shows the municipalities efforts in replacing lost sand following Sandy (taken on December 13, 2012).

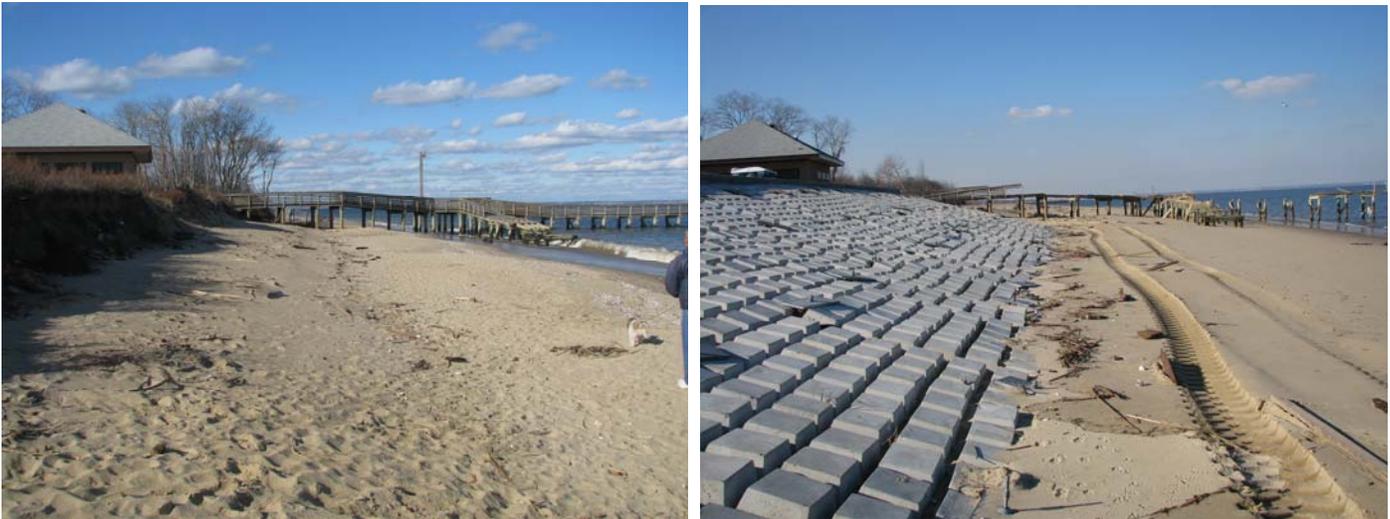
NJBPN 185 – Spy House, Port Monmouth

This site was damaged during H. Irene in 2011 which led to municipal efforts to harden the shoreline with an interlocking block revetment. The photograph on the left shows the shoreline on November 30, 2011. The photo on the right shows the revetment post Sandy (taken on December 13, 2012).

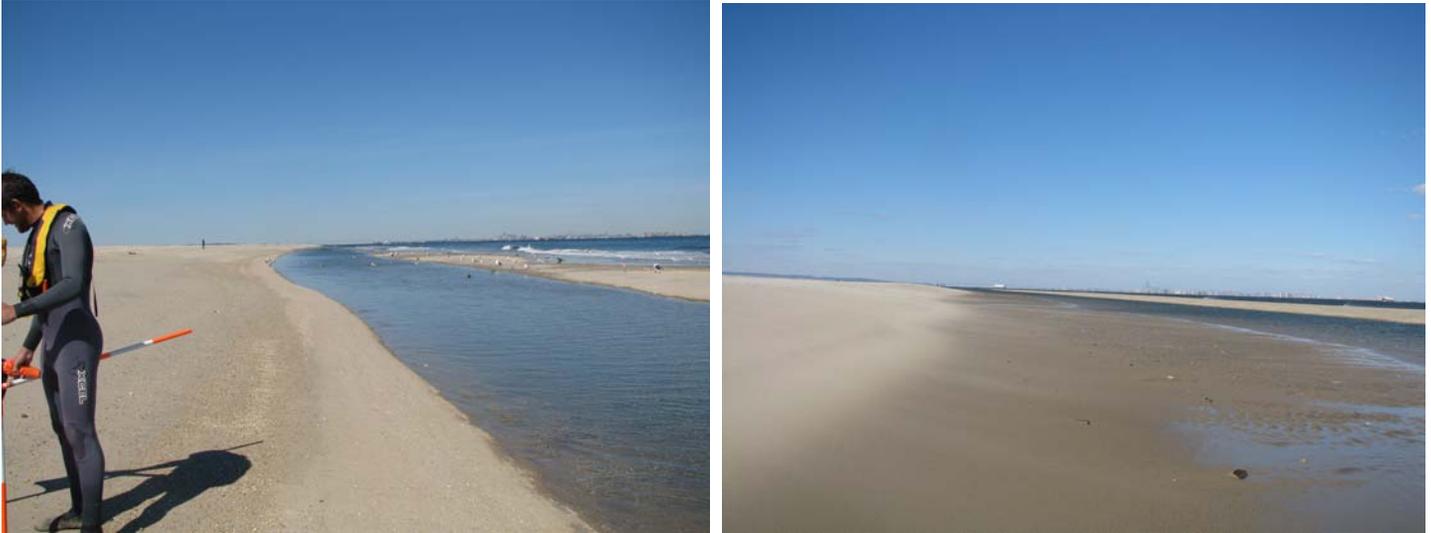
NJBPN 285 – Gunnison Beach, Sandy Hook National Seashore

This is the northernmost ocean NJBPN survey site that has shown advances in the berm position since 1999. The photograph on the left shows the shoreline on October 6, 2011. The photo on the right shows the runnel and high water line post Sandy (taken on January 22, 2013). The park was closed following H. Sandy due to the presence of ordnance delaying the fall survey.

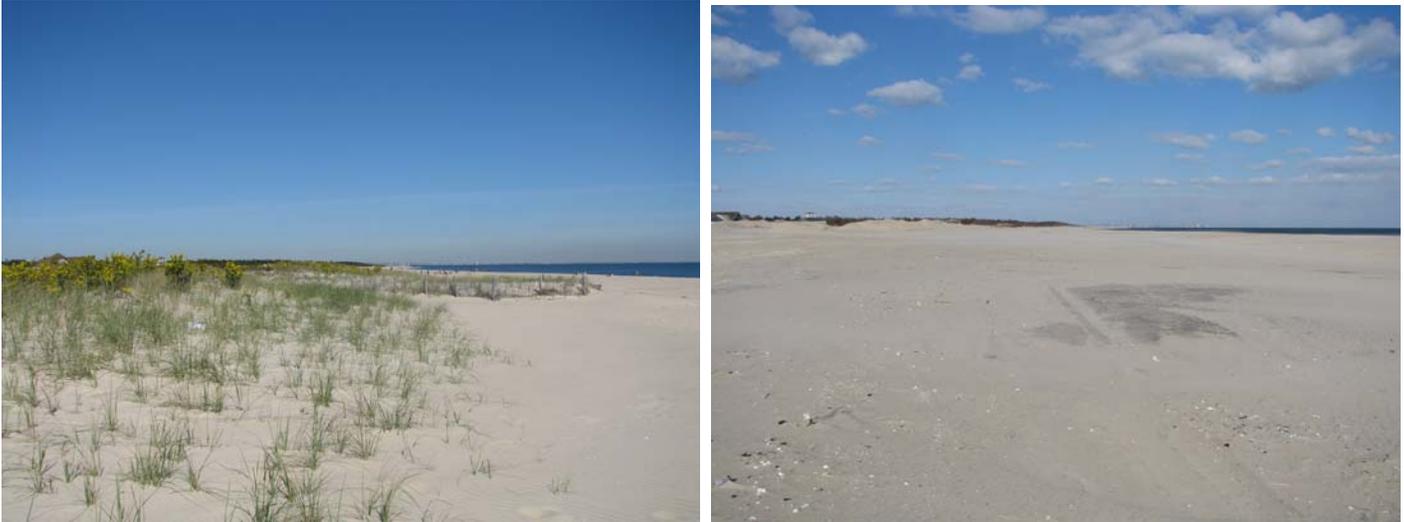
NJBPN 284 – Parking Lot E, Sandy Hook National Seashore

This Sandy Hook site has been eroding since 2010. The photograph on the left shows the shoreline on October 6, 2011. The photo on the right shows the post Sandy (taken on January 22, 2013) profile where there was considerable loss of the dune.

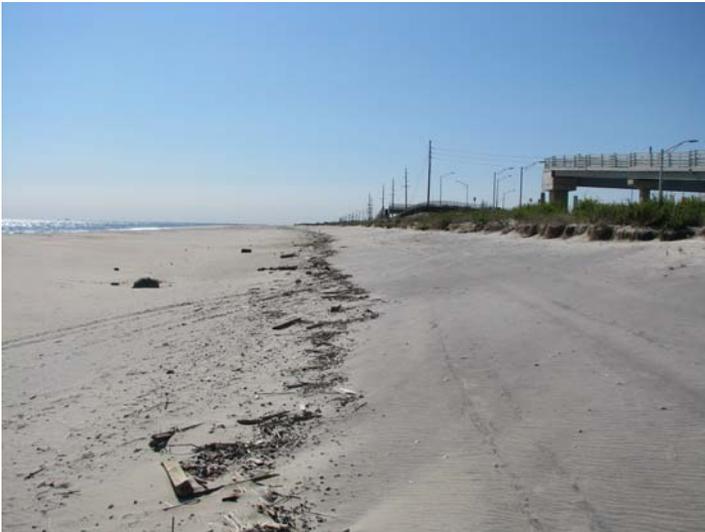
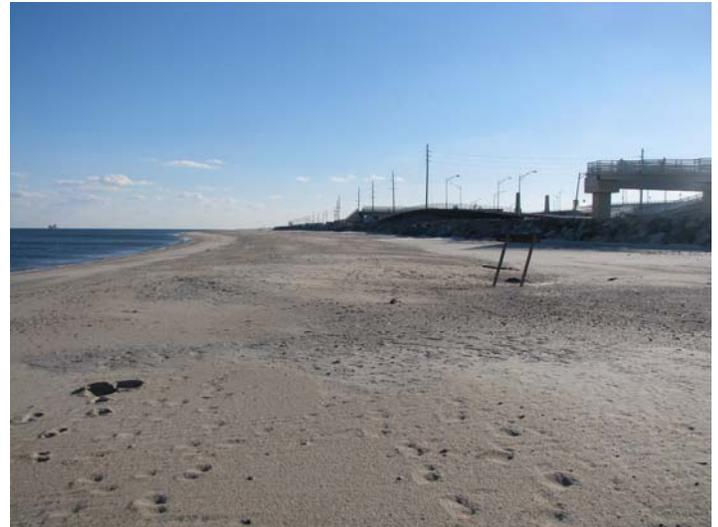
**NJBPN 184 – Highlands Beach, Sandy Hook National Seashore**

This southern Sandy Hook site is located near the entrance to the park and has gained in volume since the placement of nourishment and maintenance sands from the Federal Monmouth Co. shore protection project. The photograph on the left shows the shoreline on October 6, 2011. The photo on the right shows the post Sandy (taken on January 22, 2013) profile where there was considerable loss of the dune and exposure of the rock revetment at the base of the seawall.

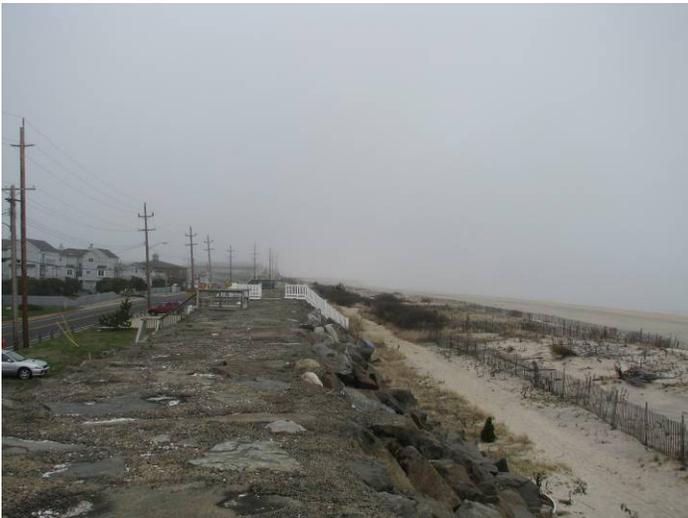
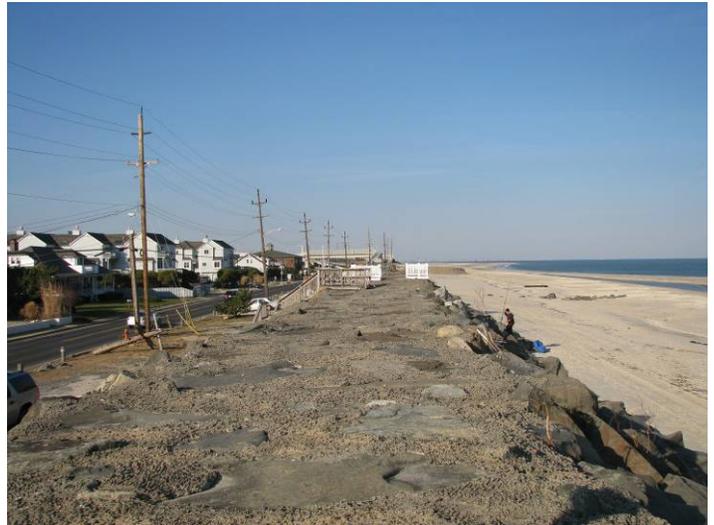
NJBPN 183 – Via Ripa Street, Sea Bright

This site was near the northern limit of the initial Federal shore protection project and has experienced only moderate sand losses since that time. An engineered dune was not constructed due to the presence of the seawall. More sand was placed in the berm to compensate the absence of the dune. A low dune established naturally between two parallel rows of sand fence. The left photograph was taken on March 22, 2012 during the spring survey. The right photo was taken November 26, 2012.

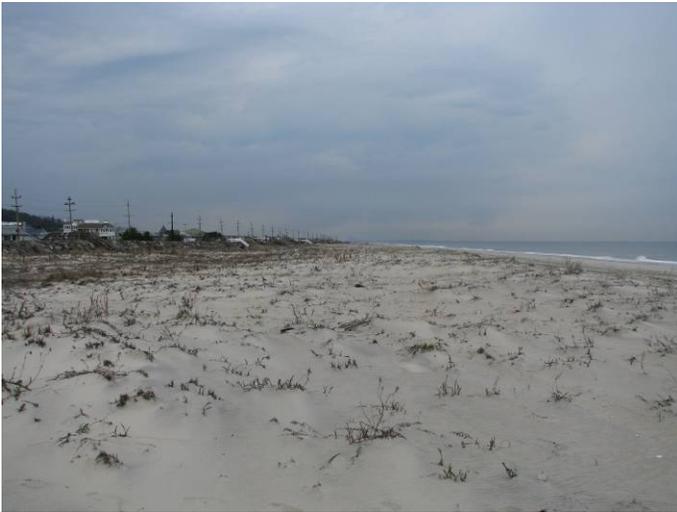
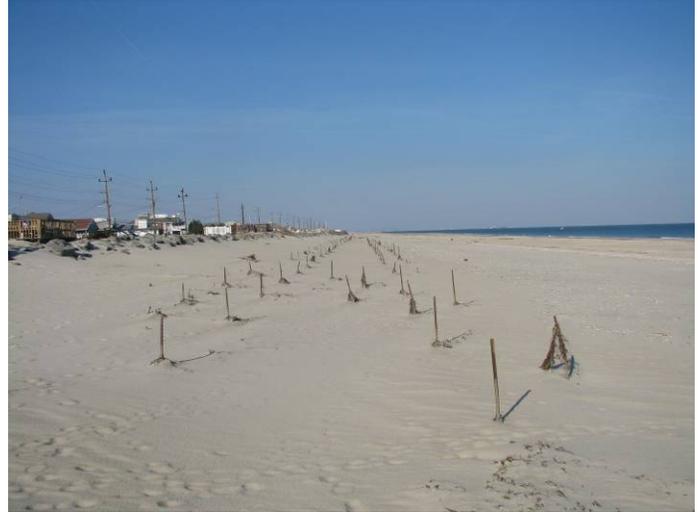
NJBPN 282 – Shrewsbury Way, Sea Bright

This site was included in the initial Federal beach nourishment project but did not include an engineered dune. A low, wide dune field was established surrounding a pair of fence rows built immediately following beach restoration and planted with grass between them. The left photograph (taken on March 28, 2012) shows the natural development of the dune system over the past 12 years. On the right, only remnants of the sand fence remained following the storm (taken November 26, 2012).

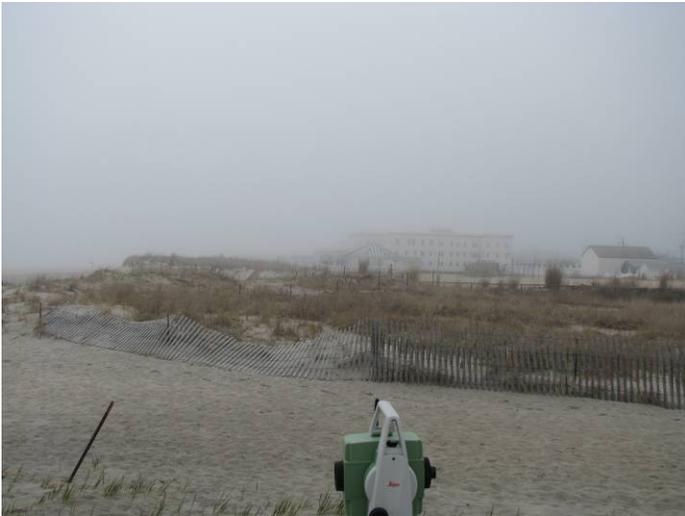
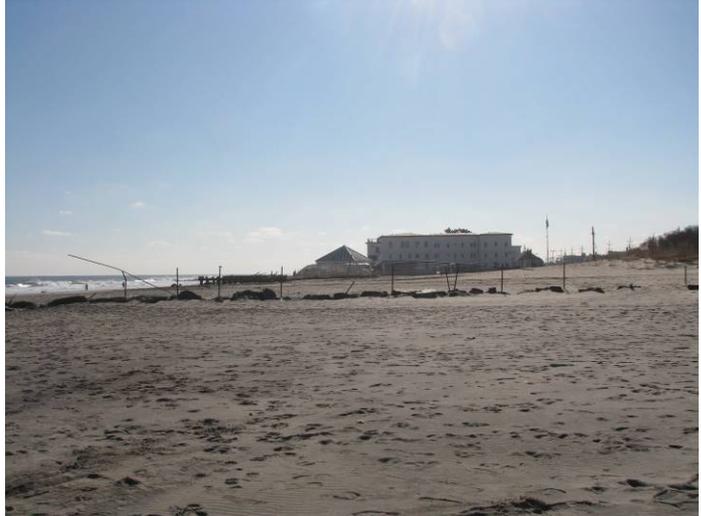
NJBPN 182 – Public Beach, Sea Bright

Low, wide dunes established naturally following the initial Federal beach nourishment project. Sand volumes have been relatively stable since that time (left photo taken March 22, 2012). Sandy’s storm surge and waves relocated sand from the dune and berm to both landward to the rocks and over the rocks, and to the nearshore (right photo November 21, 2012).

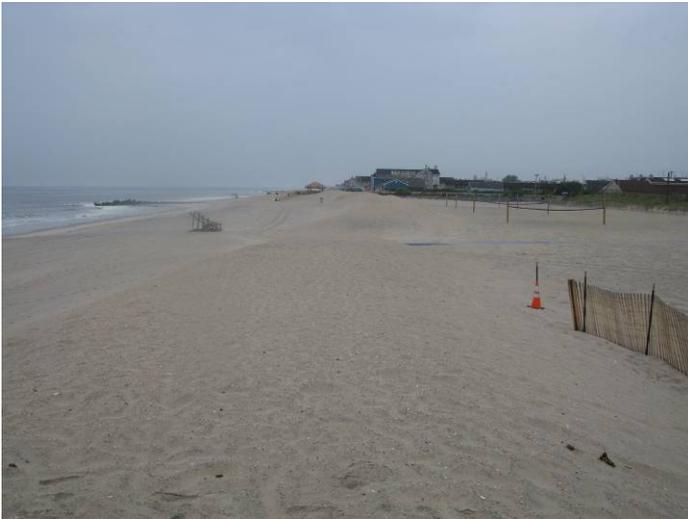
**NJBPN 181 – Municipal Beach, Sea Bright**

This site received sand during the Federal beach nourishment and maintenance projects (left photo taken May 30, 2012). This site was the most heavily damaged along the northern Monmouth County shoreline from Hurricane Sandy because there was a gap in the rock seawall and large grade-level pedestrian gaps in the small dunes (right photo taken).

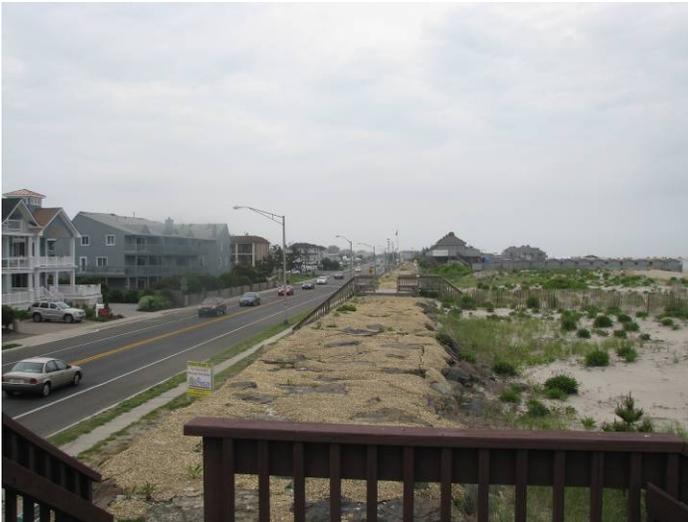
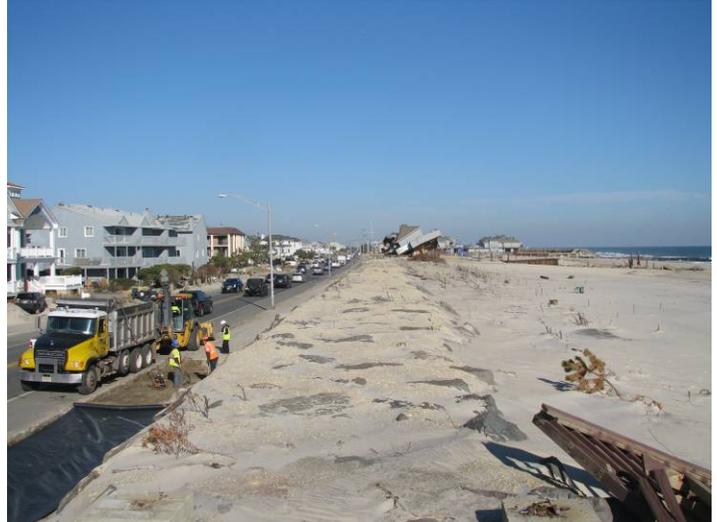
NJBPN 180 – Sunset Court, Sea Bright

This site was the recipient of sand from the initial Federal beach nourishment project. The left photograph (May 30, 2012) shows the variety in height, width and vegetation density associated with the naturally developed dunes seaward of the seawall. Sandy's waves pushed sand into a gentle ramp up the seaward rock slope and allowed the wave bores to pour over the wall into Ocean Avenue and associated properties (right photo taken November 21, 2012).

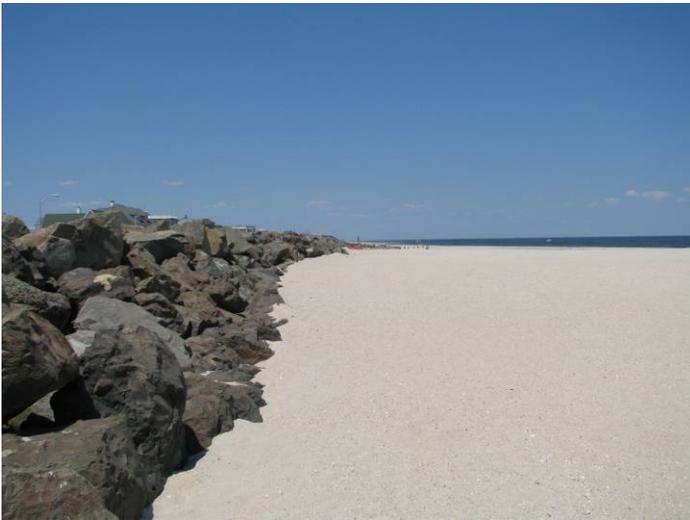
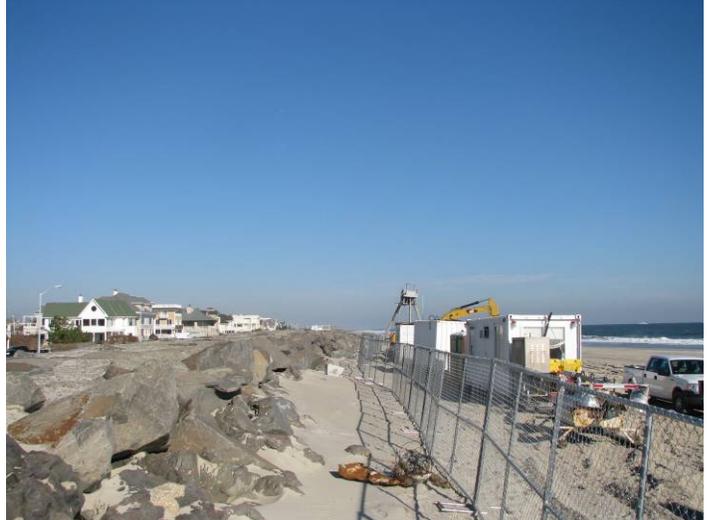
NJBPN 179 – Cottage Road, Monmouth Beach

This site has the worst erosion history of any site in Monmouth County. Chronic volume losses have been recorded over the years because the rock groins adjacent to the site block sand transport from the south. The spring 2012 survey (left photo taken May 31, 2012) recorded a high 300-ft wide berm following a renourishment fill that was completed in Jan 2012. Most of that sand was moved to the nearshore or over the seawall during Sandy. The right photograph (Nov 21, 2012) shows the renourishment activities following the storm.

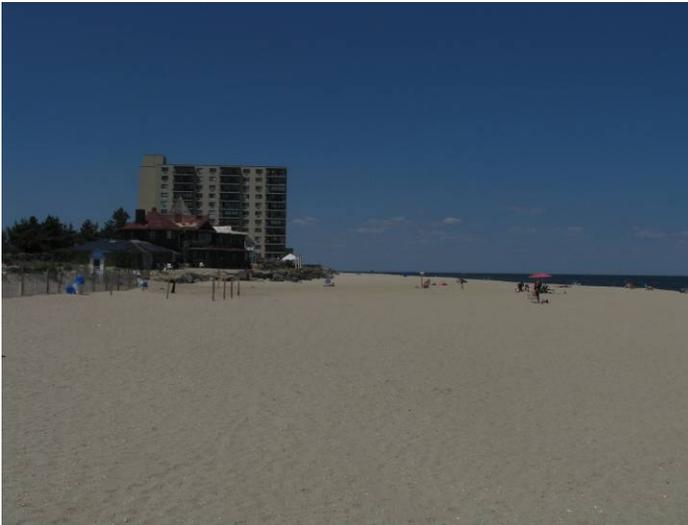
NJBPN 178 – Monmouth Beach Club, Monmouth Beach

This profile was the recipient of the initial Federal beach nourishment project and the winter 2011 to 2012 renourishment (left photo taken May 31, 2012). Hurricane Sandy removed significant amounts of sand from the berm, destroyed a moderate-sized dune and badly damaged the buildings associated with the facility (right photo taken November 25, 2012).

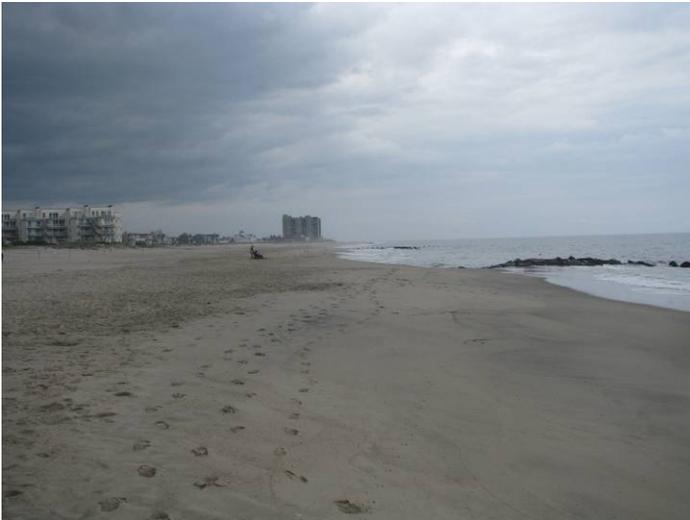
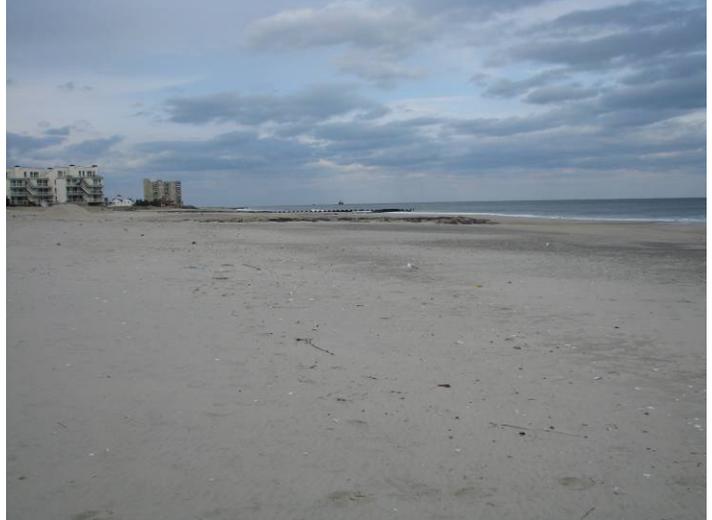
**NJBPN 177 – 404 Ocean Avenue, Long Branch**

This site was the recipient of sand from the initial Federal beach nourishment project. The ridge of sand that was present in the February 2011 survey was removed during H. Irene in August 2011. This site was the southernmost one NOT surveyed prior to Sandy, so the pre-storm profile is from the spring of 2012 (left photo taken May 14, 2012). After Sandy, the berm was reduced in elevation and pushed landward. Sand was also deposited offshore beyond the normal 16-foot ending depth for NJBPN surveys (right photo taken November 25, 2012).

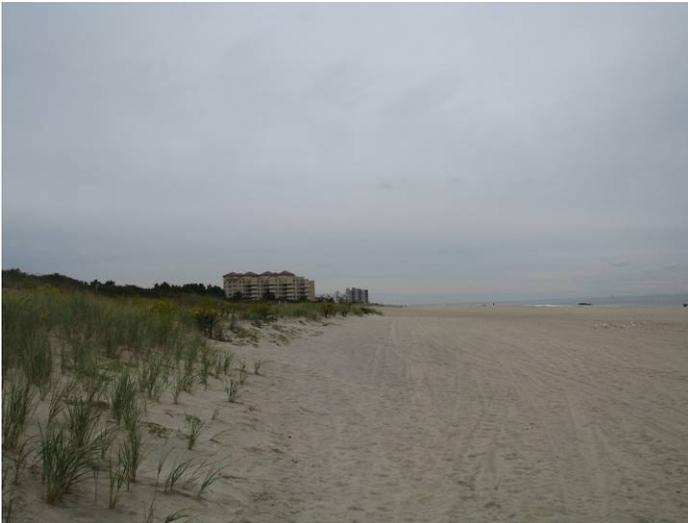
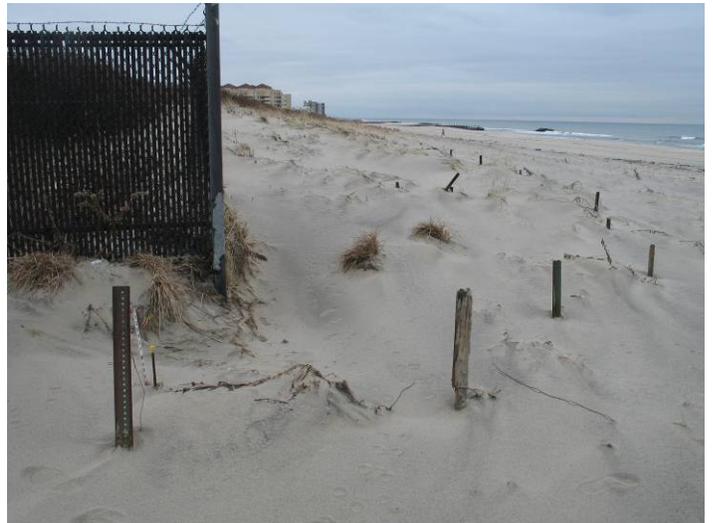
NJBPN 176 – Seven President’s Park, Long Branch

This site is a popular recreational park with a partial ridge of 25-foot elevation dunes and an expansive berm that has undergone variable volume changes through the years (left photo taken October 8, 2012). During Hurricane Sandy, the grade-level public access points created channeled flow from the storm waves and washed sand landward into the parking lots (right photo taken November 13, 2012).

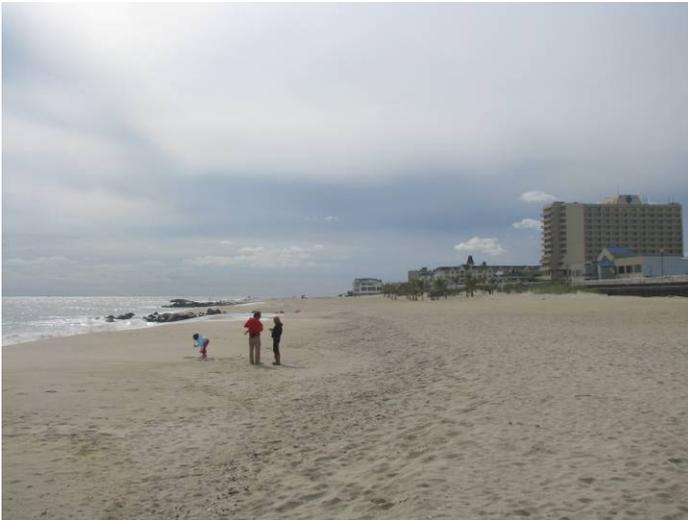
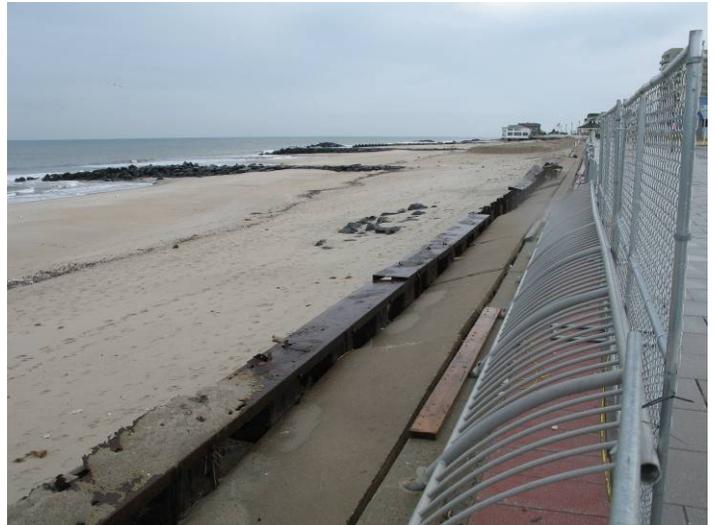
**NJBPN 175 – Broadway Avenue, Long Branch**

This site has benefitted from the Federal shore protection project and renourishment activities (left photo taken October 8, 2012). H. Sandy relocated the berm sand over the vertical steel wall, but the vast majority of sand was deposited offshore beyond the reach of the wading profile survey. The railing on the right photograph was bent landward by wave action 17 feet above the zero datum elevation (November 13, 2012).

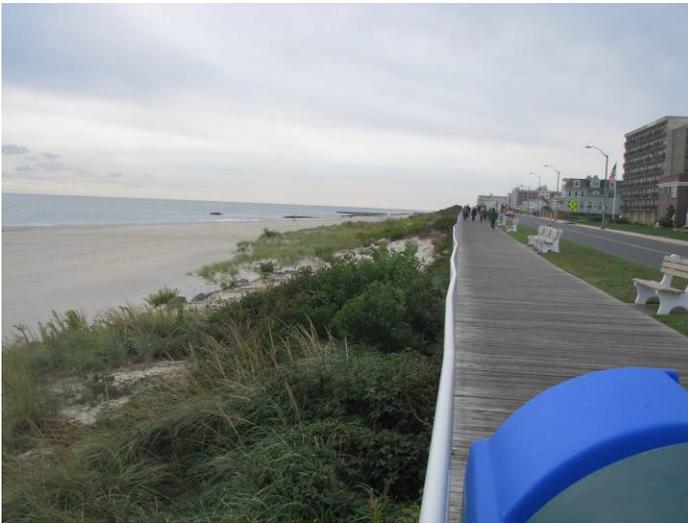
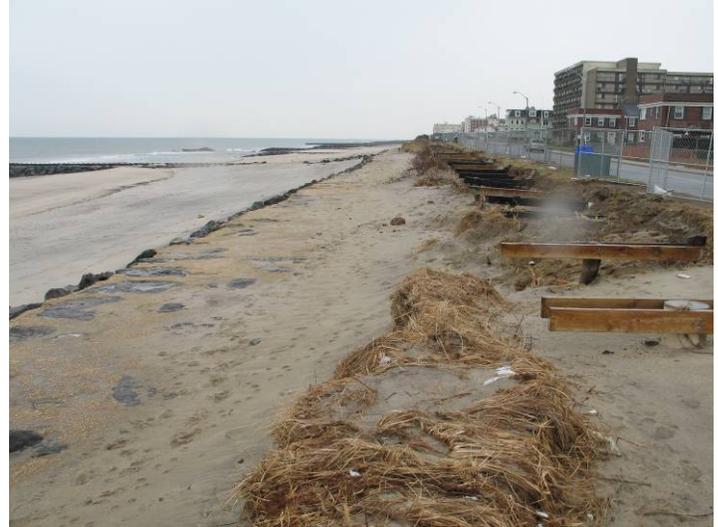
**NJBPN 174 – Morris Avenue, Long Branch**

This site also was the recipient of the Federal beach nourishment project and was a direct beneficiary from the 2010 maintenance fill completed to the south. Strong northerly littoral sand transport moved abundant sand from that project into this segment (left photo taken October 8, 2012). Hurricane Sandy removed the sand from on top of the seawall, eroded into the upper bluff sediments and destroyed the boardwalk (right photo taken November 13, 2012).

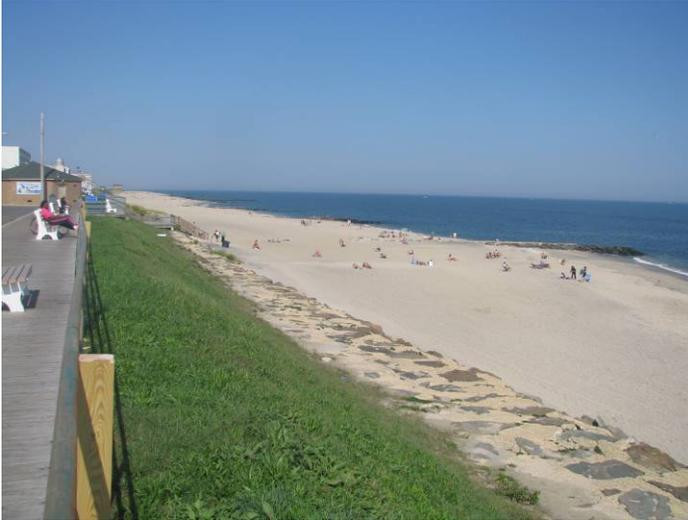
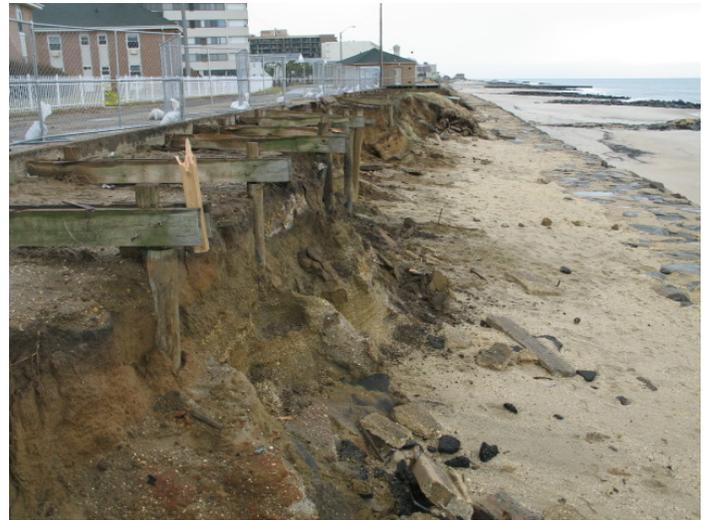
NJBPN 173 – West End Avenue, Long Branch

This site is located near the southern limit of the Federal beach nourishment project. Long Branch did not include the construction of a protective dune. It was decided at the time of project planning that the bluff elevation and the presence of the rock revetment was enough protection for landward properties and the sand was put into the berm (left photo taken October 5, 2012). While the revetment held in place during H. Sandy, the boardwalk built on the upper bluff sediments was destroyed when the bluff retreated to the edge of the old southbound Ocean Ave. roadway (right photo taken November 13, 2012). Storms in the 1950's took the center grass island and the northbound roadway plus the old boardwalk.

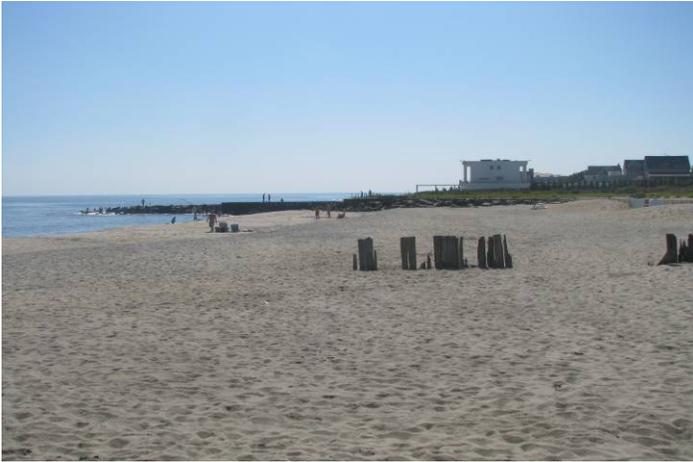
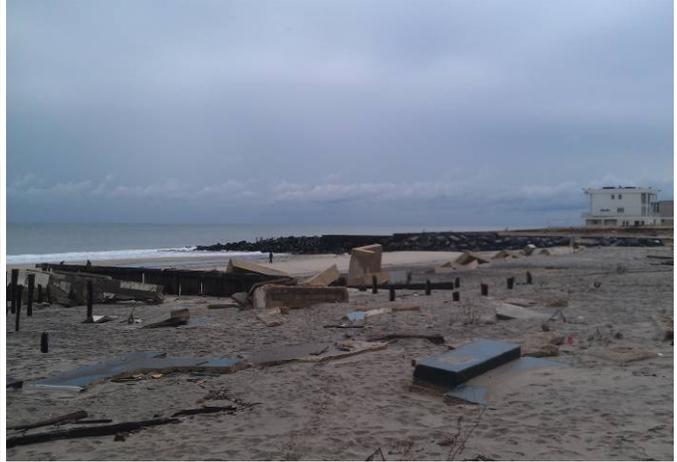
**NJBPN 272 – 805 Ocean Ave, Long Branch**

This site, established in 2010, is located on the northeastern edge of Lake Takanassee and within a groin compartment. The left photo (taken October 5, 2012) shows the relatively stable conditions of the berm prior to H. Sandy. The photo on the right (taken November 13, 2012) shows the lowered berm and debris from structures that were destroyed in the storm.

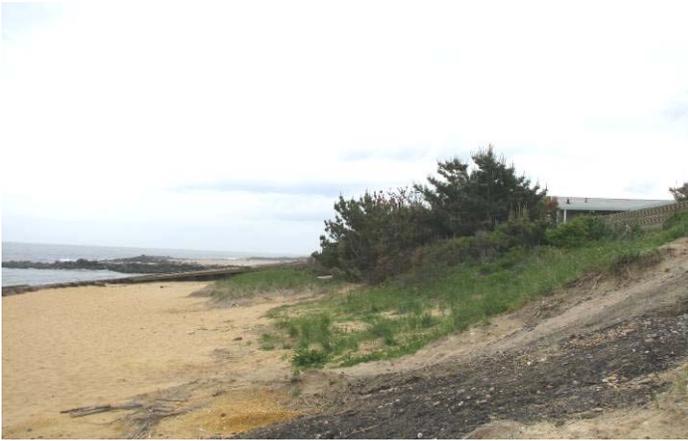
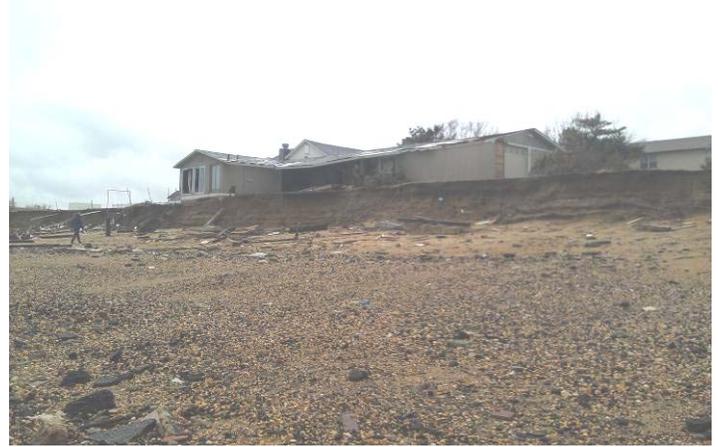
**NJBPN 171 – Pullman Avenue, Elberon**

This site is located on the highest point along the bluff shoreline and in the past, has had very little sub-aerial beach as this community was not included in the Federal beach nourishment projects (left photo taken May 13, 2012). Prior to Sandy, the private properties were separated from the shoreline by a bulkhead and rock revetment which rises 12 feet in elevation and was undamaged. However, waves apparently broke over the rock revetment, attacked upper un-armored bluff sediments and pushed the edge back 40 feet (right photo taken November 13, 2012).

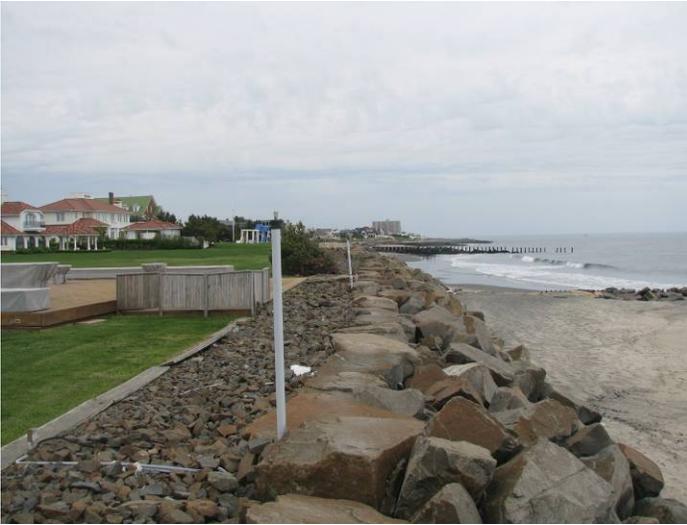
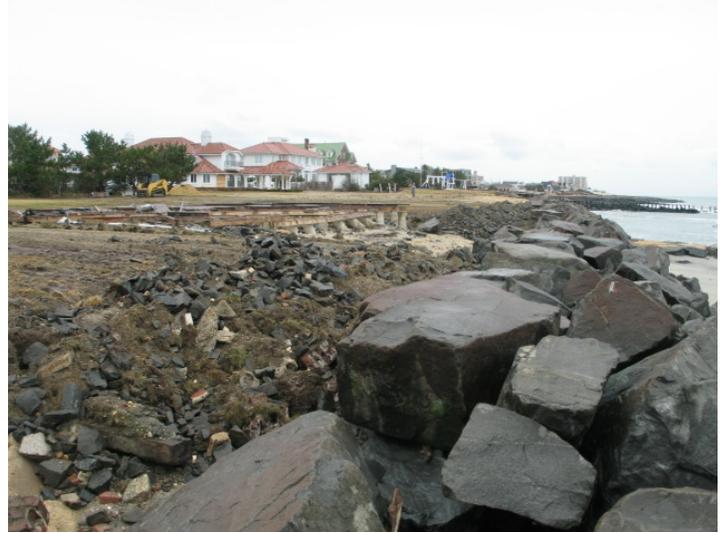
**NJBPN 170 – Roosevelt Avenue, Deal**

This profile is located between two rock groins that limit sediment movement. This area has never received sand from direct beach nourishment and has never benefited from the addition of sand from the littoral system derived from the Federal beach fills. Here the bluff is 20 feet higher than the beach and armored with rocks (left photo taken May 13, 2012). The photo on the right (taken November 13, 2012) shows the impacts of Sandy where waves crashed over the rocks and dug deeply into the area just landward of the rock revetment. Ocean Avenue was flooded at least 3 feet deep and the Deal sewage pumping station at the seaward end of Roosevelt Avenue was destroyed.

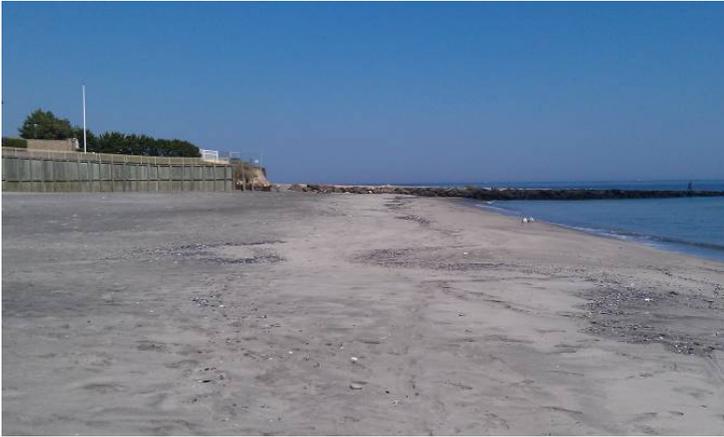
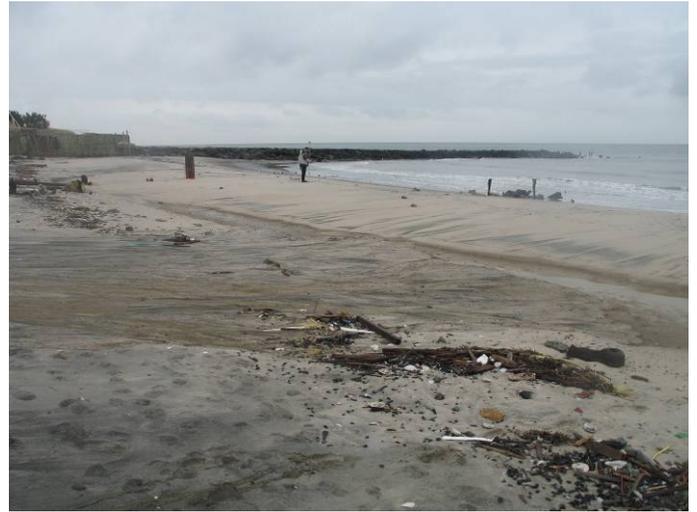
**NJBPN 169 – Darlington Avenue, Deal**

The Darlington site has a small subaerial beach contained between two larger groins. The upland bluff is partially exposed and partially protected by various types of armor. The left photo (taken on October 5, 2012) shows the pre-Sandy conditions. This site was completely inundated by storm surge and waves during Sandy (right photo taken November 13, 2012).

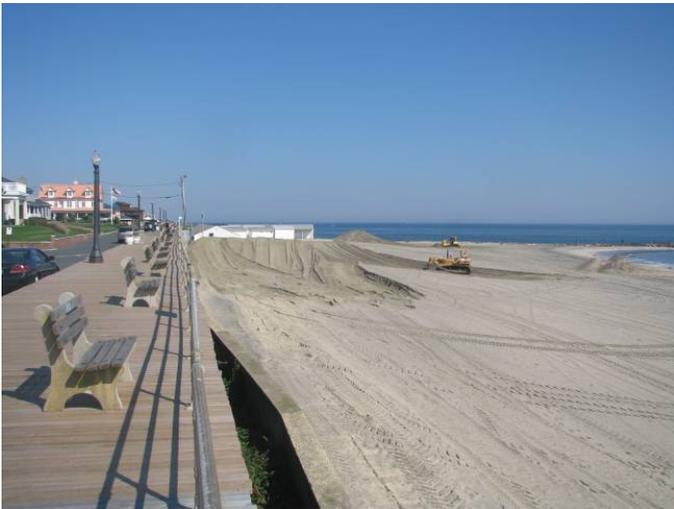
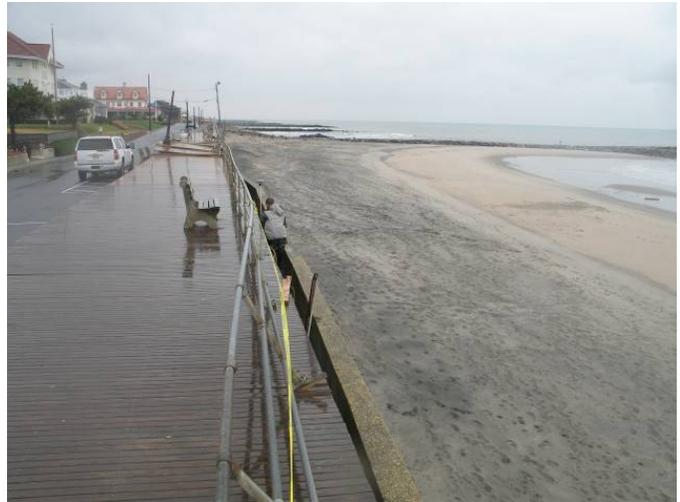
NJBPN 168 – Corlies Avenue, Allenhurst

This site in Allenhurst also represents the shoreline conditions for Loch Arbor’s 2-block shoreline. Here an old concrete wall protects the sedimentary bluff (left photo taken on October 5, 2012). Age and decay has had an effect, but Sandy’s waves clearly broke over the top of the wall with sufficient force to dislodge about 50 feet of the boardwalk (right photograph in front of the white truck, taken November 13, 2012) and negatively impact the landscaping across the street. Note that nothing remains of the white cabaña complex at the north end of the Allenhurst beach and note the bent railing in the foreground.

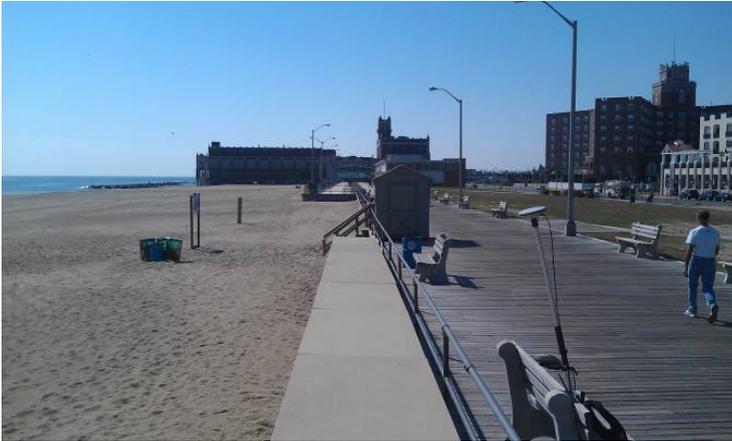
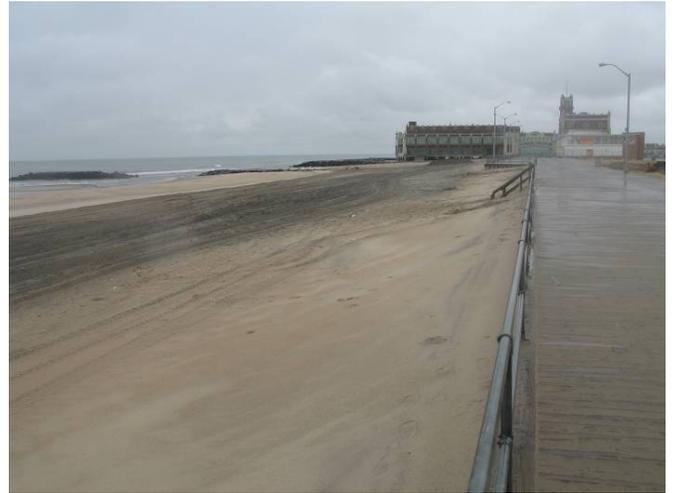
NJBPN 267 – 7th Avenue, Asbury Park

This site was included in the Federal shore protection project. The left photo (taken on October 5, 2012) shows the wide beach and no dune. Hurricane Sandy stripped sand from the beach, pushed the berm landward with sand washed up to the boardwalk as a ramp allowing the waves to pass over the structure inland. The smaller structures showing on the left photograph are missing after Sandy, but the boardwalk had minor damage as waves forced sand under and upward raising decking in an irregular pattern (right photo November 13, 2012).

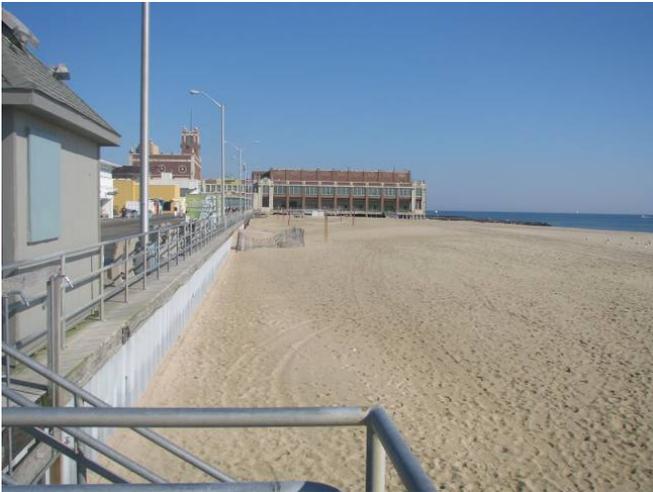
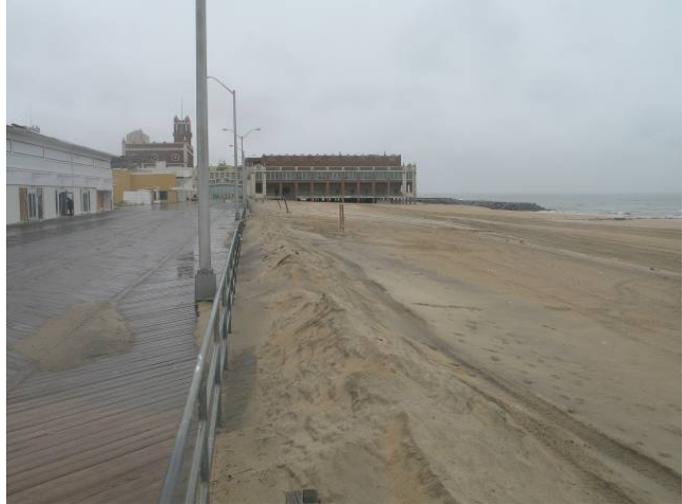
NJBPN 167 – 3rd Avenue, Asbury Park

Asbury Park experienced a broad leveling of the profile as a result of Hurricane Irene and had made gains by the Oct 2012 survey (left photo October 5, 2012). After Sandy, this site at 3<sup>rd</sup> Avenue the sand, stripped from the beach, was ramped up to the boardwalk allowing the waves to pass over the structure without destroying it (right photo taken November 13, 2012). The small building to the left side of the left photograph was gone, but boardwalk damage was limited to raised sections of decking.

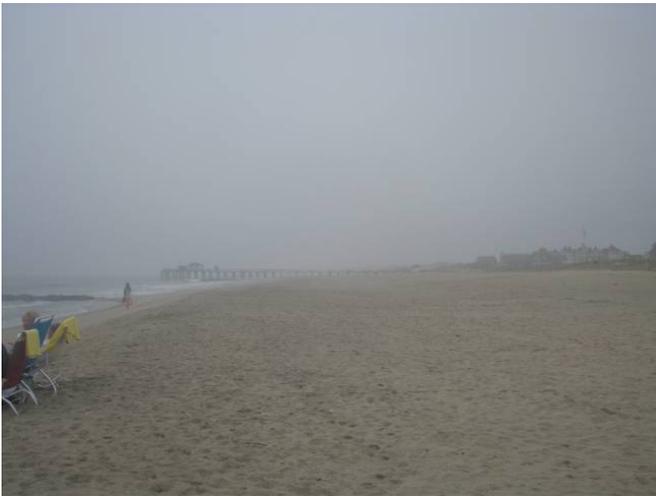
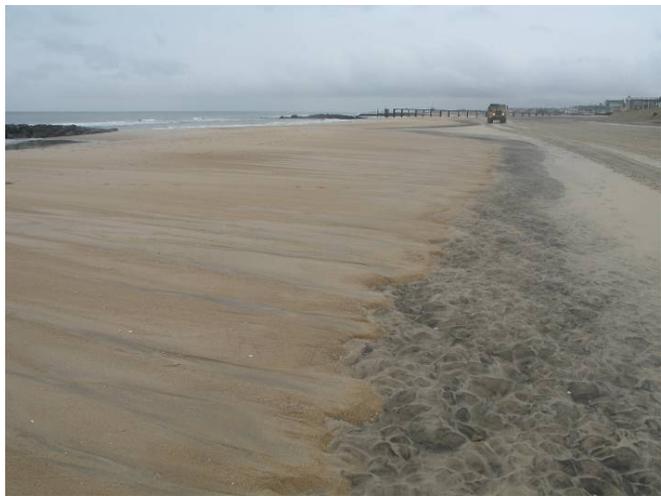
NJBPN 166 – Ocean Pathway, Ocean Grove

This site was included in the Federal shore protection project in 1999 and experienced slow sand volume loss (left photo taken on October 4, 2012). Following Sandy, the dunes along the northern Ocean Grove shoreline survived in partial sections, example below, but were removed south of Main Street. Sand was being excavated from Ocean Avenue and carted back to the beach (vehicle in right photo November 13, 2012).
