## New Jersey Beach Profile Network 2012 Annual Report on Shoreline Changes in New Jersey's Four Coastal Counties Raritan Bay to Delaware Bay Spring of 2011 Through Fall of 2012

Prepared for:  
New Jersey Department of Environmental Protection  
Division of Construction and Engineering  
1510 Hooper Avenue, Toms River, New Jersey 08753

Prepared by:  
The Richard Stockton Coastal Research Center  
Richard Stockton College of New Jersey  
30 Wilson Avenue, Port Republic, NJ 08241

July 31, 2013

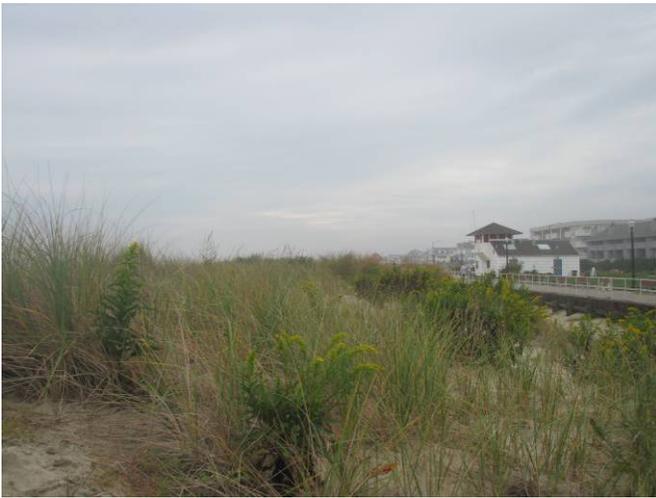
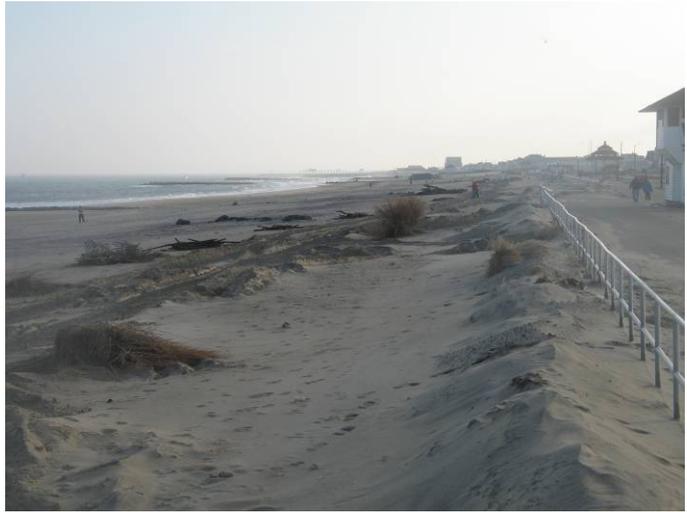
NJBPN 165 – McCabe Avenue, Bradley Beach

This site saw few changes following Irene in 2011 (left photo taken on October 4, 2012). Following Sandy, dune damage was extensive, but their effect was to reduce the damages landward. The promenade was impacted, but not destroyed but abundant sand was still present in Ocean Avenue. The swale between the dune system and the promenade was filled with sand and the volume lost was significant from the beach (right photo taken Nov 12, 2012).

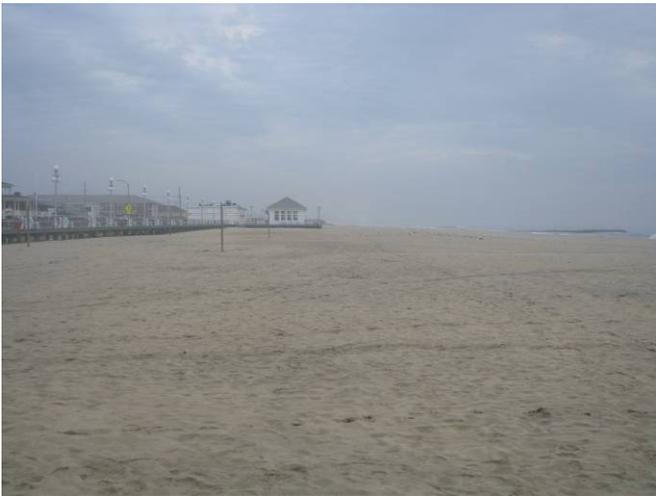
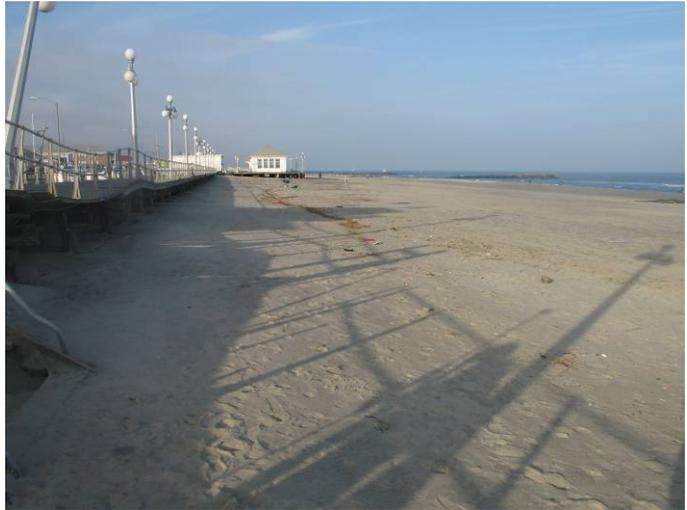
NJBPN 164 – Sylvania Avenue, Avon-by-the Sea

This site is located north of the Shark River inlet and was nourished in the 1999 Federal shore protection project (left--pre-Sandy photo, taken on October 4, 2012). During Sandy, the beach had been totally submerged and sand was washed inland well beyond Ocean Avenue. The swale between Ocean Avenue and the boardwalk was filled in. Damage to the building just north of the profile line was extensive. The small lakes were also impacted with sand burying the drainage system as well as raising lake levels with salt water. Efforts were underway to excavate the drainage and lower lake level (right photo taken November 12, 2012).

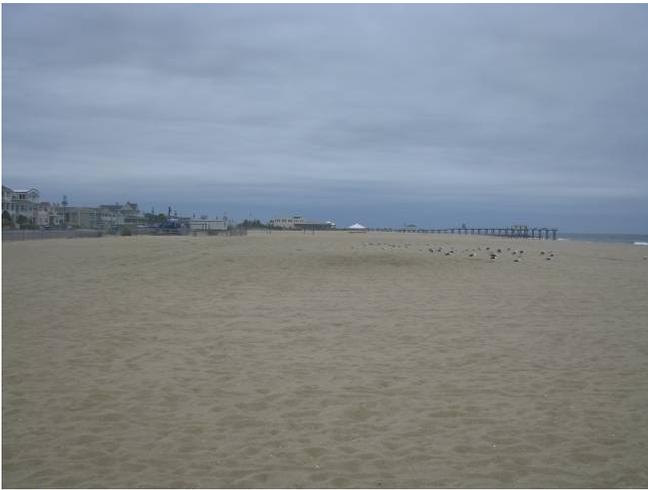
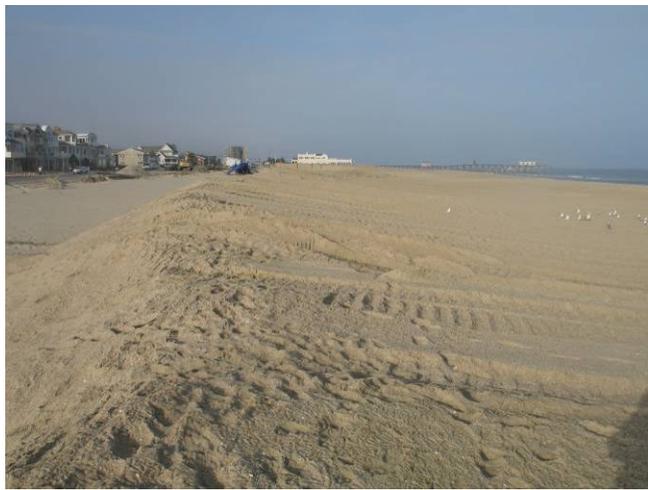
This site did not have a dune prior to Sandy but had a wide, dry beach (left photo taken on October 2, 2012). During Sandy, the dry beach was submerged by the storm surge. Sand was carried landward onto Ocean Avenue accompanied by extensive flooding (right photo taken November 12, 2012).

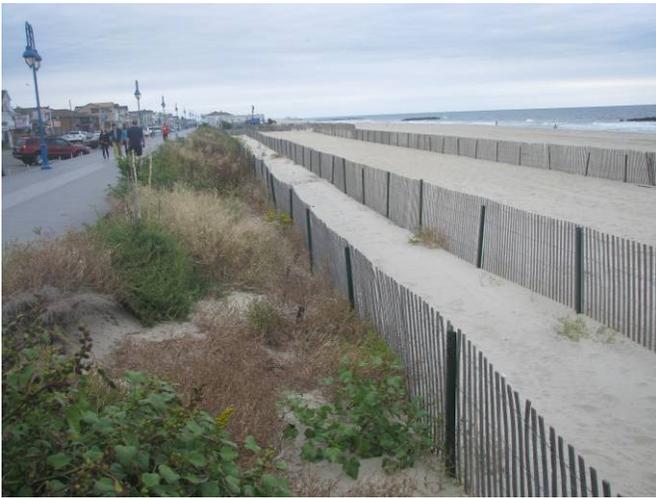
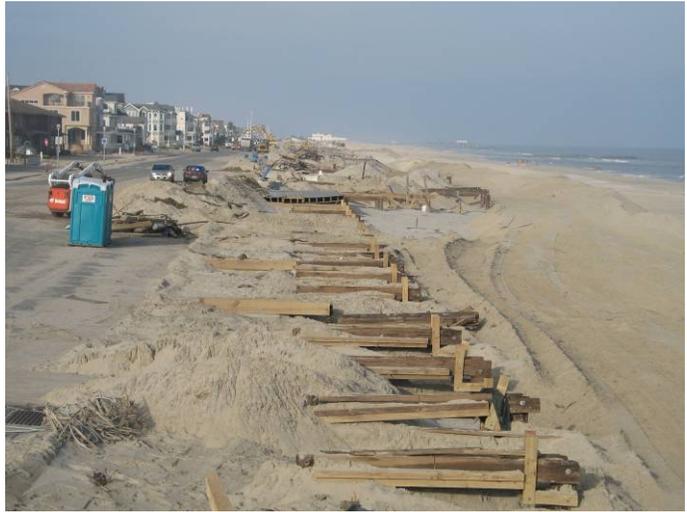
**NJBPN 162 – 18th Avenue, Belmar**

Sand was placed at this location in the 1997 Federal shore protection project and has remained relatively stable (left photo taken October 2, 2012). The southern Belmar shoreline was completely overrun by the force of Hurricane Sandy. The Lake Como segment was closed to traffic because multiple pumping pipelines were in place moving lake water back to the sea. Excavators were digging to clear the normal drainage system as well. Nothing but the supports remained from the boardwalk, with the small dune and all the fencing swept away (right photo taken November 12, 2012).

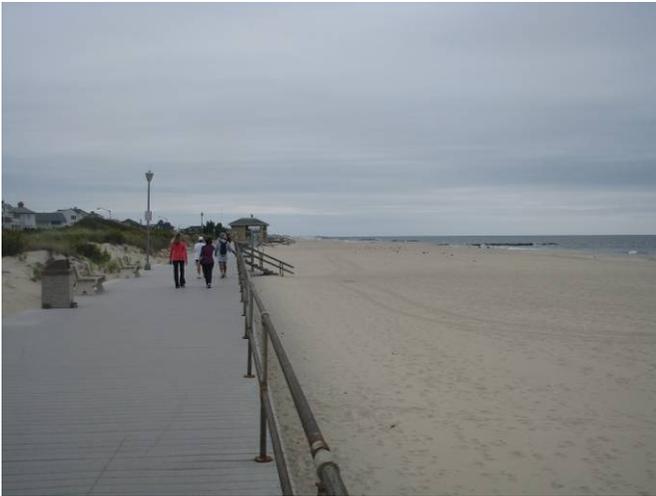
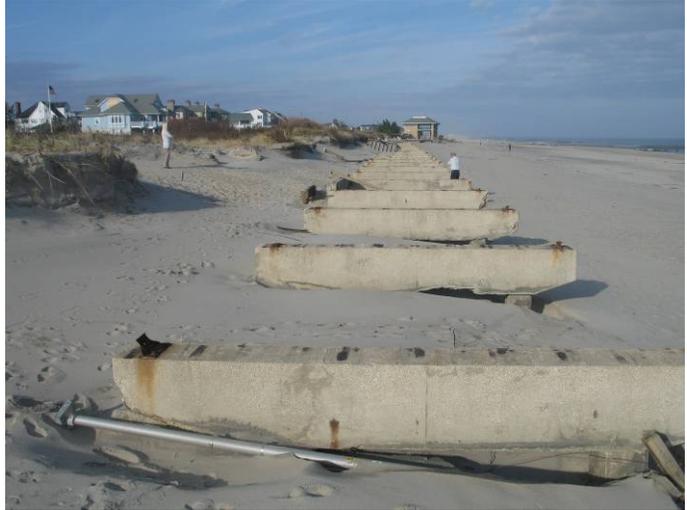
**NJBPN 161 – Brighton Avenue, Spring Lake**

This site received sand during the 1997 Federal shore protection project and has had modest volume gains (left photo taken on October 2, 2012). During Sandy, Spring Lake lost the entire boardwalk deck. Extensive damage occurred at the ocean-side bathing buildings with most of the dunes breached and some segments removed entirely. Since the boardwalk had been seaward of the dunes for over 70 years, the waves impacting the dunes acted to lift the boardwalk deck sections from the concrete supports. The fact that the steel deck retainers were rusted away by decades of neglect did not help matters in terms of boardwalk survival (right photo taken November 12, 2012).

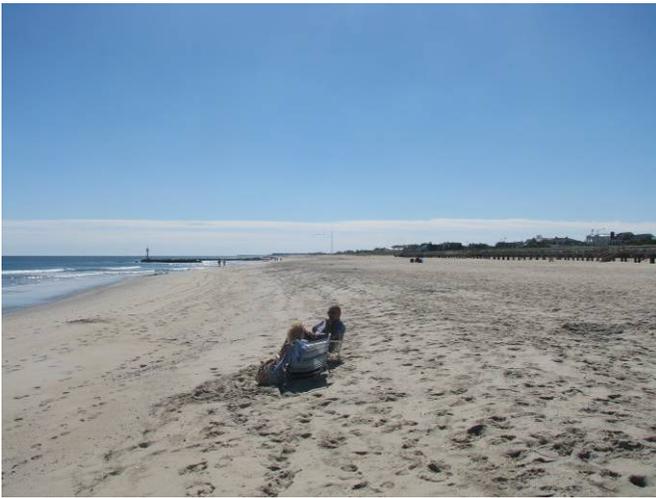
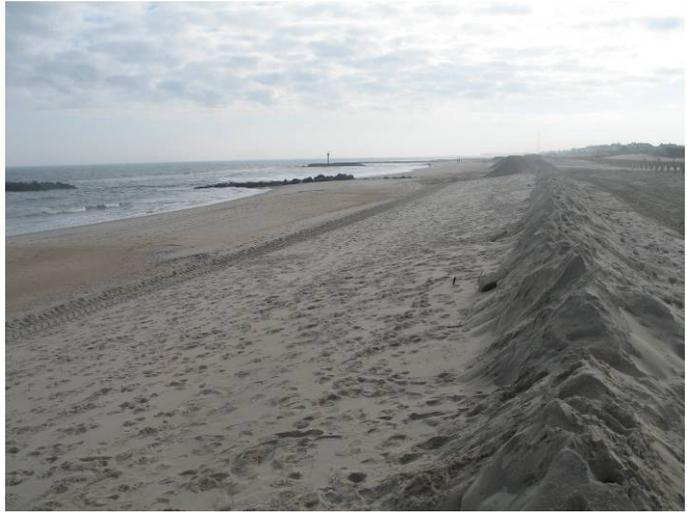
NJBPN 160 – Salem Avenue, Spring Lake

The dunes at this site also were located landward of the boardwalk (left photo taken October 1, 2012). Sandy caused serious dune erosion that allowed waves to move sand into Ocean Avenue and strip the boardwalk deck from the supports. A ridge of sand had been carted back to the beach as the feature showing on the beach on the November 12<sup>th</sup> survey line (right photo taken November 12, 2012).

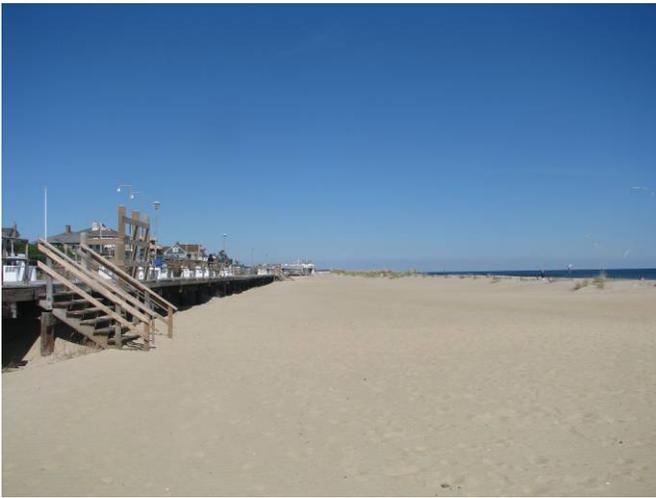
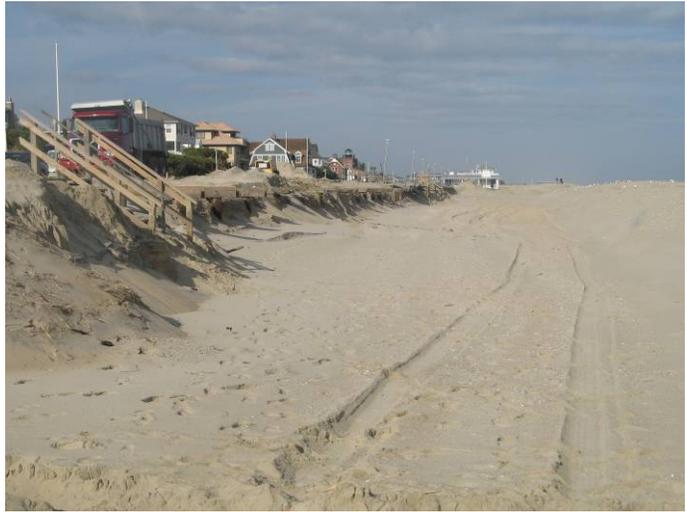
**NJBPN 159 – New York Avenue, Sea Girt**

Sand was added to this site in the 1997 Federal shore protection project and has remained relatively stable since that time (left photo taken on October 1, 2012). Sandy caused damages along the northern Sea Girt shoreline and impacted the infrastructure more intensely than at locations further south. The boardwalk was damaged and washed over completely. Sand was being carted back the beach as a sizable ridge (right photo taken November 12, 2012).

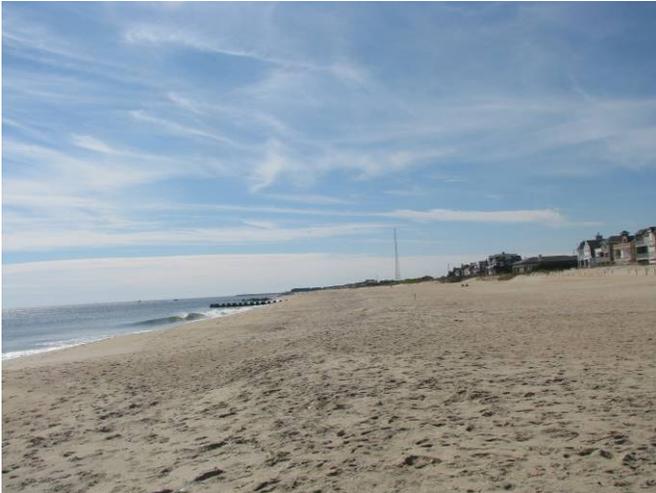
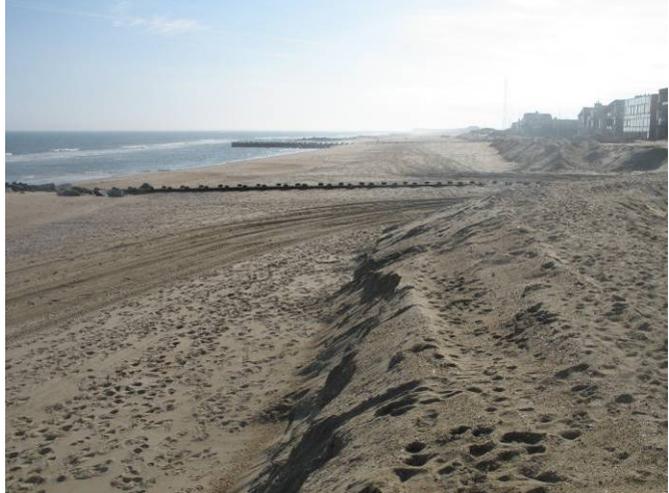
NJBPN 158 – Trenton Avenue, Sea Girt

Sand was added to this location in the 1997 Federal shore protection project and dunes formed on their own (left photo taken on October 1, 2012). H. Sandy reduced the elevation and width of the berm and the sand from the street end was carted back to the beach (see the ridge shown in the right photo taken November 12, 2012). Ocean Avenue does not continue south to this location. The beach to the north suffered dune loss, but no waves reached the homes because both the dune was substantial and the homes sit on top of the Monmouth County bluff.

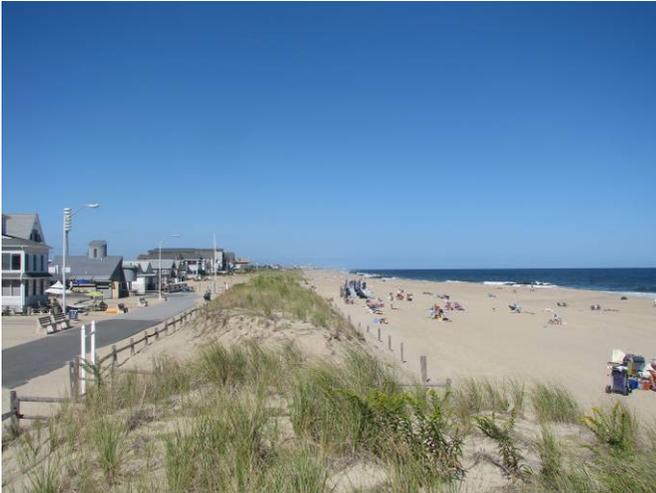
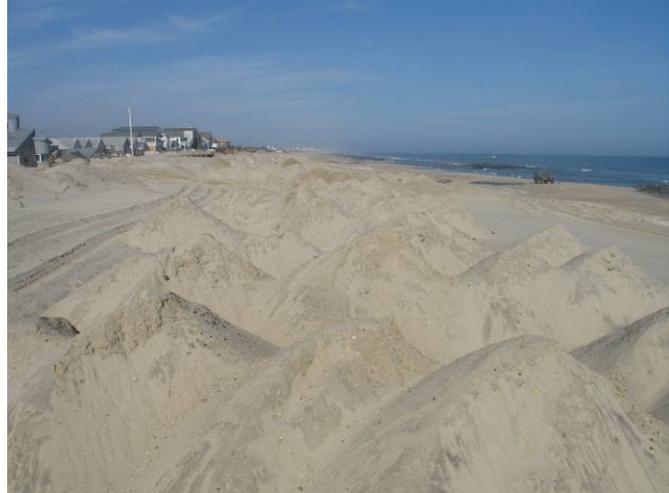
NJBPN 157 – Riddle Way, Manasquan

This site lies north of the Manasquan Inlet and within influence of the inlet jetties that can create substantial shoreline variations (left photo taken on September 21, 2012). Both Manasquan sites were heavily damaged with massive waves and flooding that transported sand among the homes and into First Avenue. The promenade survived at Riddle Way, but the dune was removed and washed landward. The public access up from First Avenue to the beach at Riddle Way had been a giant white water flume discharging into Manasquan’s beachfront development. Work was proceeding to move sand back to the beach as seen in the piles showing on the right photograph (taken November 12, 2012).

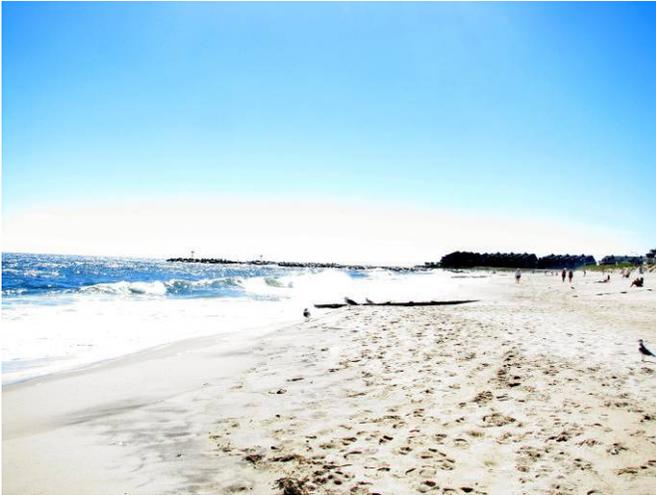
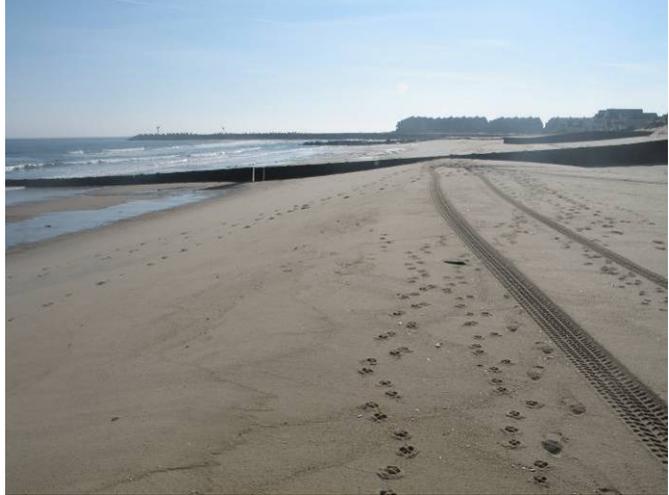
NJBPN 256 – Pompano Avenue, Manasquan

This site is located just north of the Manasquan Inlet. Sand was added in the 1997 Federal shore protection project and profile volume has steadily declined since (left photo taken on September 21, 2012). Following Sandy, damages were worse at this location than to the north. The promenade was removed, as were the dunes and all the berm sand had been transported through the homes into First Avenue in the Borough. Multiple homes had been “red-stickered” with “unfit for habitation” tags with some clearly off their foundations (right photo taken November 12, 2012).

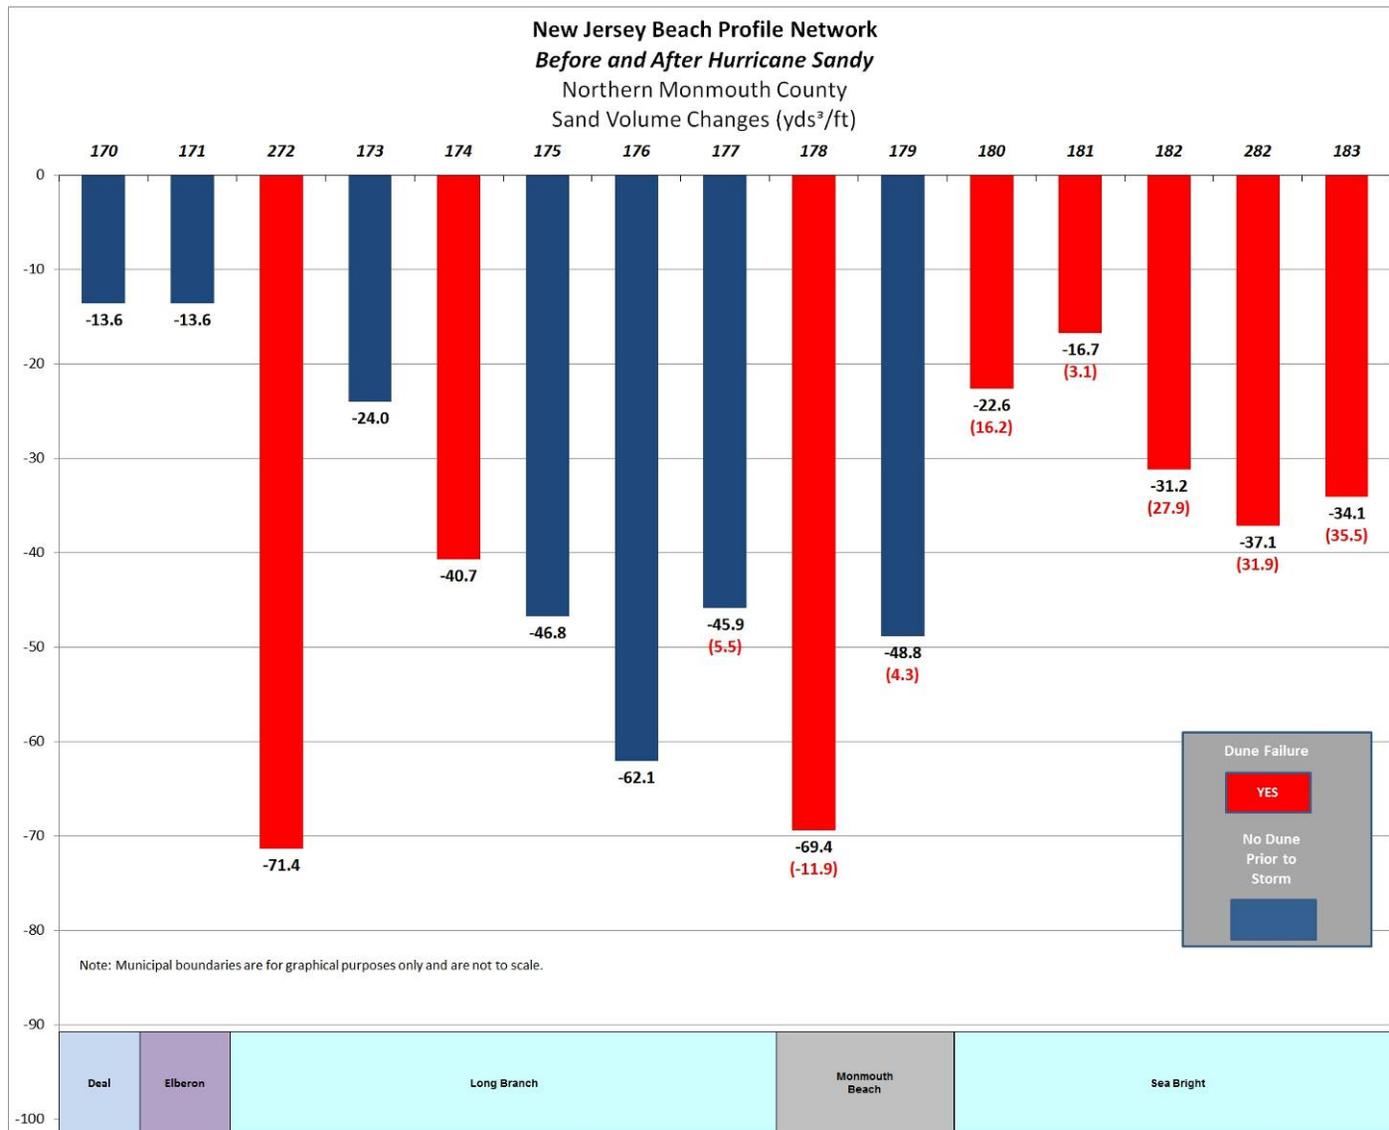
Figure 38 shows a table of sand loss volumes per foot of shoreline at each of the Northern Monmouth County sites. No beach nourishment was done at the three southern sites because Allenhurst/Loch Arbor, Deal and Elberon declined to participate in the project. The hightide ownership issues were the major stumbling block. Because there was a high sediment bluff in Long Branch fronted with a rock revetment and a very high bathing use demand on the beach space, no dune was designed into this project. Sea Bright's shoreline was defended solely by a 28-foot rock wall that had served as the only form of shore protection during the decades prior to the NY District Corps Project, and this zone was not designated as needing dunes. Fencing was installed along the Sea Bright section and planted between the rows of fence. Natural processes served to allow dunes to develop over 12 years, but with no general design specifications, the process was pretty random. A significant recommendation would be to re-assess the view on creating a wide, double ridge of sand to provide a higher level of storm protection to serve as a blocker for wave run-up that went over the seawall. More importantly, efforts must be made to close the two gaps in the rock wall in the central section of Sea Bright with huge dunes or extend the wall with a serious barrier to seal these two entry points from future waves.

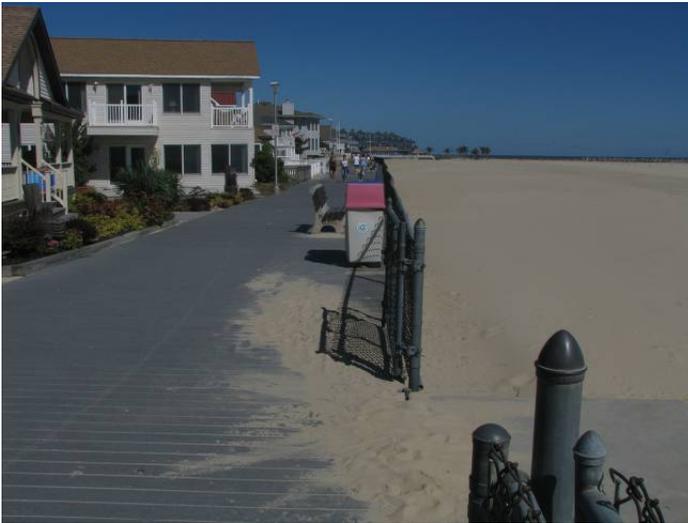
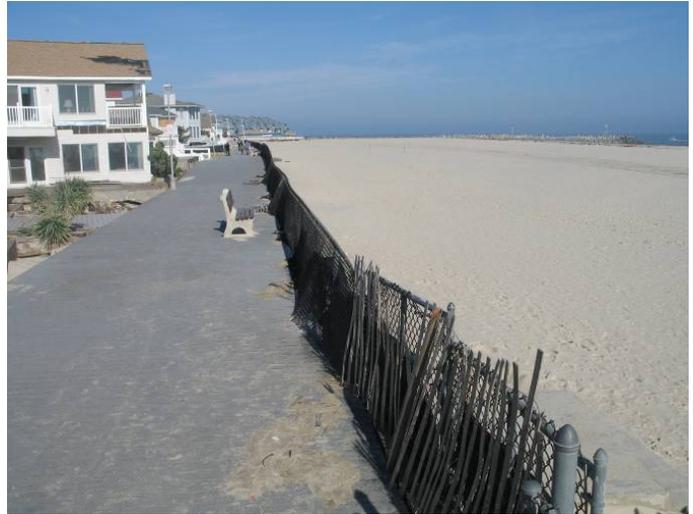
NJBPN 156 – Water Street, Point Pleasant

The photograph on the left was taken on September 21, 2012. The one on the right shows no noticeable change to the backbeach elevation following the storm (taken November 12, 2012). This urban beach did not have a dune system but was spared from more severe damages by the over 600-foot protective berm.

The two cross sections in Point Pleasant Beach demonstrated that with no dune system or a smaller, poorly vegetated dune system, there would be little resistance from the tidal surge and the associated waves to cross inland from the ocean. The entire beach and dune system along this segment of northern Ocean County experienced wide-scale overwash and breaching of dunes. The northern profile located at Water Street had no dune in front of the boardwalk, which was damaged and a large amount of sand from the beach was carried inland from wave action. Damage would have been more severe had there not been a 600-foot wide berm in front of the boardwalk. The southern profile at Maryland Avenue was significantly eroded (dune breach) with sand losses totaling 45.7 yds<sup>3</sup>/ft. along the profile due to the storm. By the time of the post-storm survey, the municipality had begun relocating sand from the berm to the former dune location.

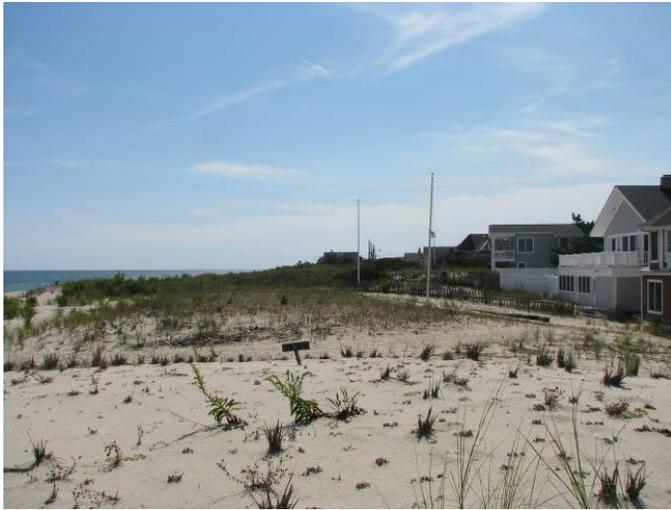
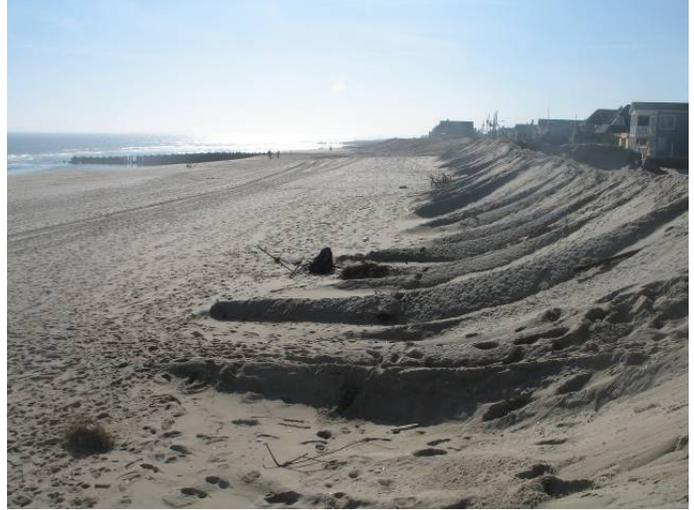
**NJBPN 155 – Maryland Avenue, Point Pleasant**

The photograph on the left shows the dune that has occurred at this site for 25 years (taken on September 17, 2012) and on the right, the damages and local restoration efforts of the former dune (taken on November 12, 2012). Lower elevation shore-perpendicular access ways may have channeled wave activity landward. The plot depicts the changes caused by the storm and the losses of the berm and poorly vegetated dune system where 45.7 yds<sup>3</sup>/ft. of sand were removed during the storm. By the time of the post-storm survey, the municipality had begun relocating sand from the berm to the former dune location.

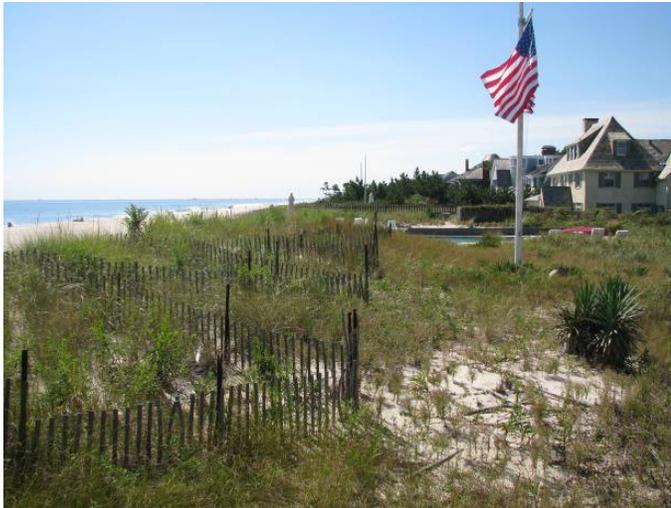
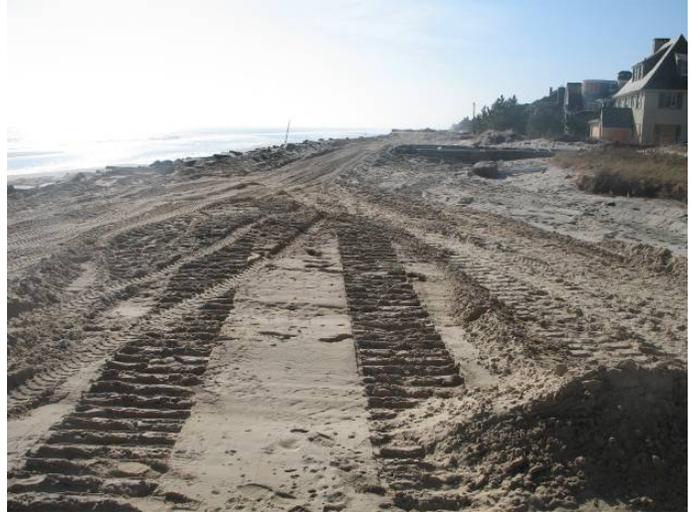
**NJBPN 154 – Johnson Avenue, Bay Head**

The photograph on the left (September 17, 2012) shows the low dunes before Sandy and on the right, post-storm conditions (November 12, 2012). The plot depicts the changes and the losses of the berm and moderate dune where 36.8 yds<sup>3</sup>/ft. of sand were removed during the storm (calculated from extending the November 2012 survey to the datum at a 1:20 slope). The dune seaward of the homes was obliterated during the storm and exposed a base rubble-mound revetment layer. The beach was lowered, and sand was overwashed between the oceanfront homes and carried landward to the backbarrier.

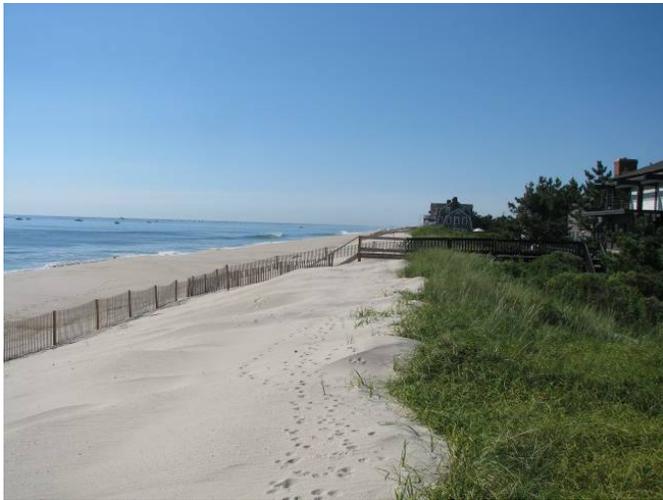
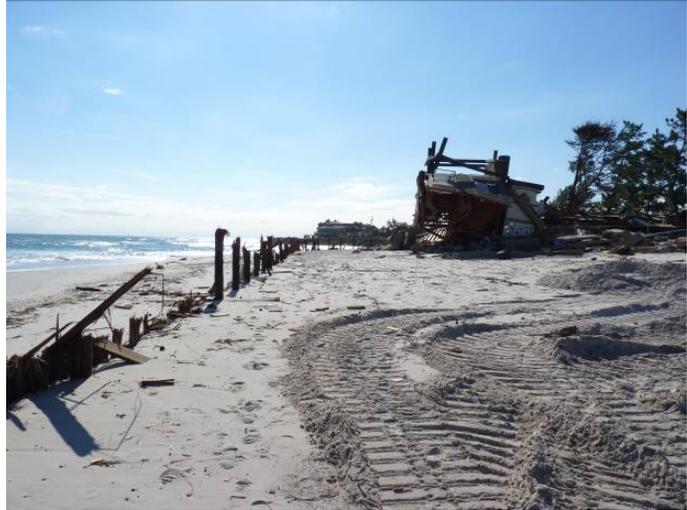
**NJBPN 153 – 1117 Ocean Avenue, Mantoloking**

Pre-storm conditions of the modified dune are shown in the September 17, 2012 (left). This view shows the results of the restoration effort following Hurricane Irene (August 2011). The November 5, 2012 (right) was taken at the same location. This profile location is within 300 feet from the temporary breach that opened during Sandy. The home at 1117 Ocean Avenue was completely removed from its location and the residence in the photograph was also destroyed.

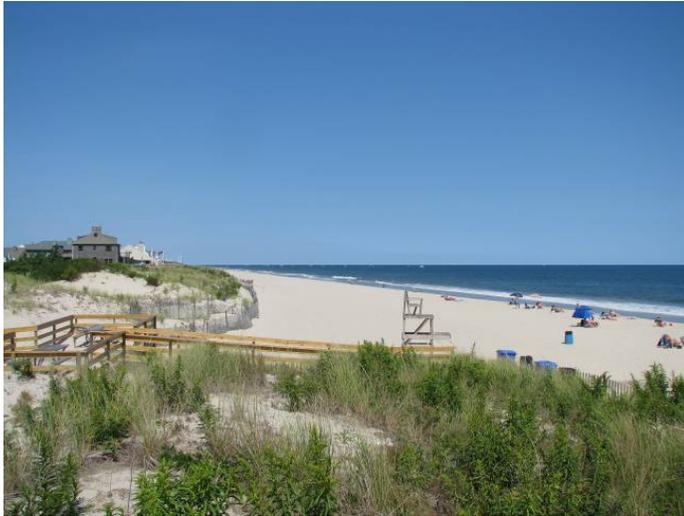
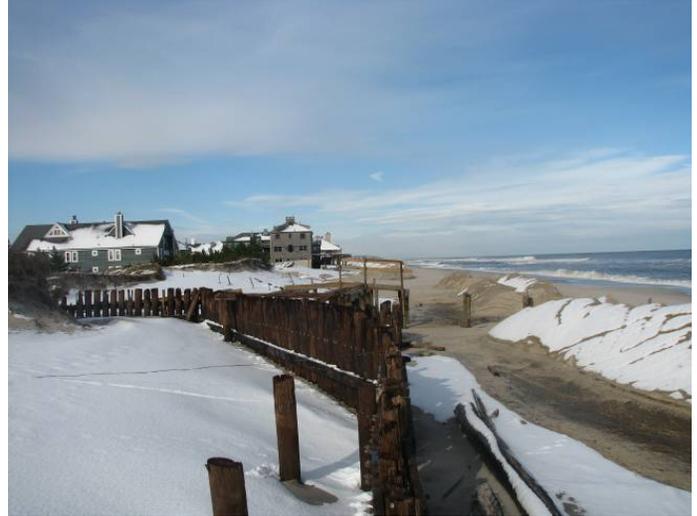
**NJBPN 152 – Public Beach #3, Brick Township**

The photograph on the left shows the public access way, dune, and moderate berm on September 14, 2012. The post-storm photo on the right (November 8, 2012) shows municipal efforts in protecting what was left of the former dunes.

The wider, higher dunes existing just north of the municipal boundary in Mantoloking continued south into Brick Township. Here there was little municipal oversight of dune maintenance so elevations, low spots and placement of access stairways to the beach were at the option of individual owners. At the municipal beach #3, the dune failed to the south on the property and waves directly impacted a multi-family building that was built very close to the beach. Overwash was evident, especially to the south toward Normandy Beach.

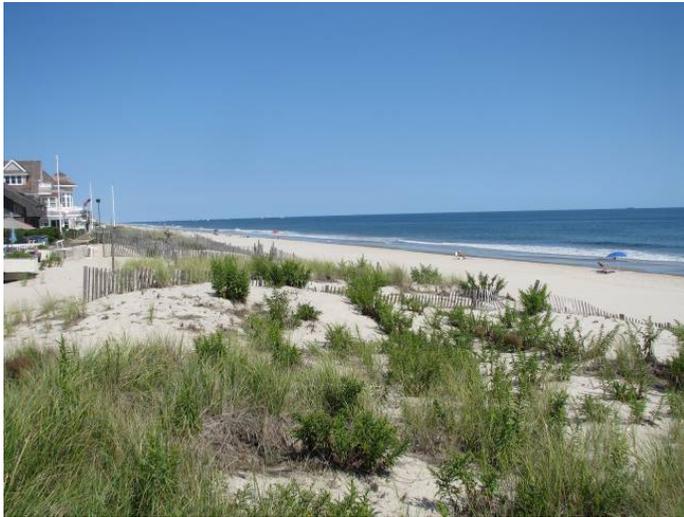
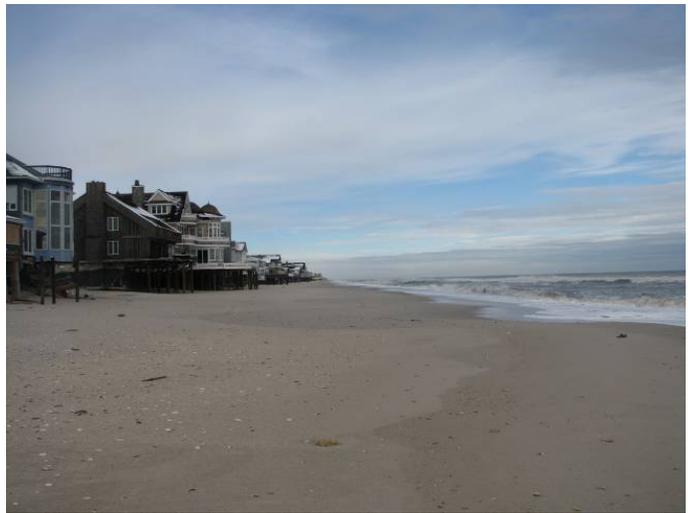
**NJBPN 151 – 1<sup>st</sup> Avenue, Normandy Beach**

The photograph on the left (September 14, 2012) shows the limited dune system and minimal berm prior to Sandy. On the right (November 8, 2012), the photo shows damages to structures and exposure of once-buried bulkheads following the storm. Significant overwash occurred at this site and many oceanfront and landward homes were damaged.

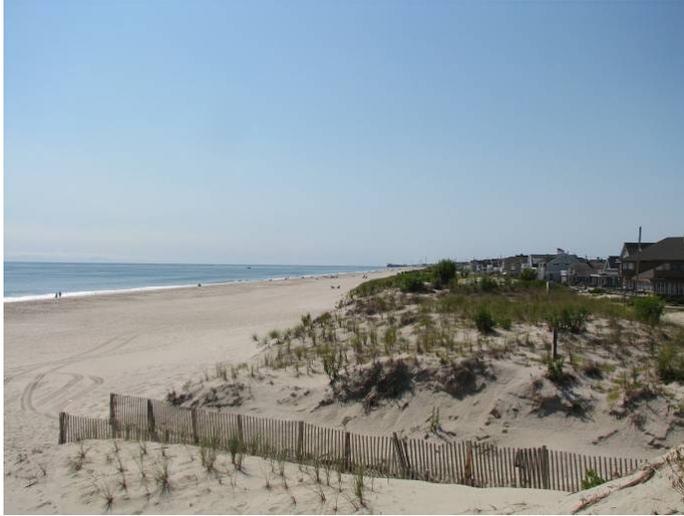
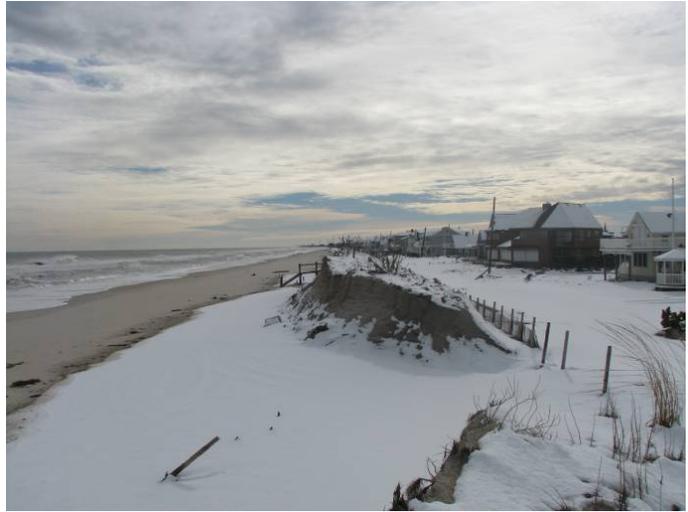
**NJBPN 150 – White Avenue, Lavallette**

The photograph on the left (September 14, 2012) shows the dune that was created over time through municipal efforts. On the right (November 8, 2012), the photo shows the losses of the berm and dune where 51.1 yds<sup>3</sup>/ft. of sand were removed during the storm. This location experienced beach and dune erosion; however, overwash only occurred where the dune was lower and breached.

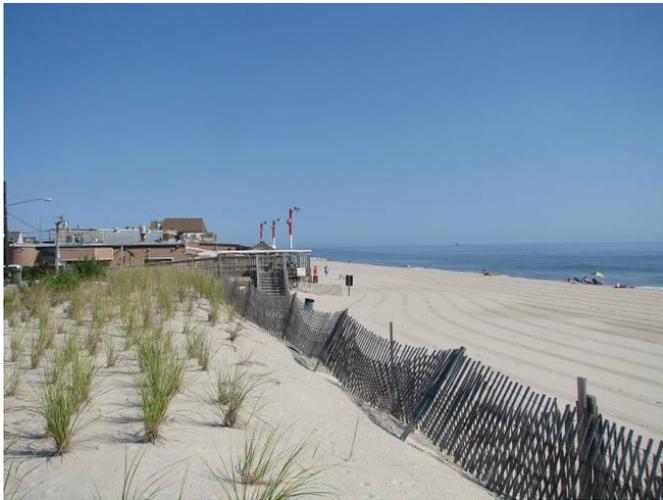
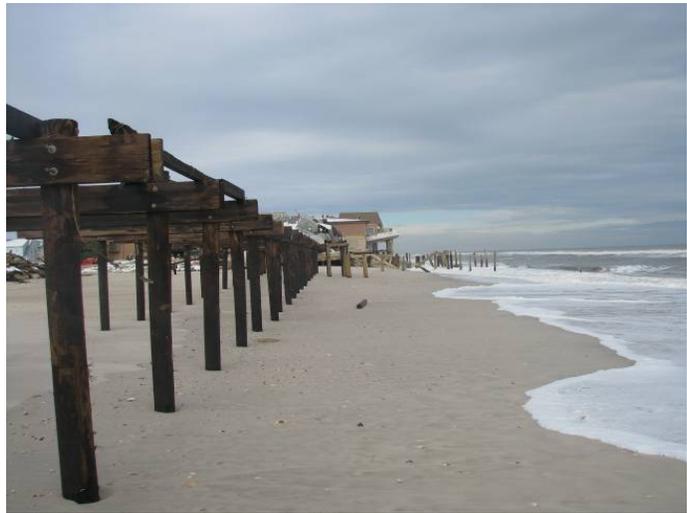
NJBPN 149 – 8<sup>th</sup> Avenue, Ortley Beach

The photograph on the left (September 14, 2012) shows a modest berm and the municipal dune present prior to the storm. On the right (November 8, 2012), 68.7 yds<sup>3</sup>/ft of berm and dune were removed during the storm. Over 10 feet of dune height was pushed landward in overwash deposits. The boardwalk was located landward of the dunes (left) Ocean Avenue was destroyed as well as several homes. The photo on the right shows a classic flat beach created by the large waves.

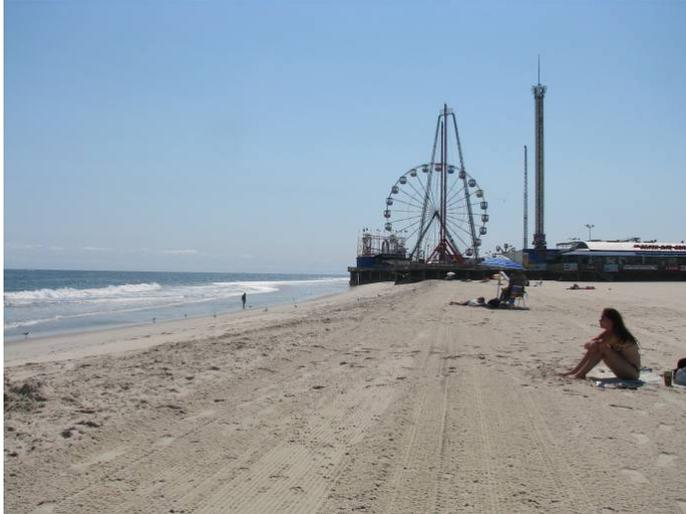
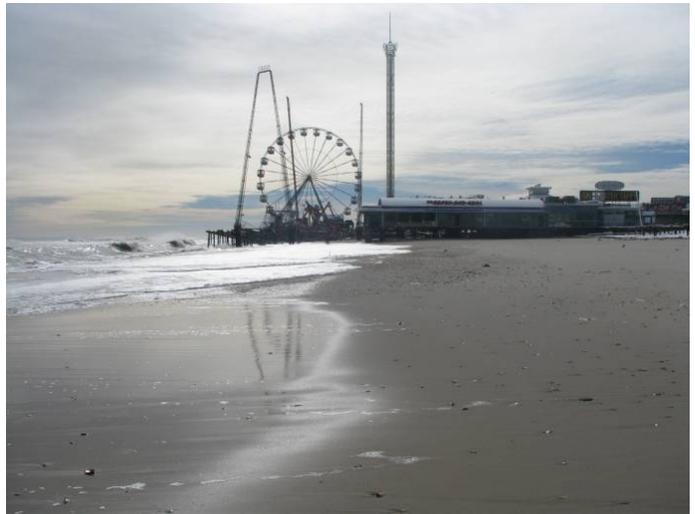
NJBPN 248 – Franklin Avenue, Seaside Heights

The September 13, 2012 photo on the left shows the bathing beach prior to Hurricane Sandy. The photo on the right shows the November 8, 2012 post-storm beach. This urban beach did not have a dune system and the photo on the right shows the obvious damages to the pier and amusements.

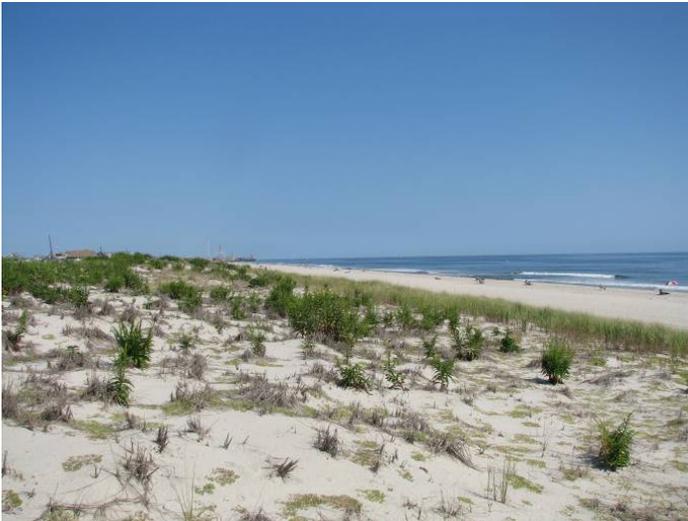
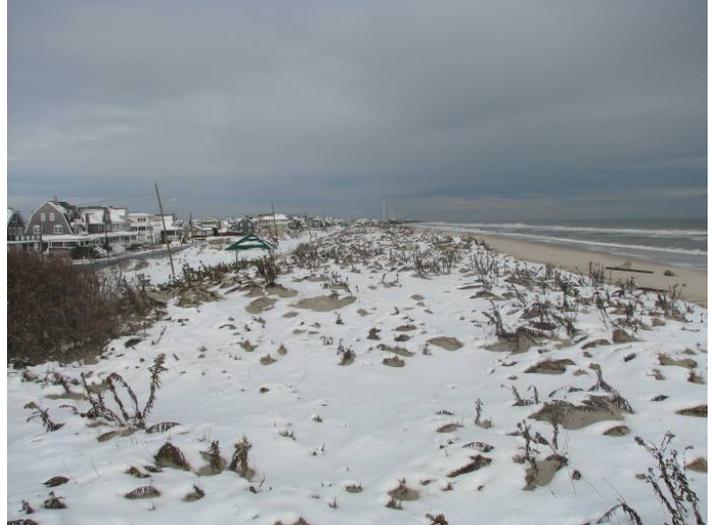
NJBPN 148 – 4<sup>th</sup> Avenue, Seaside Park

The left photograph was taken on September 13, 2012 and shows the extensive dune prior to Hurricane Sandy. On the right (taken November 8, 2012), a northeast storm had dumped snow on the shoreline nearly a week after Sandy's landfall. Although there was loss of dune from the storm, no overwash occurred at this location.

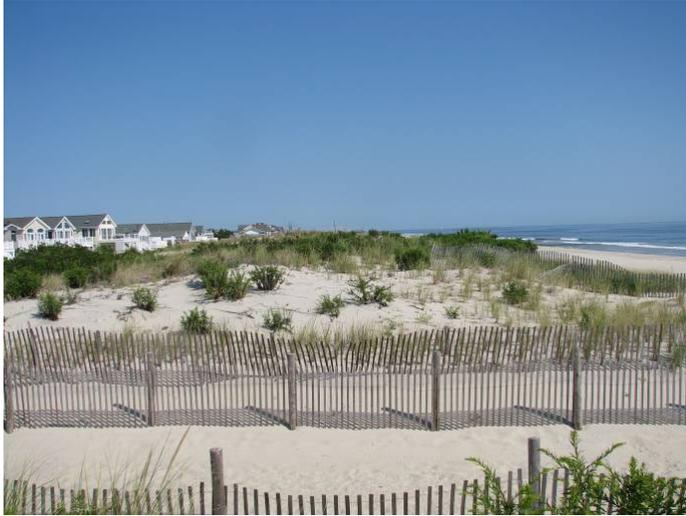
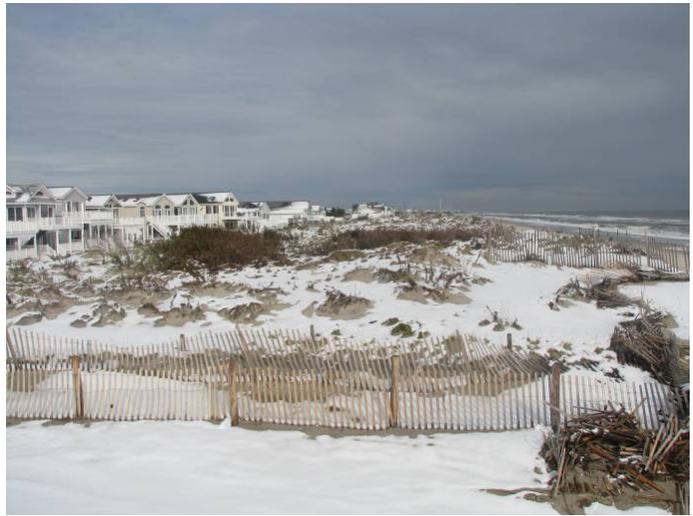
NJBPN 347 – 6<sup>th</sup> Lane, Midway Beach

The left photograph was taken on September 13, 2012 and on the right (taken November 8, 2012), a northeast storm had dumped snow on the shoreline nearly a week after Sandy's landfall. The figure below depicts the changes caused by the storm and the losses of the berm and dune where 48.7 yds<sup>3</sup>/ft. of sand were removed during the storm. Though there were measured losses of the berm and dune, enough dune remained to protect the landward homes and infrastructure.

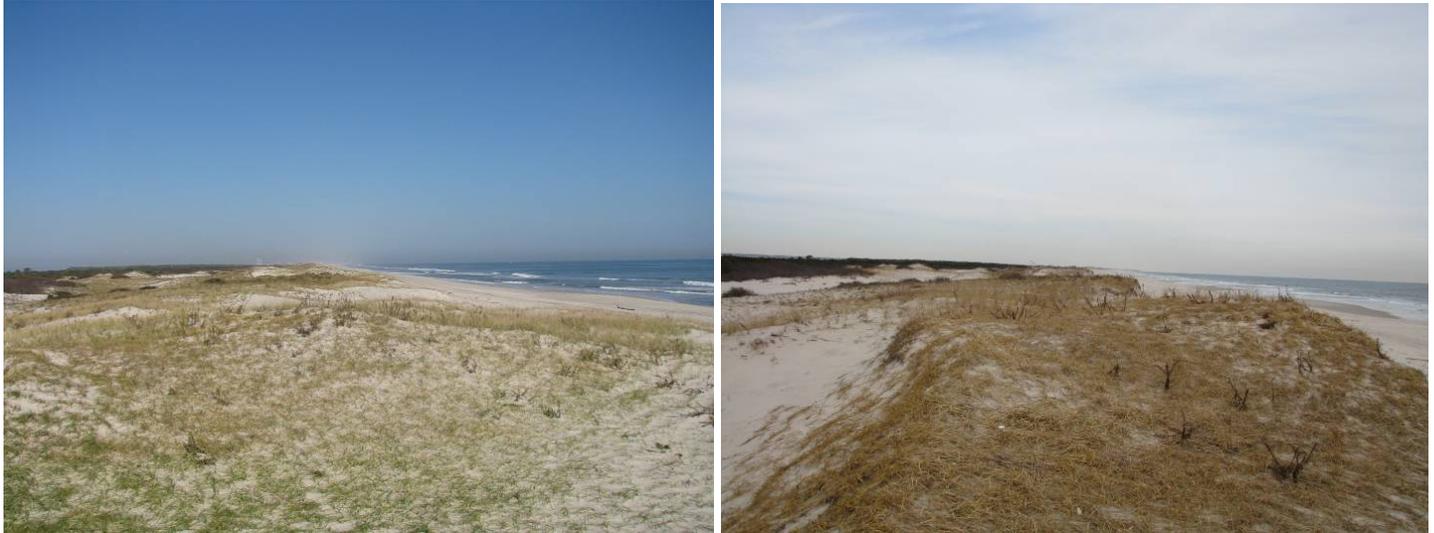
NJBPN 247 – North End, Island Beach State Park

The left photograph was taken on November 8, 2011 and shows a wide natural dune system. The right photo (taken December 12, 2012) shows the condition of the dune system nearly six weeks after Sandy’s landfall.

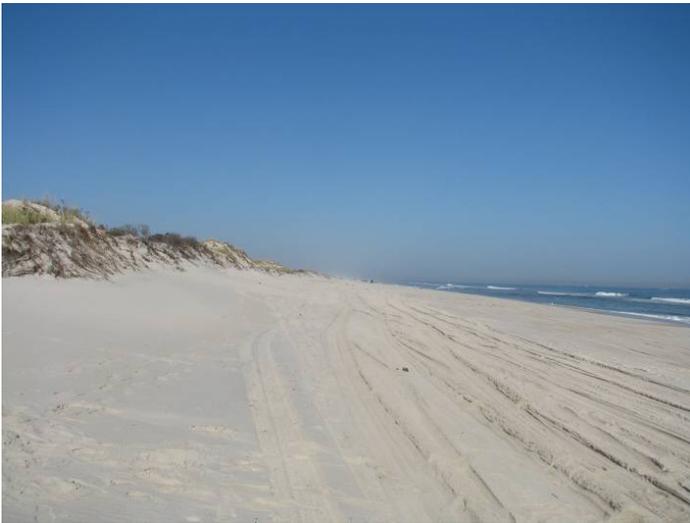
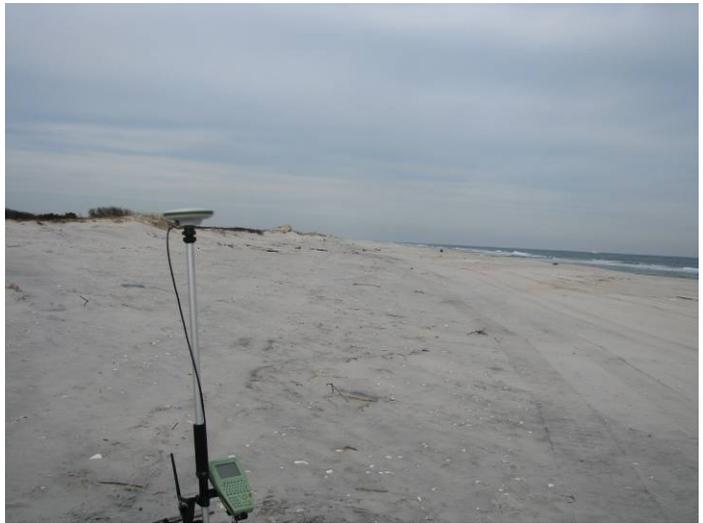
**NJBPN 246 – Parking Lot A7, Island Beach State Park**

The left photograph was taken on November 8, 2011 and shows a wide natural dune system. Six weeks after Sandy, (right photo taken December 12, 2012) the dune and berm had eroded and sand was moved into a nearshore bar.

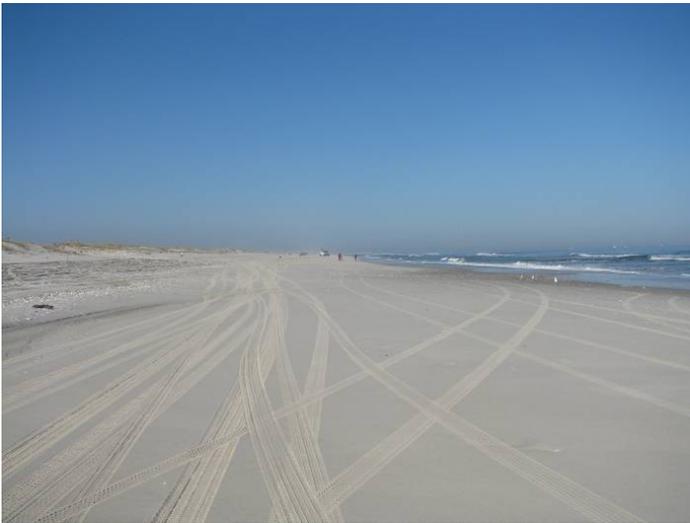
**NJBPN 146 – Parking Lot A7, Island Beach State Park**

This site within the state protected area is less than a mile from the north Barnegat Inlet jetty. The left photograph was taken on November 8, 2011 and shows the wide beach and natural dunes. The photo on the right, six weeks after Sandy (December 12, 2012) shows the conditions of the dune and berm.

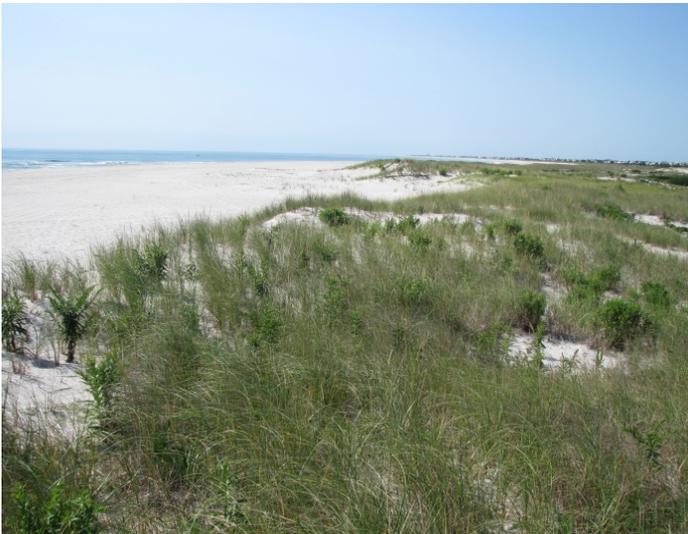
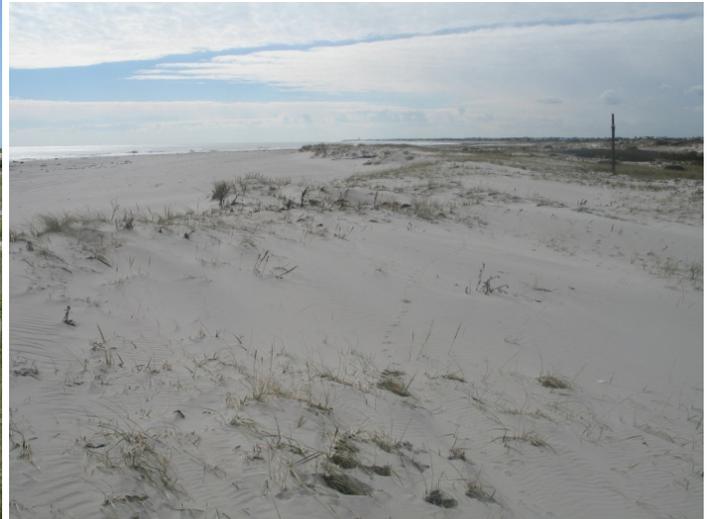
NJBPN 245 – 10<sup>th</sup> Street, Barnegat Light

This site is located approximately 1500 feet south of the Barnegat Inlet south jetty and was established to monitor the changes at the inlet. The left photo (taken on September 12, 2012) shows the dune and beach conditions before Sandy and the dense vegetation along the landward dune slope. The photo on the right (taken on November 2, 2012) shows the impact of Sandy where sand was overwashed and blown landward across the dune burying but not killing the vegetation.
