## New Jersey Beach Profile Network 2012 Annual Report on Shoreline Changes in New Jersey's Four Coastal Counties Raritan Bay to Delaware Bay Spring of 2011 Through Fall of 2012

Prepared for:  
New Jersey Department of Environmental Protection  
Division of Construction and Engineering  
1510 Hooper Avenue, Toms River, New Jersey 08753

Prepared by:  
The Richard Stockton Coastal Research Center  
Richard Stockton College of New Jersey  
30 Wilson Avenue, Port Republic, NJ 08241

July 31, 2013

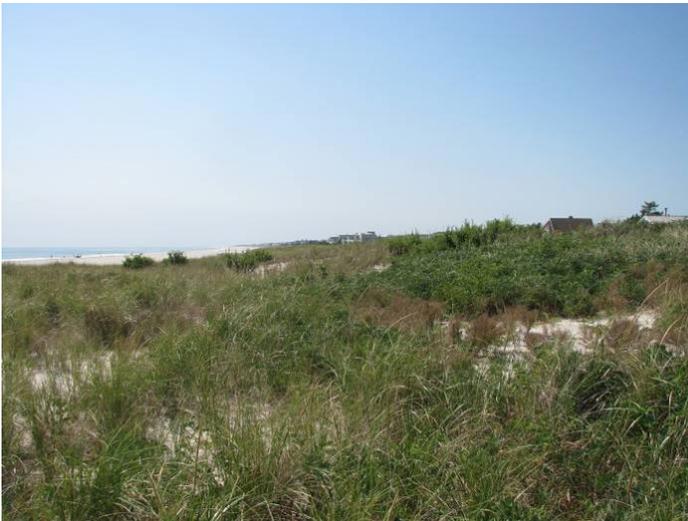
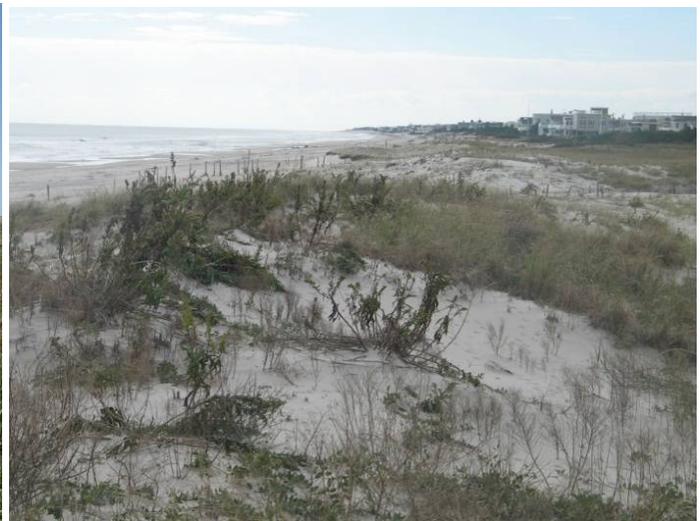
NJBPN 145 – 26<sup>th</sup> Street, Barnegat Light

The photo on the left was taken on September 12, 2012 and shows the dune and beach conditions and dense vegetation before Sandy. In the photo on the right taken on November 2, 2012 from a similar location looking south post-Sandy the impact of the storm is evident from the sand overwashed and blown landward across the dune burying the dense vegetation seen in the September picture and by the narrower beach width.

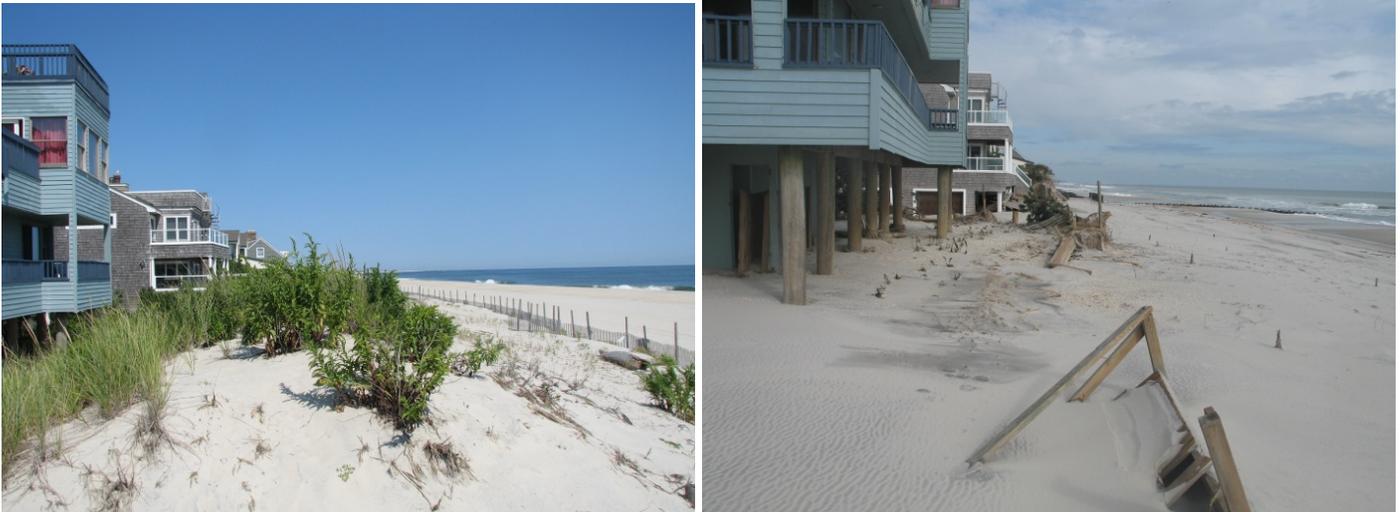
**NJBPN 144 – La Baia Street, Loveladies**

Above are two photos taken at La Baia Street before and after Hurricane Sandy. The photo on the left (taken September 12, 2012) shows the dune and beach conditions prior to the storm. In the photo on the right (taken November 2, 2012) the impact of the storm is evident. The former dune was removed and the shoreline moved 110.1 feet landward. Sand was overwashed between the oceanfront homes and carried landward to the road.

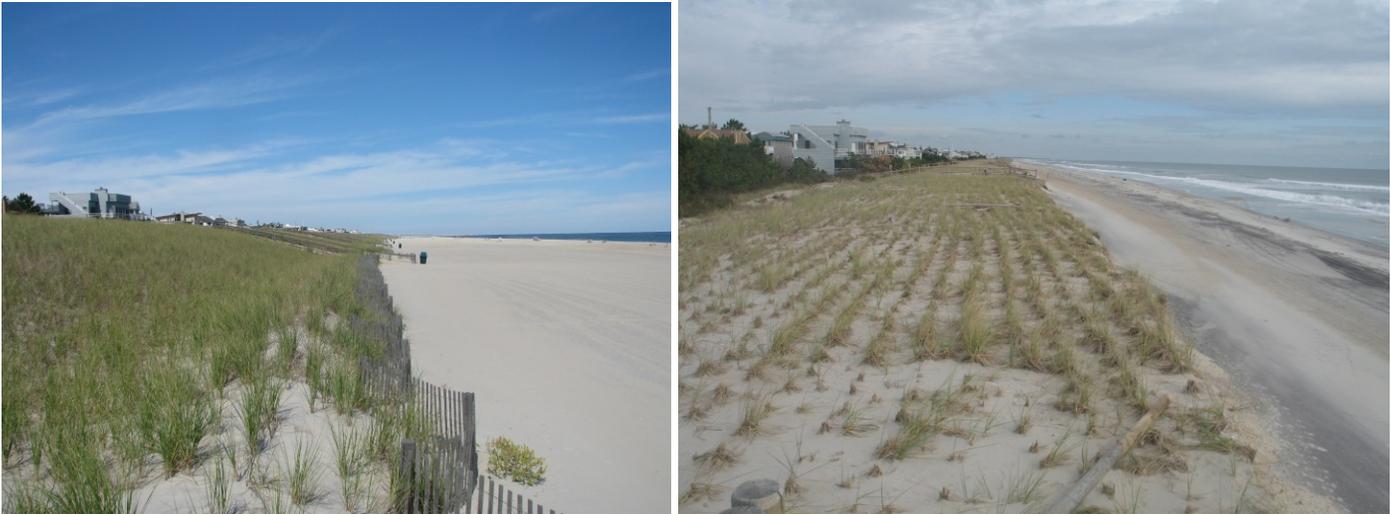
NJBPN 143 – 73<sup>rd</sup> Street, Harvey Cedars

The photo on the left was taken on September 11, 2012 while the photo on the right was taken on November 2, 2012 from a similar location looking north. This site had received sand as part of the 2010 USACE beach nourishment project for Long Beach Island. The project provided ample dune and beach width enhancement and storm protection for the oceanfront properties. The post-Sandy photo shows the impact of the storm with a significant dune scarp at the seaward crest and a narrow, lower-elevation beach remaining. However there was no evidence that sand overwashed the dune at this location.

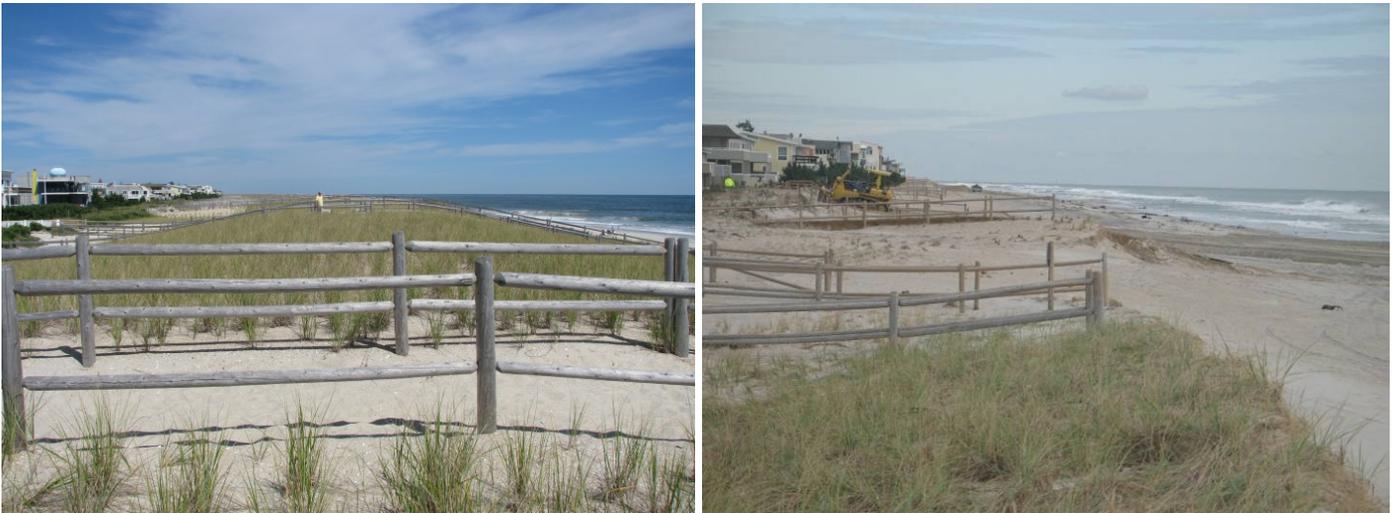
NJBPN 142 – Tranquility Drive, Harvey Cedars

The Tranquility Drive site was included in the 2010 USACE beach nourishment project. The photo on the left was taken on September 11, 2012 and shows the dune and beach conditions of the USACE engineered beach before Sandy. On the right, the photo (taken on November 2, 2012 - post-Sandy) shows the impact of the storm by the significant loss of dune seaward of the homes and the lower and narrower beach. Despite the significant loss of dune, overwash did not occur and the oceanfront properties were protected from wave damages.

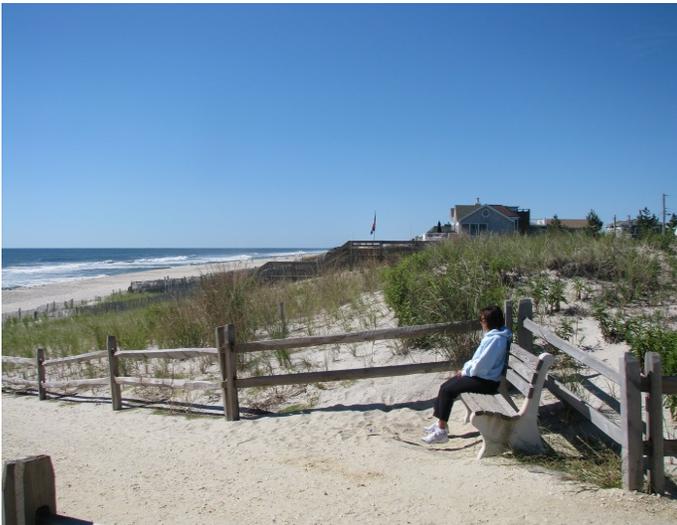
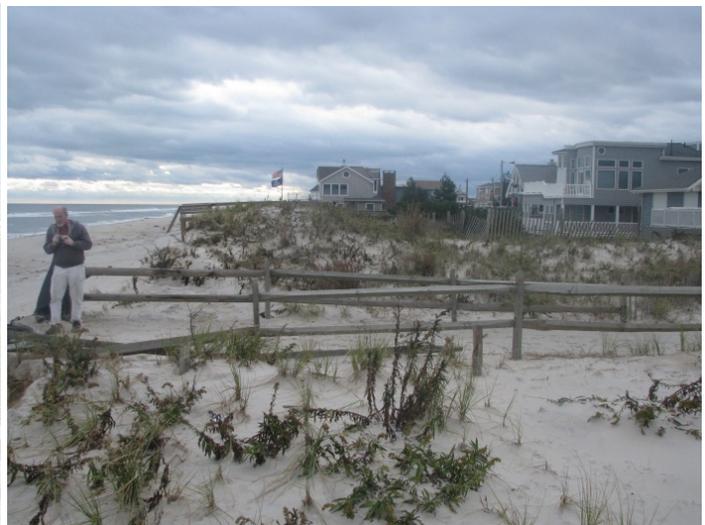
NJBPN 241 – 20<sup>th</sup> Street – Surf City

The photographs above were taken on September 11<sup>th</sup>, 2012 (left) and November 1<sup>st</sup>, 2012 (right). Both images show the view of 20<sup>th</sup> Street (site 241) looking south. This location in Surf City received a beach replenishment in 2007, which increased the sand volume and width of the dune and berm. The dune and berm both experienced substantial erosion; however no overwash occurred at this location.

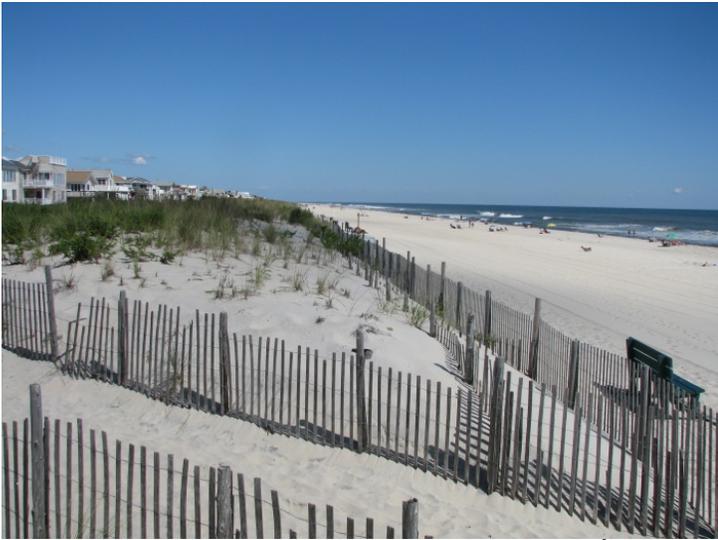
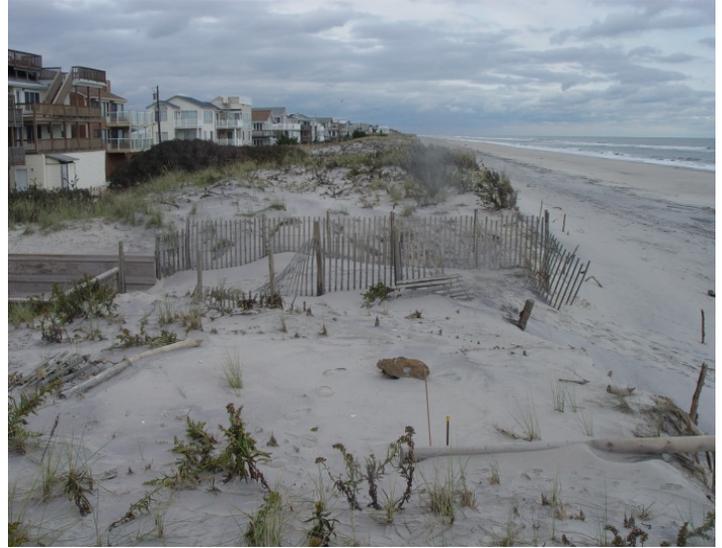
**NJBPN 141 – 8<sup>th</sup> Street, Ship Bottom**

The photographs above were taken on September 10<sup>th</sup>, 2012 (left) and November 1<sup>st</sup>, 2012 (right). Both images show the view of 8<sup>th</sup> street (site 141) looking north. This location in Ship Bottom experienced erosion of the beach and dune from Sandy, however the dune was not breached and no overwash occurred at this location.

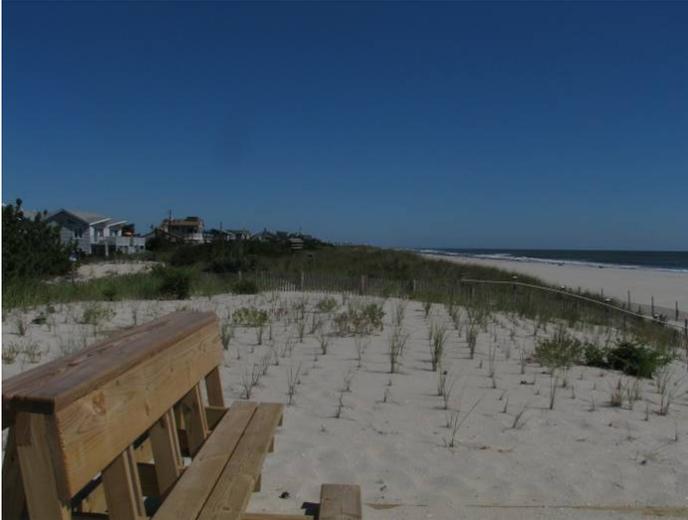
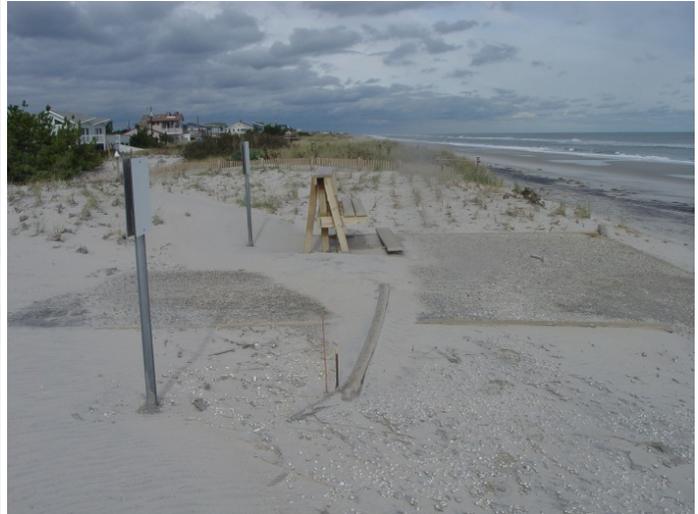
**NJBPN 140 – 32<sup>nd</sup> Street, Long Beach Township**

The photographs above were taken on September 10<sup>th</sup>, 2012 (left) and November 1<sup>st</sup>, 2012 (right). Both images show the view of 32<sup>nd</sup> street (site 140) looking north. This location in the Brant Beach section of Long Beach Township received beach replenishment in spring 2012, which increased the sand volume and width of the dune and berm. The foredune slope experienced minor erosion during Sandy, while the berm was severely eroded. No overwash occurred at this location. The park bench remained in its original position.

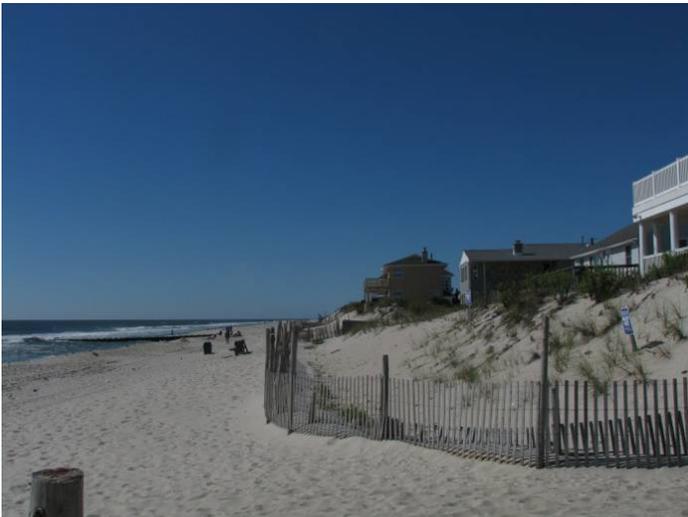
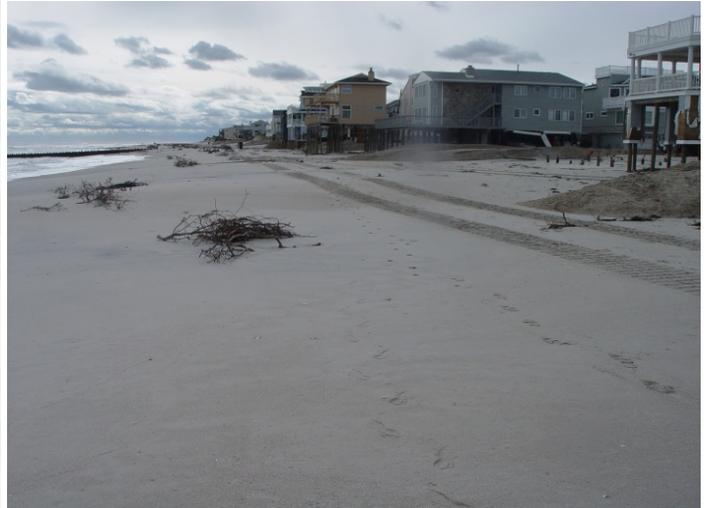
**NJBPN 139 – 81<sup>st</sup> Street, Long Beach Township**

The photographs above were taken on September 10<sup>th</sup>, 2012 (left) and November 1<sup>st</sup>, 2012 (right). Both images show the view of 81<sup>st</sup> street (site 139) looking south. It is evident in the photographs that the existing dune was completely eroded away and overwash occurred, with waves pushing water and sand under the oceanfront homes and into the streets landward of them. The dune elevation was about 16 feet.

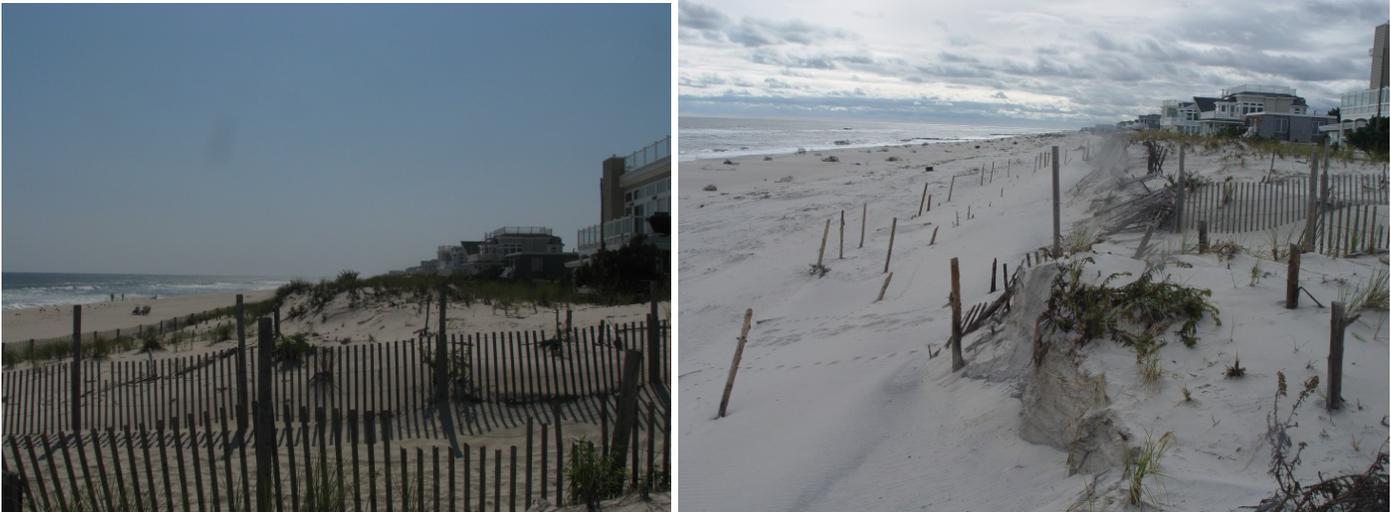
NJBPN 138 – Old Whaling Road (124<sup>th</sup> Street), Long Beach Township

The photographs above were taken on September 7<sup>th</sup>, 2012 (left) and November 1<sup>st</sup>, 2012 (right). Both images show the view of Old Whaling Road (site 138) looking south. The existing dune experienced erosion, however it was not completely removed and no overwash occurred at this location. Surprisingly, two blocks to the north a dune of comparable size and shape was eroded away and overwash occurred.

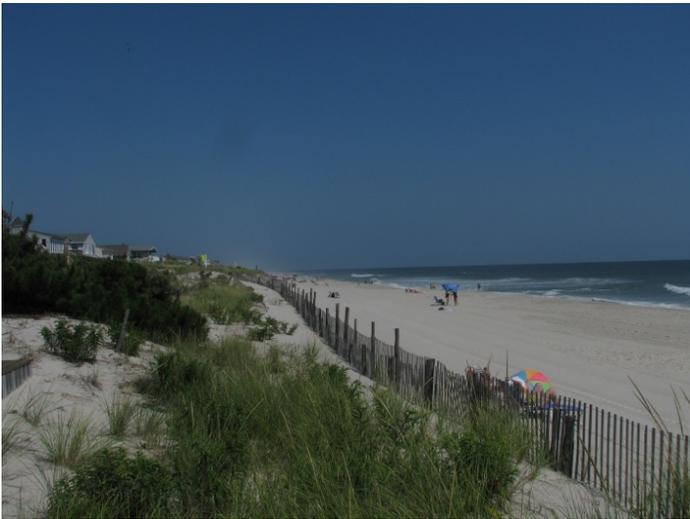
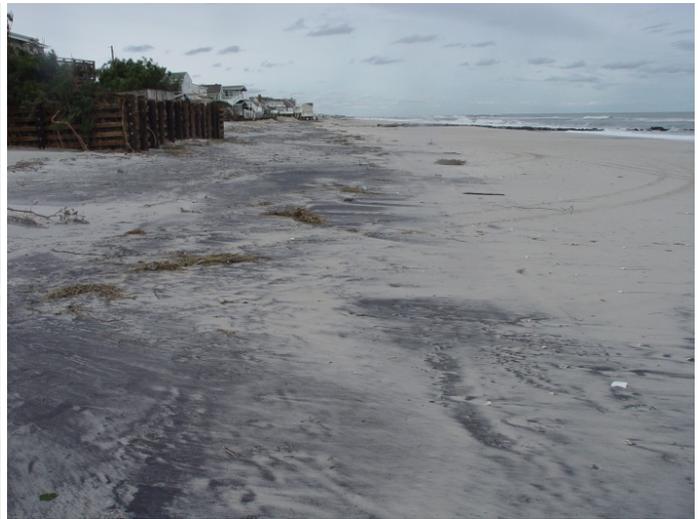
**NJBPN 137 – Taylor Avenue, Beach Haven**

The photographs above were taken on September 7<sup>th</sup>, 2012 (left) and November 1<sup>st</sup>, 2012 (right). Both images show the view of Taylor Avenue looking north. It is evident in the photographs that the existing dune was completely eroded away and overwash occurred, with waves pushing water and sand under the oceanfront homes and into the streets landward of them. The crib timber structure in the above right photograph was instrumental in saving the home from significant damage. The cribbing was back-filled with rocks and masonry debris and provided an effective barrier to direct wave impacts. The landward returns on the structure were critical in saving the property.

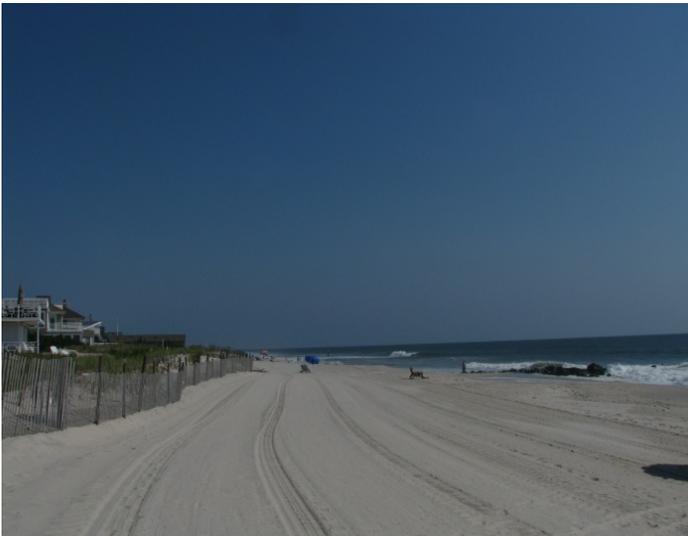
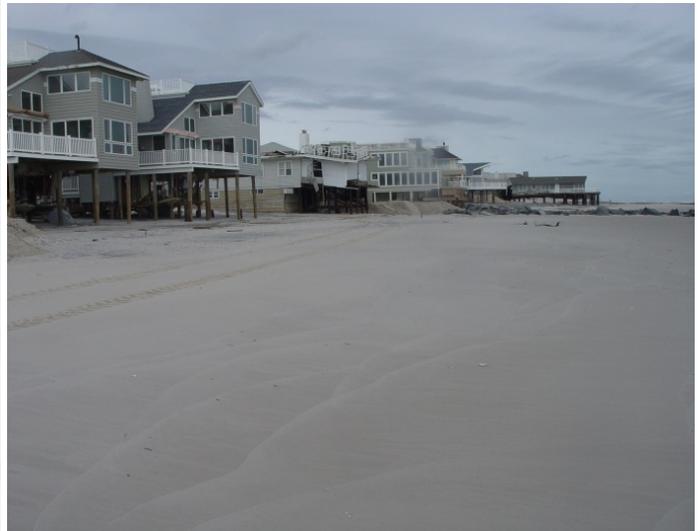
**NJBPN 136 – Dolphin Avenue, Beach Haven**

The photographs above were taken on September 6<sup>th</sup>, 2012 (left) and November 1<sup>st</sup>, 2012 (right). Both images show the view of Dolphin Avenue (site 136) looking north. It is evident in the photographs that the existing dune was completely eroded away and overwash occurred, with waves pushing water and sand under the oceanfront homes and into the streets landward of them. Damage was clear and very common.

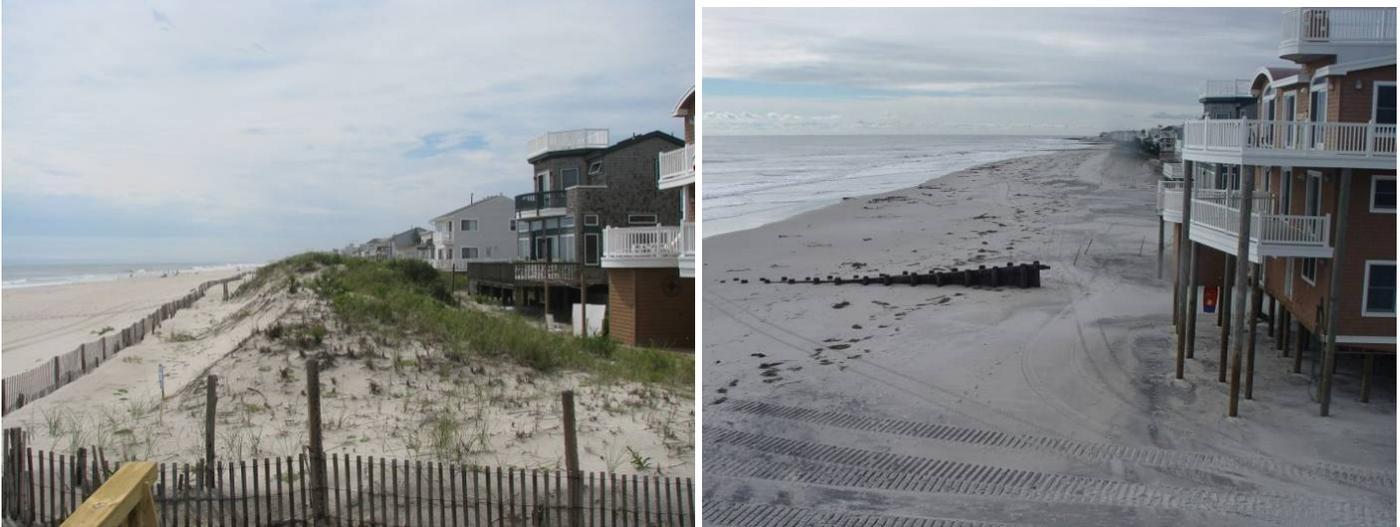
NJBPN 135 – Webster Avenue, Long Beach Township

The photographs above were taken on September 6<sup>th</sup>, 2012 (left) and November 1<sup>st</sup>, 2012 (right). Both images show the view of Webster Avenue in Beach Haven (site 135) looking south. It is evident in the photographs that the existing dune was completely eroded away and overwash occurred, with waves pushing water and sand under the oceanfront homes and into the streets landward of them exposing the timber section of an old groin that was not exposed prior to the storm.

The site #135 at Webster Avenue was typical of the wholesale damage done as the dune system was essentially erased and washed across the island into Barnegat Bay in many cases. Sand thicknesses of 3 to 4 feet were observed on Long Beach Island Boulevard and down the side streets to the bay. Low elevation homes were destroyed and even some larger structures showed serious impacts. The practice of oceanfront owners closing in the ground level area under the first habitable floor level with a concrete floor, insulated walls, and installing the furnace, hot water heater, the air conditioner compressor, and storing a myriad of possessions in an area designated as open space to allow waves to pass under the building with minimal impact, vastly increased the damage to individual properties as the wave of debris piled up against landward structures and penetrated into other ground level spaces. Individuals found that their space under the house now contained an intertwined complex of debris densely filling the entire area under the house. Clearly the dunes were too thin, too low and the beach too narrow to block Sandy in any meaningful way.

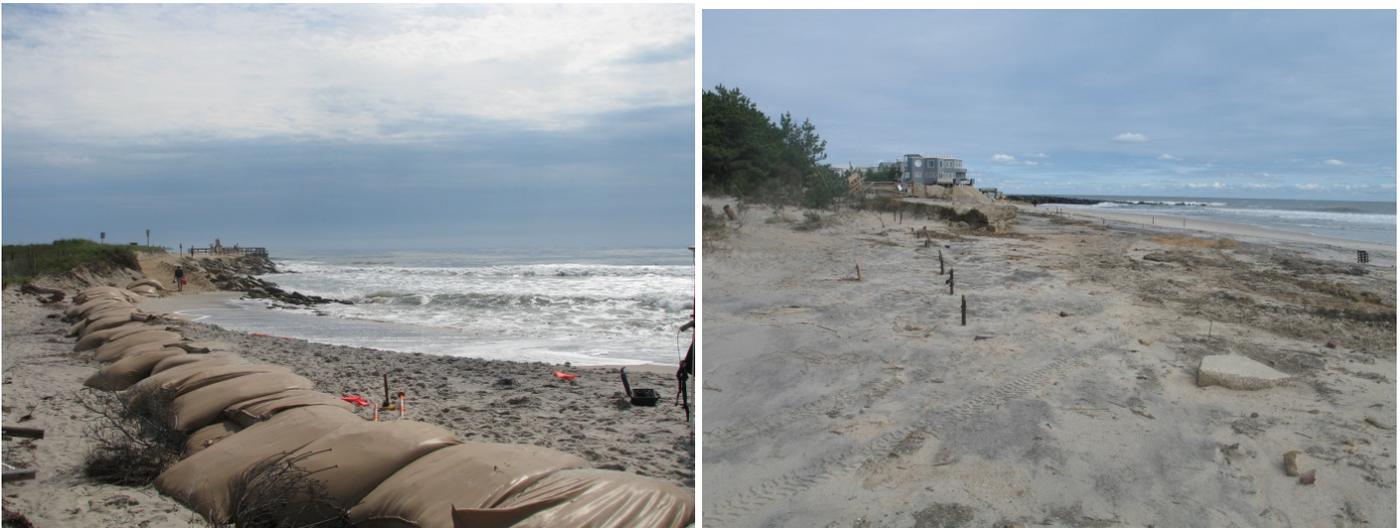
**NJBPN 234 – Forsythe National Wildlife Refuge, Holgate Entrance, Long Beach Township**

The photographs above were taken on September 6<sup>th</sup>, 2012 (left) and November 1<sup>st</sup>, 2012 (right). Both images show the view looking north at the beach-buggy entrance to the Forsythe Refuge (site 234). Wide-scale overwash occurred that extended to Barnegat Bay at this location due to the effect of Hurricane Sandy. All traces of a dune system in the natural area were flattened and moved landward as an overwash deposit.

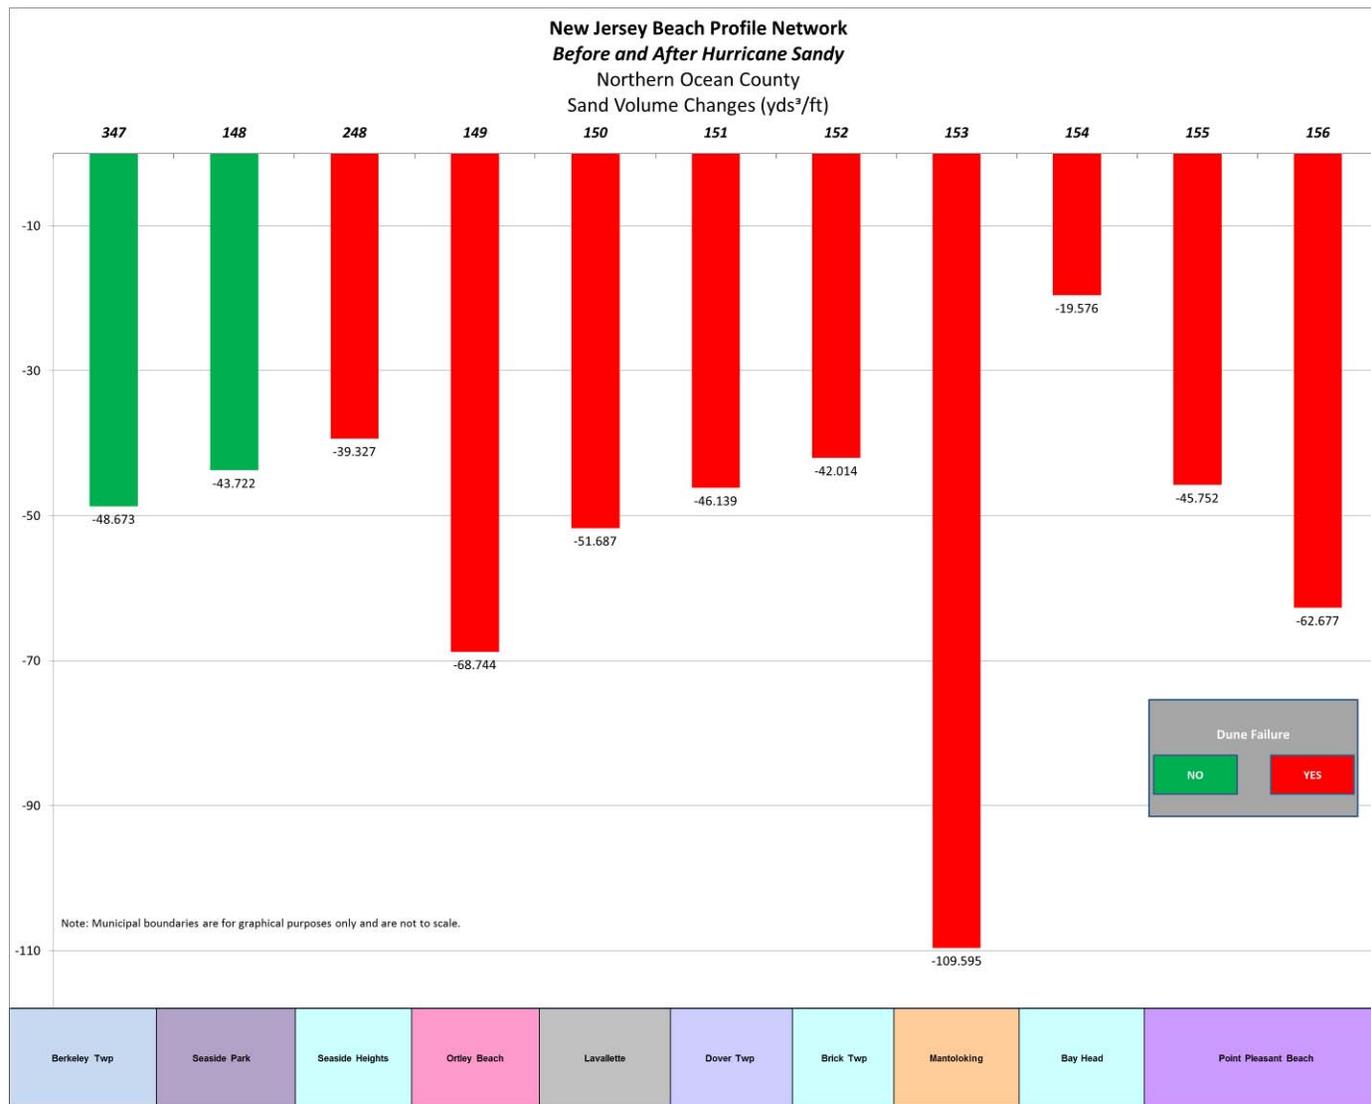
**Figure 70.** This graphic shows the sand volume loss figures for each of the communities within the developed sections of the northern Ocean County Atlantic shoreline. No Federal shore protection projects have occurred along this portion of the New Jersey shoreline. All sites experienced berm erosion and dune losses. Sites 347 and 148 contained a greater dune volume prior to the storm and though dune losses were recorded, there was no dune failure. The losses measured at Site 153 were enhanced due to the presence of a newly-opened inlet (with depths measured at approximately 18 feet). The dune at Site 154 contained a rock/timber core that was included in the pre-storm dune volume calculation.

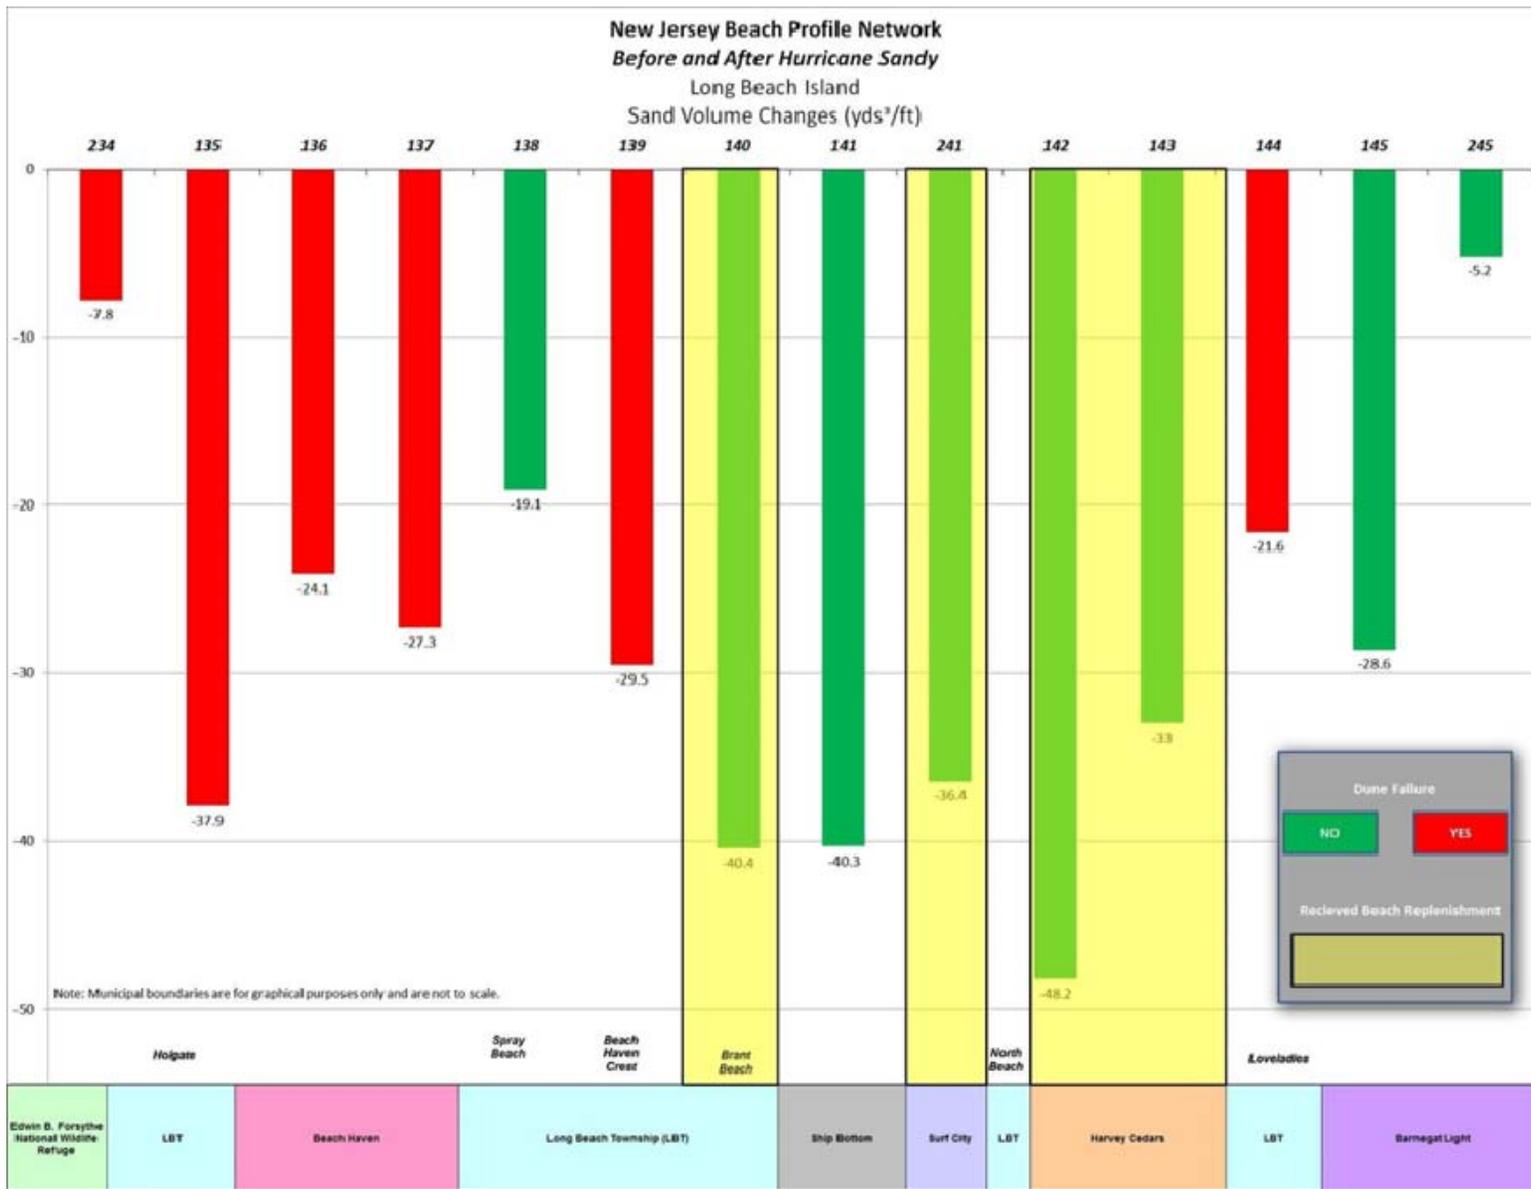
**Figure 72.** This graphic combines the loss figures with the presence or absence of the Federal Shore Protection Project and the occurrence of dune failure. It became perfectly clear that the ACOE shore protection design was sufficient to preclude structural damage along the extent of the LBI coastal shoreline where it had been completed.

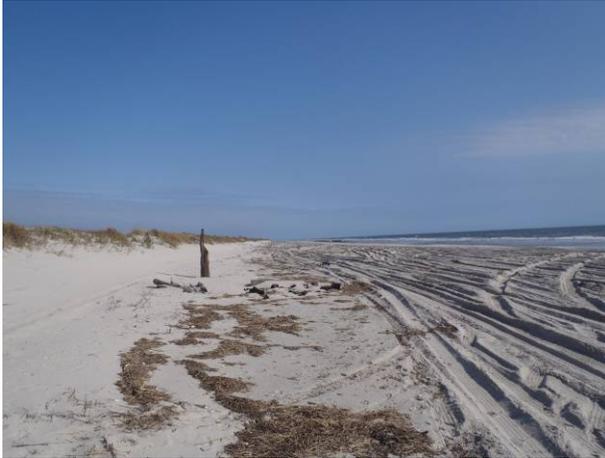
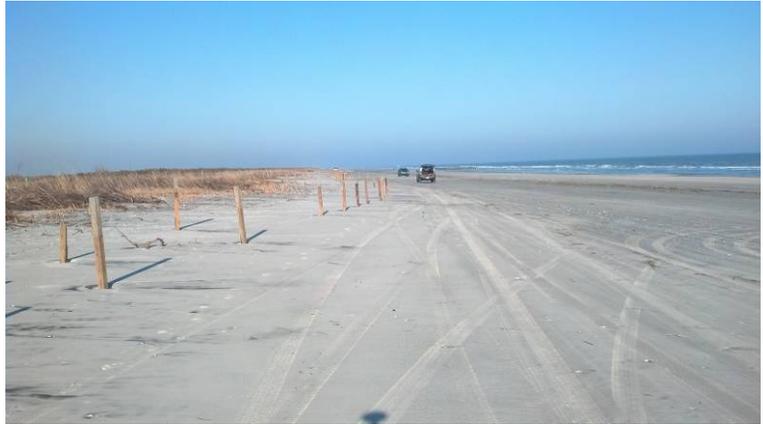
## NJBPN 134 – Green Acres Area, Brigantine

The photographs above were taken on October 26, 2012 (left) and November 11, 2012 (right). The dune on the left started from nothing in January 1993, and was washed flat by Sandy (right). It is likely that the posts in the right picture date from the original 1992 post-storm effort to re-create the dune along this open-space beach.

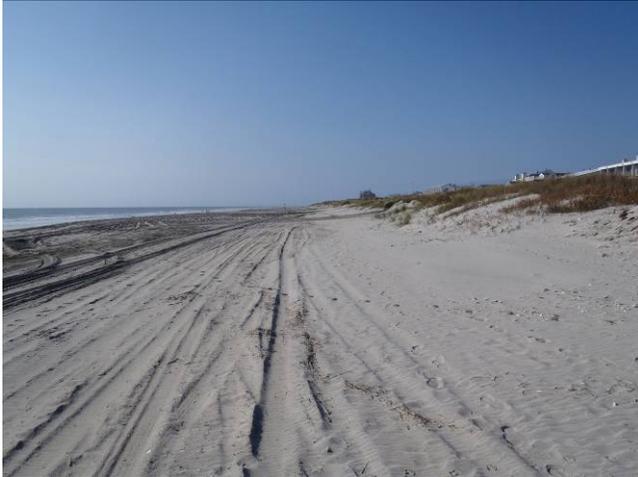
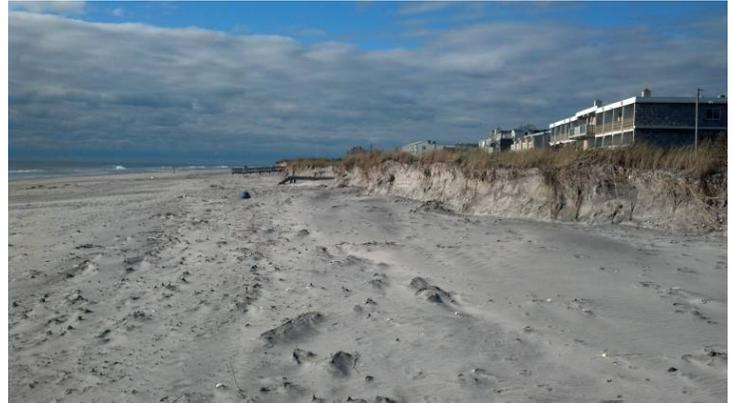
**NJBPN 133 – 4<sup>th</sup> Street North, Brigantine**

The photographs above were taken on October 26, 2012 (left) and November 3, 2012 (right). The seaward slope of the dunes was truncated by Sandy with sand moved seaward. Minor overwash at street ends occurred in places, but wholesale damage was absent.

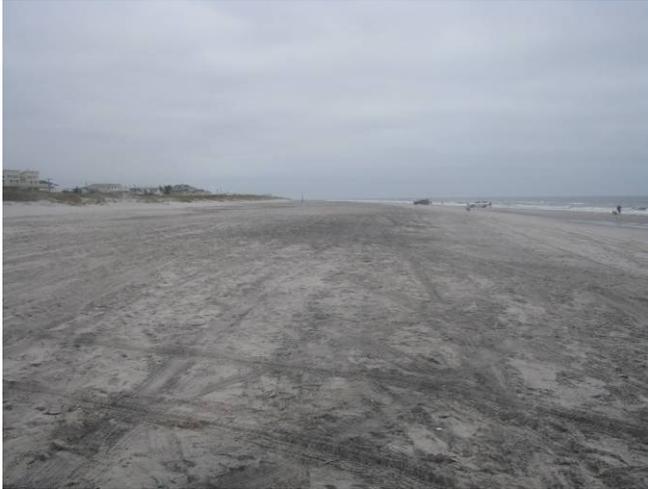
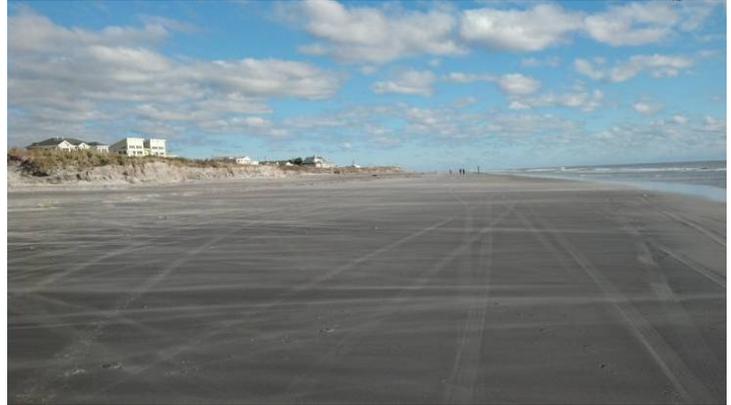
**NJBPN 132 – 15<sup>th</sup> Street South, Brigantine**

The photographs above were taken on October 25, 2012 (left) and November 3, 2012 (right). This part of the beach lies in a zone where little erosion or accretion has occurred until beach nourishment started in 1997. Since then the shoreline has moved seaward by 200 feet. But the damage was caused by a lack of dunes in front of the parking lot and the building at 15<sup>th</sup> Street South.

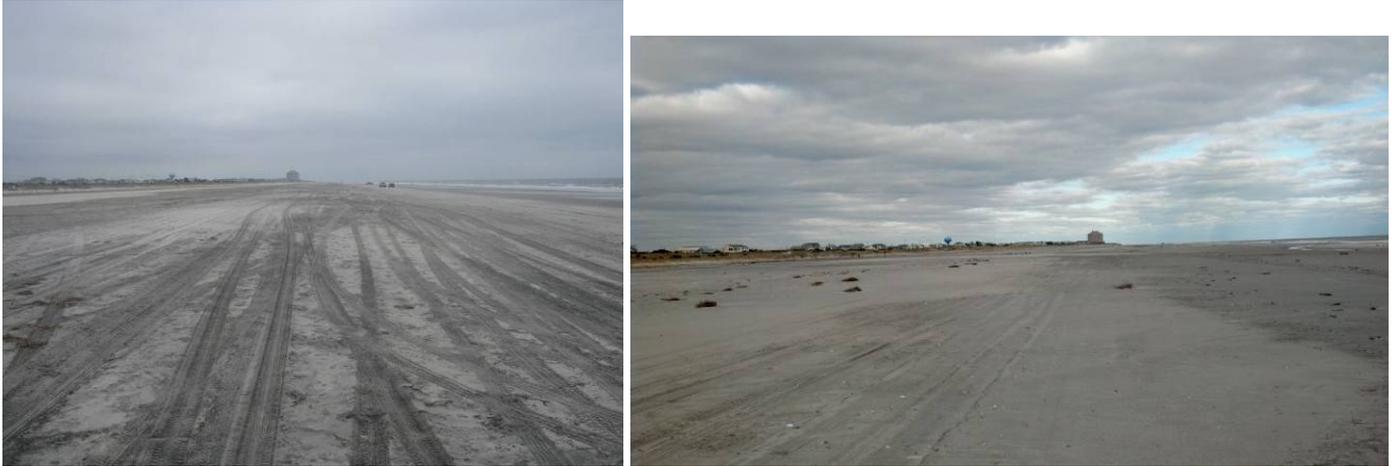
## NJBPN 131 – 43<sup>rd</sup> Street South, Brigantine

The photographs above were taken on October 25, 2012 (left) and November 3, 2012 (right). The large building at 15<sup>th</sup> Street South shows in both pictures in the distance. From the large building at 15<sup>th</sup> Street, to a mile south of this site, the beach width is huge with multiple rows of vegetated dune ridges to the landward site. The storm surge and wave energy expended itself in the dunes closest to the back beach margin with no ill effect on the development.

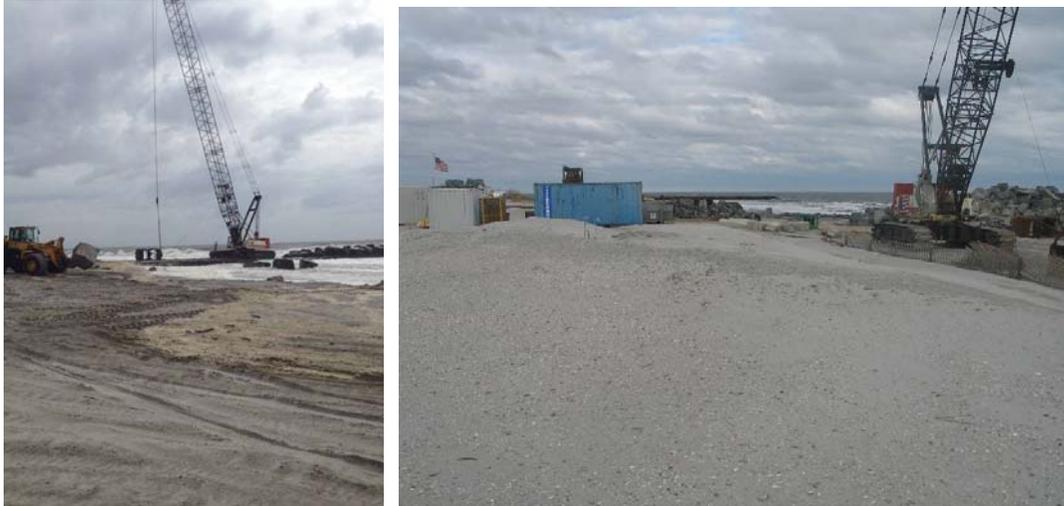
The photographs were taken on September 18, 2012 (left) and November 6, 2012 (right). Work was continuing on the rock sill being placed between the Massachusetts and Vermont Avenue groins in northern Atlantic City. The new Revel Entertainment casino was built here and a submerged, shore-parallel rock sill between the two groins was built to trap sand as a “perched” beach for a longer time period between the maintenance interval for the Federal beach project. Since the maintenance was just completed following hurricane Irene in 2011, the dune/beach system resisted the storm damage from Sandy with about three quarters of the dune surviving.

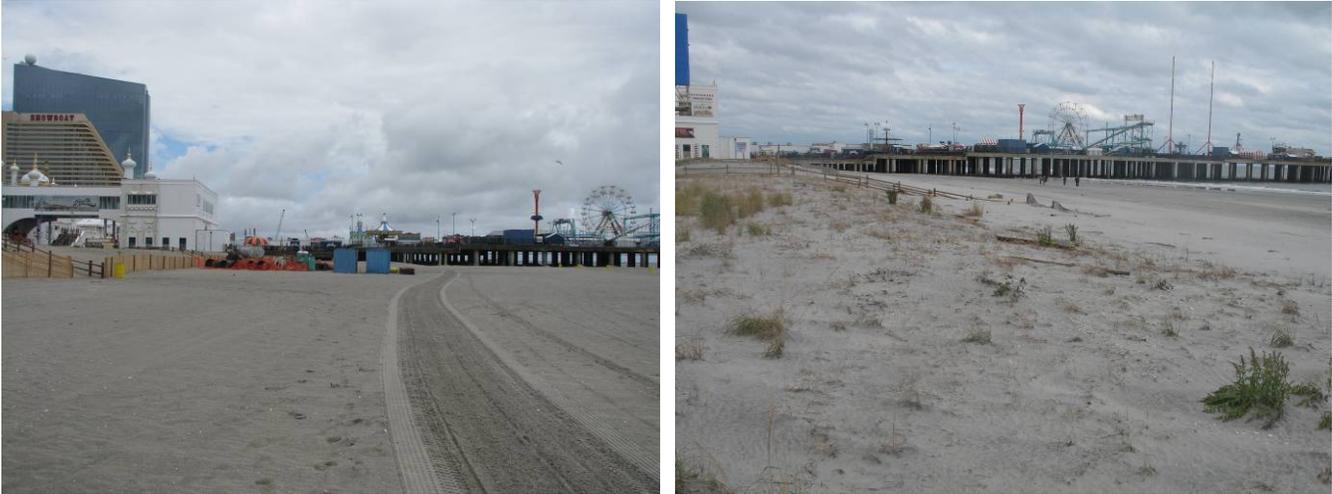
## NJBPN 130 – North Carolina Avenue, Atlantic City

The photographs above were taken on June 4, 2012 (left) and November 6, 2012 (right). The beach lost much of the berm sand volume, but the dune survived by being just high enough. Note that there is abundant debris deposited near the crest of the dune and stream gullying was in evidence on the landward side of the dune indicating that sea water had crossed it in significant volume at the height of the storm.

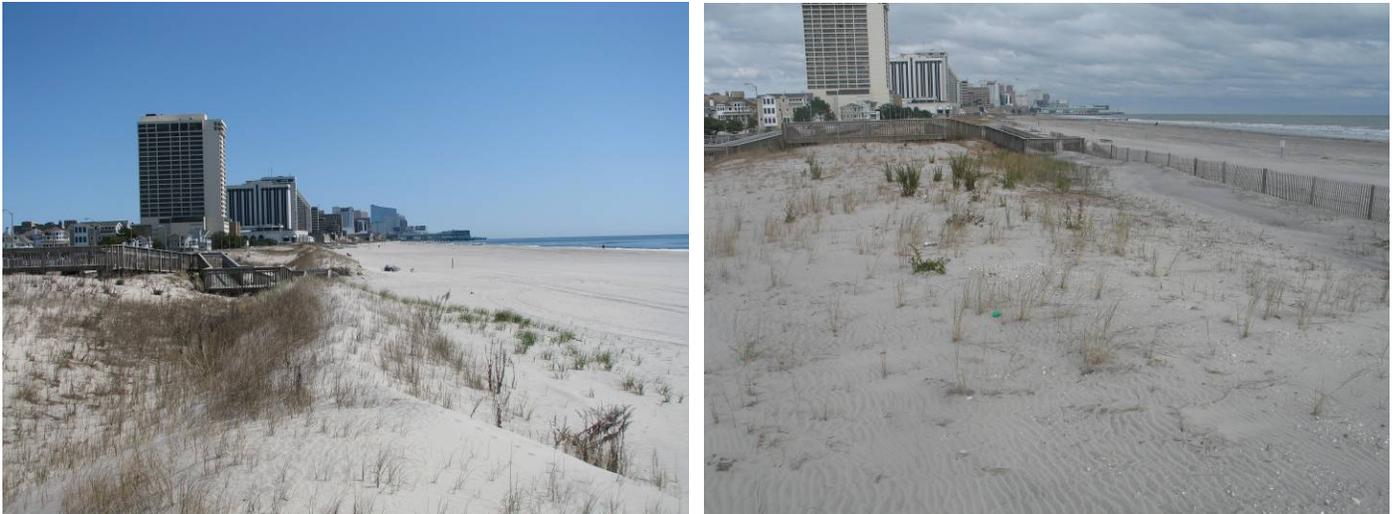
The photographs above were taken on April 13, 2012 (left) and November 6, 2012 (right). Raleigh Avenue lies in the middle of the Federal beach project and this meant that little damage was done. The dunes were invaded on the seaward slope depositing sand in the grass and knocking down an incipient foredune.

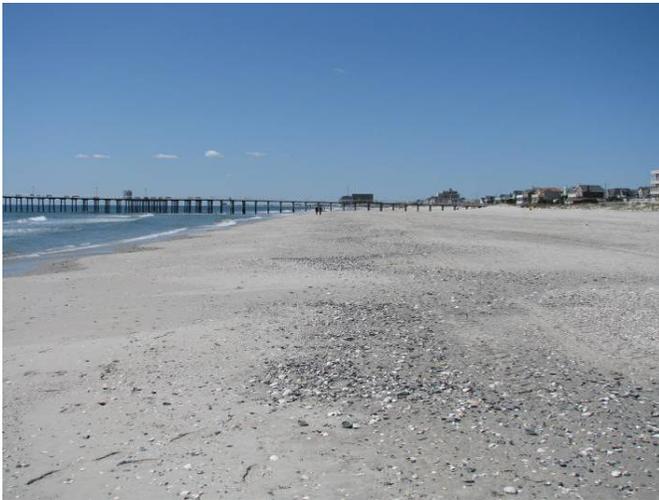
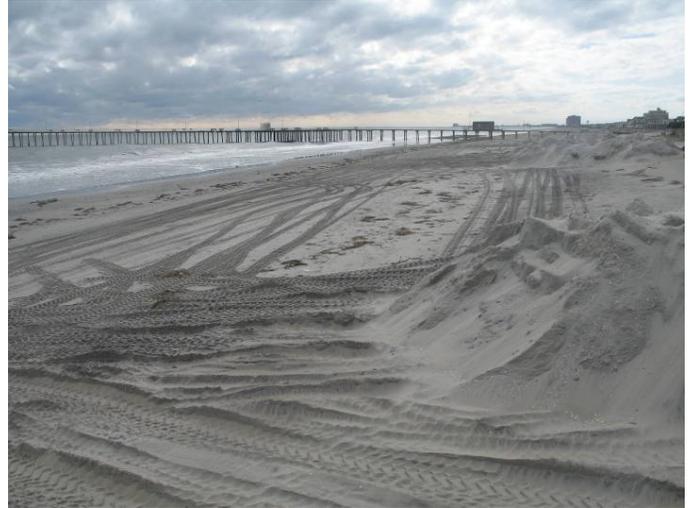
**NJBPN 128 – Dorset Avenue, Ventnor City**

The photographs above were taken on April 13, 2012 (left) and November 6, 2012 (right). Dorset Avenue in Ventnor City also is located in the middle of the Federal project with excellent retention of the sand placed in 2004.

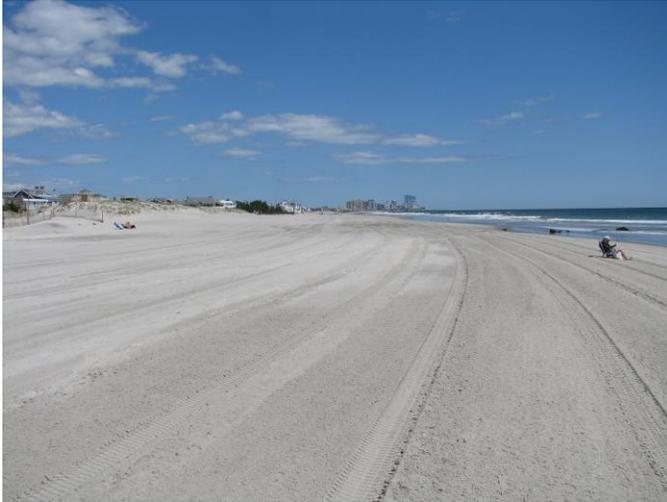
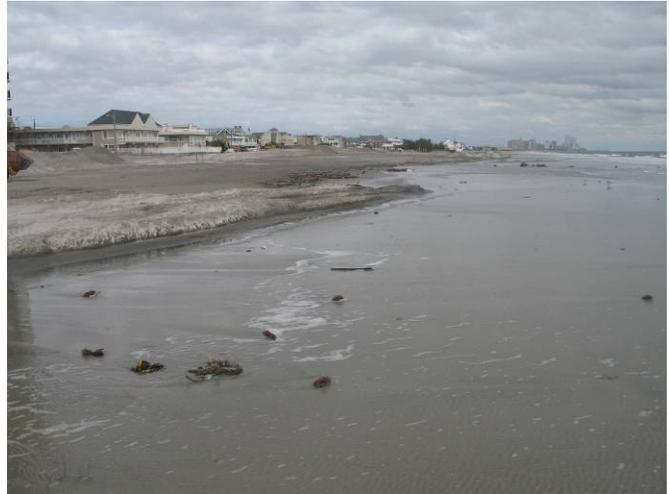
**NJBPN 127 – Benson Avenue, Margate City**

The photographs above were taken on April 13, 2012 (left) and November 6, 2012 (right). The relatively robust berm was cut down and pushed landward as a substantial deposit that included Benson Avenue and environs. The work was underway to excavate the sand at the sea-side of the bulkhead to keep water from simply running over it.
