## New Jersey Beach Profile Network 2012 Annual Report on Shoreline Changes in New Jersey's Four Coastal Counties Raritan Bay to Delaware Bay Spring of 2011 Through Fall of 2012

Prepared for:  
New Jersey Department of Environmental Protection  
Division of Construction and Engineering  
1510 Hooper Avenue, Toms River, New Jersey 08753

Prepared by:  
The Richard Stockton Coastal Research Center  
Richard Stockton College of New Jersey  
30 Wilson Avenue, Port Republic, NJ 08241

July 31, 2013

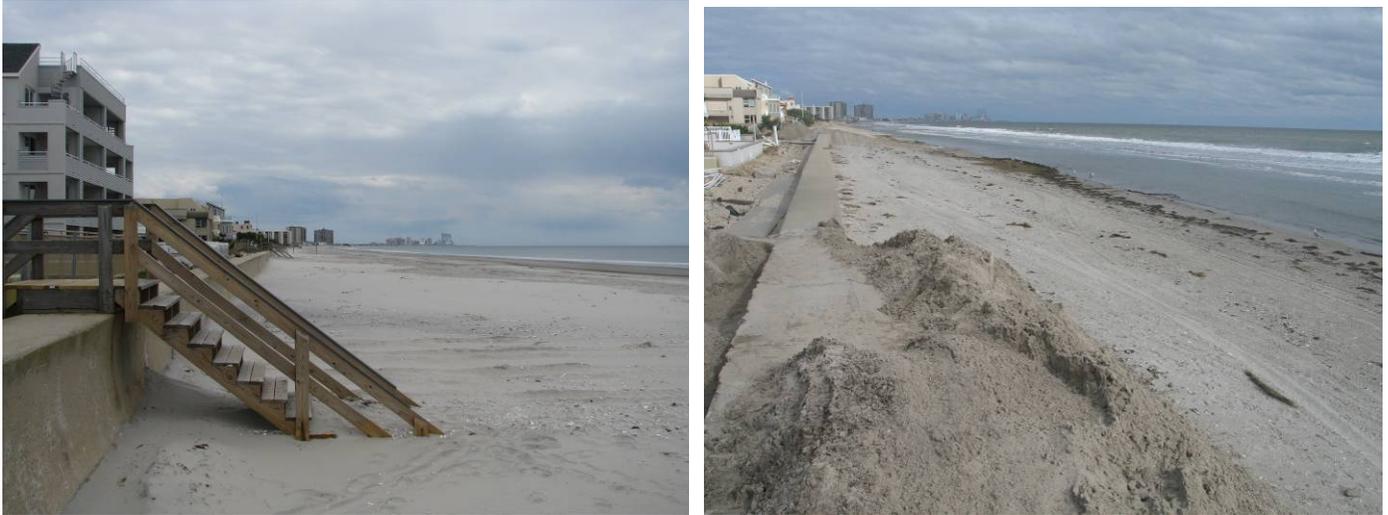
The photographs above were taken on April 11, 2012 (left) and November 6, 2012 (right). The narrow beach allowed wave energy to explode on the seawall. The water bounced over it and crashed into the homes built at the base of the wall. Street end flooding, sand deposition to Atlantic Avenue and structural damage was spread along the shoreline.

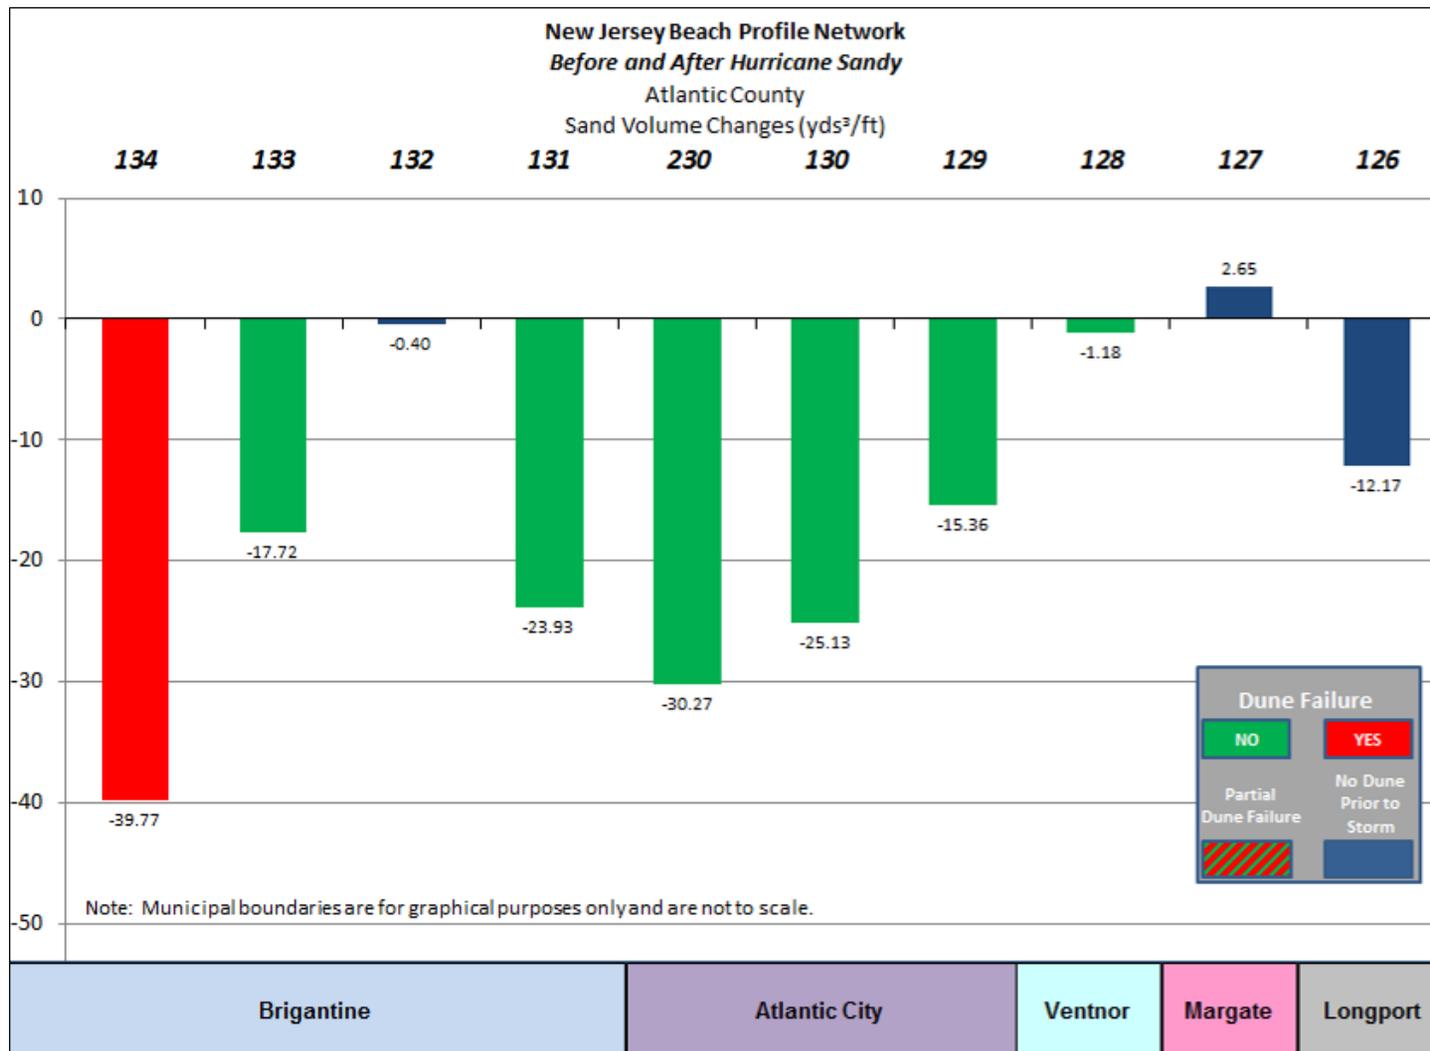
Figure 86. This graphic shows the sand volume loss figures for each of the communities within the developed sections of the Atlantic County shoreline. Federal shore protection projects have occurred along this portion of the New Jersey shoreline in Brigantine (northern portion), Atlantic City, and Ventnor. In Brigantine, prior to the storm the engineered had beach had been eroded away. Atlantic City and Ventnor’s engineered beach and dune systems have been maintained by the USACE recently and withheld the storm generated waves from breaching the dunes. All sites experienced berm erosion and dune losses except for site 127 in Margate, where sand had accumulated in front of the bulkhead adjacent to the street end (No dune at this location). The only true dune failure occurred in the national area on the north end of Brigantine (site 134), however sites 132 (Brigantine), 127 (Margate) and 126 (Longport) did not have dune systems in place prior to the storm and all experienced overwash of waves with sand being transported landward of the beach.

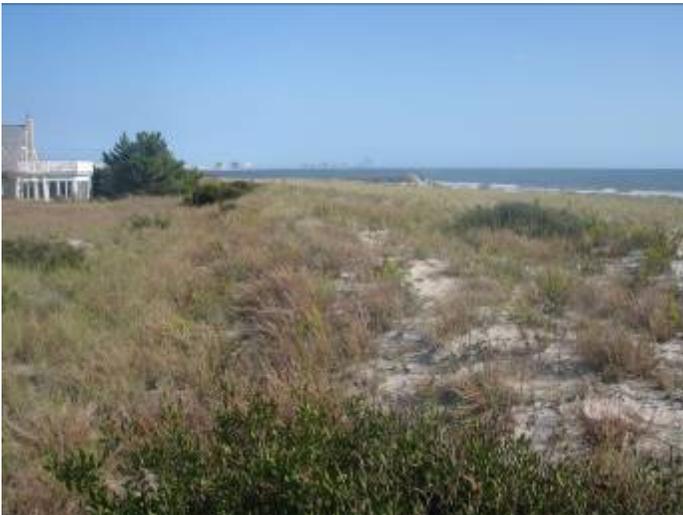
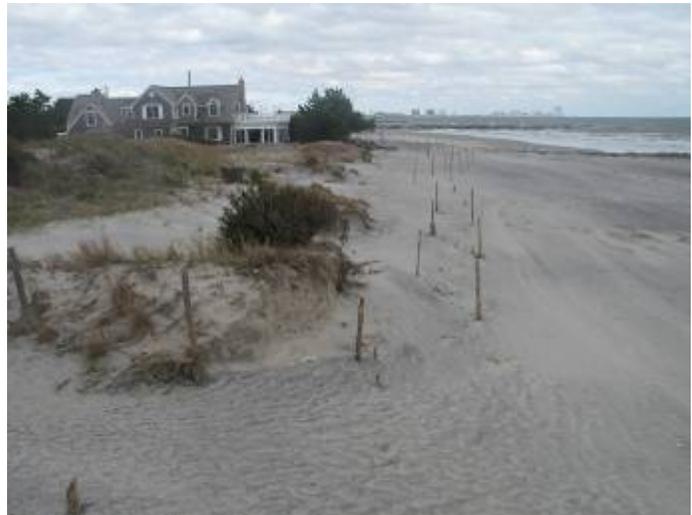
Gardens Road, Ocean City, Cape May County, Site #225;

Between October 26 and November 6, 2012 Hurricane Sandy removed 125 feet of dune vegetation at elevation 12.0 NAVD 88 or higher. The beach was not wide and occupied just 50 feet between the seaward dune toe and the zero elevation position. The home in both pictures was impacted with water inside due to wave surges, but could be repaired. The large pine trees actually helped save the home.

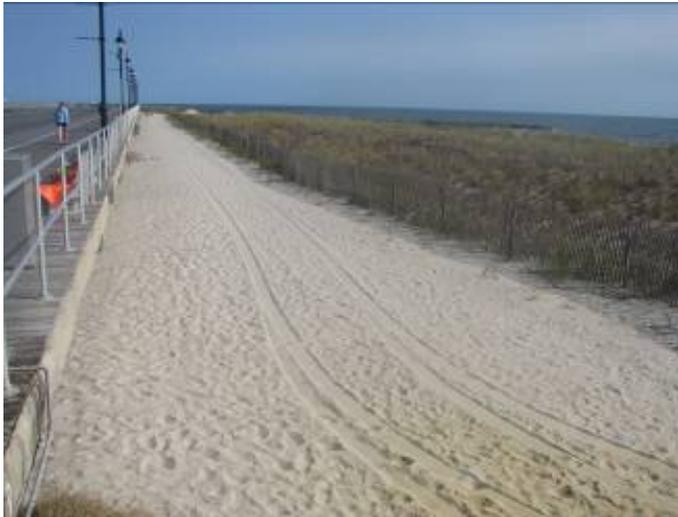
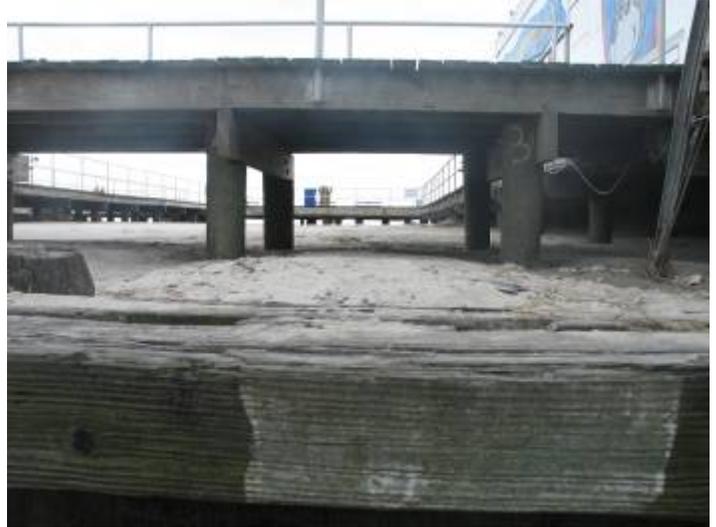
6<sup>th</sup> Street, Ocean City, Cape May County, Site #125;

The left photograph was taken October 26, 2012 just prior to the storm. The dune was intact, but the beach was extremely narrow so the initial storm action was able to attack the dune. The right photograph was taken November 6, 2012 from the back shot position standing on the street end paving that had been excavated of sand, looking seaward to the boardwalk about 120 feet distant. The sand had been deposited to the top of the timber by the storm surge. The wedge of sand was swept landward of the boardwalk and had spilled into the end of 6<sup>th</sup> Street.

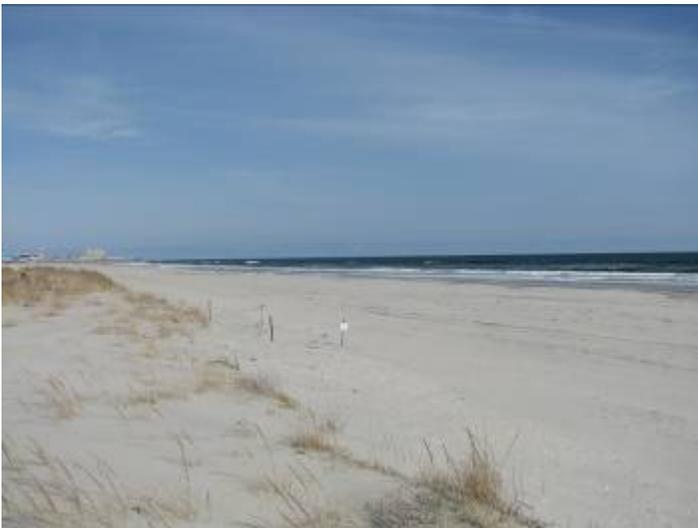
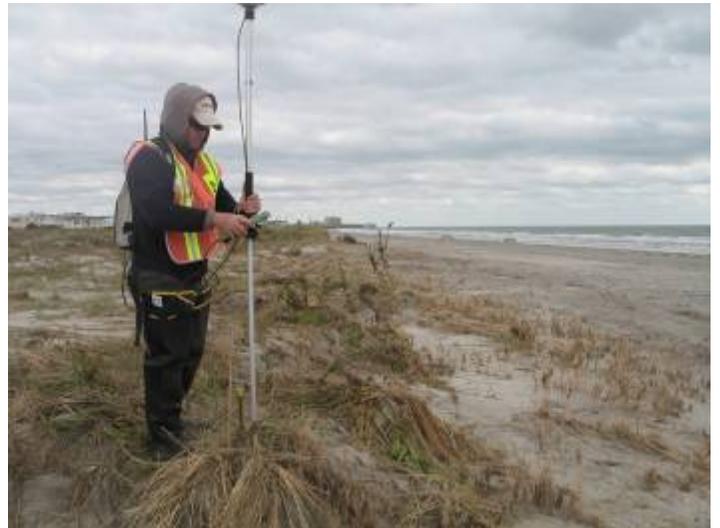
20<sup>th</sup> Street, Ocean City, Cape May County, Site #124;

The 20<sup>th</sup> Street site is at the maximum retention of beach restoration sand anywhere along the oceanfront. This site has seen the shoreline move seaward by 600 feet since the 1980's with 460 feet of dunes. The photograph on the left was taken March 2, 2012 showing the beach and gentle gradient into the seaward-most dune ridge. Following Sandy on November 6, 2012 (right photo) the zone of about 150 feet in width had been inundated by the storm surge with sand pushed landward into the first major swale. The berm was lowered as would be expected without much shoreline retreat.

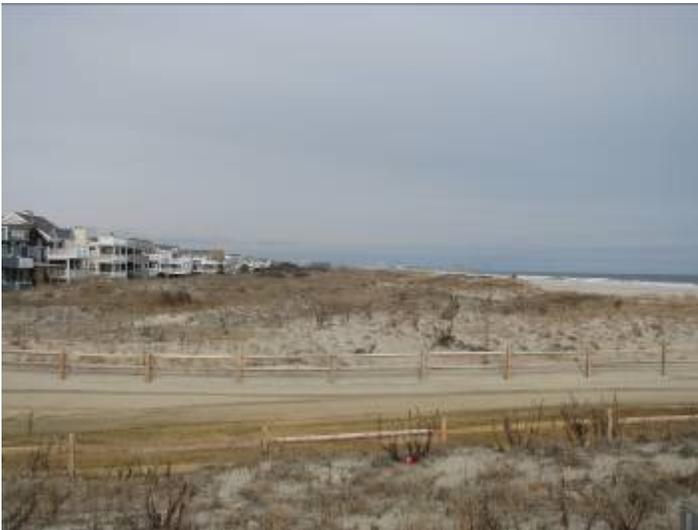
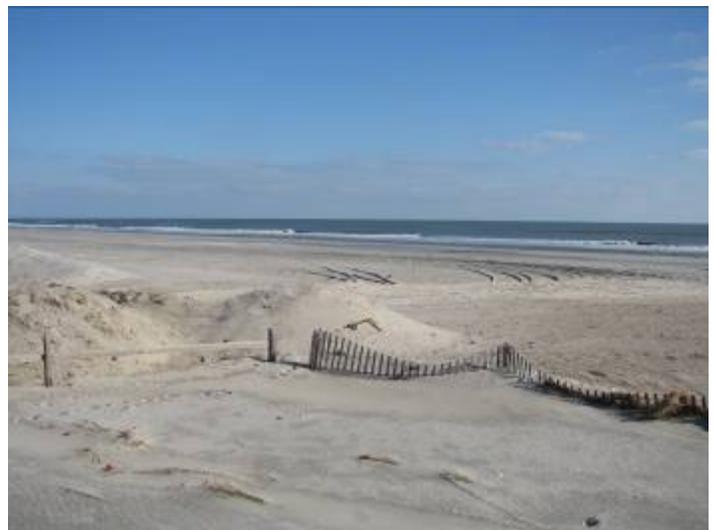
34<sup>th</sup> Street, Ocean City, Cape May County, Site #223;

The 34<sup>th</sup> Street site has always possessed a low threshold dune that really is little more than a mound with a wide access path for both vehicles and pedestrians. The March 2, 2012 view (left) shows the relatively wide dunes north of the site, but the storm barreled through the pathway into 34<sup>th</sup> Street. The piles of sand on the right picture were transported back to the beach as of November 28<sup>th</sup>. The beach berm was cut back, but since this site was surveyed a month following the storm a new berm was in the process of reconstruction.

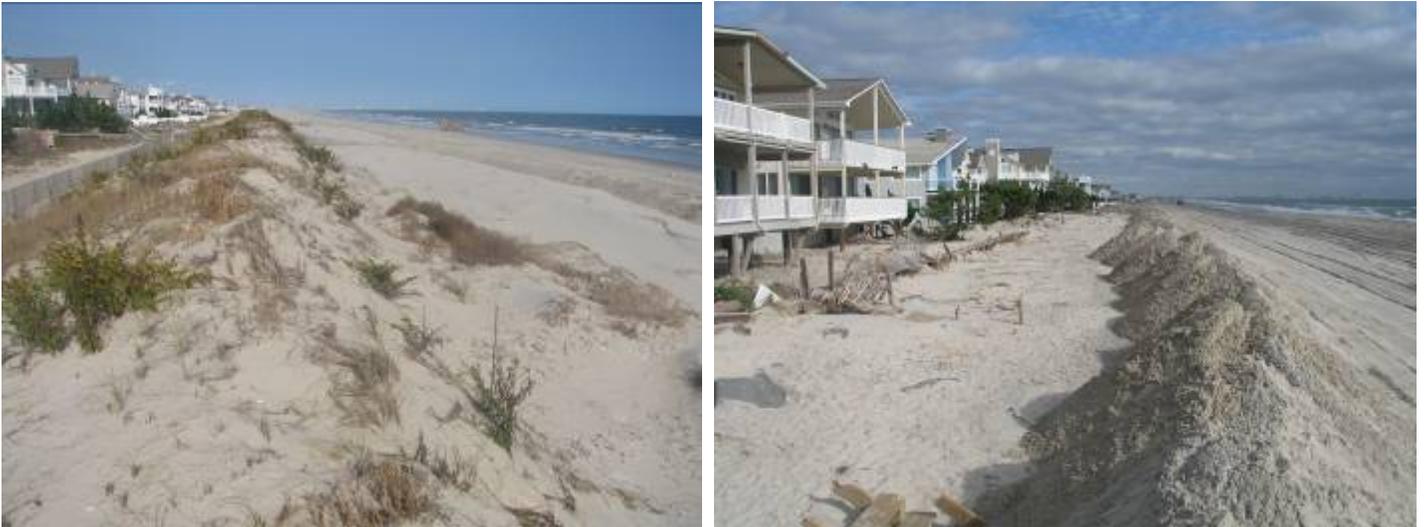
The left photograph was taken October 26, as Sandy was approaching NJ. Machines were deployed pushing up a ridge of sand seaward of the existing dunes at this site. Sandy overwhelmed the shore protection, jumped the old bulkhead and washed well inland producing damage and flooding. The right picture was taken November 6<sup>th</sup> and shows recent bulldozing efforts to provide a small measure of protection for homes with nothing between them and the sea.

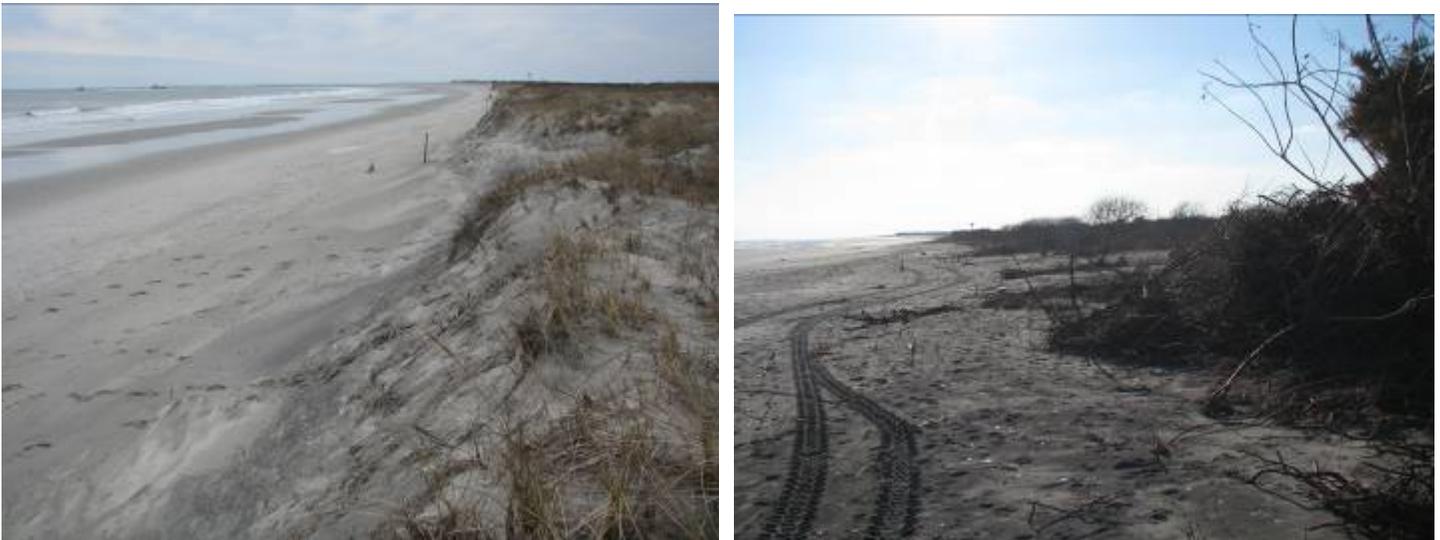
59<sup>th</sup> Street, Ocean City, Cape May County, Site #222;

The left picture, taken March 9, 2012, shows an erosional scarp in the spring of 2012. This condition did not change during the summer and the waves during Sandy carved deeply into the remaining dunes. The erosion reflected up the beach into the southernmost development in Ocean City as well. The right picture was taken November 28, 2012 and shows large scale overwash and inundation of the lower sections of the dune system. The scarp was pushed landward a minimum of 155 feet with loss in elevation to the remaining dunes because the erosion passed the crest of the main dune ridge.

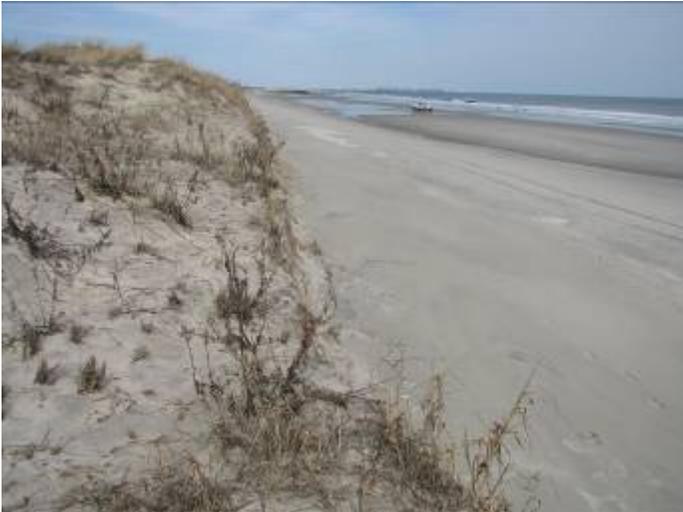
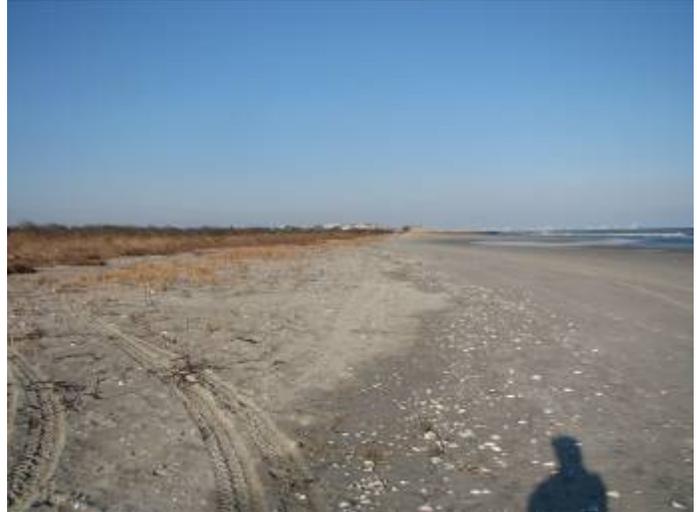
Corson's Inlet State Park, Ocean City, Cape May County, Site #221;

Positioned about a half-mile south of the development in Ocean City, the dune has been repeatedly eroded since the spring of 2012. Sandy hit this site pretty hard as a result of a narrow, low elevation beach. The November 28, 2012 picture on the right shows that the higher elevation dune was removed and the water pushed inland over lower elevation vegetation. There is an older, vegetated dune line over a hundred feet further landward that finally stopped the storm surge.

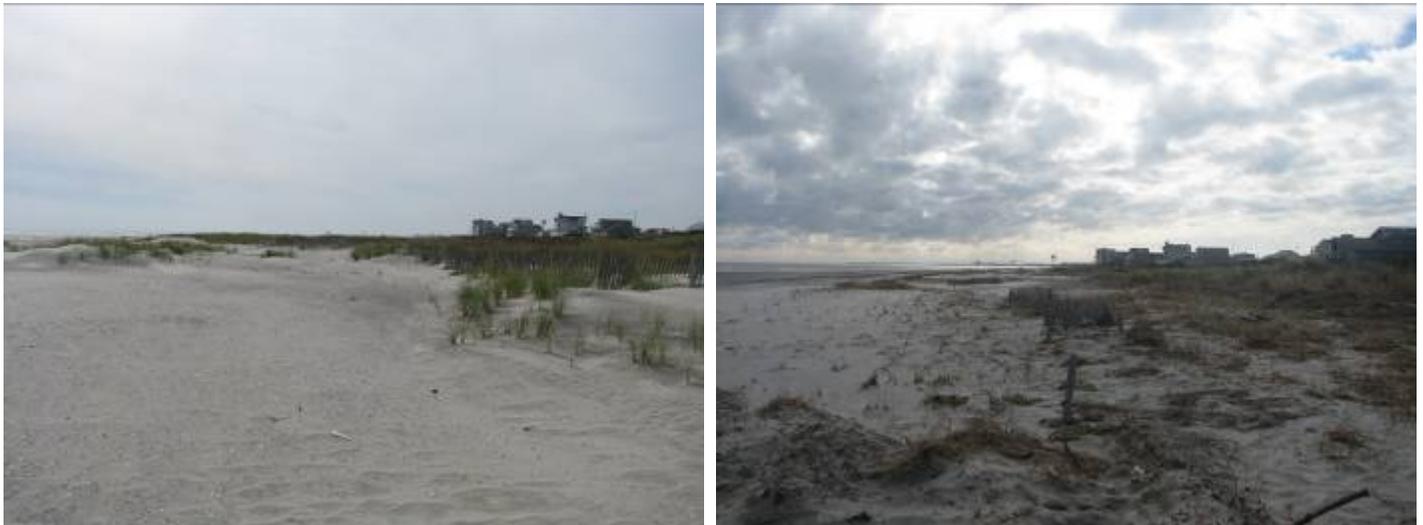
**Williams Road, Strathmere, Cape May County, Site #121;**

The left picture was taken October 17, 2012 looking across the wide dune zone area seaward of the primary feature. On November 5, 2012 the same view following Sandy shows that the area was flooded by waves that knocked down the highest primary dune, but did not flood the immediate landward area. The beach was flattened by the storm surge. The dune removed was only three feet higher than the post-storm feature however.

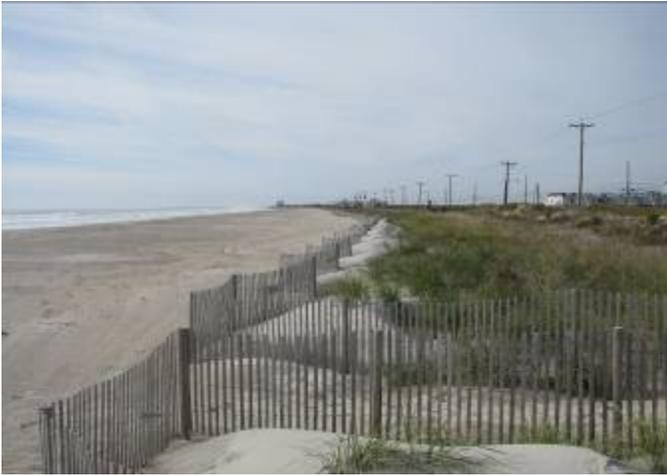
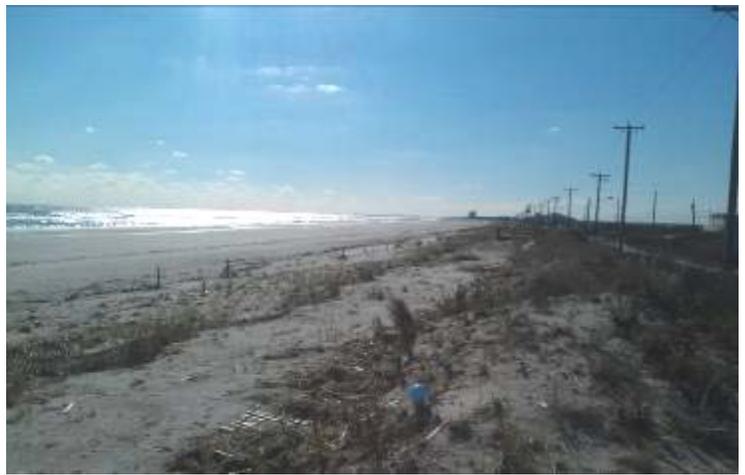
1<sup>st</sup> Street, Sea Isle City, Cape May County, Site #120;

This location is on the boundary between Sea Isle City and Strathmere along the main (and only) road parallel to the ocean. The sand transported into the dune by October 17, 2012 was washed across by Sandy as seen on the left picture on November 14, 2012. Some minor breaching occurred along Commonwealth Avenue, but the dune remained relatively intact.

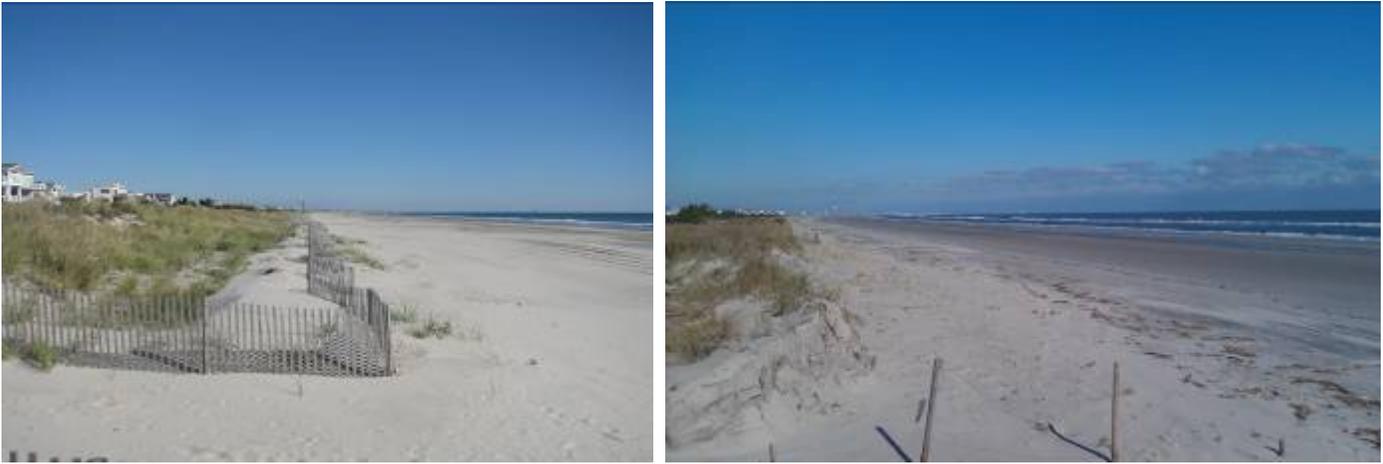
On October 22, 2012, the beach was relatively wide and dry with a decent new deposit of sand along the recent fencing installed at the seaward toe of the dune system. After Sandy on November 14, 2012 the beach was lower in elevation, all the fencing was missing and sand was pushed back into the dunes, up the seaward slope.

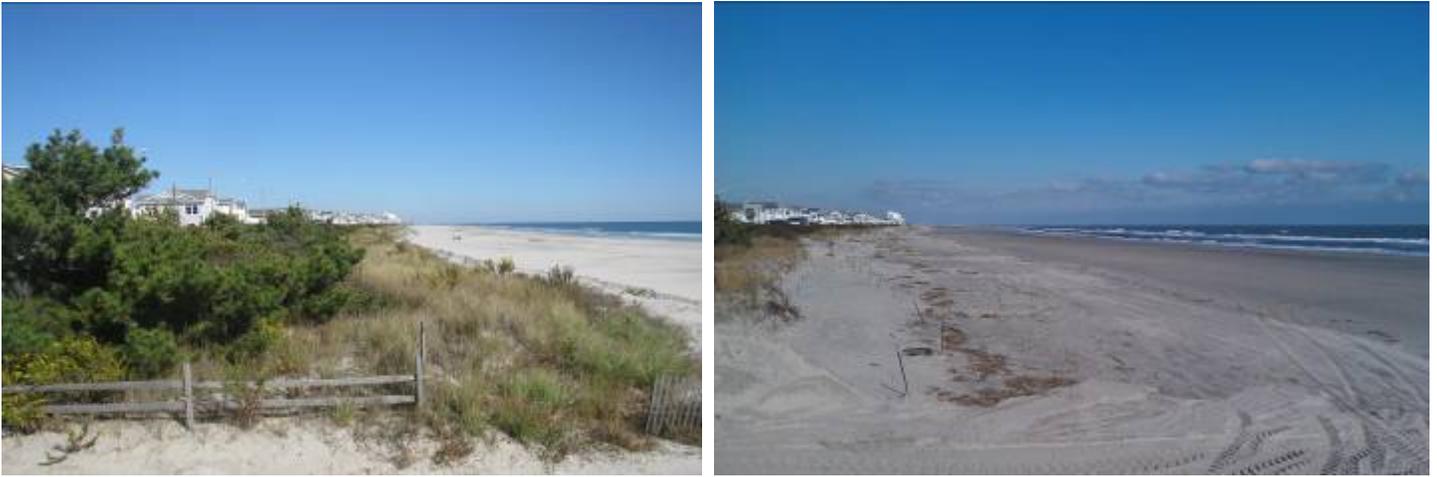
57<sup>th</sup> Street, Sea Isle City, Cape May County, Site #118;

The left picture was taken October 22, 2012 and shows the dune system landward of a wide, dry beach. Following Sandy on November 14, 2012, the beach was much lower in elevation and the dune was carved away nearly to the crest. The scarp had slumped two weeks later, but the impact can clearly be seen in the cross section below.

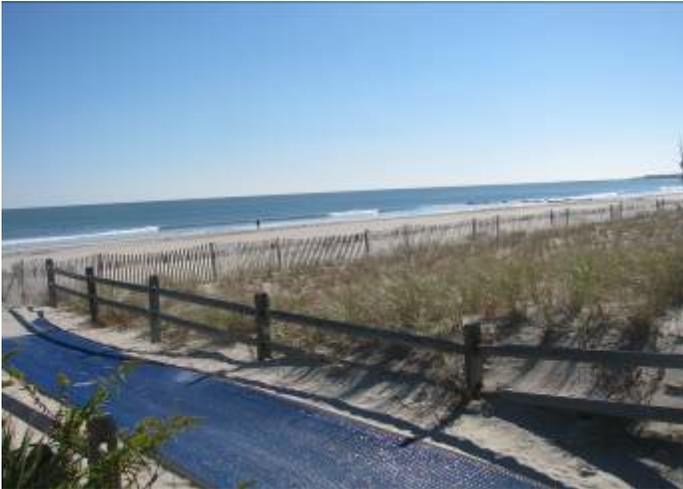
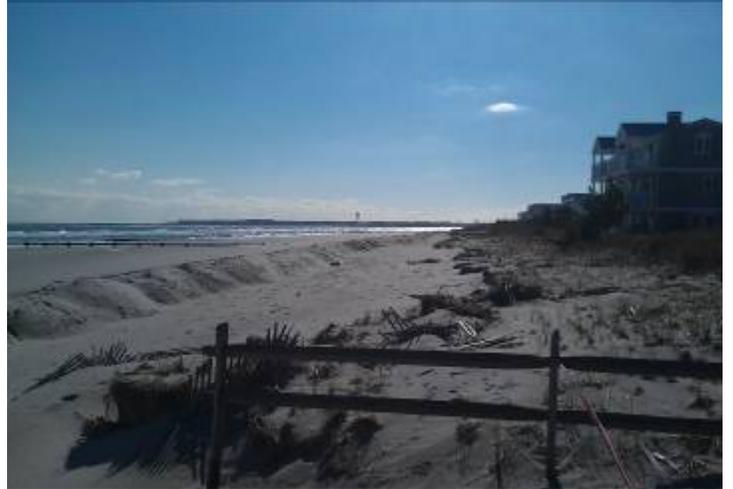
80<sup>th</sup> Street, Sea Isle City, Cape May County, Site #117;

On October 22, 2012 the beach possessed a recently deposited foredune developed at fencing installed in the past year. The beach was wider and higher than the scene following the storm. On the right, the post-Sandy clean-up was responsible for the deposition of sand, washed inland, having been hauled back to the beach to form a linear ridge to help with future storm protection.

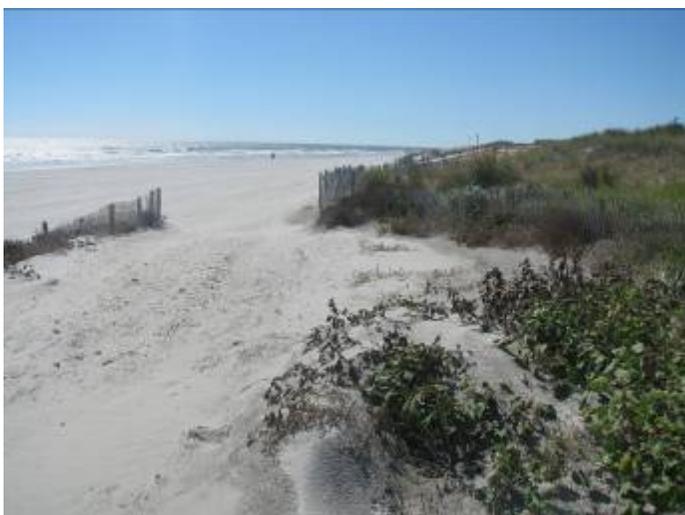
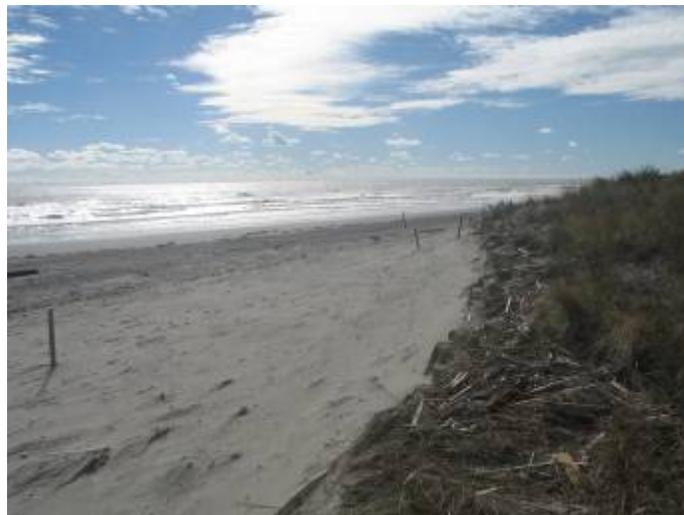
9<sup>th</sup> Street, Avalon, Cape May County, Site #216;

The September 25<sup>th</sup> photograph shows the wide berm and seasonal plant growth at the 9<sup>th</sup> Street site. Following Sandy the fence was taken out as was the wide berm with erosion cutting into the seaward dune toe slope. The litter deposited on the dune slope shows the elevation to which the waves ran up the dunes (14.0 feet NAVD88 in Avalon).

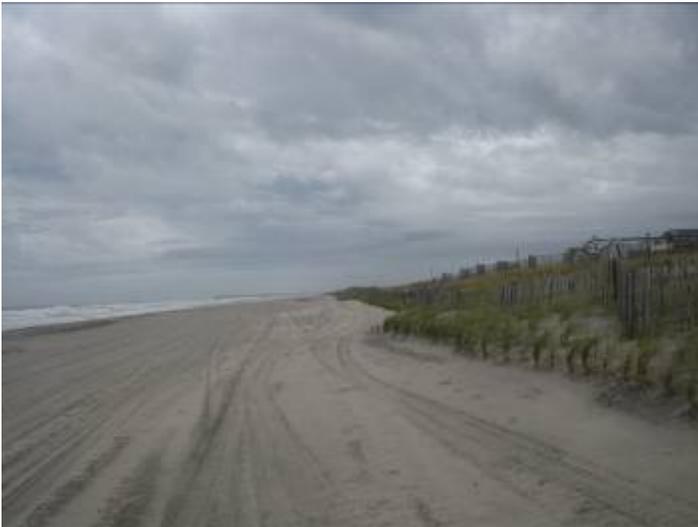
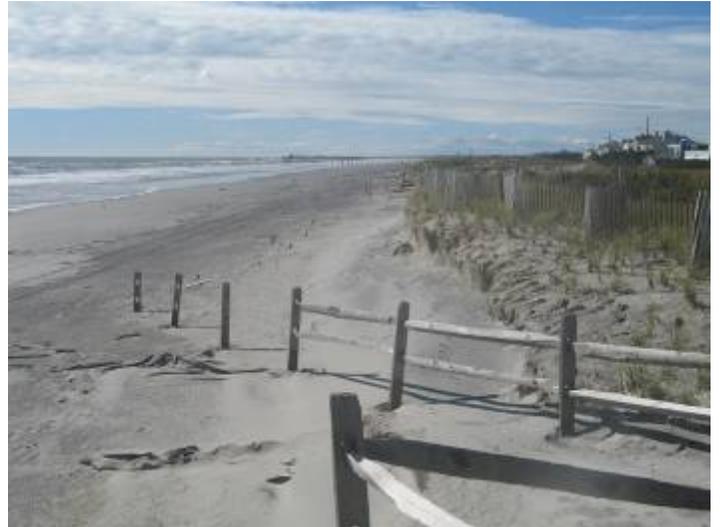
23<sup>rd</sup> Street, Avalon, Cape May County, Site #116;

The left picture was taken September 25, 2012 and shows the beach late in the summer with a generous post-sand fill berm present and a healthy season's growth in new dune plants. By October 31<sup>st</sup>, the beach was much lower in elevation as sand was carried offshore and the dune's seaward slope was cut and sand washed into the grasses. The entrance pathway was truncated at most Avalon street-end entrances.

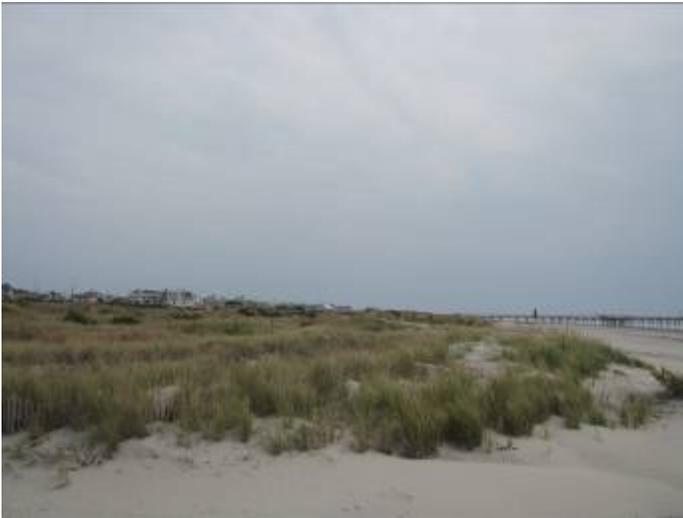
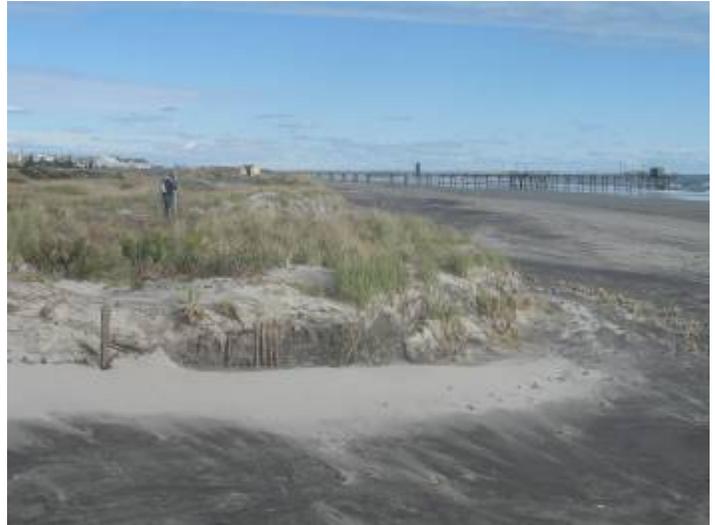
35<sup>th</sup> Street, Avalon, Cape May County, Site #115;

Between September 27<sup>th</sup> and October 31<sup>st</sup>, the beach at 35<sup>th</sup> Street suffered foredune flooding and minor erosion of the seaward toe. Sand was stripped from the berm and washed into the lower elevation dune field. The loss to individual plants can be determined by careful examination of the two photographs.

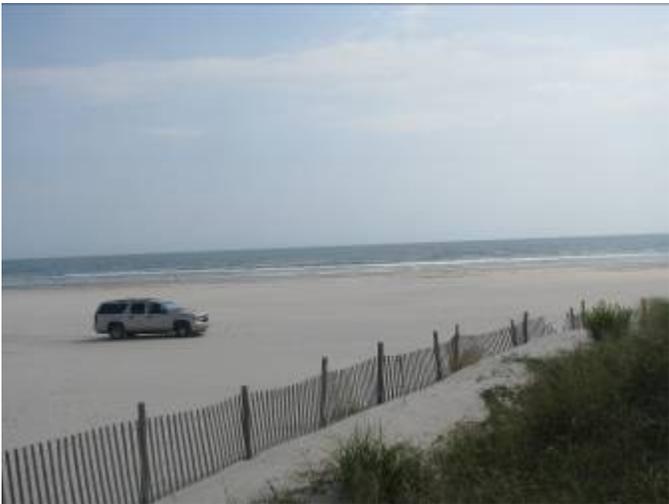
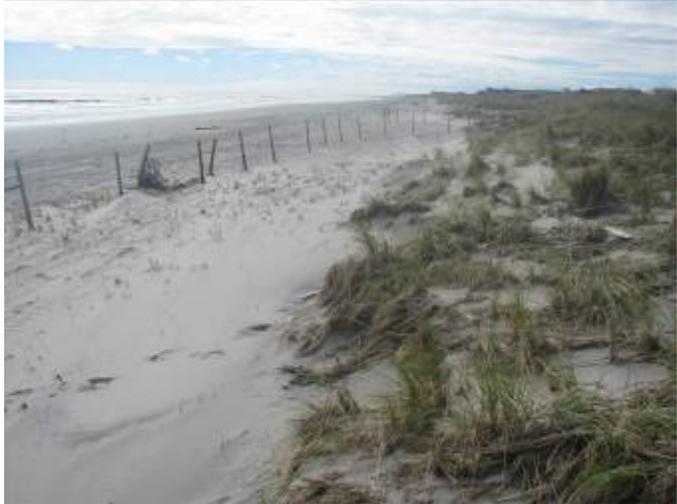
70<sup>th</sup> Street, Avalon, Cape May County, Site #114;

The left picture was taken September 28, 2012 during the late summer survey, and the nearly identical view was obtained October 31<sup>st</sup> just after Sandy. Note that there are two pairs of closely spaced fence posts that have a small angle between them in their vertical positions. The two pairs of posts are present in both photographs and show the loss in seaward dune toe grass and sand. The berm along the ocean's edge was also reduced in elevation.

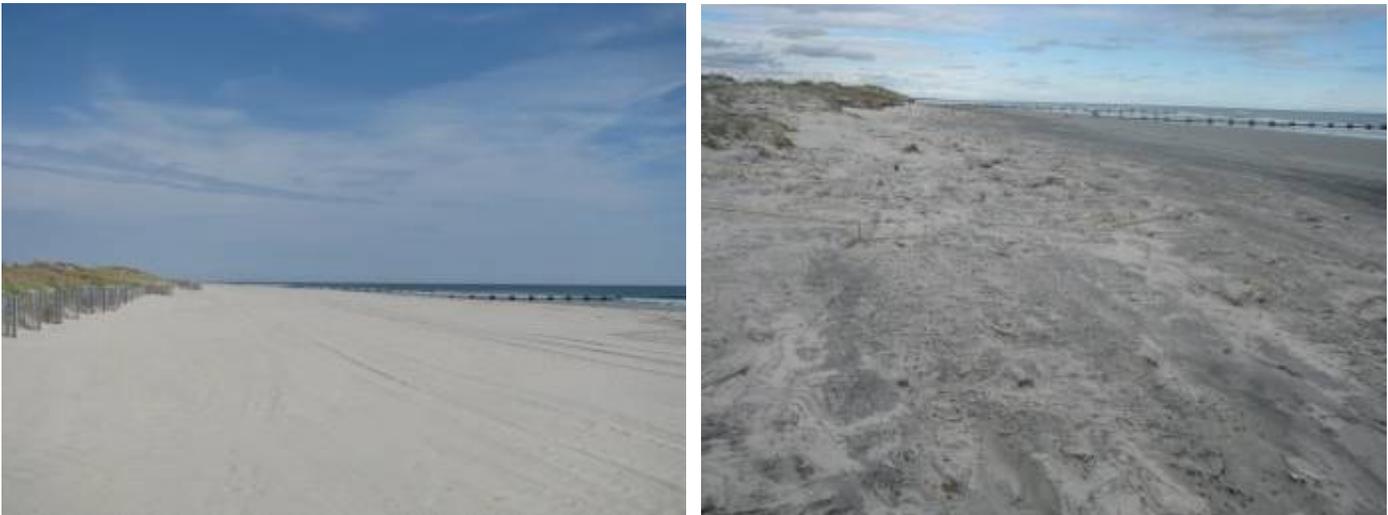
The left photograph was taken October 24, 2012 just prior to Sandy. The right picture was taken October 31, 2012 and shows the effects of lowering the berm elevation and some minor dune toe erosion. This site did not suffer significant erosion damage and no overwash beyond the dune toe area.

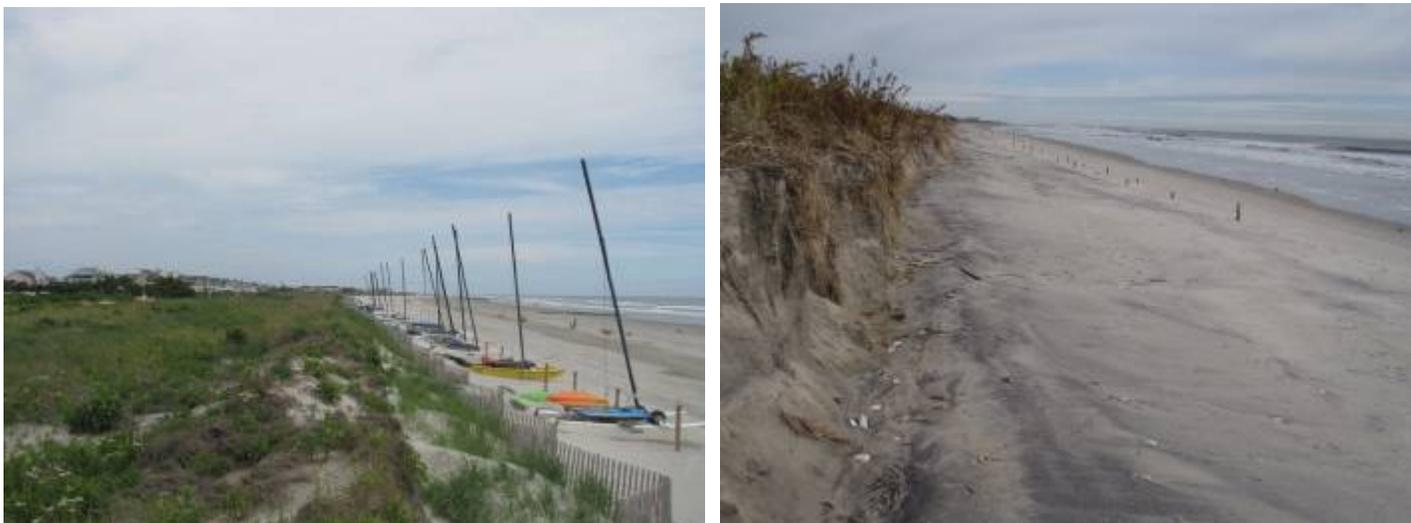
121<sup>st</sup> Street, Stone Harbor, Cape May County, Site #212;

The southern cross section in Stone Harbor was re-established just north of the terminal rock groin along the Borough oceanfront following the loss of South Point in 1990. The left picture shows the conditions in June 2012 where sand had deposited seaward of an older scarp cut into the dunes, building out to the sand fencing. Sandy eliminated all the newly-deposited material moving the beach landward uniformly by 50 feet. The catamaran pilings show a closer proximity to the surf after Sandy than prior to the storm (Nov. 8, 2012). The erosional cut in the dunes returned to approximately the location of the cut made in November 2009.

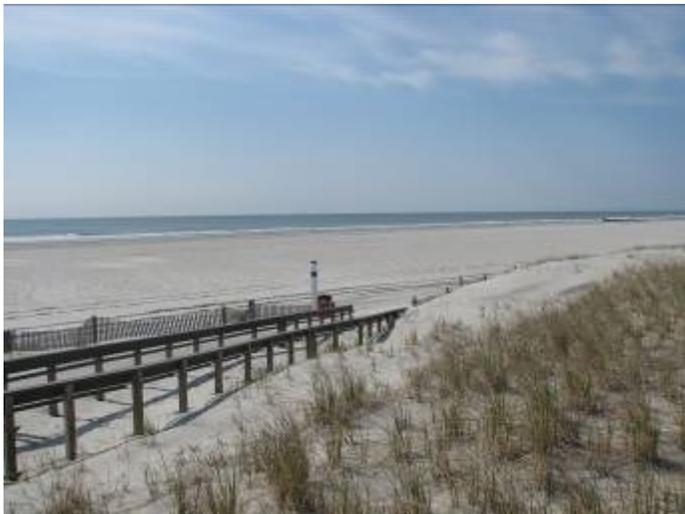
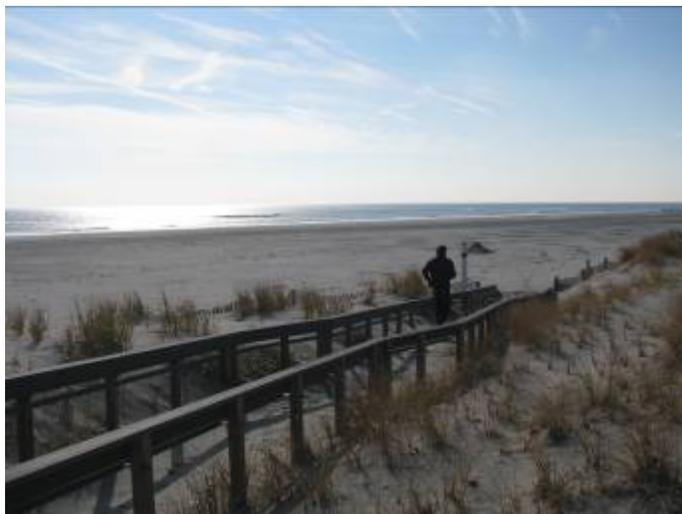
15<sup>th</sup> Avenue, North Wildwood, Cape May County, Site #111;

The view to the southeast from 15<sup>th</sup> Avenue dune crossover was taken April 4, 2012. The picture following Sandy was taken on November 29<sup>th</sup> and is on the right. Summer dune grass growth shows in spite of the storm. The waves did flow across the entire dry beach and ramped up a deposit onto the seaward dune toe. No dune breach occurred near this location. Further south at the piers, the dune was erased because it was built to pass seaward of the pier ends and was far more exposed to wave action. Erosion at the very northeast corner of the City also removed the dune south to 4<sup>th</sup> Avenue and over-topped the bulkhead revetment.

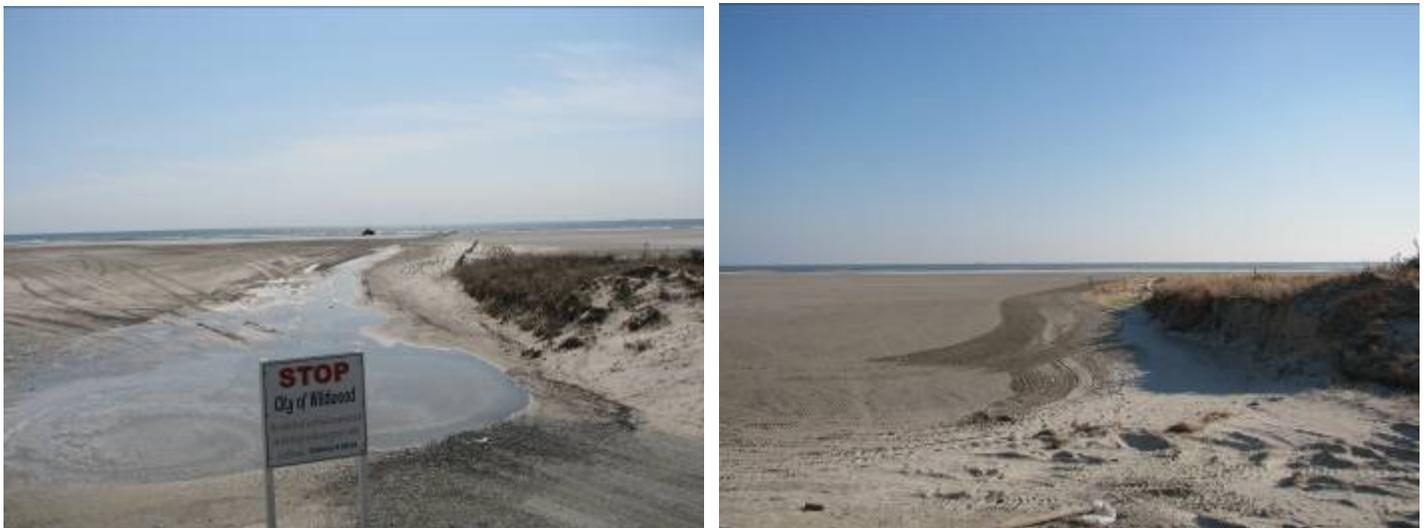
Cresse Avenue, Wildwood, Cape May County, Site #110;

On April 4, 2012 the view across the beach in Wildwood was taken from the tiny dune in front of the boardwalk. The November 29<sup>th</sup> view on the right was taken from the same location, but minus the sign. The beach gained sand at the berm 600 feet seaward of the boardwalk. The sand deposit probably was derived from the erosion of the spring survey's berm.

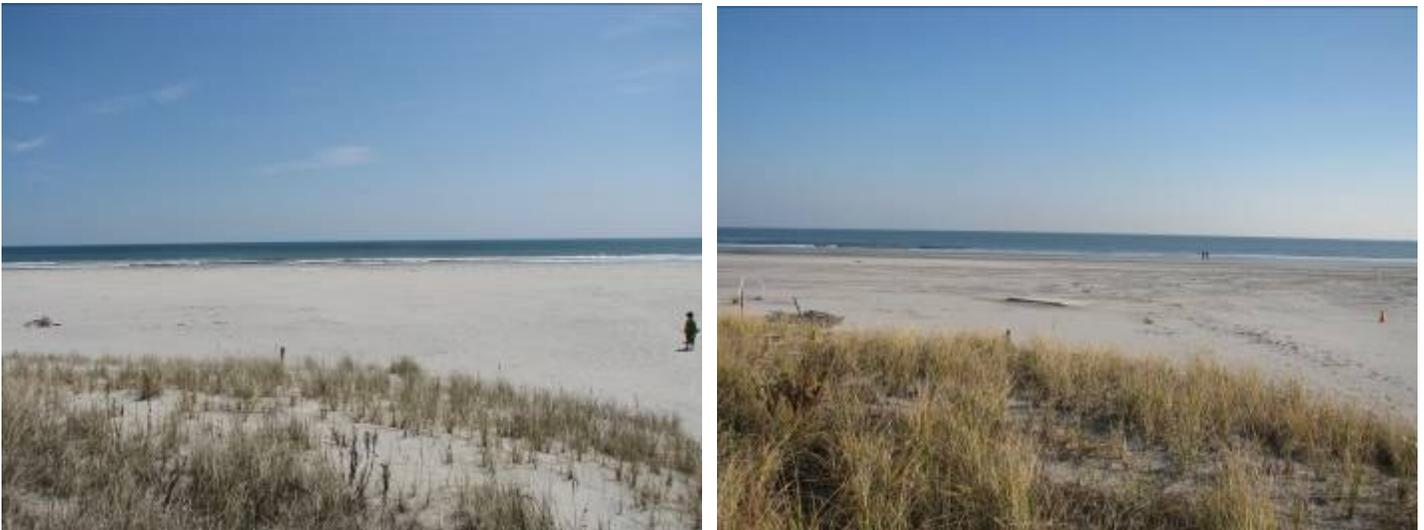
Raleigh Avenue, Lower Township, Cape May County, Site #109;

The early spring photograph of the beach taken April 4, 2012 is shown on the left. The right-hand view was taken November 29<sup>th</sup> a month after the storm. Here sand was forced landward to the toe of the dunes where a deposit filled in a slightly lower part of the beach than the berm. The sand on the berm was likely the source of the deposit since the storm surge flooded the entire dry beach.

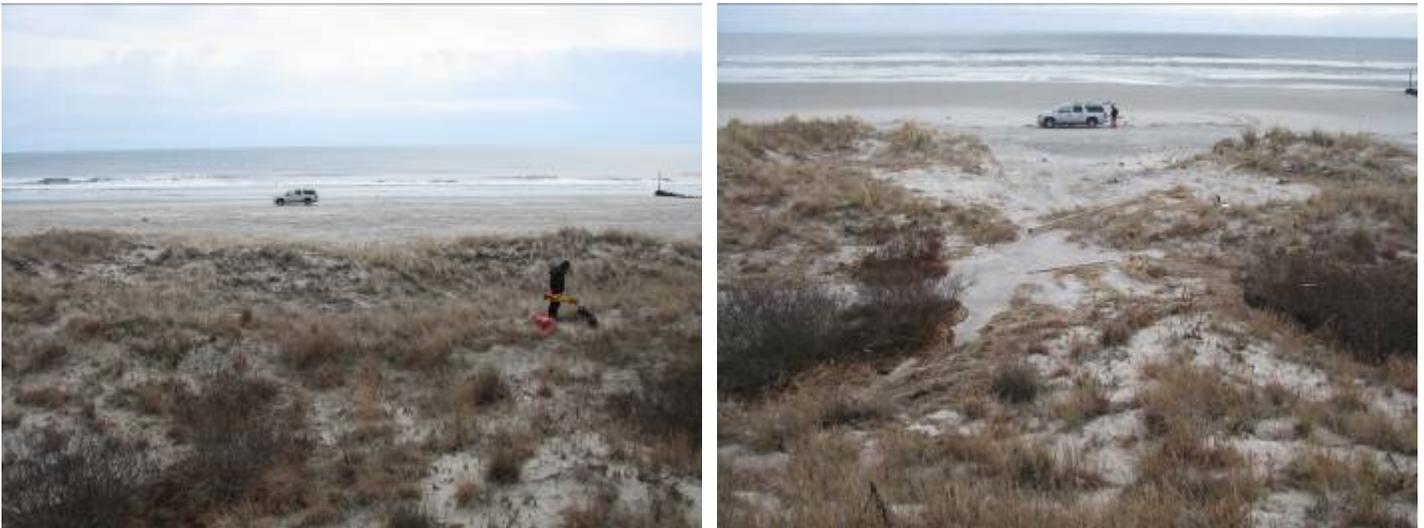
US Coast Guard Base, Lower Township, Cape May County, Site #208;

The left picture was taken March 9, 2012 looking toward the sea. The natural areas were surveyed last and done with normal procedures, so the length of the surveys are equal and extend well off shore. The outfall line shows in both photographs (December 11<sup>th</sup> for the right side) and shows that little change in beach elevation occurred. The berm was eroded somewhat and transported toward the dunes. Water reached into the new foredune area directly landward of the vehicle and washed up into the second ridgeline. The new, white sand in the center of the right photo is not present on the left side.

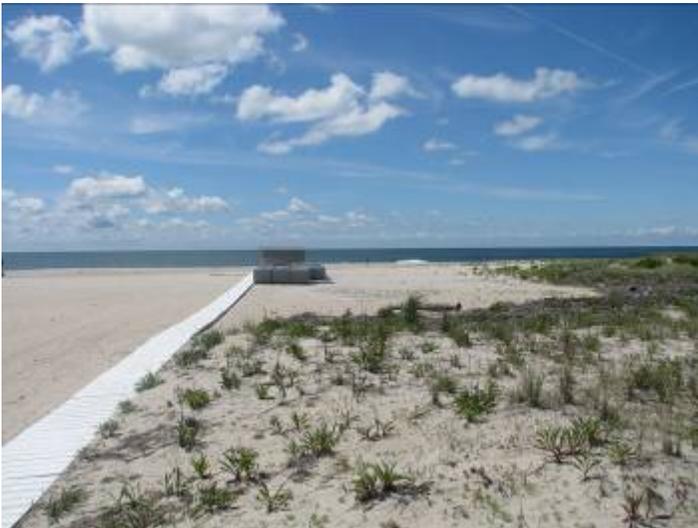
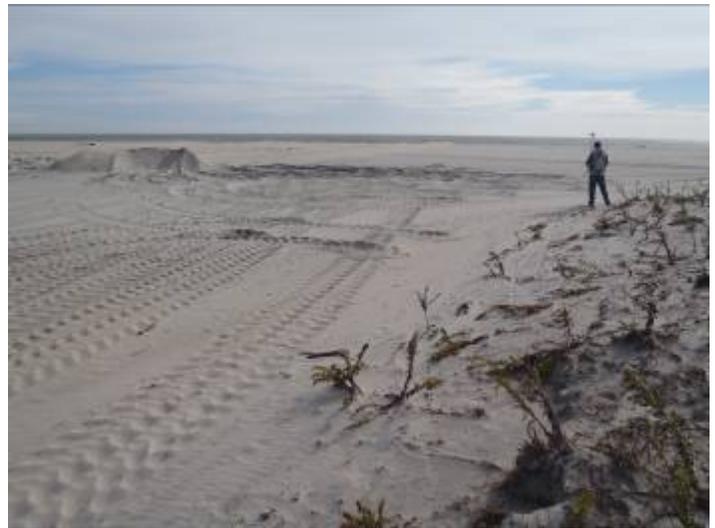
Cape May Beach Club, Cape May City, Cape May County, Site #108;

On June 5, 2012, the beach was wide with the removable boardwalk ready for the summer. The post-storm picture on the right was taken November 9<sup>th</sup> at approximately the same spot looking southeast to the ocean. Assuming that the photographers are all about the same height and were standing when they took the shots, the berm elevation covers far more of the view of the ocean in November than it did in June. The cross section below shows why.
