## New Jersey Beach Profile Network 2012 Annual Report on Shoreline Changes in New Jersey's Four Coastal Counties Raritan Bay to Delaware Bay Spring of 2011 Through Fall of 2012

Prepared for:  
New Jersey Department of Environmental Protection  
Division of Construction and Engineering  
1510 Hooper Avenue, Toms River, New Jersey 08753

Prepared by:  
The Richard Stockton Coastal Research Center  
Richard Stockton College of New Jersey  
30 Wilson Avenue, Port Republic, NJ 08241

July 31, 2013

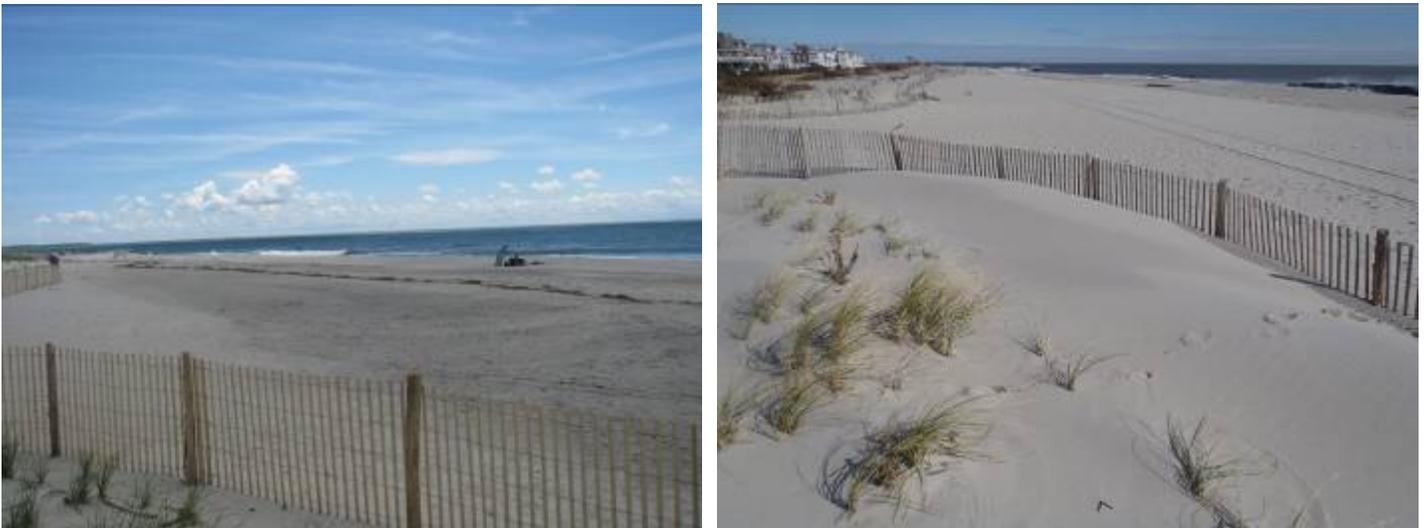
Baltimore Avenue, Cape May City, Cape May County, Site #107;

The left picture was taken in June 5, 2012 showing the beach toward the northeast. The post-storm shot on the right was taken November 9<sup>th</sup>. The sand can be seen deposited around the fencing leaving only two rows of wire above the sand while in June there were 5 rows of wire showing. Here the beach was also widened toward the zero elevation position.

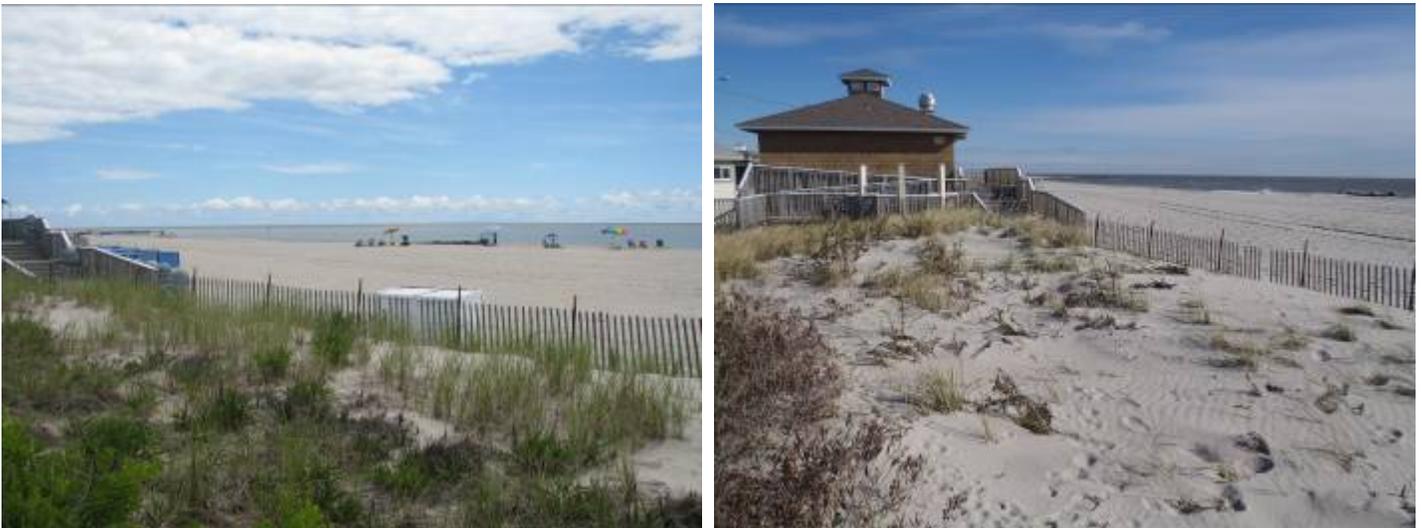
**Broadway Avenue, Cape May City, Cape May County, Site #206;**

The June 5, 2012 picture shows the popular bathing beach at the beginning of the last summer season. The right side shows the post-storm view on November 9<sup>th</sup>. The elevation increase shown below can be seen in the smaller slice of ocean in the right-hand view as compared to the left side. The seaward stair railings in both pictures have the same relative relationship to the horizon indicating that the view from the camera is almost the same elevation in both pictures.

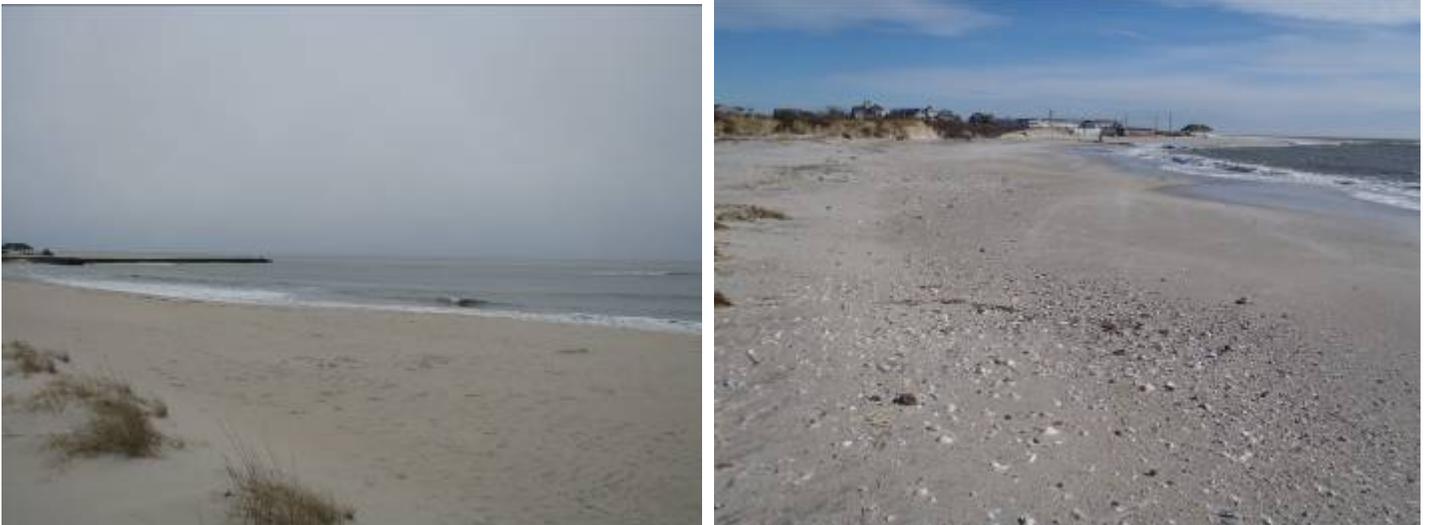
Nature Conservancy, Cape May County, Site #105;

The left picture was taken March 5, 2012 looking toward the terminal groin in Cape May City. The left shot was done November 9<sup>th</sup> showing the dune erosion and overwash into the newer dune development that has occurred over the past 22 years since the initial beach restoration took place in Cape May City in 1990.

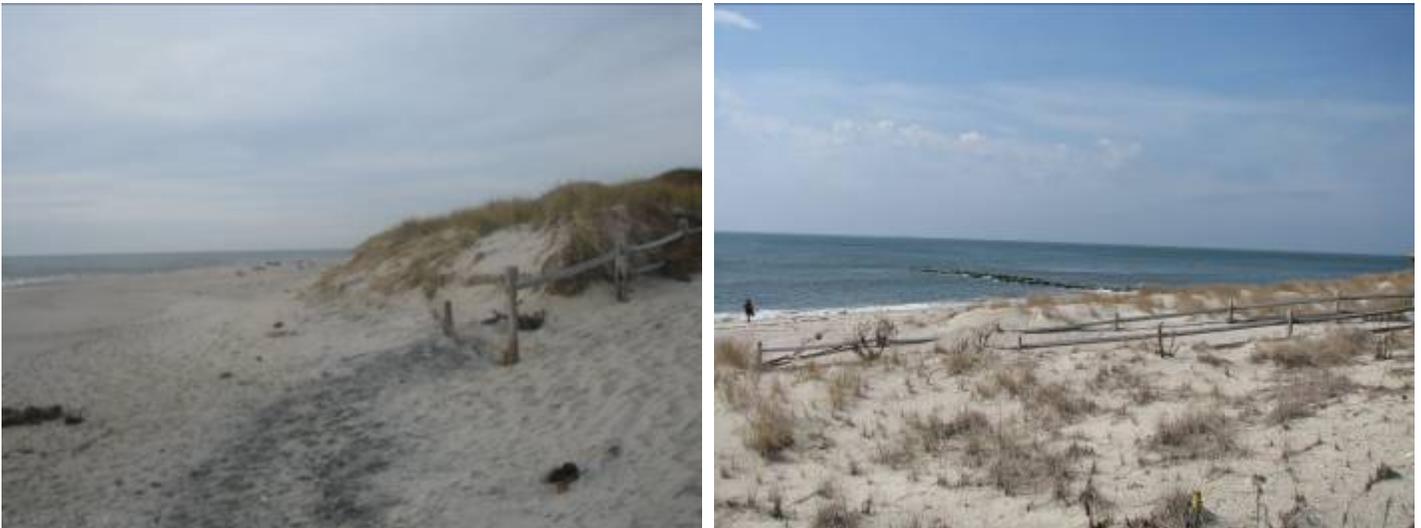
Lake Drive Cape May Point, Cape May County, Site #104;

The left picture was taken March 15, 2012 while the post-storm photograph was taken November 20<sup>th</sup> looking across the dunes to the bay. The beach was reduced in width somewhat, but no erosion occurred in the dunes. This location was essentially untouched by the storm.

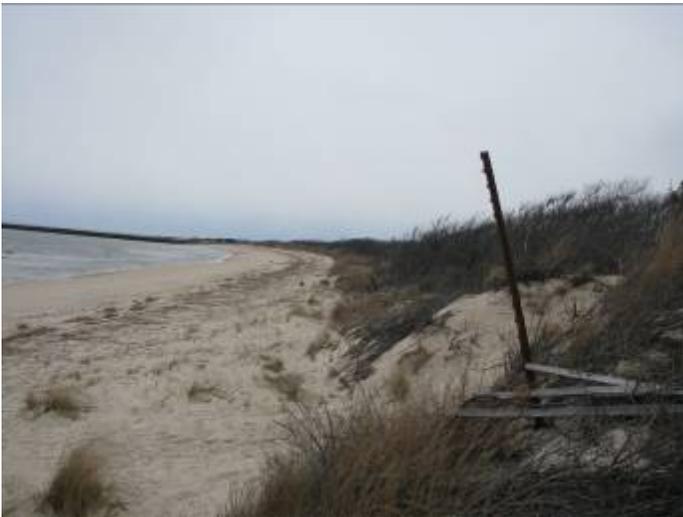
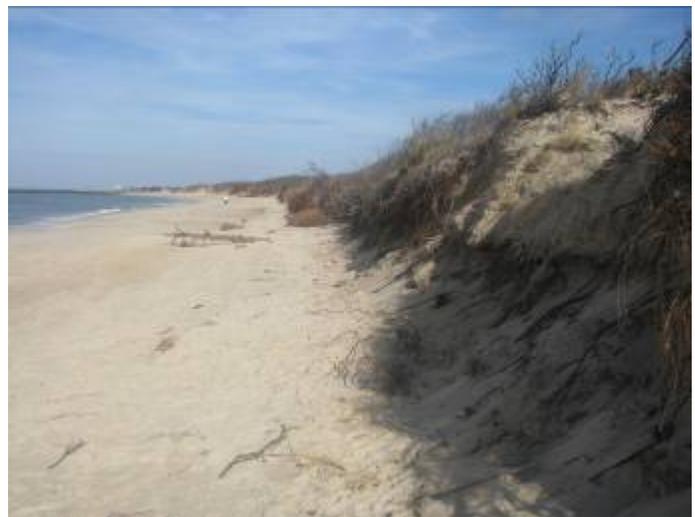
Higbee Beach State Park, Cape May County, Site #103;

The left picture was taken March 5, 2012 while the post-storm picture on the right was taken November 20, 2012. The shoreline at the State Park, south of the Cape May Canal suffered bluff erosion into the mantle of wind-deposited sand that mantles the scarp. The incipient grasses were stripped away between the high tide line and the base of the bluff during Sandy. The beach was lower but wider with some sand moved into the bay.

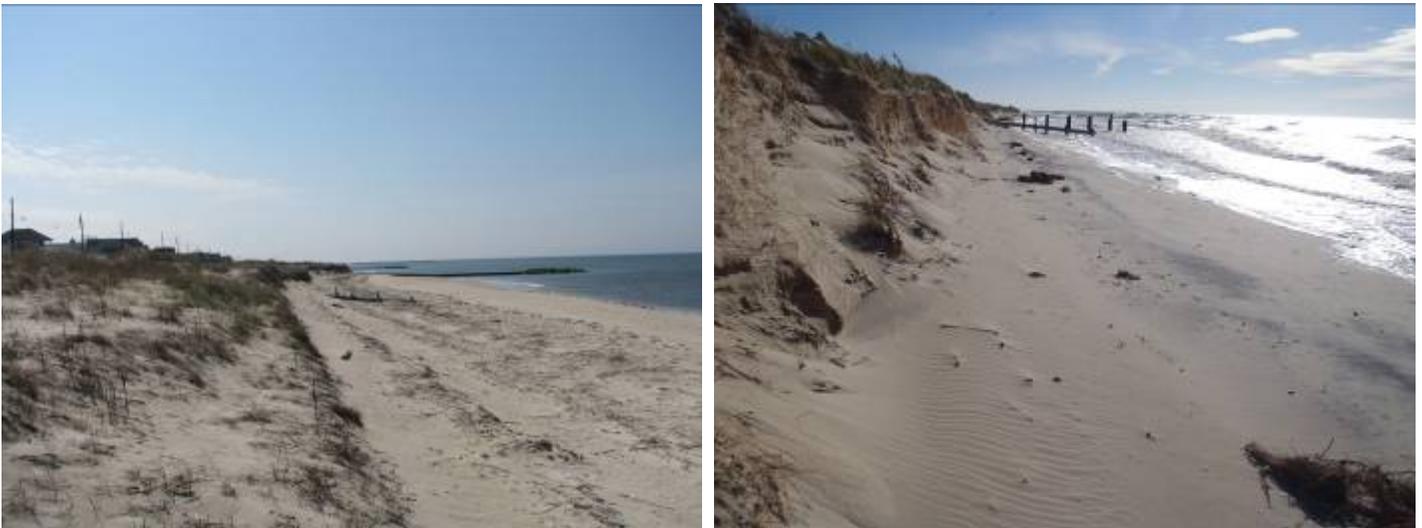
Whittier Avenue, North Cape May, Cape May County, Site #102;

At Whittier Avenue the drainage line shows the extent of beach erosion between March 15, 2012 and after Sandy on November 9<sup>th</sup>. Sand was moved offshore onto the terrace, but the dune withstood the majority of the Delaware Bay wave assault on this shoreline.

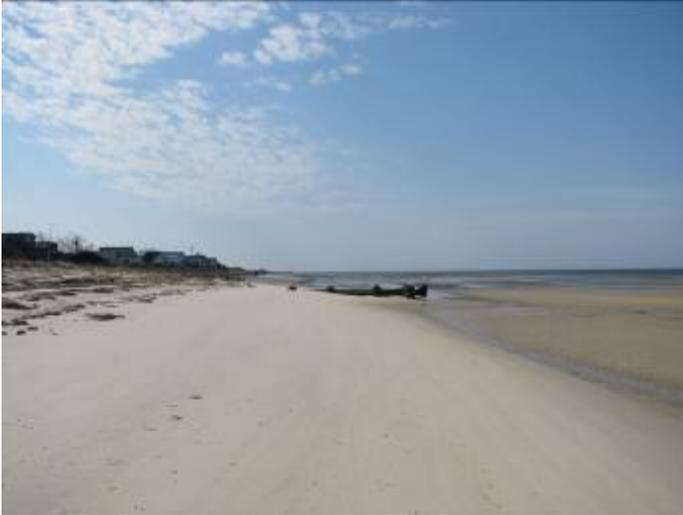
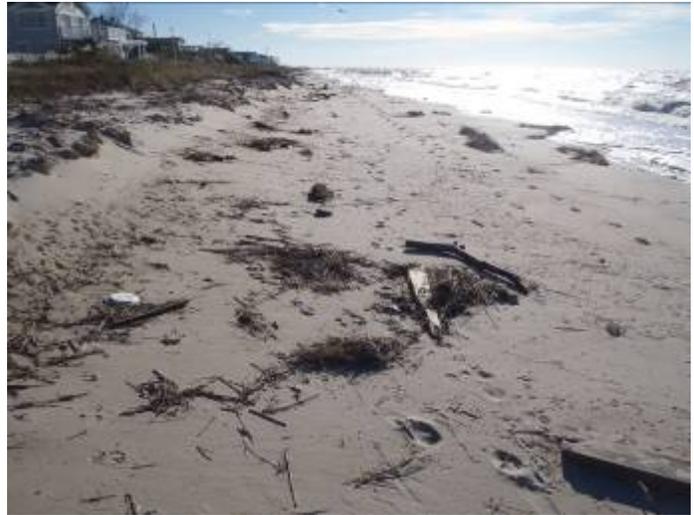
Pacific Avenue, Villas, Cape May County, Site #201;

The left view was taken March 7, 2012 looking south along the beachfront. By November 9<sup>th</sup> the storm impact was found to have eroded the beach into the toe of the dune reducing the beach elevation and creating a minor scarp. The height of the uplands bluff prevented local wave or tidal flooding.

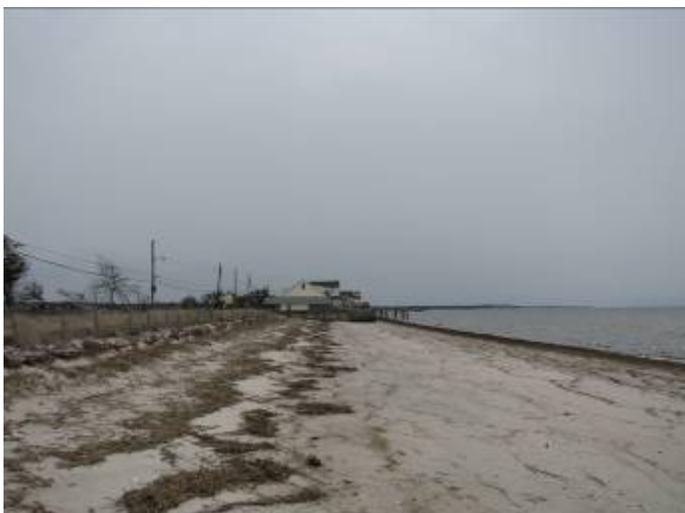
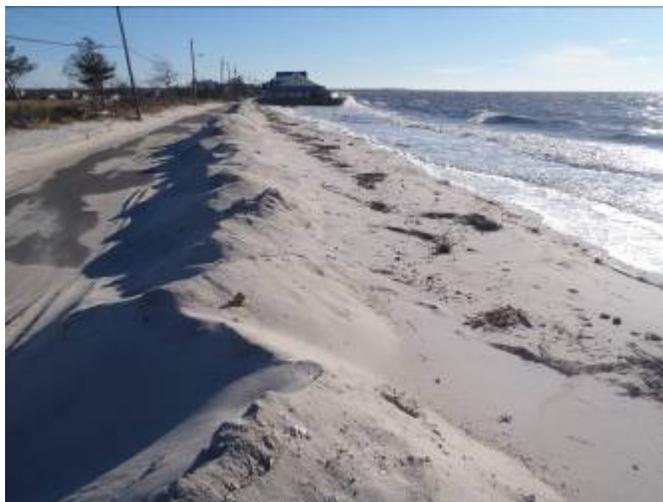
**Reeds Beach, Cape May County, Site #100;**

The left photograph was taken March 5, 2012 looking south. The dune was vegetated and the beach was higher in elevation compared to the post-Sandy picture on the right taken November 8, 2012. The sand in the center of the right photo has been transferred from the roadway back to the beach as a series of piles.
