# New Jersey Beach Profile Network

## Monmouth County

Raritan Bay and Sandy Hook  
to Manasquan Inlet

**NJBPN Profile #'s  
187 - 256**

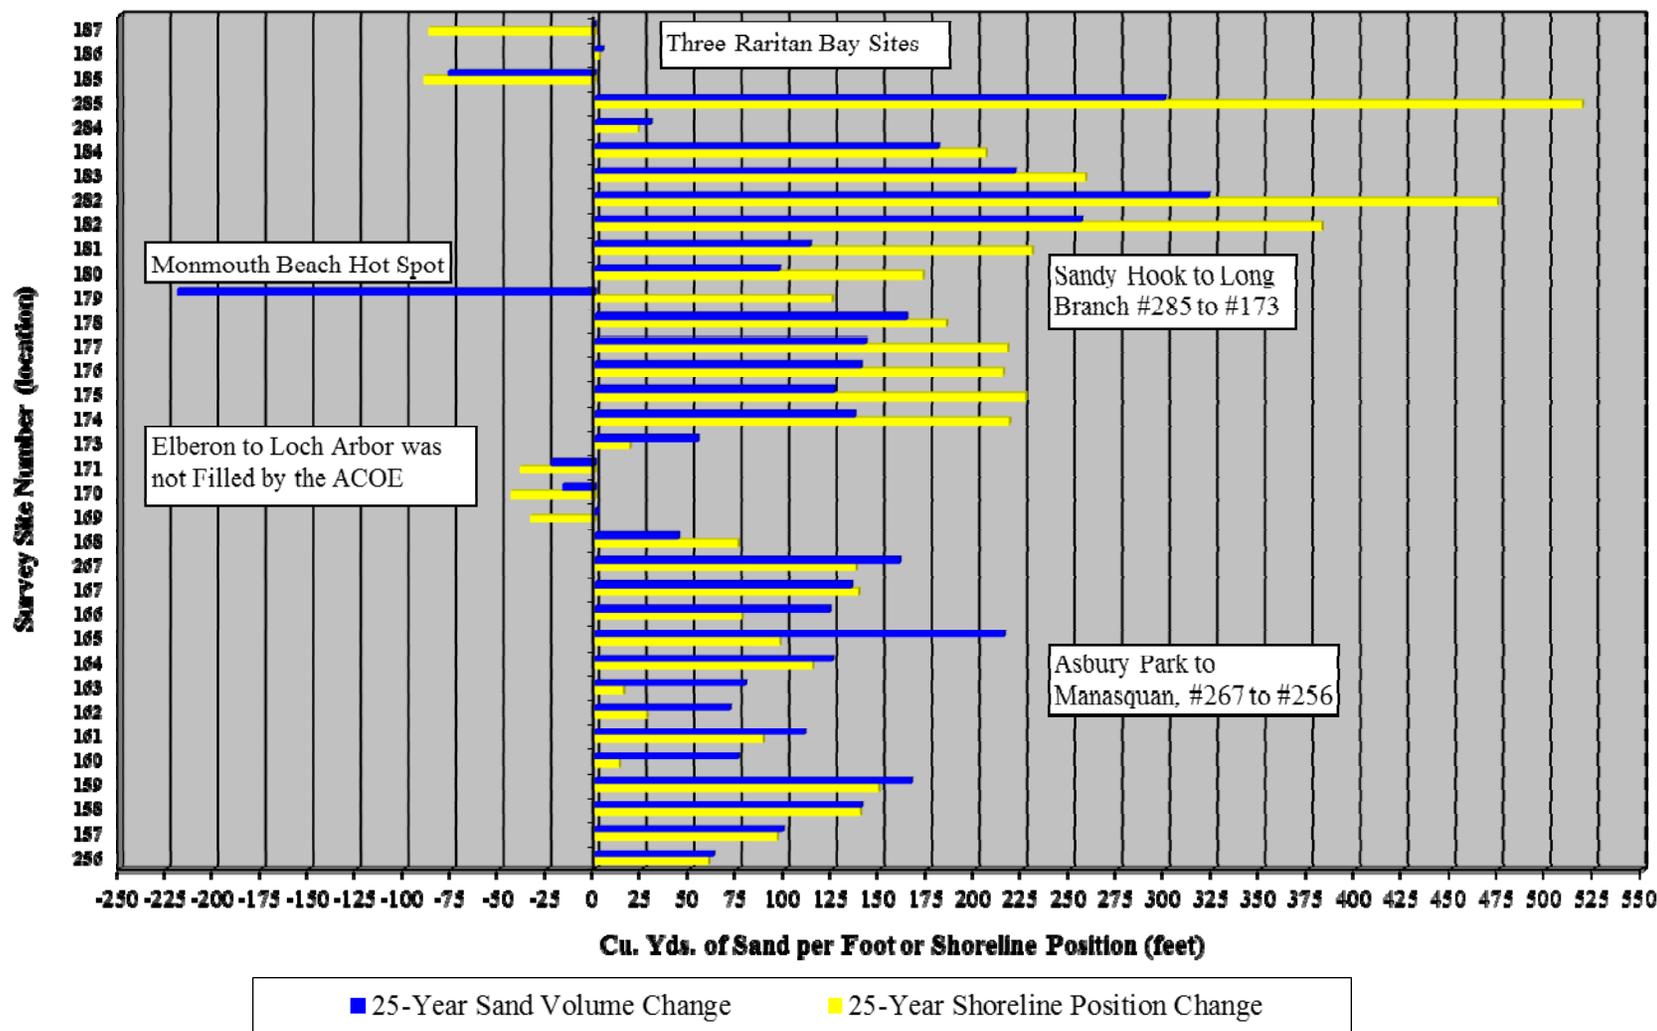
## Monmouth County, Beach Volume & Shoreline Position Changes Over 25 Years

Figure 2. The graph above shows the 25-year changes in shoreline position and volume for all 36 of the Monmouth County survey sites. Many of the sites show the influence of the Federal beach nourishment project and subsequent maintenance fill that was added to several locations in response to the 1997 storm. Though there was a substantial loss of sand in the El Nino year of 2009 and 2010, the county remains in “good shape” for volume and shoreline position when compared to the 1986 conditions. Certainly, beach nourishment is credited for the successes in Monmouth County. Only a few locations suffer from erosion and those areas were either not included of the Federal project, or are adjacent to a coastal structure that blocks the littoral flow of sand.

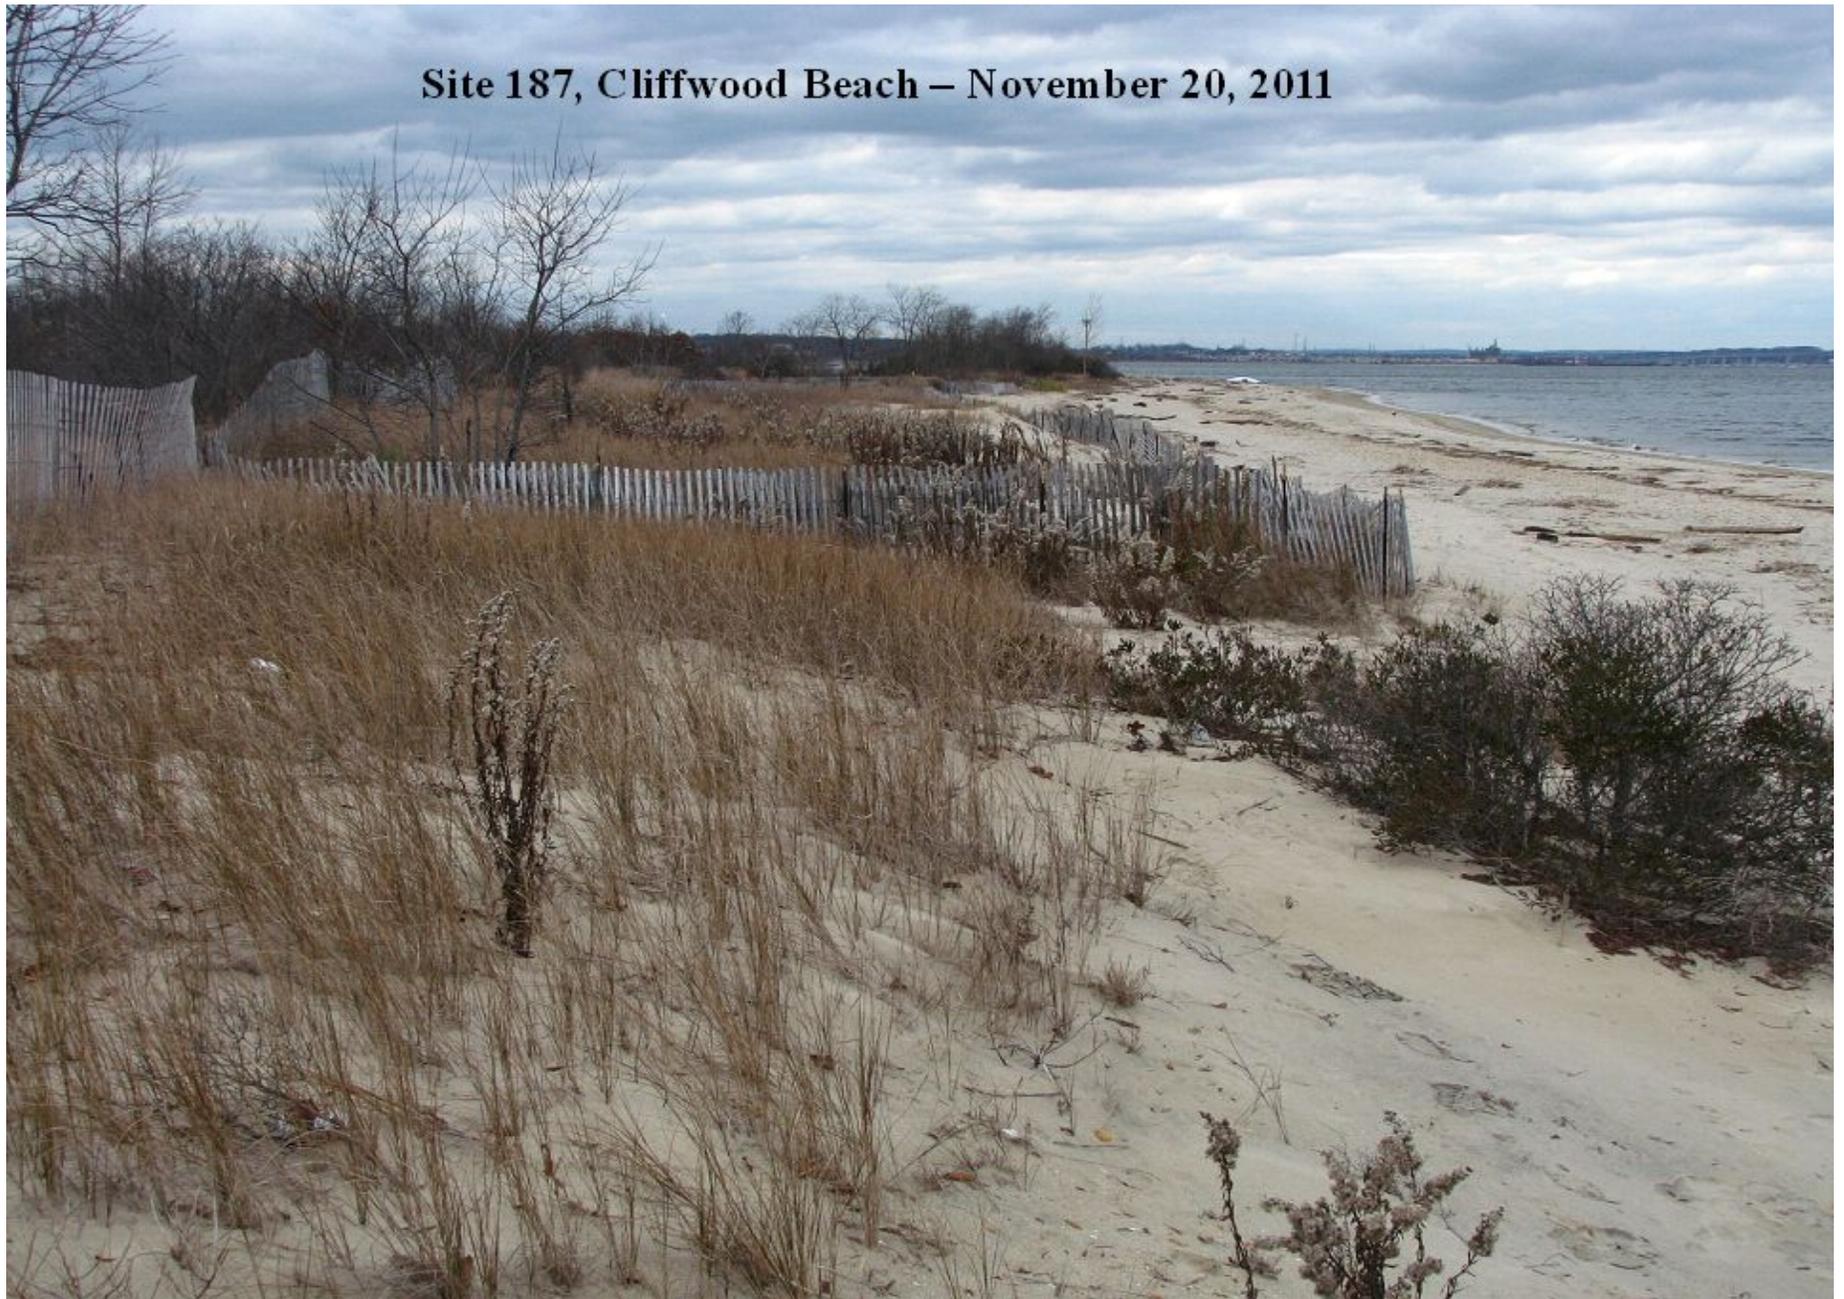
**Site 187, Cliffwood Beach – November 20, 2011**

**Figure 3: Shown above is the view looking northwest from the dune in Cliffwood Beach, NJ.**

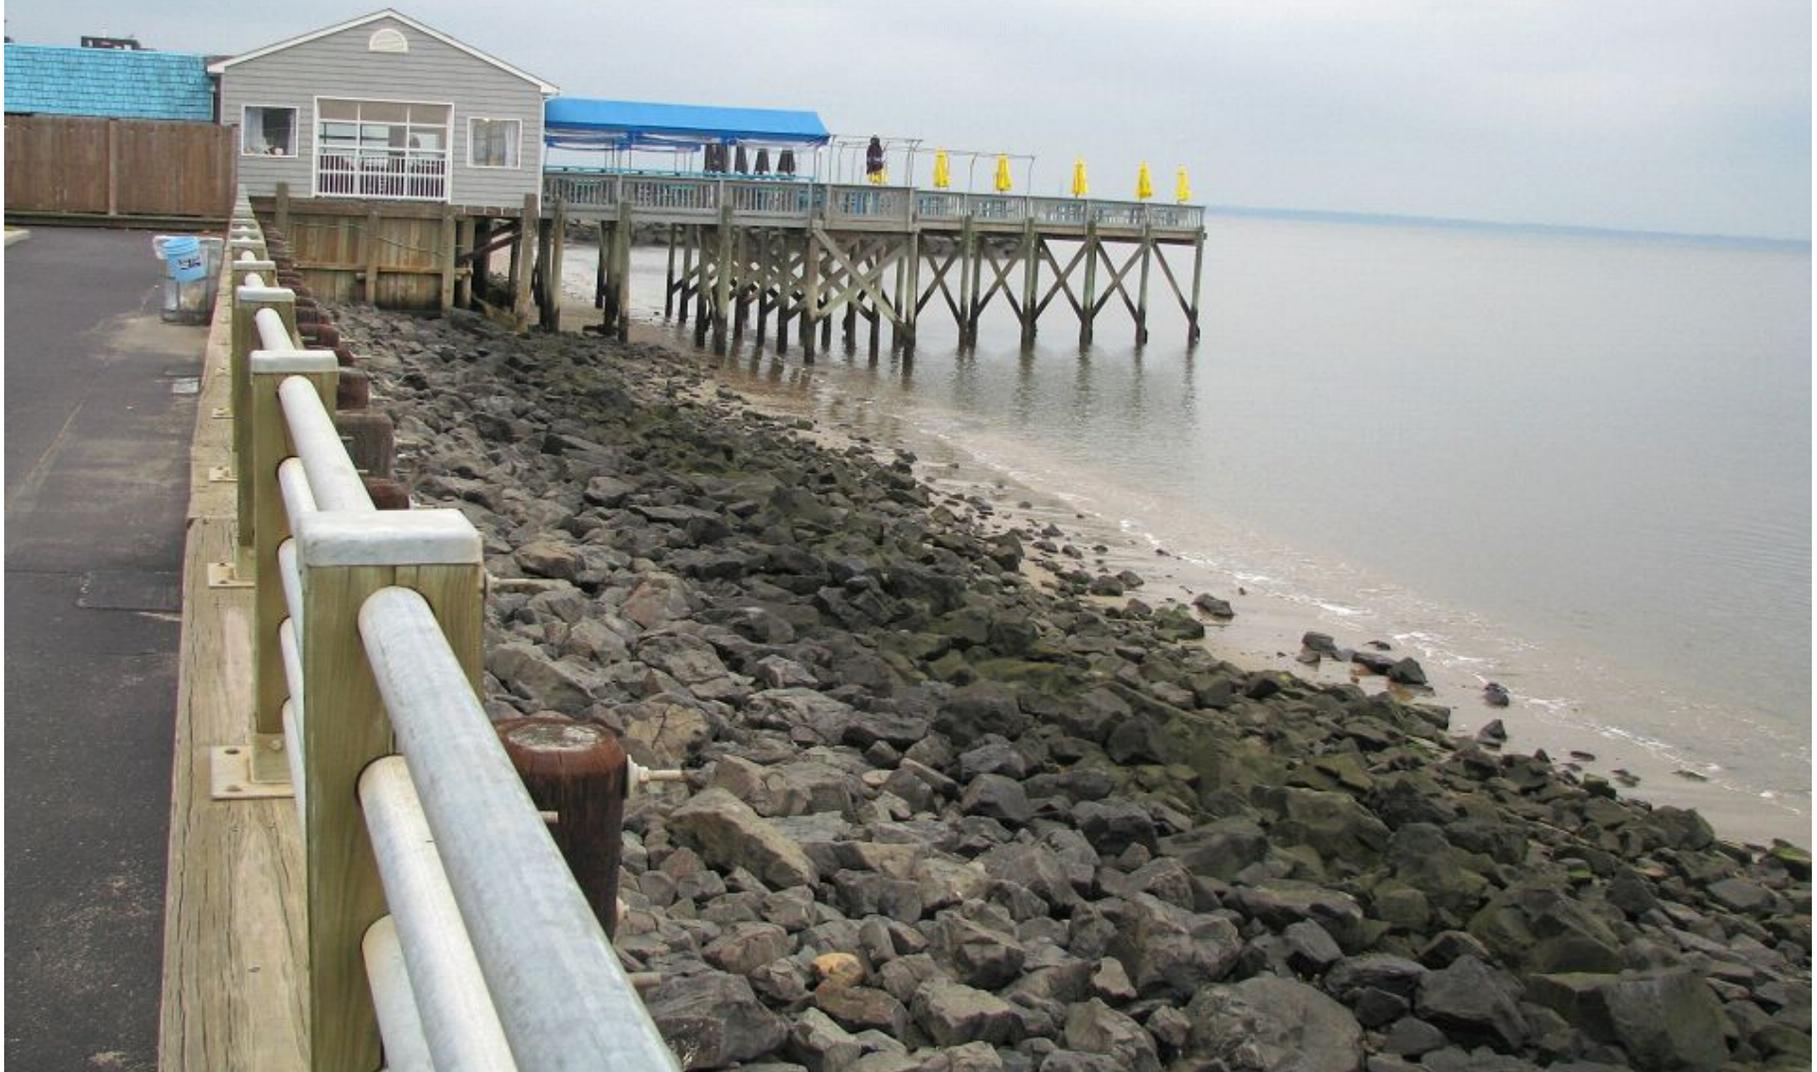
**Site 186, Union Beach – September 9, 2008 (abandoned)**

**Figure 7: Shown above is the view looking northwest from on top of the revetment. This site was abandoned in 2008 and moved 1000 northwest of the location pictured below to be closer to the municipal bathing beach where survey data was much more useful.**

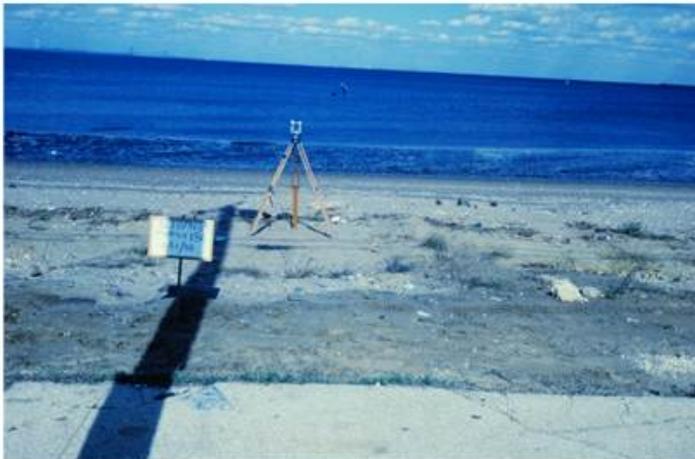
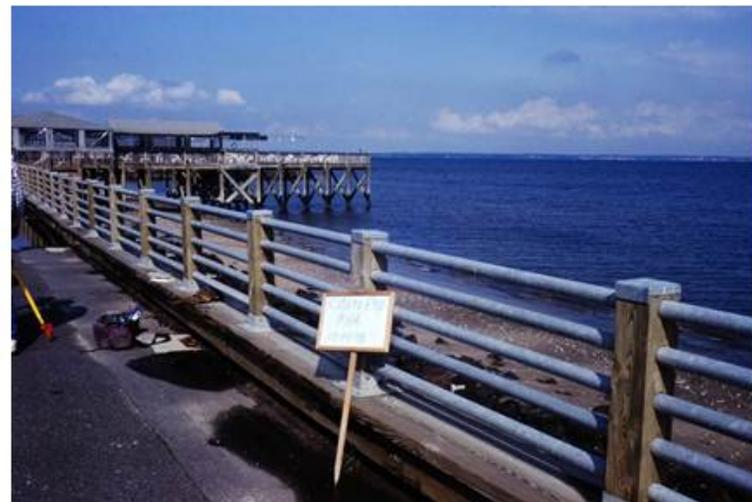
Figure 8. In 2009, the original profile location was abandoned and a new one was established about a quarter mile to the northwest along the shoreline to a public bathing beach. The new site is near the intersection of Beach and Front Streets in Union Beach. This site experienced very modest changes to the profile. (Left photo October 11, 1988 [view to the north]; right photo October 14, 1998 [view to the west]).

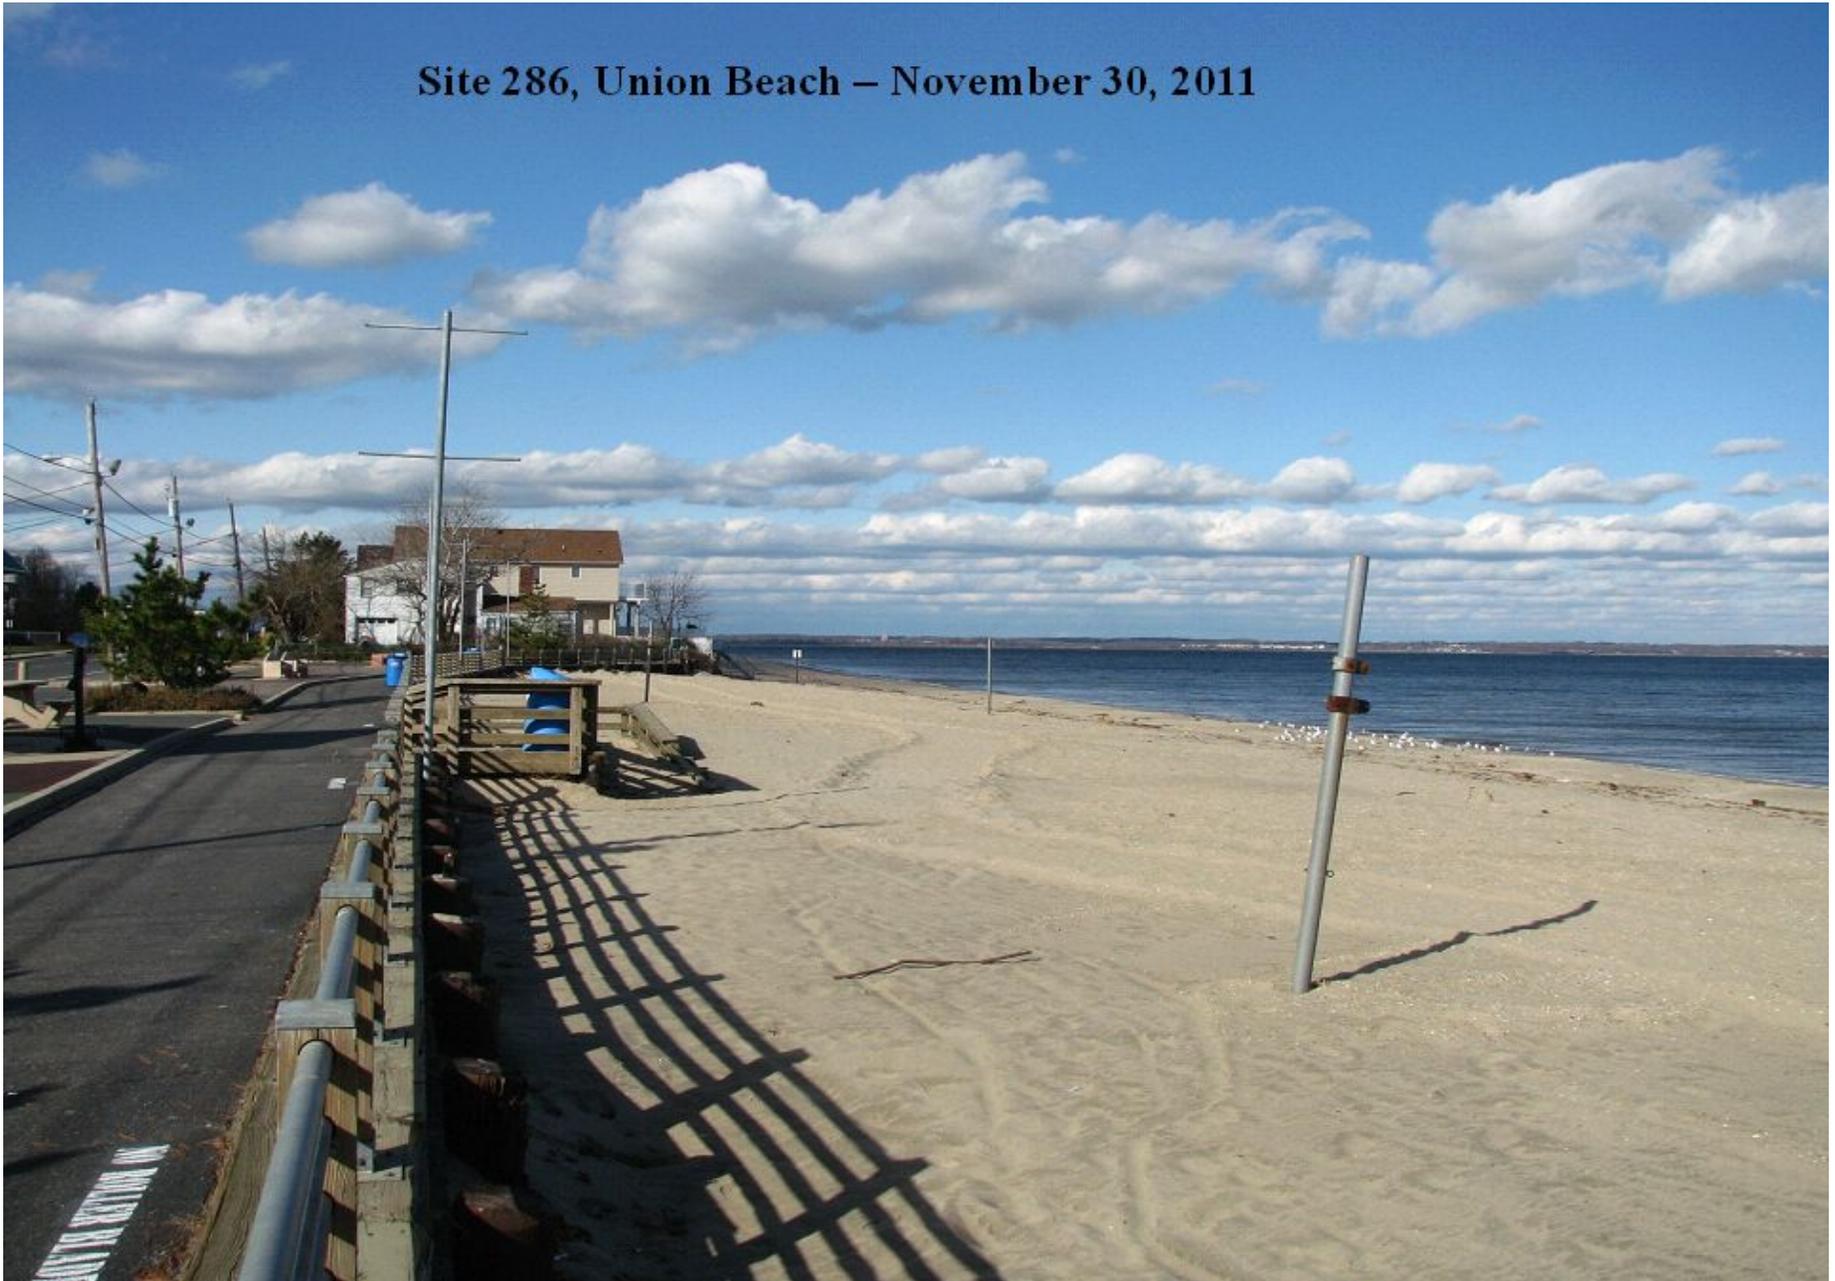
**Site 286, Union Beach – November 30, 2011**

**Figure 10: Shown above is the view looking northwest from the bulkhead at the repositioned Union Beach survey location.**

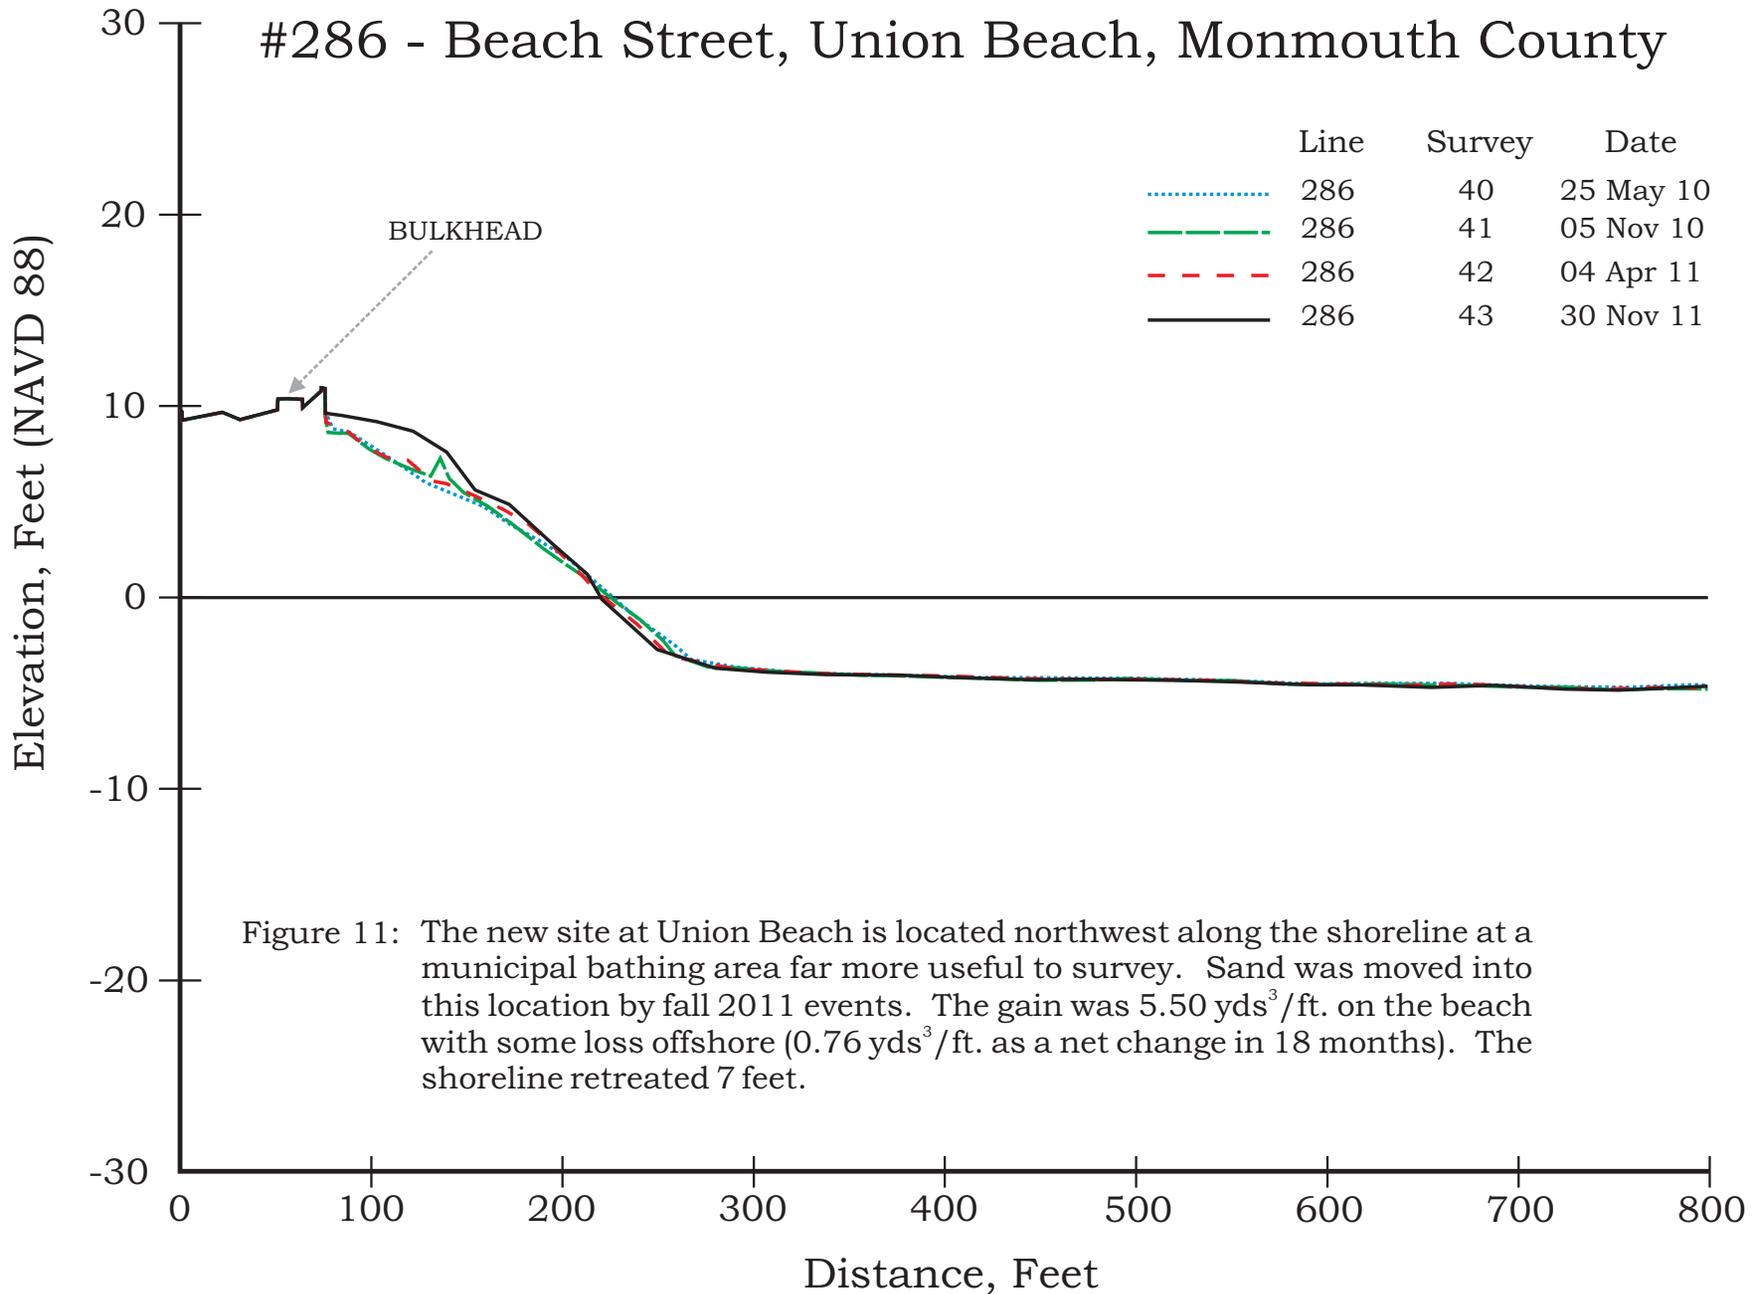
#286 - Beach Street, Union Beach, Monmouth County

Figure 11: The new site at Union Beach is located northwest along the shoreline at a municipal bathing area far more useful to survey. Sand was moved into this location by fall 2011 events. The gain was 5.50 yds<sup>3</sup>/ft. on the beach with some loss offshore (0.76 yds<sup>3</sup>/ft. as a net change in 18 months). The shoreline retreated 7 feet.

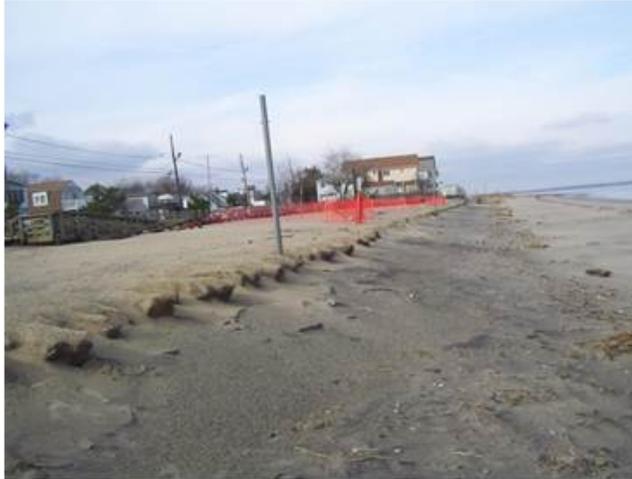
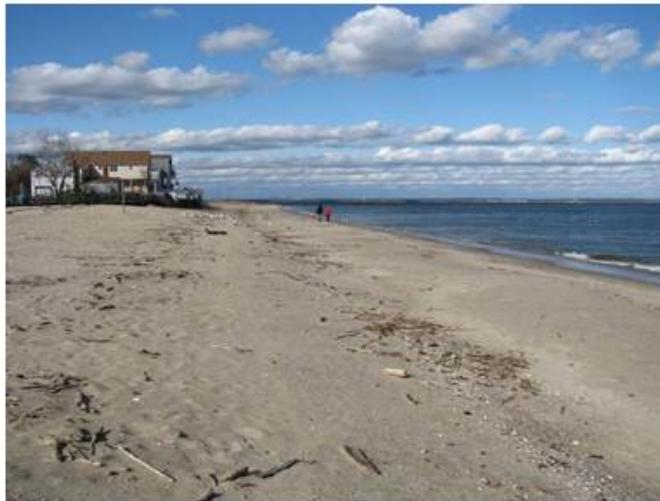
Figure 12. This site was established in 2009 after former Site 186 was abandoned. Site 186 was located southeast of this site. The new site is located at a public bathing beach near the intersection of Beach and Front Streets in Union Beach. (Top photo December 14, 2009 [view to the west]; bottom photo November 30, 2011, two years after the new site was established [view to the west]).

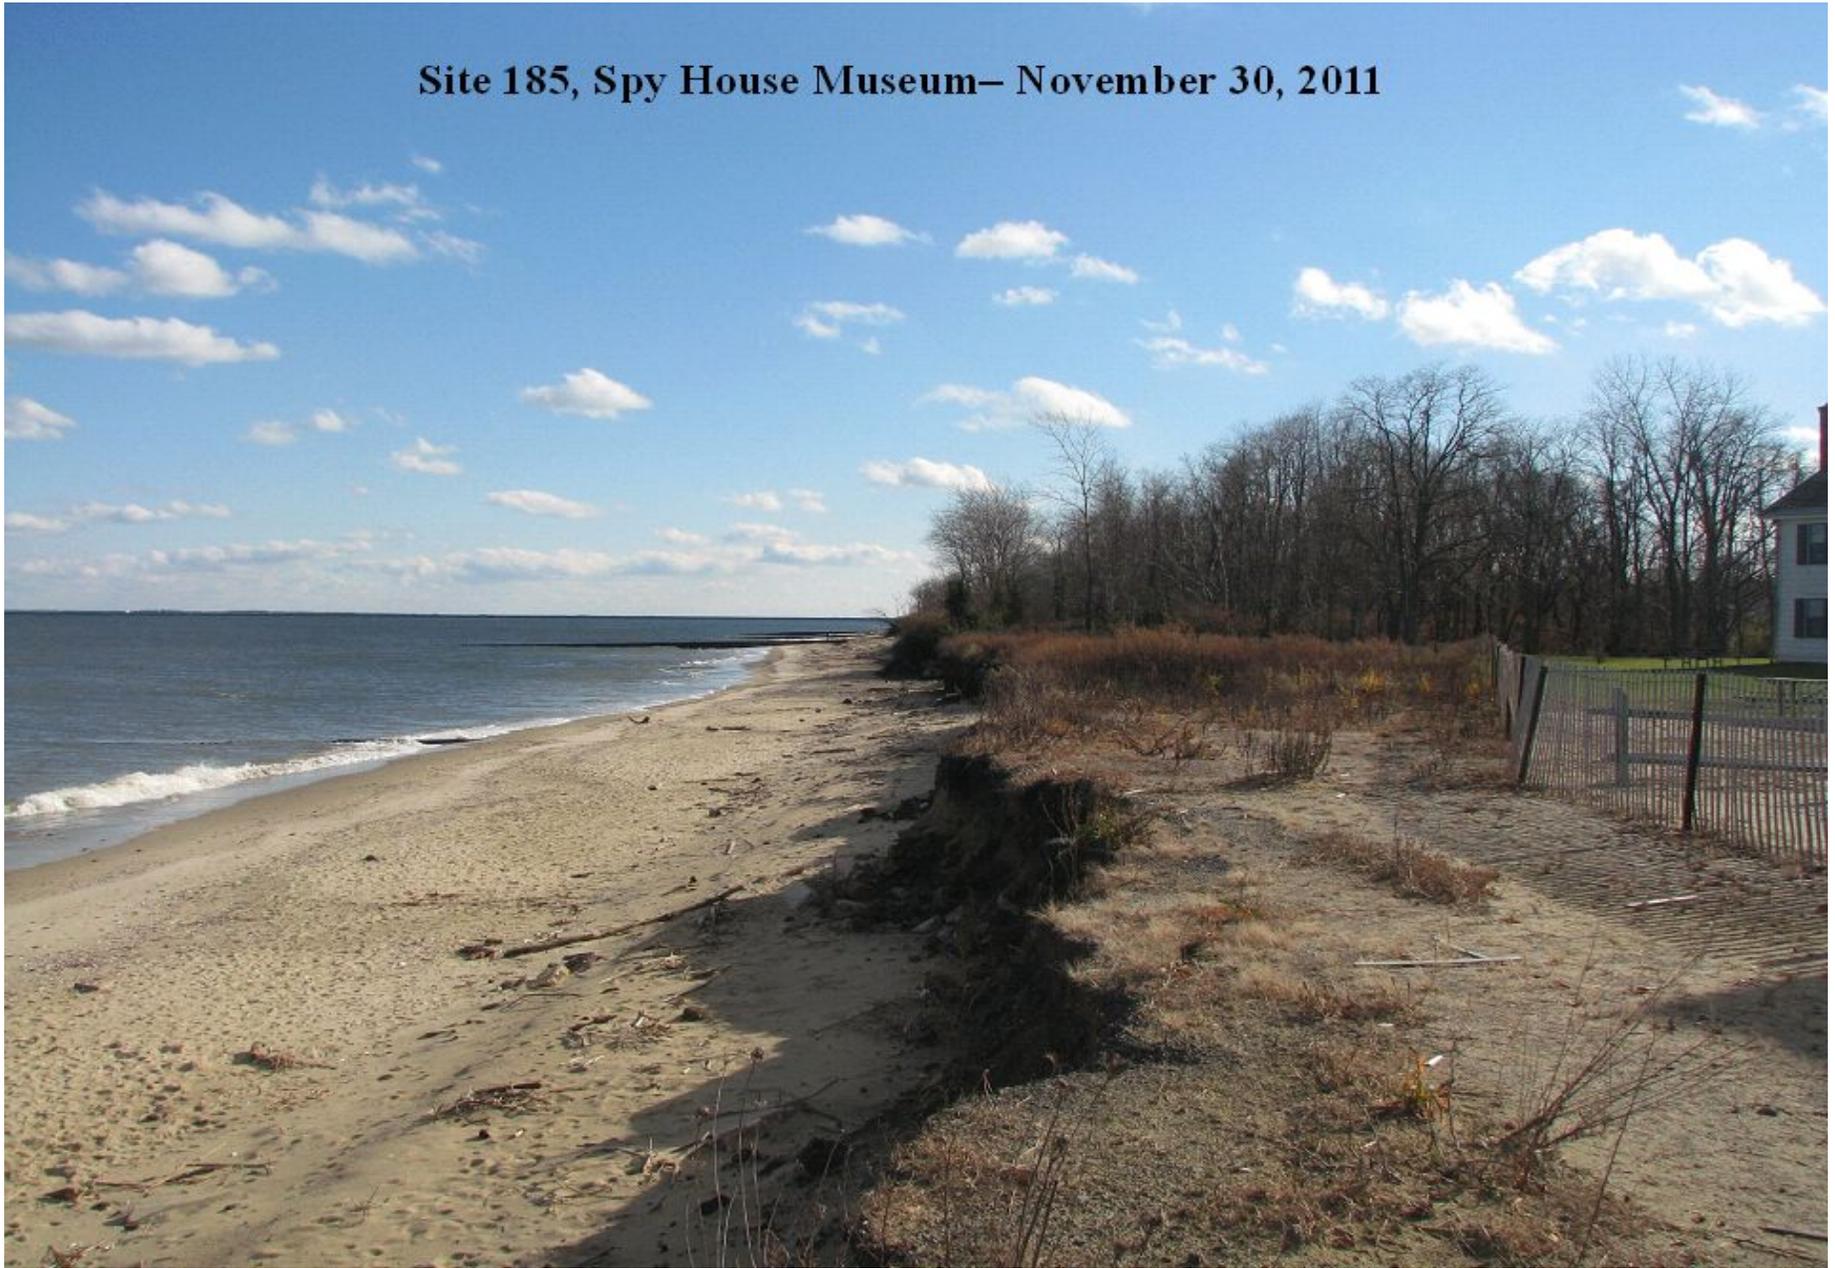
**Site 185, Spy House Museum– November 30, 2011**

**Figure 14: Shown above is the view looking southeast from on top of the scarp at the Spy House Museum in Port Monmouth, NJ.**

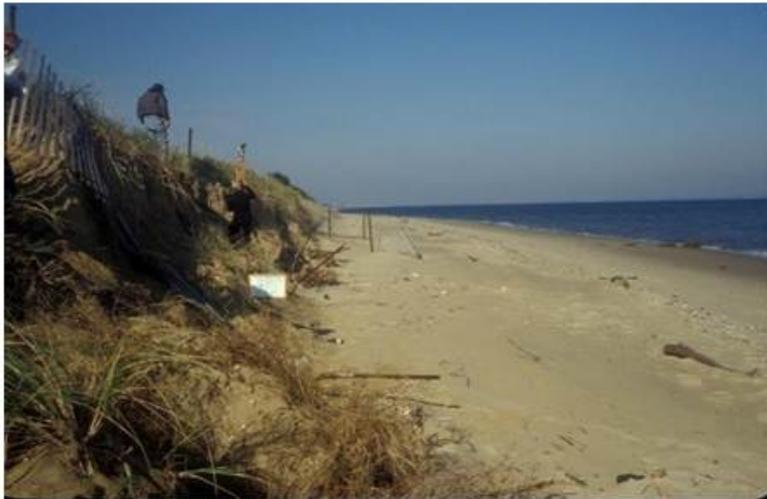
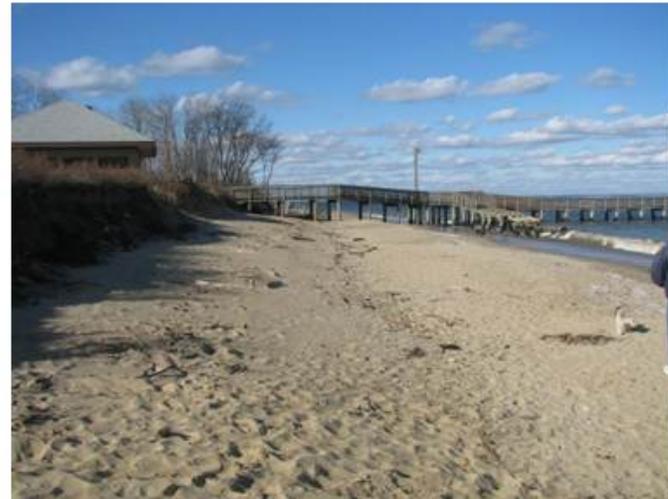
Figure 16. Though some recovery occurred in 1993, this site is in on a long-term erosional trend including the nearshore. (Left photo October 11, 1989 [view to the west]; right photo November 30, 2011 [view to the west]).

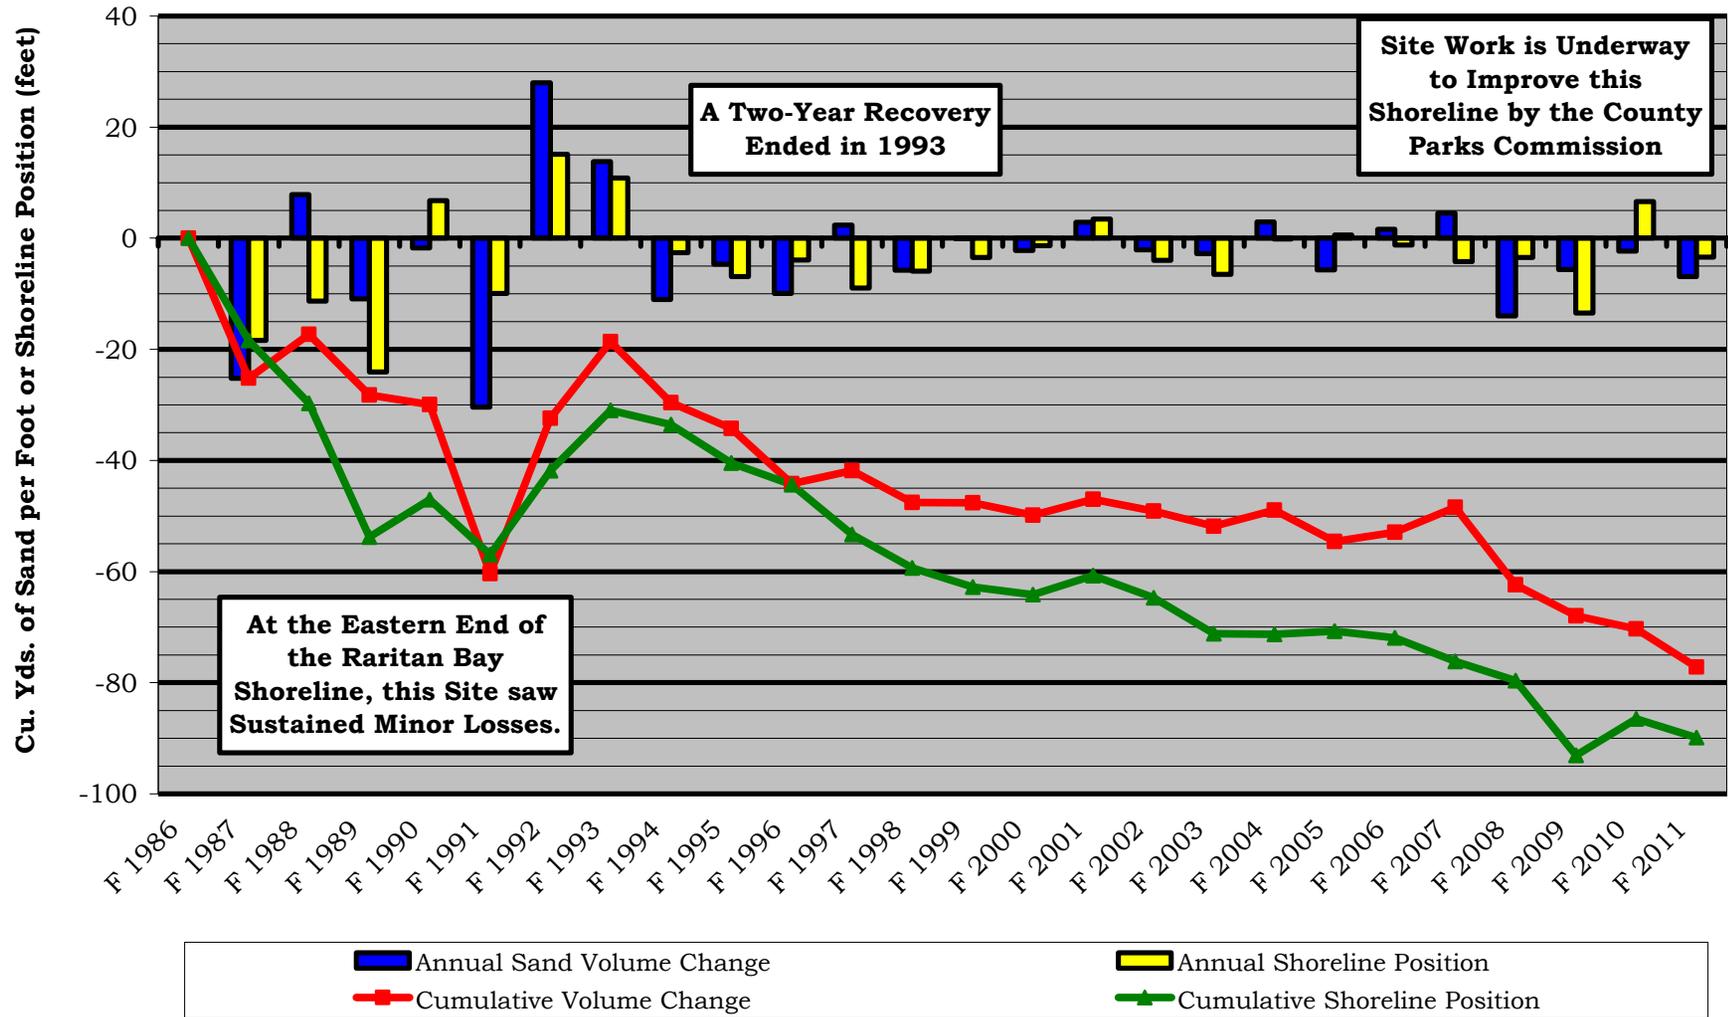
**25-Year Coastal Changes at Site 185, Spy House, Port Monmouth, Monmouth Co.**

Figure 17. Large losses to the beach and dune occurred in 1989. A lack of adequate beach width inhibits dune and bluff stability here allowing this site to be susceptible to damages from northeast storm-generated waves.

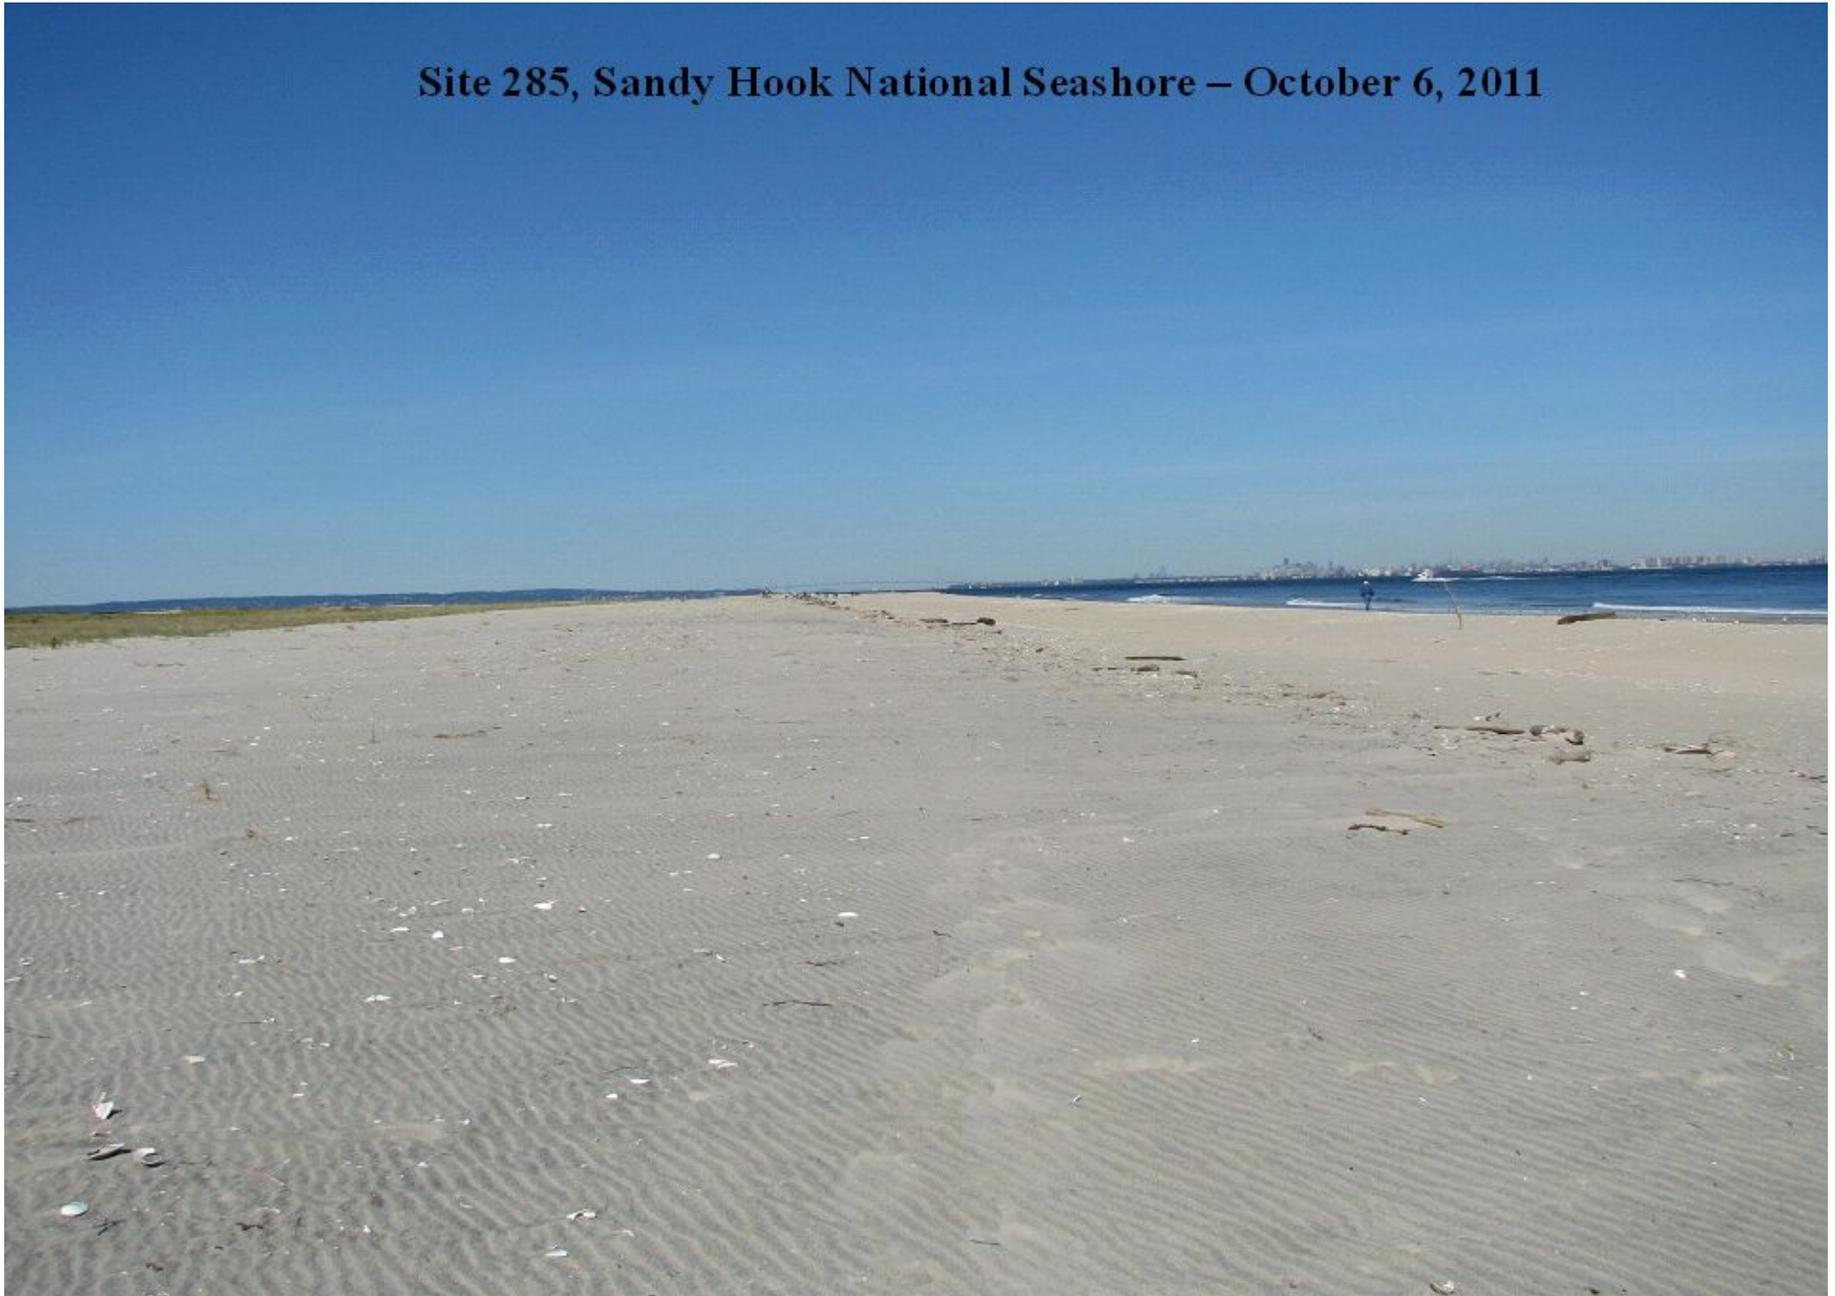
**Site 285, Sandy Hook National Seashore – October 6, 2011**

**Figure 18: Shown above is the view looking north from the wrack line at Gunnison Beach, in Sandy Hook National Seashore, NJ.**

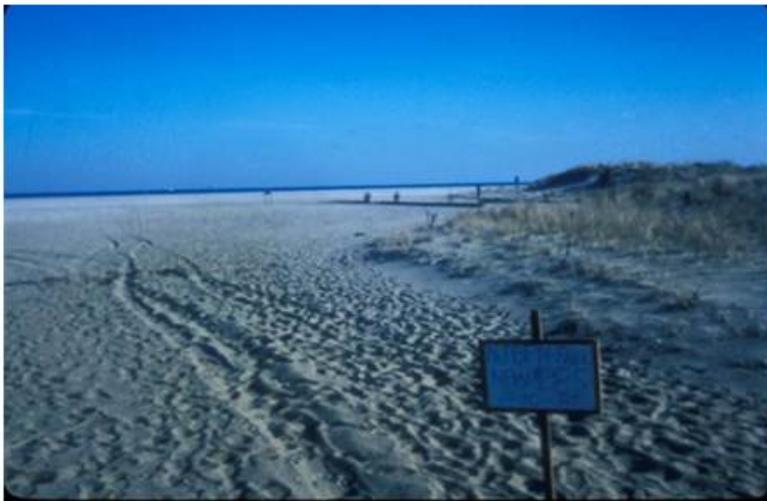
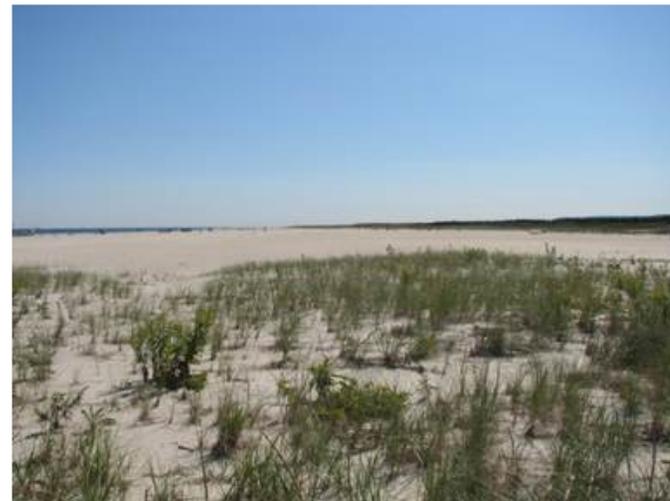
Figure 20. This site has continually gained sand with the exception of the time period from 1995 to 2001 where some of the dune material was redistributed onto the berm. (Left photo January 10, 1995 [view to the southeast]; right photo October 6, 2011 [view to the southeast]).
