# New Jersey Beach Profile Network

## Monmouth County

Raritan Bay and Sandy Hook  
to Manasquan Inlet

**NJBPN Profile #'s  
187 - 256**

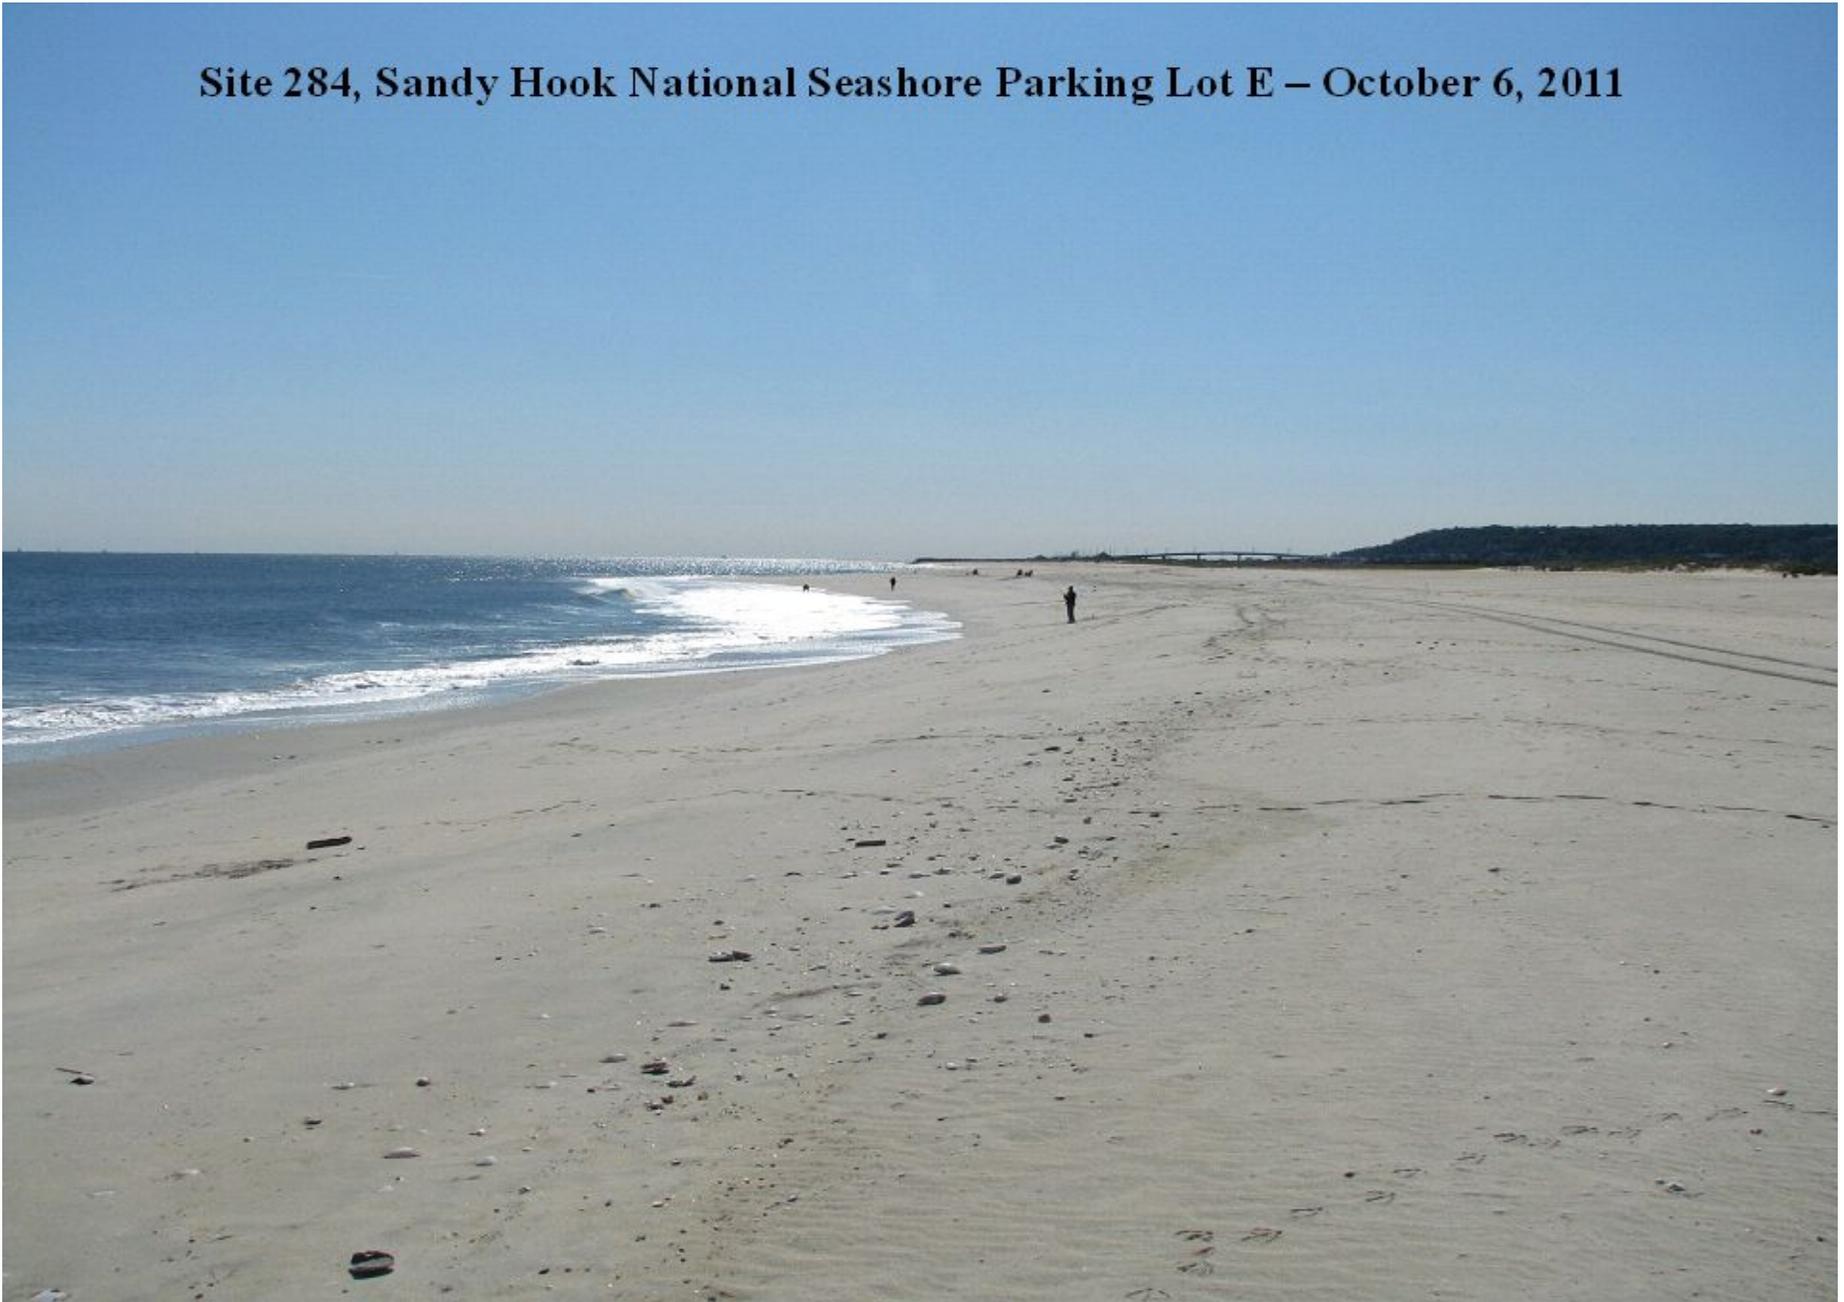
**Site 284, Sandy Hook National Seashore Parking Lot E – October 6, 2011**

**Figure 22. Shown above is the view looking south from the berm near parking lot E in Sandy Hook National Seashore, NJ.**

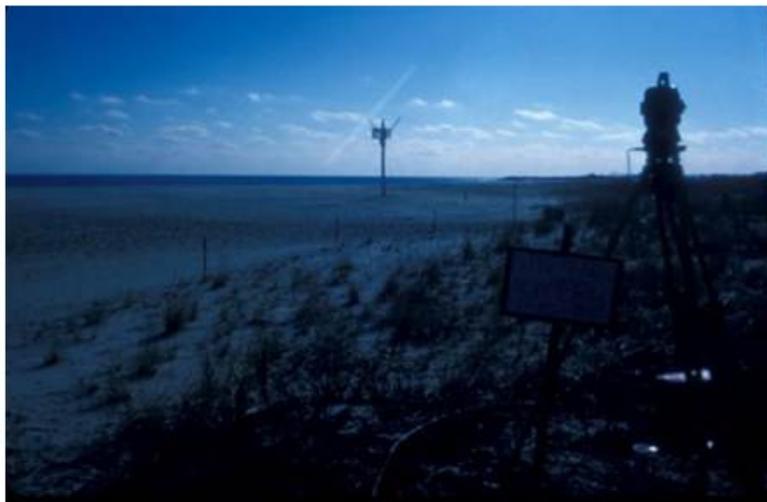
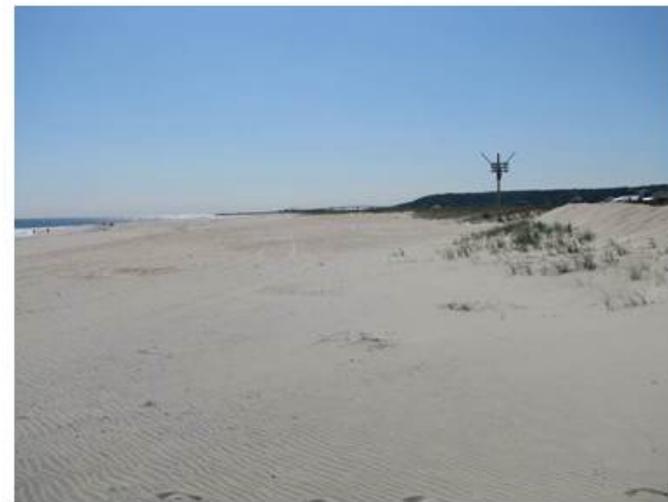
Figure 24. Sand dunes have developed on the former berm following the Monmouth County Federal beach nourishment project. Sand was placed at this location through a cooperative effort between the USACE and US Park Service in 2002. (Left photo January 10, 1995 [view to the southeast]; right photo October 6, 2011 [view to the south]).

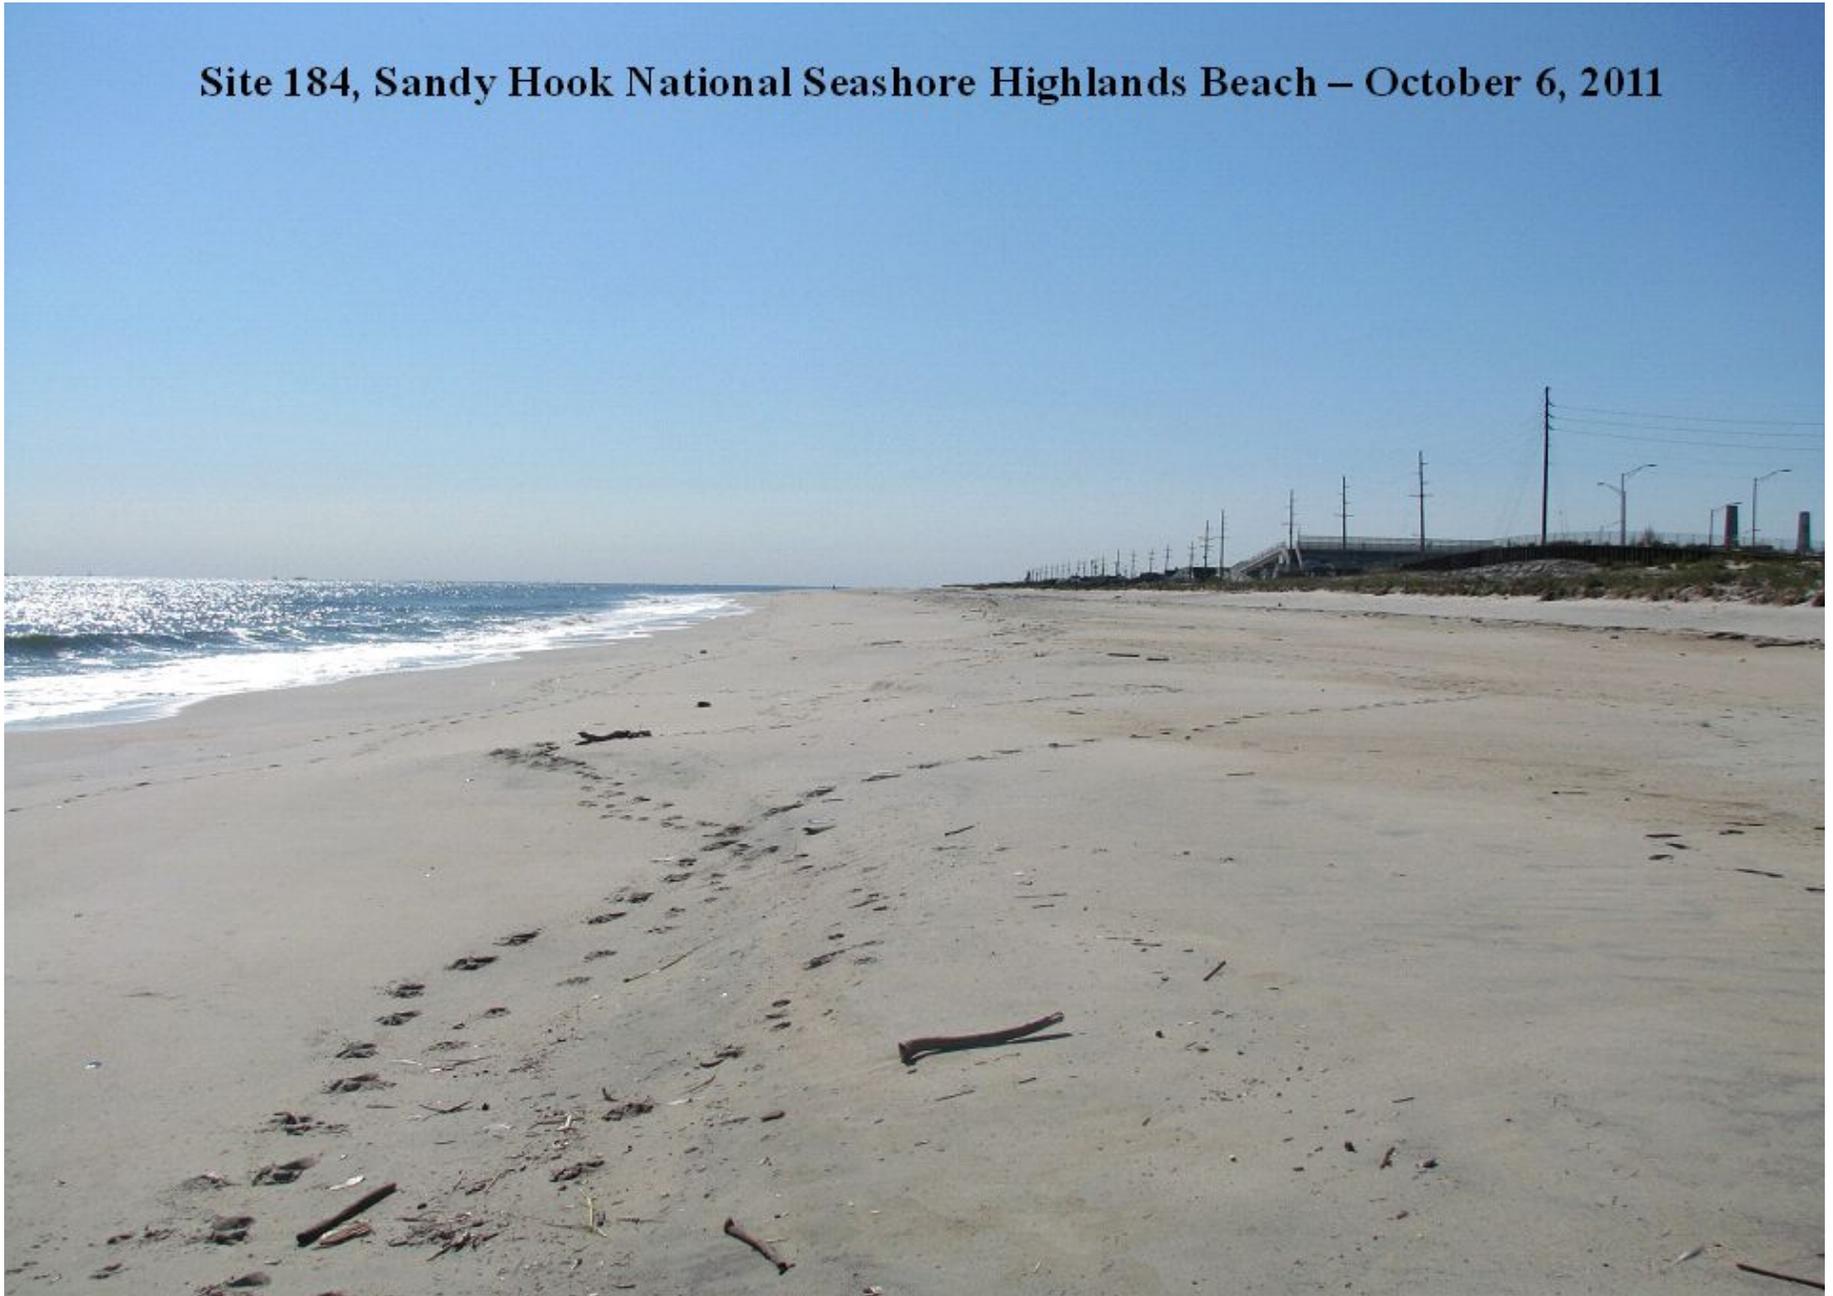
**Site 184, Sandy Hook National Seashore Highlands Beach – October 6, 2011**

**Figure 26. Shown above is the view looking south from the berm at Highlands Beach in Sandy Hook National Seashore, NJ.**

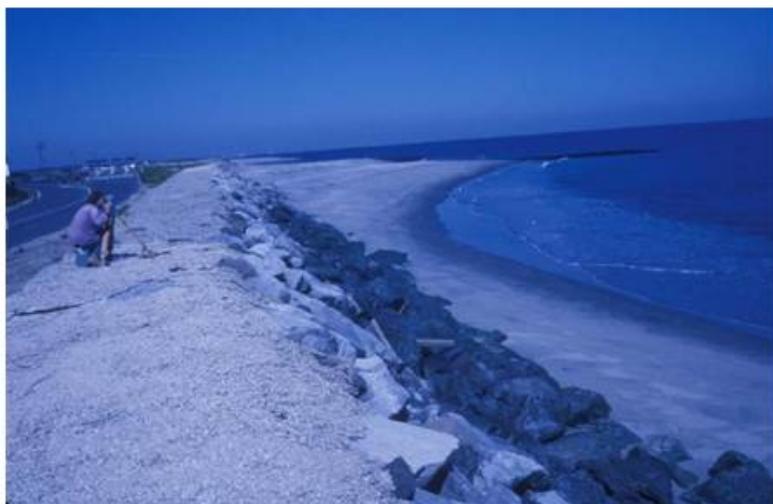
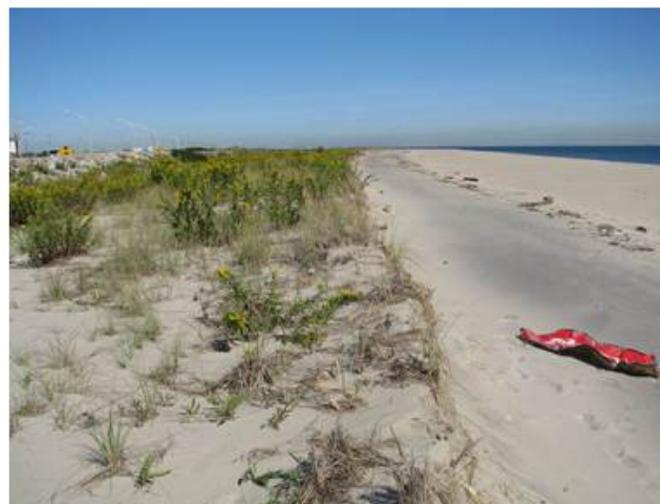
Figure 28. This site has gained in volume and the shoreline has significantly advanced seaward since the Monmouth County 1996 Federal beach nourishment project was constructed and follow-up 2002 maintenance fill. (Left photo October 5, 1987 [view to the north]; right photo October 6, 2011 [view to the north]).

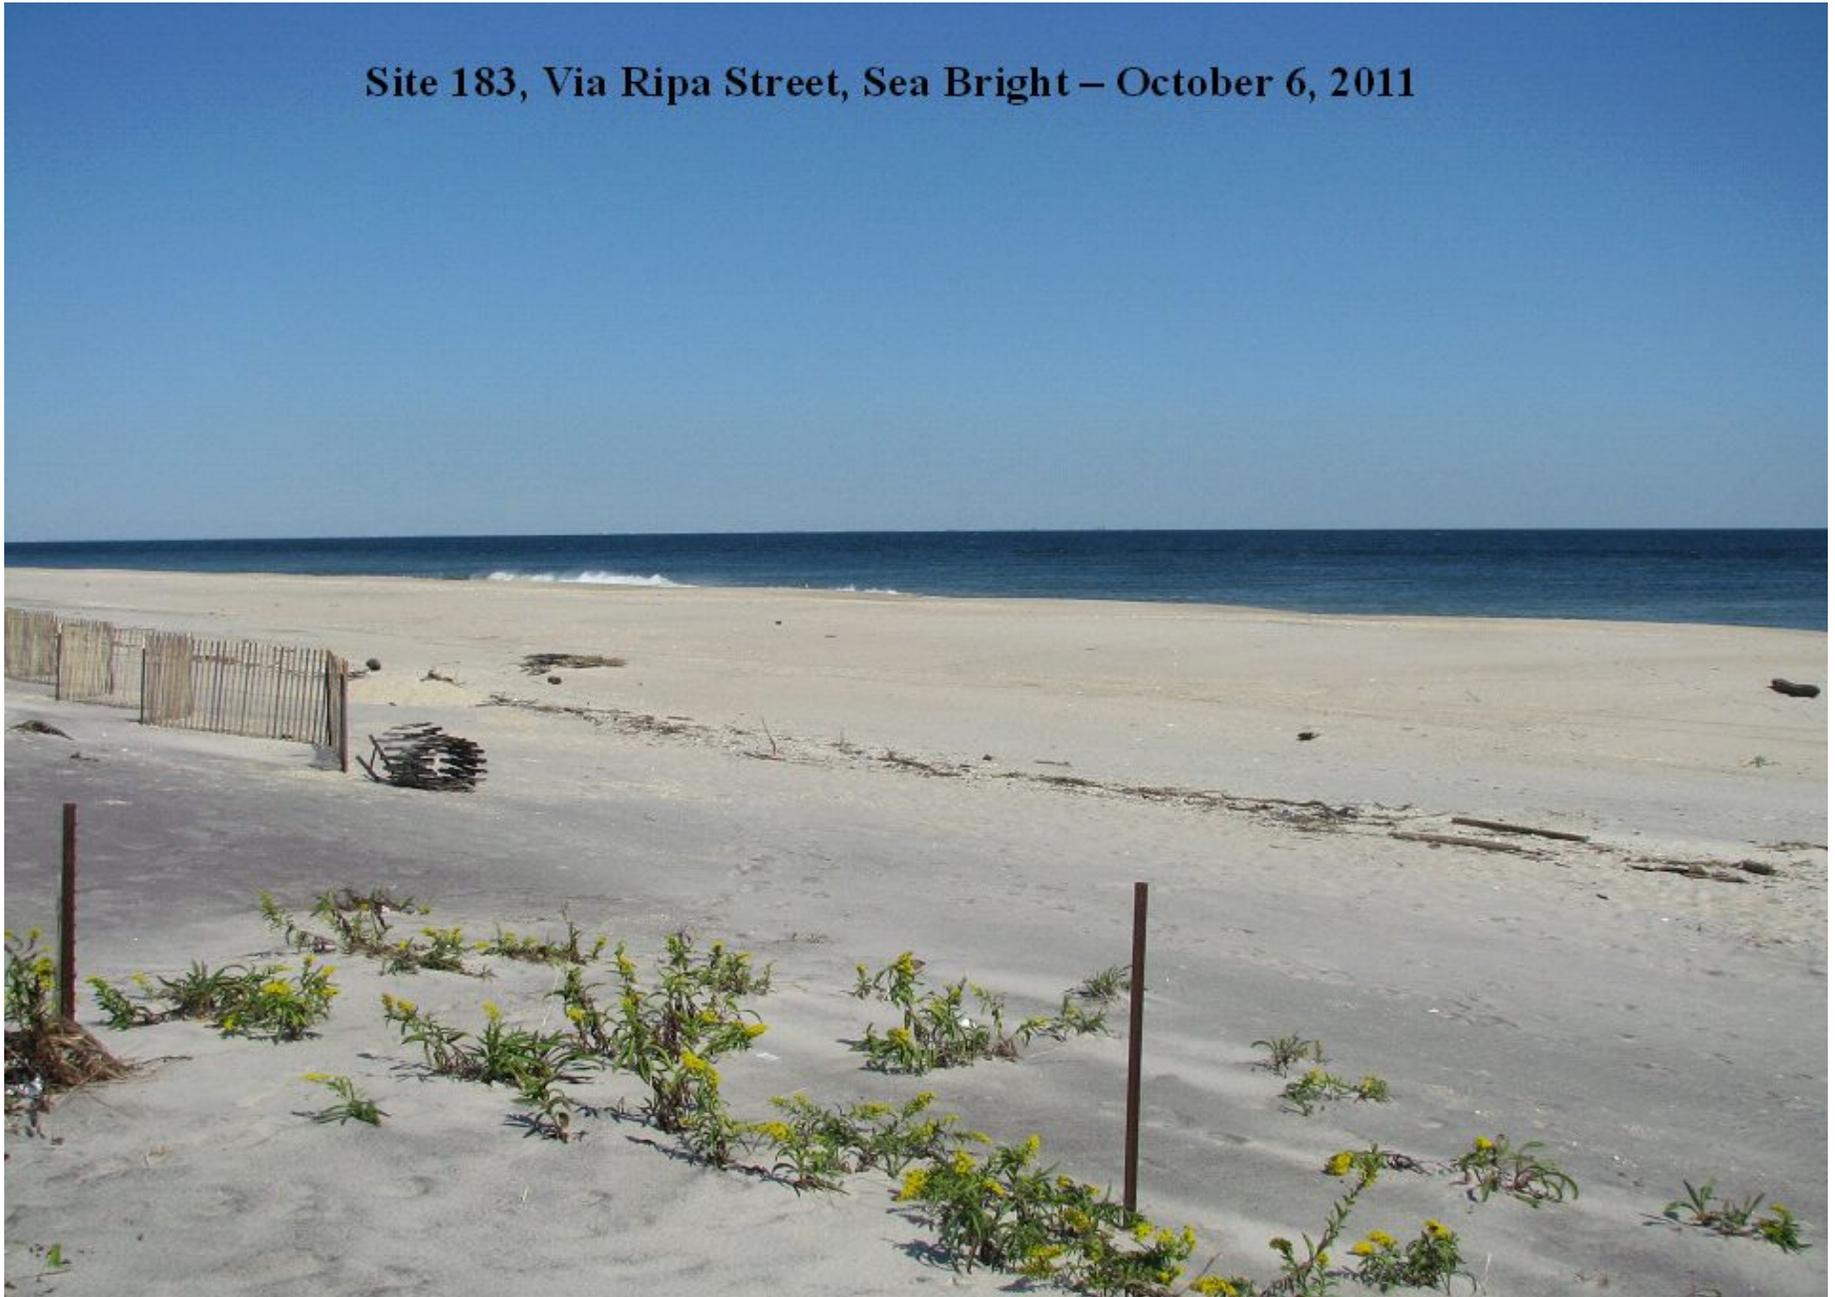
Site 183, Via Ripa Street, Sea Bright – October 6, 2011

Figure 30. Shown above is the view looking northeast from the dune at Via Ripa Street in Sea Bright, NJ.

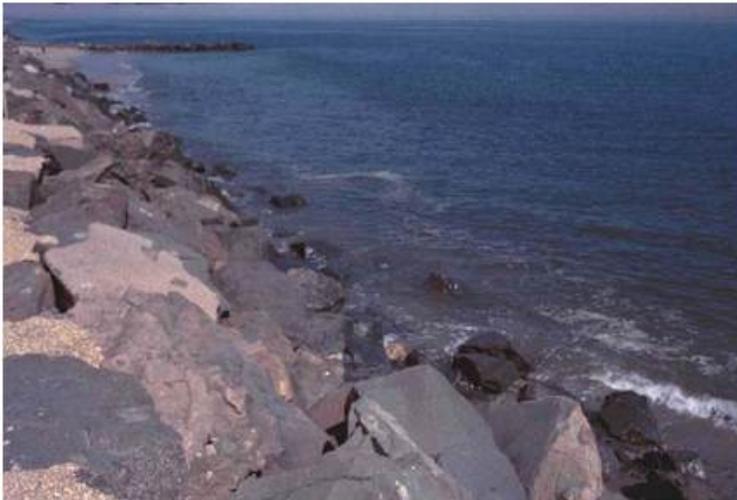
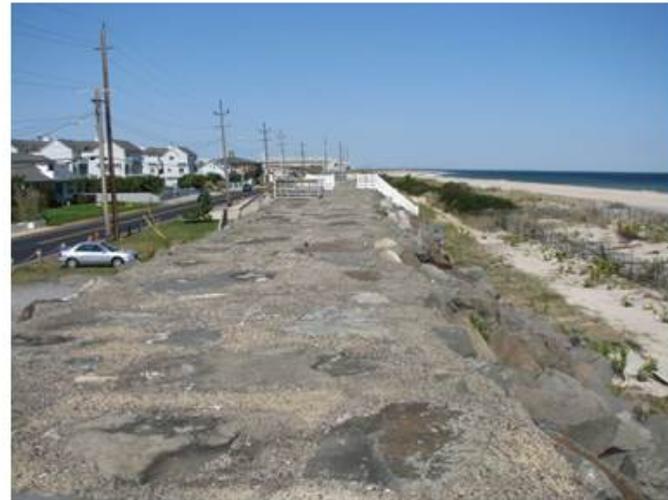
Figure 32. This site is located within the Monmouth County Federal beach nourishment project and has experienced only moderate sand losses since the 2002 maintenance fill. (Left photo October 10, 1986 [view to the north]; right photo October 3, 2011 [view to the north]).

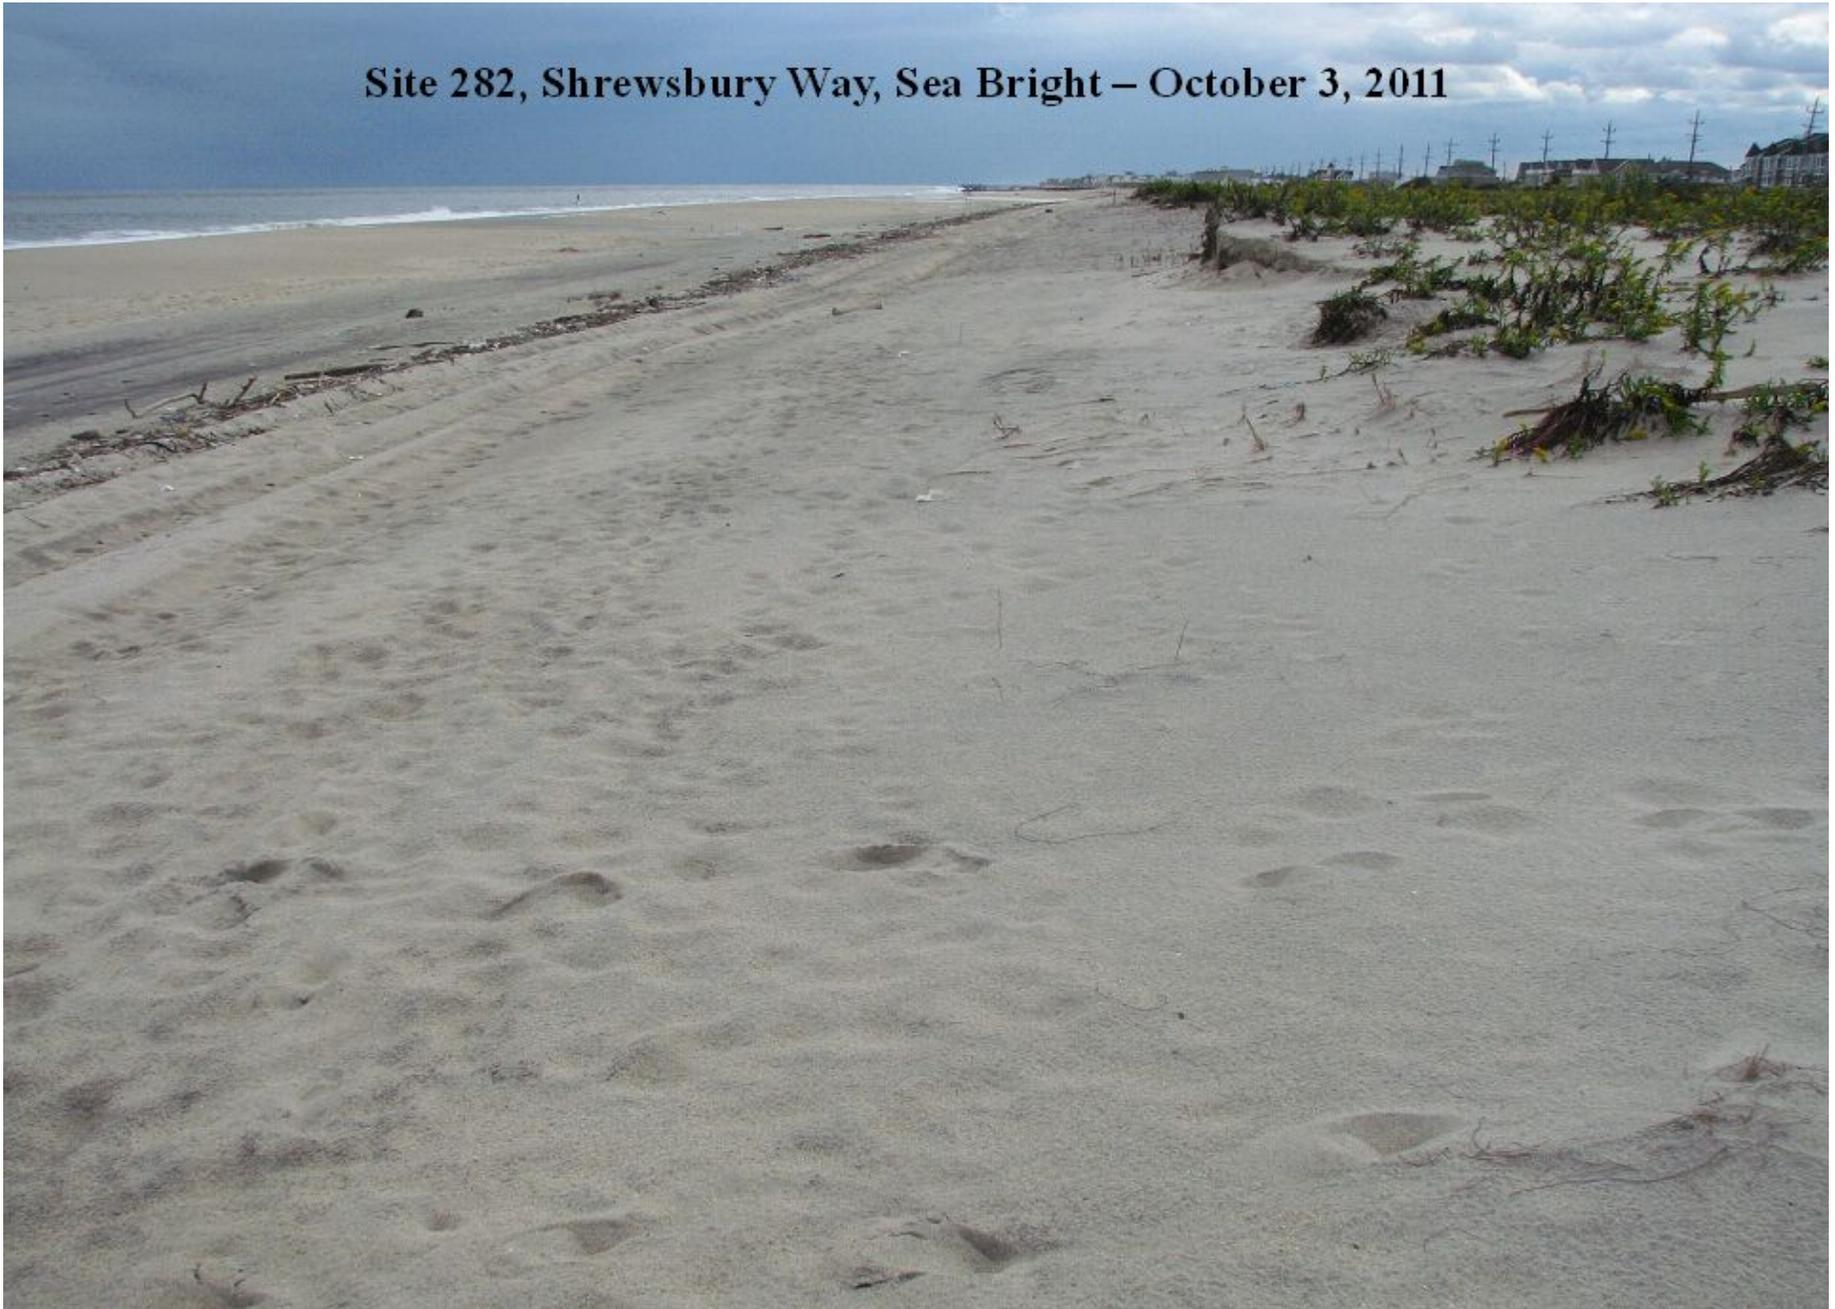
**Site 282, Shrewsbury Way, Sea Bright – October 3, 2011**

**Figure 34. Shown above is the view looking south from the dune toe at Shrewsbury Way in Sea Bright, NJ.**

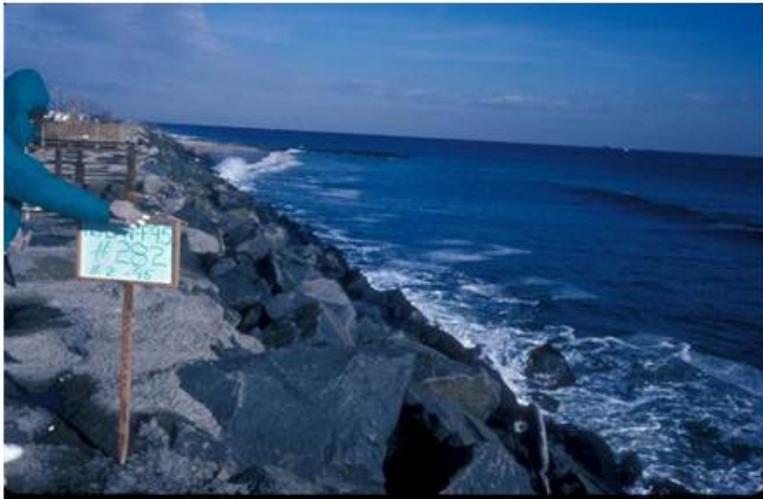
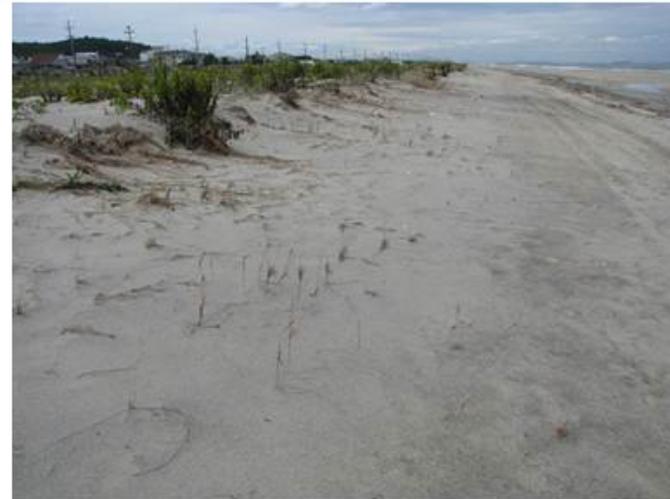
Figure 36. There was no beach during the initial survey at this location. The 1996 Monmouth County Federal beach nourishment project added over 273 cy/ft and advanced the shoreline 471 feet. Since then, this site has remained relatively stable. (Left photo November 2, 1995 [view to the north]; right photo October 3, 2011 [view to the north]).

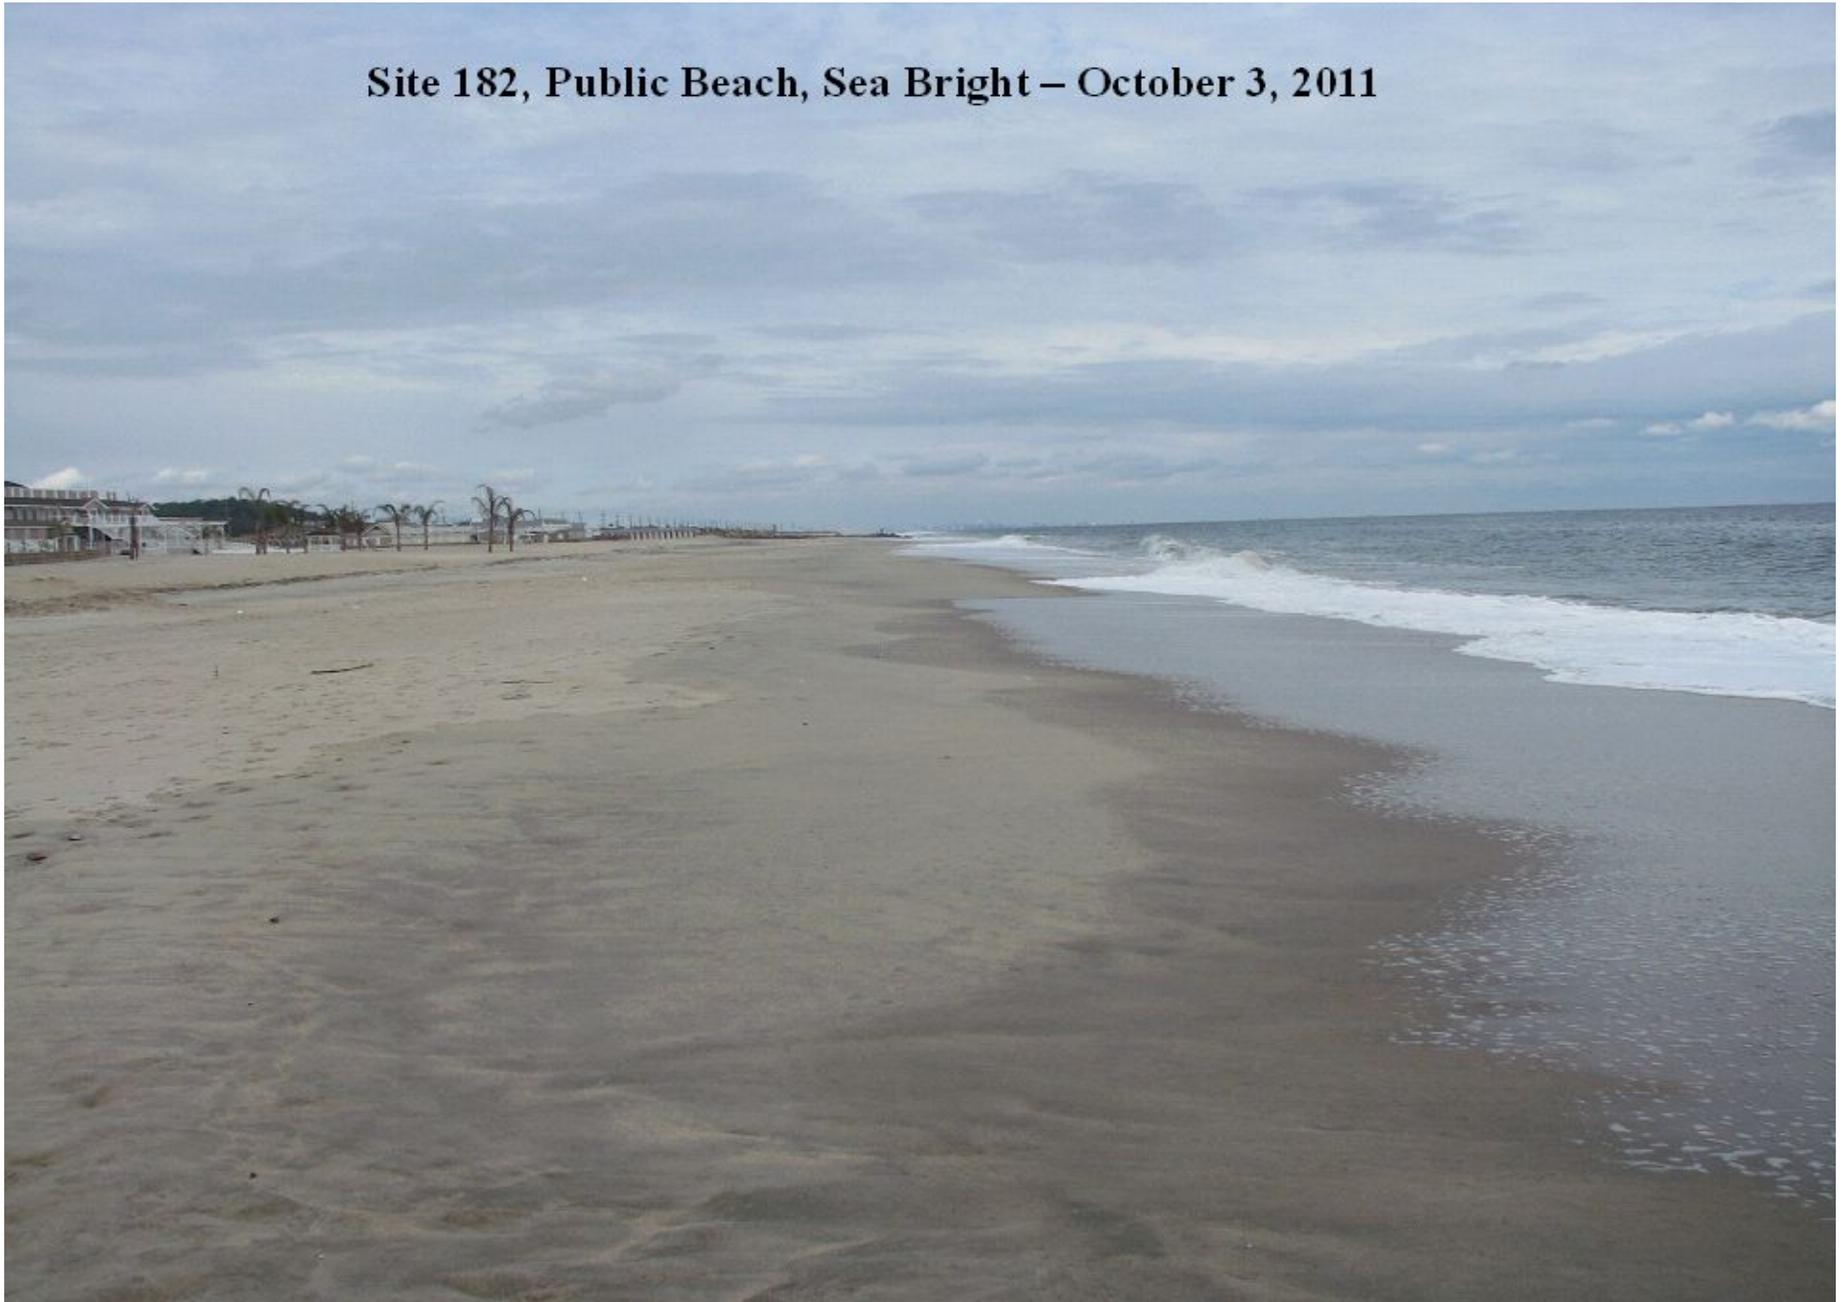
**Site 182, Public Beach, Sea Bright – October 3, 2011**

**Figure 38.** Shown above is the view looking north from the berm at the public beach in Sea Bright, NJ.

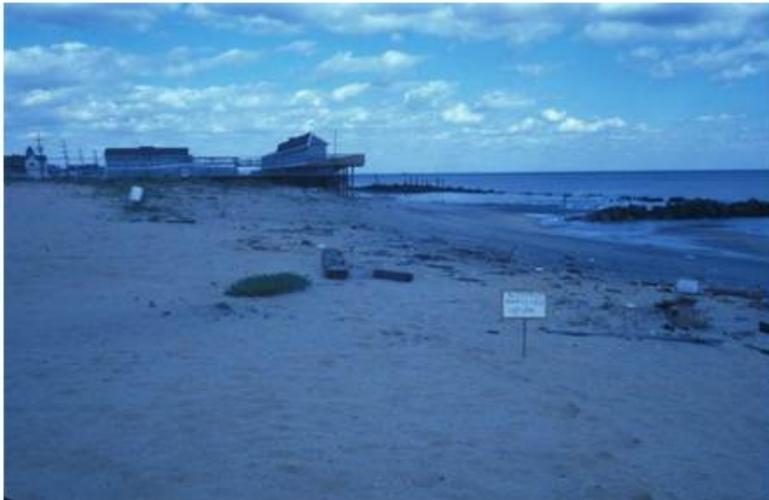
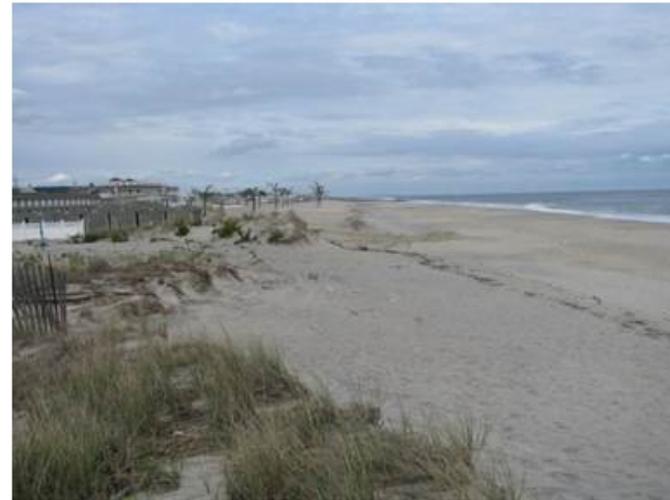
Figure 40. This site is located between two groins and had a dry beach when it was established in 1986. The 1996 Federal beach nourishment project added over 305 cy/ft to this site. Since that time, the beach and nearshore have had minimal sand losses. (Left photo October 11, 1988 [view to the north]; right photo October 3, 2011 [view to the north]).

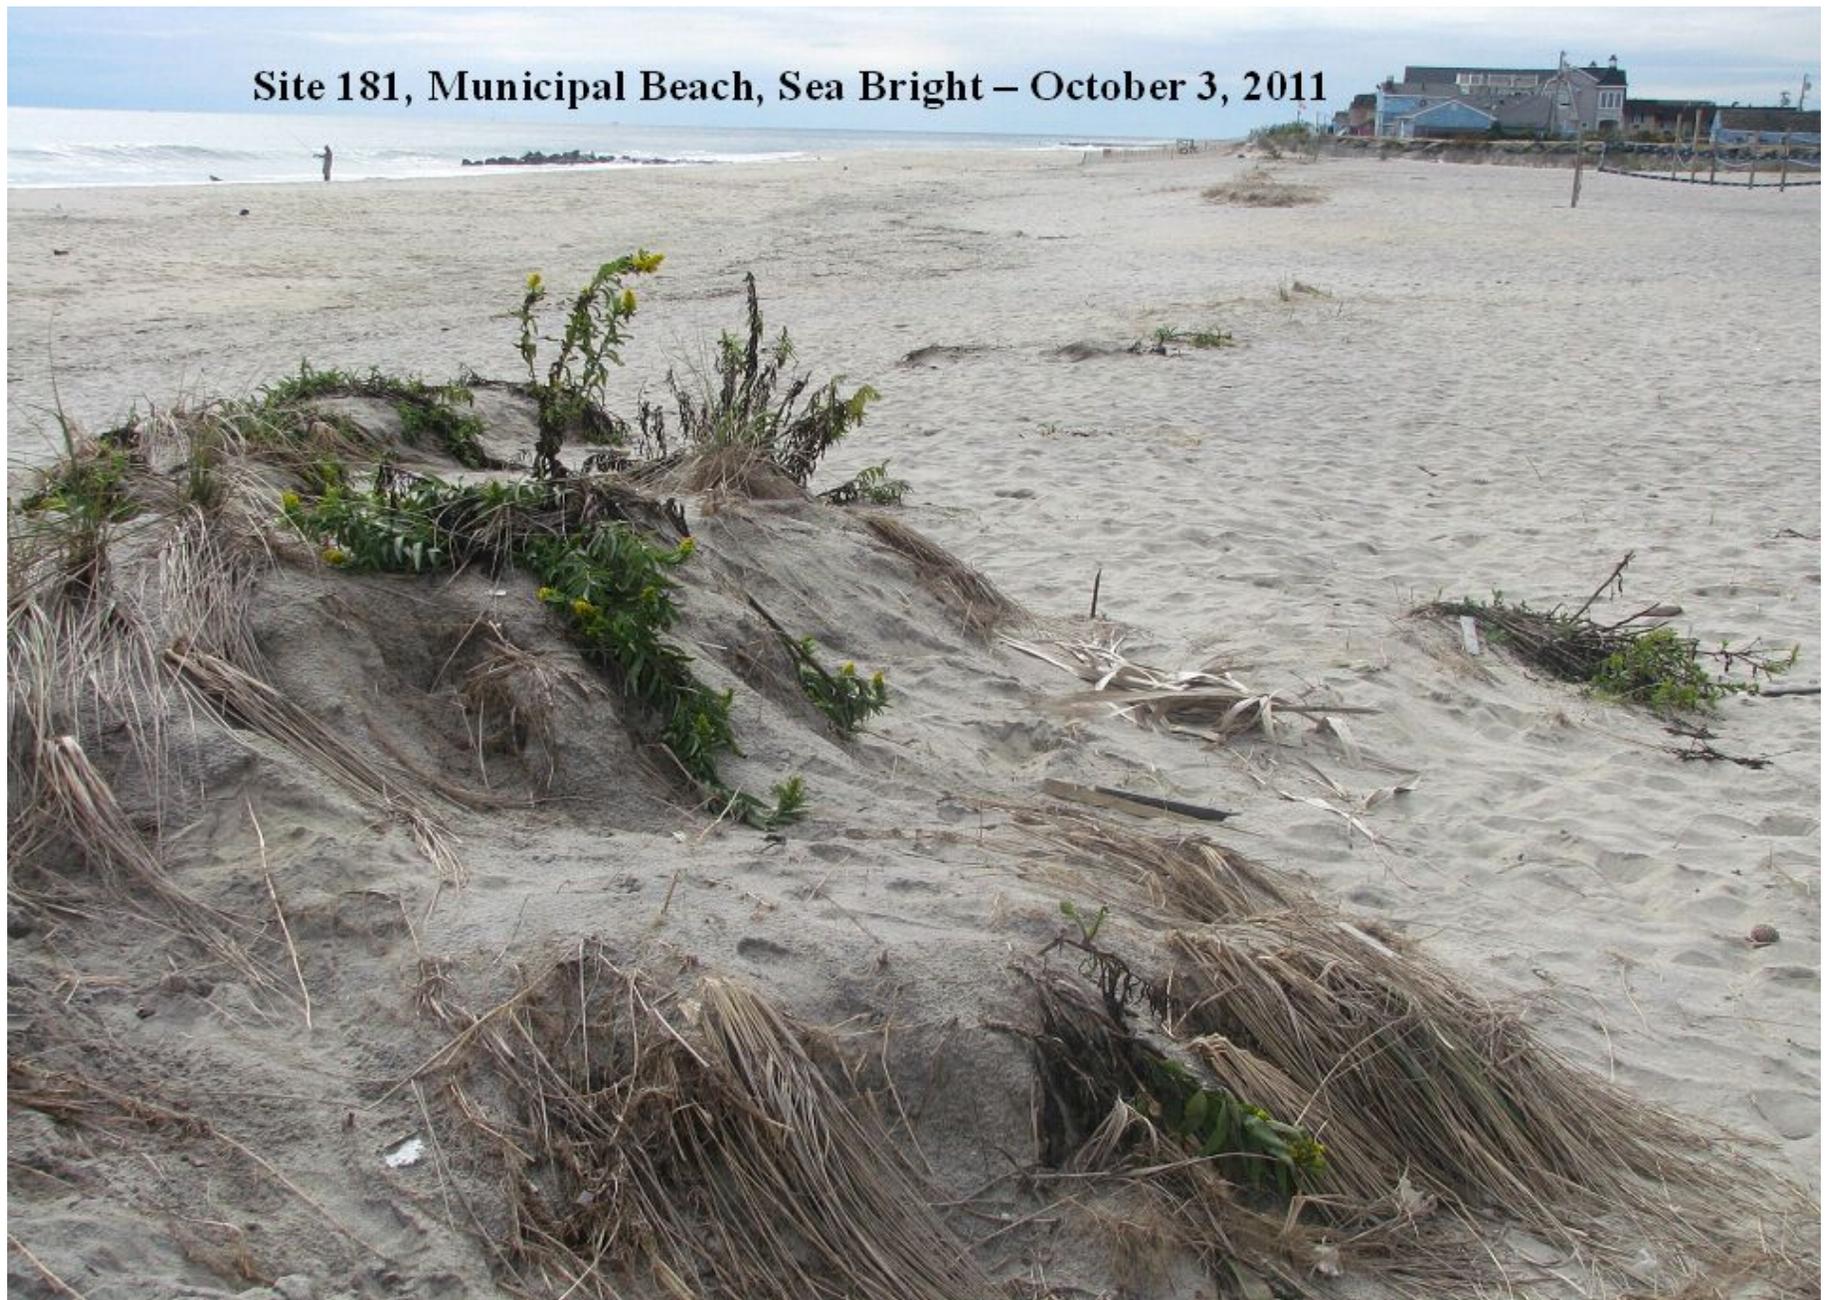
Figure 42. Shown above is the view looking south from the dune at the municipal beach in Sea Bright, NJ.

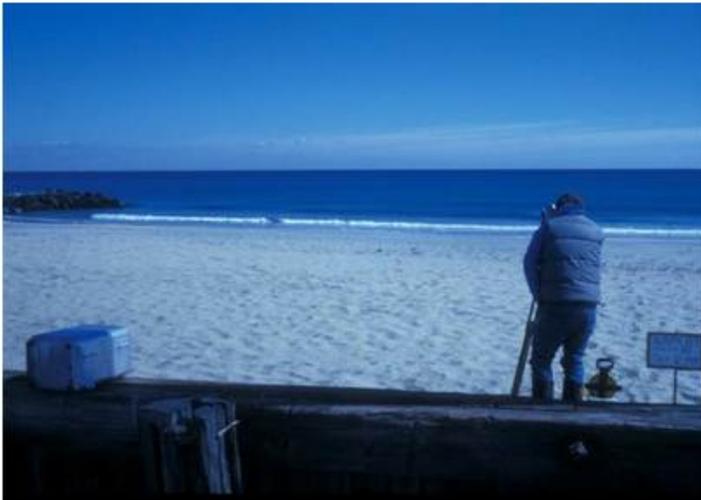
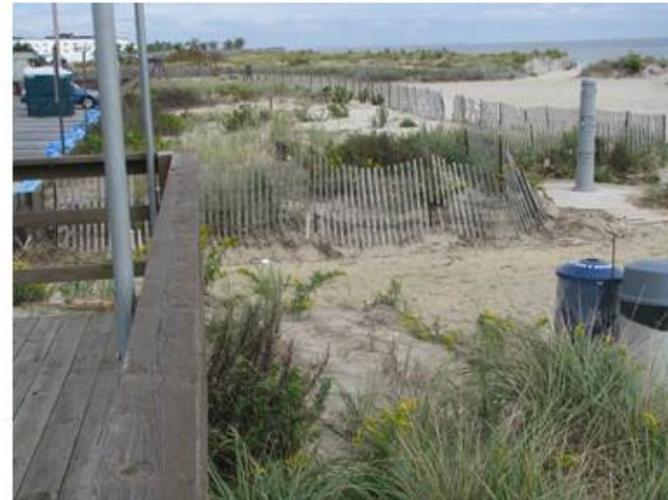
Figure 44. The present dune crest is in the same location as the 1986 berm crest. This site received sand during the Monmouth County Federal beach nourishment project and 2002 maintenance fill. (Left photo October 12, 1988 [view to the east]; right photo October 3, 2011 [view to the north]).

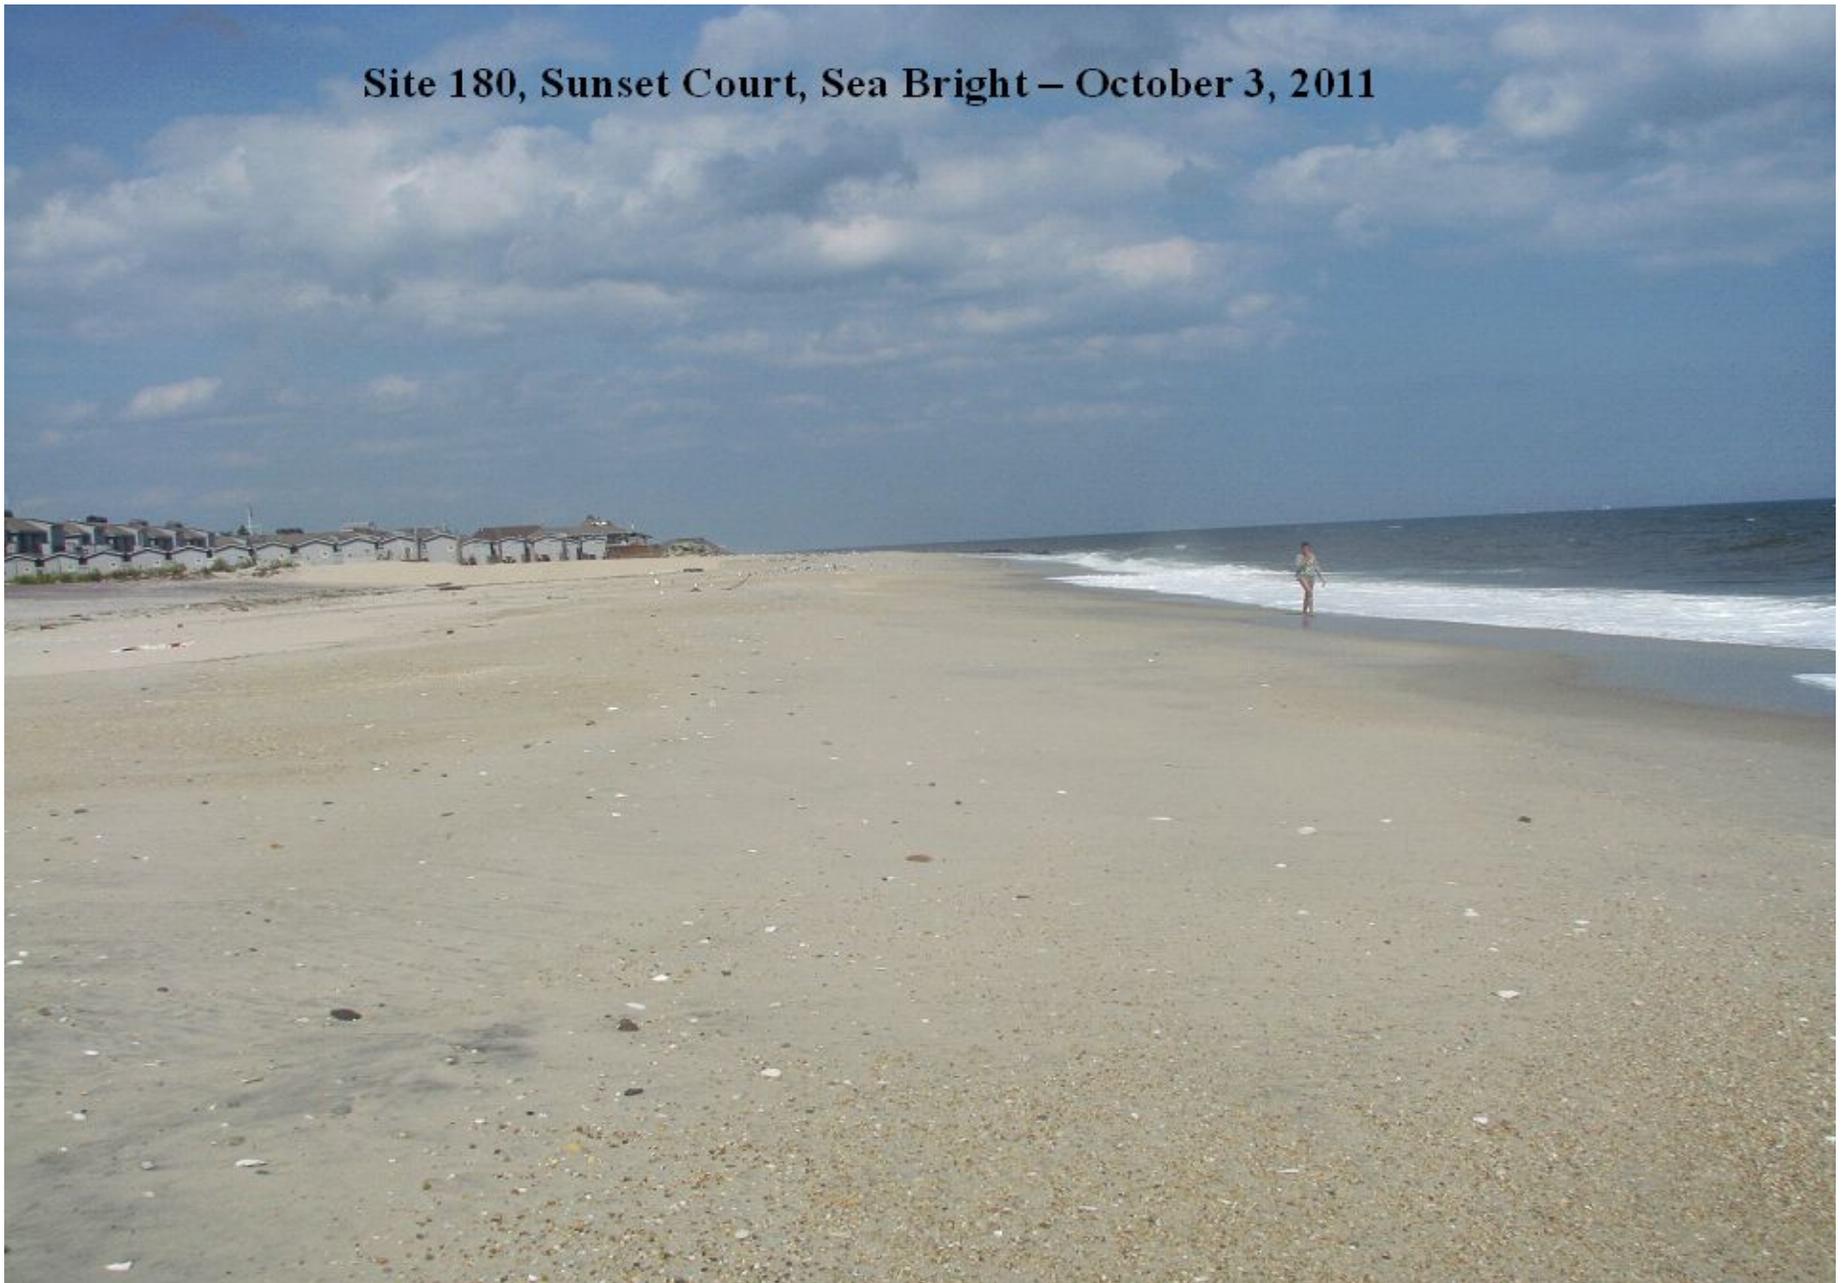
Site 180, Sunset Court, Sea Bright – October 3, 2011

Figure 46. Shown above is the view looking north from the berm at Sunset Court in Sea Bright, NJ.

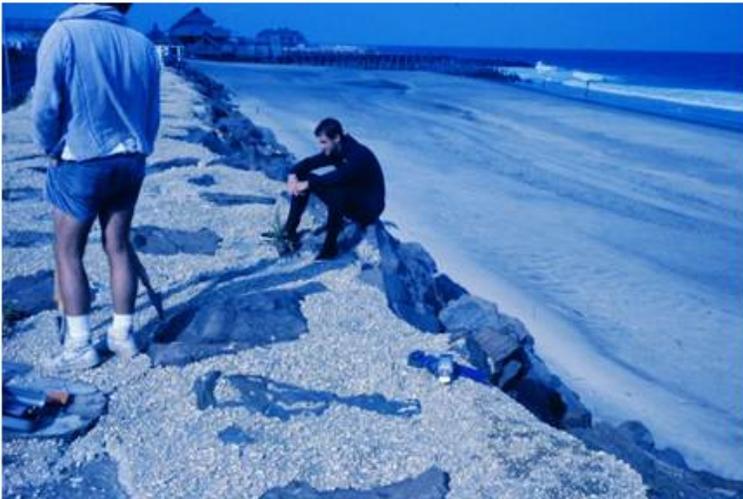
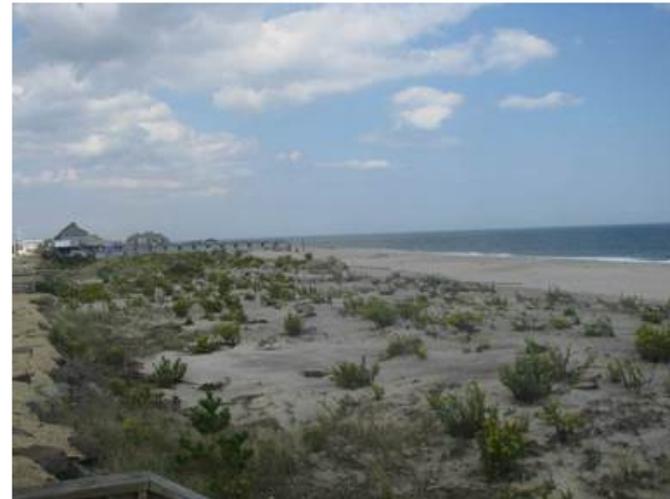
Figure 48. A wide dune field established at this site following the 1995 Monmouth County Federal beach nourishment project. Maintenance sand was added in 2002. Since that time, there has been a gradual loss of sand and shoreline retreat. (Left photo October 7, 1987 [view to the north]; right photo September 30, 2011 [view to the north]).
