# New Jersey Beach Profile Network

## Monmouth County

Raritan Bay and Sandy Hook  
to Manasquan Inlet

**NJBPN Profile #'s  
187 - 256**

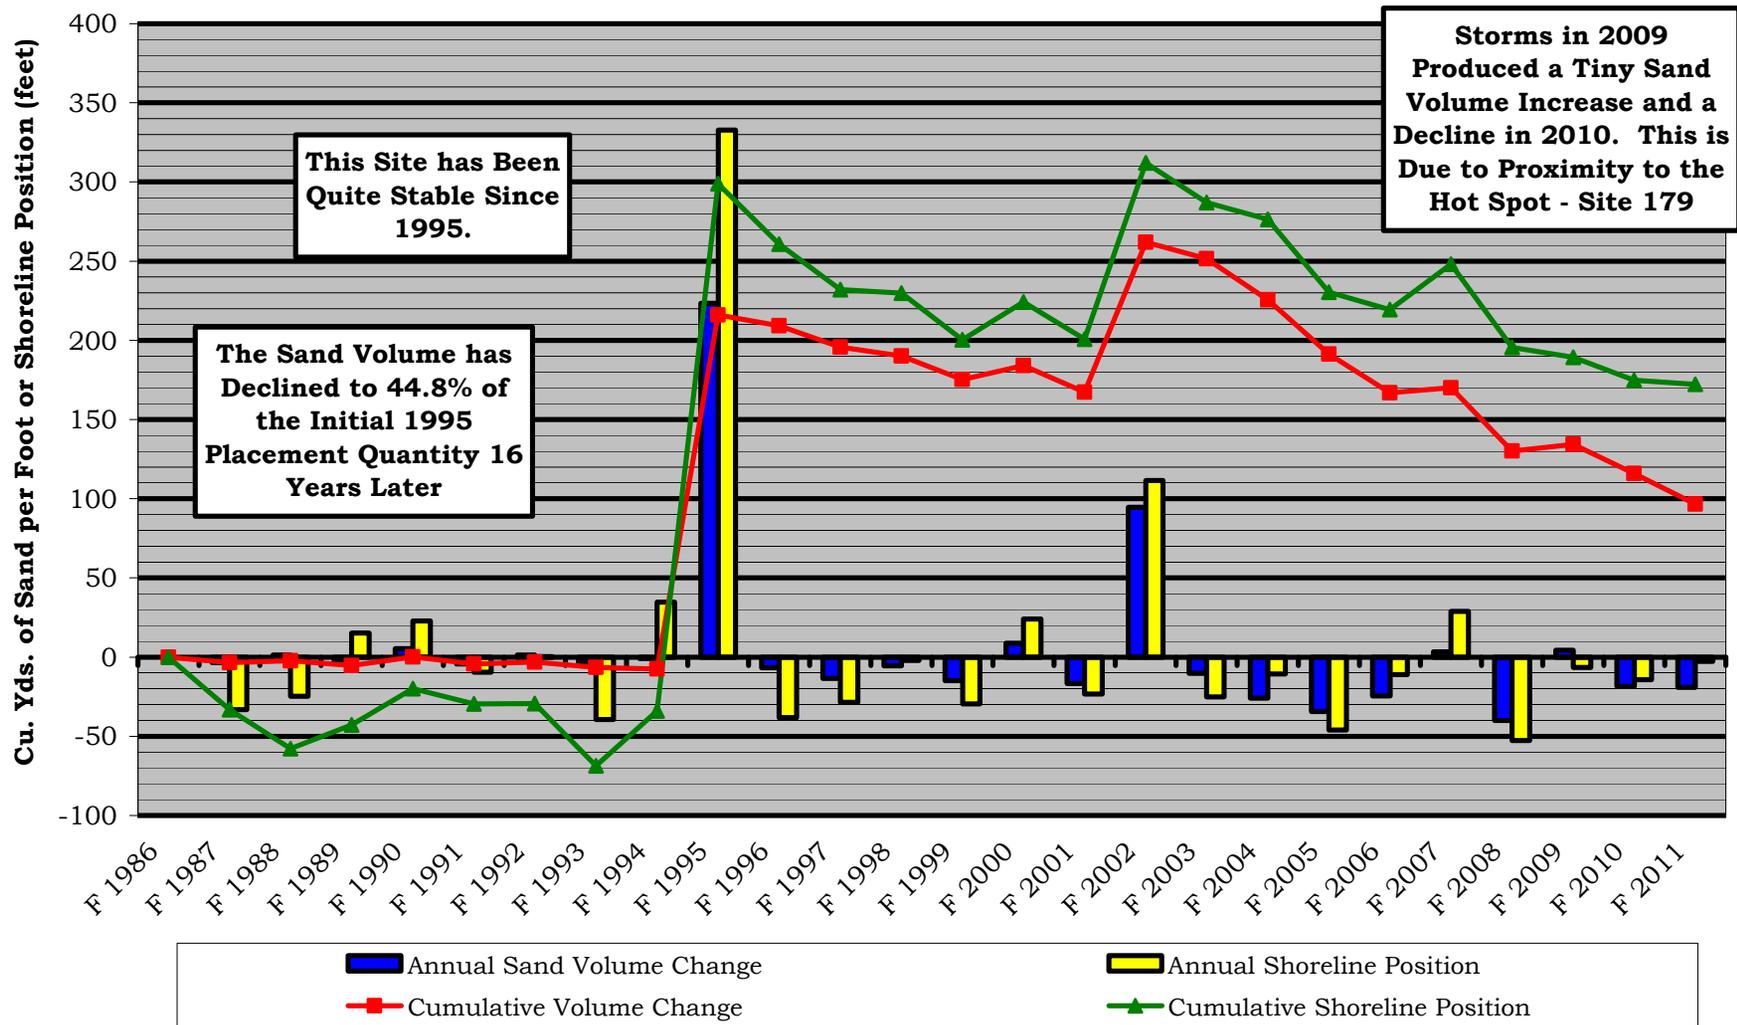
**25-Year Coastal Changes at Site 180, Sunset Court, Sea Bright, Monmouth Co.**

**Figure 49. Prior to the Federal beach nourishment project and maintenance fill, this beach at this site was very narrow and susceptible to storm damages. The site has lost volume since the Federal projects as sand moves northward during project adjustment.**

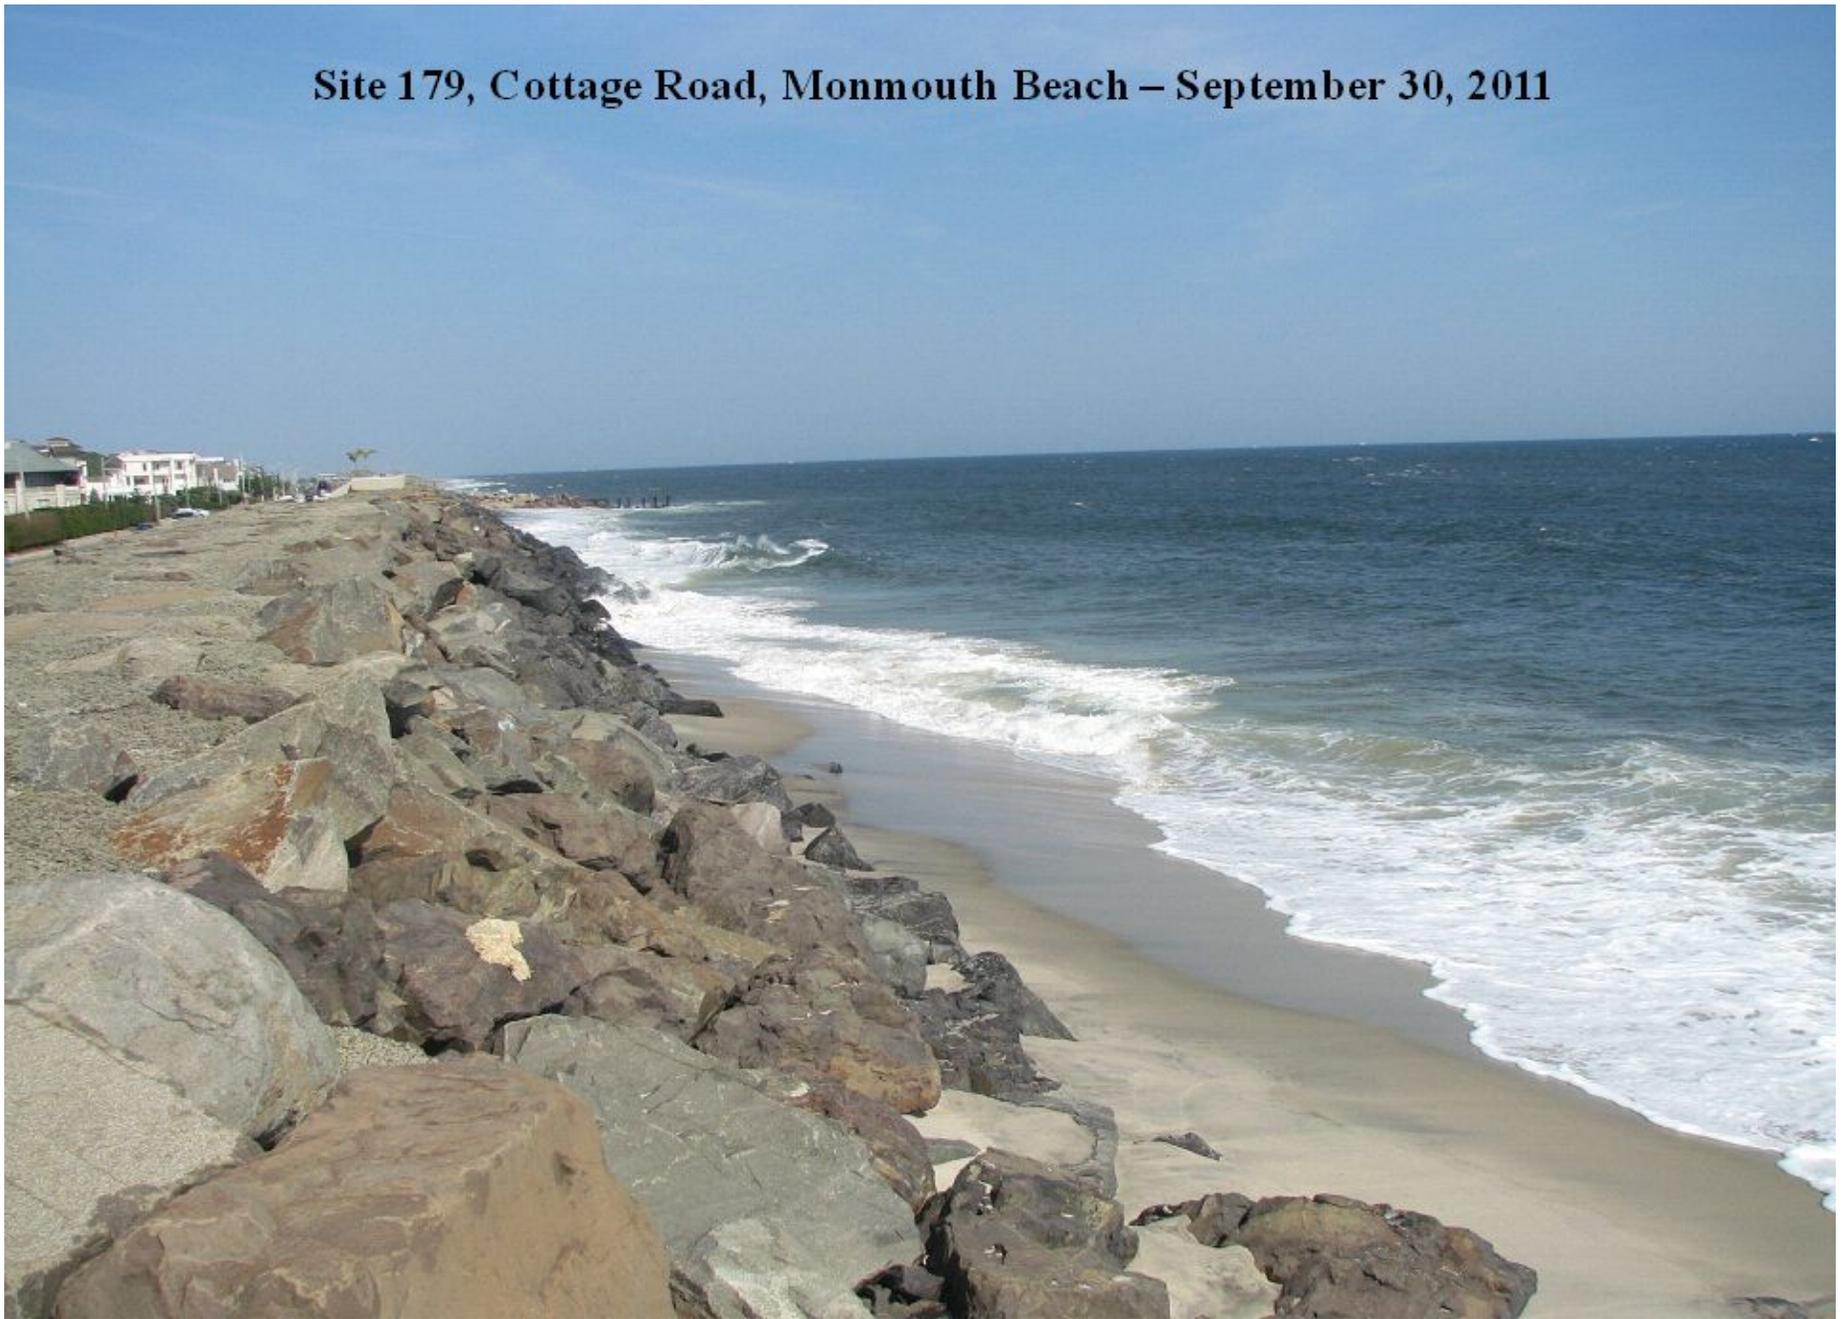
**Site 179, Cottage Road, Monmouth Beach – September 30, 2011**

**Figure 50: Shown above is the view looking north from the seaward top of the seawall at Cottage Road in Monmouth Beach, NJ.**

Site 179, Cottage Road, in Monmouth Beach has been an enigma due to persistent, rapid loss of sand deposits. Observations made the past two years may lead to possible reasons. There is a massive stone groin protecting the Monmouth Beach Club property positioned about 500 feet south of this site. In the absence of northeast storms the dominant littoral currents are directed to the north, so the sand moves north away from the groin and the Cottage Road site and is not being replaced by significant material traveling north around the groin. By the fall 2009 survey the site was devoid of sand, the dune was gone and the beach was wet at low tide, not far from the conditions existing here prior to the beach fill. Following the 2009-2010 winter storm season sand had reappeared as a dry beach fronting the rocks, a minimal, but significant improvement when compared to the fall 2009 survey situation. The littoral currents were reversed by the northeasters and were increased in magnitude during the storms. However, the groin protecting the Beach Club served to impound the sand and did not allow sediment to pass further south and the profile site beach accumulated sand during the period of severe weather. If this is the case, this location will be a perpetual “Hot Spot” for erosion.

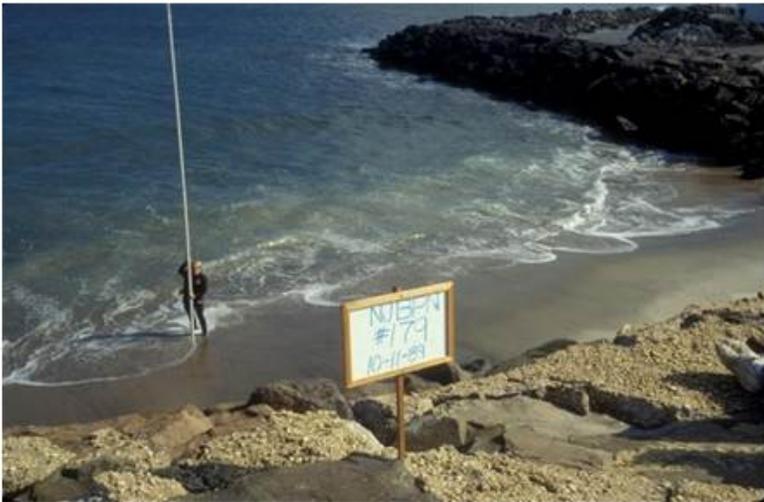
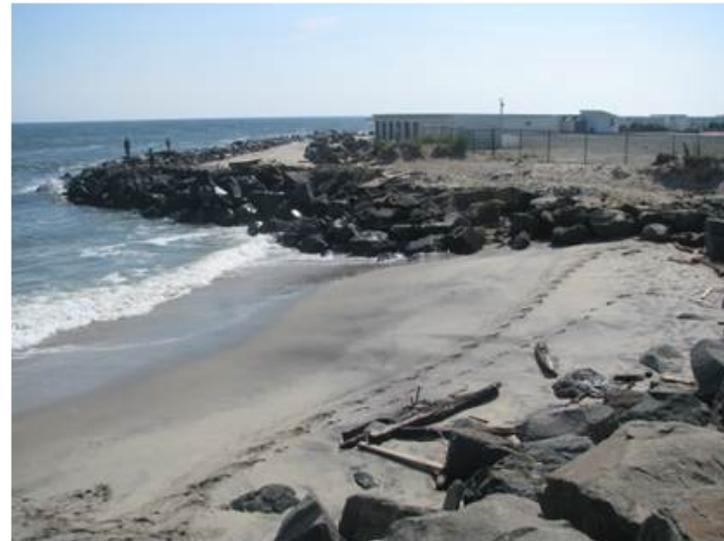
Figure 52. This profile lies north of a rock revetment that juts seaward of the natural shoreline position and blocks the northward transport of sand. The Monmouth County Federal beach nourishment and subsequent maintenance fill added sand but the site remains in an erosional state. (Left photo October 11, 1989 [view to the southeast]; right photo September 30, 2011 [view to the south]).

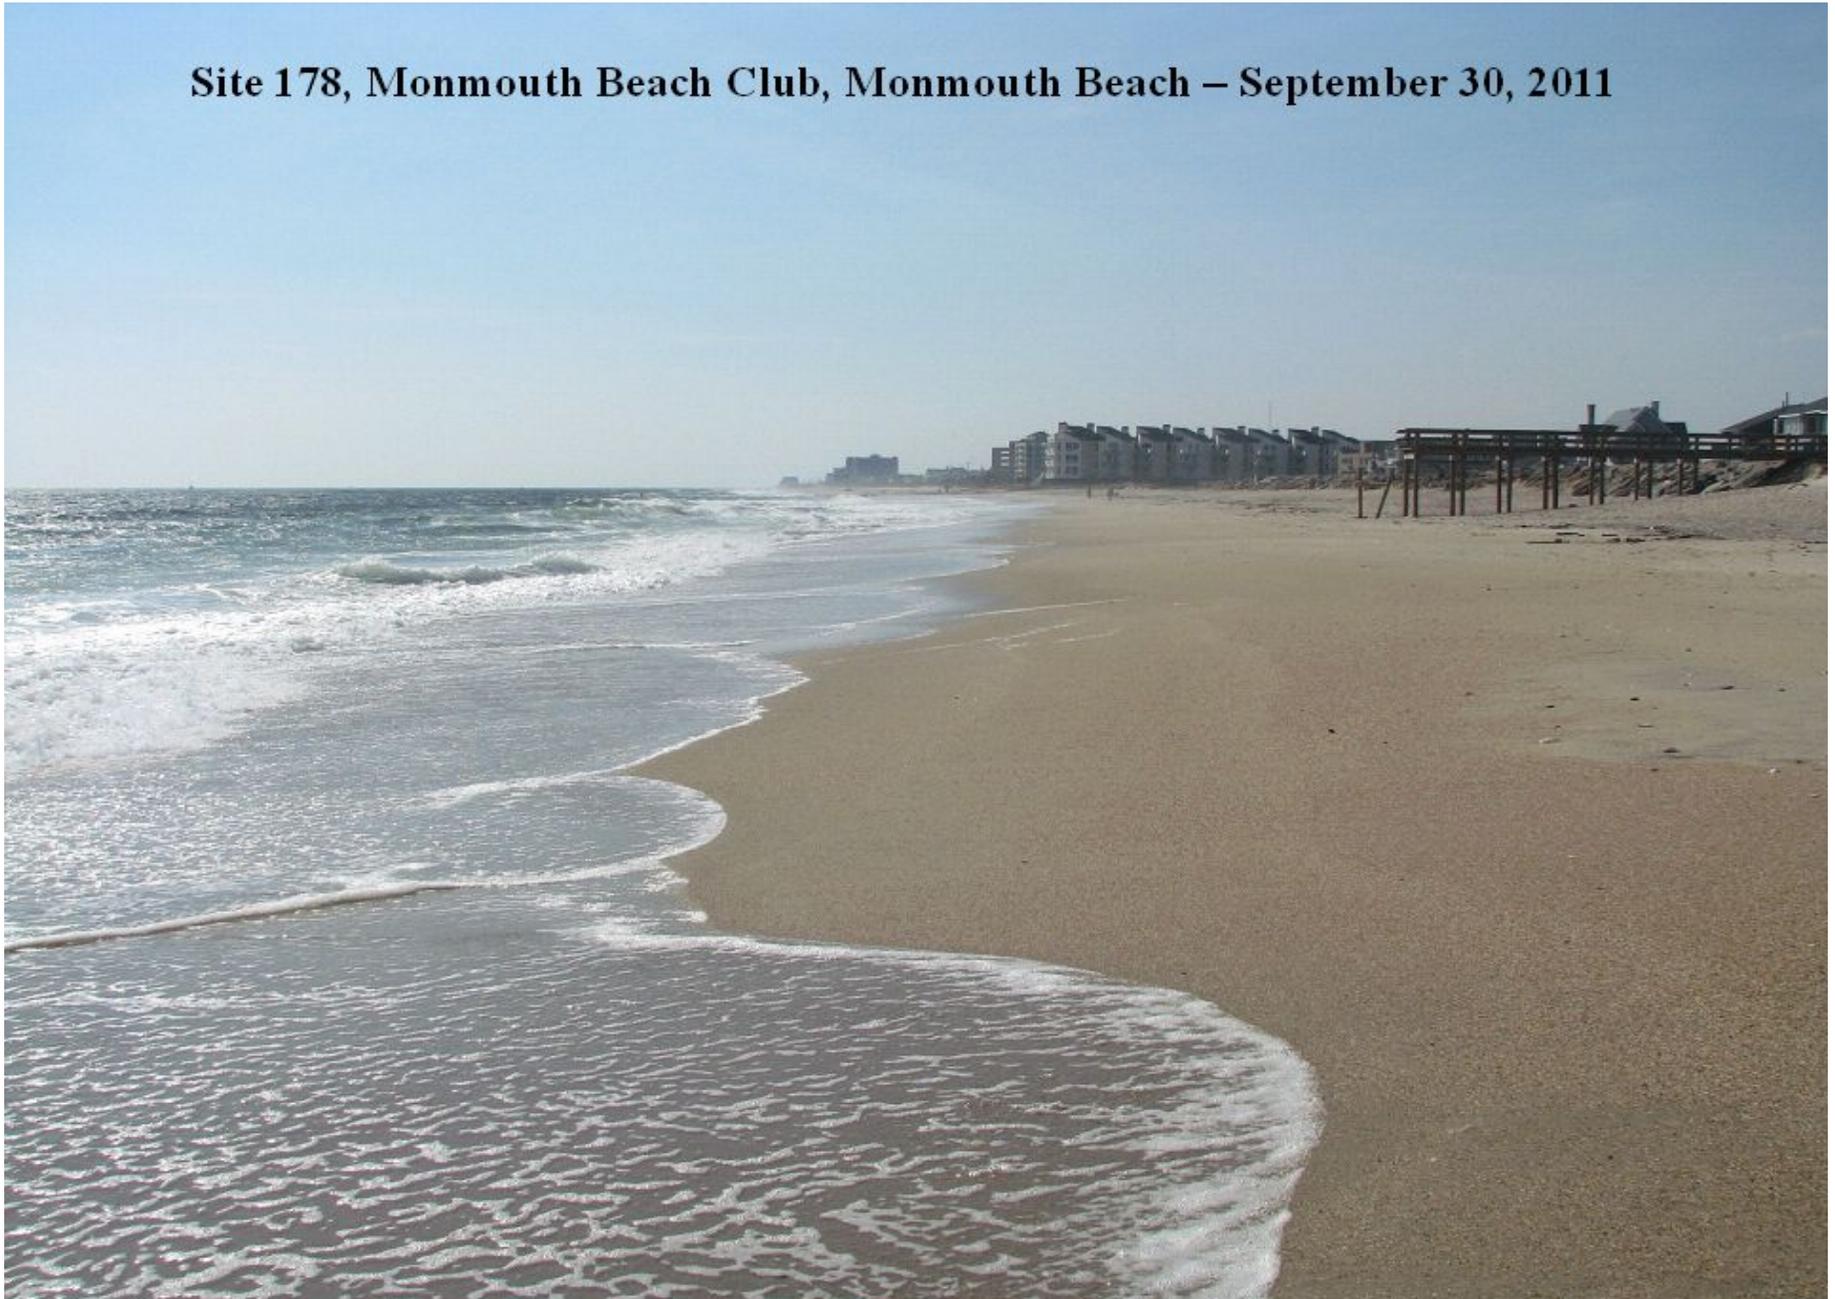
**Site 178, Monmouth Beach Club, Monmouth Beach – September 30, 2011**

**Figure 54. Shown above is the view looking south from the swash zone at the Monmouth Beach Club in Monmouth Beach, NJ.**

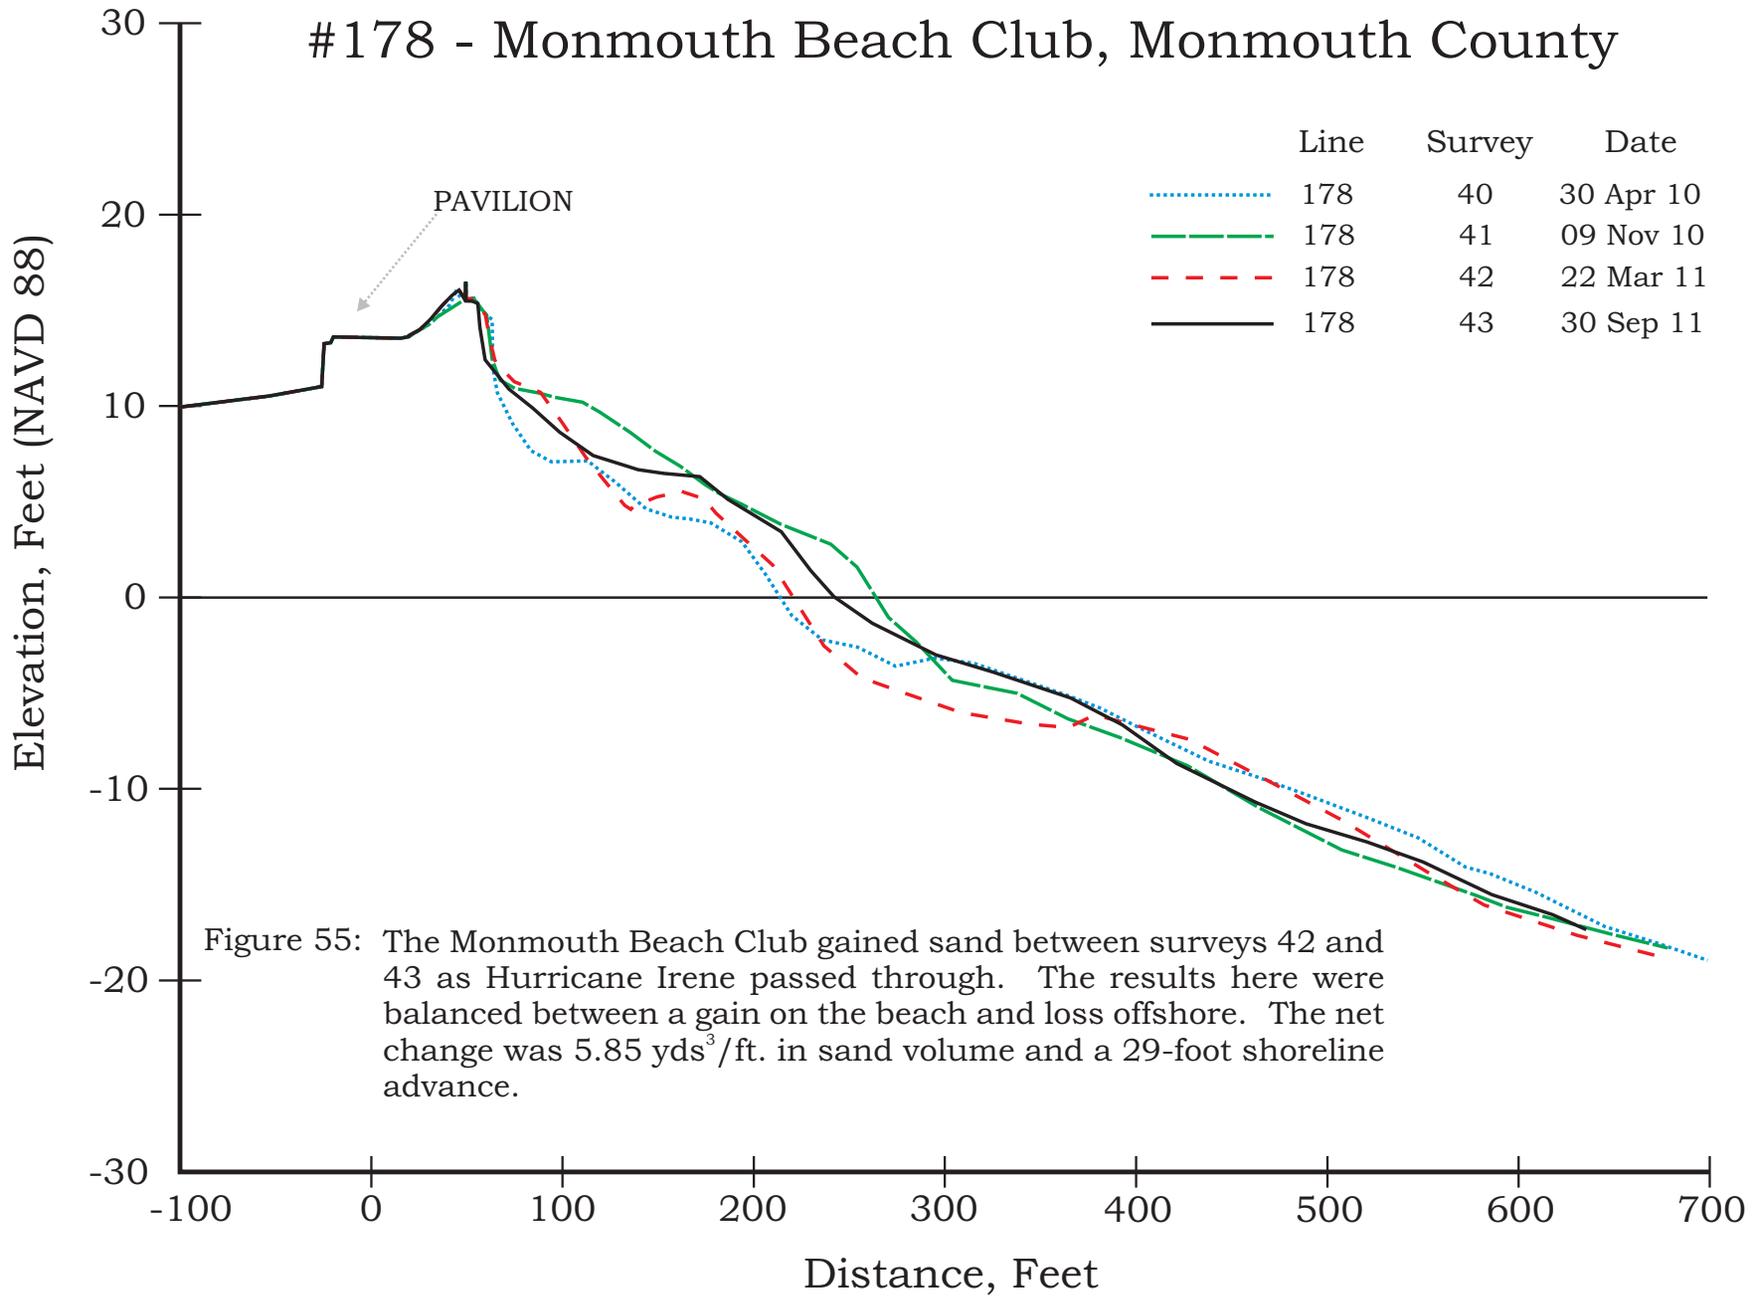
## #178 - Monmouth Beach Club, Monmouth County

Figure 55: The Monmouth Beach Club gained sand between surveys 42 and 43 as Hurricane Irene passed through. The results here were balanced between a gain on the beach and loss offshore. The net change was 5.85 yds<sup>3</sup>/ft. in sand volume and a 29-foot shoreline advance.

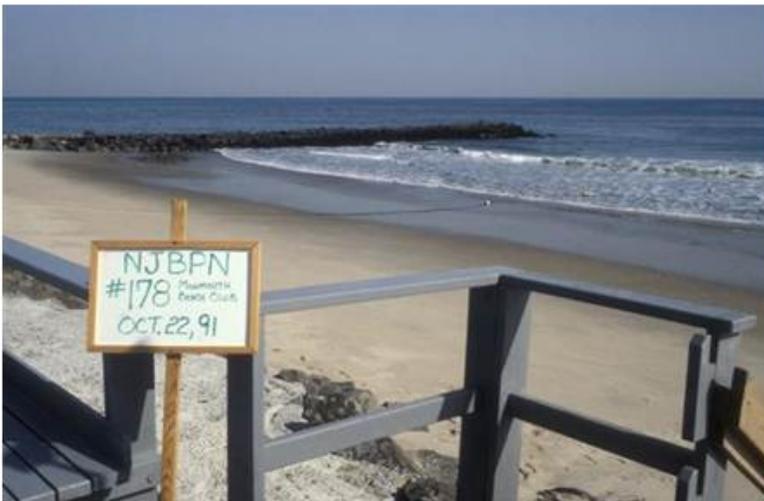
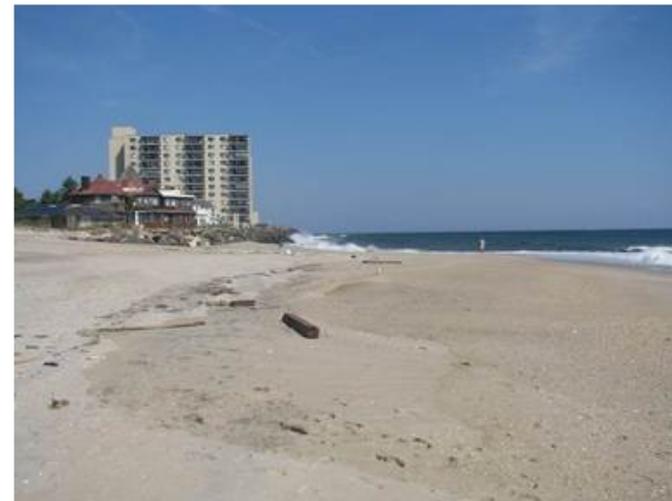
Figure 56. In 1986, this beach was narrow and steep in front of the beach club due to its proximity to the rock revetment at site 179. Sand losses have been moderate since the Monmouth County Federal beach nourishment project and maintenance fill. (Left photo October 22, 1991 [view to the northeast]; right photo taken September 30, 2011 [view to the north]).

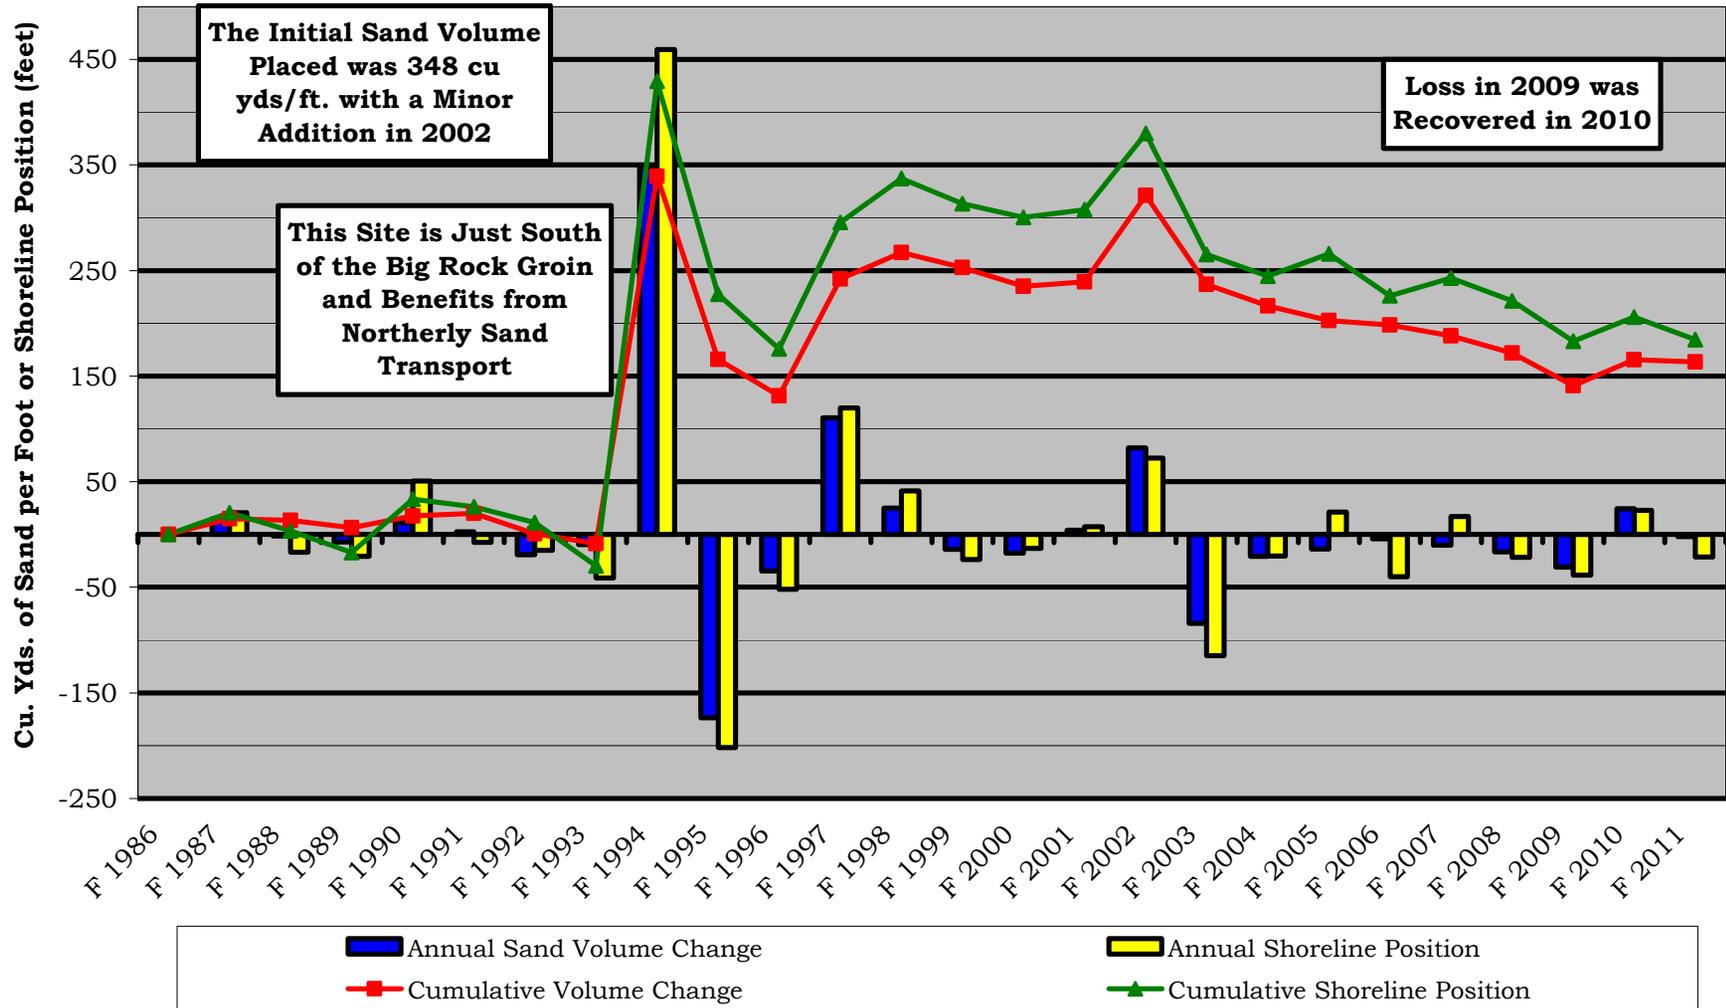
## 25-Year Coastal Changes at Site 178, Monmouth Beach Club, Monmouth Co.

Figure 57. Shoreline retreat and sand volume losses have occurred following the Federal beach nourishment and maintenance fill projects. However, this beach is in much better condition today than prior to the projects.

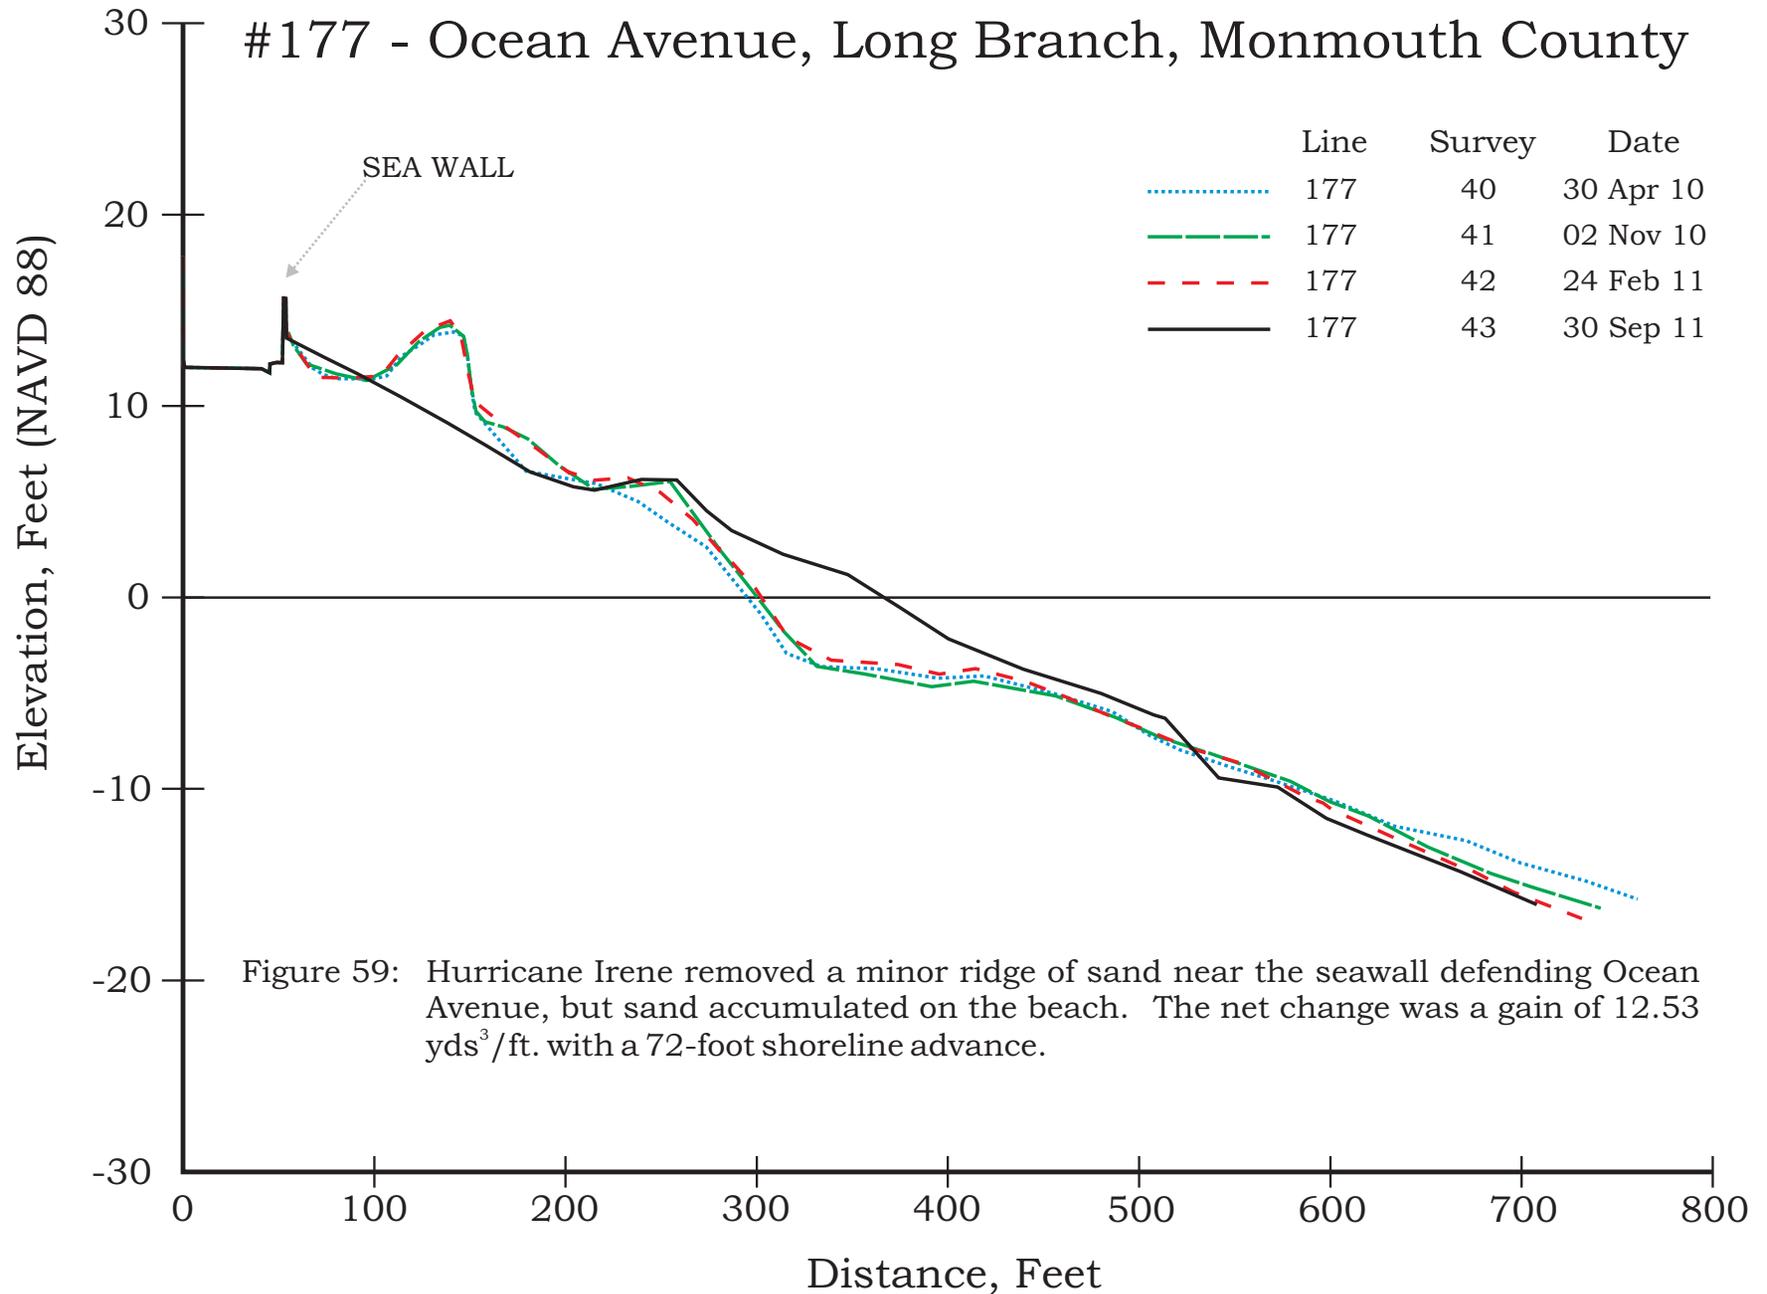
#177 - Ocean Avenue, Long Branch, Monmouth County

Figure 59: Hurricane Irene removed a minor ridge of sand near the seawall defending Ocean Avenue, but sand accumulated on the beach. The net change was a gain of 12.53 yds<sup>3</sup>/ft. with a 72-foot shoreline advance.

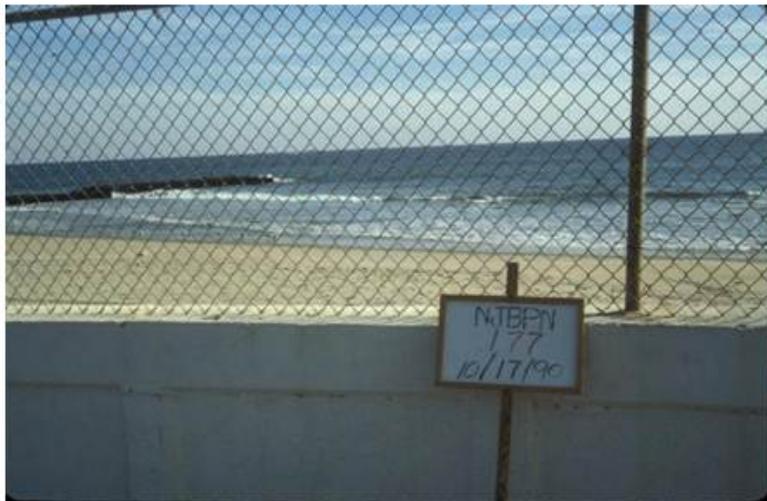
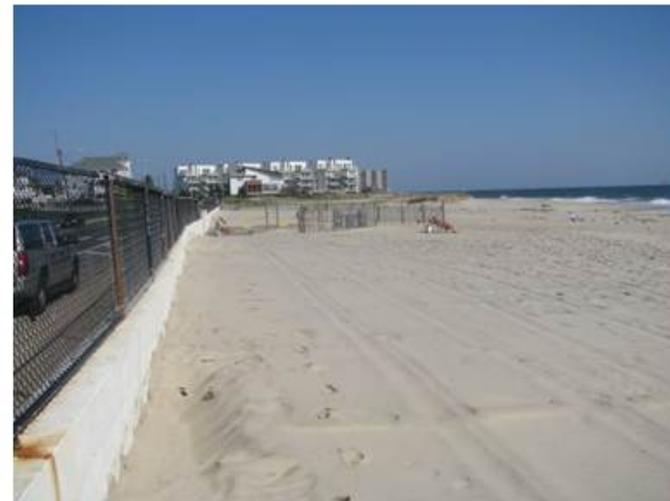
Figure 60. Sand was added to this site in the Monmouth County Federal beach nourishment project but none was added in the 2002 maintenance fill. The profile has experienced minimal sand losses since that time. (Left photo October 17, 1990 [view to the east]; right photo September 30, 2011 [view to the north]).

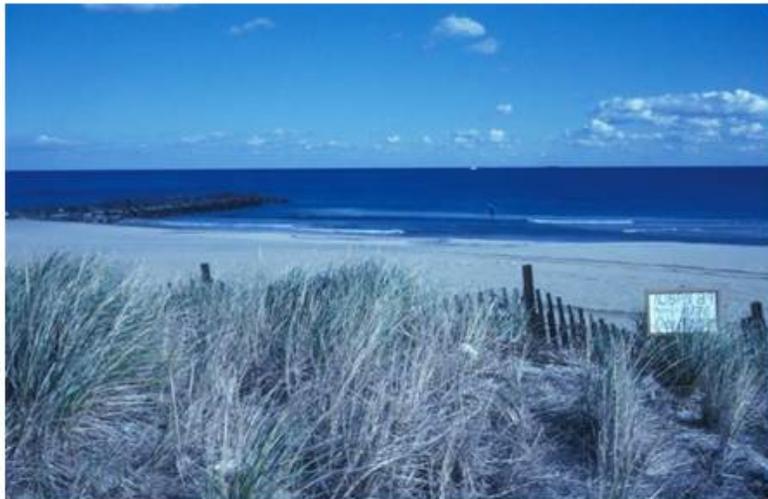
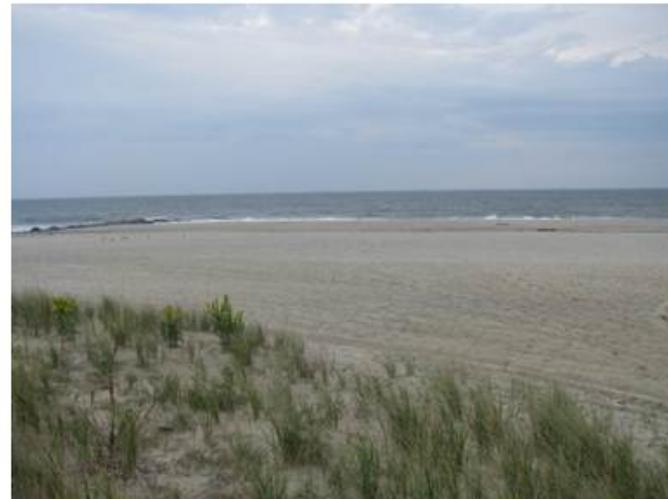
Figure 64. The northernmost Long Branch profile had a narrow beach in 1986 and sand was added in the Monmouth County Federal beach nourishment project. No sand was added in the 2002 maintenance fill. (Left photo October 12, 1988 [view to the northeast]; right photo September 29, 2011 [view to the northeast]).

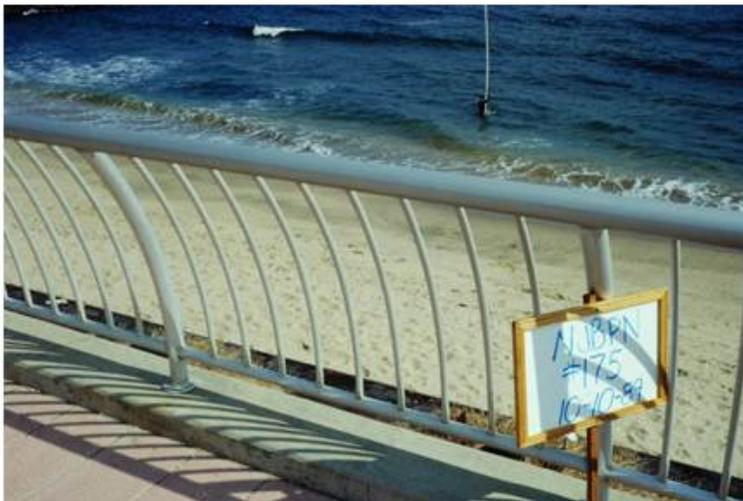
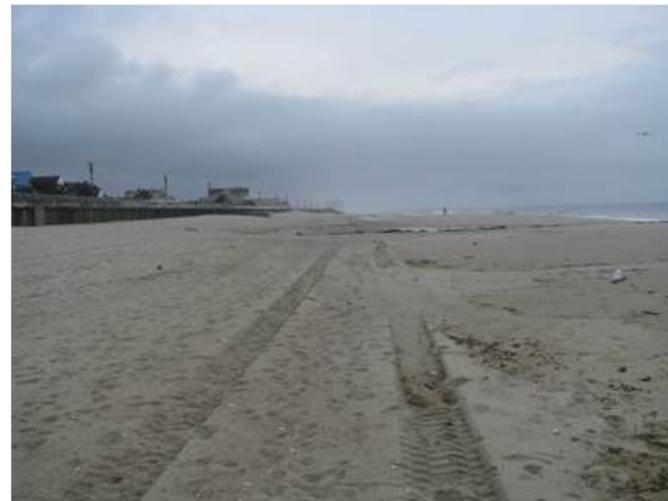
Figure 68. In 1986, the beach was located approximately 14 feet below the top of the steel bulkhead. Sand was added in the Monmouth County Federal beach nourishment project but none was added in the 2002 maintenance fill because the site is relatively stable. (Left photo October 10, 1989 [view to the northeast]; right photo September 29, 2011 [view to the north]).

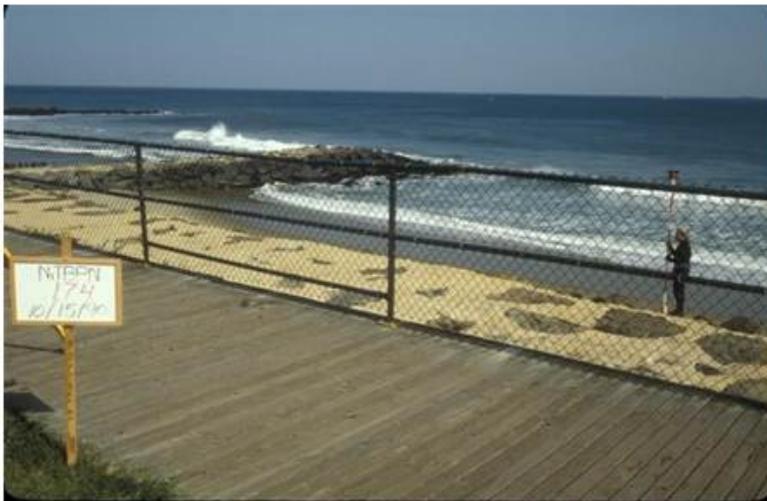
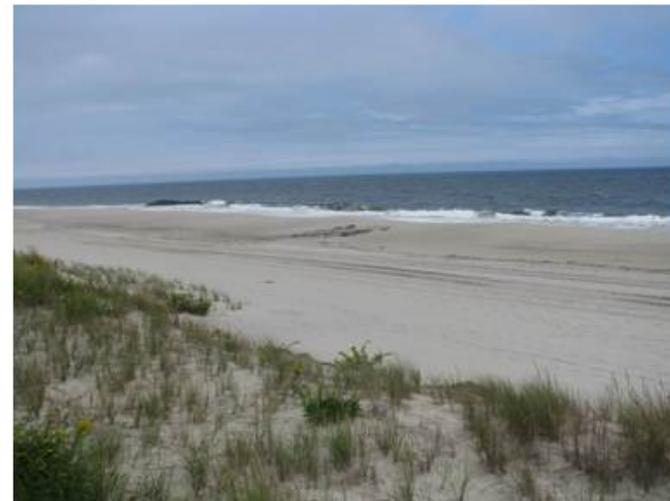
Figure 72. Sand was added in the Monmouth County Federal beach nourishment project over two seasons. This site was not included in the the 2002 maintenance fill, though sand was added in 2009. (Left photo October 15, 1990 [view to the northeast]; right photo September 28, 2011 [view to the northeast]).

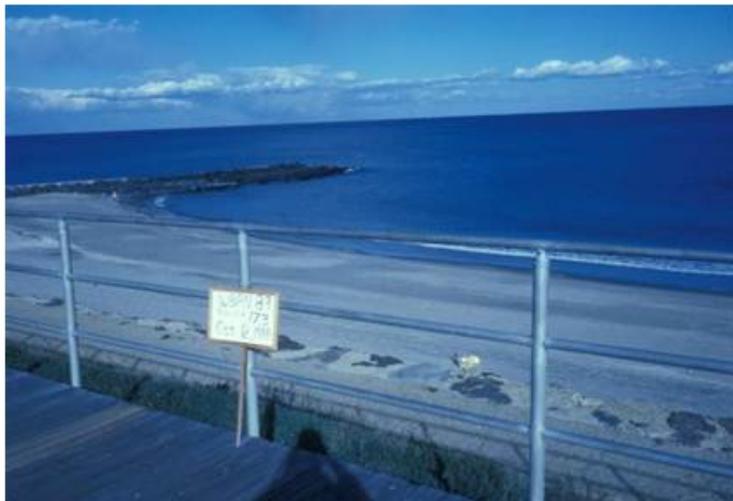
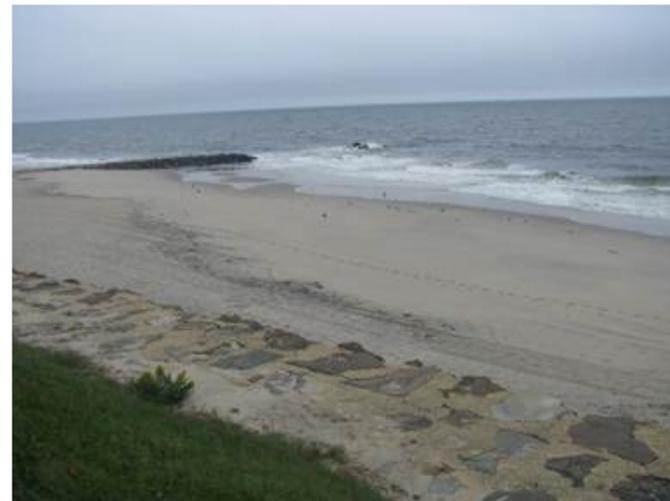
Figure 76. This site is located at the southern limit of the Monmouth County Federal beach nourishment project and is more erosional than other sites within Long Branch. (Left photo October 12, 1988 [view to the northeast]; right photo September 28, 2011 [view to the northeast]).

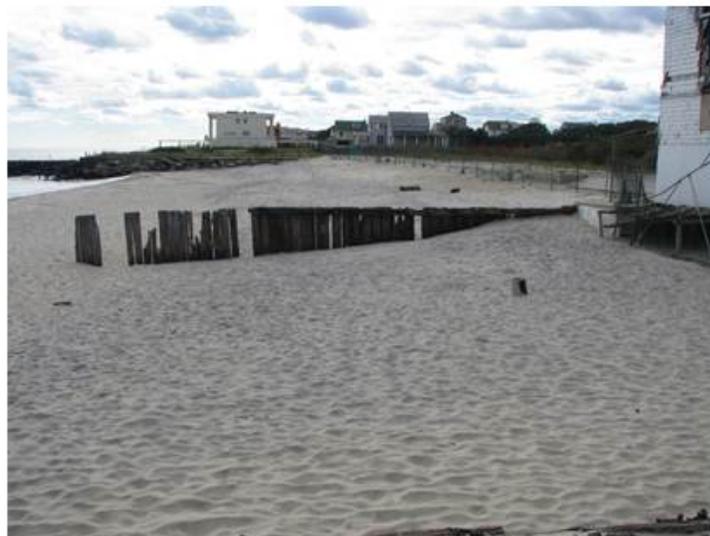
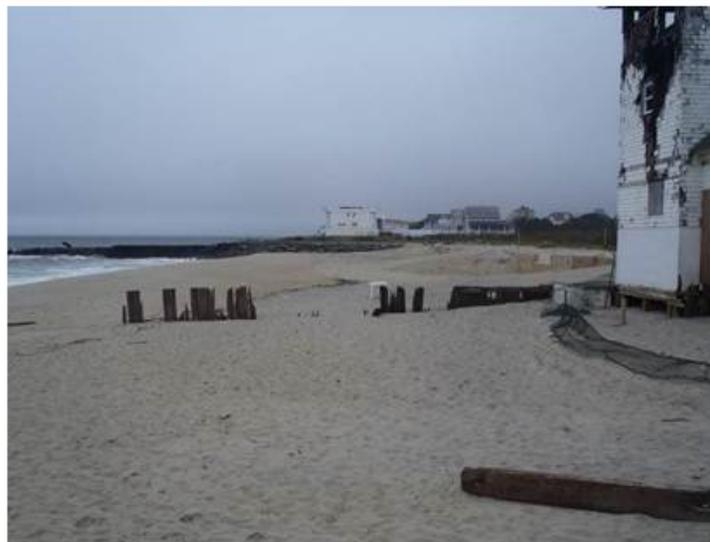
Figure 80. This new site was established in June 2010 because former Site 172 was lost to development. (Top photo October 29, 2010 [view to the south]; bottom photo September 28, 2011 [view to the south]).

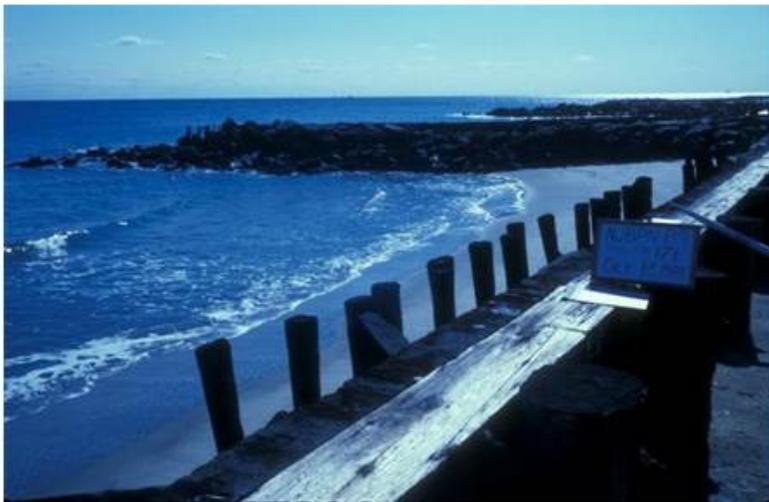
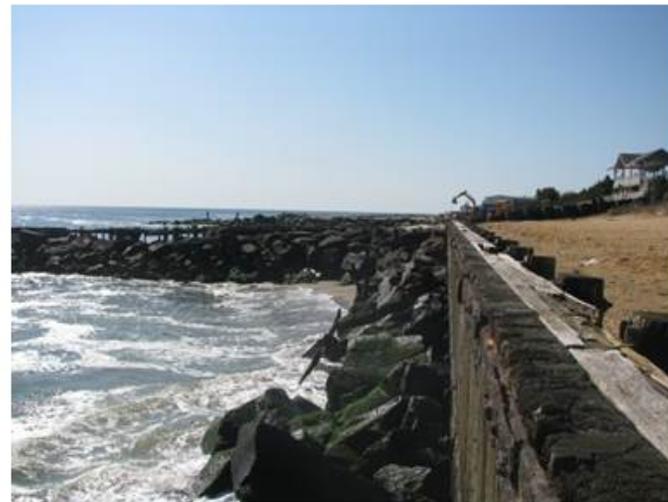
Figure 83. Sand lost from the Monmouth County Federal beach nourishment project was moved southward to this location and the beach temporarily benefitted from the project. With no new input of sand, this site (positioned at the highest elevation of the Monmouth County bluff) is in a long-term state of erosion. Typically, there is no dry sand beach at this location. (Left photo October 13, 1988 [view to the south]; right photo October 5, 2011 [view to the south]).

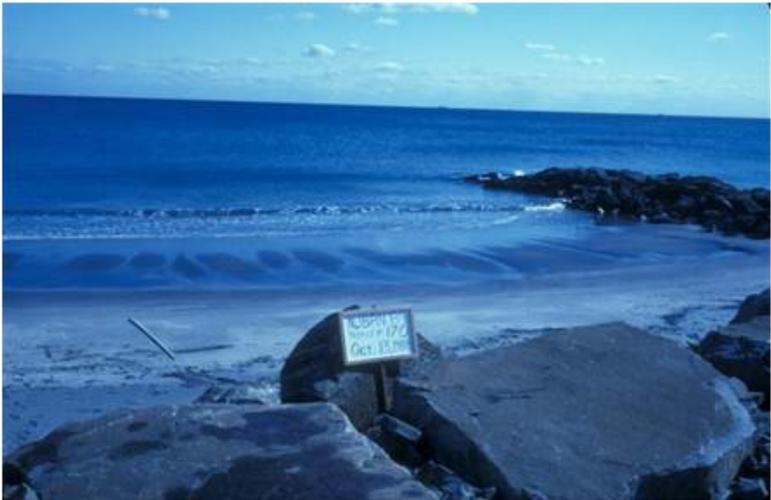
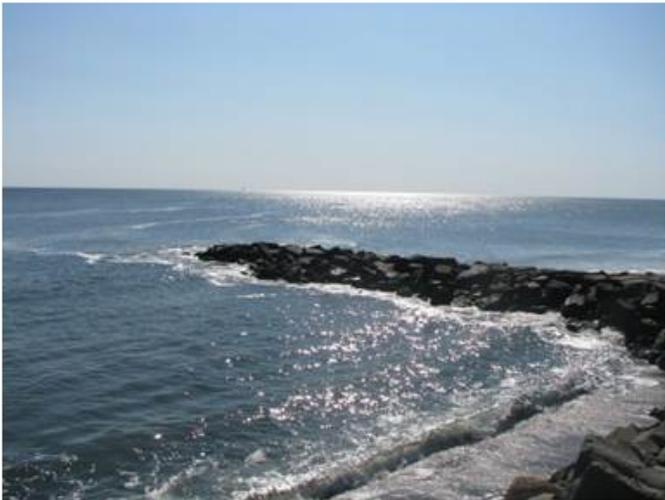
Figure 87. This site has experienced little dramatic changes over the past 25 years with the exception of the shoreline fluctuations recorded in 2005 and 2006. This location was not included in the Federal beach nourishment project but may have benefitted by the additional sand in the littoral system. (Left photo October 13, 1988 [view to the southeast]; right photo October 3, 2011 [view to the southeast]).

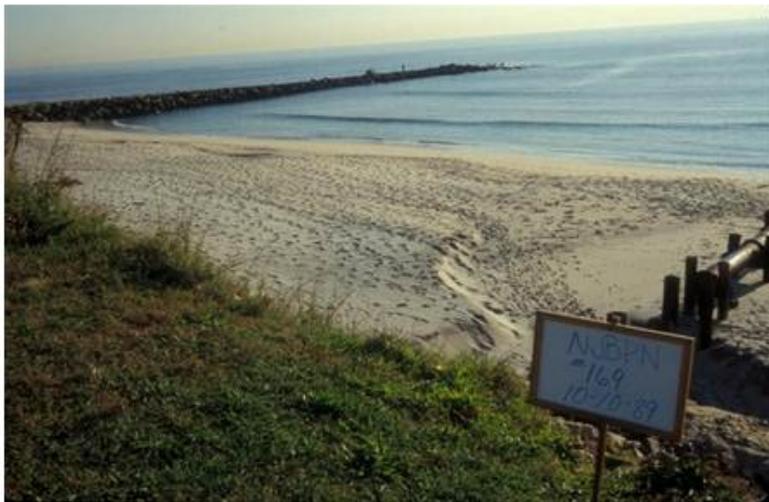
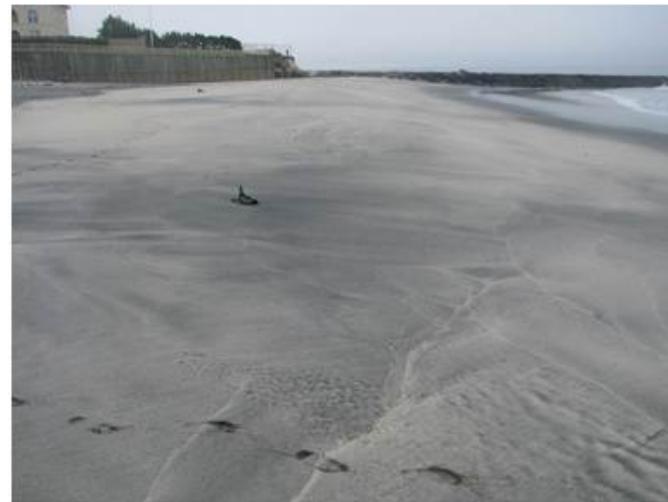
Figure 91. This site has been variable over the past 25 years with periods of erosion that can be attributed to the groins that limit northward transport of sand. Overall, this site has experienced little net change. (Left photo October 10, 1989 [view to the northeast]; right photo September 27, 2011 [view to the north]).
