# New Jersey Beach Profile Network

## Monmouth County

Raritan Bay and Sandy Hook  
to Manasquan Inlet

**NJBPN Profile #'s  
187 - 256**

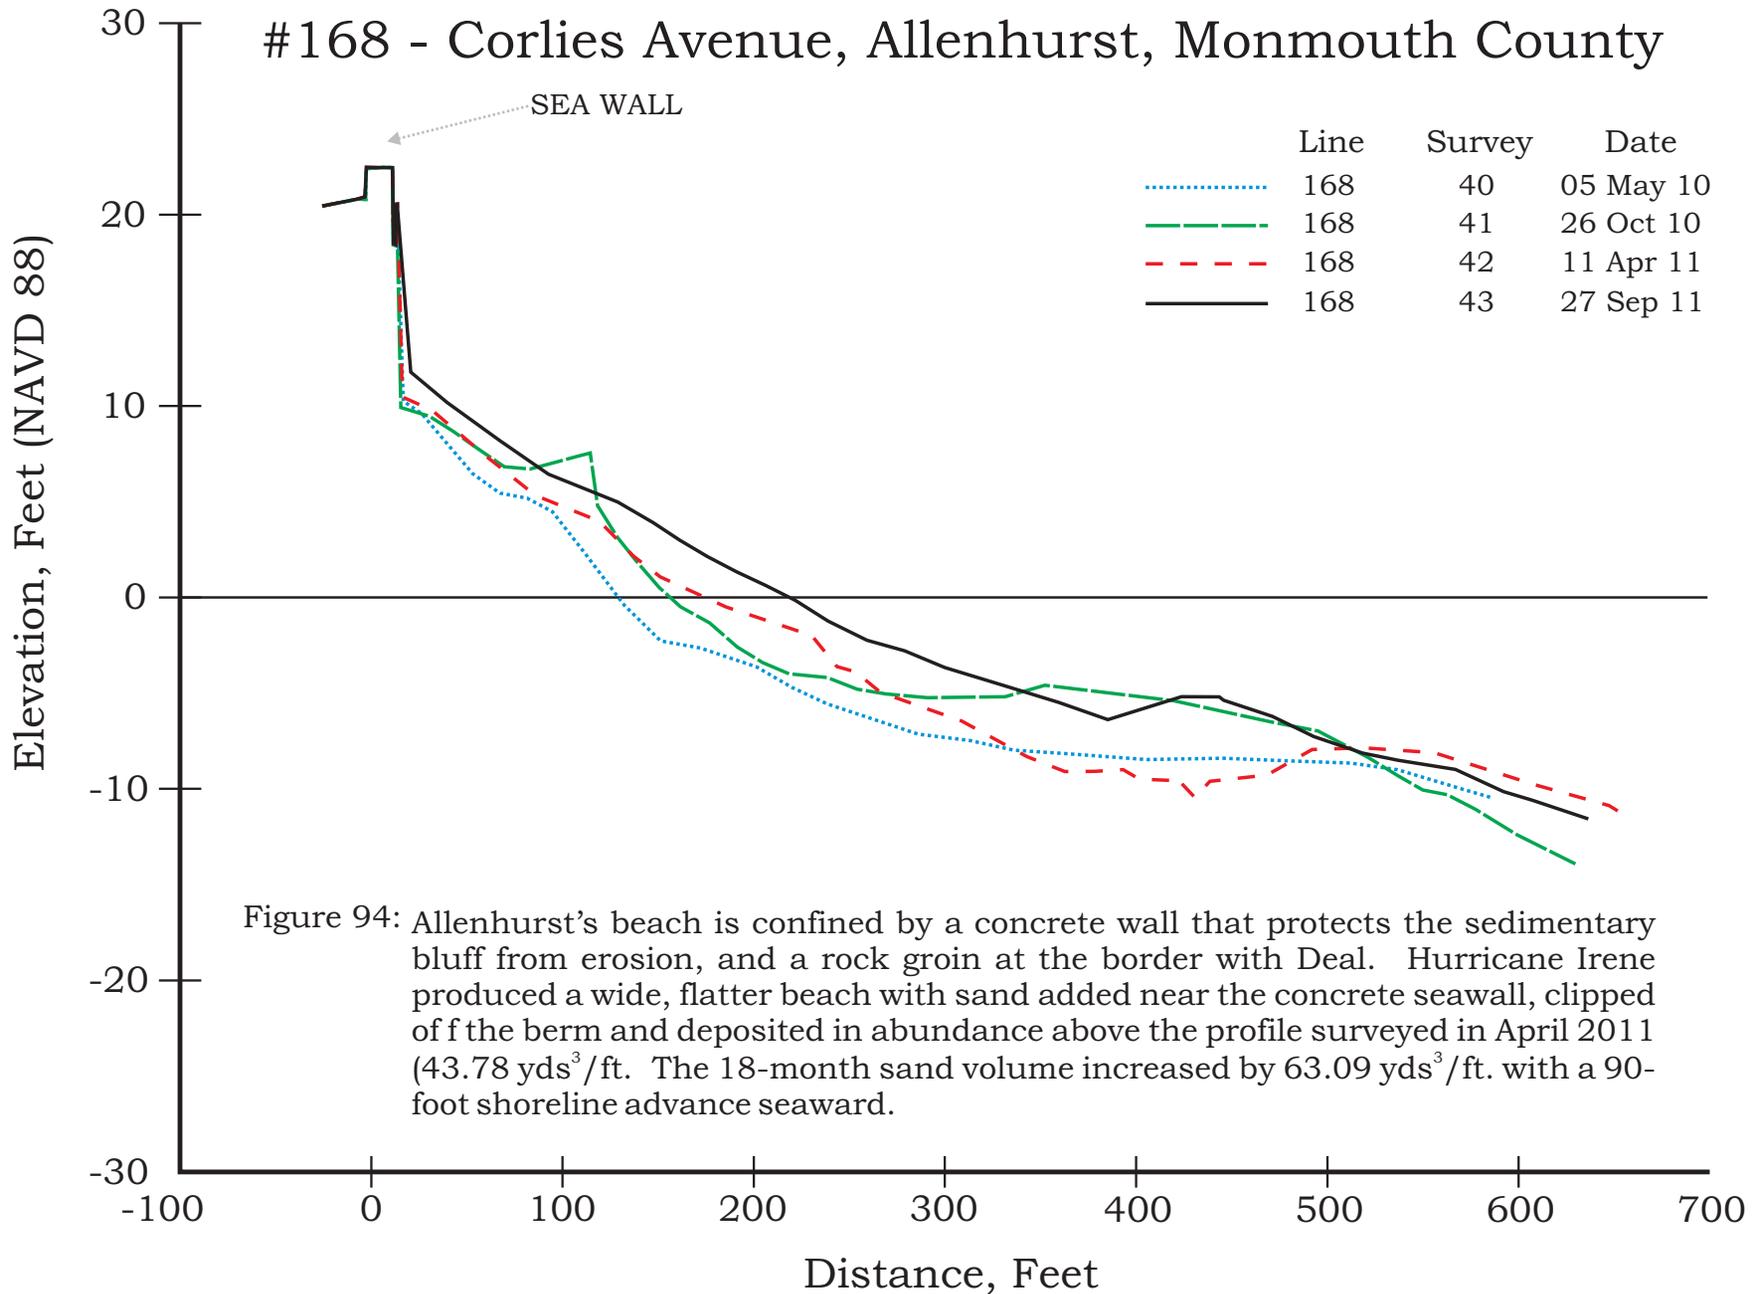
Figure 94: Allenhurst's beach is confined by a concrete wall that protects the sedimentary bluff from erosion, and a rock groin at the border with Deal. Hurricane Irene produced a wide, flatter beach with sand added near the concrete seawall, clipped of f the berm and deposited in abundance above the profile surveyed in April 2011 (43.78 yds<sup>3</sup>/ft. The 18-month sand volume increased by 63.09 yds<sup>3</sup>/ft. with a 90-foot shoreline advance seaward.

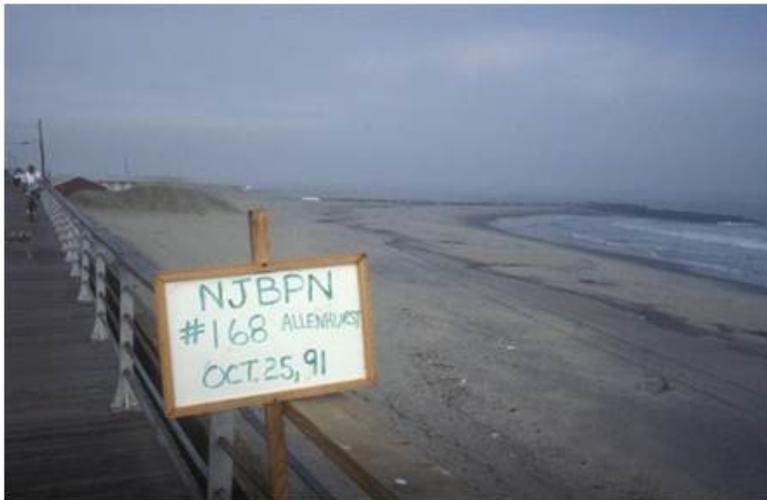
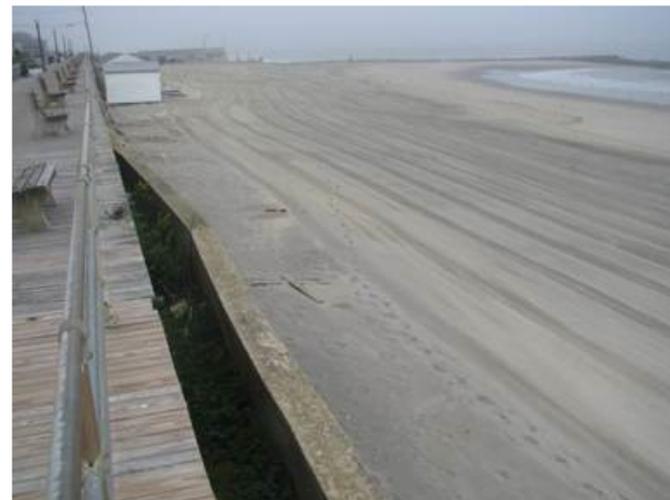
Figure 95. The municipality placed 180,000 cy of sand on this beach in 1989. Later, this beach benefitted from the beach nourishment that took place less than a mile to the south in Asbury Park. Overall, this site has experienced a net gain of sand. (Left photo October 25, 1991 [view to the north]; right photo September 27, 2011 [view to the north]).

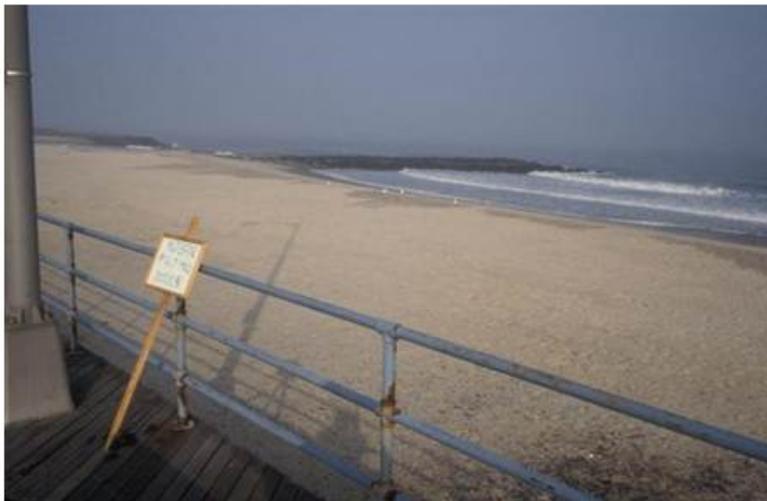
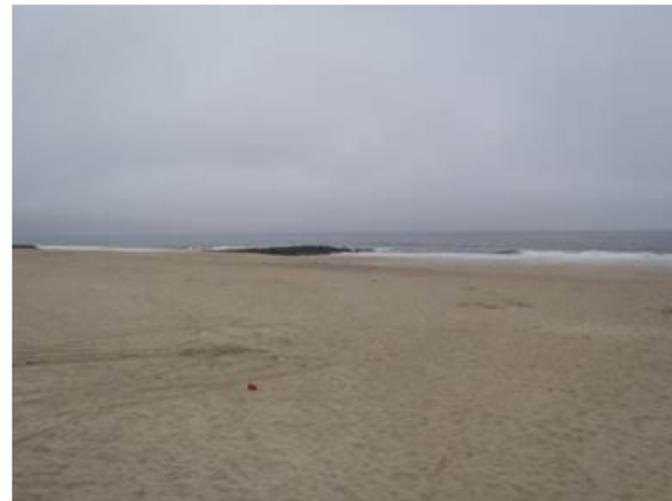
Figure 103. Sand was added to this site during the 1998 Federal beach nourishment project. No dunes were created because of the heavy recreational use. Wind transports the sand landward under the boardwalk and later removed by the municipality so that no dunes establish. (Left photo October 25, 1991 [view to the northeast]; right photo September 27, 2011 [view to the northeast]).

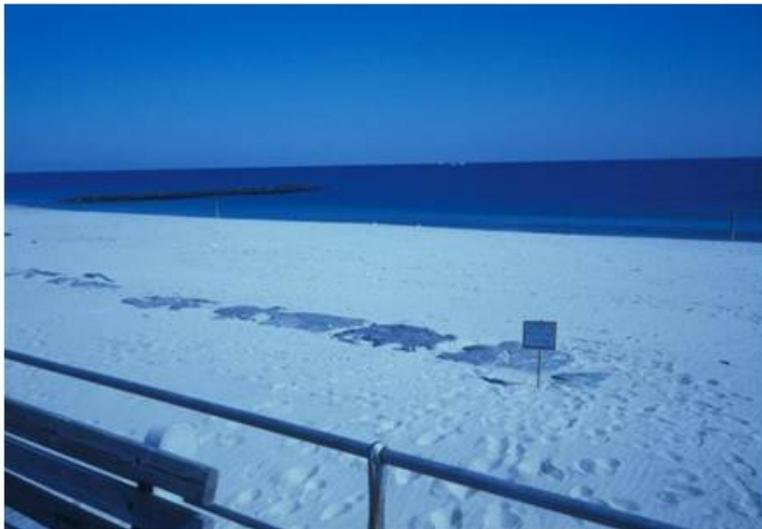
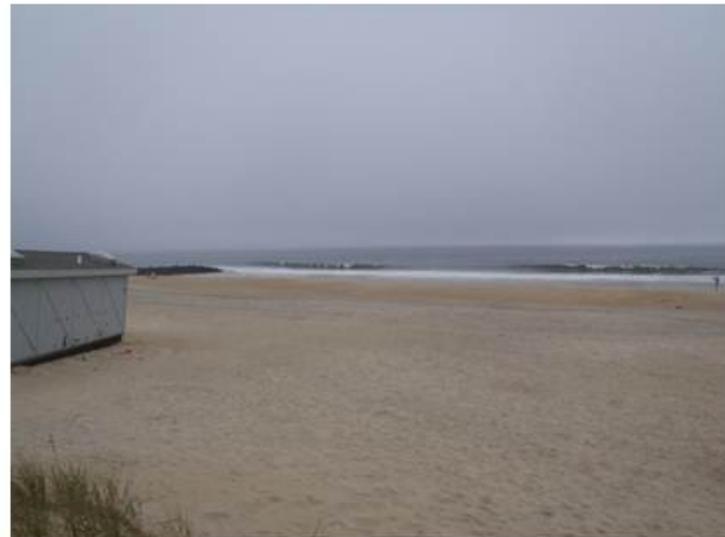
Figure 107. The USACE completed a beach nourishment project in 1999 which attributed to greater than a 300-ft advance of the shoreline. This site has remained relatively stable and no maintenance sand has been added here. Left photo October 14, 1988 [view to the northeast]; right photo September 27, 2011 [view to the northeast].

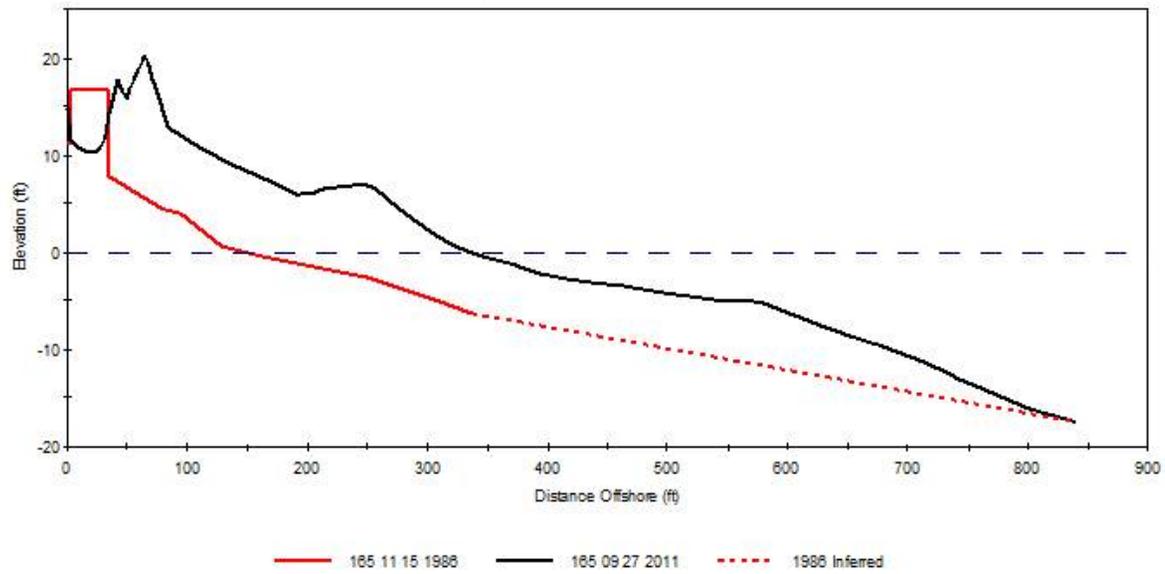
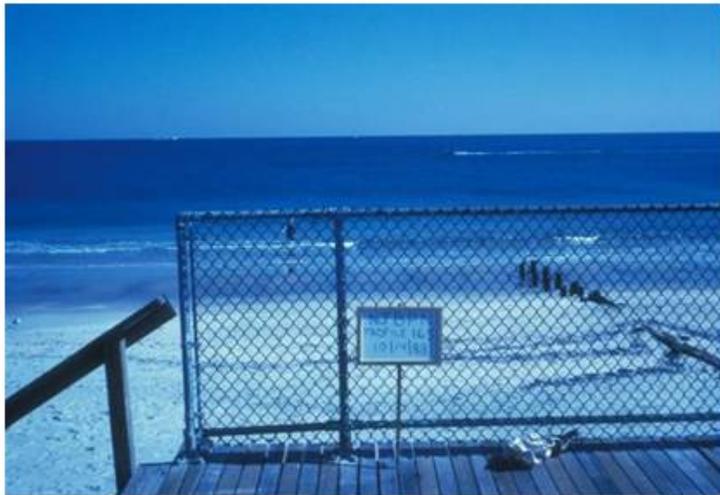
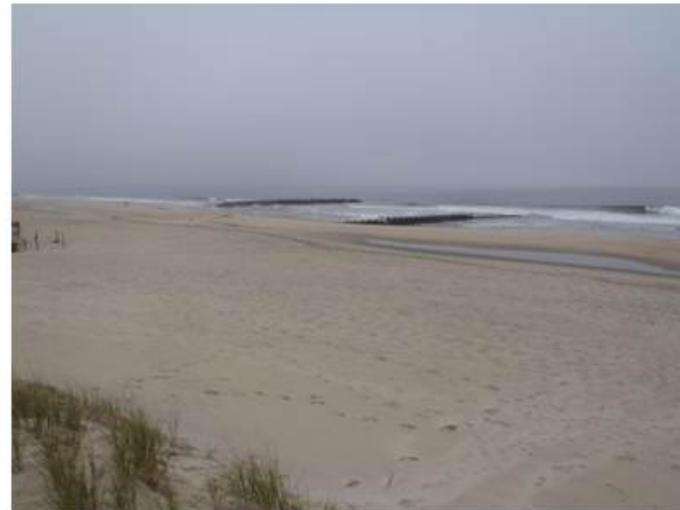
## McCABE AVENUE, BRADLEY BEACH – SITE 165

Figure 111. The boardwalk shown in the 1988 photo and cross section above was damaged in the 1992 nor'easter and the municipality moved it landward to the top of the bluff. This site received sand from the 1999 Federal beach nourishment project. No maintenance sand has been added here as the site remains relatively stable. (Left photo October 14, 1988 [view to the east]; right photo September 27, 2011 [view to the northeast]).

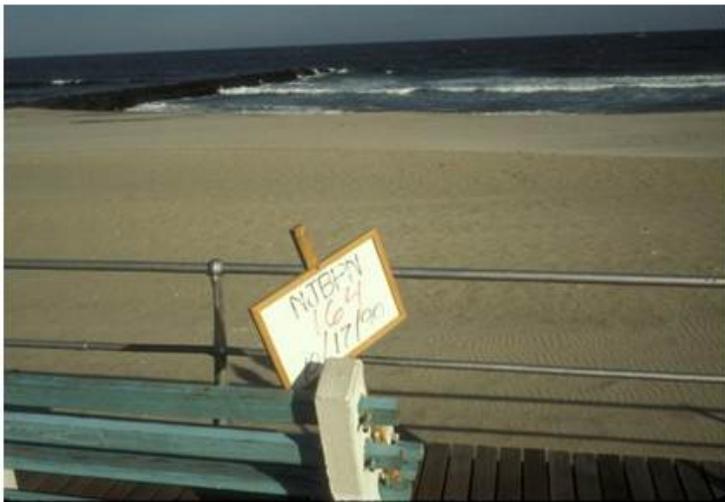
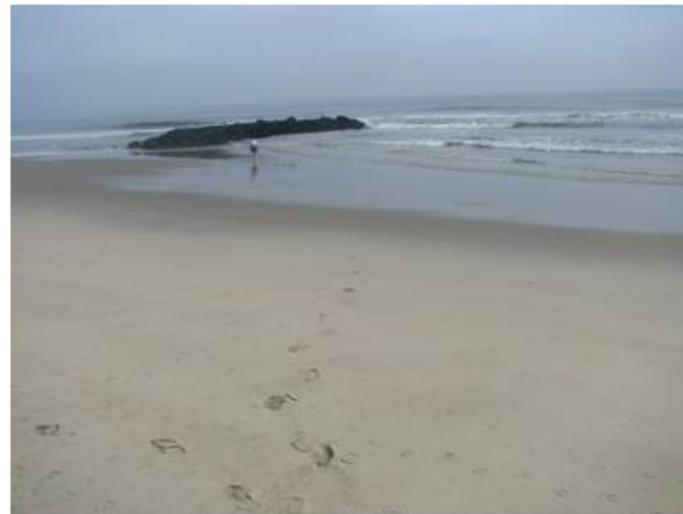
Figure 115. The shoreline began advancing two years prior to the 1999 Federal beach nourishment project. No dunes were constructed because of the heavy recreational use. The site remains relatively stable as no maintenance fill has been required. (Left photo October 17, 1990 [view to east]; right photo September 26, 2011 [view to the northeast]).

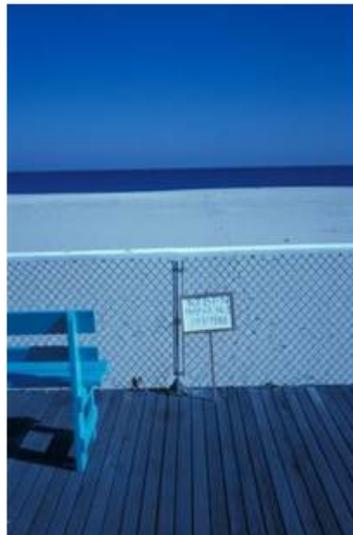
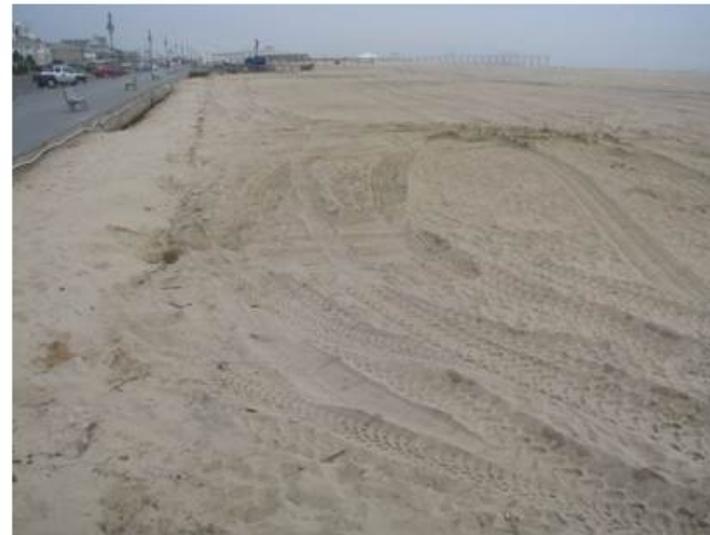
Figure 119. This site is located close to the south jetty of Shark River Inlet and has remained relatively stable over time. Variations in the shoreline location and volume are attributed to the balance of the littoral sand transport and movement of sand from offshore. (Left photo October 14, 1988 [view to the east]; right photo September 26, 2011 [view to the north]).

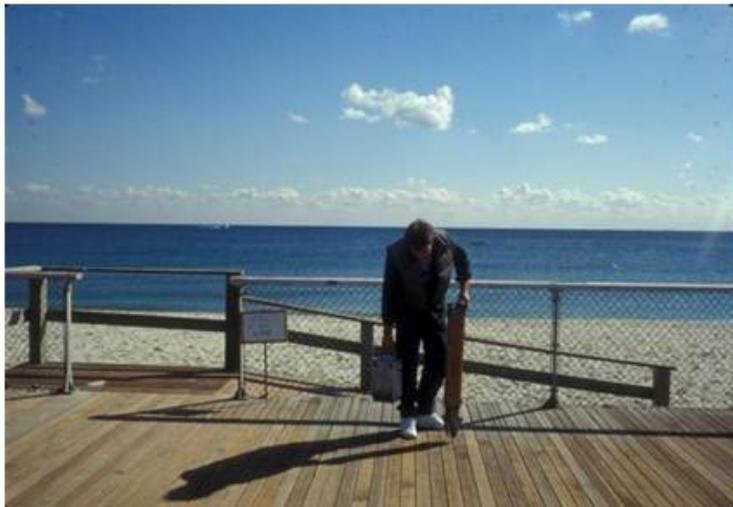
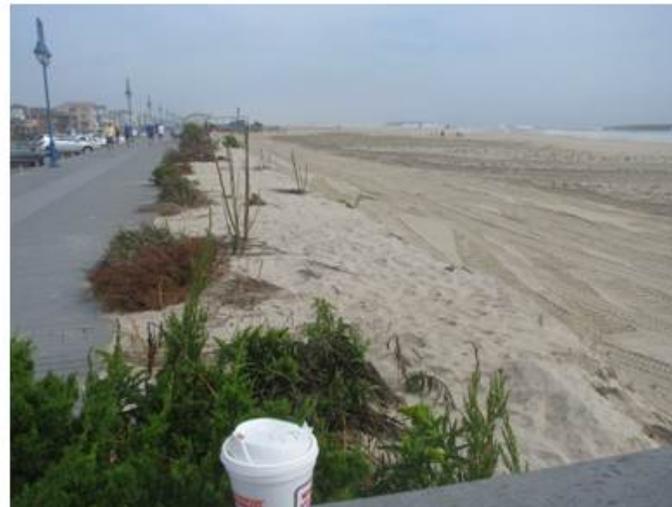
Figure 123. Sand was added to this site in the 1997 Federal beach nourishment project. Since that time, the site has had small amounts of gains and losses, but overall remains relatively stable. (Left photo October 9, 1989 [view to the east]; right photo September 26, 2011 [view to the north]).

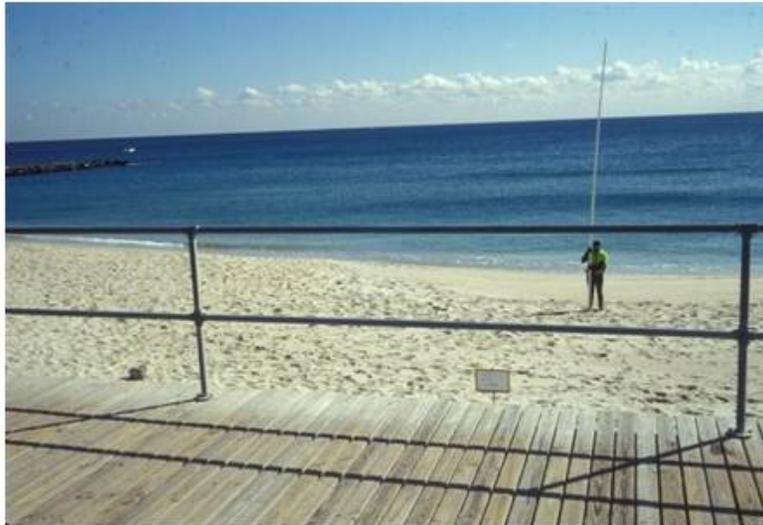
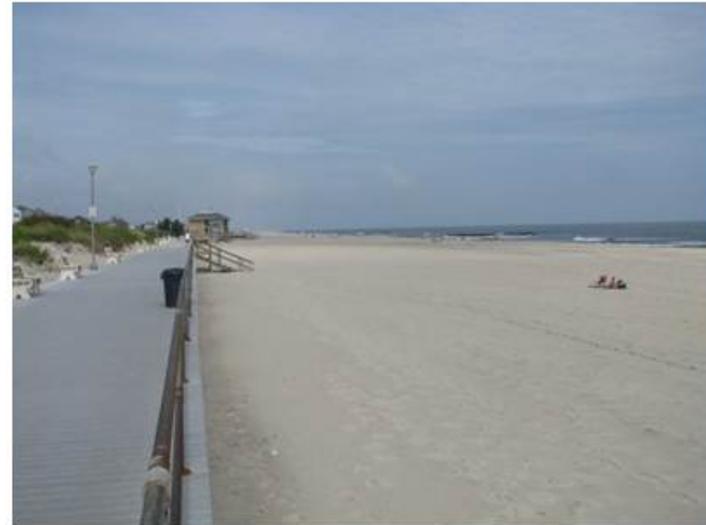
Figure 127. Sand was added to this site in the 1997 Federal beach nourishment project and the shoreline remained stable in the years that followed. (Left photo October 9, 1989 [view to the northeast]; right photo September 21, 2011 [view to the north]).

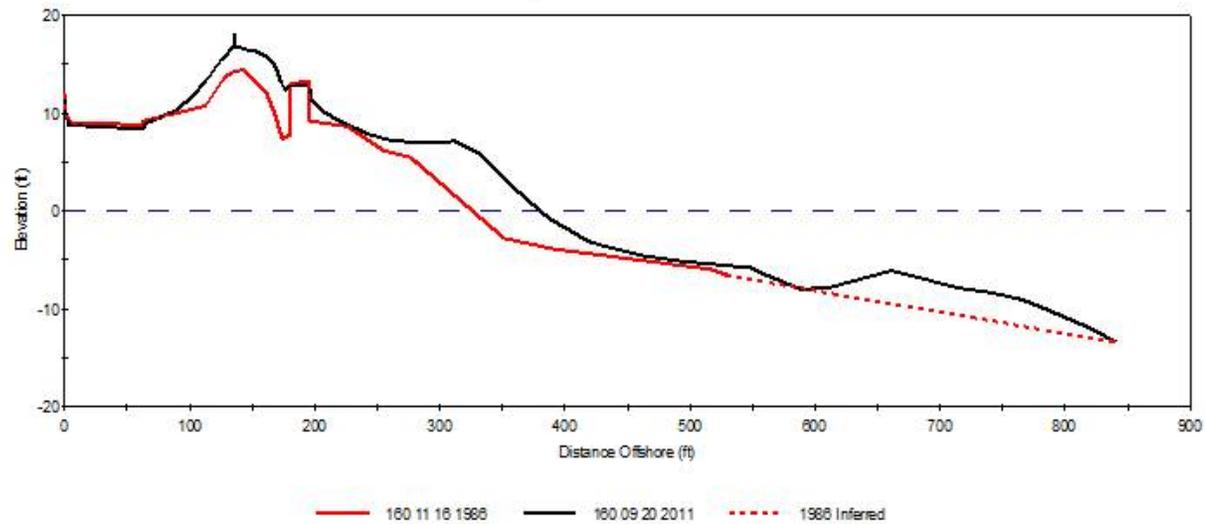
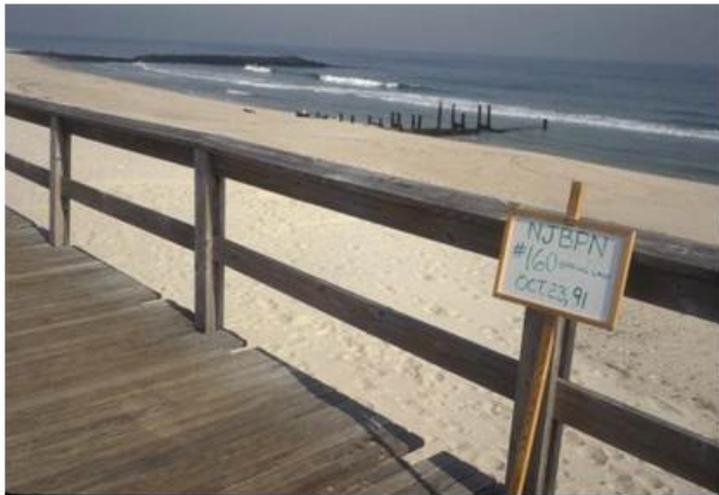
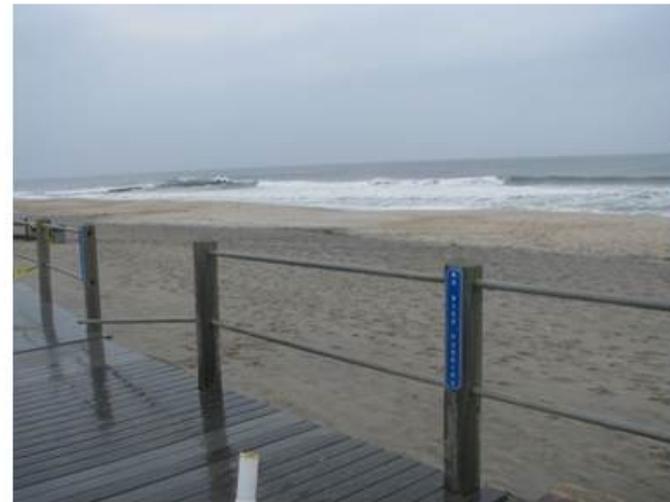
### SALEM AVENUE, SPRING LAKE – SITE 160

Figure 131. Prior to the 1997 Federal beach nourishment project, the shoreline was retreating. After the project, the dune grew under natural conditions. The site has experienced shoreline retreat over the past five years. (Left photo October 23, 1991 [view to the northeast]; right photo September 20, 2011 [view to the northeast]).

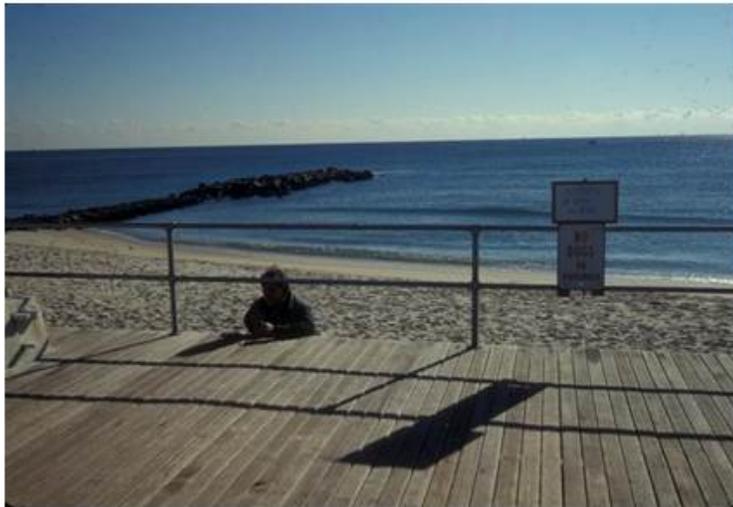
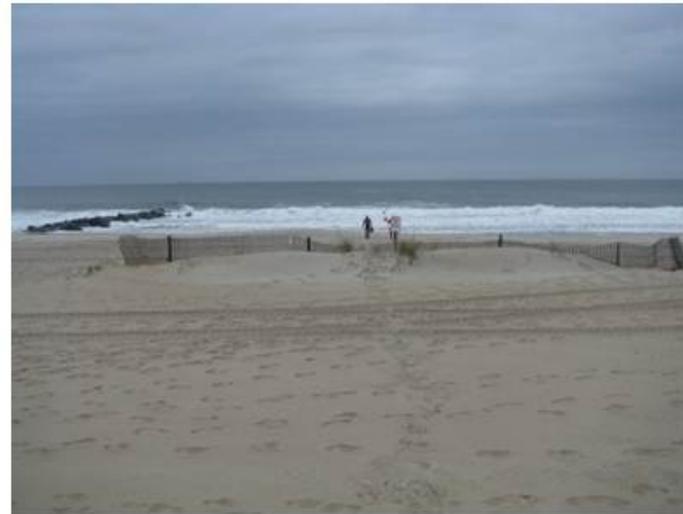
Figure 135. Sand was added to this location during the 1997 Federal beach nourishment project. Minor variations in shoreline position have occurred since then. In recent years, sand fencing was used to create dunes. (Left photo October 9, 1989 [view to the east]; right photo September 20, 2011 [view to the east]).

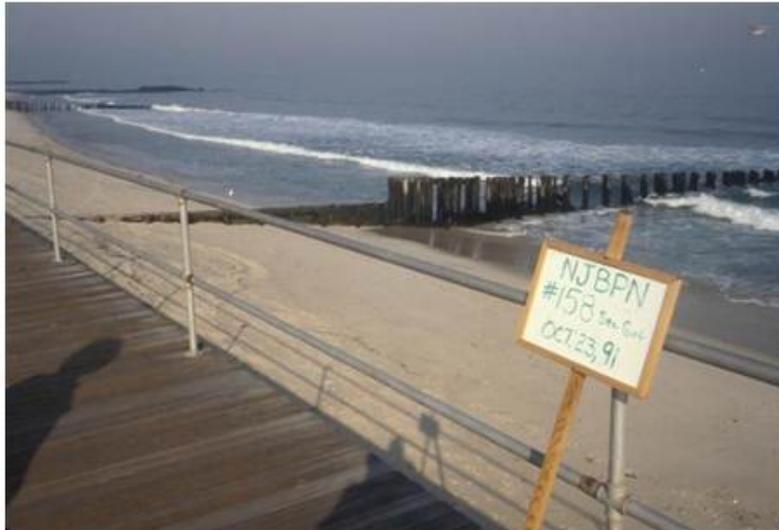
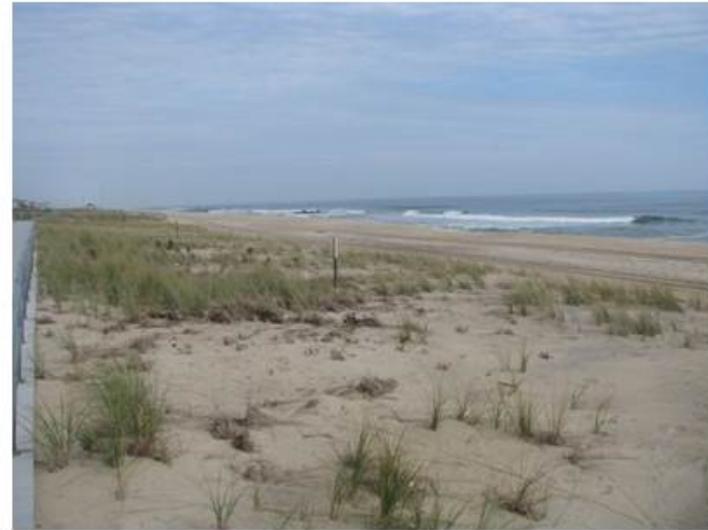
Figure 139. Sand was added to this location in the 1997 Federal beach nourishment project and dunes began to establish. Since the project, the site has experienced shoreline retreat and volume loss. (Left photo October 23, 1991 [view to the northeast]; right photo September 21, 2011 [view to the north]).

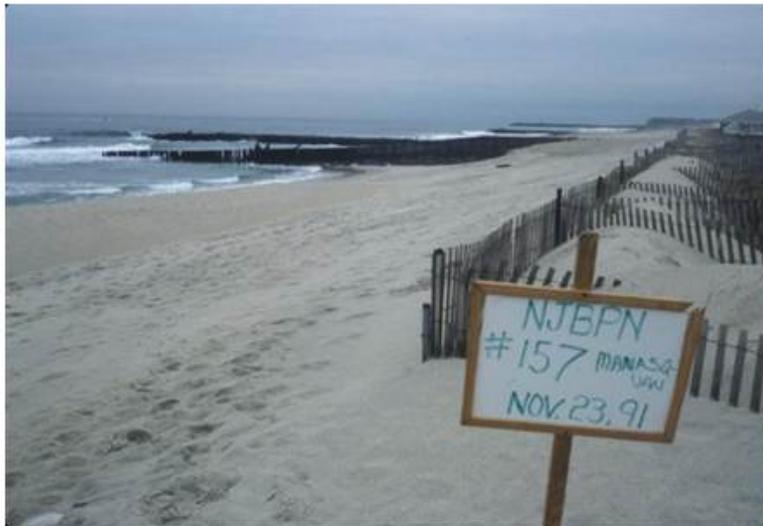
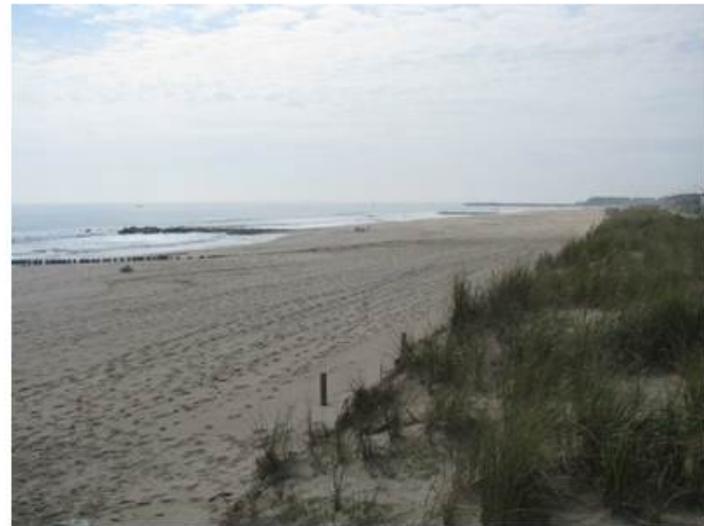
Figure 143. This location lies north of the Manasquan Inlet and within influence of the inlet jetties. Sand was added here in the 1997 Federal beach nourishment project. Since that time, this site has gradually retreated. (Left photo November 23, 1991 [view to the southeast]; right photo September 21, 2011 [view to the southeast]).

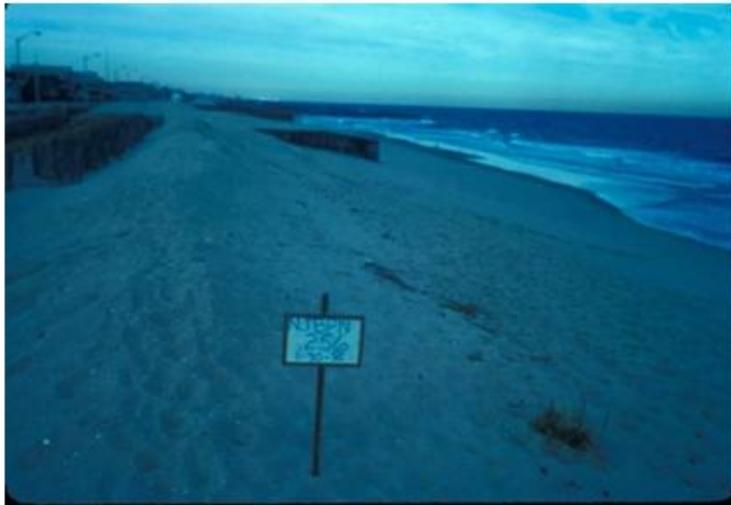
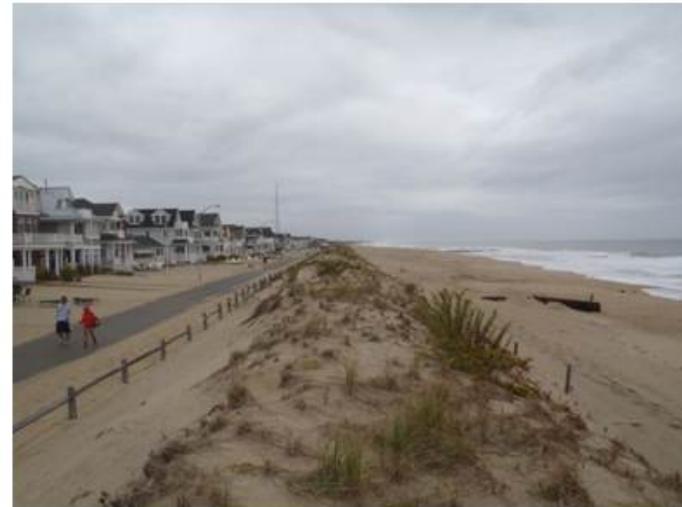
Figure 147. This site is located just north of Manasquan Inlet and the influence of its jetties. Sand was added here in the 1997 Federal beach nourishment project and the shoreline location has fluctuated since that time. Sand volumes have gradually decreased since the Federal project. (Left photo January 30, 1995 [view to the north]; right photo September 20, 2011 [view to the north]).
