New Jersey Beach Profile Network

Ocean County

Manasquan Inlet
to Little Egg Inlet

NJBPN Profile #'s
156 - 234

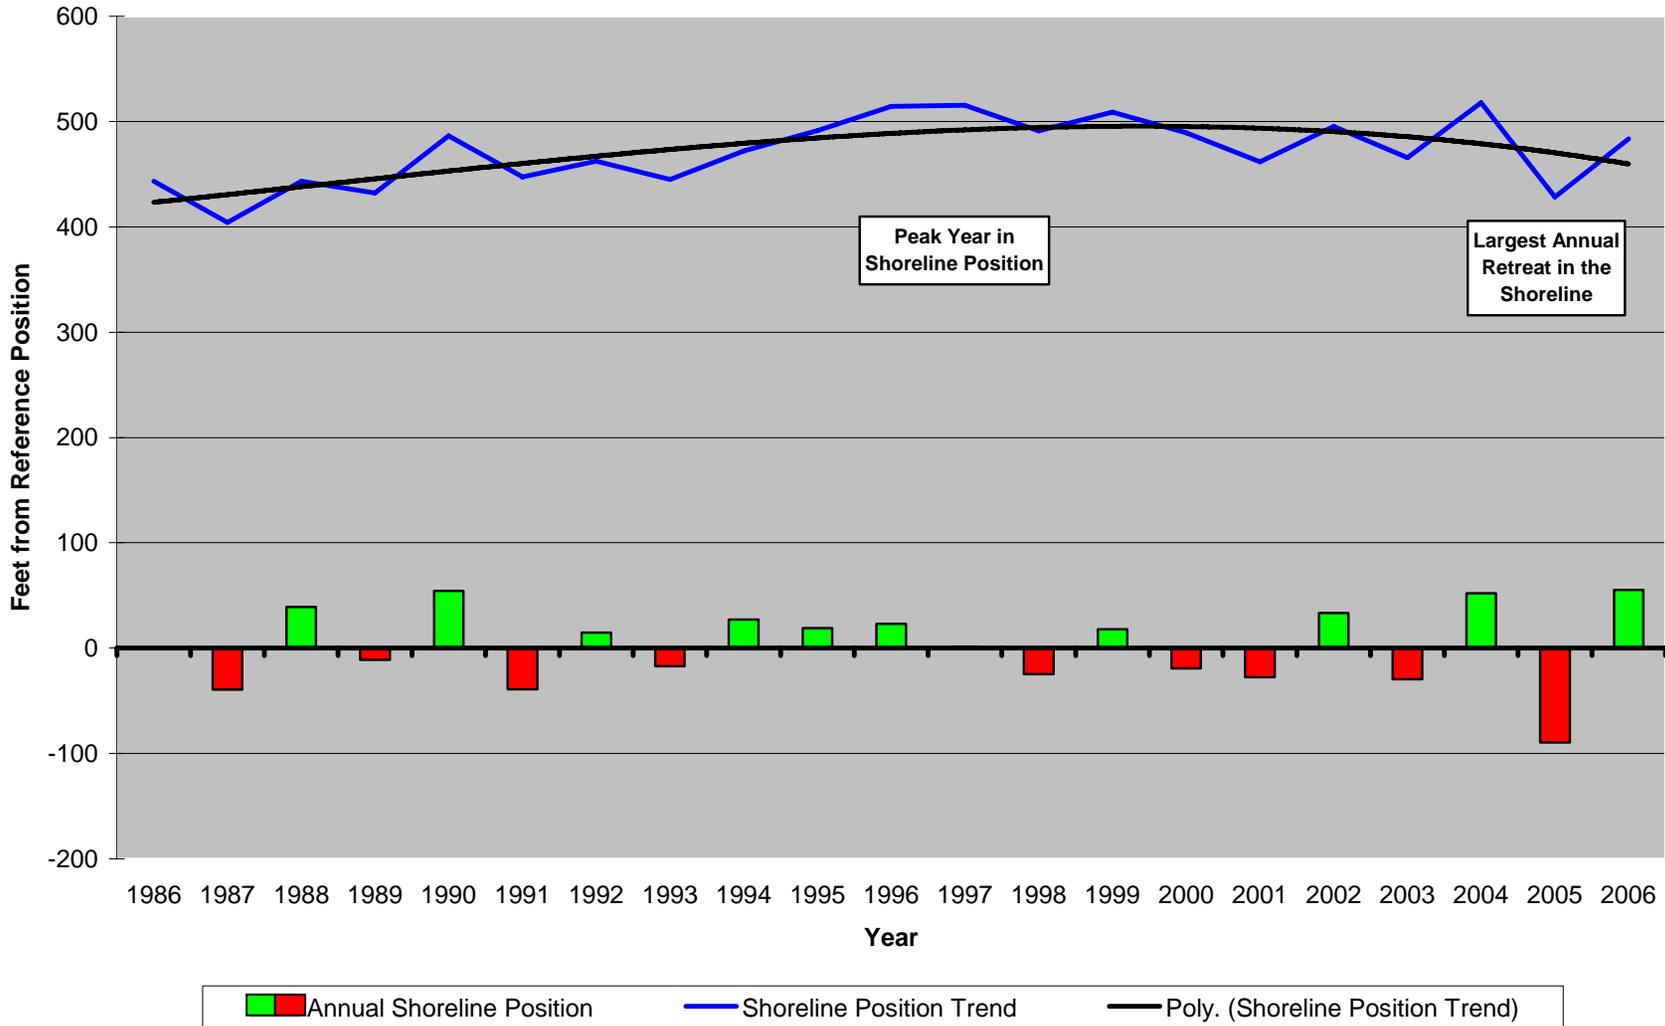
Figure 74 – Site 156. The northernmost site in Ocean County is positioned just south of the Manasquan Inlet. Protected by the jetties, the beach remained wide and changed little with storms or even trends following the Monmouth County shore protection project. The

shoreline trend was positive during the 20-year interval with a series of maximum positions seen in 1996, 1997, 1999 and 2004 all beyond 500 feet distant from the reference point landward of the boardwalk. The net change was a 50-foot advance in the position of the zero elevation shoreline position. The year 2005 saw the largest shoreline retreat with partial recovery in 2006. No major beach nourishment projects have taken place in Point Pleasant so changes were caused by natural processes related to the comparative frequency between littoral current activity going south (northeast storms) to that going north (southeast winds). Retreat is due to northeast activity, advance is related to the dominance of southeast wind-driven currents that push sand north where the inlet jetty traps and collects sand, adding to the beach width.

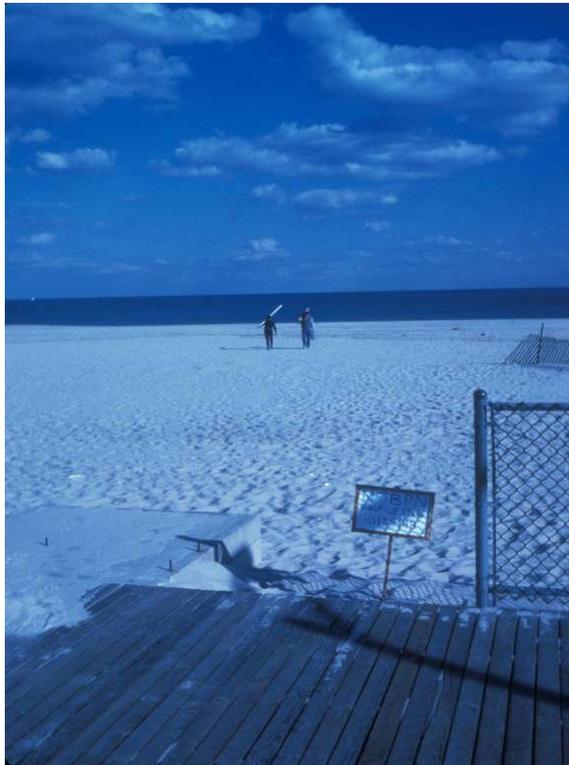
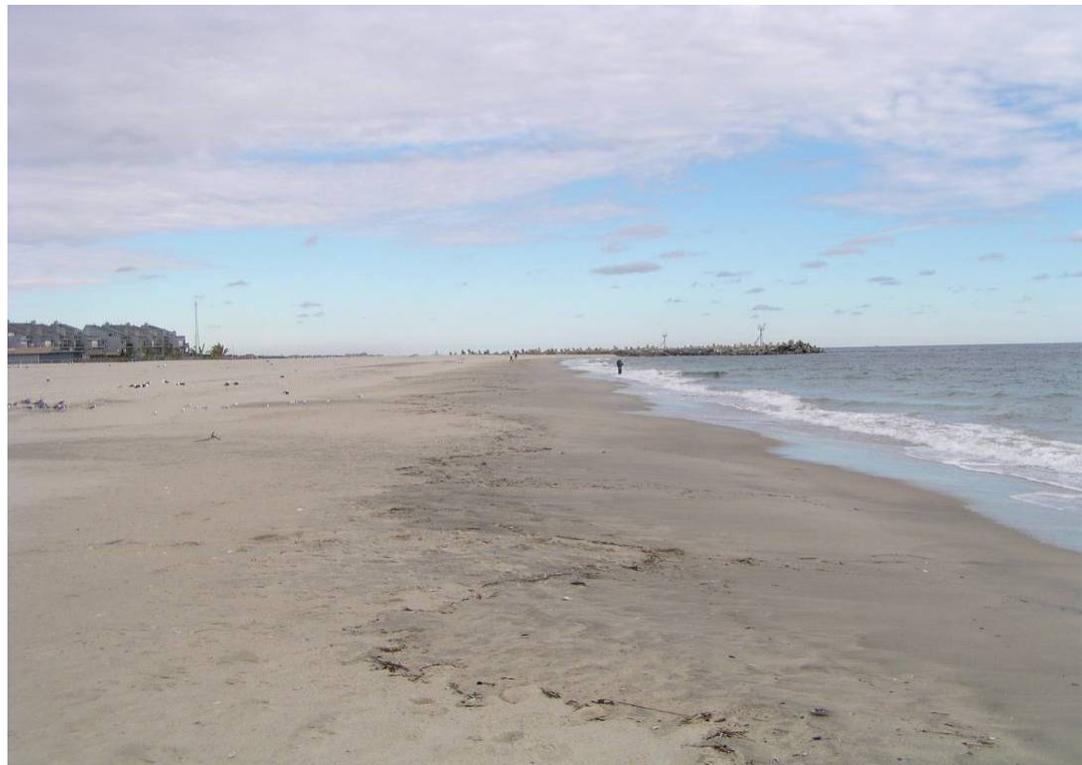
20-Year Comparison Photographs – Site 156, Water Street, Point Pleasant

The 2006 view to the north (right) from the berm crest shows the south jetty of Manasquan Inlet and the wide, dry beach preserved in its shadow toward the northeast. This beach is heavily used for recreation during the summer, with frequent raking and no effort to develop a dune system exists. The majority of the shoreline at this site is also privately owned. The photograph on the left shows the conditions of the beach in 1988.

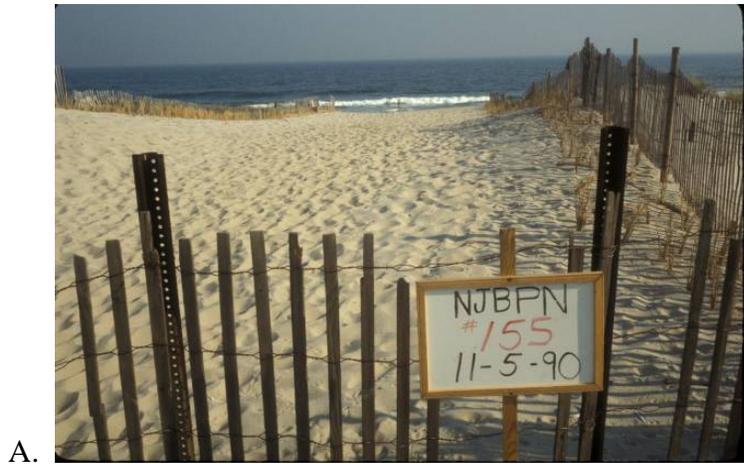
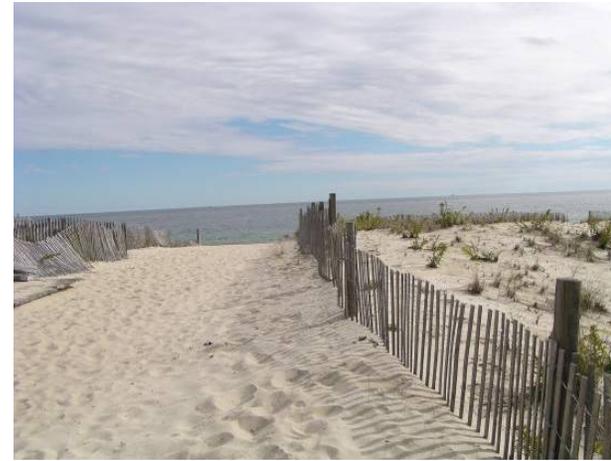
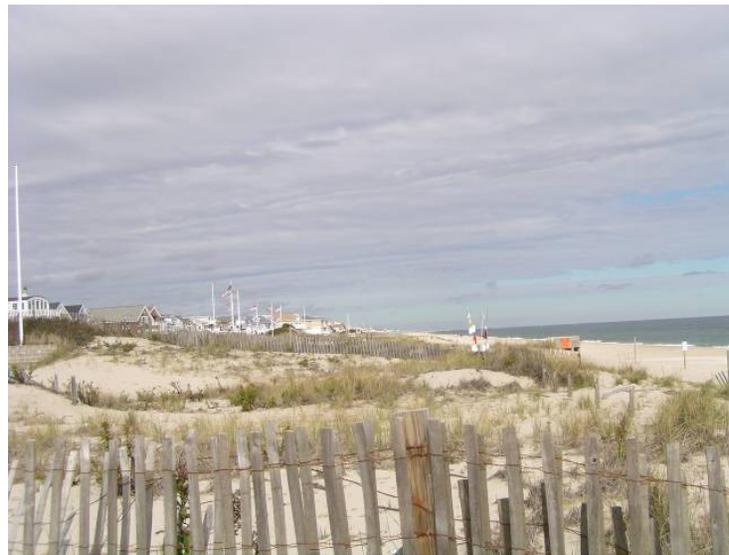
20-Comparison Photographs – Site 155, Maryland Avenue, Point Pleasant

This shoreline segment is protected by a massive dune in terms of both width and height (C, taken in 2006)). Established prior to monitoring in 1986, this feature has gained sand volume in spite of a relatively narrow beach. The beach width improved since 1986 but not in a steady fashion. In 2005, there was a substantial advance in the position of the shoreline coupled with a wider berm. Photos A and B show the beach conditions in 1990 and 2006, respectively.

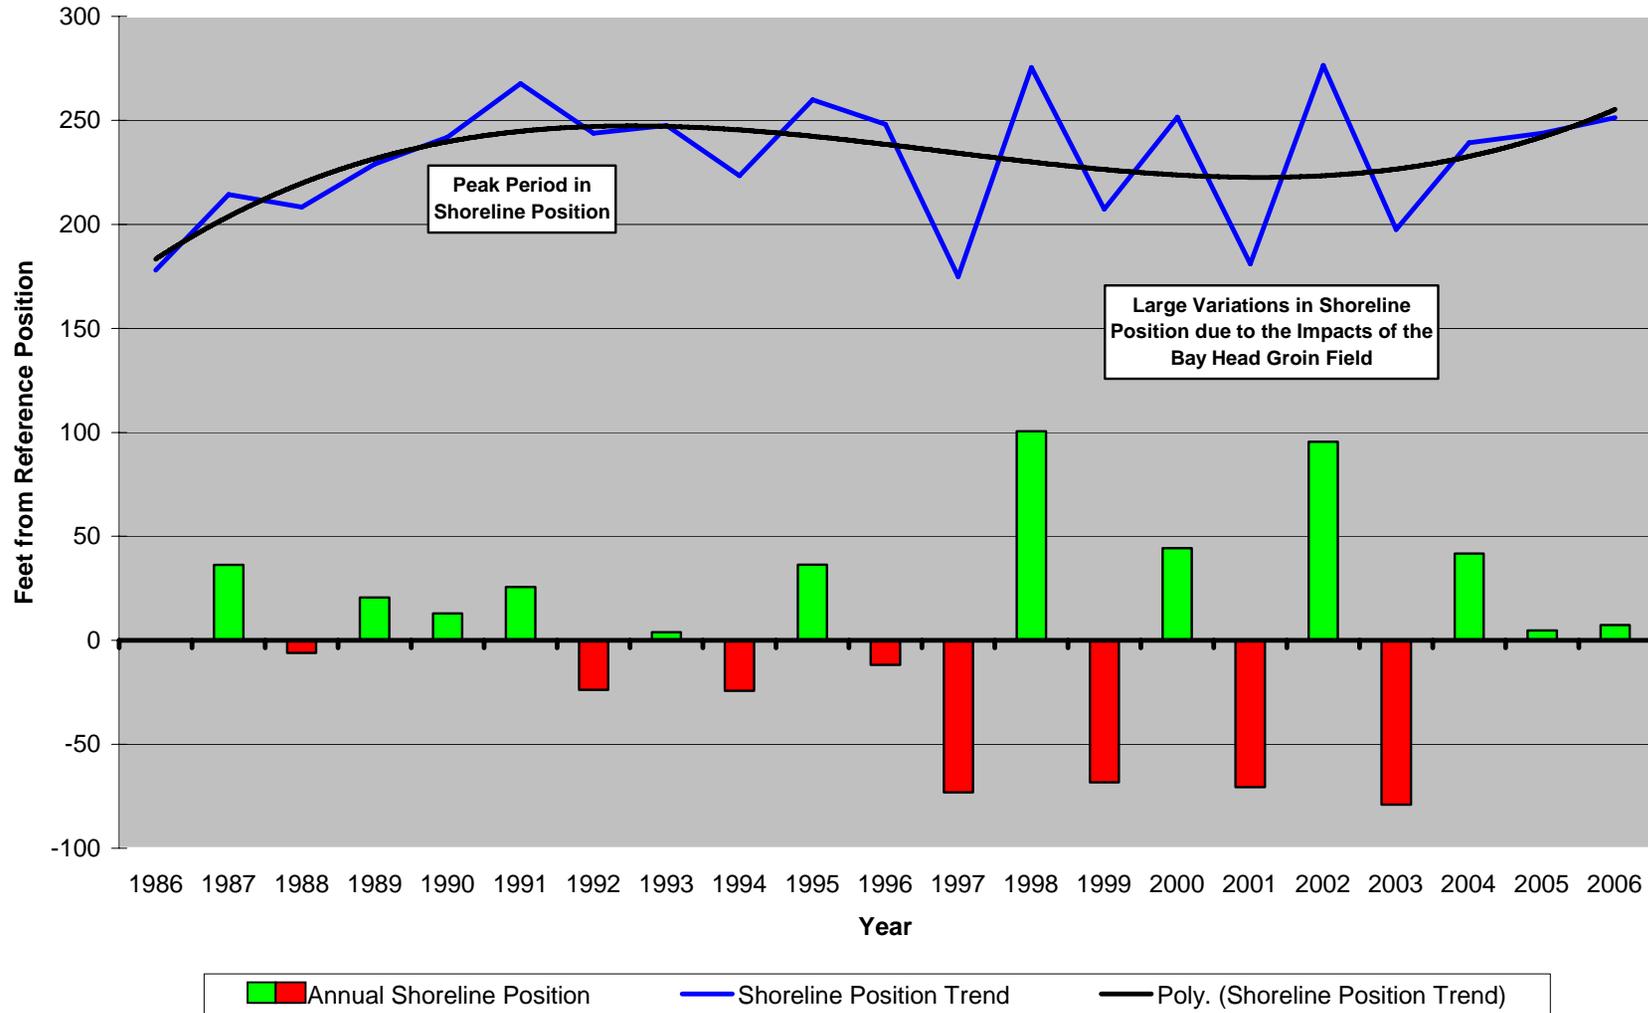
Figure 78 – Site 154. In Bay Head the variations in shoreline position were quite large with a 20-year trend of seaward advance. The 1992 Storm caused shoreline retreat with serious overwash of the tiny dune exposing the rock seawall core. Fortunately, the rock

revetment extended across about 1,600 feet of shoreline and prevented extensive damage to properties and infrastructure. This structure was exposed and scoured on both sides as waves overtopped the feature sending water and sand into the streets and adjacent properties. A dune was rebuilt after the storm to a more reasonable size and has grown larger from natural aeolian processes since. There was a yearly oscillation in shoreline position between 1997 and 2004 significant in that it represents changes in the direction of longshore transport by waves whether toward the groin field (north) or away from it (south). This produces large shifts in the shoreline depending on the direction of dominant drift for sand.

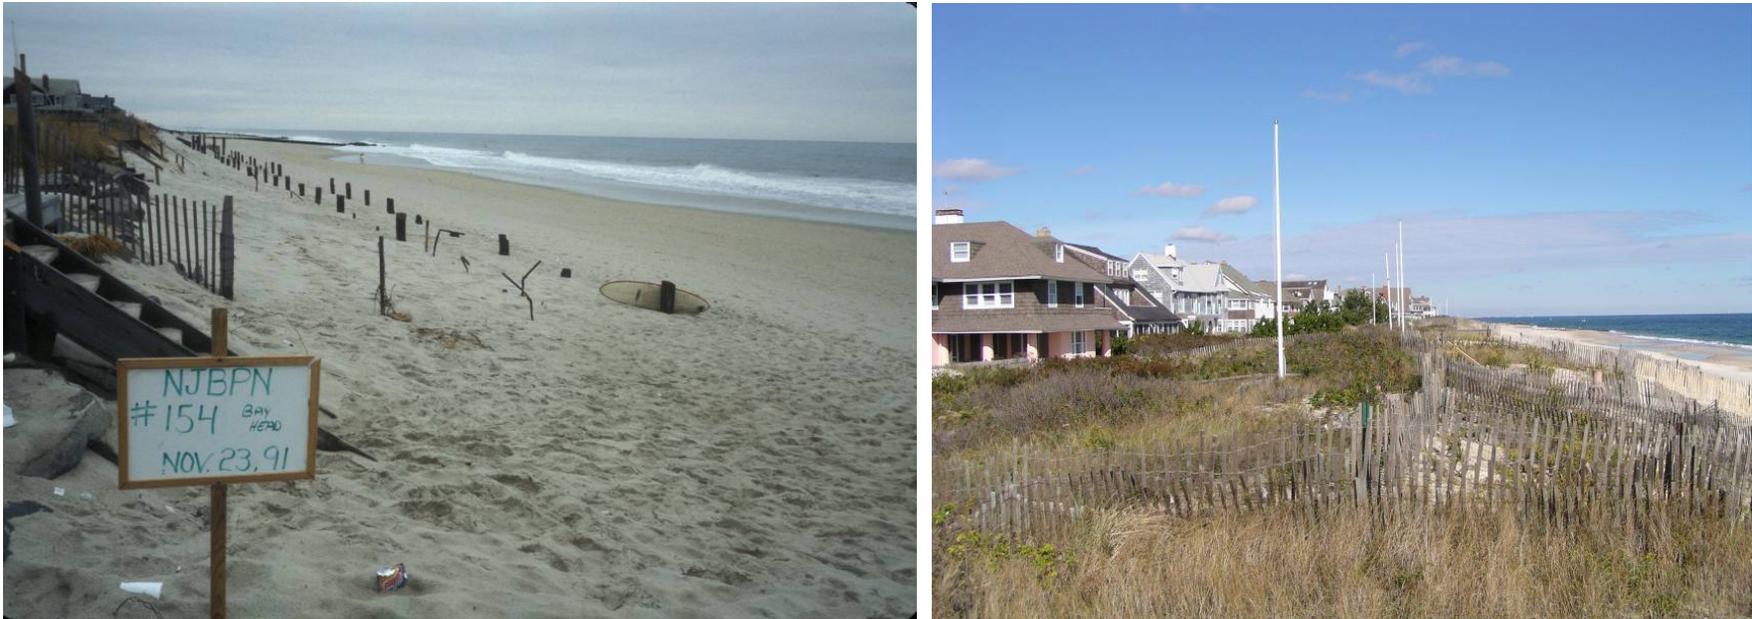
20-Year Comparison Photographs – Site 154, Johnson Avenue, Bay Head

The revetment is partially shown on the left side of the 1991 photograph (left side) and lies directly under the photographer's feet and extends north and south in the 2006 photograph (left). Exposed completely in December of 1992, the beach was deeply scoured directly seaward of the rocks and overwash topped the rock crest and washed all the dune sand down the street into route 35. Reconstruction initiated development of a substantial dune today (right) enhancing storm protection, but fortunately similar intense storm events have not occurred along the Jersey shore since.

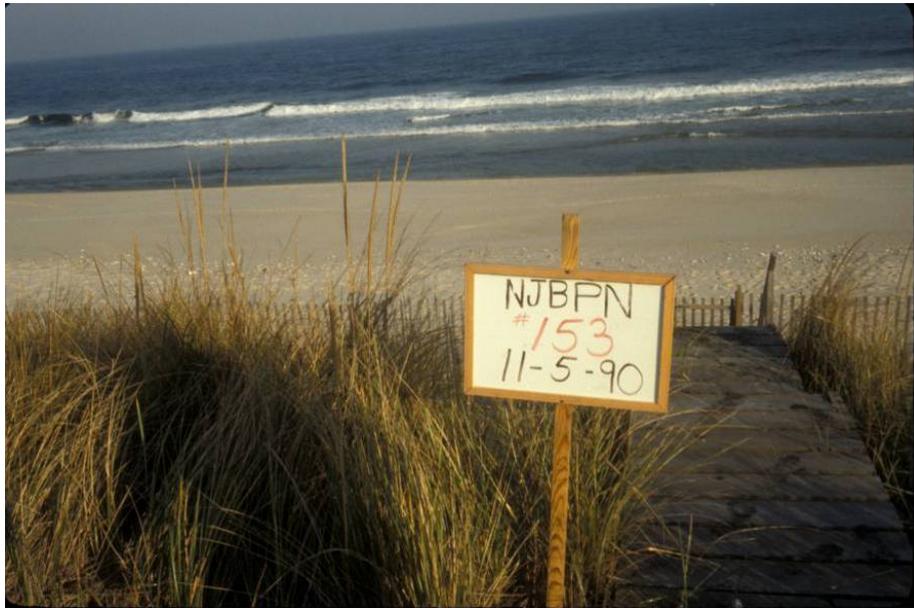
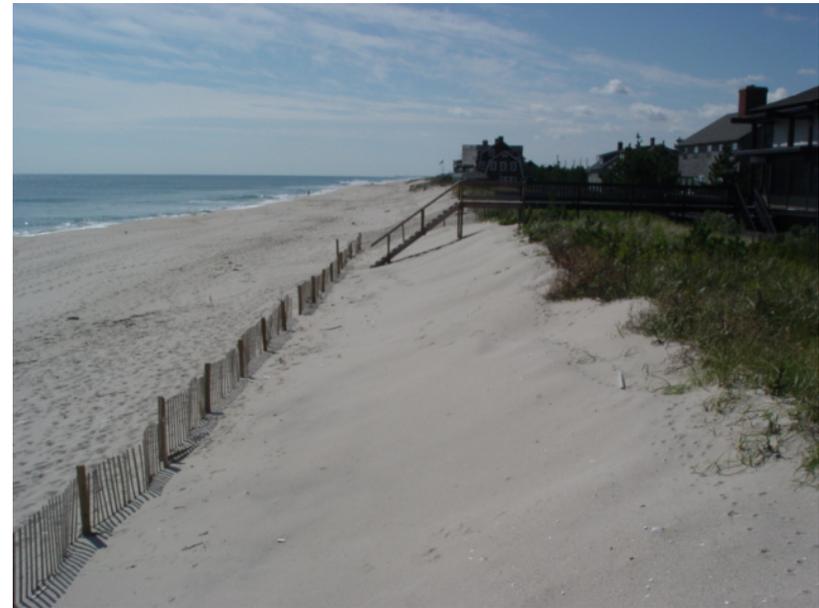
20-Year Comparison Photographs – Site 153, 1117 Ocean Avenue, Mantoloking

The 1992 northeast storm damaged the dune severely enough to erode through the crest. Restoration efforts have continued to date (right). The linear vegetation boundary represents the 2005–2006 winter erosion of the dune with the dune slope sand put back using a bulldozer to harvest sand from the storm recovery deposit on the beach. The 1992 scarp was about 25 feet landward of the most recent storm activity. Although the shoreline position has been relatively stable the beach width is insufficient to support further dune growth and marginally sufficient for supporting the current dune system, resulting in frequent erosion and vertical scarping of the seaward slope even during modest to moderate storm events.

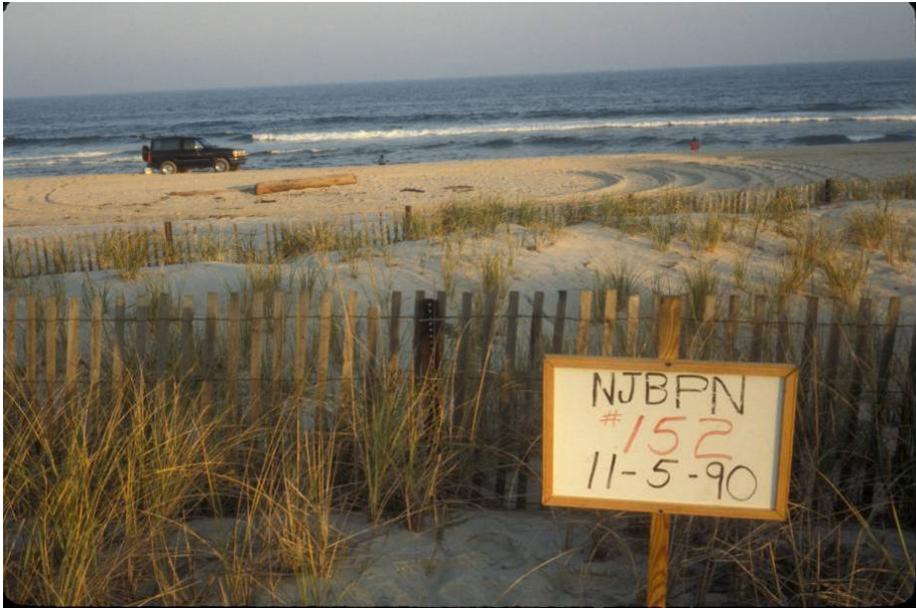
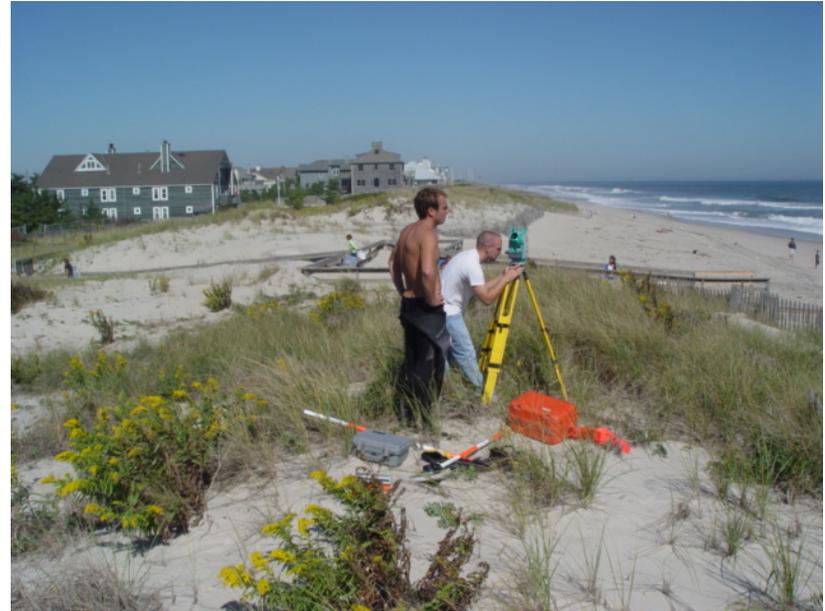
20-Year Comparison Photographs – Site #152, Public Beach #3, Brick Township

The 2006 view from the dune crest in front of the public use building for the beach (right). The dune was built naturally as a result of sand accumulation around snow fencing erected as the facility was opened in 1986 (left – 1990). Today a substantial dune and generous beach exists at this public use area. The beach's width has not changed significantly during the 20-year time interval.

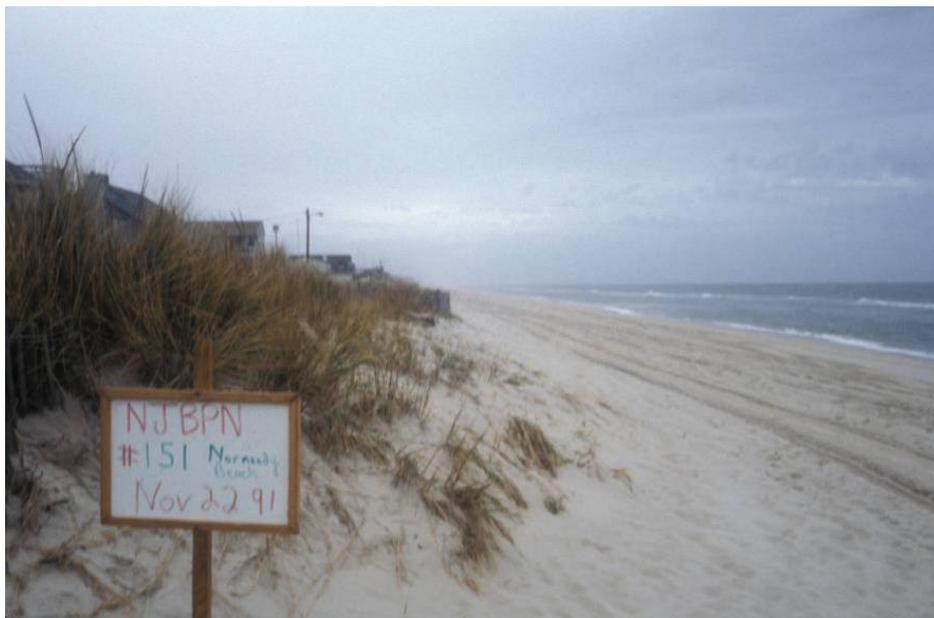
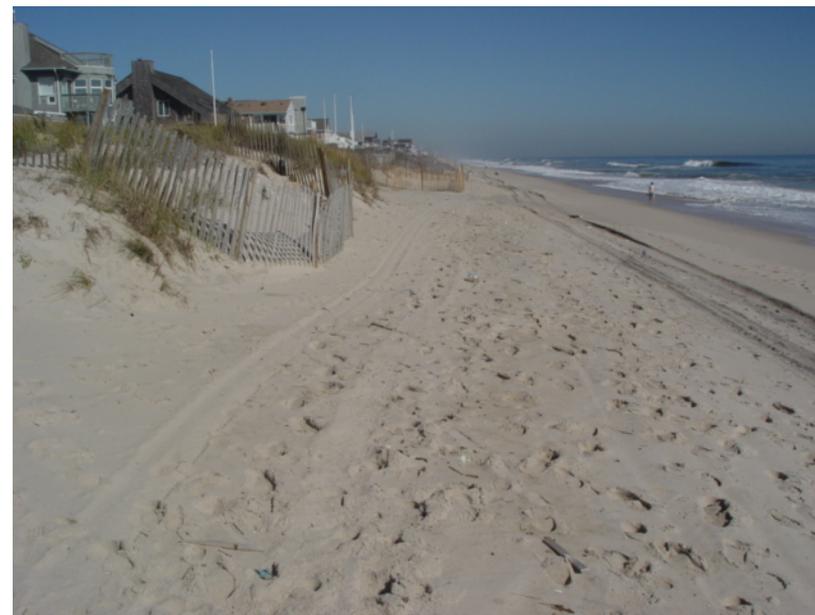
20-Year Comparison Photographs – Site 151, 1st Avenue, Normandy Beach

The dune toe lies within easy reach of ocean waves during a storm. The 1992 storm caused seaward slope erosion and overwash that pushed sand onto the landward slope. Fortunately there have been few storms since 1992 and the dune has not been called upon to defend the development positioned landward of the feature. No sand has been placed on this beach during the past 20 years. The pictures above depict the beach conditions in 1991 (left) and 2006 (right).

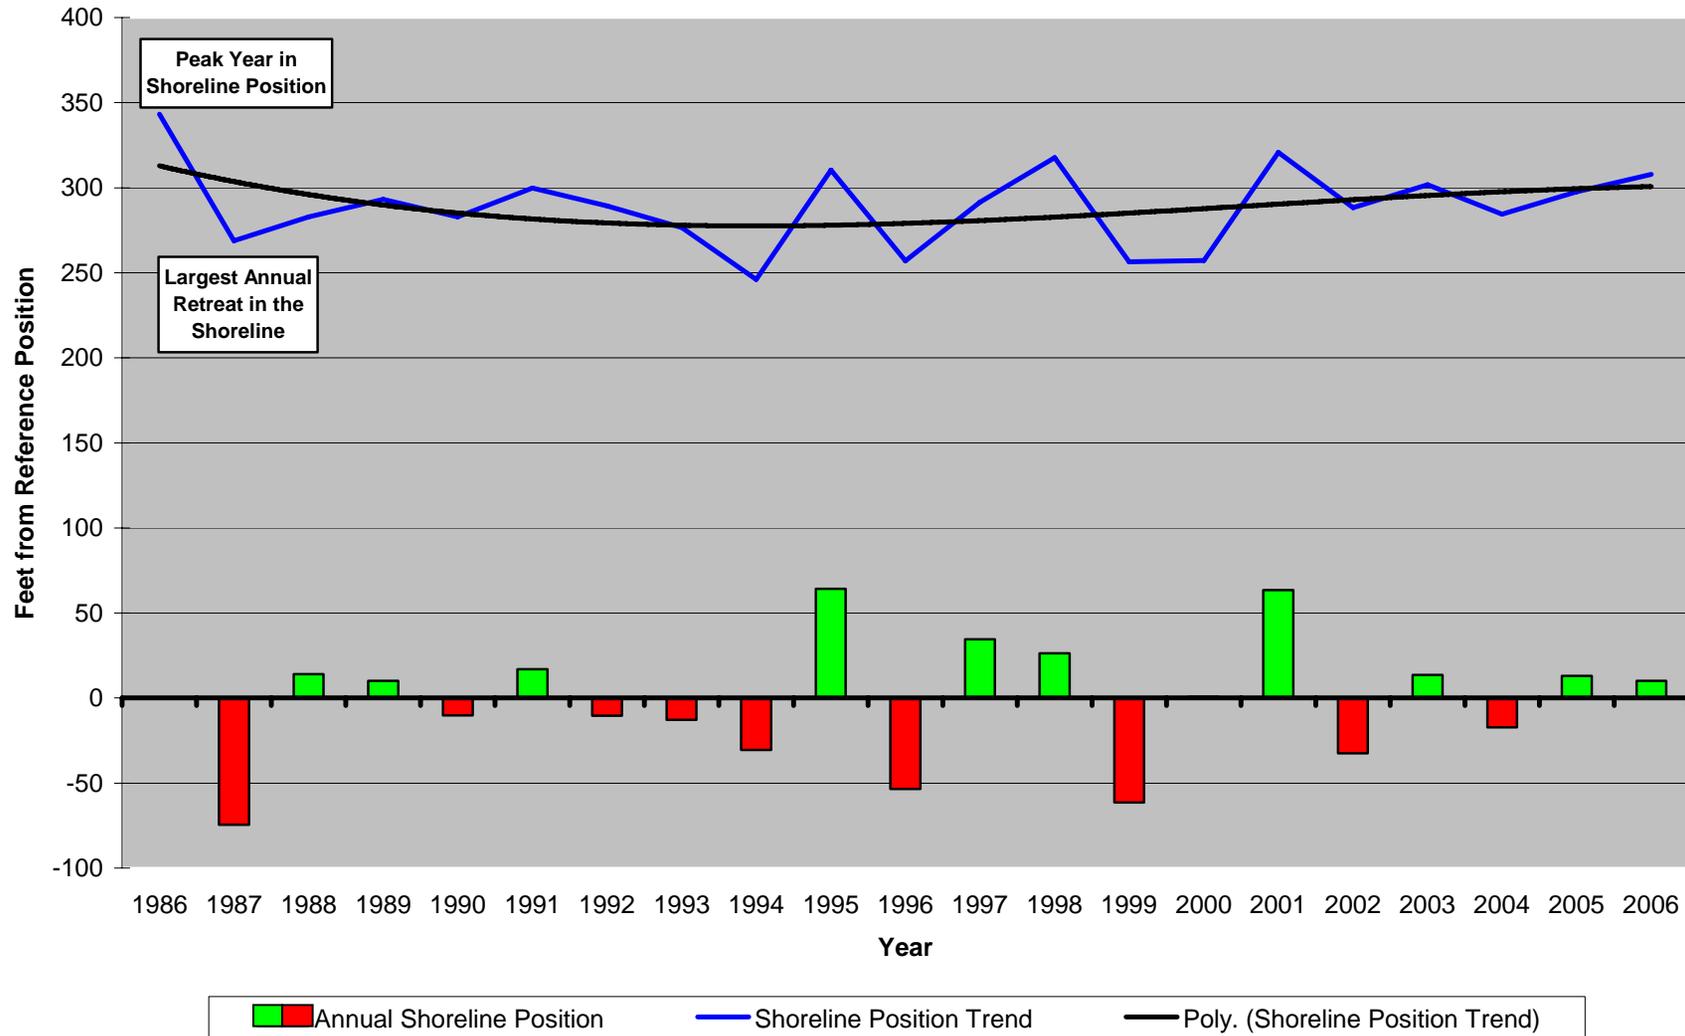
Figure 86 – Site 150. This site saw a dominant period of retreat in shoreline position from 1986 to 1994, followed by an oscillating trend between gains and losses. By 2003, the beach began to stabilize, due to calm conditions and this trend continued through fall 2006.

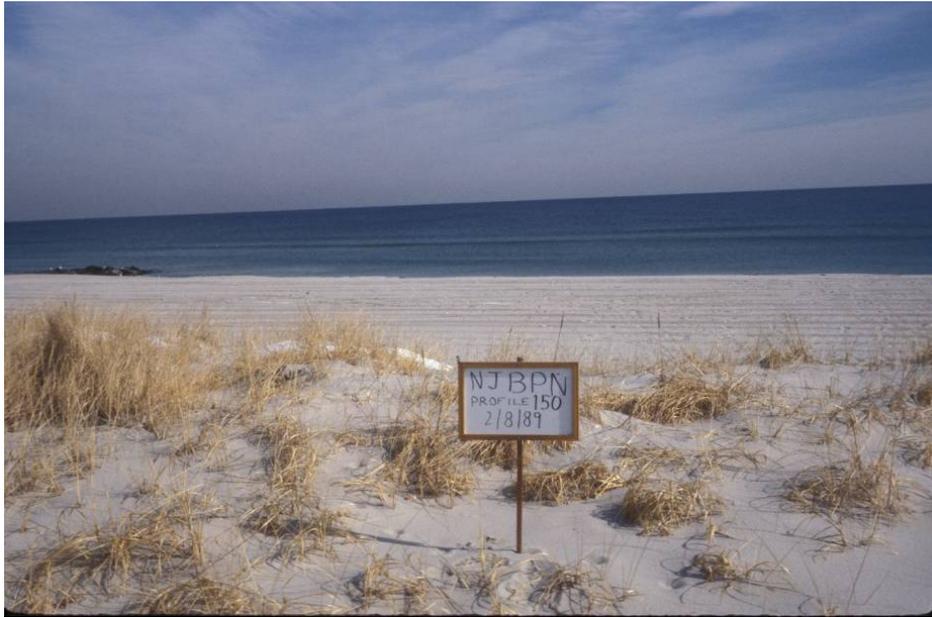
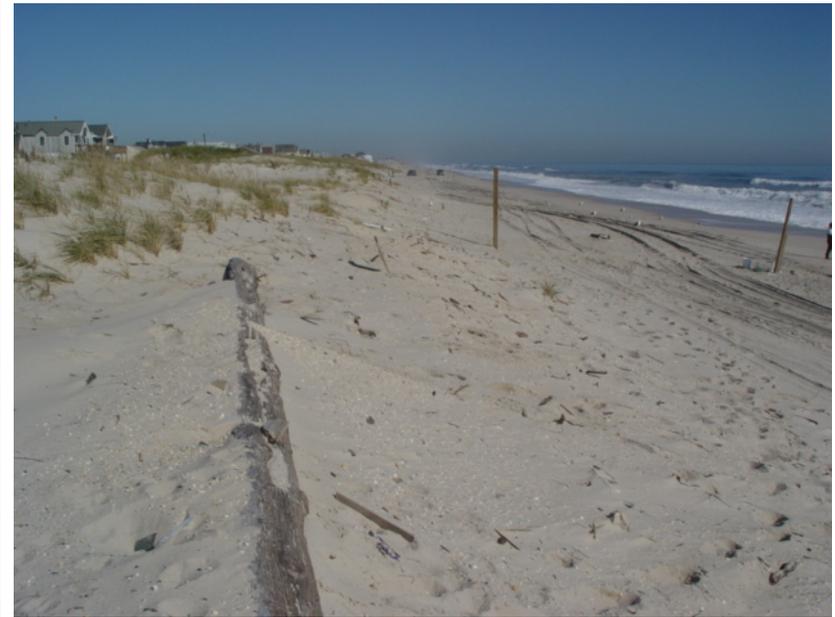
20-Year Comparison Photographs – Site 150, White Avenue, Lavallette

The beach backs up to the dune toe that the community expended effort to enhance between 1986 and 1995. Sand has accumulated nearly continuously with each survey raising the crest elevation and width of the dune. The crest elevation has increased by 10 feet and the seaward toe advanced 50 feet across the beach. The feature's ability to resist storm erosion is much greater now, but the beach is narrow to the point where minor storm waves are able to reach the toe of the dune. Additional beach width is needed to support further growth and adequately protect the feature from small storms, ensuring its stability and effectiveness to resist larger storm events when they occur.

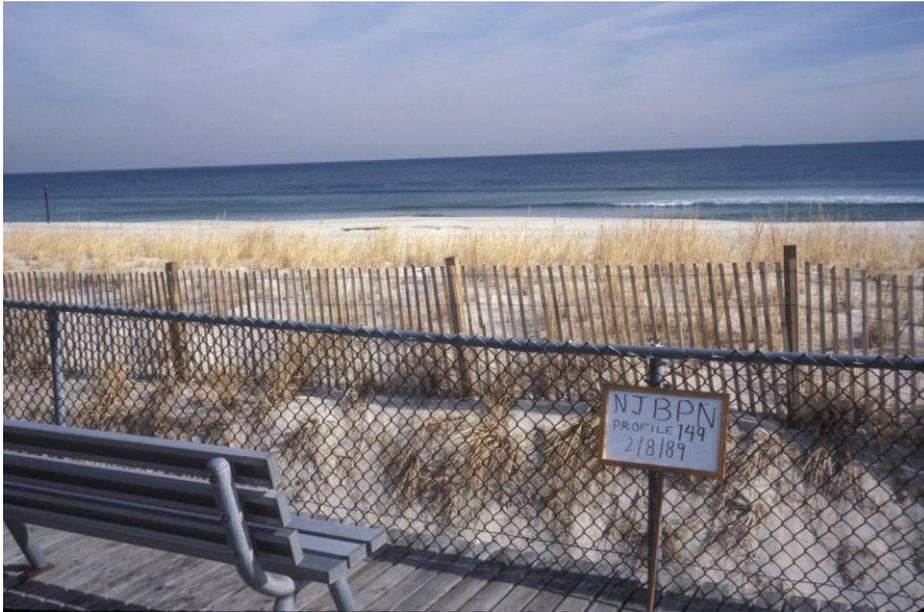
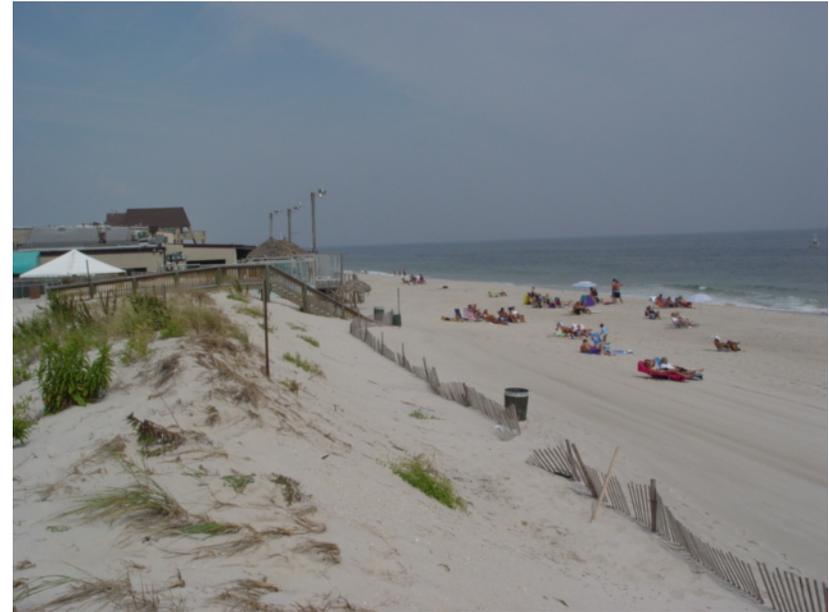
20-Year Comparison Photographs – Site 149, 8th Avenue, Ortley Beach

Looking north from the dune crest (right photograph), the beach at the end of the summer in 2006 was wider than it had been for several years. The cross section shows the extent of beach loss as a result of shoreline retreat, which allowed minor erosion on the seaward slope. There was some growth in dune crest elevation, but overall degradation of the beach has increased the risk level for storm damage. The picture on the left depicts the conditions of the dune and beach in 1989.

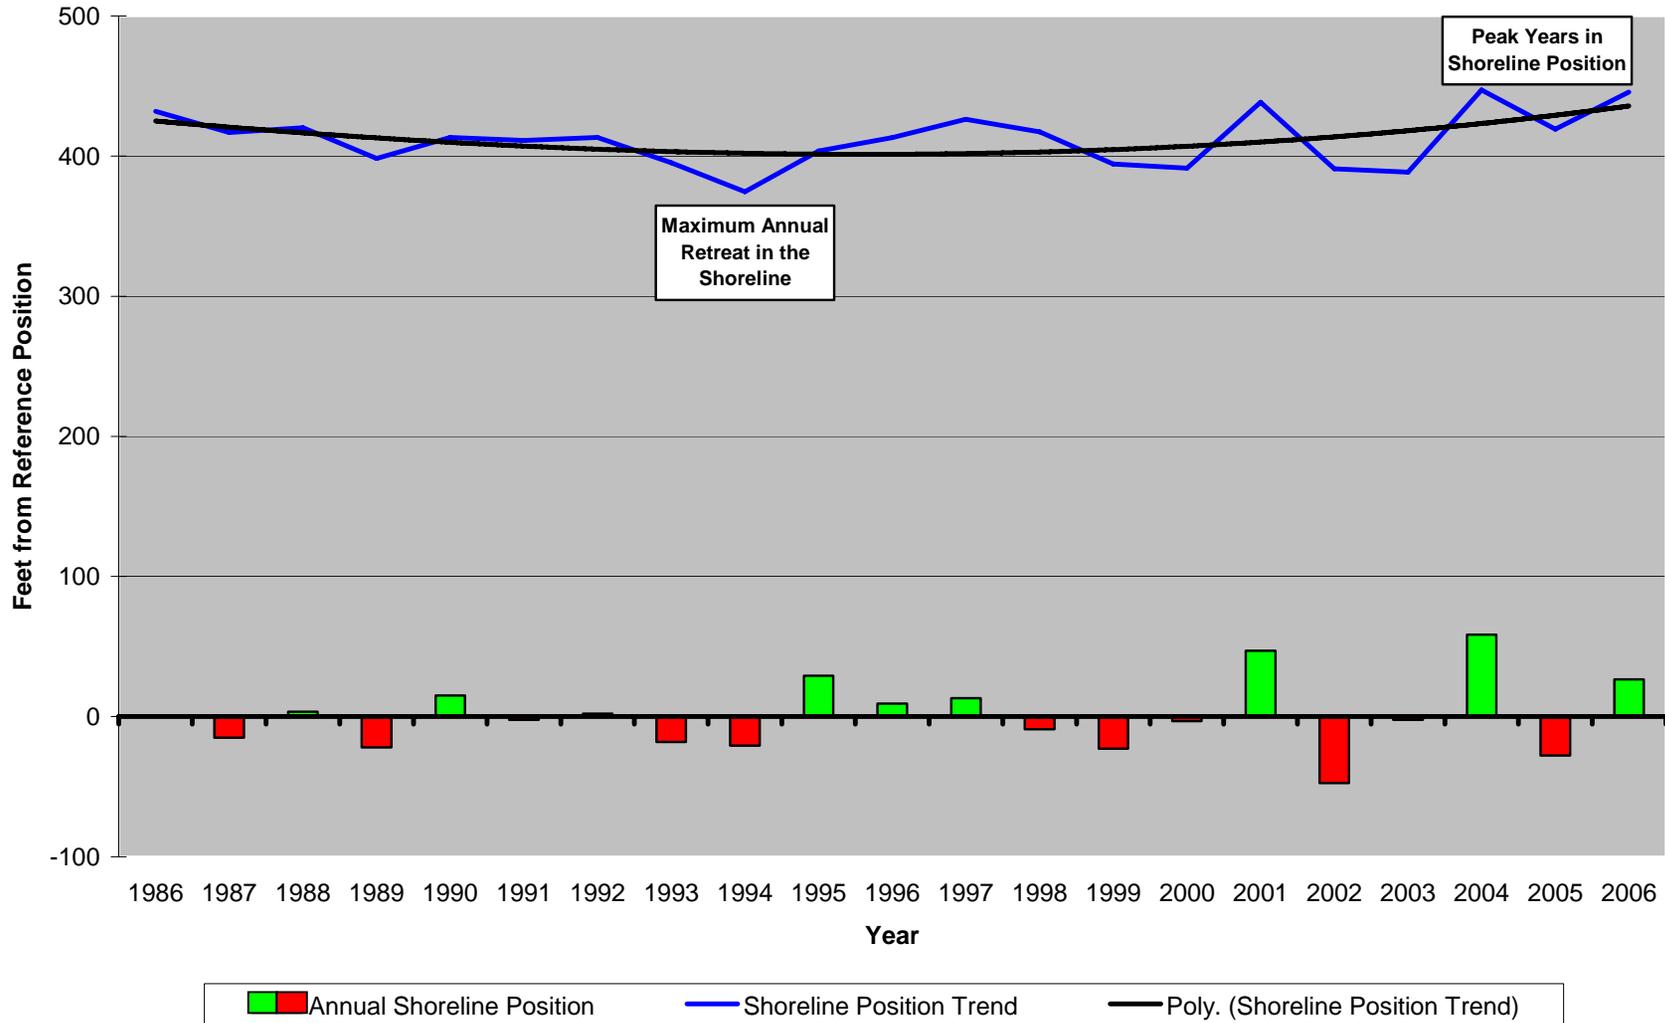
Figure 90 – Site 148. The shoreline trend was positive at Seaside Park with a modest advance in shoreline position over 20 years. The annual variation was relatively small leading up to 2006. The dune system has flourished with the wider beaches and stable shoreline.

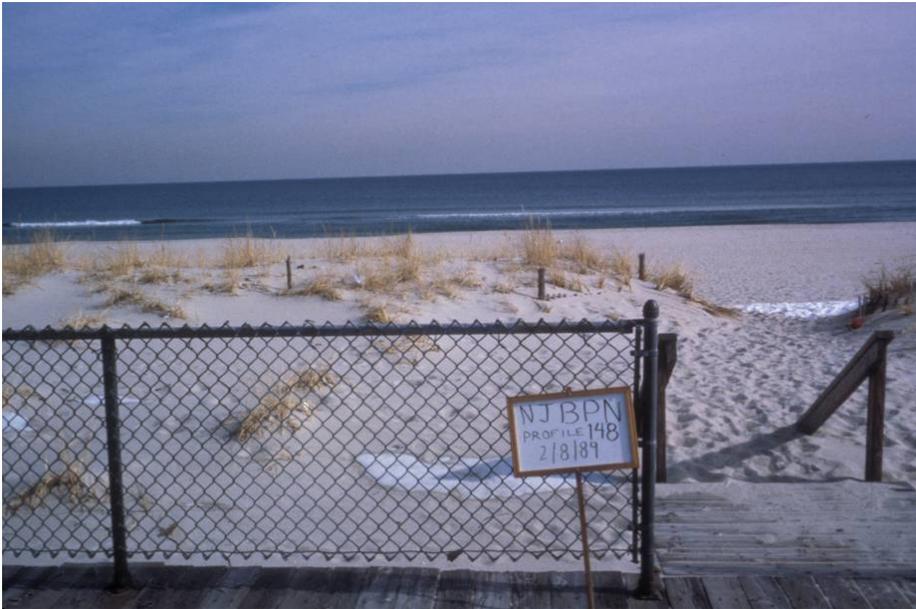
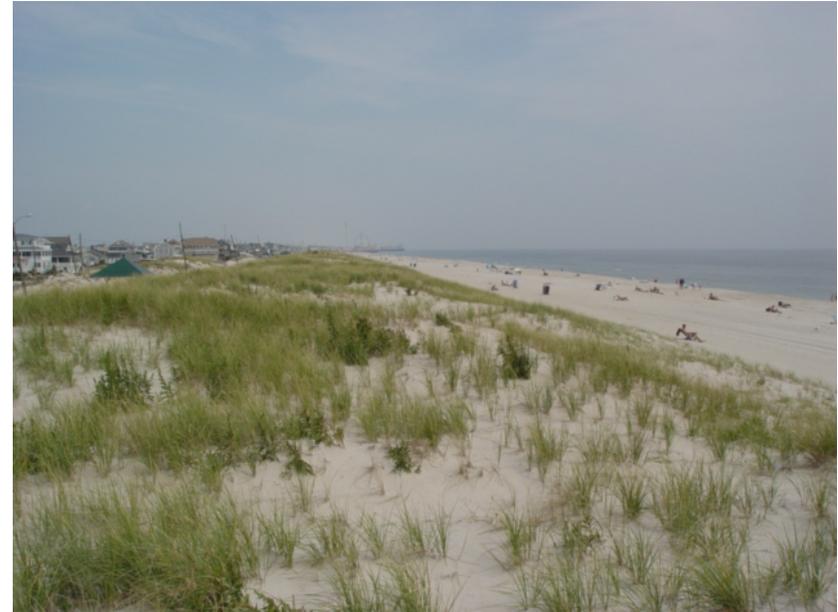
20-Year Comparison Photographs – Site 148, 4th Avenue, Seaside Park

This 2006 view (right) across the dune from the crest shows the beach and expanse of the dune system that comprise the Seaside Park beach. As the cross section shows, the dune crest is twice as high 20 years later and the beach elevation and width has improved the storm protection situation significantly for the boardwalk, public infrastructure and oceanfront properties. The view of the ocean from the boardwalk was obstructed in 2006, however, the photograph from 1989 (left) shows that this was not always the case.

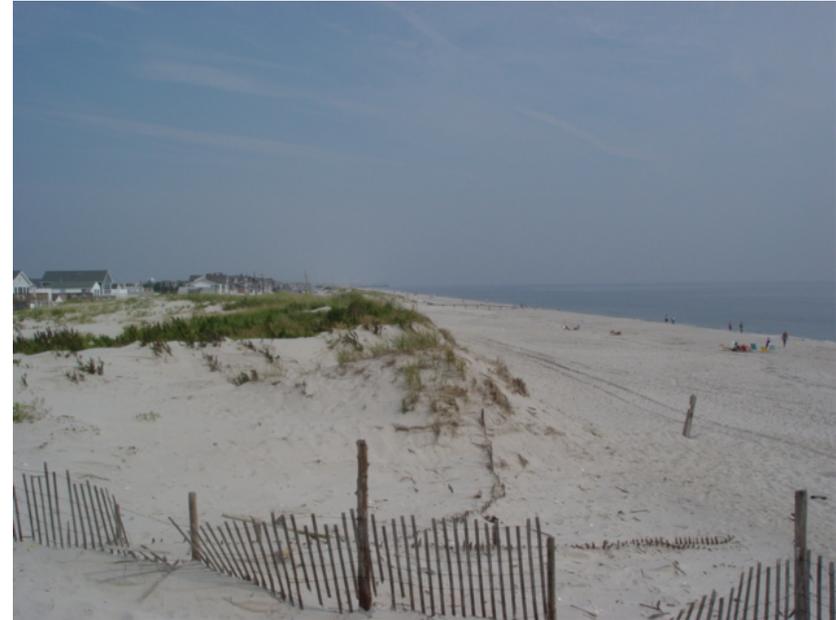
20-Year Comparison Photographs – Site 347, 6th Avenue, Midway Beach

The view to the north from the dune crest at 6th Avenue in Berkeley Township shows the gap in the dune for the access path and the beach when the berm was relatively wide at the end of the summer of 2006 (right). The 1986 survey line ran down the center of the access path causing the site to be shifted south several feet to include the dune that had been developed on site. This comparison is evident in the cross section below. The picture on the left was taken in 1989.

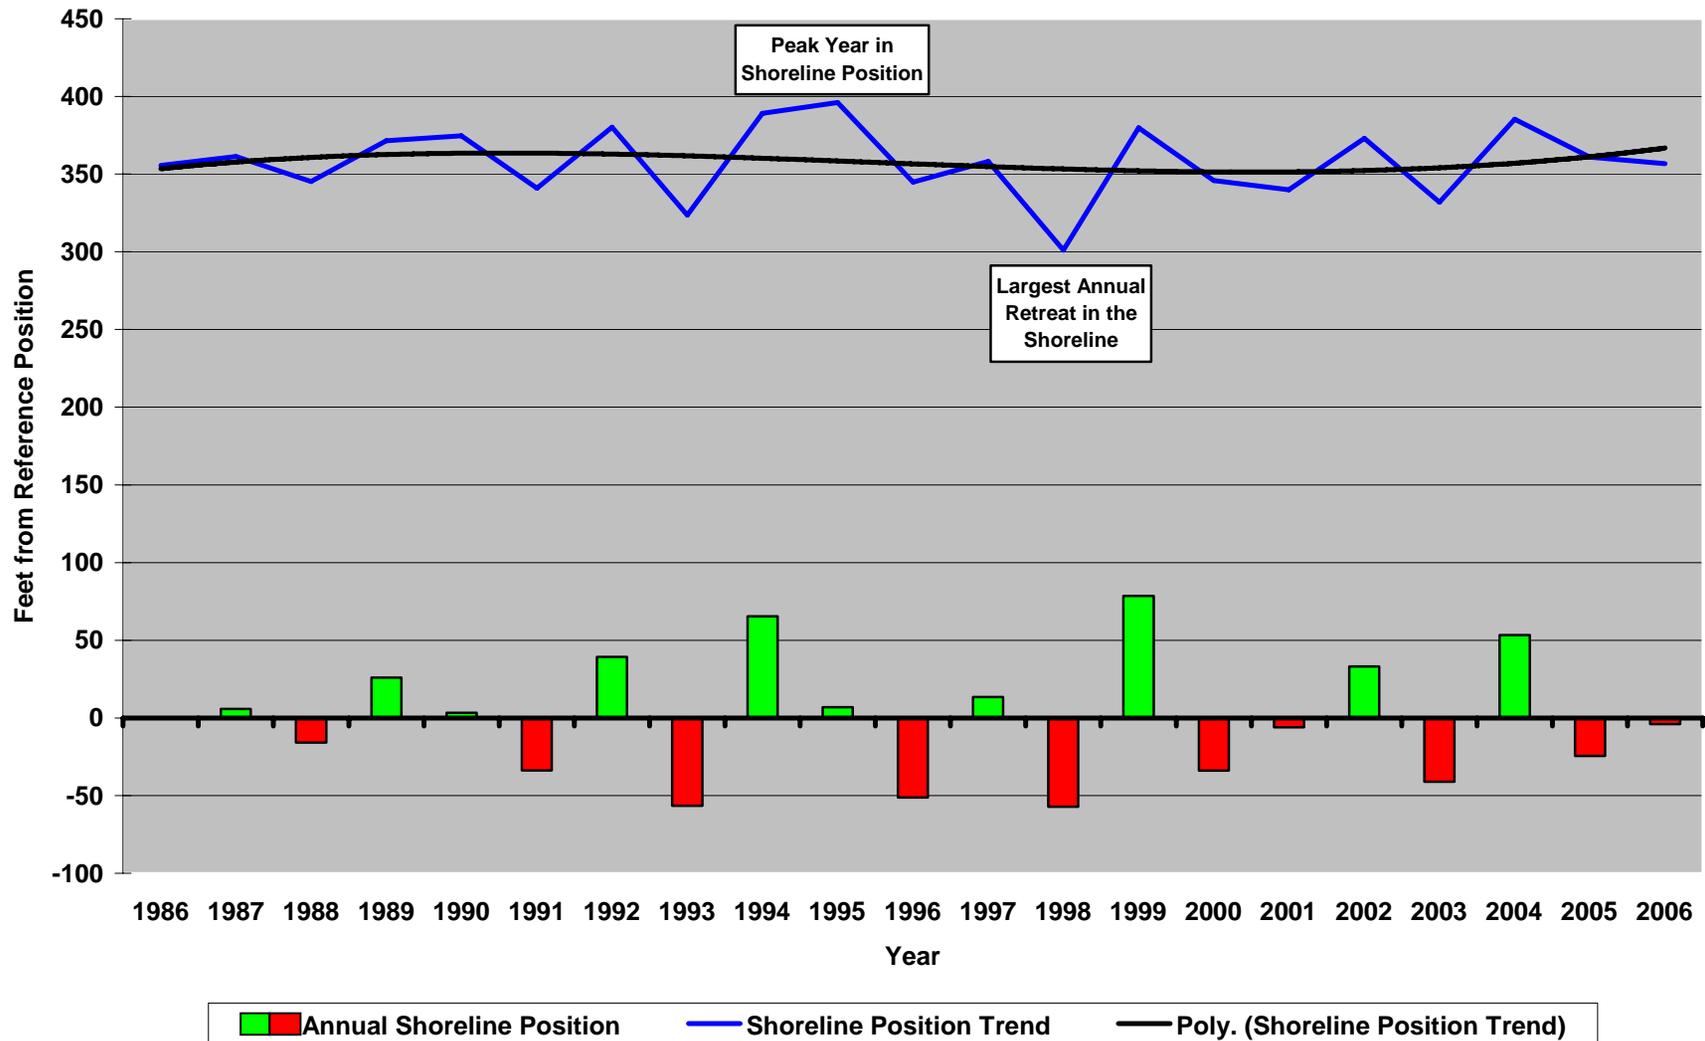
Figure 94 – Site 247. This site, along with sites #246 and #146 are within the Island Beach State Park and cover a totally natural dune/beach system. The trend was modestly positive with a 15-foot shoreline advance over 20 years.

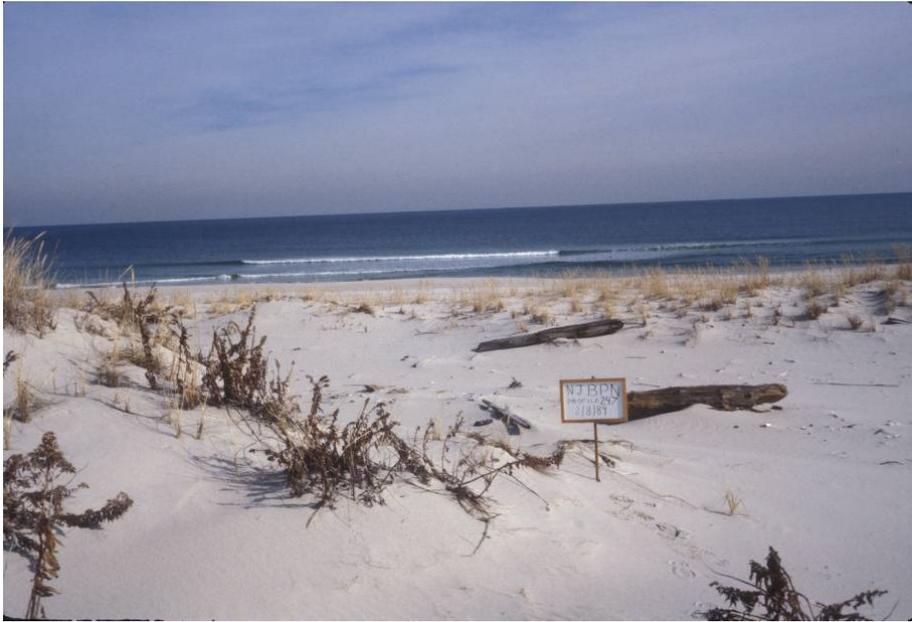
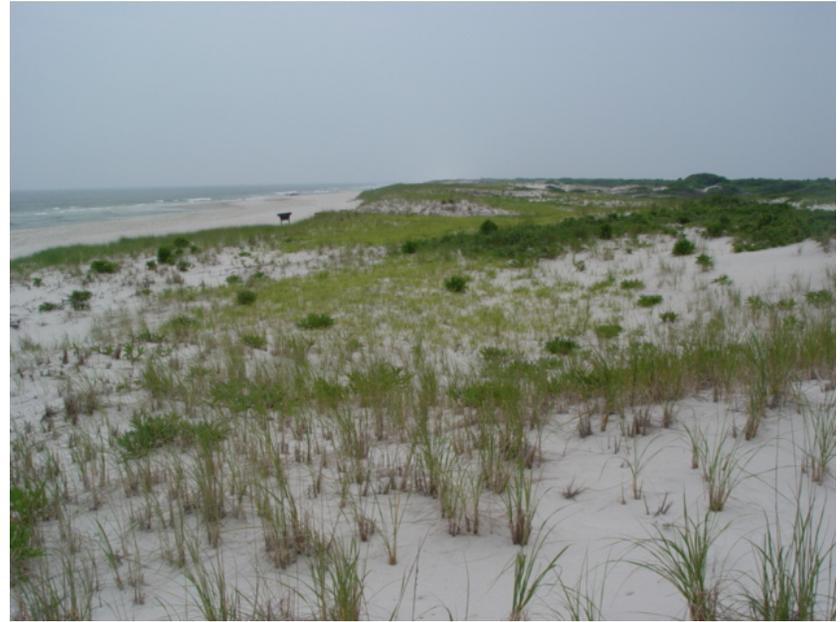
20-Year Comparison Photographs – Site 247, Northernmost Profile, Island Beach State Park

A major shift in dune position occurred during this study interval. An isolated storm breach in the dune system after the December 1992 northeast storm and wind deflation on the backside of the dune present in 1989 (left) caused the dune crest to incrementally shift seaward to its present location by 2006 (left).
