New Jersey Beach Profile Network

Ocean County

Manasquan Inlet
to Little Egg Inlet

NJBPN Profile #'s
156 - 234

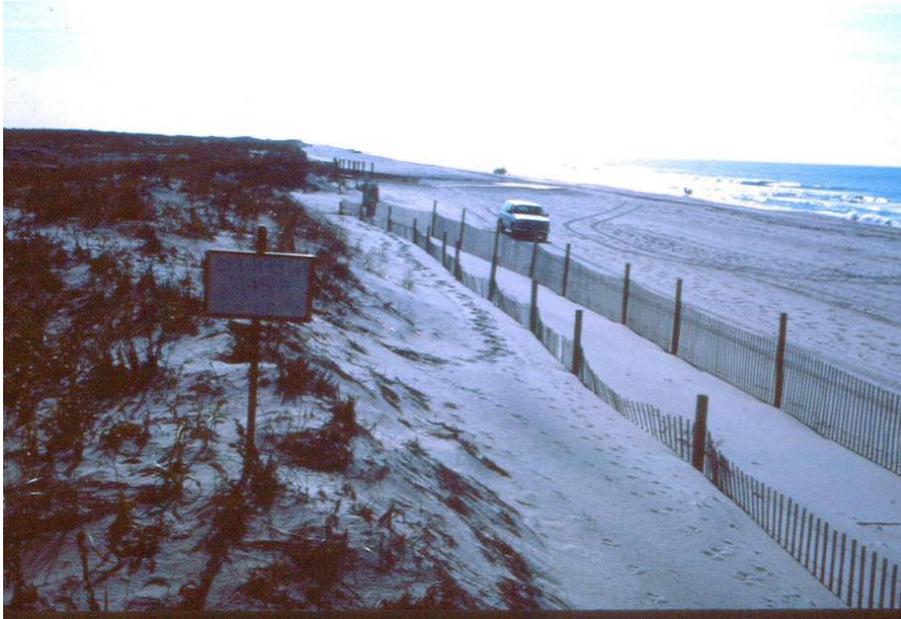
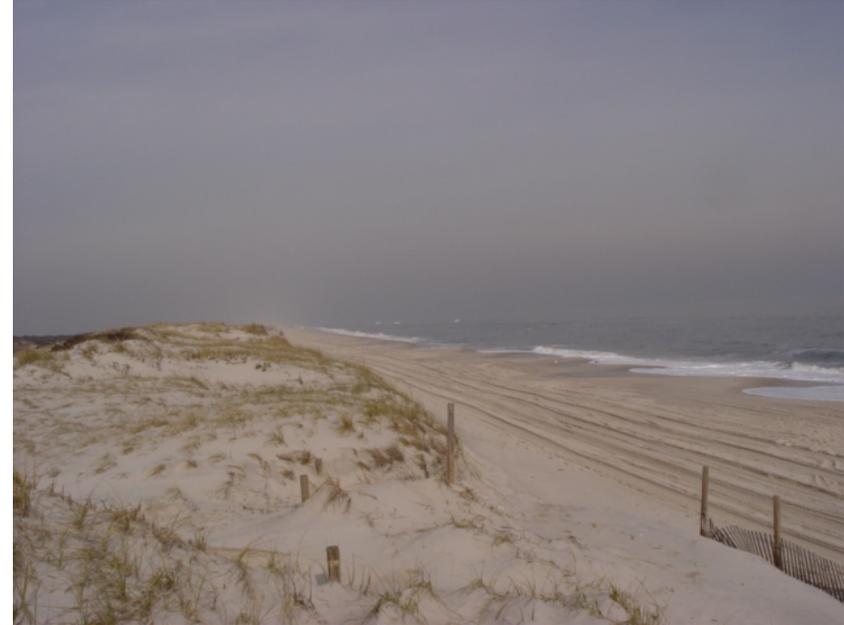
20-Year Comparison Photographs – Site 246, Middle Profile in Island Beach State Park

By 2006 the dune had grown significantly in size while the beach suffered minor losses. The photographs above were taken in 1995 (left) and 2006 (right). The vegetation growth line seen in the 1995 photo marks the location of the vertical scarp line left after the powerful 1991 and 1992 northeast storms eroded the seaward dune slope and caused the dune to retreat. Fencing installed after these events, visible in 1995, have been buried as the foredune developed seaward restoring much of the seaward slope losses. Aeolian processes have transported a substantial amount of sand over the dune crest and landward slope raising the dune elevation several feet. The current beach width is marginal for supporting further seaward advancement of the dune system as storm wave run up can easily reach the dune toe causing erosion and damage that removed portions of the lower fence line seen in the 2006 photo.

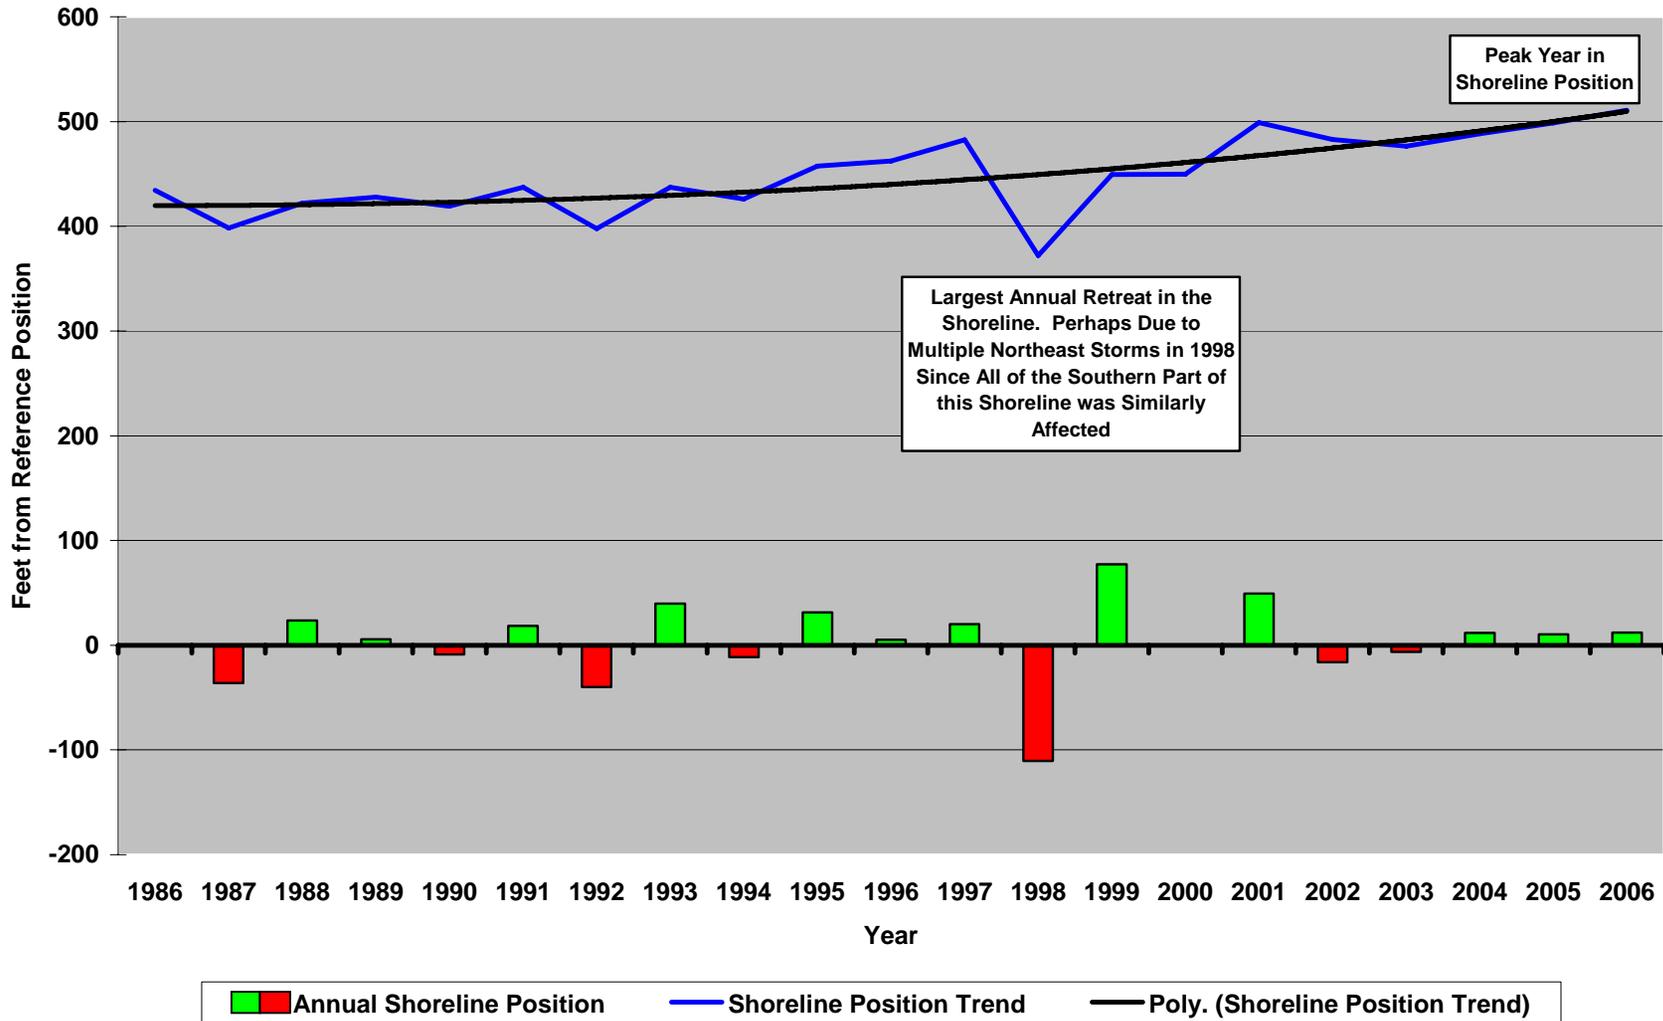
Figure 98 – Site 146. The south site of the State Park beach saw shoreline advance during the 20-year interval. The trend was one of gradual advance in the shoreline position with a broad growth in a new foredune that almost equals the original dune in size and height.

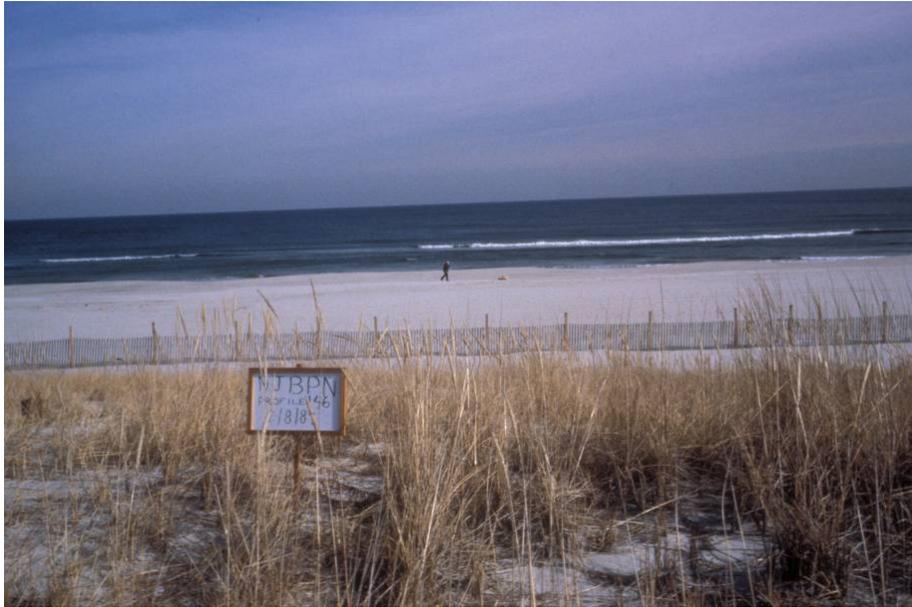
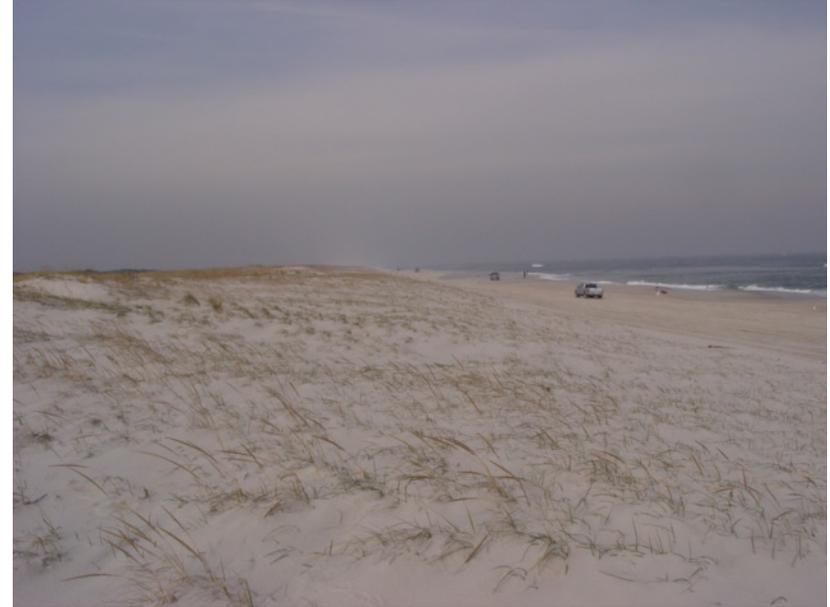
20-Year Comparison Photographs – Site 146, Southernmost Site, Island Beach State Park

The 2006 photograph on the right shows the wide foredune slope that has accumulated since 1986. The extent and scope of the accretion can be seen in the cross section plot shown below. The 109.17 yds³/ft of sand volume was added to the beach most likely due to trapping of the sand by the north jetty of Barnegat Inlet. This is the last site south before the inlet, located about a half mile north of the jetty. The additional sand volume produced the shoreline position advance, increasing the beach width, which allowed the dune growth to continue unimpeded by wave run up. The picture on the left shows the conditions of the beaches during the 1989 survey.

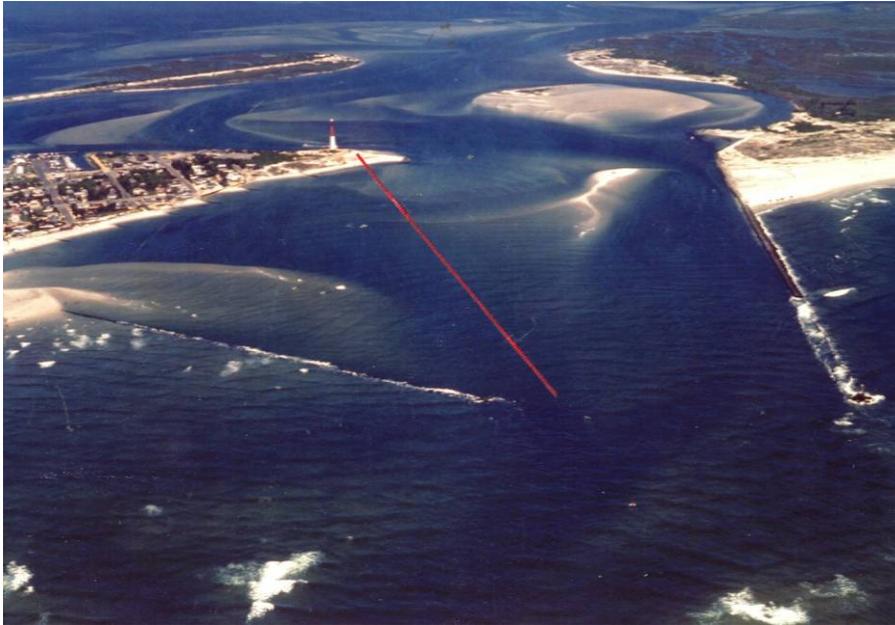
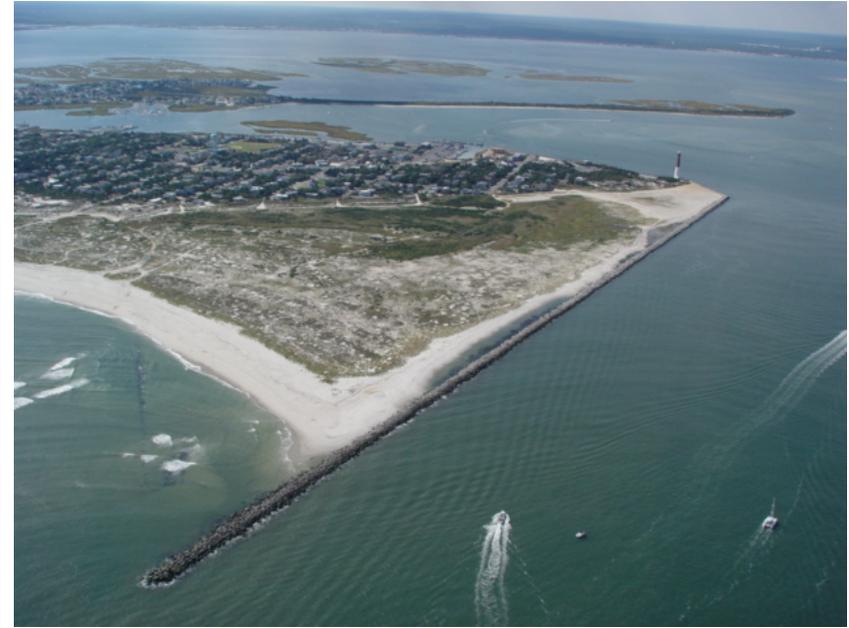
20-Year Comparison Photographs – Site 245, 10th Street, Barnegat Light

Viewing the northernmost Long Beach Island profile location at 10th Street in Barnegat Light Borough requires aerial photography because of the sheer size of the changes related to changing the south jetty to Barnegat Inlet from 1988 to 1991. This huge project by the US Army Corps of Engineers realigned the south jetty from an angled position starting at 8th Street in the Borough to a parallel orientation to the north jetty starting at Barnegat Lighthouse. The left photograph was taken in 1982 prior to any construction. The new jetty was built along the red alignment without removal of the old south jetty. The parallelism was designed to reduce the extensive shoaling and meandering of the main channel that caused frequent fatal boating accidents along with a need for repetitive dredging. The right photograph was taken in 2003 and shows the vast deposit of ebb-tidal delta sand seen along the lower edge of the left photo and the transfer of sand north along the shoreline to the new jetty. The old jetty shows in the water as a trace in the 2003 view extending back to the old shoreline. Vegetation growth is changing the region into a maritime forest and providing phenomenal storm protection for the homes exposed to erosion in 1982, but it has effectively removed some of the economic value attributable to a waterfront home.

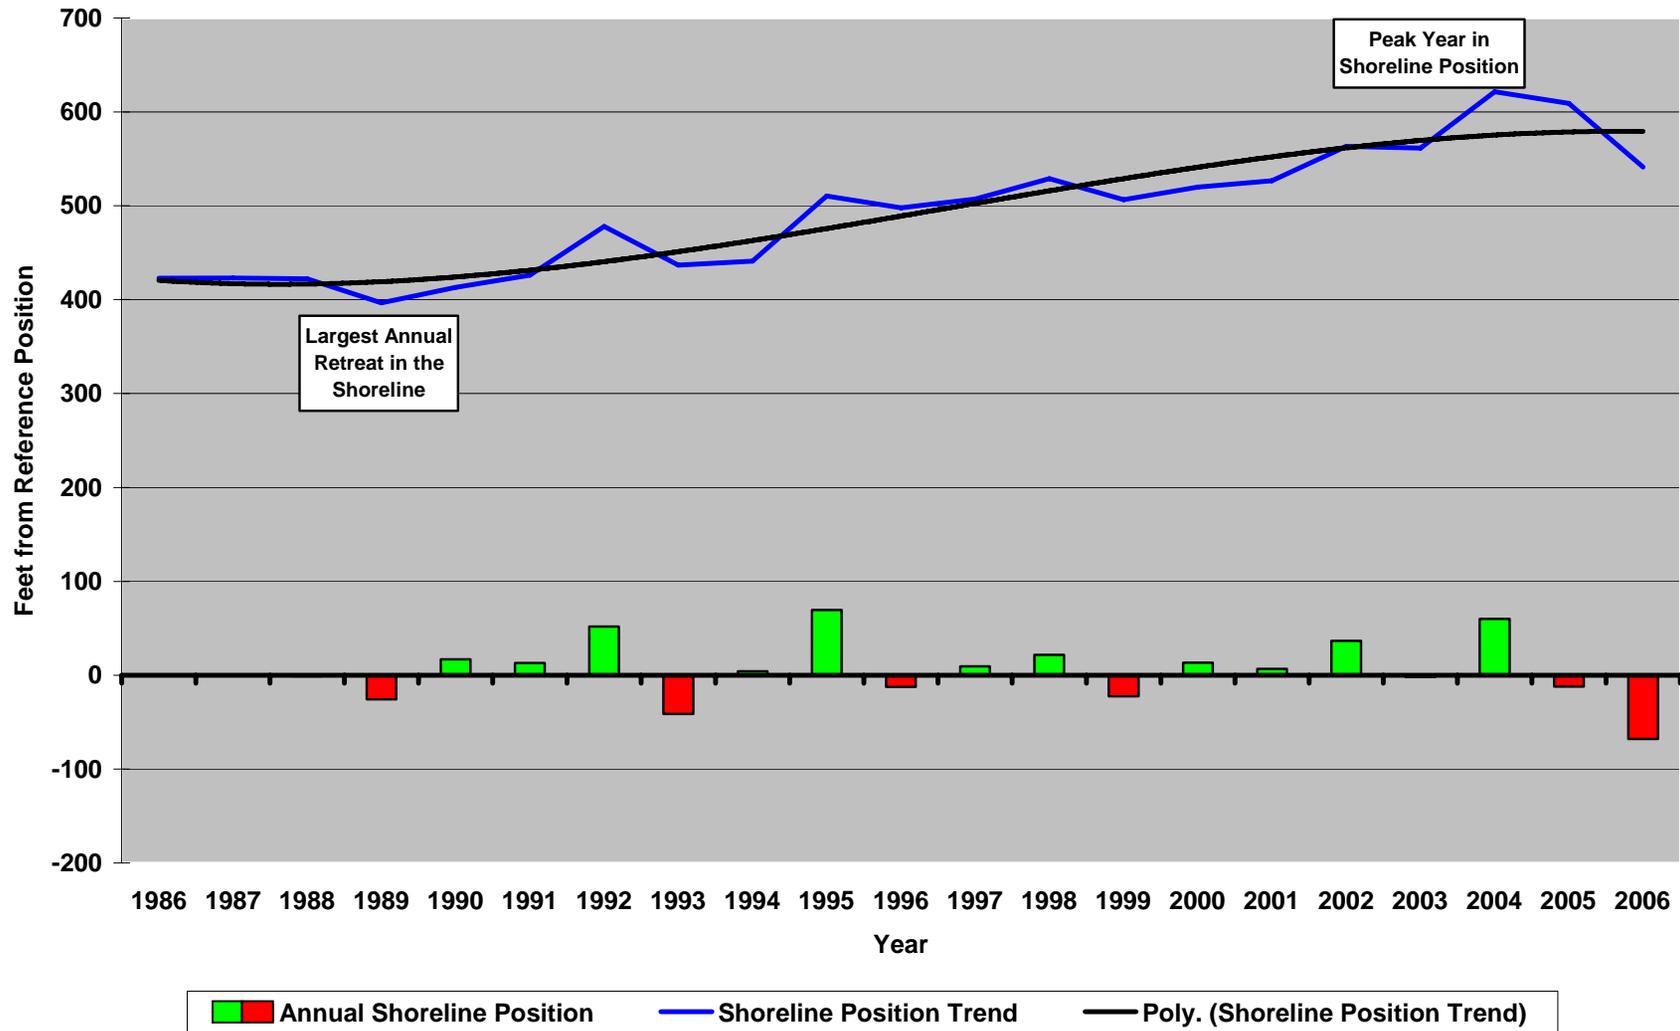
Figure 102 – Site 145. This profile was the closest to Barnegat Inlet in 1986 and reflects the advance in shoreline position that started in 1990. Some retreat began in 2005 and 2006, but this site has the second largest increase in shoreline position and beach volume along

Long Beach Island. There were few large annual changes in the shoreline position due to the jetty sheltering effect discussed in the previous Figure (100 and 101) descriptions.

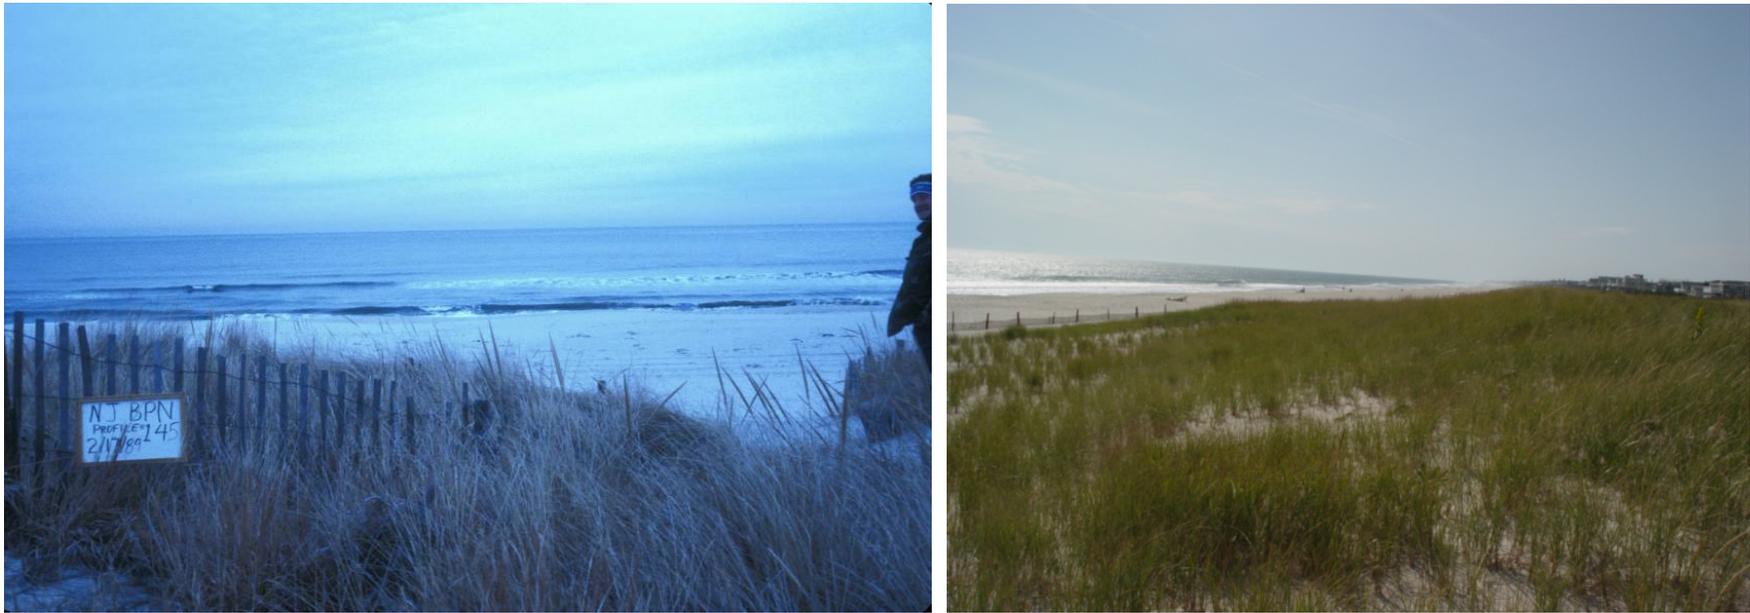
20-Year Comparison Photographs – Site 145, 26th Street, Barnegat Light

The photograph on the right (taken in 2006) shows a view to the south that illustrates the huge expanse of dune that developed as the shoreline advanced when sand was transferred north along and onto the beach from offshore. The magnitude shows in the cross section below as the dune crest moved almost a hundred feet seaward and supported a berm on portions of the 1986 profile that was offshore in 2 feet of water at that time. The picture on the left was taken during the 1989 survey. The alteration in location of the south rock jetty to Barnegat Inlet produced the largest sand accumulation seen along the NJ shoreline in the past 20 years.

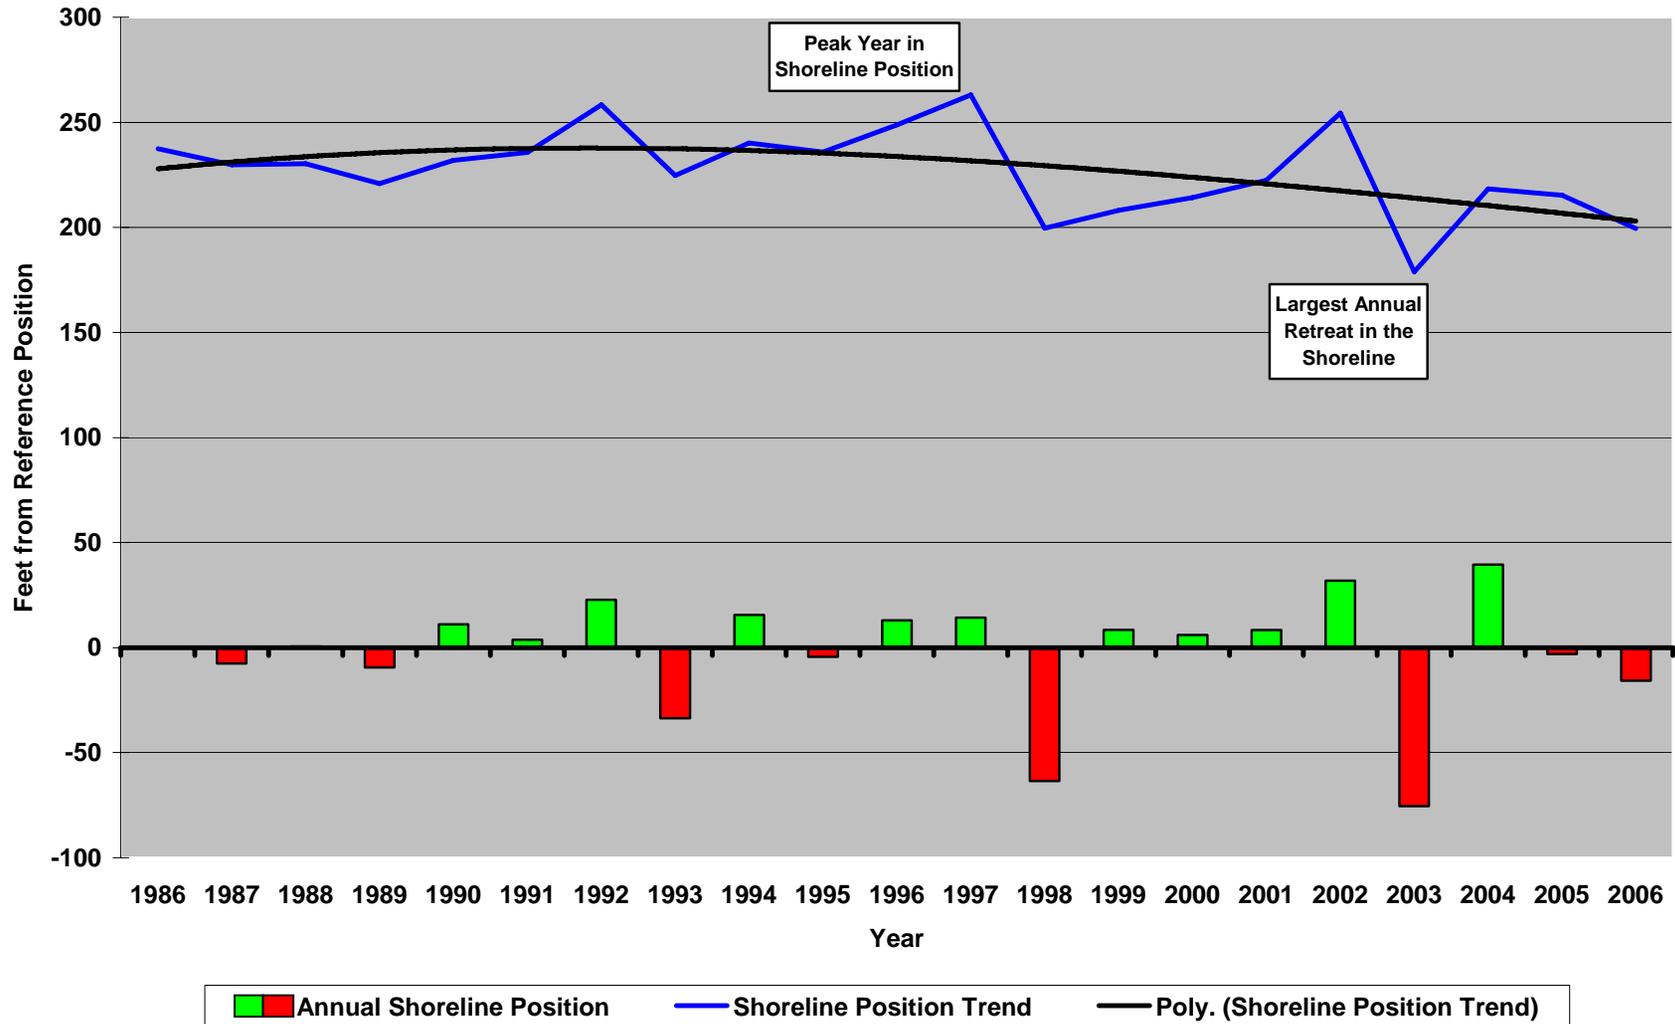
Figure 104 – Site 144. South in Loveladies, the shoreline trend was one of retreat as the large scale picture of the northern end of Long Beach Island adjusted to the new inlet jetty location. The large deposit produced a broad, curved shoreline retreat for a mile or so south of

the neutral point between deposition to the north and erosion to the south. Here the shoreline retreated by 40 feet, an amount guaranteed to cause significant problems to this shoreline's storm resistance.

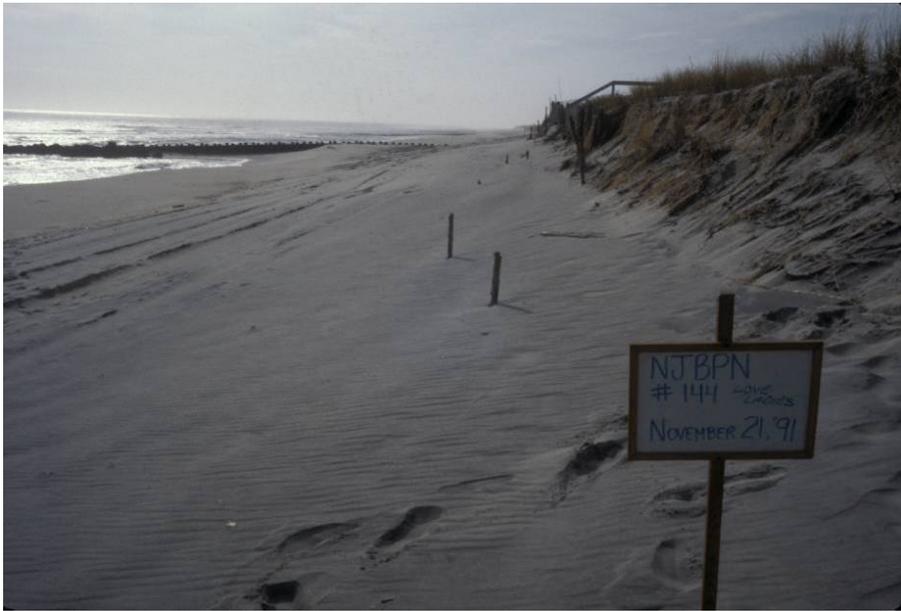
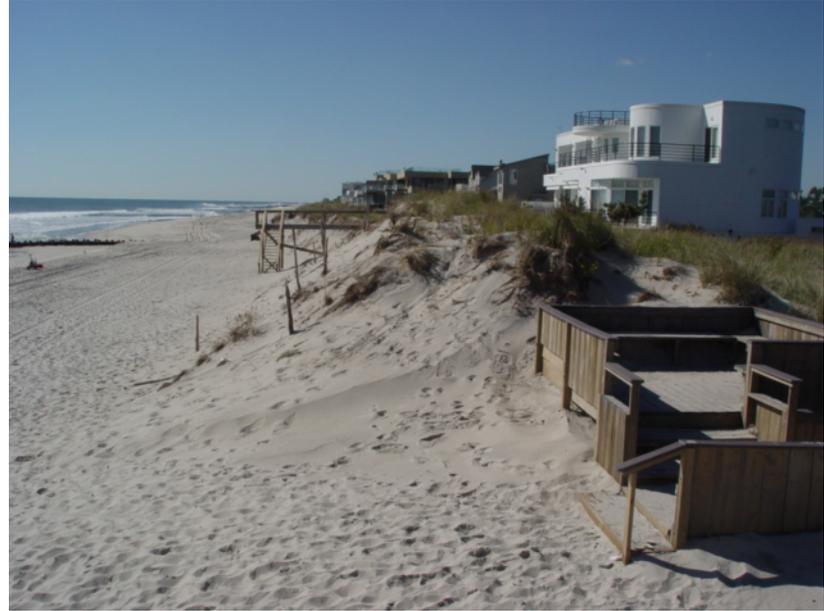
20-Year Comparison Photographs – Site 144, La Baia Street,

Site 144 did not directly receive sand from a State-sponsored truck-in fill completed in 1995, but material did migrate north along this beach. 465,000 cubic yards of mainland quarry sand was hauled over 18 months to beaches between Loveladies and Harvey Cedars. Redistribution has spread this material along the oceanfront across multiple times the distance of initial placement. Note the retreat in both the berm crest and dune seaward slope generated by the shift in regional shoreline configuration. The photographs above were taken in 1991 (left) and 2006 (right).

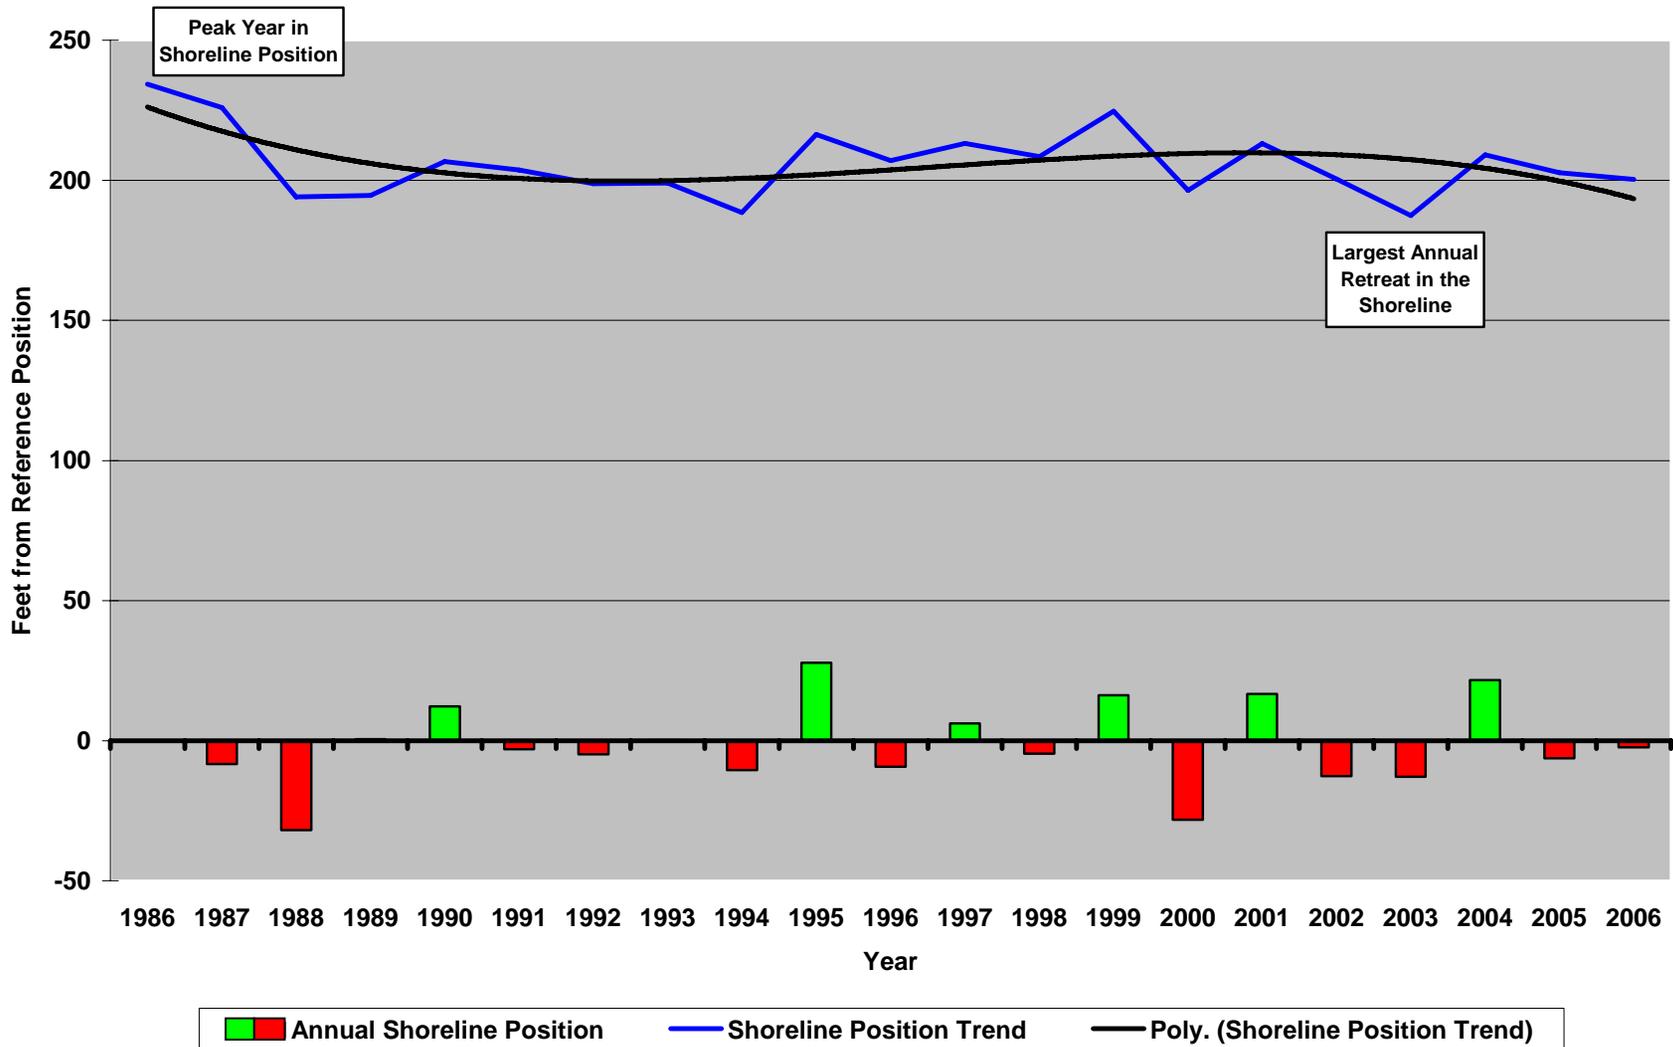
Figure 106 – Site 143. In spite of the impact of 465,000 cubic yards of sand added to the beach in 1994 -95 during a state and local sponsored project, the shoreline position at this site retreated approximately 50 feet over the 20-year period. The advance produced by the

beach nourishment project shows in the 1995 survey and is maintained until 2000 when erosion pushed the shoreline position back nearly to that present in 1994. By 2006 the majority of the positive impact from the project was gone, which is not to impugn the value of the effort because had it not been done, the shoreline may have been 40 feet further landward precariously exposing dune system, shorefront infrastructure and property to storm damage.

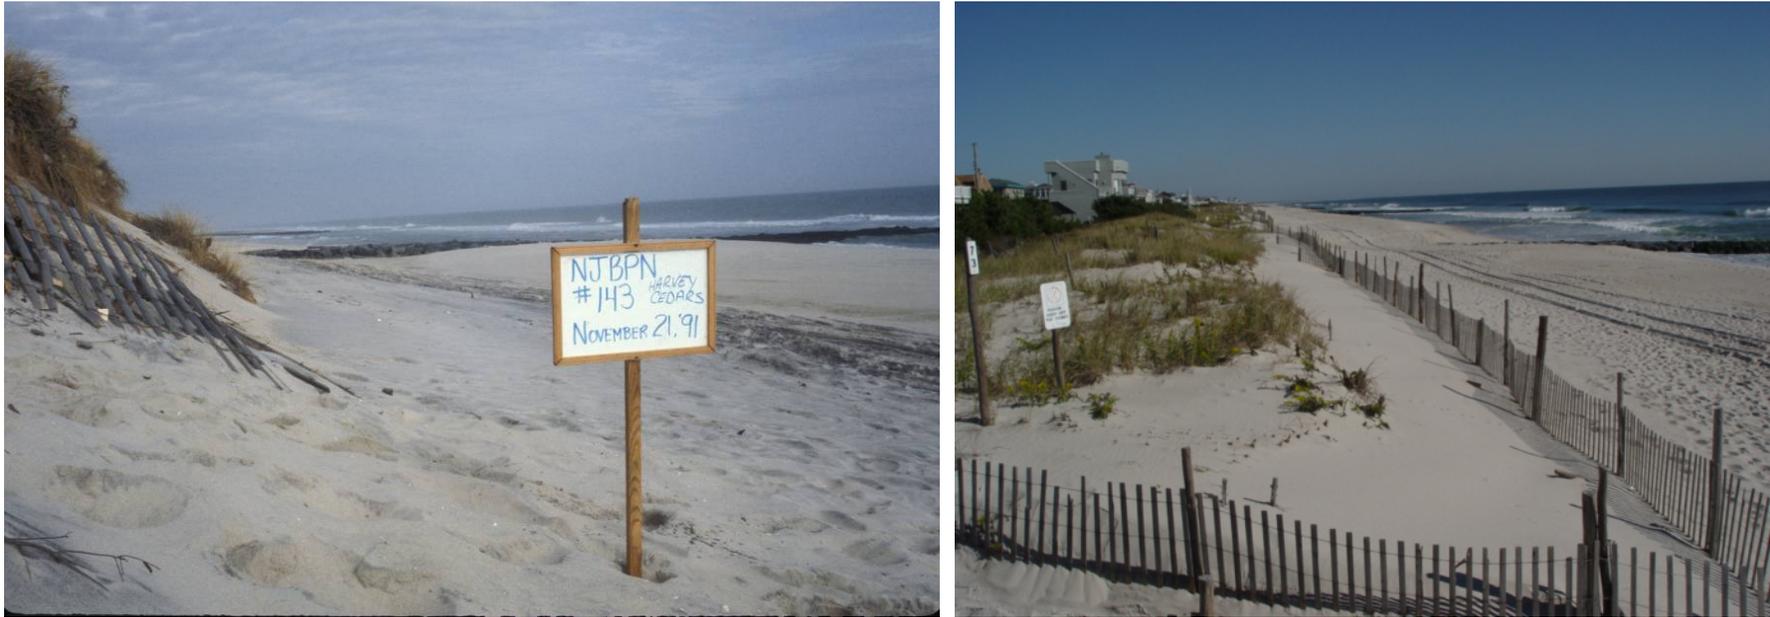
20-Year Comparison Photographs – Site 143, 73rd Street, Harvey Cedars

The photographs above were taken in 1991 (left) and 2006 (right). This view toward the north shows the dramatic reduction in dune width between site 145 and the two just to the south. The beach is relatively wide in this fall 2006 photograph as summer accretion was still in place. The dune's seaward slope has retreated about 20 feet since 1986 along with the zero elevation position.

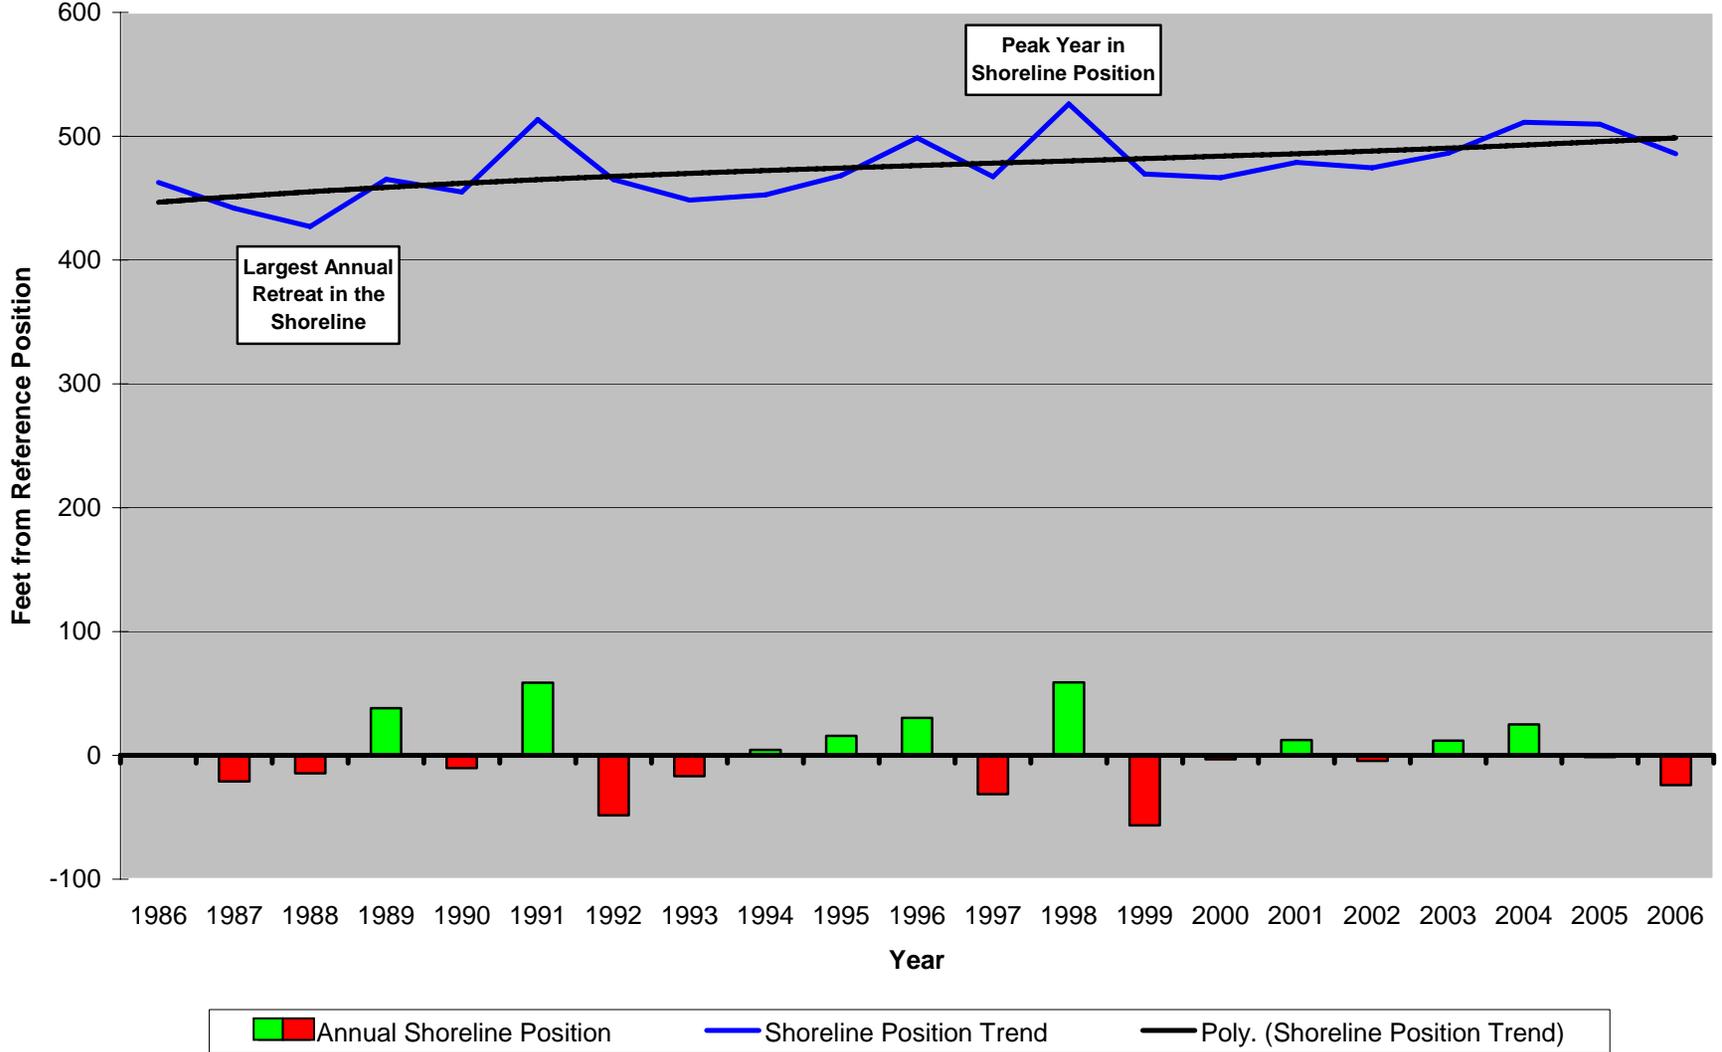
Figure 108 – Site 142. The negative shoreline trend reversed at Tranquility Drive with approximately 50 feet of advance in 20 years.

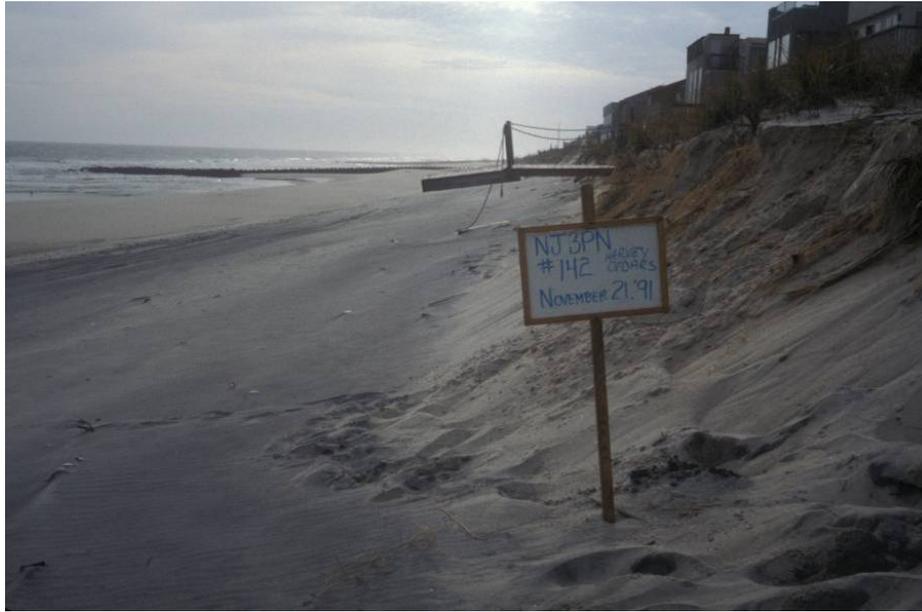
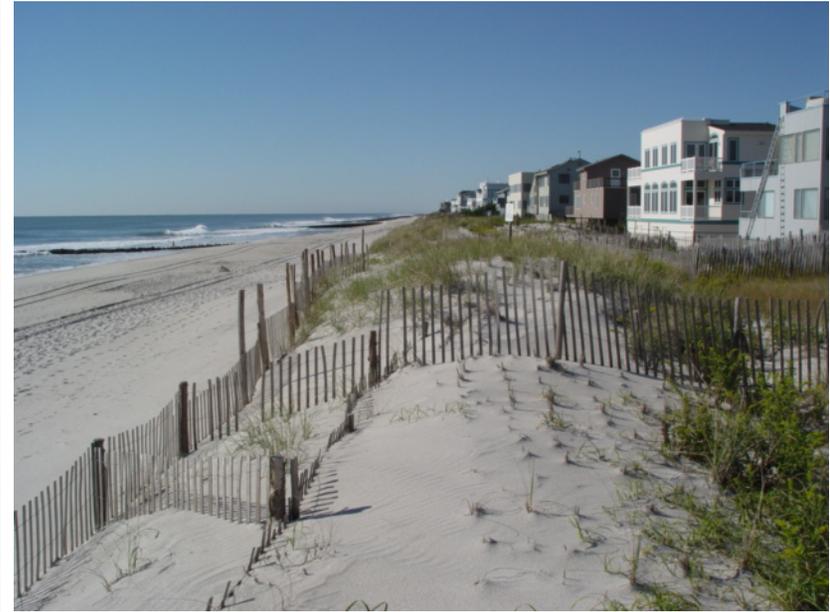
20-Year Comparison Photographs – Site 142, Tranquility Drive, Harvey Cedars

This dune contains about twice the sand volume it had in 1986. This site is south of the inlet dynamics that dominate regional changes along the Long Beach Island shoreline sites to the north (both positively and negatively). The beach elevation is much higher and the dune system is growing as a result of sand accumulation both from natural processes and enhanced by the 1994 state and local beach nourishment project. The photographs above were taken 1991 (left) and 2006 (right).

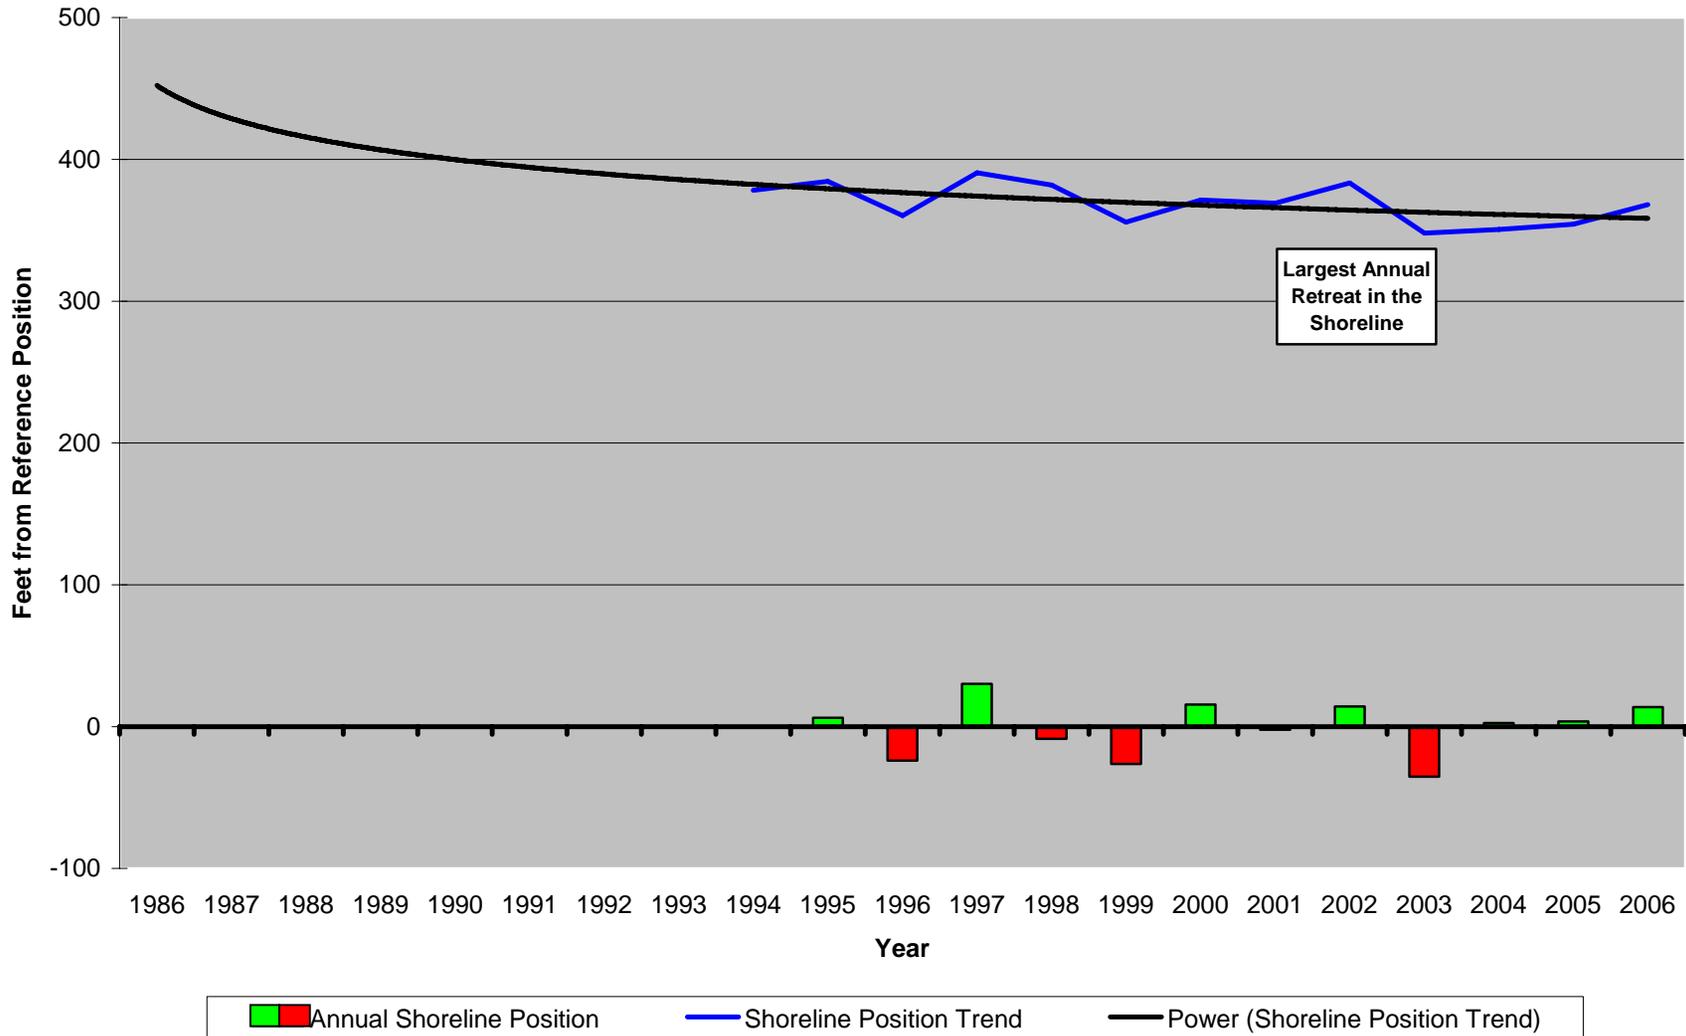
Figure 110 – Site 241. This profile was established to fill a gap in the data collection along the island; this site saw a minor retreat over the 13 years of study. The shoreline position trend was progressively negative. The 2007 ACOE project is not shown in the trend analysis.

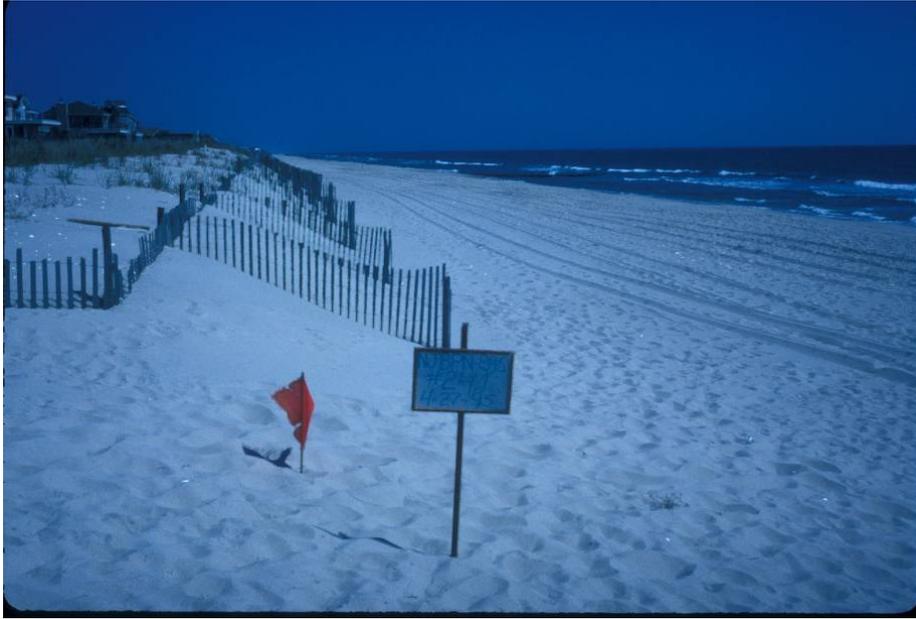
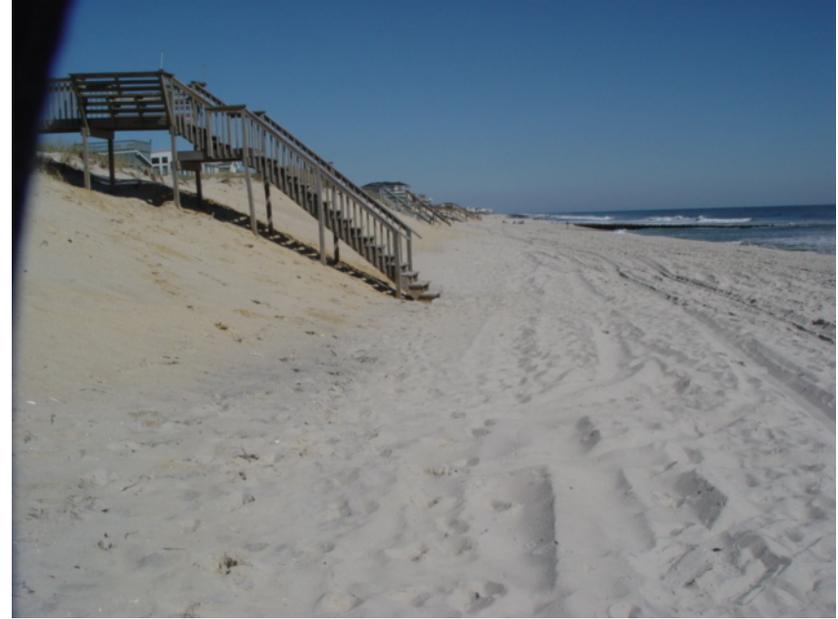
20-Year Comparison Photographs – Site 241, 20th Street, Surf City

This site was established in 1994 to fill a gap in municipality coverage on Long Beach Island. The beach width in the 1995 photo (left) reflects summer accretion and there is plenty of sand on the beach with a healthy dune system. The beach width is slightly narrower in the 2006 photo, allowing wave run up to reach the dune toe. The orange tinted sand seen on the seaward dune slope combined with the absence of dune fencing and plants are evidence of recent storm damage erosion. The practice of bulldozing beach sand back up to the scarp is regularly used to repair the dune. The cross section shows modest dune crest deposition and loss in beach width prior to the 2007 ACOE beach nourishment project.
