New Jersey Beach Profile Network

Ocean County

Manasquan Inlet
to Little Egg Inlet

NJBPN Profile #'s
156 - 234

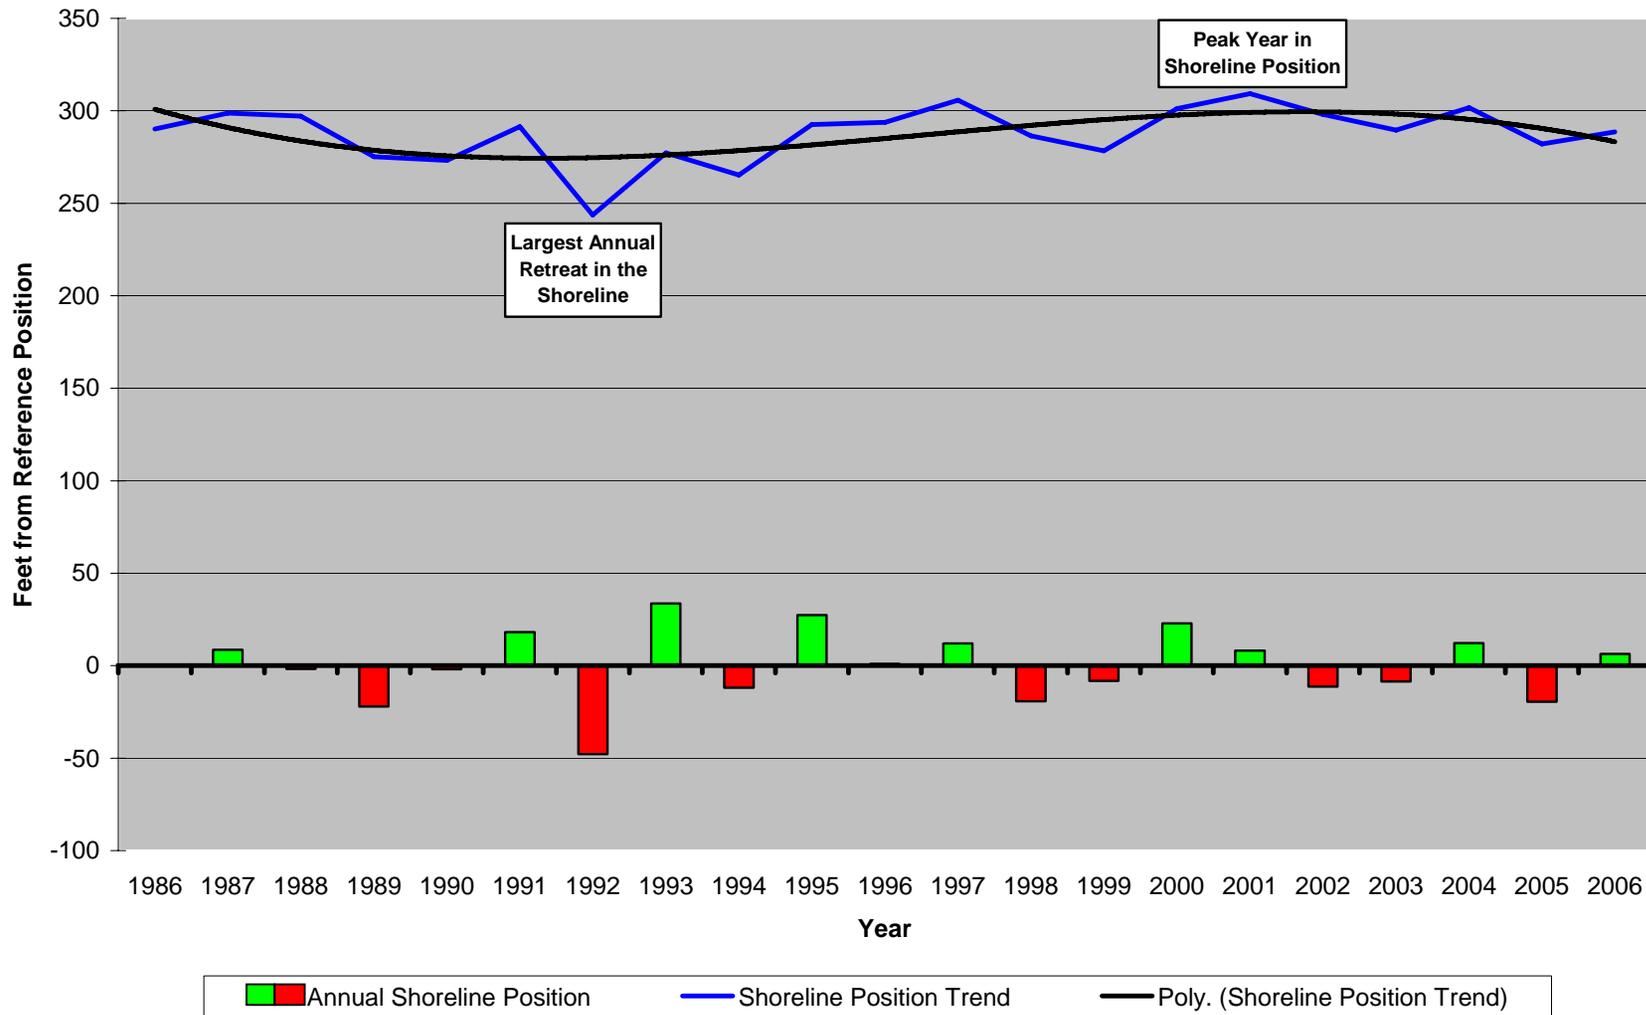
Figure 112 – Site 141. The Ship Bottom beach width changes were in response to storm activity without a clear long-term trend direction. The 1992 northeast storm produced the maximum shoreline retreat with incremental recovery several years following achieving full recovery by 1997. The maximum seaward shoreline position was observed in 2001, and was followed by gradual retreat.

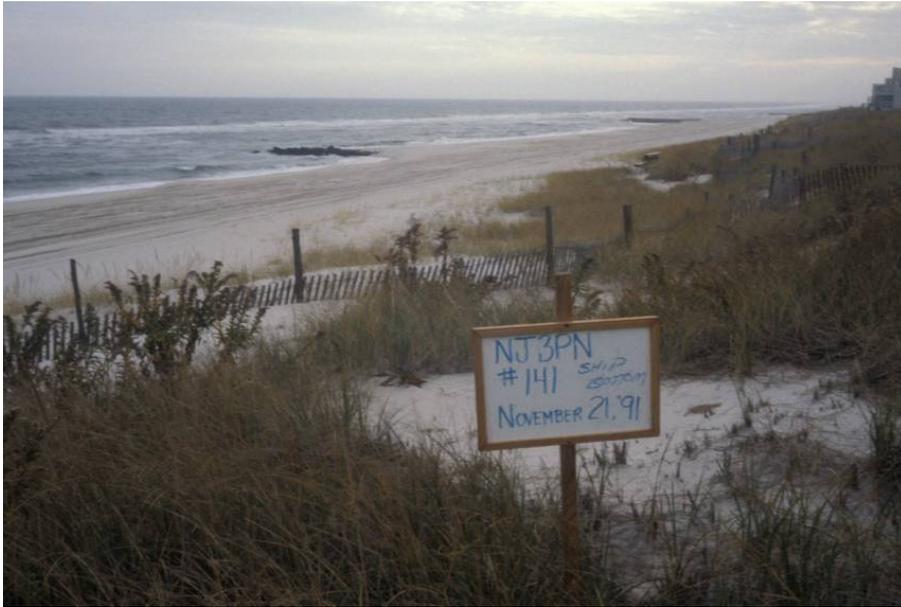
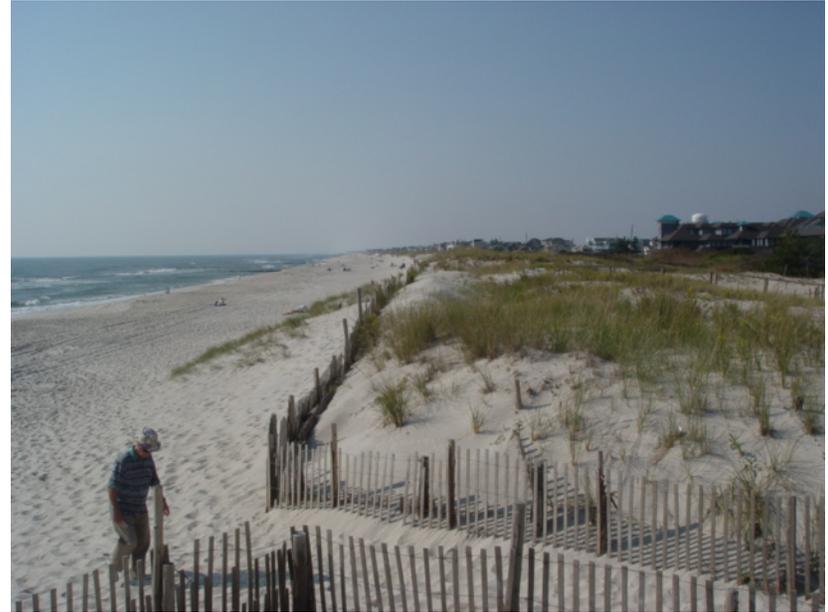
20-Year Comparison Photographs – Site 141, 8th Street, Ship Bottom

The 2006 view (right) across the dunes and beach shows the width of protection provided at this site. The dune nearly doubled in volume as the seaward slope advanced seaward by 35 feet. The actual shoreline position did not shift much over 20 years. The picture on the left shows the conditions of the beach during the 1991 survey. Early colonizing plants are seen in the 1991 photo spreading seaward onto the upper beach starting the aeolian process that created the fore dune ridge seen in the 2006 photo. The site has been slightly accretional during the 20 year study interval with intermittent episodes of storm related erosion.

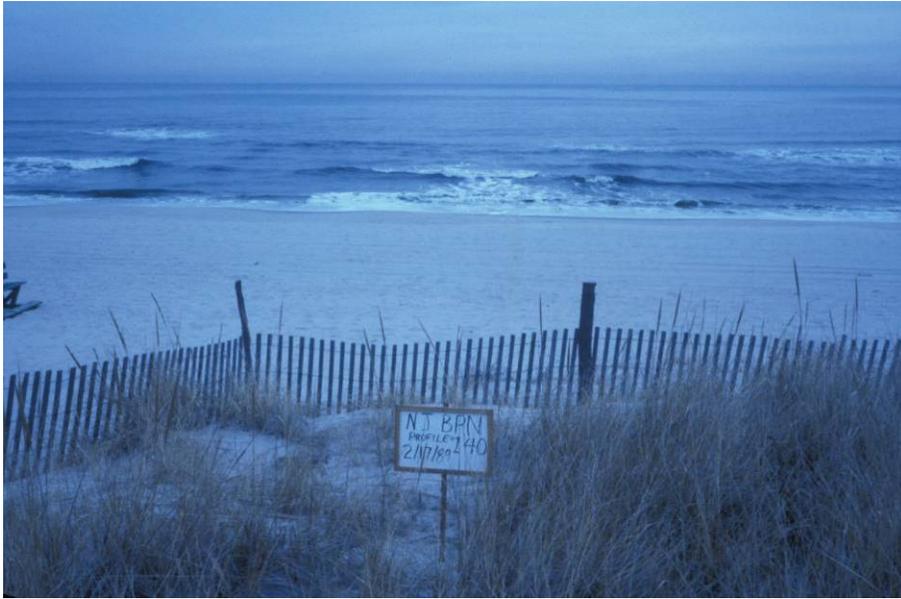
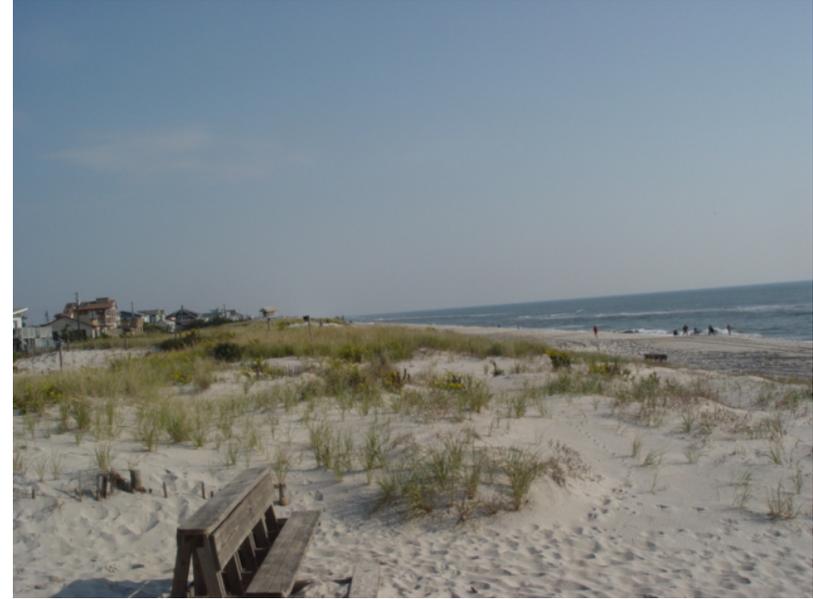
20-Year Comparison Photographs – Site 140, 32nd Street, Long Beach Township

The dune toe merges very gradually with the beach at this location. The dune growth was substantial over the 20-year interval. Sand was added from the landward toe to the seaward toe raising the crest elevation several feet. The installed fencing has been buried by accretion and dune grass has flourished collecting more aeolian sand. Once again the shoreline position remained relatively stable with episodes of substantial variations but ending the 20 year period essentially where it was in 1986. The photographs above were taken in 1989 (left) and 2006 (right).

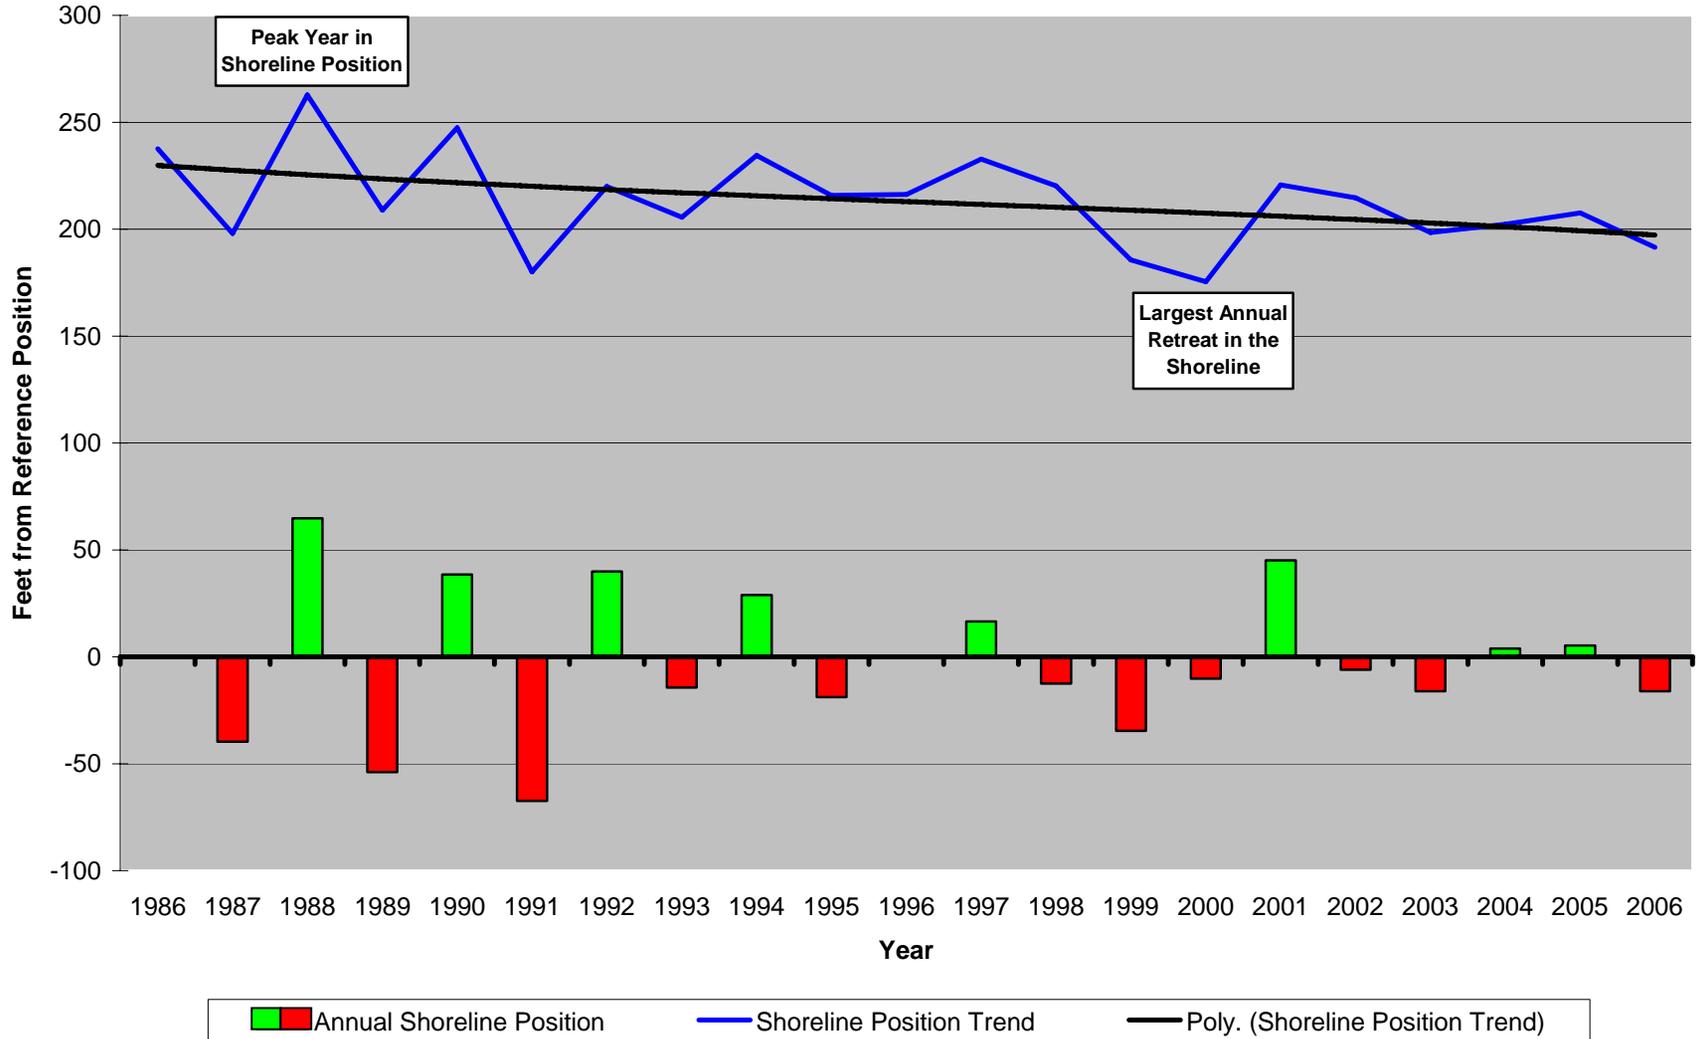
Figure 116 – Site 139. Oscillatory shoreline movement marked the first 10 years at this site. The advances or retreats were in the range of 40 to 60 feet and are fairly large for Long Beach Island. The trend, however, was negative in the amount of 35 feet.

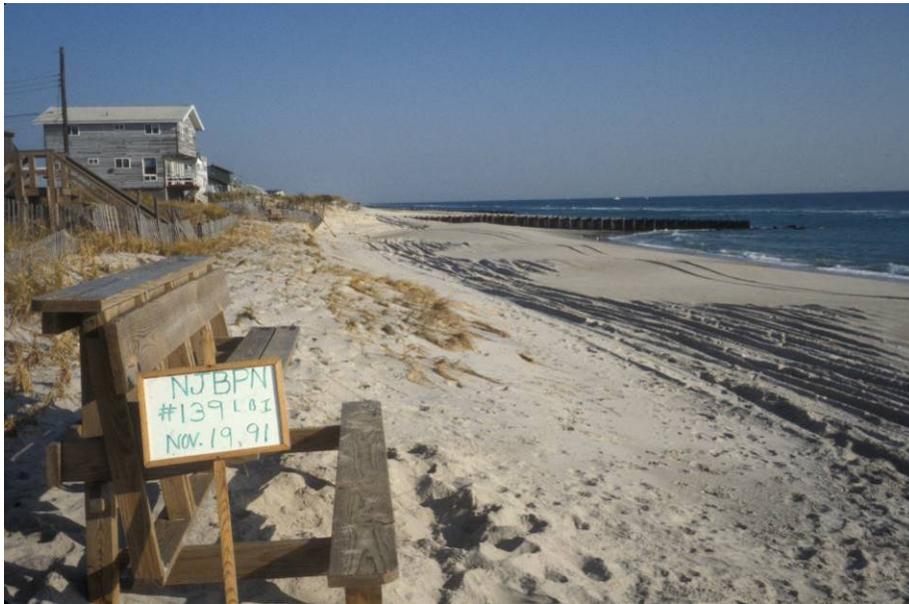
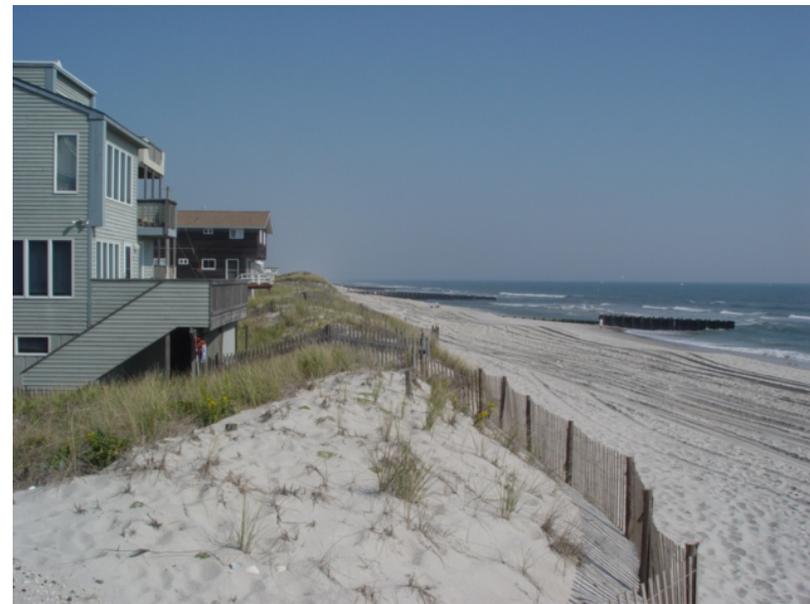
20-Year Comparison Photographs – Site 139, 81st Street Long Beach Township

The variability of the beach and dune width along the Long Beach Island shoreline means that risk of severe storm damage also varies greatly. Here the dune is very narrow and the beach slopes seaward from the dune toe placing the oceanfront properties at risk to potential storm damage from a moderate strength event. The pictures above were taken in 1991 (left) and 2006 (right). The height of the dune has grown in recent years as relatively calm seas have prevailed but the dune width is essentially the same. The modest growth provides limited protection from a severe storm but has prevented modest storm events of the last decade from causing property damage. Opportunity for natural seaward advances of the dune toe are very limited by the narrow width of the beach.

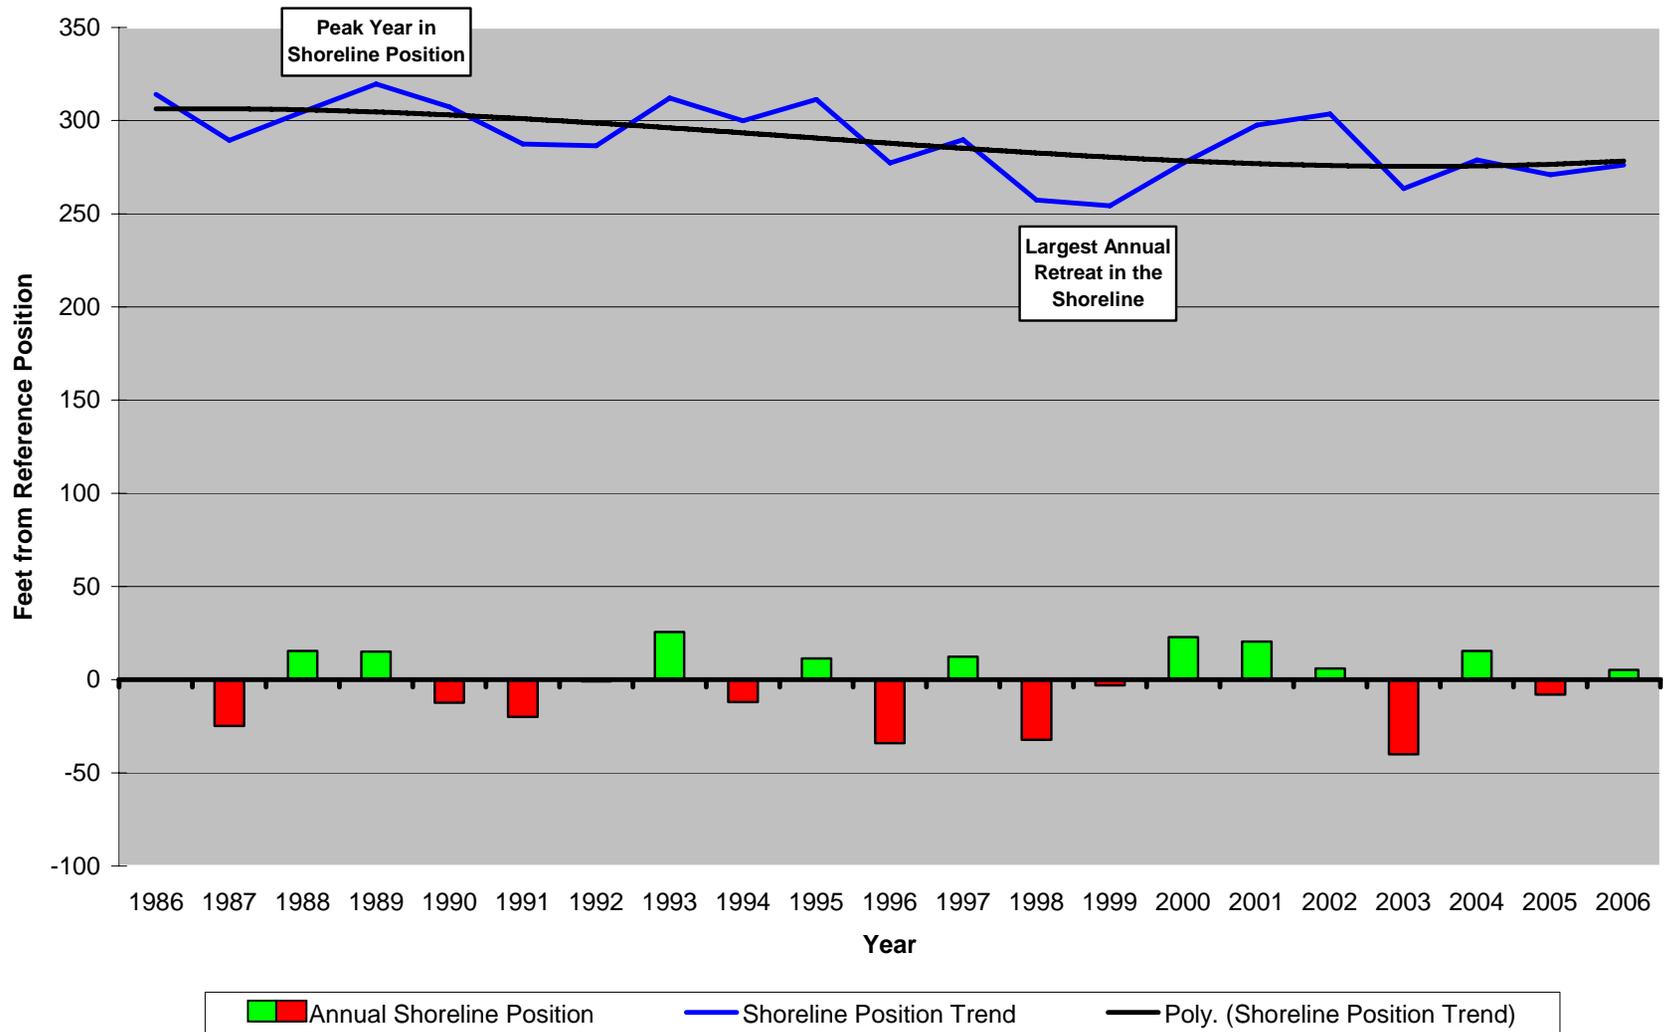
Figure 118 – Site 138. The shoreline retreat documented at this site amounted to a 20-year shift of 30 feet that appeared to be progressive, except for a trio of years where advances occurred between 2000 and 2002.

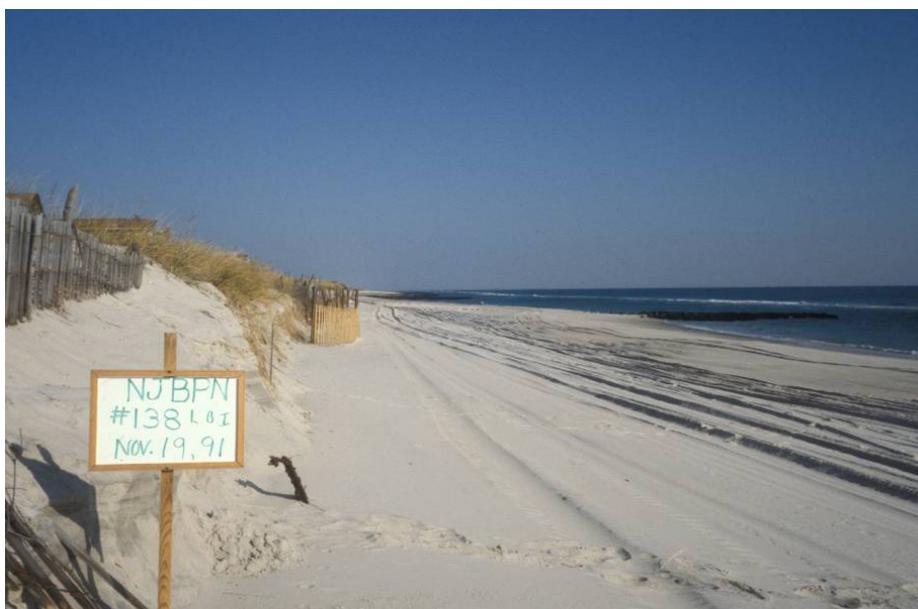
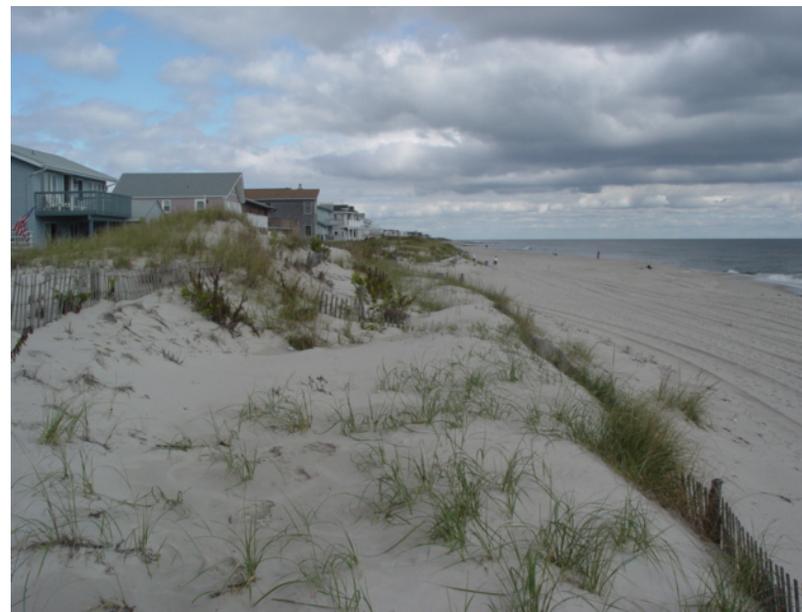
20-Year Comparison Photographs – Site 138, Old Whaling Road, Long Beach Township

Variable maximum dune elevations may determine which homes get damaged and which survive intact after a severe storm in this region. There are considerable variations in the crest elevation that will produce breaching in the low sections. The beach is fairly narrow and the dune toe did retreat somewhat in its position. Additional sand accretion did raise the crest elevation by 3 feet adding some bulk to the shore protection quality of the feature along the profile line. The beachface retreated about 30 feet between 1986 and 2006. The photographs above were taken in 1991 (left) and 2006 (right).

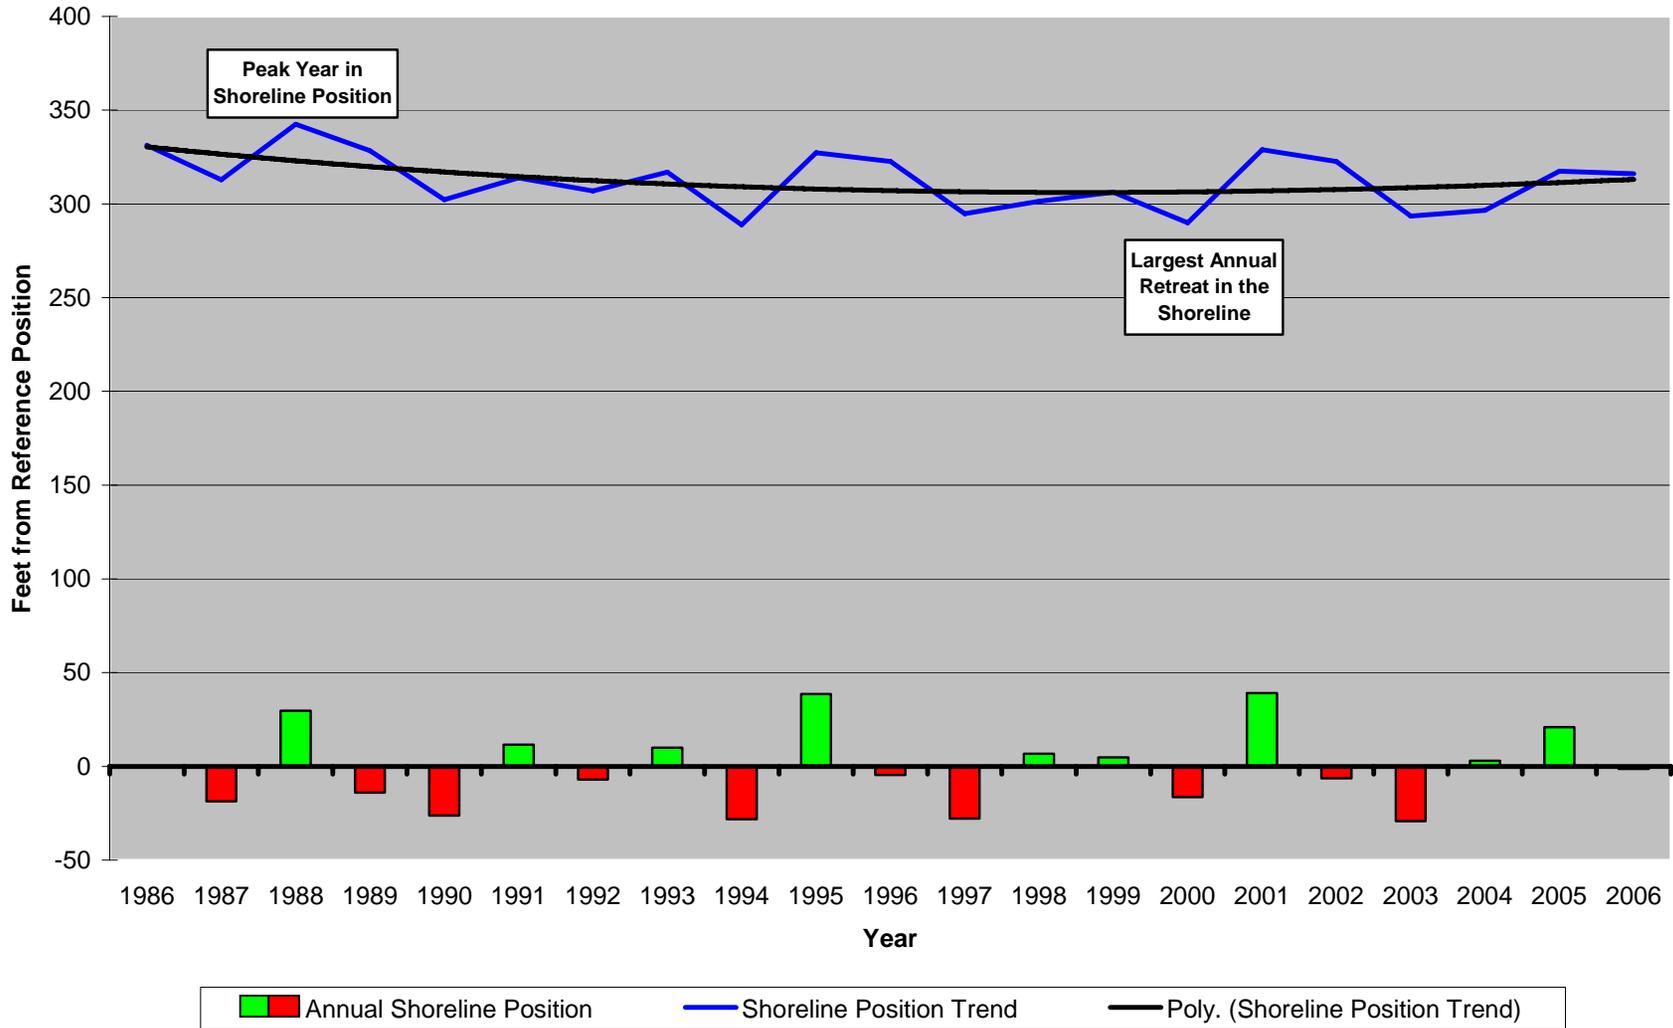
Figure 120 – Site 137. The shoreline trend line at Taylor Avenue declined during the first decade then leveled out for the second with variations occurring within seasonal ranges. Annual variations remained relatively small in the range of 25 feet.

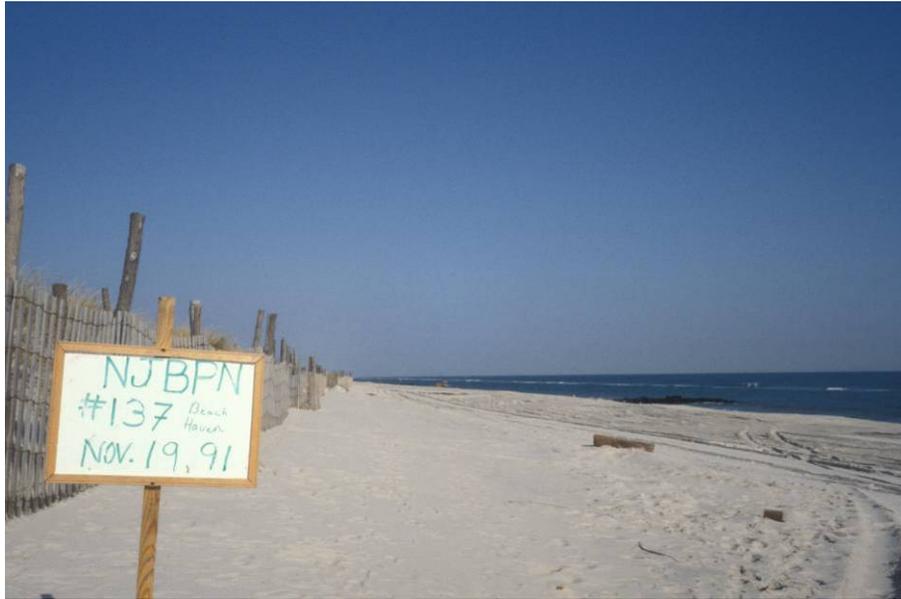
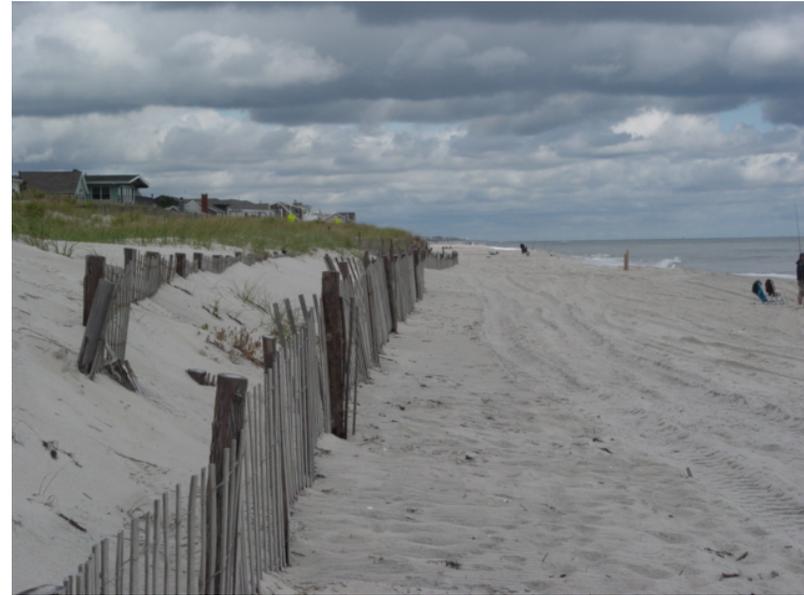
20-Year Comparison Photographs – Site 137, Taylor Avenue, Beach Haven

Over the 20 years of study, 25 cubic yards of sand was added to the dune field. A substantial fore dune ridge developed around installed fencing adding width and height to the feature. This provides reasonable protection for the ocean front properties and infrastructure from moderate storms. The shoreline remained nearly in the same location over the 20 year study period. The photographs above were taken in 1991 (left) and 2006 (right). The exposed fences in 1991 have been nearly completely buried with a subsequent straight line fence added to gather additional sand and prevent beach patrons from walking across the feature.

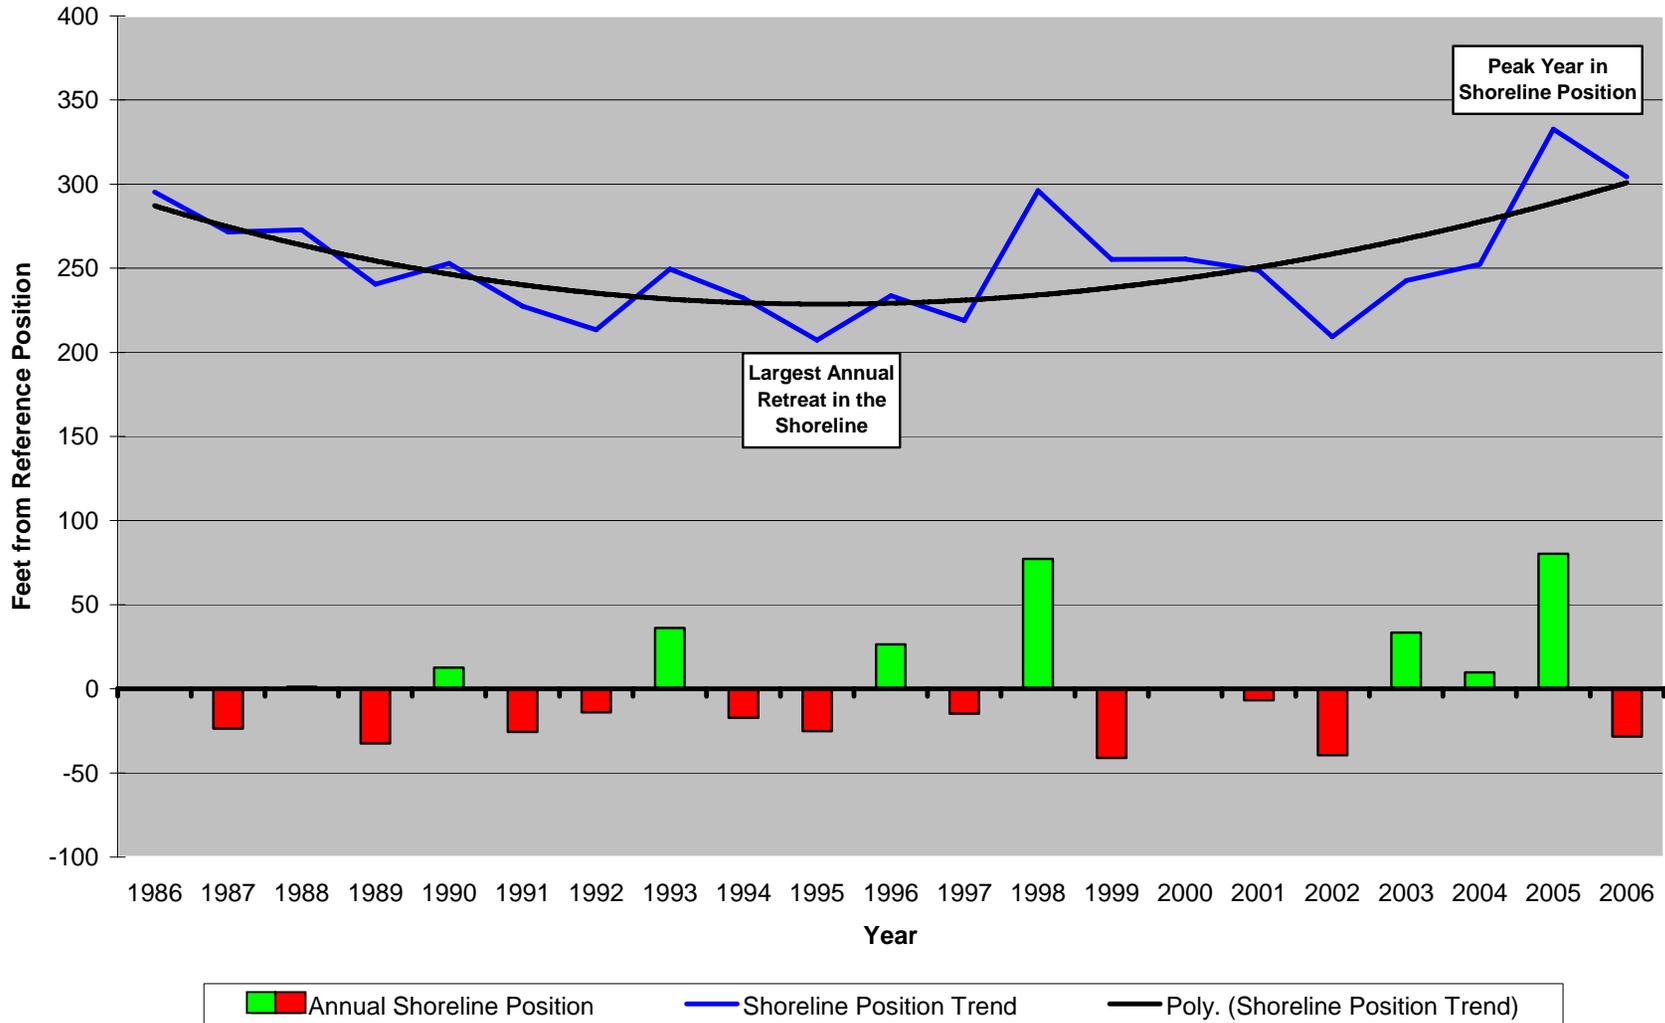
Figure 122 – Site 136. The Dolphin Avenue site retreated to a point 215 feet from the reference at the zero elevation position, and then advanced to a peak in shoreline location in 2005 only to shrink landward by 2006. The trend line returned to the 1986 position by 2006.

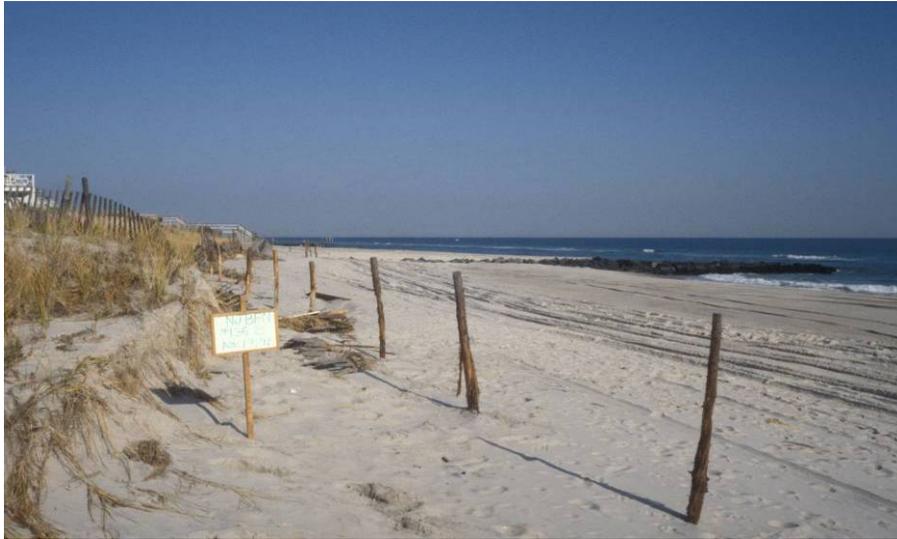
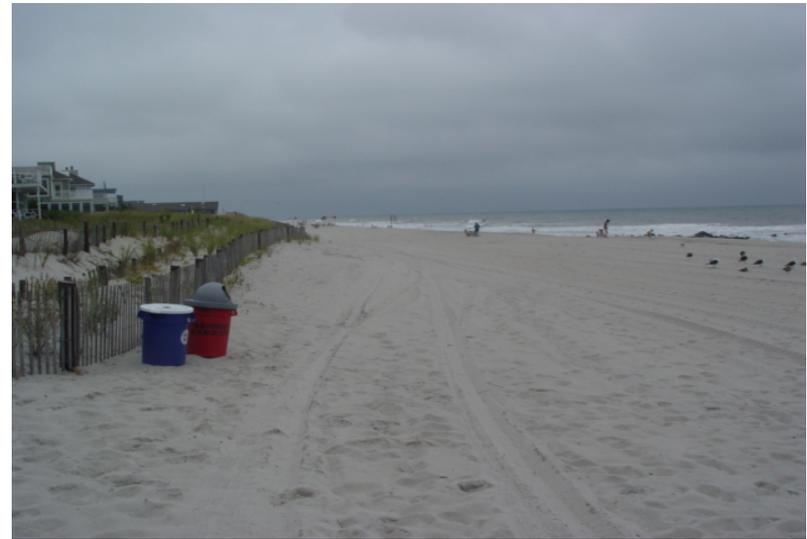
20-Year Comparison Photographs – Site 136, Dolphin Avenue, Beach Haven

The photograph on the right shows the 2006 view to the south near the dune toe at Dolphin Avenue. The dune grew higher by 3 feet and wider by approximately 10 feet. The beach in 2006 remained fairly wide late in the summer season prior to any winter storm activity. The photograph on the left was taken during the fall of 1991. The photos below show the impact of the proximity that the northern homes had on the width of the dune (lower left) compared to the affect of a greater setback, which yielded much wider dunes to the south.

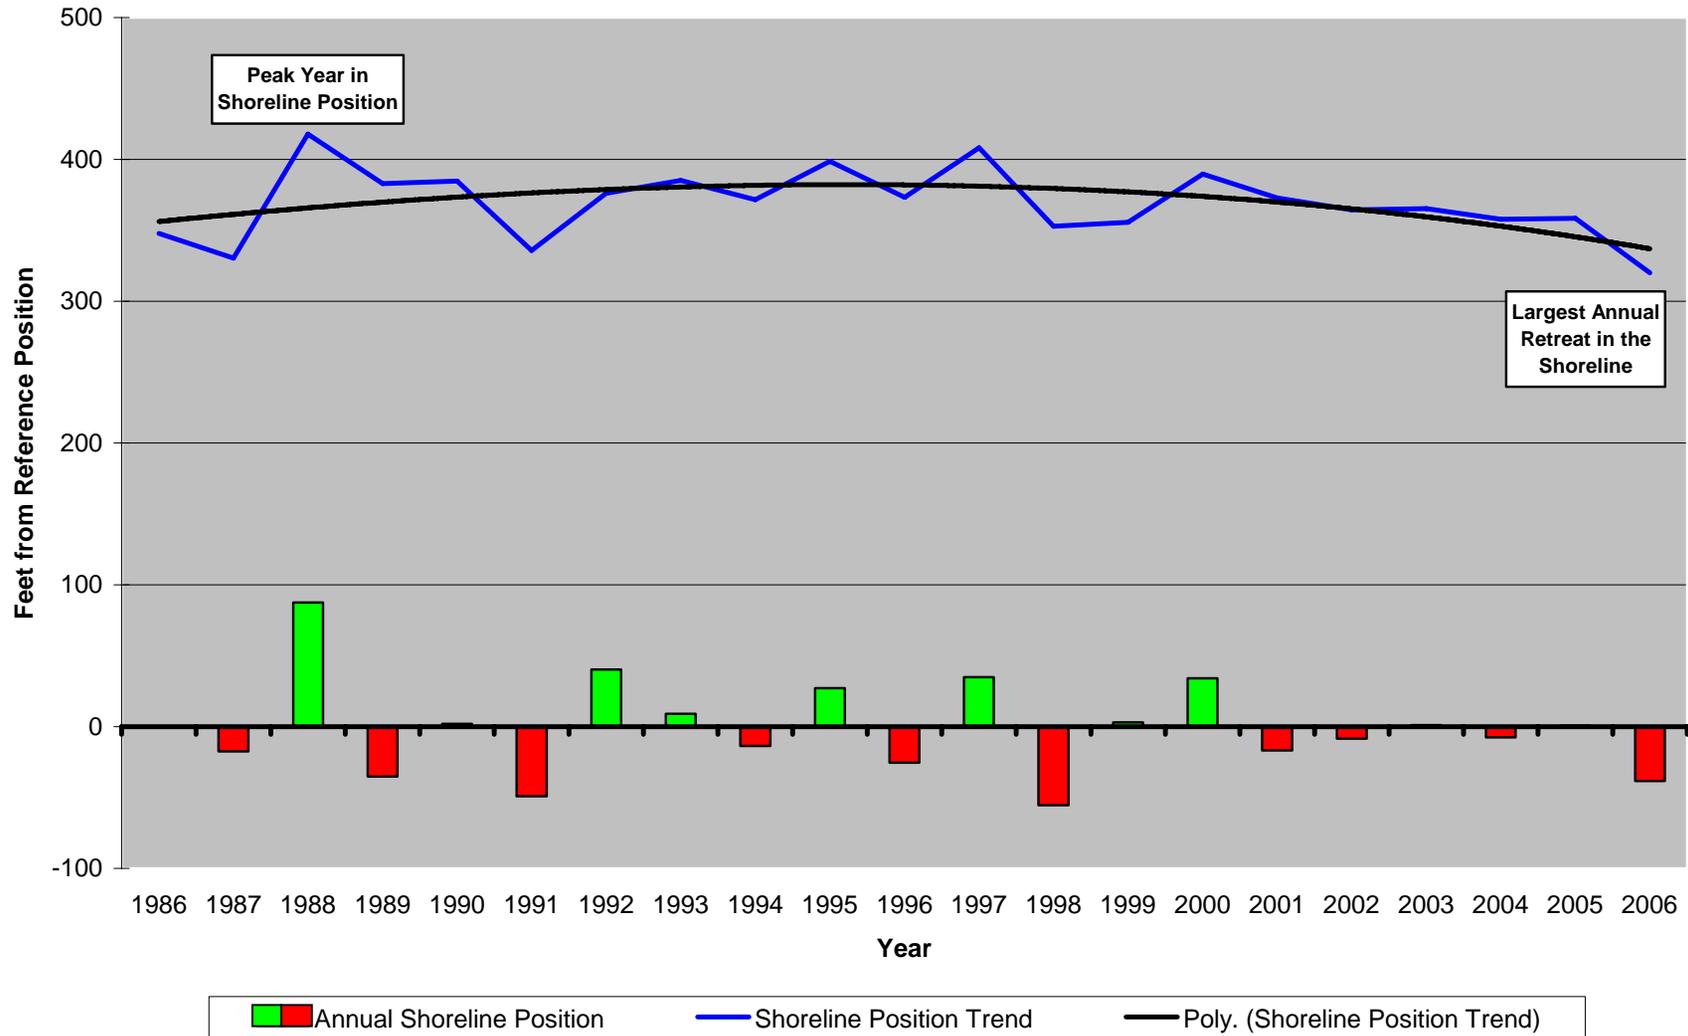
Figure 124 – Site 135. Modest levels of annual change dominate this site. After an initial period of modest advance a six-year shoreline recession trend caused the shoreline position to retreat slightly landward of the 1986 position by the end of the 20-year study period.

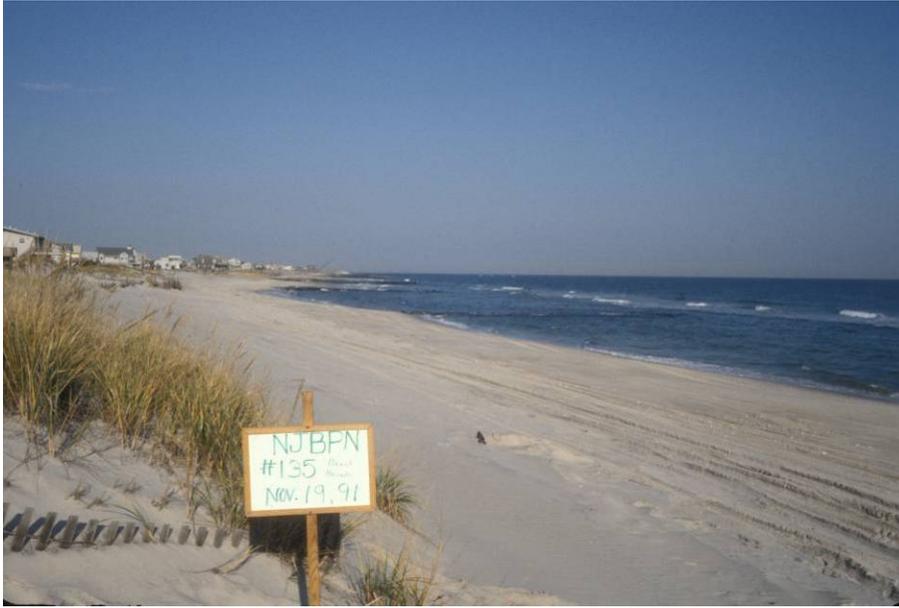
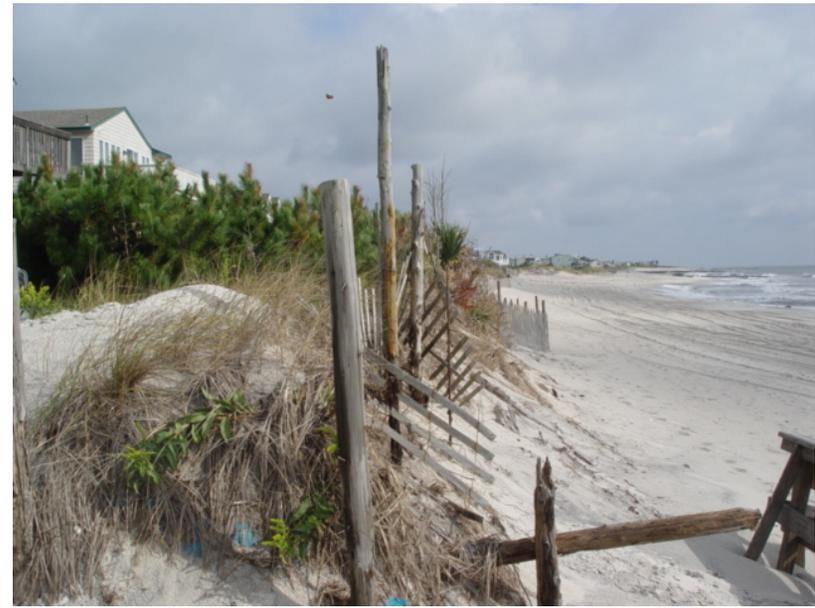
20-Year Comparison Photographs – Site 135, Webster Avenue, Long Beach Township

At this site the narrow beach has resulted in several episodes of significant dune slope erosion. The dune scarp shown in the 2006 photo (right) is an example of this erosion that has produced a low level of storm protection along this beach. The narrow beach with its limited sand source has slowed natural recovery and little mechanical efforts were evident to repair the damage, resulting in repetitive and cumulative storm damages. The dune crest and width have retreated significantly as a result of these erosional episodes. The beach itself has retreated over time, pulling back about 25 feet. The dune profile shows the erosional trend in the plot below. The picture on the left was taken during the fall of 1991 survey prior to the significant dune erosion.

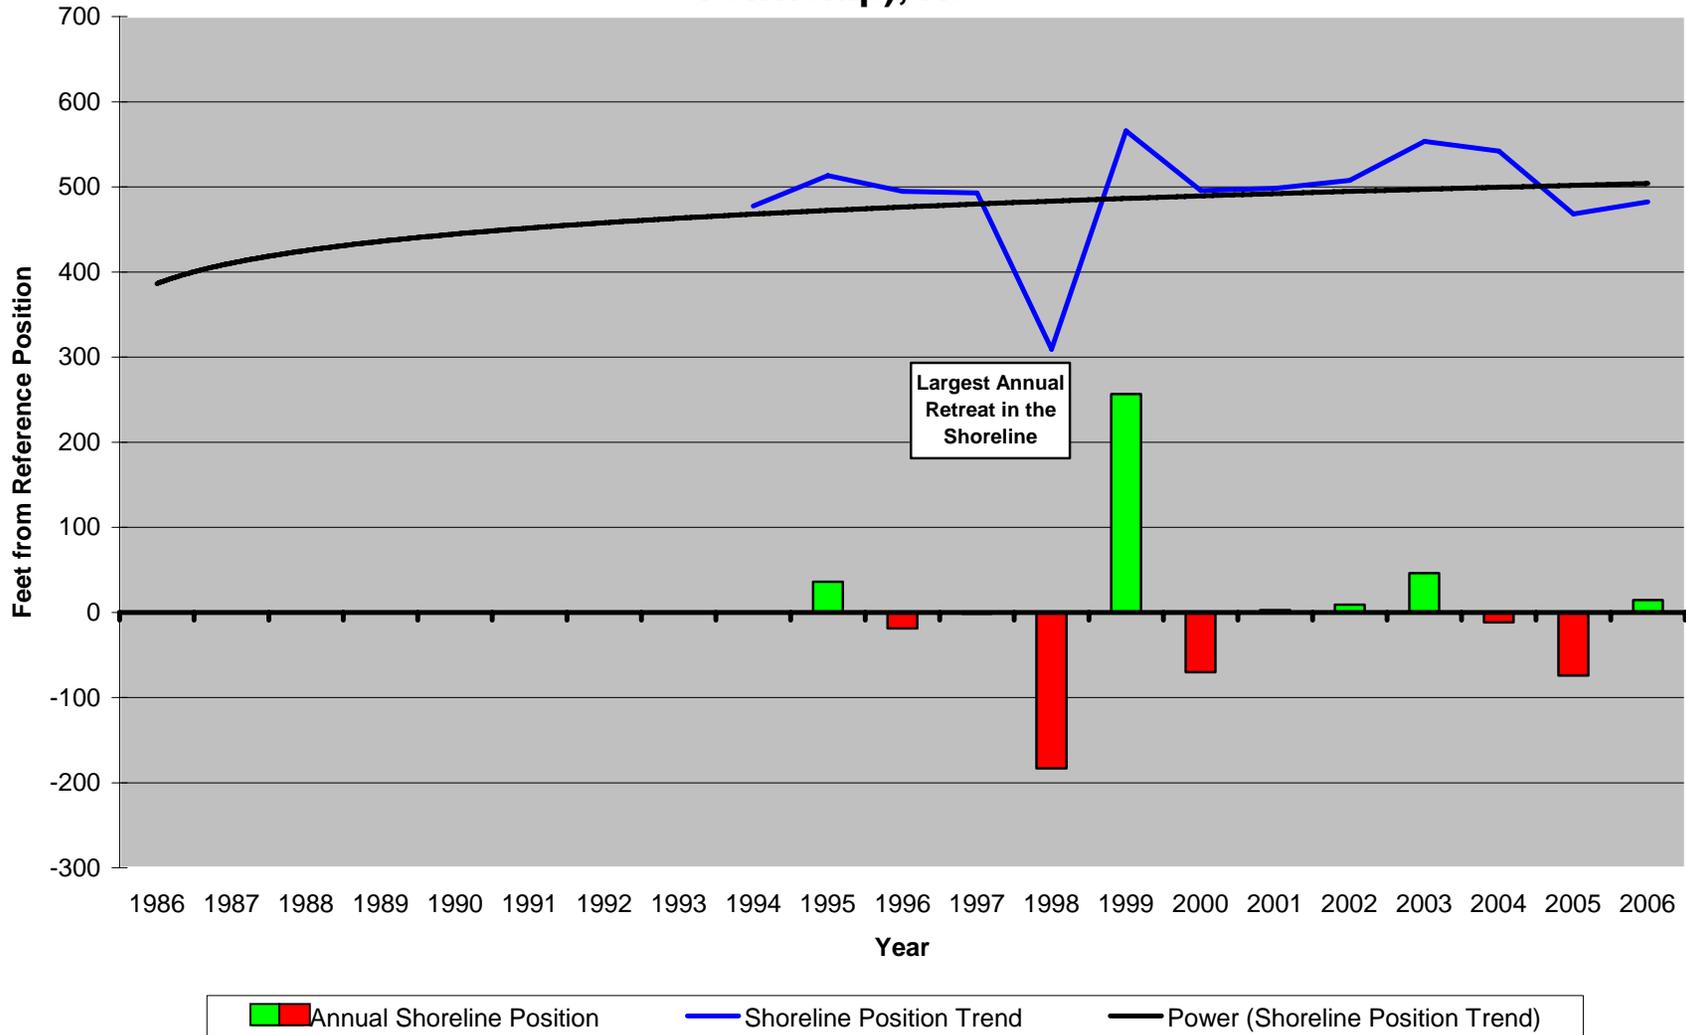
Figure 126 – Site 234. 1998 and 1999 produced the largest shoreline variation during the 12-year study interval. This site was added to the program in 1994 at the entrance to the Forsythe National Wildlife refuge to gain insight on beach changes south of the developed area

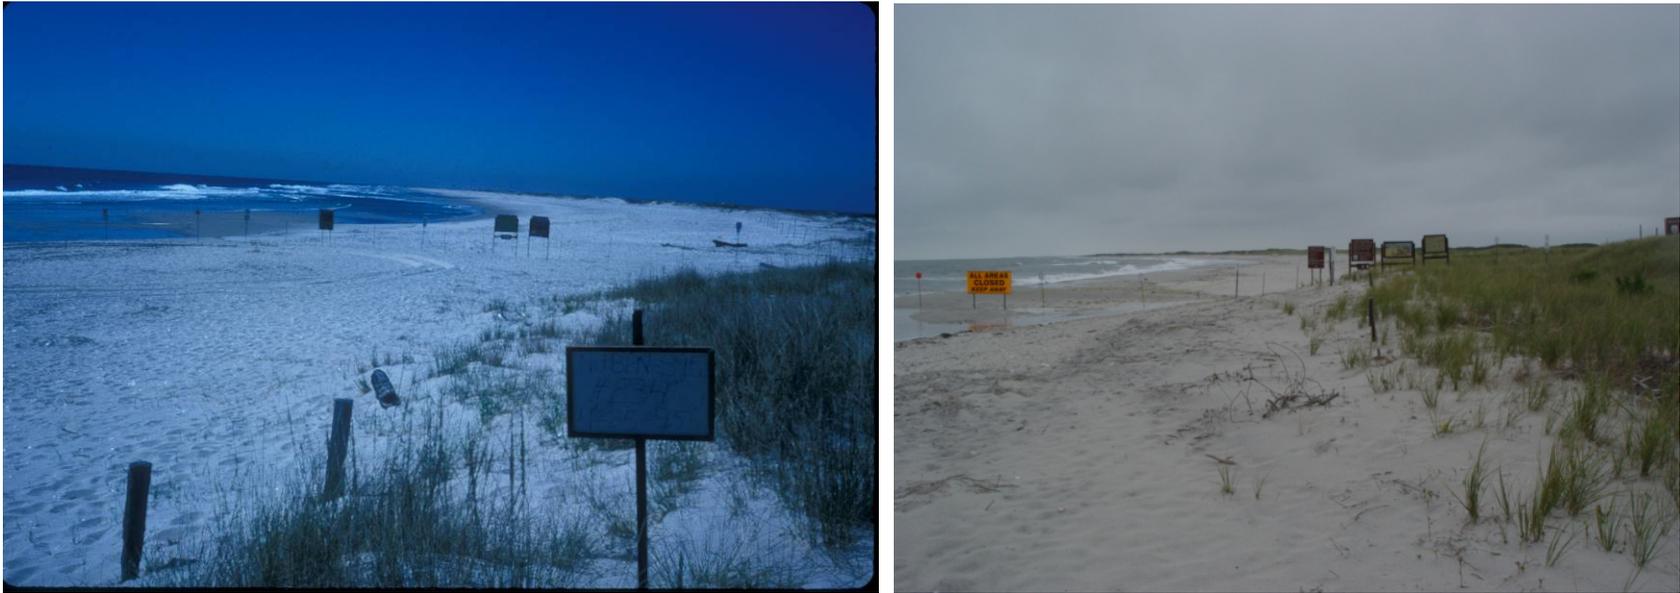
20-Year Comparison Photographs – Site 234, Forsythe National Wildlife Refuge, Long Beach Township

Sand arrives at this site infrequently, but in large quantities as it migrates around the groin into an area of natural beach that extends south for over 2 miles to Little Egg Inlet. Since this segment is Federal land, the State NJBPN project did not continue south to the spit tip. No data were collected on Little Beach Island for the same reasons. The pictures above were taken in 1995 (left) and 2006 (right).
