New Jersey Beach Profile Network

Ocean County

Manasquan Inlet
to Little Egg Inlet

NJBPN Profile #'s
156 - 234

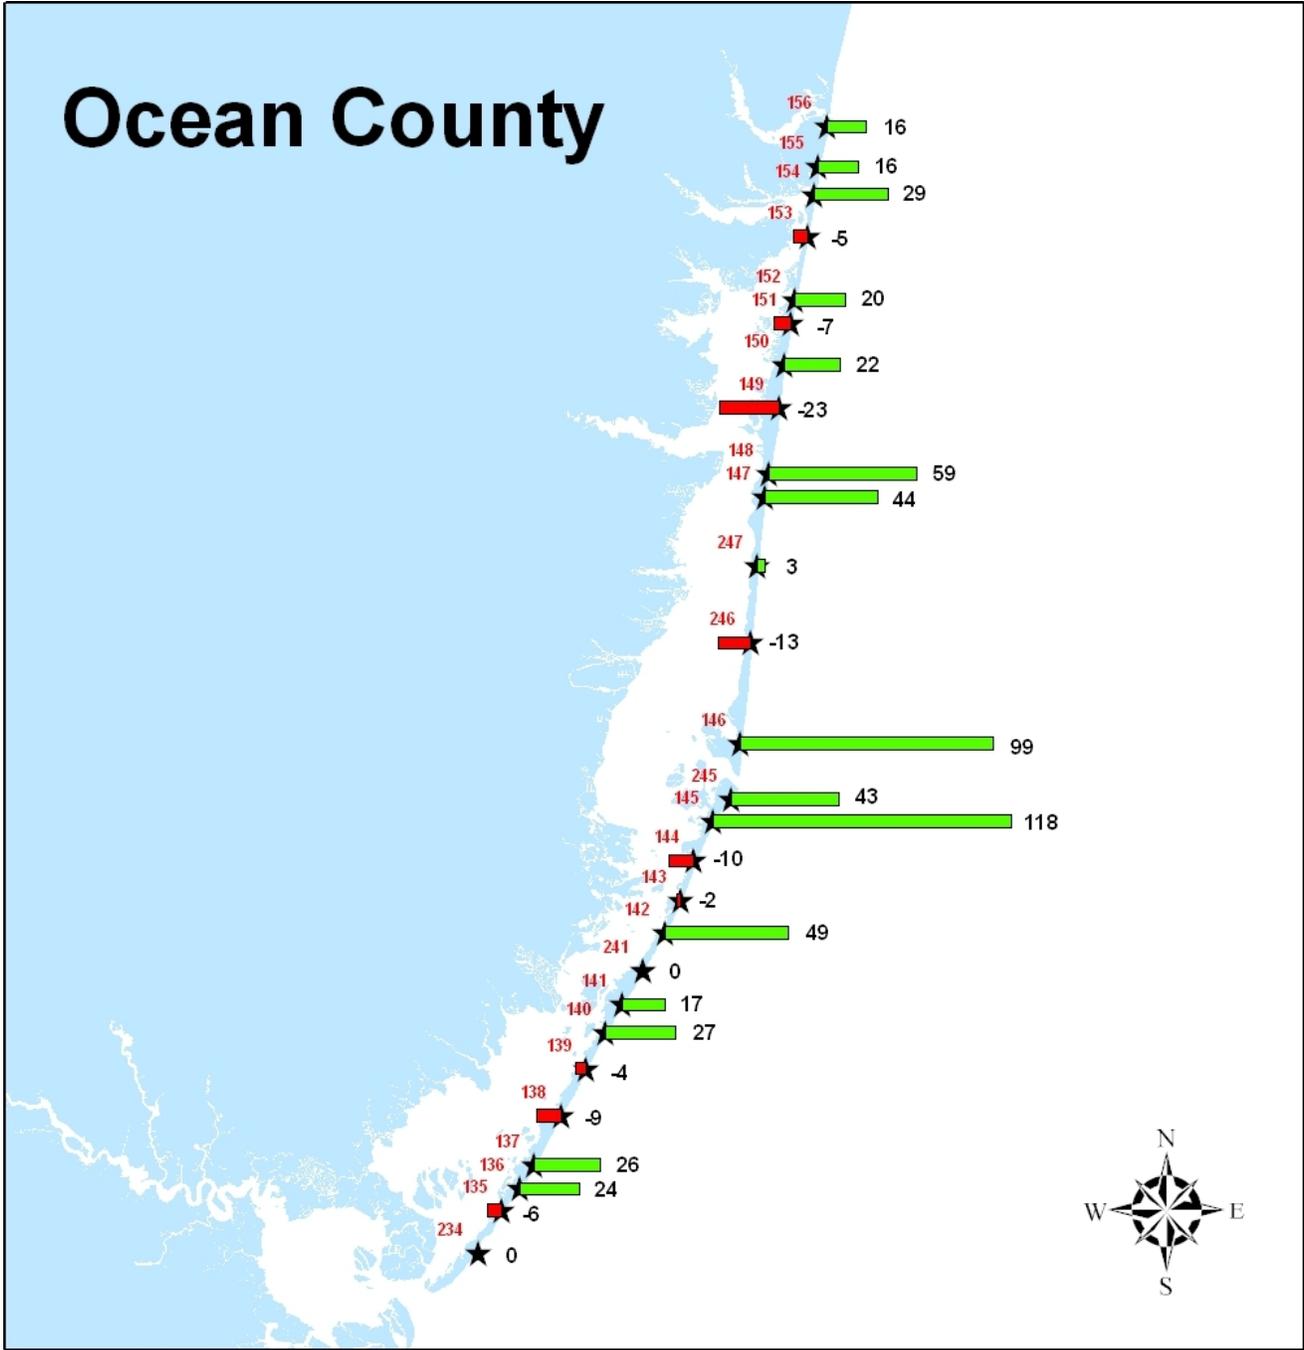
Summary Illustration 3: The Ocean County shoreline very recently received its first substantial beach restoration project funded by the federal government. This was confined to Surf City, Long Beach Island, NJ. The majority of the shoreline changes were natural as sand moved onto or off the beach or was transported north or south by littoral currents. The State of NJ conducted a large truck-fill in Harvey Cedars in 1994 – 1995, but that material was distributed along the adjacent shoreline so it does not appear as a shoreline advance. Large advances around Barnegat Inlet were due to the jetty reconstruction on the Long Beach Island side and trapping on the north side.

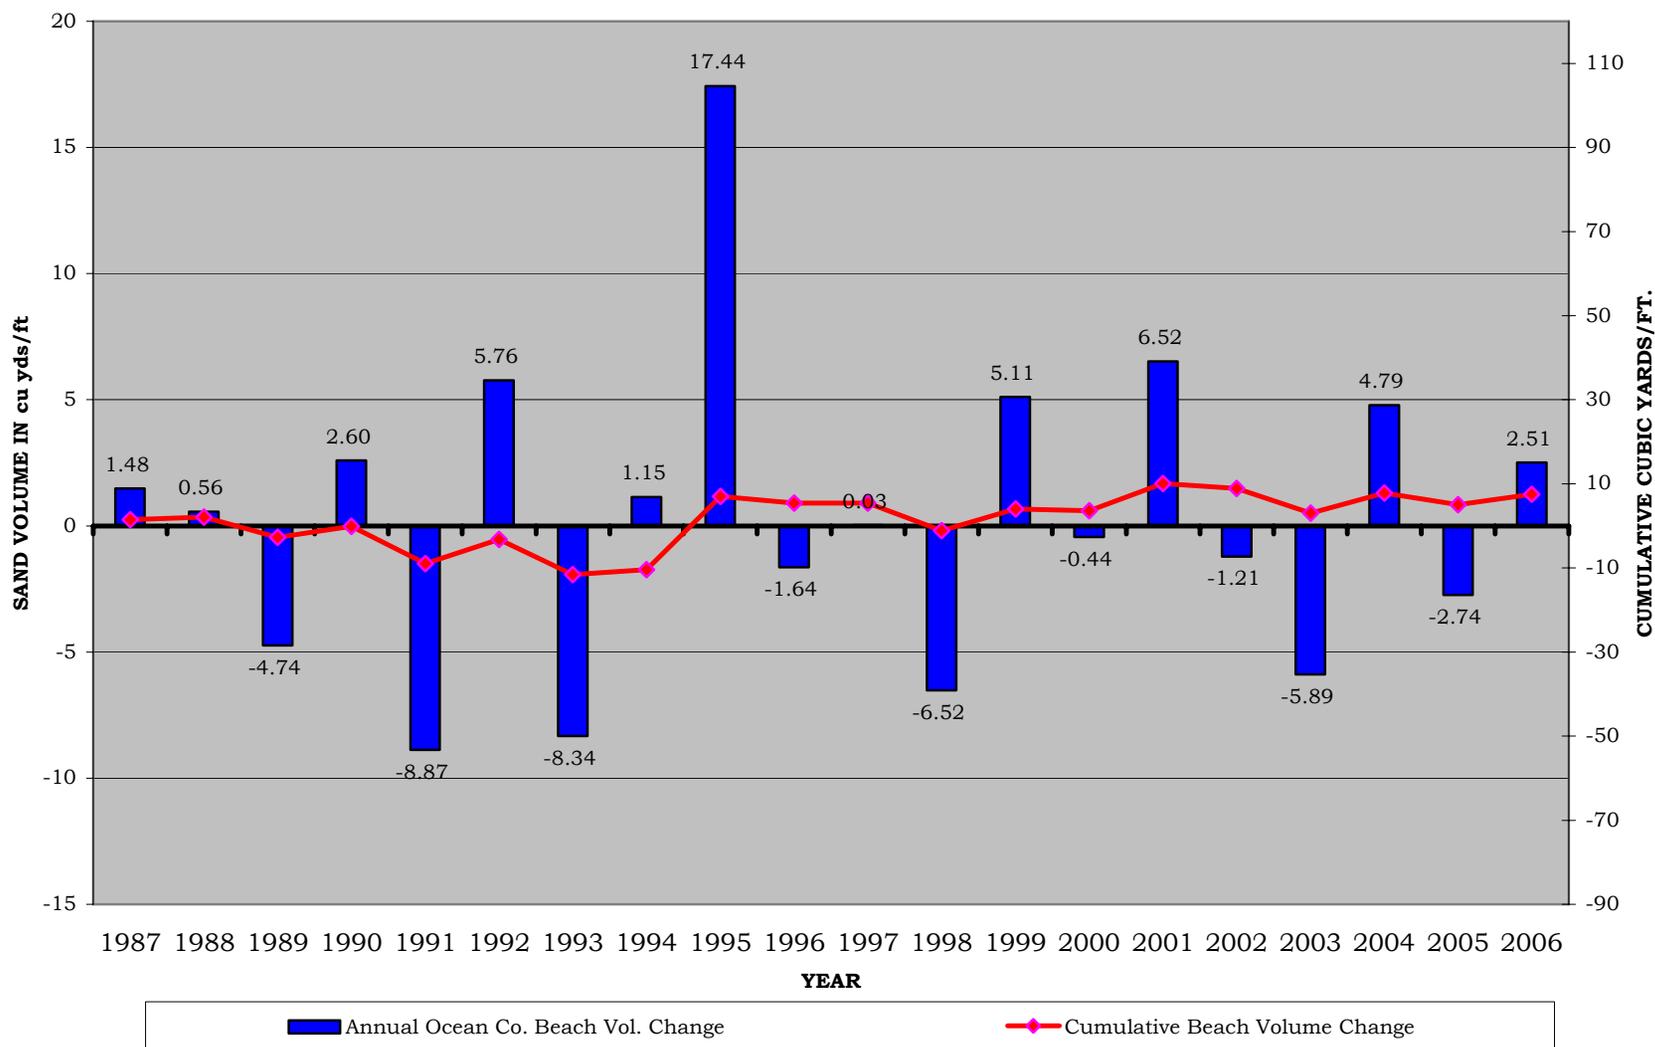
AVERAGE BEACH SAND VOLUME CHANGE for 27 PROFILES in OCEAN COUNTY 1987 - 2006

Summary Illustration 4: The sand volume trends in Ocean County reflect minimal beach restoration effort (1995) with large scale beach fills. The trend went negative as a result of the 1991 and 1992 northeasters, but recovered by 2006 to post a small gain of 7.56 yds³/ft.
