New Jersey Beach Profile Network

Ocean County

Manasquan Inlet
to Little Egg Inlet

NJBPN Profile #'s
156 - 234

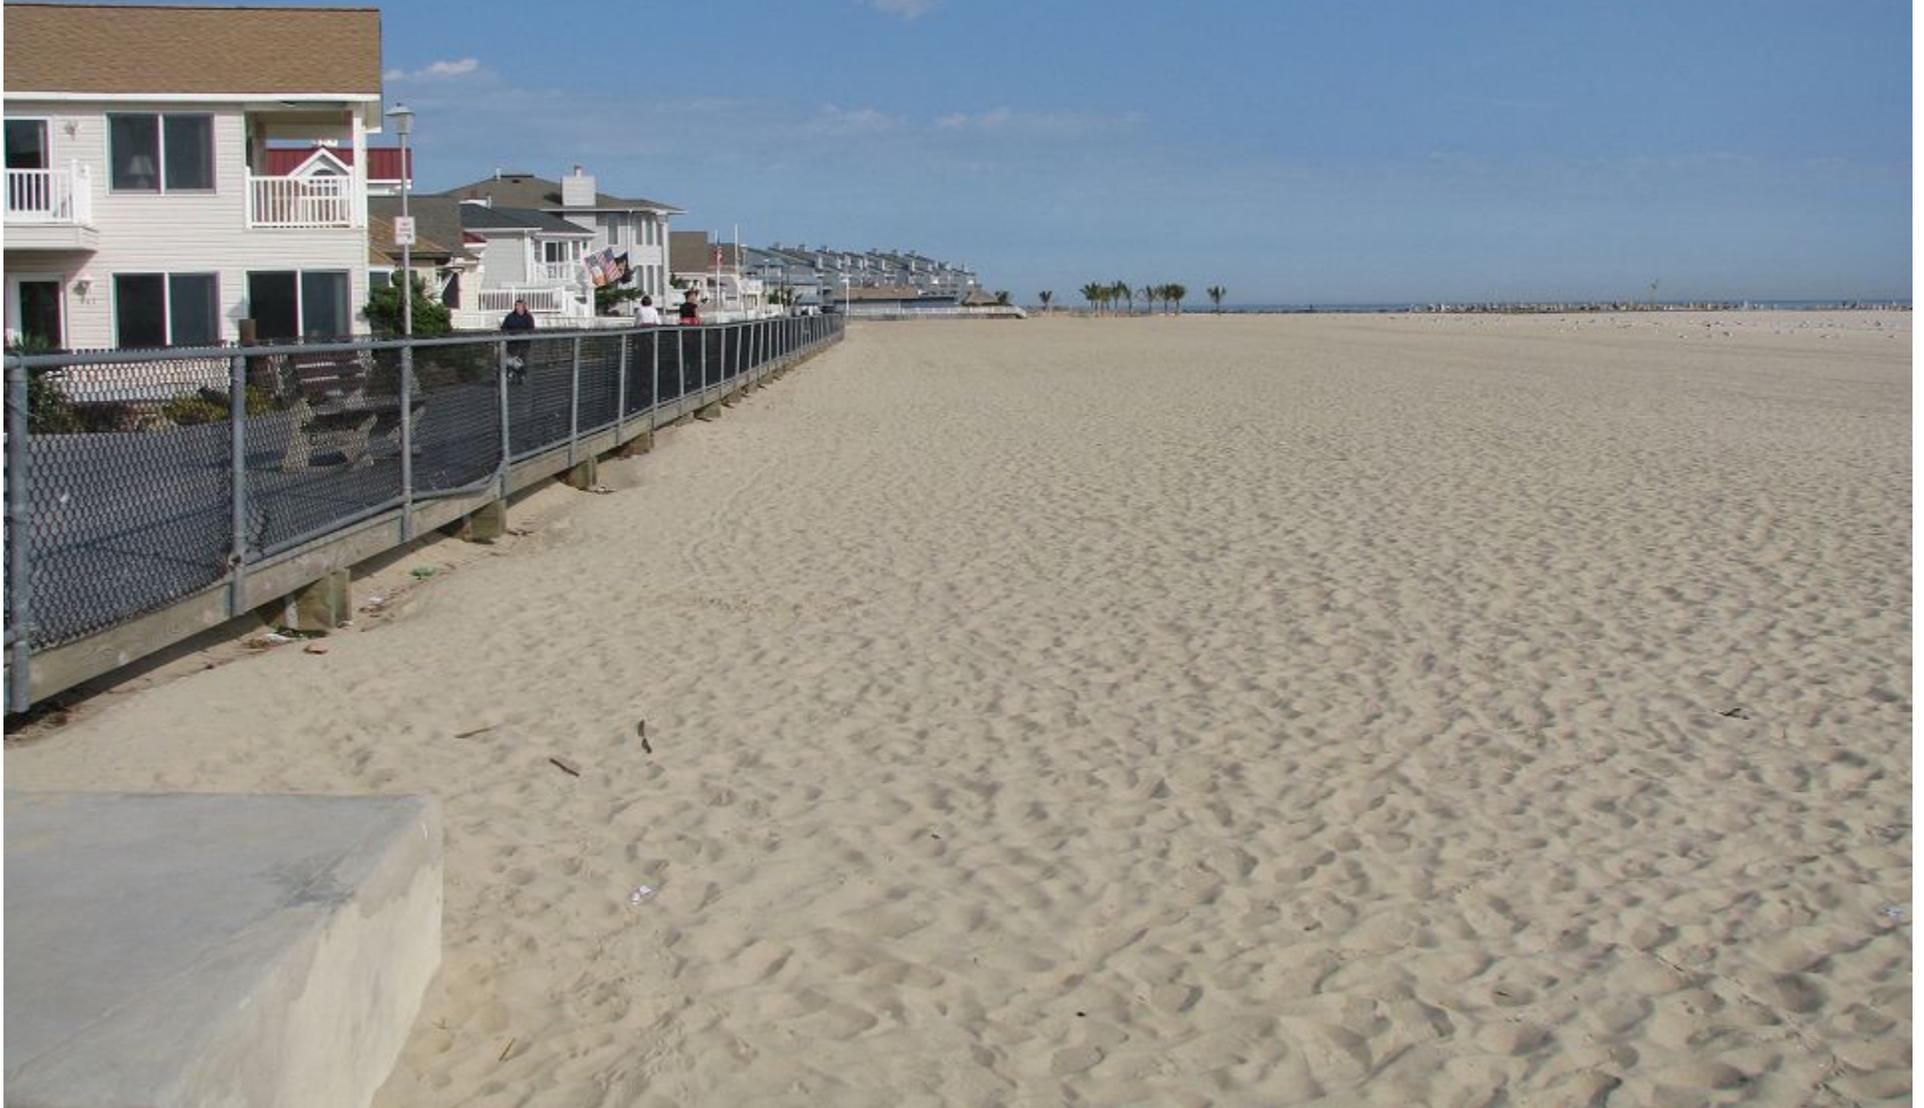
Site 156, Water Street, Point Pleasant, NJ – October 18, 2011

Figure 151. Shown above is the view looking north from the beach at Water Street in Point Pleasant, NJ.

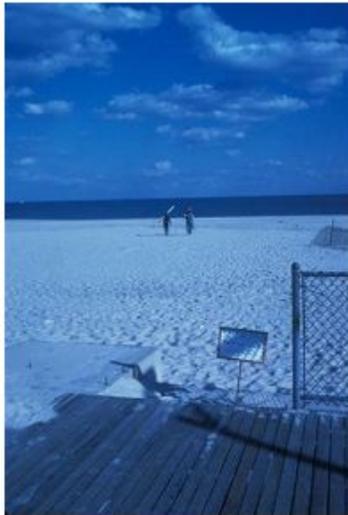
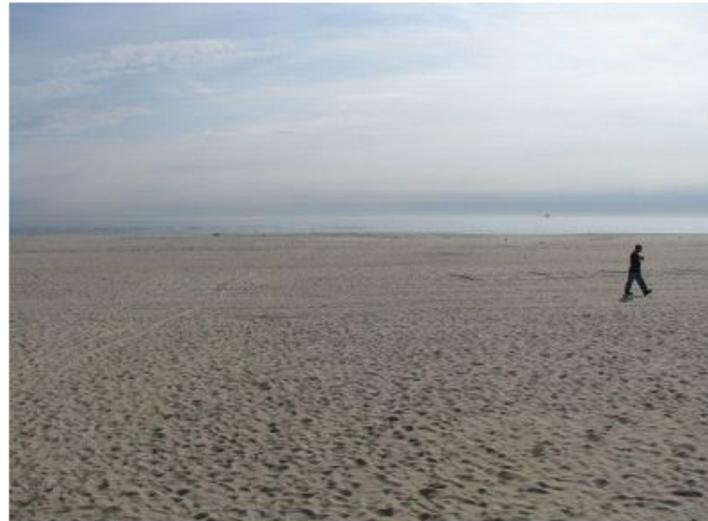
Figure 153: above shows that the beach at Water Street in Point Pleasant Beach has gained a significant amount of sand since its initial survey in 1986. The shoreline advanced by 135 feet and 55,994 cu.yd/ft. of sand was added to the beach. Photo on the left was taken in 1988 and shows the view looking east from the boardwalk. Photo on the right was taken in October of 2011 and shows the view from the beach looking east.

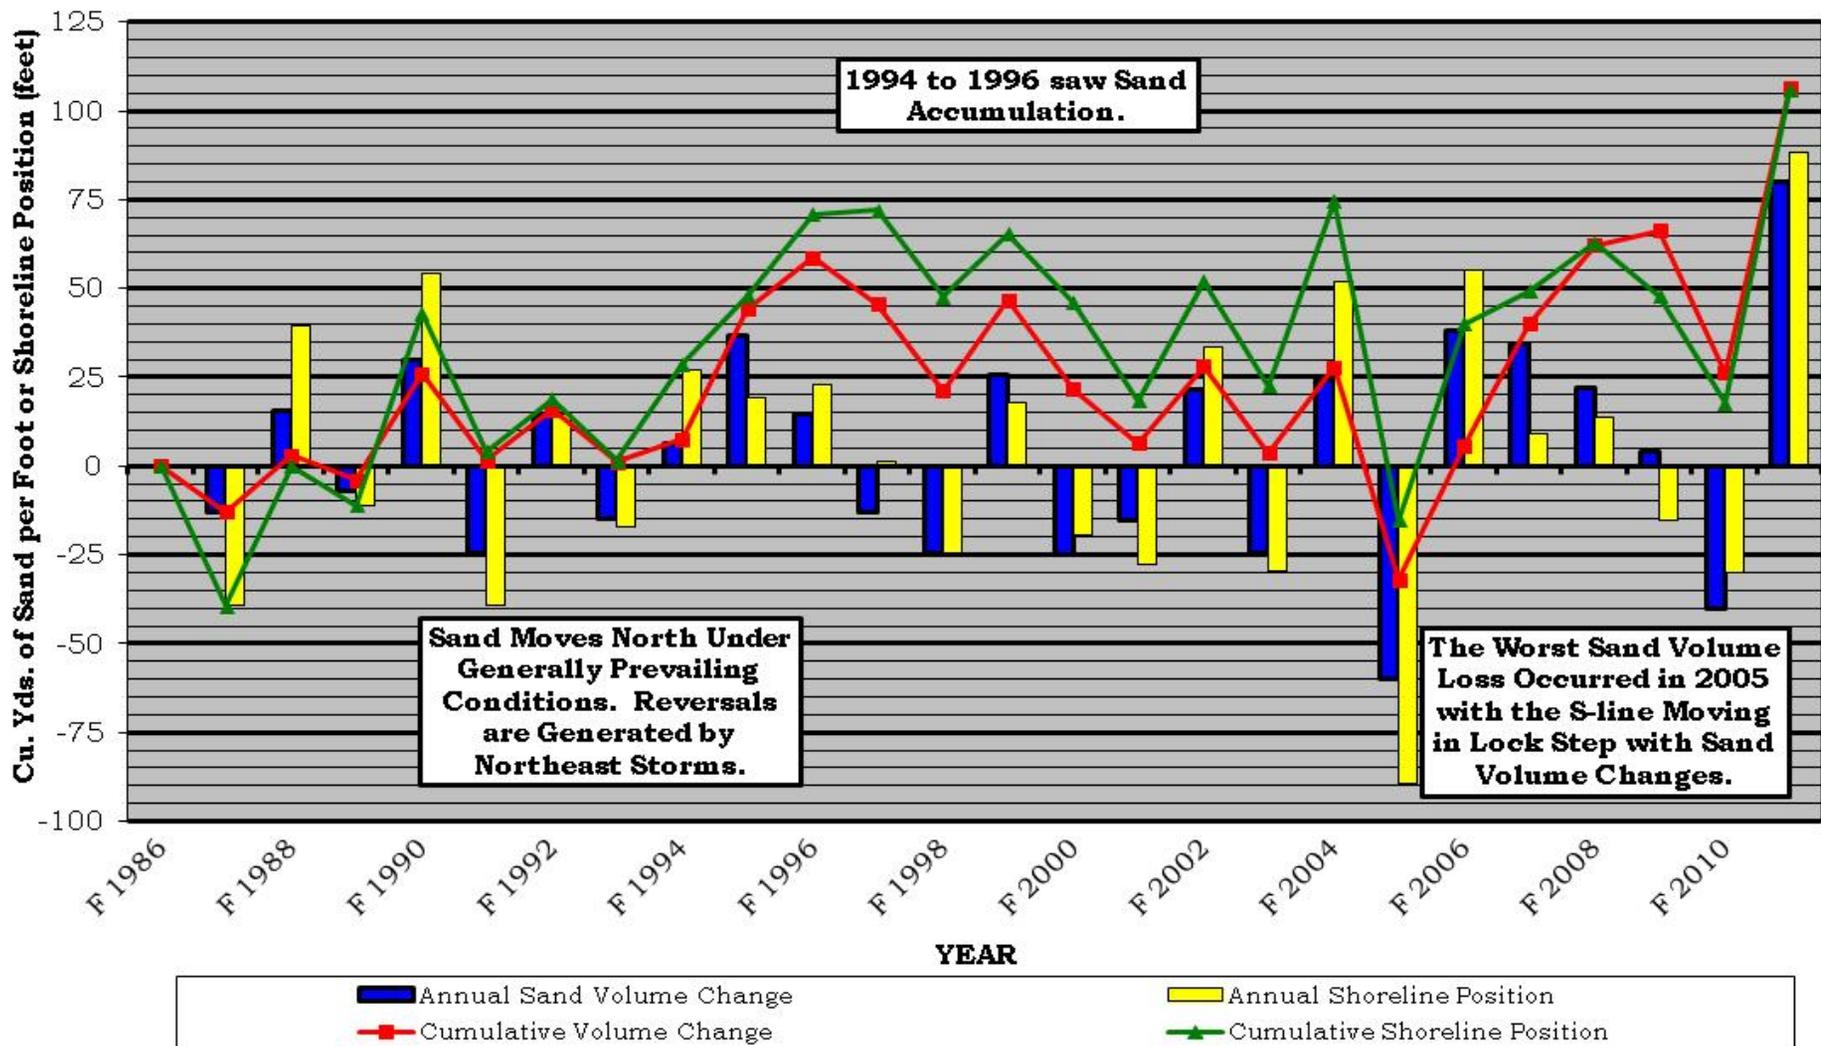
25-Year Coastal Changes at Site 156, Water St., Point Pleasant Beach, Ocean Co.

Figure 154. Profile 156 is the northernmost site in Ocean County and is positioned just south of the Manasquan Inlet. Protected by the jetties, the beach remained wide and changed little with storms following the Monmouth County shore protection project. In 2005 the worst sand volume and shoreline position loss occurred followed by a partial retrieval in 2006. In the fall of 2011 Hurricane Irene moved a tremendous amount of sand north along the ocean county shoreline resulting in the largest sand volume and shoreline position gain in the 25 year history.

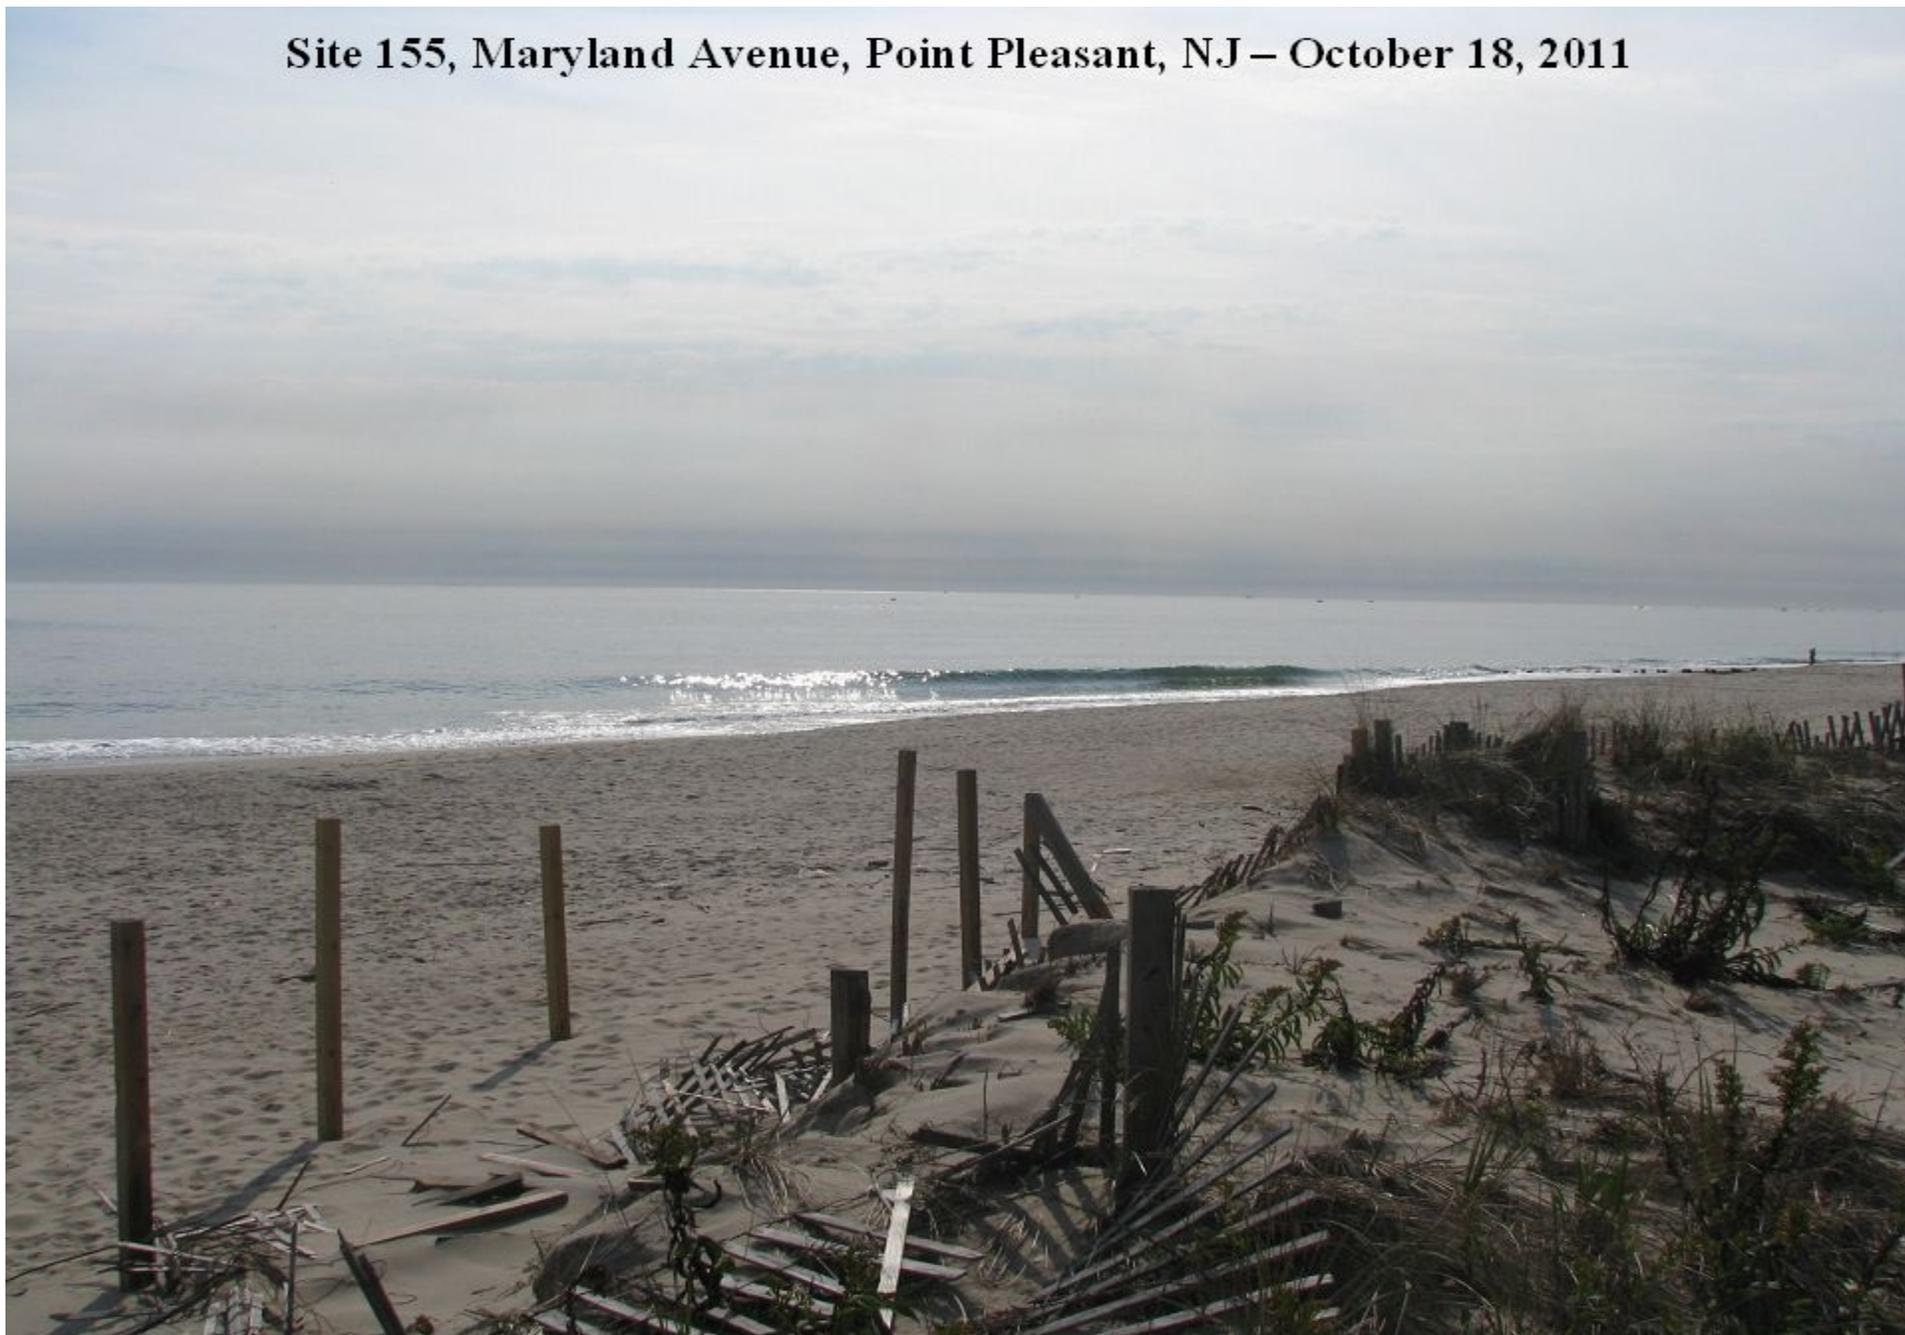
Site 155, Maryland Avenue, Point Pleasant, NJ – October 18, 2011

Figure 155. Shown above is the view looking southwest from the dune at Maryland Avenue in Point Pleasant, NJ.

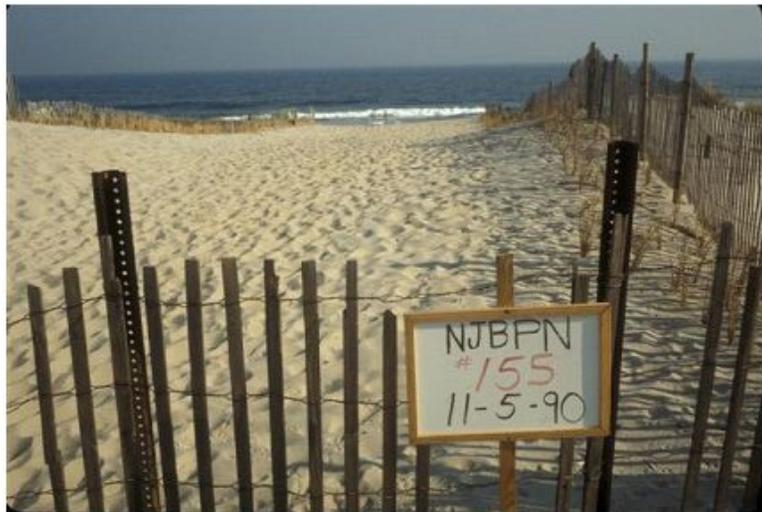
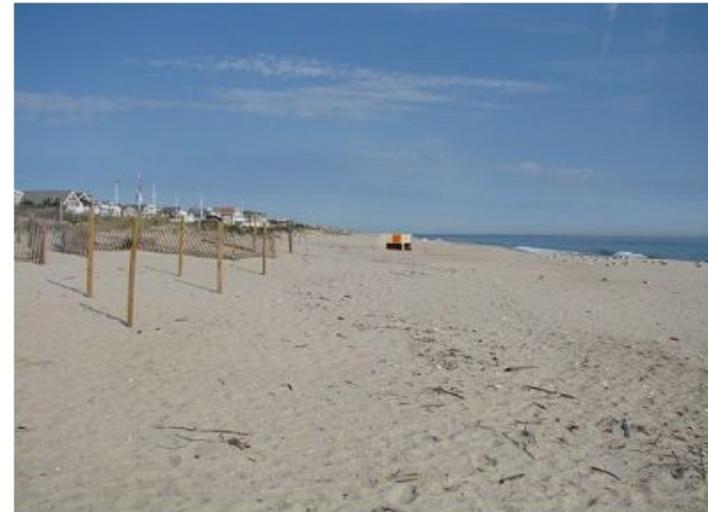
Figure 157 above shows the changes to the beach at Maryland Avenue in Point Pleasant Beach since its initial survey in 1986. Gains to the dune, berm, and beachface resulted in a net gain in sand volume of 18,277 cu.yd/ft. and a shoreline advance of 75 feet. Photo on the Left was taken in November of 1990 and shows the view from the access path looking east. Photo on the Right was taken in October of 2011 and shows the view to the north from the dune toe.

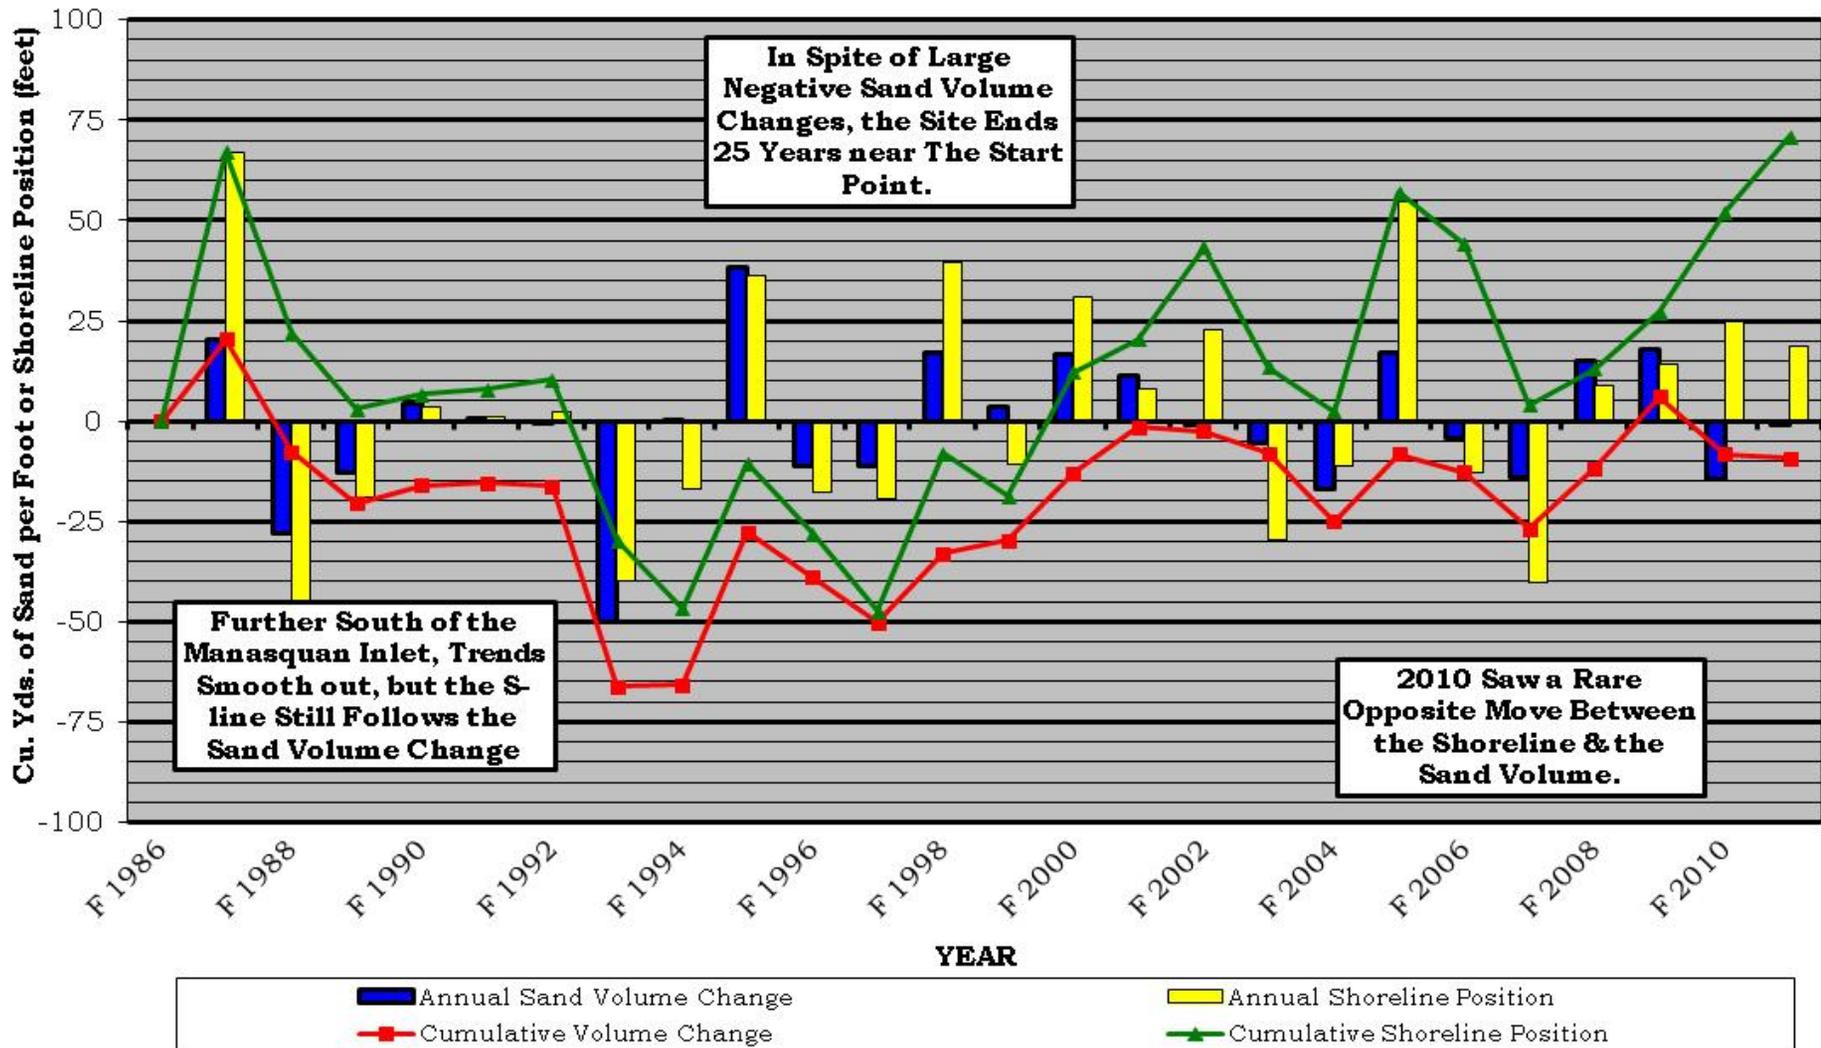
25-Year Coastal Changes at Site 155, Maryland Ave., Point Pleasant Beach, Ocean Co.

Figure 158. Profile 155 is located well south of the Manasquan Inlet. Storms in 1991 and 1993 resulted in losses in sand volume and shoreline position. In the following years a slow recovery added sand, culminating in 2011 where the shoreline position ended in the nearly the same position as where it began in 1986. There has been no influence by beach nourishment activities from here south along the northern Ocean County shoreline.

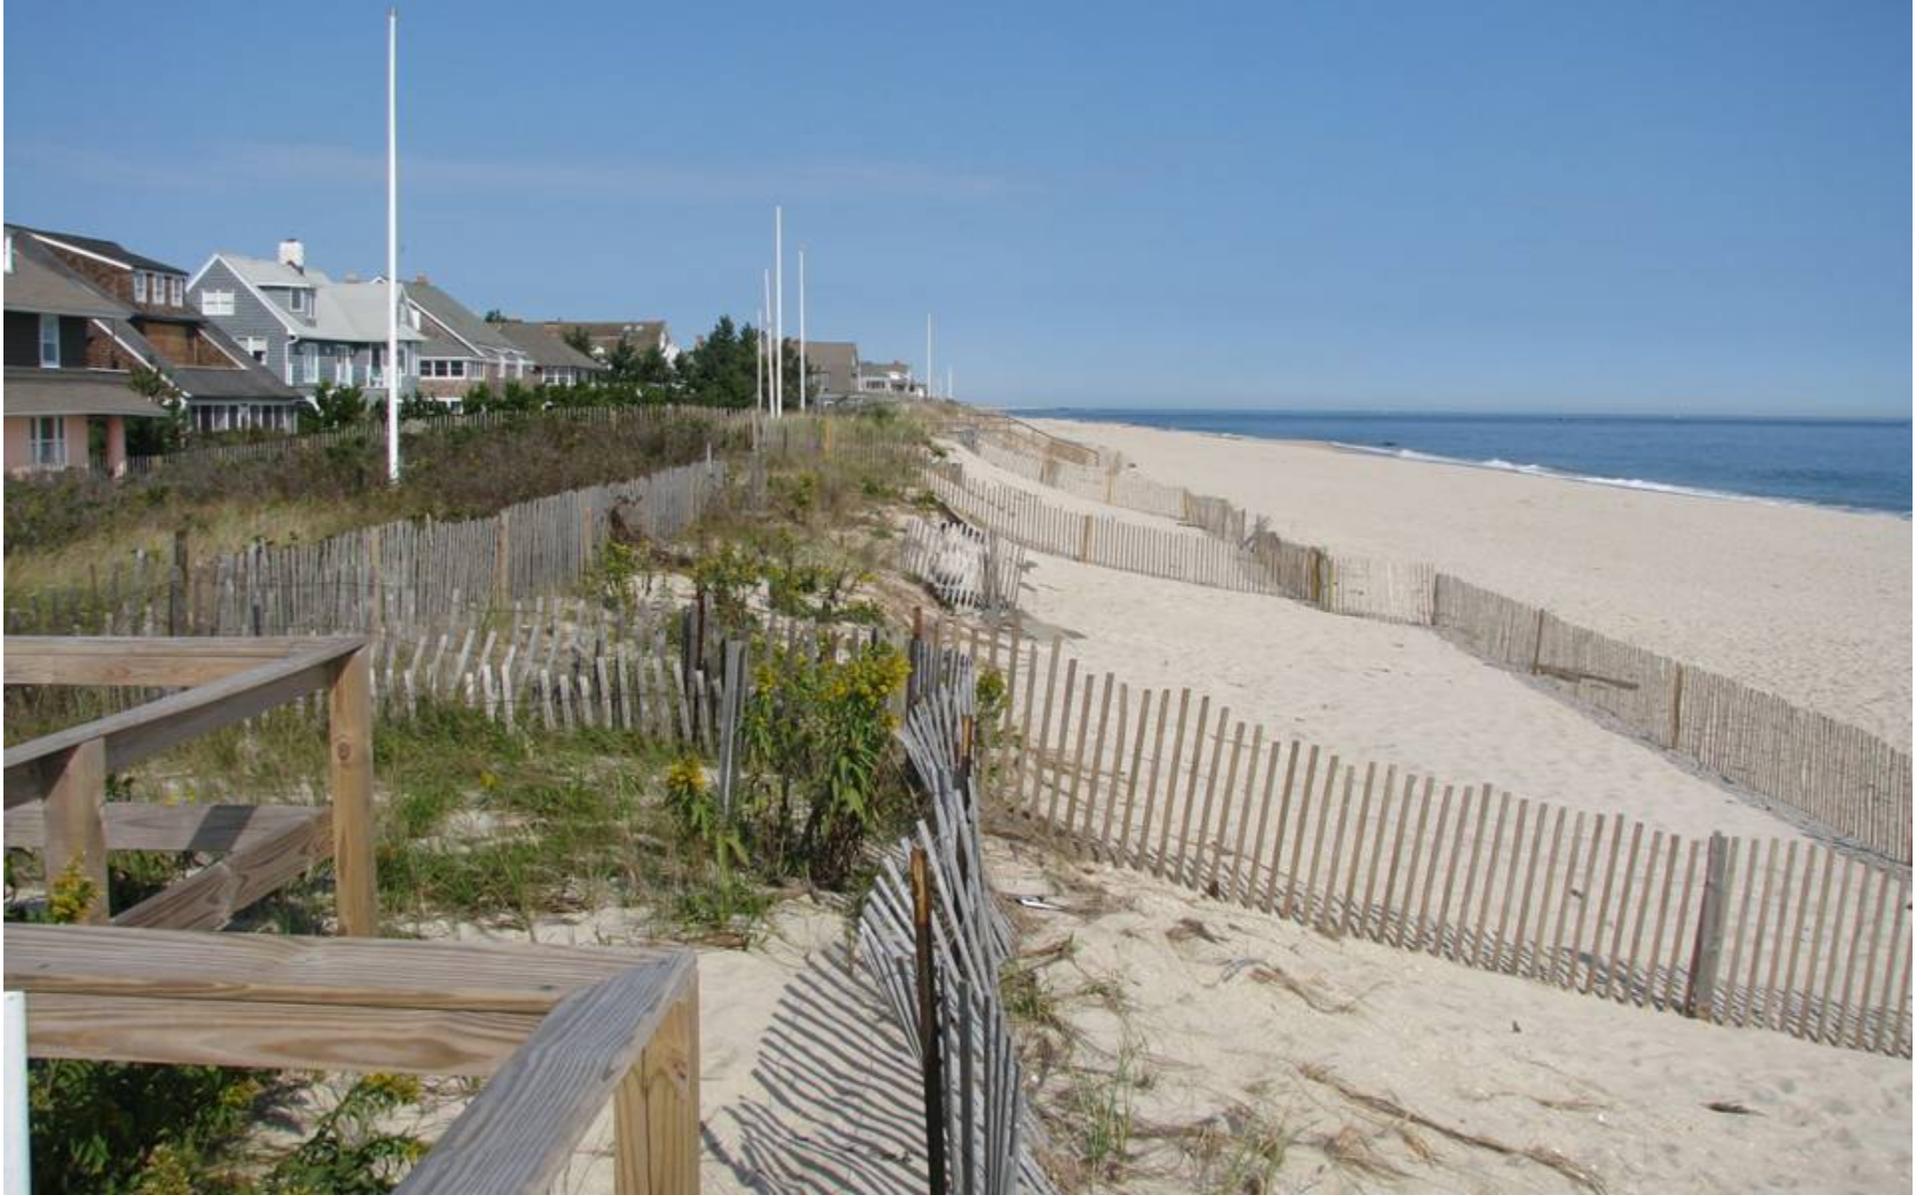
Site 154, Johnson Avenue, Bay Head, NJ – October 18, 2011

Figure 159. Shown above is the view looking north from the seaward crest at Johnson Street in Bay Head, NJ.

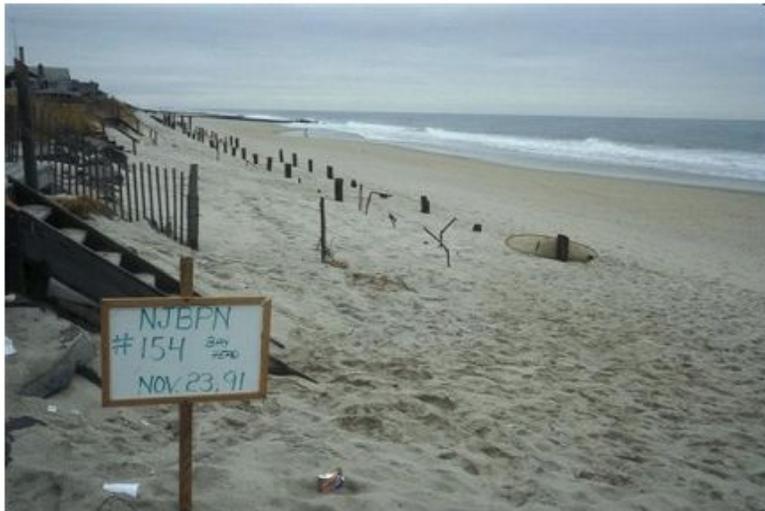
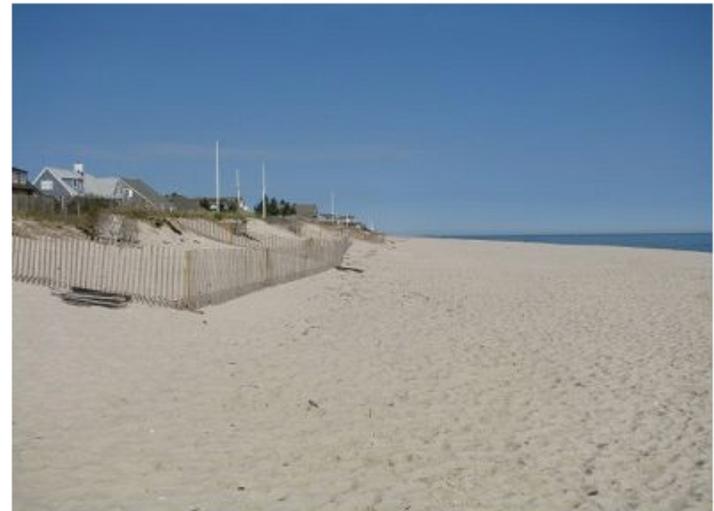
Figure 161 above shows that a significant amount of sand has been added to the beach since its initial survey in 1986. The shoreline advanced by 81 feet and there was a net gain in sand volume of 49,632 cu.yd/ft. Photo on the left was taken in November of 1991 and shows the view to the north. Photo on the right was taken in October of 2011 and shows the view to the north from the dune toe. The wider beach is clearly visible.

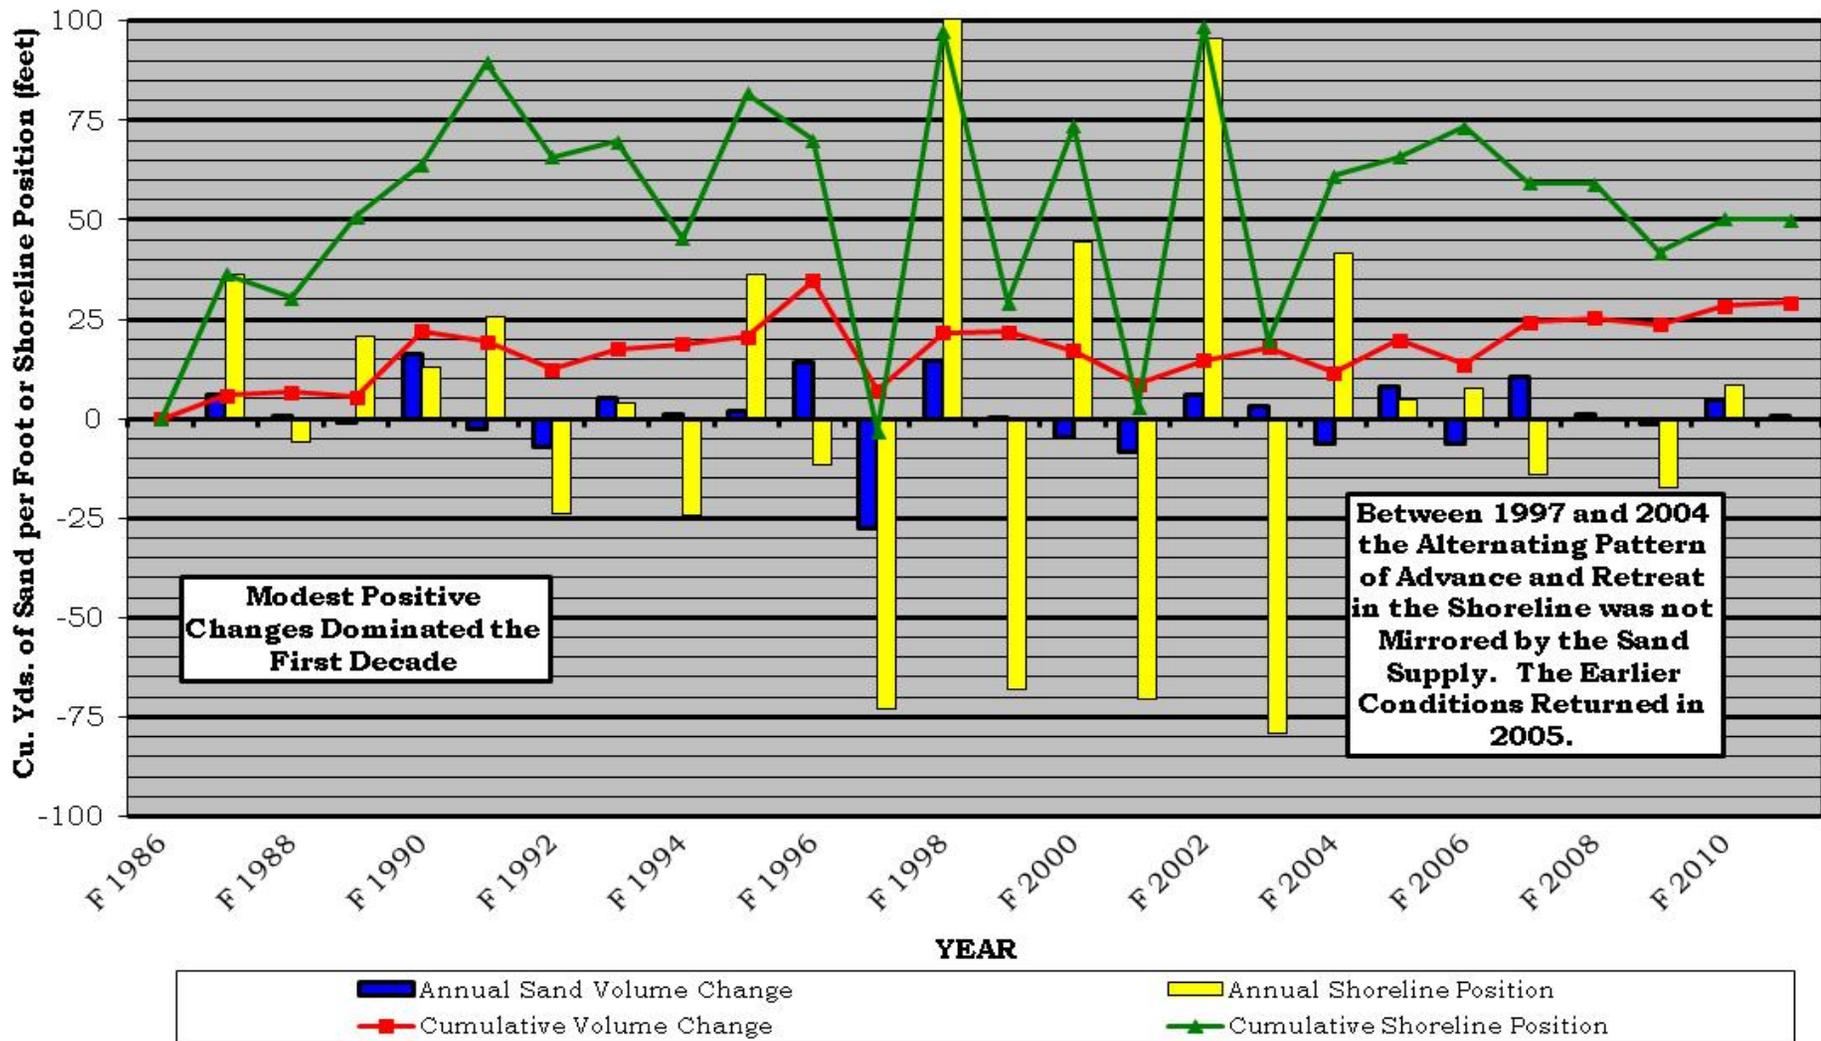
25-Year Coastal Changes at Site 154, Johnson Ave., Bay Head, Ocean Co.

Figure 162. Profile 154 in Bay Head saw dramatic changes in shoreline position(s) between 1997 and 2004. The 25 year trend was towards sand accretion as the sand volume steadily increased despite the huge changes in shoreline position. These unusual oscillations in shoreline position were the result of changes in the direction of longshore transport by waves whether toward the groin field (north) or away from it (south). The result of this as indicated above is the large shifts in the shoreline depending on the direction of the dominant drift of sand.

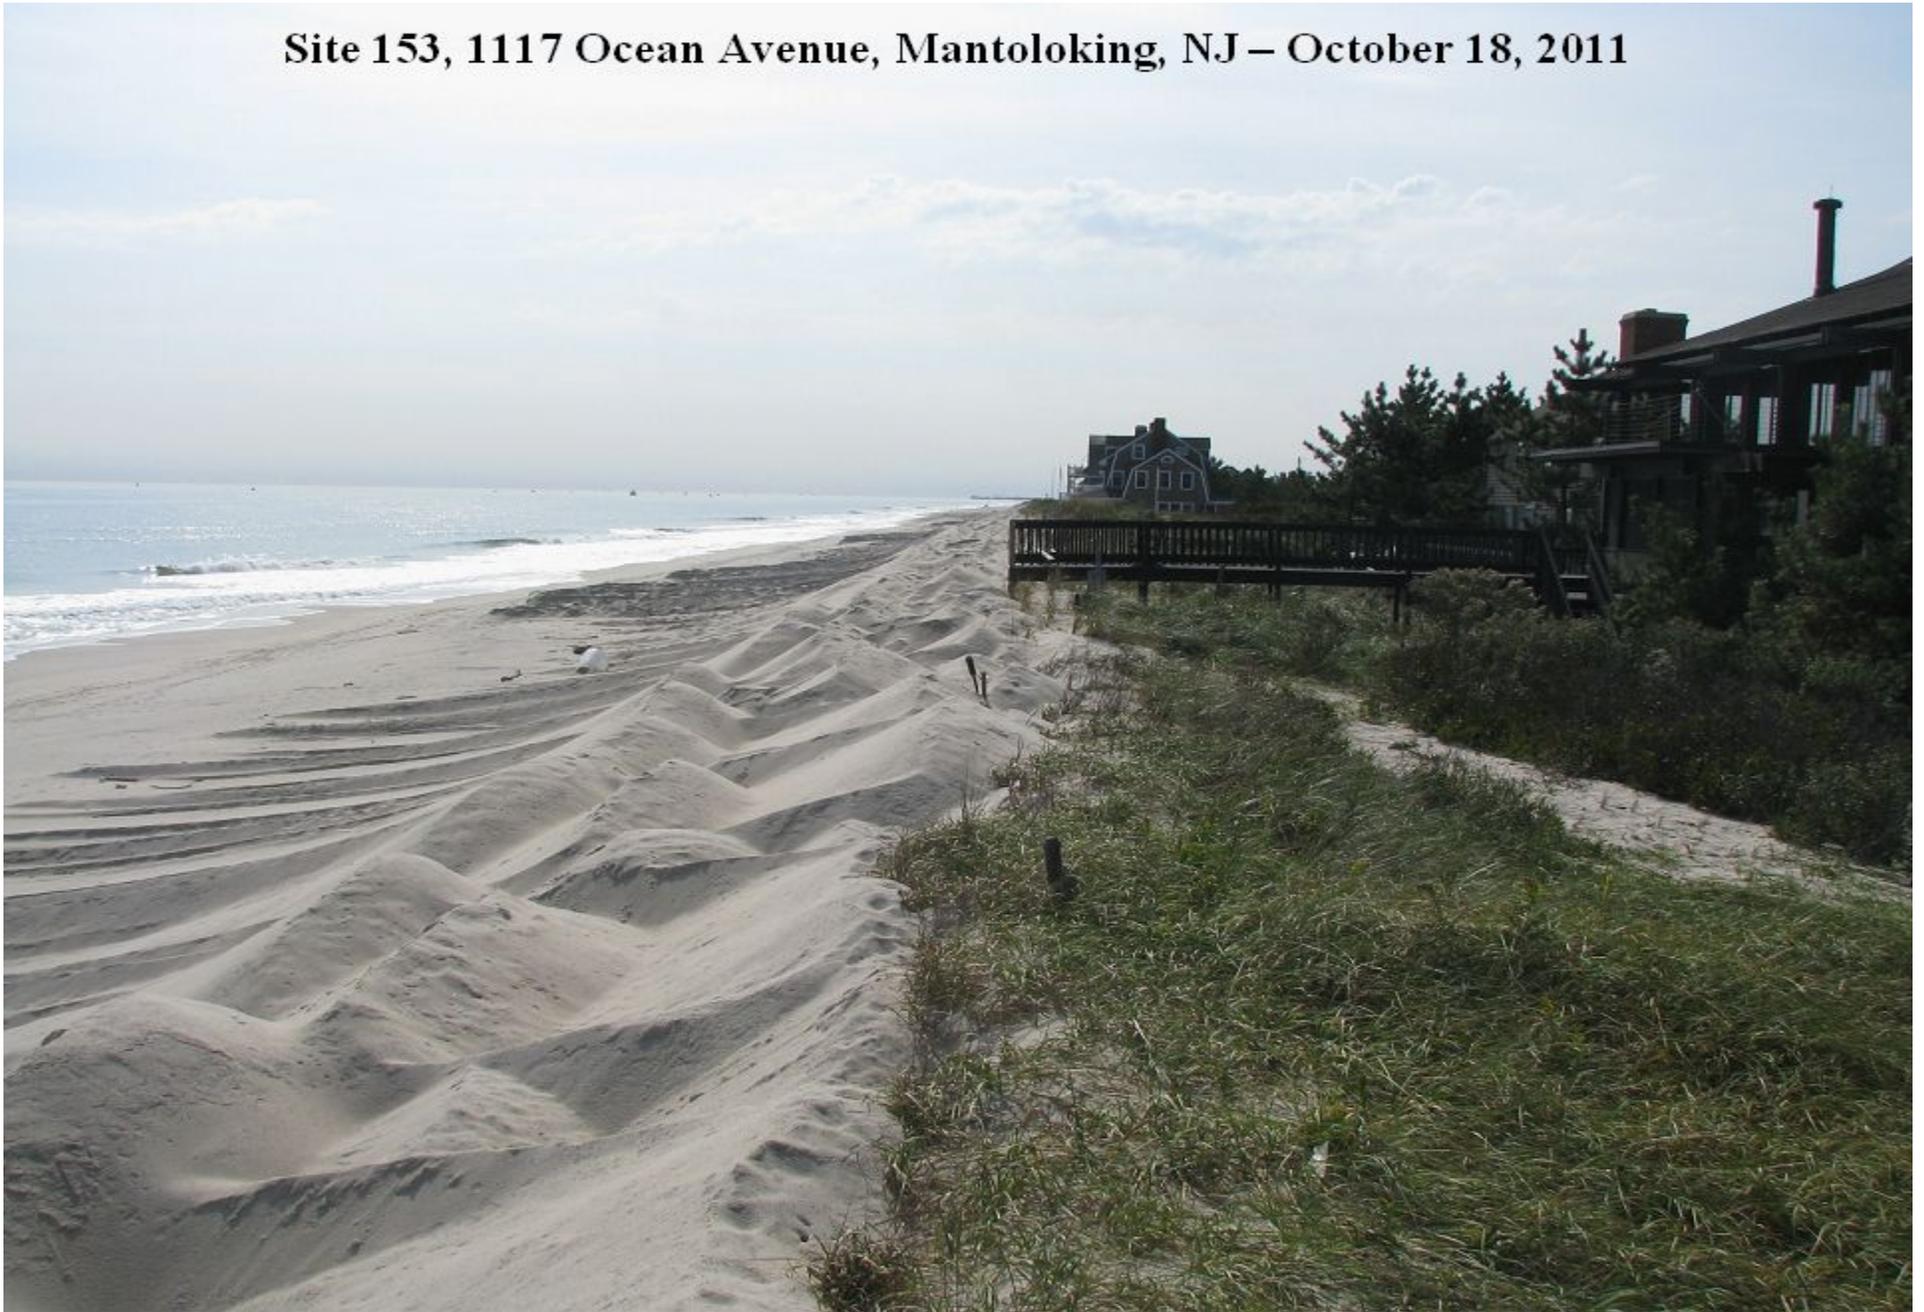
Site 153, 1117 Ocean Avenue, Mantoloking, NJ – October 18, 2011

Figure 163. Shown above is the view looking south from the dune crest at 1117 Ocean Avenue in Mantoloking, NJ. Bulldozing sand from the berm to the dune slope has become a common practice in the Borough of Mantoloking.

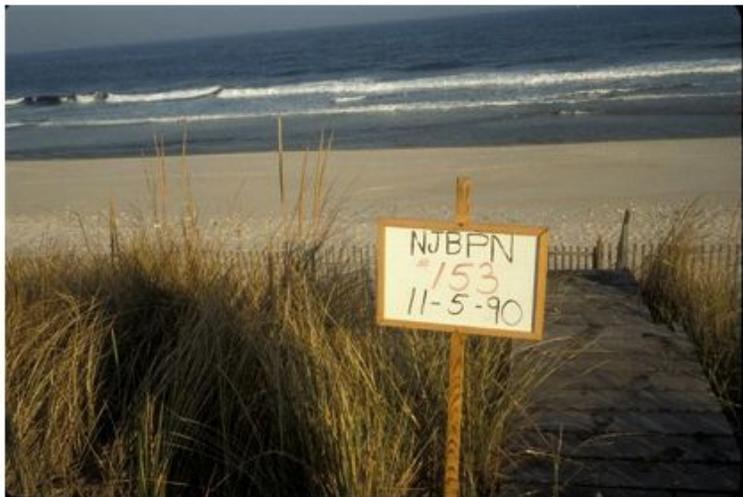
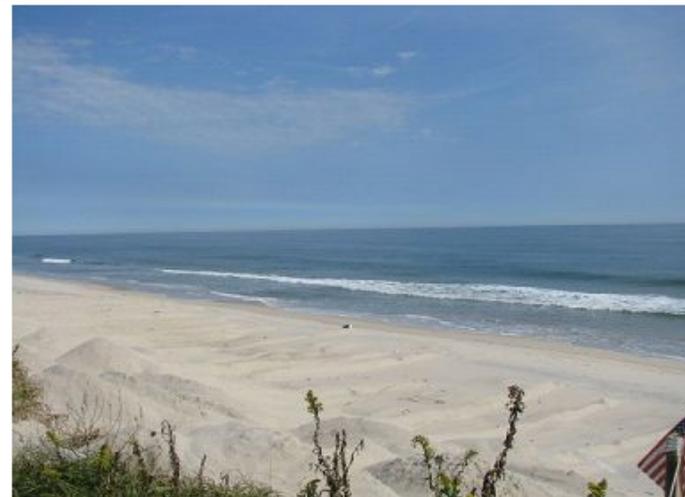
Figure 165 above shows at 1117 Ocean Avenue in Mantoloking there were only minor changes to the dune, berm, and offshore slope. The shoreline retreated minimally by 3 feet, while there was a net loss in sand volume of 8.969 cu.yd/ft. Photo on the left was taken in November of 1990 and shows the view from the dune looking east. Photo on the right was taken in October of 2011 and shows the view looking northeast.

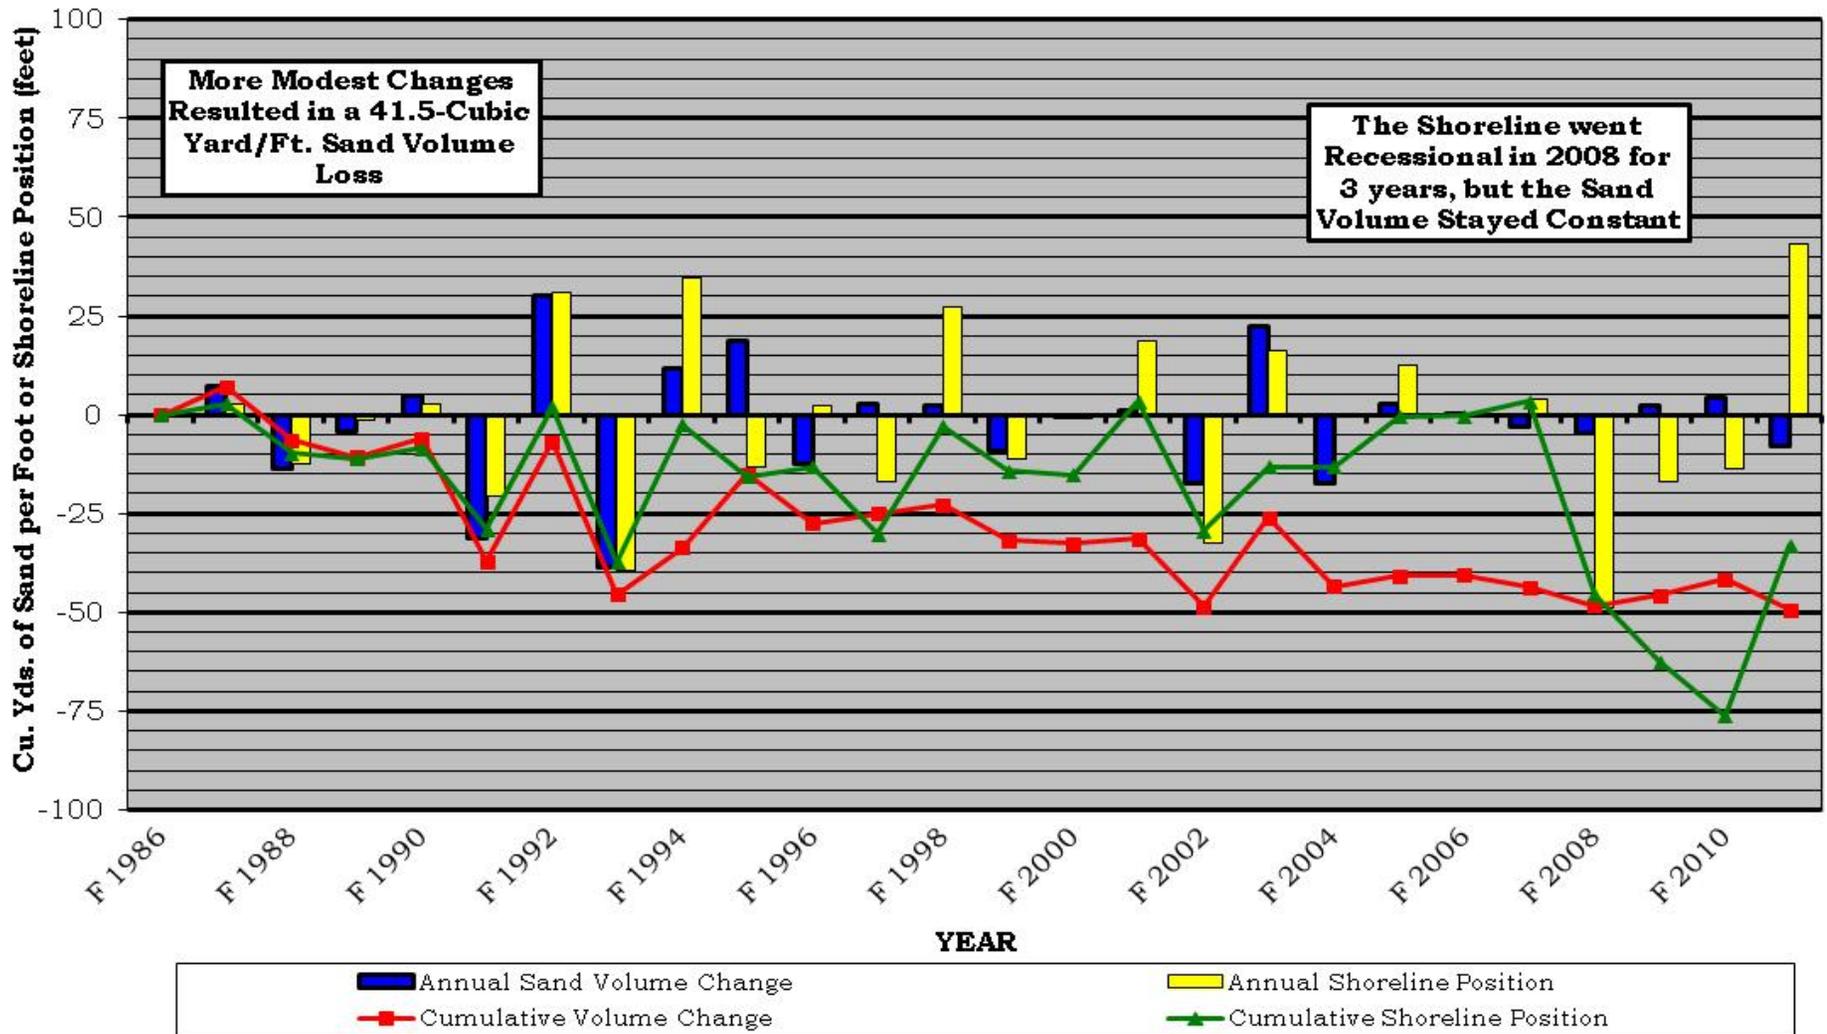
25-Year Coastal Changes at Site 153, 1117 Ocean Ave., Mantoloking, Ocean Co.

Figure 166. Profile 153 in Mantoloking has no hard structures in its beach; therefore the shifts are related to individual storm impacts and seasons with higher than average storm activity. The beach width is insufficient to support further dune growth and marginally sufficient for supporting the current dune system, resulting in frequent erosion and vertical scarping of the seaward slope even during modest to moderate storm events. The trend has been toward shoreline and sand volume loss.
