New Jersey Beach Profile Network

Ocean County

Manasquan Inlet
to Little Egg Inlet

NJBPN Profile #'s
156 - 234

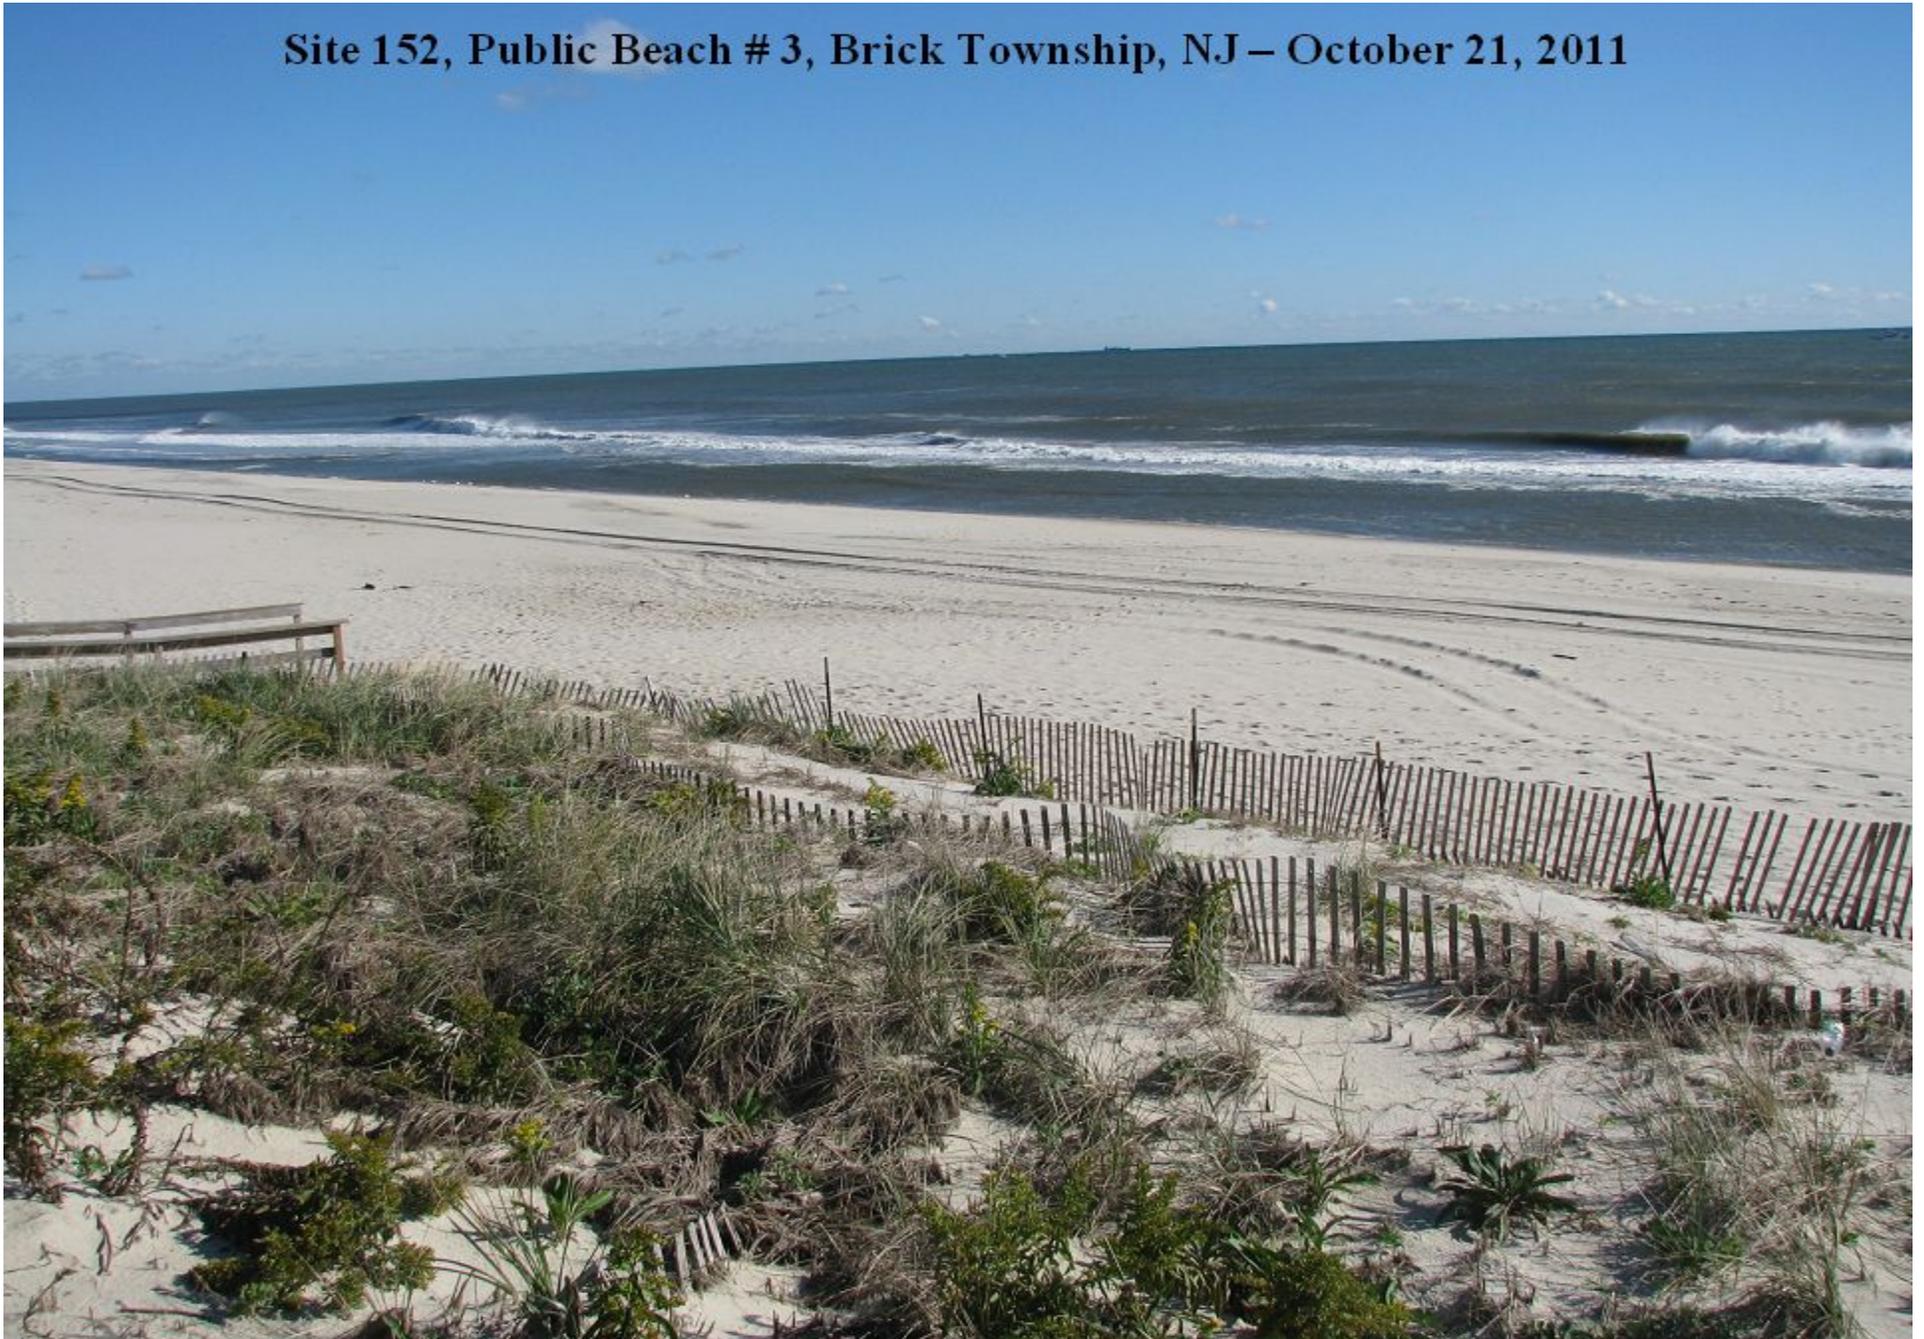
Site 152, Public Beach # 3, Brick Township, NJ – October 21, 2011

Figure 167. Shown above is the view looking northeast from the dune crest at public beach # 3 in Brick Township, NJ.

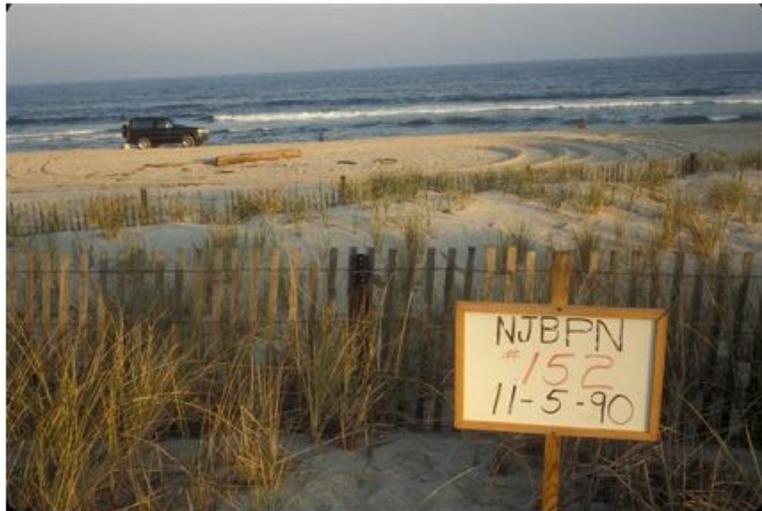
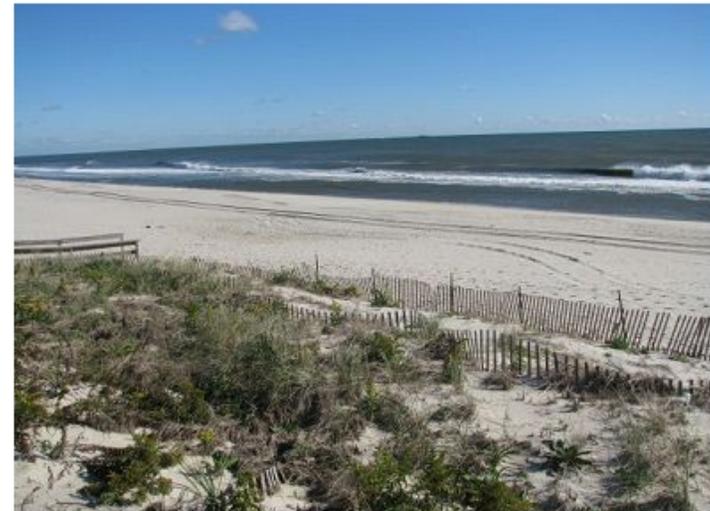
Figure 169 above shows that there were gains to dune, berm, and nearshore slope. These changes are reflected in the numbers as the shoreline advanced 4 feet and the site gained 44.866 cu. yd/ft.

Photo on the left was taken in November of 1990, and shows the view east from the dune.

Photo on the right was taken in October of 2011 and shows the view looking northeast from a noticeably higher dune.

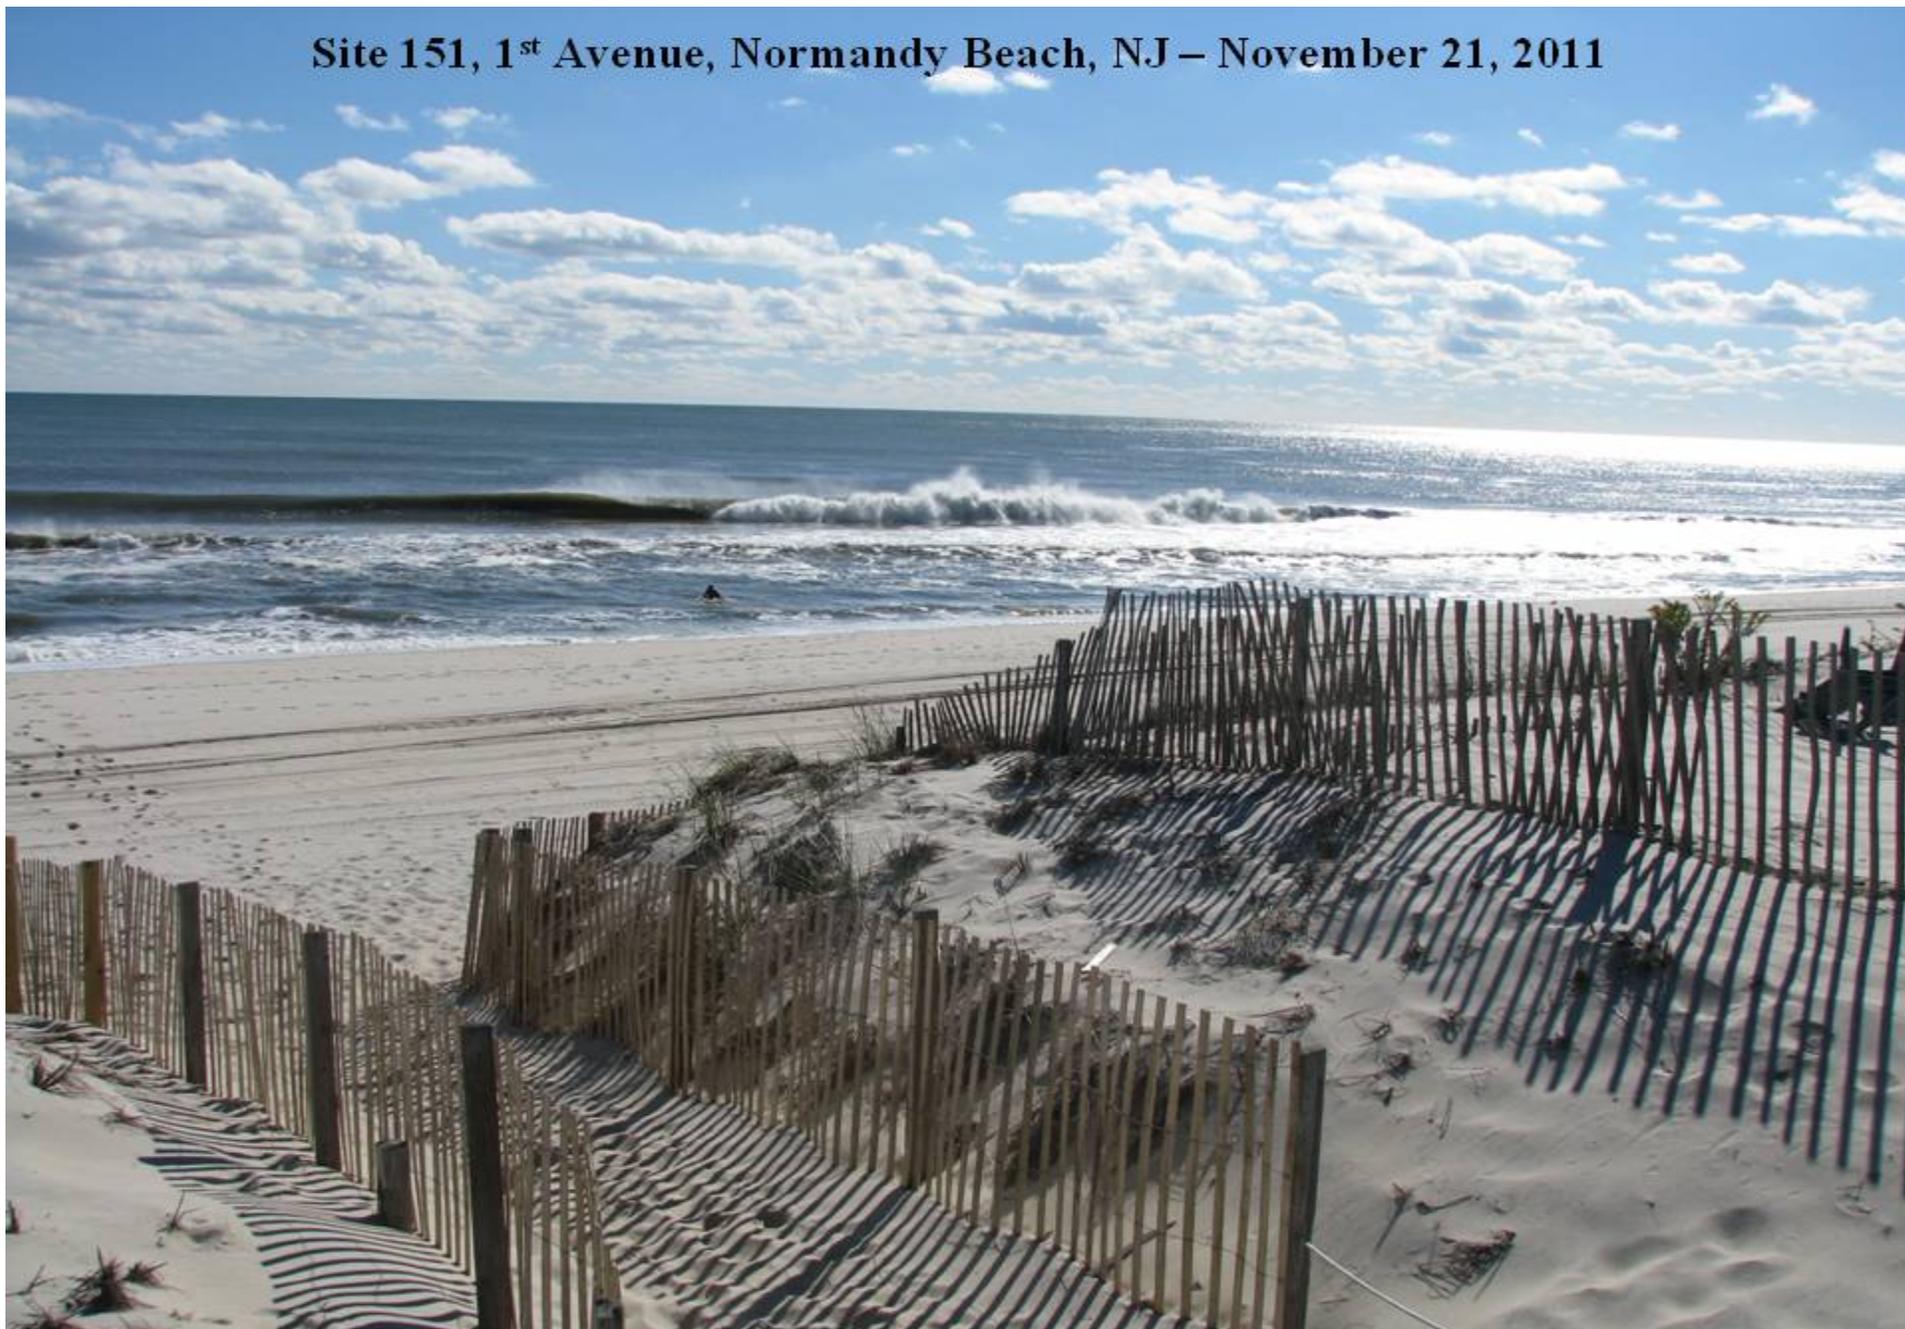
Site 151, 1st Avenue, Normandy Beach, NJ – November 21, 2011

Figure 171. Shown above is the view looking southeast from the dune at 1st Street in Normandy Beach, NJ.

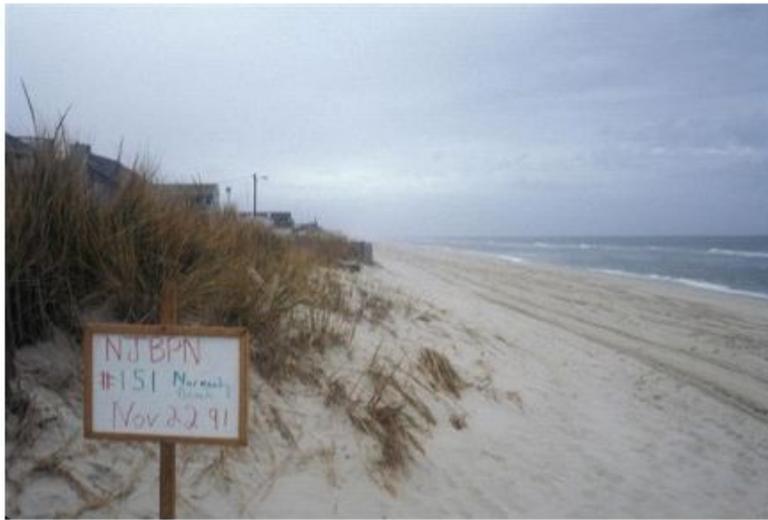
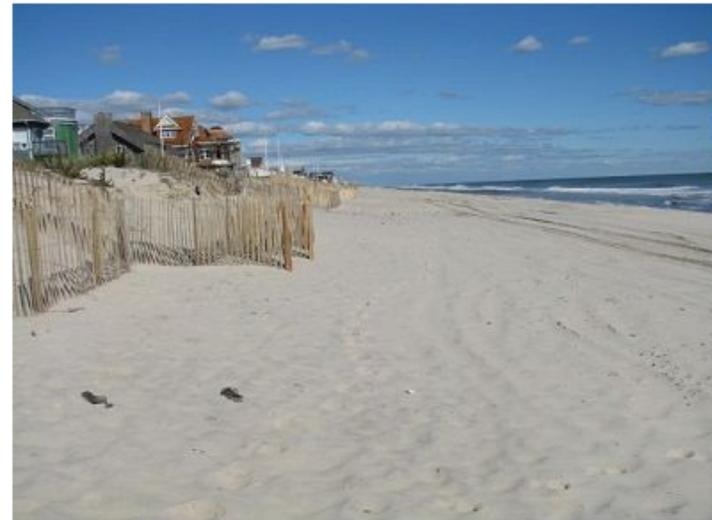
Figure 173 above shows that since the initial survey in 1986 there has been relatively little change. This is apparent in both the shoreline and volume changes, as the shoreline retreated 19 feet and the net loss in volume was a negligible 2.286 cu.yd/ft.. Photo on the left was taken in November of 1991 and shows the view to the north from the dune. Photo on the right was taken in October of 2011 and shows the view to the north from the dune toe.

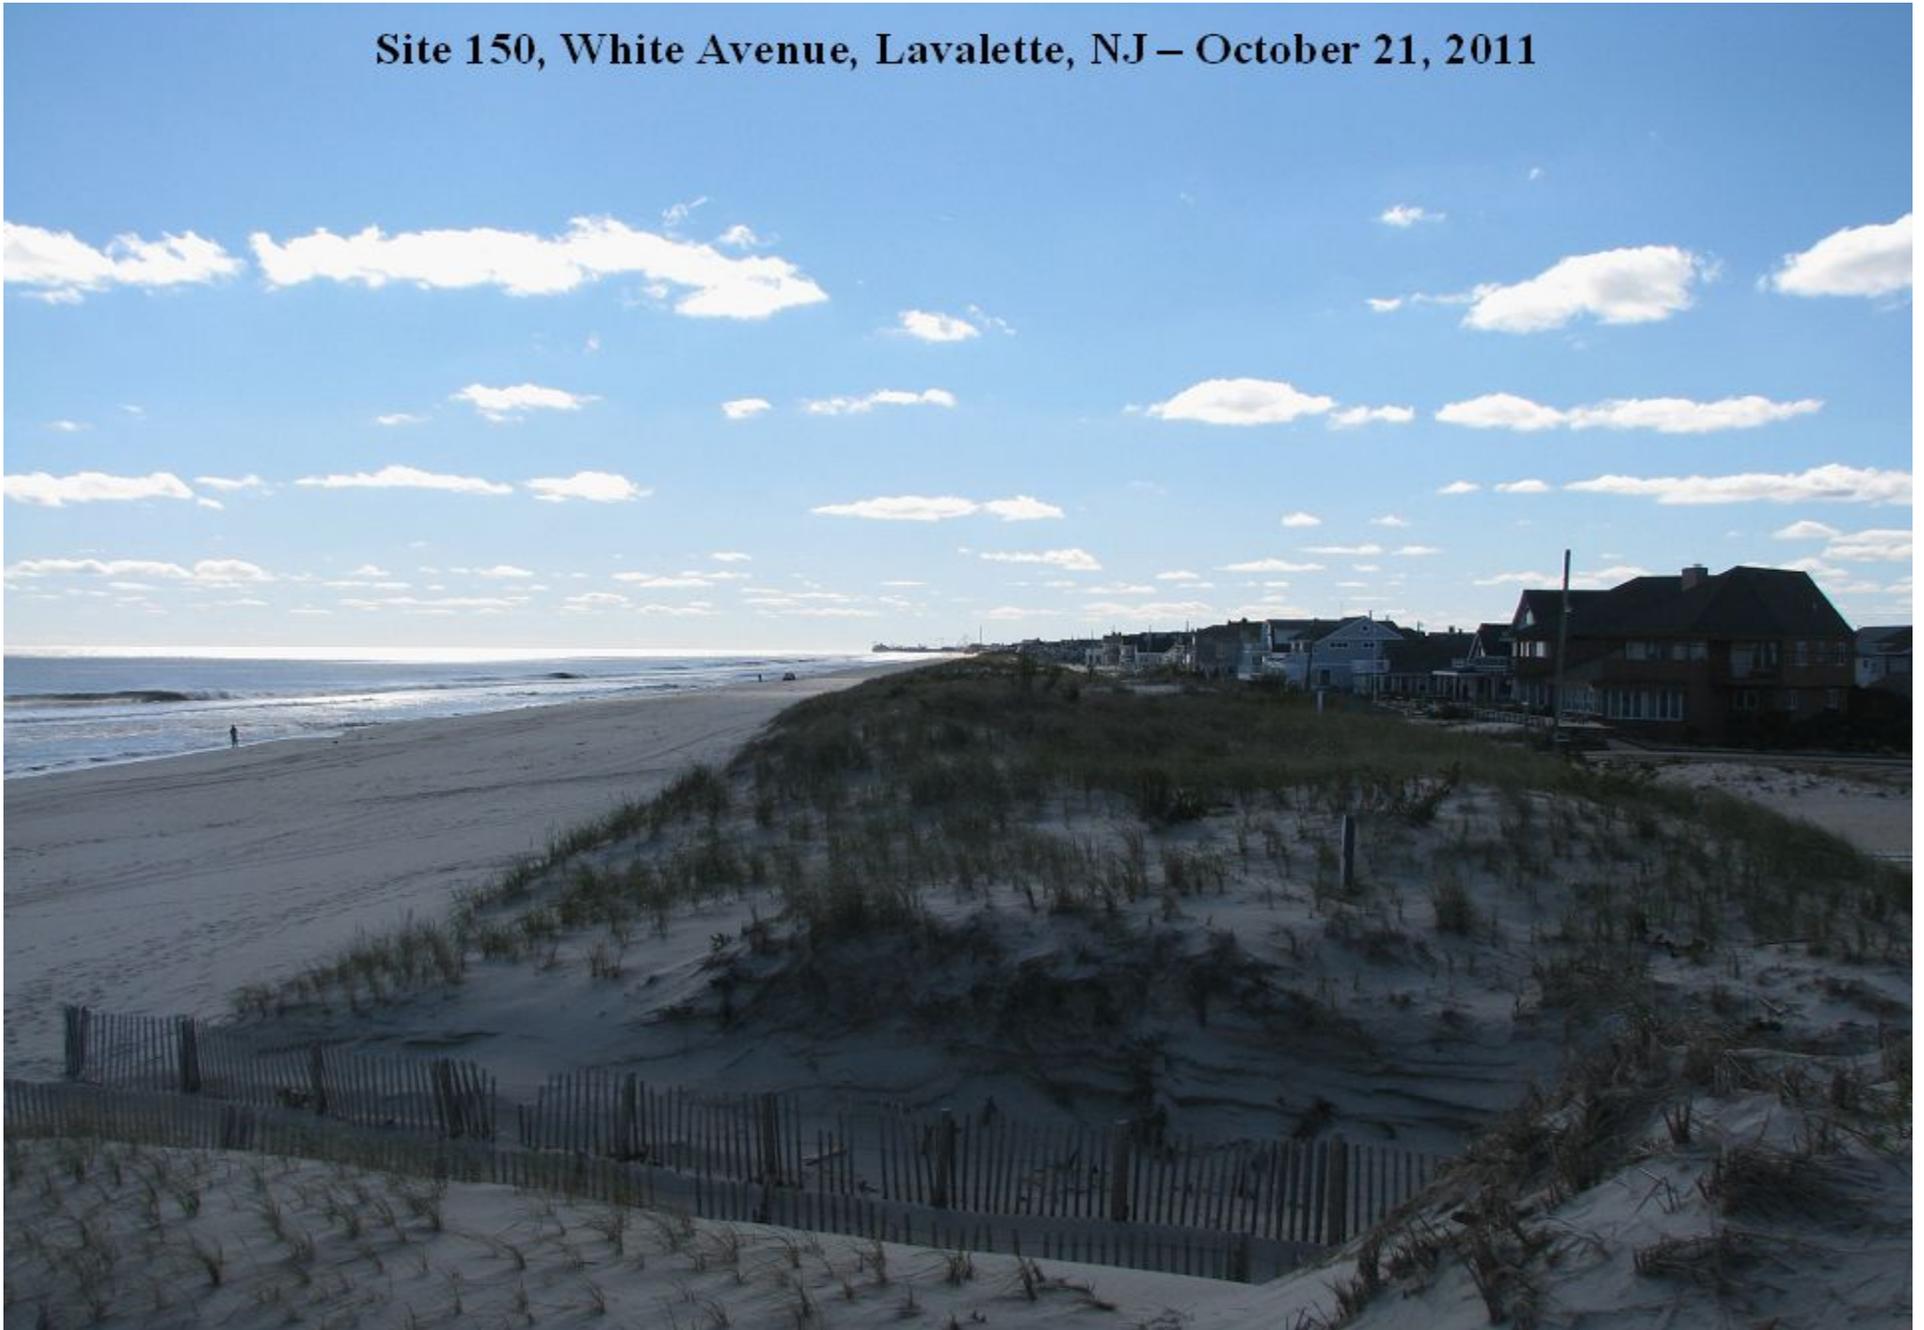
Site 150, White Avenue, Lavalette, NJ – October 21, 2011

Figure 175. Shown above is the view looking south from the dune crest at White Avenue in Lavalette, NJ.

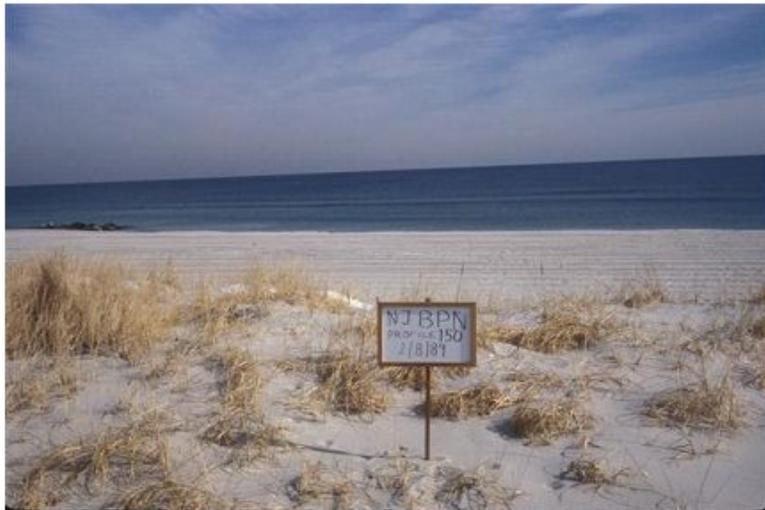
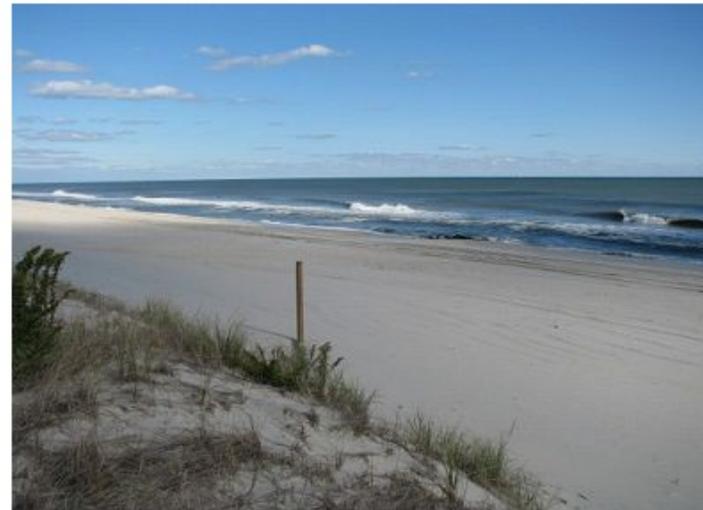
Figure 177 above shows that the dune, berm, and offshore slope have gained sand since the initial survey in 1986. The shoreline retreated by 4 feet while there was a net gain in sand volume of 30.846 cu.yd/ft. Photo on the left was taken in February of 1989 and shows the view from the dune looking east. Photo on the right was taken in October of 2011 and shows the view from the seaward crest looking northeast.

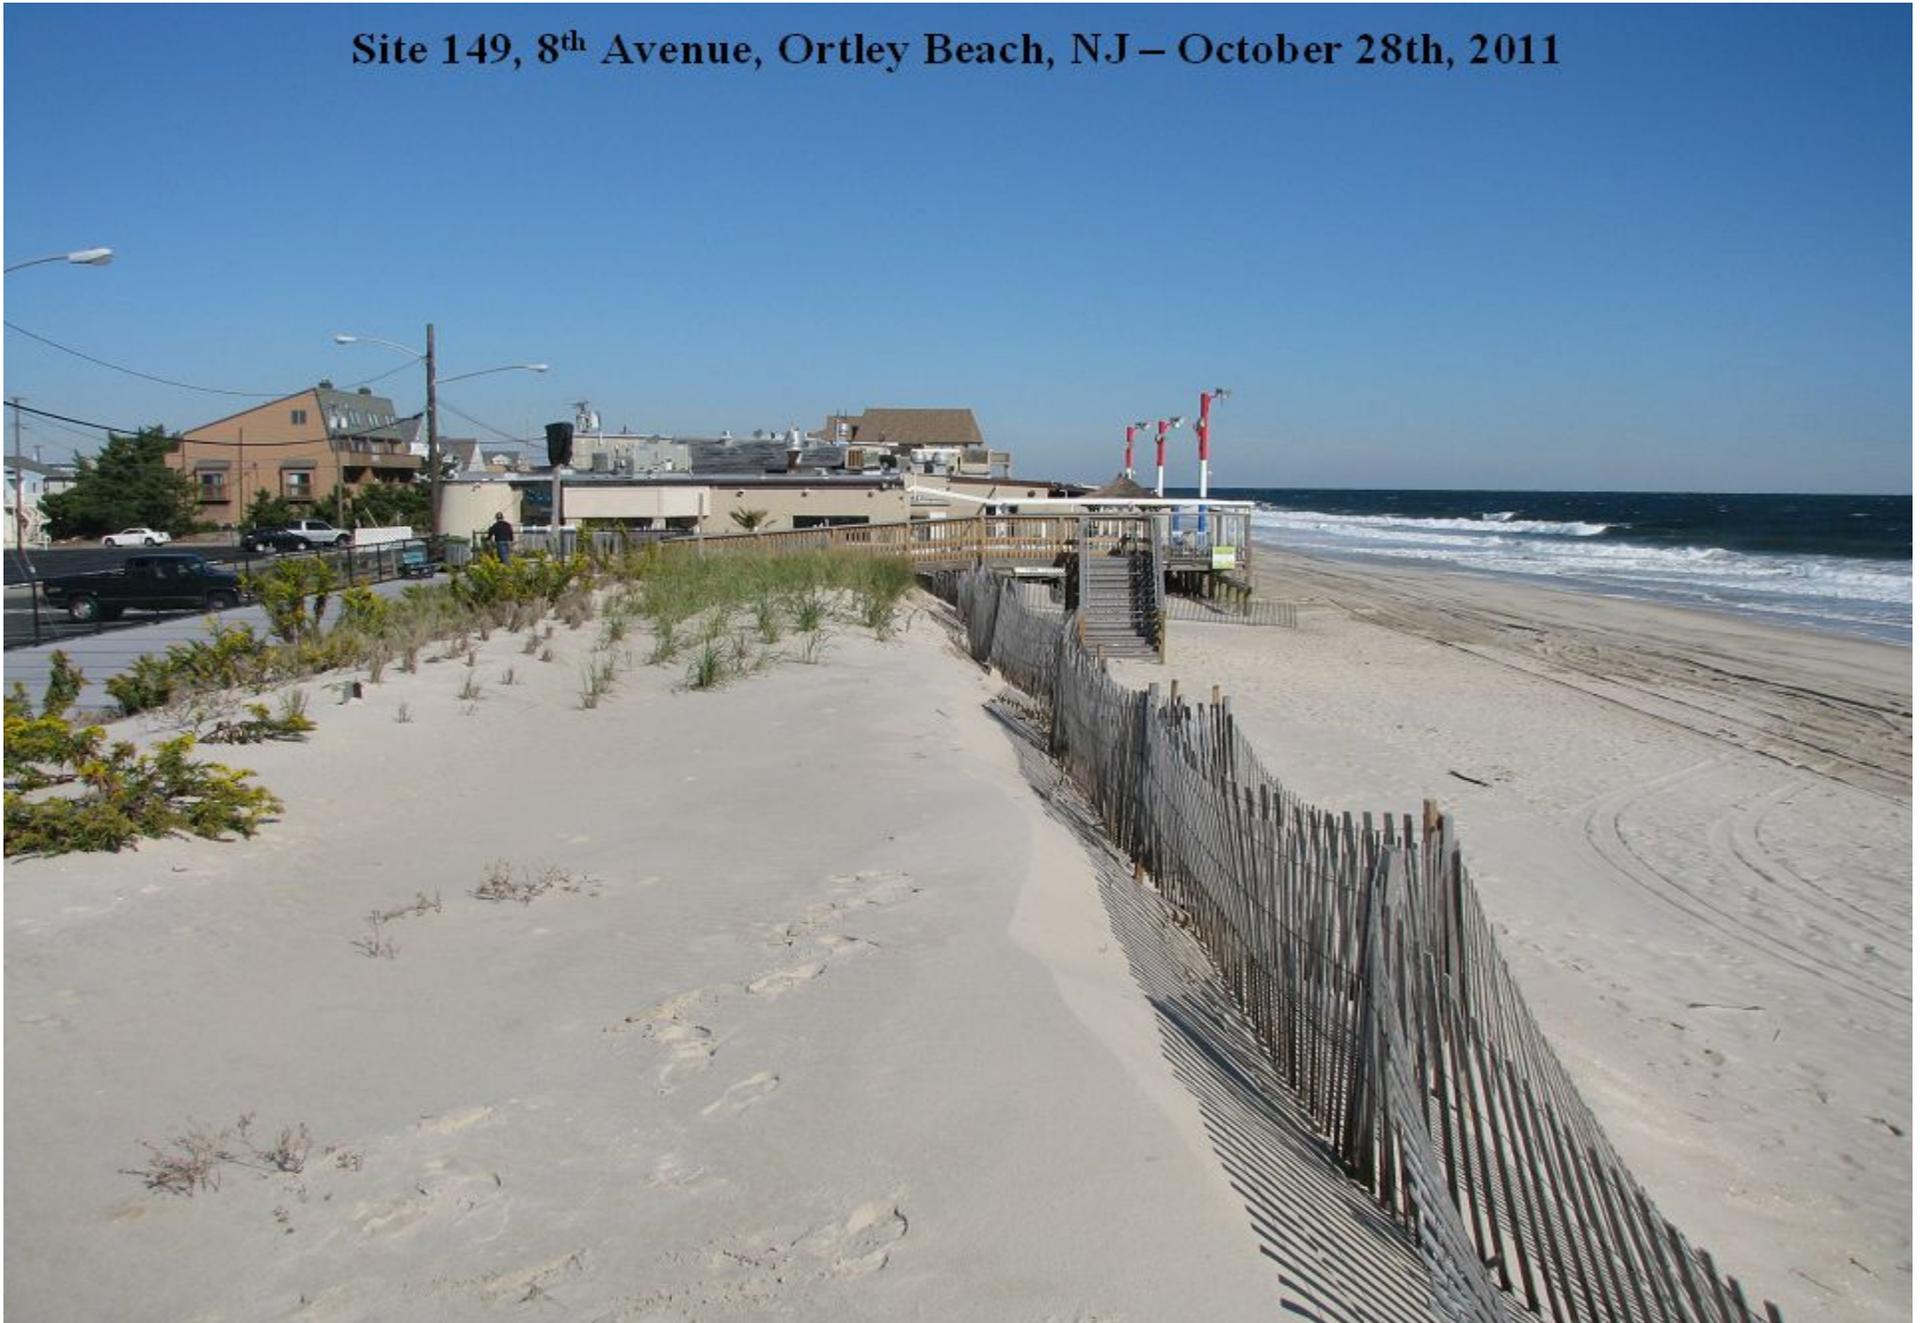
Site 149, 8th Avenue, Ortley Beach, NJ – October 28th, 2011

Figure 179. Shown above is the view looking north from the seaward crest at 8th Avenue in Ortley Beach, NJ.

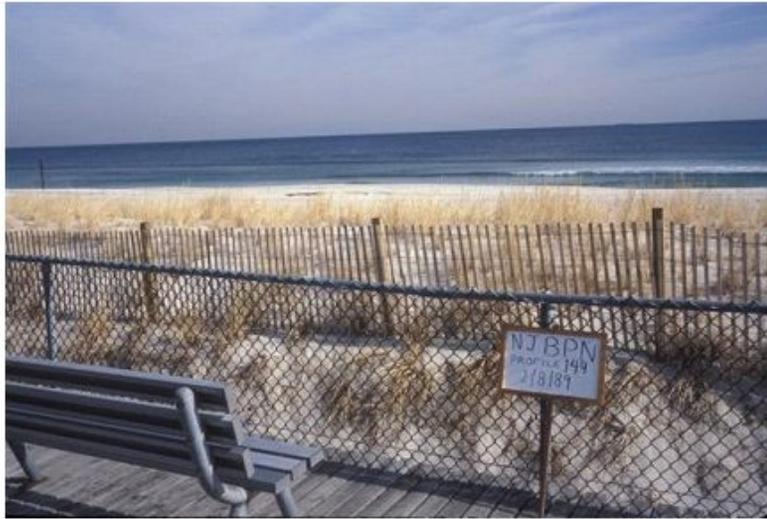
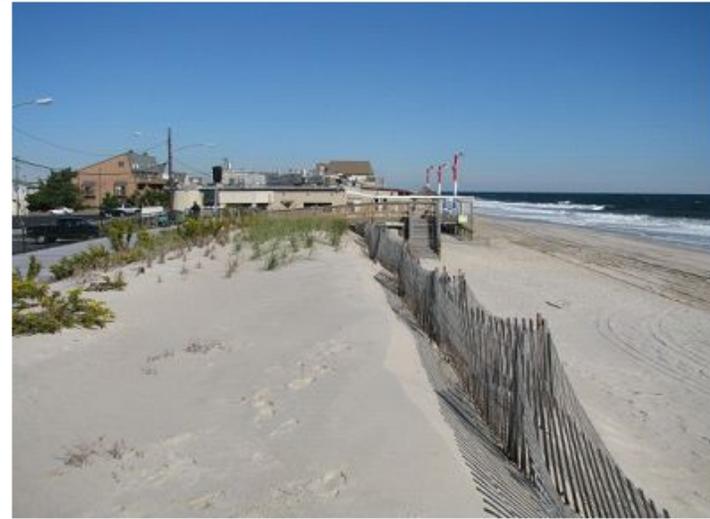
Figure 181 above shows the changes to the beach at 8th Street in Ortley Beach since its initial survey in 1986. The dune has grown vertically, however losses to the dune toe and beach face resulted in a shoreline retreat of 16 feet and a net loss of 7.402 cu.yd/ft. of sand. Photo on the left was taken in February of 1989 and shows the view looking northeast from the boardwalk. Photo on the right was taken in October of 2011 and shows the view north from the crest of the dune.

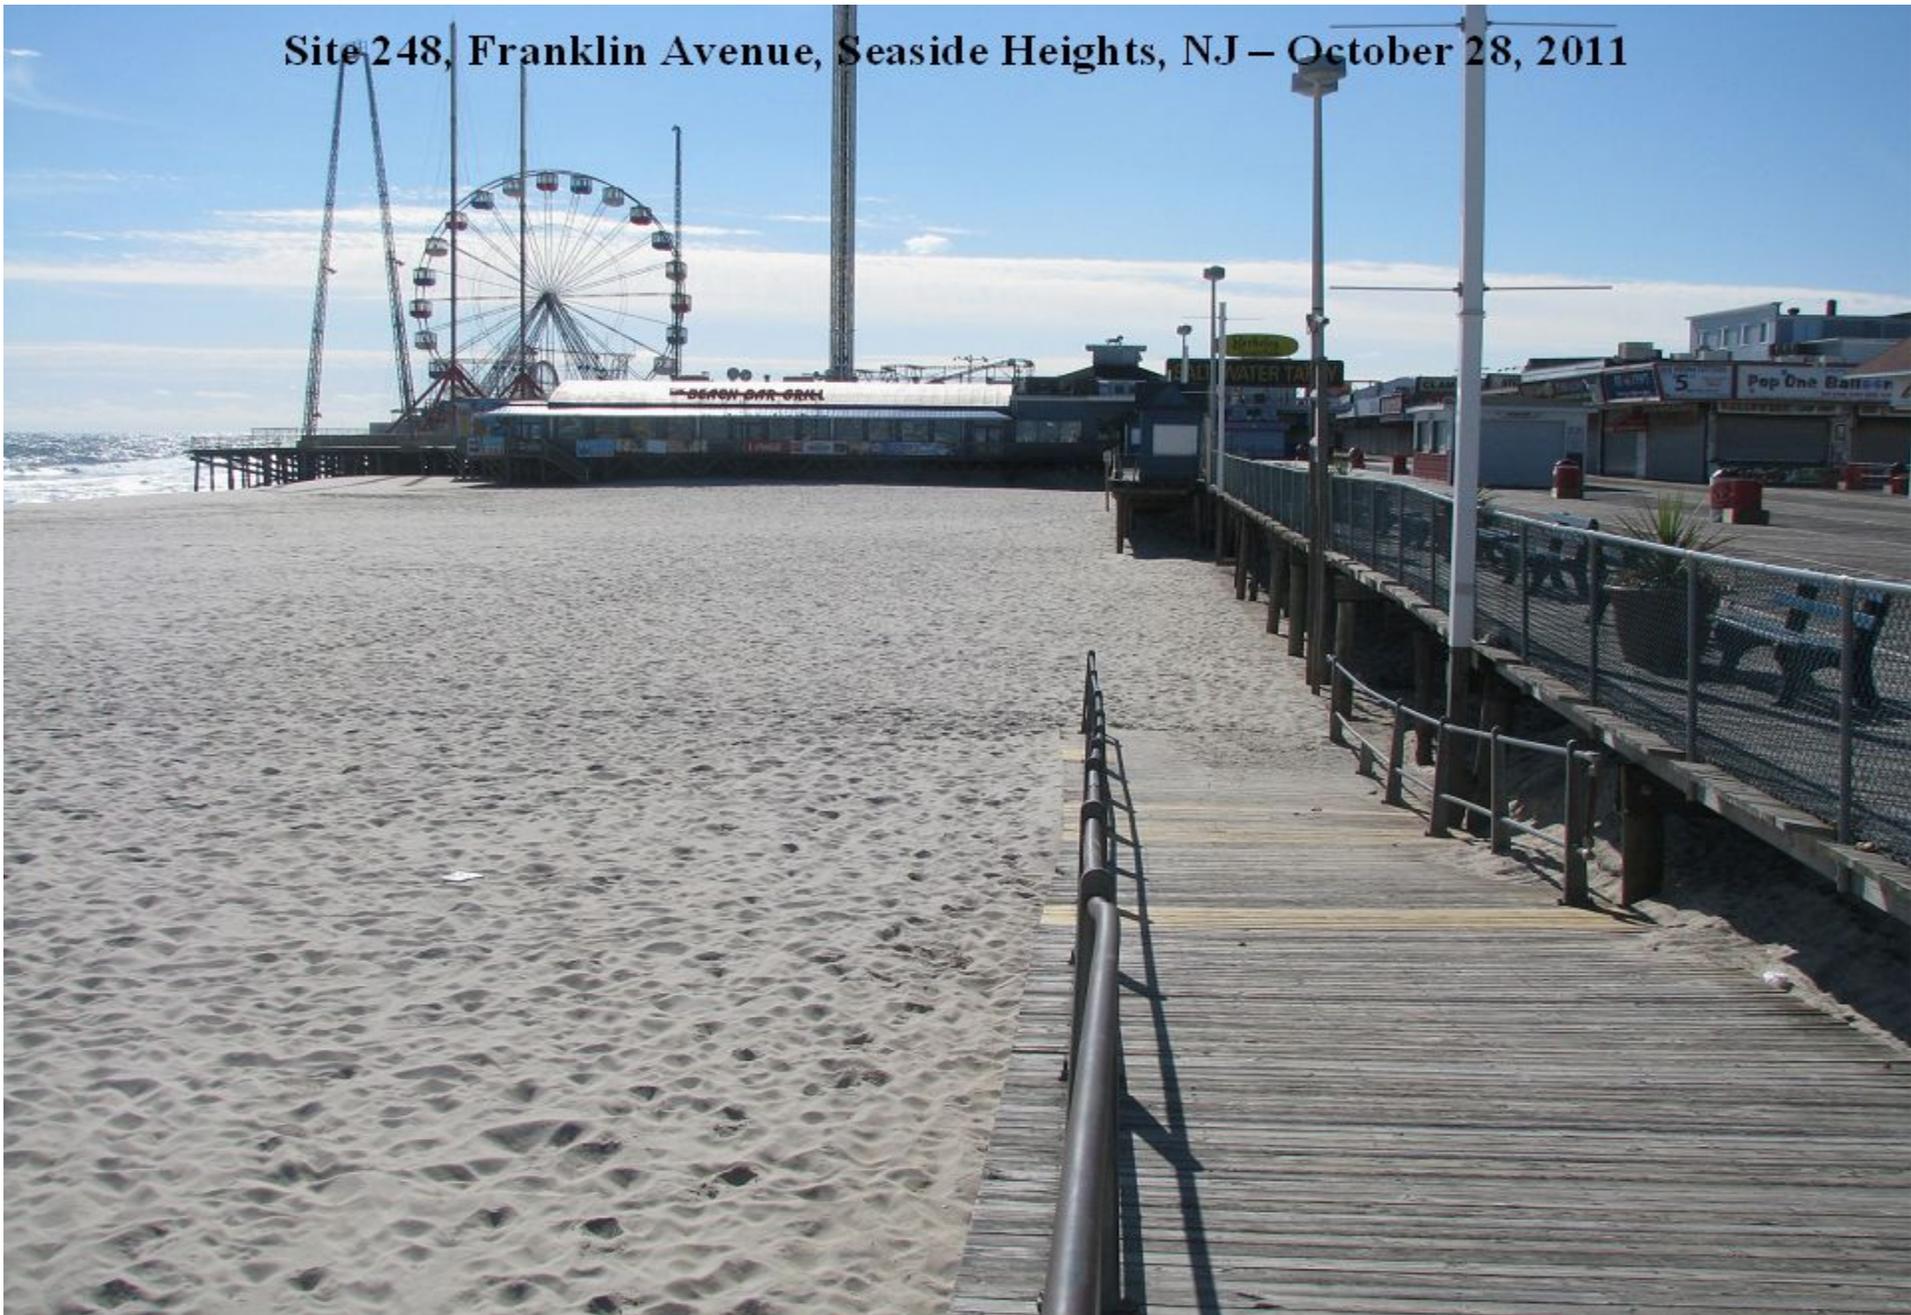
Figure 183. Shown above is the view looking south from the boardwalk at Franklin Avenue in Seaside Heights, NJ.

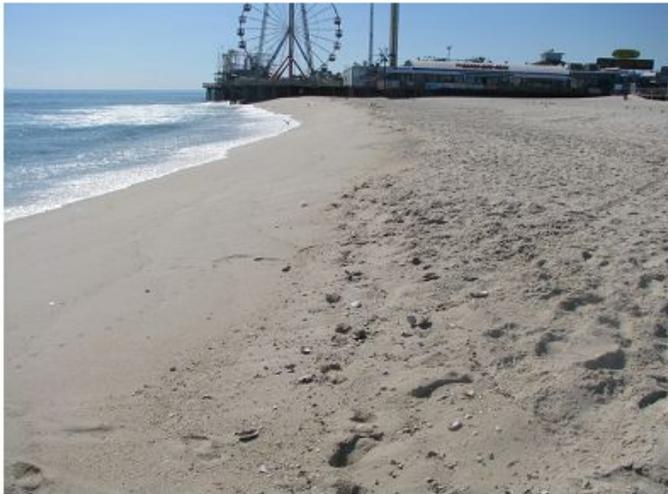
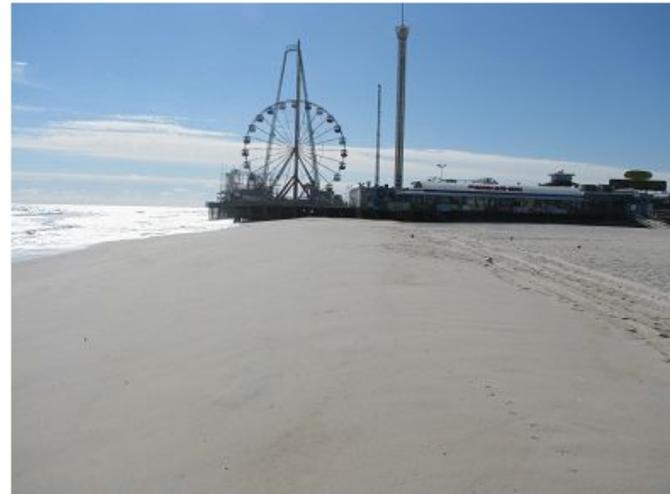
Figure 185 above the Franklin Avenue site in Seaside Heights. This site was added to the NJBPN network in 2009 to record changes to this municipal beach. Since the initial survey in 2009 the beach has gained 41 feet of shoreline and 19,333 cu.yd/ft. of sand .
Photo on left taken October 6, 2009. View to the south.
Photo on right taken October 28, 2011. View to the south.

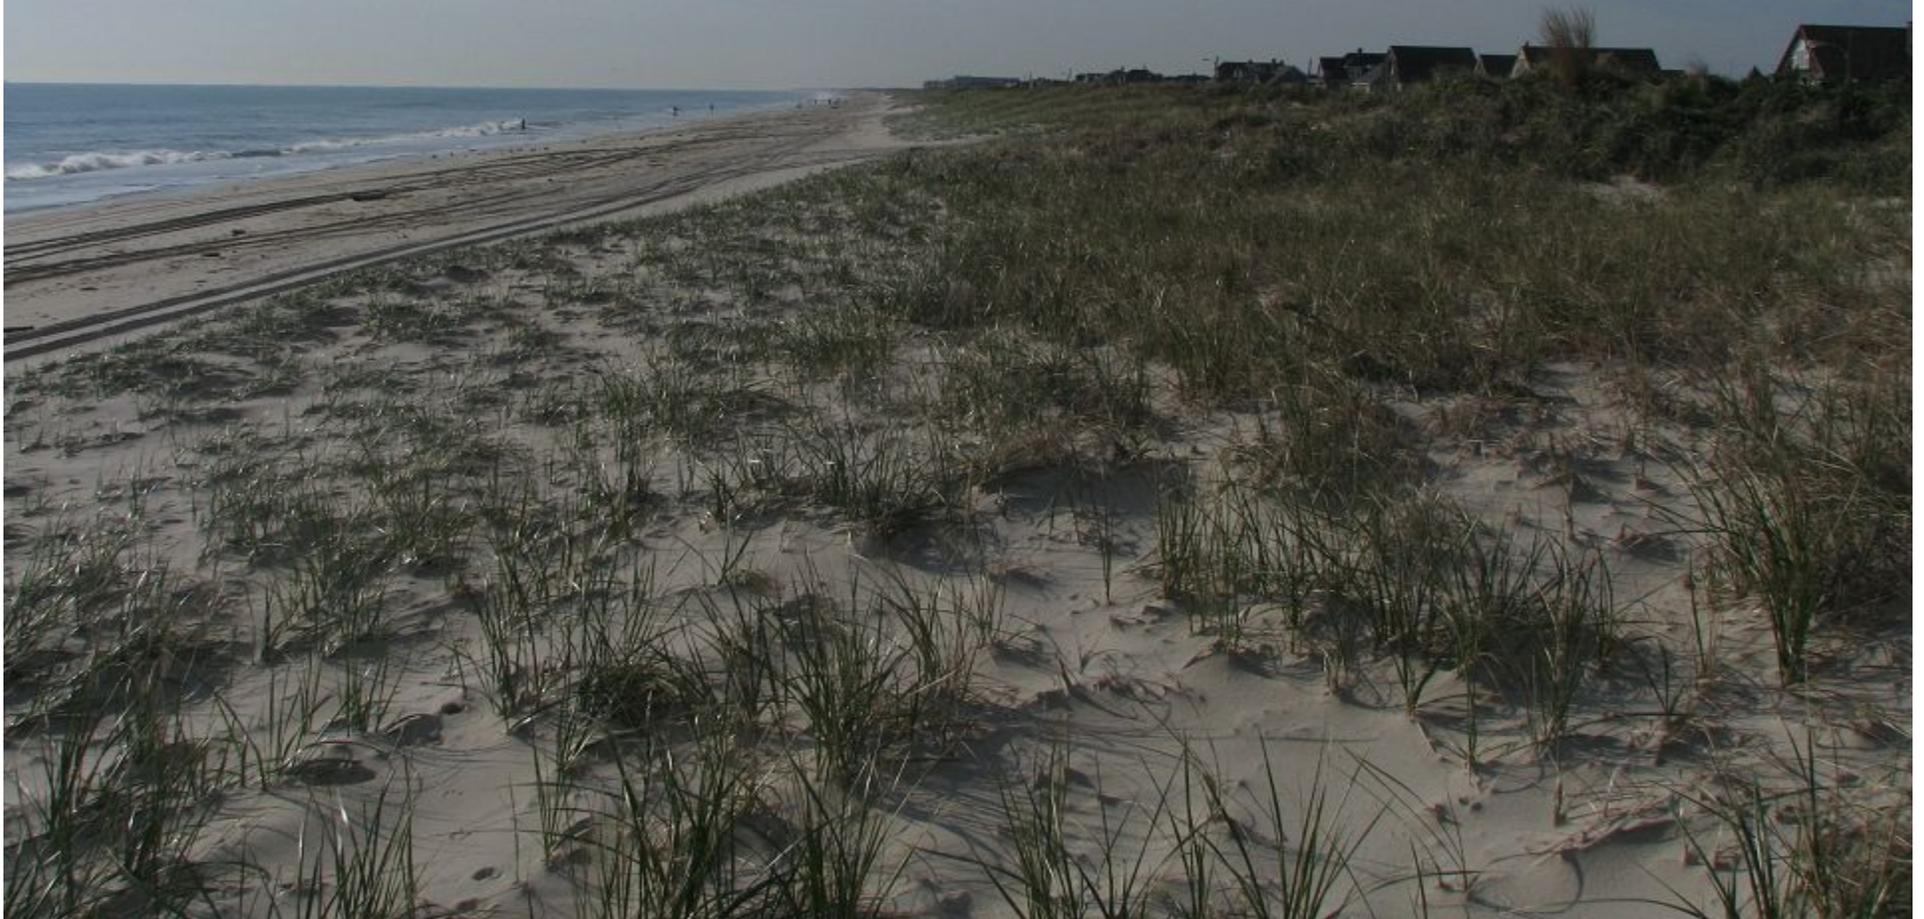
Site 148, 4th Avenue, Seaside Park, NJ – October 31, 2011

Figure 186. Shown above is the view looking south from the dune at 4th Avenue in Seaside Park, NJ.

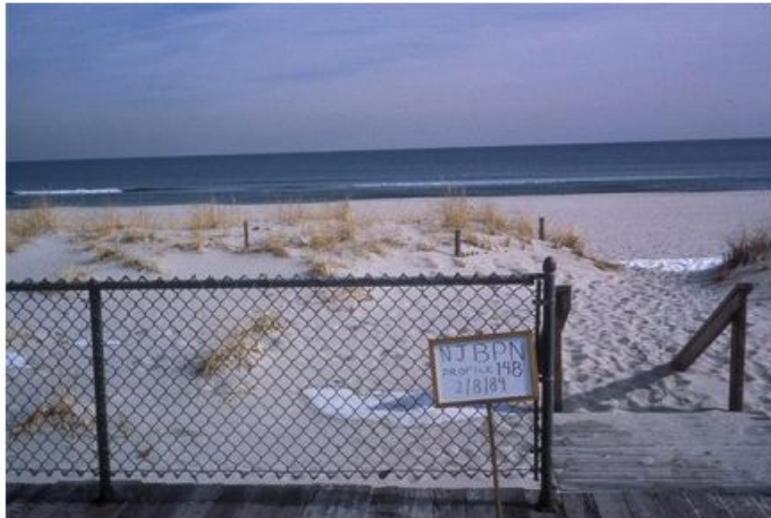
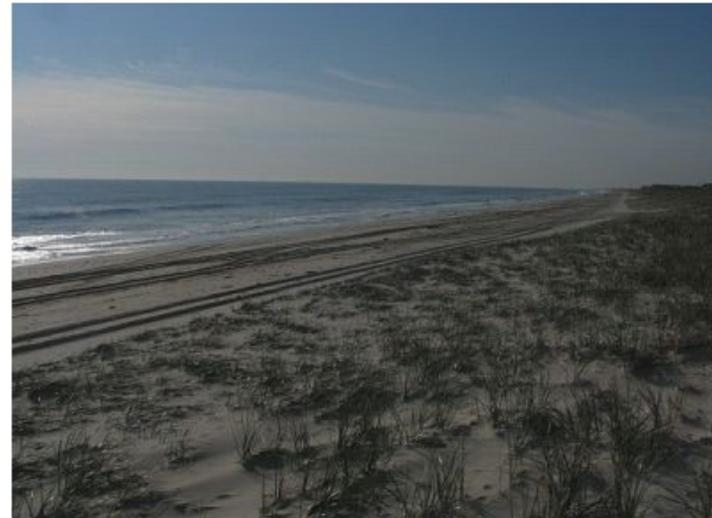
Figure 188 above shows that since the initial survey in 1986 the dune grew both horizontally and vertically, while sand was added to the beachface, and offshore slope. As a result of the changes the shoreline advanced 39 feet and an additional 62,212 cu.yd/ft. of sand was added. Photo on the left was taken in February of 1989 and shows the view to the east from the boardwalk. Photo on the right was taken in October of 2011 and shows the view to the south from the dune crest.

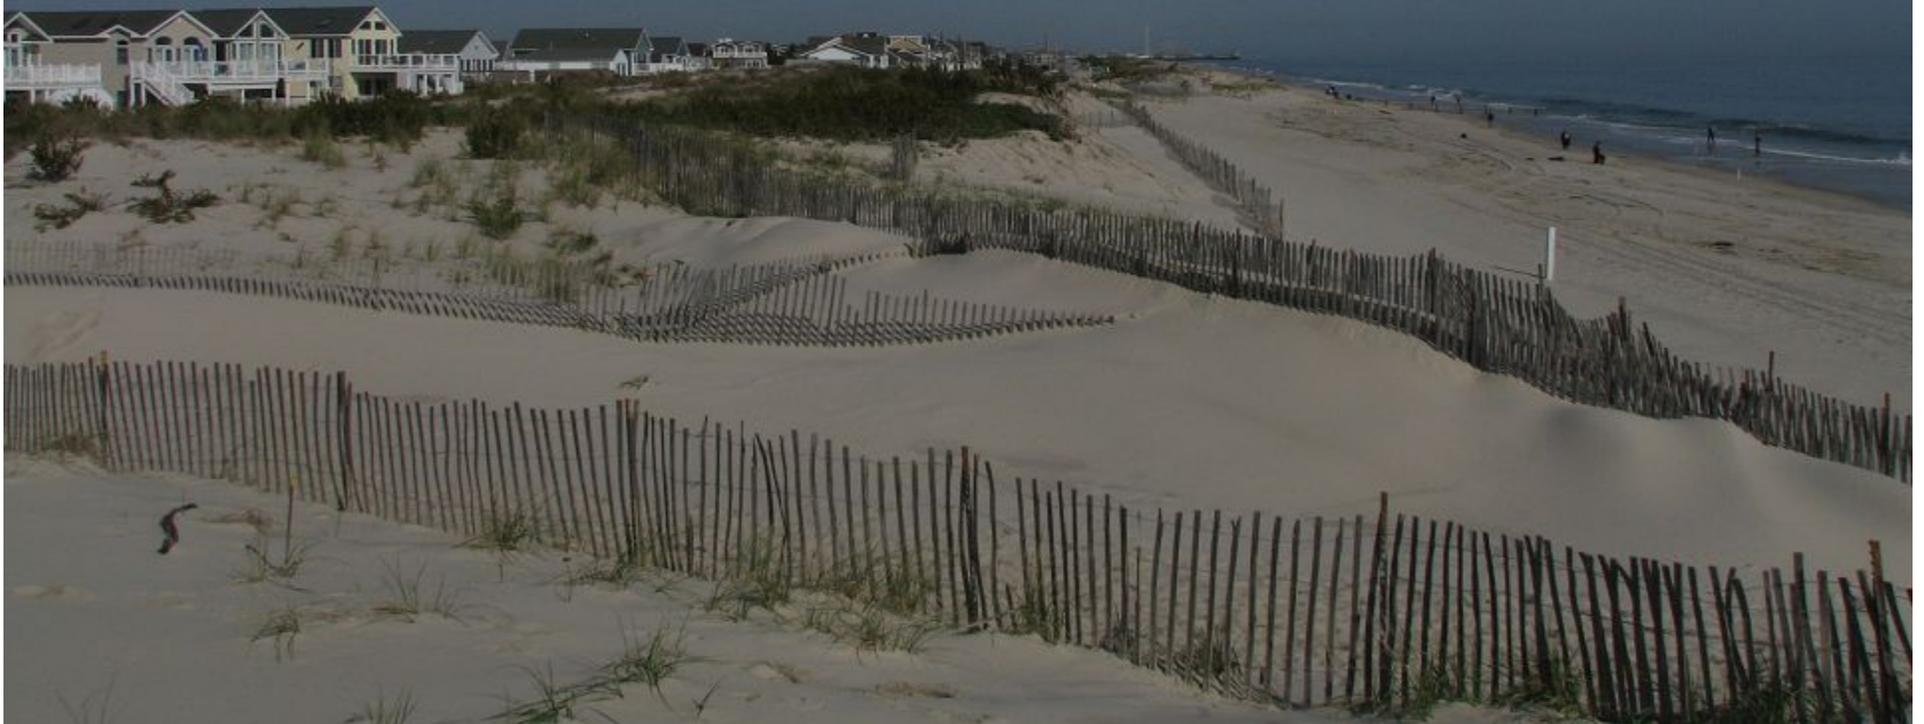
Site 147, 6th Lane, Midway Beach, NJ – October 31, 2011

Figure 190. Shown above is the view looking north from the dune at 6th Lane in Midway Beach, NJ.

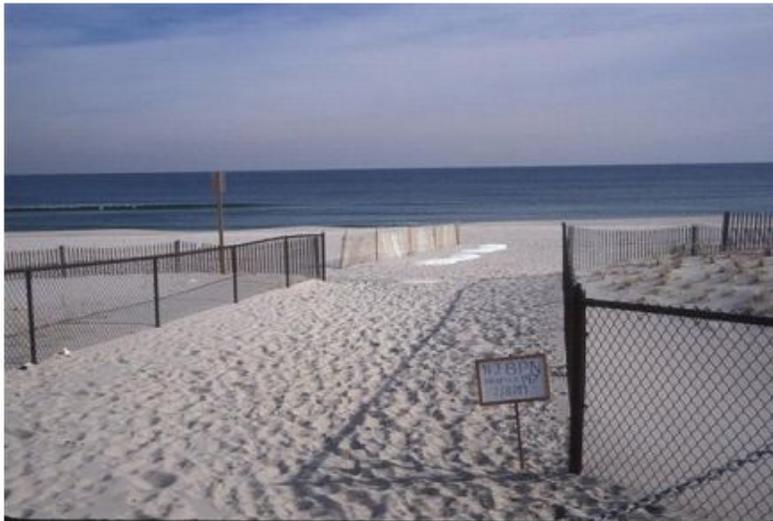
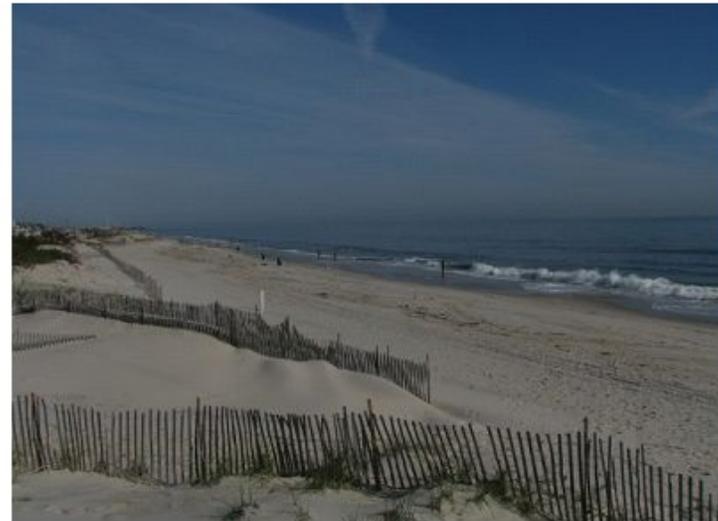
Figure 192 above shows the original survey line which ran along the access path (red line). The profile was later moved south to capture changes in the dune that was growing adjacent to the path (black line). The shoreline retreated 21 feet. Photo on the left was taken in February of 1989 looking east up the access path. Photo on the right was taken in October of 2011 and shows the view from the foredune crest looking north.
