New Jersey Beach Profile Network

Ocean County

Manasquan Inlet
to Little Egg Inlet

NJBPN Profile #'s
156 - 234

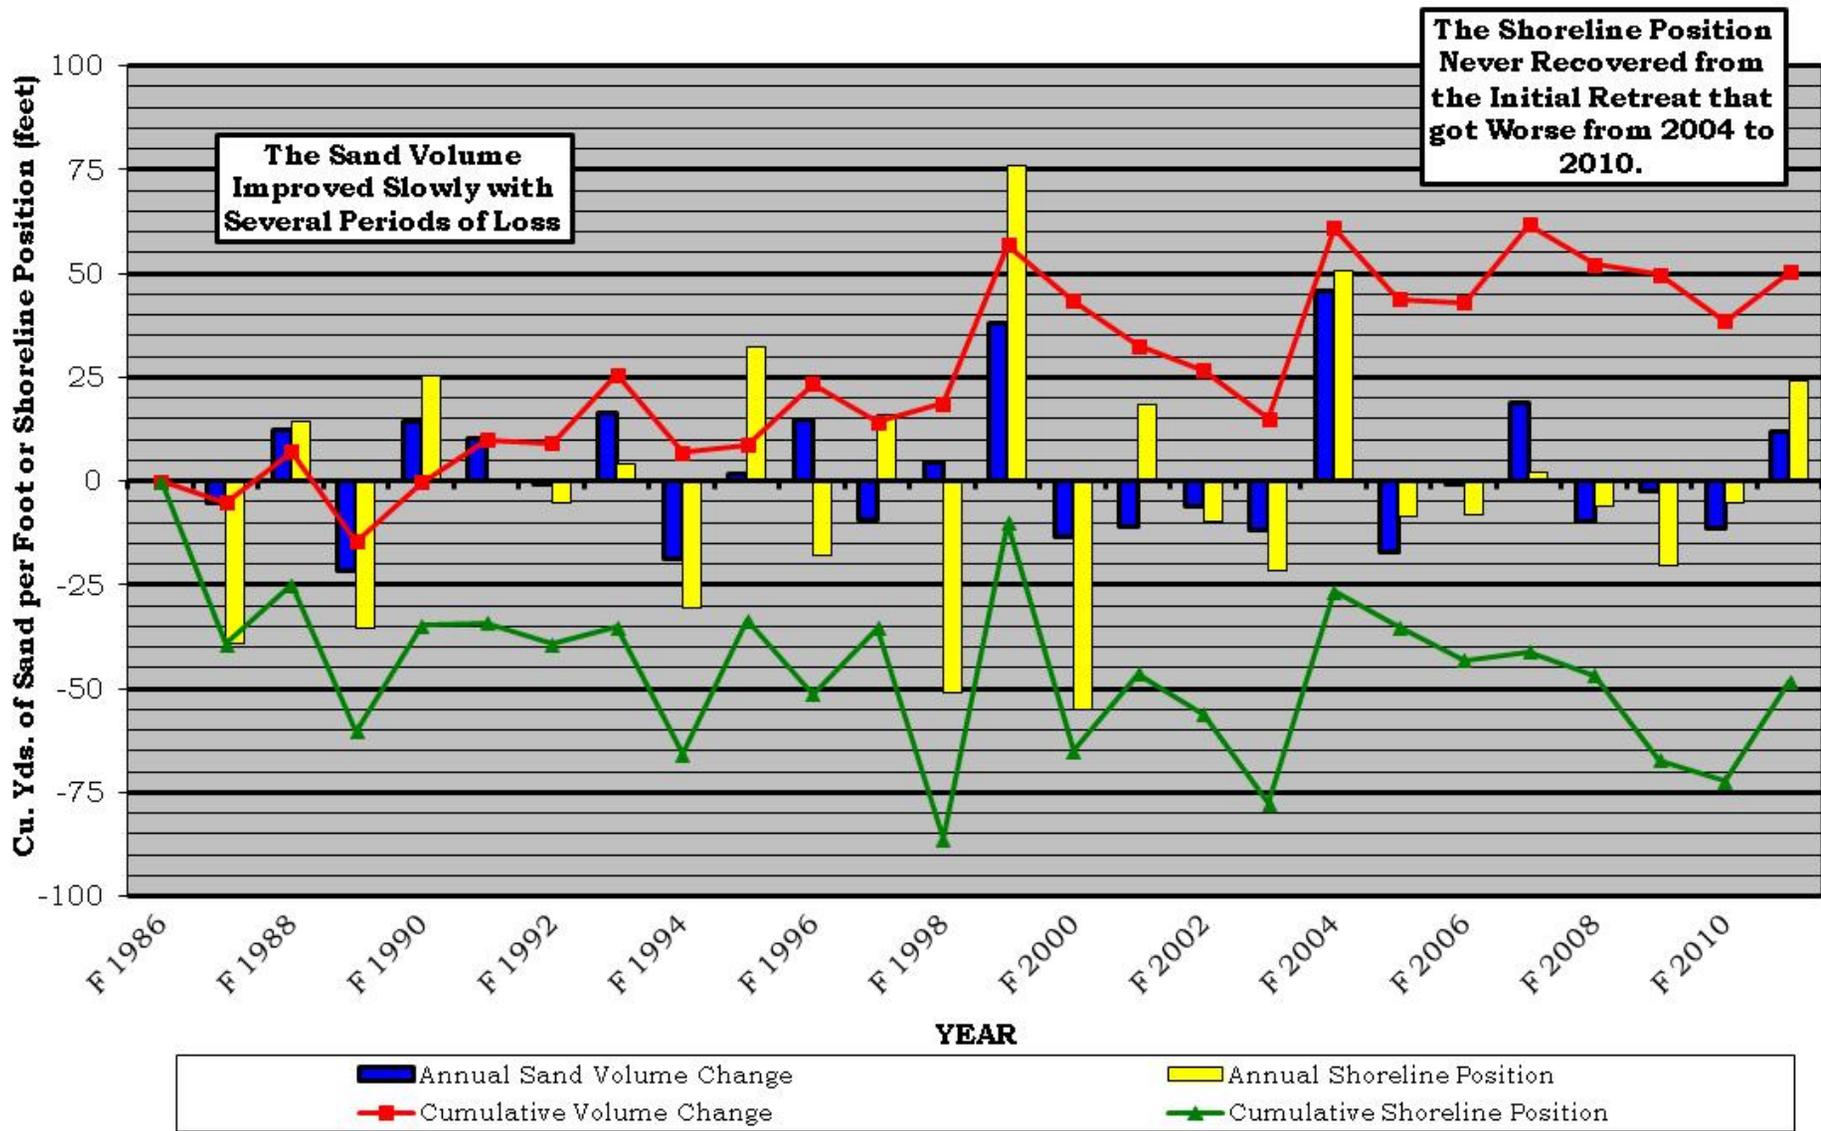
25-Year Coastal Changes at Site 347, 6th Lane, Midway Beach, Ocean Co.

Figure 193. Profile 347 in Midway Beach steadily gained sand volume starting in 1990; this pattern continued through 2011. The shoreline position however began with a retreat and never recovered. The worse losses were from 2004 to 2010.

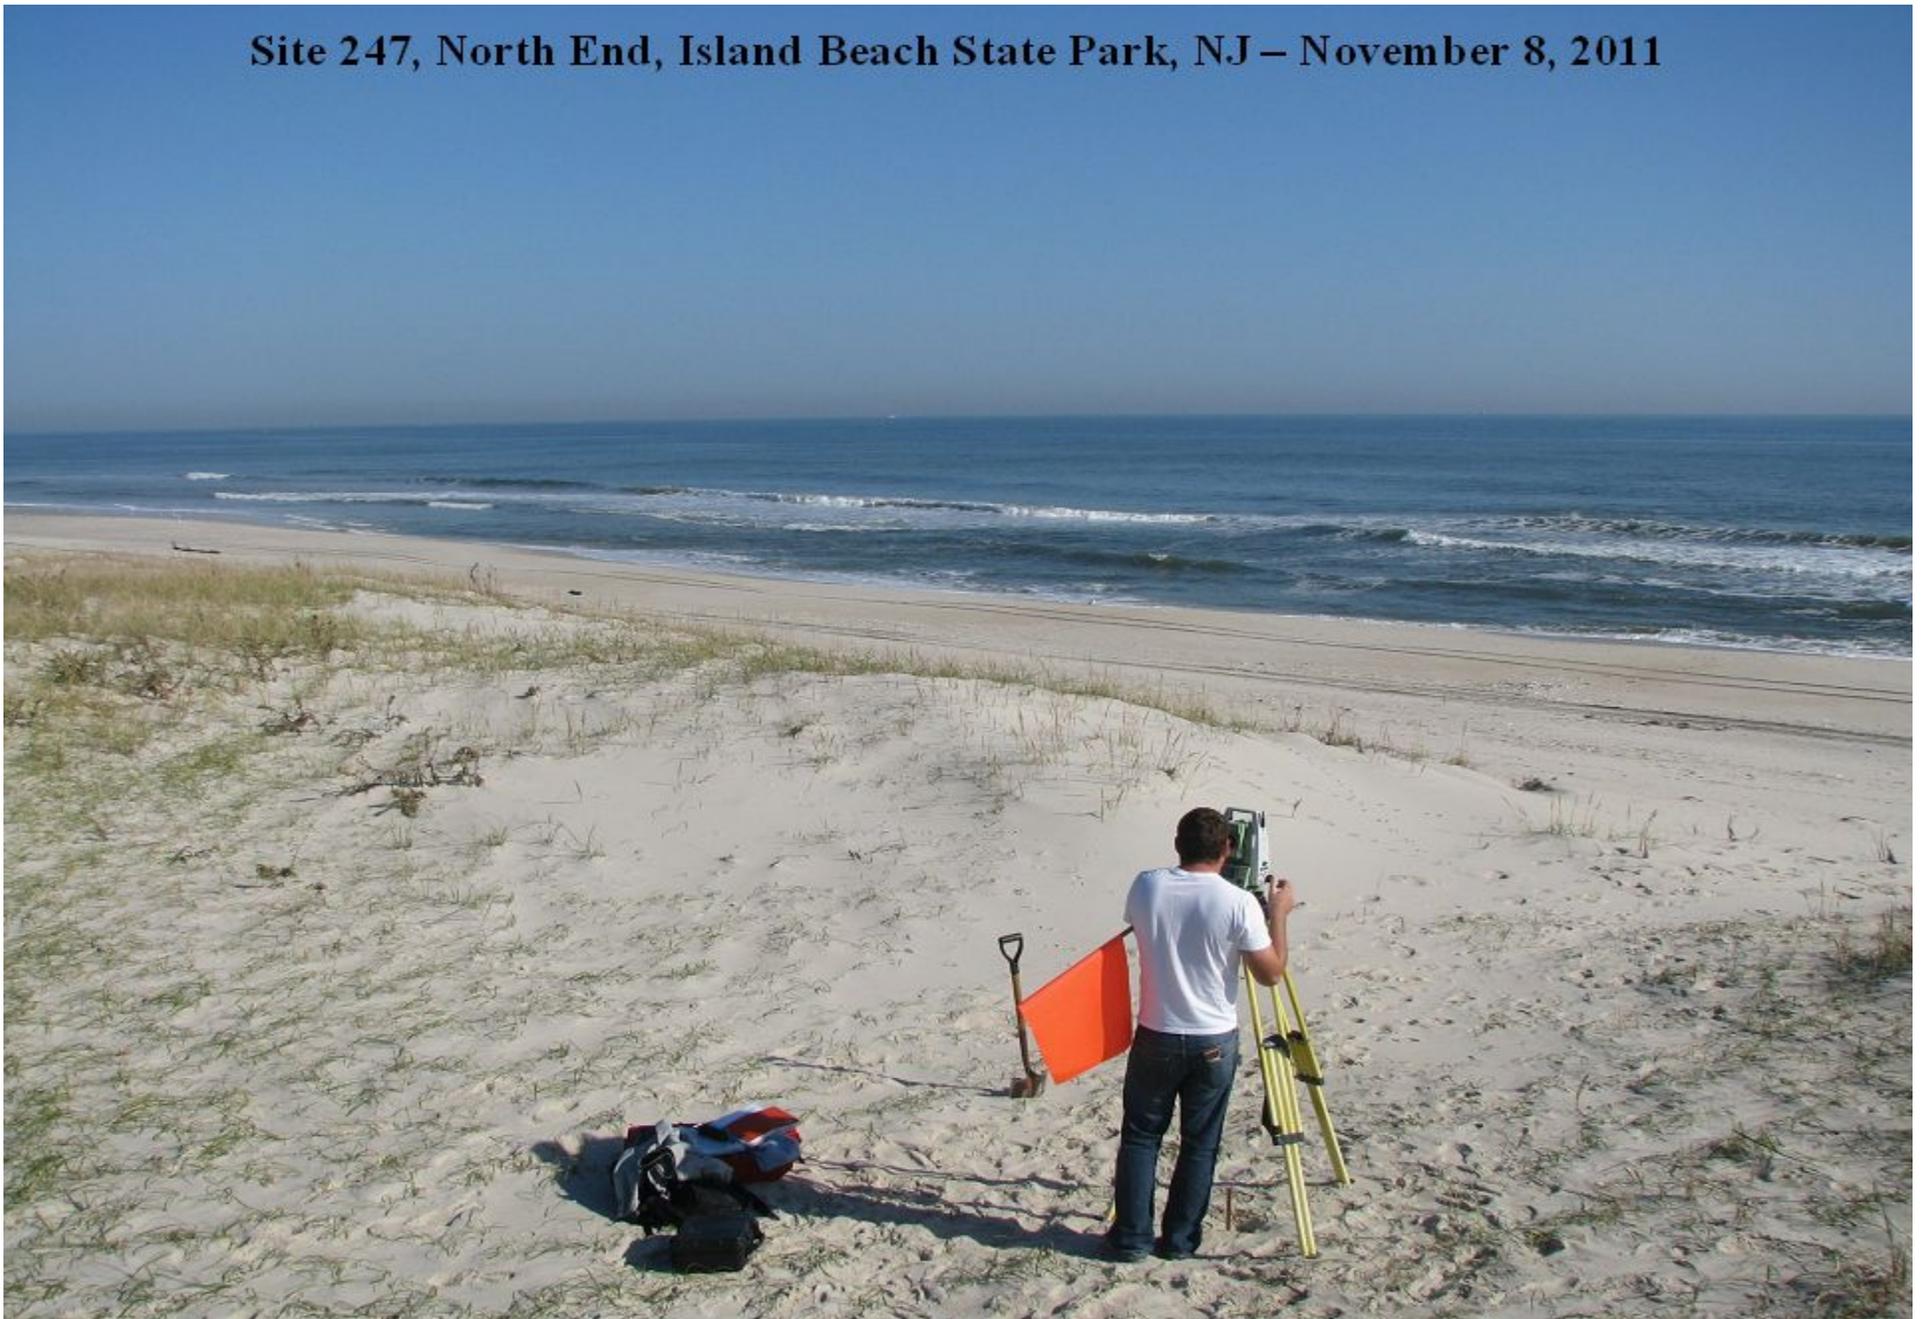
Site 247, North End, Island Beach State Park, NJ – November 8, 2011

Figure 194. Shown above is the view looking northeast from the dune at the North End of Island Beach State Park, NJ.

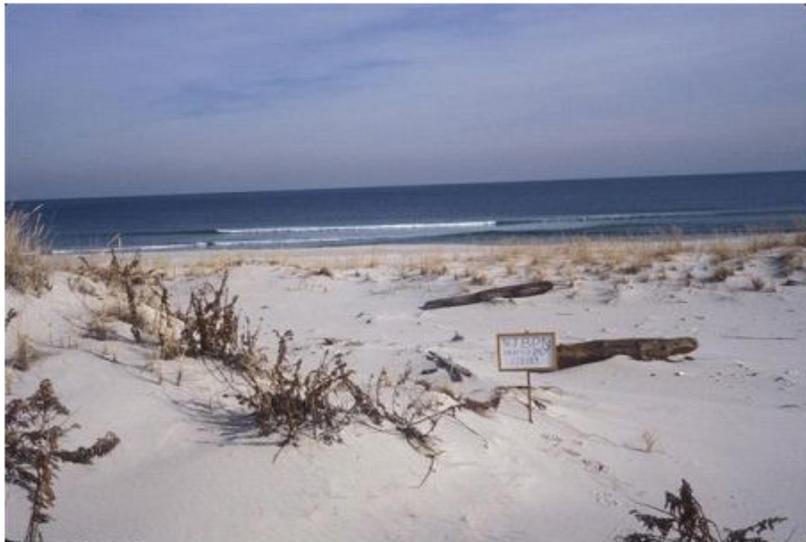
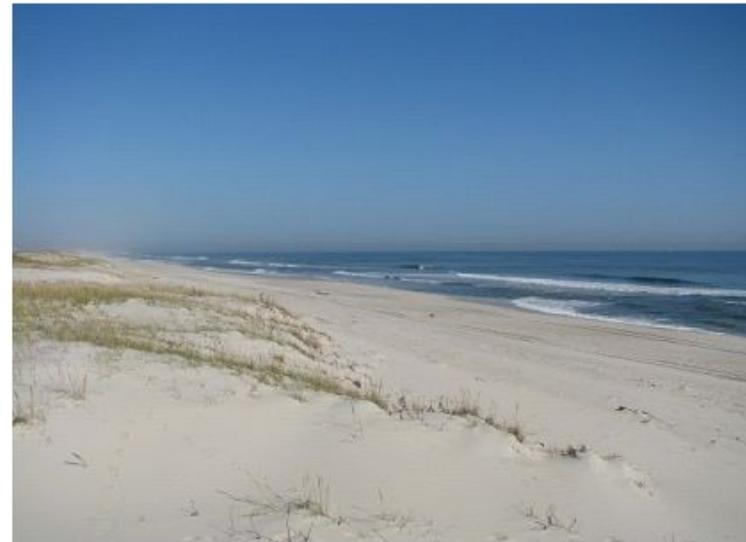
Figure 196 above shows the initial survey in 1986 compared to the November 2011 survey. By 2011 the dune developed a deep swale and grew vertically. The shoreline advanced by 14 feet and there was a net gain in sand volume of 8.304 cu.yd/ft. Photo on the left was taken in February of 1989 and shows the view from the dune crest looking east. Photo on the right was taken in November of 2011 and shows the view from the dune crest looking north.

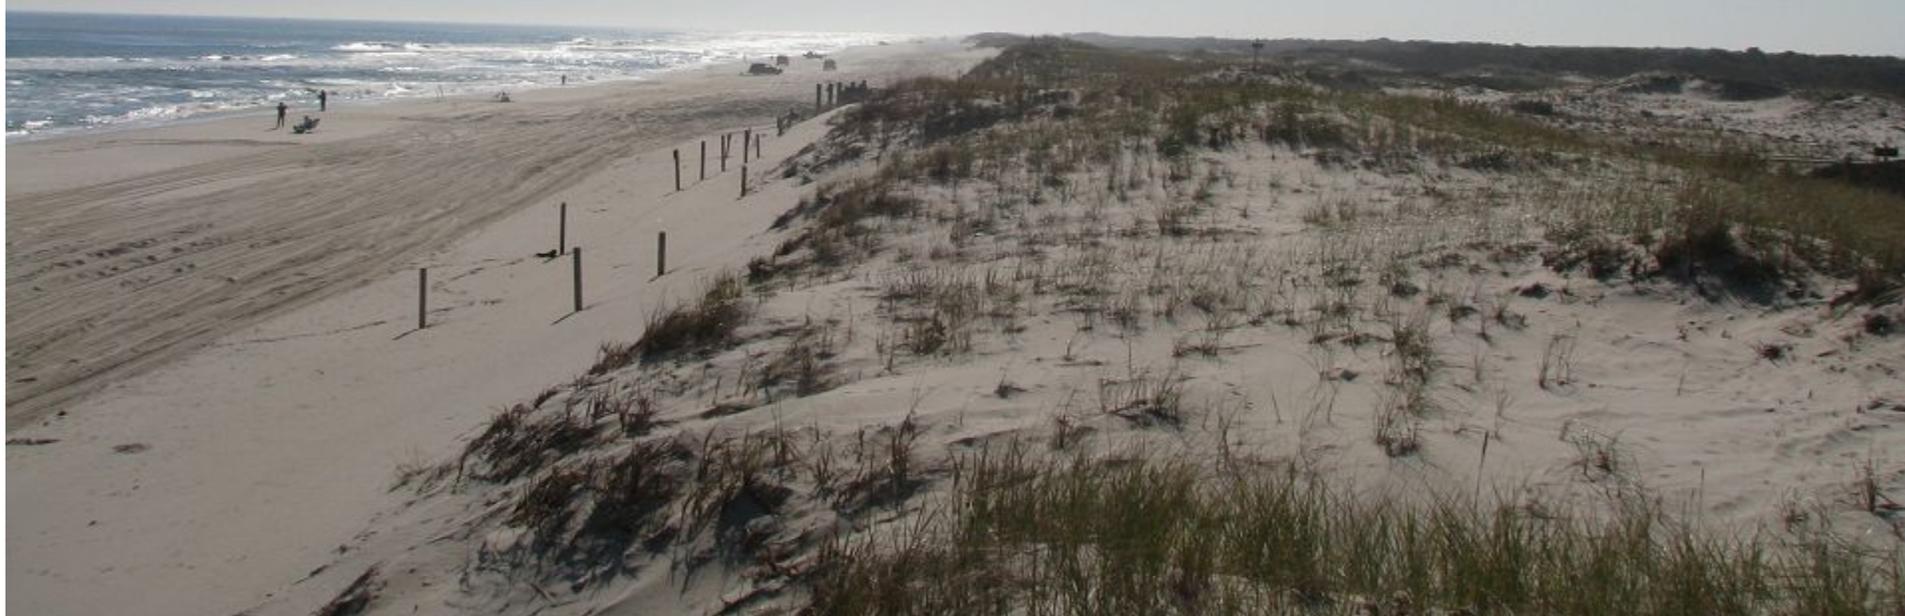
Site 246, Parking Lot A7, Island Beach State Park, NJ – November 8, 2011

Figure 198. Shown above is the view looking south from the seaward crest of the dune near parking lot A7 in Island Beach State Park, NJ.

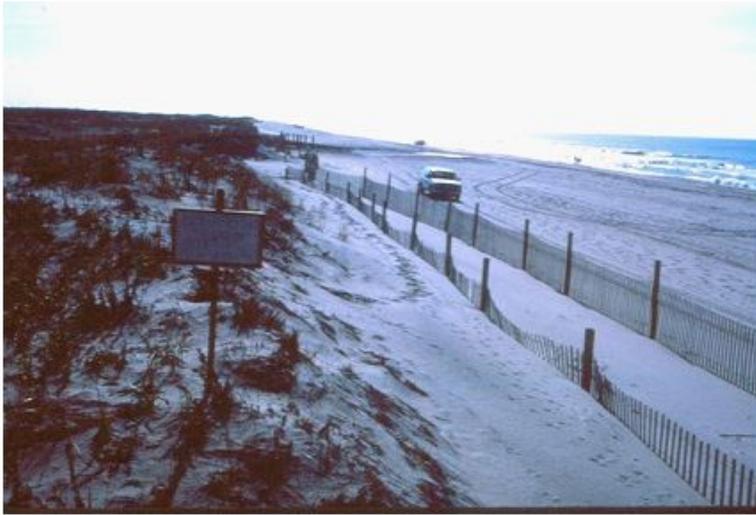
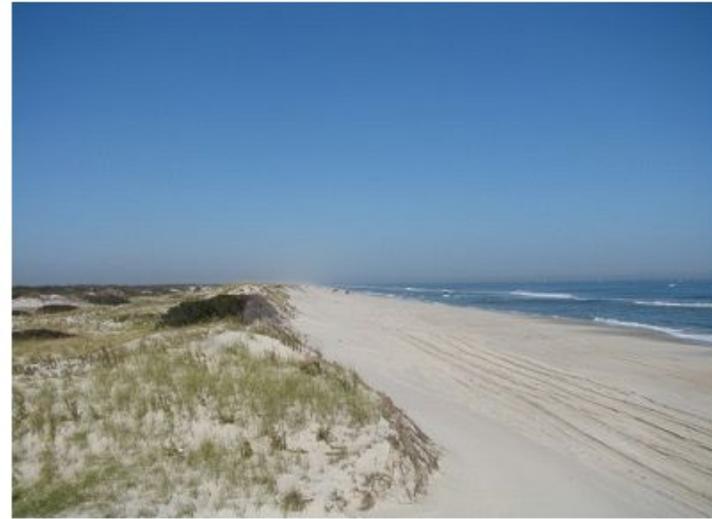
Figure 200 above shows the losses to the dune and beach that this site has sustained since the initial survey in 1986. The shoreline retreated 64 feet and the net loss in sand was 37,823 cu.yd/ft.

Photo on the left was taken in 1995 and shows the view from the fore dune crest looking north.

Photo on the right was taken in November of 2011 and shows a similar view north from the fore dune crest.

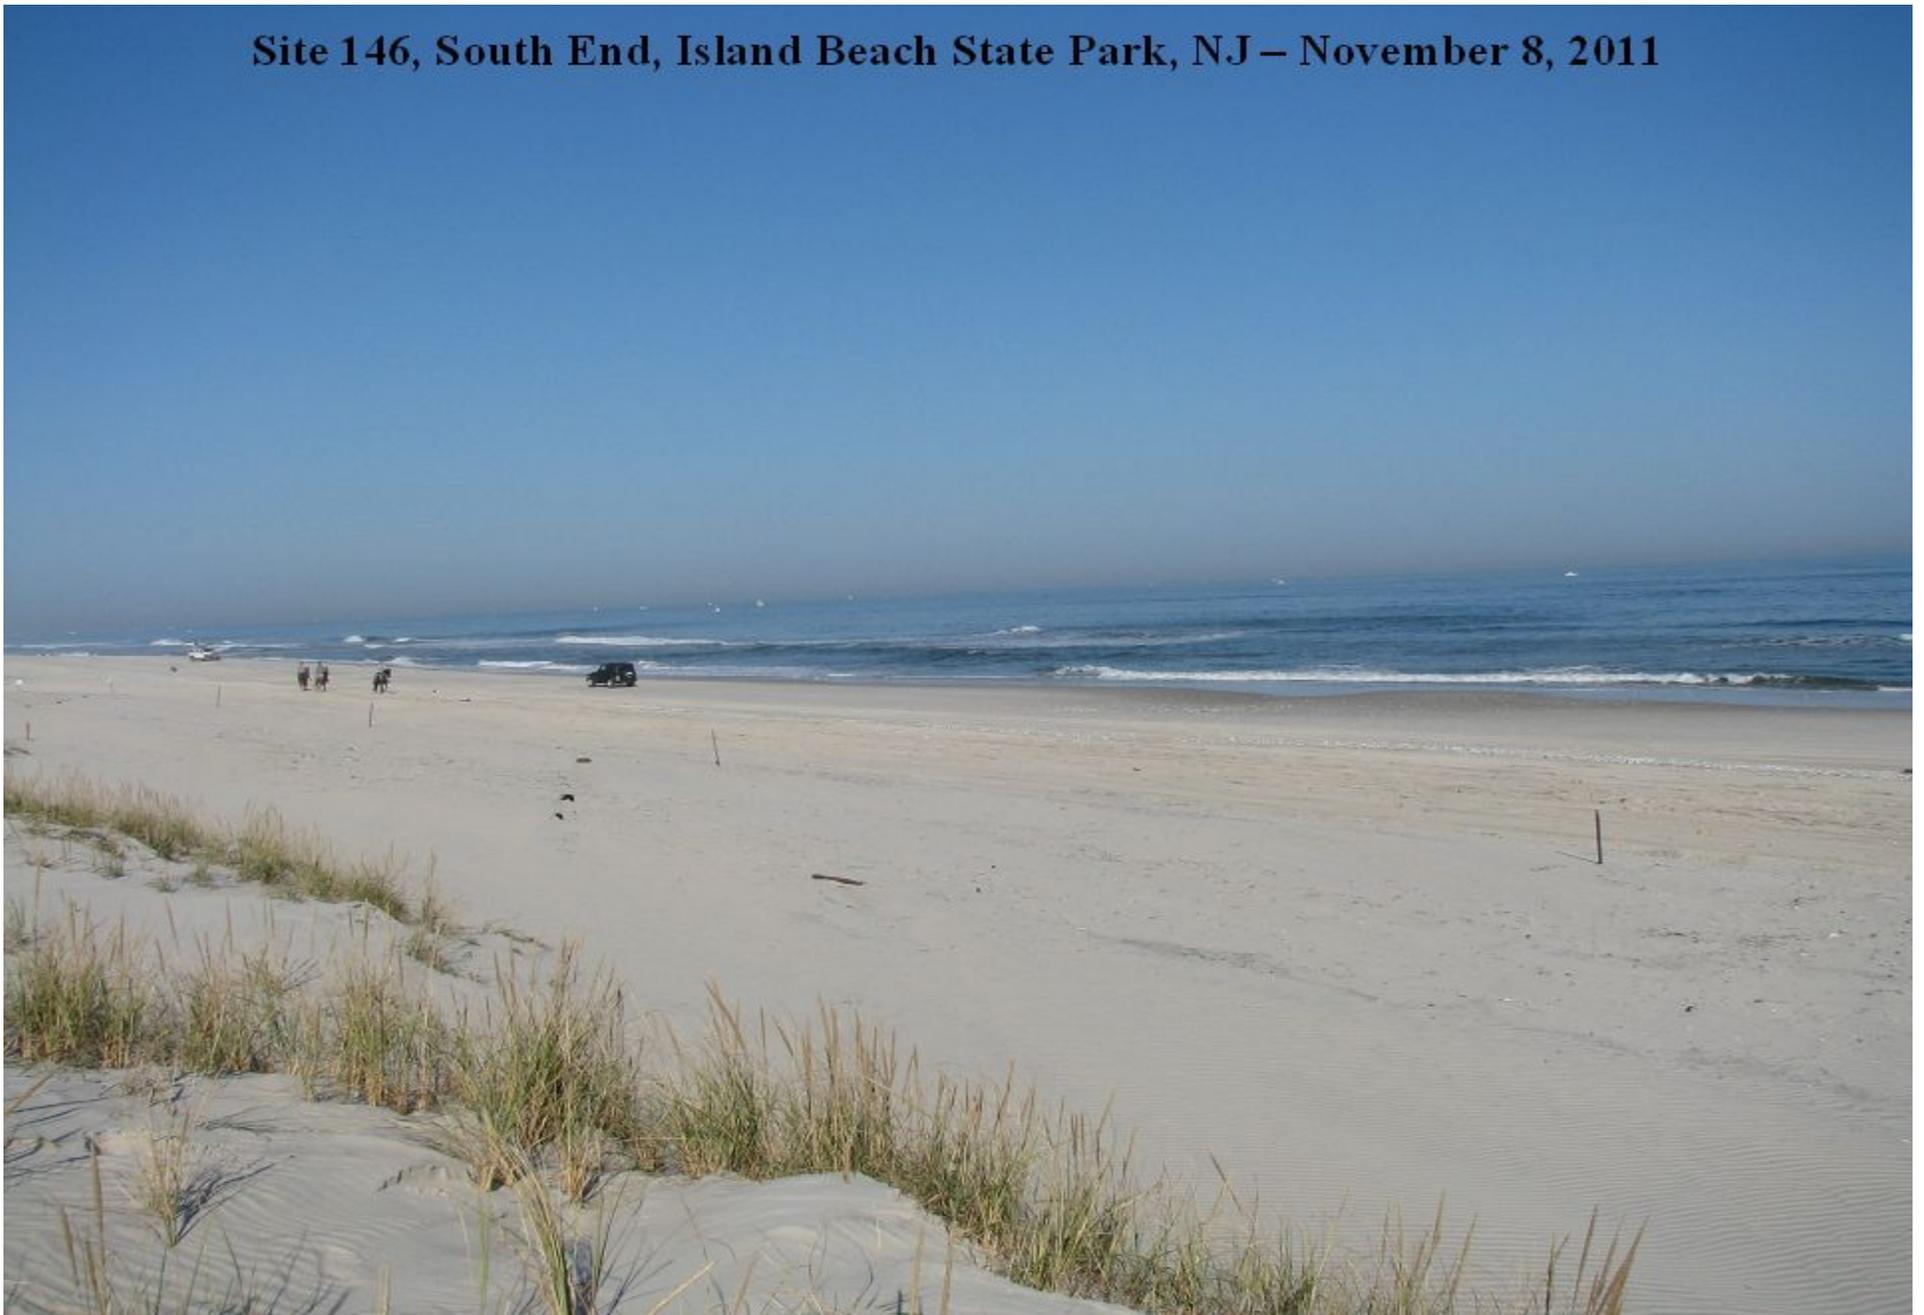
Site 146, South End, Island Beach State Park, NJ – November 8, 2011

Figure 202. Shown above is the view looking northeast from the seaward crest of the dune at the south end of Island Beach State Park, NJ.

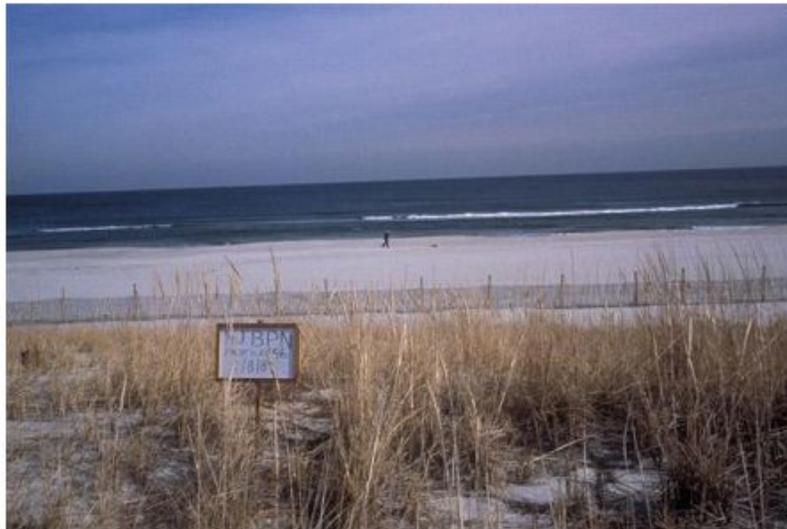
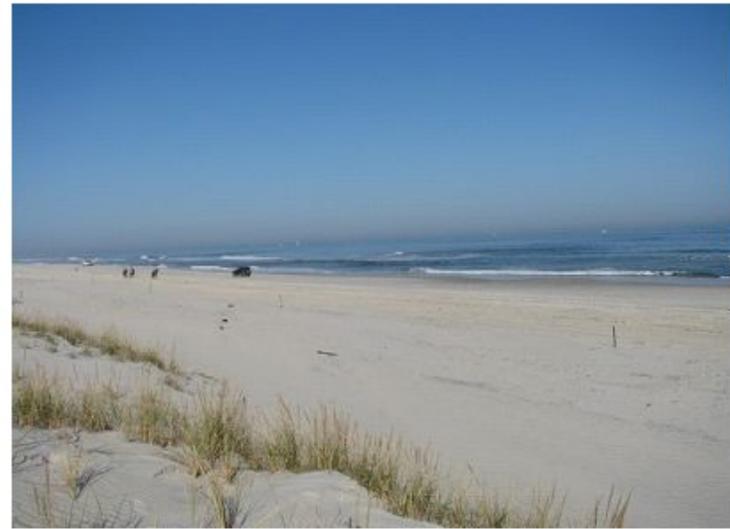
Figure 204 above shows the extensive growth to the dune and beach that has occurred since the initial survey in 1986. In which time the shoreline advanced 95 feet and the net gain in sand was 111.8 cu.yd/ft. Photo on the left was taken in February of 1989 and shows the view east from the dune crest. Photo on the right was taken in November of 2011 and shows the view northeast from the seaward crest.

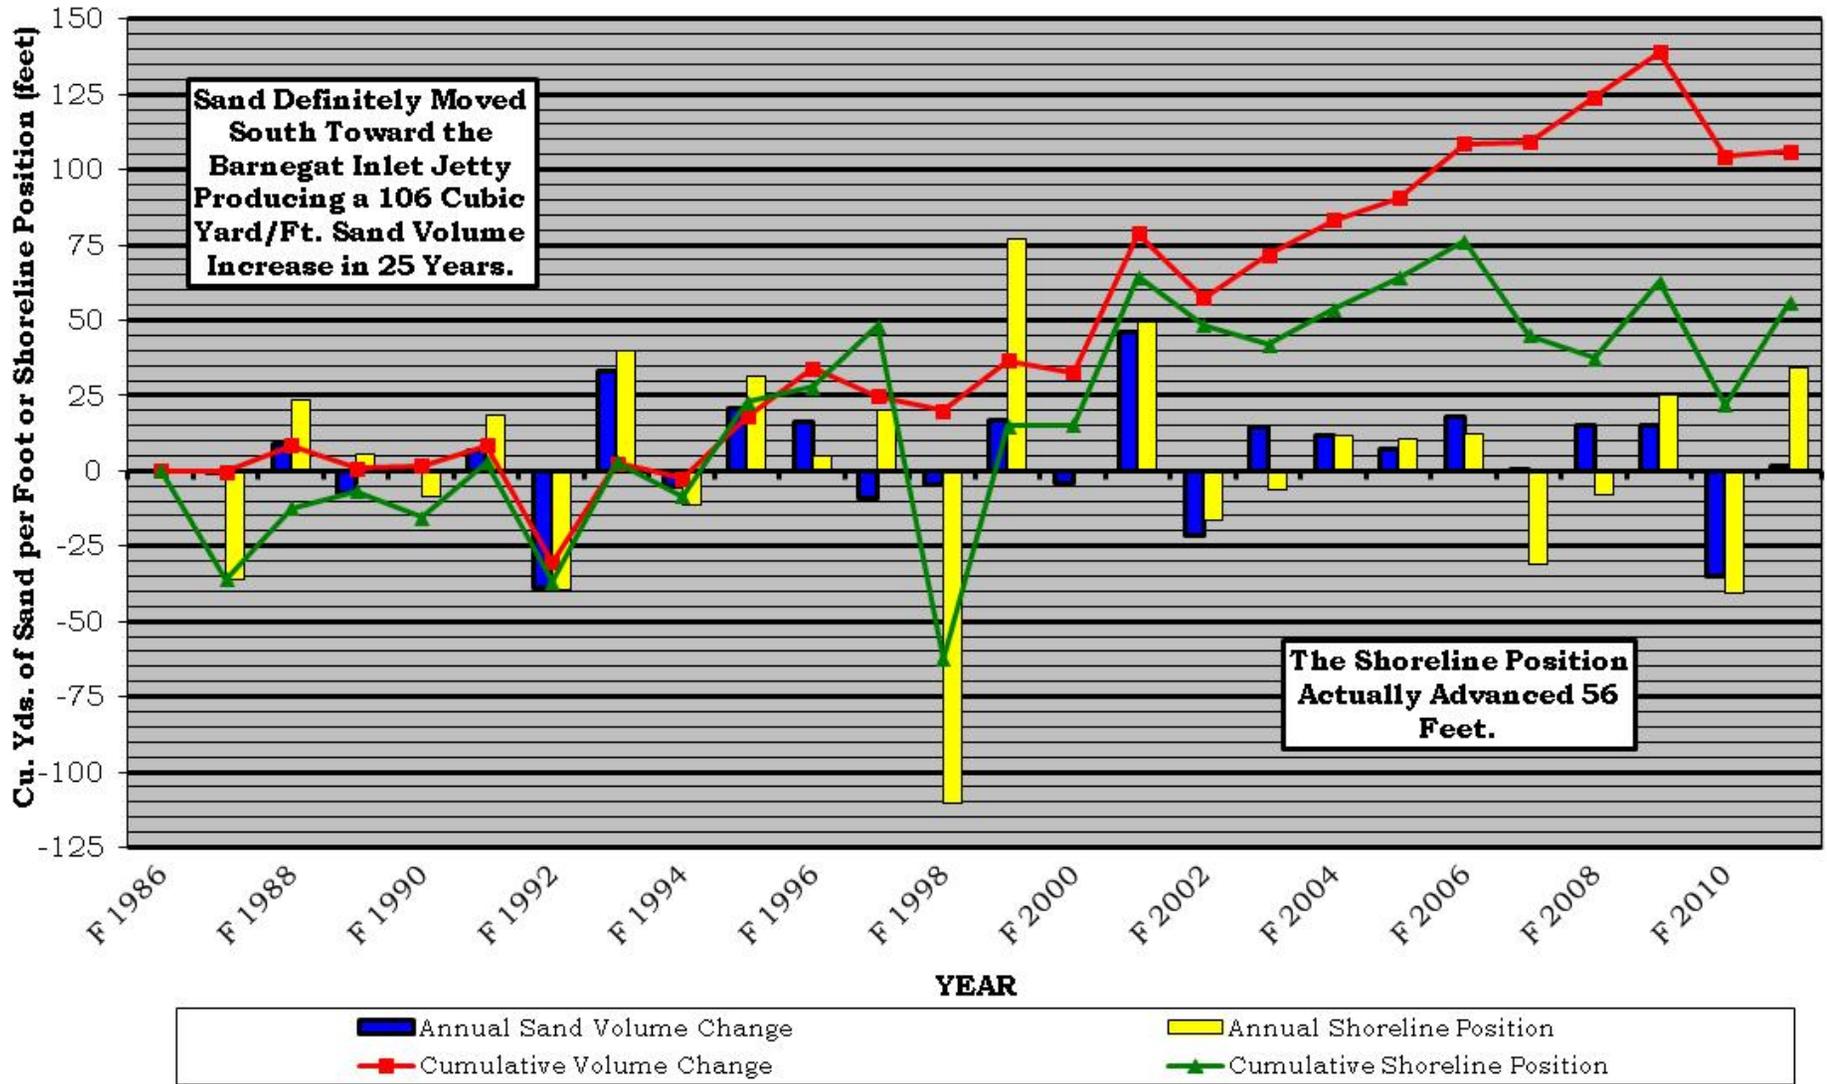
25-Year Coastal Changes at Site 146, South End, Island Beach State Park, Ocean Co.

Figure 205. Profile 146 at the south end of Island Beach State Park saw the shoreline advance and the sand volume increase as sand moved south toward the Barnegat Inlet Jetty.

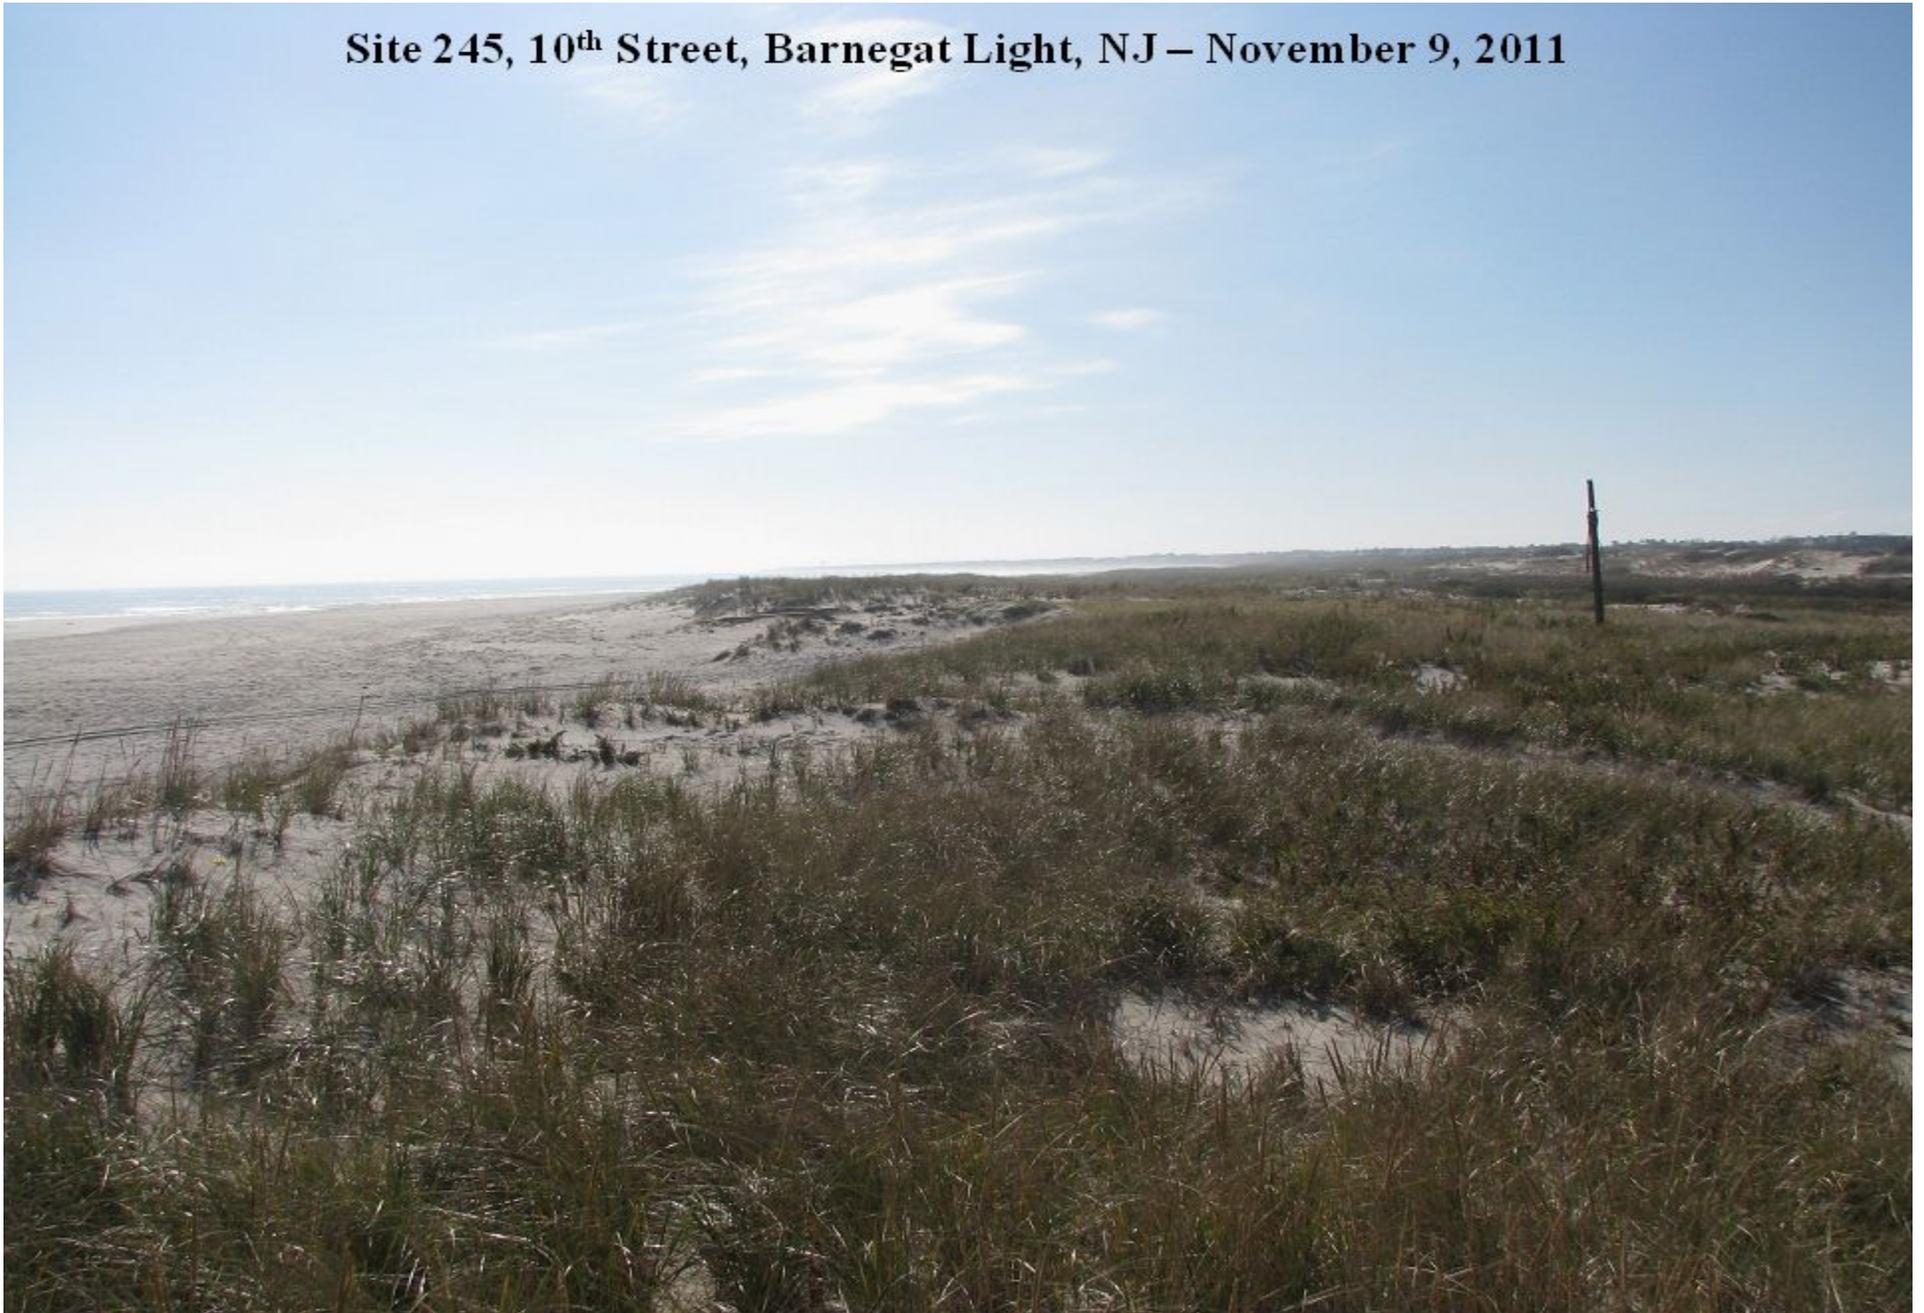
Site 245, 10th Street, Barnegat Light, NJ – November 9, 2011

Figure 206. Shown above is the view looking south from the dune at 10th Street in Barnegat Light, NJ. The mast of a fishing vessel once submerged offshore, which is now buried in the dune as a result of the massive accretion at the new south jetty for Barnegat Inlet, is shown on the right side of the image.

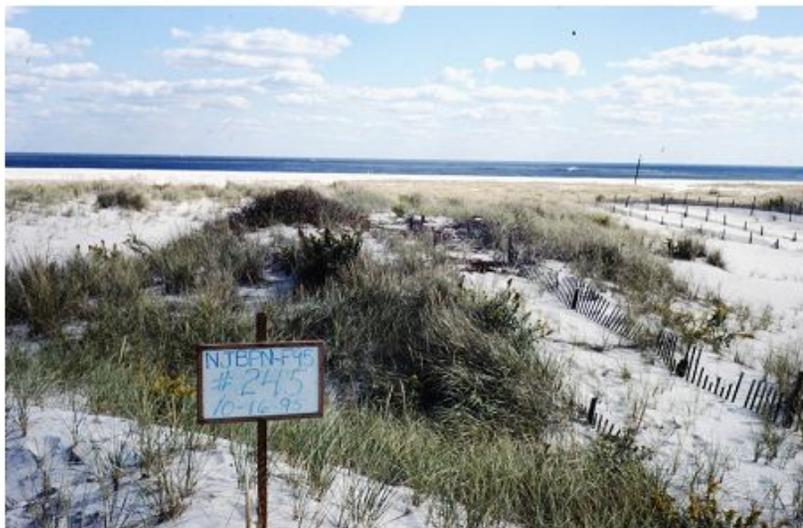
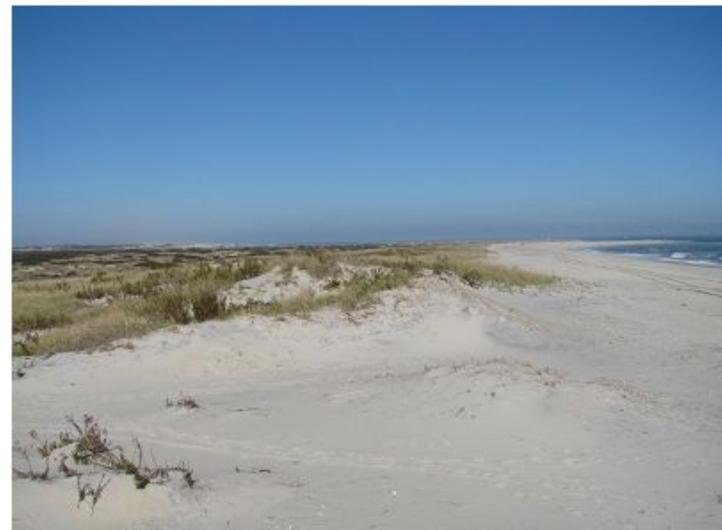
Figure 208 above shows the site at 10th street in Barnegat Light. This site was established in 1994 to monitor changes associated with Barnegat Inlet. The shoreline advanced 47 feet and there was a net gain in sand of 51,078 cu.yd/ft. Photo on the left was taken in October of 1995 and shows the view looking east. Note the absence of the foredune crest. Photo on the right was taken in November of 2011 and shows the view from the foredune crest looking north.

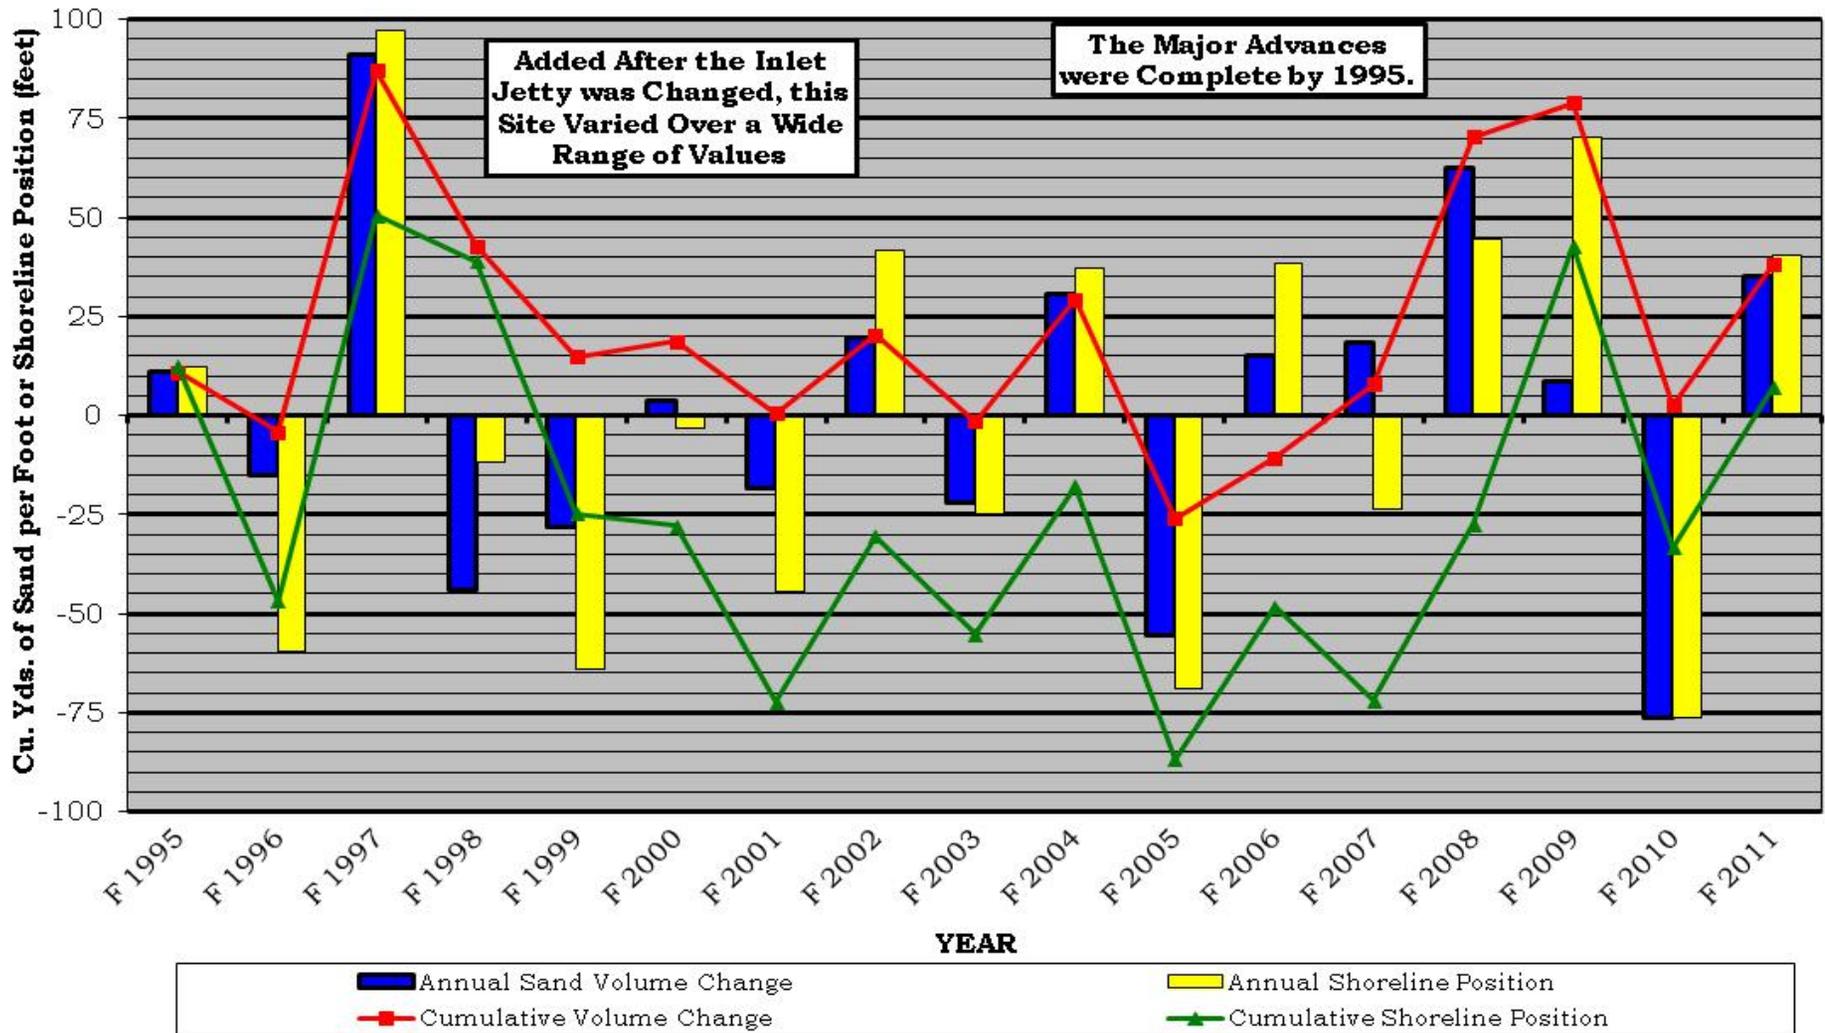
17-Year Coastal Changes at Site 245, 10th Street, Barnegat Light, Ocean Co.

Figure 209. Profile 245 in Barnegat Light was established in 1994 to follow changes associated with Barnegat Inlet, the figure does not show the huge gains achieved prior to 1994. Since then this site has been highly variable. The general trend seems to be towards a slight shoreline retreat and a slight sand volume gain. Due to the proximity to jetty this site is sheltered from northeast storm waves and any major erosion events.

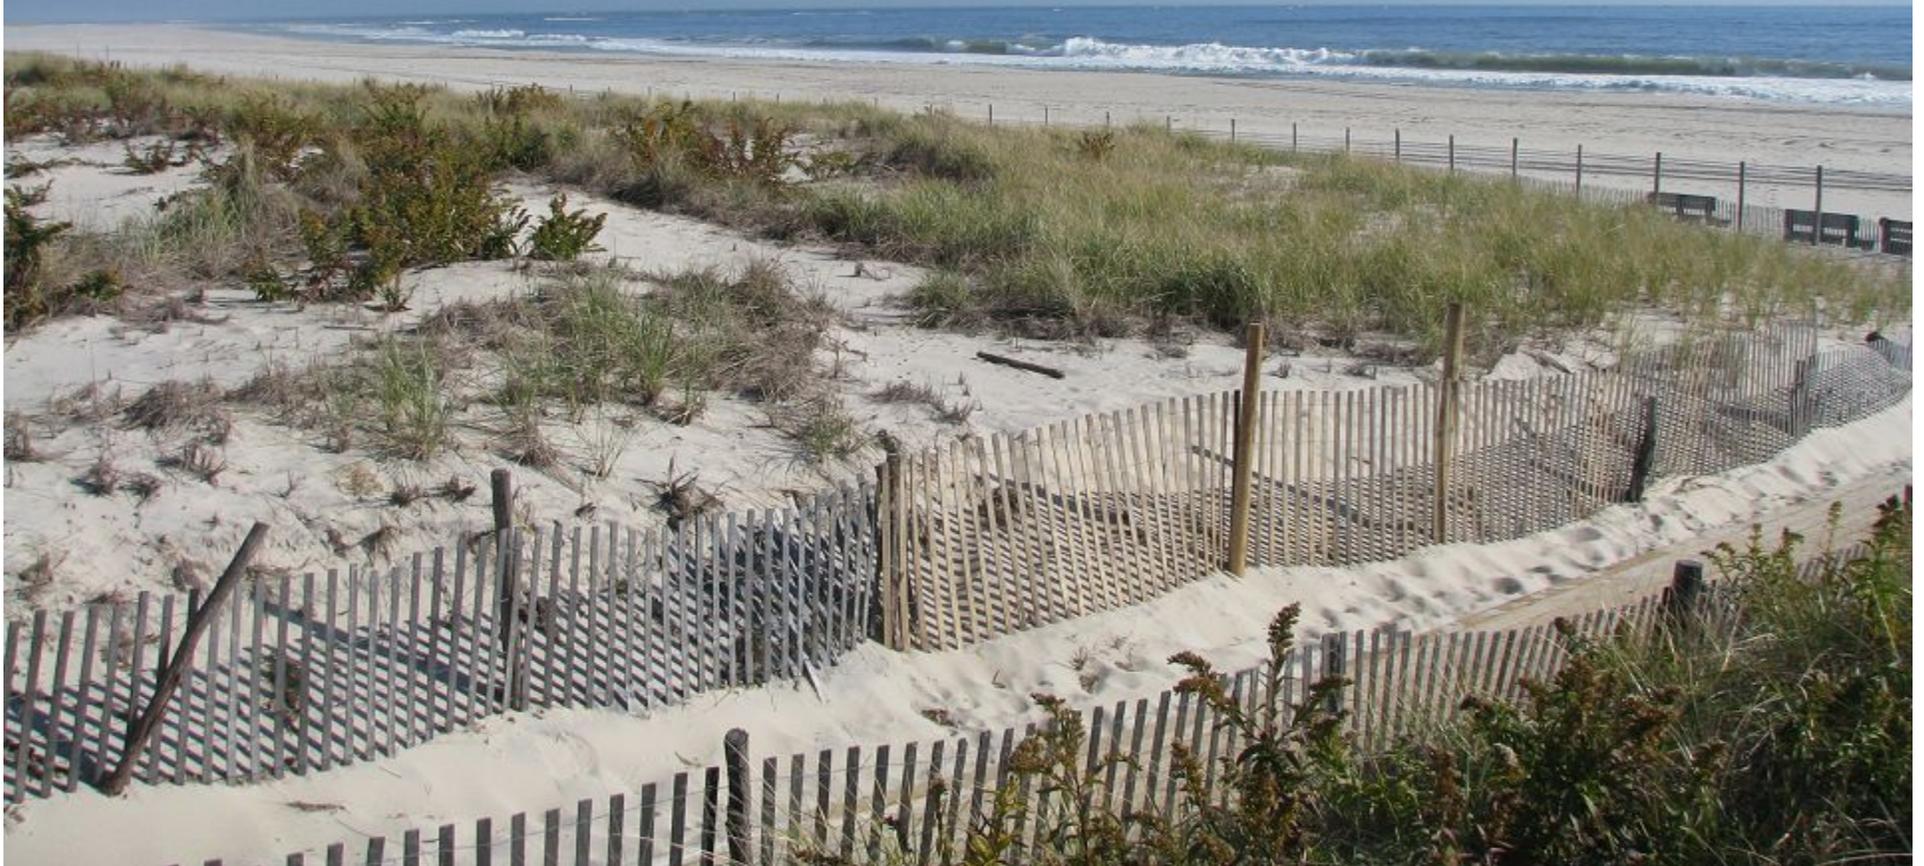
Site 145, 26th Street, Barnegat Light, NJ – November 9, 2011

Figure 210. Shown above is the view looking northeast from the dune at 26th Street in Barnegat Light, NJ.

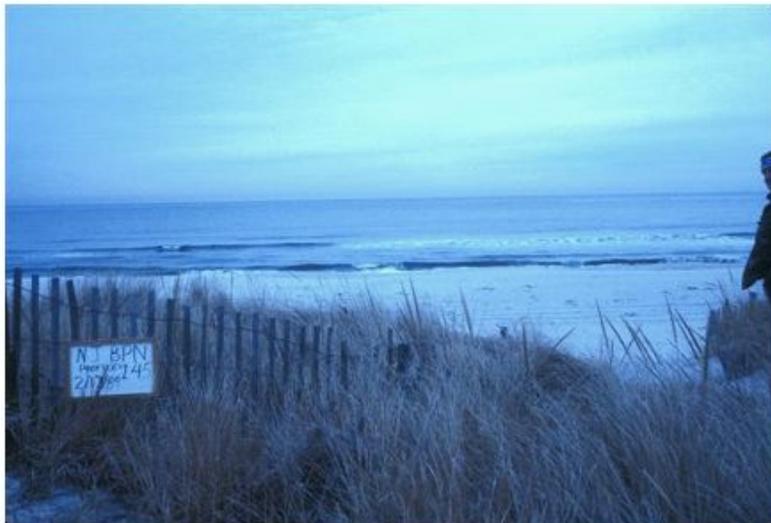
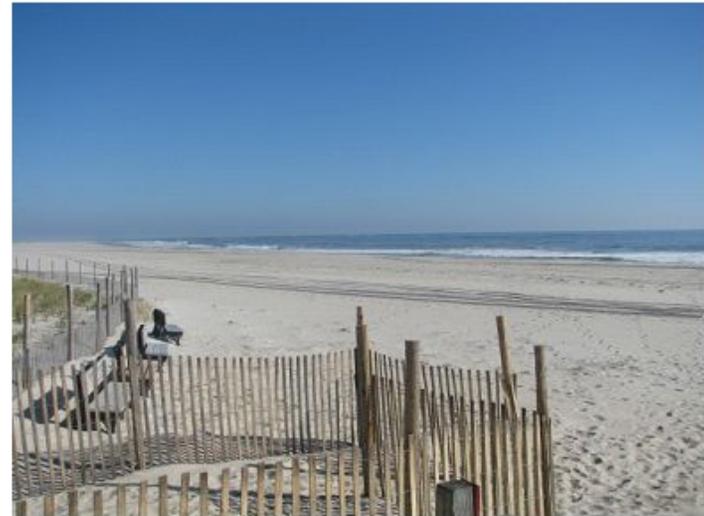
Figure 212 above shows the dramatic gains between the initial survey in 1986 and the November 2011 survey. Sand was added to nearly every part of this survey resulting in a shoreline advance of 197 feet and a net gain of 92,816 cu.yd/ft. of sand. Photo on the left was taken in February of 1989 and shows the view from the dune looking east. Photo on the right was taken in November of 2011 and shows the view looking northeast.
