New Jersey Beach Profile Network

Ocean County

Manasquan Inlet
to Little Egg Inlet

NJBPN Profile #'s
156 - 234

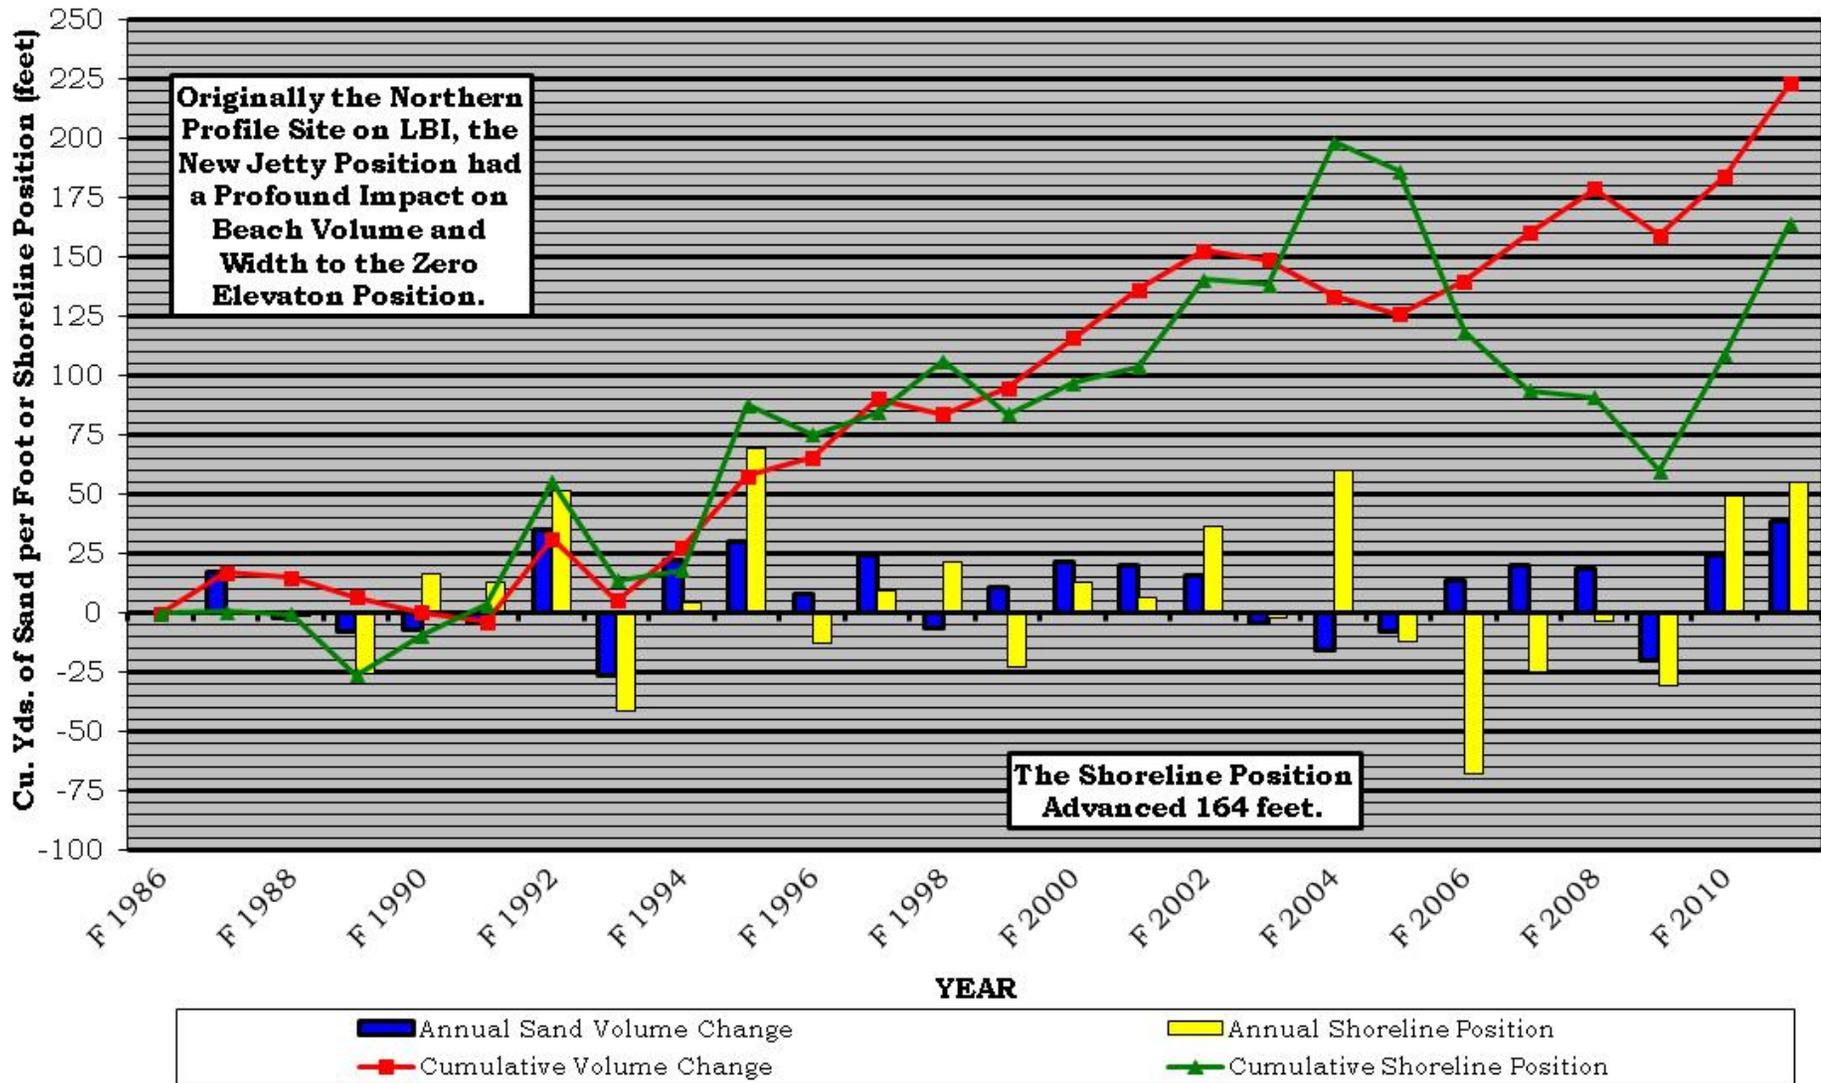
25-Year Coastal Changes at Site 145, 26th Street, Barnegat Light, Ocean Co.

Figure 213. Profile 145 located in Barnegat Light was originally the northern most profile on Long Beach Island until site 245 was established in 1994 . The profound impact of new Barnegat Inlet South Jetty is apparent in the figure above as the shoreline and the sand volume increased dramatically since its initial survey in 1986.

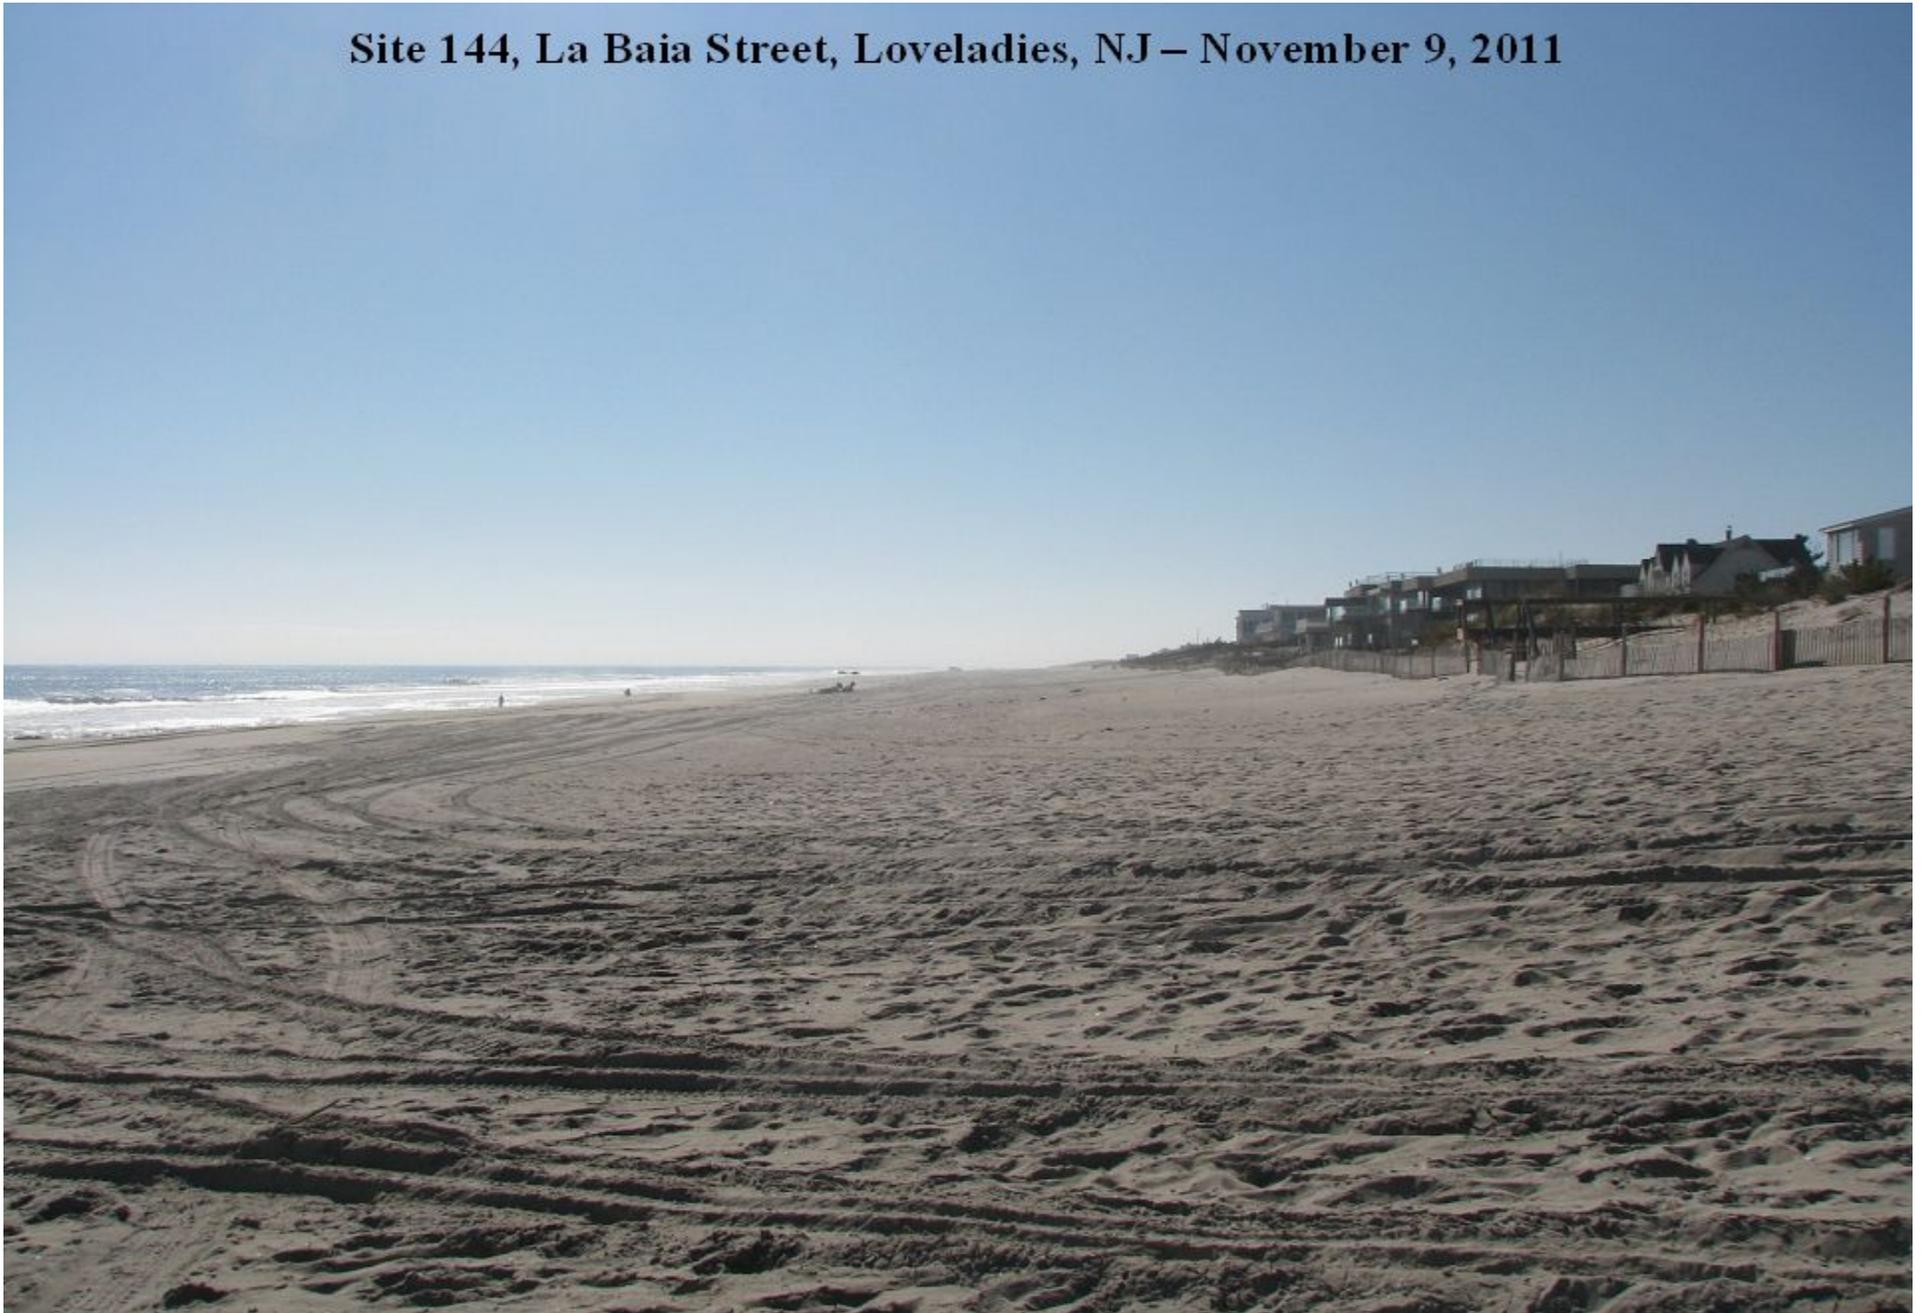
Site 144, La Baia Street, Loveladies, NJ – November 9, 2011

Figure 214. Shown above is the view looking south from the dune toe at La Baia Street in Loveladies, NJ.

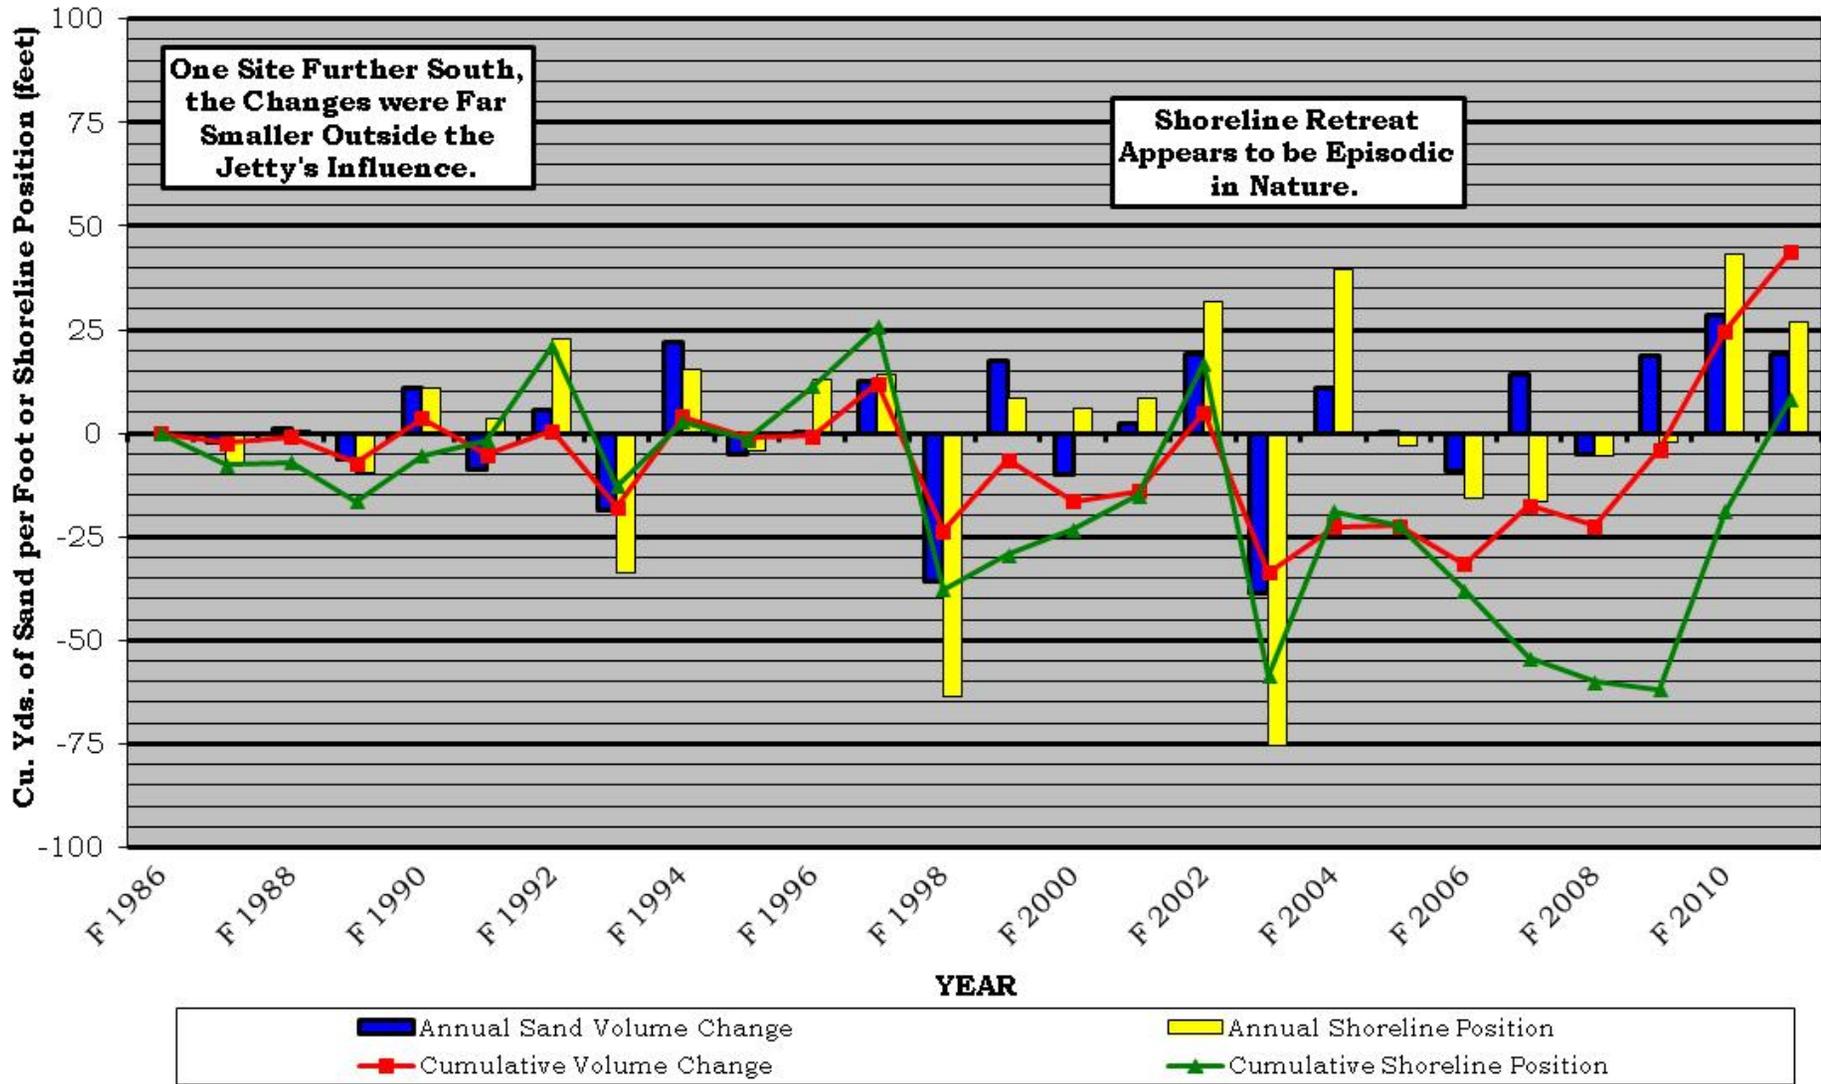
25-Year Coastal Changes at Site 144, La Baia Street, Loveladies, Ocean Co.

Figure 217. Profile 144 in Loveladies is far enough south to have been influenced little from the Barnegat Inlet Jetty's installation in 1991. The general trend up until 2008 appeared to be that of shoreline retreat and sand volume loss, however, that trend seemed to reverse with recovery taking place from 2009 through 2011.

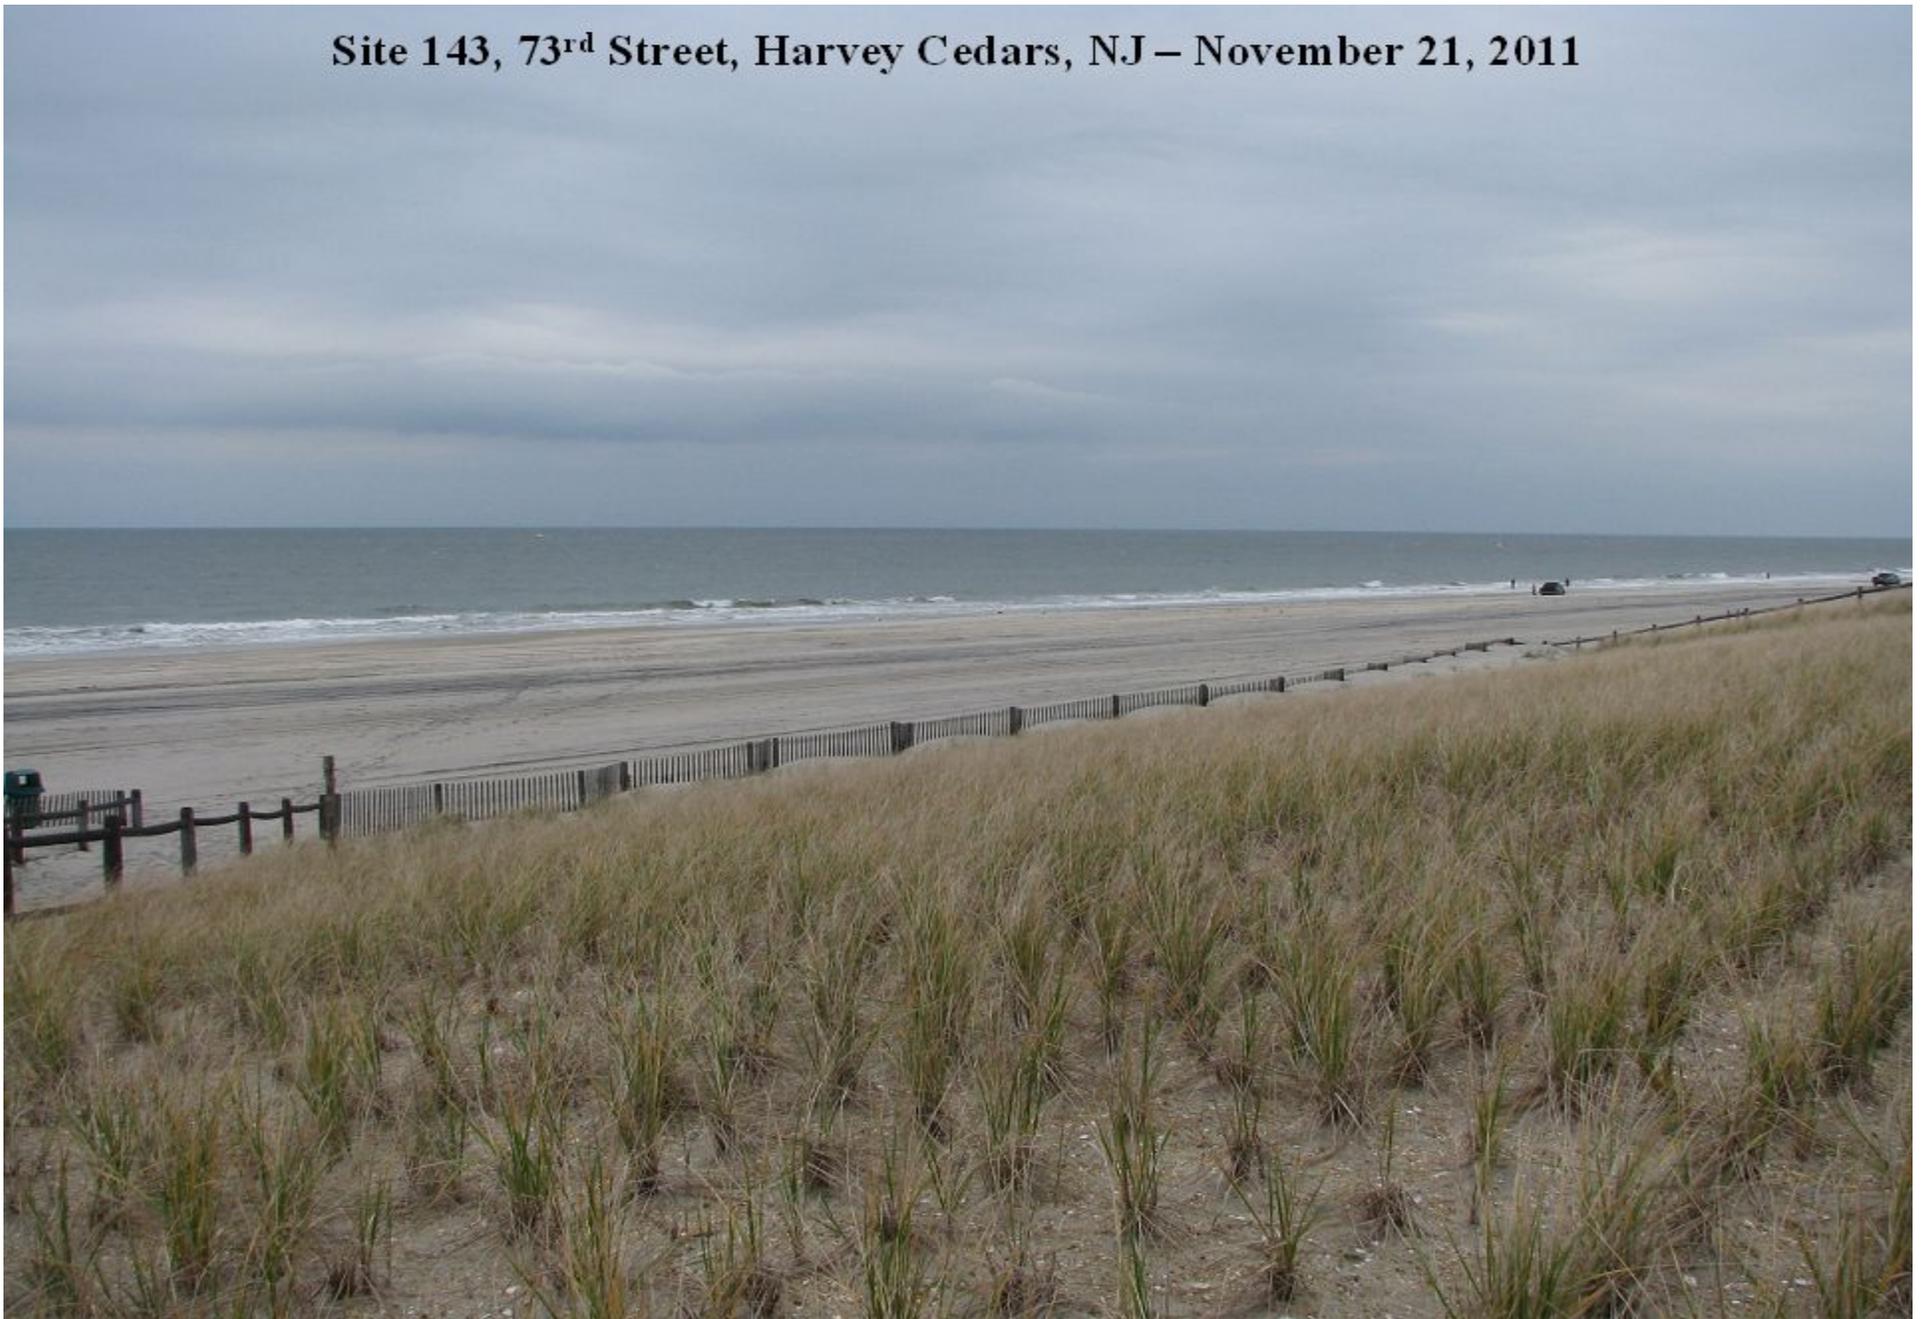
Site 143, 73rd Street, Harvey Cedars, NJ – November 21, 2011

Figure 218. Shown above is the view looking southeast from the dune at 73rd Street in Harvey Cedars, NJ.

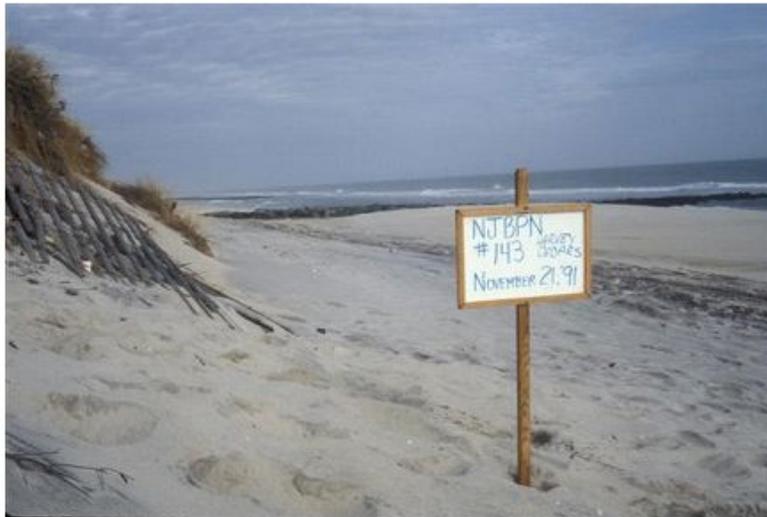
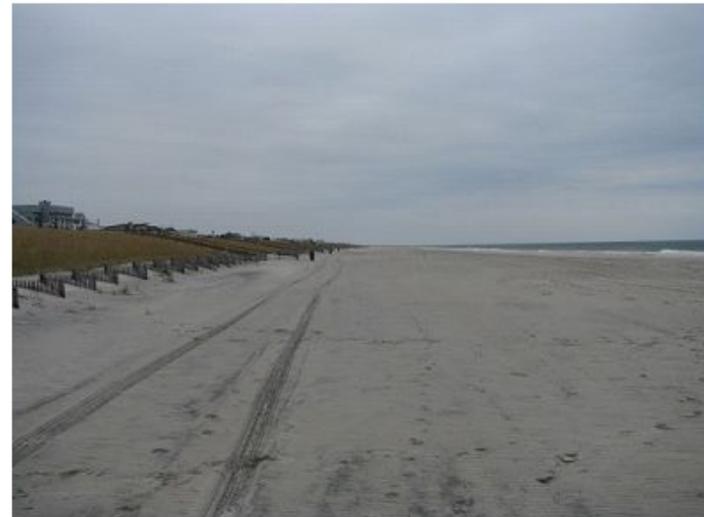
Figure 220 above shows the initial survey in 1986 and the survey from November of 2011 which saw the shoreline advance 189 feet and 111.27 cu.yd/ft. of sand added to the beach. In spring 2010 the ACOE added 242.44 cu.yd/ft. of sand to the beach. Photo on the left was taken in November of 1991 and shows the view from the dune to looking northeast. Photo on the right was taken in November of 2011 and shows the view from the dune toe and the dramatically wider beach.

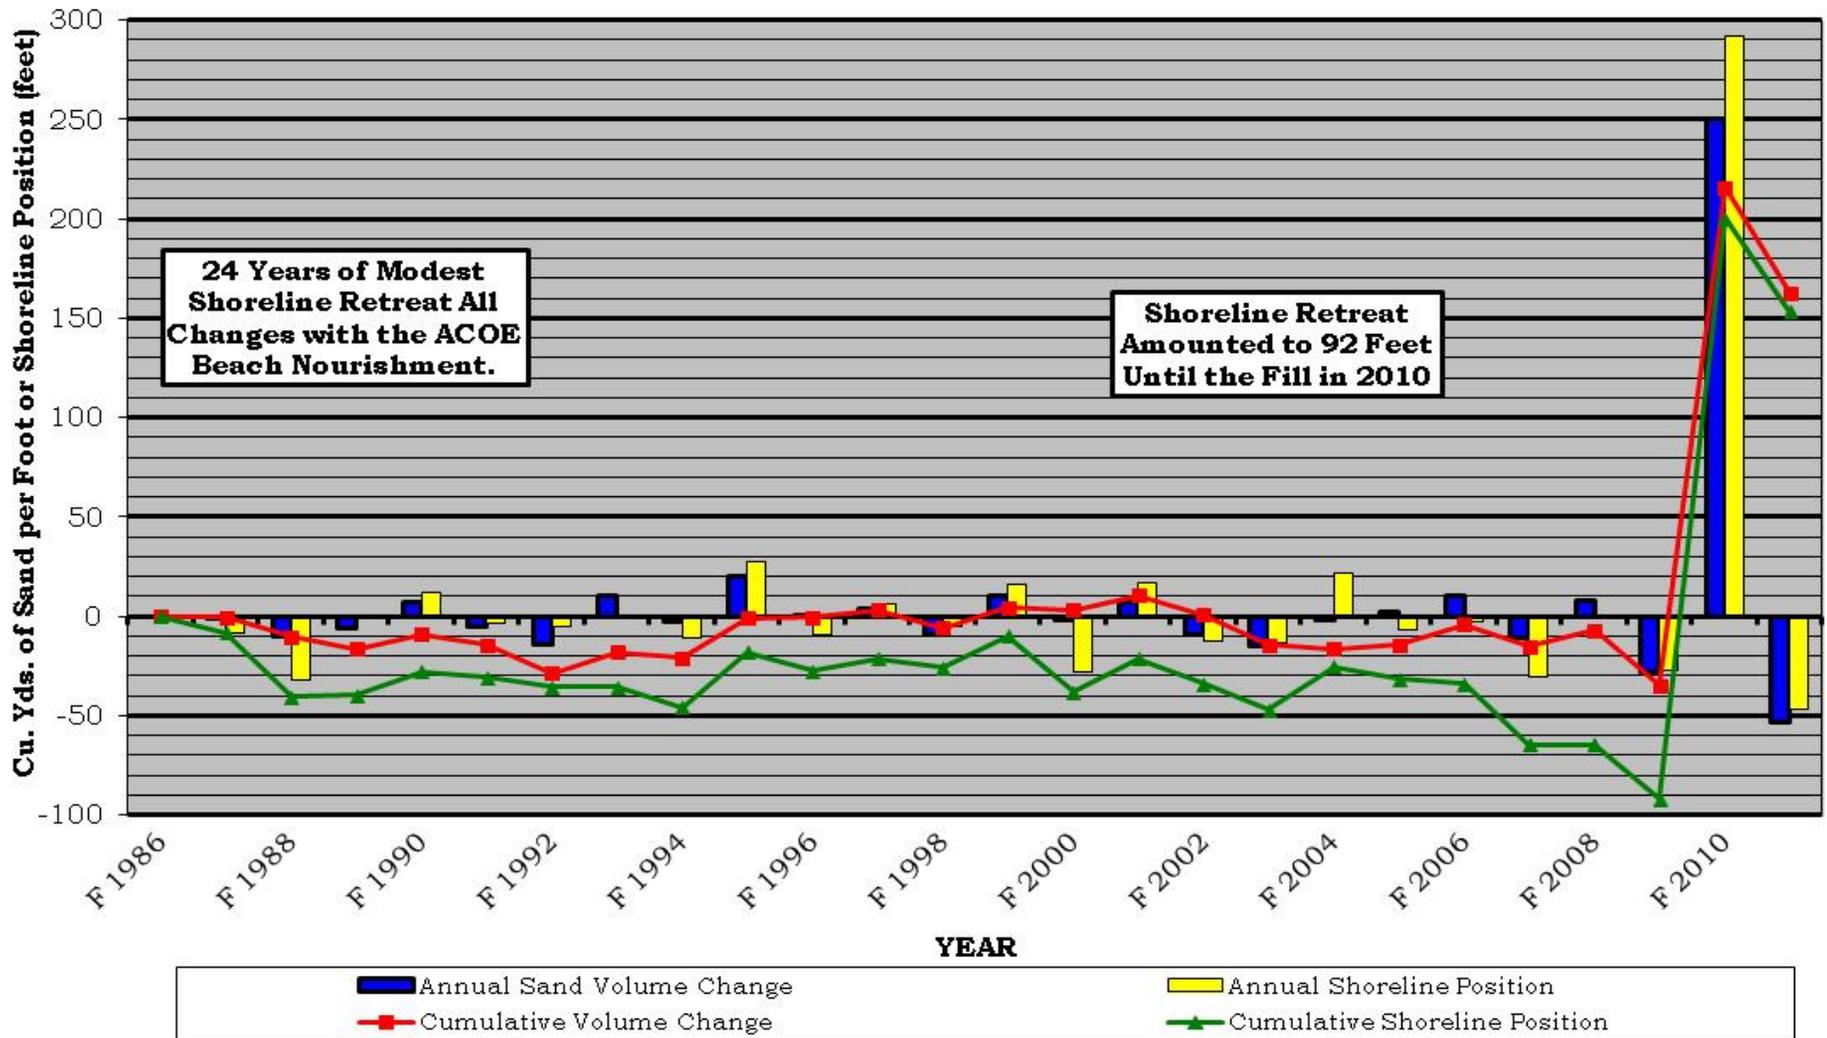
Figure 221. Profile 143 in Harvey Cedars was the beneficiary of 465,000 cubic yards of sand added to system in 1994-95 during a state and local sponsored project. Despite the fact that little effect is shown on the figure above the additional sand in the system surely helped to maintain the beaches up until 2006. From 2006 until 2010 the shoreline steadily retreated landward until it became necessary for ACOE to deposit sand onto the beach to protect the shorefront infrastructure.

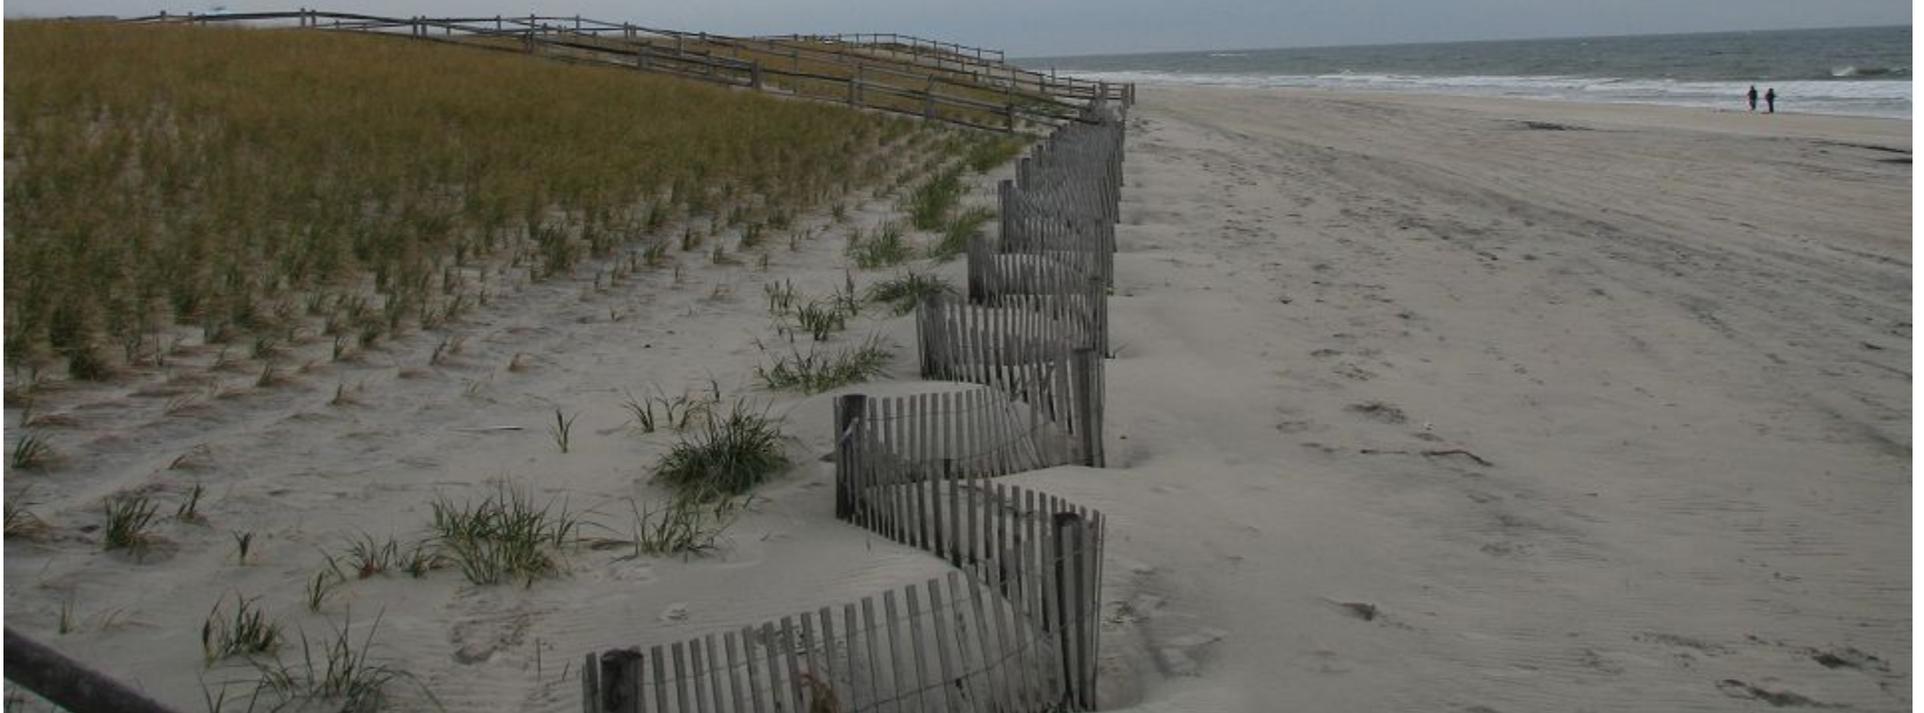
Site 142, Tranquility Drive, Harvey Cedars, NJ – November 21, 2011

Figure 222. Shown above is the view looking north from the fence line at Tranquility Drive in Harvey Cedars, NJ. The sand trapping effect of the dune fencing is apparent in this picture.

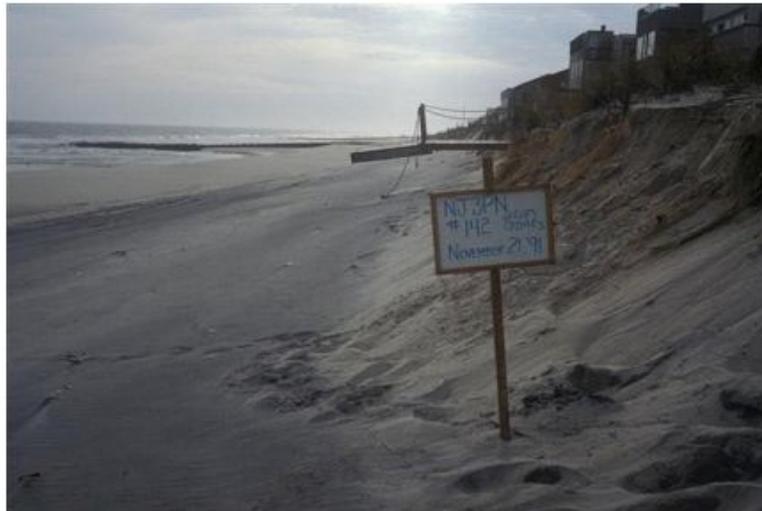
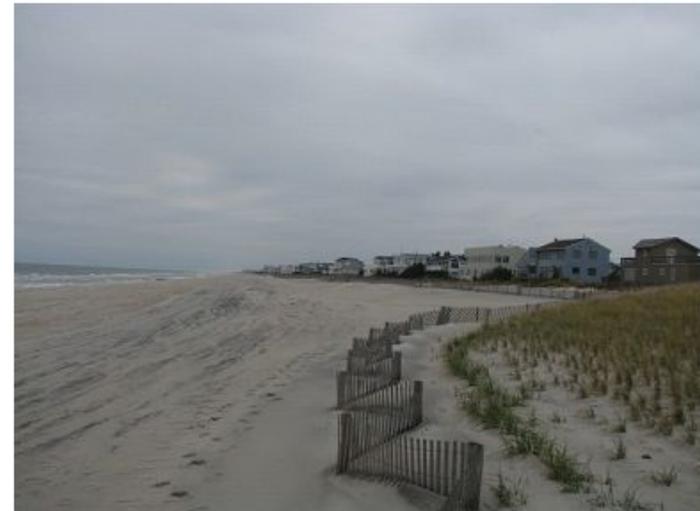
Figure 224 above shows the dramatically different topography between 1986 and 2011 in which time the shoreline advanced 209 feet, and the beach gained 141.459 cu.yd/ft. of sand. A replenishment project in 2010 added 134.73 cu.yd/ft of sand. Photo on the left was taken in November of 1991 shows the view south from the dune toe and the exposed groin. Photo on the right was taken in November of 2011 and shows the view south. The groin exposed in 1991 is no longer visible.

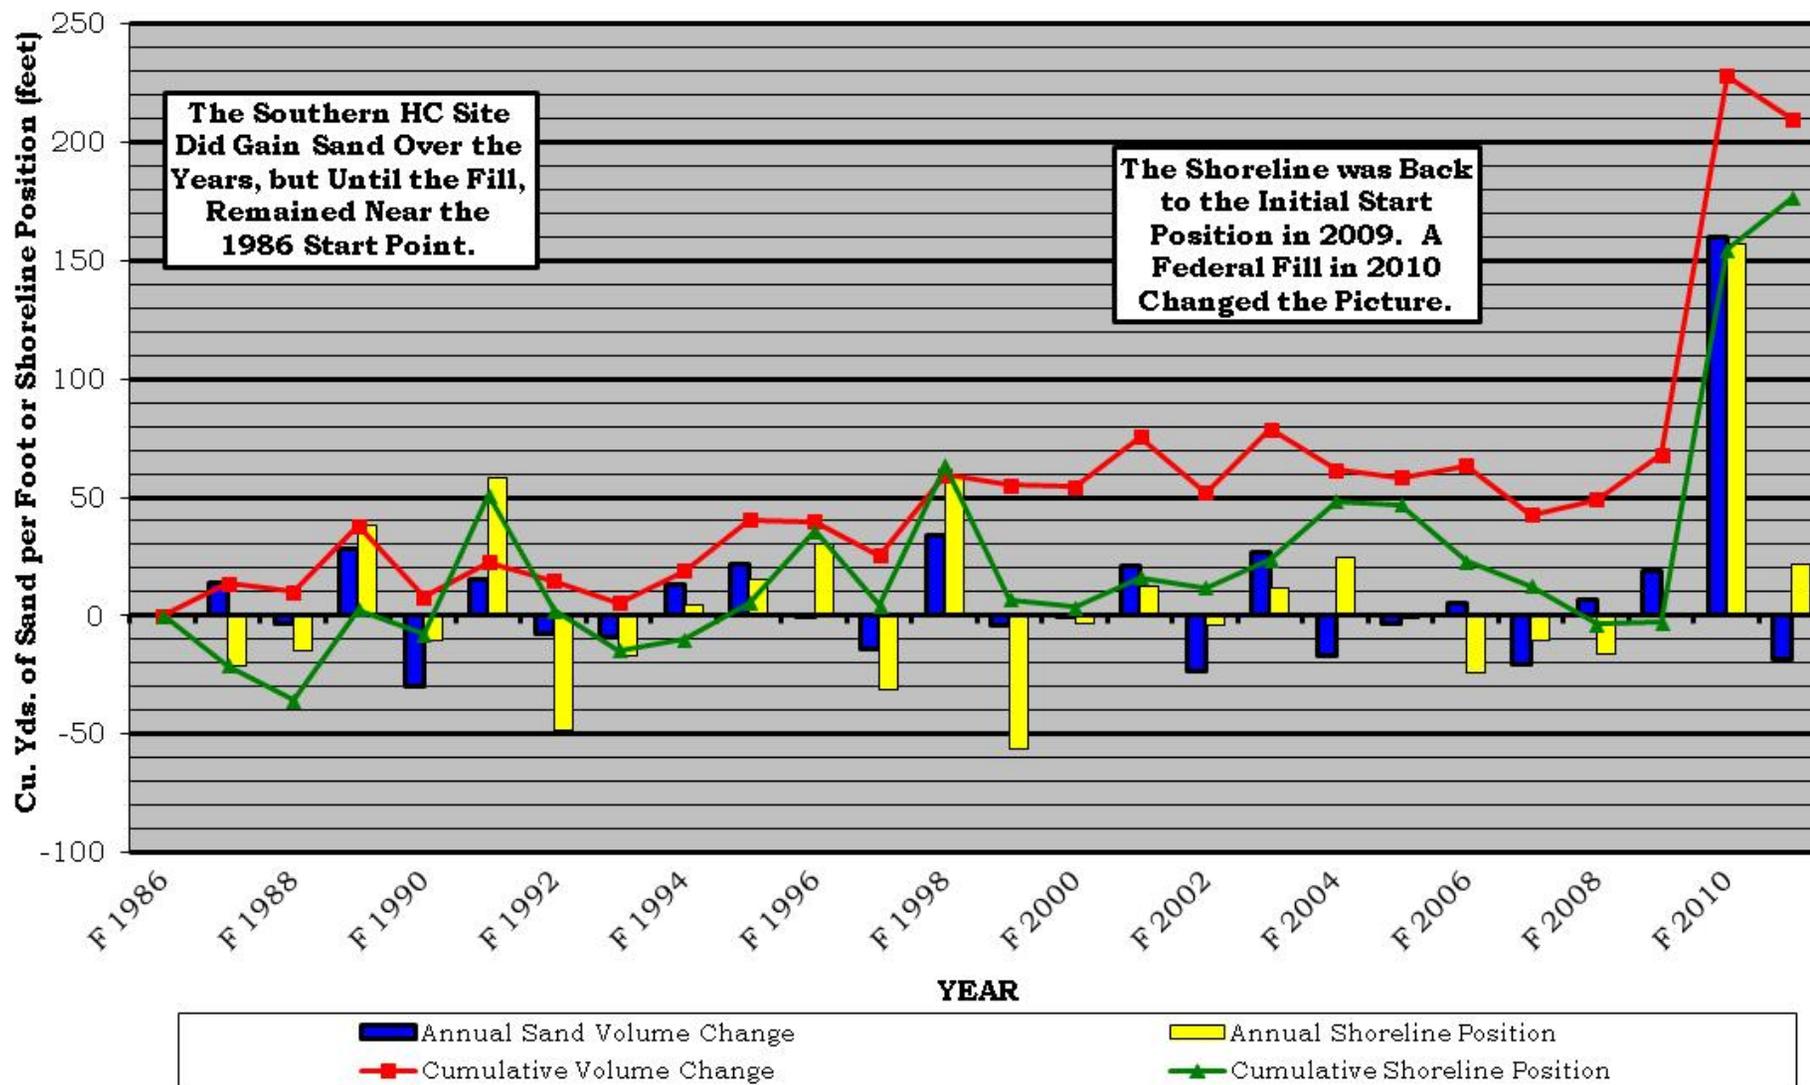
Figure 225. Profile 142 in Harvey Cedars was also the beneficiary of the ACOE fill project in 2010. Prior to the fill project in 2010 this site gained sand volume and was in the same approximate position as the initial survey in 1986.

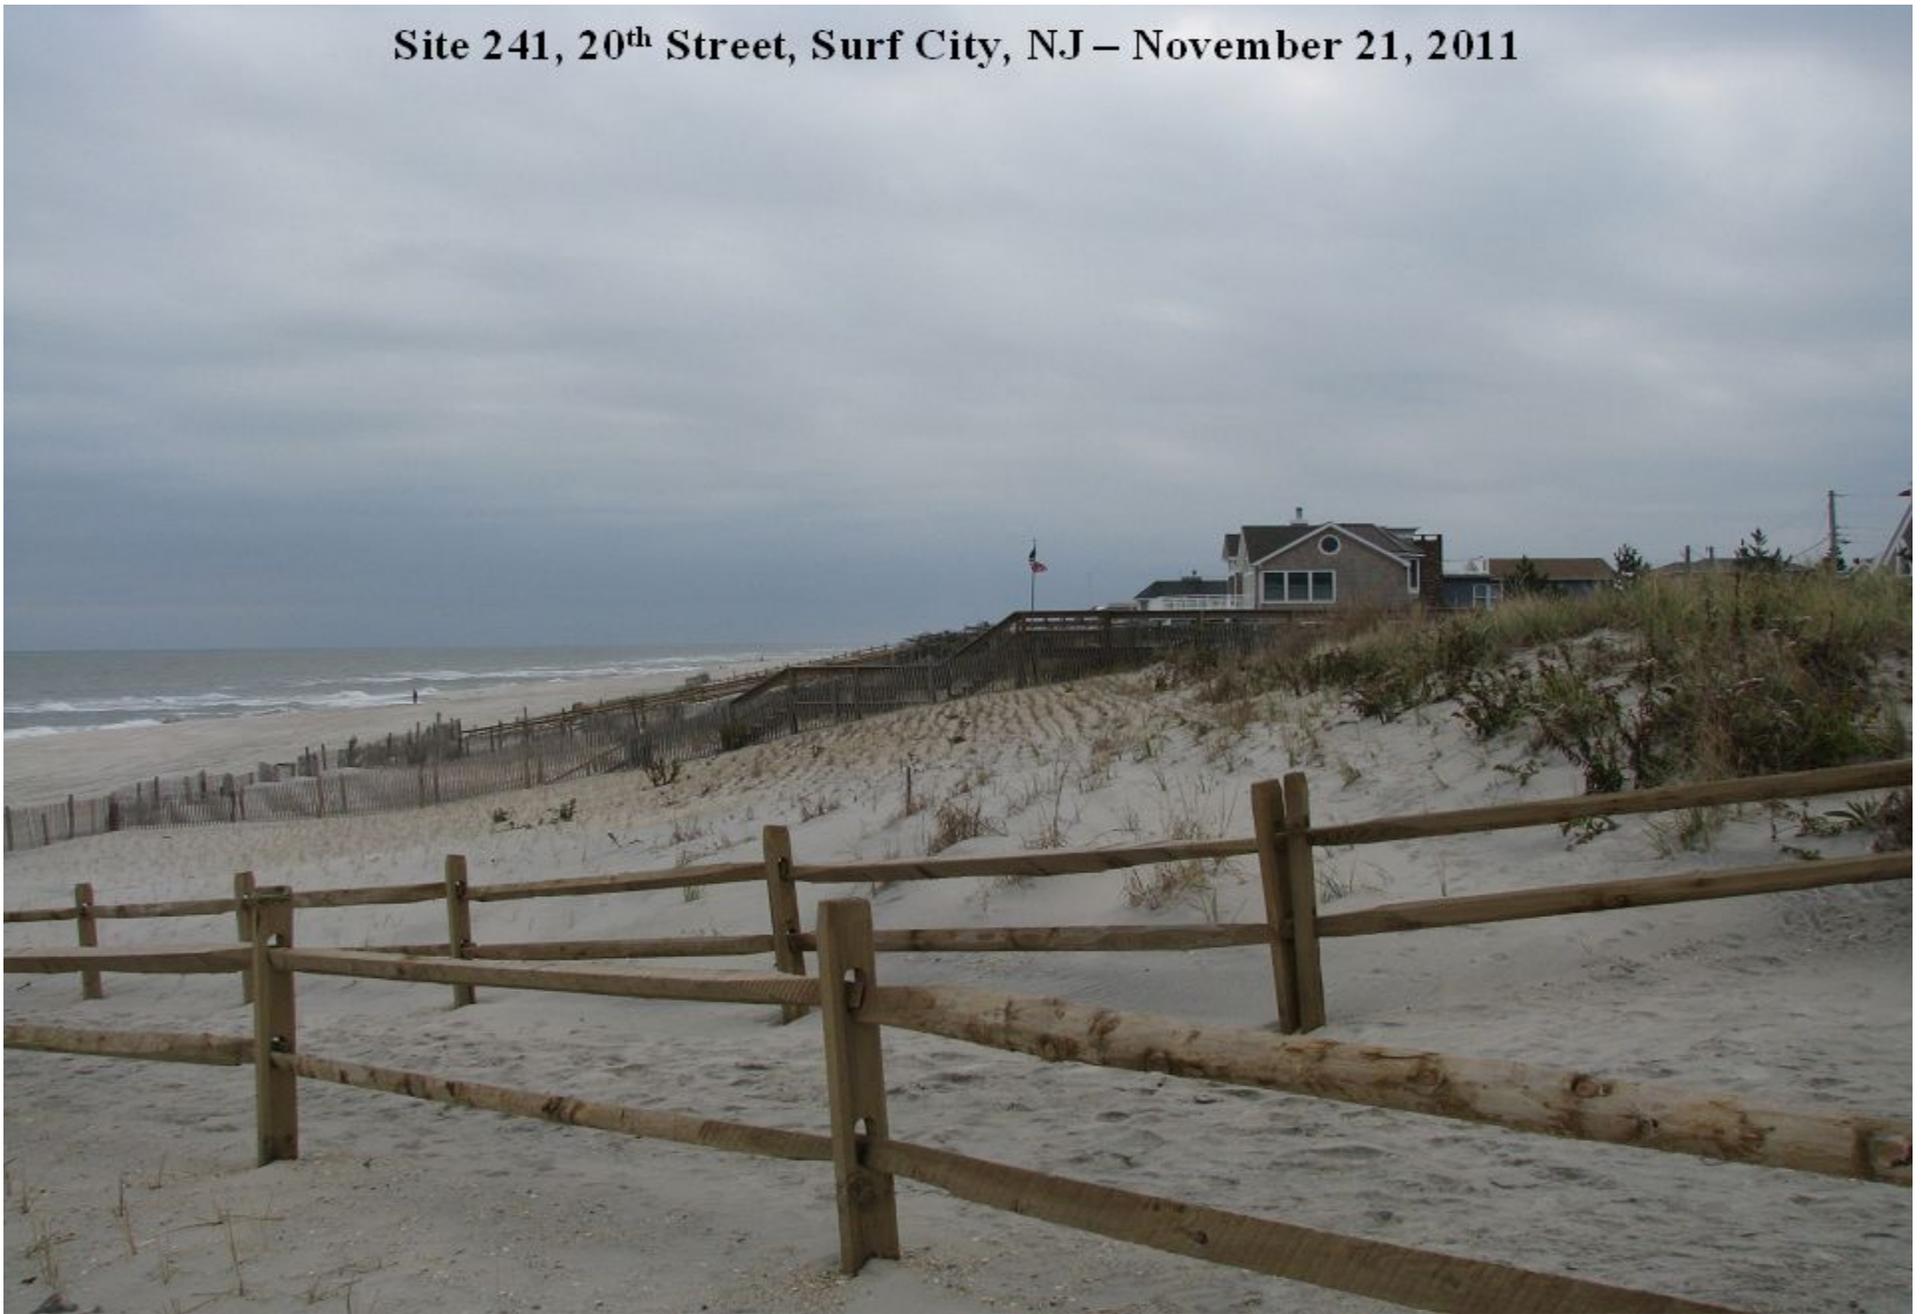
Site 241, 20th Street, Surf City, NJ – November 21, 2011

Figure 226. Shown above is the view looking south from the dune at 20th Street in Surf City, NJ.

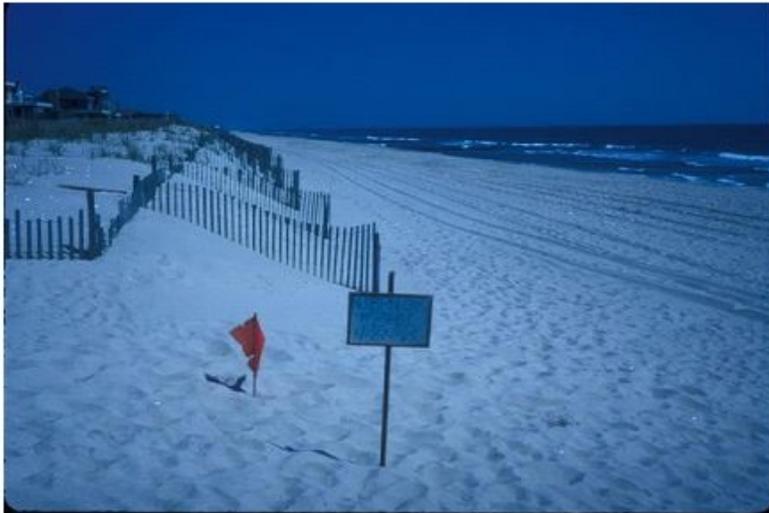
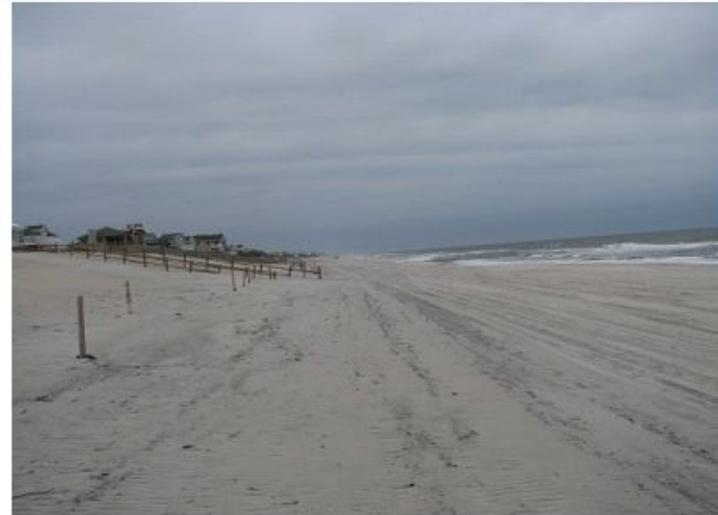
Figure 228 above shows that the dune and beachface gained sand and migrated seaward since the initial survey in 1994. As a result of these changes the shoreline advanced 42 feet and there was a net gain in volume of 30.822 cu.yd/ft. Photo on the left was taken in April of 1995 and shows the view north from the seaward crest. Photo on the right was taken in November of 2011 and shows the view to the north from the dune toe.

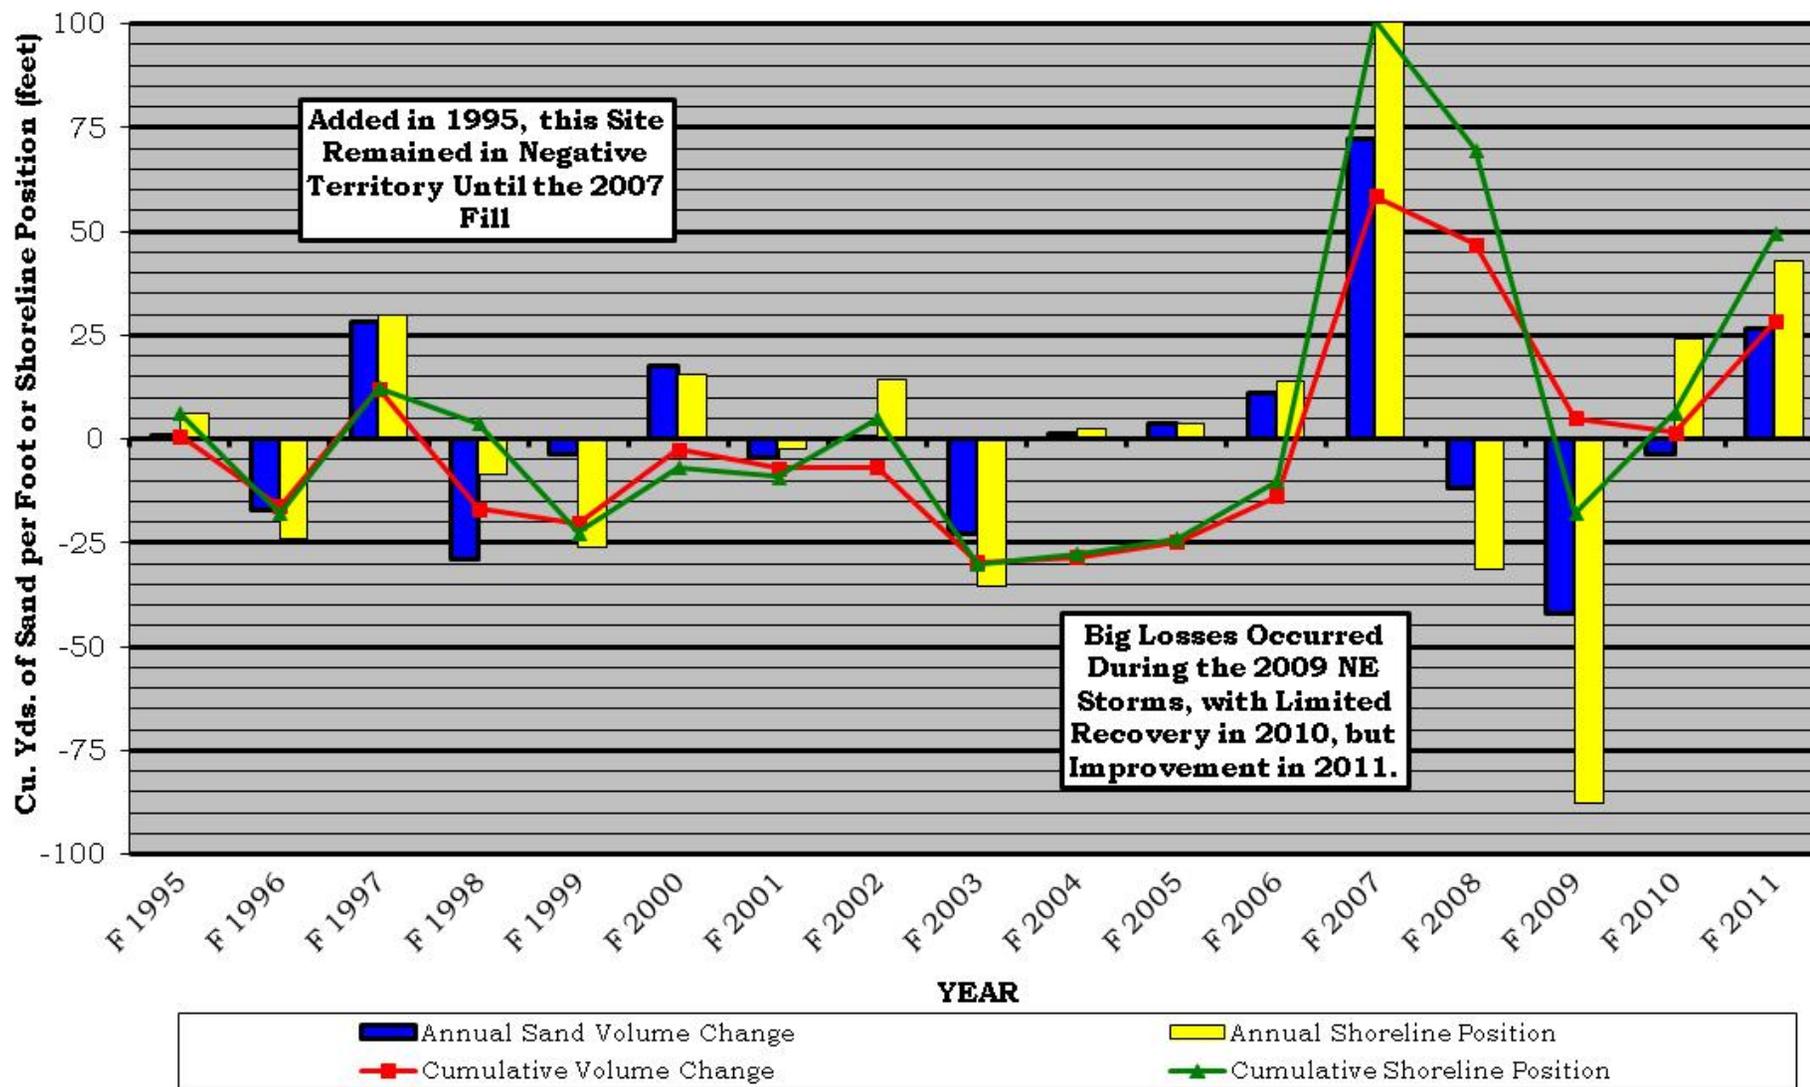
Figure 229. Profile 241 in Surf City was added in 1995 and was trending downward in both shoreline position and in sand volume until the 2007 fill project. Losses in 2008 & 2009 returned the shoreline and sand volume to near pre-fill conditions before a recovery in 2011.
