New Jersey Beach Profile Network

Ocean County

Manasquan Inlet
to Little Egg Inlet

NJBPN Profile #'s
156 - 234

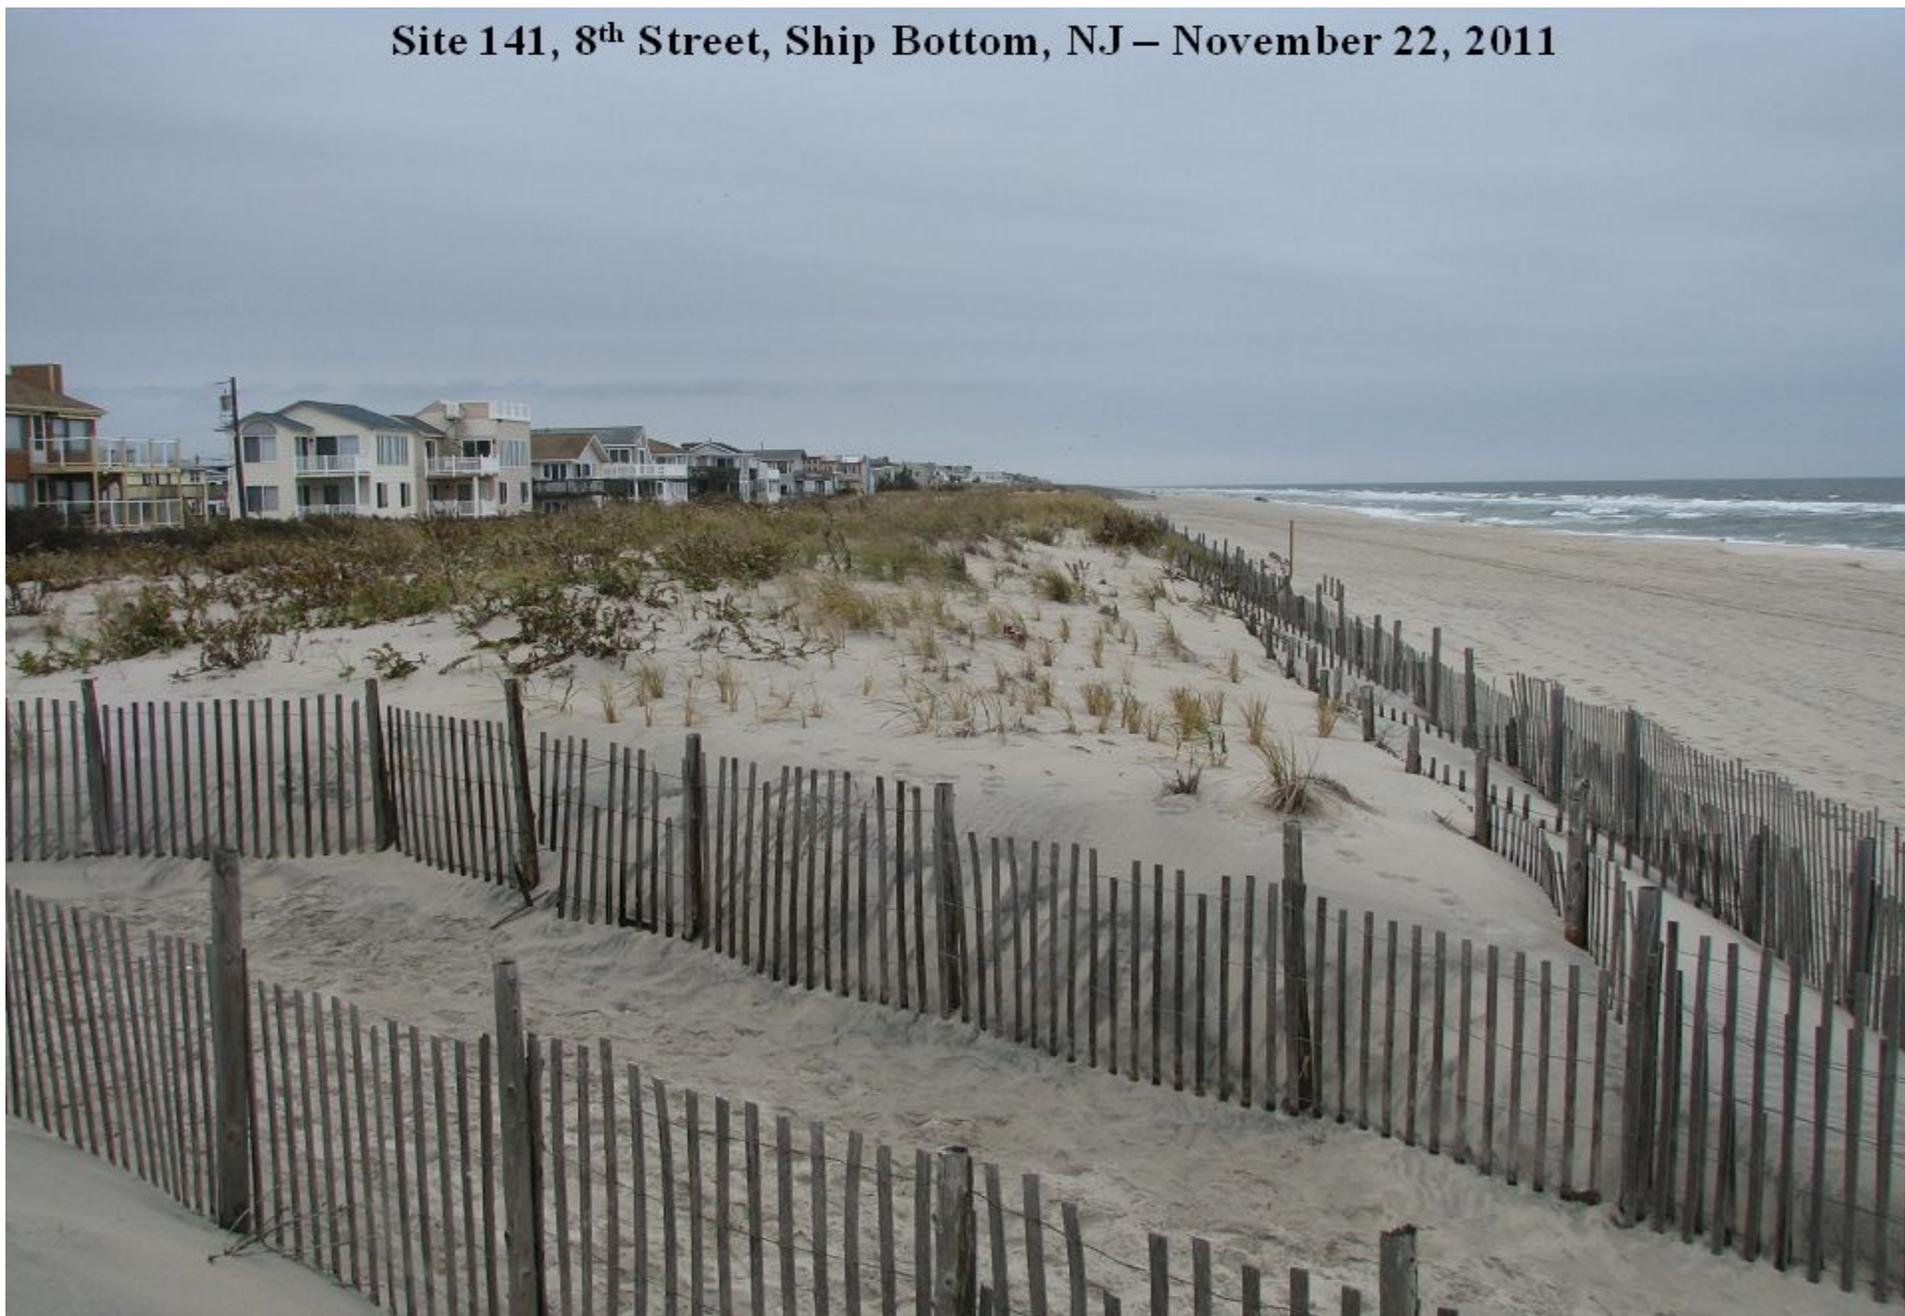
Site 141, 8th Street, Ship Bottom, NJ – November 22, 2011

Figure 230. Shown above is the view looking north from the dune crest at 8th Street in Ship Bottom, NJ.

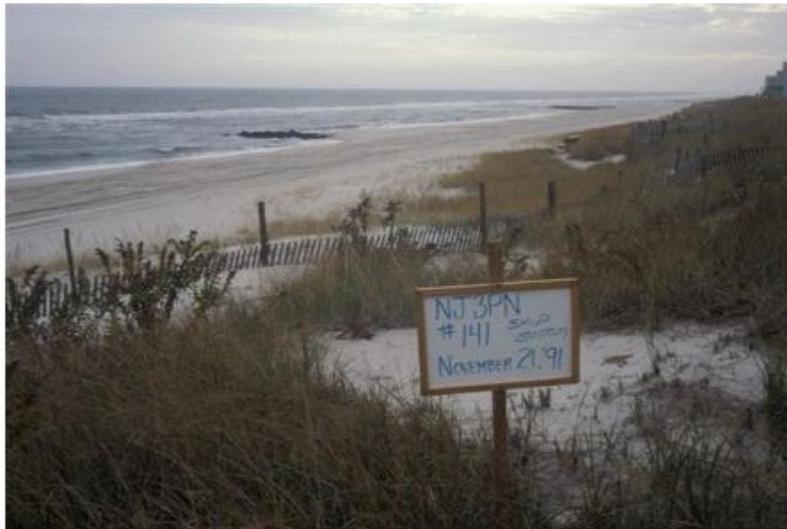
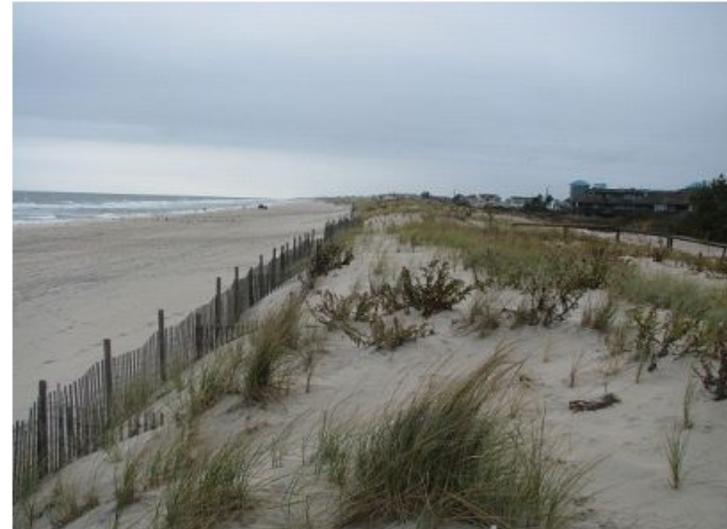
Figure 232 above shows that the dune, berm, and beachface all have grown since the initial survey in 1986. These changes are reflected in numbers as the shoreline advanced 76 feet and the profile gained 56.851 cu.yd/ft. of sand. Photo on the left was taken in November of 1991 and shows the view from the dune crest looking southeast. Photo on the right was taken in November of 2011 and shows the view from the seaward crest looking south.

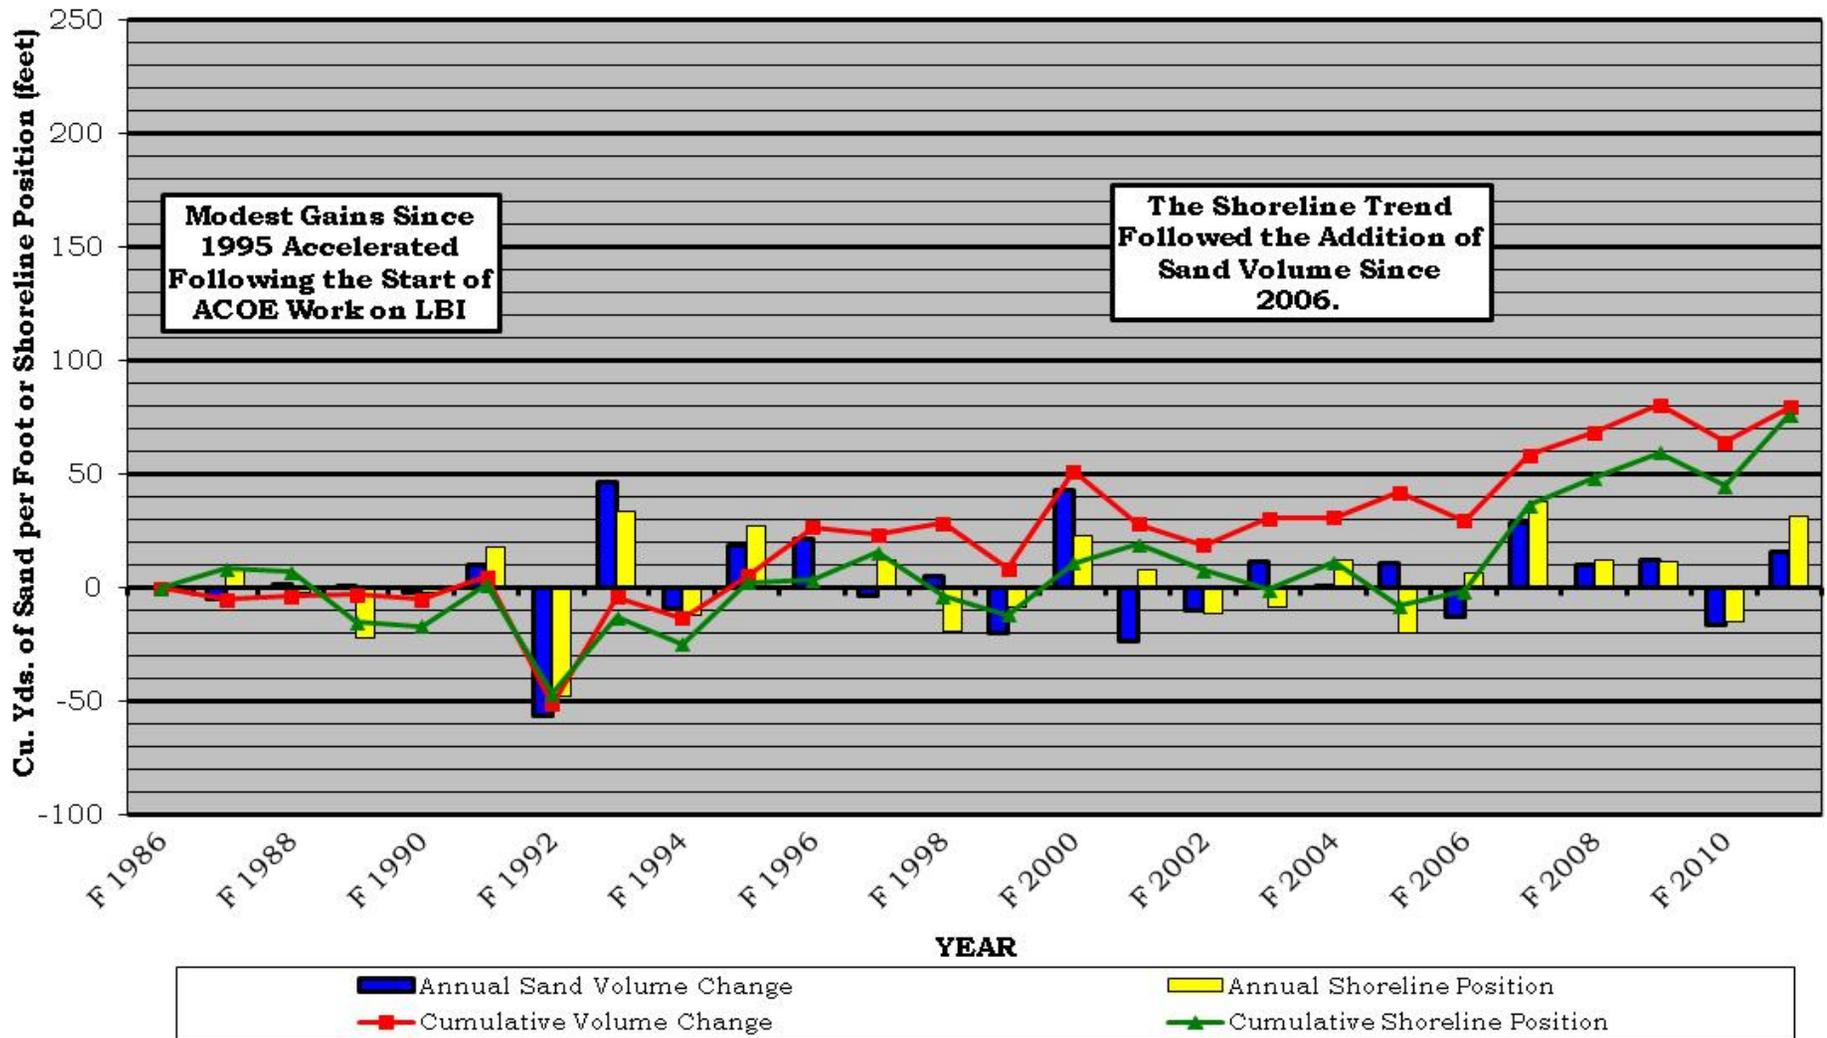
Figure 233. Profile 141 in Ship Bottom was relatively stable throughout its history. The 1992 northeast storm resulted in the largest loss of sand volume and shoreline position. This was followed by recovery in 1993, and a pattern of modest gain(s) beginning in 1995 which added sand volume and advanced the shoreline. In 2006 the sand volume increase accelerated and the shoreline advanced in lockstep along with it.

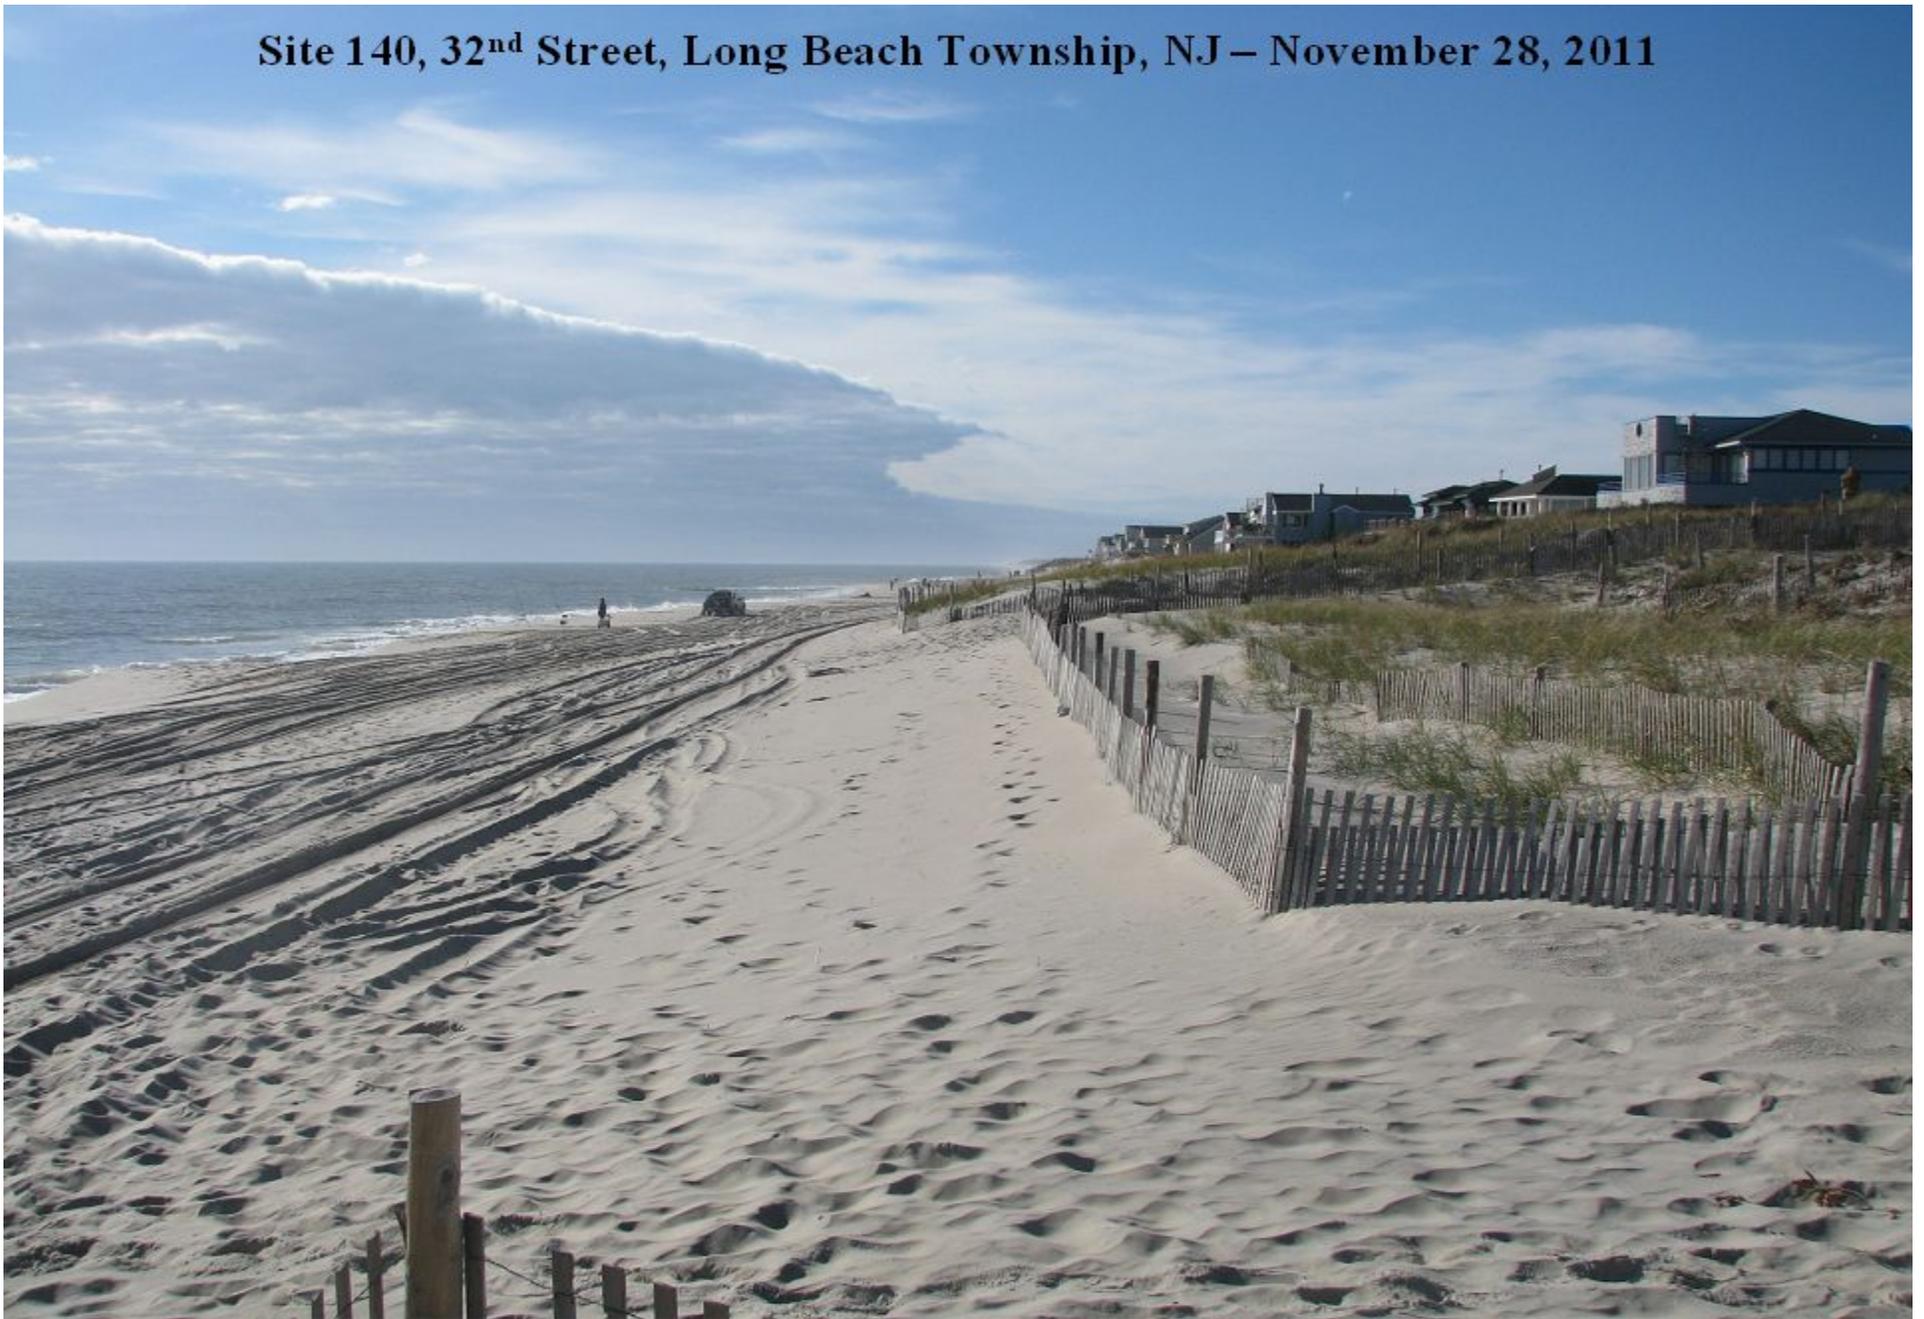
Site 140, 32nd Street, Long Beach Township, NJ – November 28, 2011

Figure 234. Shown above is the view looking south from the dune toe at 32nd Street in Long Beach Township, NJ.

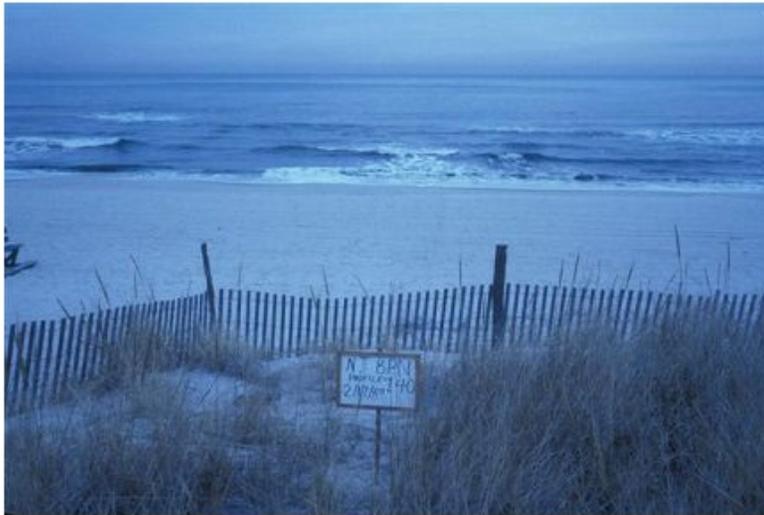
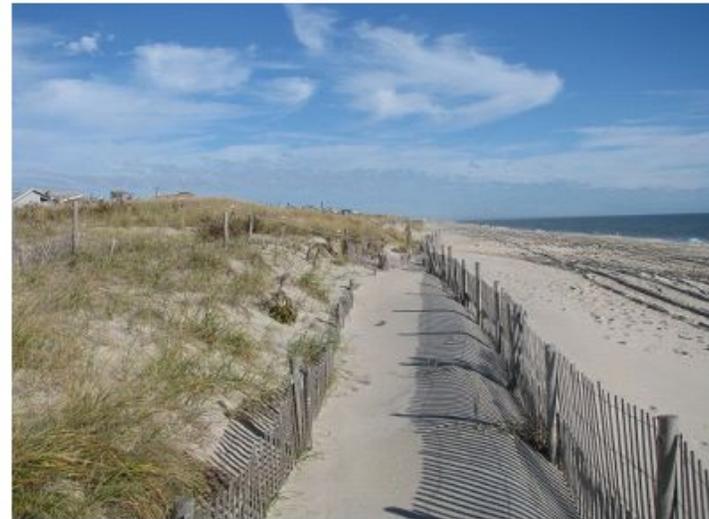
Figure 236 above shows that the dune grew horizontally since the survey in 1986. Minor changes to the beachface resulted in a shoreline retreat of 10 feet, however, the significant gains to the dune resulted in a net gain of 17.565 cu.yd/ft. of sand. Photo on the left was taken in February of 1989 and shows the view east from the dune crest. Photo on the right was taken in November of 2011 and shows the view north from the seaward crest of the dune.

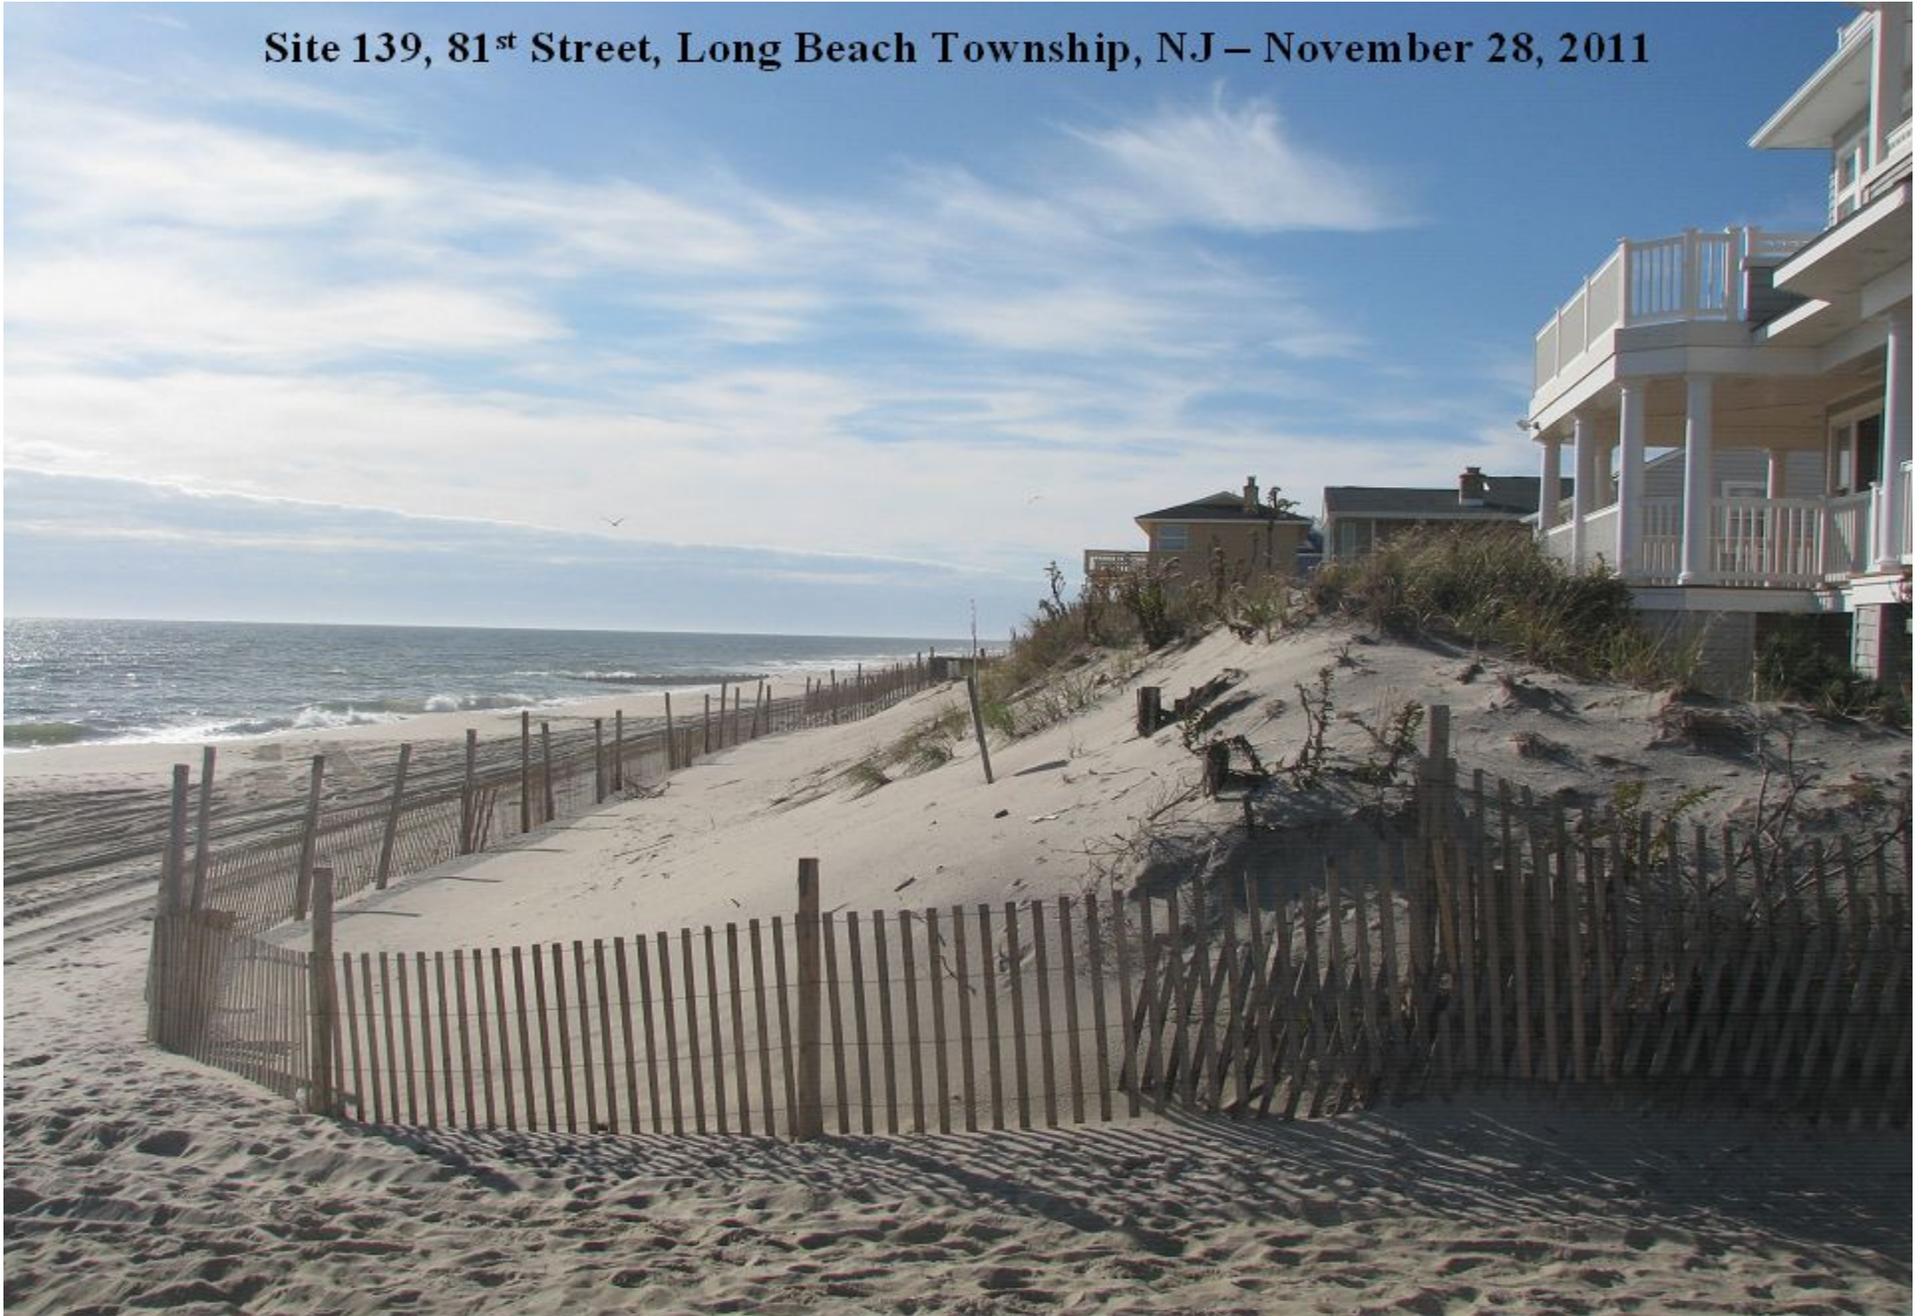
Site 139, 81st Street, Long Beach Township, NJ – November 28, 2011

Figure 238. Shown above is the view looking south from the dune at 81st Street in Long Beach Township, NJ.

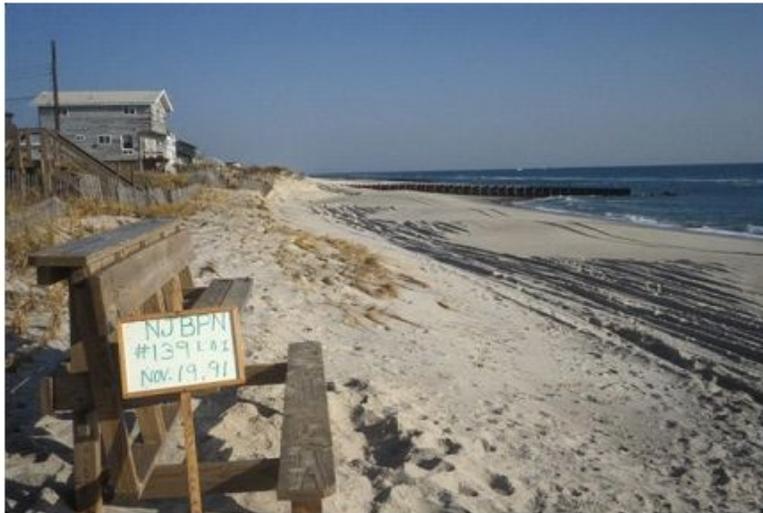
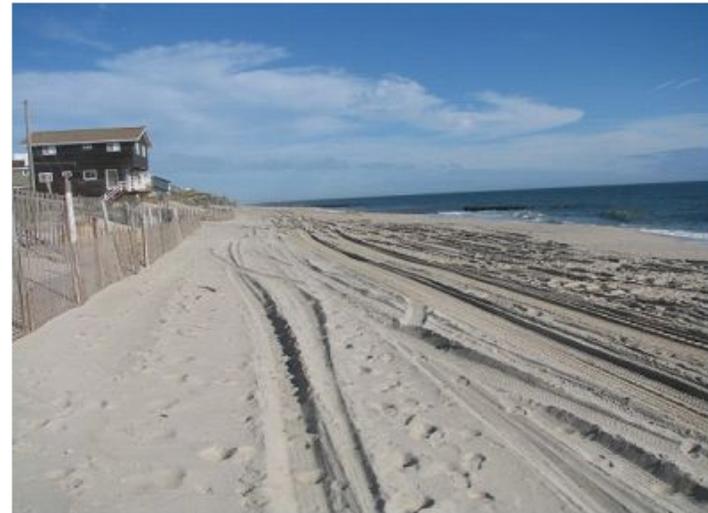
Figure 240 above shows that when compared to the initial survey in 1986 the 2011 survey shows losses to the dune, berm, and beachface; and gains to the offshore slope. The shoreline retreated 35 feet and there was a net loss of 14,593 cu.yd/ft of sand. Photo on the left was taken in November of 1991 and shows the view to the north from the seaward crest. Photo on the right was taken in November of 2011 and shows the view to the north from the dune toe.

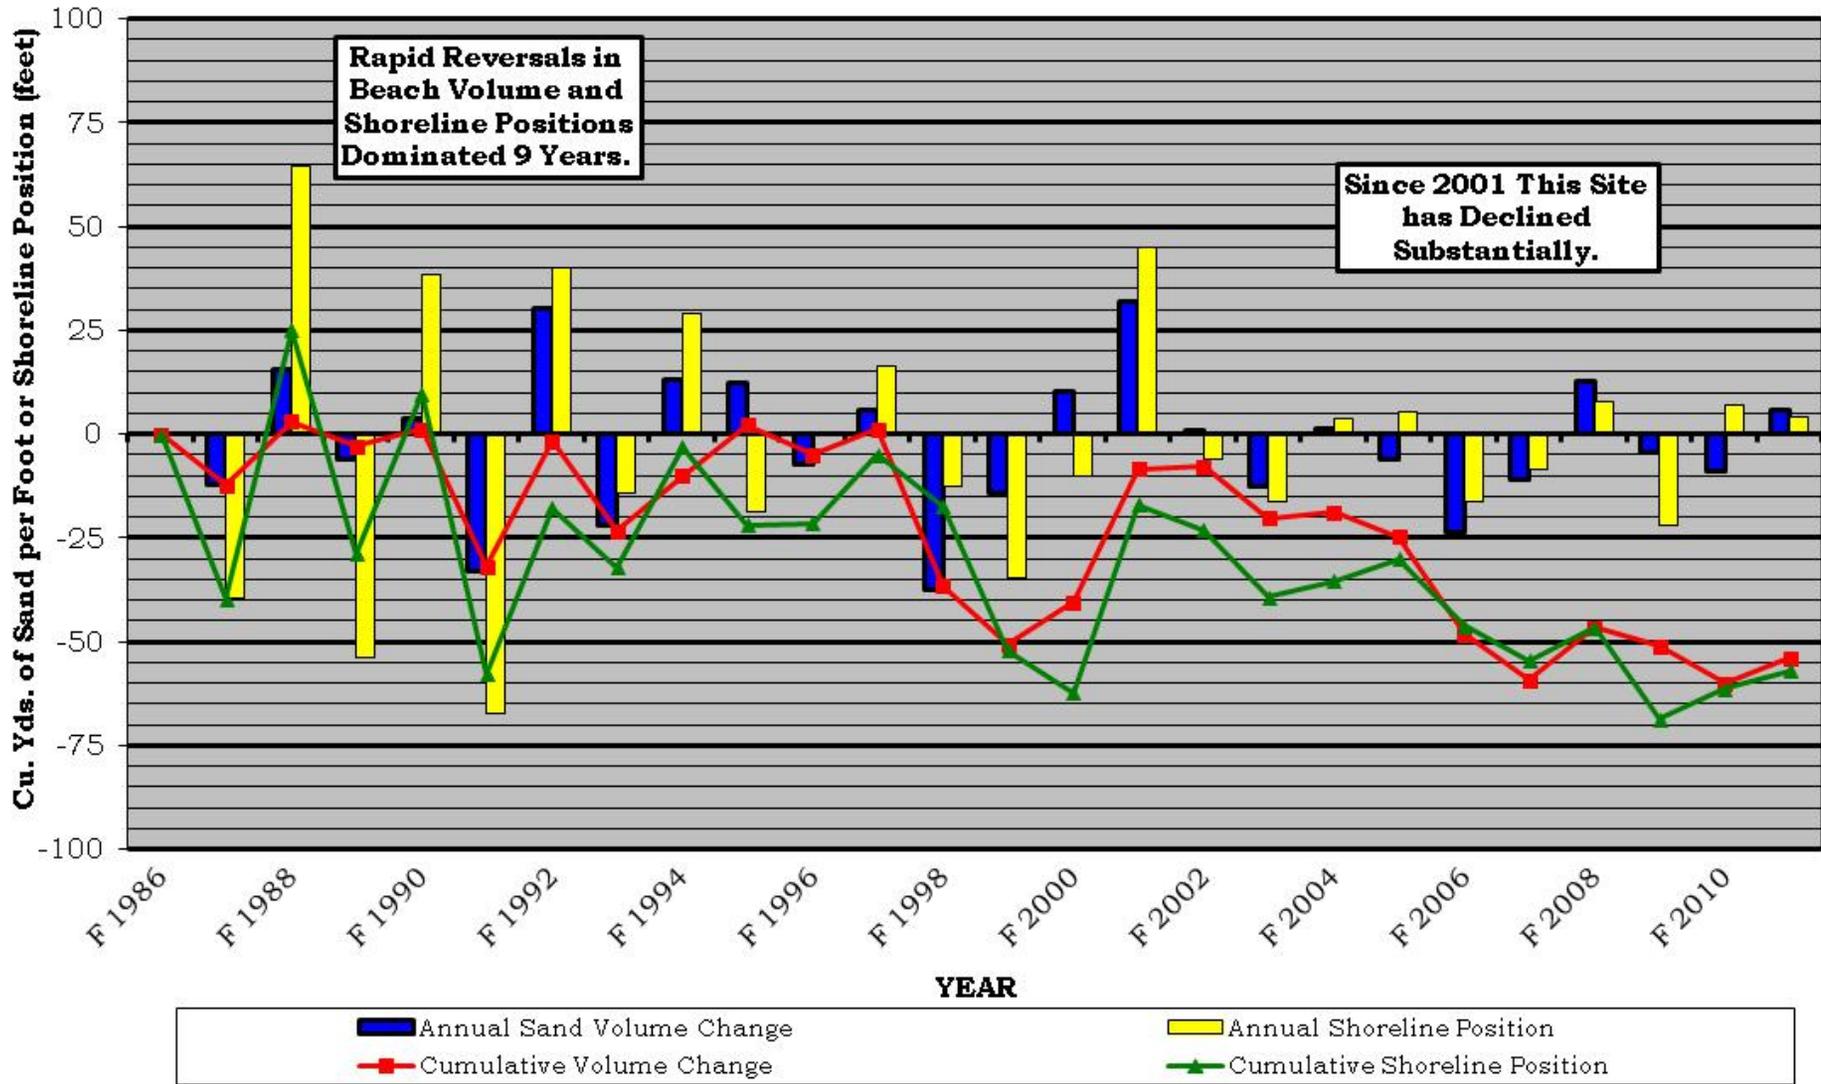
Figure 241. Profile 139 in Long Beach Township saw tremendous oscillations in the first 10 years of monitoring. From 2001 on the trend was a negative one as both the shoreline position and the sand volume decline substantially.

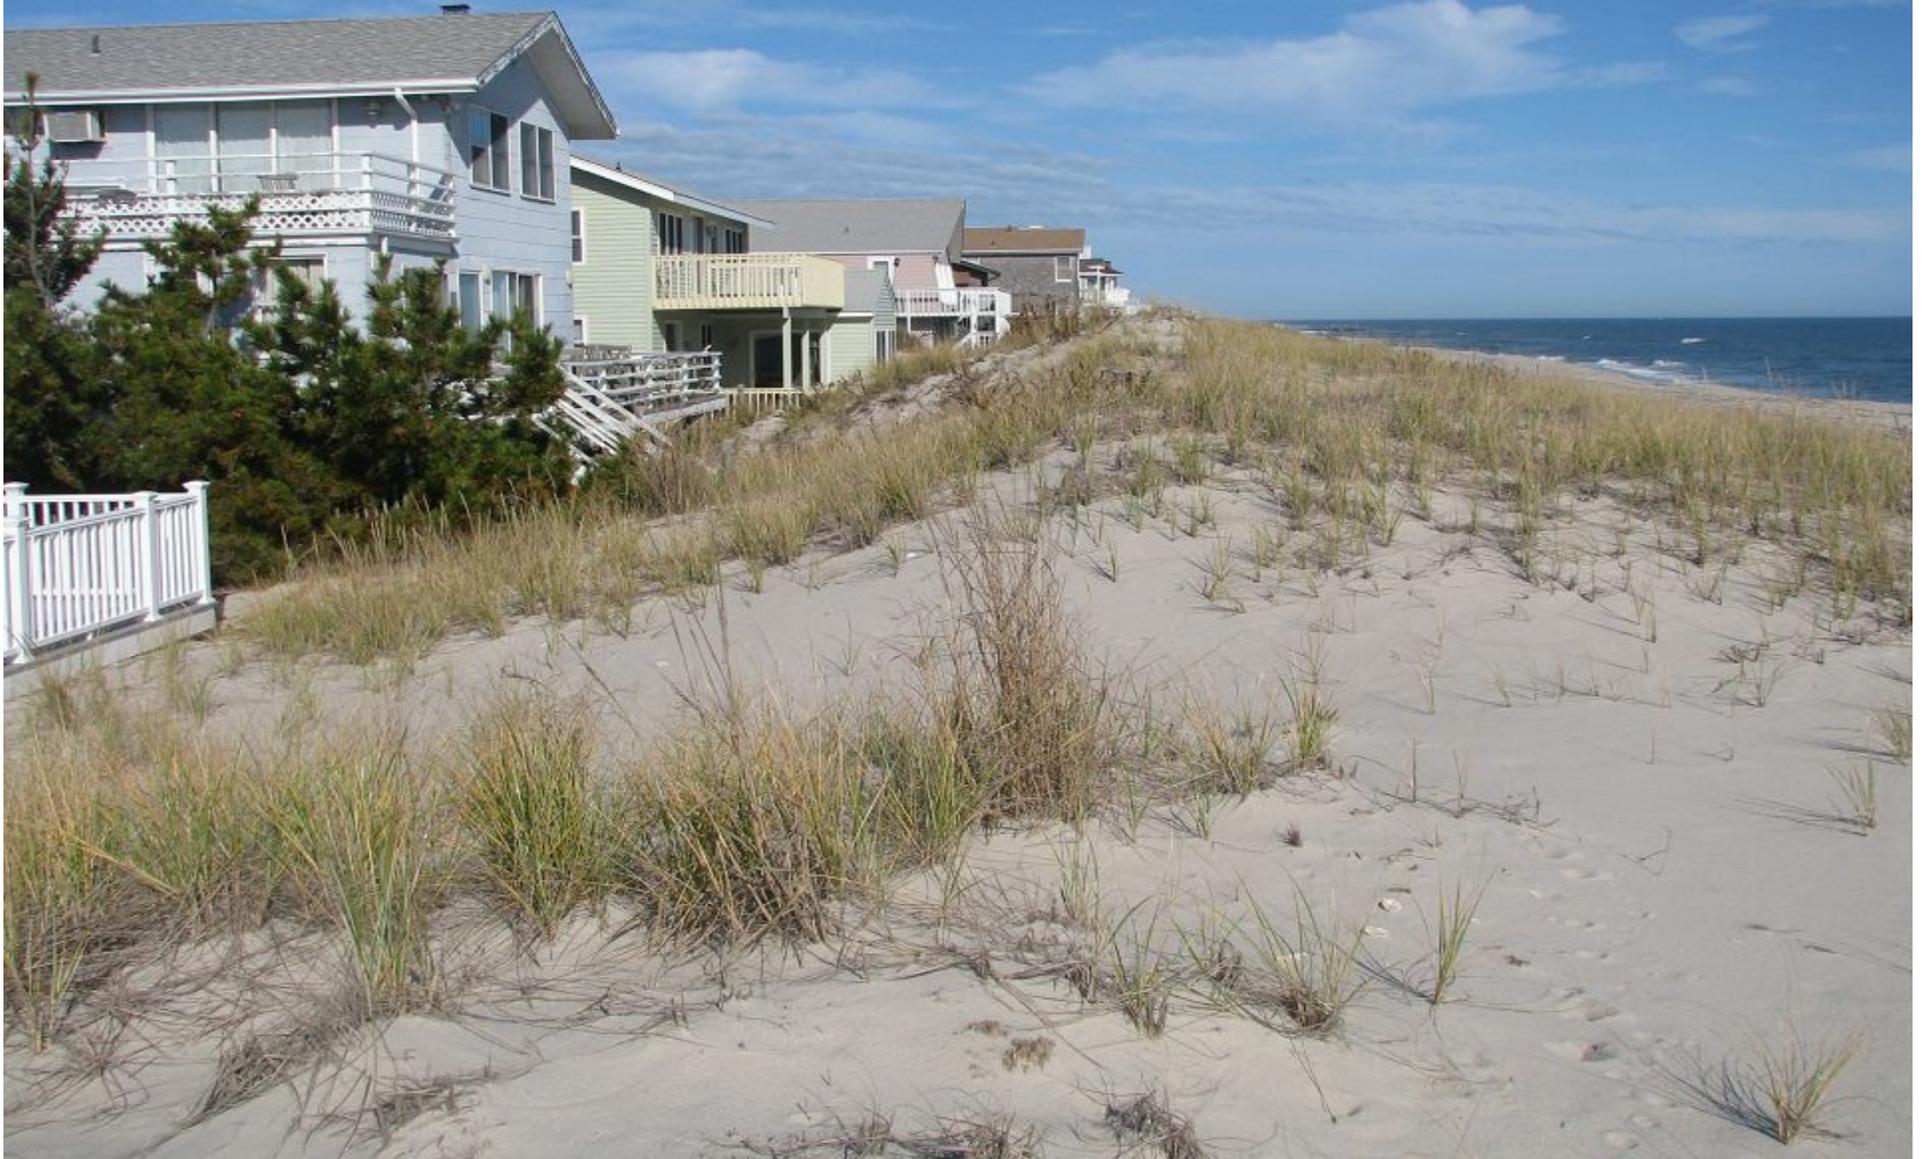
Site 138, Old Whaling Road, Long Beach Township, NJ – November 28, 2011

Figure 242. Shown above is the view looking north from the dune at Old Whaling Road in Long Beach Township, NJ.

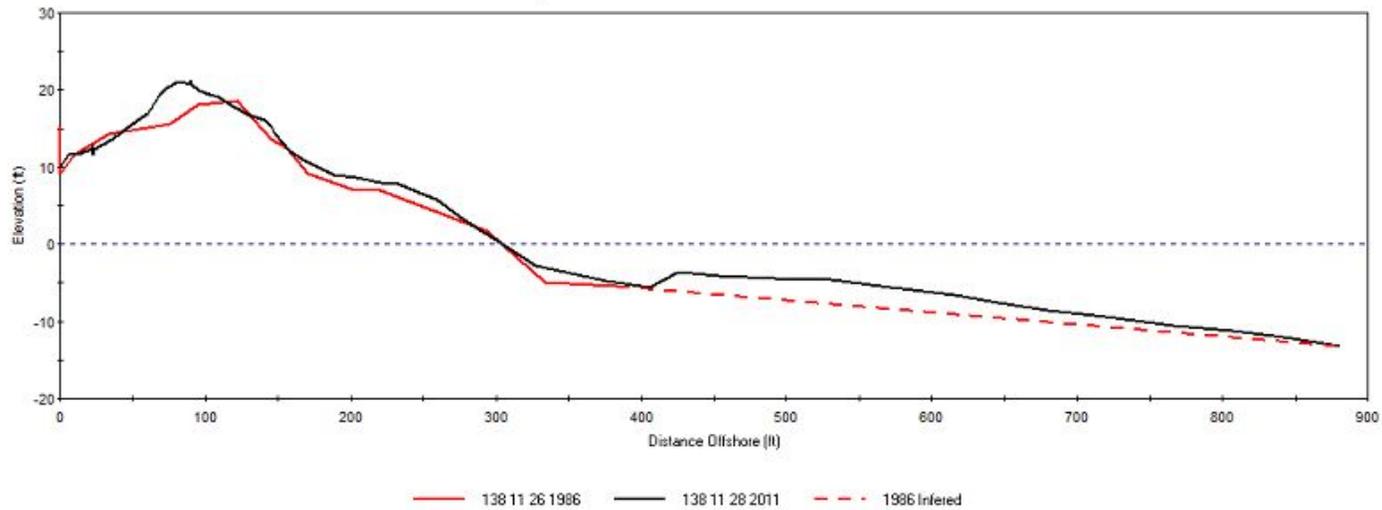
OLD WHALING ROAD, LONG BEACH TOWNSHIP – SITE 138

Figure 244 above shows that this site's initial survey in 1986 is very similar as to its condition in 2011. Minor gains to the dune, berm and offshore slope resulted in a net gain of 15.29 cu.yd/ft of sand, a shoreline advance of just 1 foot. Photo on the left was taken in November of 1991 and shows the view north from the dune toe. Photo on the right was taken in November of 2011 and shows the view north from the beach.

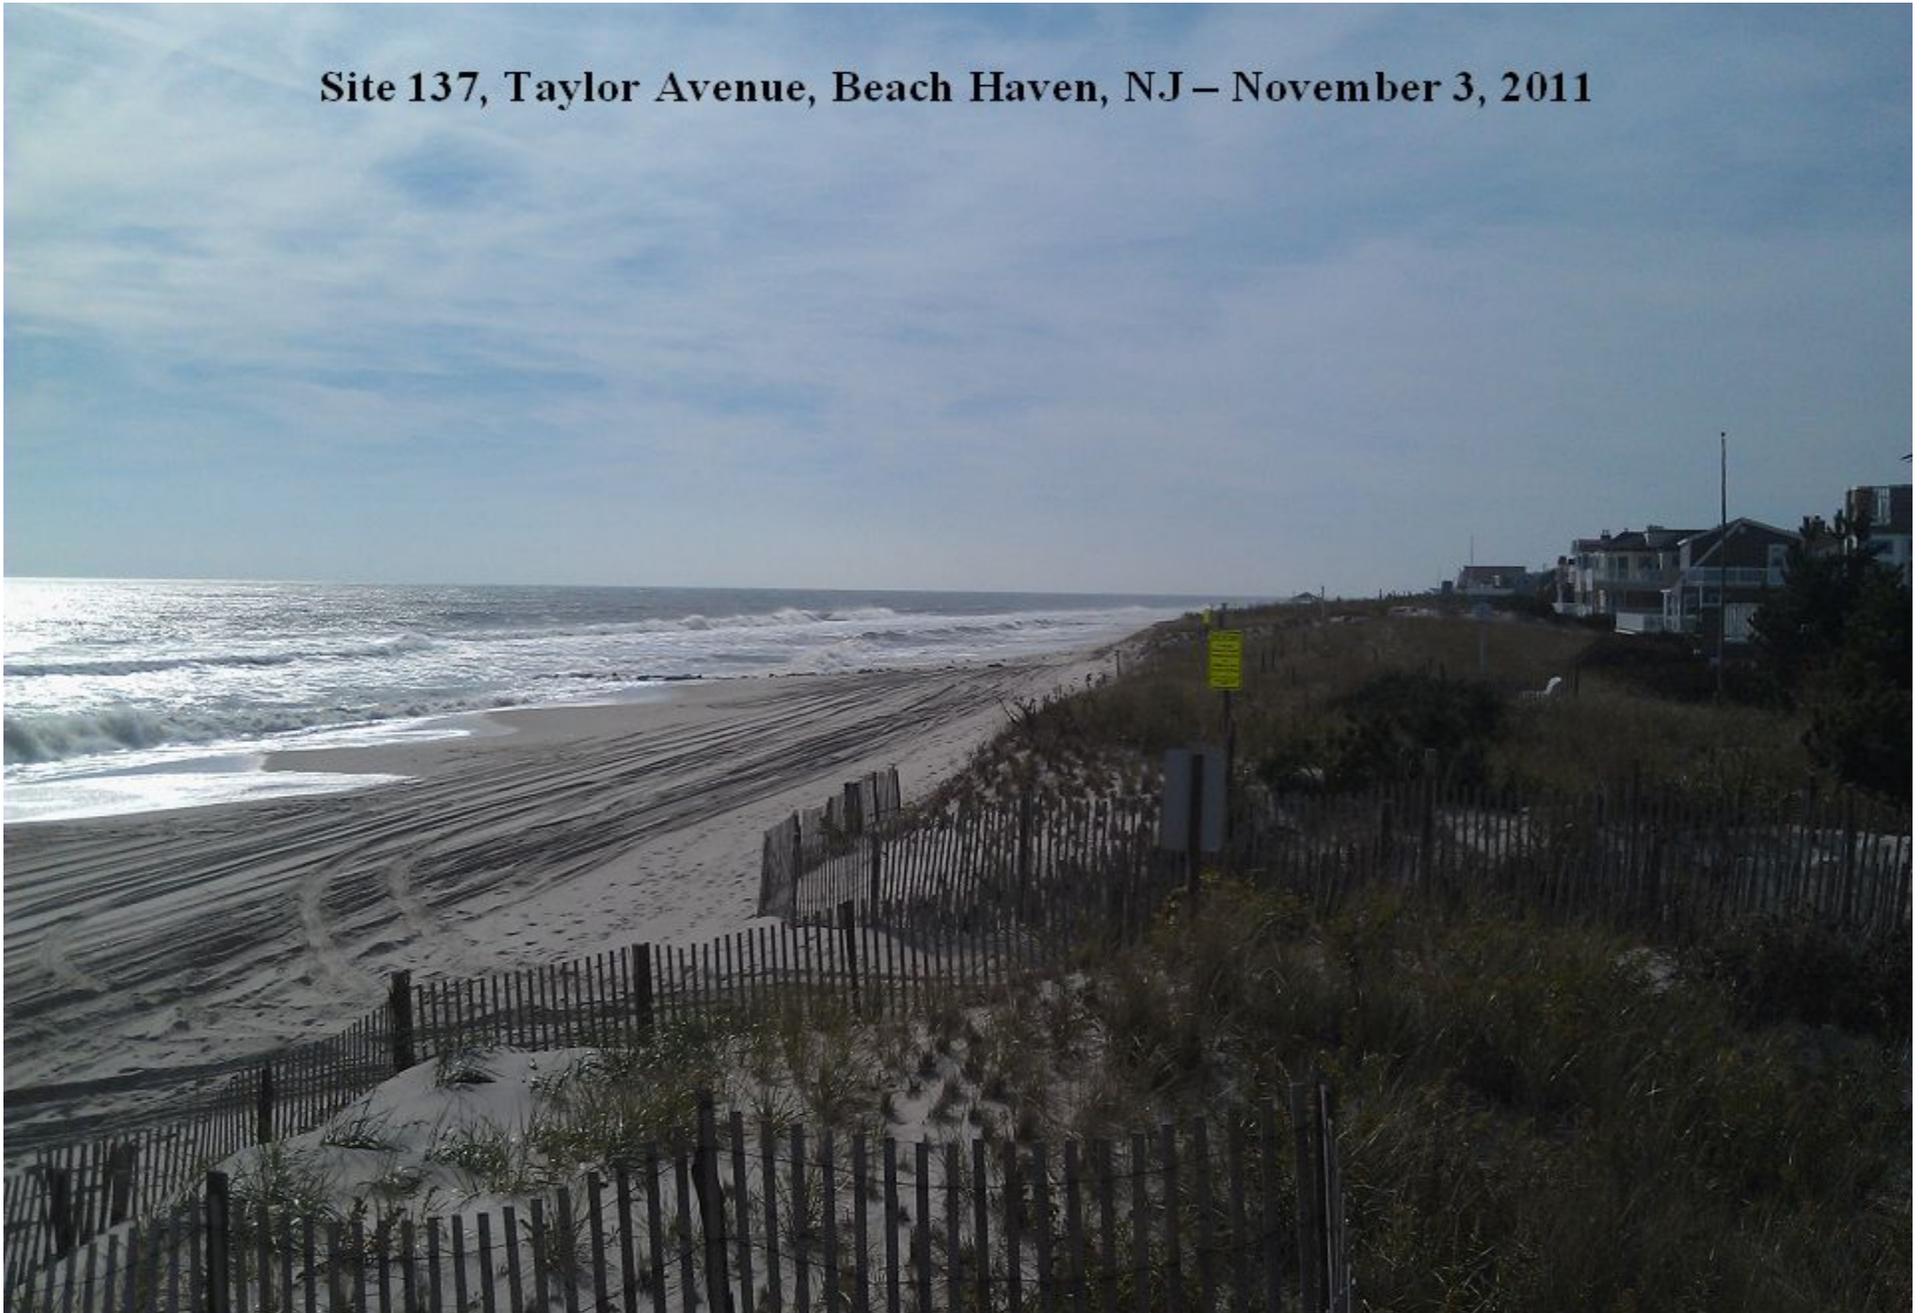
Site 137, Taylor Avenue, Beach Haven, NJ – November 3, 2011

Figure 246. Shown above is the view looking south from the dune crest at Taylor Avenue in Beach Haven, NJ.

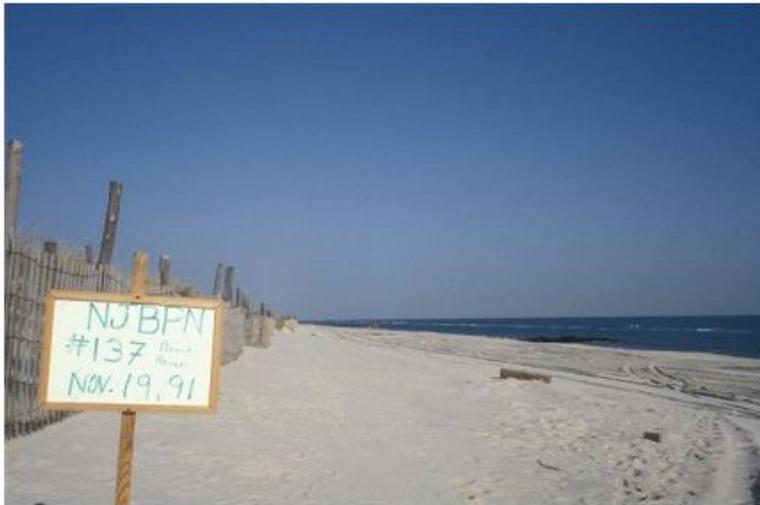
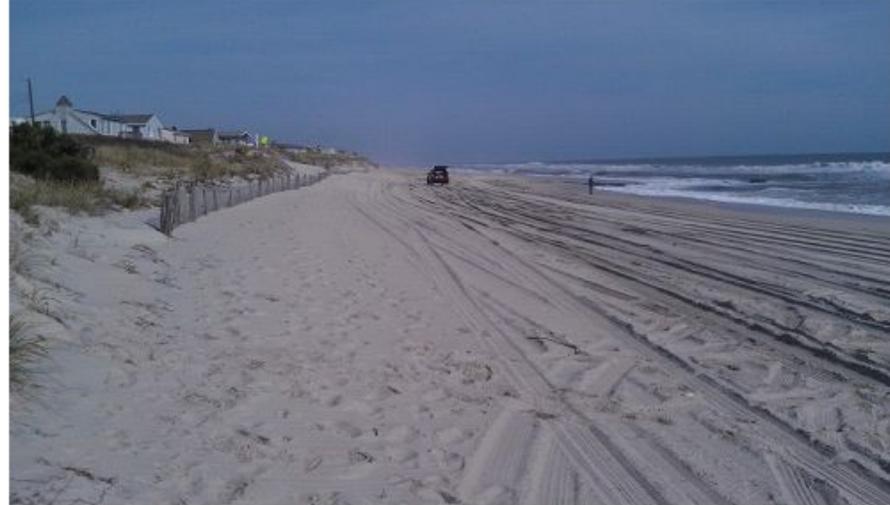
Figure 248 above shows that the dune grew vertically, the beachface lost sand, and an offshore bar developed, since this site's initial survey in 1986. The shoreline retreated 37 feet and there was a net loss of 3.212 cu.yd/ft of sand. Photo on the left was taken in November of 1991 and shows the view north from the dune toe. Photo on the right was taken in November of 2011 and again shows the view north, the dune growth is clearly visible.

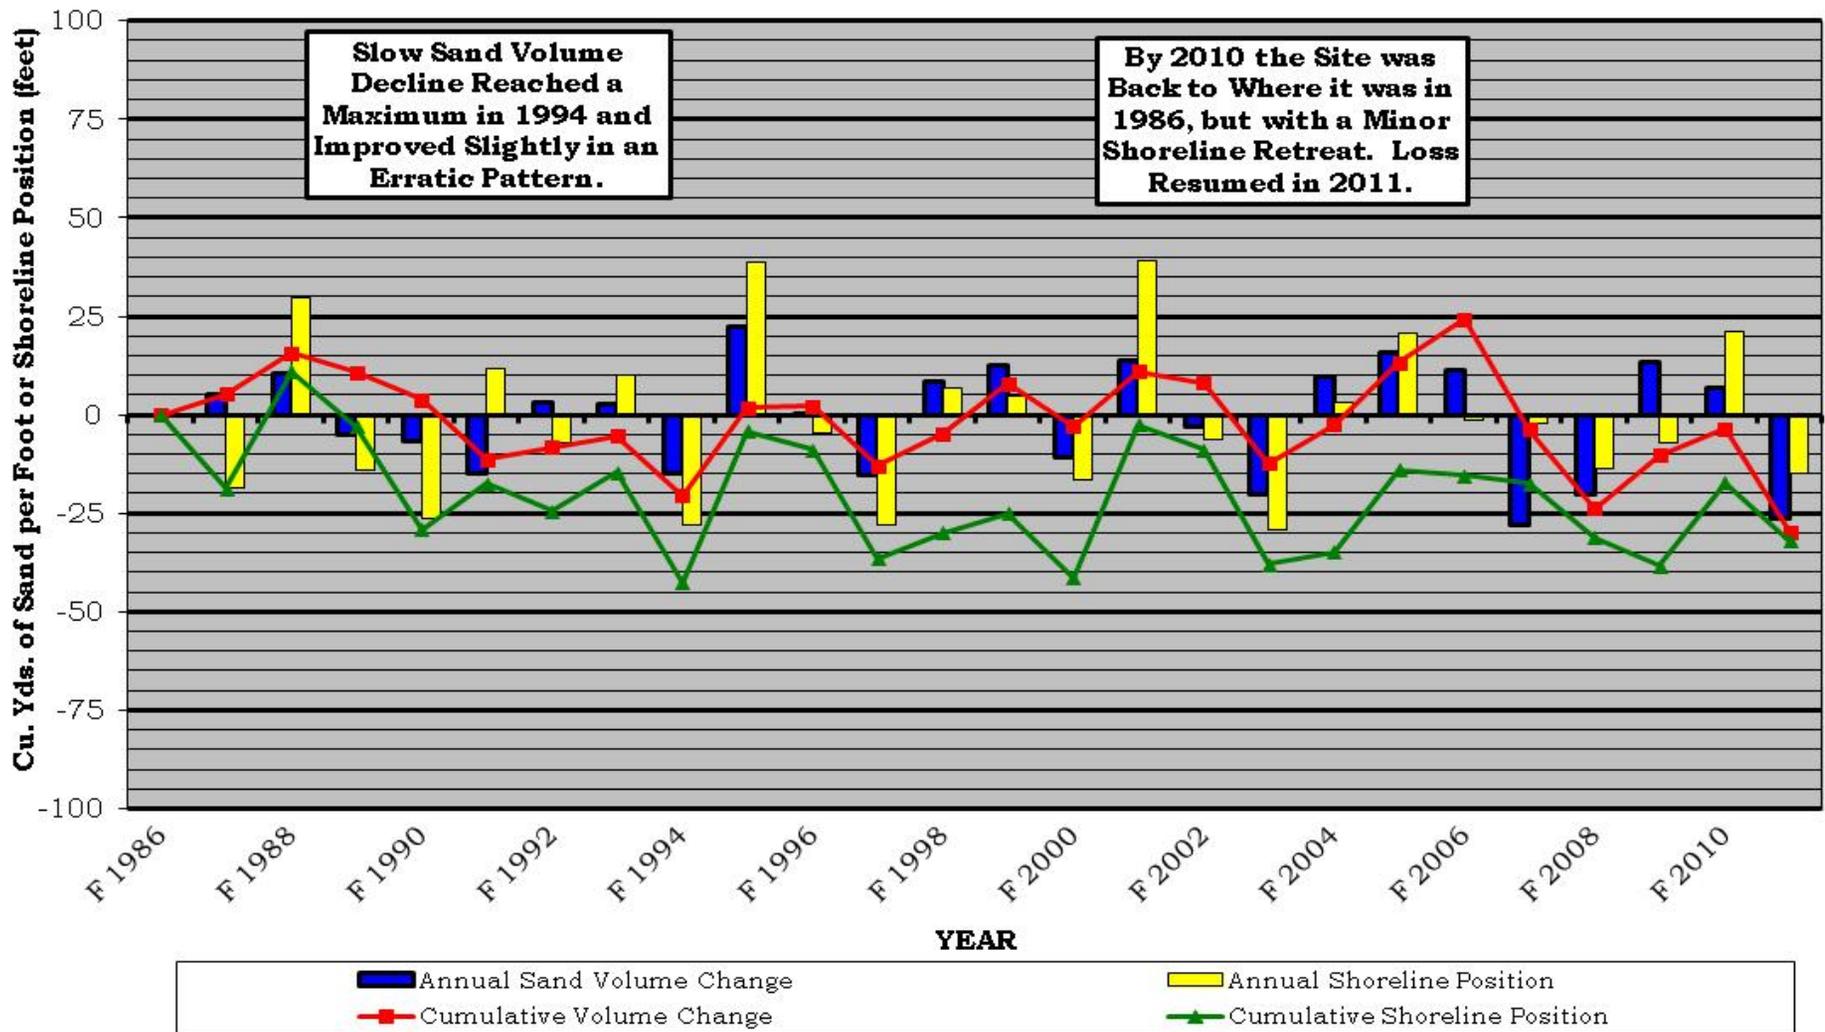
Figure 249. Profile 137 in Beach Haven remained relatively stable with variations occurring within seasonal ranges. The maximum loss of sand volume occurred in 1994 and subsequently a recovery took place in 1995. From there the sand volume slowly increased reaching a maximum in 2006 before beginning to decline again. Despite the variations in sand volume(s) the shoreline position remained within a range of 25 feet from where the shoreline was in 1986.
