New Jersey Beach Profile Network

Ocean County

Manasquan Inlet
to Little Egg Inlet

NJBPN Profile #'s
156 - 234

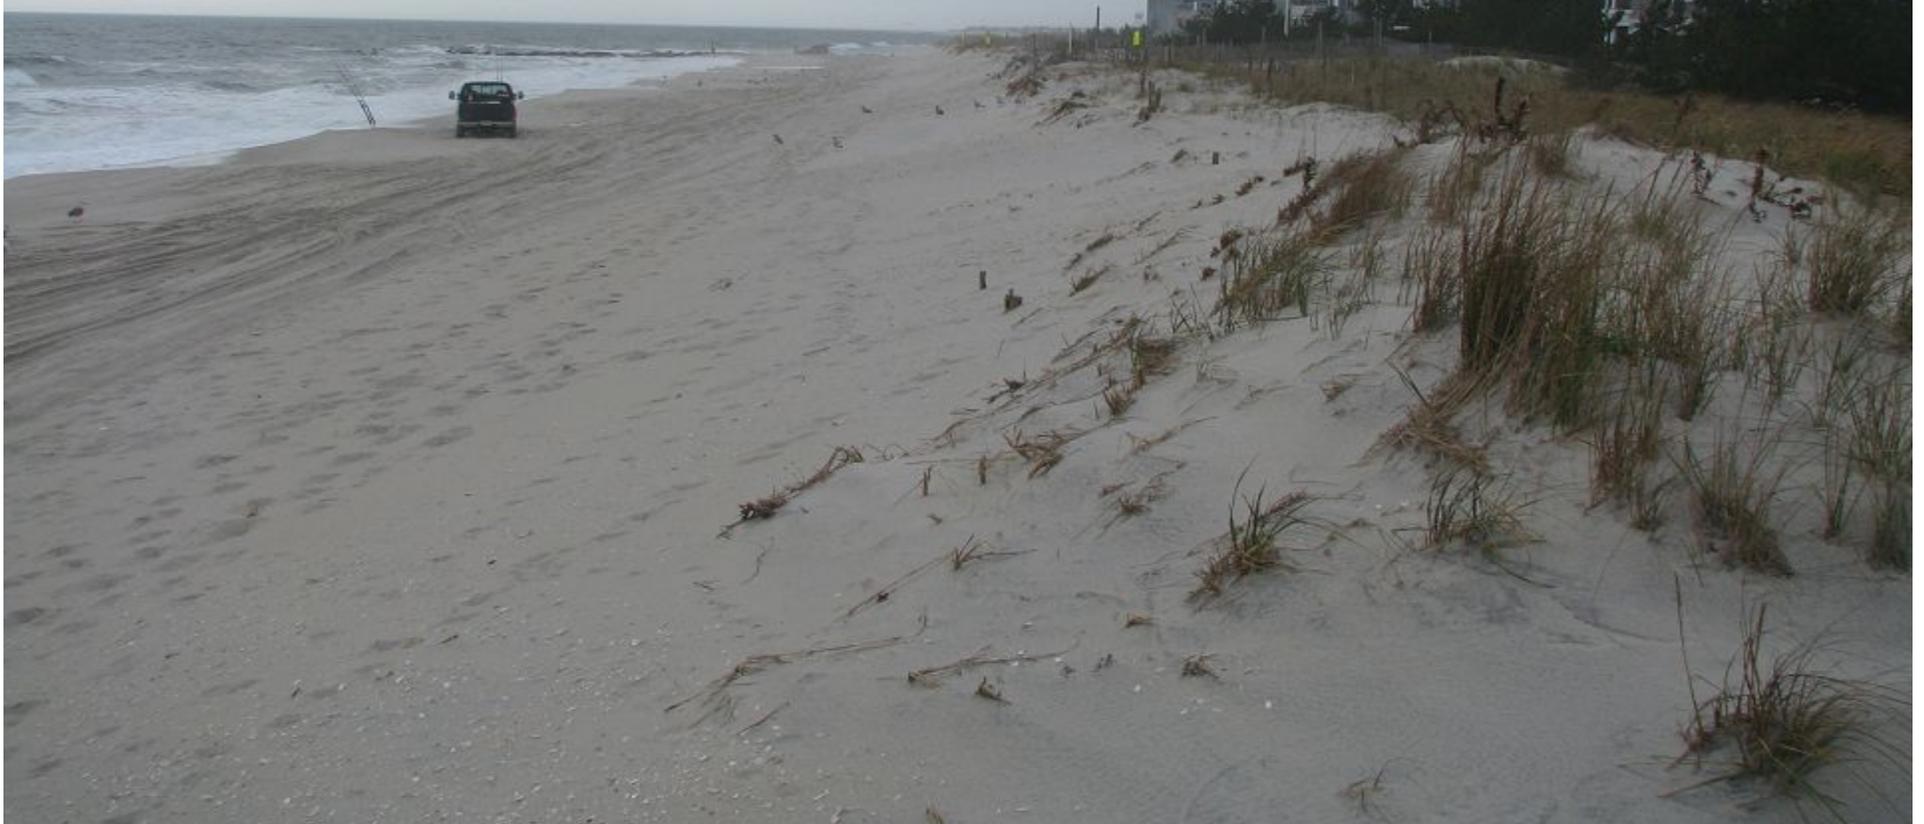
Site 136, Dolphin Avenue, Beach Haven, NJ – November 29, 2011

Figure 250. Shown above is the view looking south from the dune at Dolphin Avenue in Beach Haven, NJ.

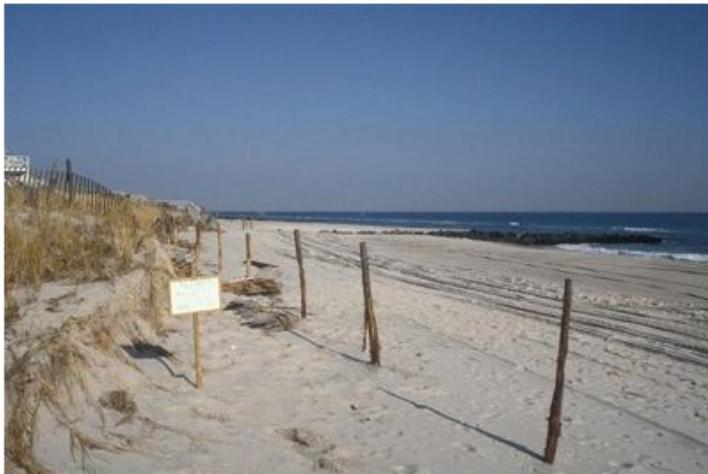
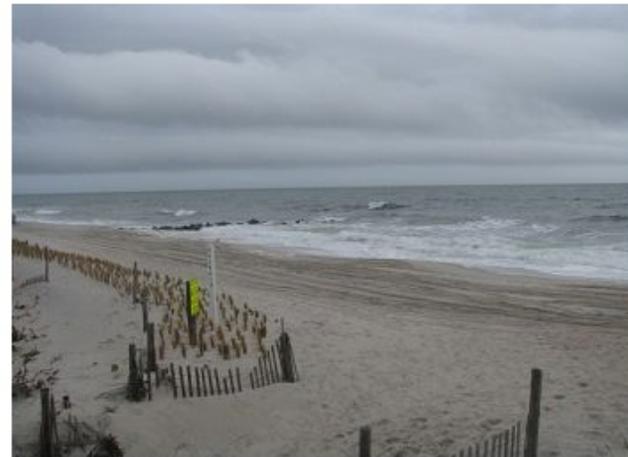
Figure 252 Shown above are the changes the Dolphin Avenue site has sustained since it's initial survey in 1986. The dune grew horizontally and vertically ,while the beachface migrated landward resulting in a loss of 34 feet of shoreline. The gains, however, offset the losses and resulted in an additional 24,294 cu.yd/ft of sand. Photo on the left was taken in February of 1991 and shows the view to the north with a lower dune but a wider beach. Photo on the right was taken in November of 2011 and shows the view to the north from atop a significantly higher dune.

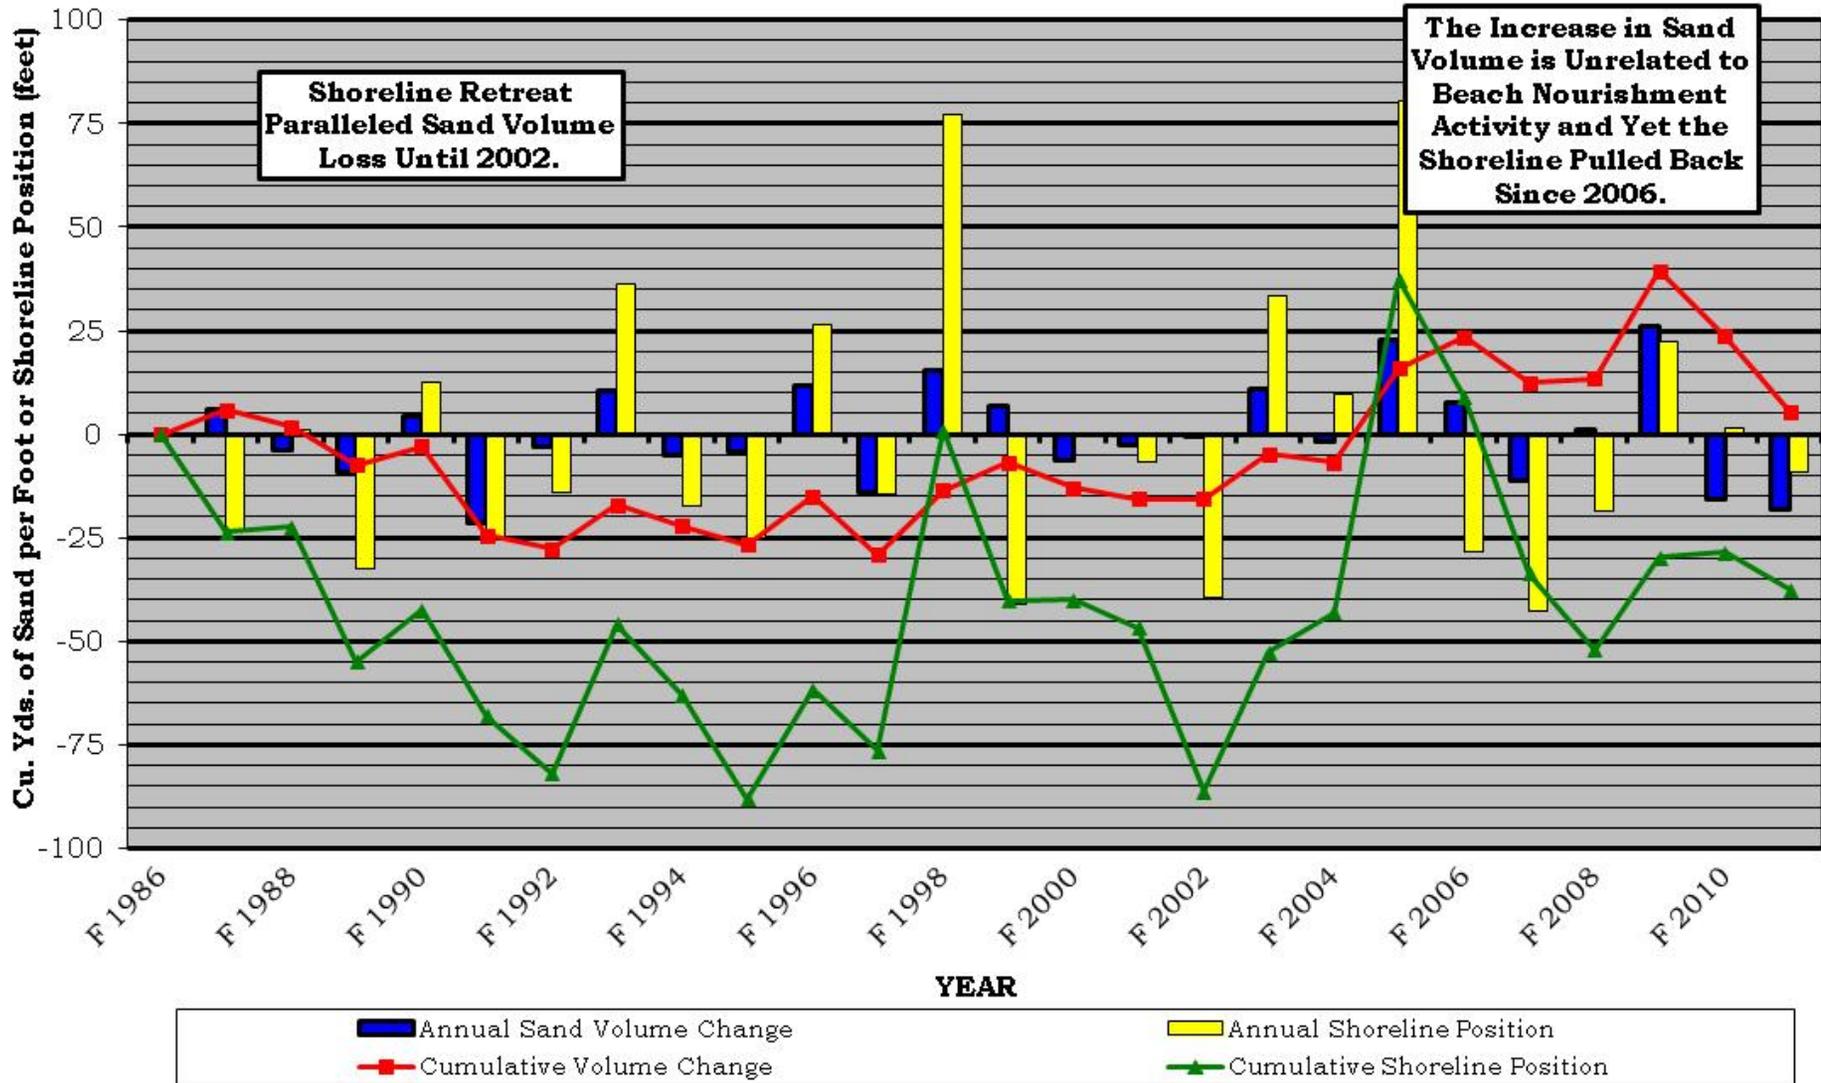
Figure 253. Profile 136 in Beach Haven had dramatic variations in shoreline position and in sand volume in its 25 year history. From 1989 until 2006 the trend was towards sand volume loss and shoreline retreat. If not for dramatic recoveries in 1998 and 2005 the trend might have been entirely negative.

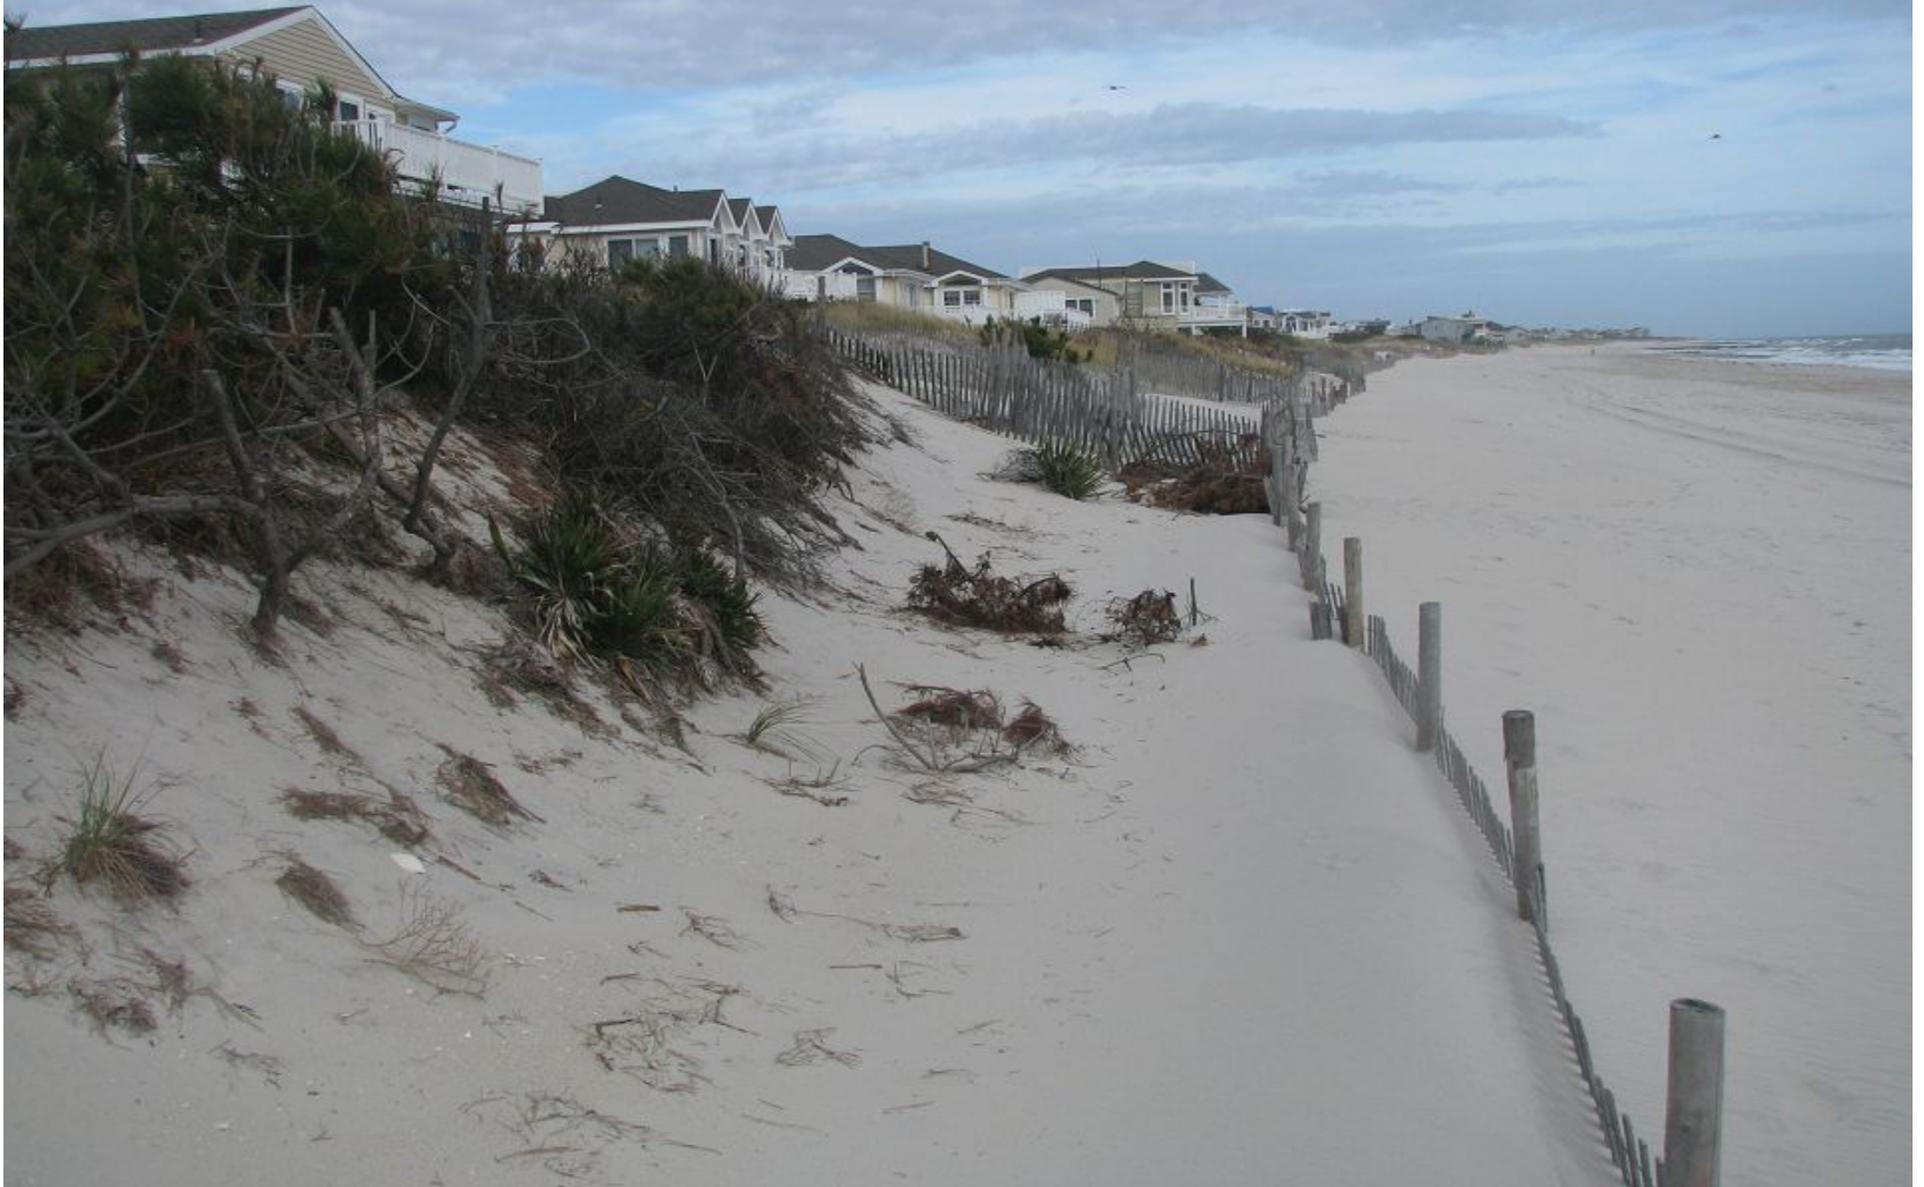
Site 135, Webster Avenue, Long Beach Township, NJ – November 29, 2011

Figure 254. Shown above is the view looking north from the dune at Webster Avenue in Long Beach Township, NJ.

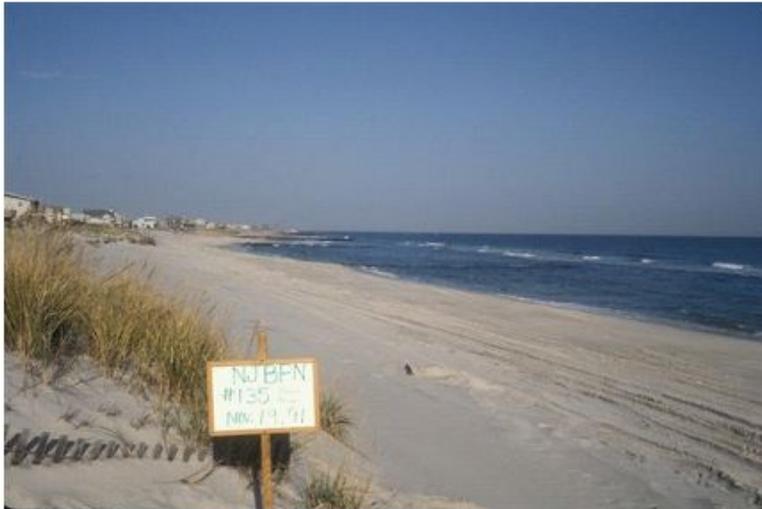
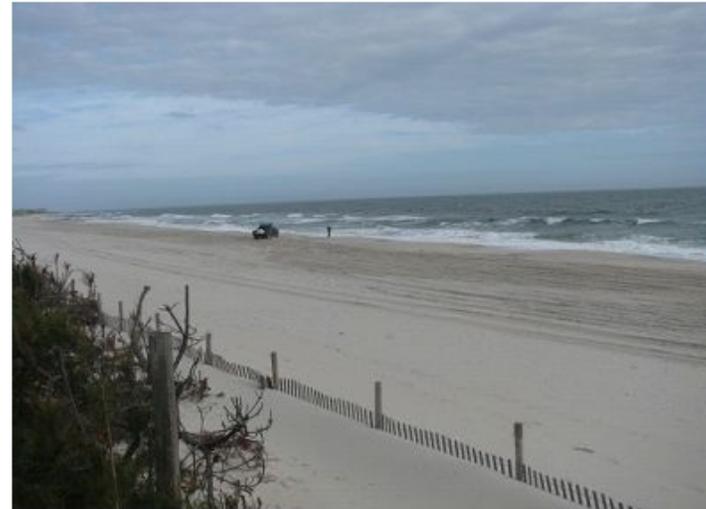
Figure 256 Shown above is site 135 where the beachface advanced seaward, and the dune crest migrated landward and grew vertically since the initial survey in 1986. There was a net gain in sand volume of 13.487cu.yd/ft., and the shoreline advanced 32 feet. Photo on the left was taken in November of 1991, and shows the view north from the seaward crest. Photo on the right was taken in November of 2011 and shows the view north, however, the beach is noticeably wider.

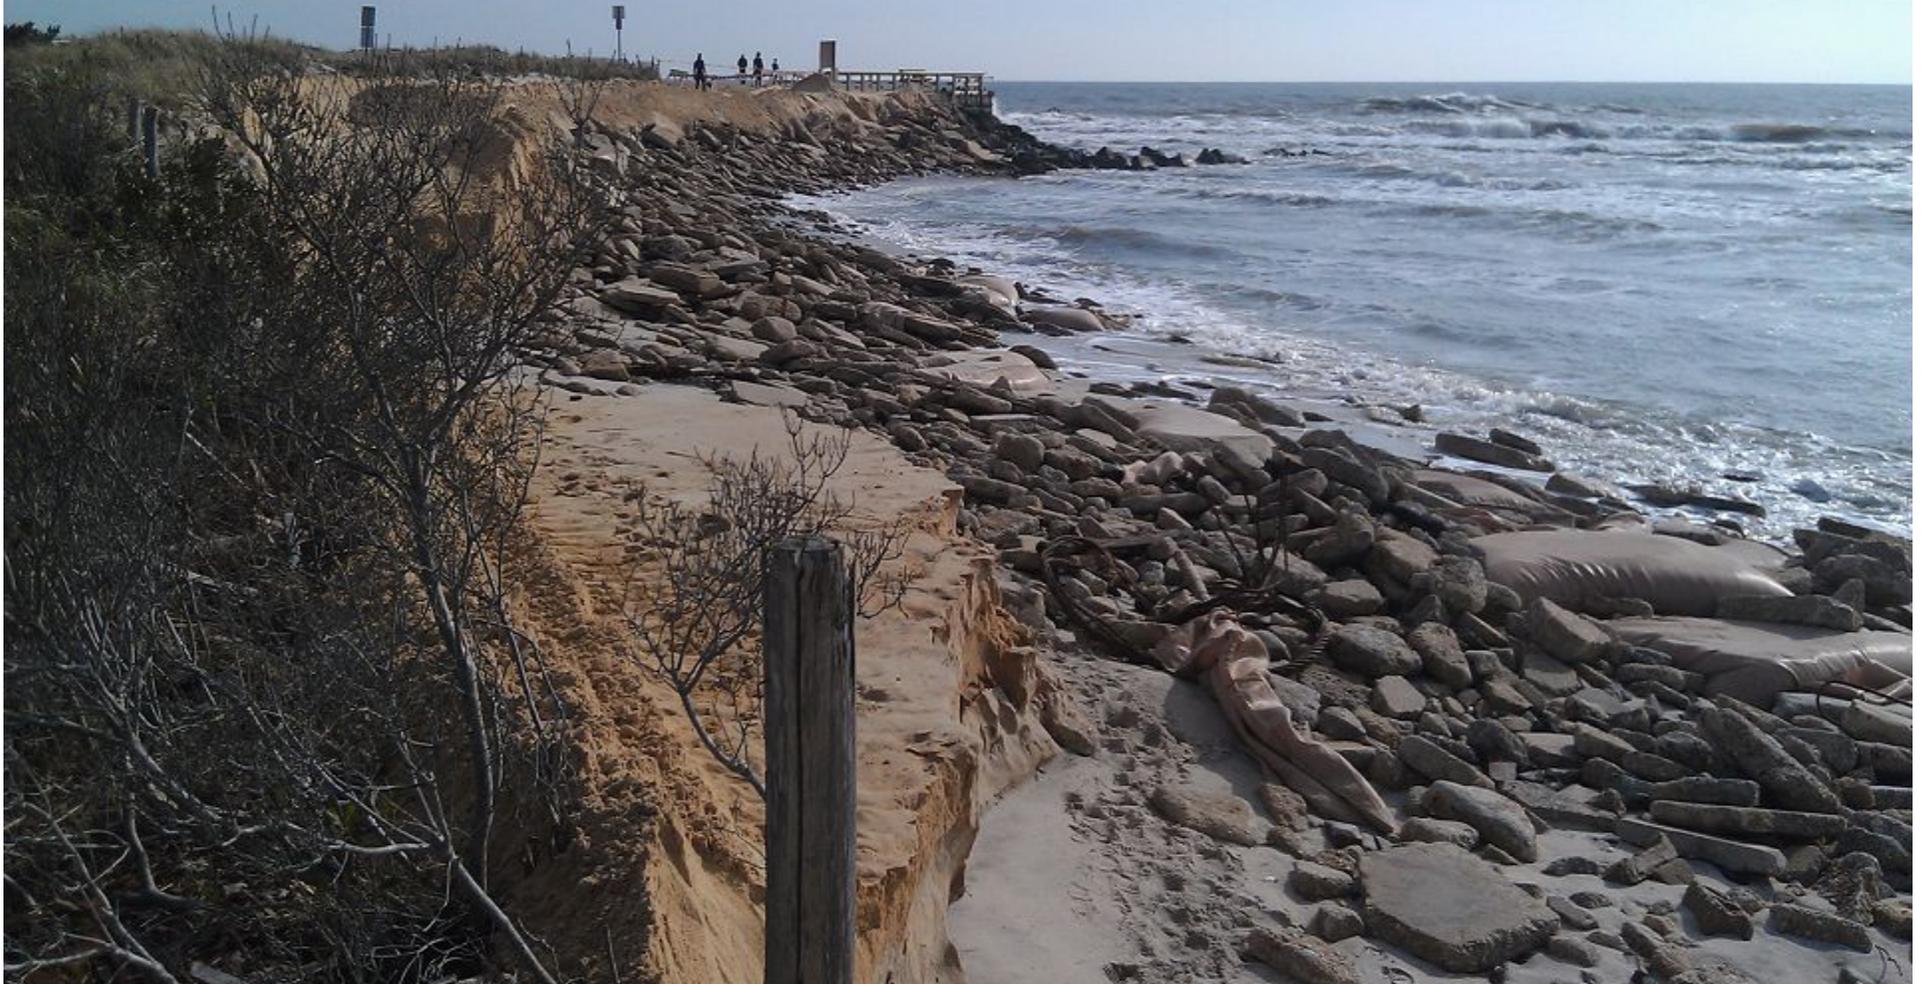
Figure 258. Shown above is the view looking north from the top of the scarp at the Holgate Wildlife Reserve in Long Beach Township, NJ. This site suffered dune loss and overwash from Hurricane Irene.

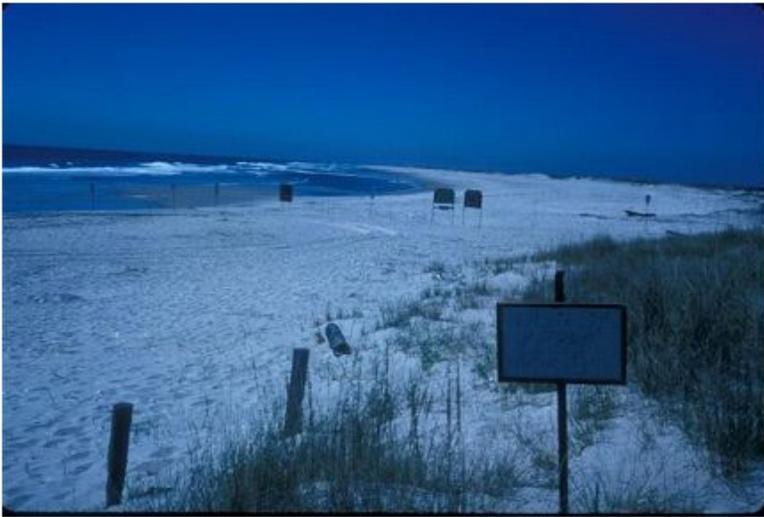
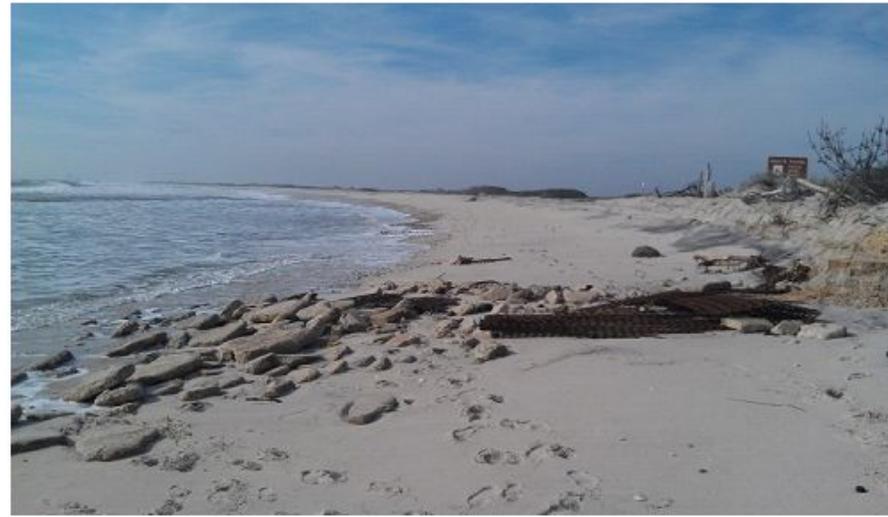
Figure 260 Shown above are the tremendous losses that the southern most site in LBI sustained since the initial survey in November of 1994. The shoreline retreated 205 feet while the net loss in volume was 134.79 cu.yd/ft. of sand. Photo on left was taken in April of 1995, and shows the view from the seaward crest looking south and the width of the beach. Photo on right was taken in November of 2011, and shows the dramatic loss of sand and the exposed rocks.

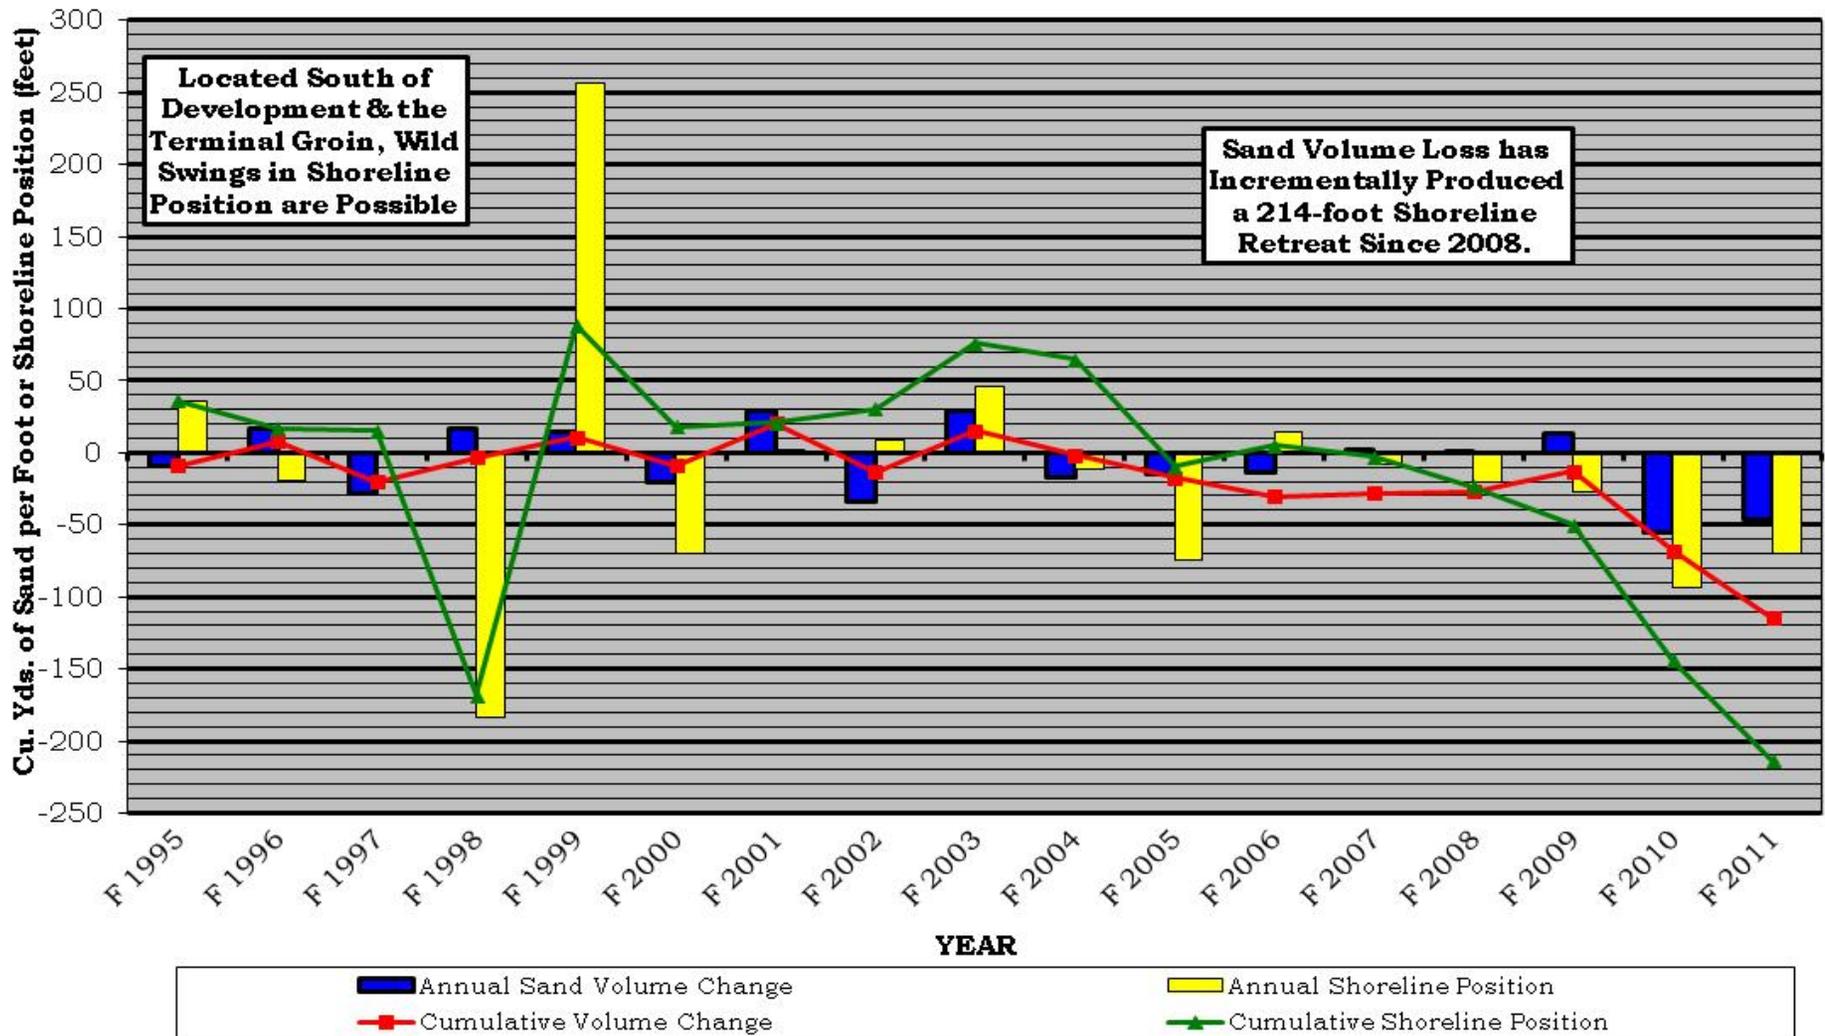
Figure 261. Profile 234 in Long Beach Township was established in 1995 and is located south development and of the terminal groin where wild swings in shoreline positions are possible. This was on display between 1998 and 1999 where the shoreline retreated 180 feet (in '98) only to advance back 250 feet in ('99). The sand volume remained stable for nearly the entire 16 year history until 2010 and 2011 when an incremental sand volume loss produced the lowest shoreline position in this sites history.
