**FINAL REPORT FOR 2021
ON THE CONDITION OF THE MUNICIPAL BEACHES
IN
THE TOWNSHIP OF UPPER, CAPE MAY COUNTY, NEW JERSEY**

**PREPARED FOR: THE TOWNSHIP OF UPPER
PO BOX 205
TUCKAHOE, NEW JERSEY 08250**

**PREPARED BY: THE STOCKTON UNIVERSITY COASTAL RESEARCH CENTER
30 WILSON AVENUE
PORT REPUBLIC, NJ 08241
DECEMBER 22, 2021**

**Annual Report for 2021
To
The Township of Upper
On the Condition of the Municipal Beaches in Strathmere**

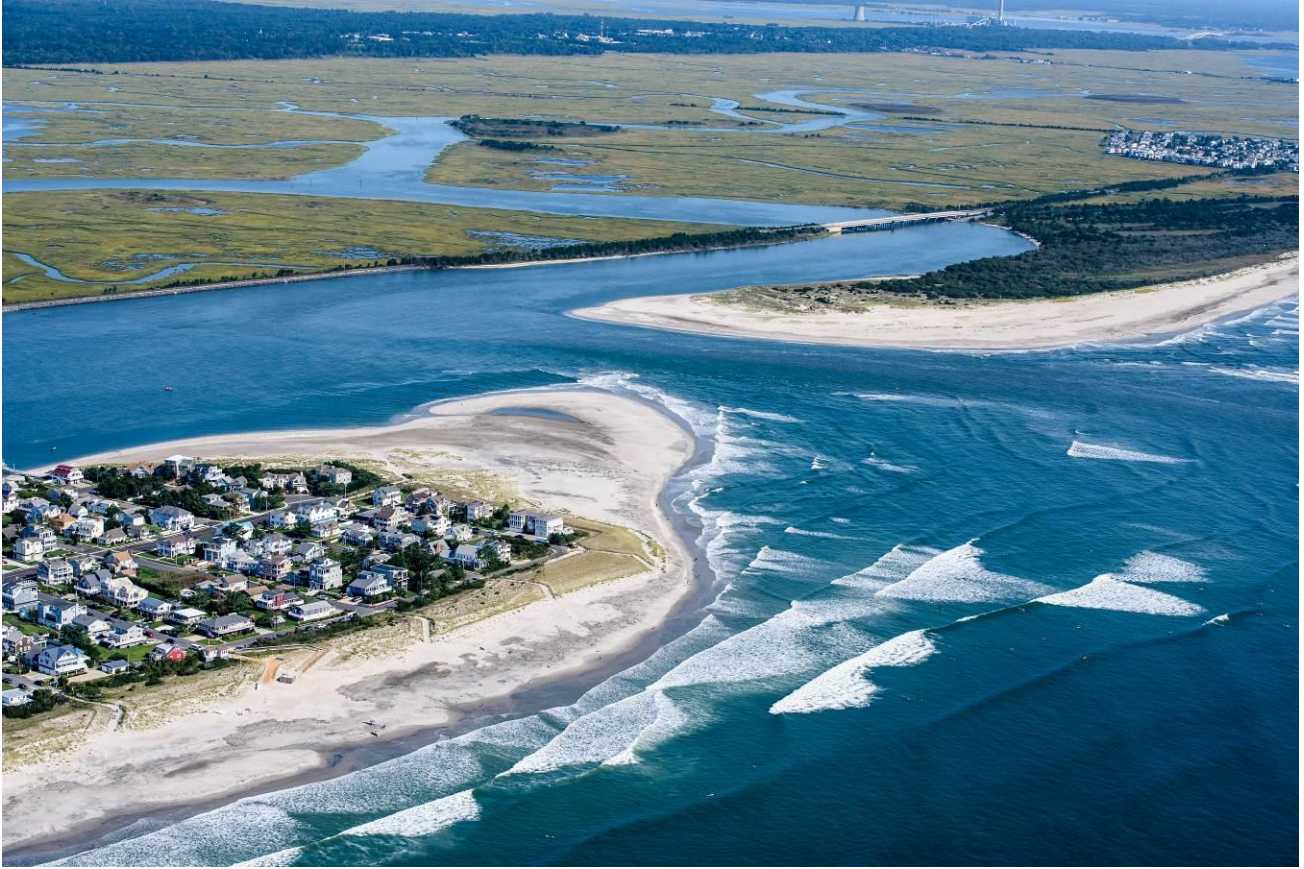
This aerial view of Strathmere, taken September 11, 2021, shows how the combination of wave approach and refraction around the nearby offshore bathymetry of Corson's Inlet generates enhanced transport of sand from the oceanfront near the inlet into the main channel. This process is enhanced by flood tidal currents twice each day which act to create the sand spit making up the NJ State park area in Strathmere, but this also means the northernmost developed oceanfront is constantly under erosional stress if large offshore sand supplies are not present as a result of inlet processes. (Photo by Ted Kingston).

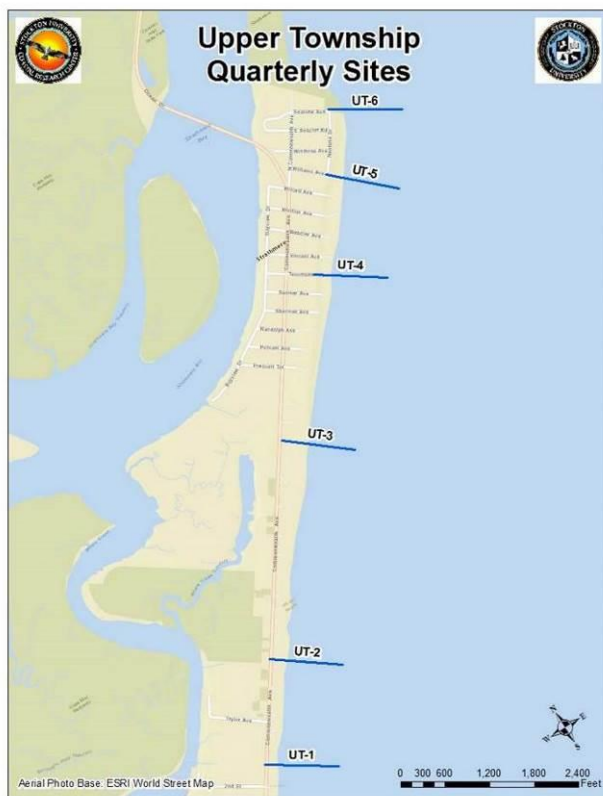
Figure 1. Locations of the 6 beach profile stations for the engineered beach in Upper Township.

The six cross sections are positioned along the Strathmere oceanfront from Seaview Avenue at the northern extent of residential development, south to the Sea Isle City boundary with Strathmere. The general locations are shown on Figure 1, page 3.

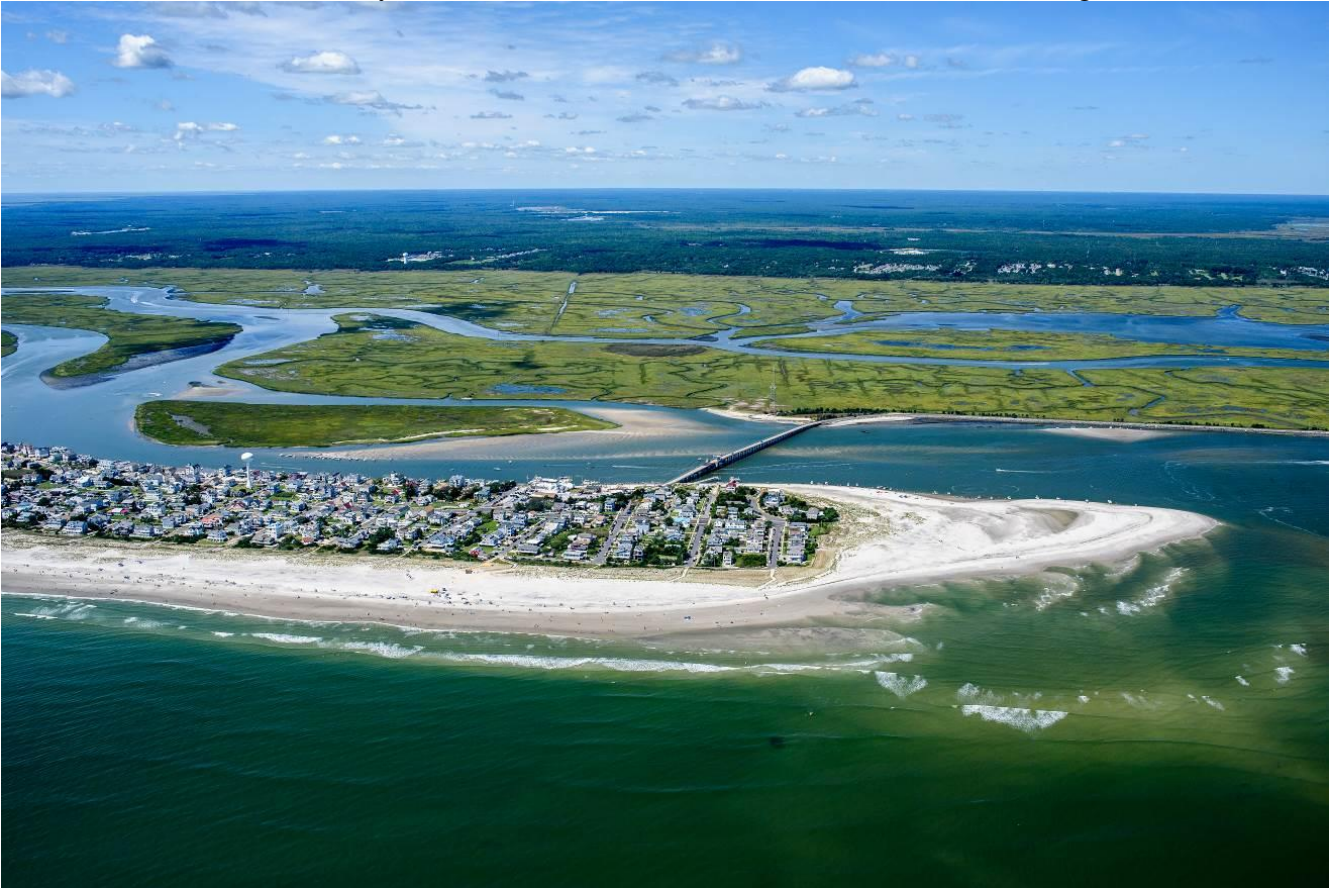
Figure 2. This September 4, 2021 photograph of the north end of Strathmere shows the inlet shoals around the Strathmere island tip with offshore bars extending past UT-6 at Seaview Avenue. (Photo by Ted Kingston)

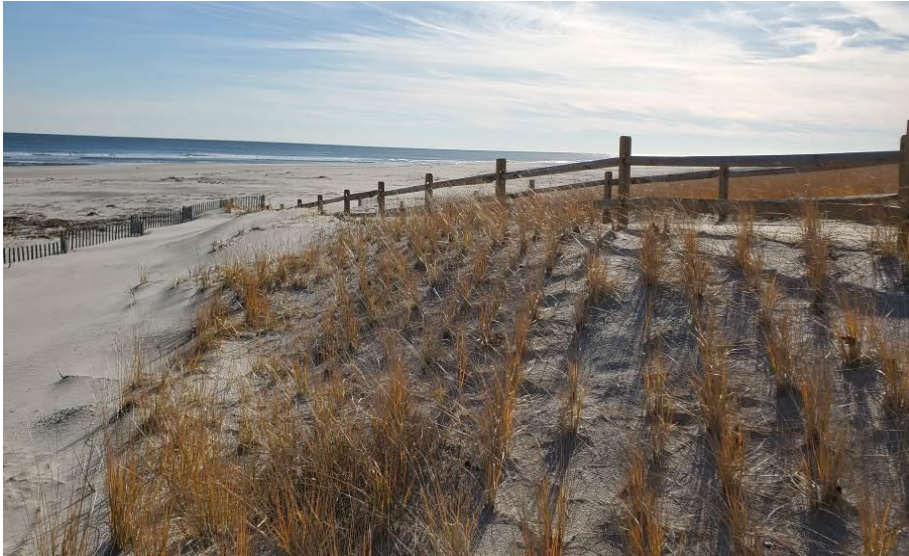
3a. December 15, 2020

Figures 3a to 3c. Seaview Avenue survey site. View to the south.

Photograph 3a shows a view to the south a year following the last sand placement with wind deposition showing at the dune toe and a sufficiently wide beach remaining at the site.

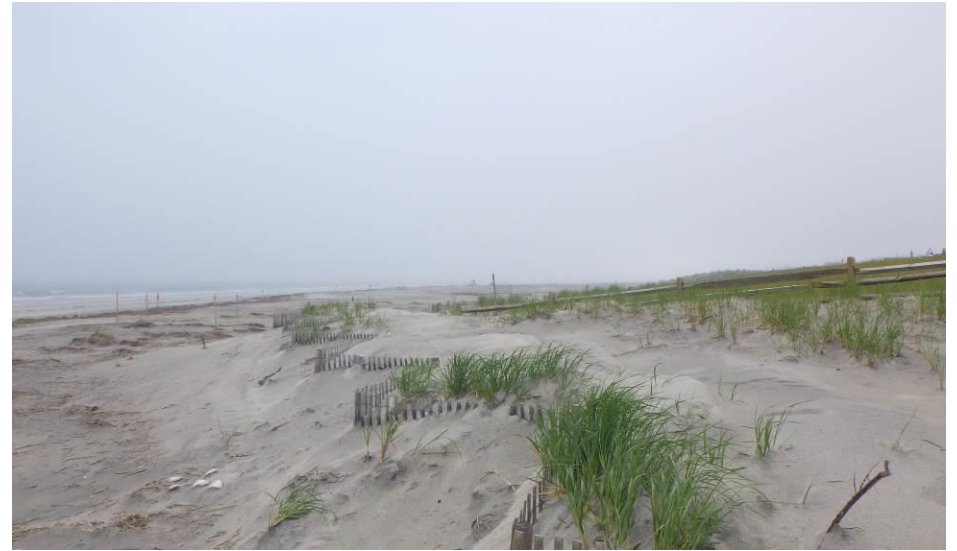
3b. June 3, 2021

Photograph 3b shows that by June 2021 wind transport had all but buried the sand fencing and dune grass plants were colonizing the fence line naturally.

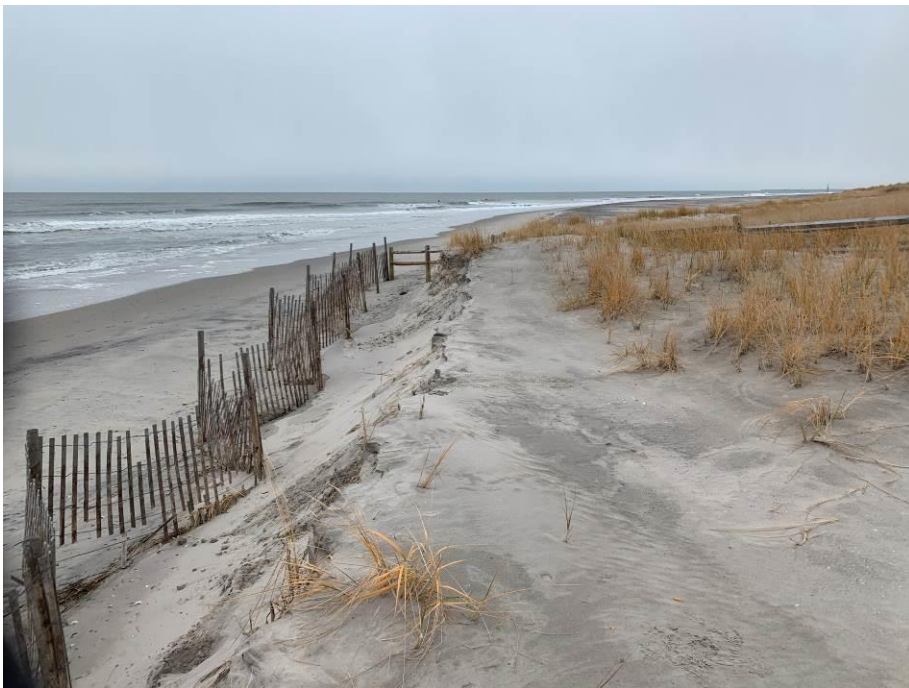
3c. December 8, 2021

Photograph 3c demonstrates just how quickly the shoreline retreats toward the dunes. The June wind deposited sand at the fence line has been eroded away with the water's edge at the fencing as of early December 2021.

The latest issue to emerge is the rapid increase in erosion rates seen at Seaview Avenue (UT-6) location where the scape in the beach berm has moved into the 2020 restoration sand fencing from the second cycle nourishment by the USACE. Sand supplies to the south must move quickly toward the inlet to prevent dune erosion this winter.

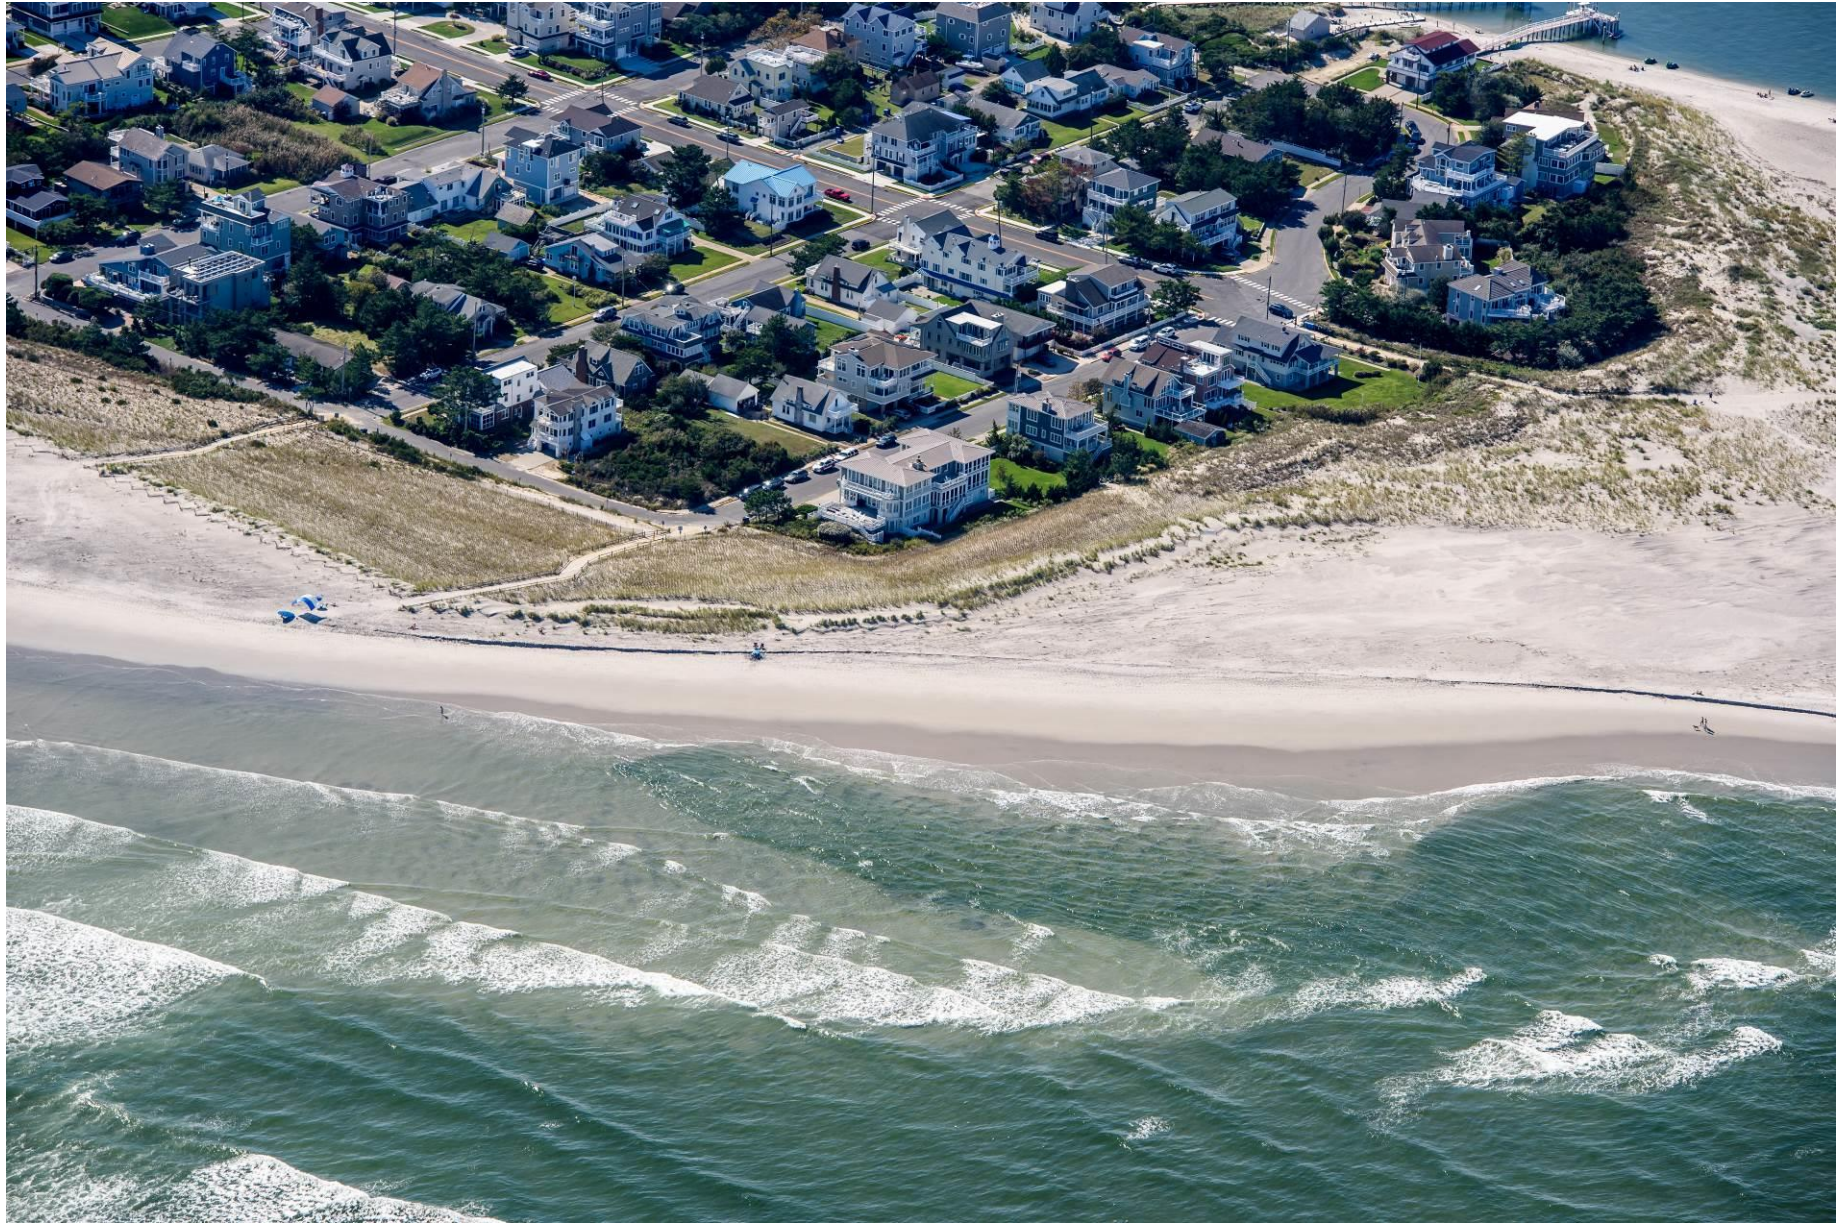
Figure 4. Aerial view of Seaview Avenue profile beach September 25, 2021. While shallow wave-like bars still lie just offshore, the beach berm has been cut into a vertical scarp right at the end of Seaview Avenue and that scarp continues into the NJ State Park land to the northwest. Significant volumes of new sand moving north toward the inlet from the southern bar system is required if the erosion is not to move into the 2019-2020 USACE rebuilt dunes this winter. It is the common combination of the breaking incoming wave angles to the shoreline beach combined with the flood-tidal currents moving into Corson's Inlet that generate rapid sand transfer away from this critical region. The five residential properties north of Seaview Avenue at the park boundary probably represent over \$15,000,000 in ratable assets.

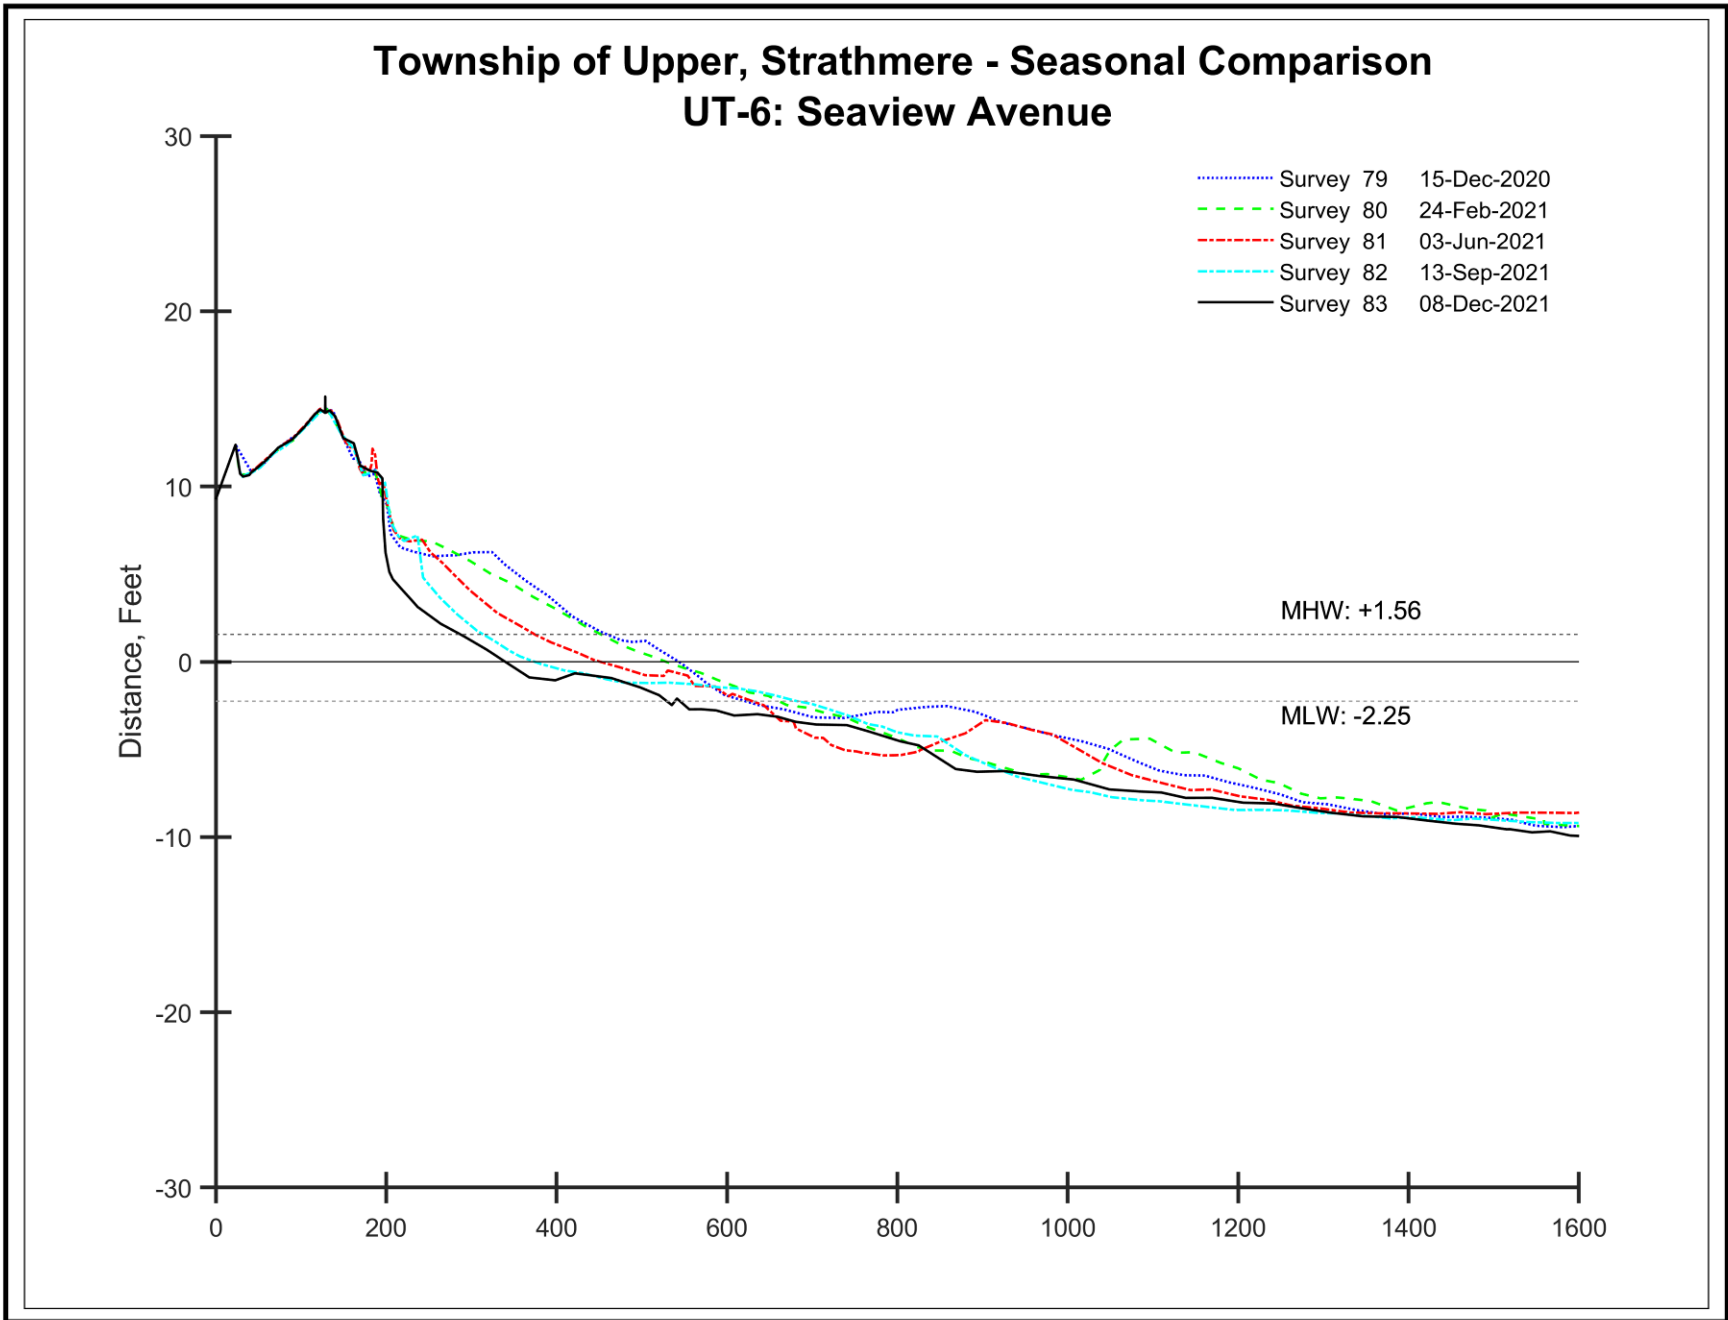
Figure 5. This 2021 sequence of surveys present the case for rapid shoreline retreat. Note that between December 2020 and February 2021 three significant northeast storms had only minimal impact on the beach configuration at the site. Things commenced to deteriorate after the February survey with equal losses recorded in June, September and December 2021 in spite of the absence of storm activity that matched events during the first quarter of the year.

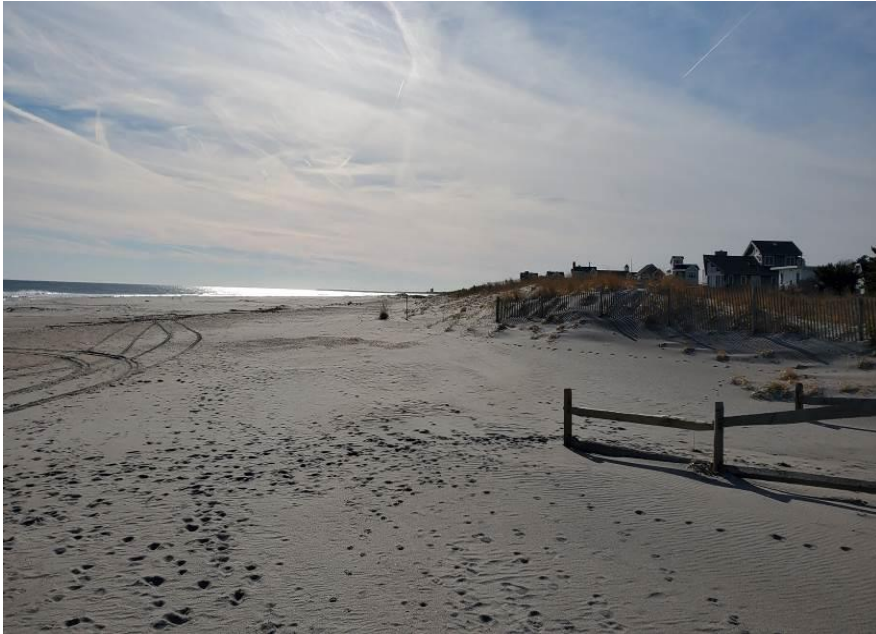
6a. December 15, 2020

Figures 6a to 6c. UT-5 survey site on Williams Avenue.

Figure 6a shows the beach surface from the seaward dune toe to the water line as of the end of 2020.

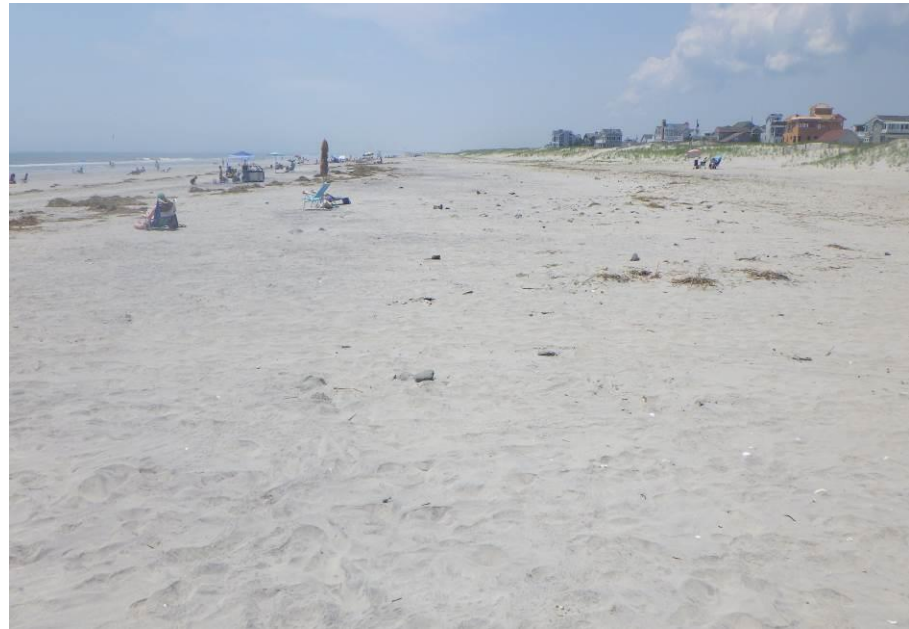
6b. June 7, 2021

Figure 6b was taken in June 2021 looking south across the central region on the upper beach between the dune and the berm.

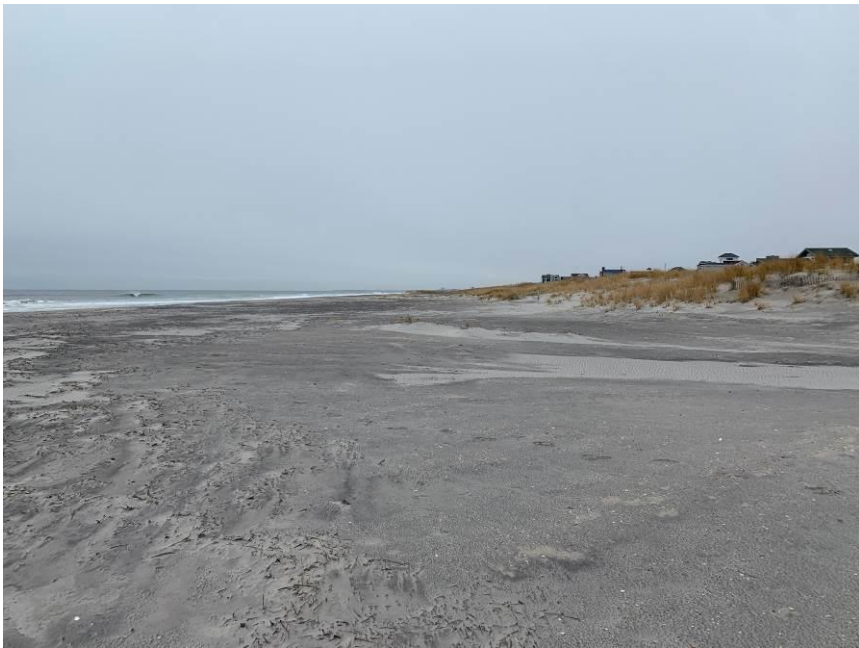
6c. December 8, 2021

Figure 6c. The December 2021 view from the upper beach area shows the decreased width, but no dune damage to date.

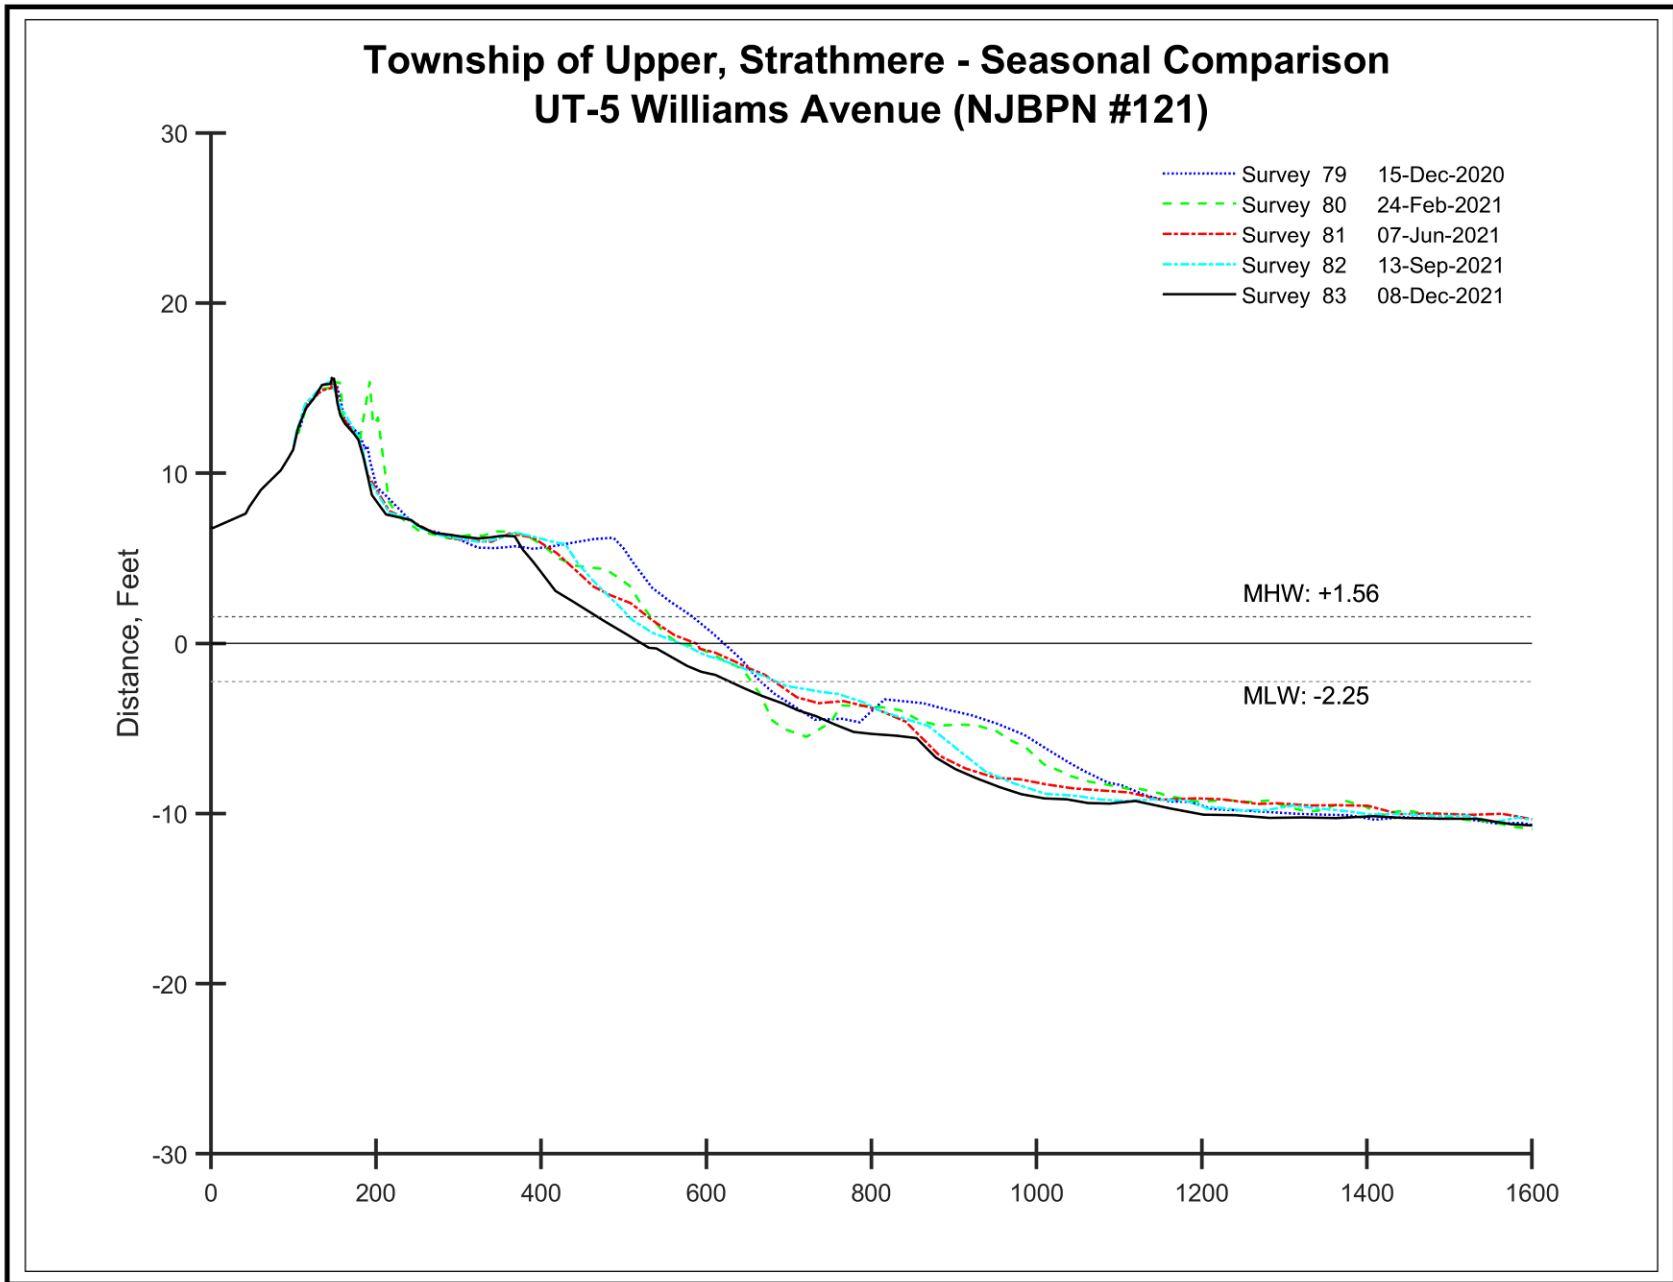
Figure 7. The site is still within influence derived from tidal currents associated with Corson’s Inlet. Sand deposited offshore forms into bars which migrate landward to attach to the beach. This process continued in 2021, but the berm crest retreated 99 feet since December 2020.

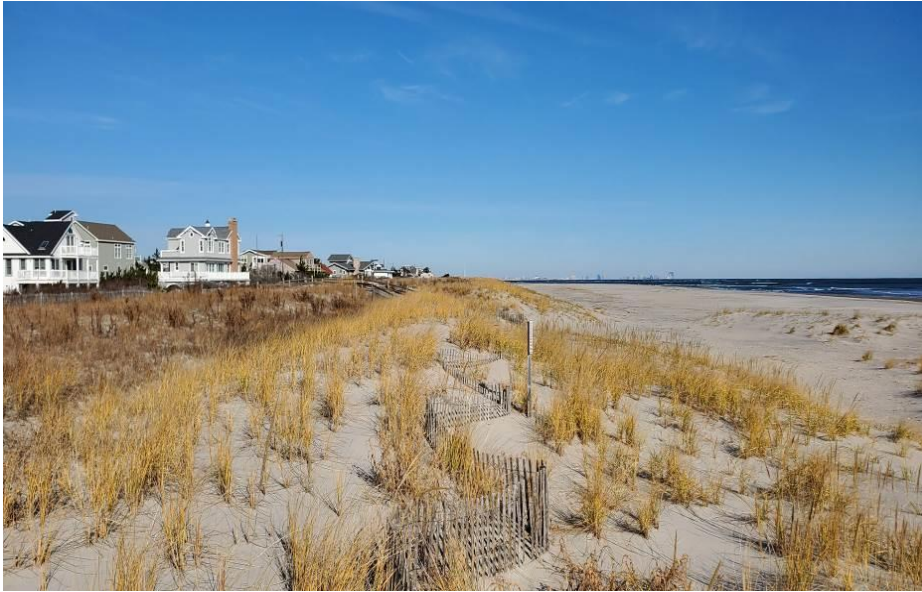
Figure 8a. December 15, 2020

Figure 8a shows minimal change to the primary dune field as all the added material was deposited on the mid-beach foredune to the right side of the photograph.

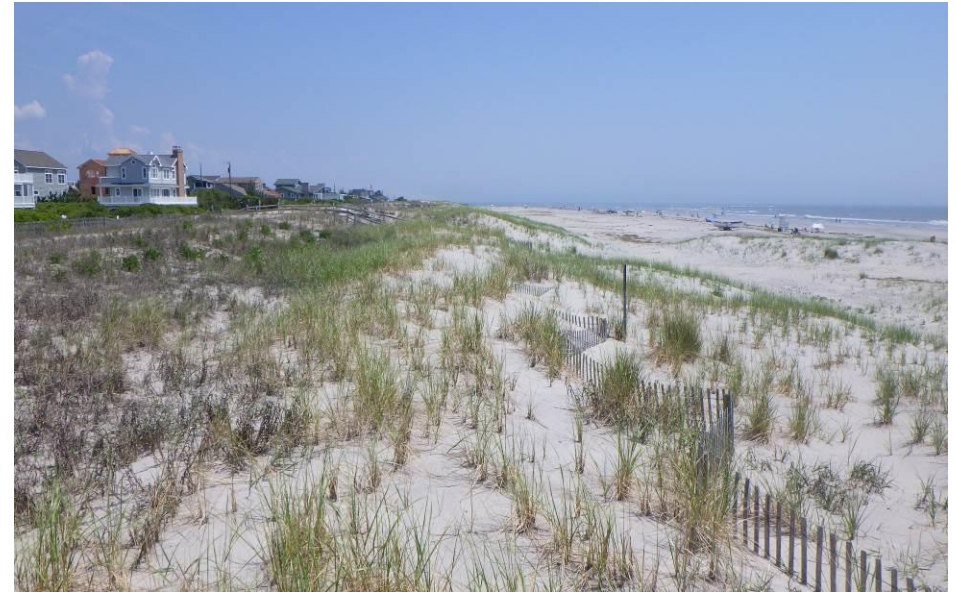
Figure 8b. June 7, 2021

Figure 8b. The summer photograph shows enhanced grass growth at the primary dune and a view across the growing mid-beach dune field.

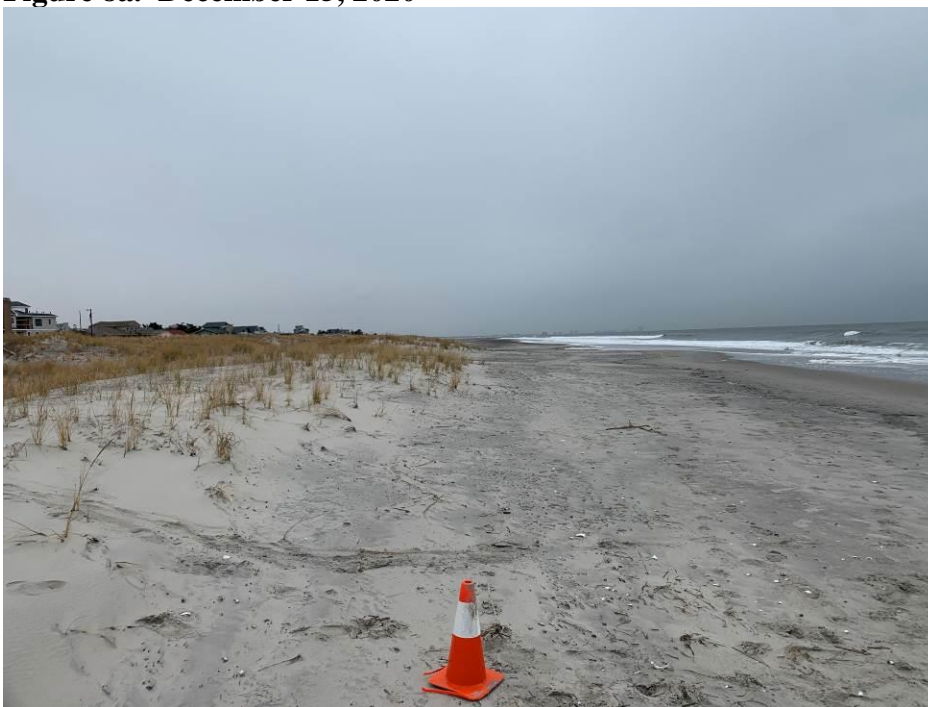
Figure 8c. December 8, 2021

Figure 8c. By December 2021 a view to the north along the mid-beach foredune system shows a developing array of dunes normally expected to become a primary dune field.

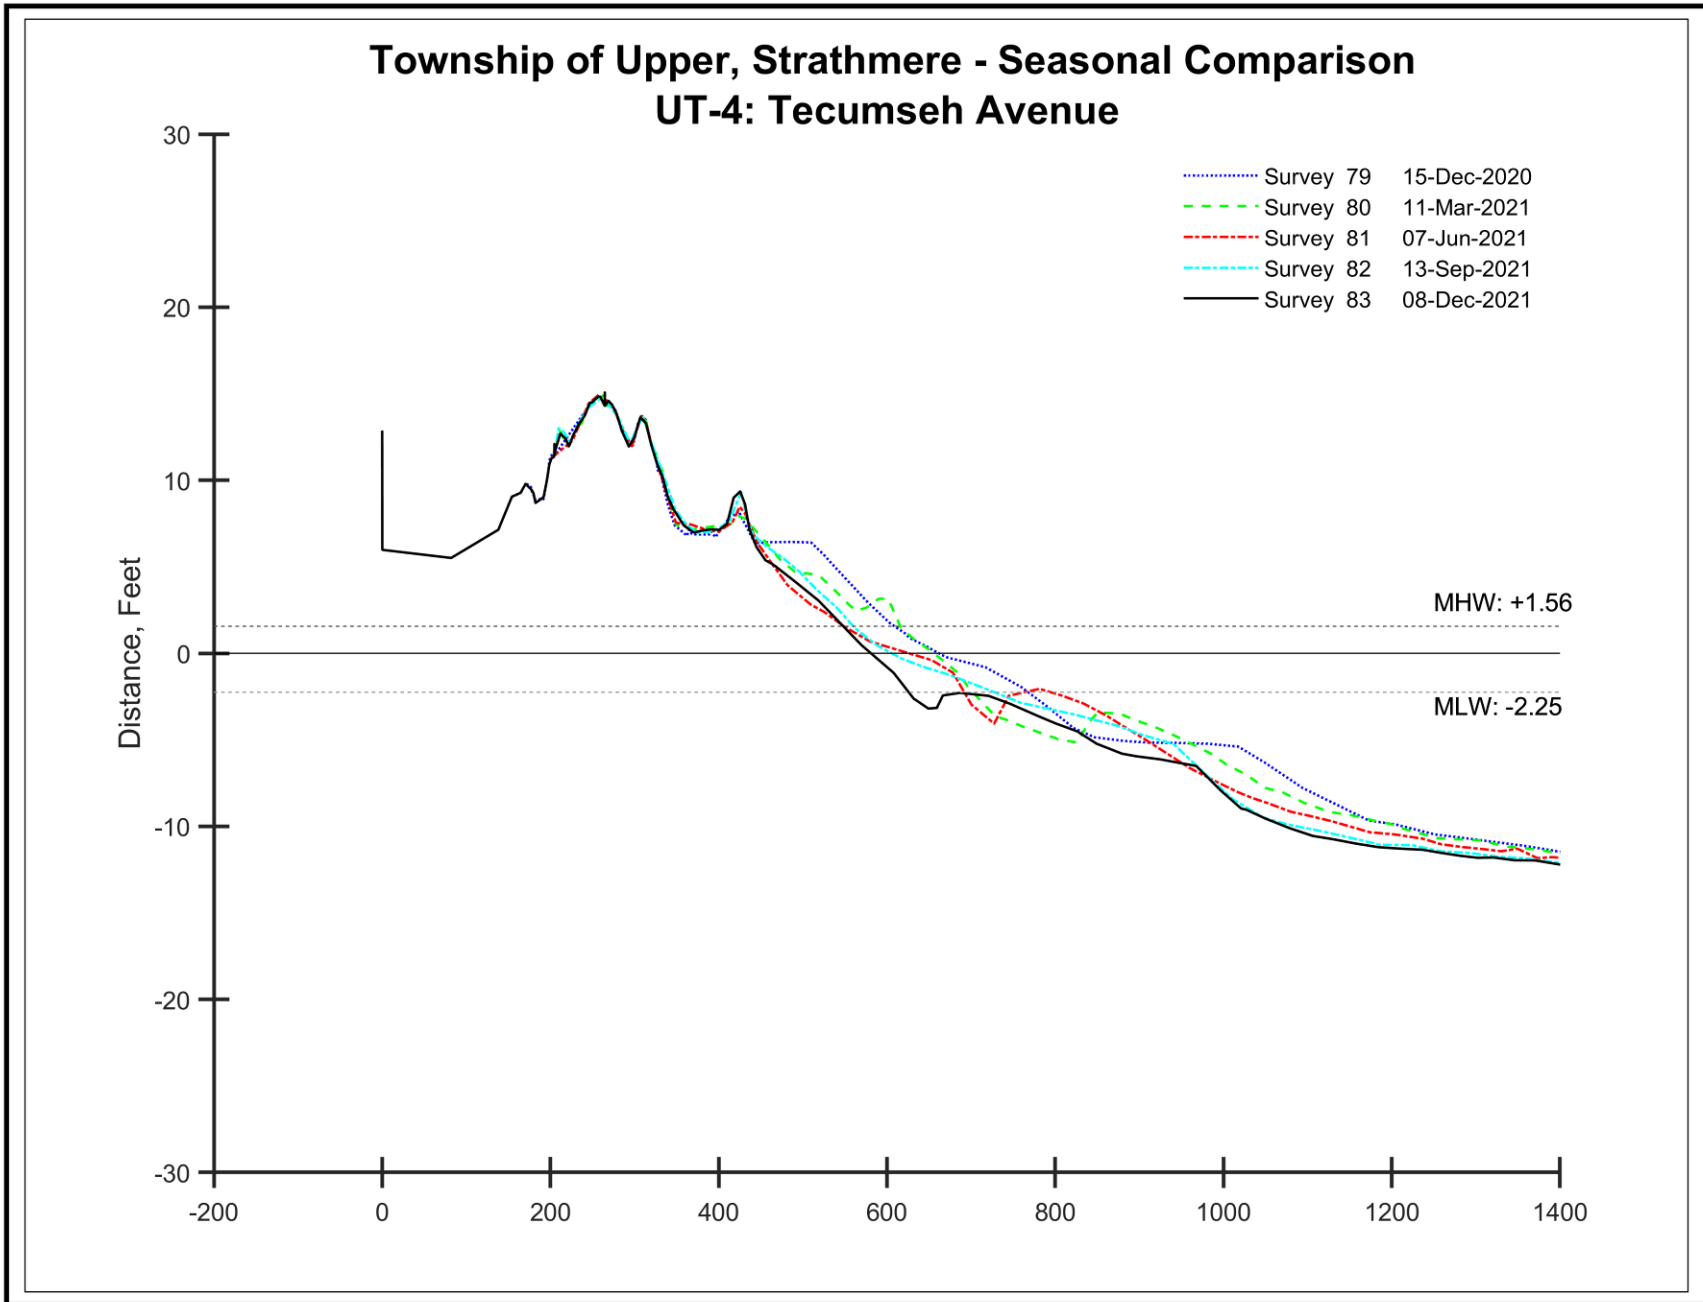
Figure 9. This location suffered early year storm erosion on the beach without a great deal of berm development over the summer. The June offshore bar made it to the beachface by September with another bar about to move onto the beach as of December 8, 2021.

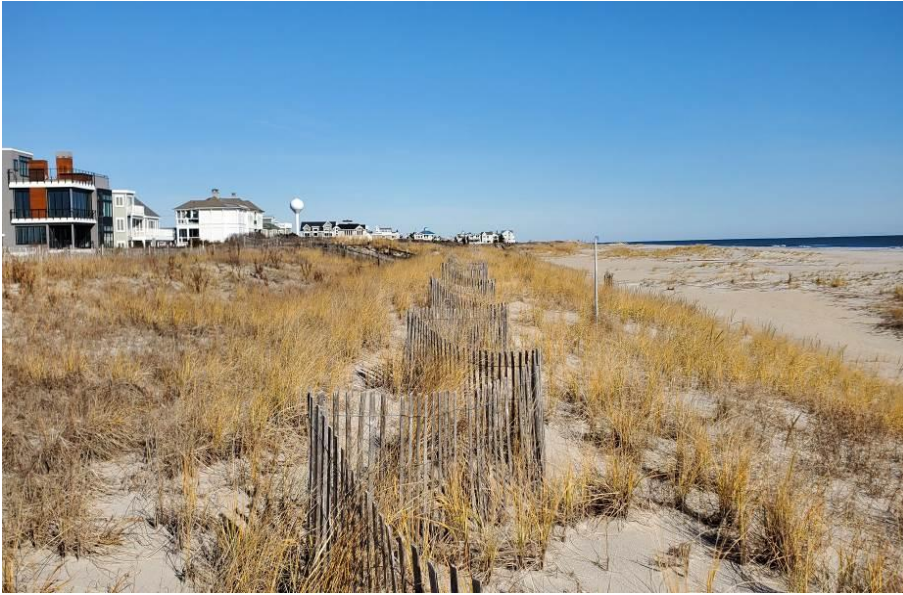
10a. December 15, 2020

Photo 10a is a view along the sand fence to the north showing minimal sand accumulation at the fence, but additions in the foredune area on the dry beach surface.

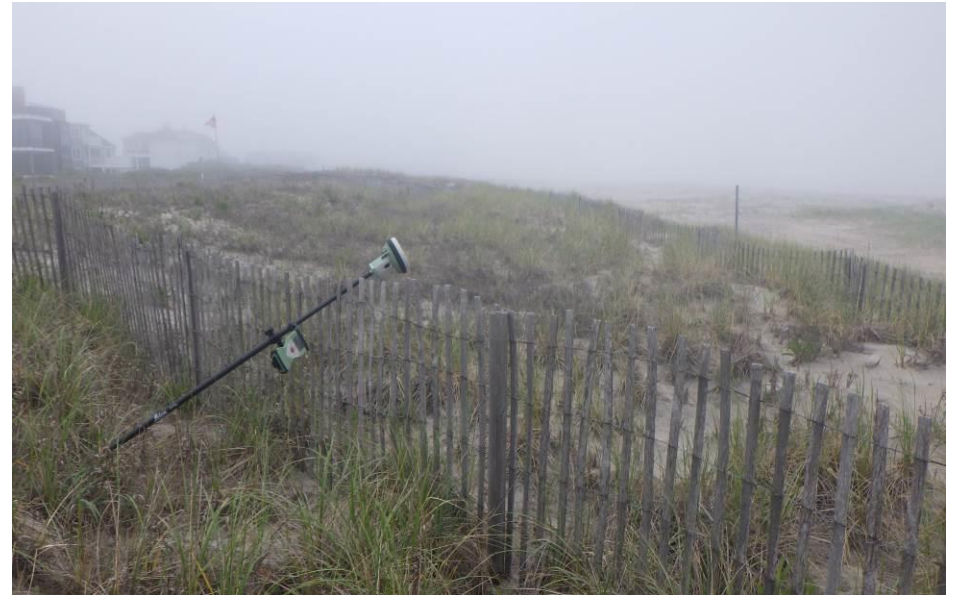
10b. June 4, 2021

Photograph 10b this foggy day view to the north shows summer grass growth and a poor view of the open beach.

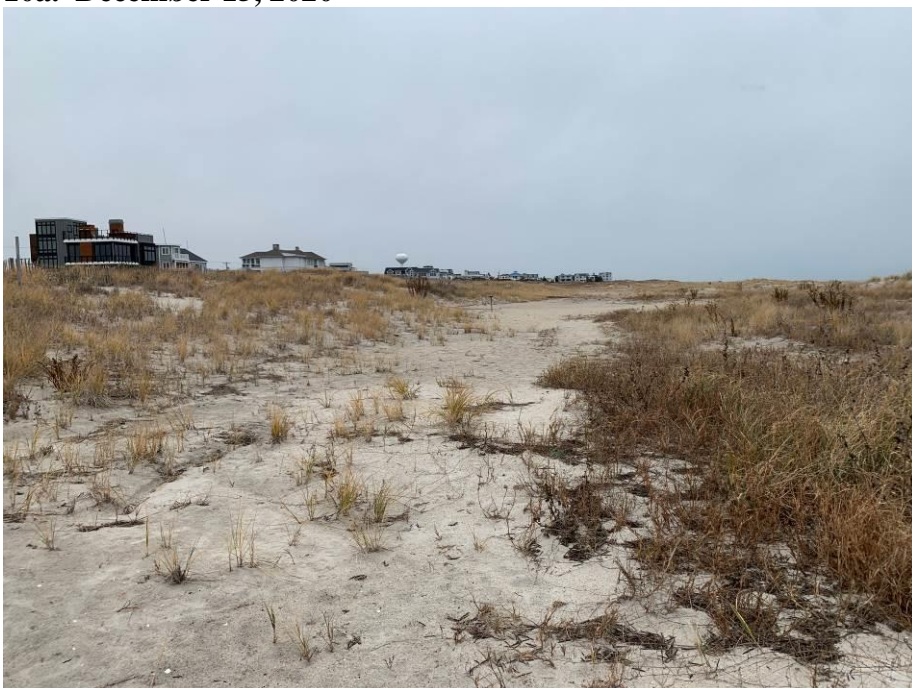
10c. December 8, 2021

Photograph 10c. The valley between the old primary dune and its buried fencing is between a vibrant new foredune system rapidly becoming the main area where new sand is added.

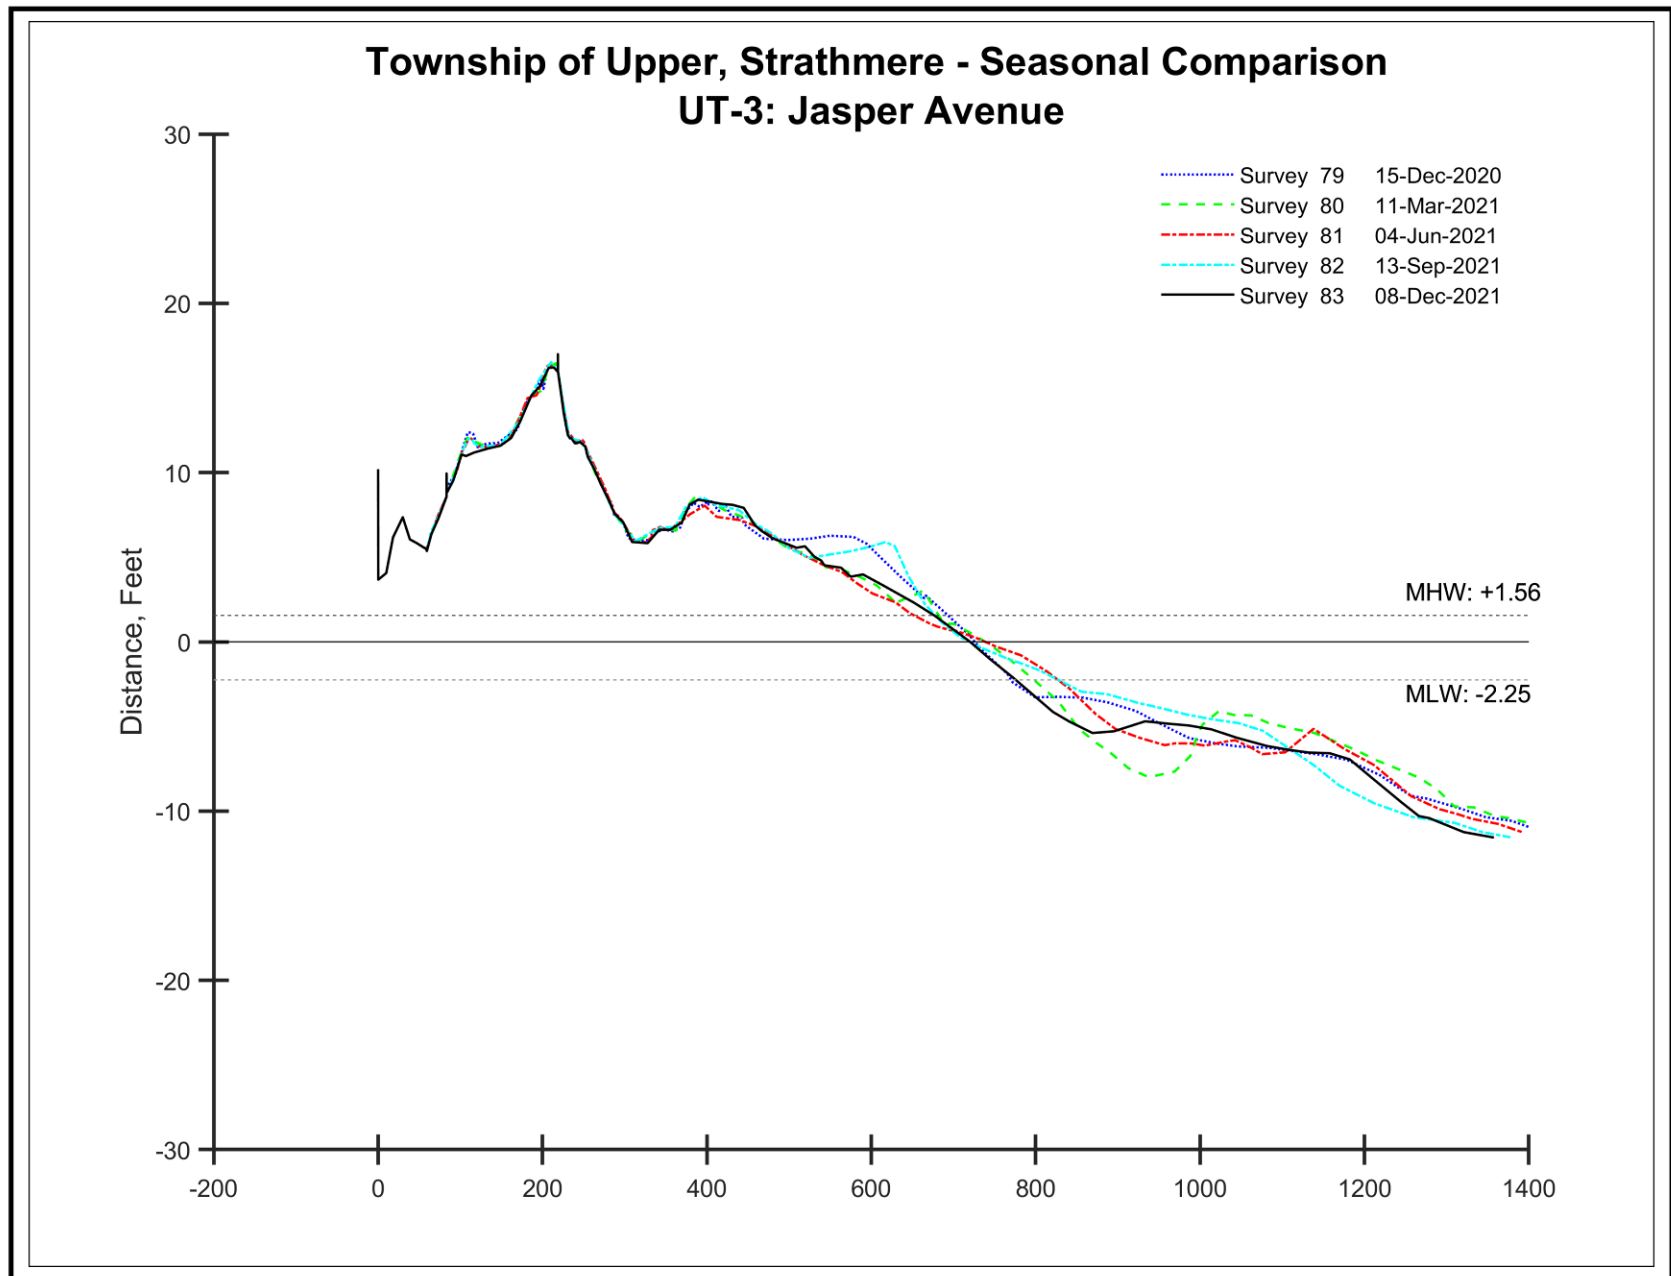
Figure 11. For the past several years all the dune accretion took place on the emerging foredune seaward of the primary feature. The winter 2021 storms removed the December 2020 berm which did not recover very much by June 2021. As of September, however, the berm was back in place. The fall season saw its second removal in 2021.

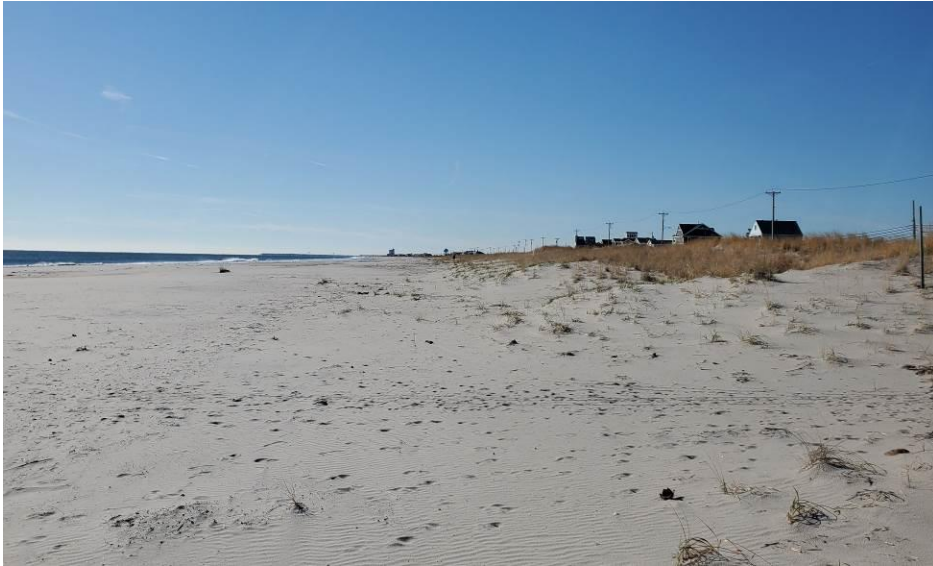
12a. December 15, 2020

Figure 12a is a beach view at the toe of the dune across the open beach. The pattern of change is only one where the beach appears wider than it did earlier in 2020.
