**FINAL REPORT FOR 2021
ON THE CONDITION OF THE MUNICIPAL BEACHES
IN
THE TOWNSHIP OF UPPER, CAPE MAY COUNTY, NEW JERSEY**

**PREPARED FOR: THE TOWNSHIP OF UPPER
PO BOX 205
TUCKAHOE, NEW JERSEY 08250**

**PREPARED BY: THE STOCKTON UNIVERSITY COASTAL RESEARCH CENTER
30 WILSON AVENUE
PORT REPUBLIC, NJ 08241
DECEMBER 22, 2021**

**Annual Report for 2021
To
The Township of Upper
On the Condition of the Municipal Beaches in Strathmere**

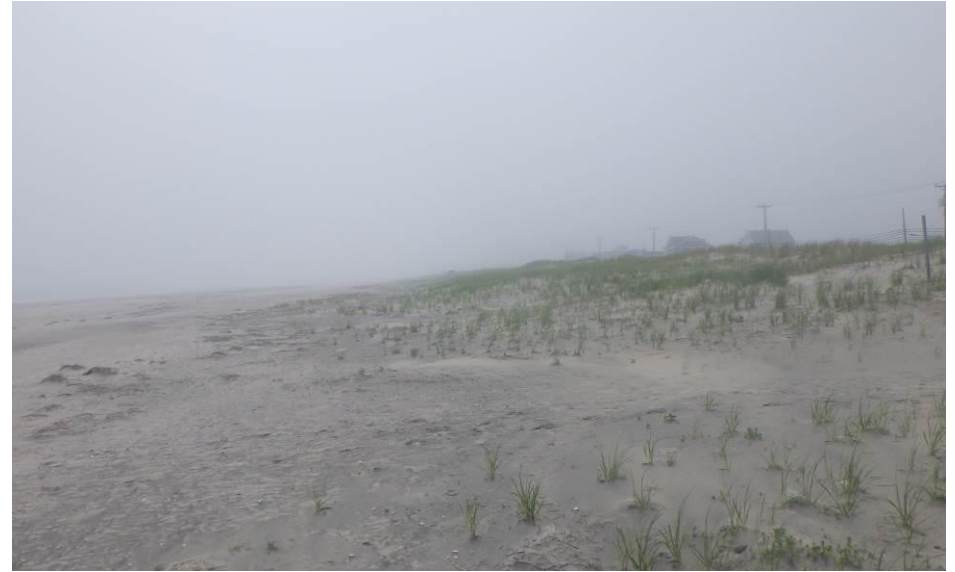
Figure 12b. June 4, 2021

Photograph 12b taken on a foggy day with new grass plants springing up along the seaward dune toe.

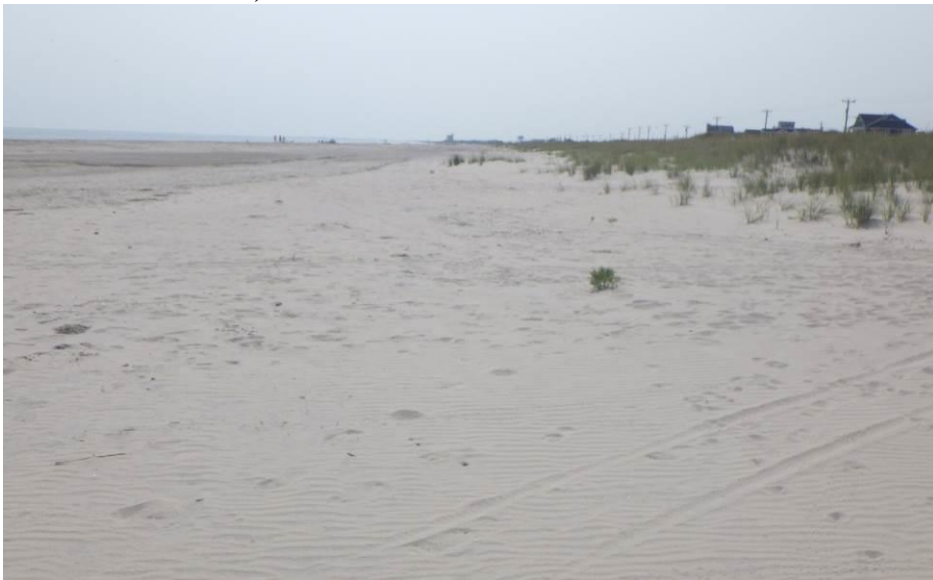
12c. September 13, 2021

Photograph 12c. This view in September depicts wind deposition into the new grass at the dune toe with little change obvious in the general beach condition.

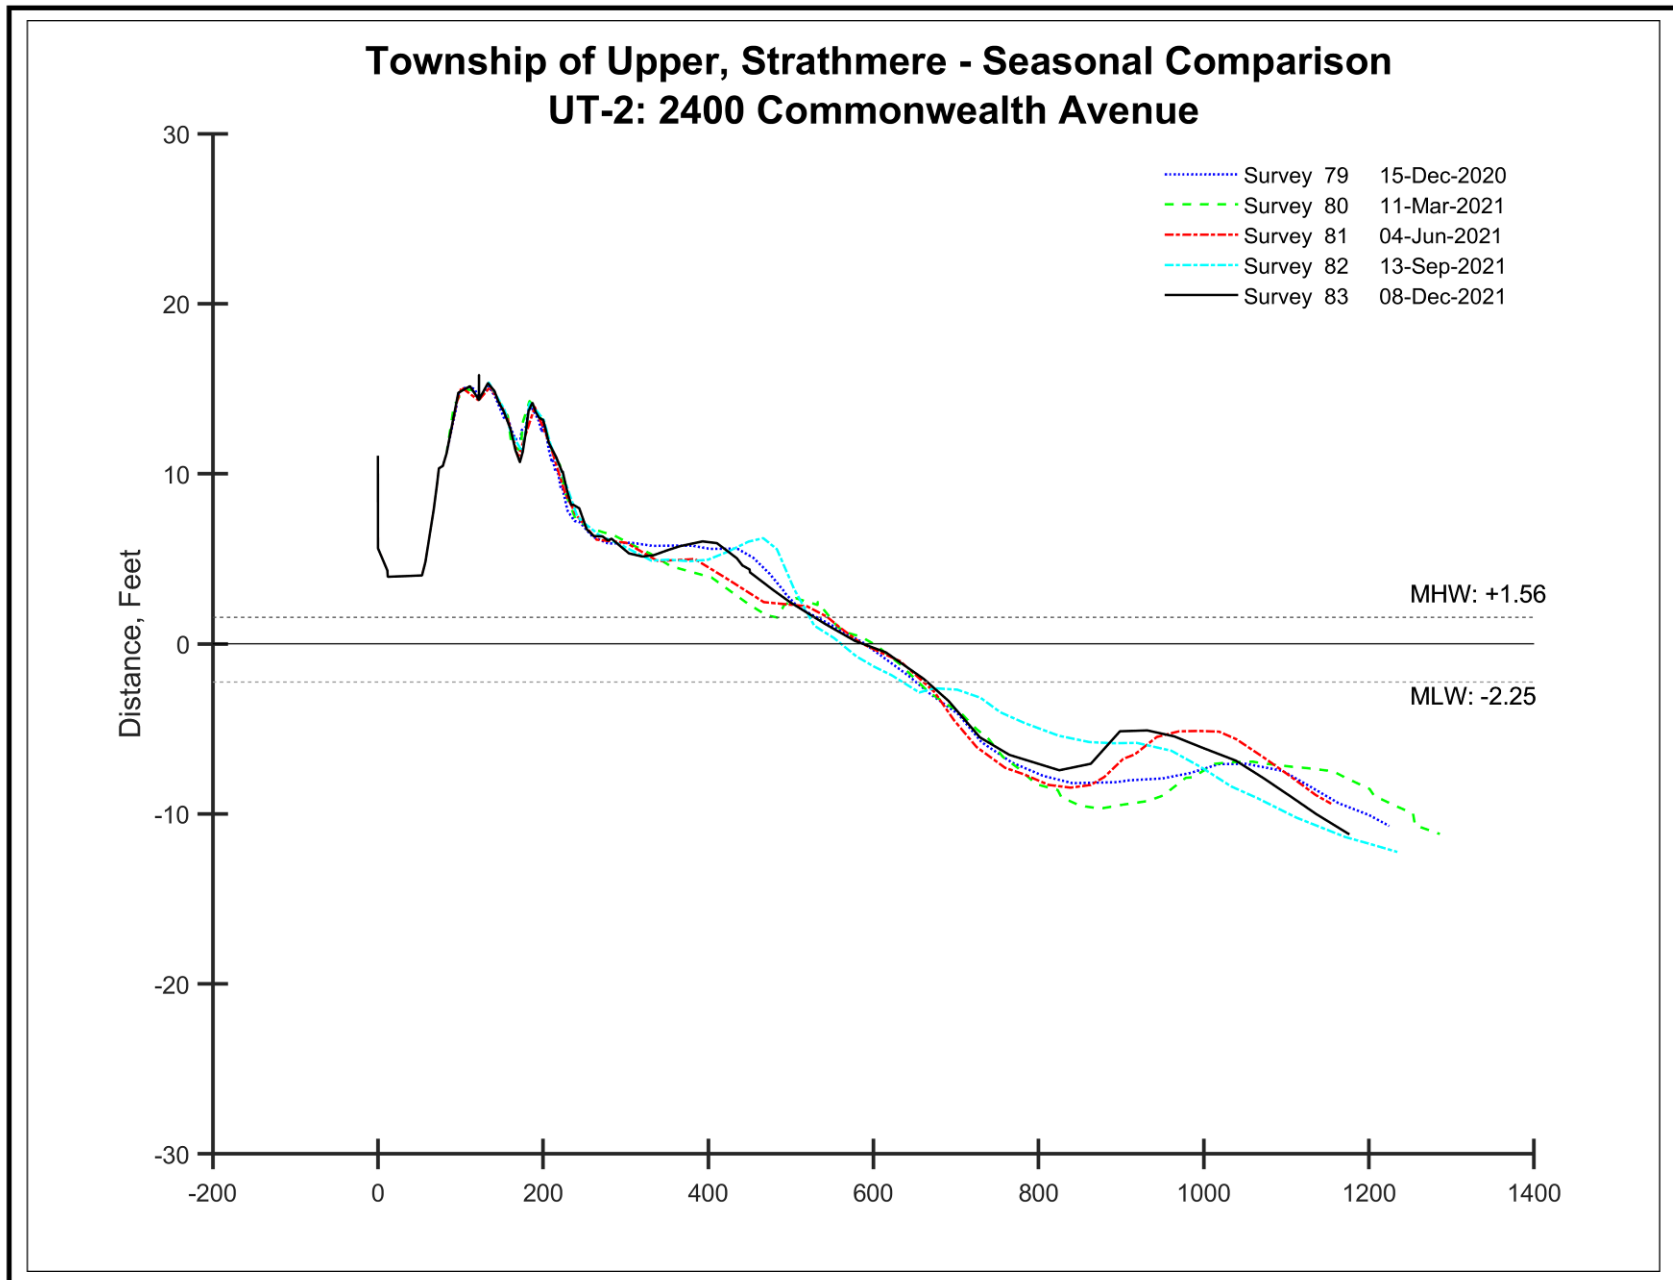
Figure 13. Located in the middle of the mid-Whale Beach area, this site remains quite stable. The primary dune developed a significant foredune nearly at the same elevation as the reference position on the original dune. The beach berm was degraded by the early winter storms with a repetitive growth of a berm ridge in December 2020, September 2021 remaining a little landward as of December 2021. Offshore, the bar system was present after the northeast storms in March 2021 and grew larger by June. It attached to the beach by September with a new bar formed as of December 2021.

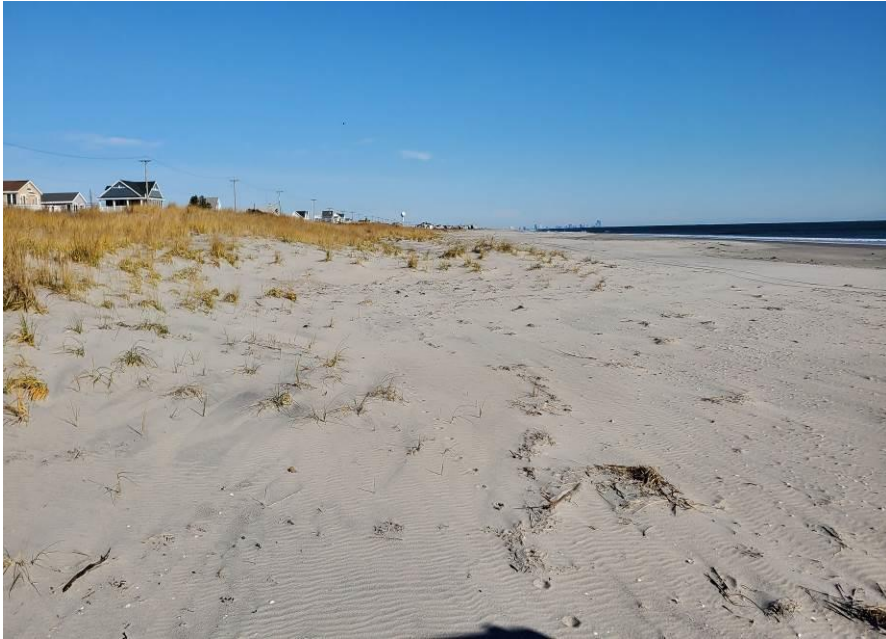
14a. December 15, 2020

Photograph 14a is a view to the north at the seaward toe of the dunes across the beach showing the extent of sand accumulation. There is far more sand present than was on the site prior to the federal project completion.

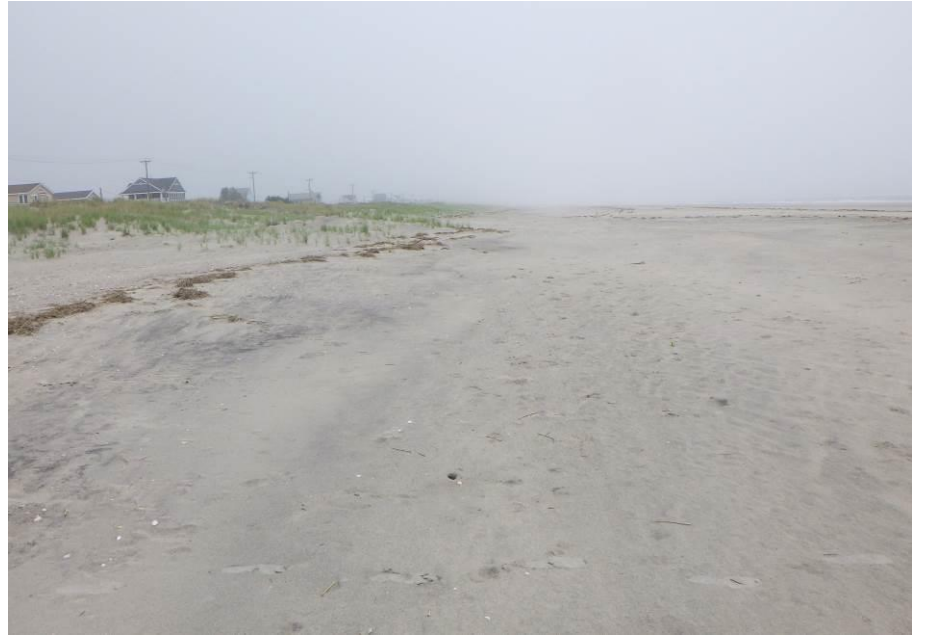
14b. June 4, 2021

Photograph 14b shows the beach six months later after three notable northeast storms. Likely, the debris at the beginning of the seaward dune toe slope came from the February 1 & 2, 2021 storm. Summer growth has added luxuriant vegetative cover to the dune.

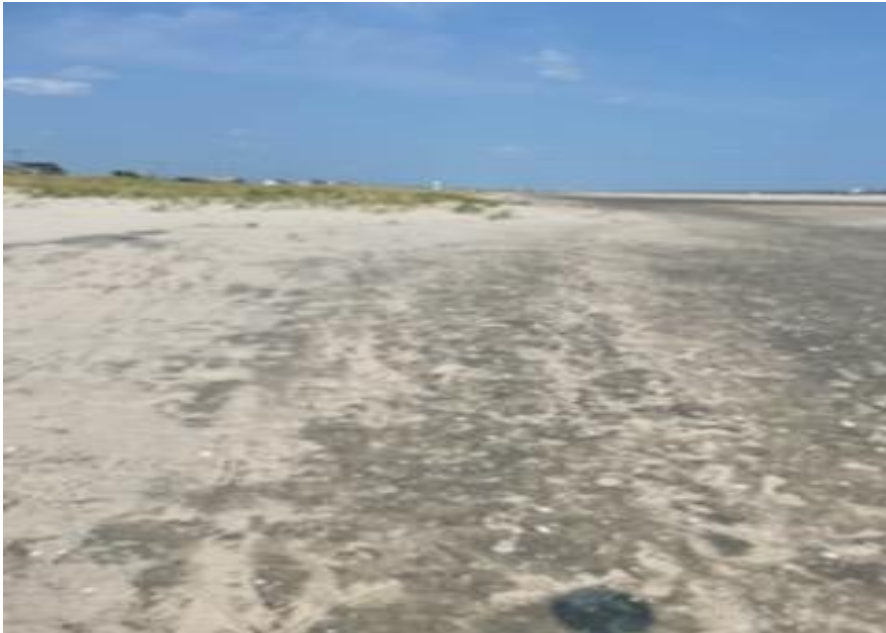
14c. September 13, 2021

Photograph 14c This early fall view shows the beach width re-established after the offshore bar moved onto the beach.

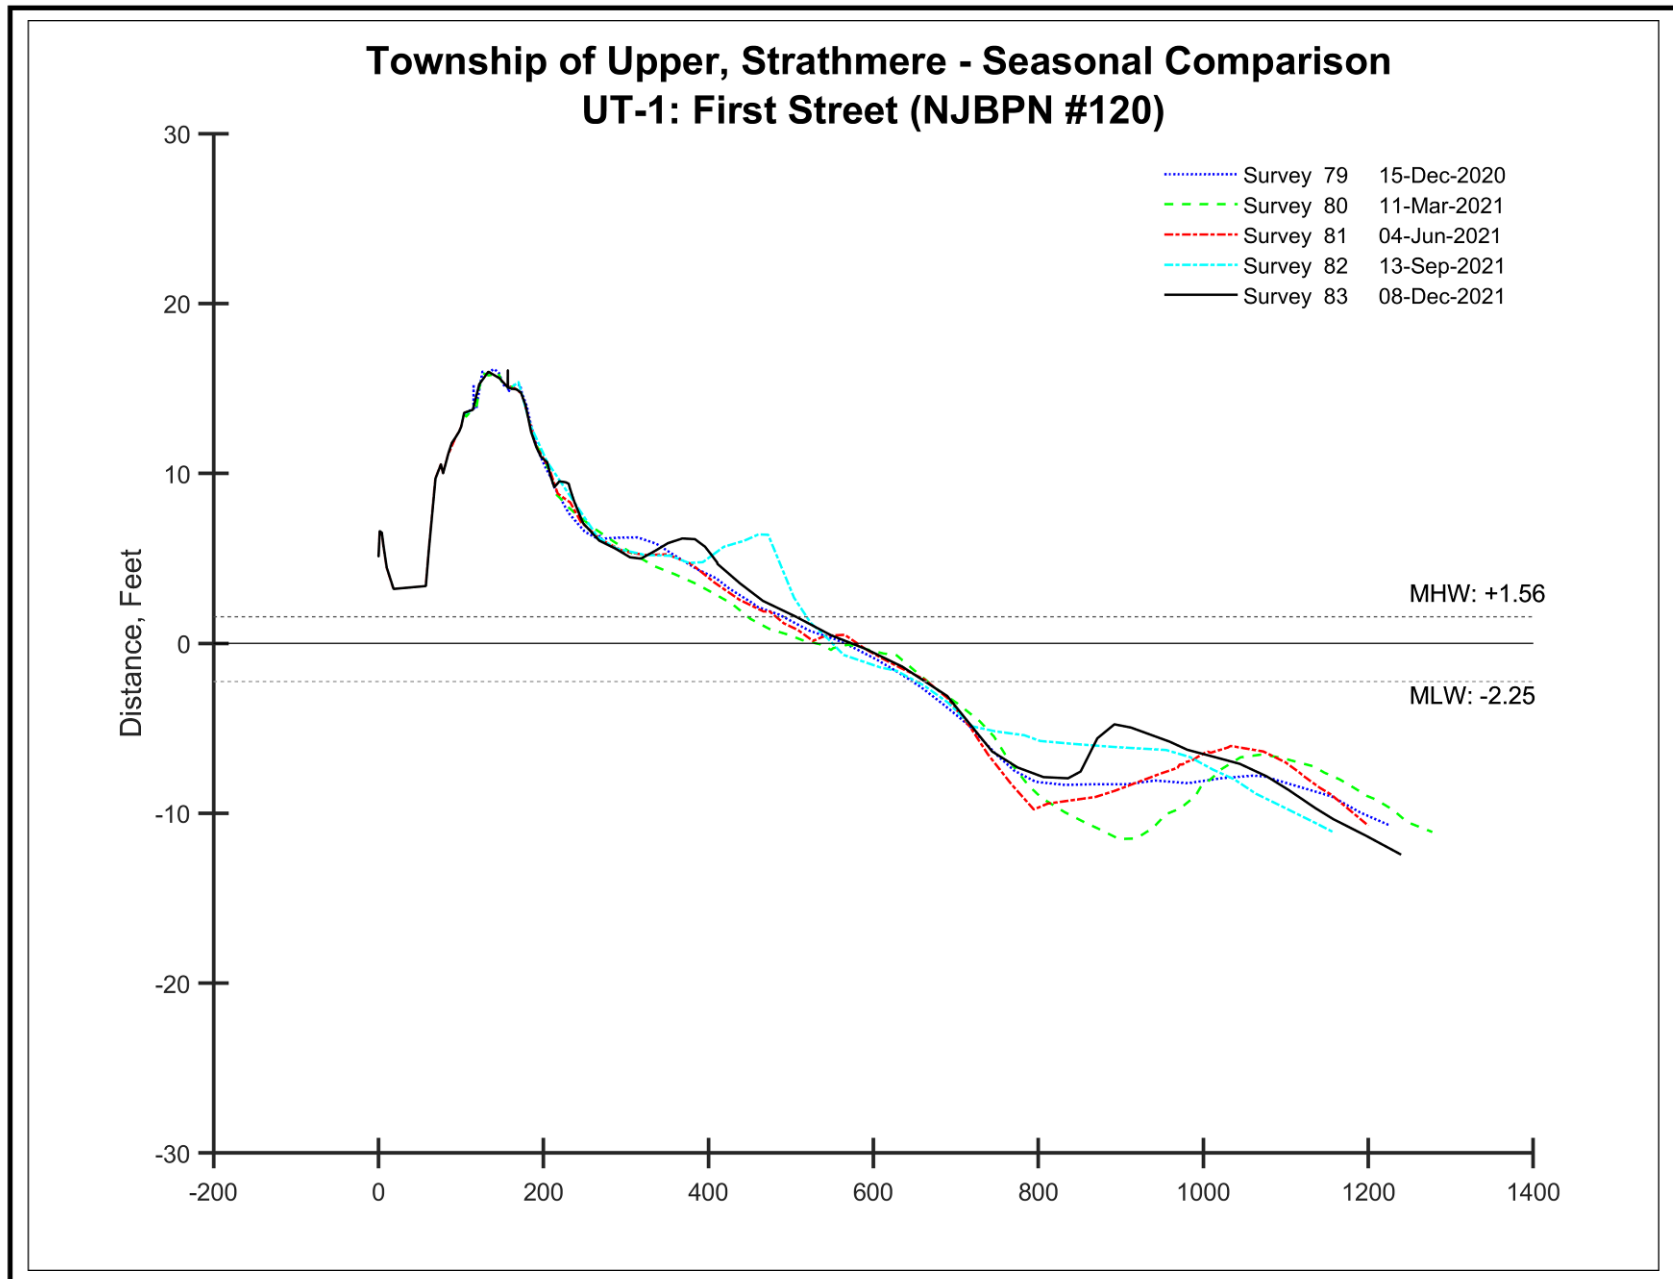
Figure 15. Seasonal variations related to changes in storm intensity appear well illustrated in this site's five transects. The December 2020 beach developed a flat beachface and large offshore bar after the storms as of March 2021. By June the bar moved landward, and some sand was added to the beachface. As of September, the bar had attached to the beach and a significant berm ridge had developed. The December 2021 survey showed both a new offshore bar, but closer to the beach and the September berm ridge pushed landward on the beach. This is indicative of more unsettled weather patterns emerging in the fall.
