**ANNUAL REVIEW FOR 2018
OF THE CAPE MAY POINT, NJ MUNICIPAL BEACHES**

PREPARED FOR: THE BOROUGH OF CAPE MAY POINT
215 LIGHTHOUSE AVENUE
CAPE MAY POINT, NJ 08212

PREPARED BY: STOCKTON UNIVERSITY COASTAL RESEARCH CENTER
30 WILSON AVENUE
PORT REPUBLIC, NJ 08241

May 20, 2018

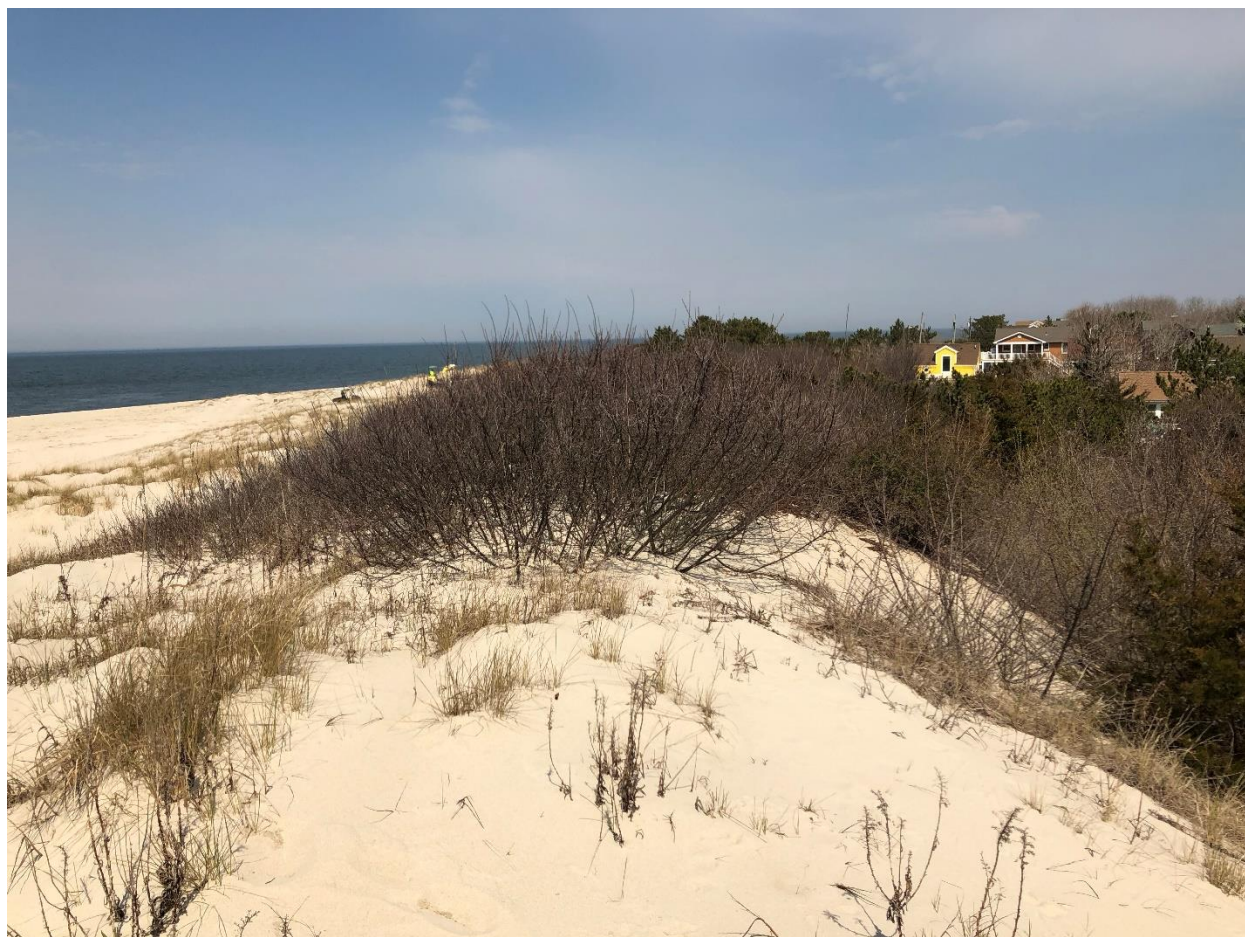
The photo above taken on April 24, 2018 from the instrument set-up location on the dune crest near Brainard Avenue looking west gives a scope and scale to the Cape May Point dune system. The alignment of the roof peaks on Stites Avenue with the Delaware Bay horizon means that the dune is within 4 feet of the roof peak elevation or about 33 feet above the water surface at high tide. The distance from the grass at the dune toe on the beach to the homes is about 500 feet. The Borough's efforts since the 1980's has produced a high level of storm protection.

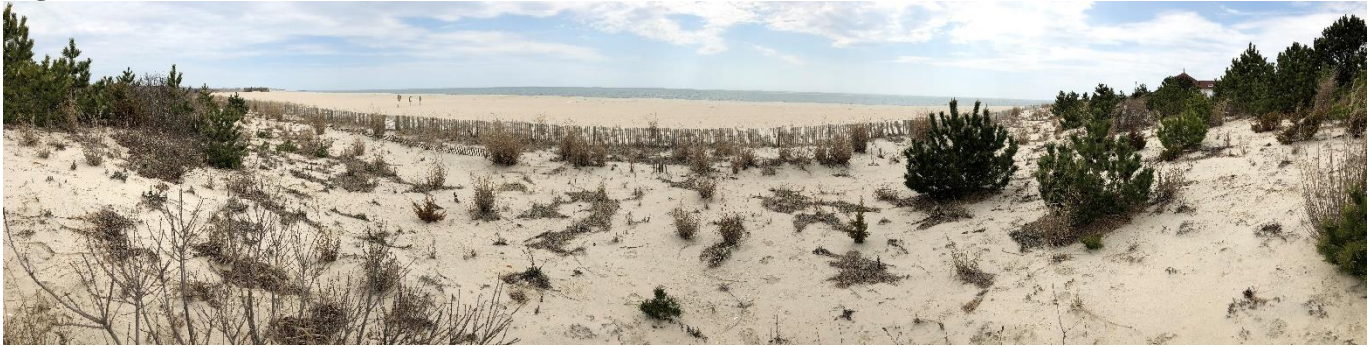
Figure 1. This year a series of panoramic views were taken from the dunes to provide an extended view of the entire beach cell. The photo taken in April 12, 2018 shows the dune and its vegetation looking over the beach seaward of the dunes. This remains a substantially wider beach as a result of the USACE work.

CMP-0 (Cell 0) is the northeastern-most cell that borders the State Park and is bounded to the southwest by a rock groin. This location has benefited tremendously from the USACE Lower Cape May Meadows – Cape May Point restoration project, where initial construction was completed June 2007. The project added over 250 feet of recreational beach berm and established a stable dune system 100 feet wide at the toe with a crest elevation of 18 feet NAVD88. Prior to the initial project the beach was narrow; a small dune armored with tensor mats on the seaward slope protecting the exposed dune system from severe erosion. There is no public access from Lighthouse Avenue to the beach.

1. Cells 0 and 1 do not have structures; the beaches at Lighthouse and Lehigh Avenue gained substantial new sand and remain stable to accretive. Both beaches have steep slopes into deep water with strong tidal currents into and out of Delaware Bay.

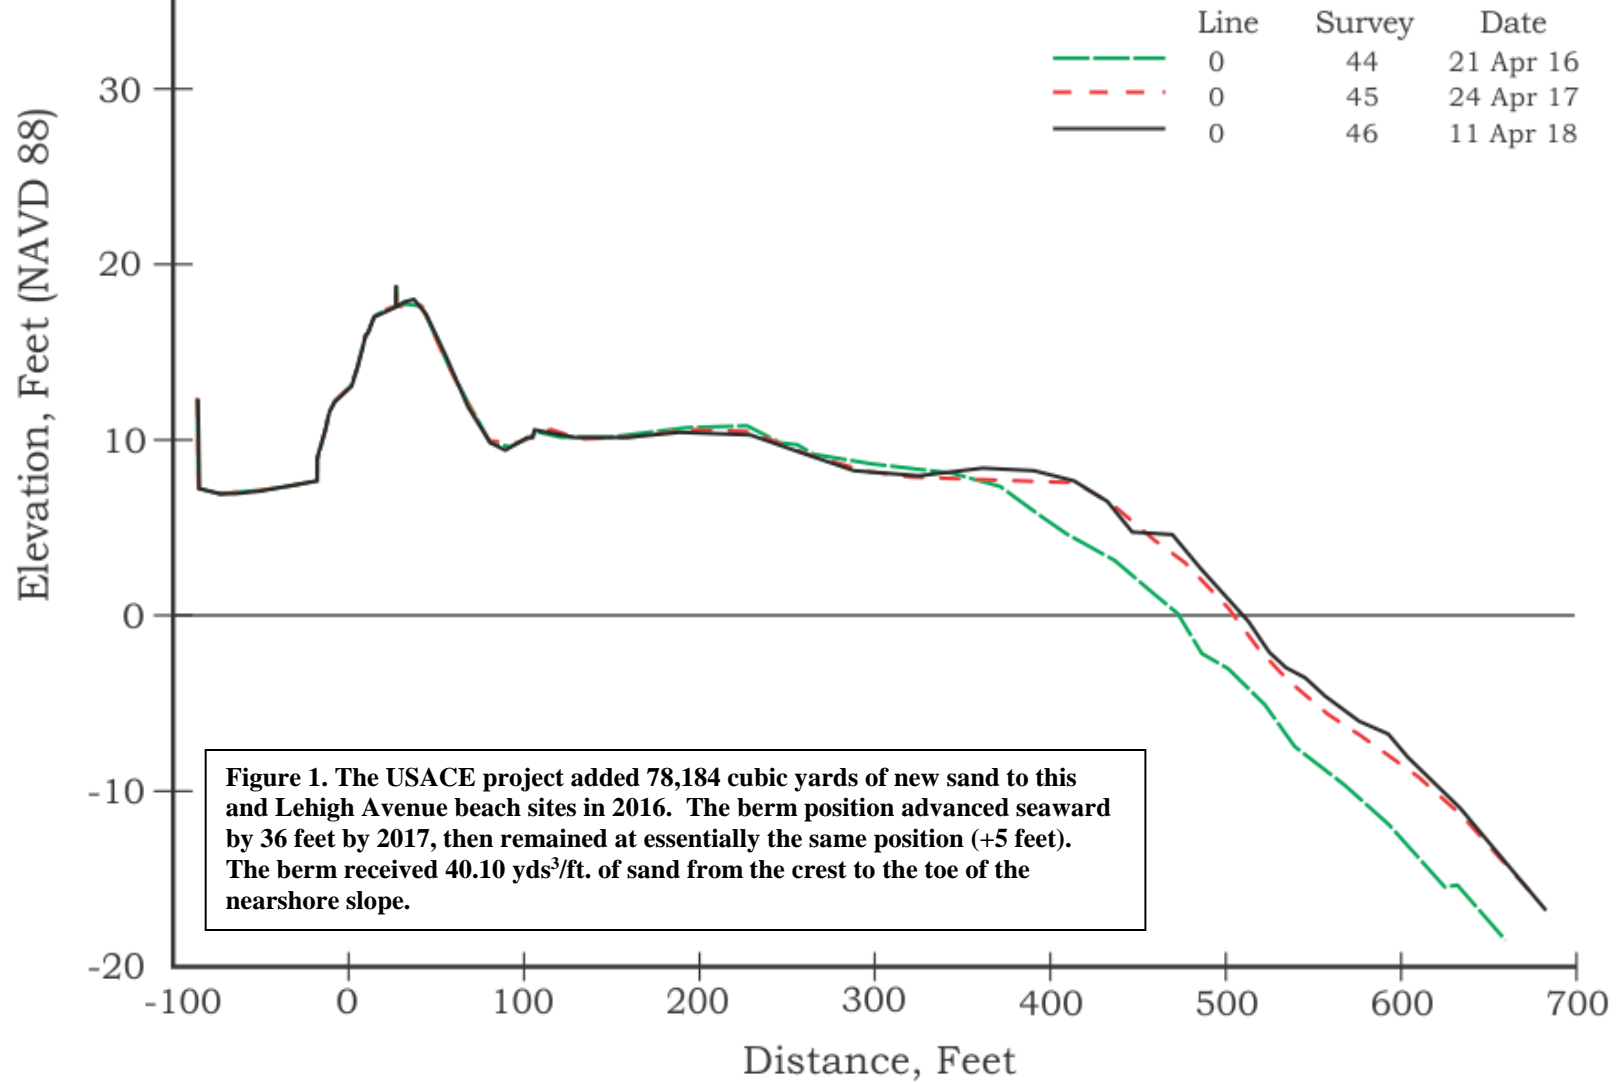
CMP - Line 0 - Lighthouse Avenue

The USACE authorized a second maintenance project with construction from November 2012 to January 2013. The project restored the design beach width and elevation. The beach width increased by 58 feet with 63.13yds³/ft. of sand added per foot of shoreline seaward of the dune toe. Following the project the beach elevation ranged from 10-11 feet NAVD 88 and extended 275 feet seaward of the dune toe.

In 2016, USACE activity added 78,184 cubic yards of new material to this site and the Lehigh Avenue beach immediately to the southwest. The cross sections show that the beach grew wider following the 2016 survey and remained stable since.

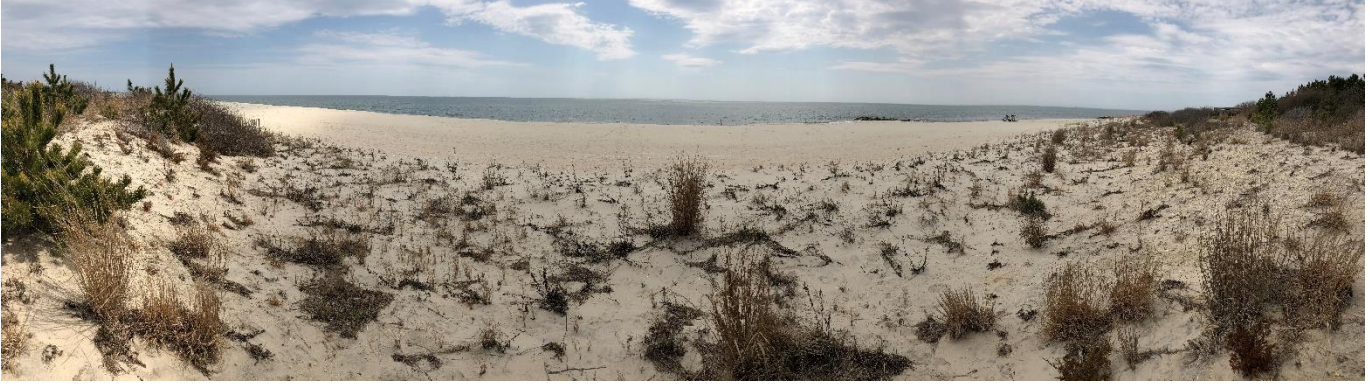
Lehigh Avenue

Figure 2. Taken on April 12, 2018, the photo shows the dunes and a stable to slightly accretive beach. Dune vegetation is sparse directly seaward of the reference location, but improves to the sides.

CMP-1 (Cell 1) stretches from the Lighthouse Avenue groin to Lehigh Avenue. Prior to the initial USACE project no dry beach was present between the rock groins. Shore protection was provided by a rock seawall that armored the seaward dune slope. Beyond the groins the seafloor steeply dropped into the adjacent tidal channel. The initial USACE project re-established a dry recreational berm and covered the seawall with sand to restore the dune.

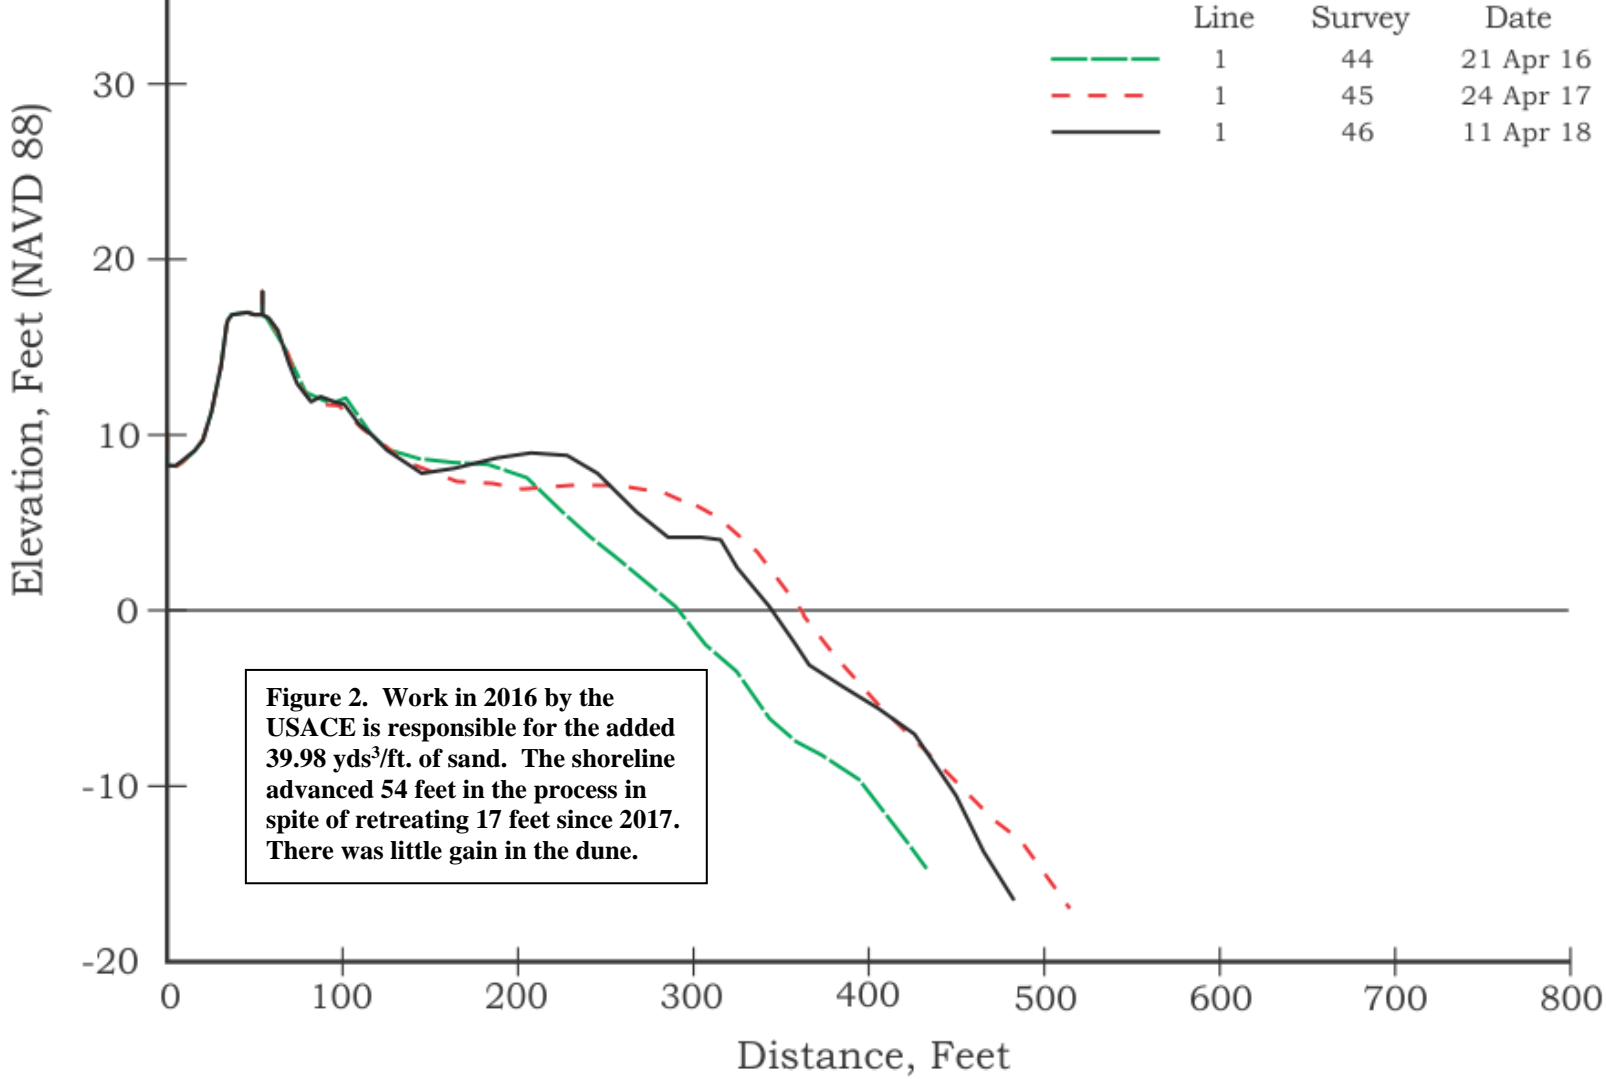
CMP - Line 1 - Lehigh Avenue

This site also received sand during the USACE authorized second maintenance project conducted between November 2012 and January 2013. The project restored the design beach width and elevation. The beach width increased by 60 feet with 56.39yds³/ft. of sand added to each foot of shoreline seaward from the dune toe. Following the project the beach elevation was 10 feet NAVD 88 and extended about 170 feet seaward of the seaward dune toe. The most recent project counted both Lighthouse and Lehigh sites as one placement volume at 78,174 cubic yards. The visual impact is like that seen at Lighthouse Avenue with both sites seeing similar shoreline advances. Both sites also remained quite stable during the following year.

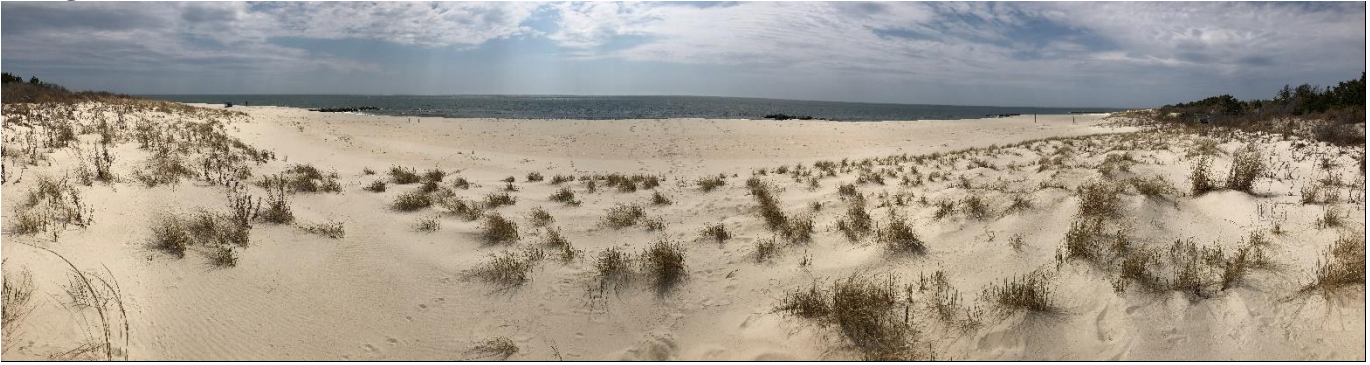
Lehigh to Whilden Avenues

Figure 3. This view from the beach entrance shot April 12, 2018 shows the beach from groin to groin along with the dunes.

The CMP-2 (Cell 2) beach is the southeastern-most of the groin cells with an early installation of the “Beachsaver” units from 1993, which still are functioning and show on the profile cross-section at the 520-foot distance from the reference point and remain relatively stable. Sand added to the system during the initial USACE project has resulted in the near burial of a rock seawall that served as property protection prior to the project. No additional sand was placed here during the 2013 2nd maintenance cycle.

2. Cell 2 at Whilden Avenues, the shoreline position (zero datum) is approximately 110 feet distance from the breakwater structure. Depth of the scour trough landward of the units has decreased to -10.5 feet NAVD88 with about half the reef structure now exposed above the sea floor around the units. The swimming area remains limited, especially closer to the groins but should be manageable mid-beach this year. The CRC again recommends installing a line of floats indicating the maximum distance for swimming that should be about 30 feet from the breakwater reef. This is due to wave surge turbulence during larger wave size events.

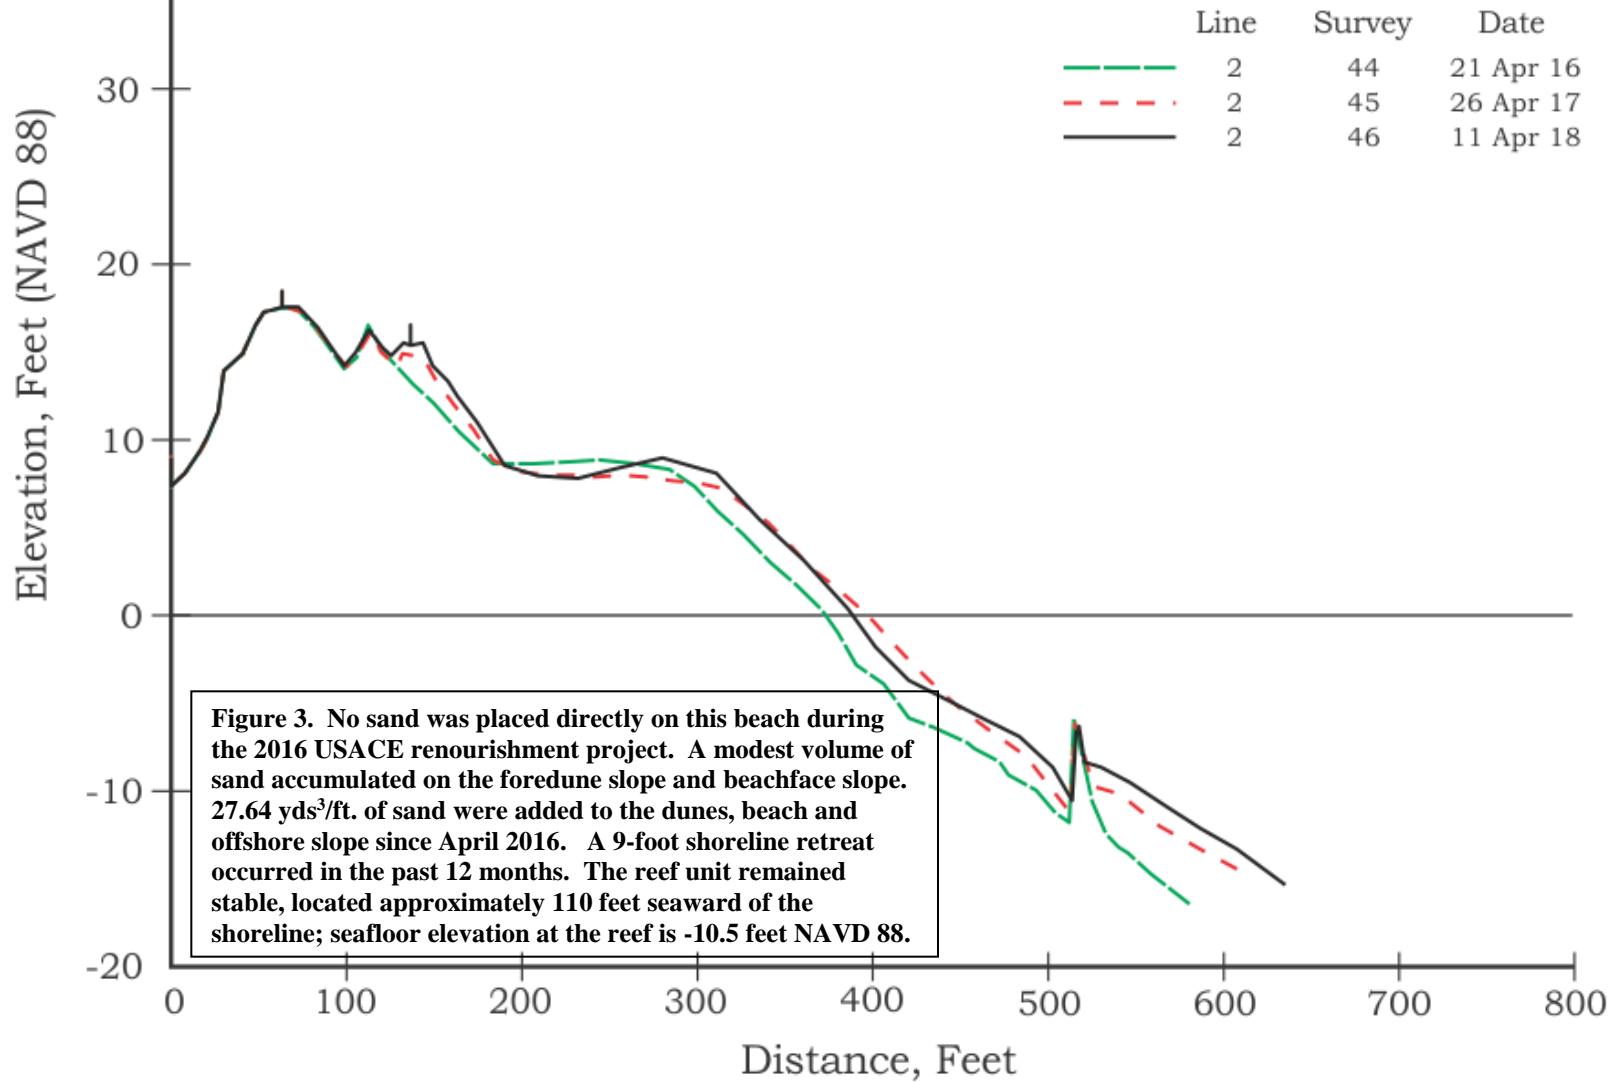
CMP - Line 2 - Wilden Avenue

The recent cycle of USACE sand placement also did not directly put sand into this cell. However, the natural transfer of material created a 16-foot shoreline advance and an net gain of 27.64 yds³/ft. in sand volume. This gain occurred in the first year following the 2016 project with minor changes since.

The “Beachsaver” unit crest has been incrementally buried by sand reducing its exposure above the seabed from 6 to 3.5 feet above the nearshore seabed slope. Landward of the units, a trough remains at similar depths to last year, with a 110-foot area between the zero elevation position and the barriers. The top elevation has remained constant for many years, so the structure appears stable. At low tide the distance would be less than 110 feet and at high tide a bit more. The depth at the base of the beachsaver is 10.25 feet NAVD 1988.

The reef crest protrudes up to elevation -6 feet NAVD88. In this position the units are unlikely to be encountered by swimmers this season within the middle of the groin cell. Caution and restrictions should be in placed closer to the groins where the shoreline sand extends outward toward the concrete reef along each groin. The lower profile exposed in the water column means less wave surge over the reef and a lower risk of swimmer injury from the surging waves.

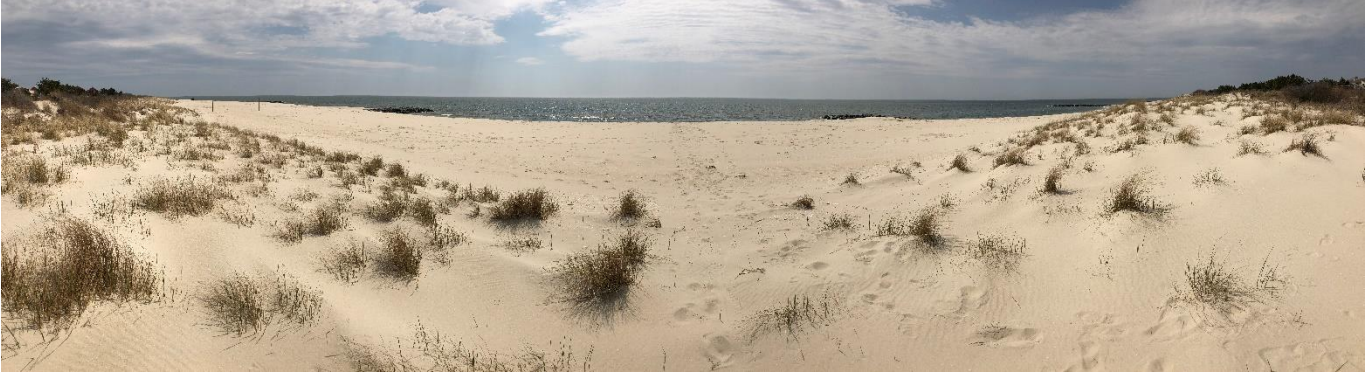
Whilden to Coral Avenues;

Figure 4. This view from the profile reference position on April 12, 2018 shows the dune vegetation and the beach extent seaward of this location.

CMP-3 is bounded by rock groins at Whilden Avenue and Coral Avenue. This beach cell was the other original 1993 “Beachsaver” unit installation in Cape May Point. Sand added to the system during the initial USACE project had resulted in the near burial of the entire beach unit structure. No additional sand was placed here during the 2nd maintenance cycle (2012-2013). No new sand was added here during the 2016 USACE project either. Sand accumulated on the dunes, and minimally on the beach. The largest sand volume gain occurred at and beyond the beachsaver reef offshore.

3. Cell 3 at Coral Avenue, the shoreline position remained constant; the breakwater units in April 2018 were approximately 100 feet from the shoreline position (zero datum). The beachface slope remains fairly steep with a diminished depth at the scour trough landward of the units (-10 feet

NAVD88). The reduction in exposed reef structure above the sand surface reduces the wave turbulence over the reef and makes for safer swimming.

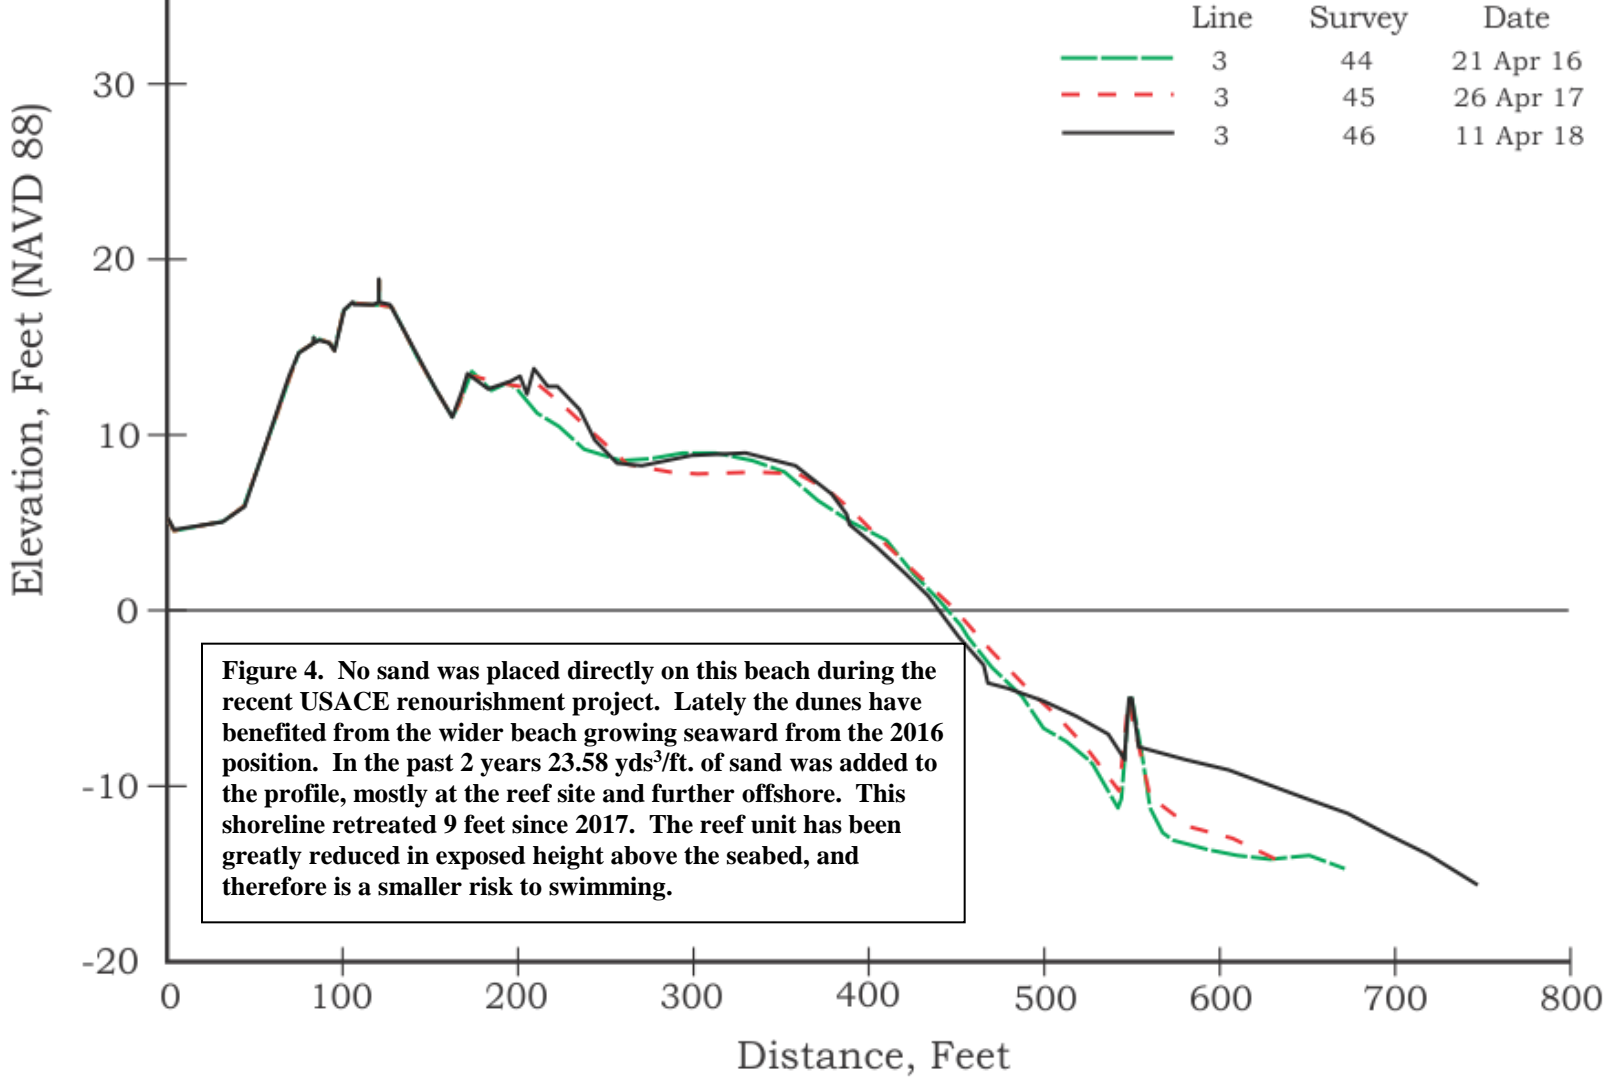
CMP - Line 3 - Coral Avenue

The minor retreat at the zero elevation on the beach width keeps the “Beachsaver” units within relative close proximity to the shoreline, approximately 100 feet. The concrete crest protrudes to elevation -5.0 feet (NAVD88 zero datum) while the base is at -8 to -9 feet NAVD88. Sand deposition has reduced the exposure from 6 to 2.5 feet above the seabed. This location has been restricted for several years as the beach width brings the zero elevation position within 100 feet of the reef structure. Water access could be allowed here in mid-beach but water access near the groins where the units are closer to shore should be prohibited. The wave surge turbulence over the reef has been reduced since less of it is exposed above the sand.

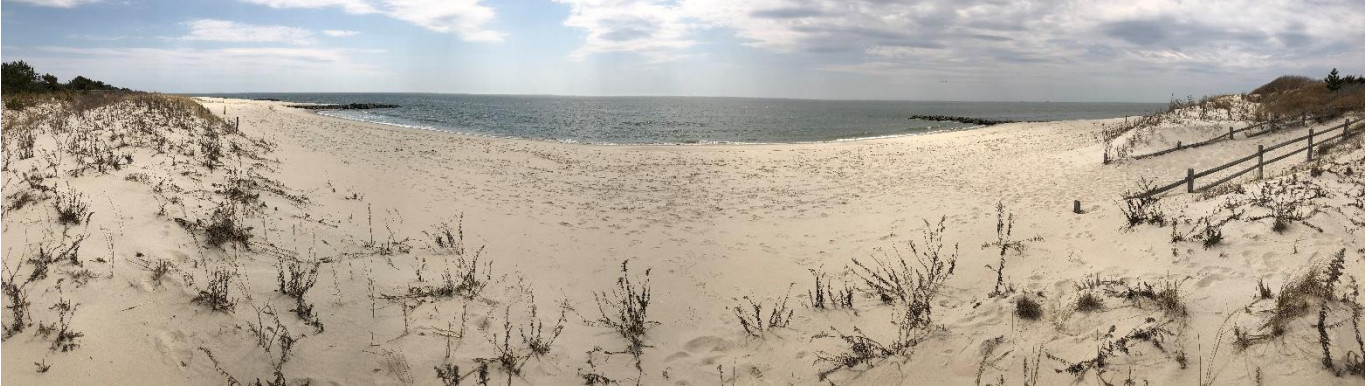
Coral Avenue to Lake Drive

Figure 5. A similar view on April 12, 2018 shows the entire cell between the two groins along with the beach entrance path and the foredune vegetation.

The Lake Drive (CMP-4, Cell 4) beach cell is bounded by the rock groins at Coral Avenue and south of Lake Drive (closer to Surf Avenue). This cell does not contain any nearshore “Beachsaver” structures but it has received sand both during the initial project and in the 2nd maintenance cycle nourishment project. Over the 2012/2013 winter, the USACE reported sand placement of 37,000 cubic yards in the Lake Drive beach cell (Dwight Pakam, USACE). This site also received modest sand placement in 2016 (42,300 cubic yards, Dwight Pakam, personal communication).

4. Cell 4 has no structures offshore and a relatively flatter nearshore slope. This site remains overall a good option for a swimming beach in Cape May Point this season and the recreational berm is about the same this year. The relatively shallow slope platform in the water between groins make wading and swimmer relatively safer for beach patrons.

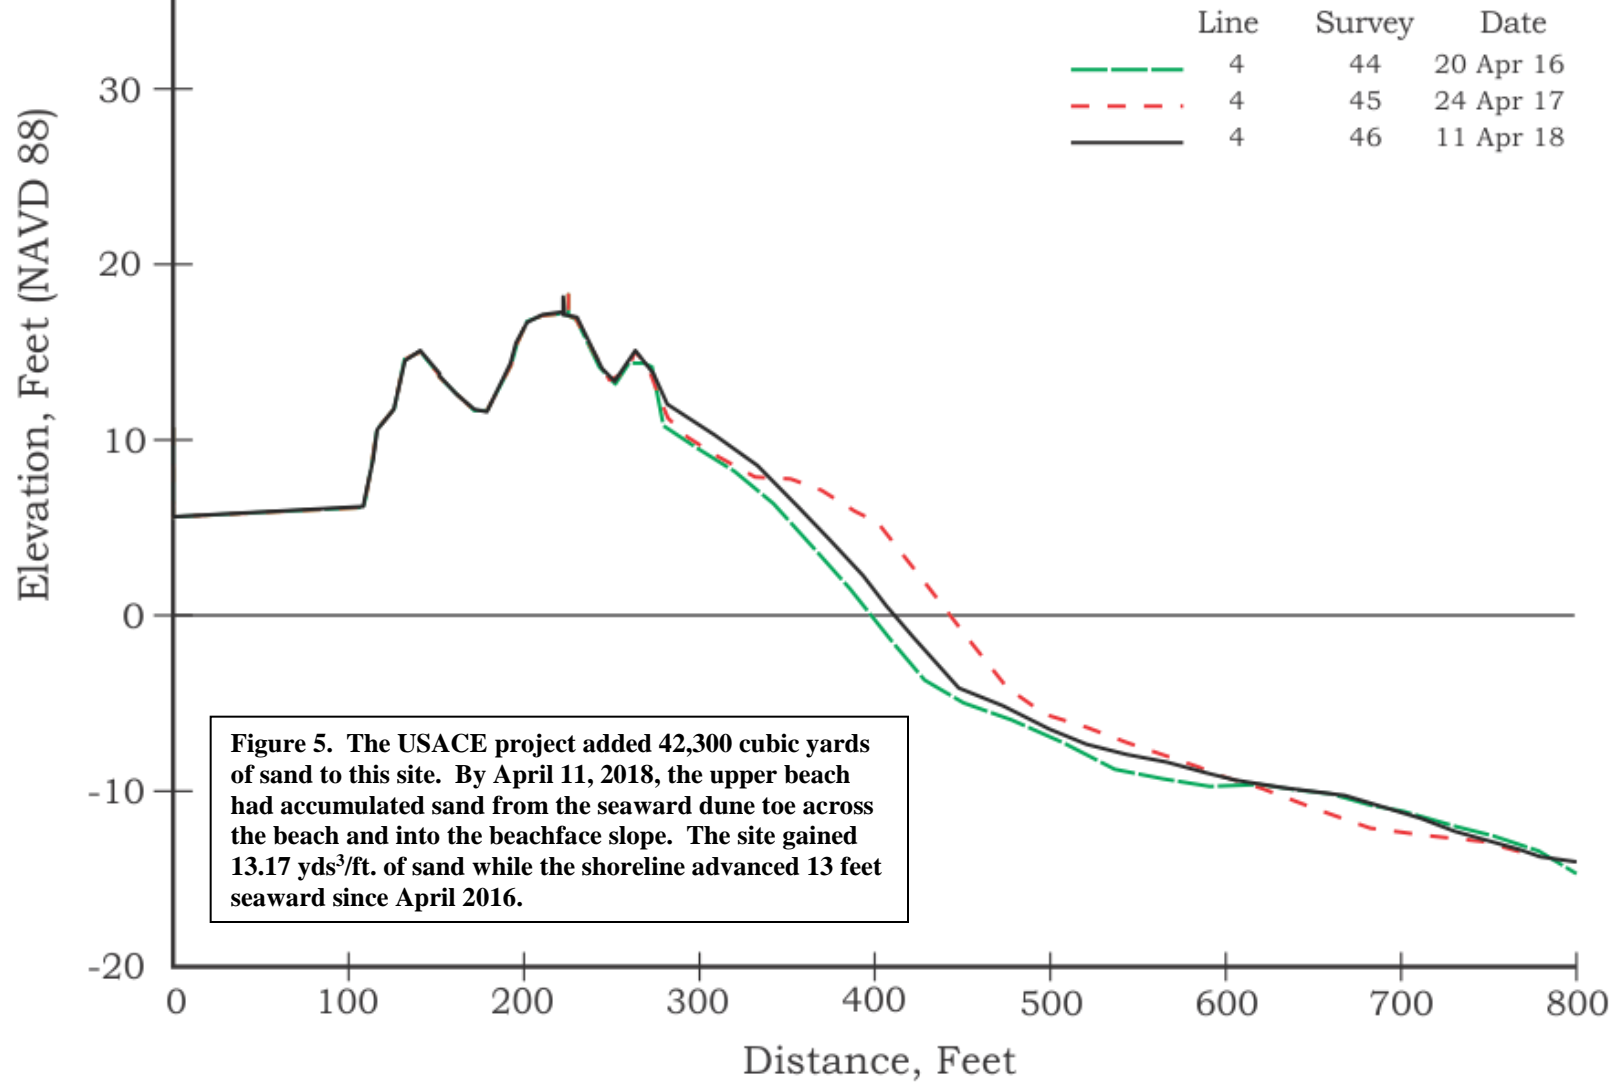
CMP - Line 4 - Lake Avenue

The 2016 placement volume was spread into the dunes and offshore over the following year. The net change was a small gain of 13.17 yds³/ft. as the sand adjusted to the wave conditions. The beach is not as wide as it was in 2017, but wider than it was in 2016. The 2017 to 2018 change saw a 32-foot shoreline retreat combined with the loss of 10.52 yds³/ft. in sand volume.

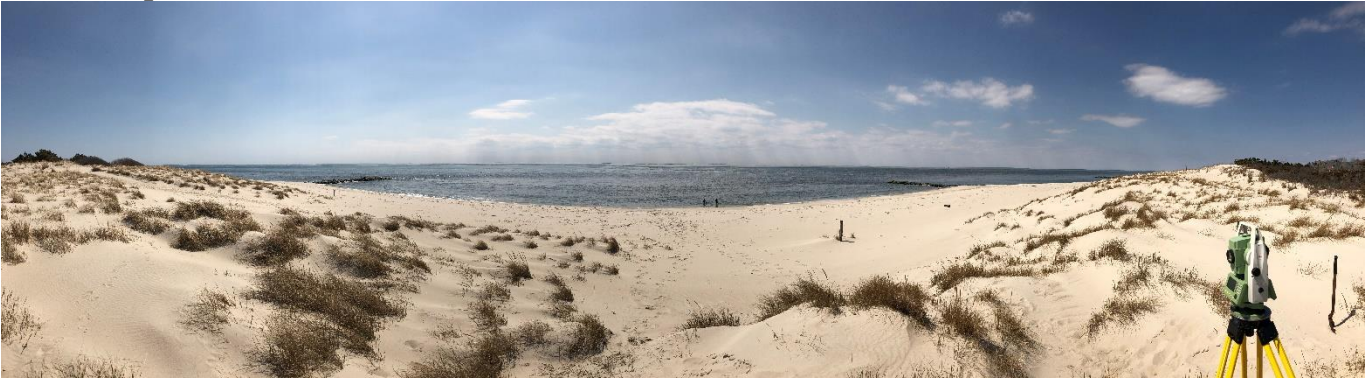
Surf to Cape Avenues

Figure 6. The view above was taken April 12, 2018 and includes the survey instrument, the dune vegetation, the beach extent and the two cell-defining groins.

CMP-5 (Cell 5) contains the nearshore “beachsaver” units installed in 2002 during the USACE CMP-227 experimental project. The breakwater units are still present, located just over 200-feet seaward of the zero elevation shoreline position. These units are furthest from the shoreline and lowest in elevation in the cell’s mid-section where swimming is allowed. That prevents individuals from encountering the units. In this cell the units pose little threat to recreational swimming but swimming along the rock groins should be restricted where the units are closer to shore due to sand accumulation at the rocks.

5. Cells 5 and 6 contain the newer units but pose minimal risk for swimming in 2018. Both reef structures lie in greater than -8 feet of water approximately 200 hundred feet from the shoreline at low tide. The “Double Tee” structure in Cell 6 is buried with additional sand. Swimming near the groins should always be avoided since the units are slightly closer to the beach adjacent to the rocks.

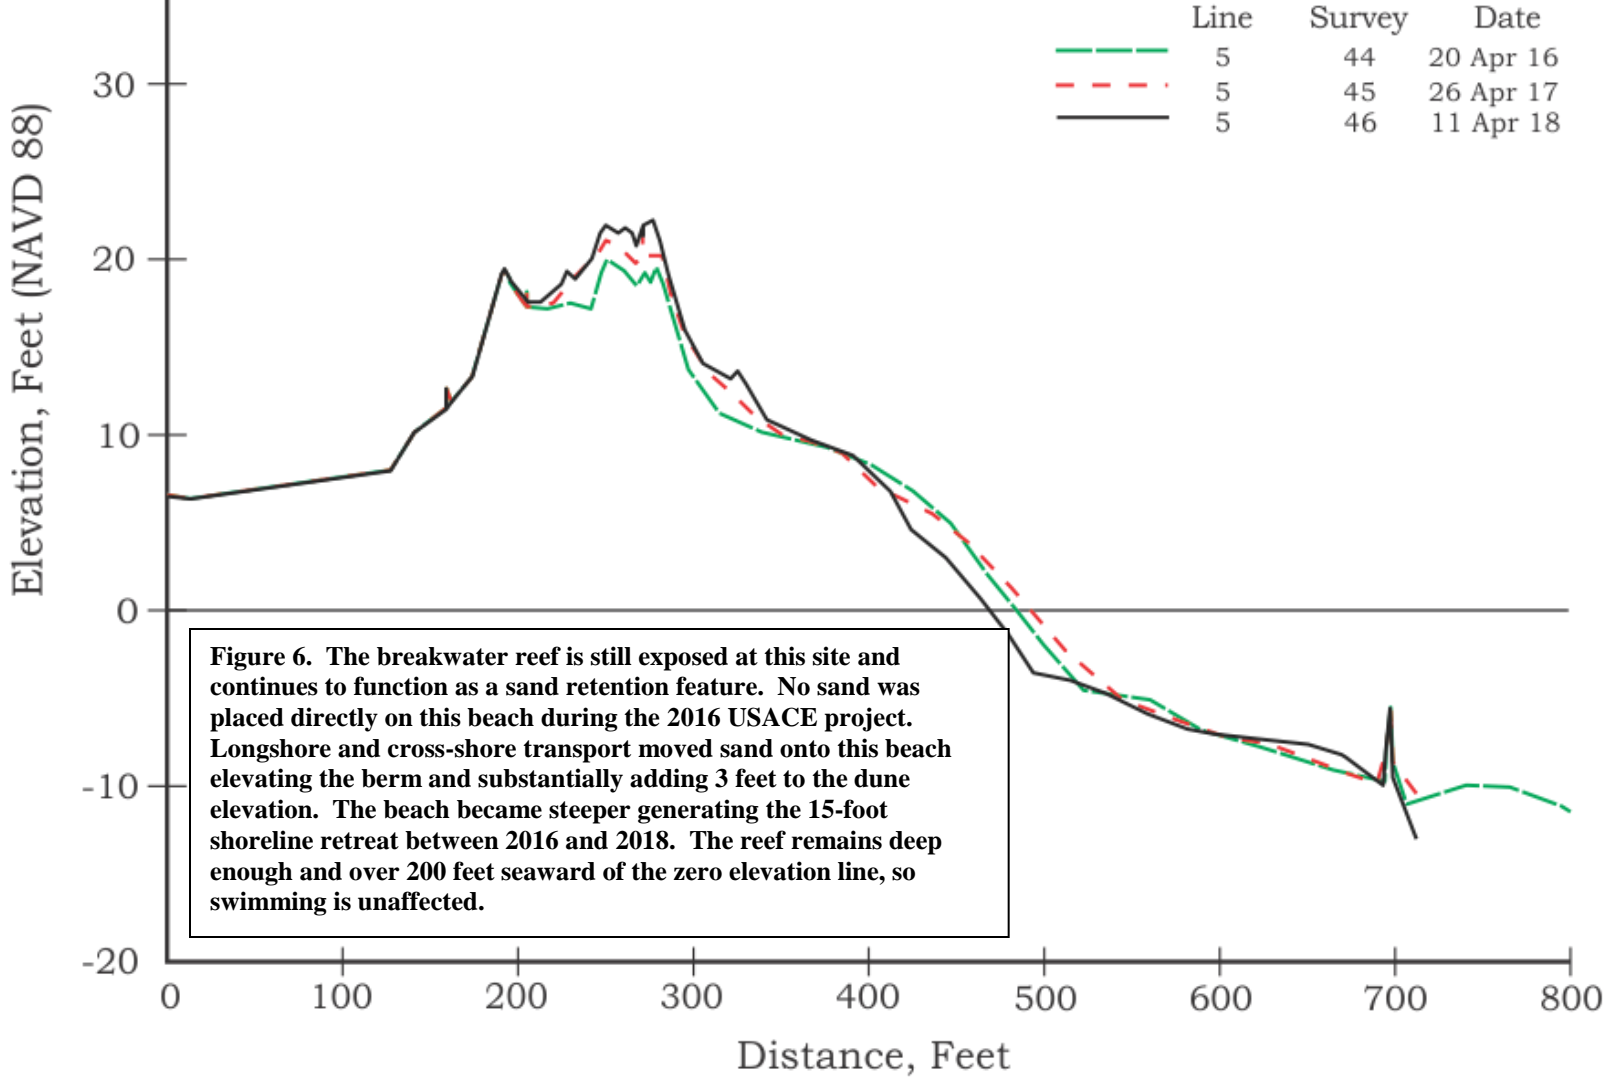
CMP - Line 5 - Cape Avenue

Sand did accumulate on the landward side of the beachsaver array, but offshore a very steep decline occurred making the seabed considerably deeper compared to the 2016 survey.

No sand was placed west of Lake Drive during the 2012-2013 USACE renourishment project or during the recent 2016 effort, but natural processes have moved sand from east to west along the Borough’s shoreline over time. The wider beaches have provided a source of sand for the wind to move sand onto the seaward slope and crest of the dune. This process added 3.15 yds³/ft. in sand volume combined with a 15-foot shoreline retreat landward. The majority of the shoreline retreat occurred in 2017 at 24 feet of landward shoreline movement cancelled most of the 2016 to 2017 advance. The sand volume in the past year declined by 4.70 yds³/ft.

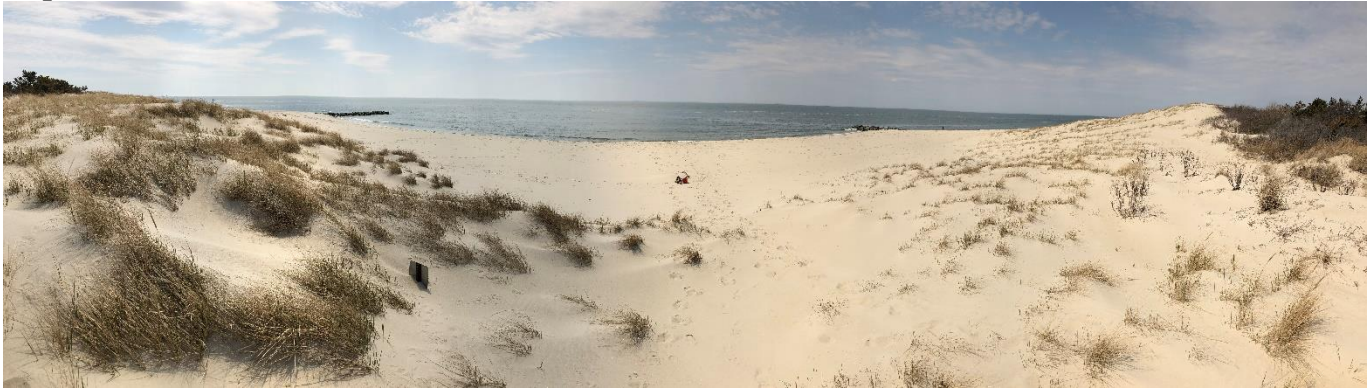
Cape to Pearl Avenues

Figure 7. This view was taken April 12, 2018 at the dune crest looking south across the beach. The beach access pathway from Pearl Avenue traverses the trees before climbing up the landward dune slope. This past winter the summit accumulated almost 10 feet vertically making the ascent the most challenging in Cape May Point.

CMP-6 (Cell 6) is bounded by the rock groins at Cape Avenue and Pearl Avenue. The nearshore bay floor contains the “Double Tee” structures that were installed as part of the USACE CMP-227 experimental project. These units were quickly buried and have remained buried by sand in the past nine annual surveys. Consequently, they have limited ability to influence additional sand retention.

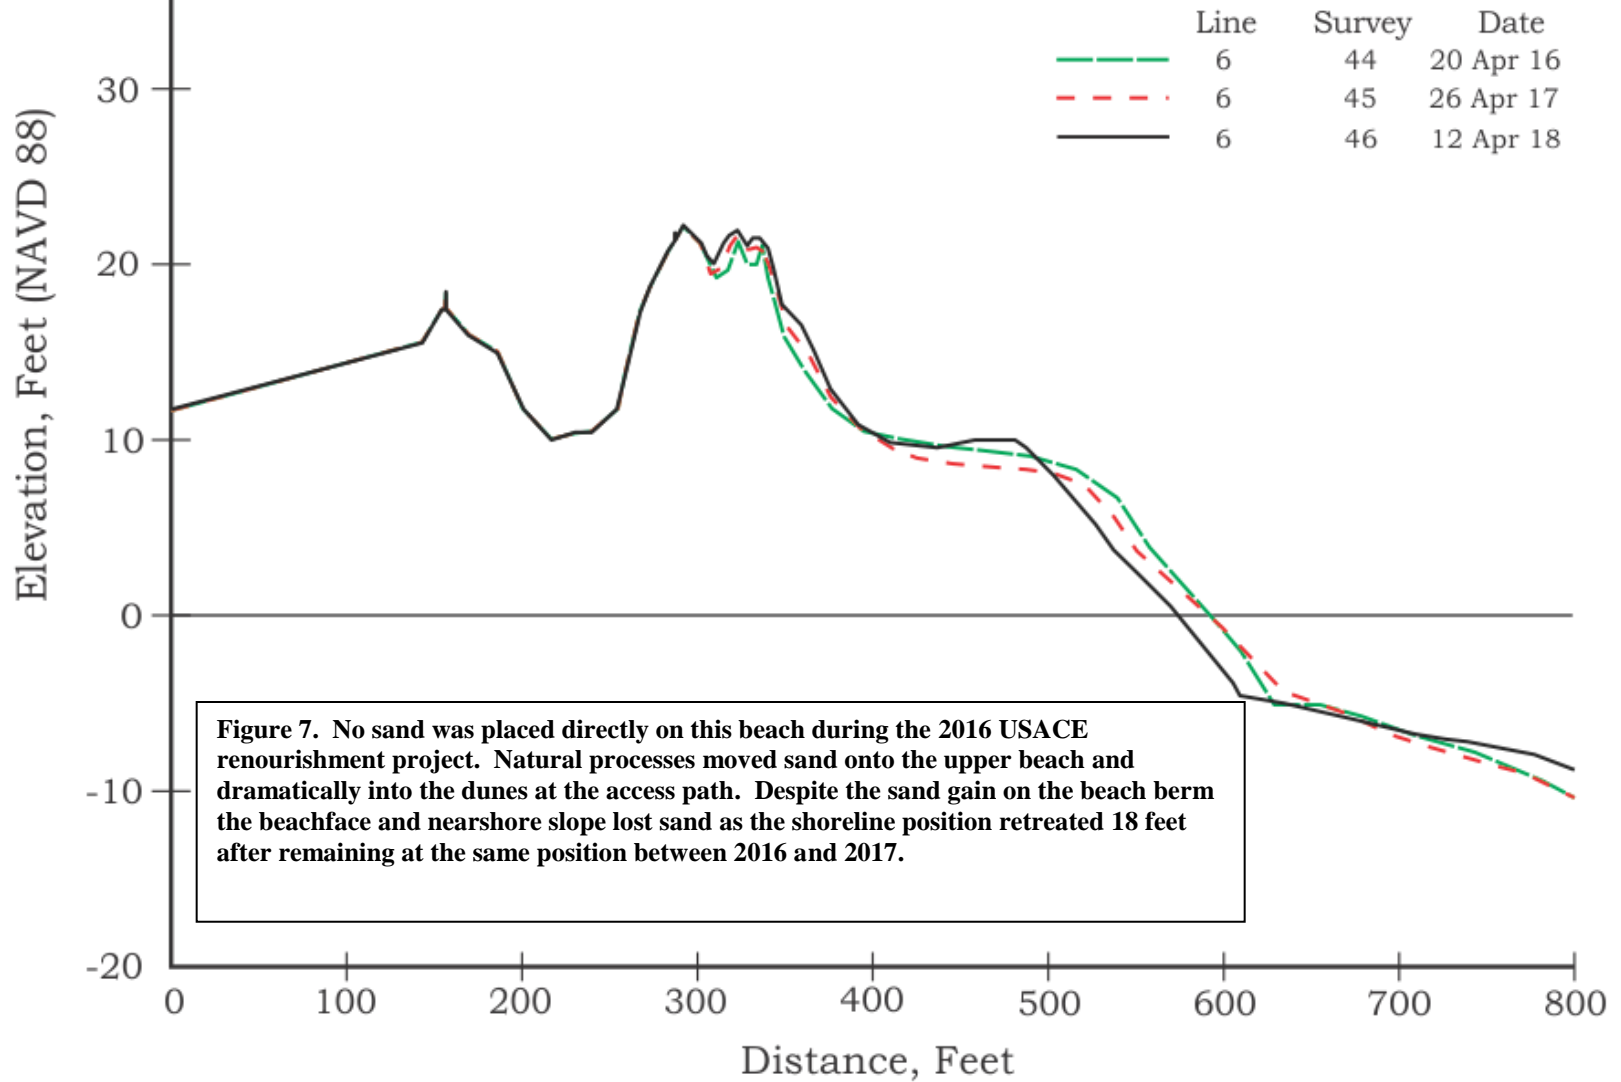
CMP - Line 6 - Pearl Avenue

Sand shed from the initial up drift federal project beaches moves into this site seasonally by predominant longshore drift. The barrier units are located on the seafloor 11 feet below the 0.0 ft. NAVD88 datum and buried by 4 feet of sand nearly 100 feet offshore. The units however might be accessible adjacent to the rock groins, and any recreational activity in the water close to the rock groins is already prohibited.

No sand was placed this far west during the USACE nourishment project, so beach building has been a result of natural processes. By April 2018, sand added to the dunes and offshore, but the beachface retreated 18 feet. Over the past two years the sand volume did increase a small amount (2.34 yds³/ft.). The past year saw an 18-foot shoreline retreat combined with a 1.33 yds³/ft. sand volume gain, therefore the changes appear to be consistent and relatively small in sand quantity added or lost.

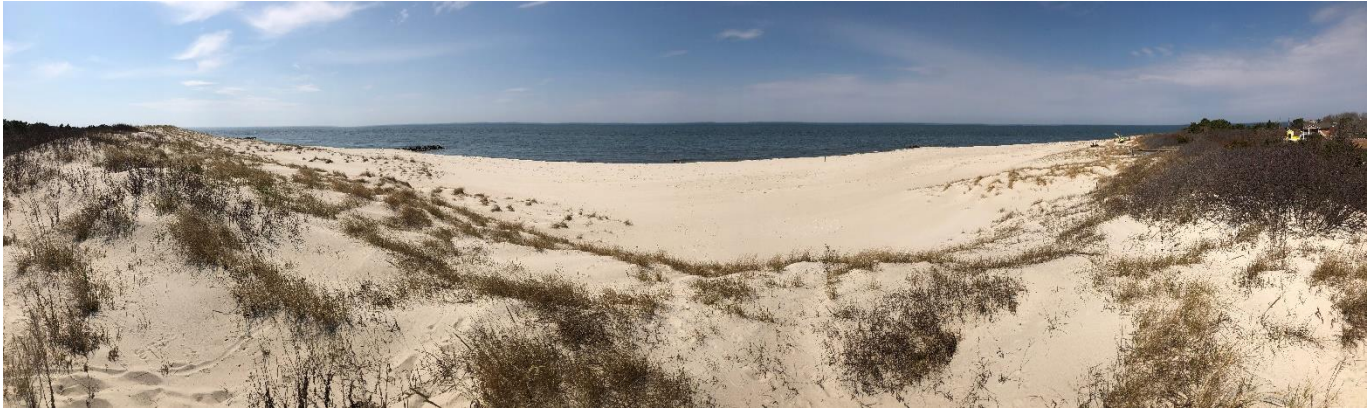
Pearl to Stites Avenues

Figure 8. The April 12, 2018 view at CMP-7 shows the scale of the dunes defending this cell's beach.

Profile CMP-7, located southeast of Brainard Avenue, (Cell 7) is bounded by the rock groins near Pearl Avenue and Stites Avenue. The cell has not received any sand directly from the past USACE beach restoration or maintenance projects. Natural processes dominated by longshore drift continue to transfer sand from east to west along the Borough's shoreline. With no structures present at this location the wide dry beach should provide beach patrons with abundant recreational area and good nearshore swimming conditions for the summer season.

6. Cells 7 at Stites Avenue benefited from a stable berm area enhancing the recreational value of the beach, this paired with the shallow offshore platform will offer a relatively safe option for swimming.
