**ANNUAL REVIEW FOR 2018
OF THE CAPE MAY POINT, NJ MUNICIPAL BEACHES**

PREPARED FOR: THE BOROUGH OF CAPE MAY POINT
215 LIGHTHOUSE AVENUE
CAPE MAY POINT, NJ 08212

PREPARED BY: STOCKTON UNIVERSITY COASTAL RESEARCH CENTER
30 WILSON AVENUE
PORT REPUBLIC, NJ 08241

May 20, 2018

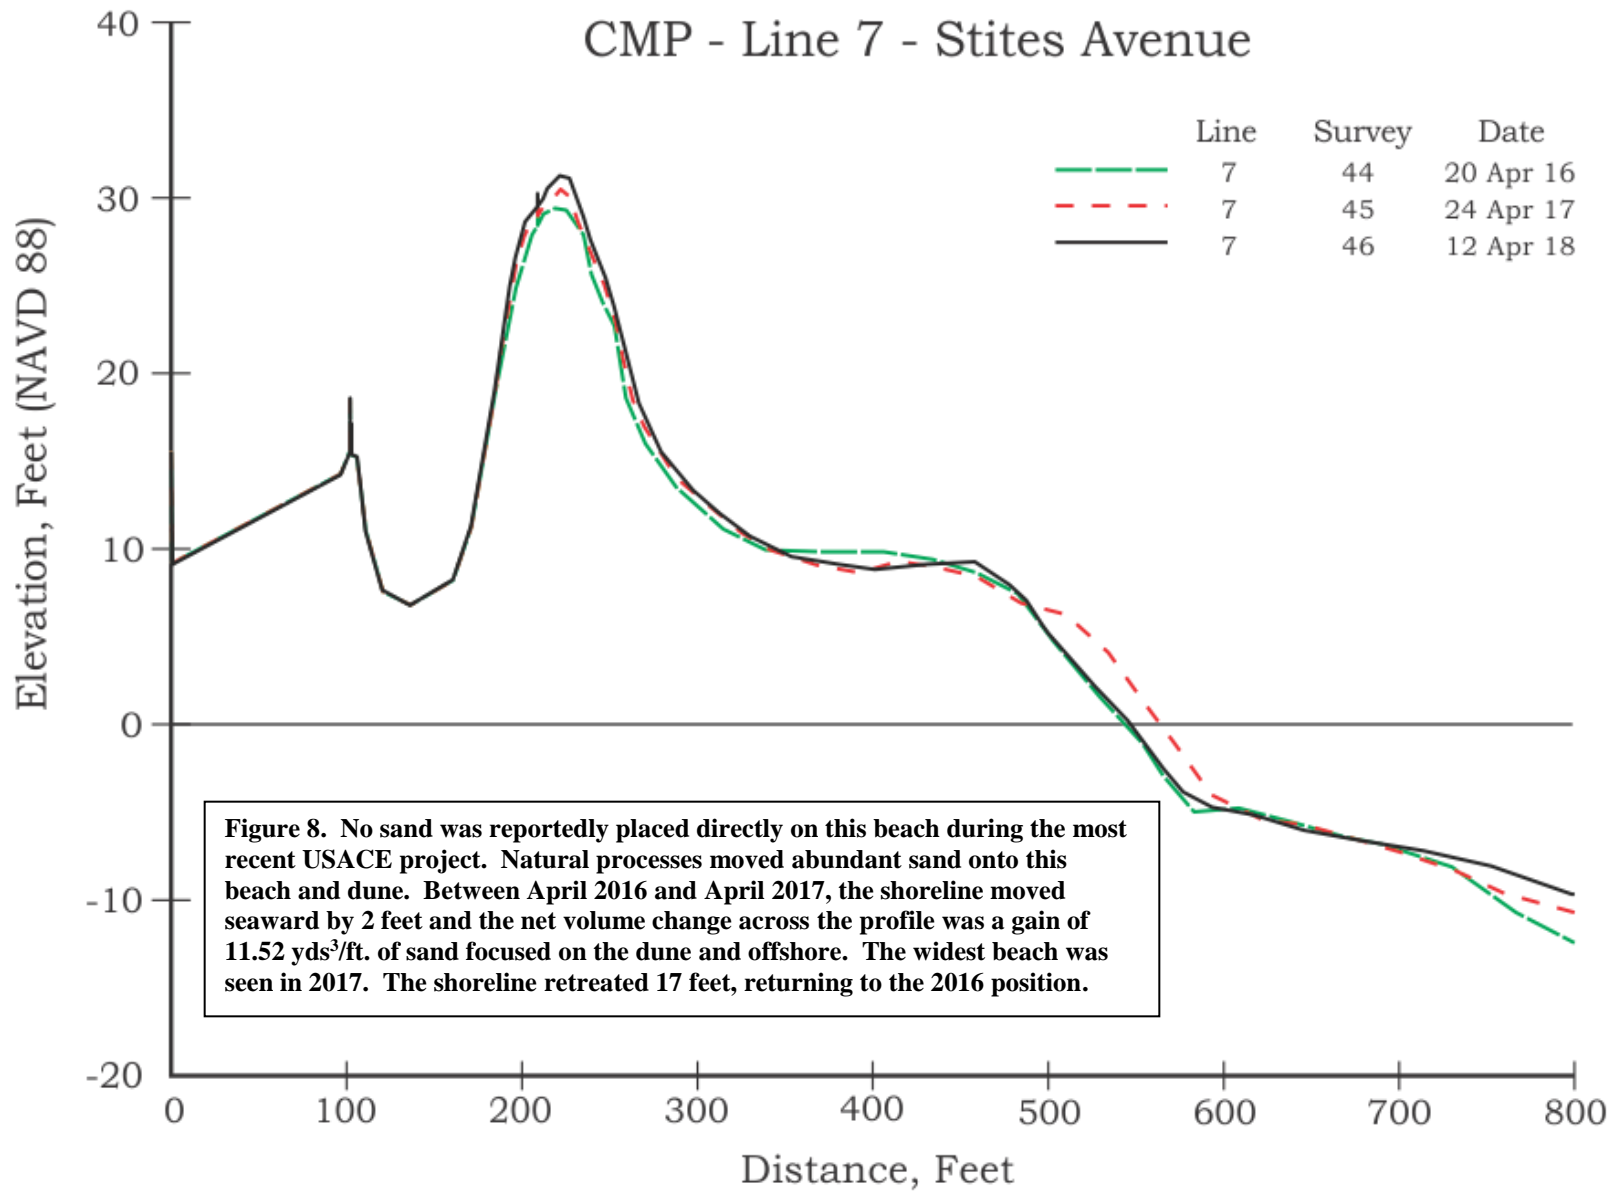
CMP - Line 7 - Stites Avenue

Between April 2016 and April 2018 the sand volume increased by 11.52 yds³/ft. while the shoreline advanced just 2 feet. During the past year, the sand volume declined by just 0.06 yds³/ft. with a 17-foot shoreline retreat. Aeolian transport moved sand to the seaward dune slope and up to the crest. Stites Avenue is the first Cape May Point dune to grow higher than 30 feet in elevation. The wind transport effect has been evident on the Stites Avenue beach access pathway where sand deposition has repeatedly buried the pathway and seating area at the dune crest. This year public works has modified the pathway with a retaining wall on the west side to capture sand and removed the stairway to the beach because the dune has ramped up to the walkover elevation. The pathway is a slope down to the beach extending straight out from the crest area seating space.

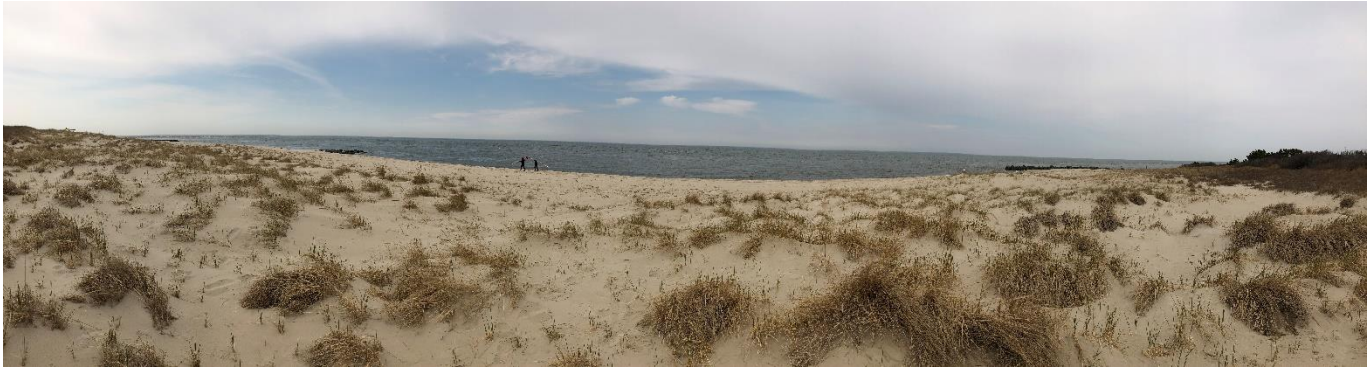
Stites to Alexander Avenues

Figure 9. This westernmost cell is defined by The Township of Lower to the right of the Alexander Avenue groin and the CMP-7 cell to the left of the groin on the beach. The tiny figures are the survey crew members much reduced in size by the panoramic view.

The Alexander Avenue location, CMP-8 is the western most beach cell in the Borough. Sand placement was never included for this location during the USACE projects. Natural processes have moved sand from the project beaches to this location. The beach extends seaward nearly to the tip of the western groin. Sediment loss from this cell moves onto the western Delaware Bay shoreline and shoals locally known as the “Cape May Rips”. The offset landward in the beach west of the Alexander Avenue groin means that most of the sand is transported to the nearby bay floor and does not appear on the Sunset Beach shoreline. The dominance of the tidal currents over minimal wave transport landward for sand allows the currents to distribute sand on the shallow bay floor in the vicinity, with minimal quantities making it to the Sunset Beach shoreline.

7. Cell 8 at Alexander Avenue has remained at last year’s width, but the available recreational area has been substantially improved at this beach since 2005. The sand lost from Alexander Avenue does not accumulate on the Sunset Beach segment, but adds to the sediment layers on the nearshore Delaware Bay floor instead.

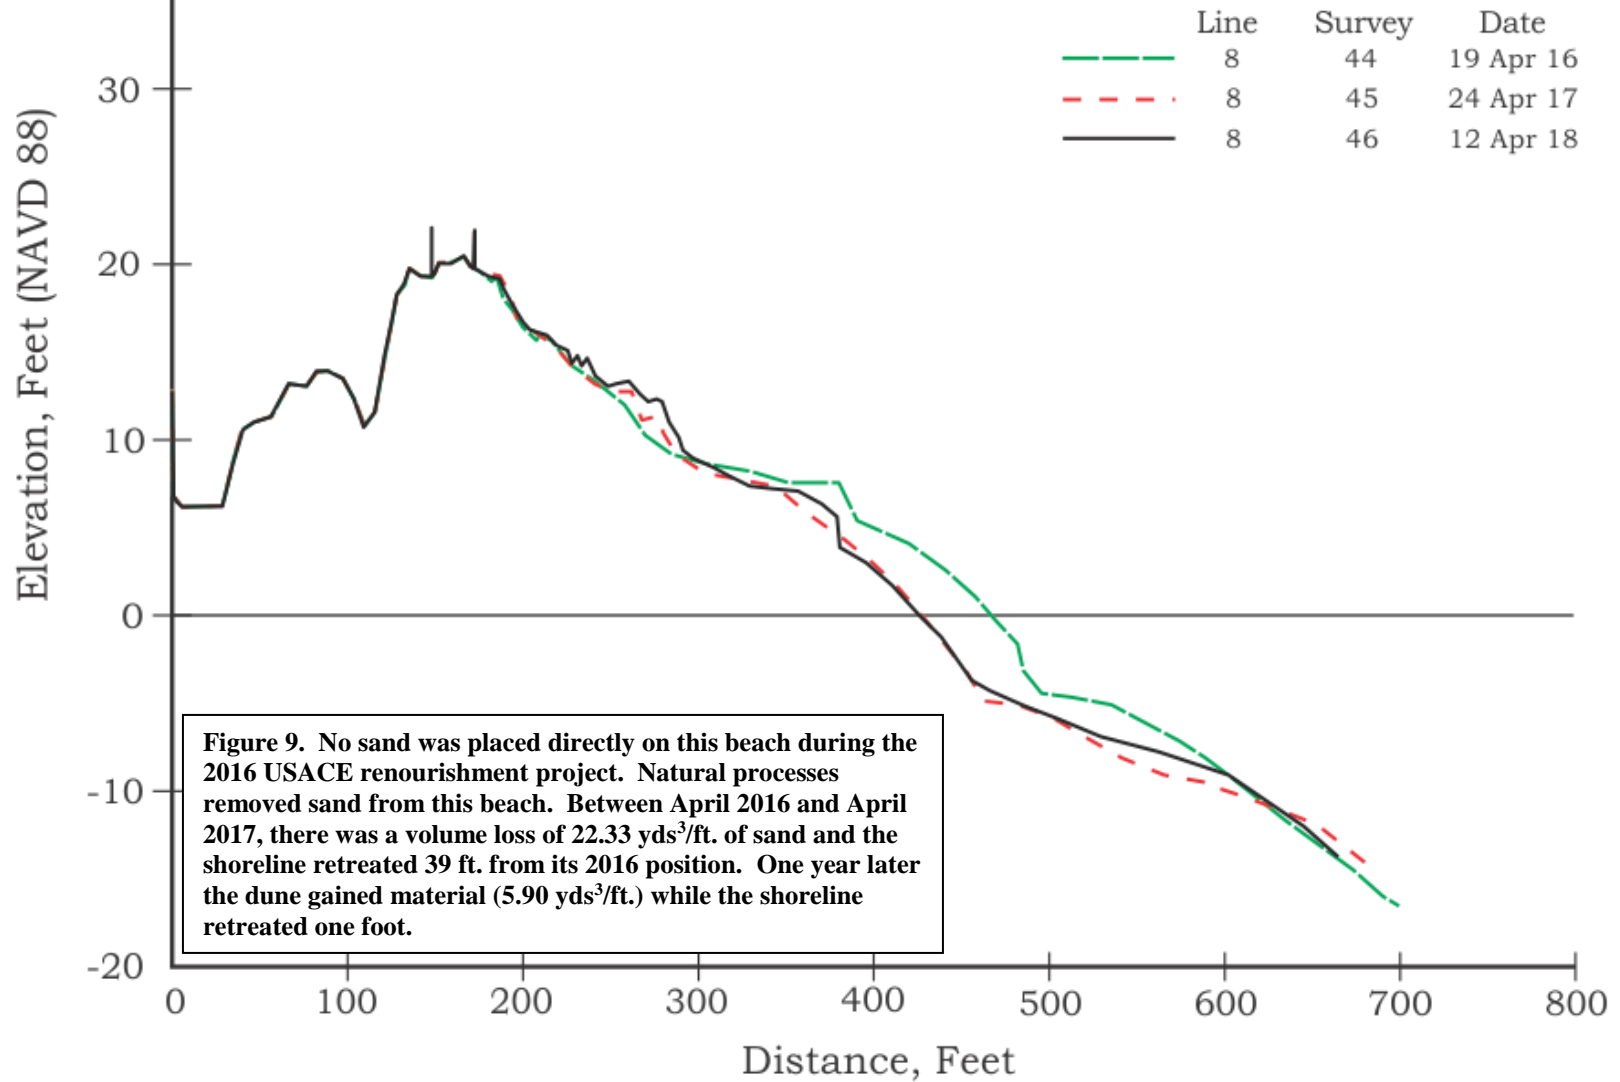
CMP - Line 8 - Alexander Avenue

Following completion of the initial USACE project sand began to accumulate in increasing amounts, 2015 was the first year in which this accretive trend stopped. In 2016, the accretive trend continued with a large wedge of sand accumulating from the seaward dune crest seaward to the profile limits. The dune advanced seaward 20 feet as a result of sand accumulation on the seaward slope. However, by April 2017, the shoreline retreat was 39 feet as 22.33 yds³/ft. in sand volume left the cell. By April 2018, the conditions stabilized as sand added to the seaward dune slope, but changed very little elsewhere along the profile line. The recent annual change was a gain of 5.90 yds³/ft. as the shoreline retreated one foot.

The dry beach provides ample area to support summer recreational activity onshore while the nearshore slope is steeper in this cell with water depths of -10 feet NAVD88 within 100 feet of the shoreline. The steeper slope and drop off near the end of the western groin along with strong tidal currents in this region should probably limit swimming activity by most to the shallow nearshore region. Swimming has not been permitted at Alexander Avenue for many years, but the final groin is a long-time favorite for fishing activities.
