**2018 ANNUAL REPORT - TO THE CITY OF NORTH WILDWOOD
ON THE
CONDITION OF THE CITY BEACHES**

**PREPARED FOR: THE CITY OF NORTH WILDWOOD
901 ATLANTIC AVENUE
NORTH WILDWOOD, NJ 08260**

**PREPARED BY: THE STOCKTON UNIVERSITY COASTAL RESEARCH CENTER
30 WILSON AVENUE
PORT REPUBLIC, NJ 08241
March 5, 2019**

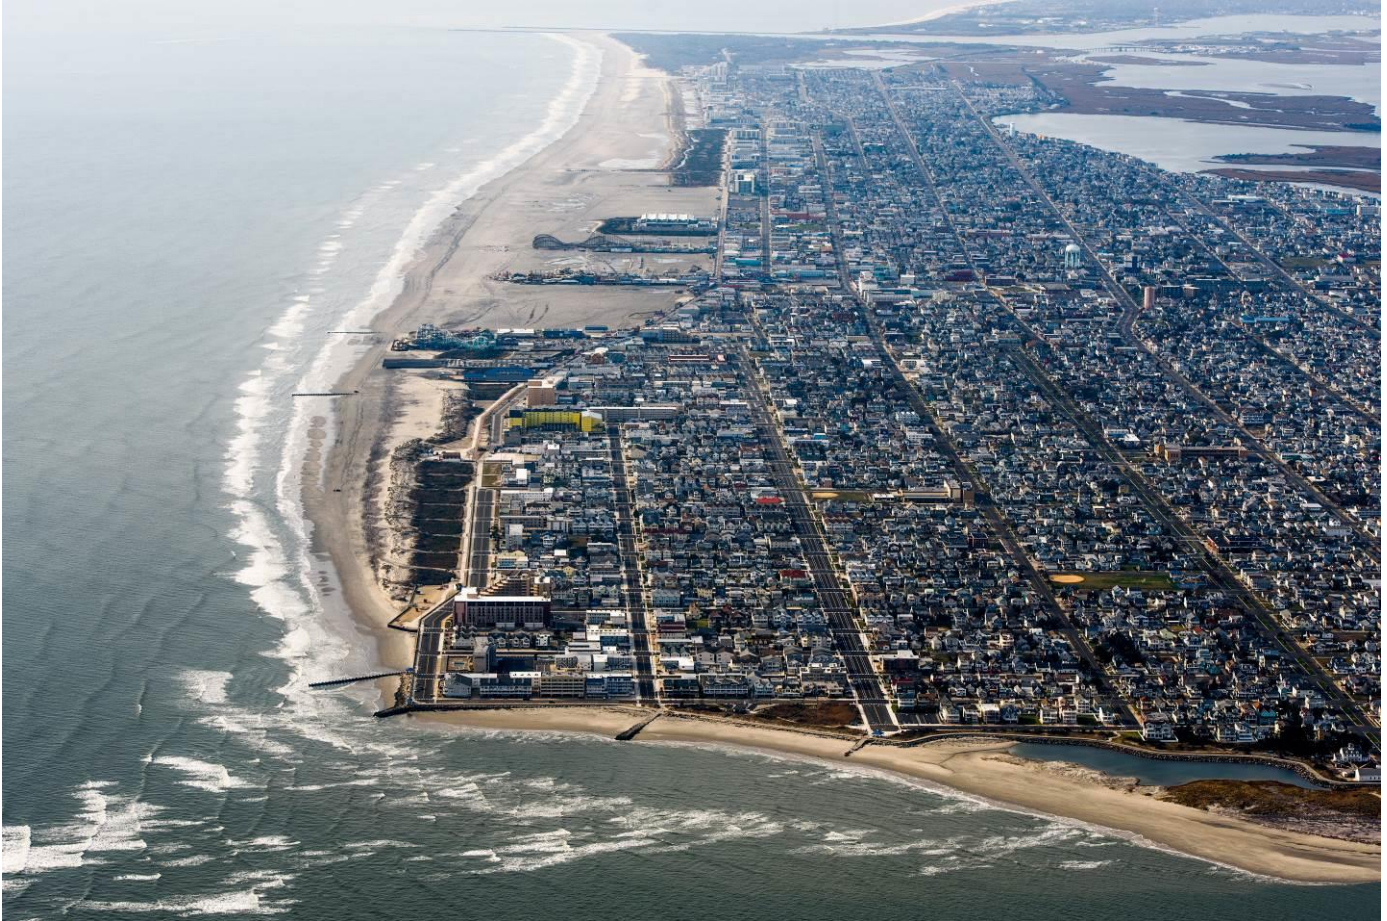
Aerial view of North Wildwood looking southeast from Hereford Inlet on November 18, 2018 showing nearly the entire City plus the rest of the Wildwoods barrier island to Cape May Inlet. The new bulkhead is evident starting at 5th Avenue, the narrow beach seaward of the dunes south to the lifeguard office at 15th Avenue, and the wider beach further south to the three amusement piers. There are two bars, one at the low tide line, the other offshore extending from the inlet south into Wildwood. The accumulation of shoal sand northeast of the inlet jetty is also evident with the expectation of greater accretion to come in 2019. Yes, the vast width of the Wildwood beach is largely due to the fact that Wildwood and Wildwood Crest development is essentially parallel to Surf Avenue in North Wildwood. (Aerial photo taken by Ted Kingston)

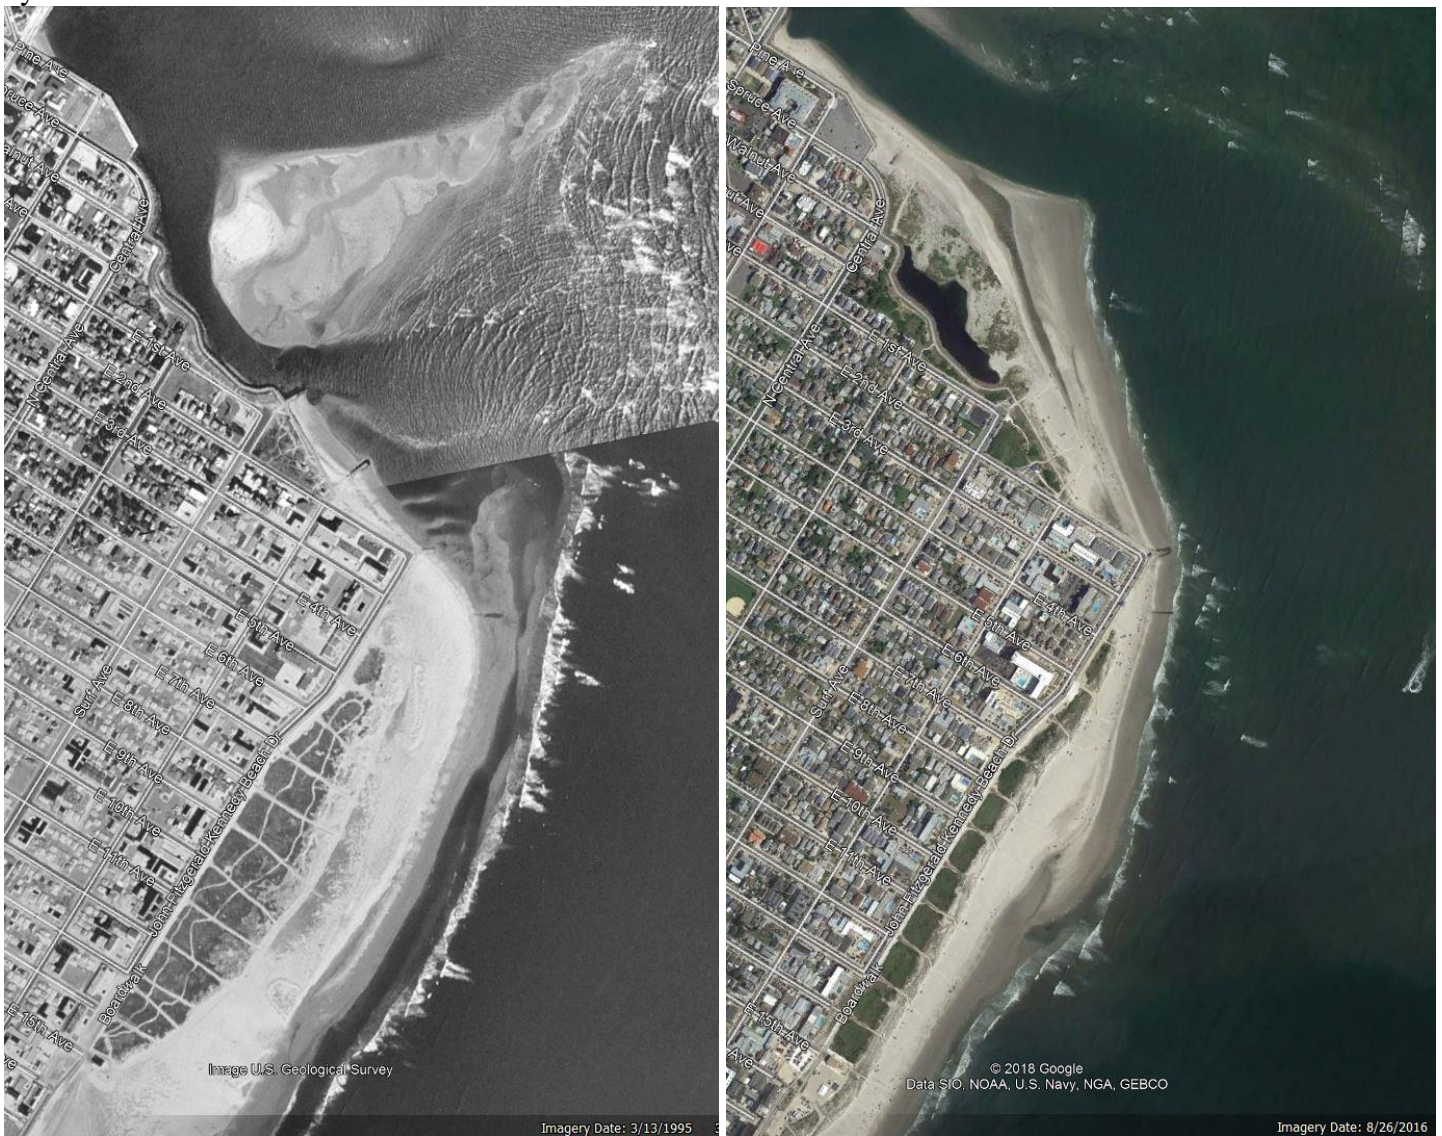
Figure 1. The northeast quadrant of the City of North Wildwood between March 1995 and August 2016 shows that oceanfront erosion appears related to large changes in shoal position and exposure at low tide in Hereford Inlet. In 1995, an exposed island sat between Central and Surf Avenues forcing a branch of the main tidal channel against the North Wildwood shoreline. There was no beach at the inlet shore until southeast of Surf Avenue. There was an extensive exposed sand flat system attached to the beach front bar system extending into the inlet. The ebb-tidal currents exited in proximity to the oceanfront beach and deposited sand in transport where wave action could easily move it to the beach bar system, and eventually onto the dry beach. In the mid-1990's the main channel shifted to the northeast, away from North Wildwood allowing the flood-tidal currents to move sand from the oceanfront beach into the inlet along the North Wildwood shoreline depositing the sand spit that has been present since. At its maximum extent (2001), this spit was over 600 feet in average width, with a pond created when the spit tip attached to the inlet shoreline near New Jersey Avenue (extended). As of the August 2016 view, the beach narrowed rapidly starting at 7th Avenue to the inlet, but still showed a dry beach width at the inlet jetty. Sand was continuing to be transported into the inlet generating the new spit reaching almost to Central Avenue. Since then the main tidal channel has shifted more to the northeast and a new island shoal formed by 2011 with a secondary channel between it and the City's inlet shoreline. Since 2011, this shoal has migrated toward the inlet jetty further constricting the channel close to North Wildwood. This channel needs to close considerably before the 1995 conditions are re-established. Then and only then will the oceanfront beaches preferentially receive sand instead of shedding it both south into Wildwood City and northwest into Hereford Inlet.

Presented below are two air photographs showing the northeast corner of the City from March 1995 prior to major oceanfront changes and from August 2016 just prior to the most recent sand losses. In the 1995 view, the beach width at the north end of the City's oceanfront was close to 1,000 feet in width and when retreat commenced in that time frame, the loss rate did not appear to depend on storm frequency or seasonality for loss evaluation. Then the only survey site was the NJ State site at 15th Avenue where work commenced in 1986 and showed that between 1994 and 2004, 1,057 feet of shoreline retreat occurred. This is the data confirming the

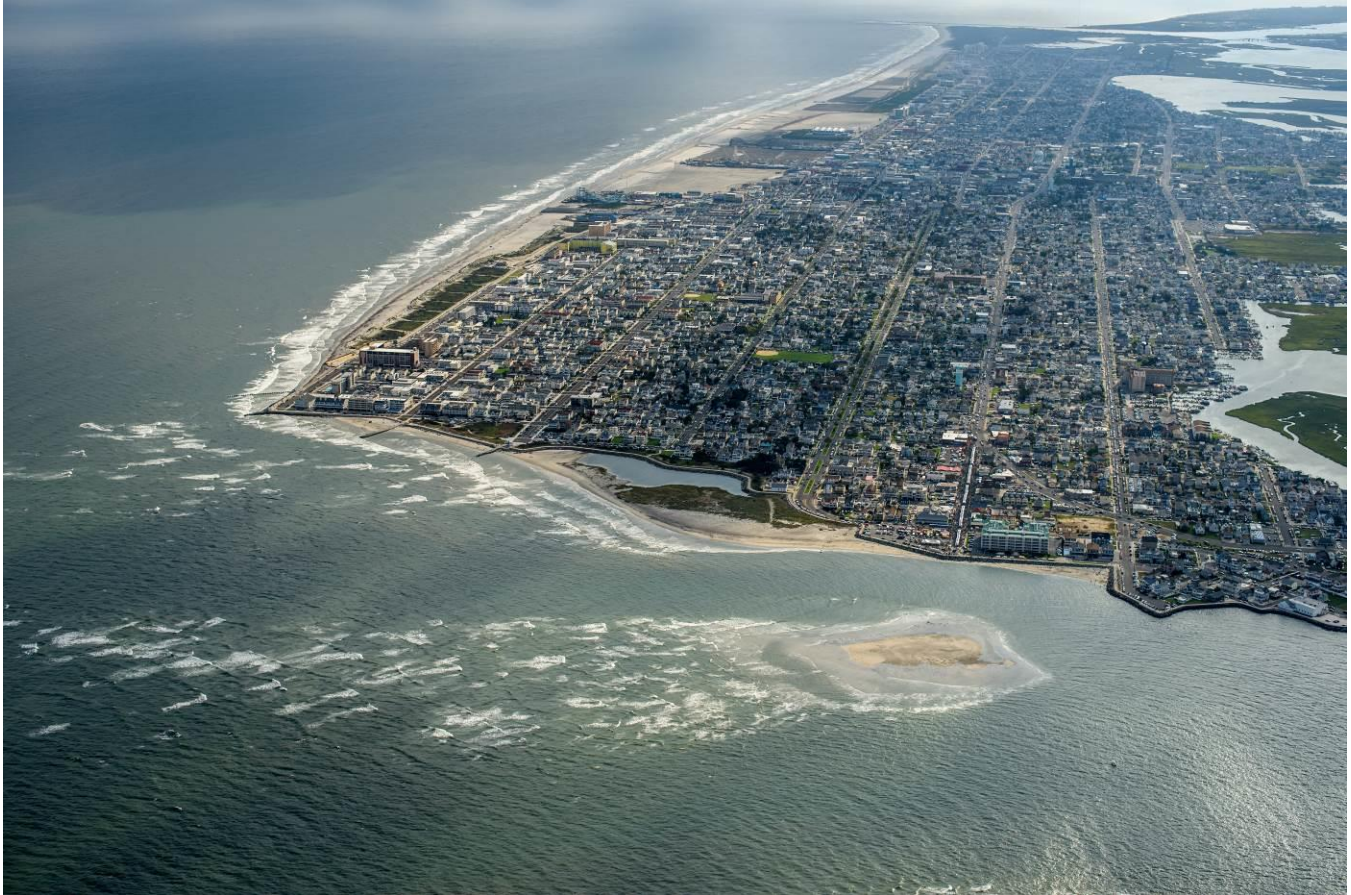
Figure 2. September 22, 2018 view from over Hereford Inlet looking southeast at the inlet shoreline, the new island shoal and the depleted oceanfront beaches. The island shoal was present in August 2016, but 350 feet further northwest up channel. The pattern of breaking waves indicate where shallow water exists presently and outlines the main tidal channel in the foreground northeast of the island shoal. The secondary channel lies between the shoal and the North Wildwood shoreline. To the northeast of the 2nd and Kennedy Boulevard jetty there is a narrow, 8-foot deep channel which funnels sand into the inlet from the oceanfront beach, while immediately offshore from this channel there lies 50 acres of shoals less than 5 feet deep at high tide (November 2018 survey data). The inlet beach is eroding to the point where the Surf Avenue vehicle entrance ramp exits into the water, not on the beach sand and the small pond, present since the 1990's is again open to tidal flow across the beach every high tide. This island shoal needs to move two city blocks to the southeast and about 100 yards closer to North Wildwood to re-establish conditions at the inlet replicating those in place in 1995.

A recent aerial photograph (Figure 2) on September 22, 2018 from a series of shots by Mr. Ted Kingston for the CRC (Figure 2). It shows the best relationship between the inlet, its beaches and shoal system and the North

Wildwood inlet and oceanfront shorelines. The changes since August 2016, in spite of almost 500,000 cubic yards of Wildwood City sand hauled back to the northern North Wildwood shoreline demonstrate the intensity of sand movements away from the 2nd Ave. and Kennedy Blvd. corner of the City.

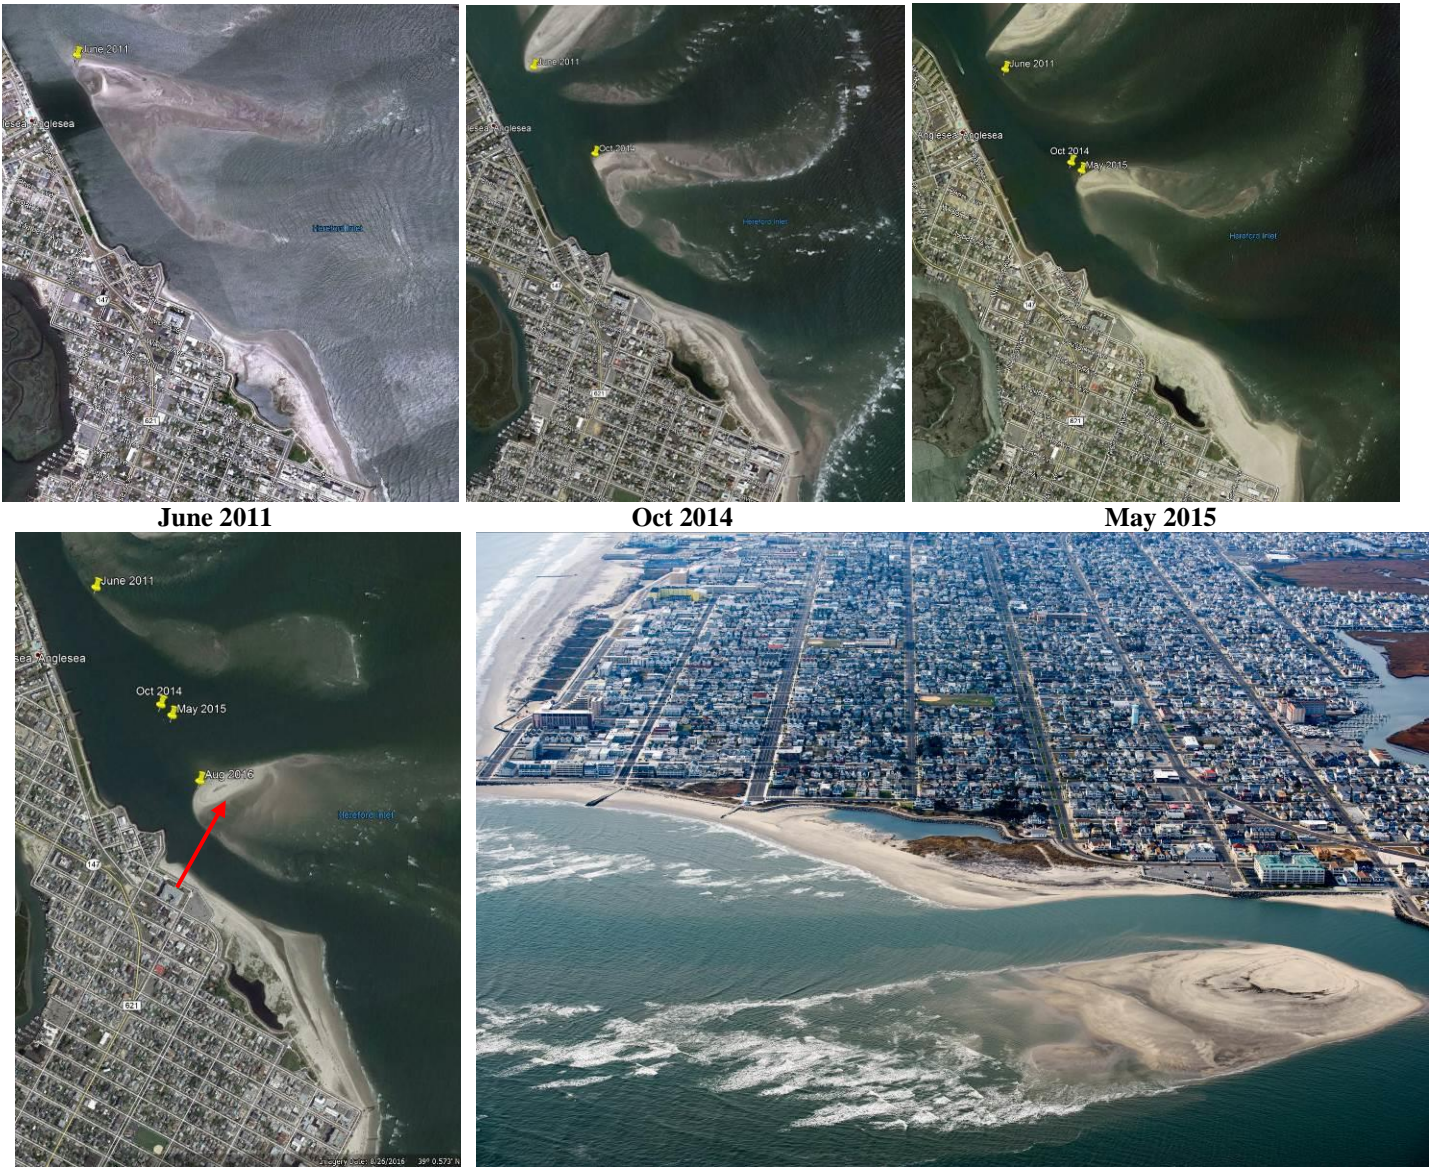
Above are three snapshots from 2011, 2014 and 2015. On the lower left, an Aug 2016 photo - Red Arrow points to the Sept 2018 position, while on right shows the shoal as of Nov 18, 2018.

Figure 3. A series of aerial photographs taken from Google Earth starting in 2011 to show the progressive southeasterly migration of an exposed island shoal in Hereford Inlet which is moving toward the inlet jetty and closer to the North Wildwood inlet shoreline. As it approximates the 1995 position (Figure 1), the impact on the inlet and oceanfront beaches can be expected to cause; a), the inlet beach between the jetty and Central Avenue to virtually disappear, and b), sand to be deposited immediately seaward of the 2nd to 3rd Avenue oceanfront beach where it will move landward adding to the beach width at the jetty. This presumes that the 1995 shoal position scenario will duplicate said conditions in 2019 or 2020. The most recent air photograph is from November 18, 2018 and shows a larger island since Aug. 2016 with a channel between it and North Wildwood exiting about 500 feet north of the inlet jetty.

Further examination of the Google Earth historical aerial series shows that the shoal island formed sometime prior to 2011 about 2,600 feet northwest of its 2016 position. The set of photographs (Figure 3) show the progression over the past 7 years where the new island shoal has been moving steadily toward the 1995 position shown in Figure 1. There appears to be a cyclic progression between the proximity of an island shoal to the North Wildwood shoreline and ebb-tidal flow dominance generating a sand supply for the oceanfront beach and following the loss of the shoal, a return of flood-tidal flow dominance which transports beach sand into the inlet along the North Wildwood inlet shoreline toward the northwest. Historical mapping has shown such cycles all during the 20th Century, most recently in the 1960's when a very large spit dominated the inlet shore in North Wildwood.

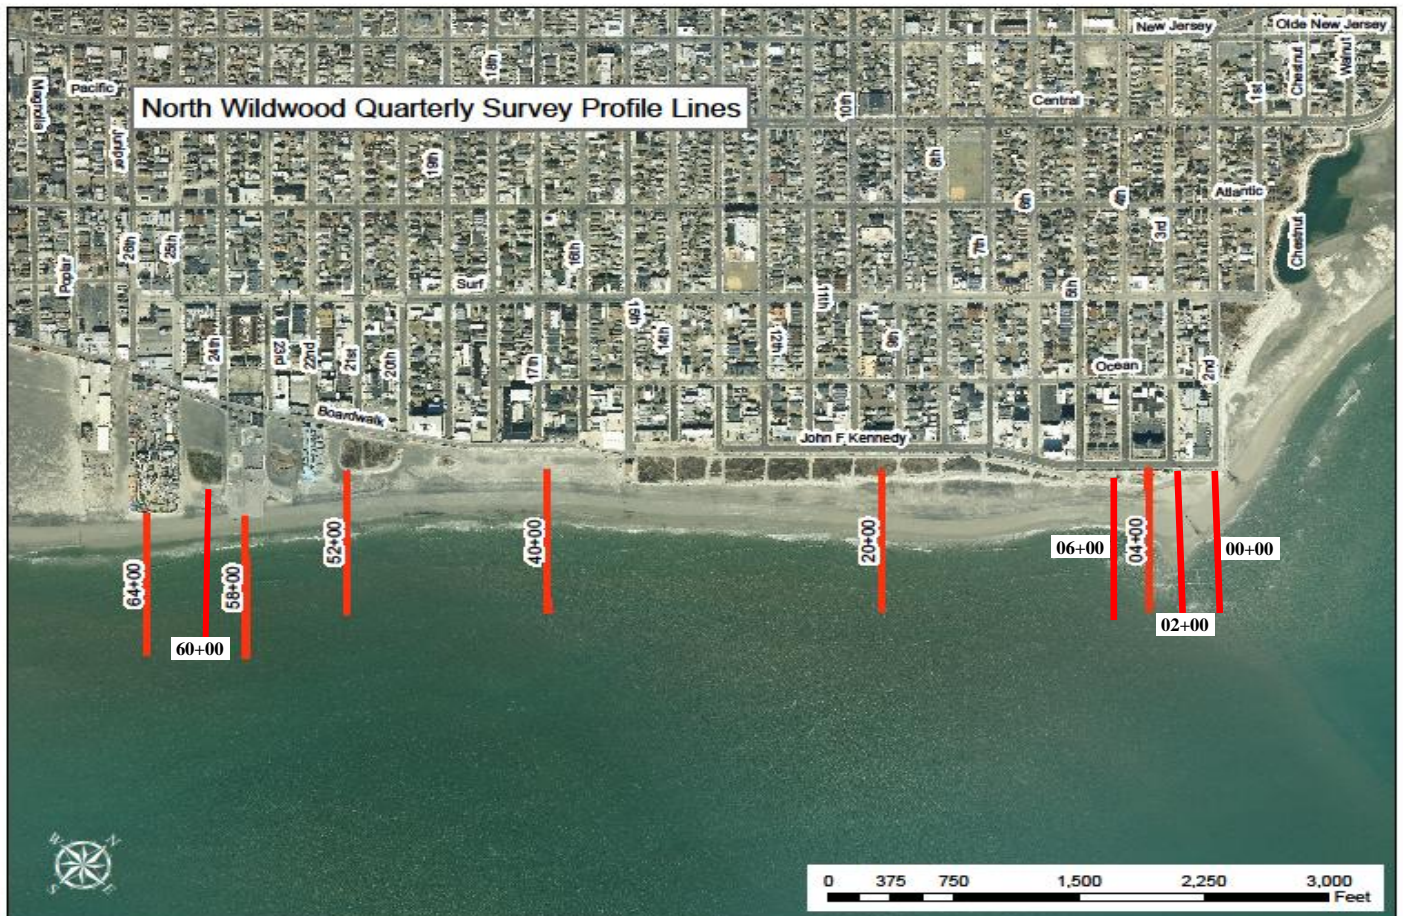
Figure 5. Shown above are locations of ten representative profile sites of the 54 profile stations where shoreline changes were measured on the City’s oceanfront from October 2017 to November 2018. For each of the ten profile stations descriptions and cross sections are provided to show typical changes over the year. This year surveys were included at the jetty, 200 feet, 400 feet, and 600 feet south of the jetty in the set of profiles. In addition, 6 survey lines are completed along the inlet beach in Hereford Inlet. They are spread non-uniformly from the 2nd Avenue jetty to Central Avenue northwest of the jetty. Four go at 200-foot spacing from the jetty to 600 feet northwest, another at 1,200 feet and the final survey line at 2,400 feet northwest at the end of Central Avenue. These survey line data are included in the Digital Elevation Maps (Figure x).

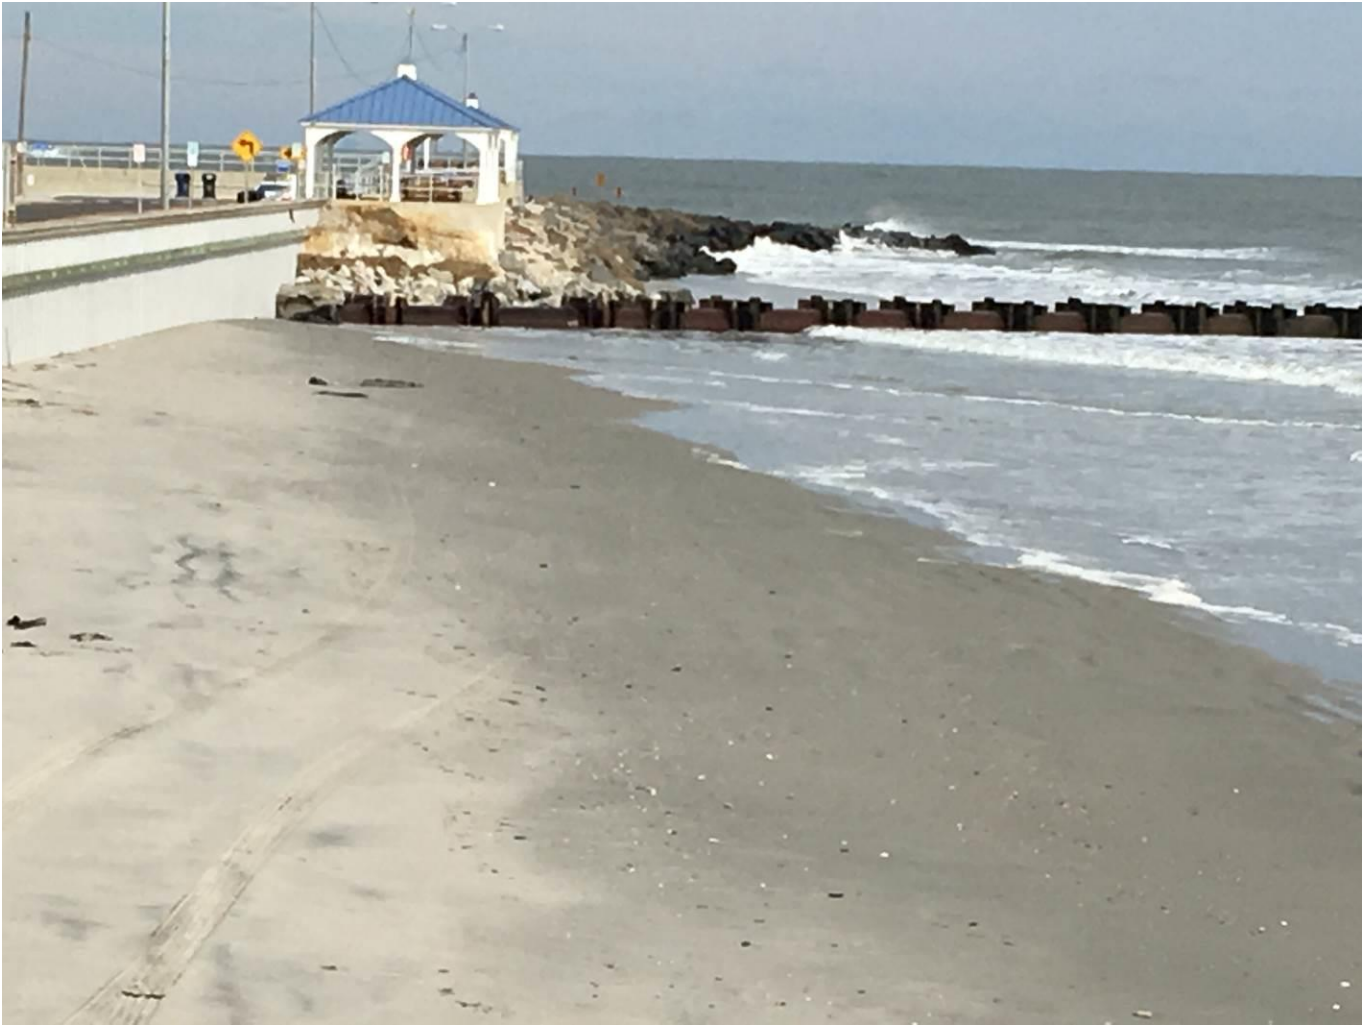
Figure 10. View to the north taken November 11, 2018 showing the inlet gazebo and inlet jetty beach. This position approximates 02+00 station with site 00+00 located on the other side of the pipeline.

The site is currently not useable for recreational purposes other than watching the sea from the gazebo or fishing. However, the most recent survey finds that offshore 32.50 yds³/ft. of new sand has been added extending in a berm-like deposit closing out with the June 2018 profile at a 380-foot distance from the seawall. The prospect of the island shoal, now located between Central and Atlantic Avenues (extended into the inlet) to further enhance sand deposition in this vicinity appears better than previously noted.

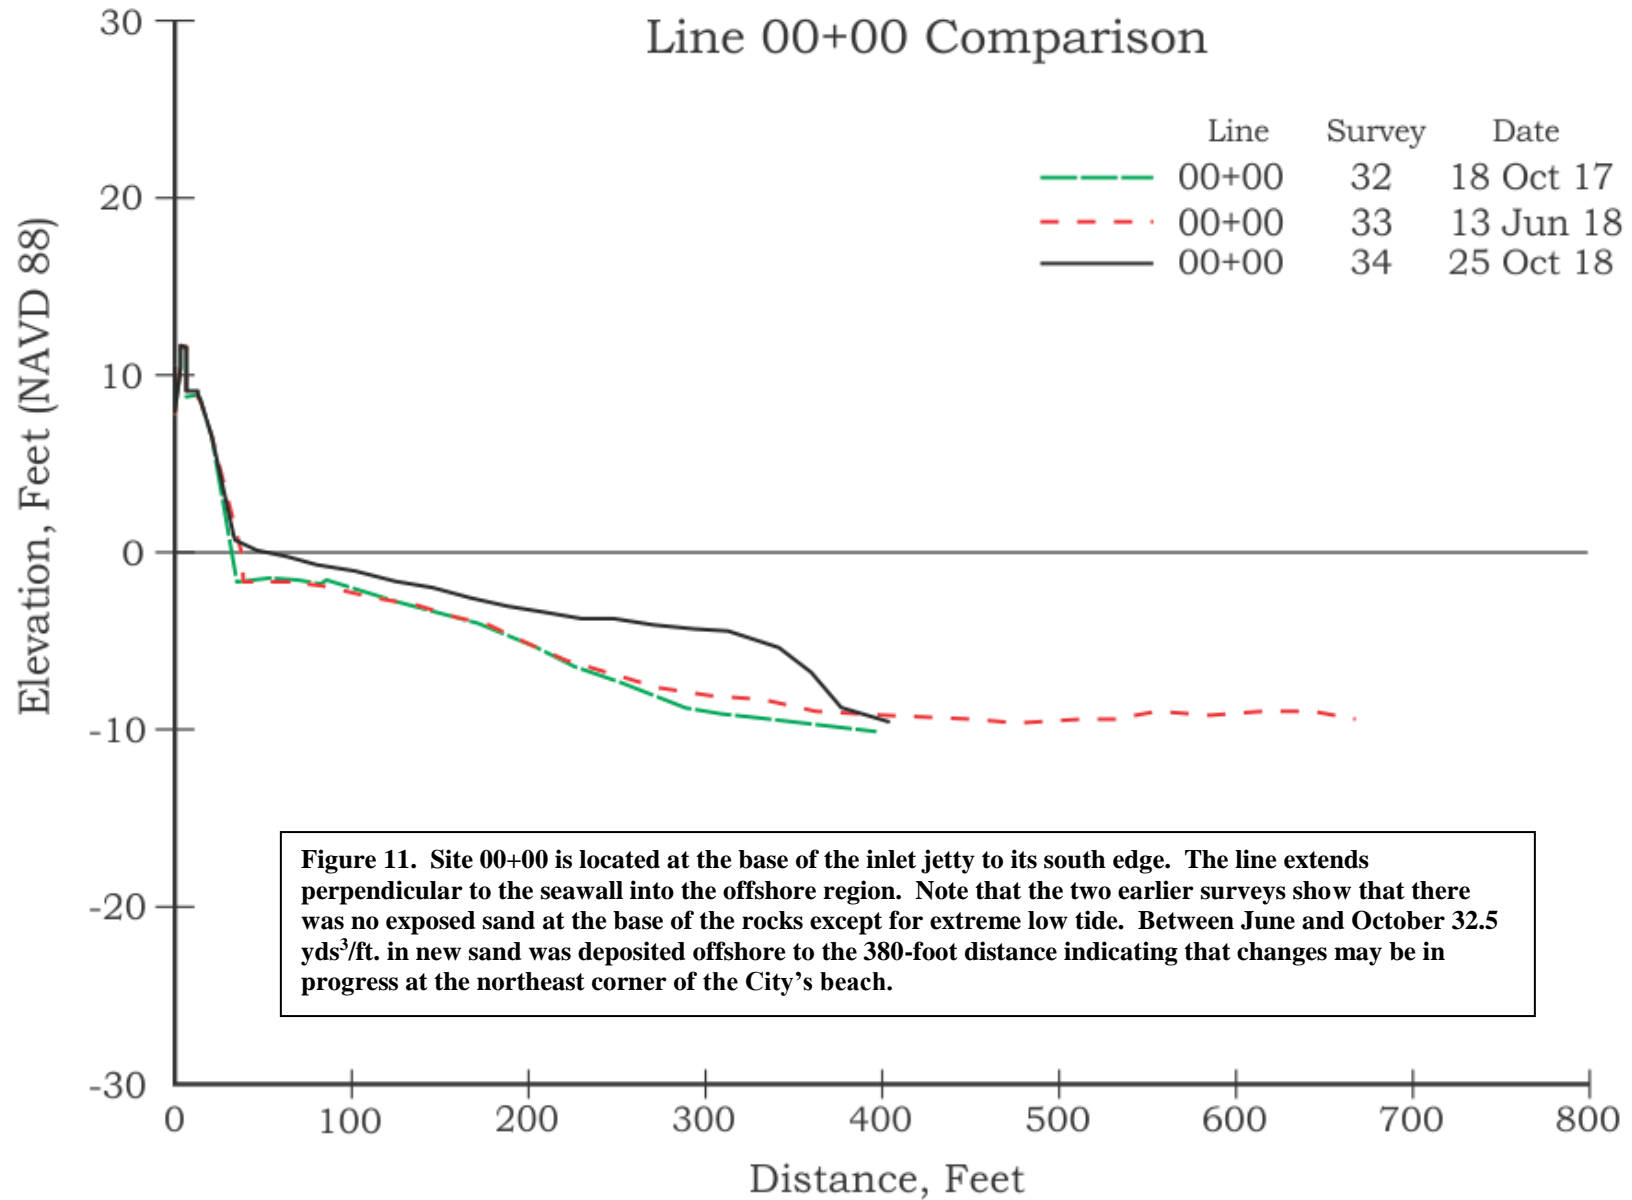
Line 00+00 Comparison

This year the first profile line was included to show the additions to the offshore region in the immediate vicinity of the Hereford Inlet jetty. This line starts at the oceanfront side of the jetty and extends perpendicular to the seawall into the ocean. There is no high tide beach present, with the first data points as of October 2018 presently just above zero elevation NAVD 88. This represents a substantial improvement since June 2018 when the beach points started a -1.5 feet elevation (approximately low tide).

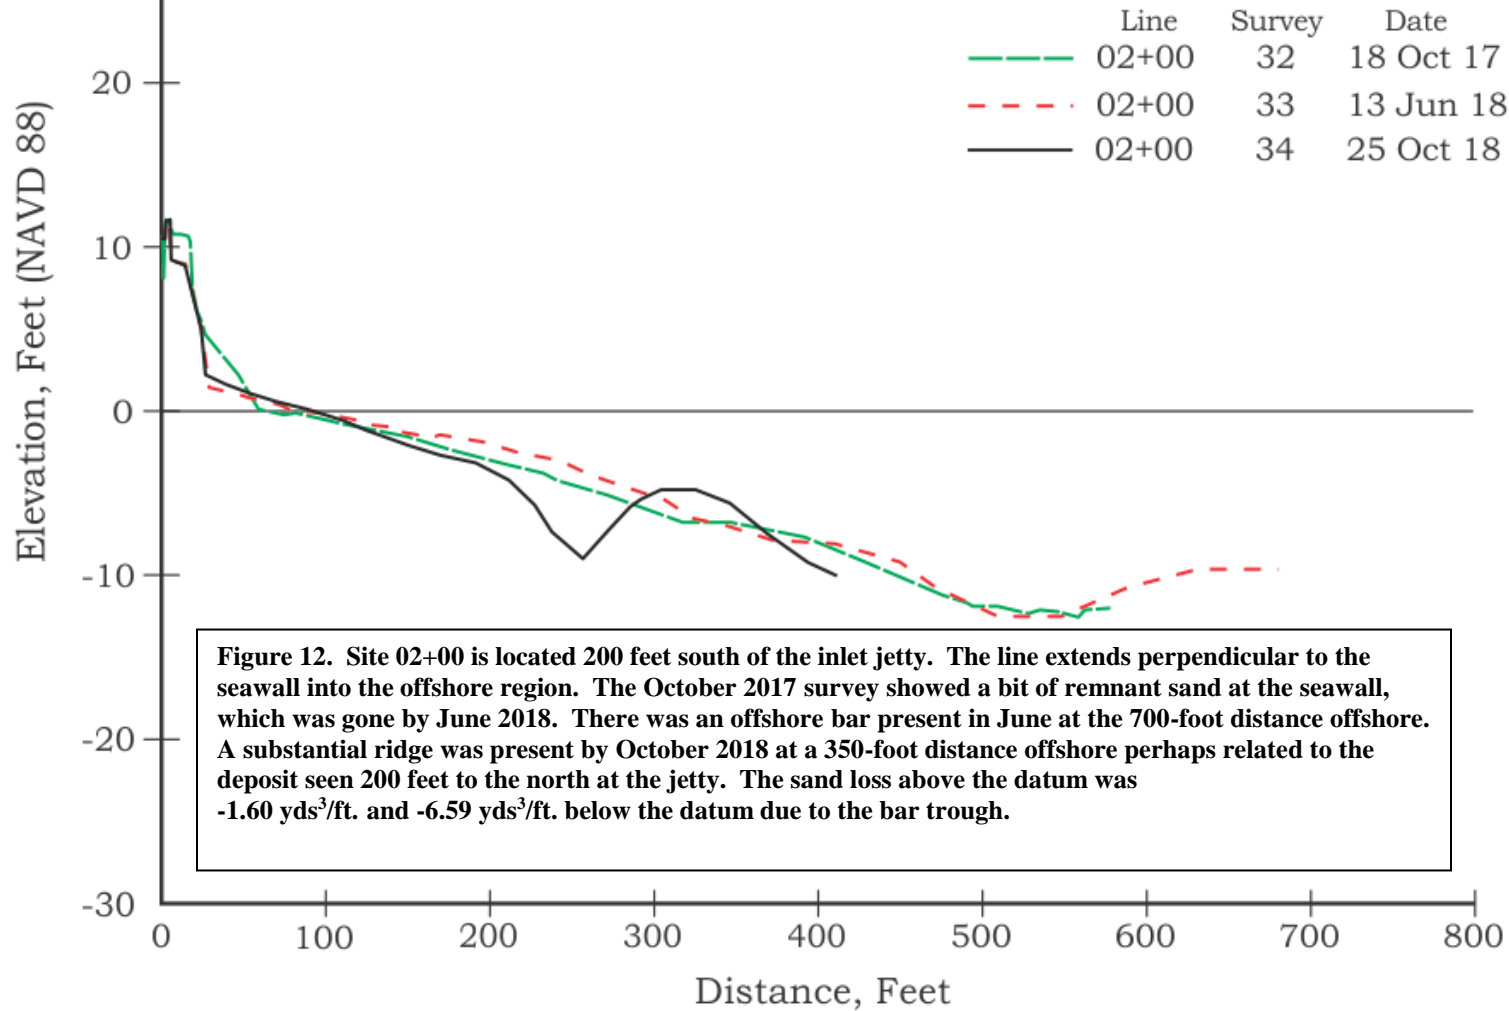
Line 02+00 Comparison

The photograph above for site 00+00 (Figure 6) also serves to illustrate conditions 200 feet south of the inlet jetty. Here, sand also appears on the beach in November 2018, but in a much smaller volume. The beach starts at approximately the elevation of mean high tide at the rocks and slopes quickly below the zero datum elevation. The late October 2018 survey showed that offshore, a sizeable bar had formed with a trough between the beach and the bar. This trough essentially produced the small negative sand volume change seen (-6.59 yds³/ft. below the zero datum).

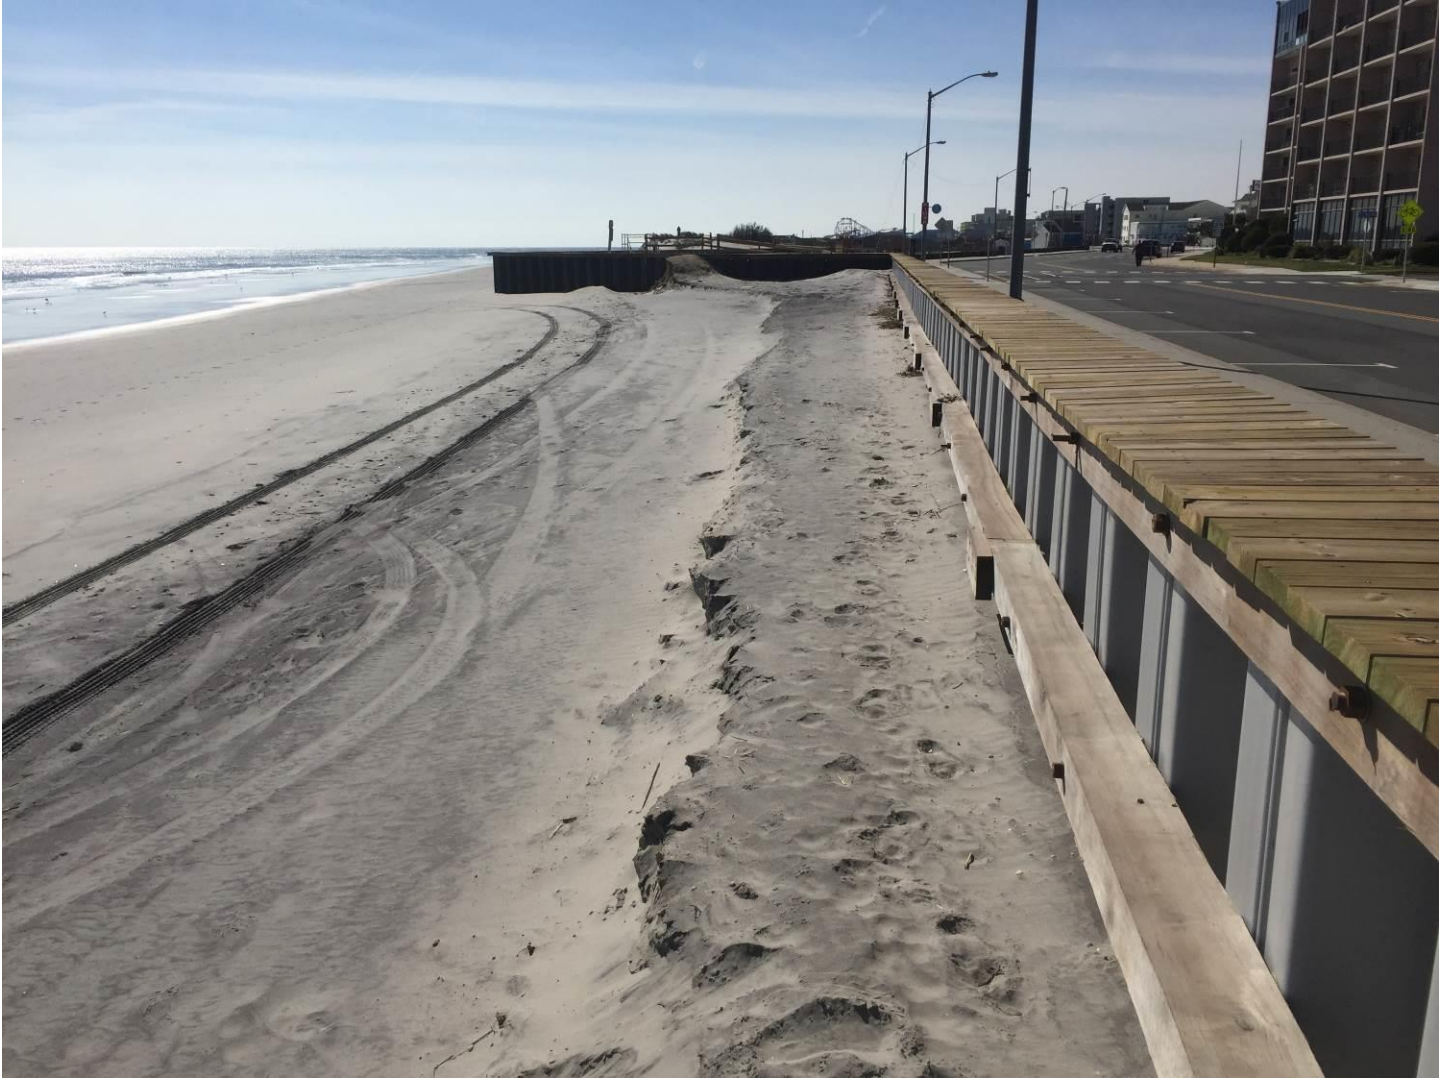
Figure 13. View to the south taken from directly in front of the cap on the new bulkhead that starts just south of the 3rd Avenue gazebo on November 5, 2018. The beach is wet almost to the bulkhead as the fall 2018 survey indicates in figure 10 and the sand loss extends 320 feet offshore totaling 28.42 yds³/ft. Clearly the sand that has appeared at the inlet jetty at site 00+00 did not arrive by transport north along the shoreline. Sand from this location has moved south generating the losses documented. The 5-foot remnant of the sand back-passed from Wildwood during the late spring of 2018 is all that is left in place from that effort.

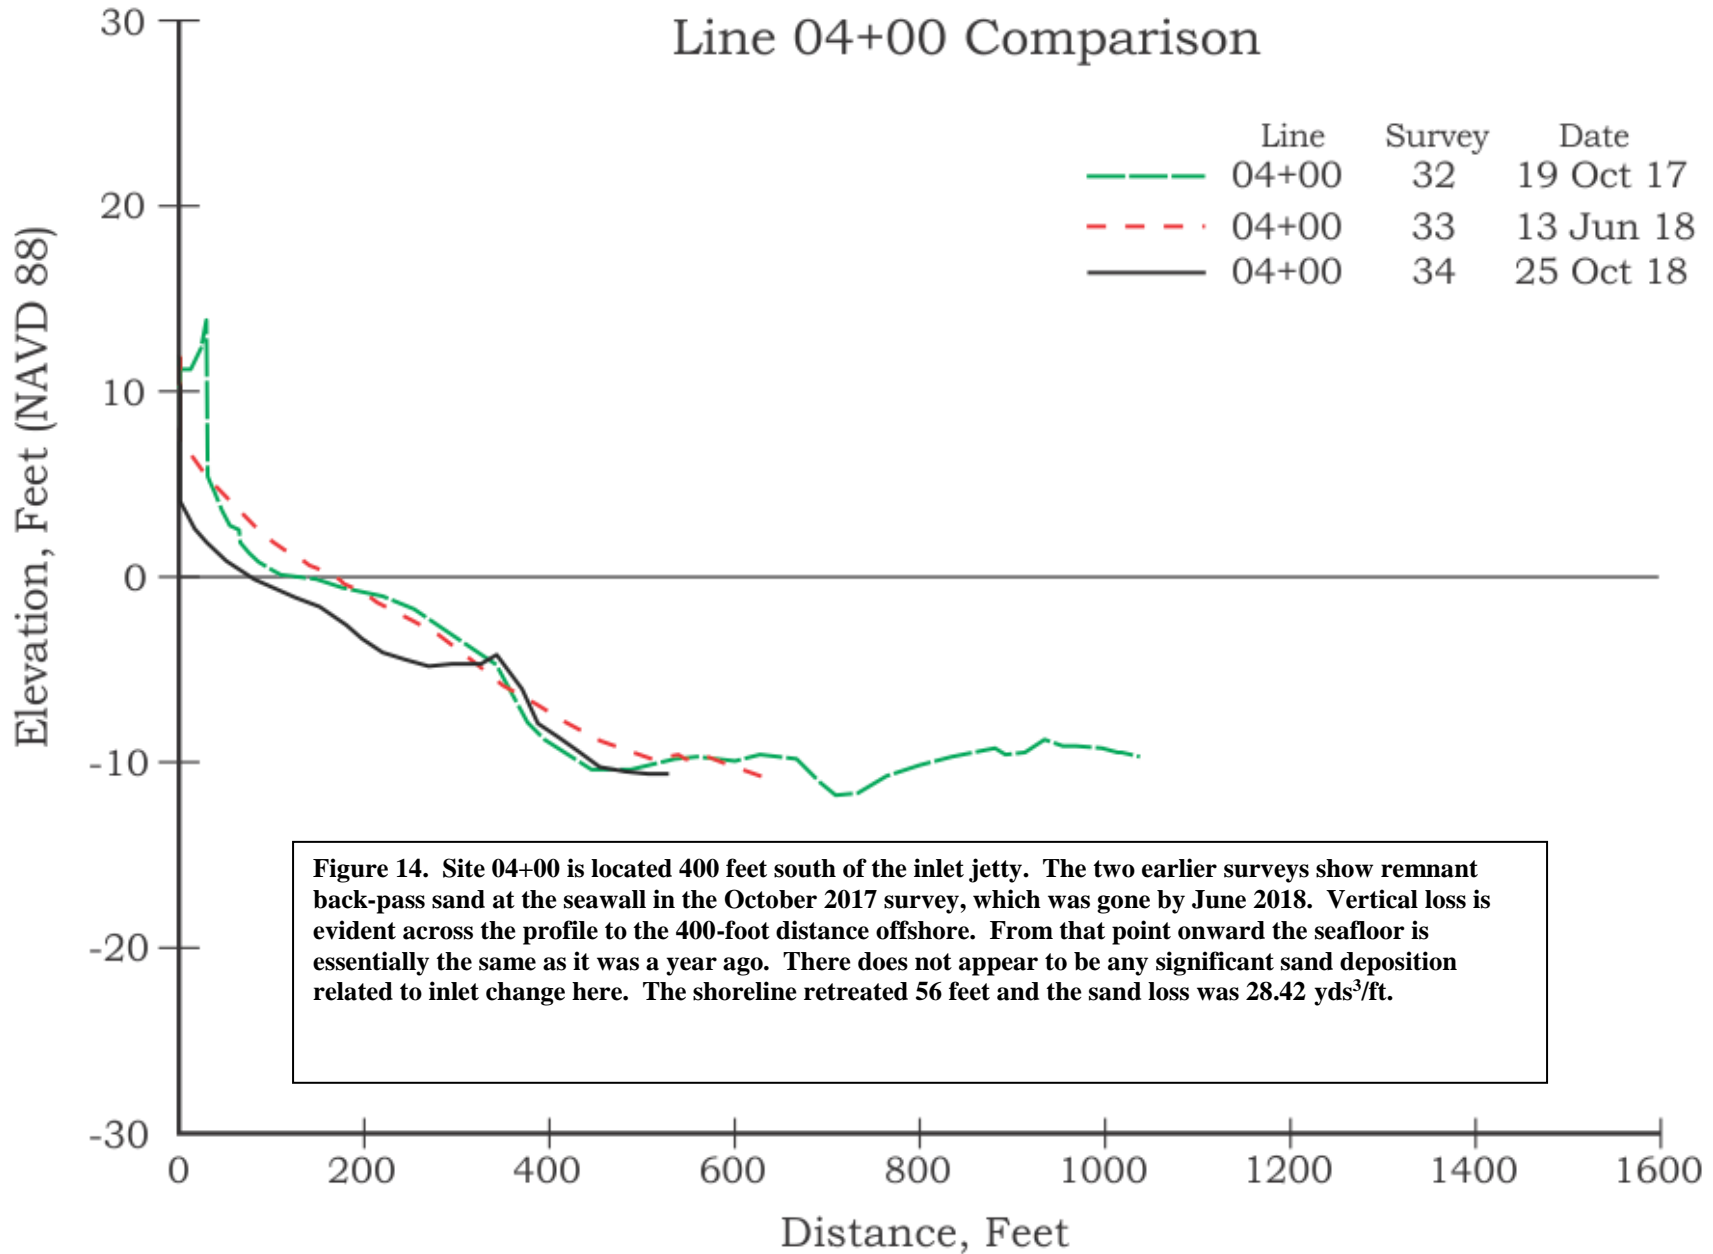
Line 04+00 Comparison

The site is located in the northern portion of the island adjacent to Hereford Inlet 400 feet south of the 2nd Avenue jetty. This area has typically been an erosional shoreline due to its proximity to the inlet and the direct impact from northeast storms. Sand placed here during episodes of back-passing show in the October 2017 and June 2018 survey data, but the beach was eroded to a narrow strip by October 2018. An offshore bar was present in the fall of 2018 indicating sand accumulation offshore related to inlet geomorphic changes which may prove positive to the north end beach.

Figure 14. Site 04+00 is located 400 feet south of the inlet jetty. The two earlier surveys show remnant back-pass sand at the seawall in the October 2017 survey, which was gone by June 2018. Vertical loss is evident across the profile to the 400-foot distance offshore. From that point onward the seafloor is essentially the same as it was a year ago. There does not appear to be any significant sand deposition related to inlet change here. The shoreline retreated 56 feet and the sand loss was 28.42 yds³/ft.

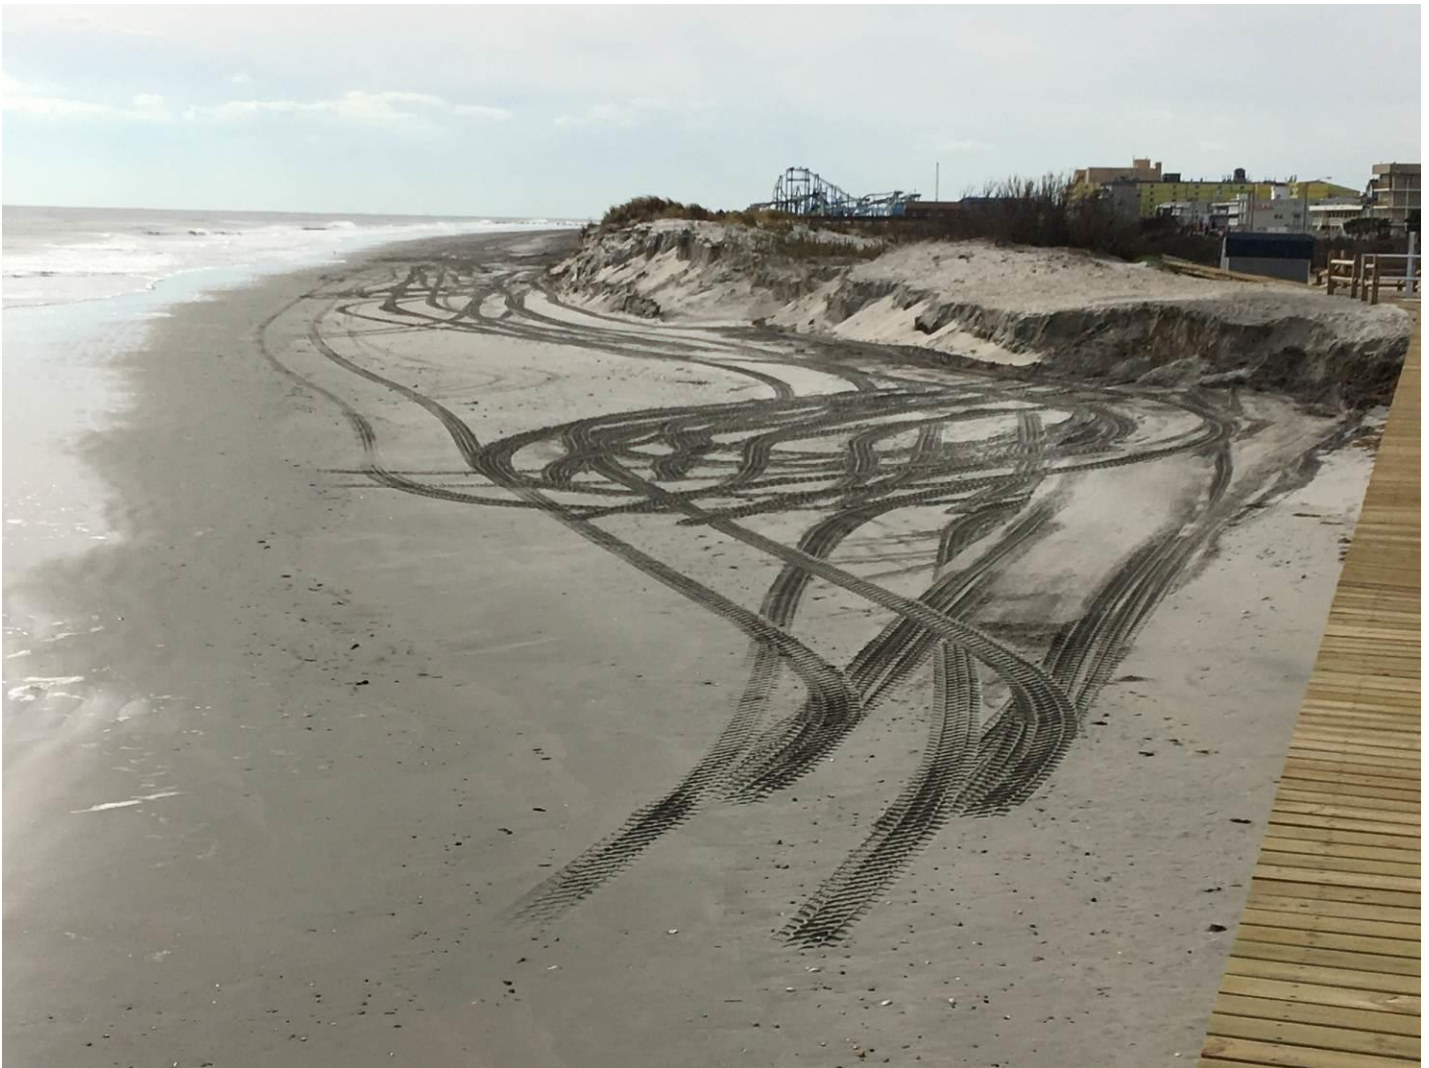
Figure 15. Site 06+00 is on the beach in proximity to where the dune returns to the beach. The view shows the extent of the erosion here and the minimal beach width remaining. The profile plot below paints a grim picture of dune loss and beach retreat reaching nearly 50 cubic yards of sand per foot since October 2017. In fact, the sand loss since June 2018 was 48.61 yds³/ft. meaning that it was the 2018 pattern of northeast storms from March into May that was responsible for the losses in spite of the sand transferred here from Wildwood by Memorial Day 2018.

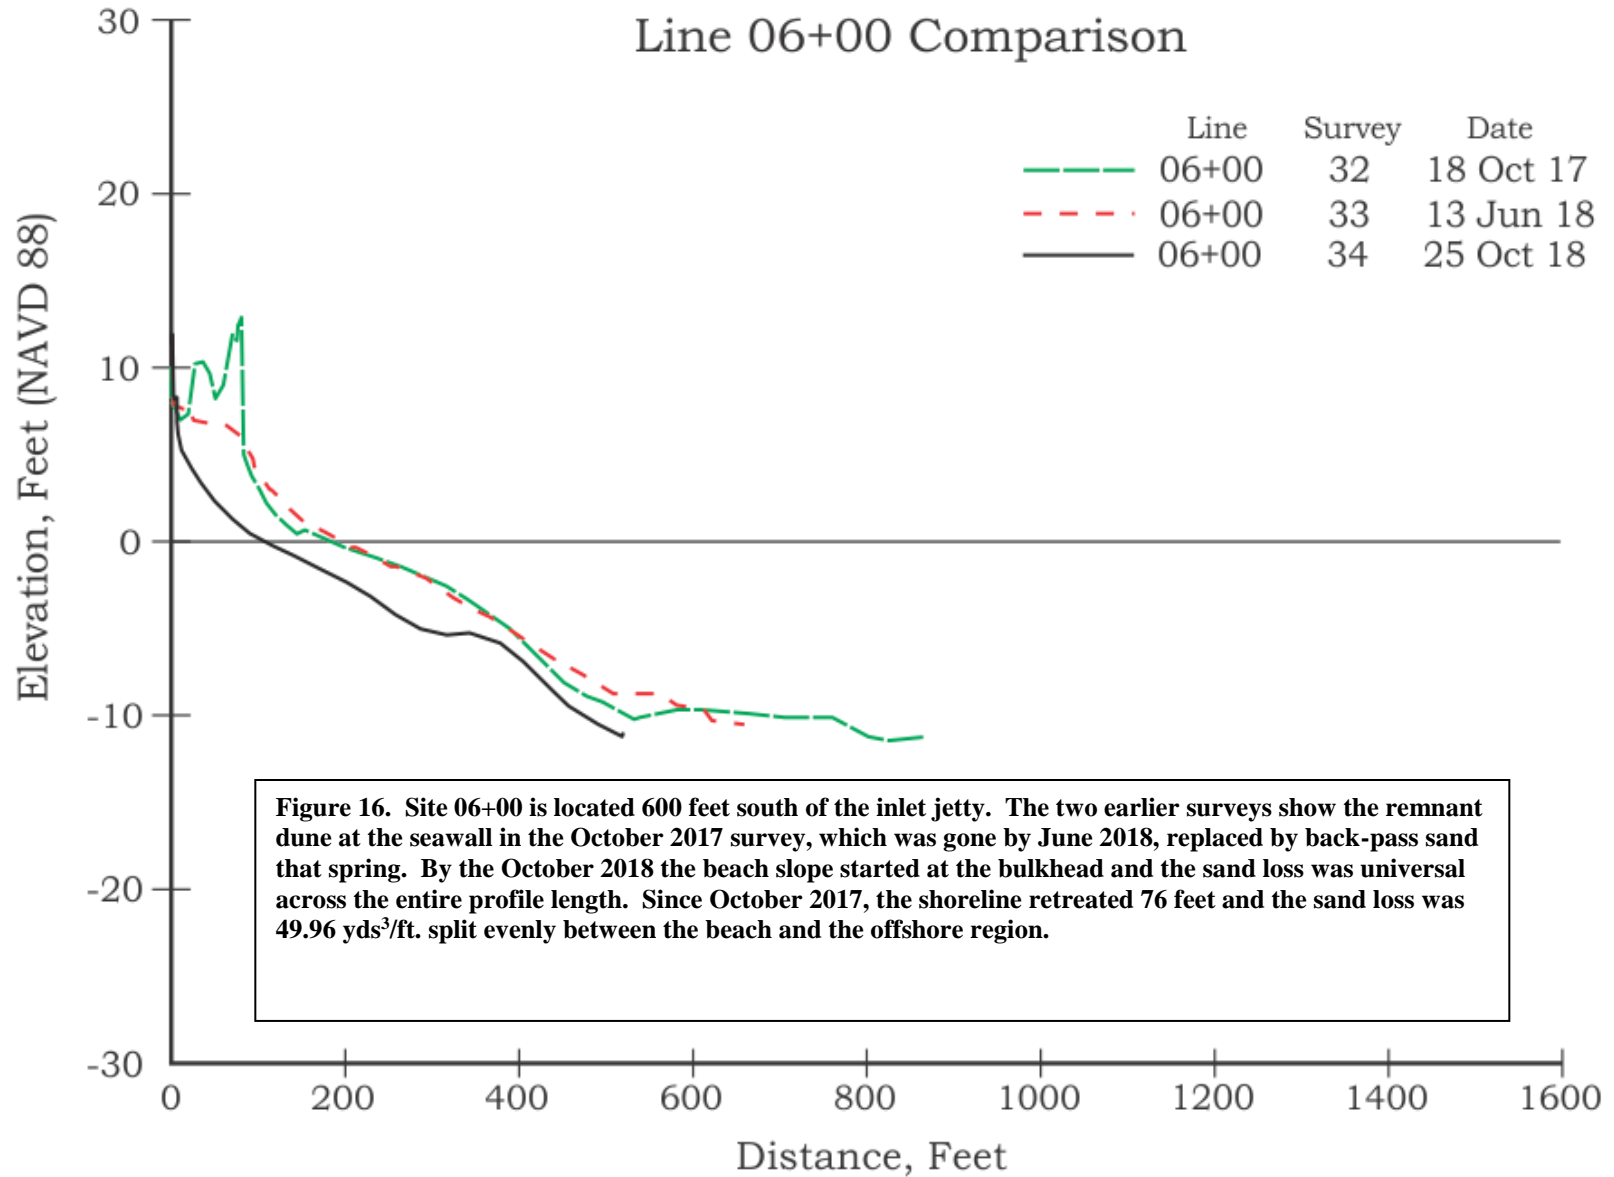
Line 06+00 Comparison

The third of the northern survey sites added to the review this year is located at the end of 4th Avenue where the new bulkhead was completed in early 2018. In 2017 a remnant dune existed at this site, replaced by sand transported from Wildwood City by the time of the June 2018 survey. As of October 25, 2018 the erosion had cut the sand supply back to a starting point for sand elevation at 9.0 feet which rapidly declined to zero elevation within 110 feet of the bulkhead. Erosion dominated the entire cross section to the ending point offshore.
