**2018 ANNUAL REPORT - TO THE CITY OF NORTH WILDWOOD
ON THE
CONDITION OF THE CITY BEACHES**

**PREPARED FOR: THE CITY OF NORTH WILDWOOD
901 ATLANTIC AVENUE
NORTH WILDWOOD, NJ 08260**

**PREPARED BY: THE STOCKTON UNIVERSITY COASTAL RESEARCH CENTER
30 WILSON AVENUE
PORT REPUBLIC, NJ 08241
March 5, 2019**

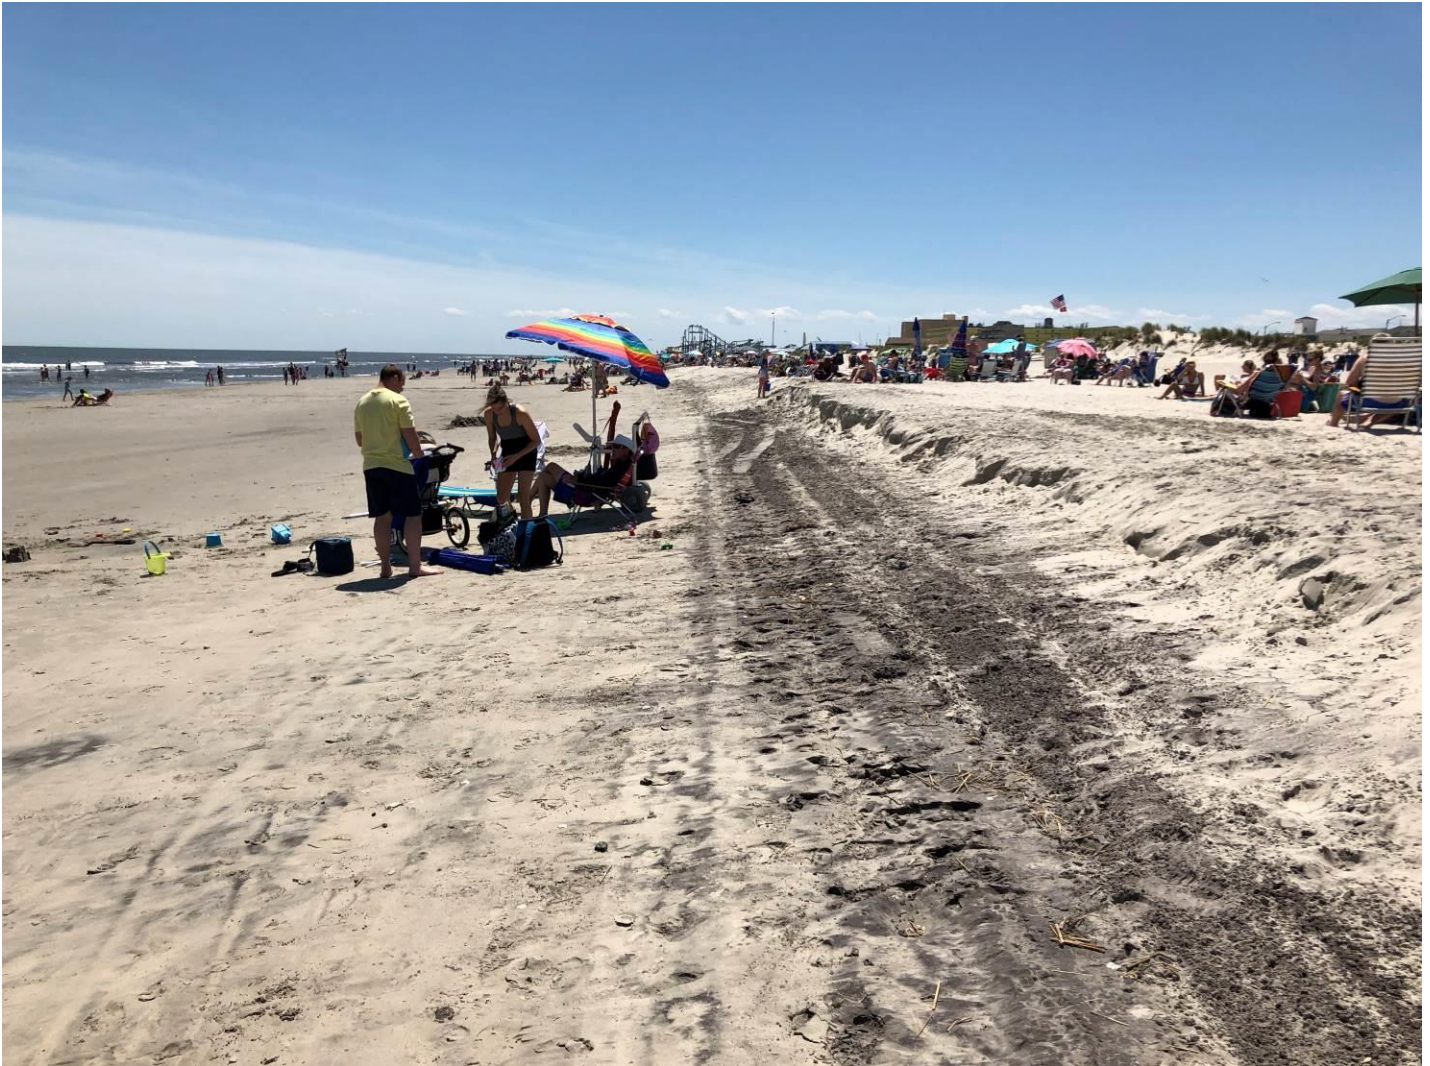
Figure 17. View to the south taken from the beach at 10th Ave. on June 16, 2018 following sand placement from Wildwood. The erosion seen in the plot of surveys (Figure 14) is evidence that beach loss continued through the summer into the fall because the October 2018 survey plot shows a 67-foot shoreline retreat since the June 2018 survey. The annual retreat of 119 feet does show the storm impact during the spring of 2018.

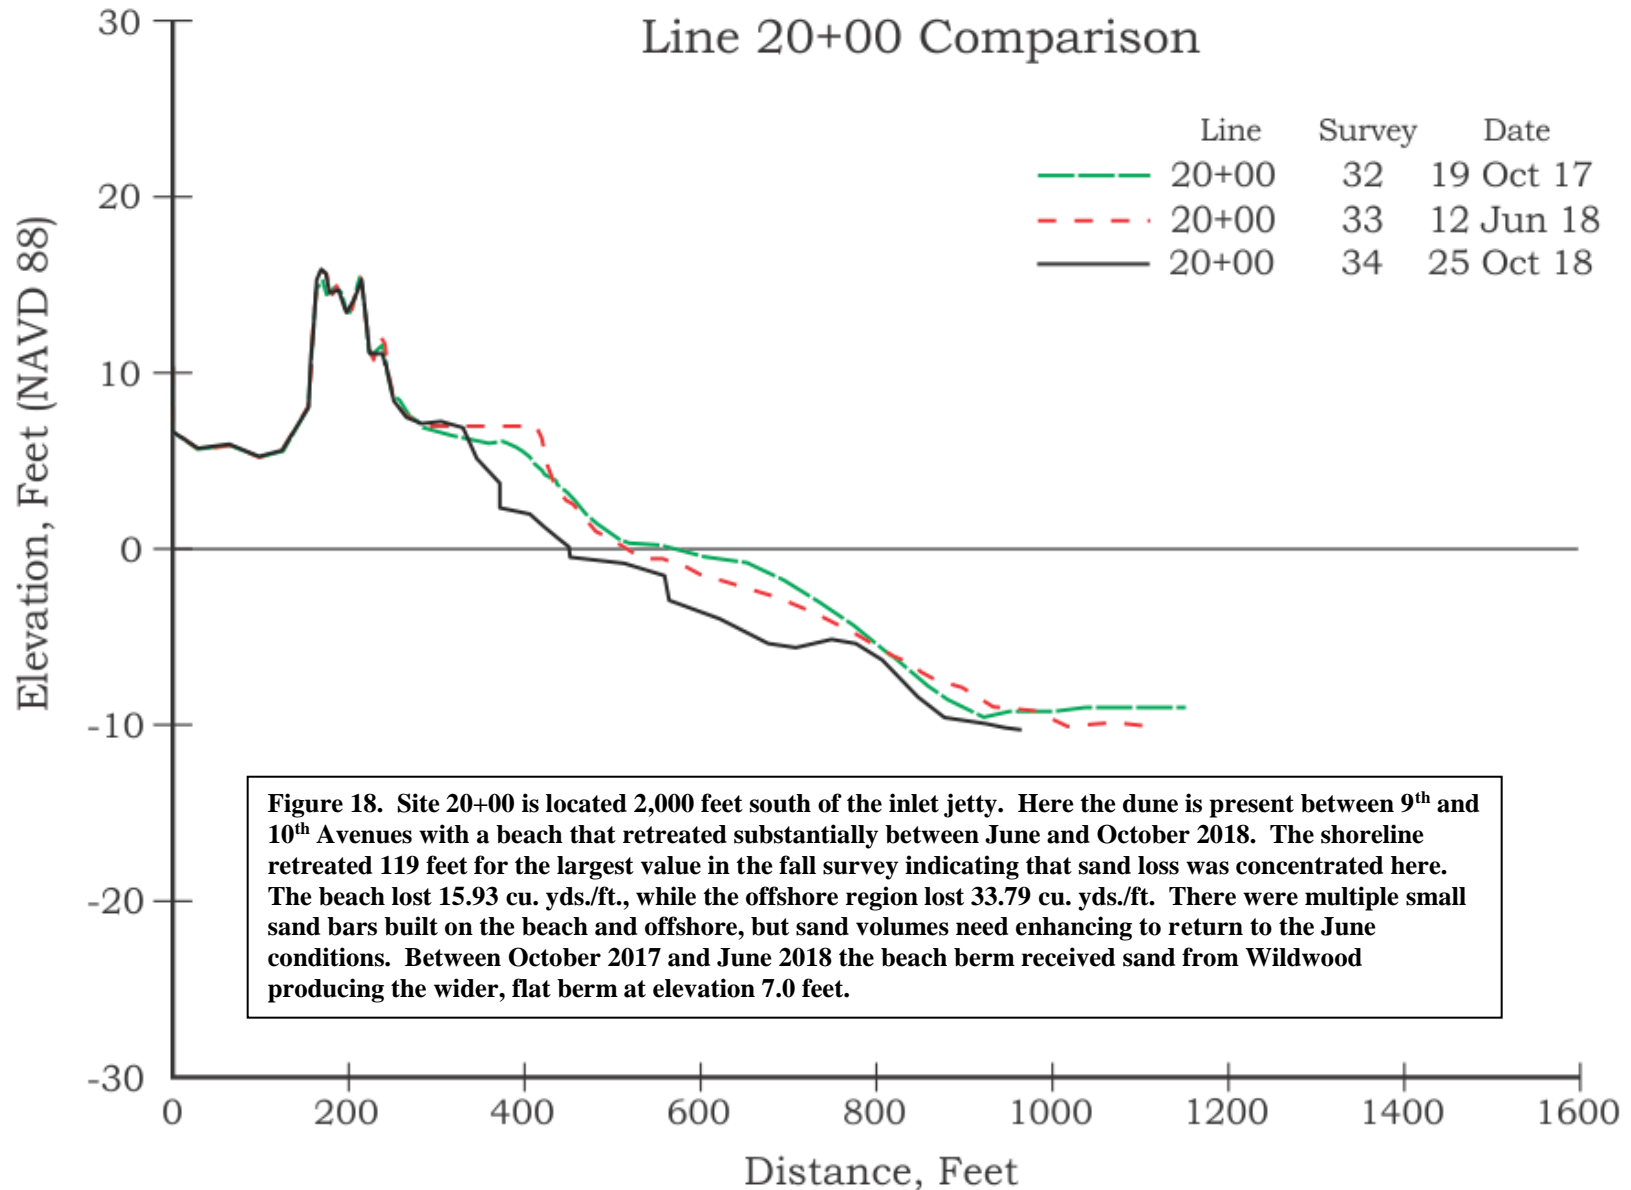
Line 20+00 Comparison

This site is located 2,000 feet south of the inlet jetty and is near the transition from erosion to stability and even accretion from time to time. Dune erosion has occurred here during storms, but frequently has resolved with wind transport and deposition after the storm event. Beach retreat was most dramatic between June and October 2018, after the spring series of northeast events had concluded with a minor event the day prior to Memorial Day 2018. The beach loss has an impact on both the dune stability and the available recreational space between 8th and 15th Streets. The pattern of beach retreat indicates that the transport of sand south toward Wildwood has continued, but the appearance of sand offshore at the Hereford Inlet jetty might show changes at the inlet that could prove beneficial to the oceanfront beach in general.

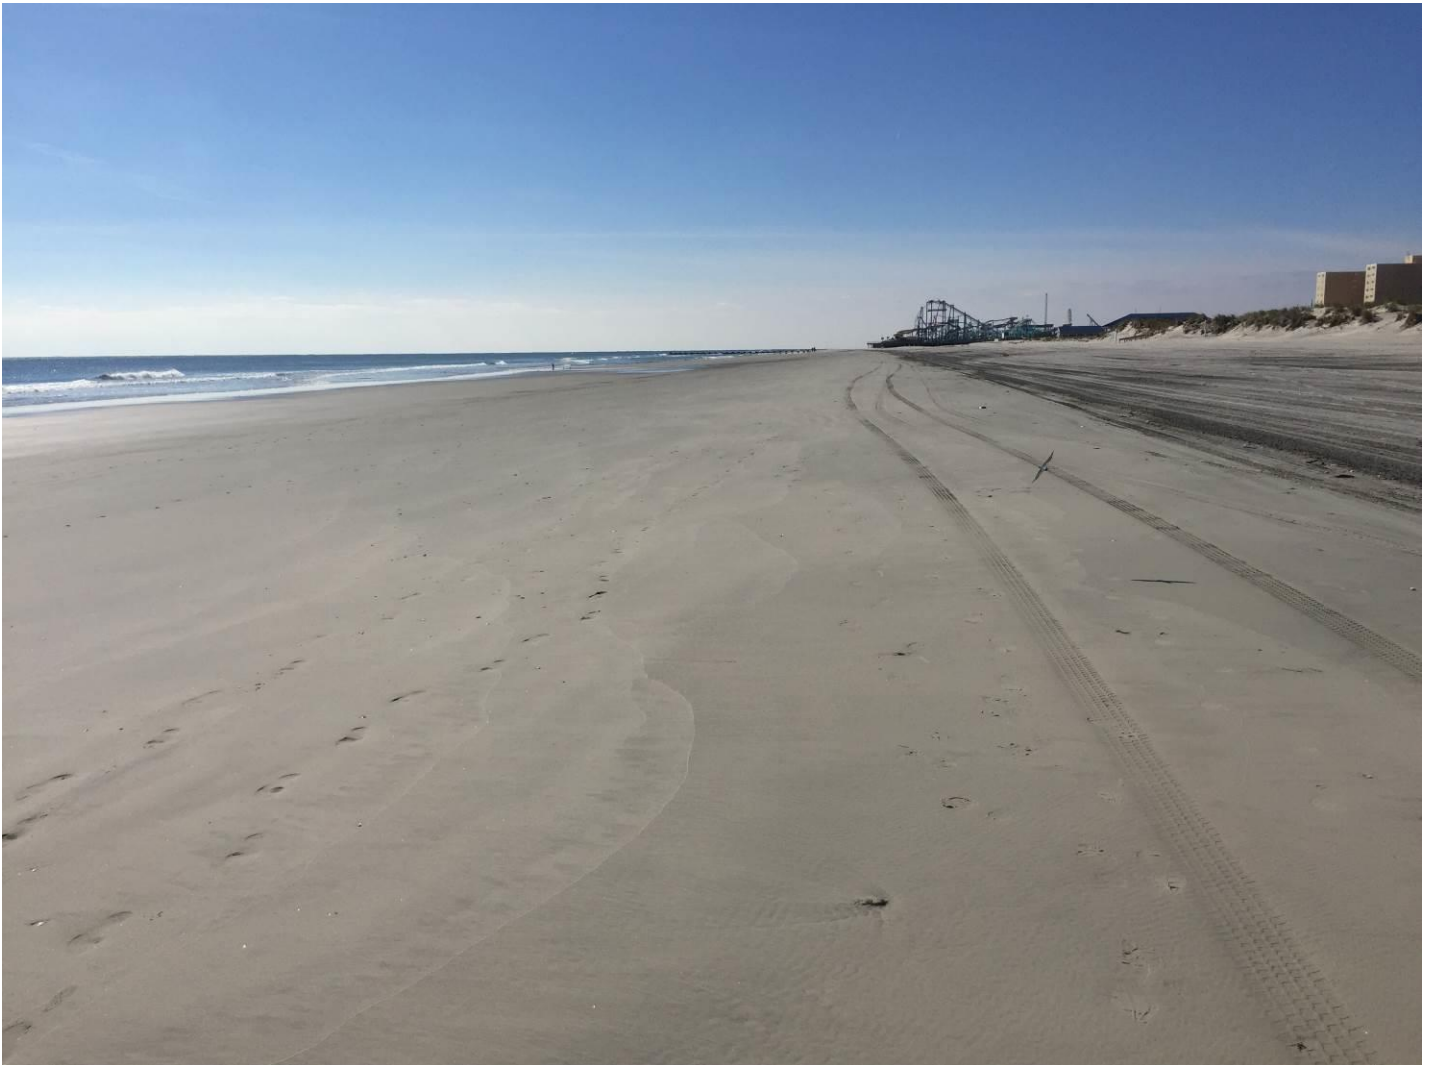
Figure 19. View to the south along the upper beach on November 5, 2018. Beach flattening has moved the wet/dry surf line close to the dunes. While no erosion of the dunes has occurred as yet, the narrow beach where the most visitors tend to gather presents a space problem for the coming season. There is a bar offshore, but not in the position to add to the beach in the near future.

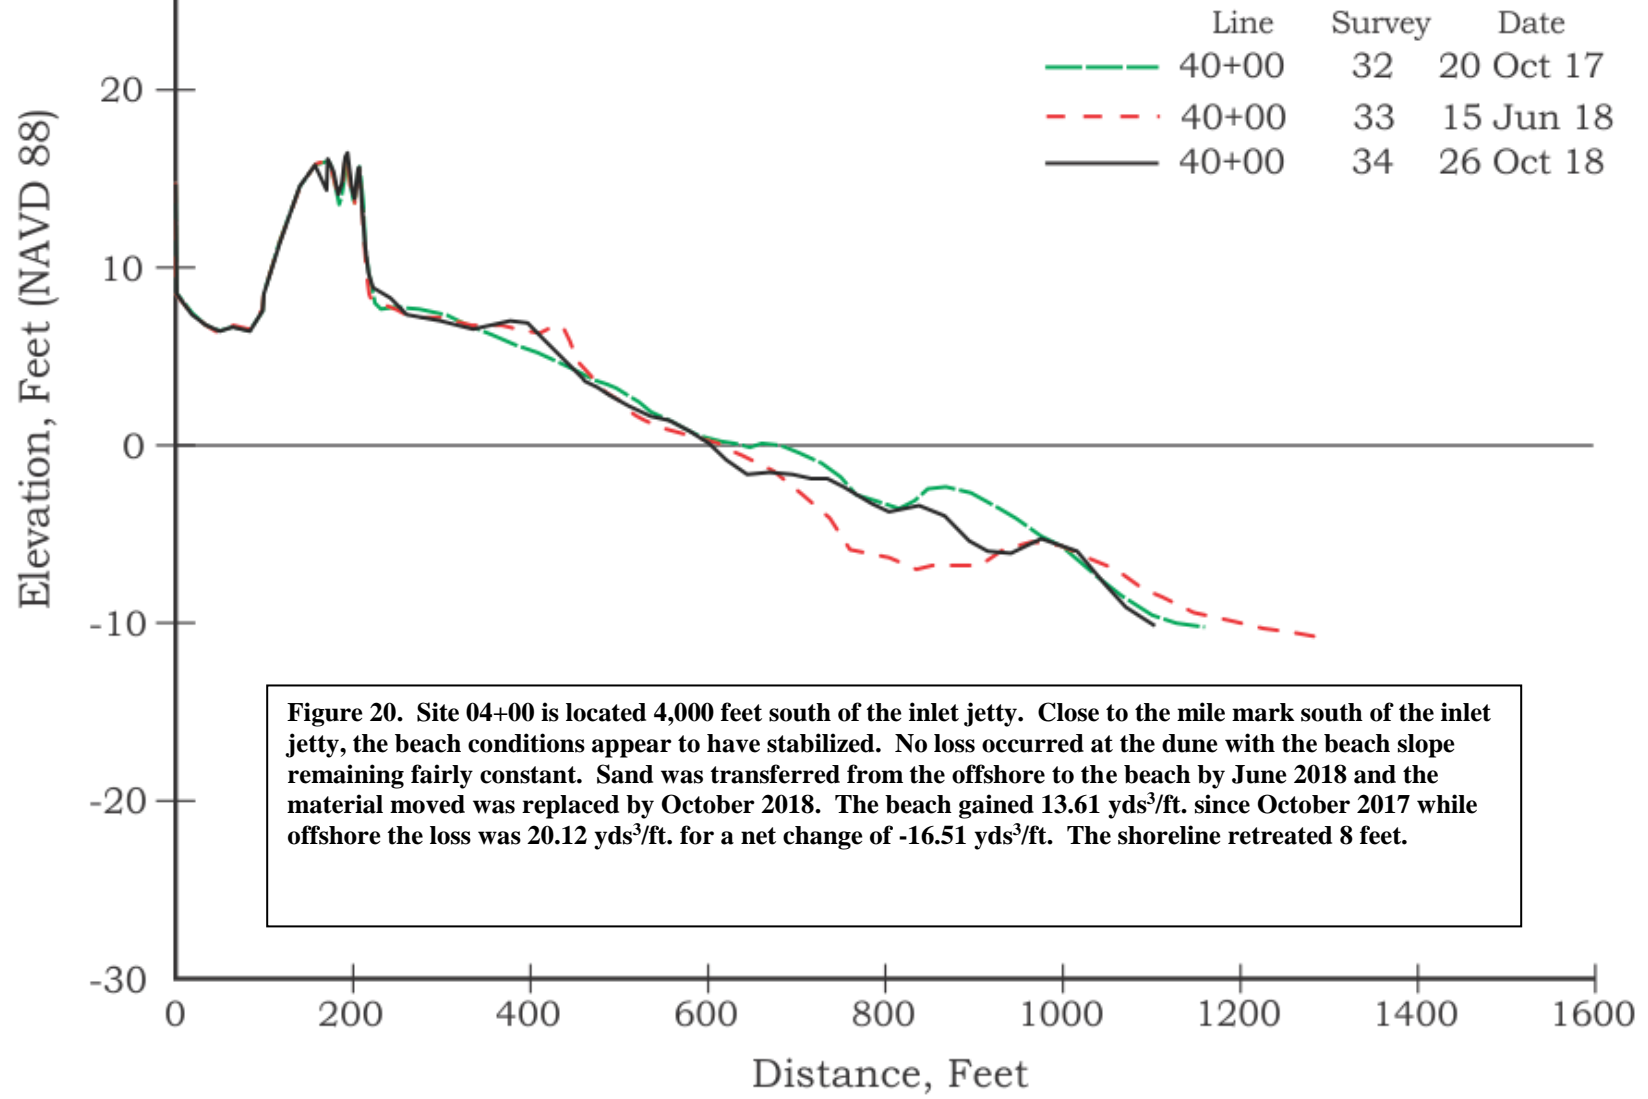
Line 40+00 Comparison

Positioned 4,000 feet south of the 2nd Avenue jetty, this site is located two blocks south of the lifeguard station in the mid-section of the City's oceanfront beaches. Following initial construction in 2009 this region has remained relatively stable. The dry sand expanse has diminished over the past decade, leaving the visitor area dependent on wave run-up conditions. The bar offshore must migrate to the shoreline to have any expanse of recreational beach this summer.

Beach accretion did occur over the entire year from October 2017 to October 2018 adding 13.61 yds³/ft. of sand, but the offshore region lost material leaving the site with a net loss for the year. The shoreline retreated 72 feet.

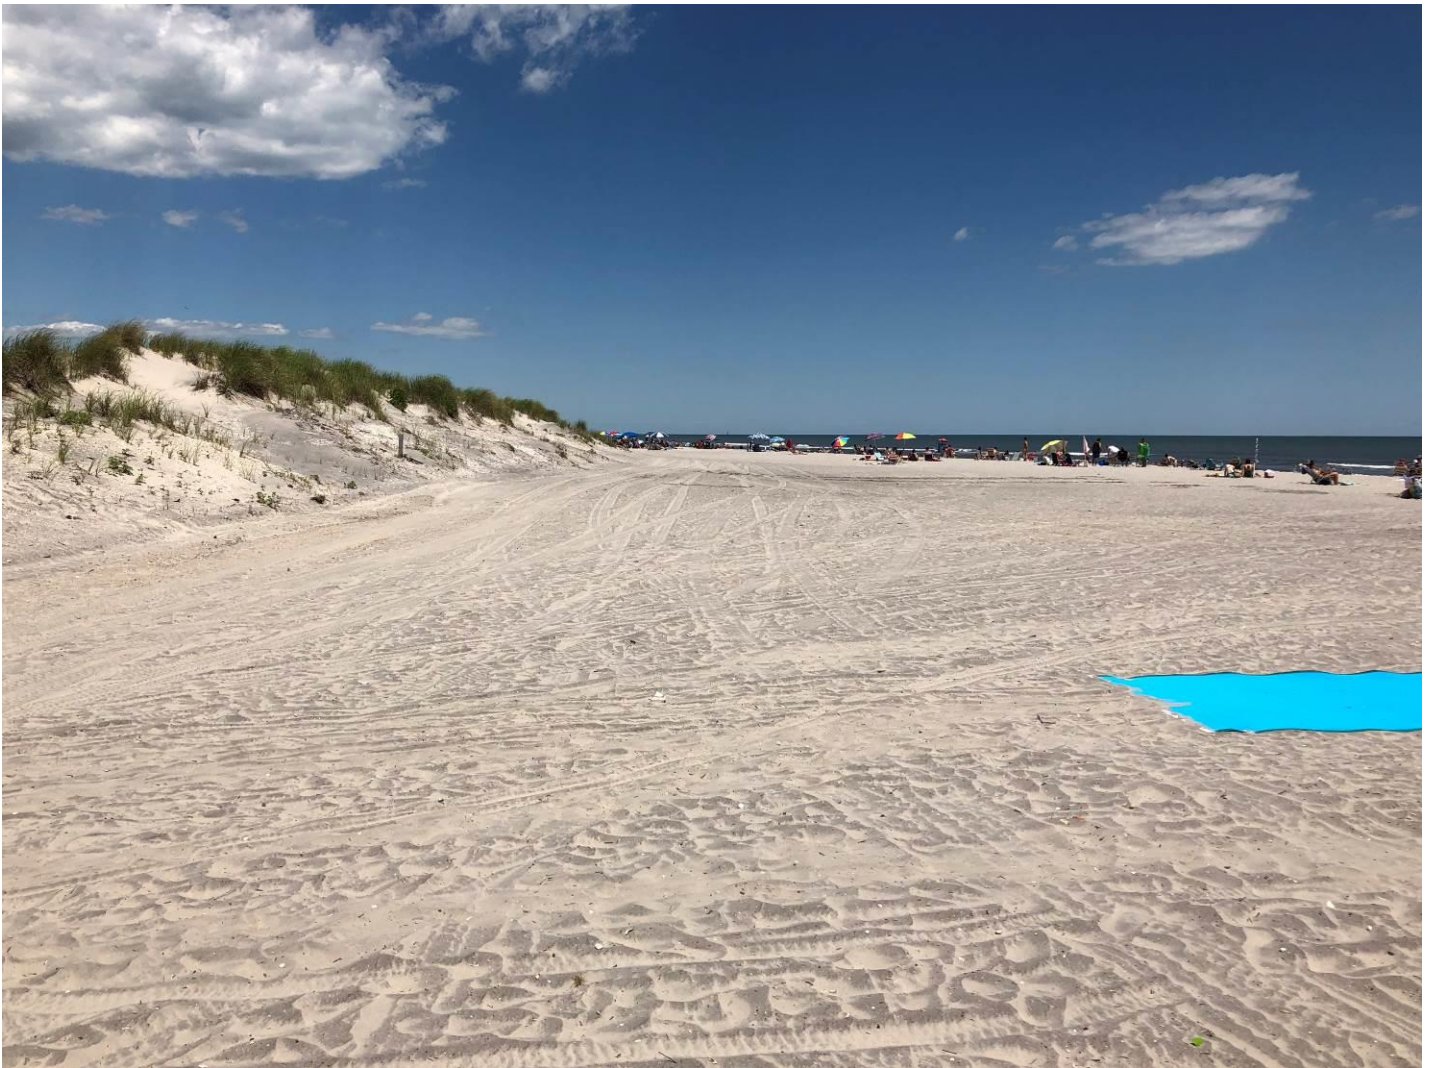
Figure 21. View to the north taken from the dune toe at 21st Avenue on June 16, 2018. The view along this part of the dune system shows a wider beach extending north from where the project design had the dune shift seaward in order to pass seaward of the three piers and the fourth structure at the Wildwood boundary. The start of the dune shift seaward commences just south of this survey line.

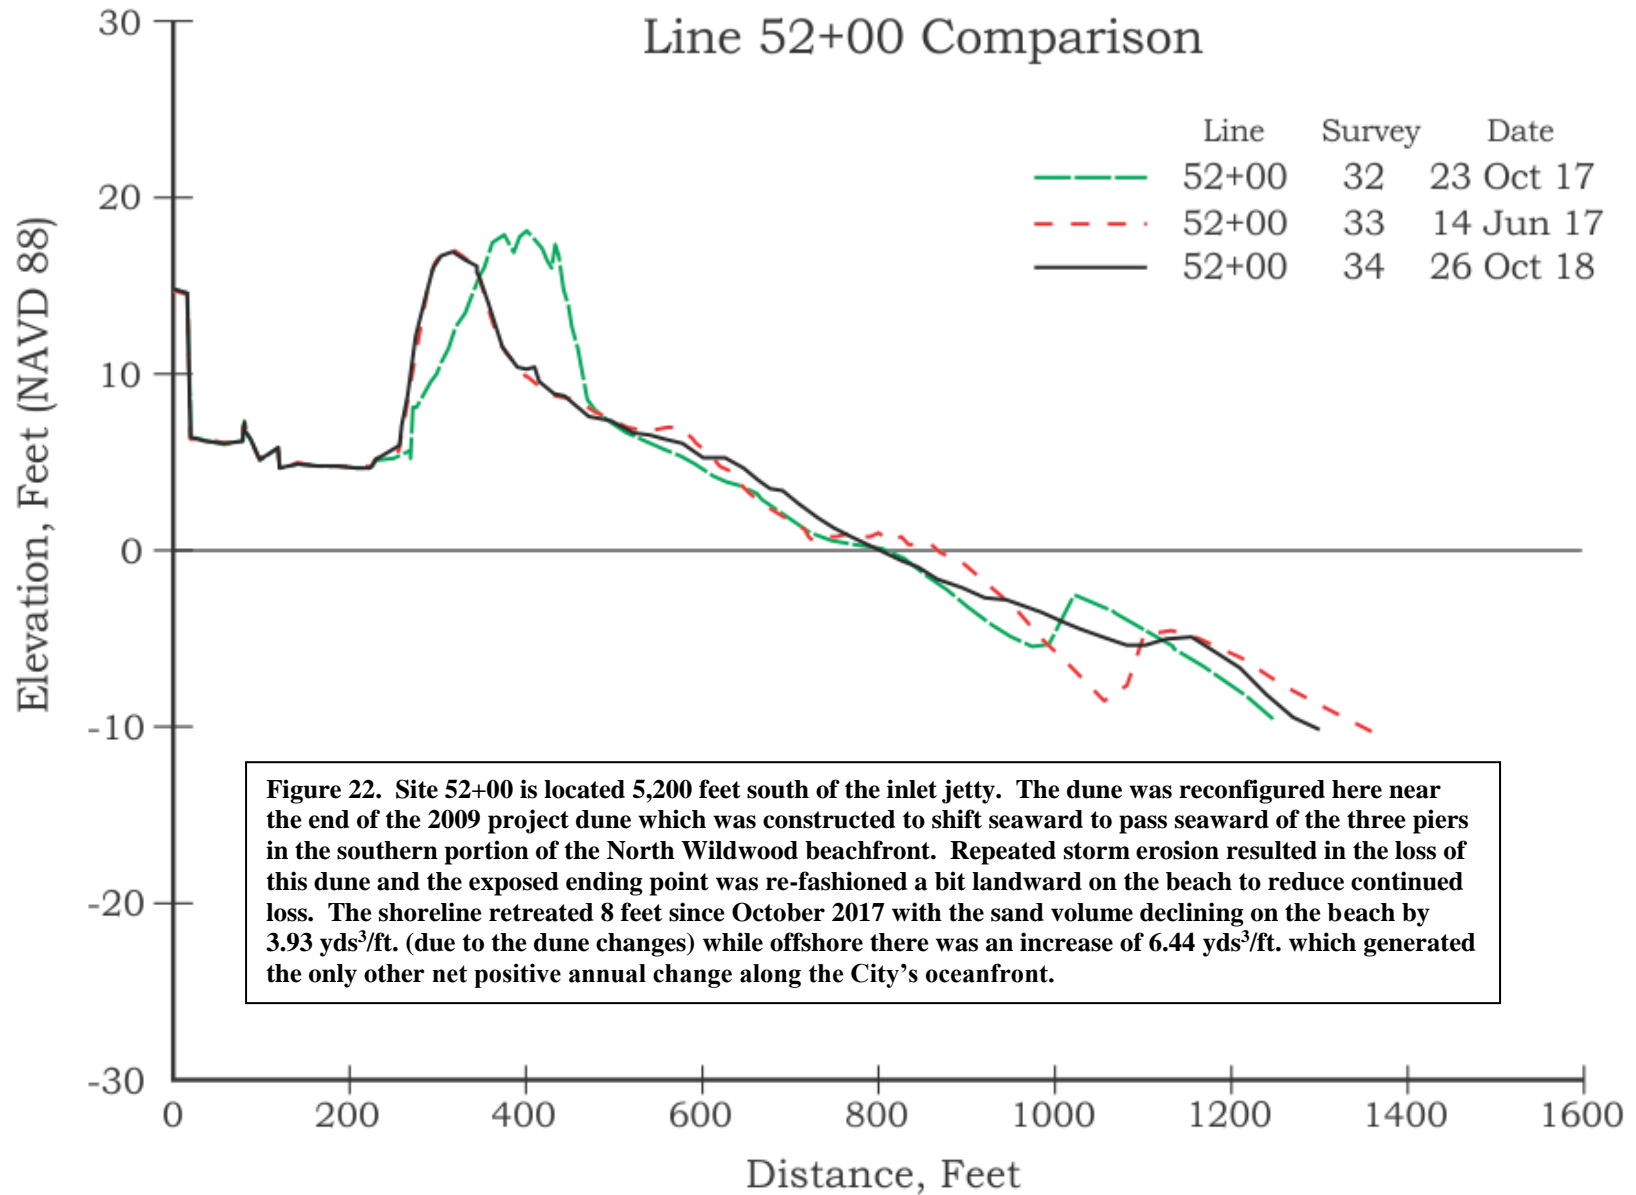
Line 52+00 Comparison

Several hundred feet of dry beach still protected the dune system at this location and to the north, to the south the beach width seaward of the dune was diminished significantly from the initial project design. Immediately south of this location, the engineered dune was initially built with a seaward jog in its alignment from just seaward of the boardwalk to run seaward of the eastern ends of the timber and Morey's piers in North Wildwood.

This element of the original 2009 project was abandoned following Hurricane Sandy which wiped out the dune across the zone occupied by the three ocean piers. Morey's Surfside Pier installed a steel bulkhead fronting their pier, extended along the northeast side for about 100 feet. A new dune system was created landward of the pier ends combining an island dune originally present between the Morey's pier and the adjacent timber pier. No dune was replaced south of Morey's Surfside pier.

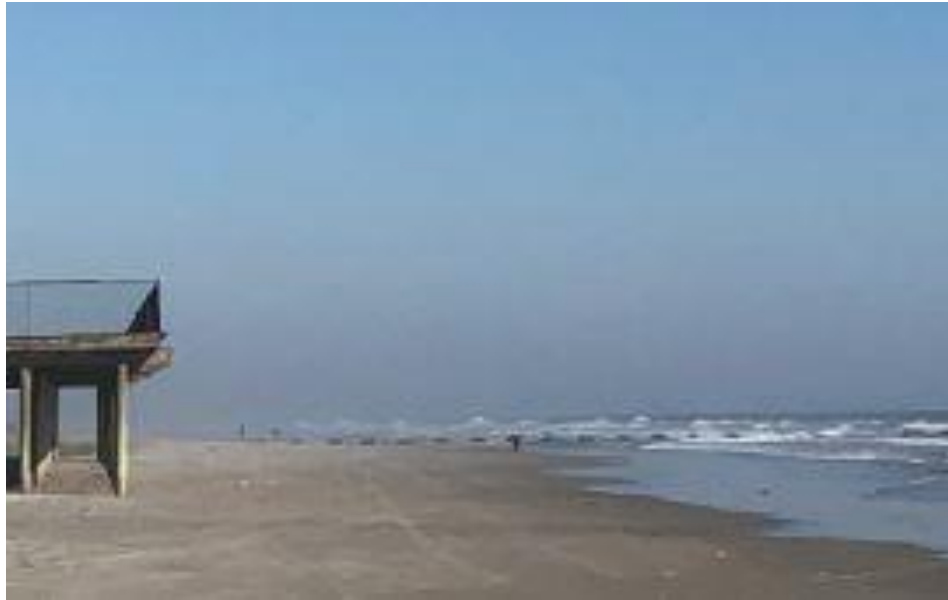
Figure 23. A close up view of the beach at the very seaward end of the timber pier indicating that no dry beach or dune feature remains at the pier's end (November 11, 2018). The dune extends to the pier and in between it and Morey's Surfside pier utilizing an older island dune existing on beach raking debris from years ago. This was essentially the same configuration the beach presented a year ago.

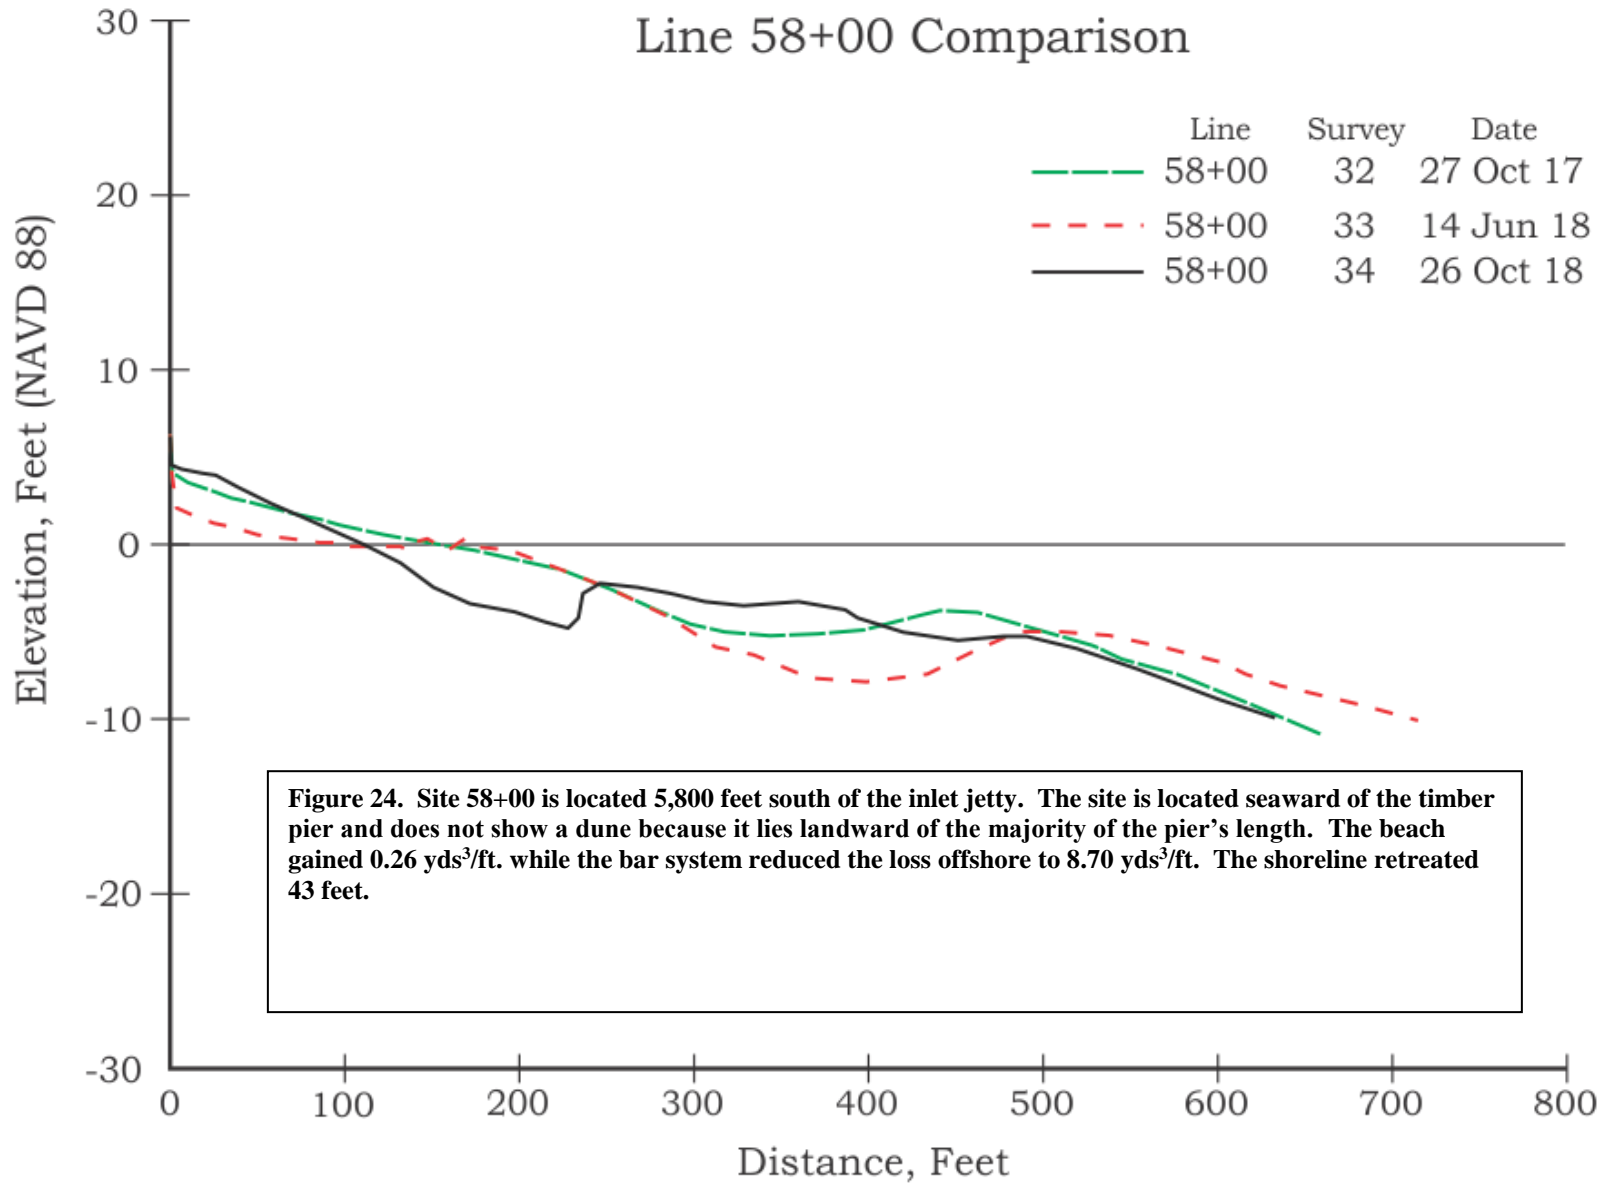
Line 58+00 Comparison

This site is located in the southern section of the City's oceanfront where the engineered dune system was originally constructed seaward of the piers. The original NJDEP project permits mandated a seaward jog in the dune system, which resulted in their vulnerability to the spate of frequent storms since 2009. With limited beach width seaward of the feature to attenuate wave action and absorb the energy before impacting the seaward slope, the dune suffered severe erosion. During Sandy, the proximity of the dunes seaward of the piers to the shoreline made them no match for this event. Dunes were entirely washed away south of 22nd Avenue and the beachface and berm flattened by the storm waves and surge.

An effort was made in 2013 to restore the dune, but events in 2014 forced re-positioning the dune system landward between the piers and including a large vegetated island dune that had existed between Morey's Surfside Pier and the adjacent timber pier. The dune was merged with the landward end of the northeast side bulkhead wall put in for defense of the seaward end of the Surfside Pier. Sand was placed beside each timber pier as well to mitigate storm waves reaching boardwalk development.

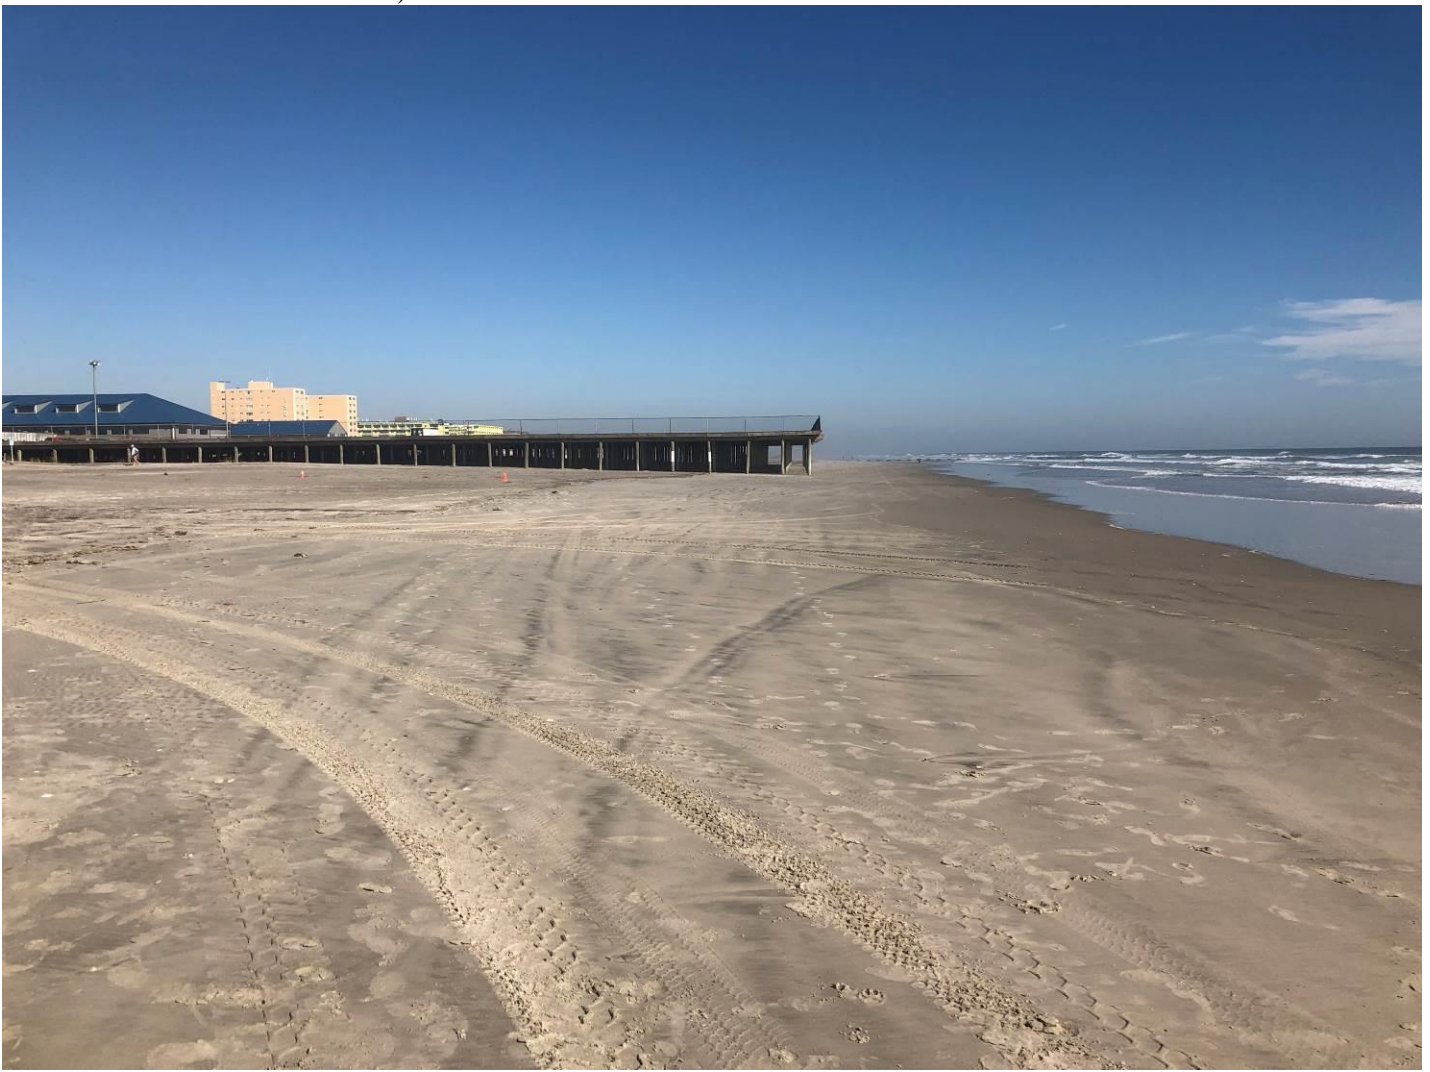
Figure 25. Site 60+00 was included this year in the survey plots presented, with calculations for sand volume and shoreline changes. The view was taken November 11, 2018. This site lies in proximity to 24th Avenue, between the Surfside Pier and the timber pier to the north in the photograph. The dune lies well landward of the end of the pier due to post-2009 erosion. The as-built project dune extended seaward of all three piers and was exposed to wave erosion immediately by the 2009 Veteran's Day northeast storm. Following multiple episodes of dune damage, the dune was moved landward parallel with the dune line to the north.

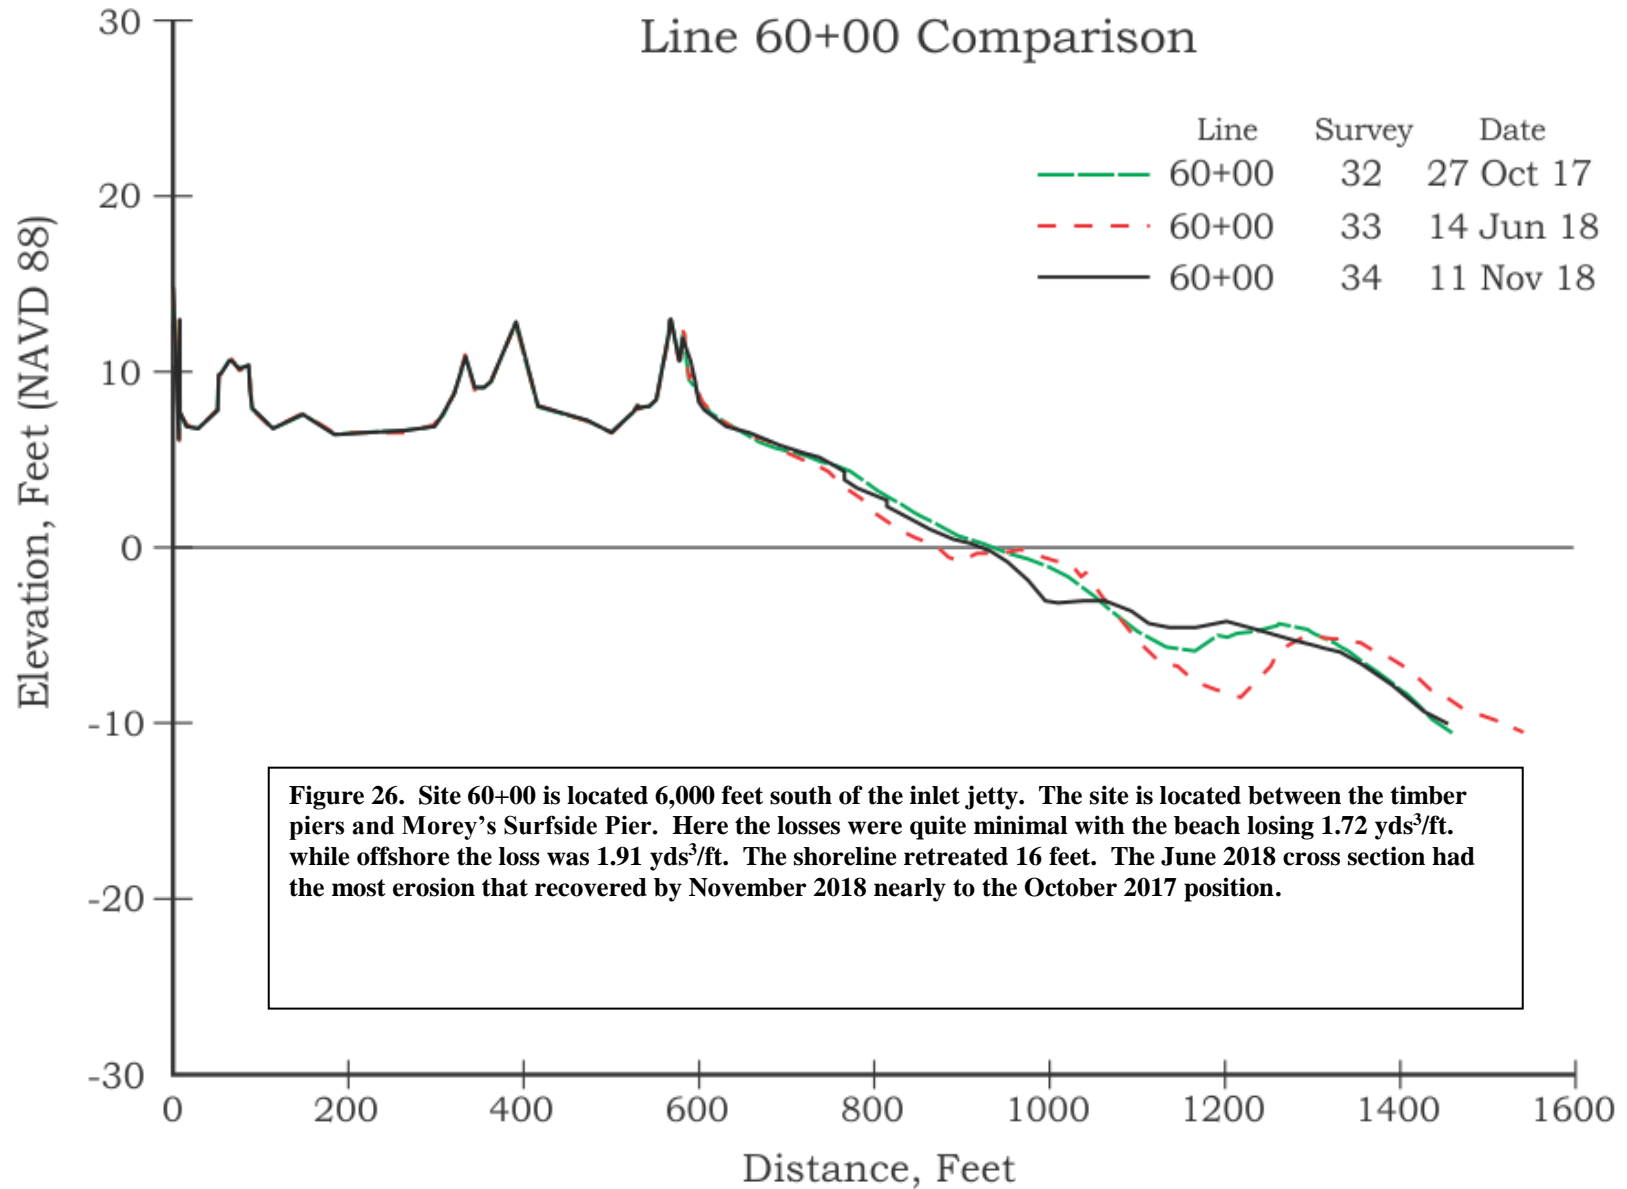
Line 60+00 Comparison

In an effort to better define the beach zone where piers dominate in North Wildwood, this site was included to show the changes to enhance dune protection since Hurricane Sandy. The main feature is an old dune island likely developed around beach raking debris left in a variety of places when the North Wildwood beach was much wider. In the 1990's multiple island dunes existed from 15th Avenue south to here because sand accumulated among the debris and plant seeds always accompanied the grass stems and other organics washed up onto the shoreline. These germinated, established and trapped more sand enhancing these features. The majority of these features are long eroded away as the beachfront retreated between 1994 and 2009.

The piers originally had the 2009 dune built seaward of the pier ends on the outer beach, but storm erosion starting November 2009 and climaxing with Hurricane Sandy in October 2012 saw complete loss of the dune seaward of the three piers. The existing situation was completed in 2014 and has established quite well. The beach seaward remained stable with minor annual losses in both shoreline position and sand volume (loss of the berm above the zero datum).

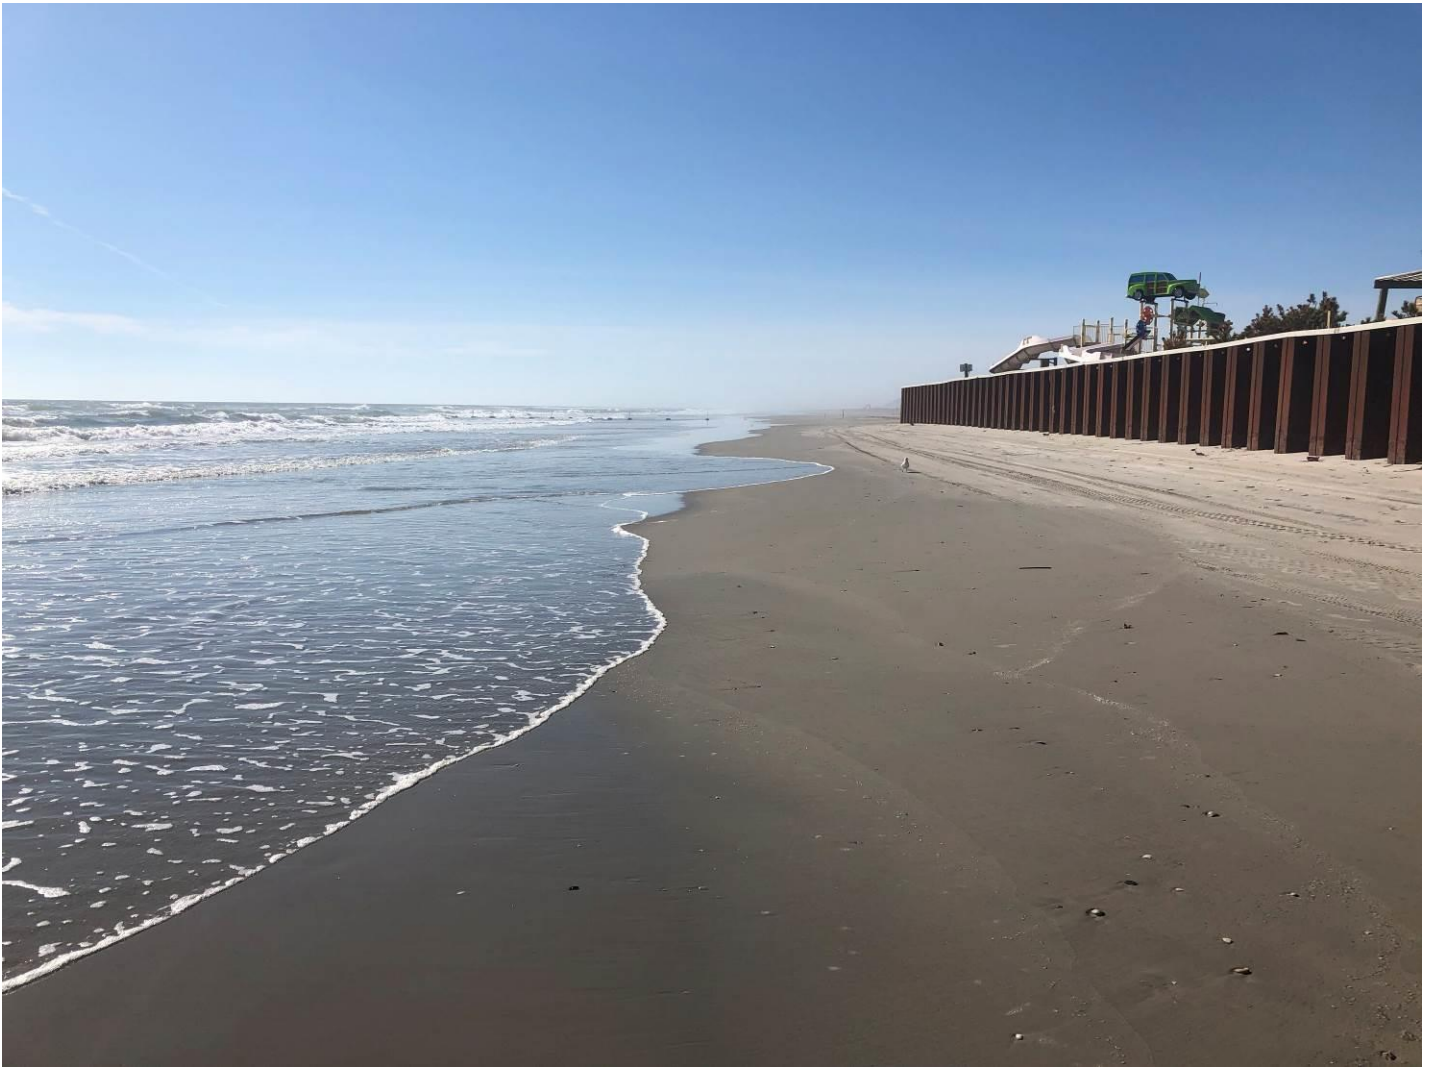
Figure 27. View to the south taken on November 11, 2018 near 26th Avenue showing the beach at the Surfside Pier's seaward end steel bulkhead. Waves easily reach the bulkhead making a dry berm unlikely until the shoreline advances about 100 feet further seaward. Little change has occurred at the bulkhead in over a year with summer accumulations allowing minor beach use immediately seaward of the steel wall.

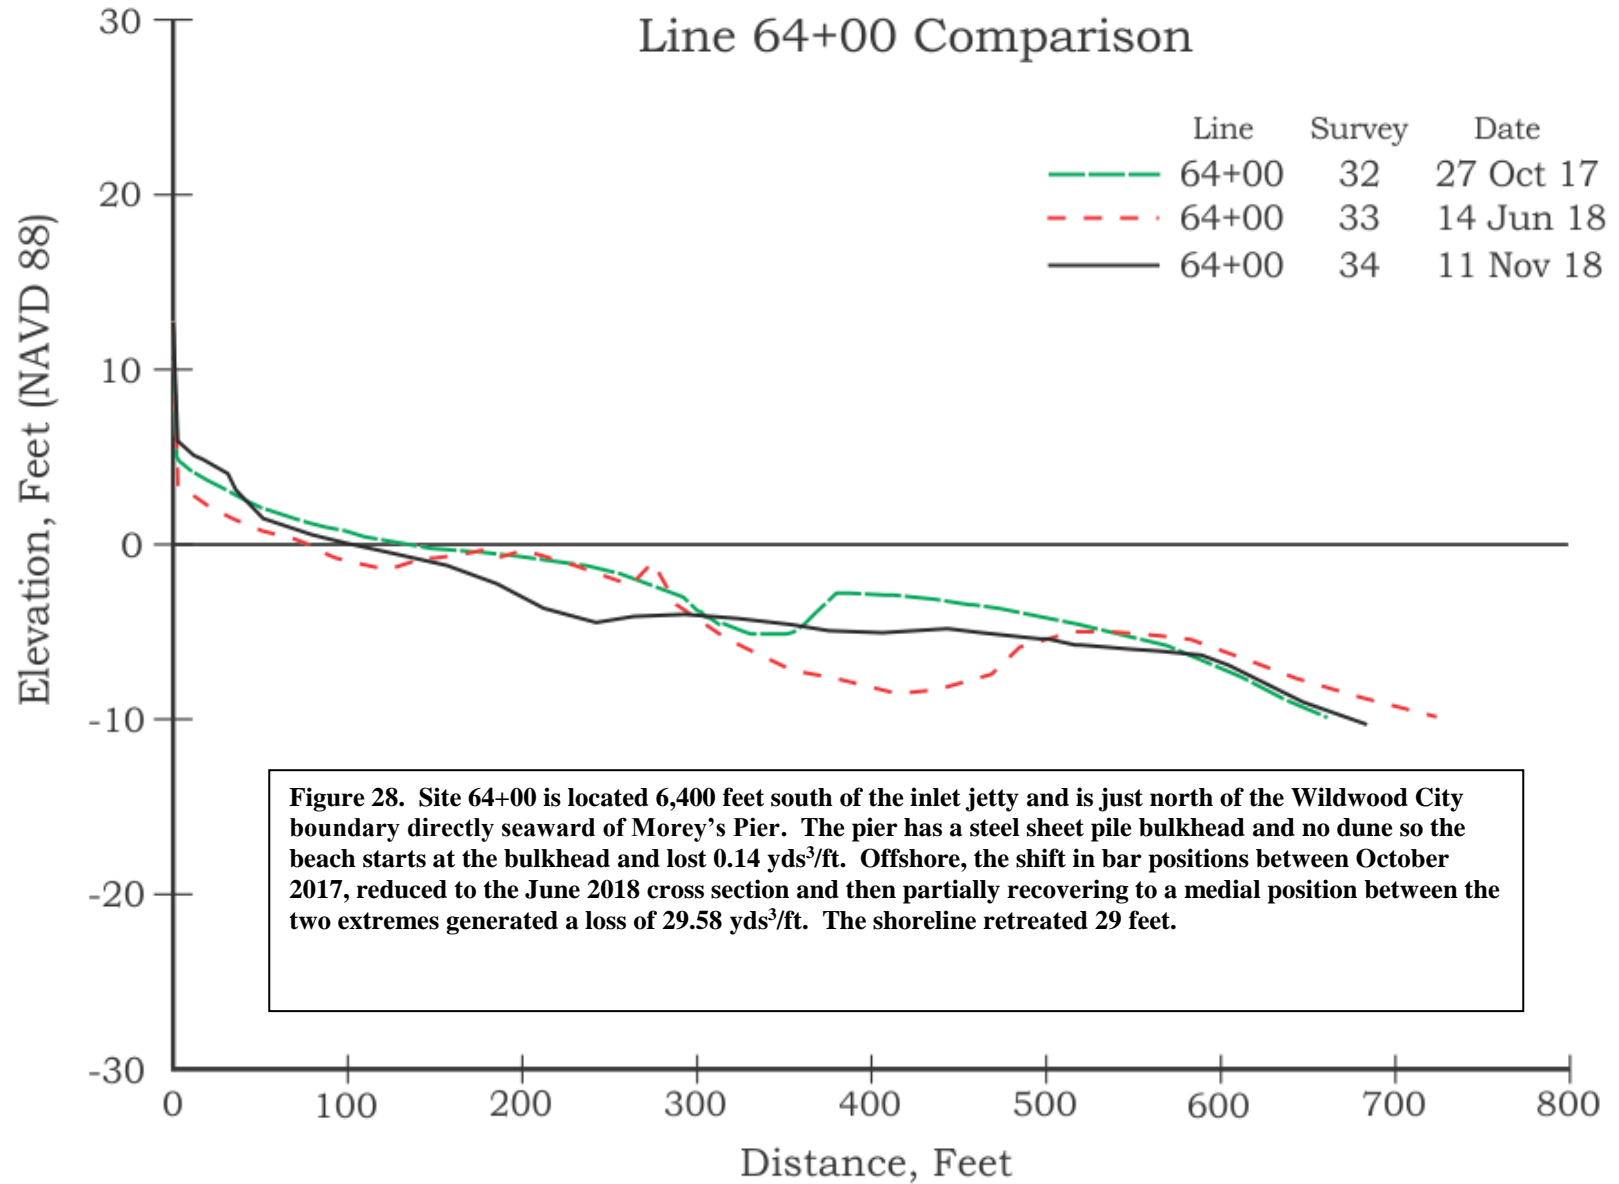
Line 64+00 Comparison

This is the southern-most cross section of the selected profiles within the larger database. Located seaward of the Surfside Pier and Ocean Oasis Water Park and Beach Club this site represents conditions at the south end engineered beach and its taper near the Wildwood and North Wildwood border. Initially the engineered beach design template placed the dune feature 30 feet seaward of the pier's steel bulkhead. A series of storm events that followed construction in 2009 resulted in multiple episodes of erosion followed by restoration efforts to maintain this section of dune. The beach seaward of the feature is narrow and prone to storm erosion.

Like the profile at Line 58+00 located to the north of the piers, by the spring 2014 survey (April 25th), the beach and dune had eroded to a point where the City was forced to reposition this feature landward of the easternmost point of the piers. No dune was replaced south of Surfside Pier because the City of Wildwood declined to allow the original design to be re-established. The proximity to Ocean Oasis also mitigated against dune success due to the location in even mild storm wave activity.

Figure 28. Site 64+00 is located 6,400 feet south of the inlet jetty and is just north of the Wildwood City boundary directly seaward of Morey’s Pier. The pier has a steel sheet pile bulkhead and no dune so the beach starts at the bulkhead and lost 0.14 yds³/ft. Offshore, the shift in bar positions between October 2017, reduced to the June 2018 cross section and then partially recovering to a medial position between the two extremes generated a loss of 29.58 yds³/ft. The shoreline retreated 29 feet.
