An Analysis of Thirty Years' Study of Sand Redistribution and Shoreline Changes in New Jersey's Four Coastal Counties Raritan Bay, the Atlantic Ocean Coast, and Delaware Bay Fall 1986 Through Fall 2016

VOLUME 4 of 4 CAPE MAY COUNTY & APPENDIX

Prepared for:
New Jersey Department of Environmental Protection
Division of Construction and Engineering
1510 Hooper Avenue, Toms River, New Jersey 08753

Prepared by:
The Stockton University Coastal Research Center
30 Wilson Avenue, Port Republic, NJ 08241

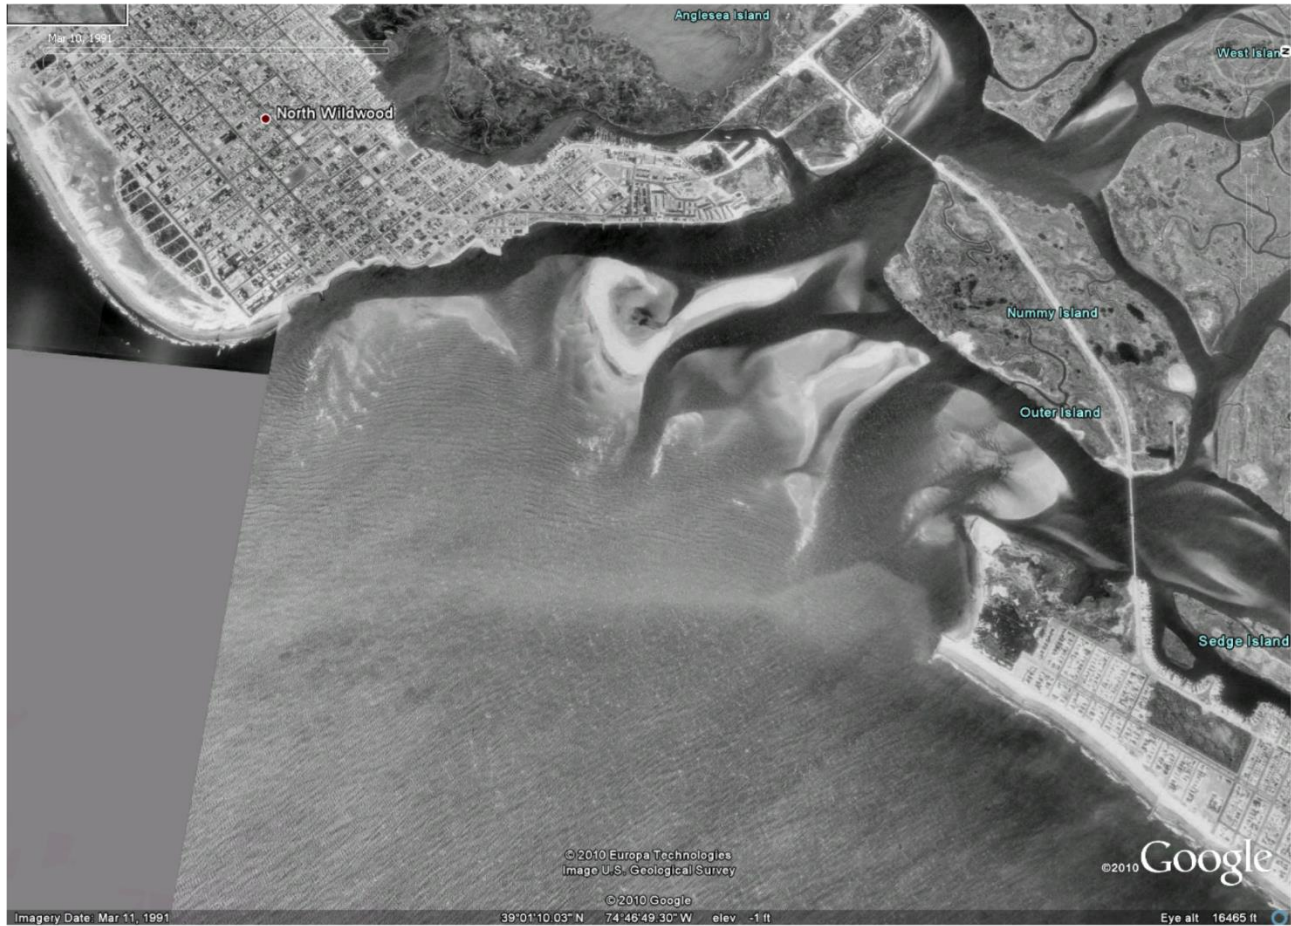
Hereford Inlet, Cape May County, March 10, 1991, seven years prior to the initial NJ State and municipally funded beach restoration. Bird habitat consisted of four large intertidal shoals situated between the 123rd Street groin in Stone Harbor and the rock revetment protecting North Wildwood. 25 years and 4.8 million cubic yards of beach restoration later, nesting habitat had expanded into a 7,500 foot long spit extending to a point south of the third shoal in the photo.

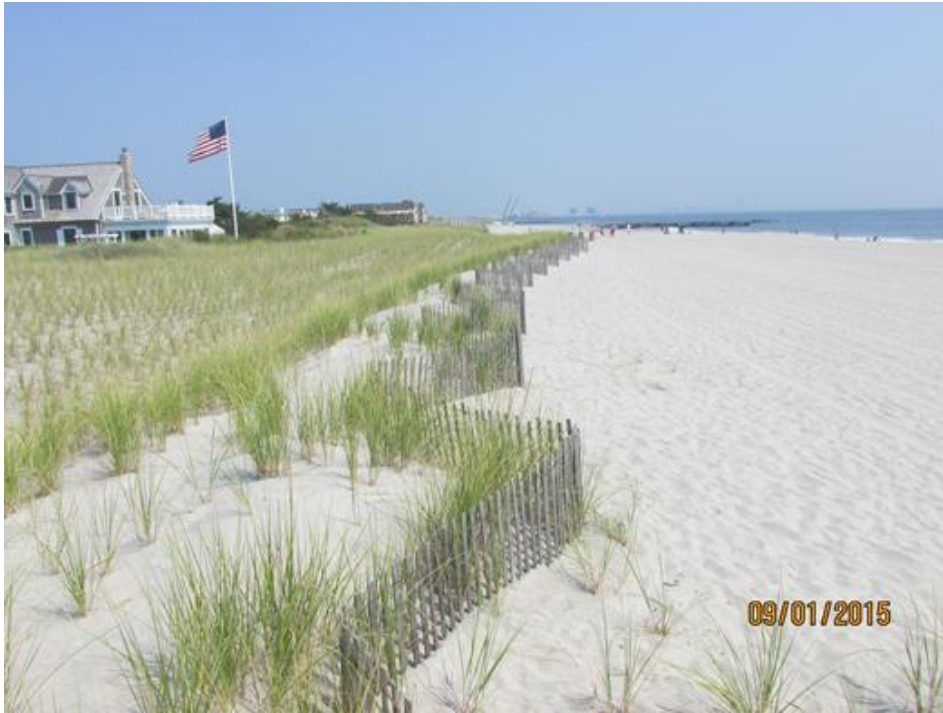
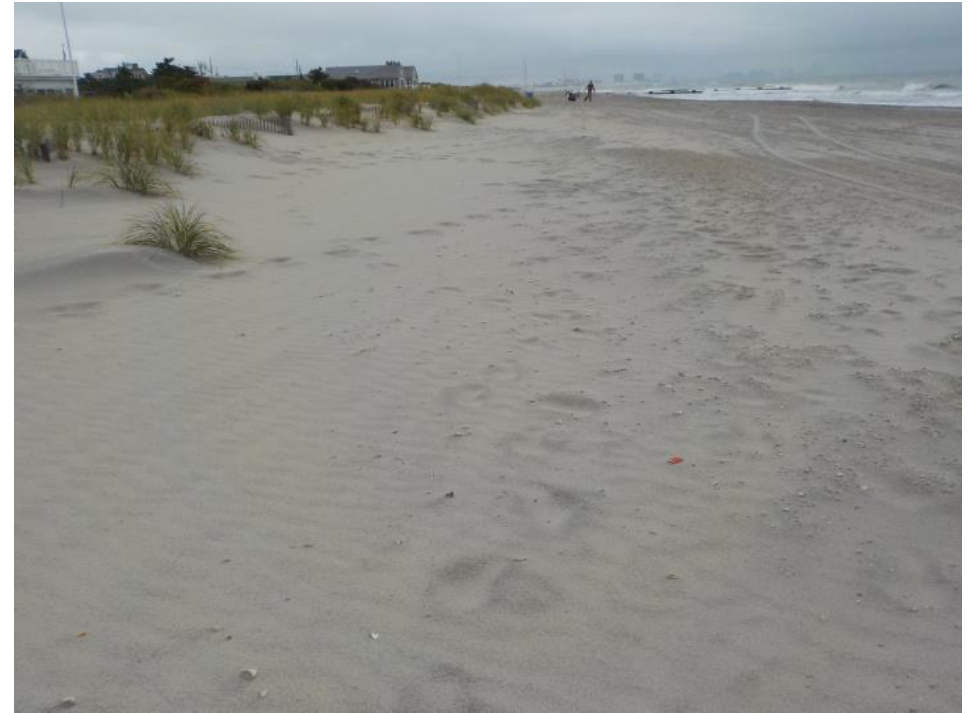
Figure 453a & 453b. The Gardens Road site is the northernmost profile in Ocean City and located in proximity Great Egg Inlet. (Left photo is from September 1, 2015. Right photo is from September 20, 2016). The dune and some of the berm that was created by the 2013 Federal emergency beach fill remained throughout 2015 and 2016. Seasonal berm elevation changes occurred, but the shoreline position was relatively constant. Over the 18-month study interval the site saw 25.21 yds³/ft in sand volume gains combined with a 28 ft shoreline advance.

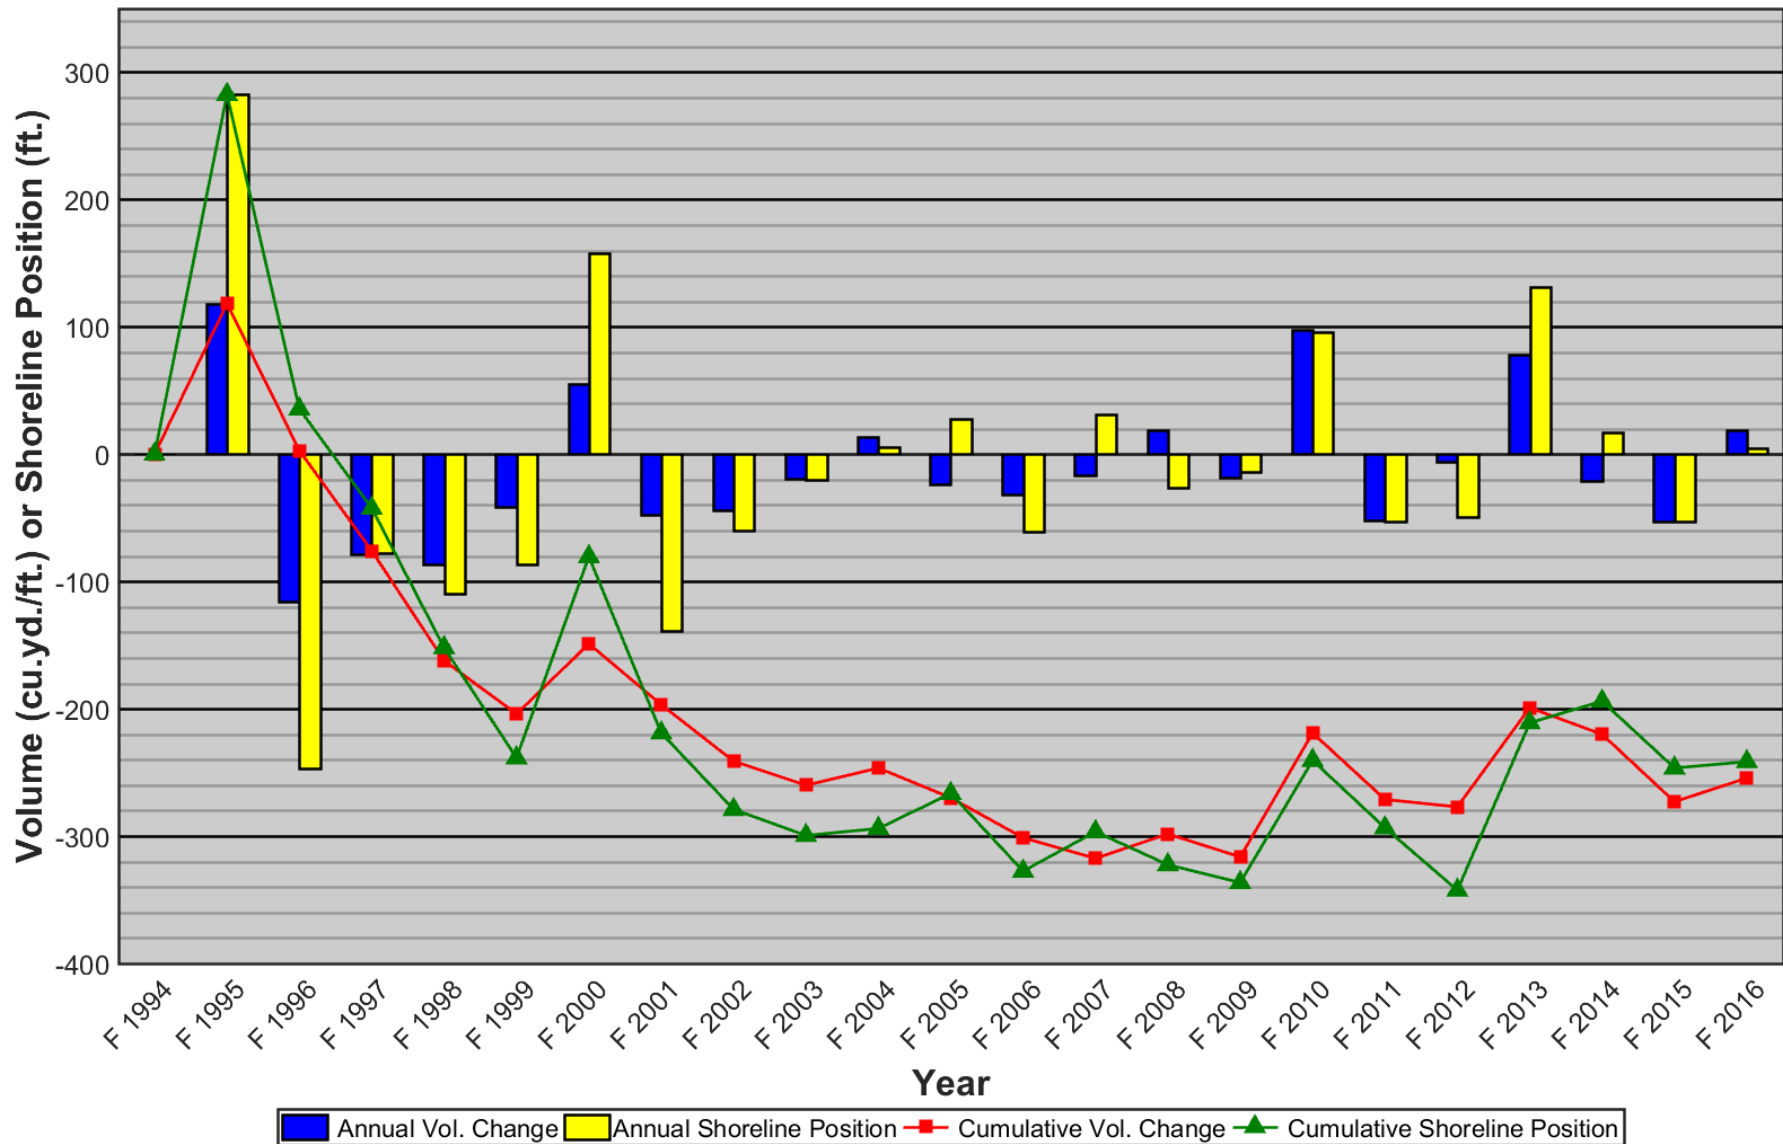
Figure 455. Established at Great Egg Inlet in Ocean City in 1994, the initial beach restoration effort in 1991 was missed, but the repair following the 1992 northeast storm followed in 1995 as a major enhancement. However, the long term trend was both a shoreline retreat of 240 ft and a sand volume loss of 250 yds³/ft. from the 1994 starting point. Minor additions of sand took place in 2000, 2010 and in 2013 following Hurricane Sandy.

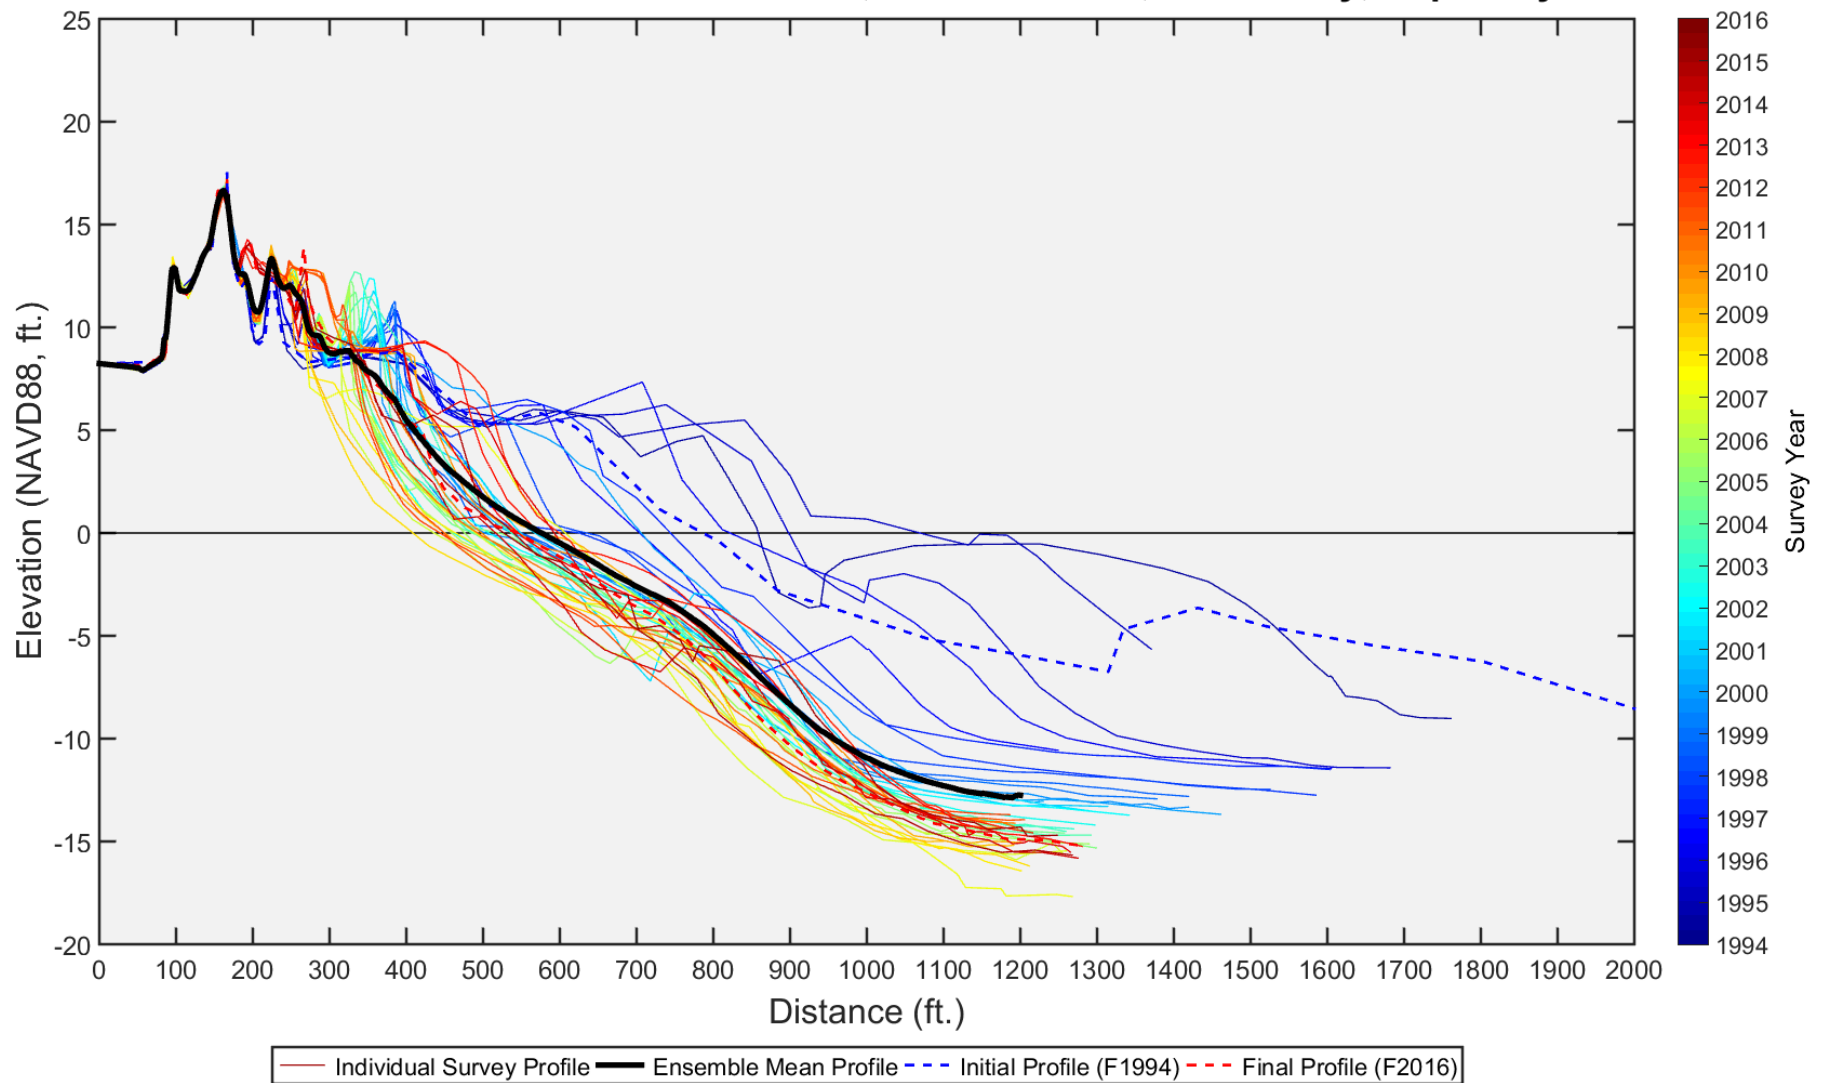
Figure 456. The progression of profiles over time for Gardens Road shows that the shoreline positions early in this series were well seaward of the current positions. The past 15 years have seen variation around the mean position with no extensive sand volume or shoreline advances since 1995. The original 1994 survey (blue dashed line) was significantly more robust than the most recent survey (red dashed line). The initial survey followed the first modern beach restoration by 2 years.

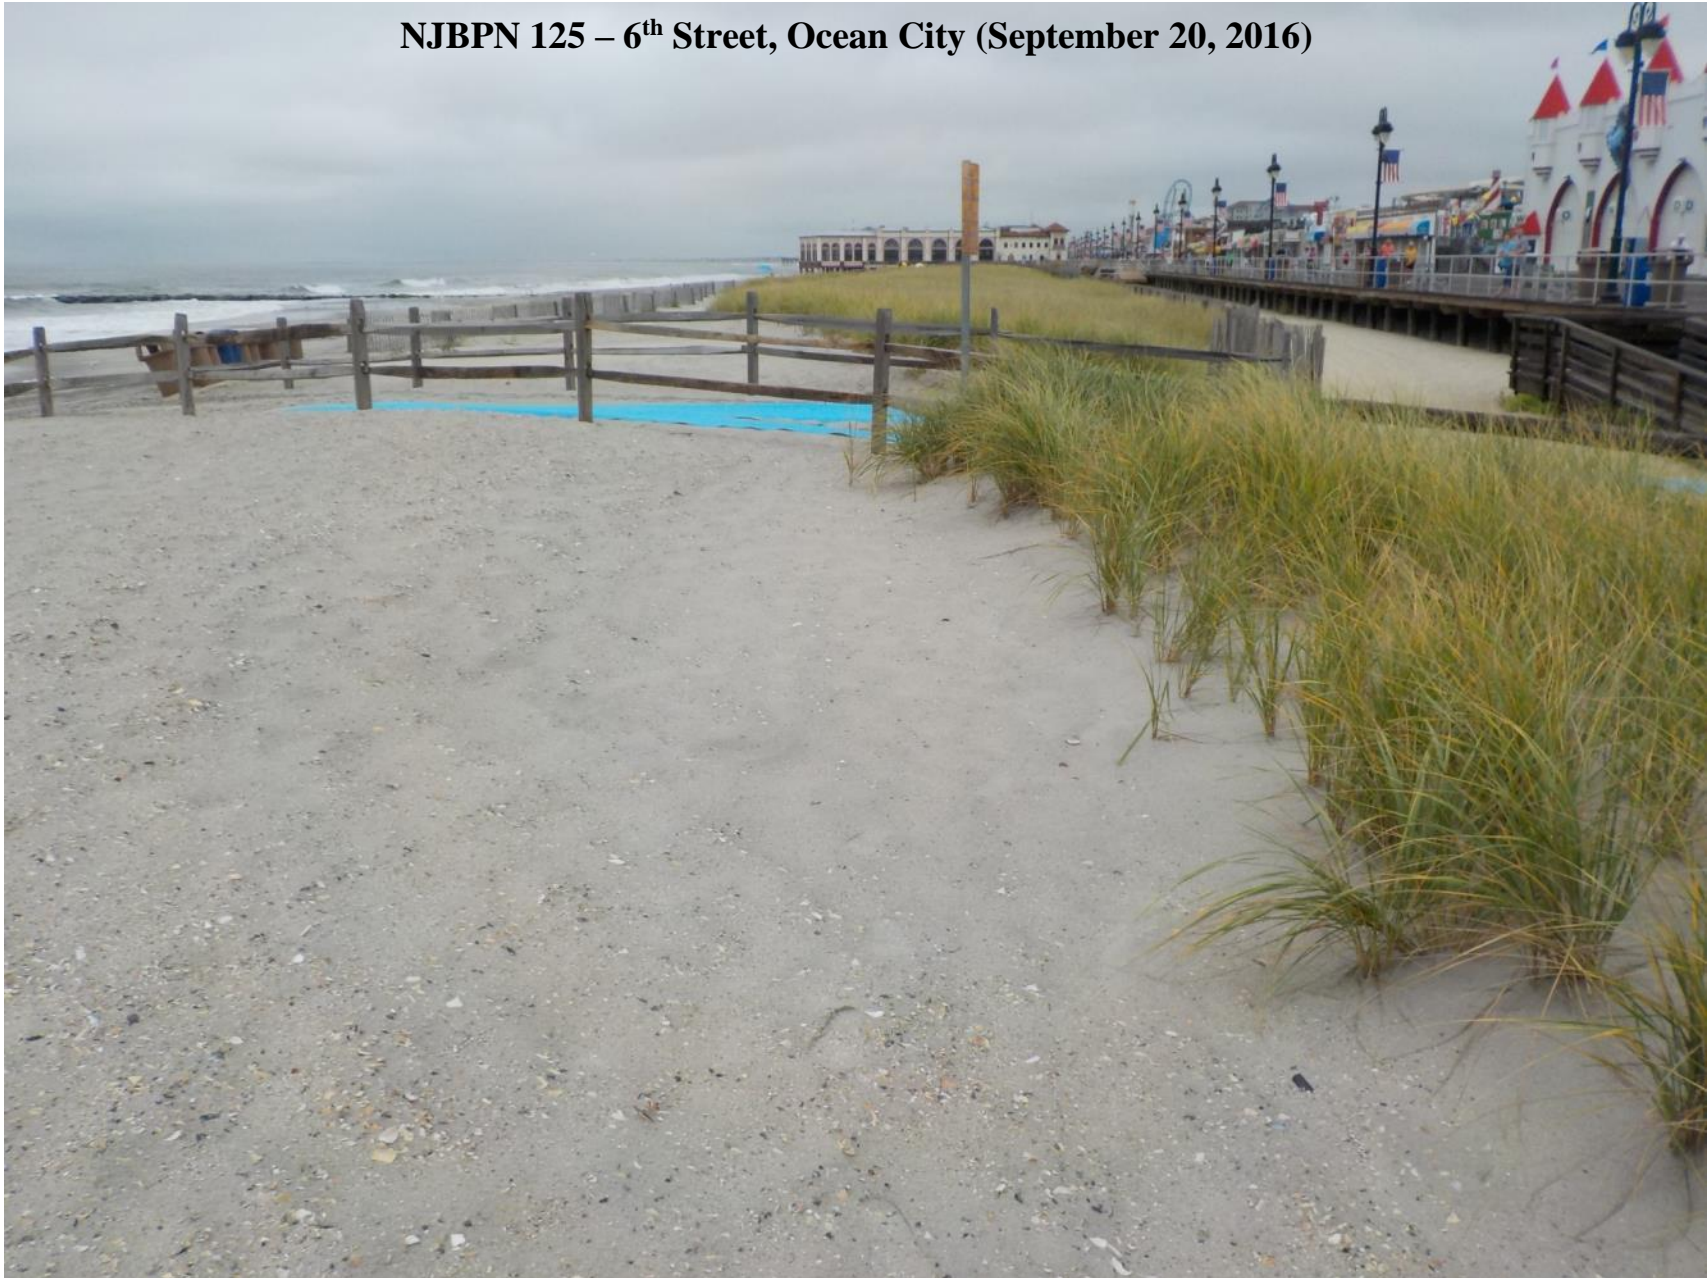
NJBPN 125 – 6th Street, Ocean City (September 20, 2016)

Figure 458. Sixth Avenue in Ocean City is subject to rapid rates of erosion. This view to the south shows the dune toe near the boardwalk and the existing berm at the beach. The pedestrian access path is at the end of 6th Ave.

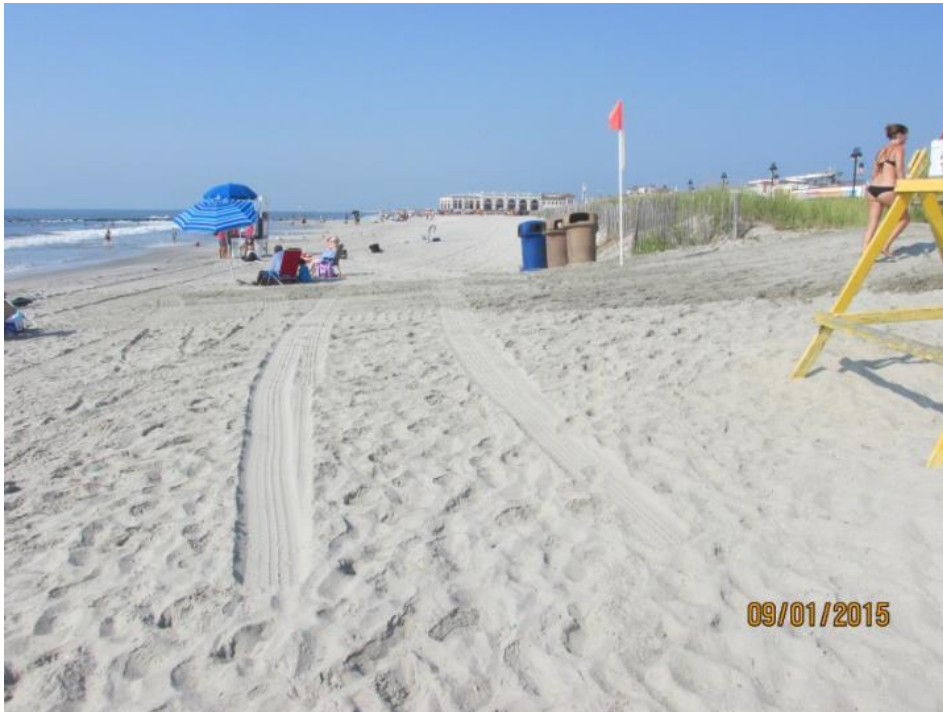
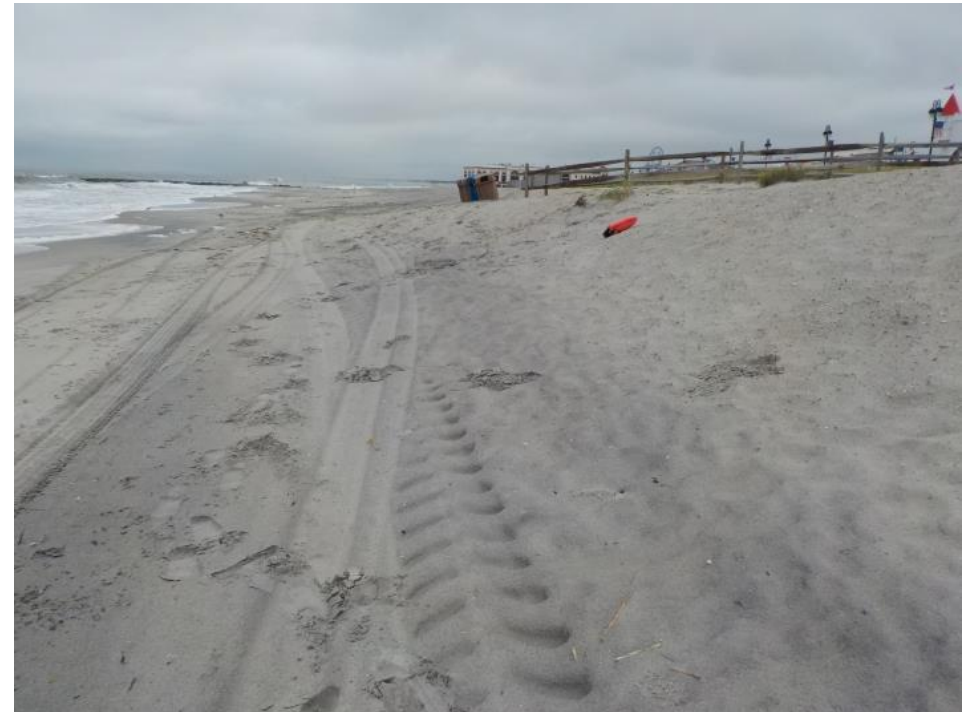
Figure 459a & 459b. The left photo (taken September 1, 2015) shows a modest berm still present from the USAACE (2013) beach fill. The right photo (taken September 20, 2016) shows approximately the same berm width with slightly more sand at the fencing.

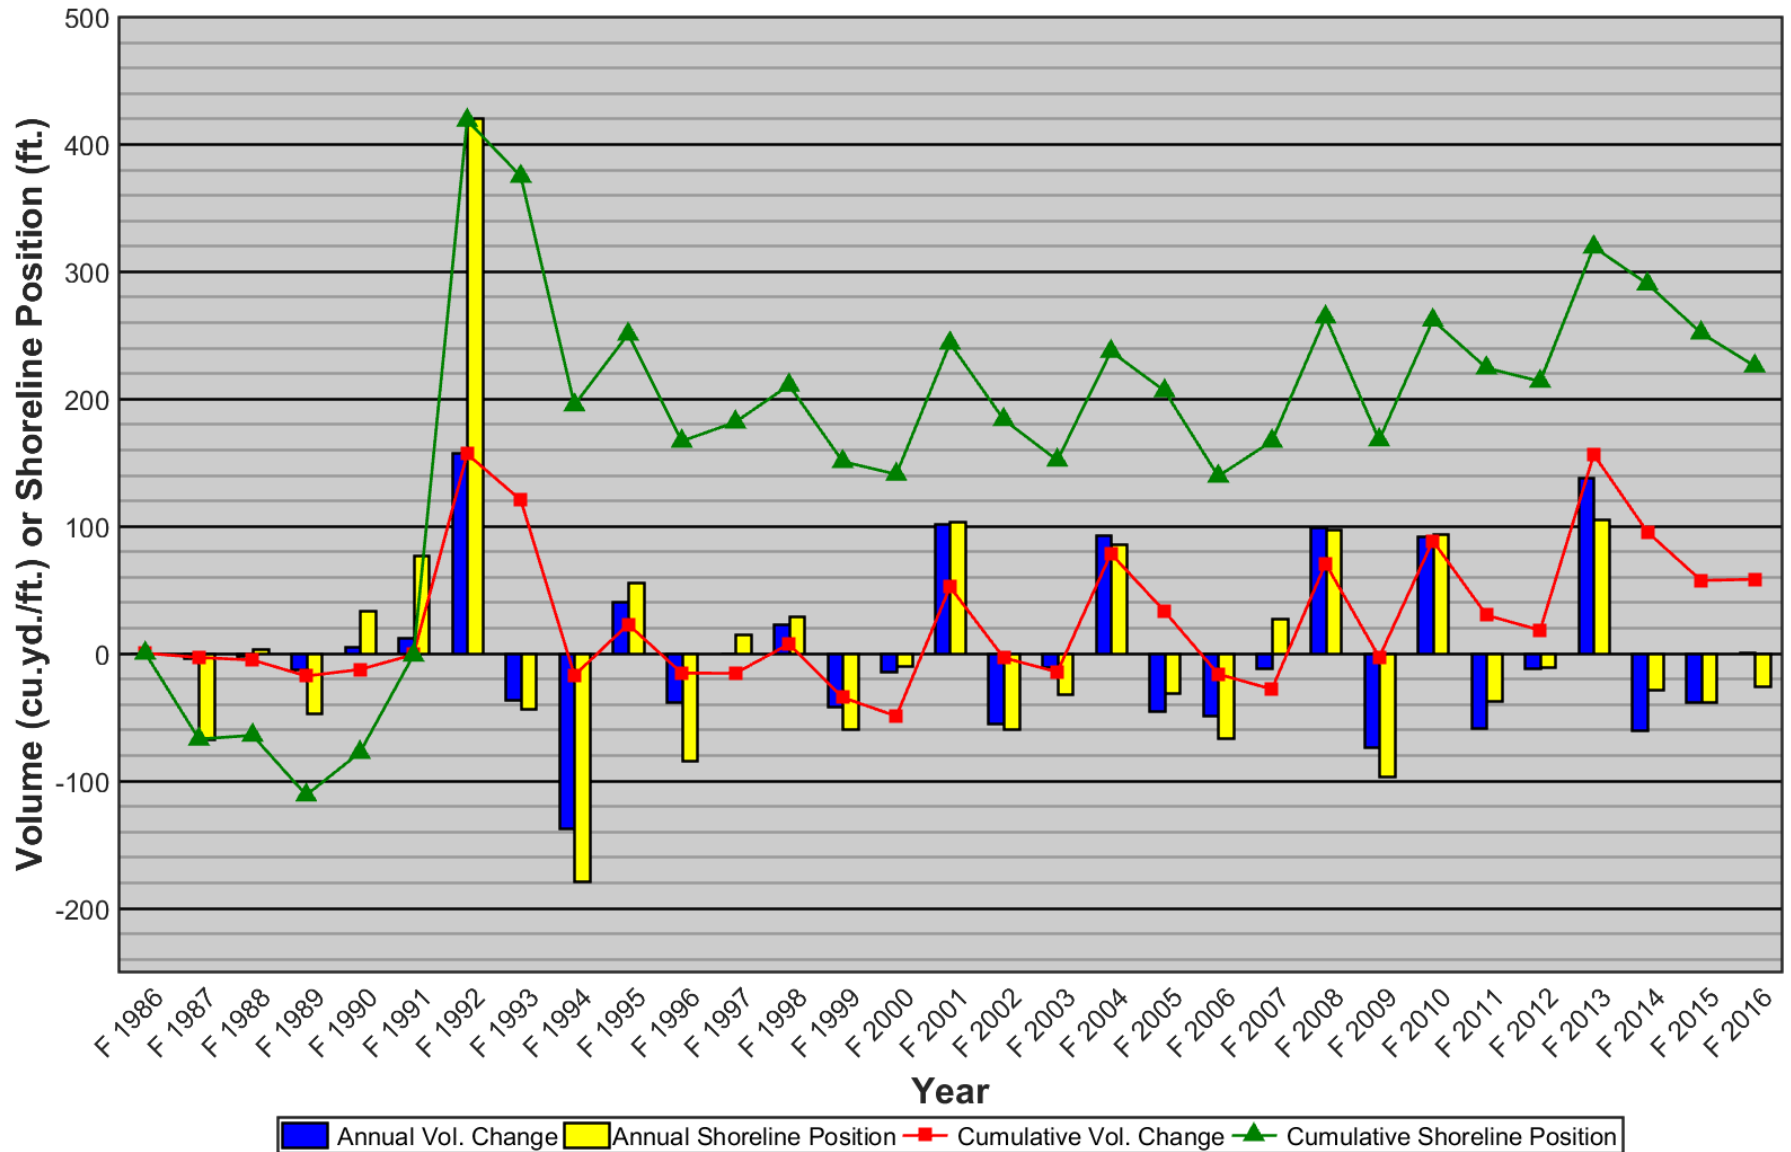
Figure 461. Ocean City saw its first episode of the recent beach nourishment actions in 1992, just prior to a major northeast storm. Multiple maintenance efforts have kept this site above the conditions present between 1986 and 1991 with a more impressive shoreline advance than sand volume gain. Initial beach nourishment efforts occurred in 1952 as 2.54 million cubic yards of sand were pumped onto the municipal beaches. During the 1960's and 1970's, the City owned a dredge that pumped dredged material from the bayside lagoons across the island to the beaches every winter until either the dredge wore out or the operator retired. The shoreline ended the 30-year time period 223 ft seaward of the 1986 position with 60 yds³/ft. in added sand volume.

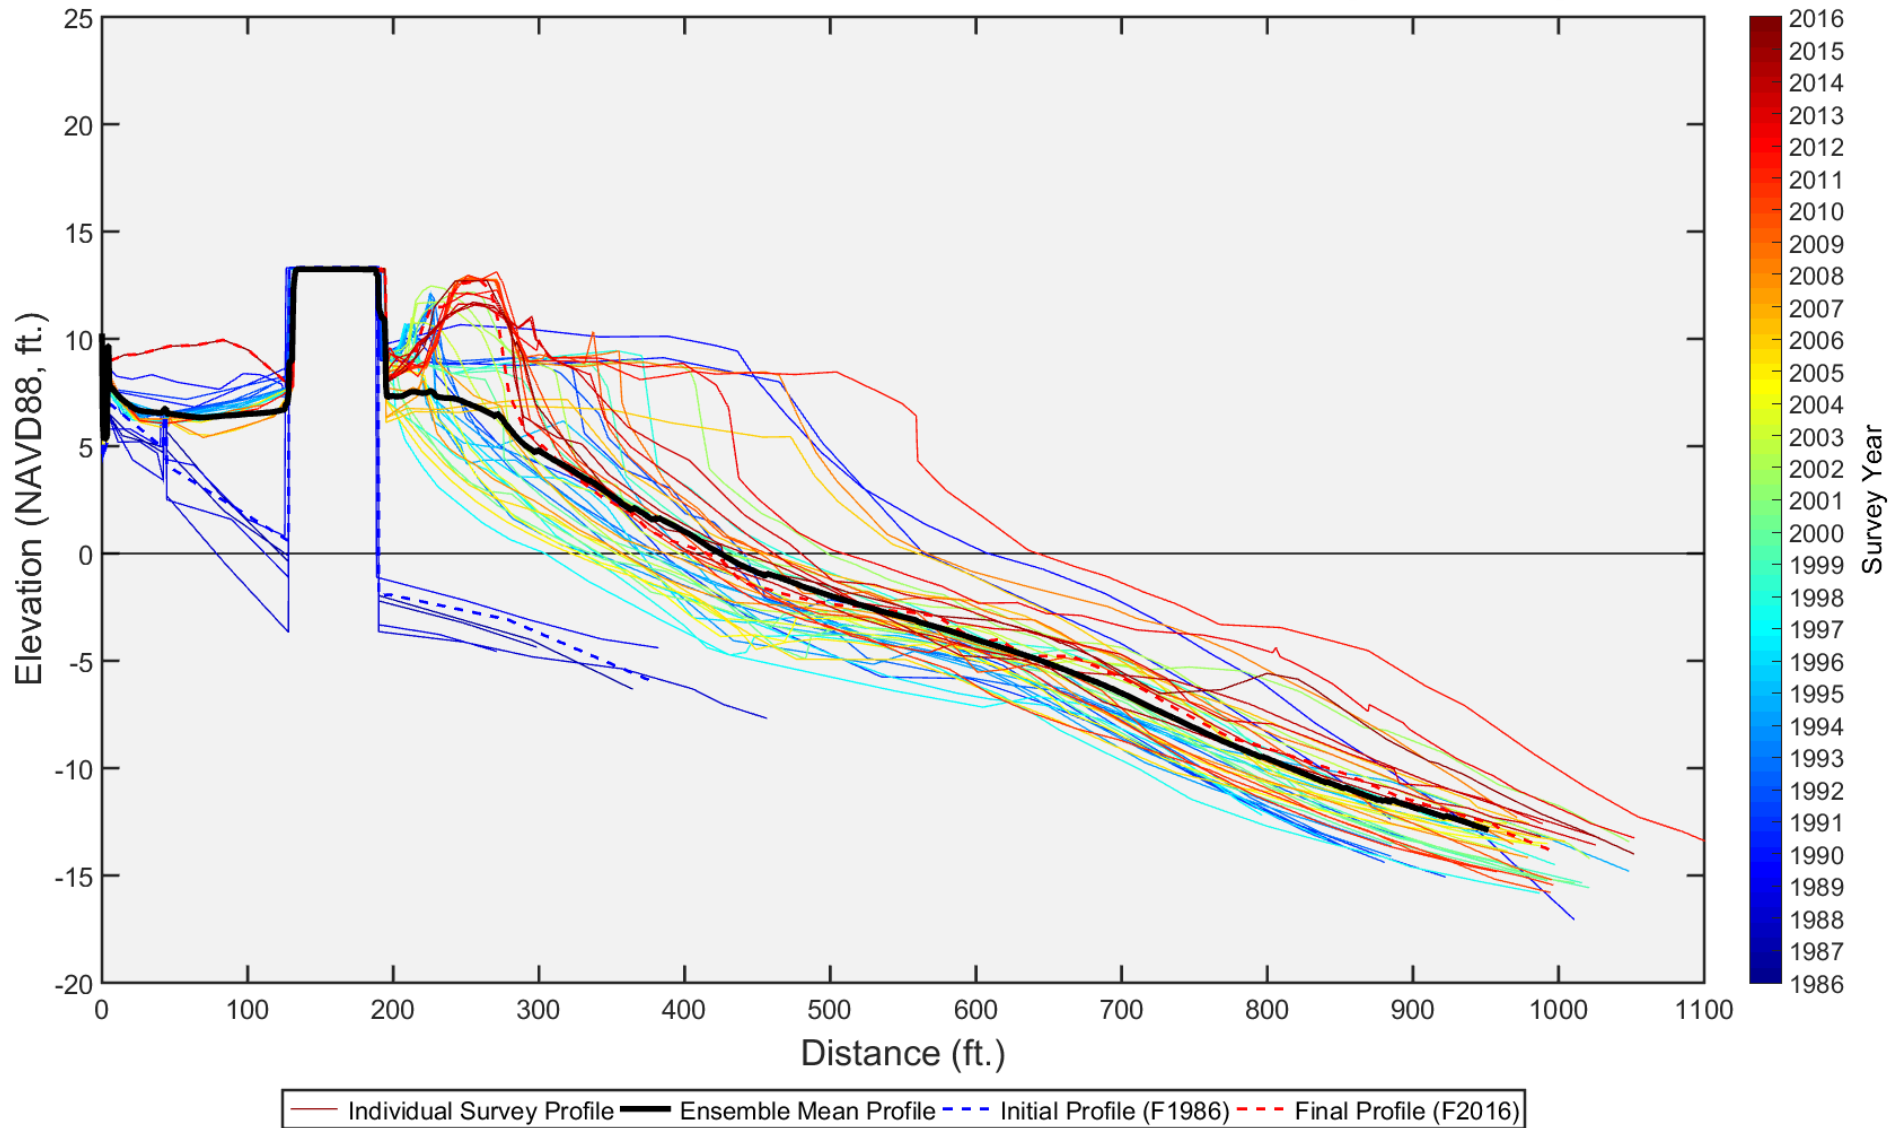
Figure 462. The earliest surveys showed low tide reached under the boardwalk to a street end revetment with clear urgency for additional shore protection. The initial fill was a pronounced addition compared to the early surveys, but shoreline retreat pushed the beach back to the boardwalk several times before maintenance occurred. Recent work has kept the dune in place with a reasonable beach width seaward protecting the boardwalk, properties and infrastructure, once exposed to direct wave attack.

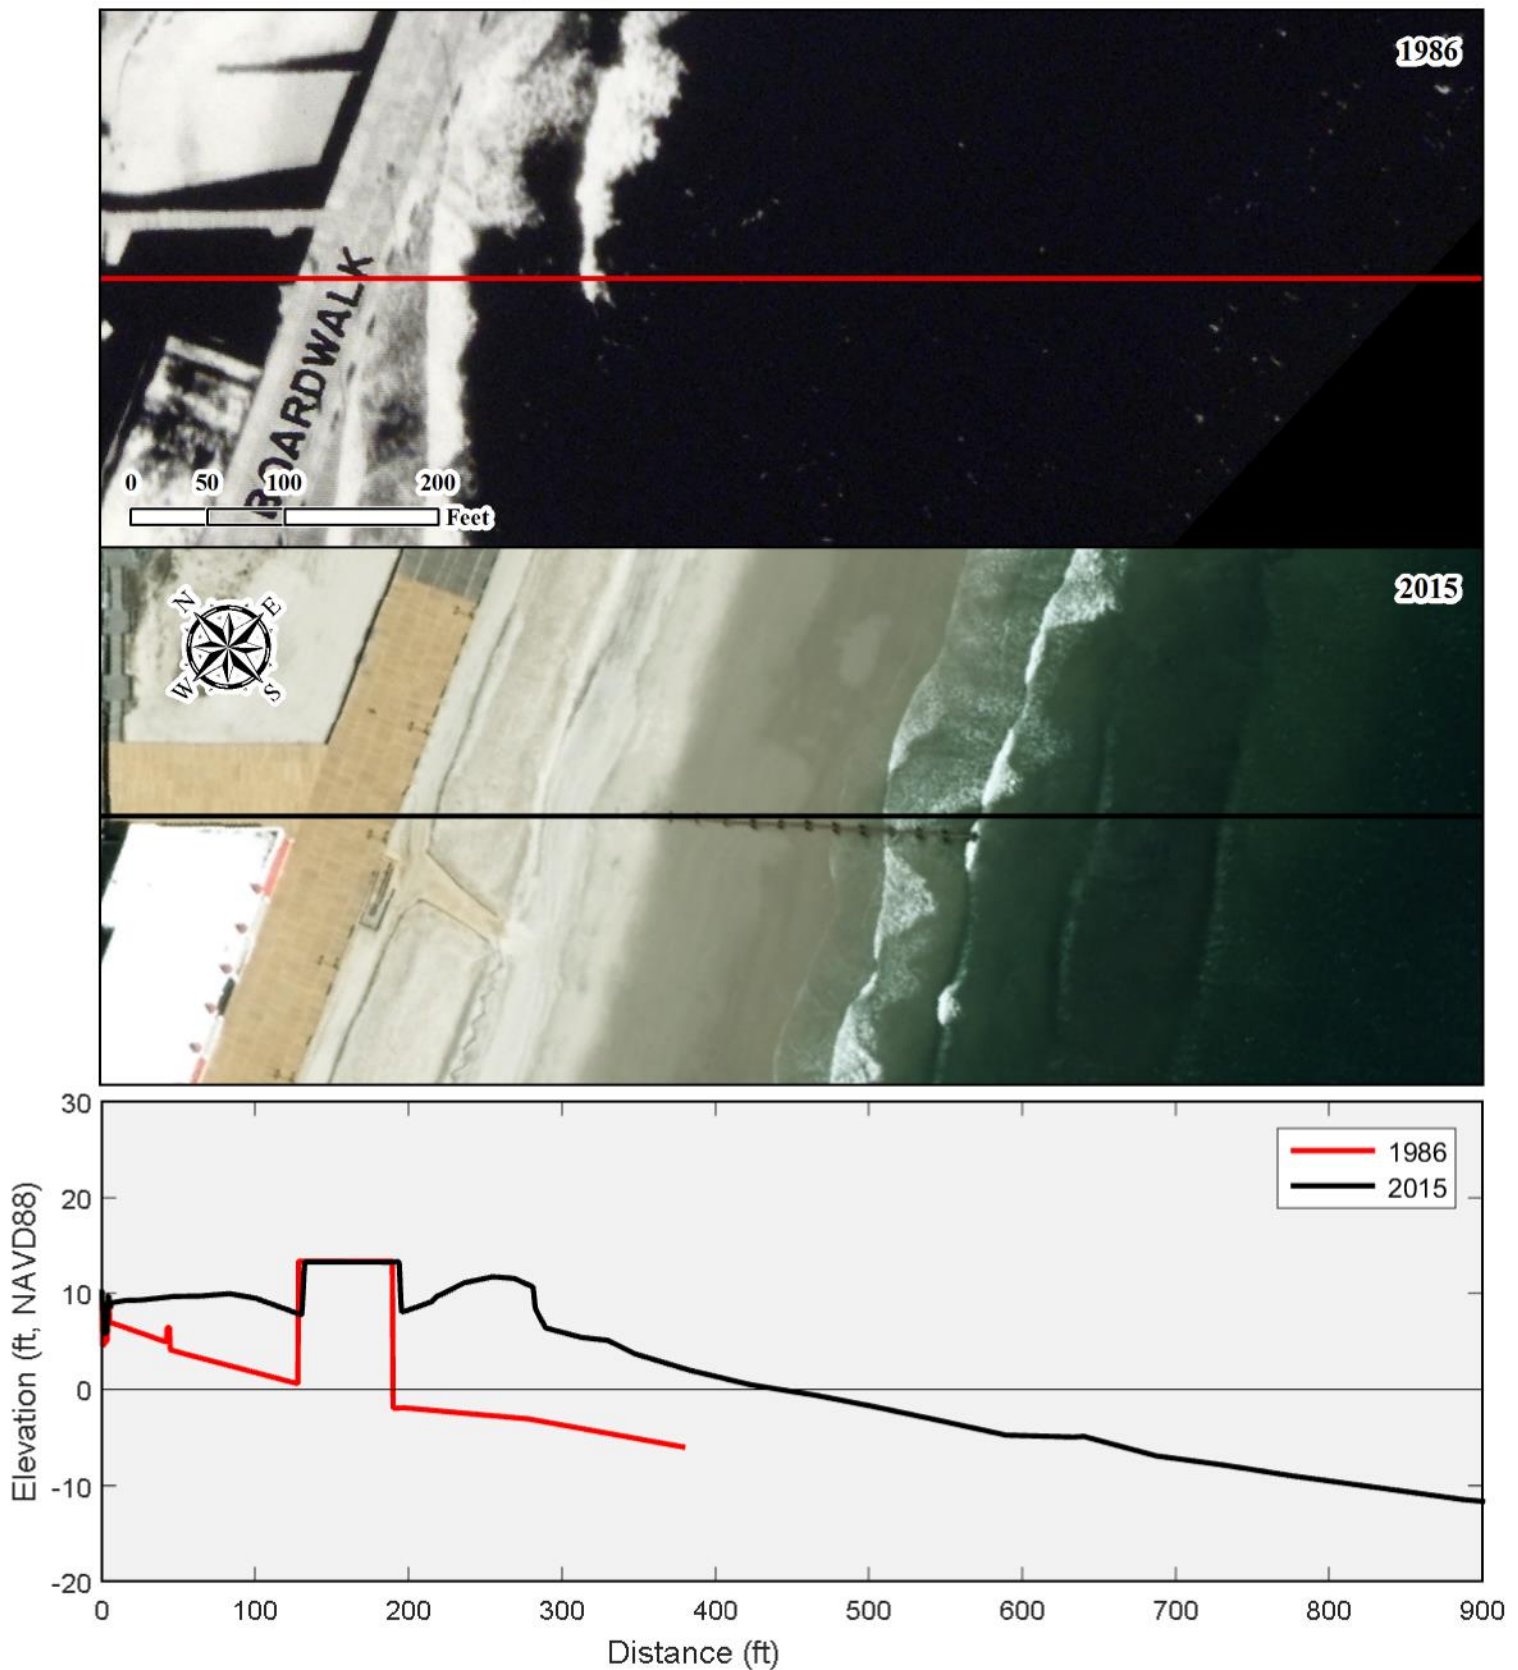
Figure 463. The 1986 air photograph shows that high tide was at or under the boardwalk. The starting point for this survey was adjacent to the landward bulkhead protecting the street pavement end. This region in Ocean City has been volatile in terms of erosion, forcing repetitive maintenance to keep a dune and beach in place.

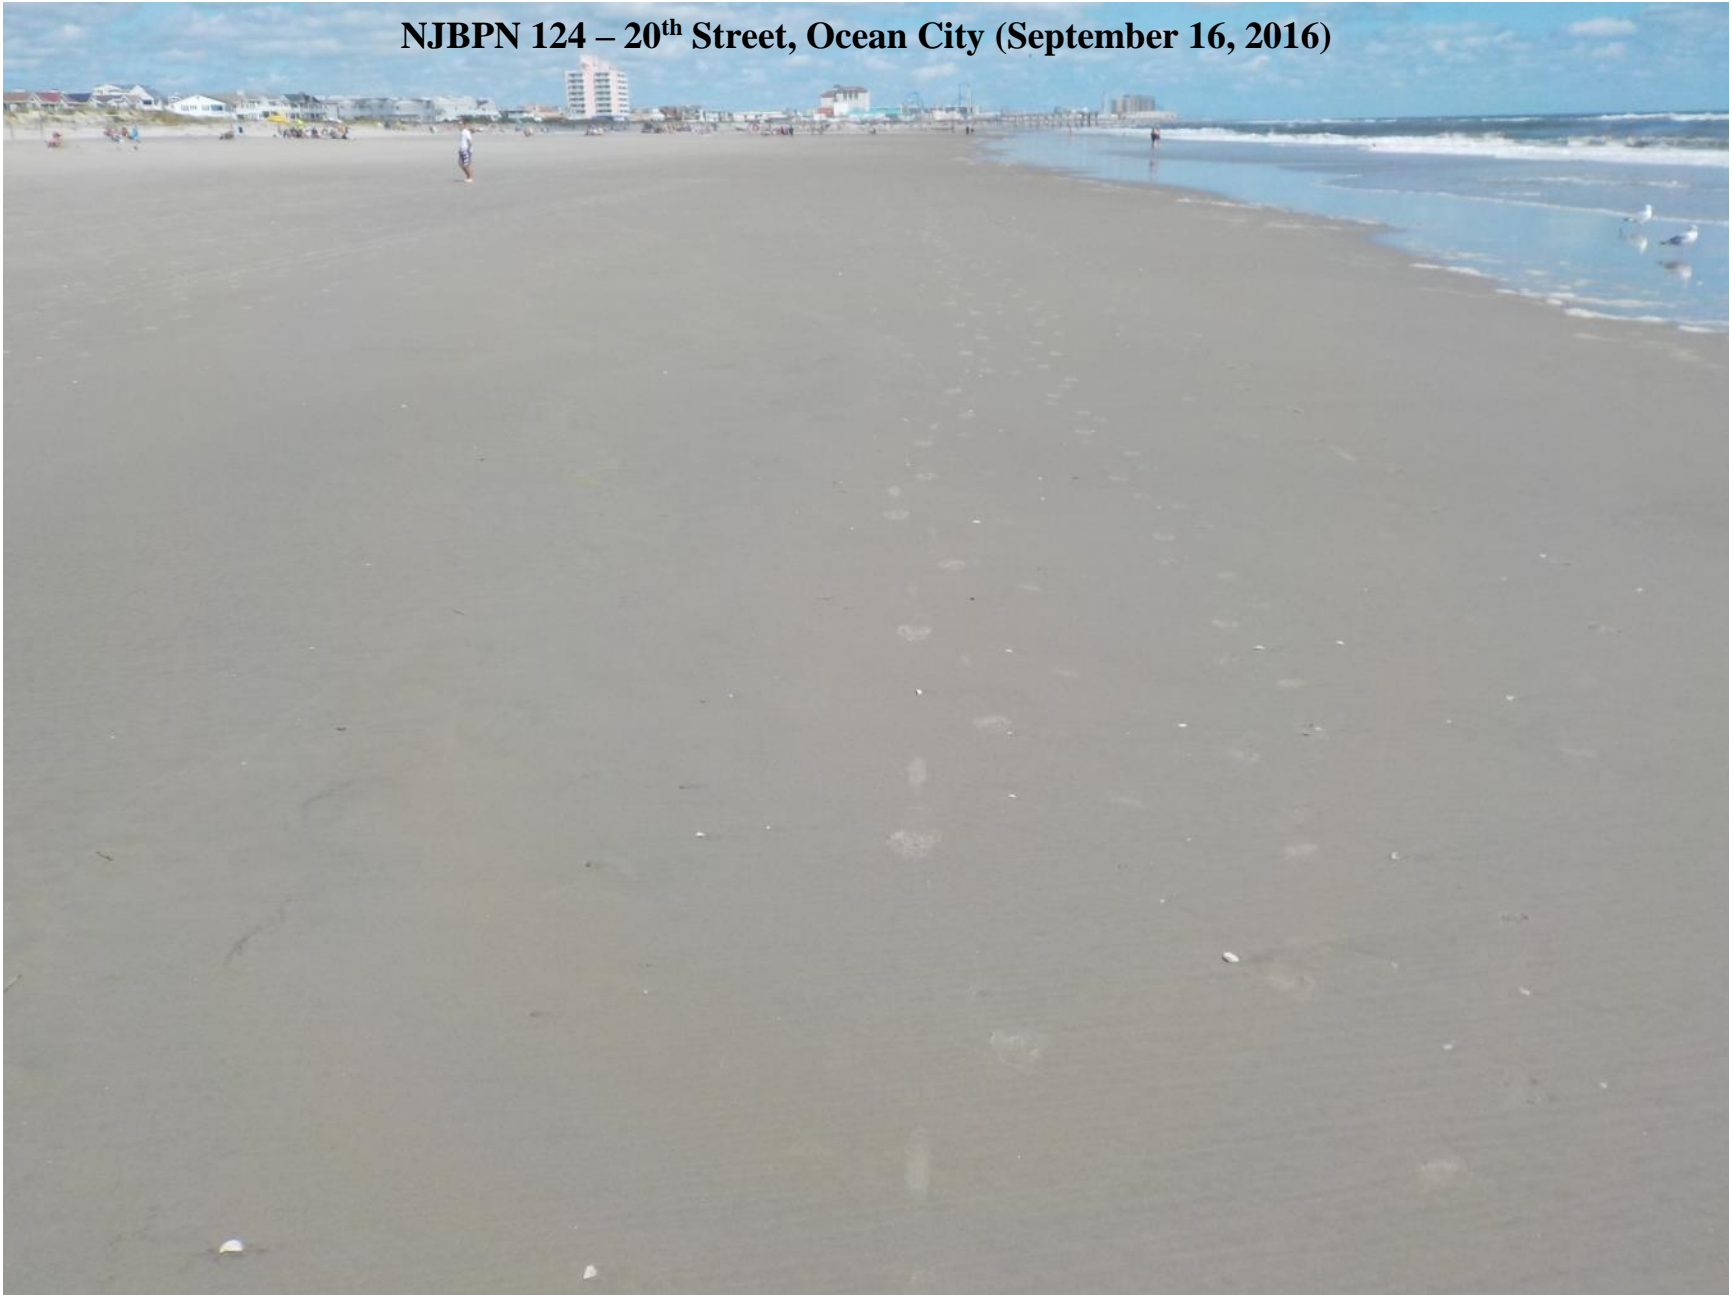
Figure 464. This northerly view at the water's edge is in contrast with the two pictures below taken at the dunes that have developed on the 1991 beach restoration and augmented by repetitive fill work to the north. No added sand was directly placed here since 1991, it all arrived naturally over the time interval.

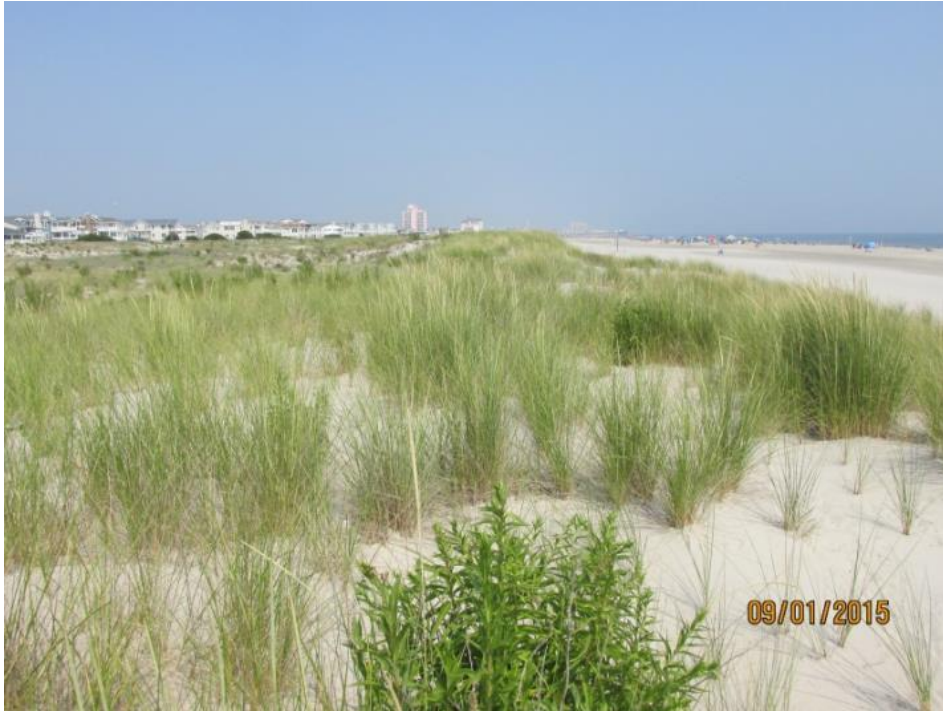
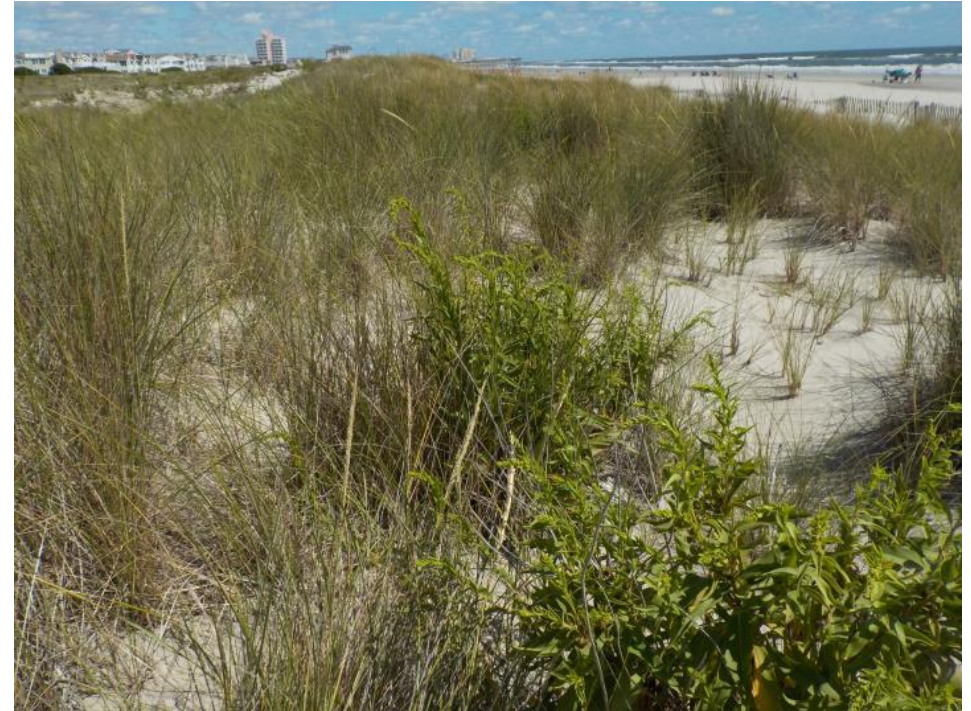
Figure 465a & 465b. The 20th Street profile is located near the center of the island and hosts an extensive dune and wide berm. The area has been accretional since the initial beach restoration in 1992. Photo on the left was taken September 1, 2015. Right photo was taken September 16, 2016. The dune continued to move slightly seaward and there were volumetric gains over the course of 2016.
