An Analysis of Thirty Years' Study of Sand Redistribution and Shoreline Changes in New Jersey's Four Coastal Counties Raritan Bay, the Atlantic Ocean Coast, and Delaware Bay Fall 1986 Through Fall 2016

VOLUME 4 of 4 CAPE MAY COUNTY & APPENDIX

Prepared for:
New Jersey Department of Environmental Protection
Division of Construction and Engineering
1510 Hooper Avenue, Toms River, New Jersey 08753

Prepared by:
The Stockton University Coastal Research Center
30 Wilson Avenue, Port Republic, NJ 08241

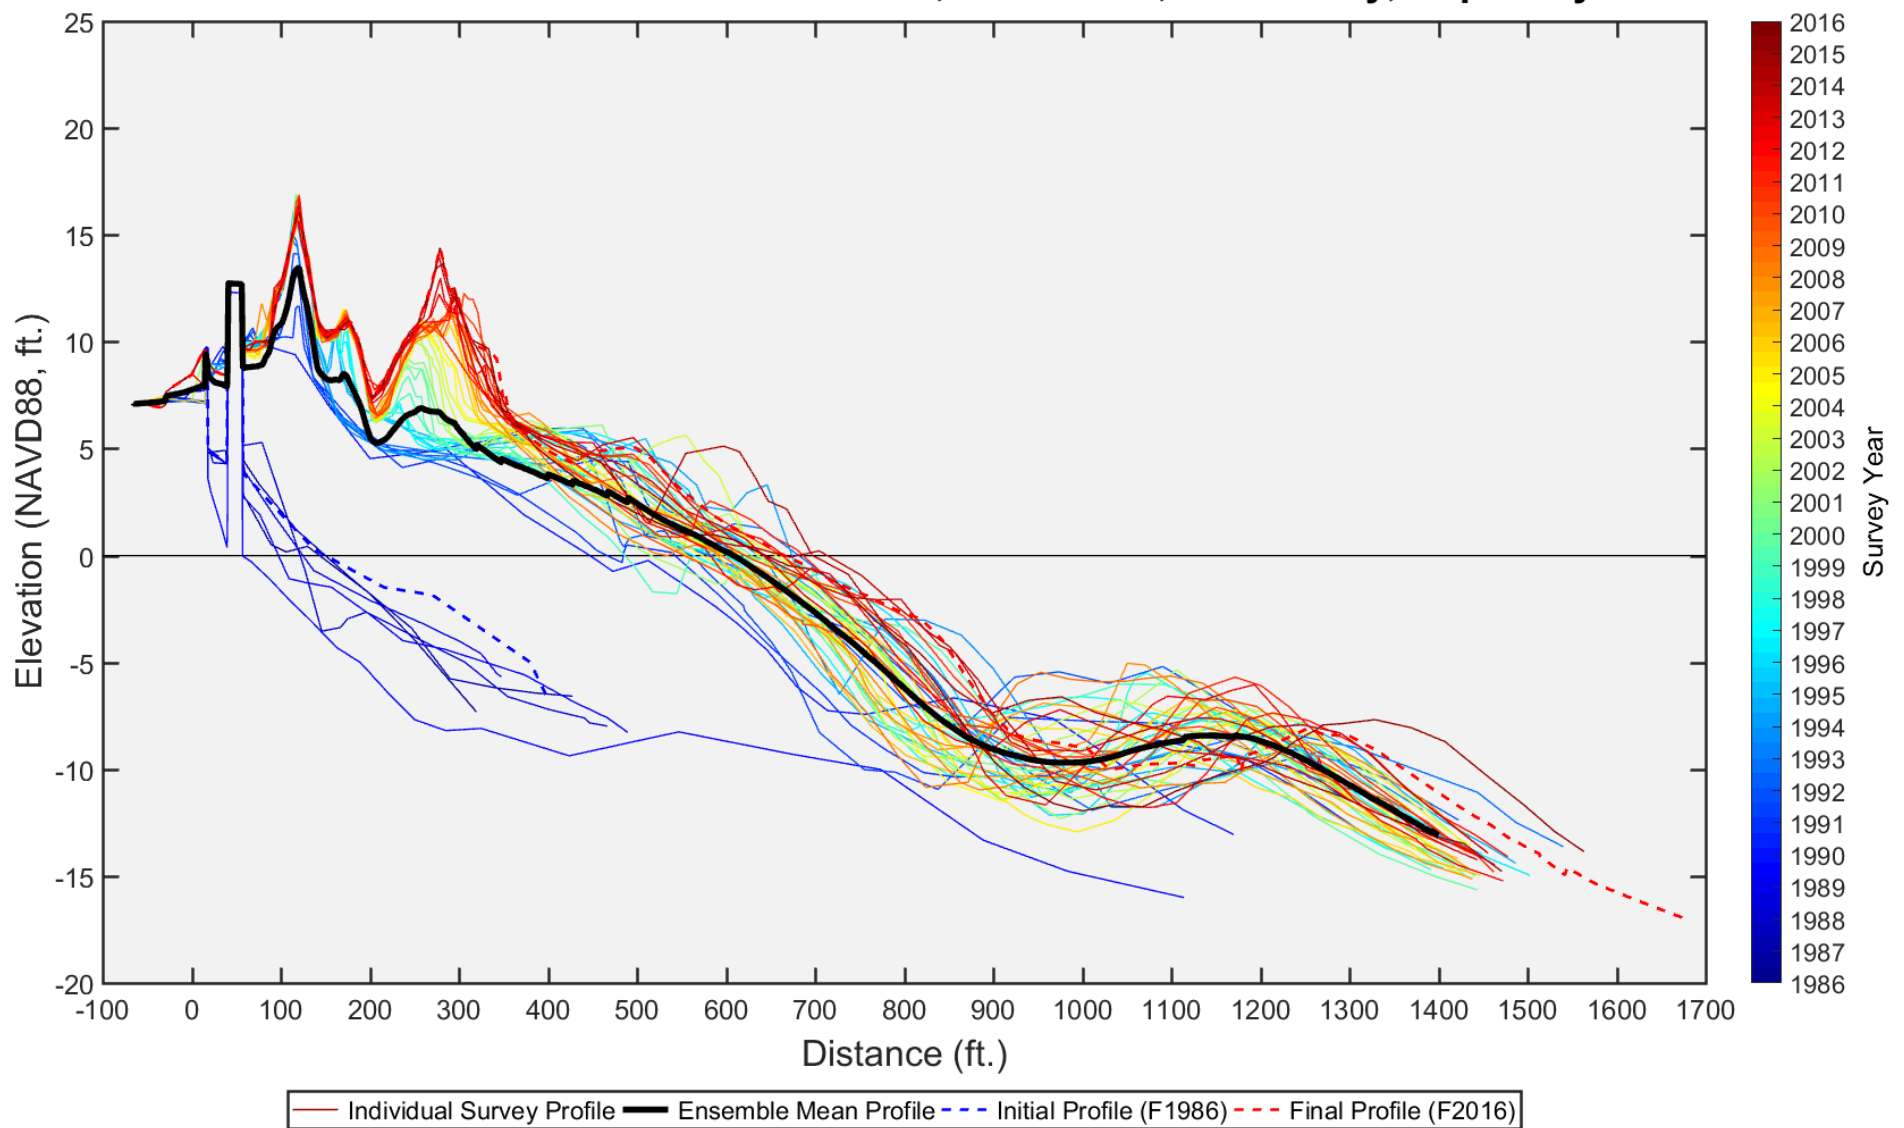
Figure 468. The contrast between the pre-1992 project and all surveys afterwards is remarkable and demonstrates a dramatic effect from the sand placement. The general trend in the post-project envelope has been one where the dunes have grown massively large and the beach generally moved seaward in cycles of change. Given that this site saw zero maintenance since the original fill placement, the effect is all the more impressive. Hurricane Sandy was of little impact, but if Sandy had occurred in October 1991, the boardwalk and property damage would have been catastrophic. Evidence for this was seen in the \$4 million in boardwalk damage between 19th and 12th Streets suffered during the “Perfect Storm” of Halloween 1991. The December 1992 NE Storm eroded the beach but without any damage to the boardwalk or homes along this oceanfront section between the Gardens and 34th Street.

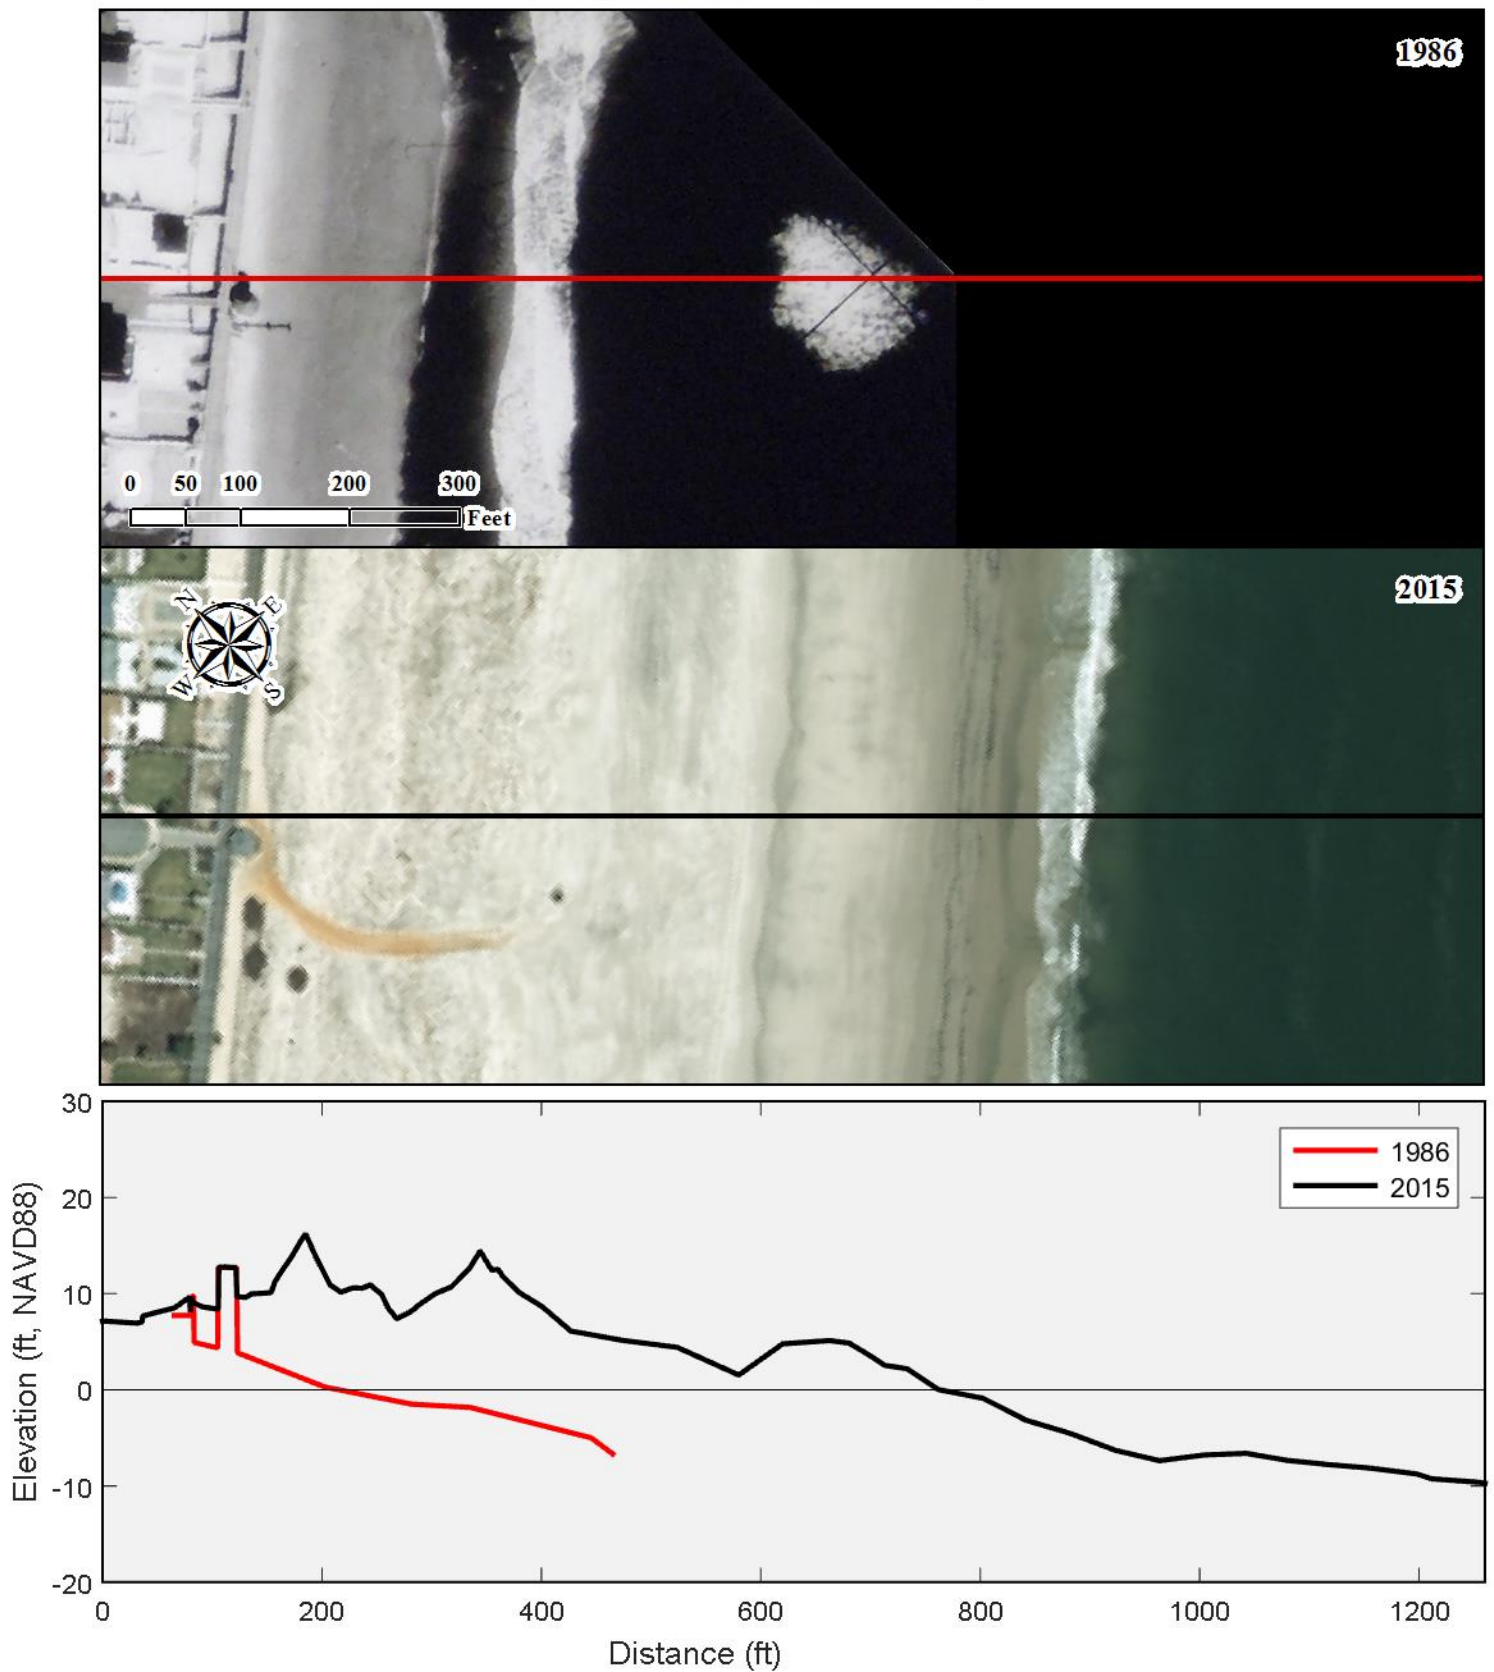
Figure 469. By 1986, high tide was at the timber bulkhead at 20th Street and early in the NJBPN surveying prior to the 1992 beach fill, low tide was under the boardwalk. At this location the sand volume was never subject to chronic erosion, instead conditions were a result of diminished material within the local sand budget. Conditions were enhanced over the next 25 years by adding material to the local budget moved south by littoral processes derived from the 6th to 12th Street project area.

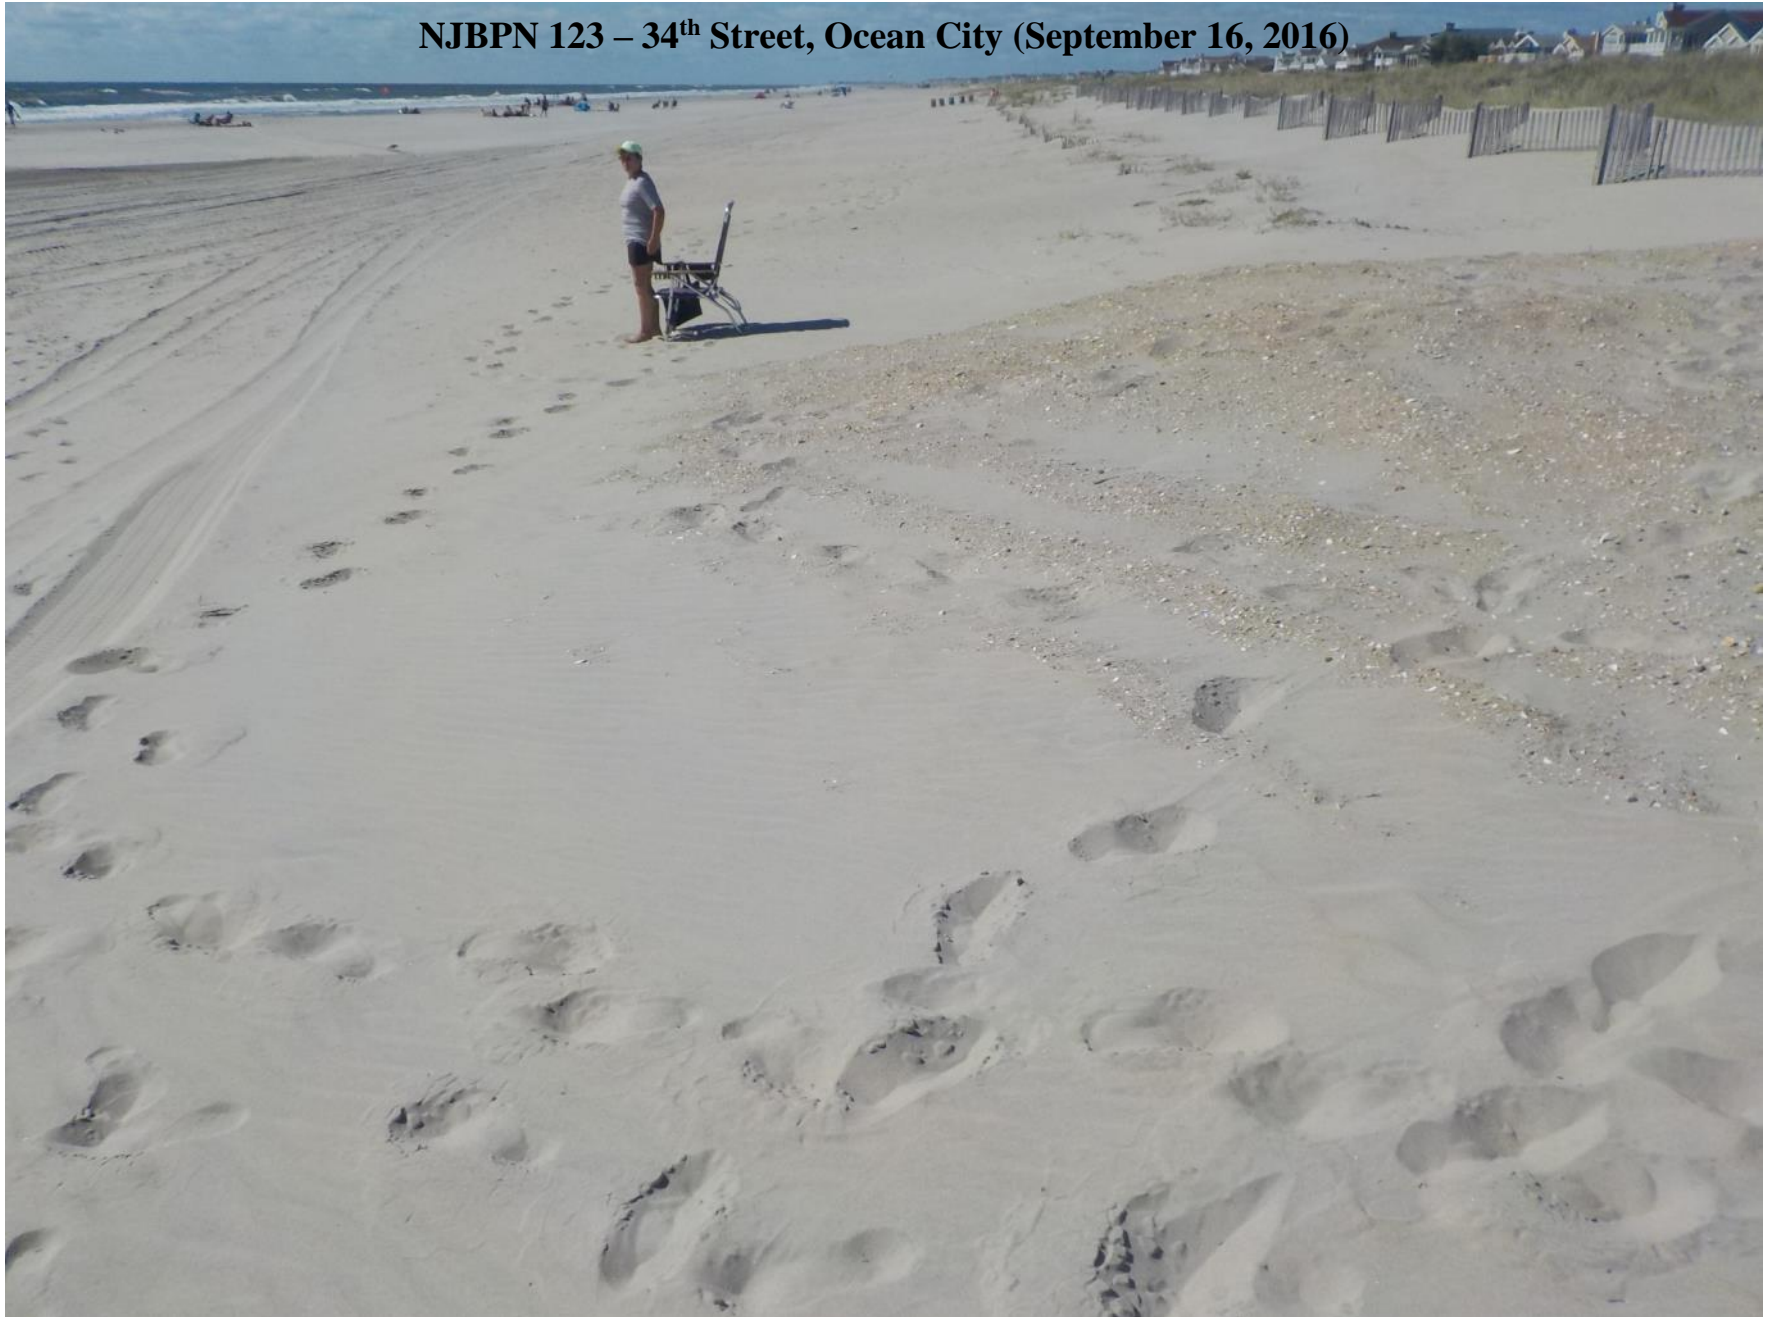
Figure 470. View to the south along the beach at 34th Street in Ocean City. The 2015 fill commenced several blocks to the south and continued to 59th Street.

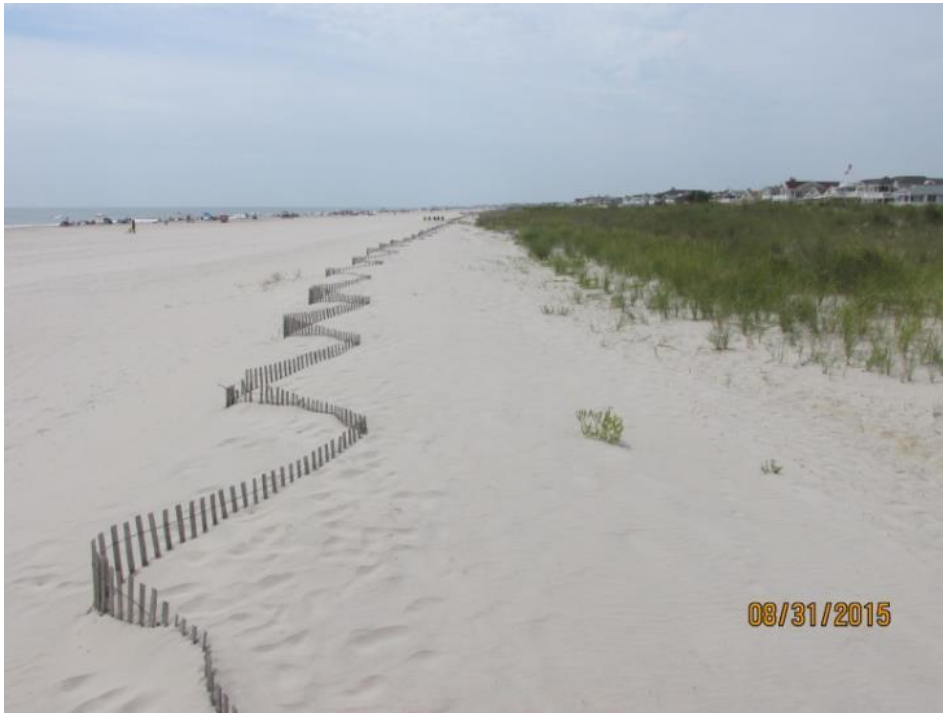
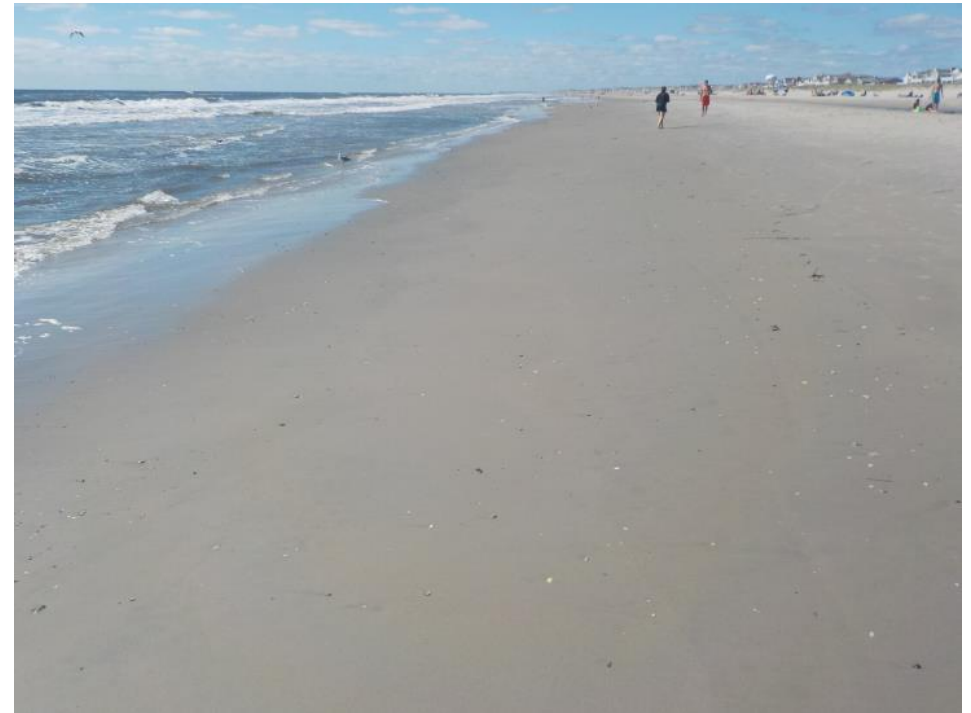
Figure 471a & 471b. The comparison photos show a view to the south (left taken August 31, 2015 and right photo taken September 16, 2016) and the extent of the beach at 34th Street. The dune fencing has become almost buried from Aeolian transport and a large bar can be seen offshore in the photograph to the right.

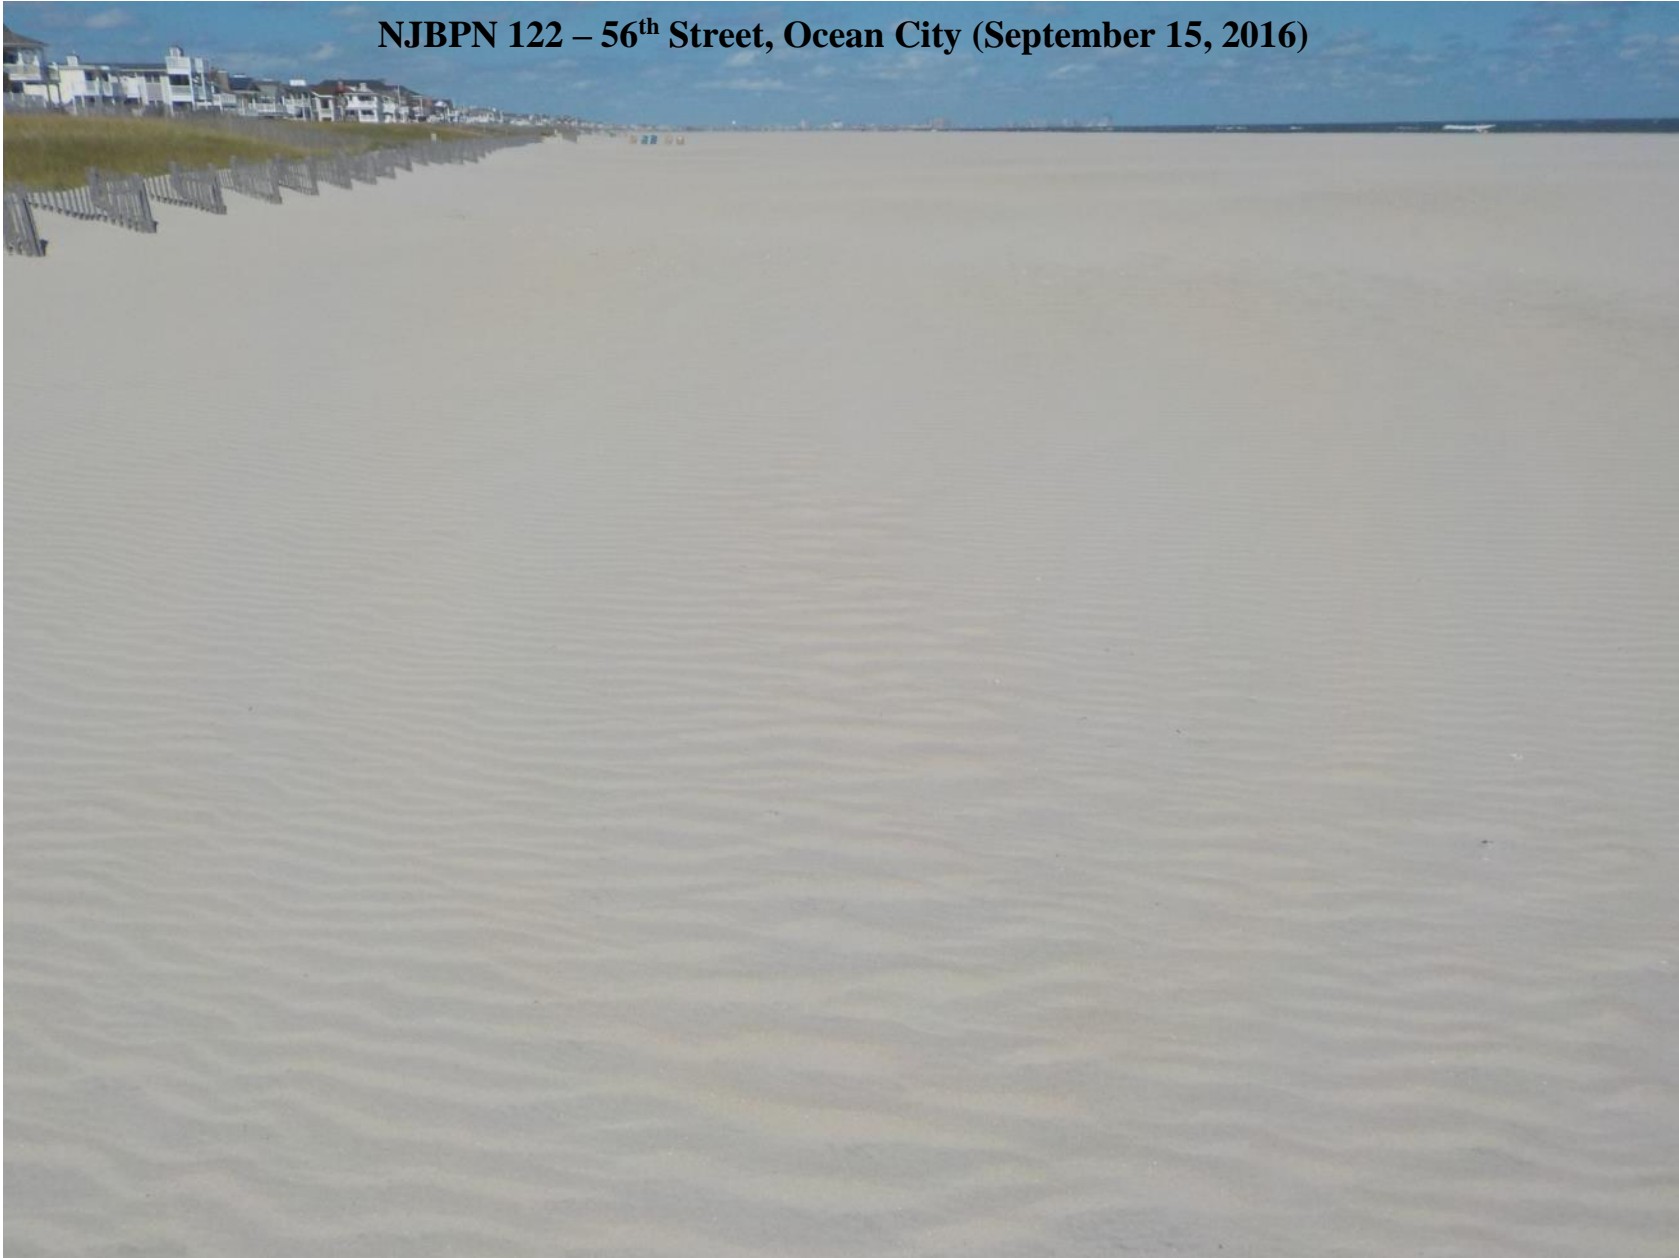
NJBPN 122 – 56th Street, Ocean City (September 15, 2016)

Figure 476. A view of the new federal beachfill looking north, with the dune grass in place and thriving. The width of dry beach is outstanding.

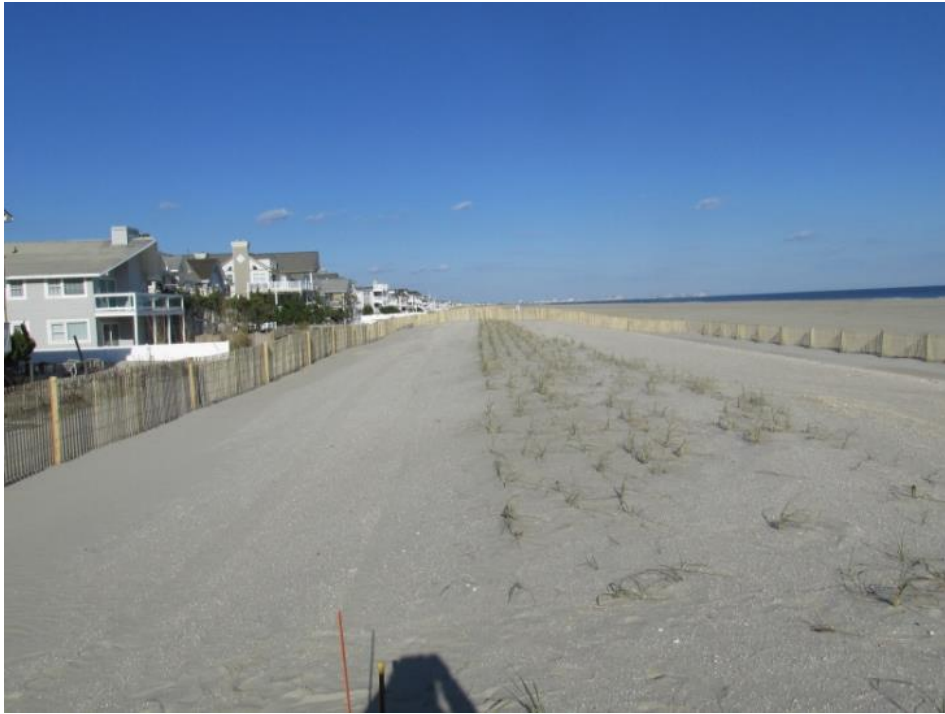
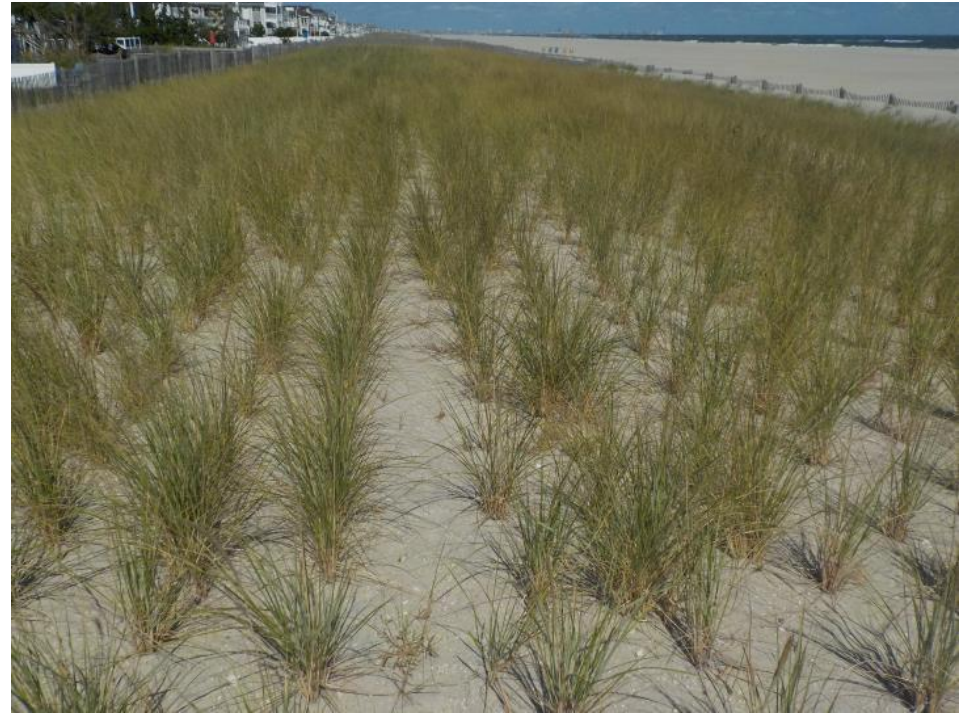
Figure 477a & 477b. In 2015, the 56th Street site received its first sand replenishment since the 1995 state beach fill. The site is now included in the federally authorized project. The November 24, 2015 (left) photo shows the immediate post-project dune and berm. On the right (photo taken September 15, 2016) after a year of growth the grass appears healthy and vigorous. The wider beaches provide sand and space for continued natural dune development.

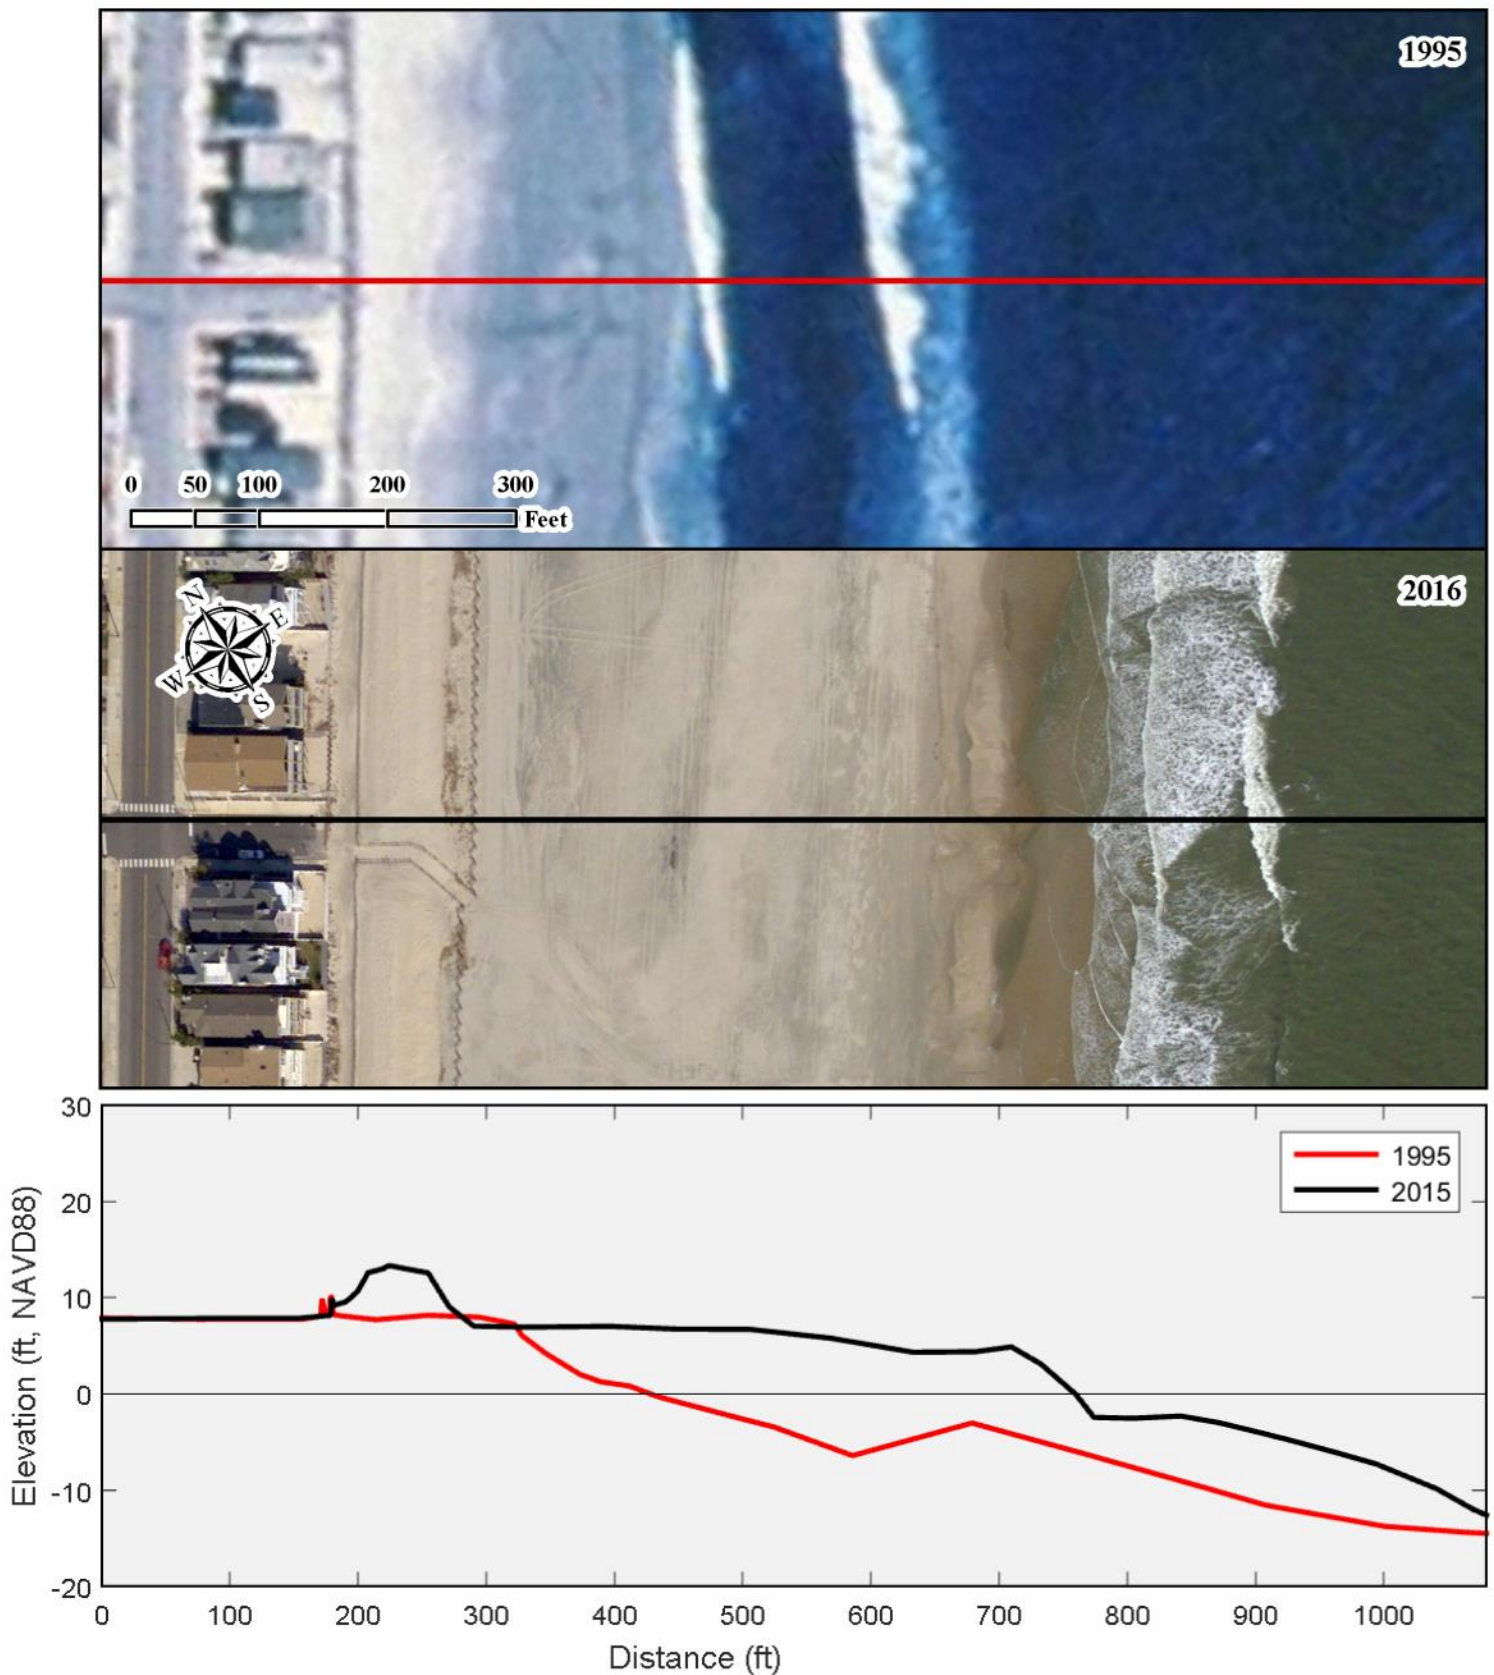
Figure 481. The USACE very recent work here has made a significant difference in beach width and dune development. Hurricane Sandy breached this section due to a lack of either sufficient beach width or dune system formation to provide ample shore protection. The USACE project beach will support further dune development and enhanced shore protection.

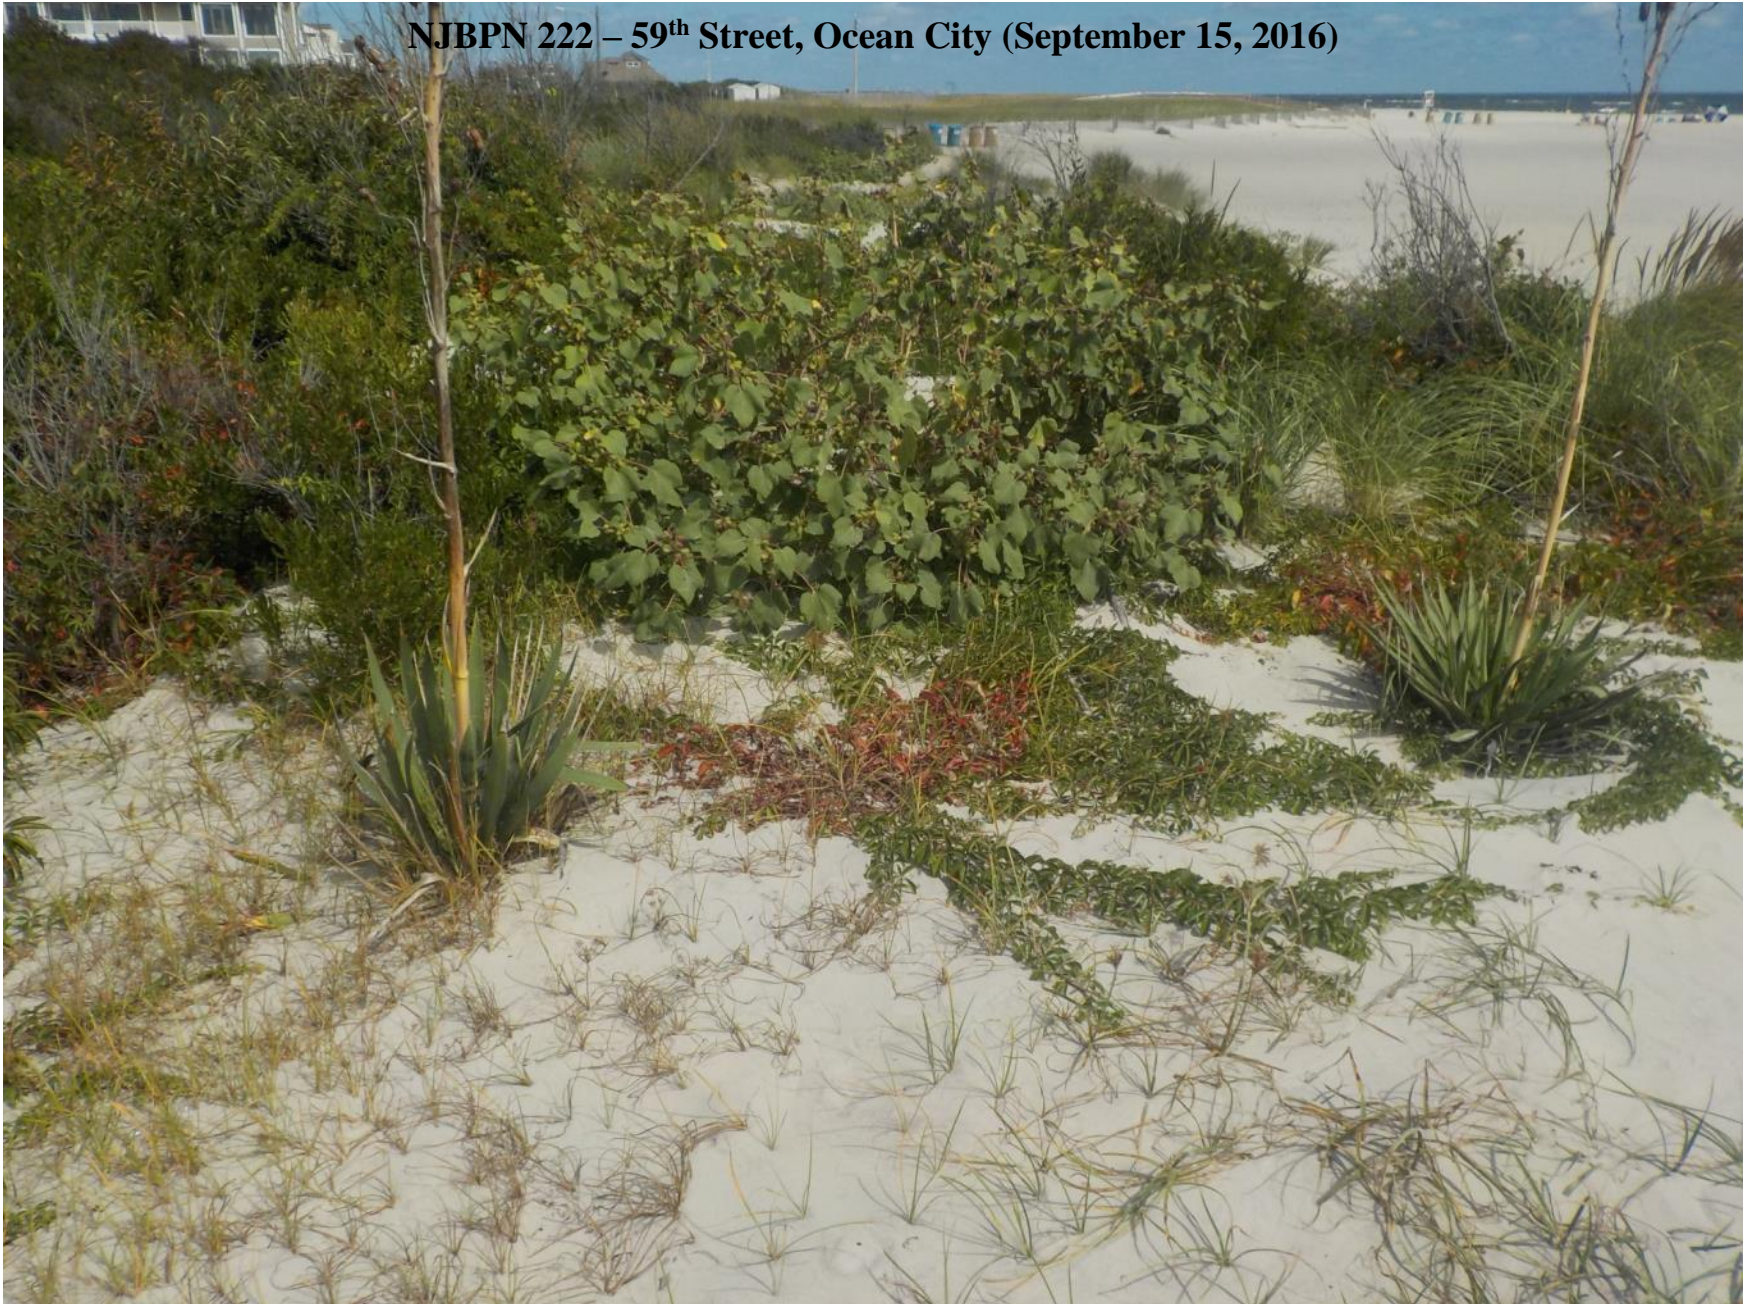
Figure 482. The new beach at 59th Street is much wider than prior to the 2015 fill effort. The early 2015 survey demonstrates the comparison prior to and subsequent to the fill project.

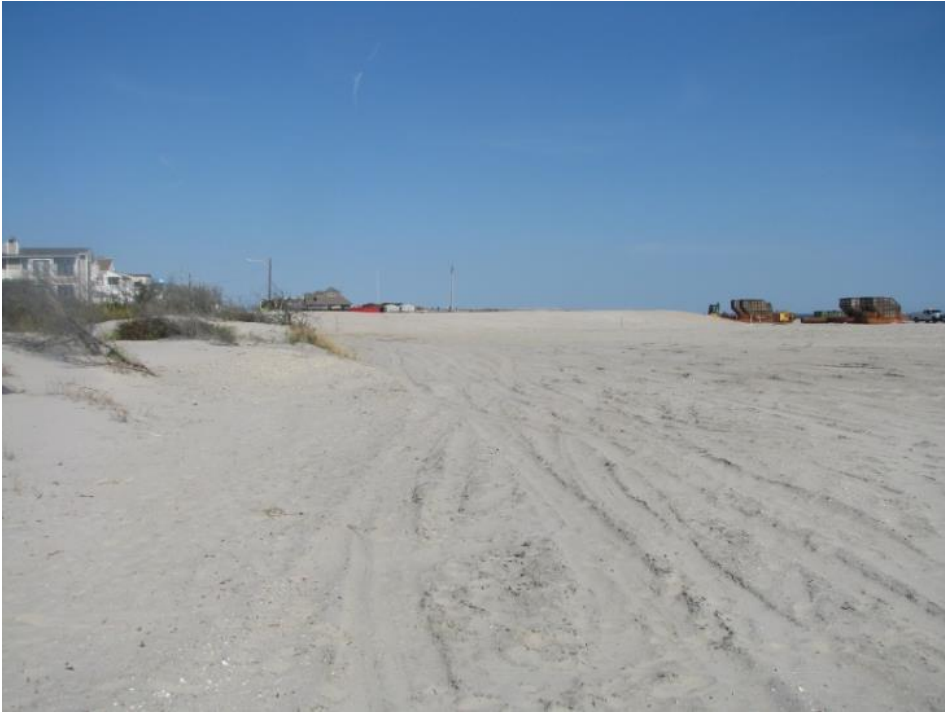
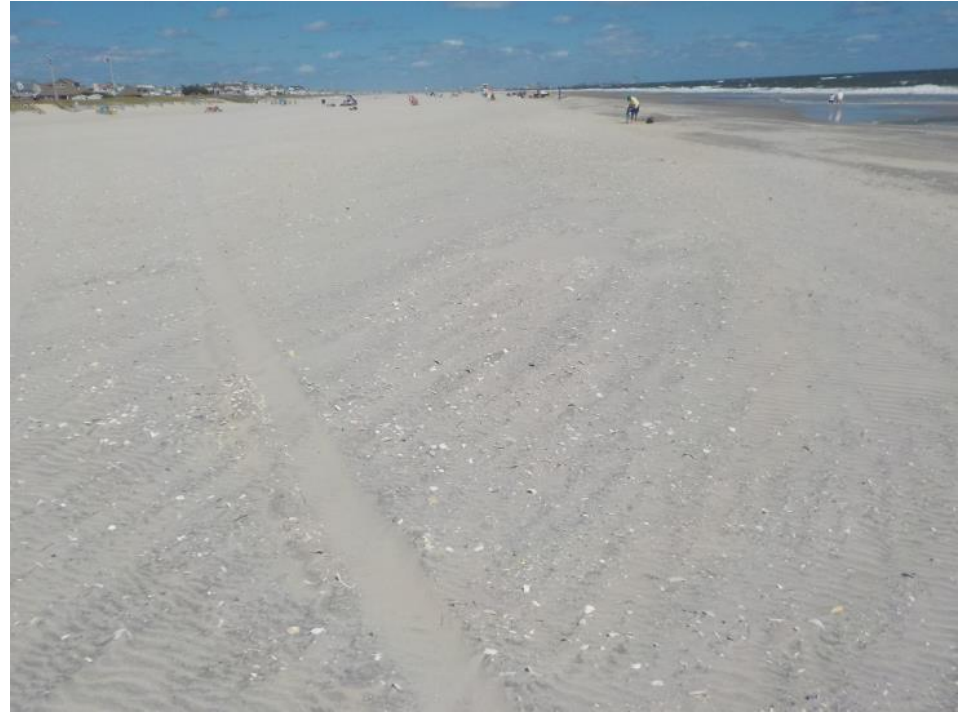
Figure 483a & 483b. The 59th Street site is located at the southern end of Ocean City's developed shoreline, just within the Corson's Inlet State Park. This site is also within the 2015 federal beach fill project area. The equipment was still present in the left photograph taken October 20, 2015, while the open beach was the view in the September 15, 2016 photograph on the right.

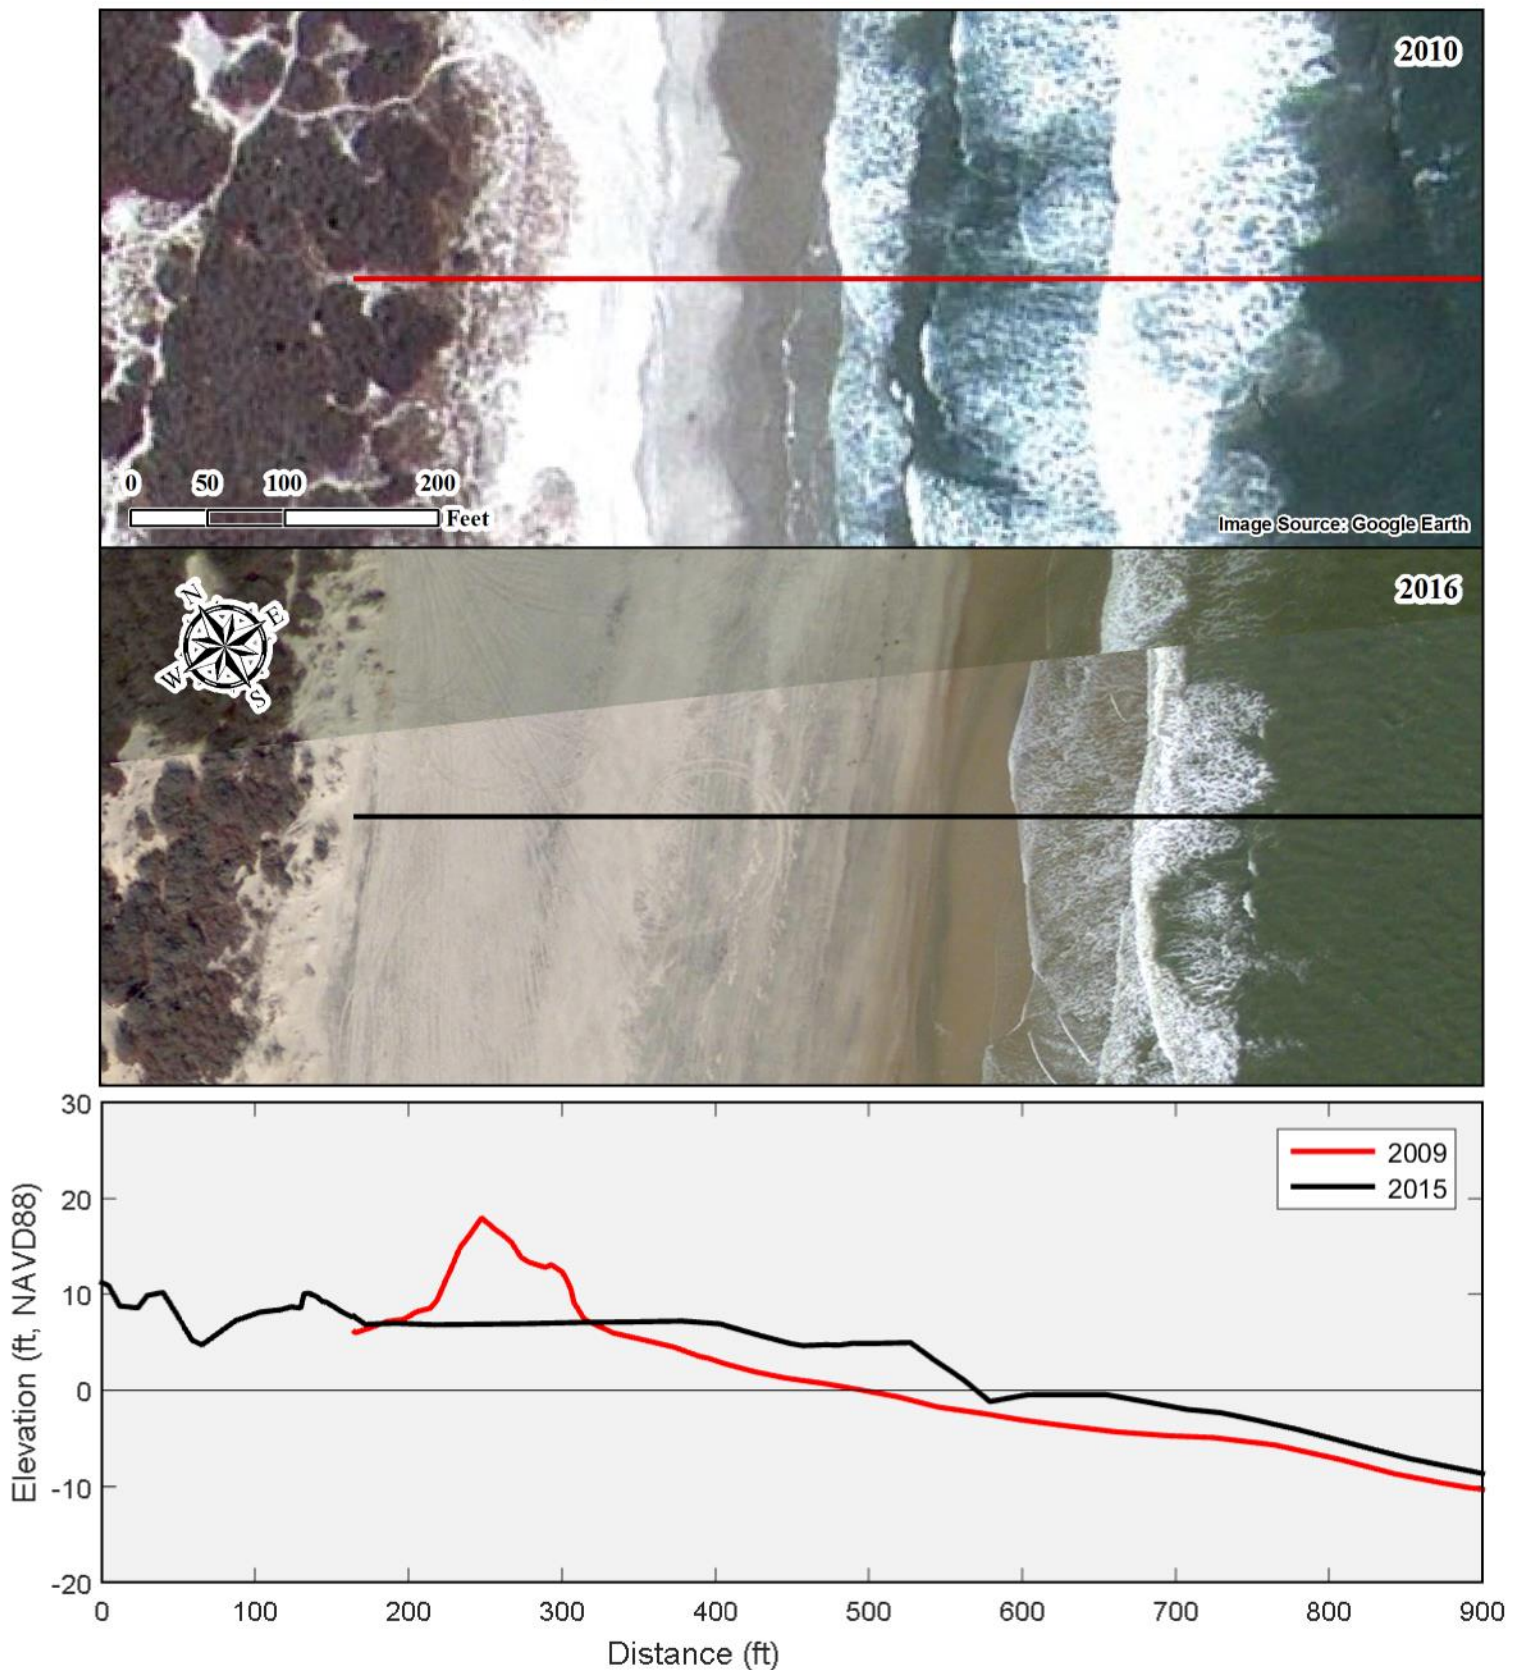
Figure 487. Hurricane Sandy washed the dune inland at this relatively new location, with recent addition of sand beginning to re-establish the feature. Sand shed from the recent fill between 34th and 59th Streets in Ocean City is providing the source material.
