An Analysis of Thirty Years' Study of Sand Redistribution and Shoreline Changes in New Jersey's Four Coastal Counties Raritan Bay, the Atlantic Ocean Coast, and Delaware Bay Fall 1986 Through Fall 2016

VOLUME 4 of 4 CAPE MAY COUNTY & APPENDIX

Prepared for:
New Jersey Department of Environmental Protection
Division of Construction and Engineering
1510 Hooper Avenue, Toms River, New Jersey 08753

Prepared by:
The Stockton University Coastal Research Center
30 Wilson Avenue, Port Republic, NJ 08241

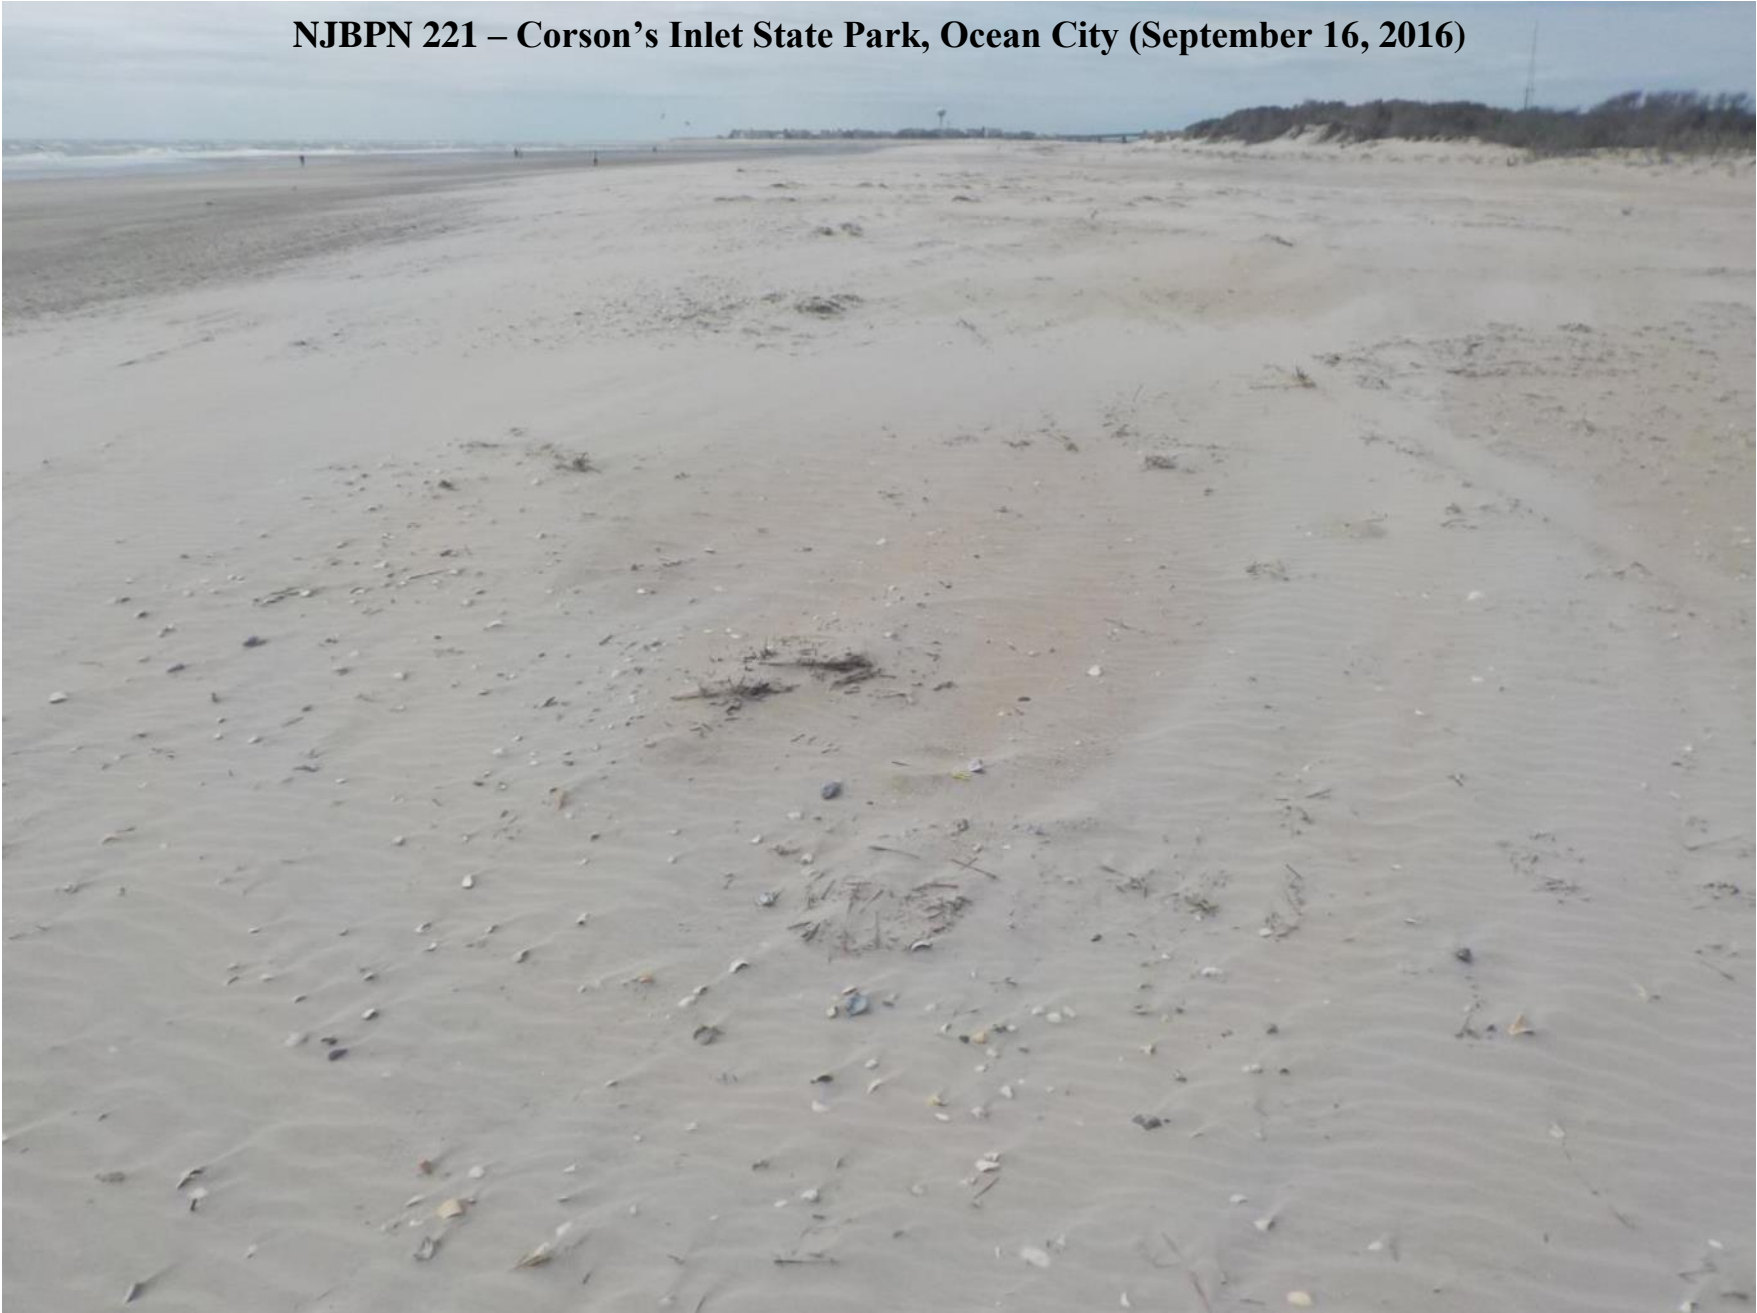
Figure 488. View to the south a year following sand placement in Ocean City. Littoral transport has added material to the park shoreline widening the beach.

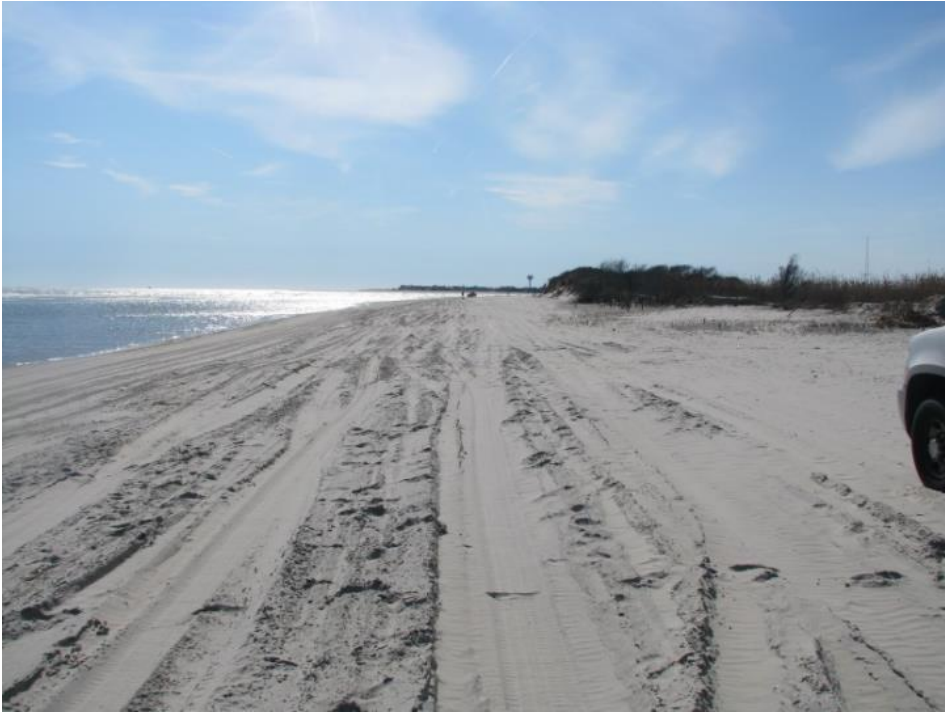
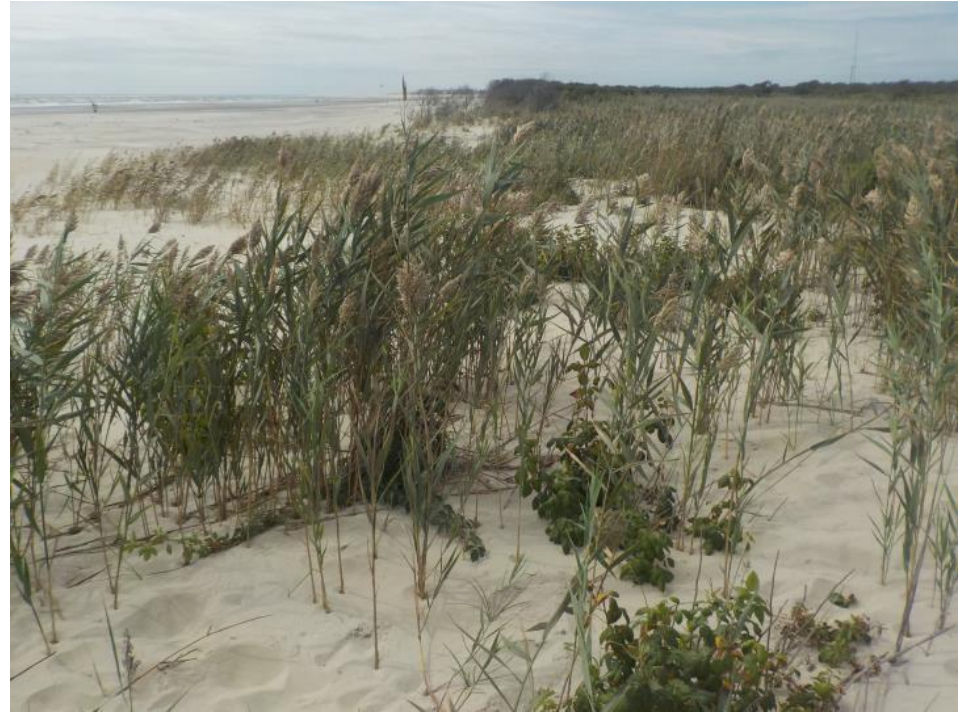
Figure 489a & 489b. The left view was taken as the Ocean City beach project was completed on October 19, 2015. The right photograph shows the beach and dune a year later following some sand migration into the area. Plants have colonized the upper beach starting the natural process of dune growth.

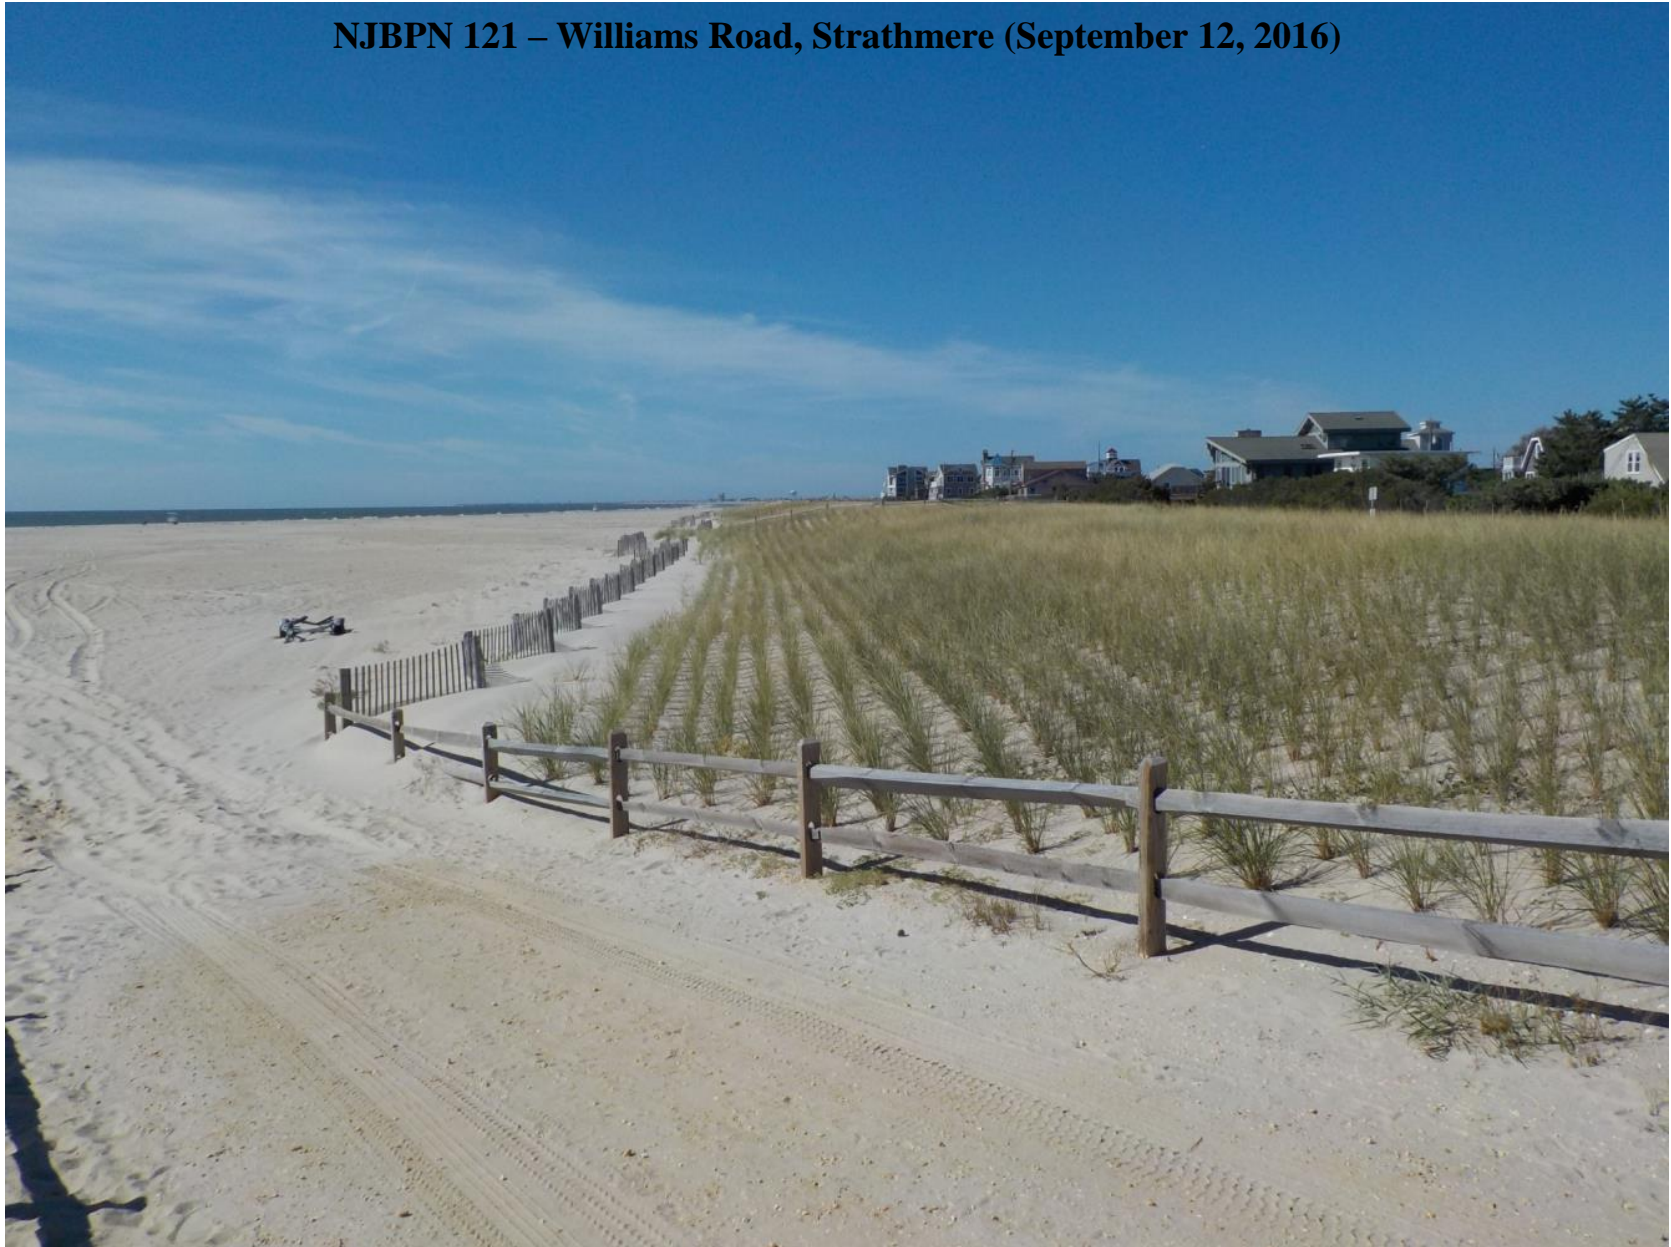
NJBPN 121 – Williams Road, Strathmere (September 12, 2016)

Figure 494. View to the south along the seaward dune toe from the vehicle access pathway to the beach. The plants are doing well and a small foredune is developing at the fence line.

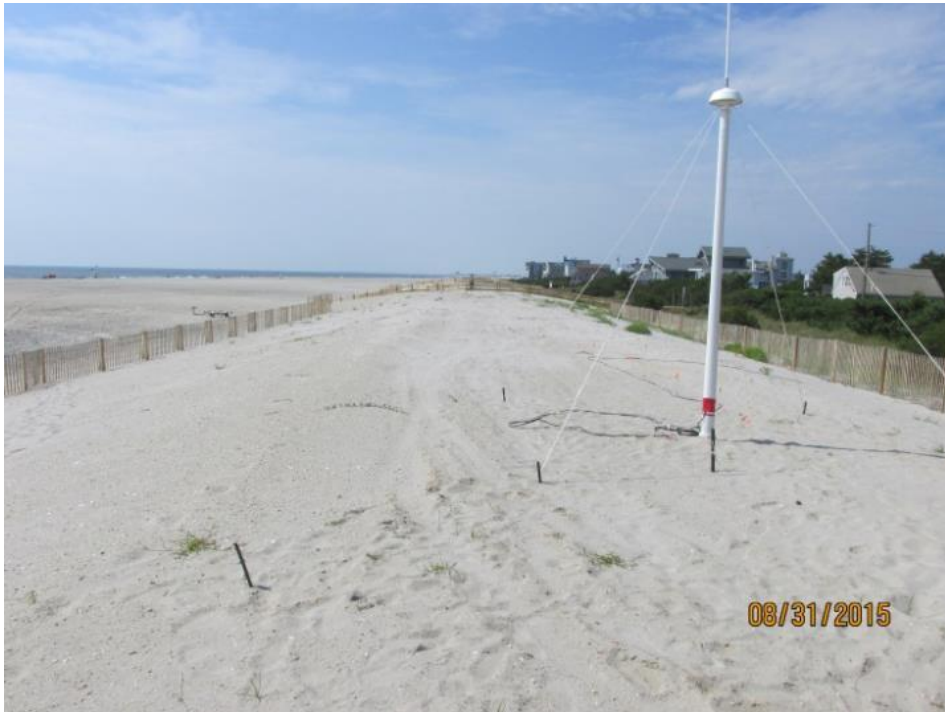
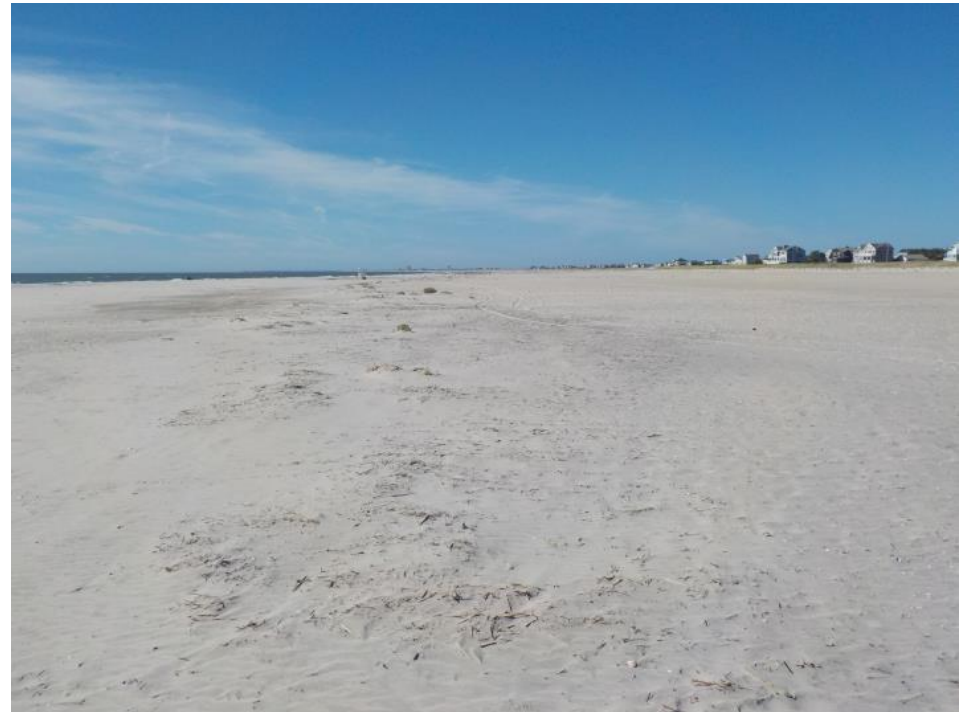
Figure 495a & 495b. The Williams Road site is strongly influenced by the ebb-tidal delta at Corson's Inlet. The left photograph was taken August 31, 2015 following the Ludlam Island US Army Corps of Engineers project was completed. The right photograph was taken September 12, 2016 as a panorama across the wide beach deposited seaward of the dune.

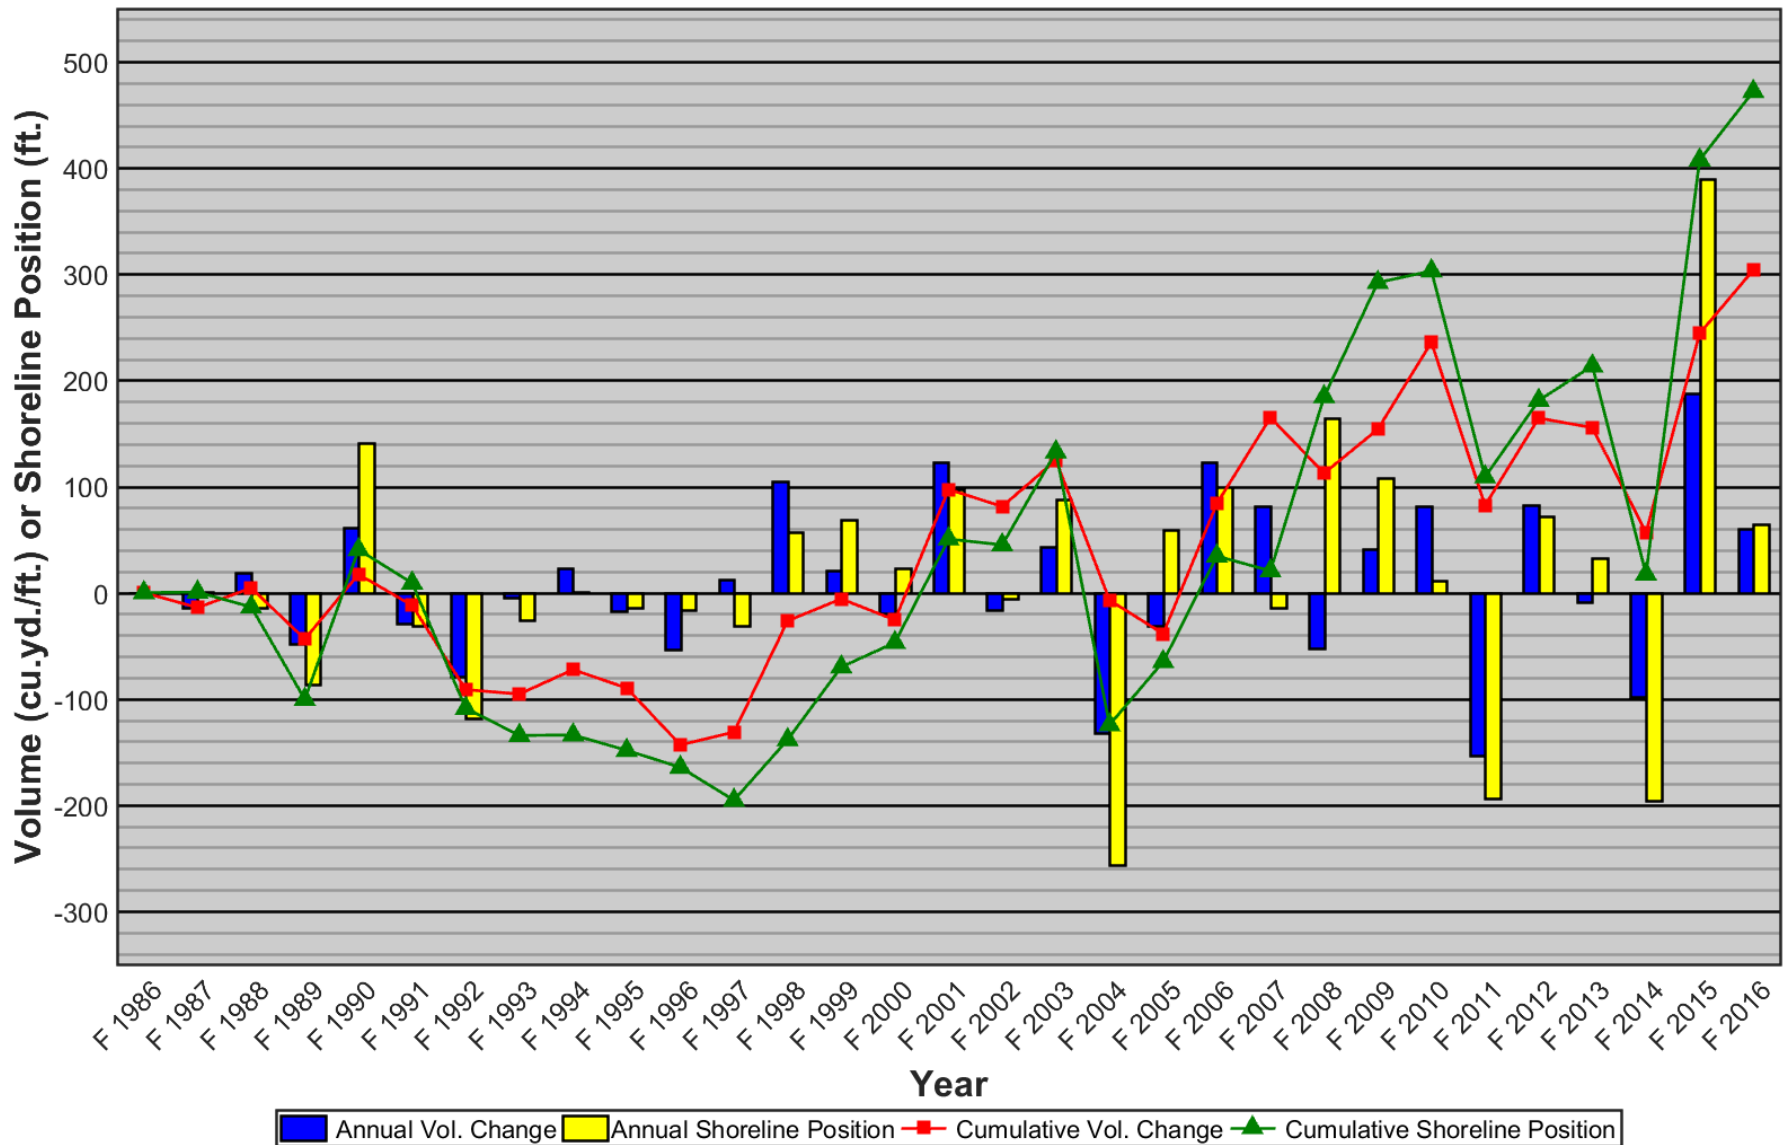
Figure 497. Williams Road is located in proximity to the south side of Corson’s Inlet. The early survey profiles show considerable retreat leading to a 2001 NJ State co-sponsored beach restoration project. The State returned in 2009 with a much larger project generating a substantial improvement at this location. By 2014, storm erosion had reduced the beach close to the 1986 conditions, so the 2015/2016 USACE project was a most welcome influx of new sand to the system.

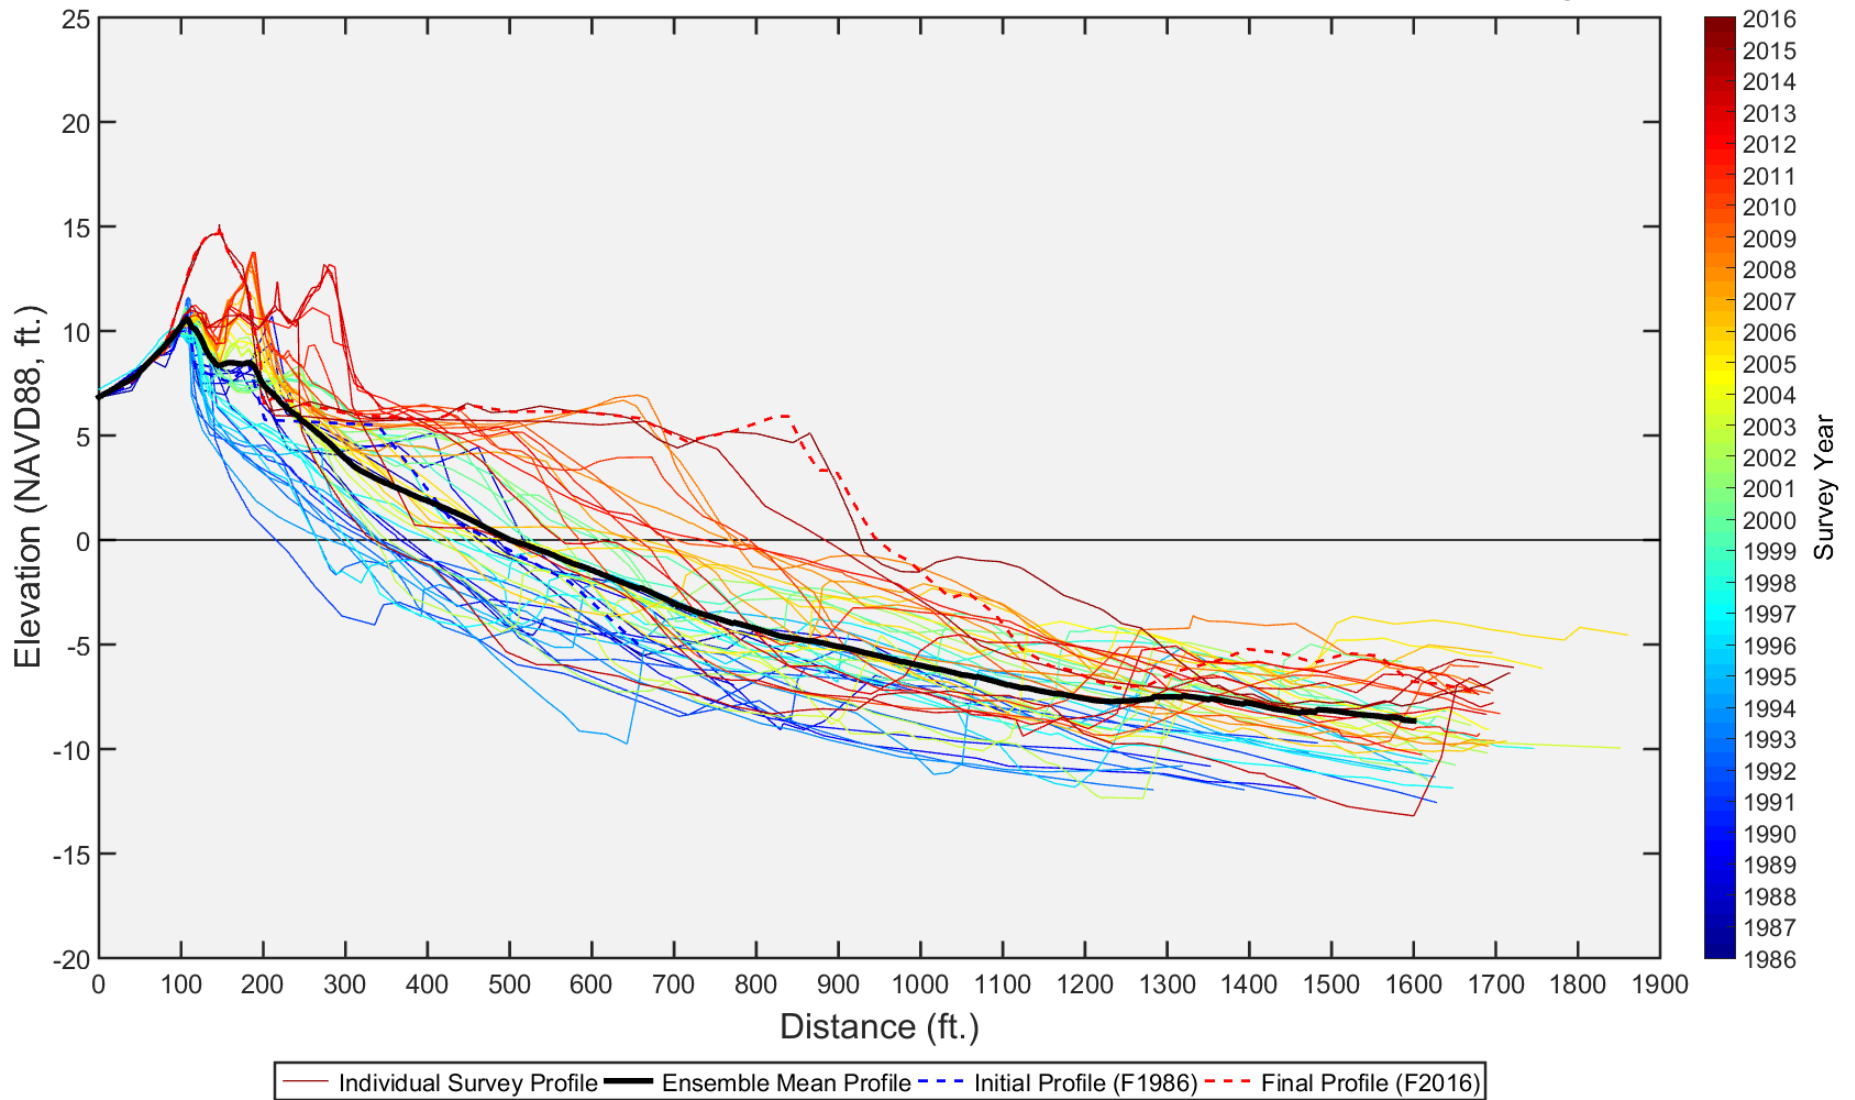
Figure 498. This display shows the trend toward a wider beach with a much larger dune system by 2016. Sand was added here in 1984, 2001, and 2009 by the State of New Jersey and in 2015 by the USACE. More extreme changes occur closer to the inlet (Seaspray Avenue), but this site is still close enough to the inlet to display large excursions from the mean profile (bold black line) position as shown. Greater stability exists farther south from this site and the inlet.

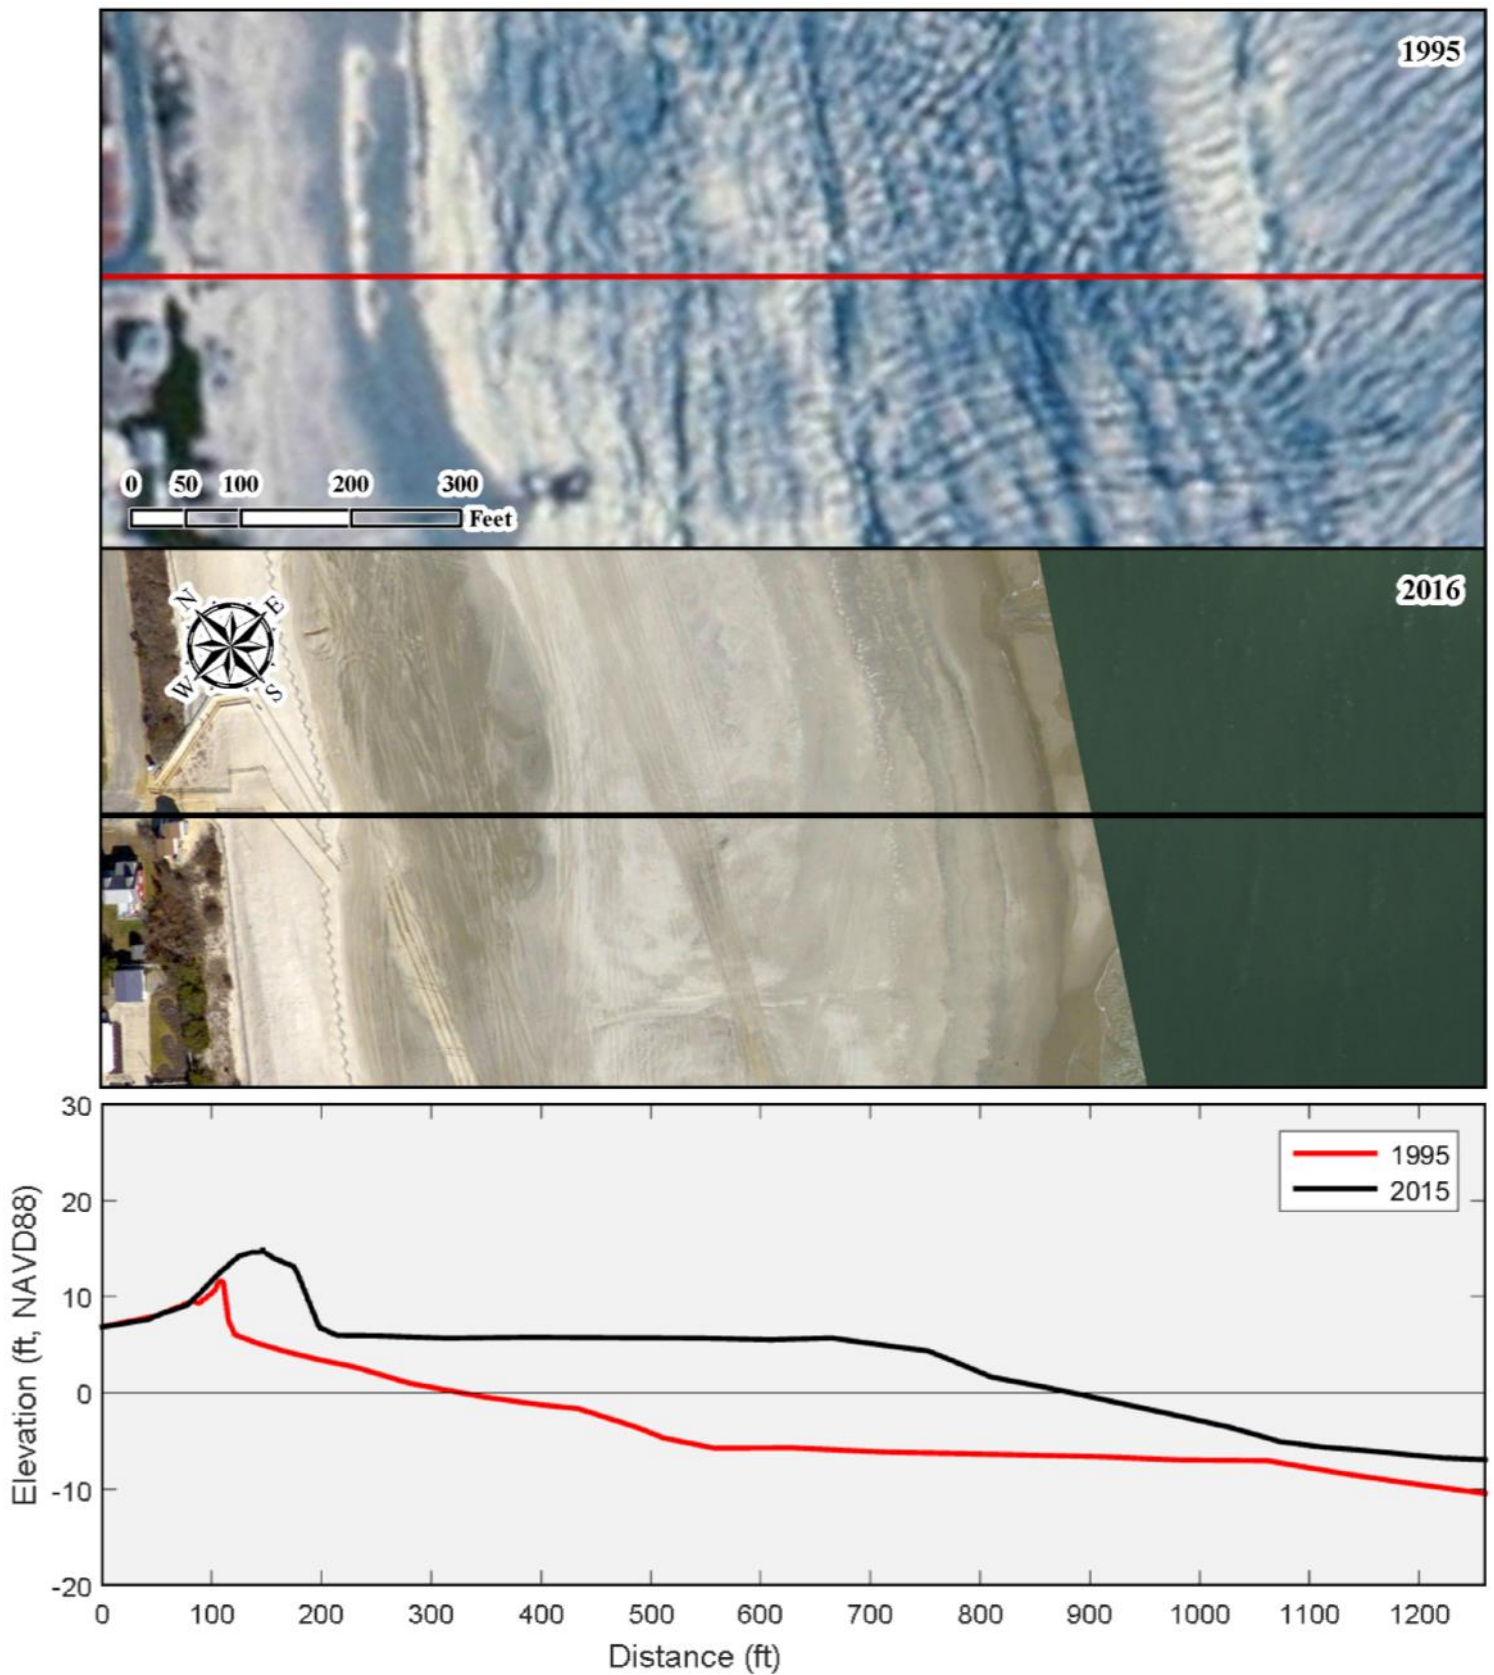
Figure 499. Inlet variations have had a pronounced impact on the width of this beach. Development along the inlet coastline has been threatened by the shifting shoreline and would continue to be threatened if nothing had been done to combat the erosion. Beach fill work was completed here in 1984, 2001, 2009 and 2015, and has had a pronounced impact on the beach configuration, with the shoreline advancing almost 600 feet from 1995 to 2015.

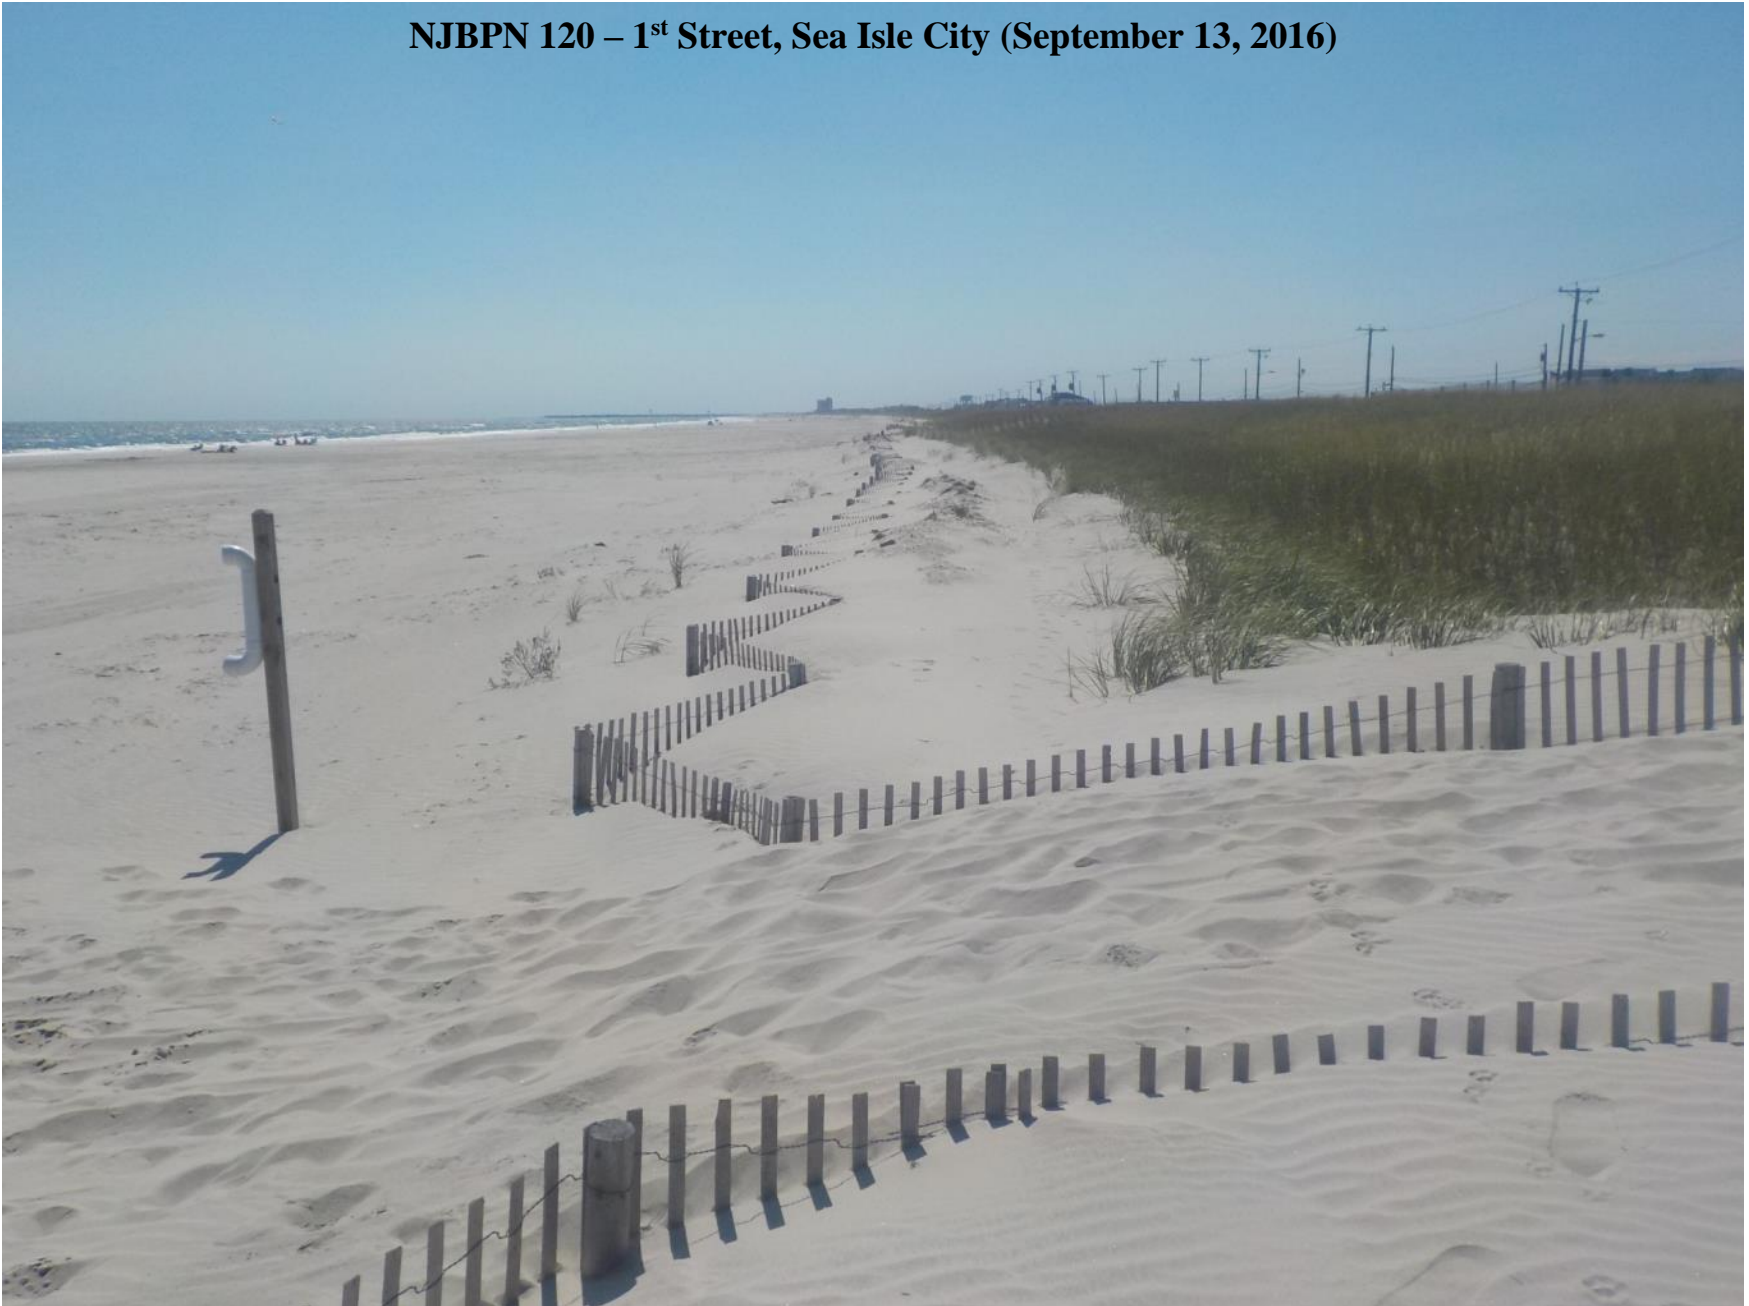
Figure 500. View to the south in the fall of 2016 showing sand accumulation at the fence line and the width of the dry beach.

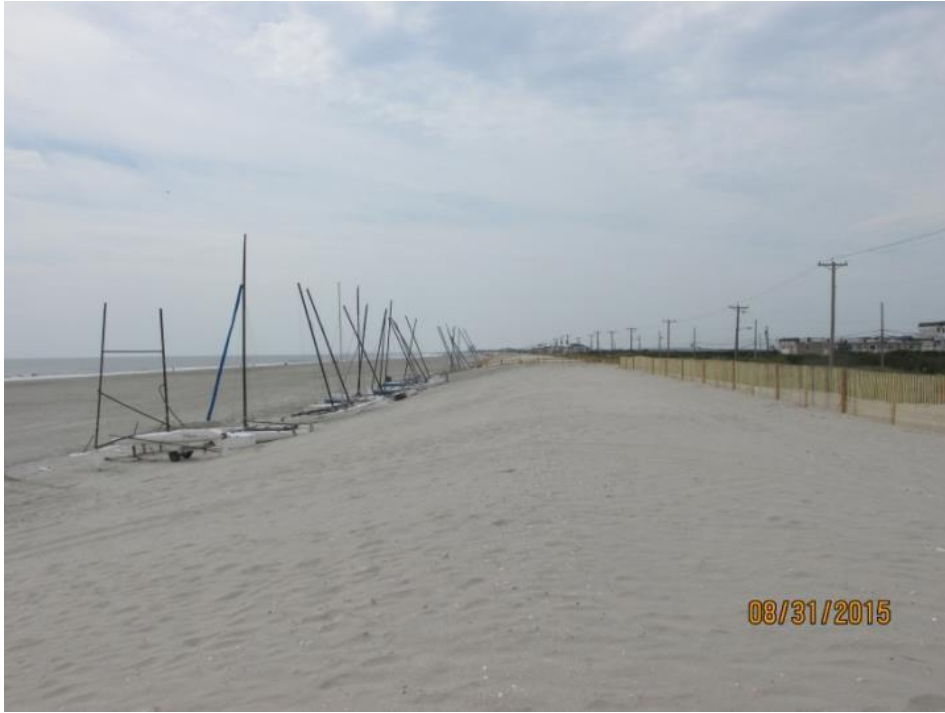
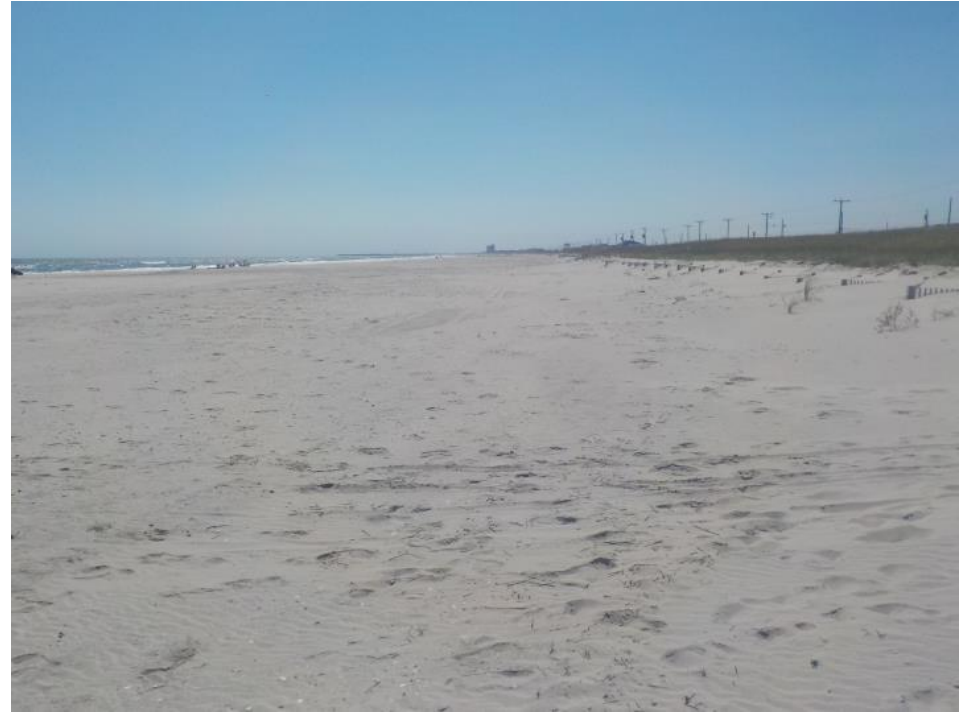
Figure 501a & 501b. Photo on the left was taken August 31, 2015 at the toe of the new foredune and the original dune that is located landward of the new fence was constructed in 1998 with a geo-tube core. The photo on the right was taken September 13, 2016, which was a year after the federal project. The dry beach width was increased and aeolian transport resulted in sand accumulating on the seaward dune slope.

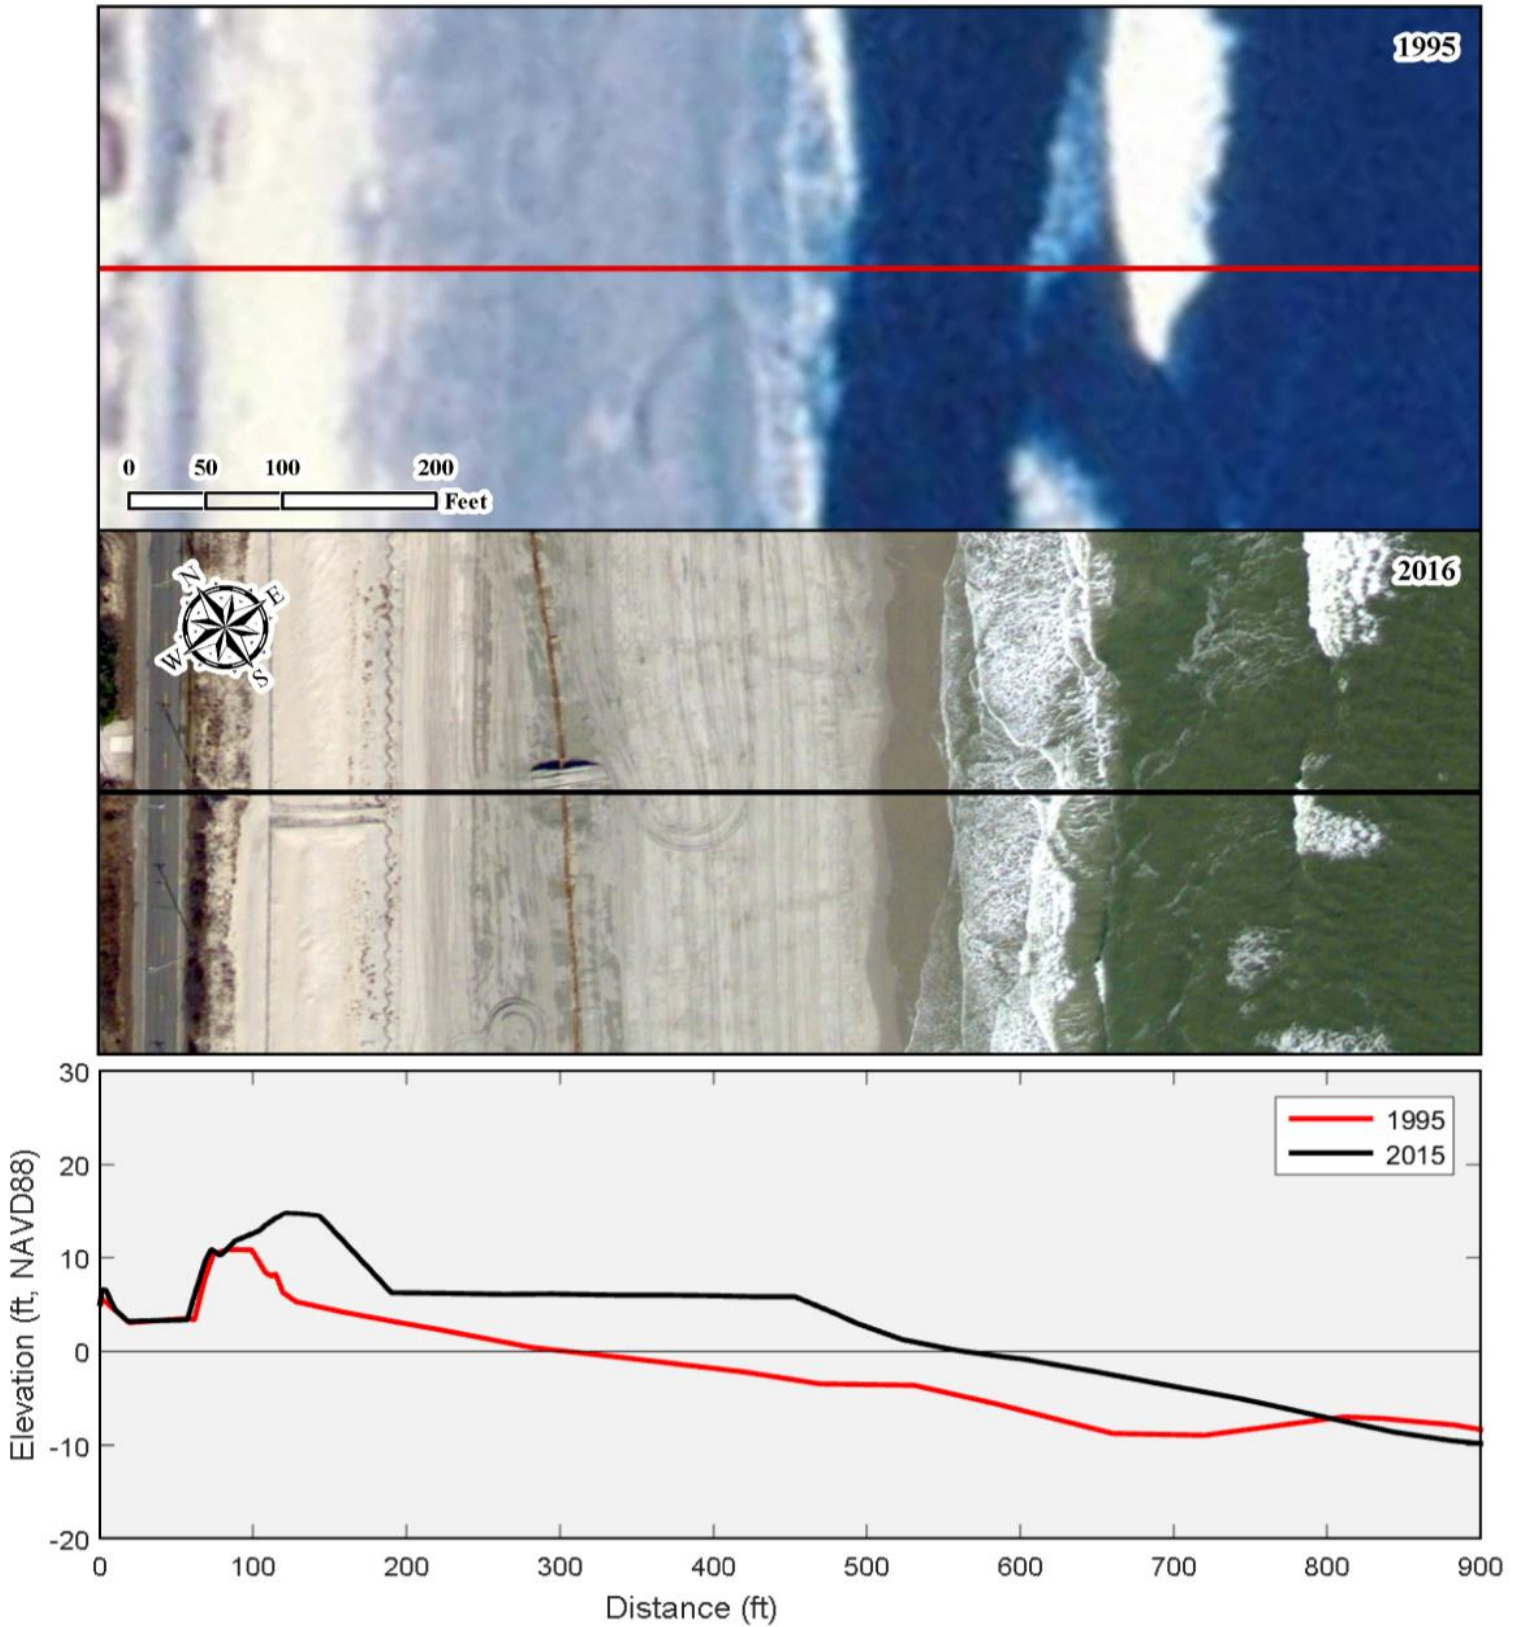
Figure 505. Recent USACE beach restoration work has made a difference in the dune and beach width. The original dune contains a 10 ft diameter geo-textile sand-filled tube that extends 2,400 feet south into Sea Isle City.

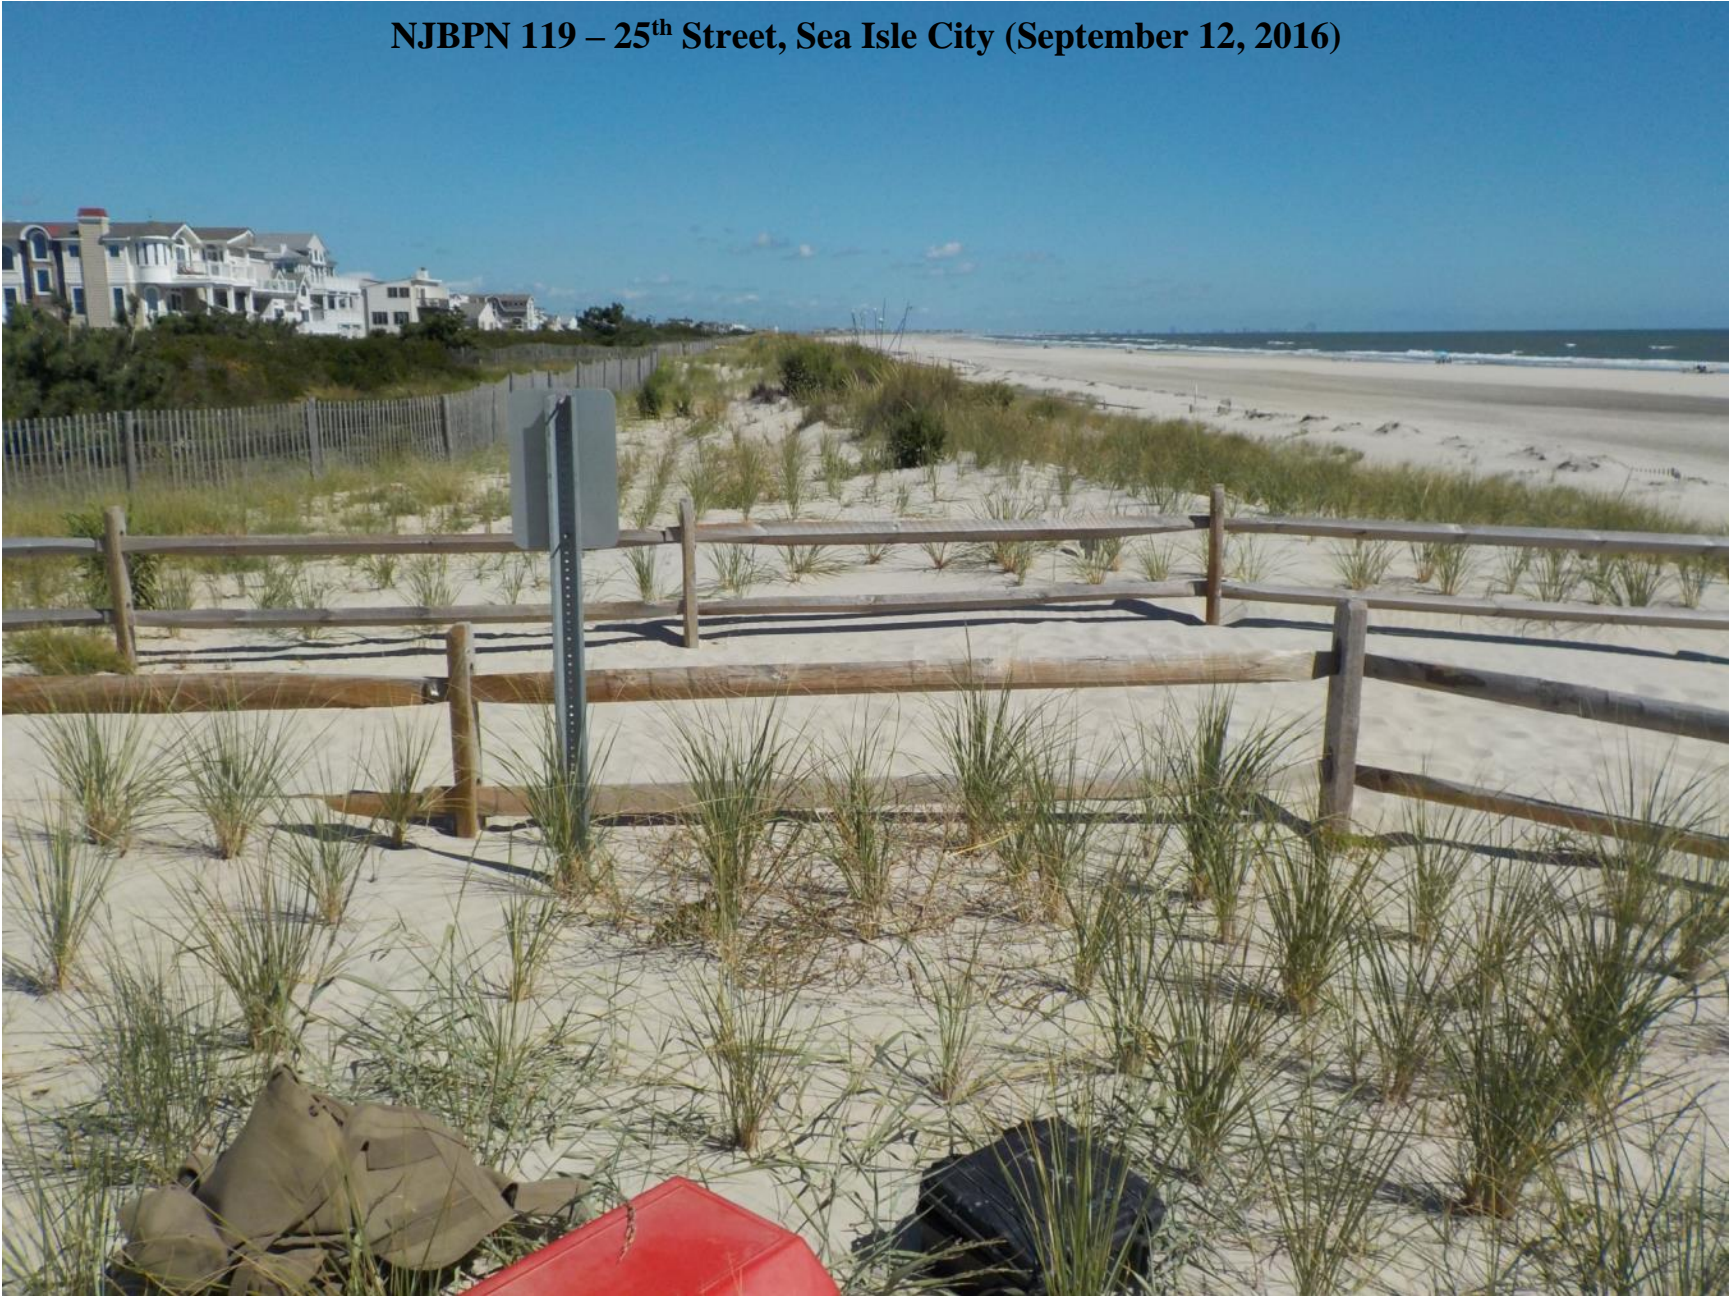
Figure 506. View to the north from 25th Street in Sea Isle City at the public access pathway. The dune grass has developed and the 2016 beach is much improved.
