An Analysis of Thirty Years' Study of Sand Redistribution and Shoreline Changes in New Jersey's Four Coastal Counties Raritan Bay, the Atlantic Ocean Coast, and Delaware Bay Fall 1986 Through Fall 2016

VOLUME 4 of 4 CAPE MAY COUNTY & APPENDIX

Prepared for:
New Jersey Department of Environmental Protection
Division of Construction and Engineering
1510 Hooper Avenue, Toms River, New Jersey 08753

Prepared by:
The Stockton University Coastal Research Center
30 Wilson Avenue, Port Republic, NJ 08241

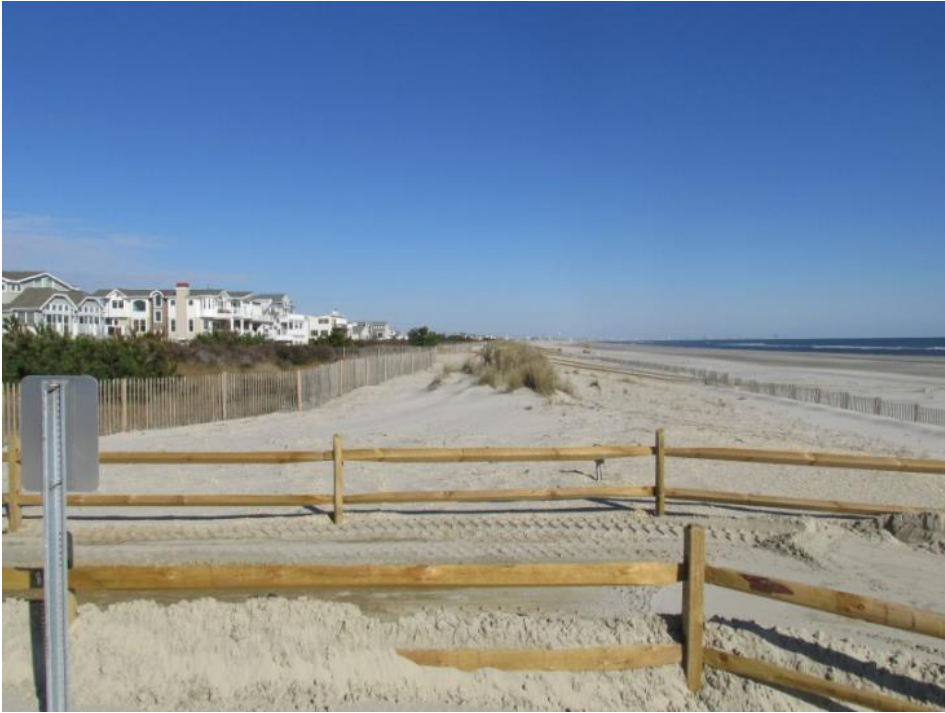
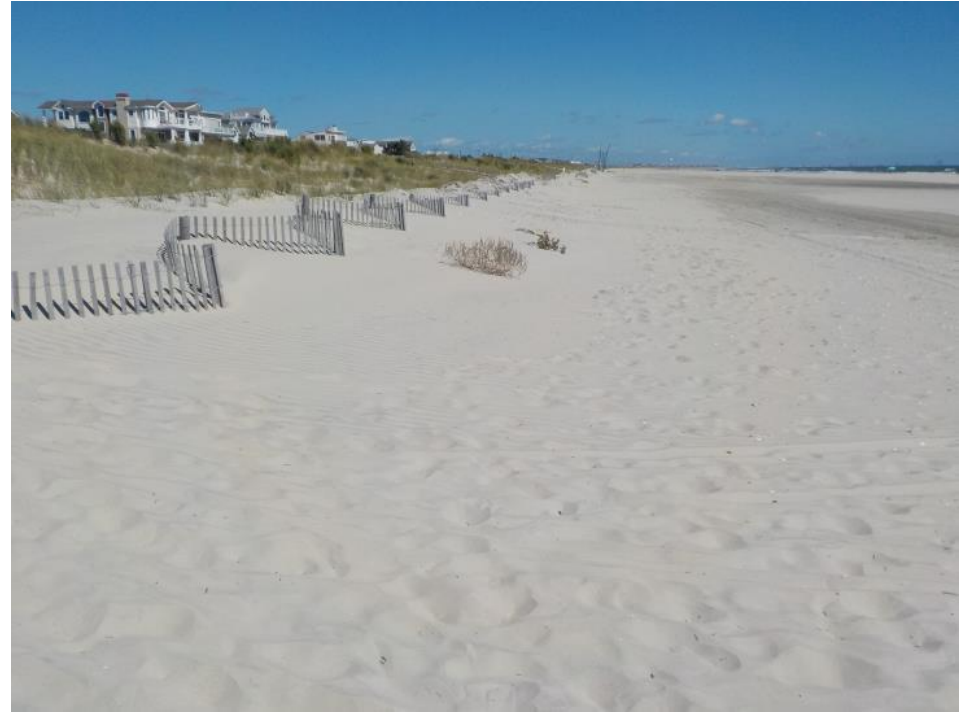
Figure 507a & 507b. The 25th Street site is positioned near the northern limit of development east of Commonwealth Avenue. The site is reasonably stable and was enhanced in 2009 under the NJ State project. The left photo taken on November 24, 2015 shows the fenced dune zone and new pedestrian access path. The right photo taken on September 16, 2016, shows sand accumulation around the fencing and vegetation growth on the seaward dune slope a year later.

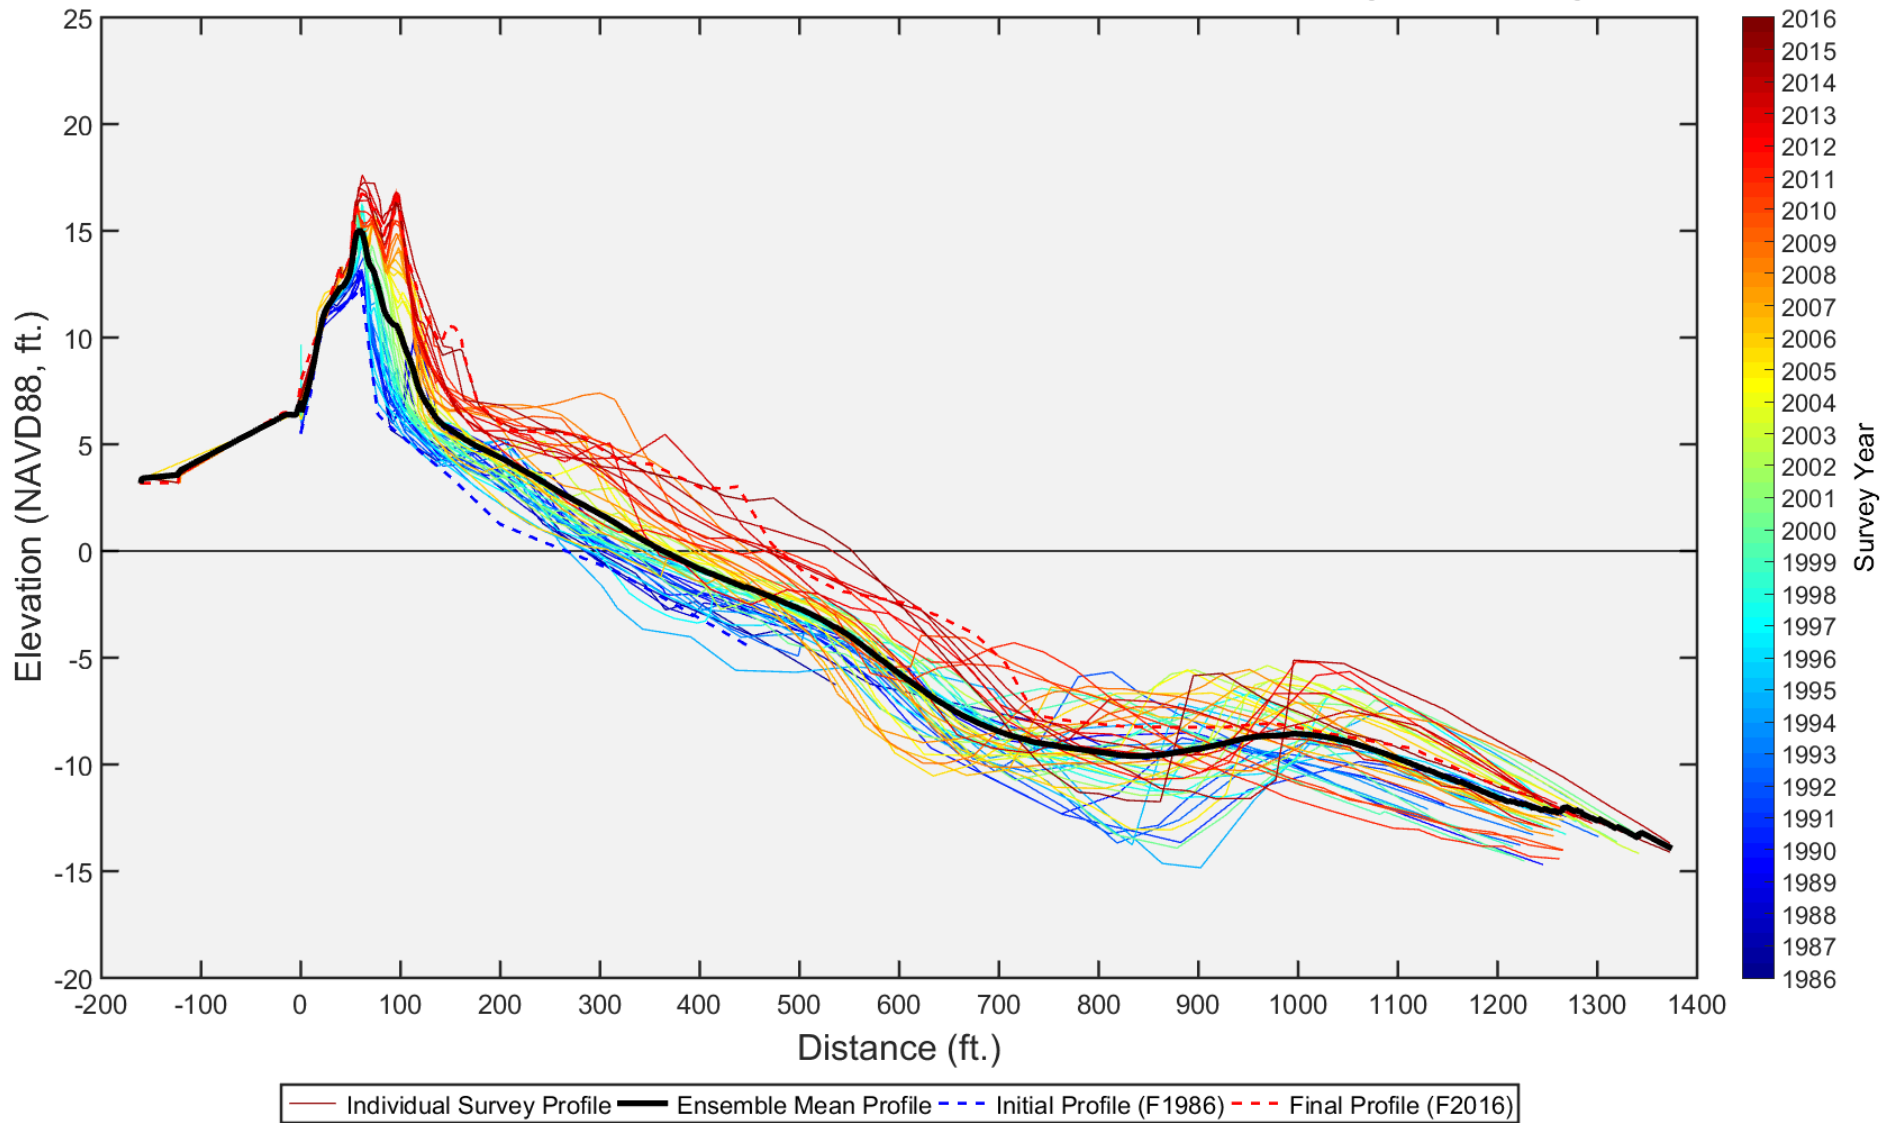
Figure 510. The general positive trend in beach conditions shows up well at this location where the colors progress uniformly from blue (early surveys) to red most recent surveys). The dune is wider and higher in elevation and the shoreline has progressed seaward with a steady increase in beach width and elevation as a result of offshore bar formation and landward migration.

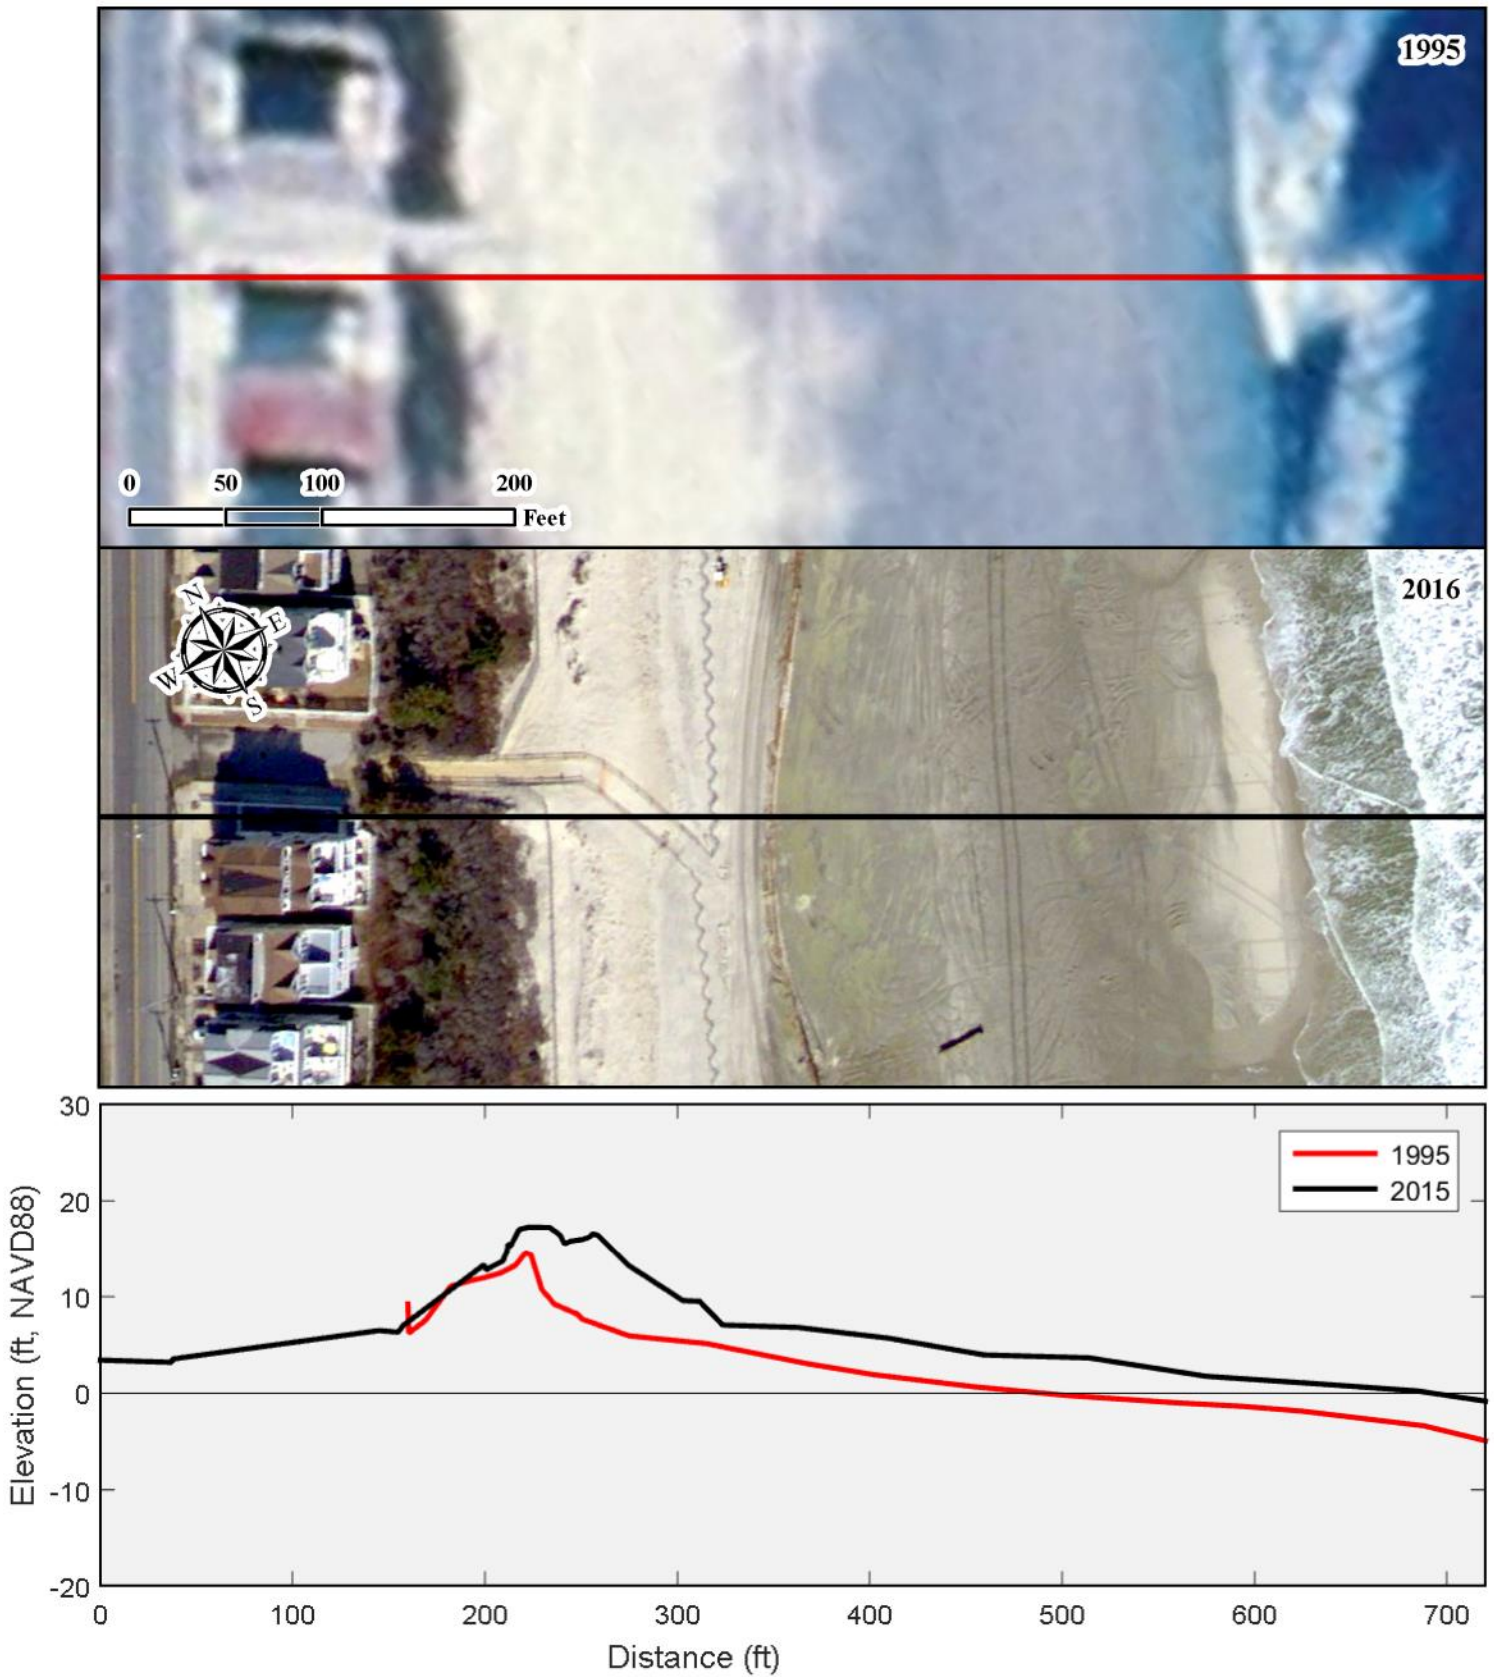
Figure 511. Recent beach restoration efforts on Ludlam Island have enhanced the dune and generated a higher and wider beach.

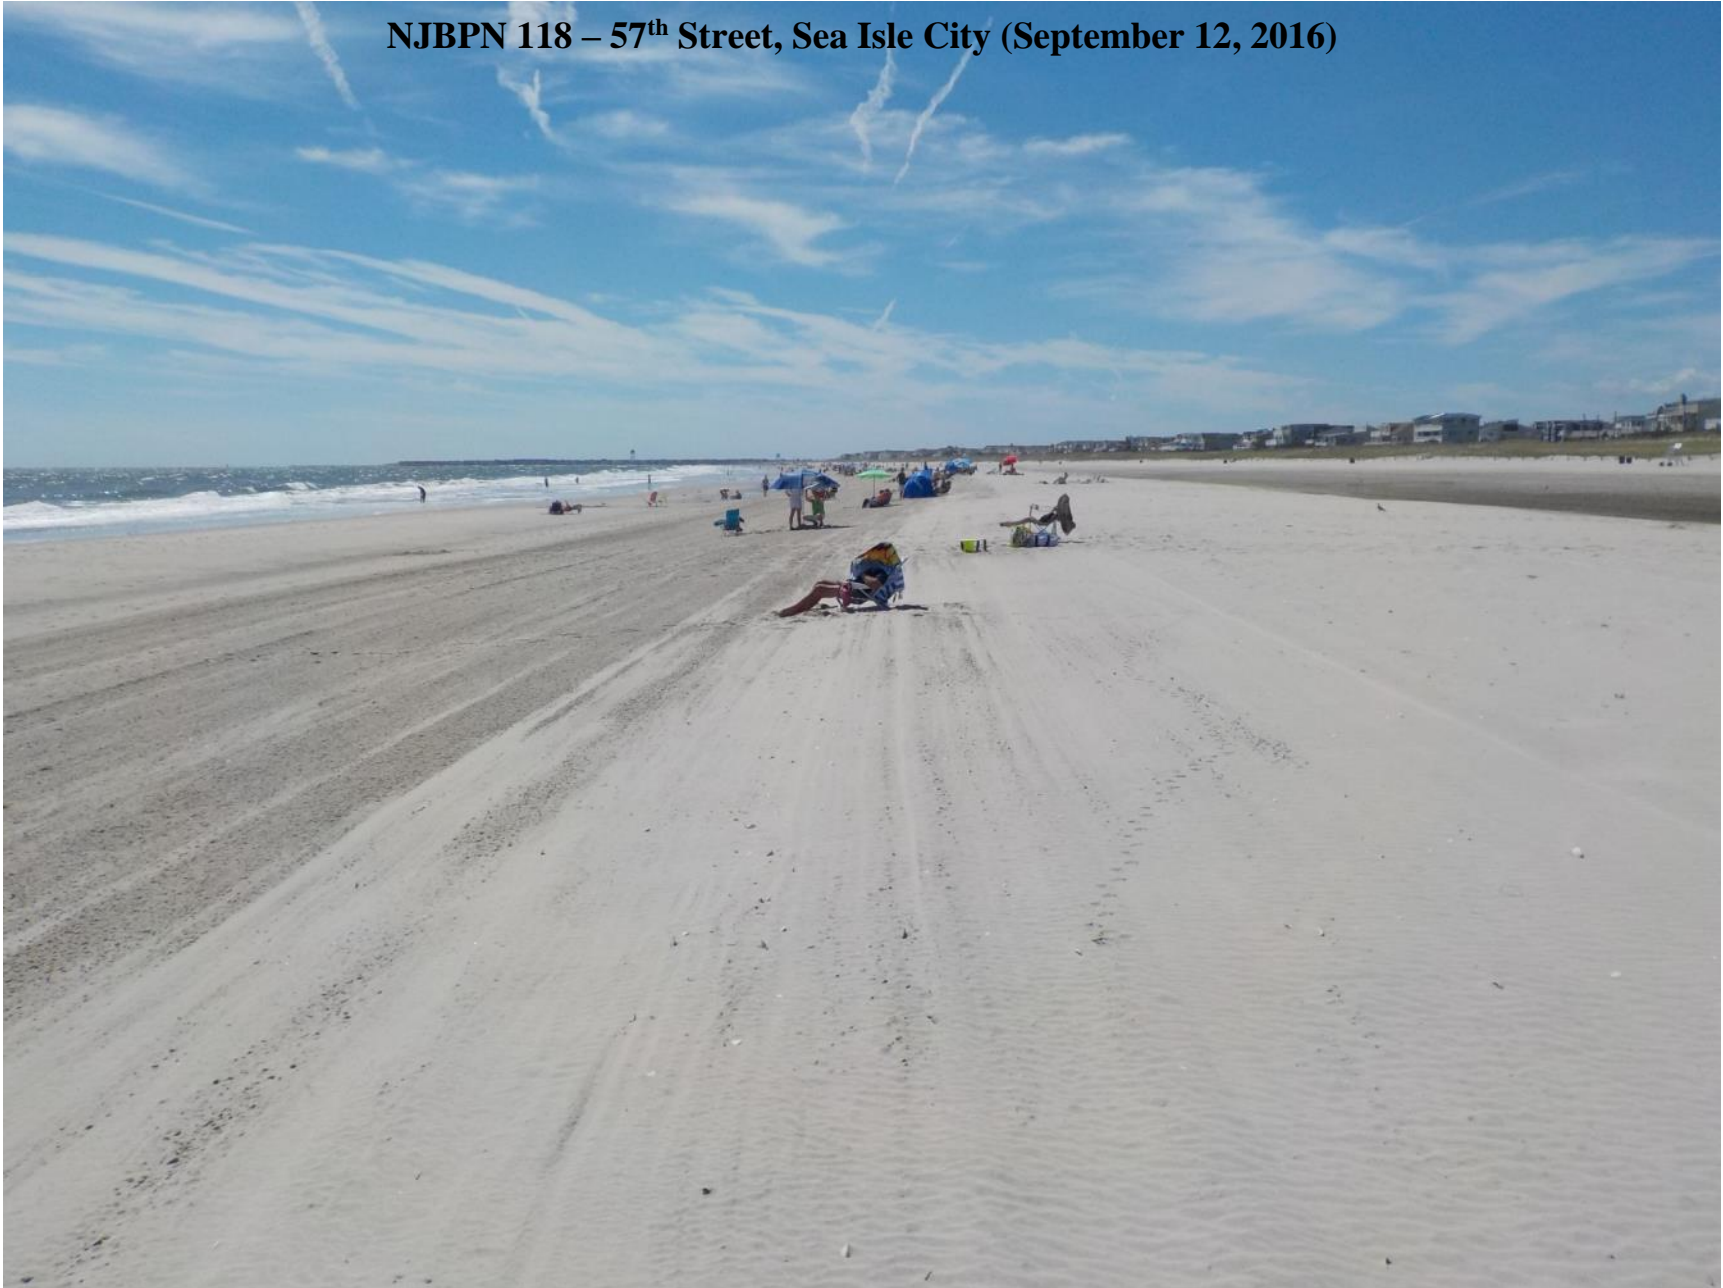
NJBPN 118 – 57th Street, Sea Isle City (September 12, 2016)

Figure 512. Looking south at the beach berm at 57th Street in Sea Isle City. The wider beach developed a high elevation berm in 2016 with a swale to the landward side.

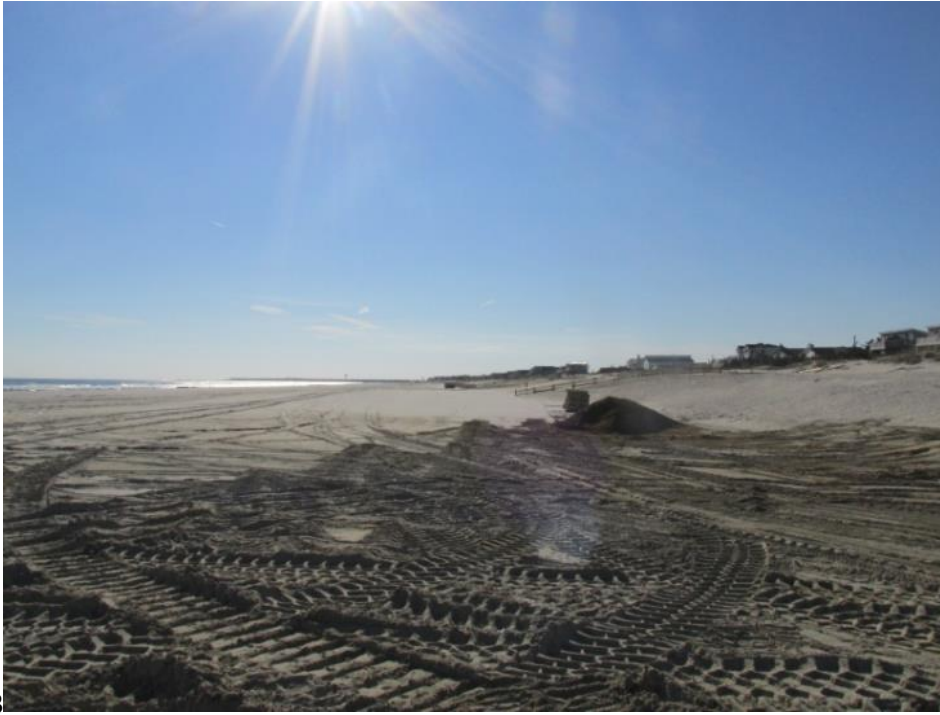
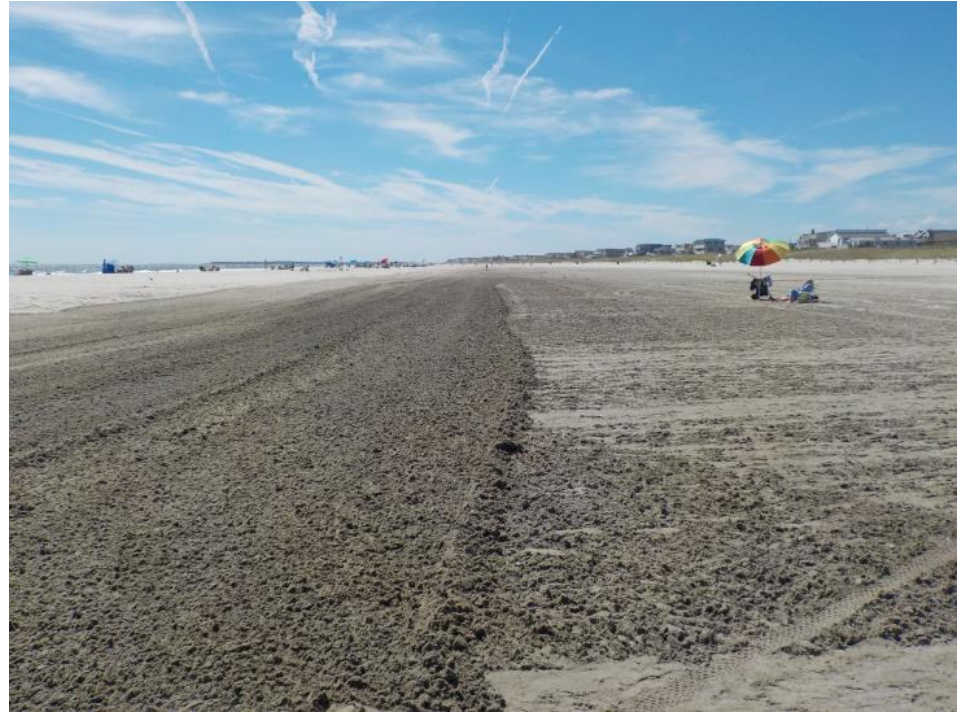
Figure 513a & 513b. The left photo was taken on November 24, 2015 and shows work in progress for the federal project as it moved south toward Townsend's Inlet. The right photo taken on September 12, 2016, shows a graded and raked sand beach late in the bathing season.

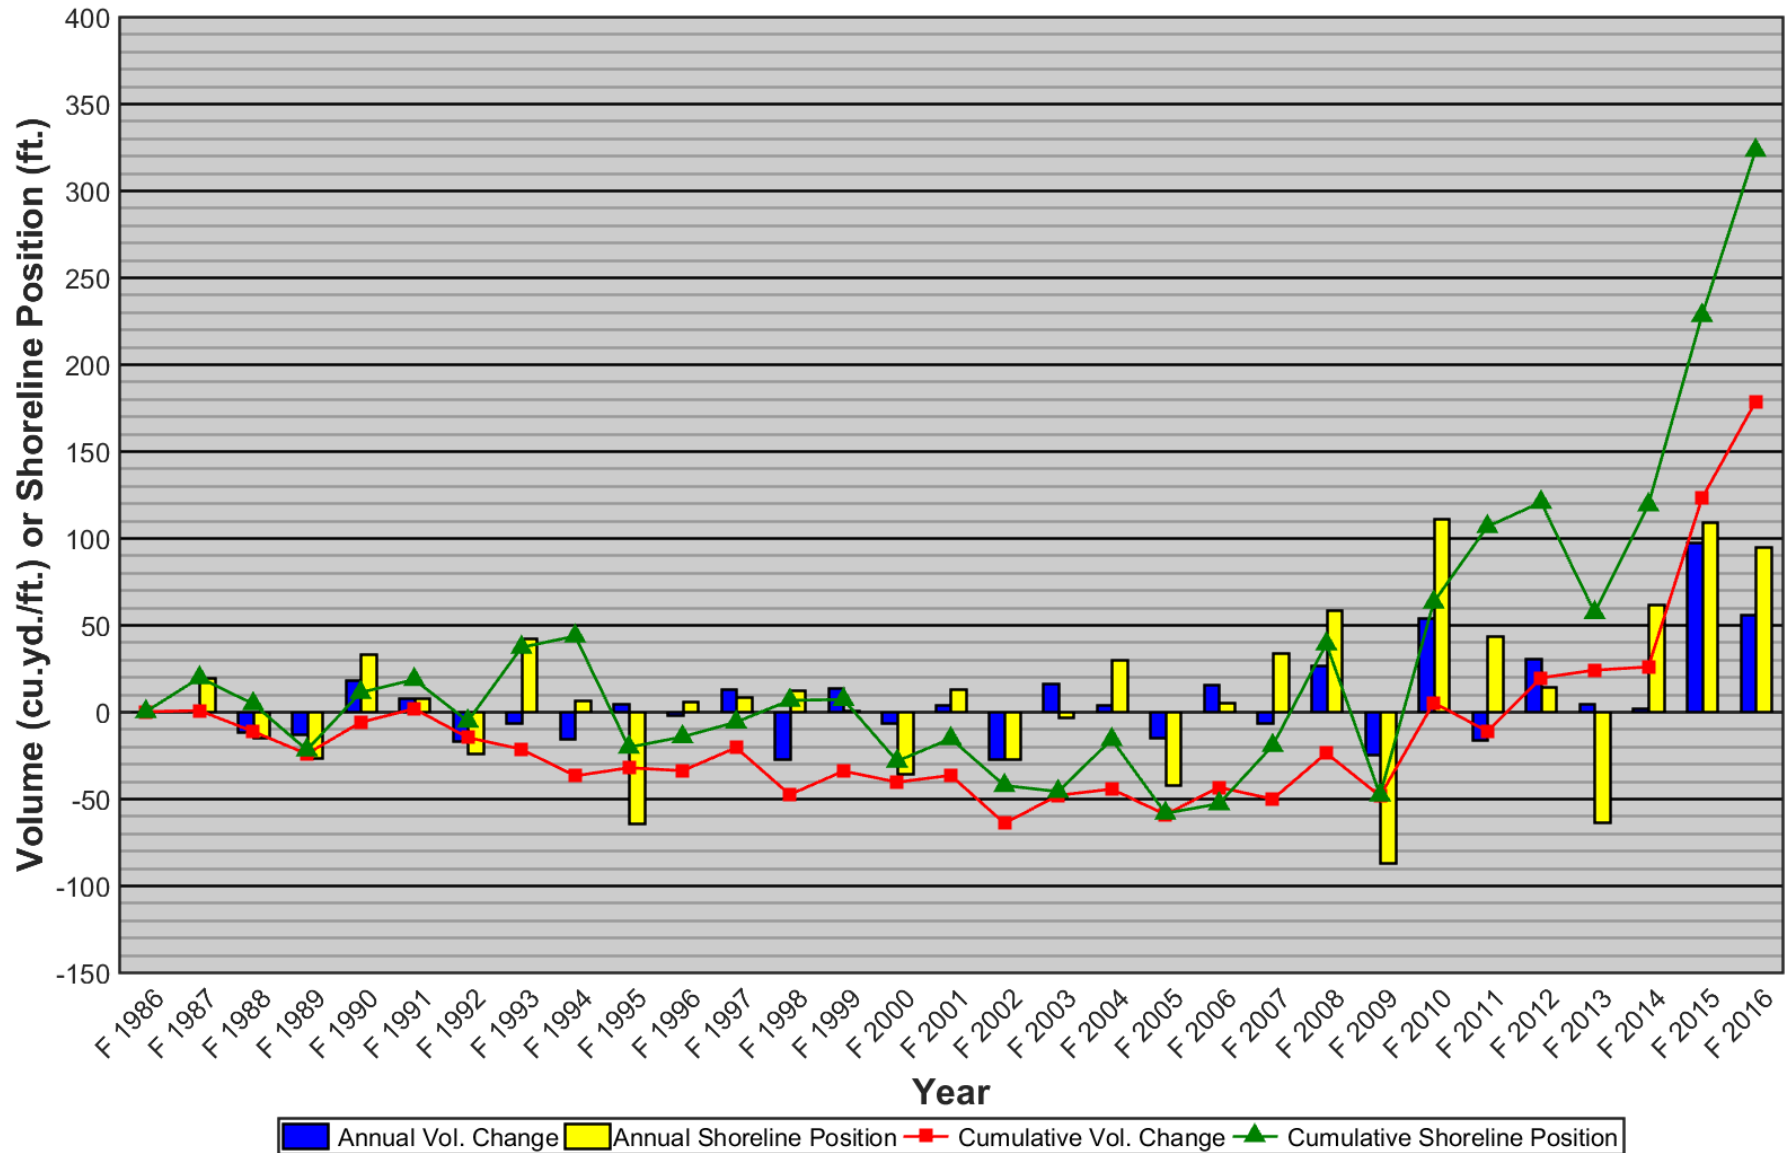
Figure 515. In the middle of Sea Isle, the beach lies seaward of a promenade, which rests on a double timber bulkhead with a rock revetment seaward of the front bulkhead. Installed after the 1962 northeast storm, this feature has been buried in dune sand such that its presence is all but forgotten. The beach here retreated somewhat between 1986 and 2010. The recovery back above the starting conditions in 1986 is likely due to the 2009 NJ State project sand arriving at the site by 2010. Rapid advance commenced in 2015 with the USACE project, with additional material placed following NE Storm Jonas in 2016.

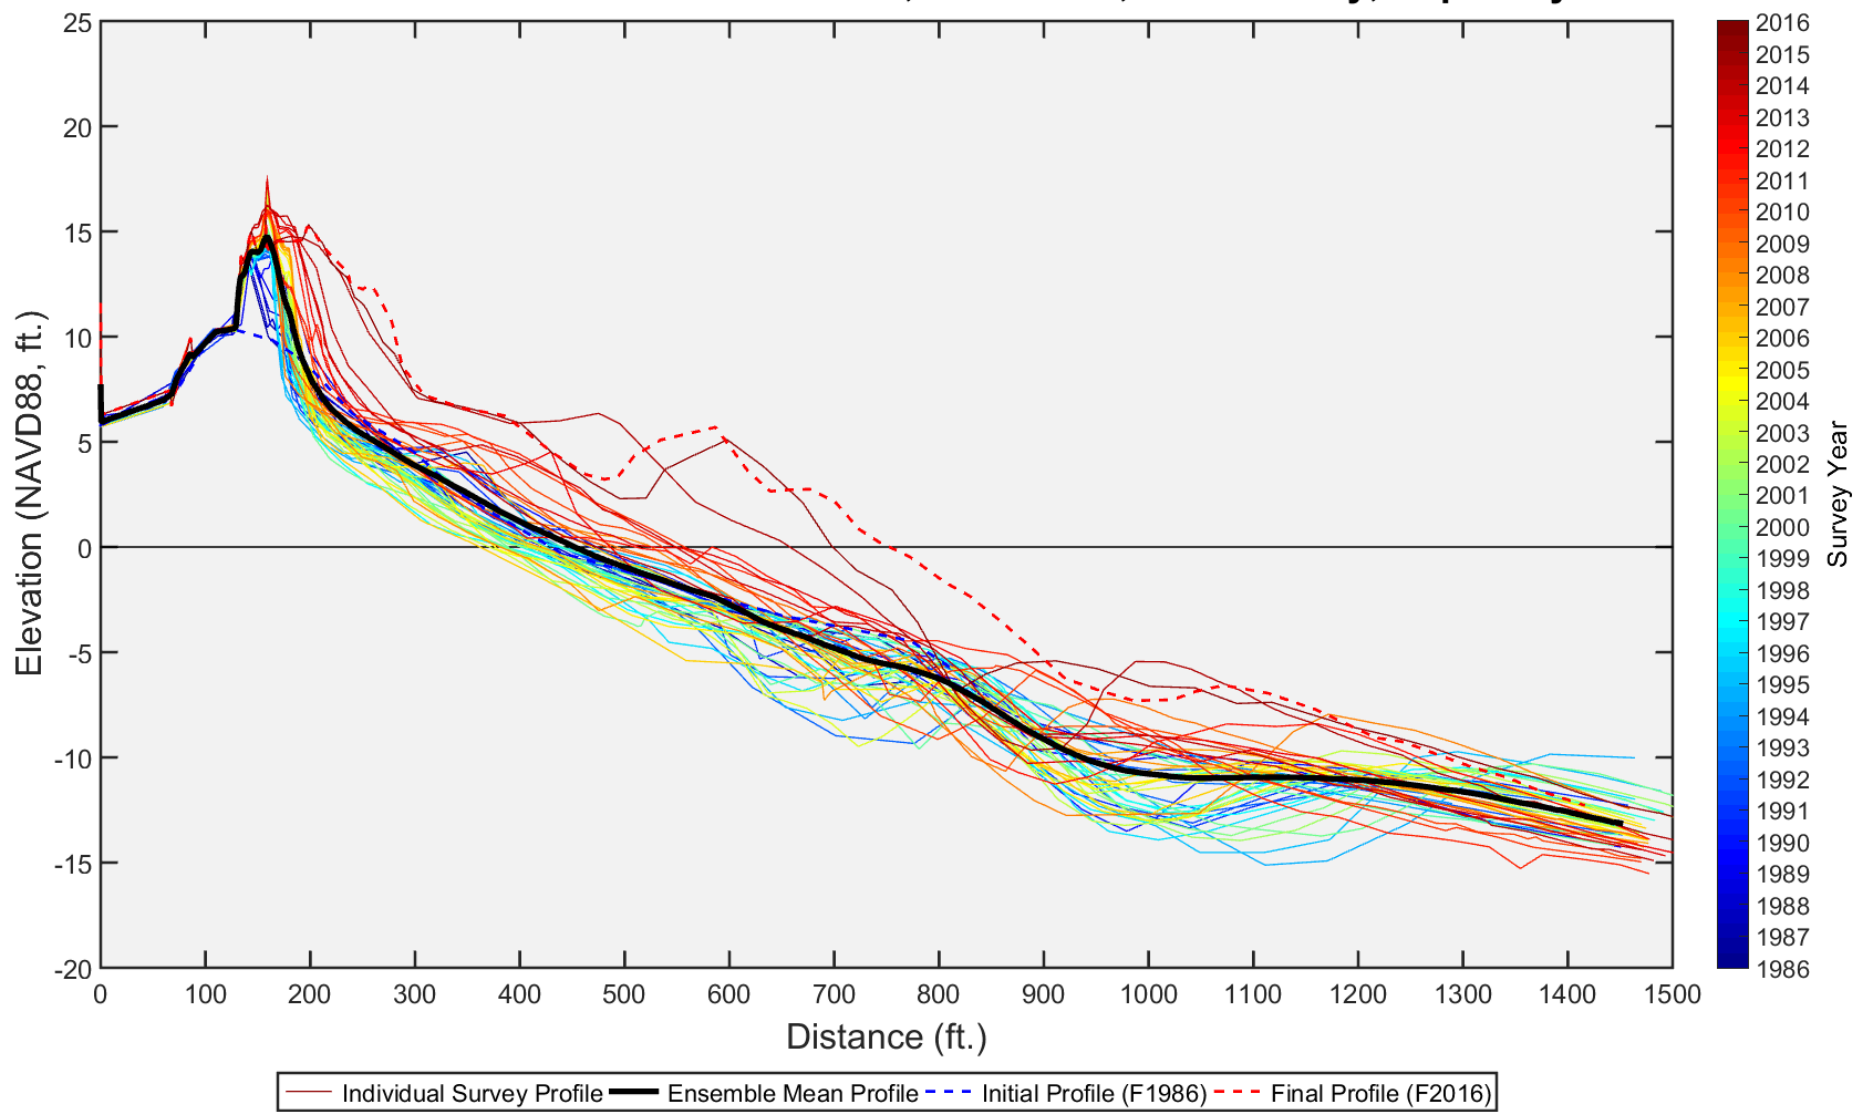
Figure 516. The profile envelope is fairly tight at this location indicating a generally stable to slightly accretional beach. The 2015 USACE post-project profiles are shown in red as the widest beach with added material in the dunes.

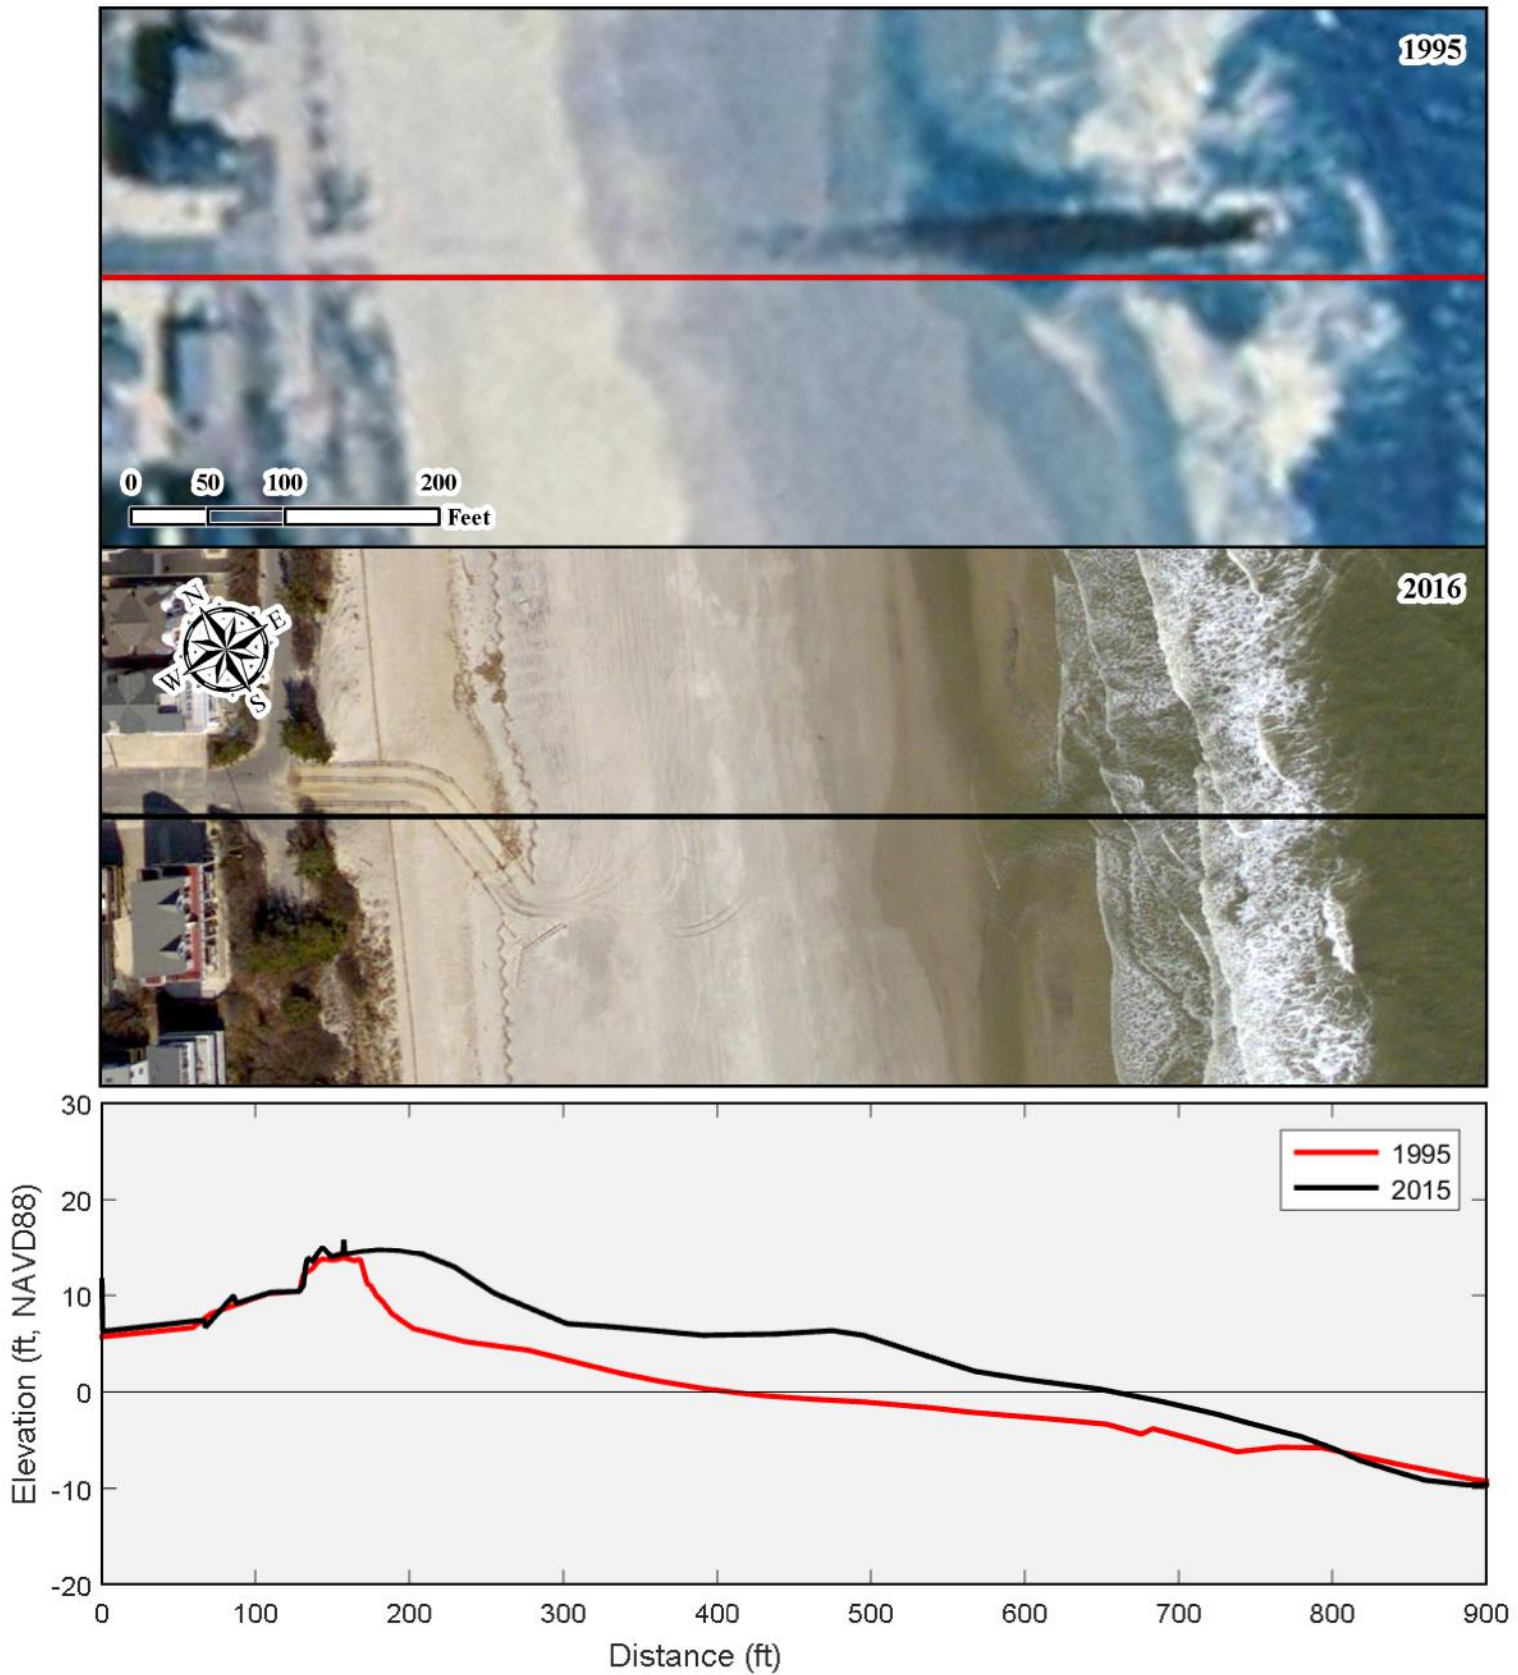
Figure 517. There is a promenade built on top of twin timber bulkheads, with a rock revetment in front of the seaward bulkhead. This was done following the 1962 northeast storm. The 2016 beach restoration under federal authority has dramatically enhanced the dune and beach seaward of the promenade, resulting in a shoreline advance of about 350 feet.

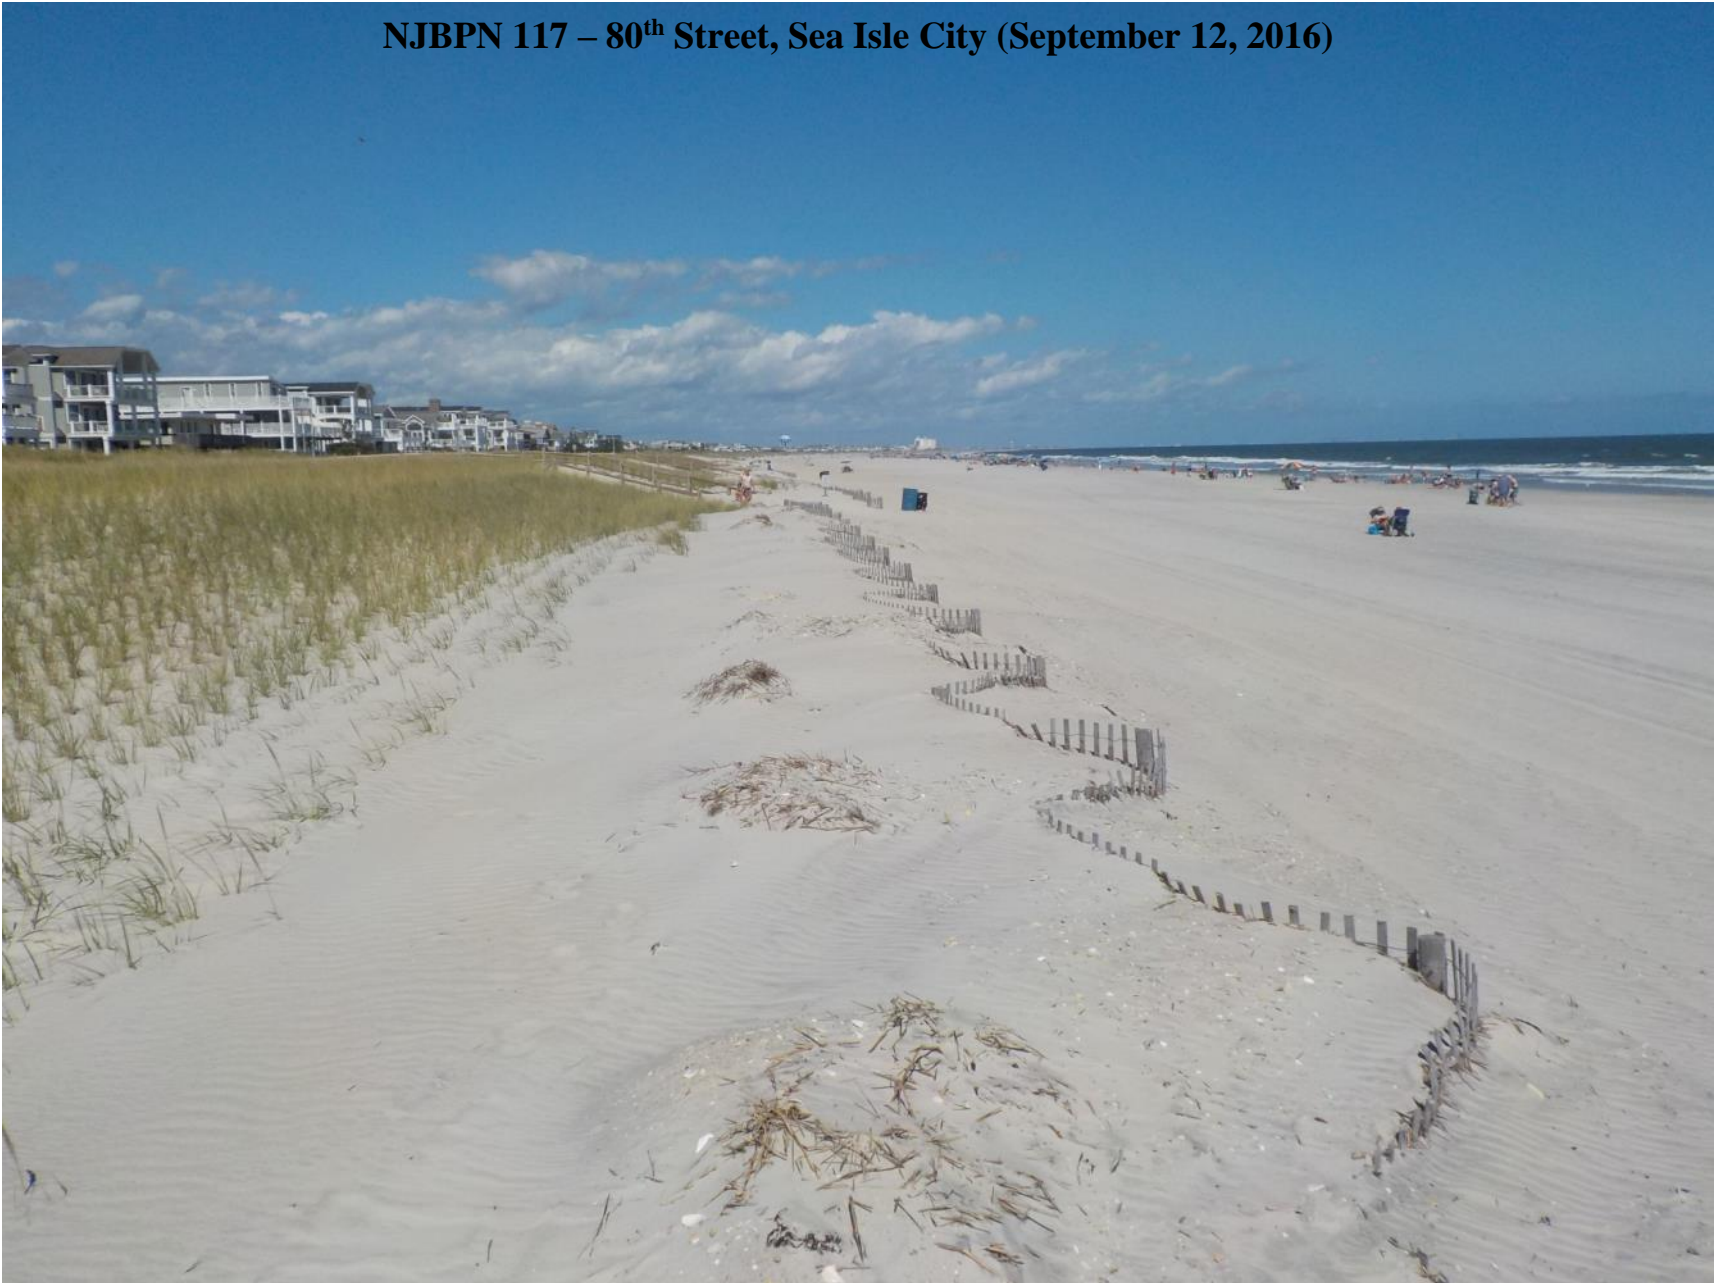
NJBPN 117 – 80th Street, Sea Isle City (September 12, 2016)

Figure 518. View to the north along the dune toe at the south end of Ludlam Island. The fencing was all but buried within a year of its installation.

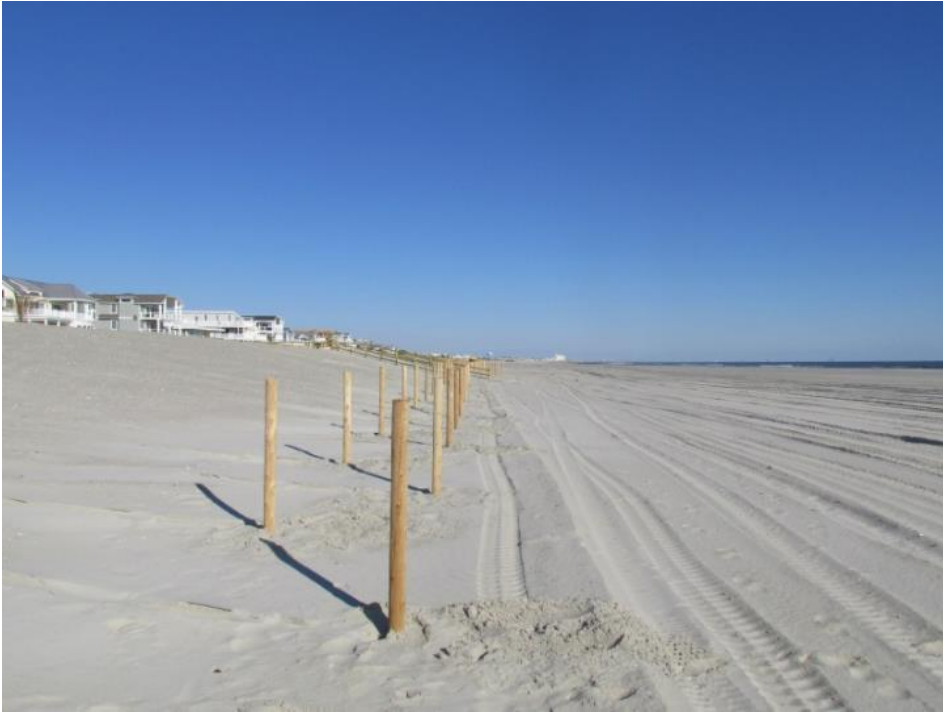
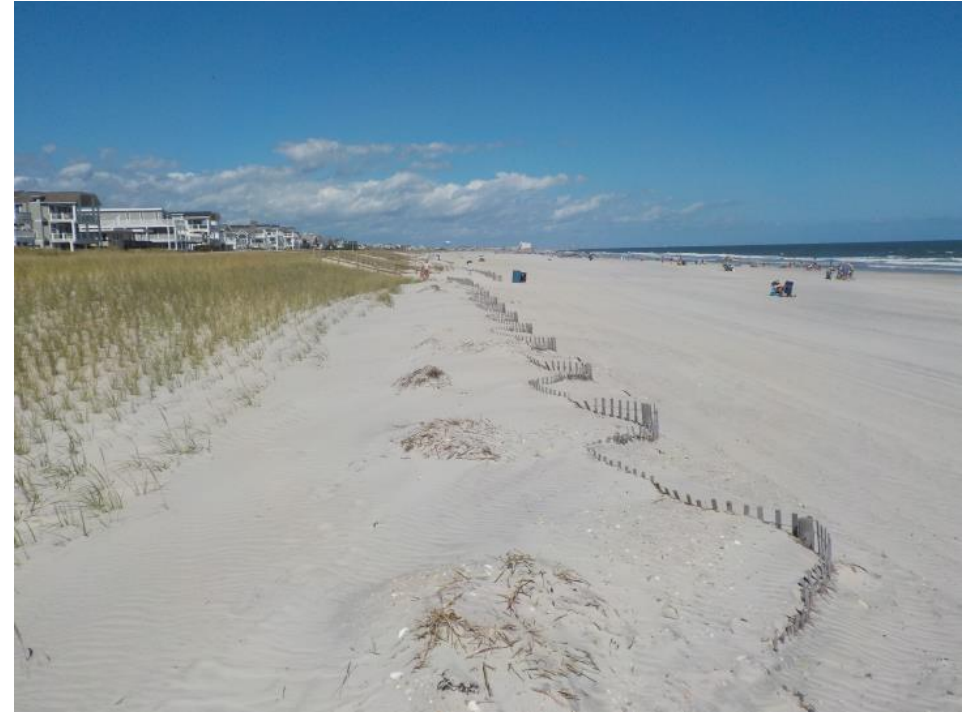
Figure 519a & 519b. The left photo was taken November 24, 2015 and shows the new fence line on the dune feature being installed during the federal project. The right photo, taken on September 12, 2016, shows the significant amount of wind-transported sand that was deposited around the newly installed, 4-foot high fence over a period of one year.

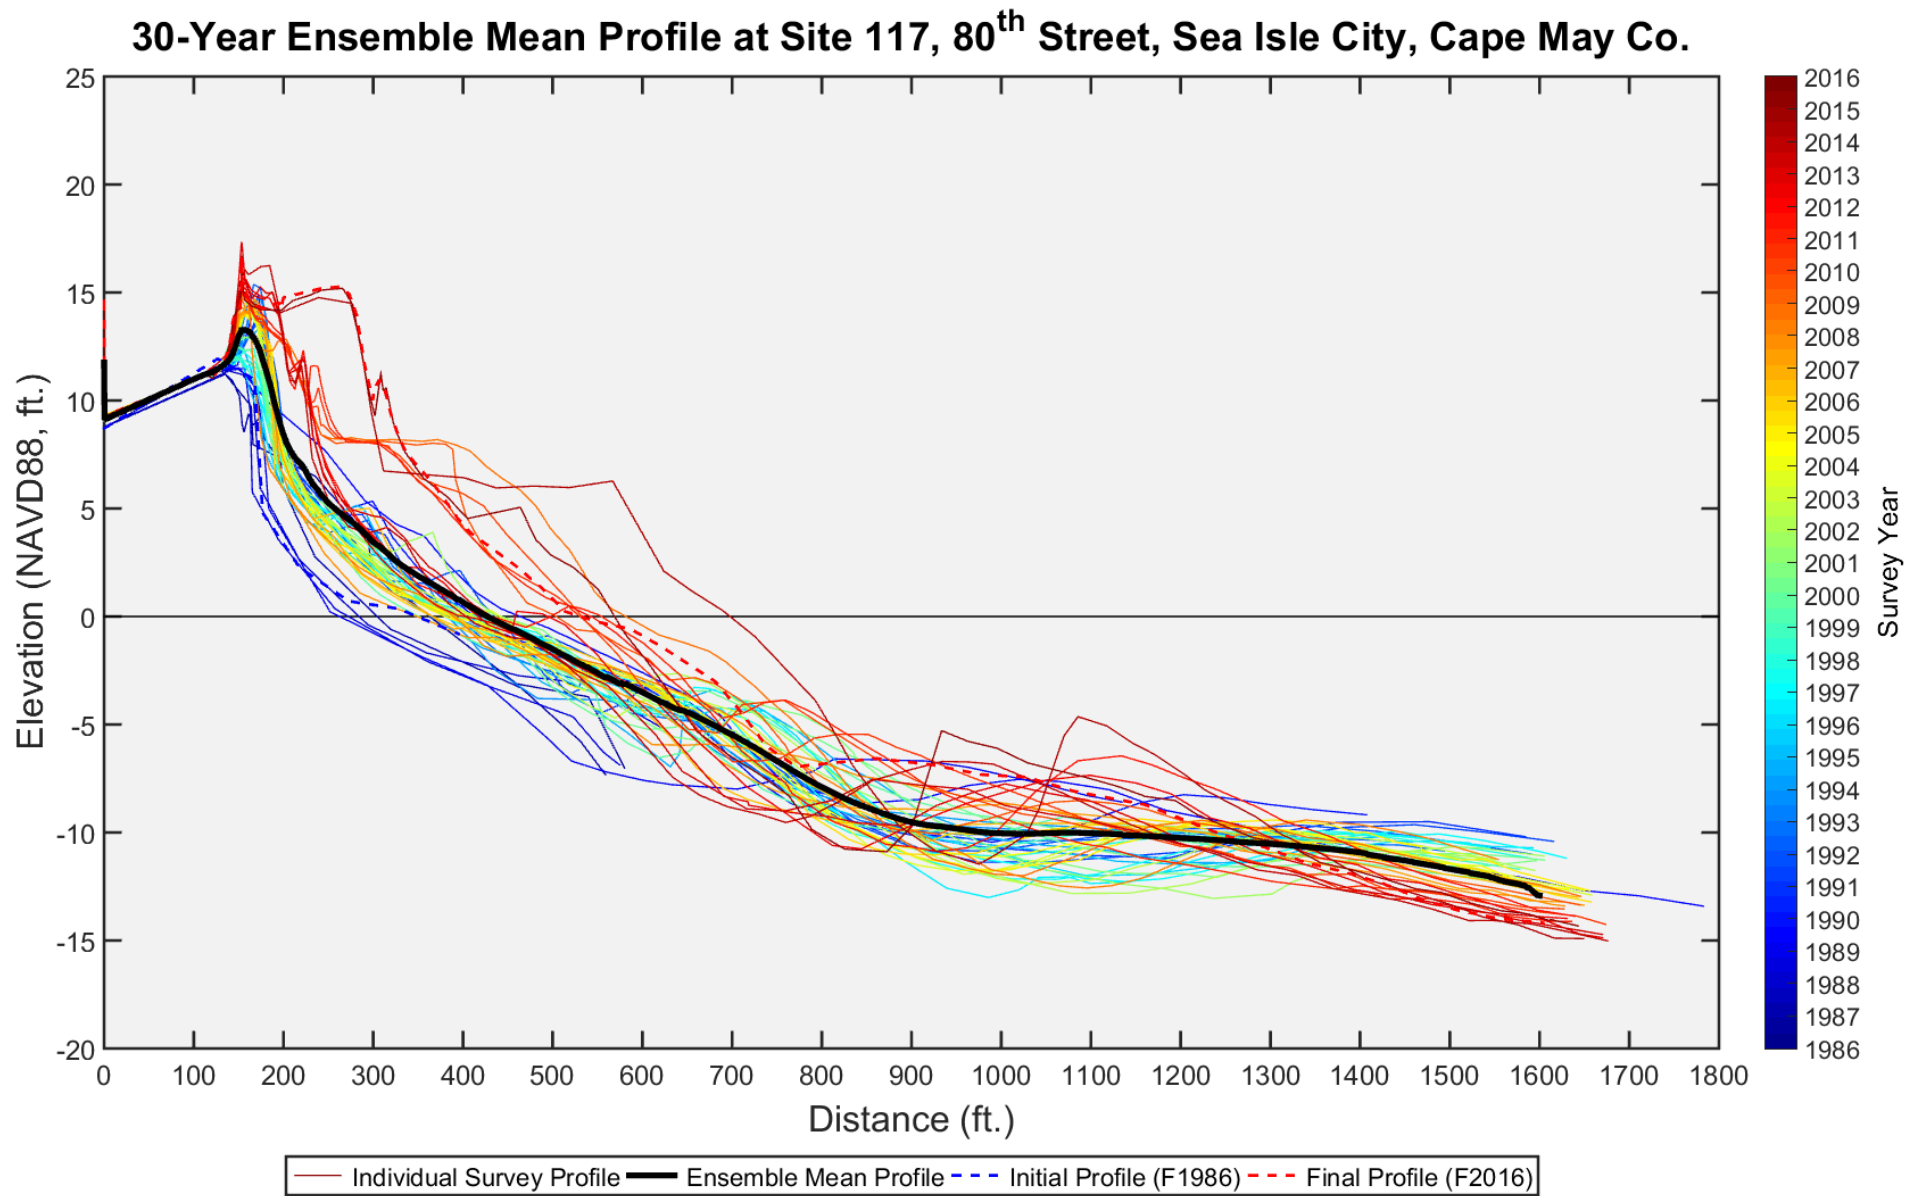
Figure 522. The random beach nourishment efforts over the years and the site’s proximity to Townsends Inlet have randomized the color positions as a trend at this site between episodes of erosion and sand placement. The dune and beach has grown larger as the 2015 USACE project was completed.
