An Analysis of Thirty Years' Study of Sand Redistribution and Shoreline Changes in New Jersey's Four Coastal Counties Raritan Bay, the Atlantic Ocean Coast, and Delaware Bay Fall 1986 Through Fall 2016

VOLUME 4 of 4 CAPE MAY COUNTY & APPENDIX

Prepared for:
New Jersey Department of Environmental Protection
Division of Construction and Engineering
1510 Hooper Avenue, Toms River, New Jersey 08753

Prepared by:
The Stockton University Coastal Research Center
30 Wilson Avenue, Port Republic, NJ 08241

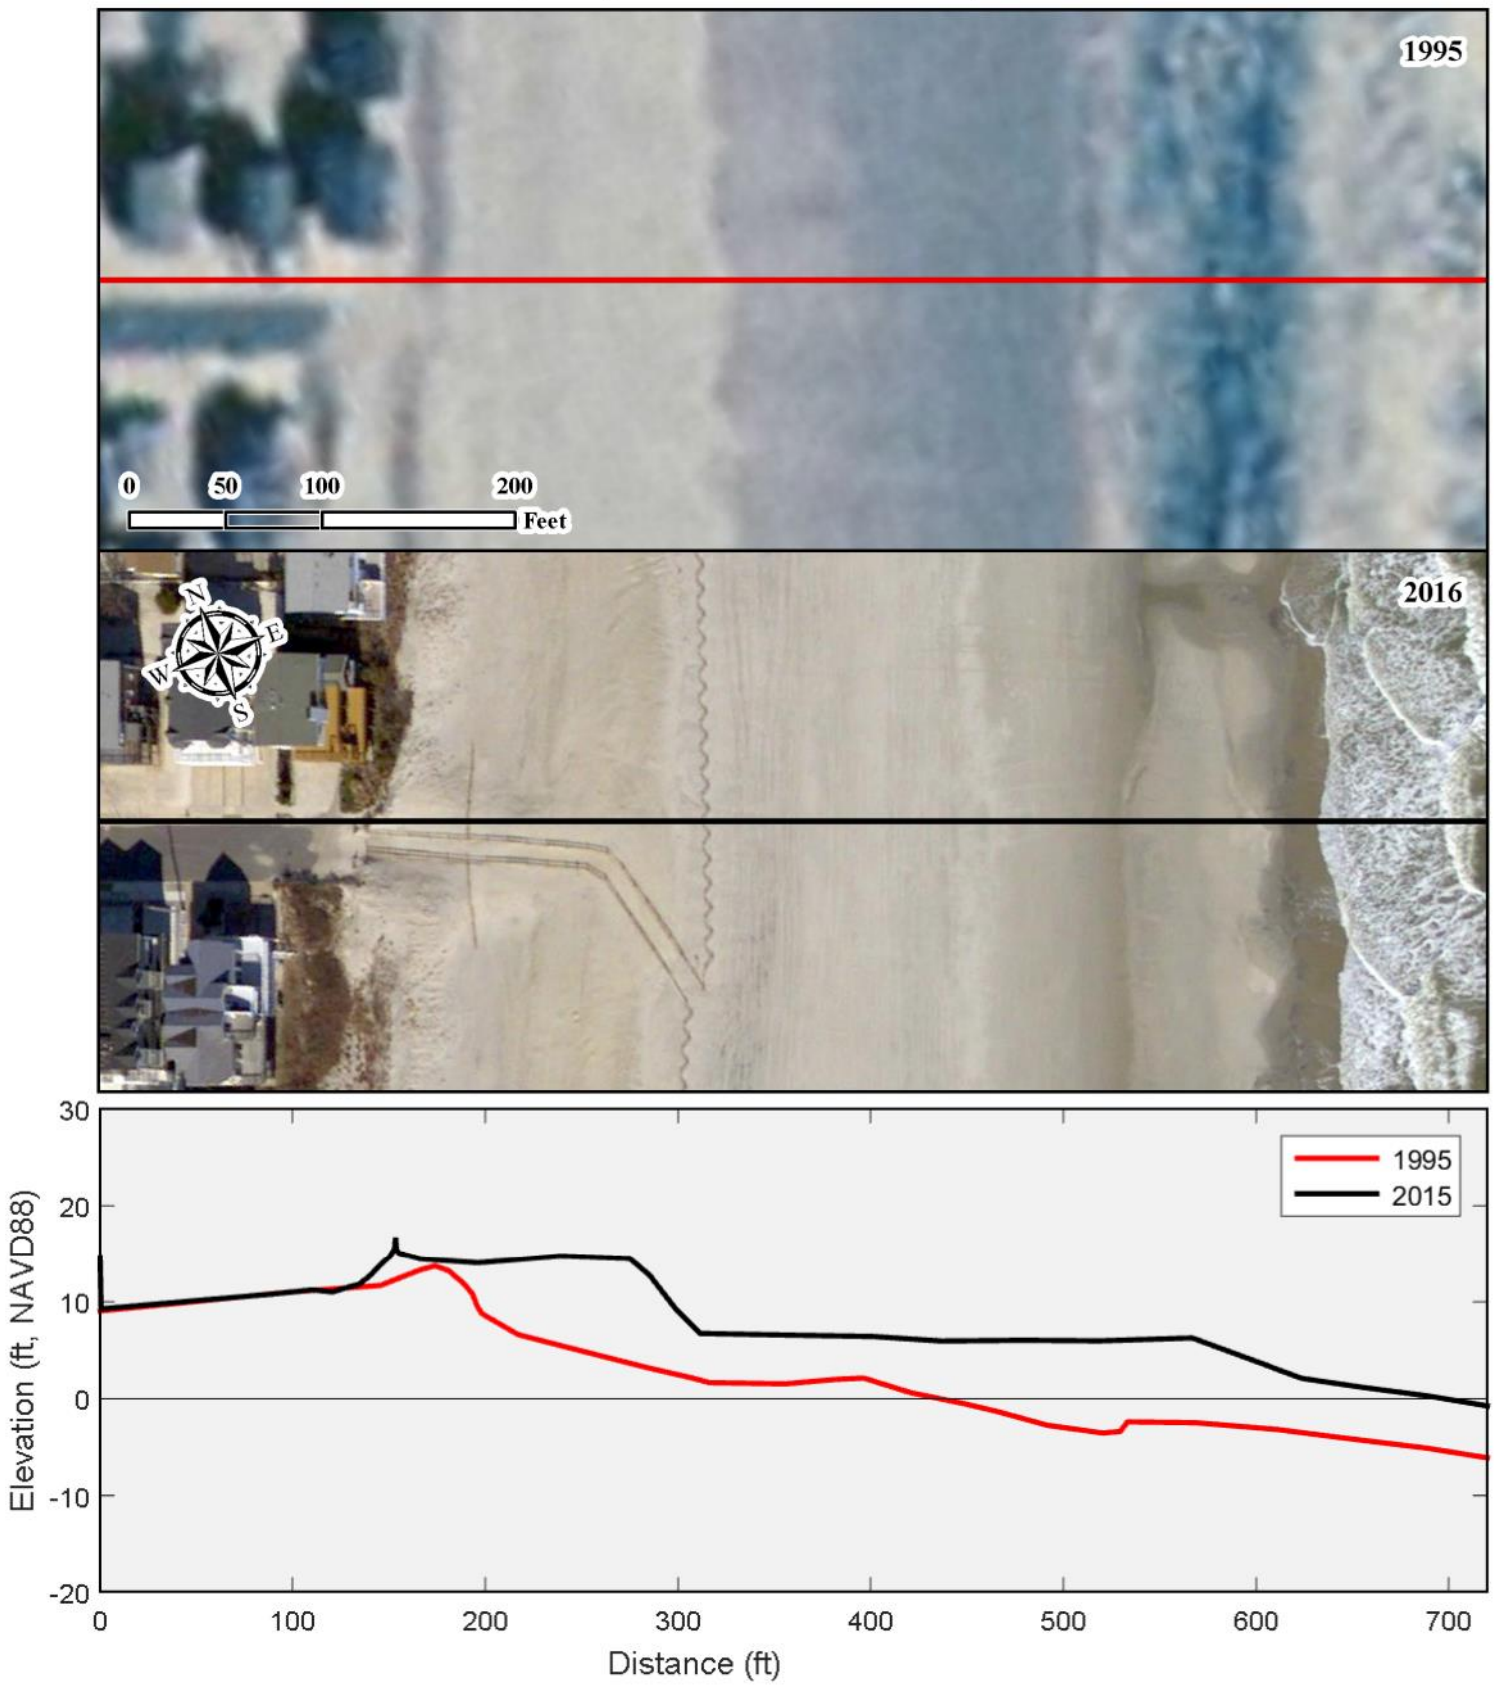
Figure 523. Periodic beach nourishment and the federal project in 2015 enhanced this beach in Sea Isle City with a much wider dune, a higher beach, and a shoreline increase of almost 300 feet.

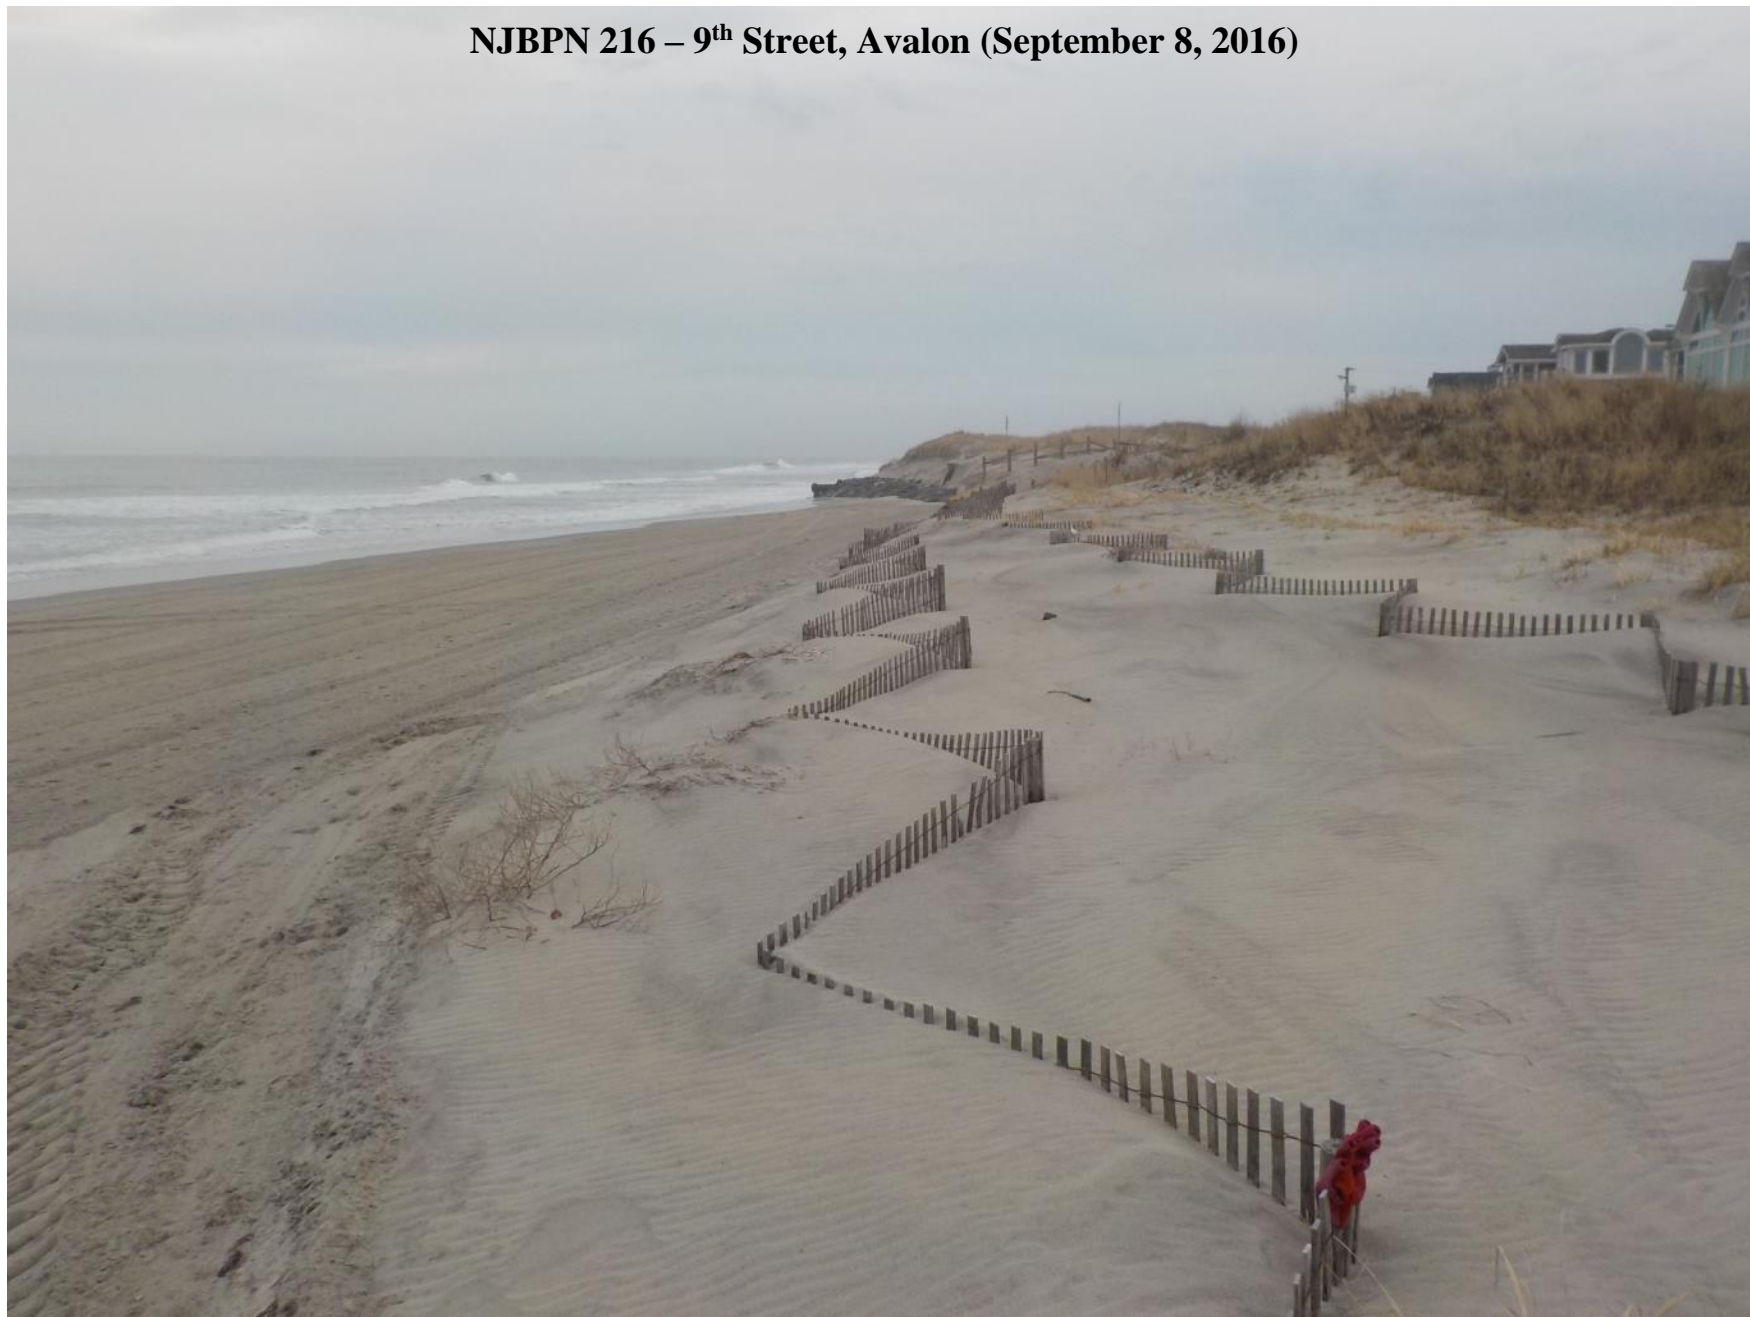
Figure 524. Two rows of sand fencing lie buried in sand placed by the Borough, yet beach erosion still reached the rock revetment at 12th Street.

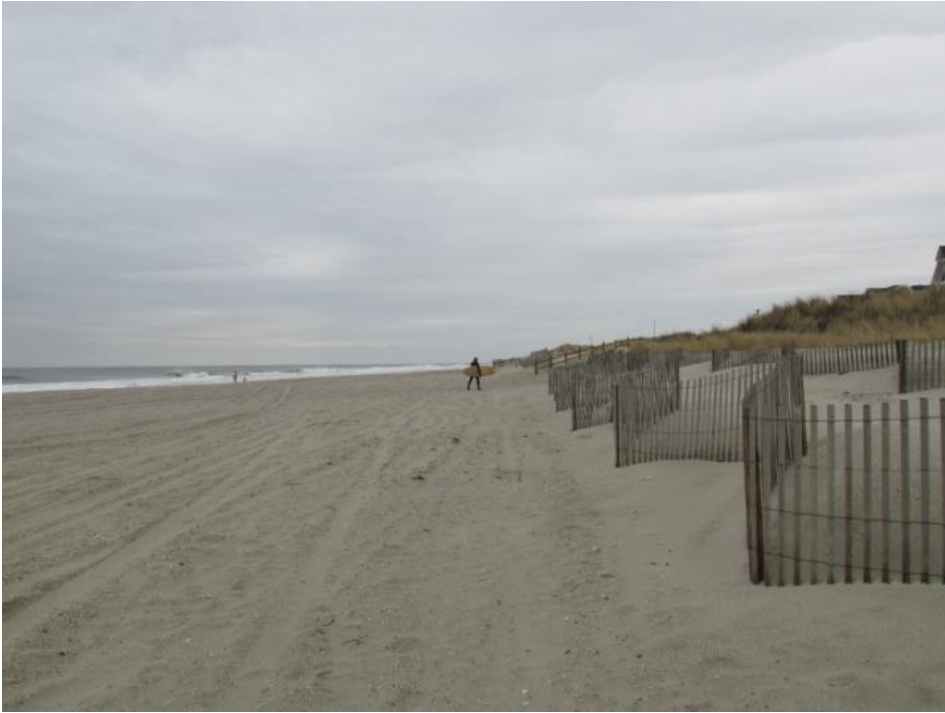
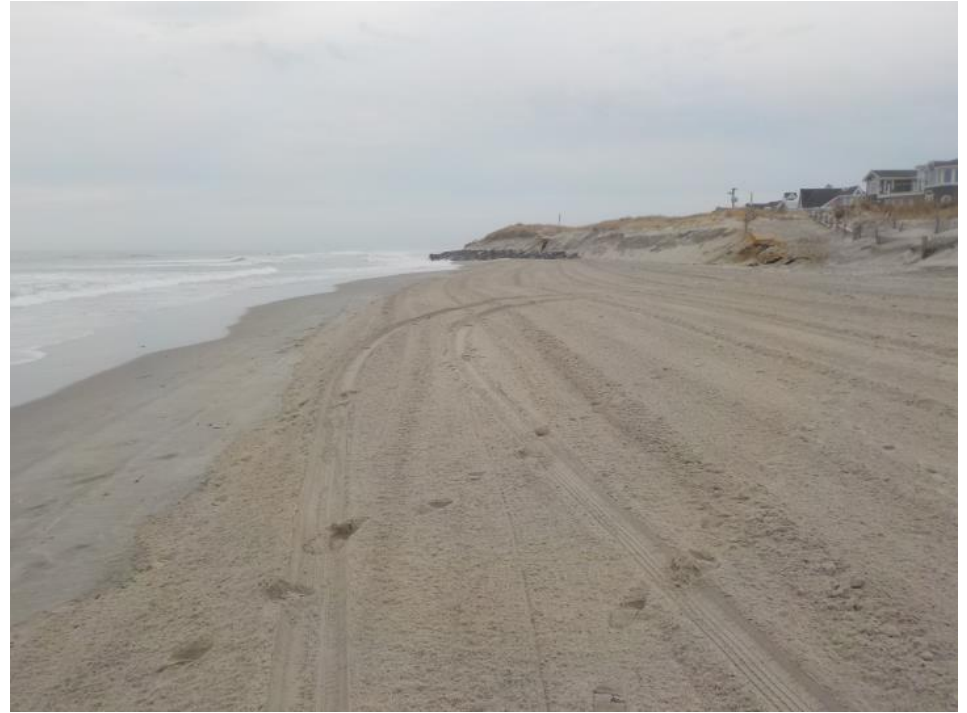
Figure 525a & 525b. The 9th Street site is located near the Townsend's Inlet south jetty. The left photo taken, on October 7, 2015, followed an Avalon-funded beach restoration in 2015 augmenting the post-Sandy federal work in 2013. Sand filled in the fencing nearly to the top of the 4-foot fence, but shoreline retreat due to several storms and frequent onshore wind and wave conditions was so extensive, that by September 8, 2016, the beach was at the 12th Street revetment rocks three blocks south of the site.

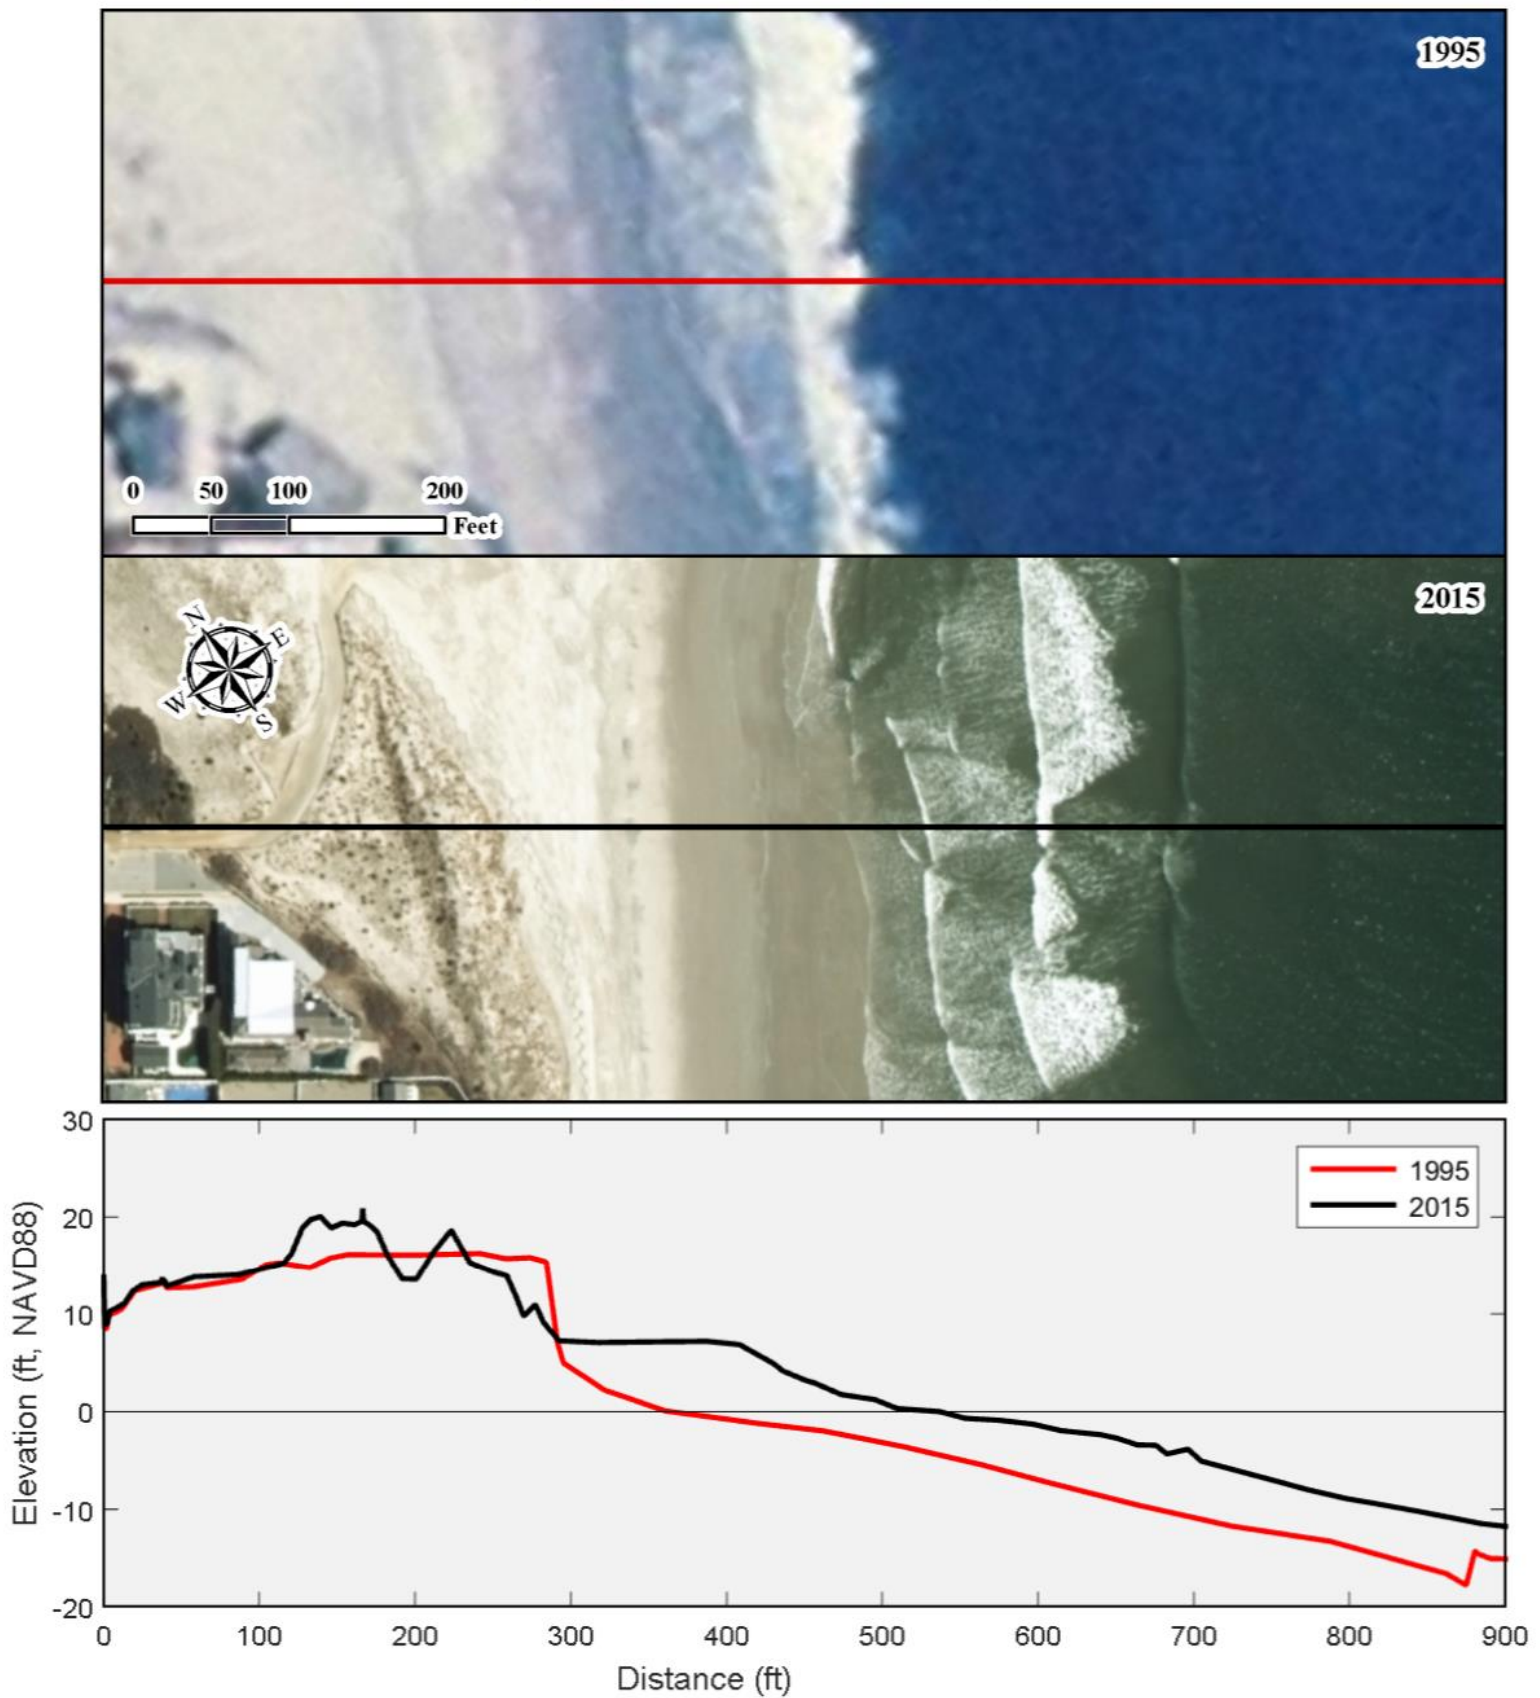
Figure 529. Added in 1994 to provide better inlet beach coverage, this site has benefitted from beach restoration since 1987, when Avalon produced its initial effort. Now part of the federal shore protection program, the site continues to be periodically nourished in order to maintain the dune and beach configuration.

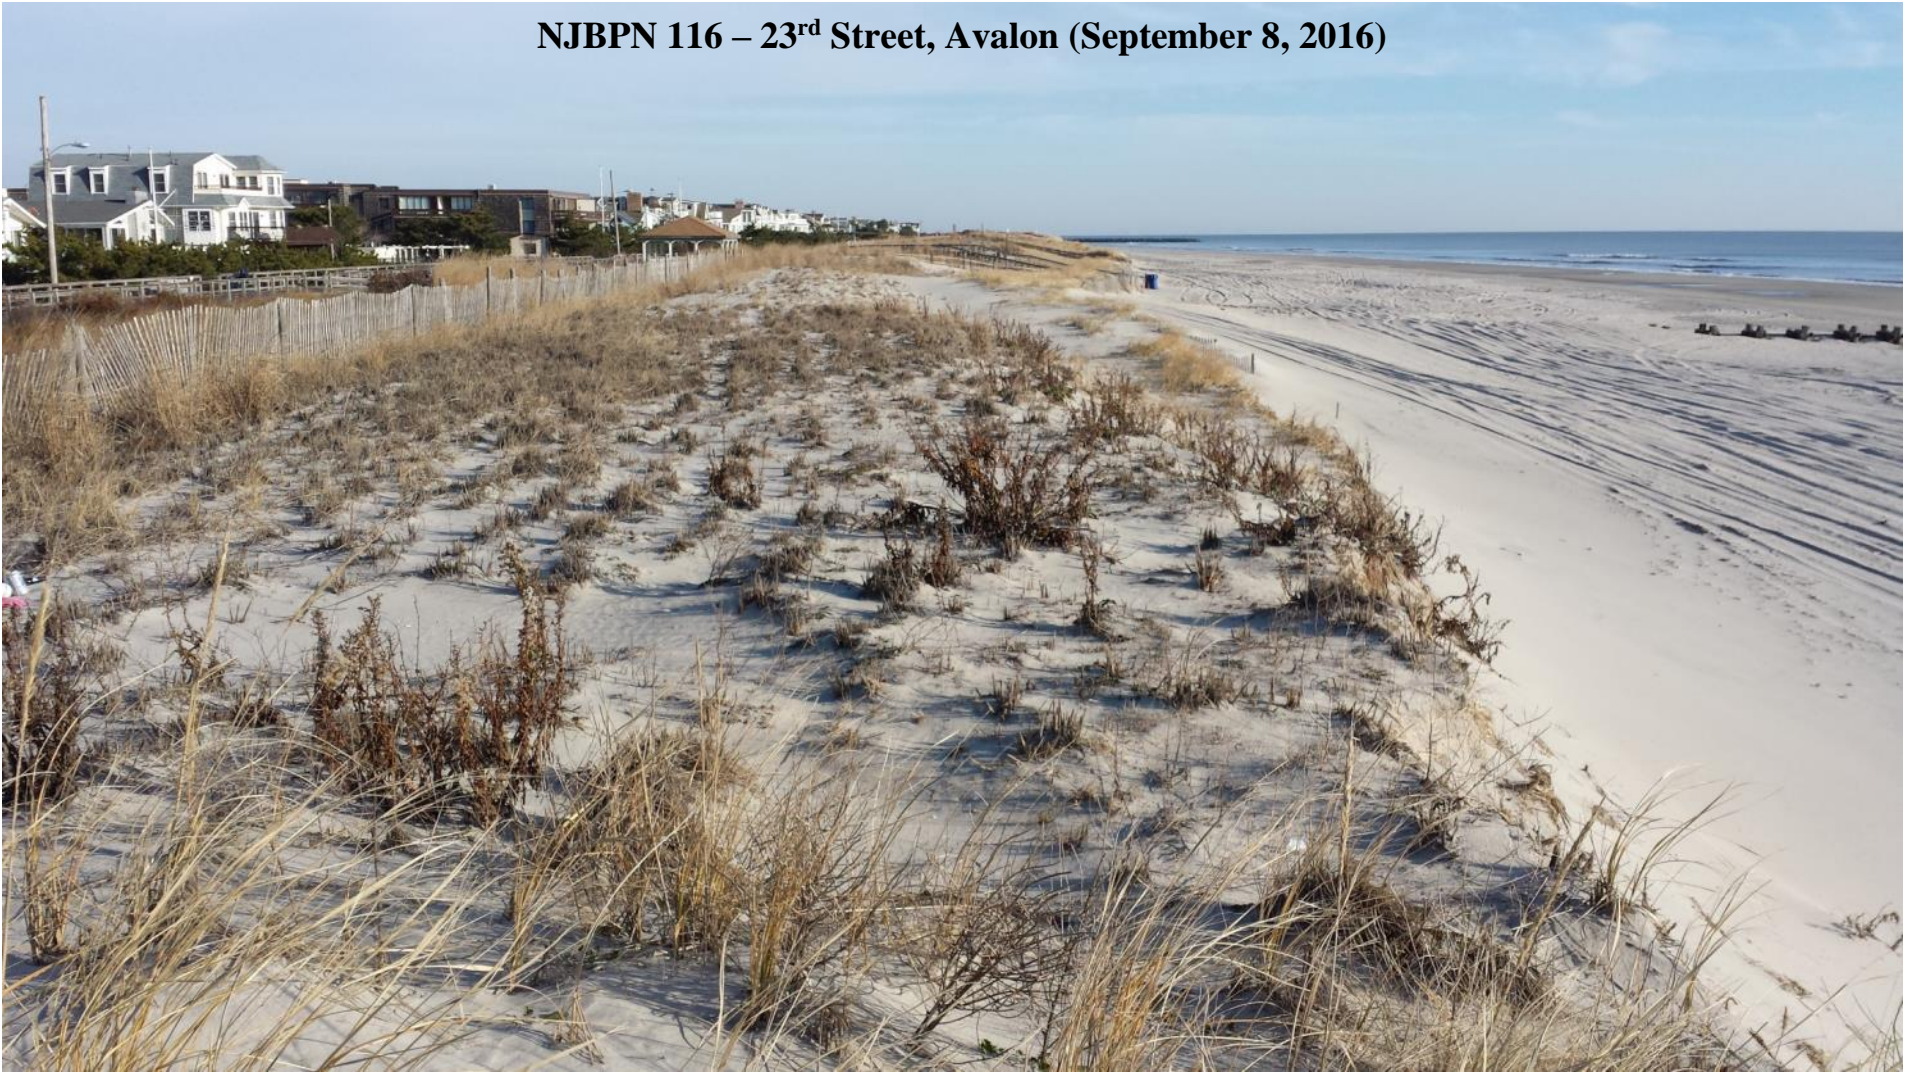
Figure 530. By September 2016, the beach was in fair condition with the storm water discharge line still buried at the dune toe, but not out on the berm. Wind deposition had added sand to the dune and its seaward slope.

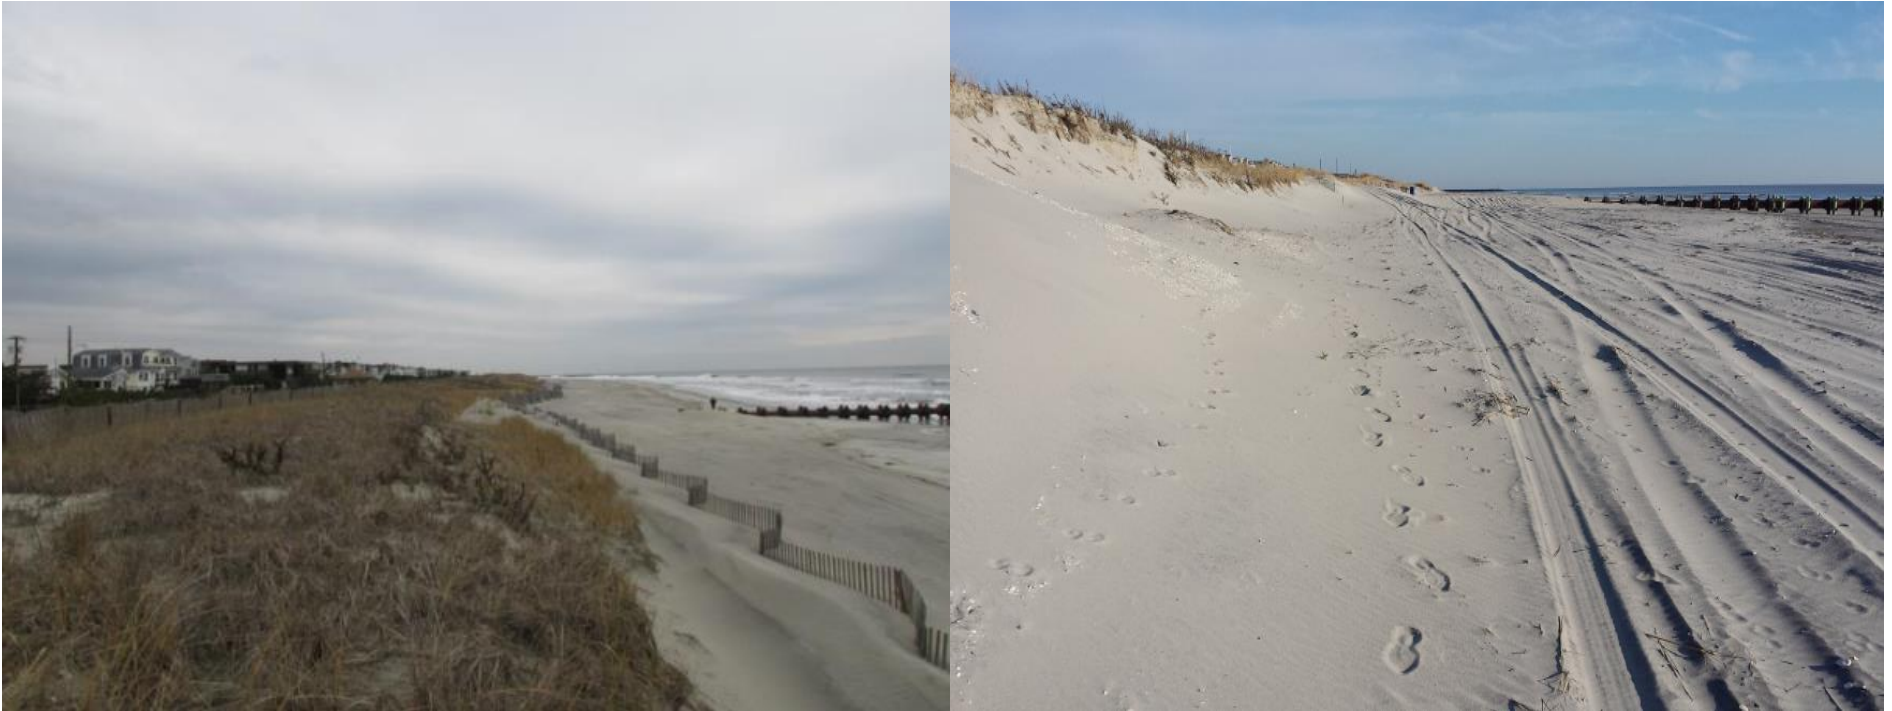
Figure 531a & 531b. The left picture was taken from the dune crest on October 15, 2015 following the Borough beach project. By September 8, 2016 (right picture) the beach was slightly wider and sand had deposited at the dune toe.

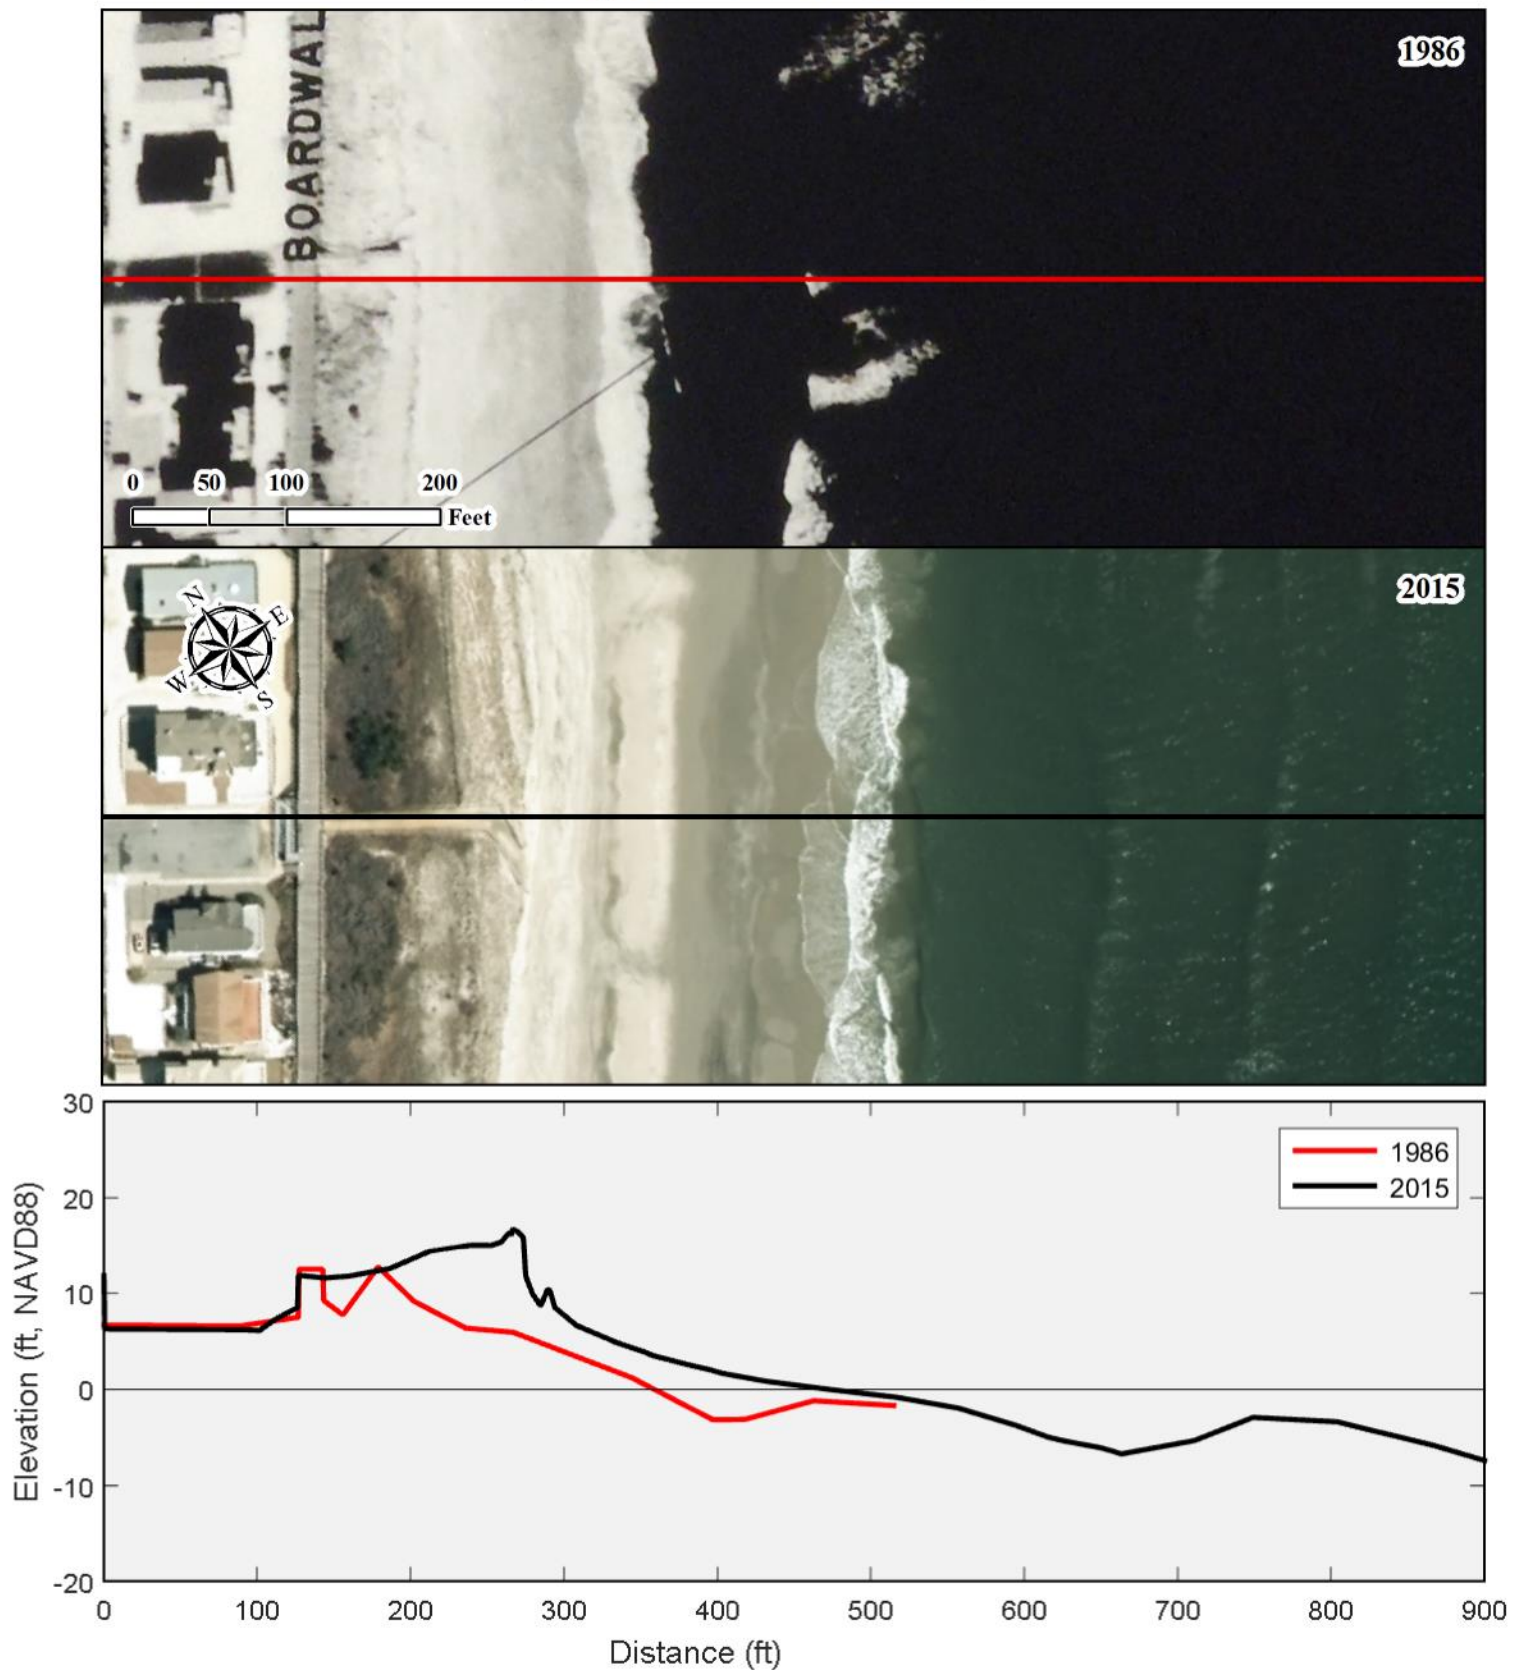
Figure 535. This Avalon site was repeatedly supplied with sand from Townsend’s Inlet ebb-tidal delta since 1987, so the 1986 photograph depicts a pre-nourished narrow beach and low dune that became dramatically worse by April 1987 (the high water line was landward of the boardwalk). This dramatic shoreline retreat triggered the initial beach restoration during that year. The beach has grown slightly from 1986 to 2015 and the dune has become much more robust.

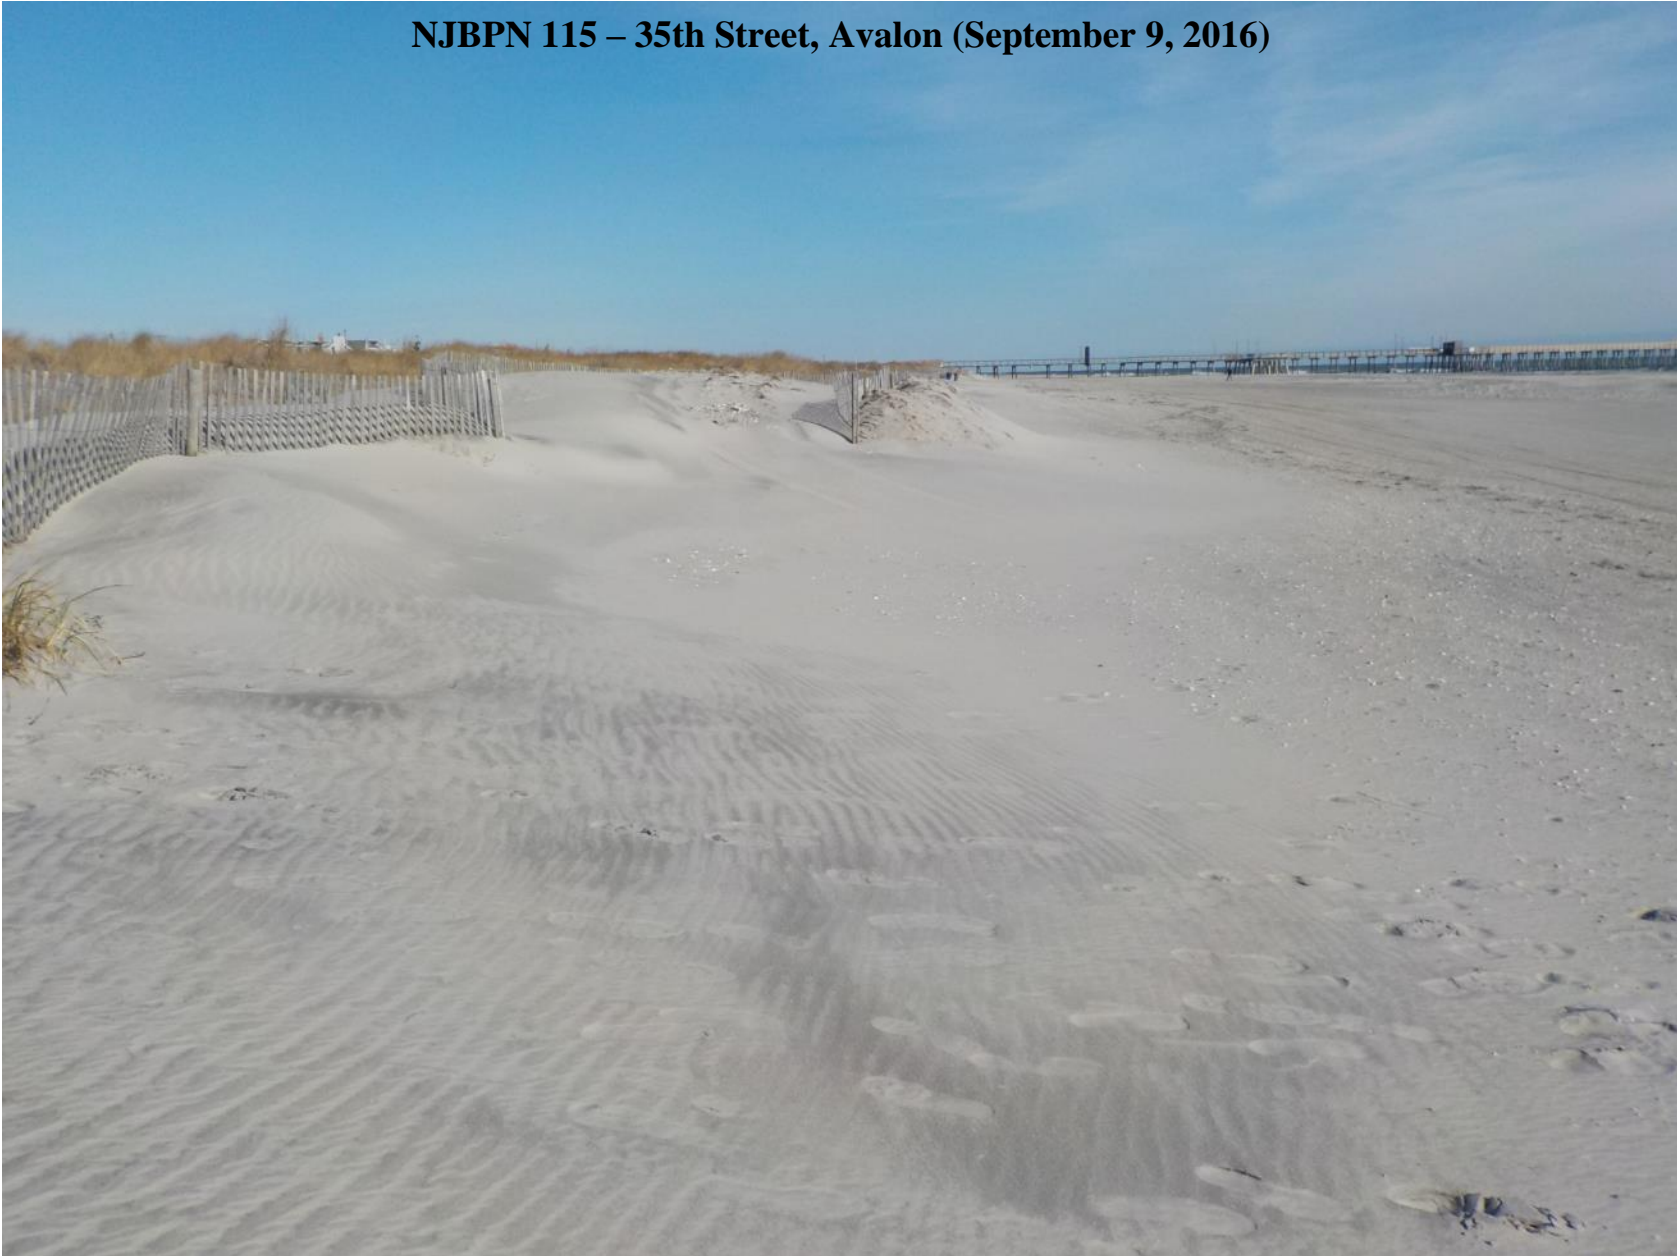
NJBPN 115 – 35th Street, Avalon (September 9, 2016)

Figure 536. Looking north from the dune toe at 35th Street in Avalon, the newly extended pier at 32nd Street now reaches the ocean again. Sand was transported north from this site in 2016 by the Borough in a back-passing operation. Wind deposition has added to the dunes, while the harvest zone (for the back-passing operation) was completely filled back by June.

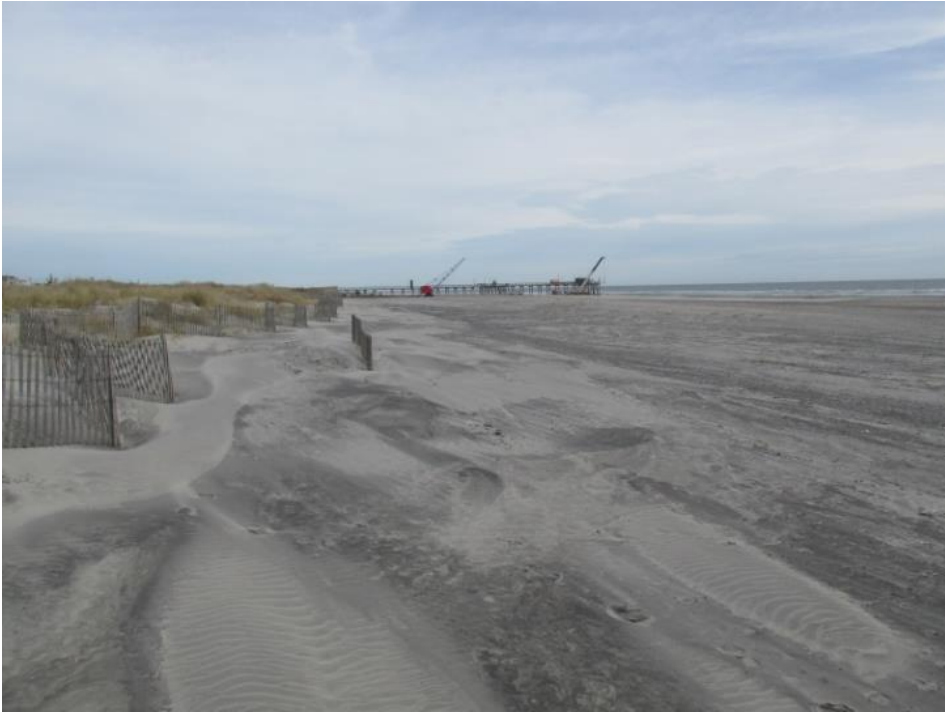
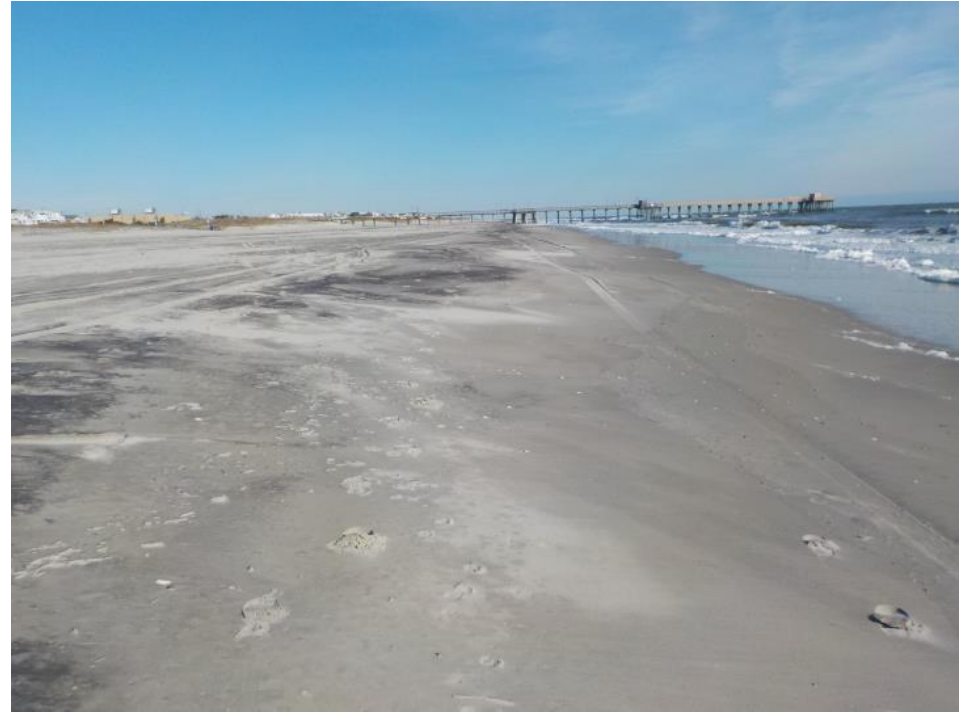
Figure 537a & 537b. Photo on the left is 35th Street as of October 6, 2015 and shows a wide beach, with aeolian sand deposition along the dune fence that has seen sand blown into the dunes yet again. The photo on the right was taken from the berm on September 9, 2016 and shows the new, extended pier and the general beach width at this site several months following sand harvesting for the back-passing project. Sand volume has already naturally recovered and restored the beach width and berm elevation to pre-project conditions.

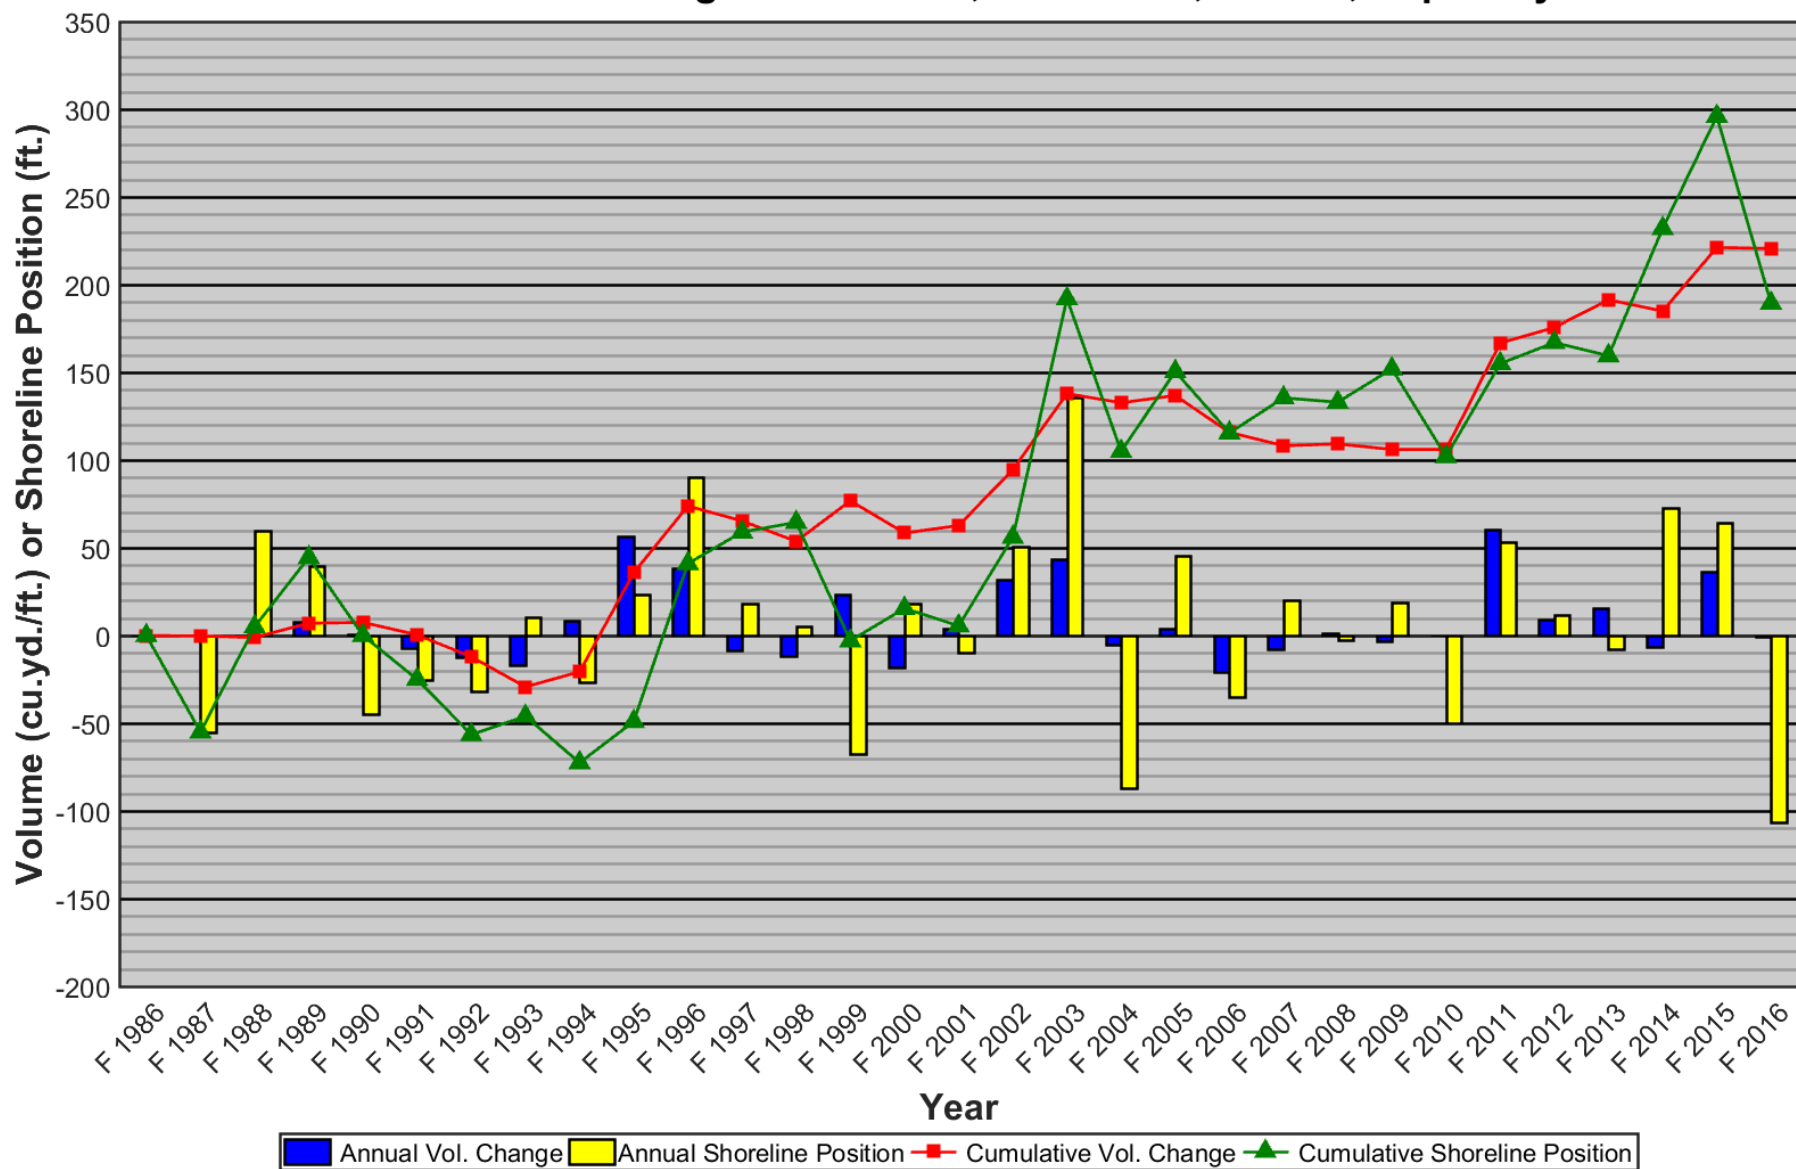
Figure 539. The 35th Street site represents a significant trend in beach enhancement without a direct placement of sand ever occurring. The 1987 fill had a minor impact by 1990 that faded badly by 1994. Recovery due to the influx of new sand followed by a drop in sand volume reached another low point by 2001 as sand cycled through on longshore currents. The USAACE project occurred, but sand was not placed this far south. Longshore currents, however, carried sand south from the fill area and caused material to accumulate at this site fairly rapidly. The next 8 years saw relative stability with subsequent advances in 2013 and 2015, resulting in a net gain in volume of 220 yds³/ft. and a 190-foot shoreline advance.
