An Analysis of Thirty Years' Study of Sand Redistribution and Shoreline Changes in New Jersey's Four Coastal Counties Raritan Bay, the Atlantic Ocean Coast, and Delaware Bay Fall 1986 Through Fall 2016

VOLUME 4 of 4 CAPE MAY COUNTY & APPENDIX

Prepared for:
New Jersey Department of Environmental Protection
Division of Construction and Engineering
1510 Hooper Avenue, Toms River, New Jersey 08753

Prepared by:
The Stockton University Coastal Research Center
30 Wilson Avenue, Port Republic, NJ 08241

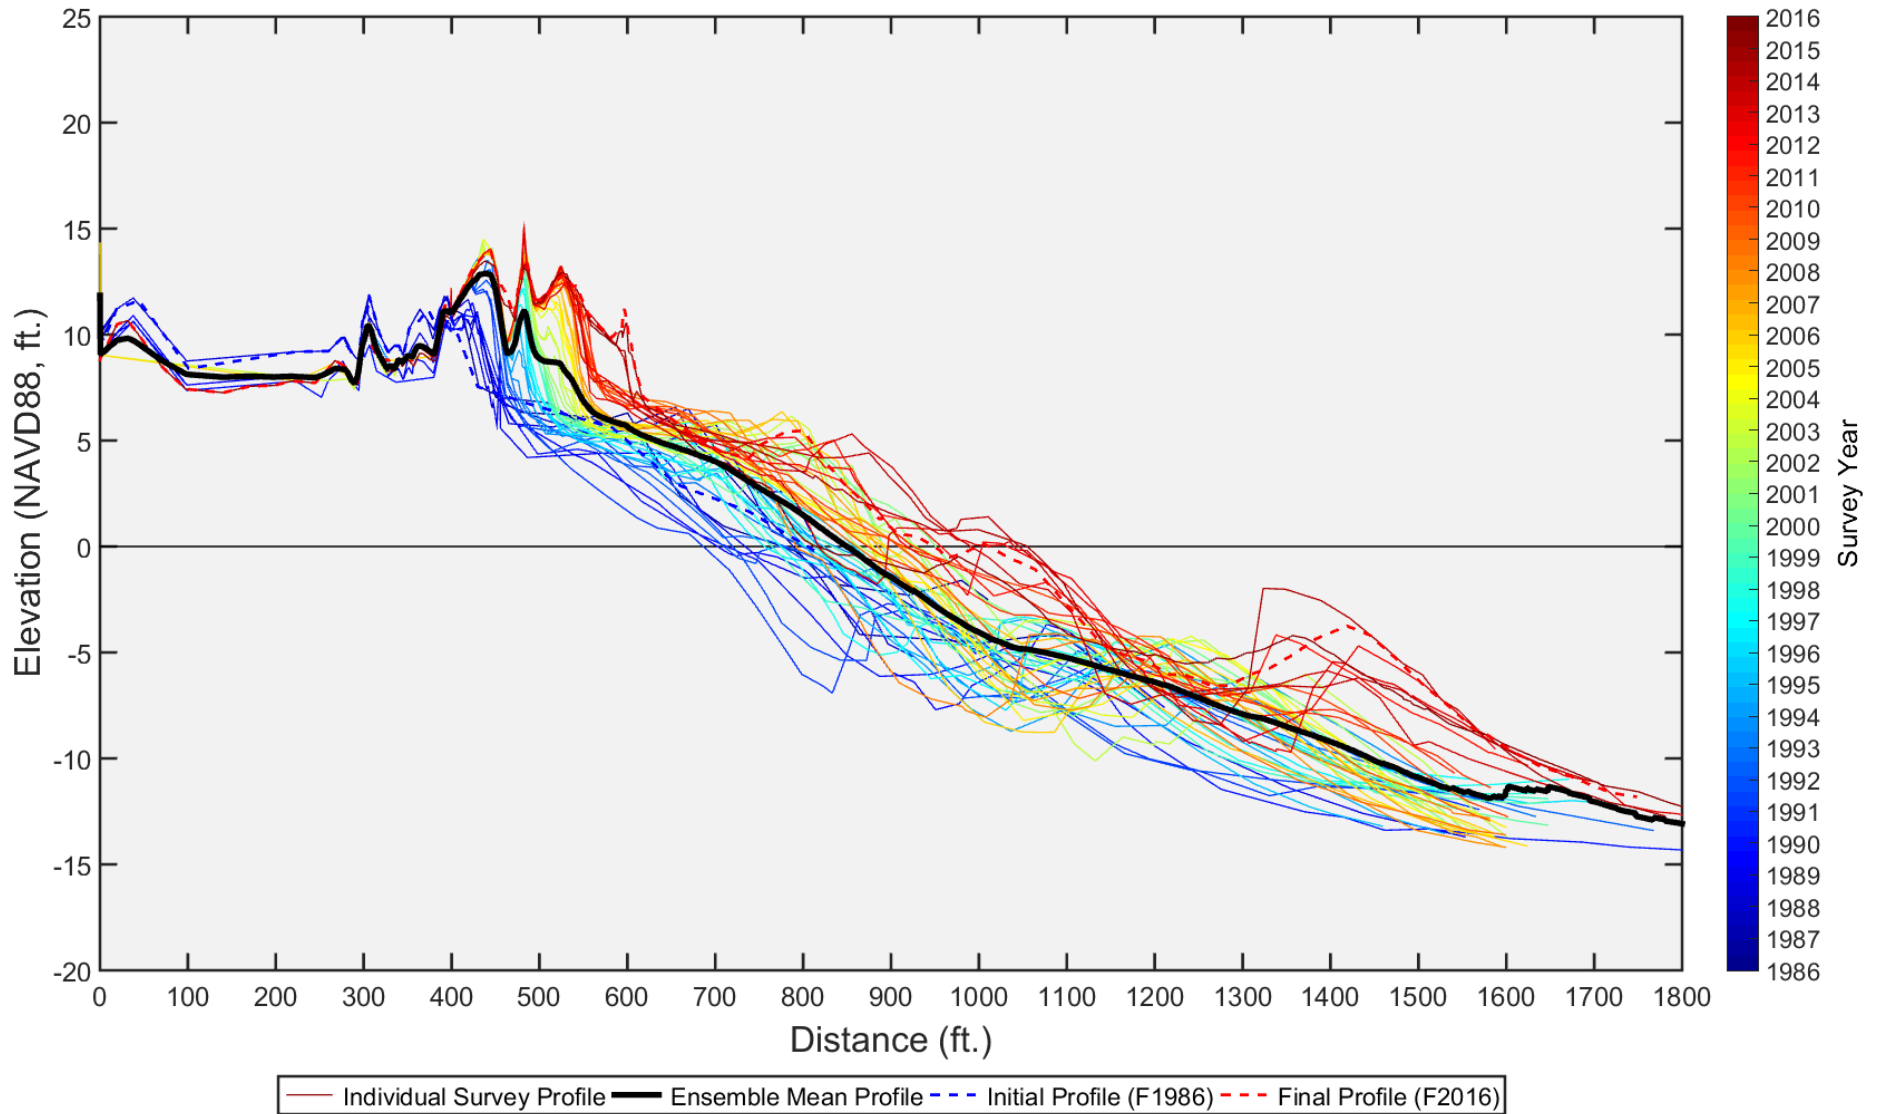
Figure 540. The general trend of beach enhancement can be seen in the progression of colors over time from blue to red with the later cross sections being higher in elevation and having shoreline positions farther seaward. The dune has also doubled in width from the early surveys.

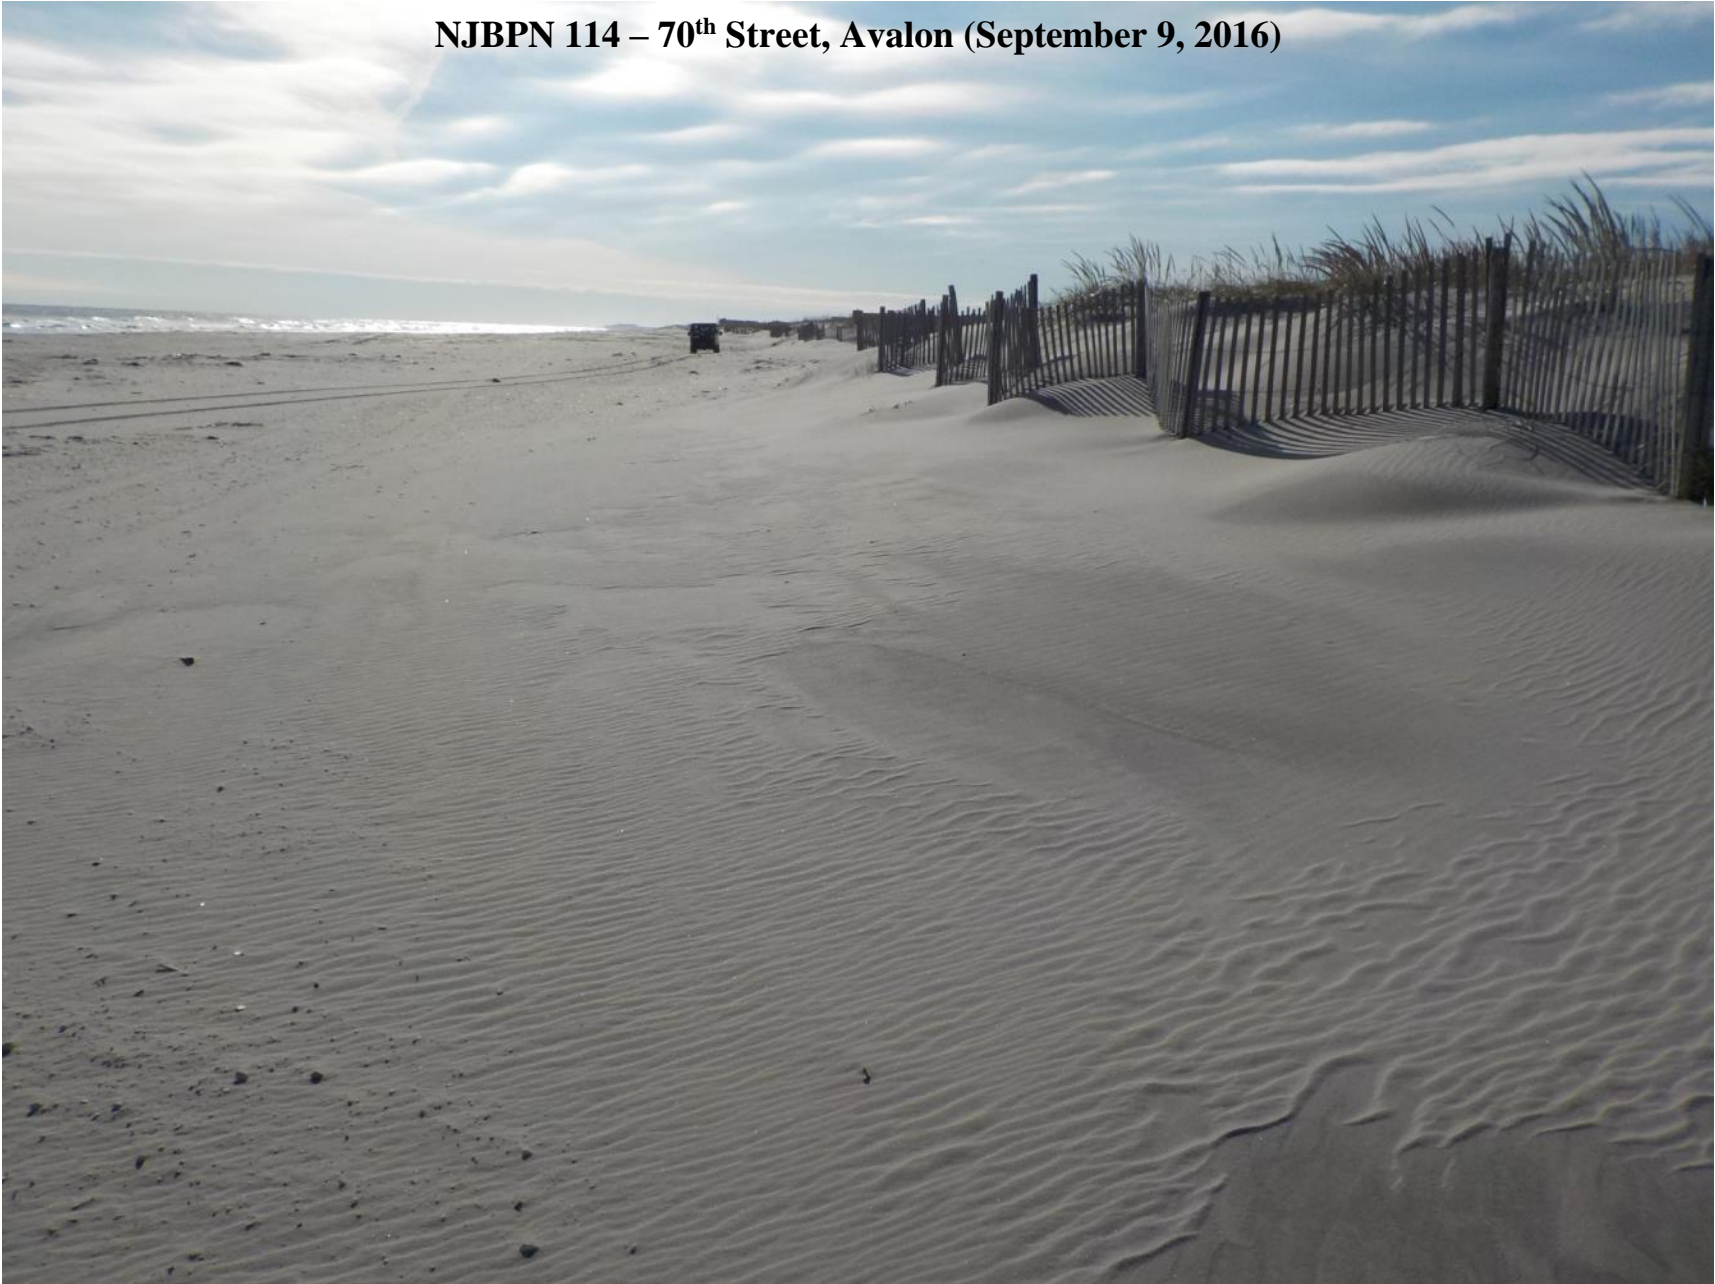
NJBPN 114 – 70th Street, Avalon (September 9, 2016)

Figure 542. Looking south along the dune toe at 70th Street in Avalon. This site is very stable, with the dune and beach accreting large amounts of sand. The accretional nature of this site is due to it being located at the northern taper of the federal project with sand only placed here once in 2003.

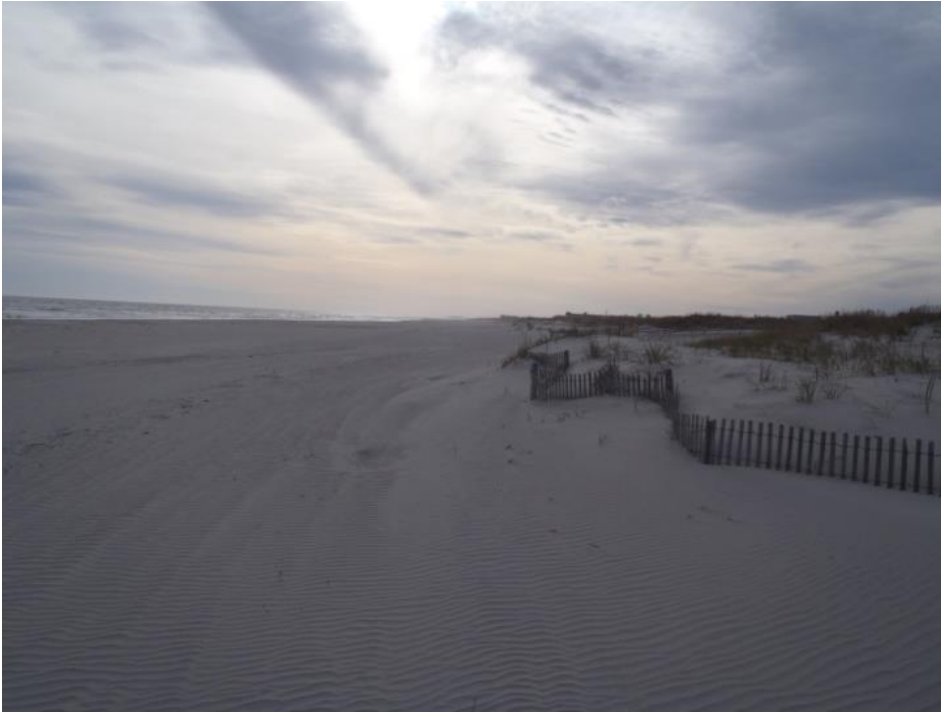
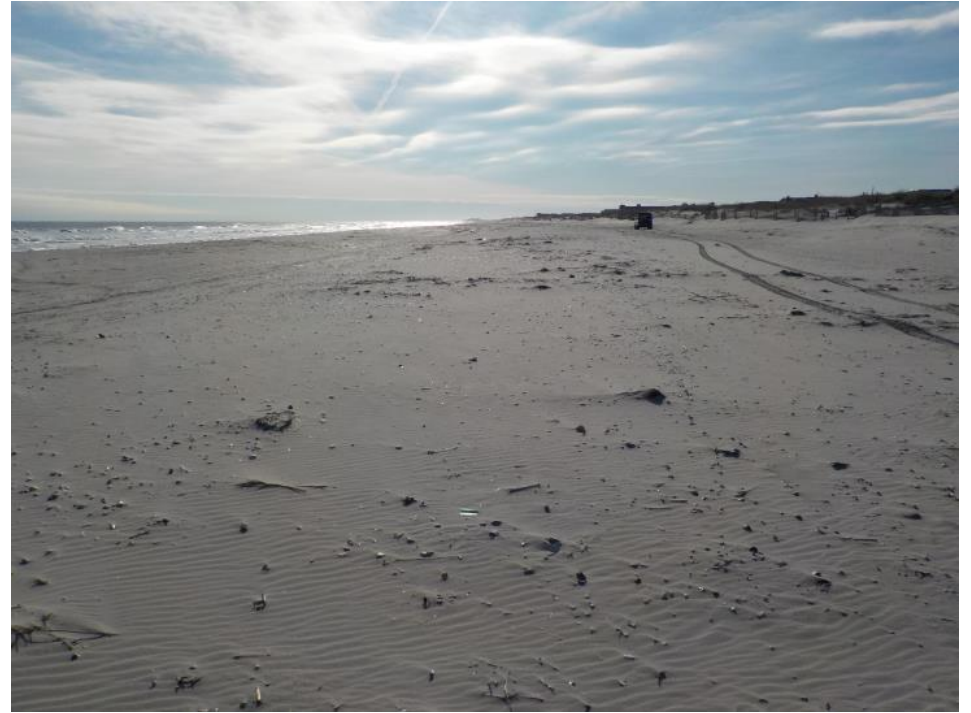
Figure 543a & 543b. The 70th Street location has been a stable area for decades and lies at the very north limit of the Stone Harbor segment of the Seven Mile Island USACE shore protection project that has a break between 31st Street and 70th Street, due to long term shoreline stability in that section. The left photo was taken October 8, 2015, and shows fencing added in 2014 being partially buried by constant wind transport of sand into the dune area. The right photograph was taken September 9, 2016 out on the berm midway between the dune toe and the swash.

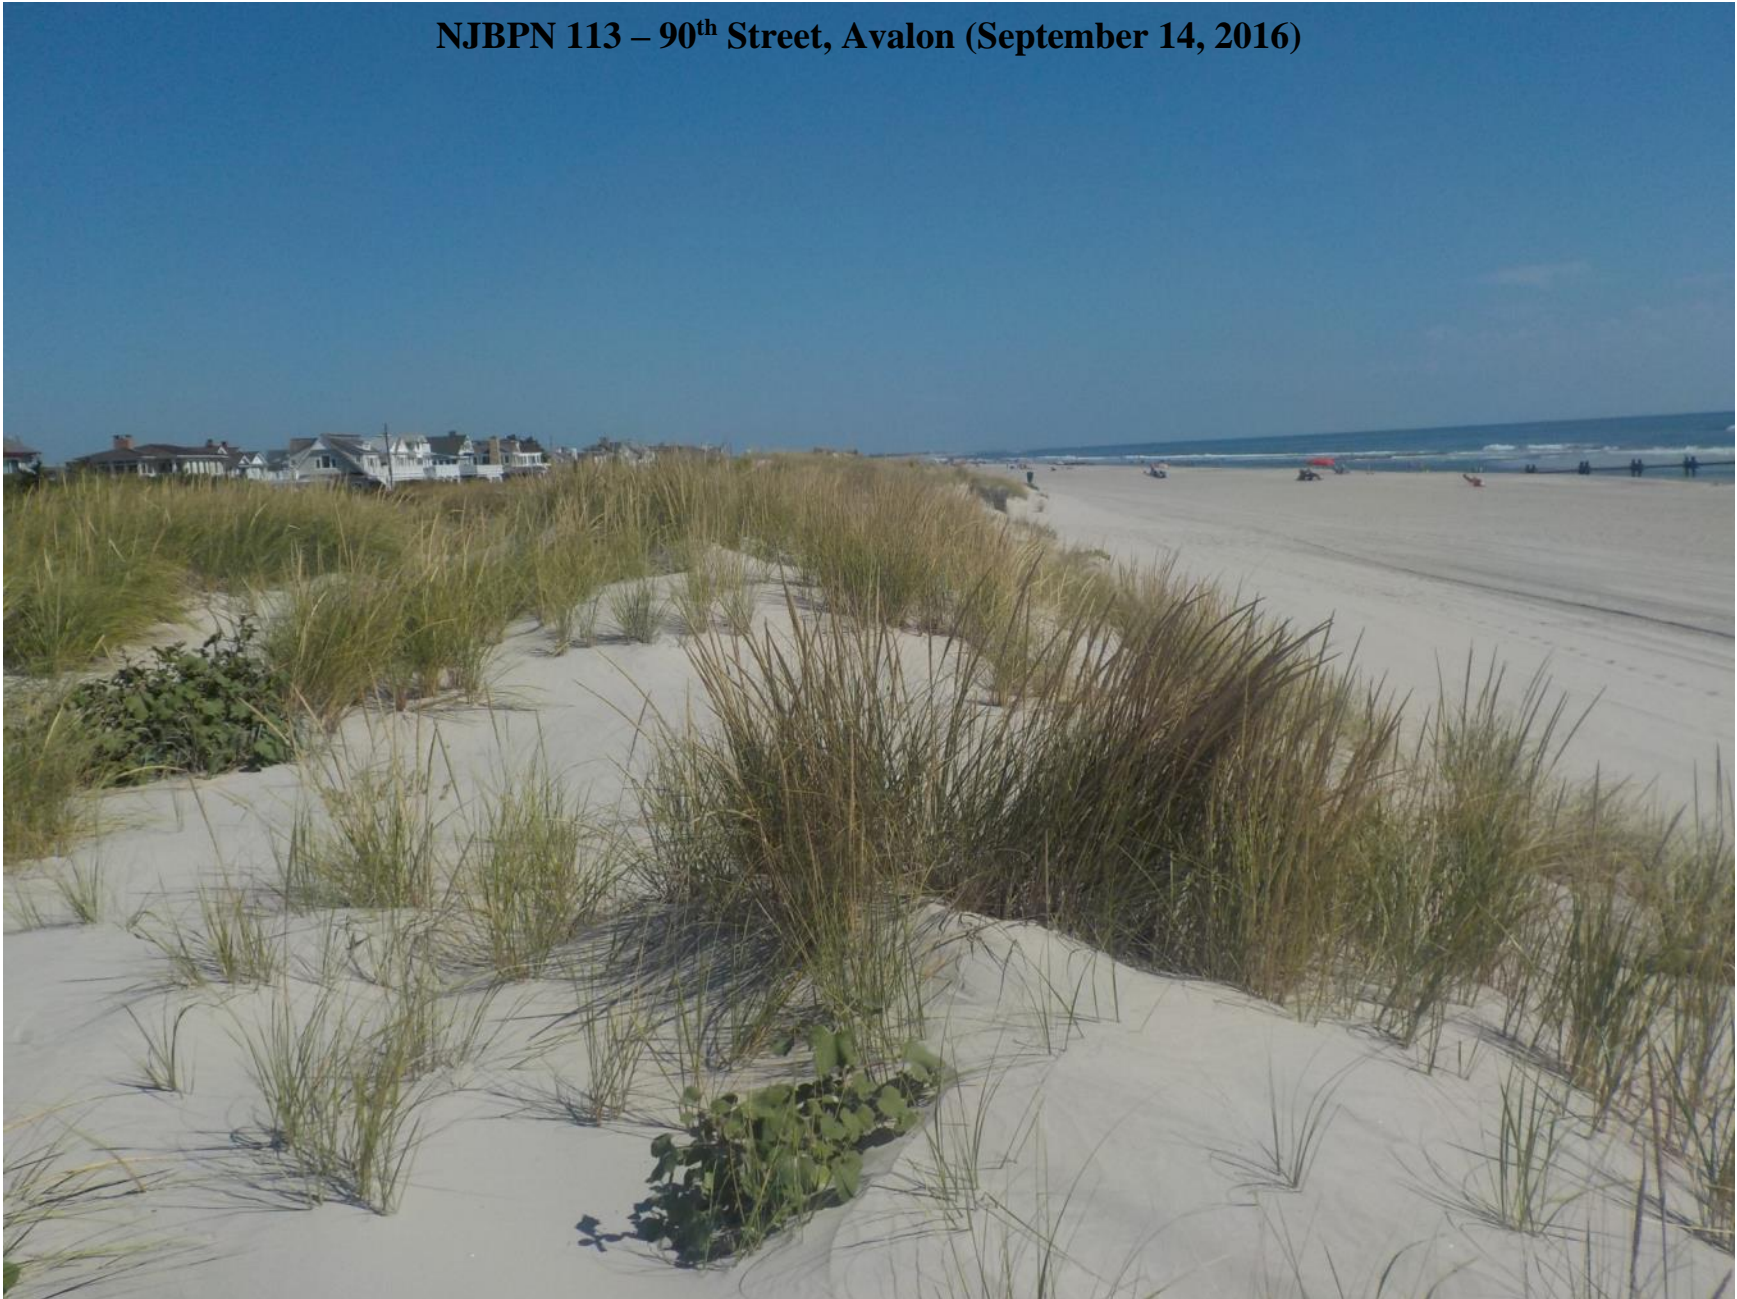
Figure 548. View north along the dune toe showing sand accumulation in the dunes and at the fence line. USACE work is anticipated here in spring 2017.

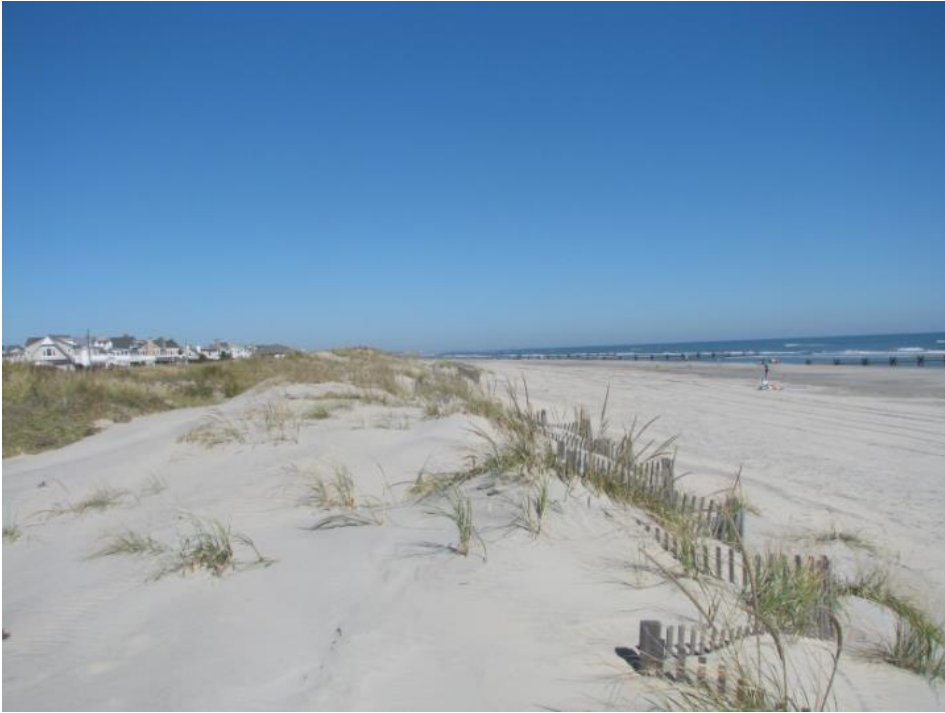
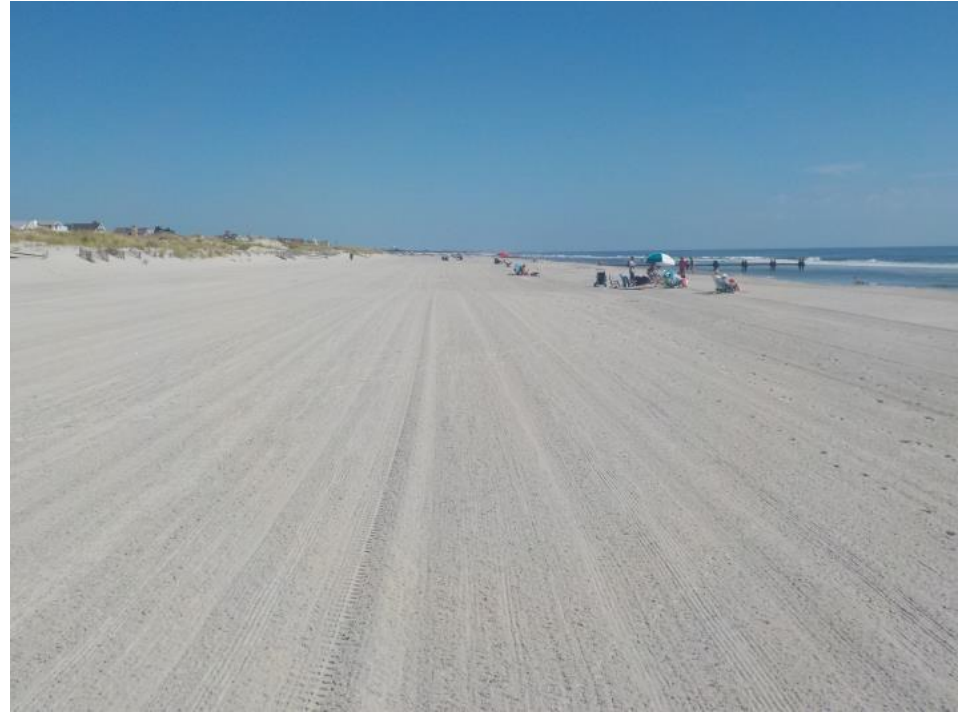
Figure 549a & 549b. The 90th Street location has been quite stable and has not required maintenance as frequently as sites farther south. The left photo, taken on October 12, 2015, shows a narrower beach with sand accumulation around the fencing. The right photograph was taken September 14, 2016 on the mid-berm looking north showing the wide relatively stable recreational beach.

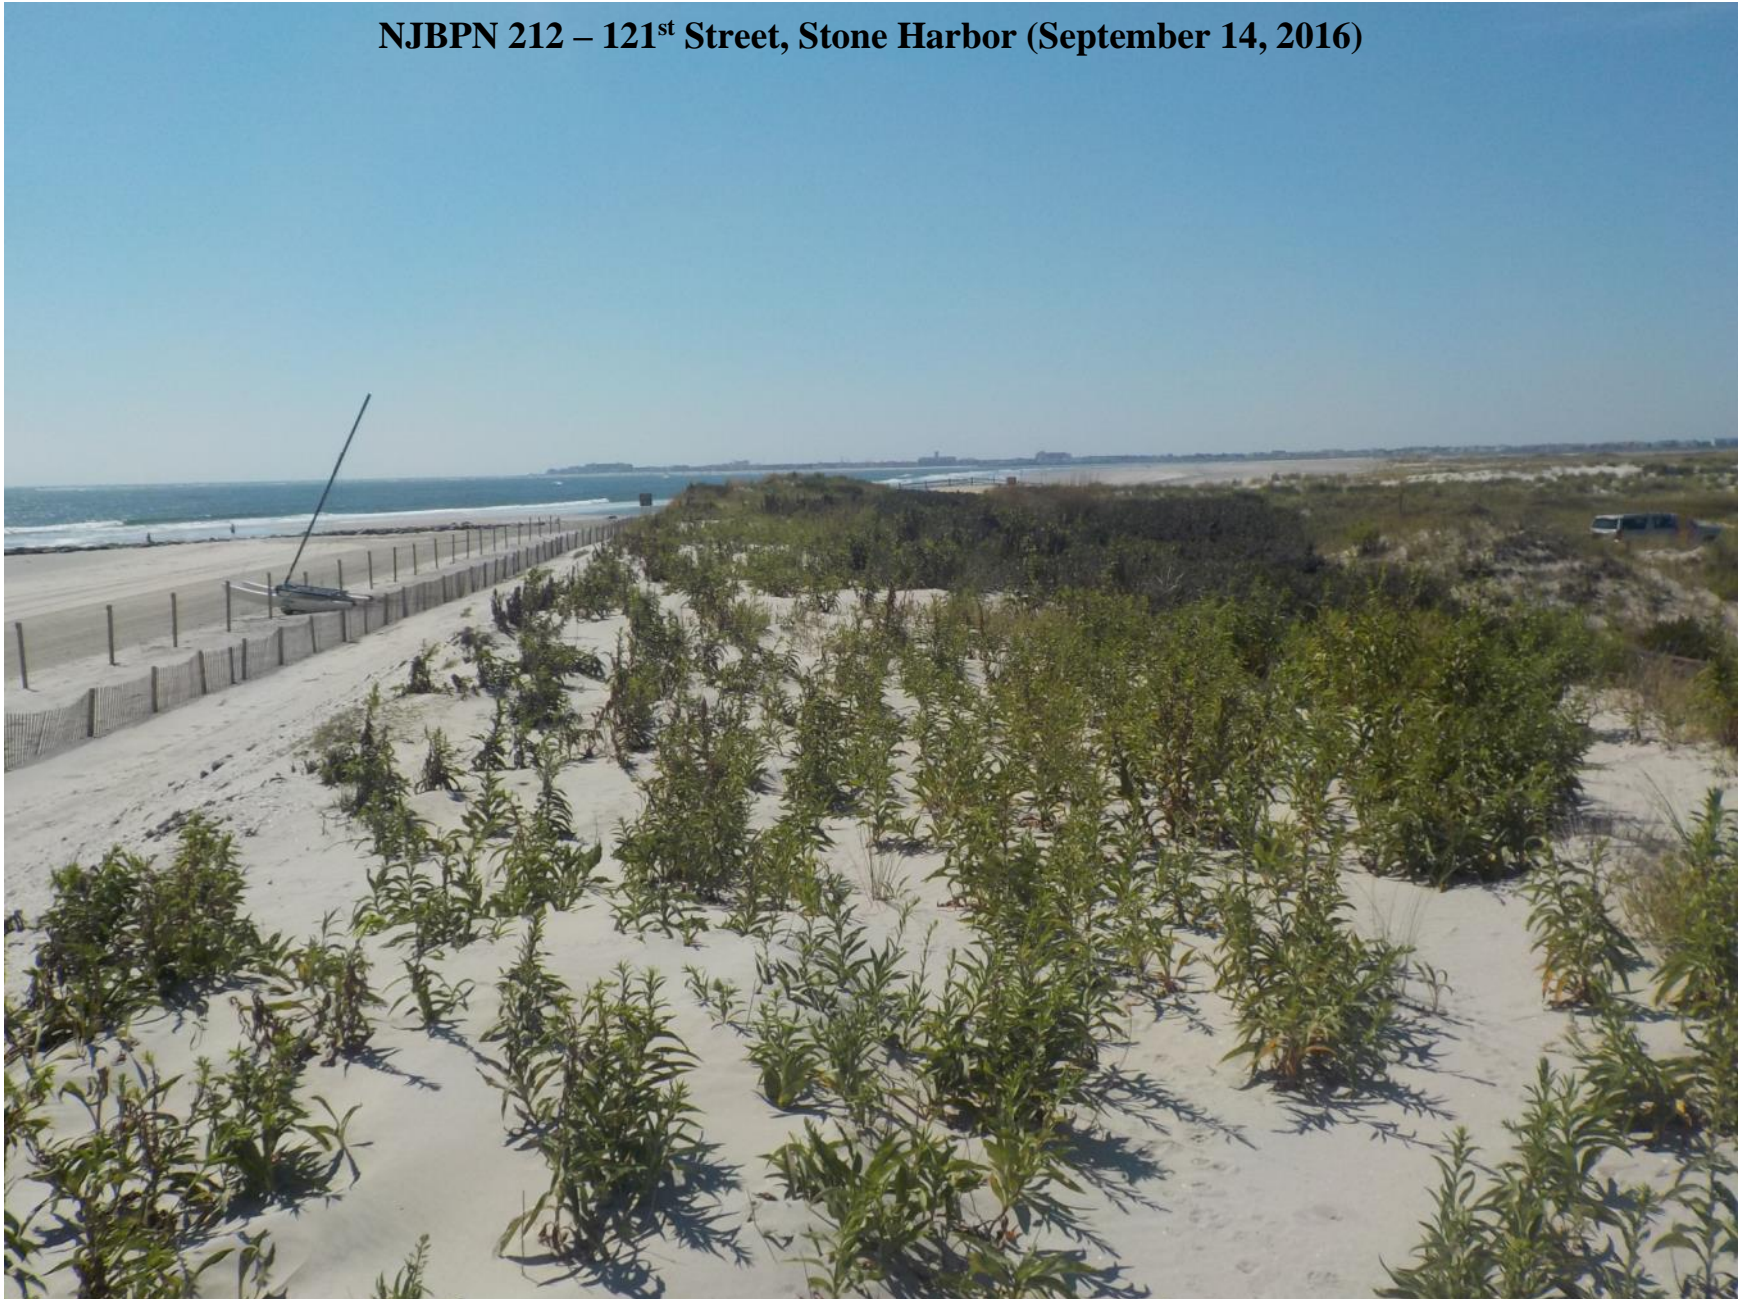
Figure 554. This is a particularly great view to the south along the very southern Stone Harbor dune crest showing the terminal groin and the offset between it and the beach at South Point. Beach nourishment here has had a pronounced benefit to the bird habitat creation since 1998 as sand lost from Stone Harbor moves to the point.

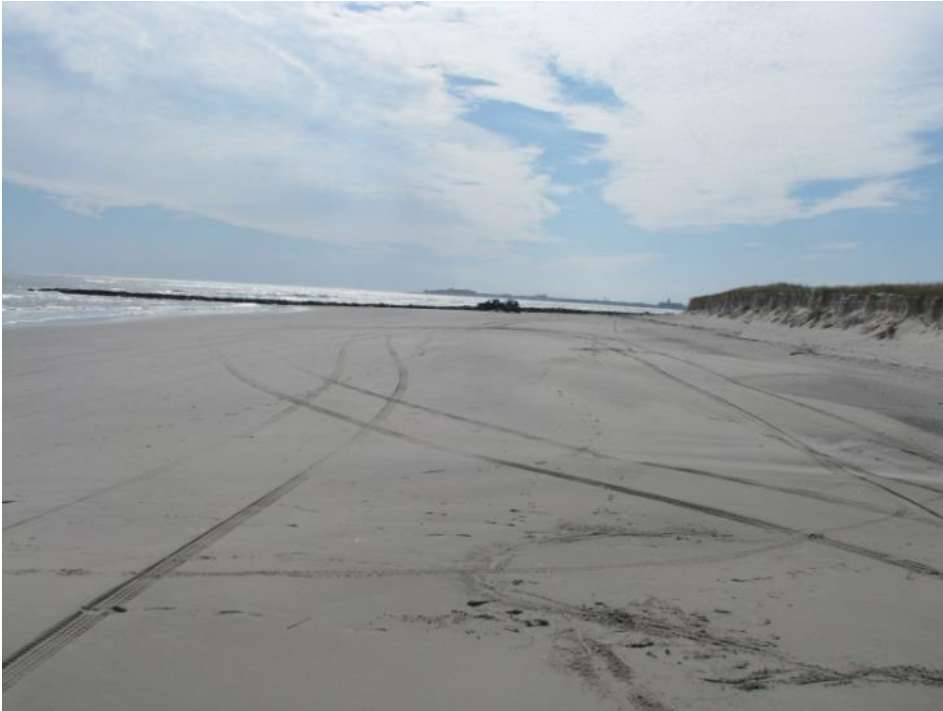
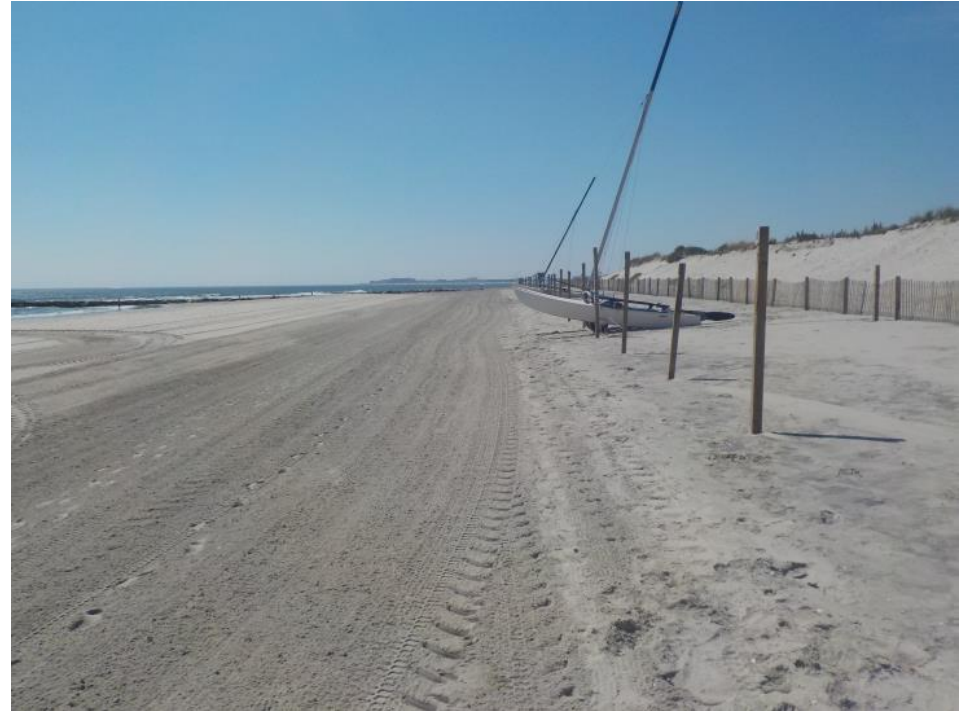
Figure 555a & 555b. The south end Stone Harbor site has shown a long-term erosional trend that may be influenced by changes surrounding Hereford Inlet. The site has been the recipient of numerous beach nourishment projects including municipal and Federal efforts. Most recent was spring 2013 as a post-Sandy restoration. The State of NJ is currently funding a maintenance effort into spring 2017. The left photo, taken on October 13, 2015, shows a wet beach nearly to the dune toe. By September 14, 2016 (right photo), the raked section of the beach was still subject to high tide wave run-up.

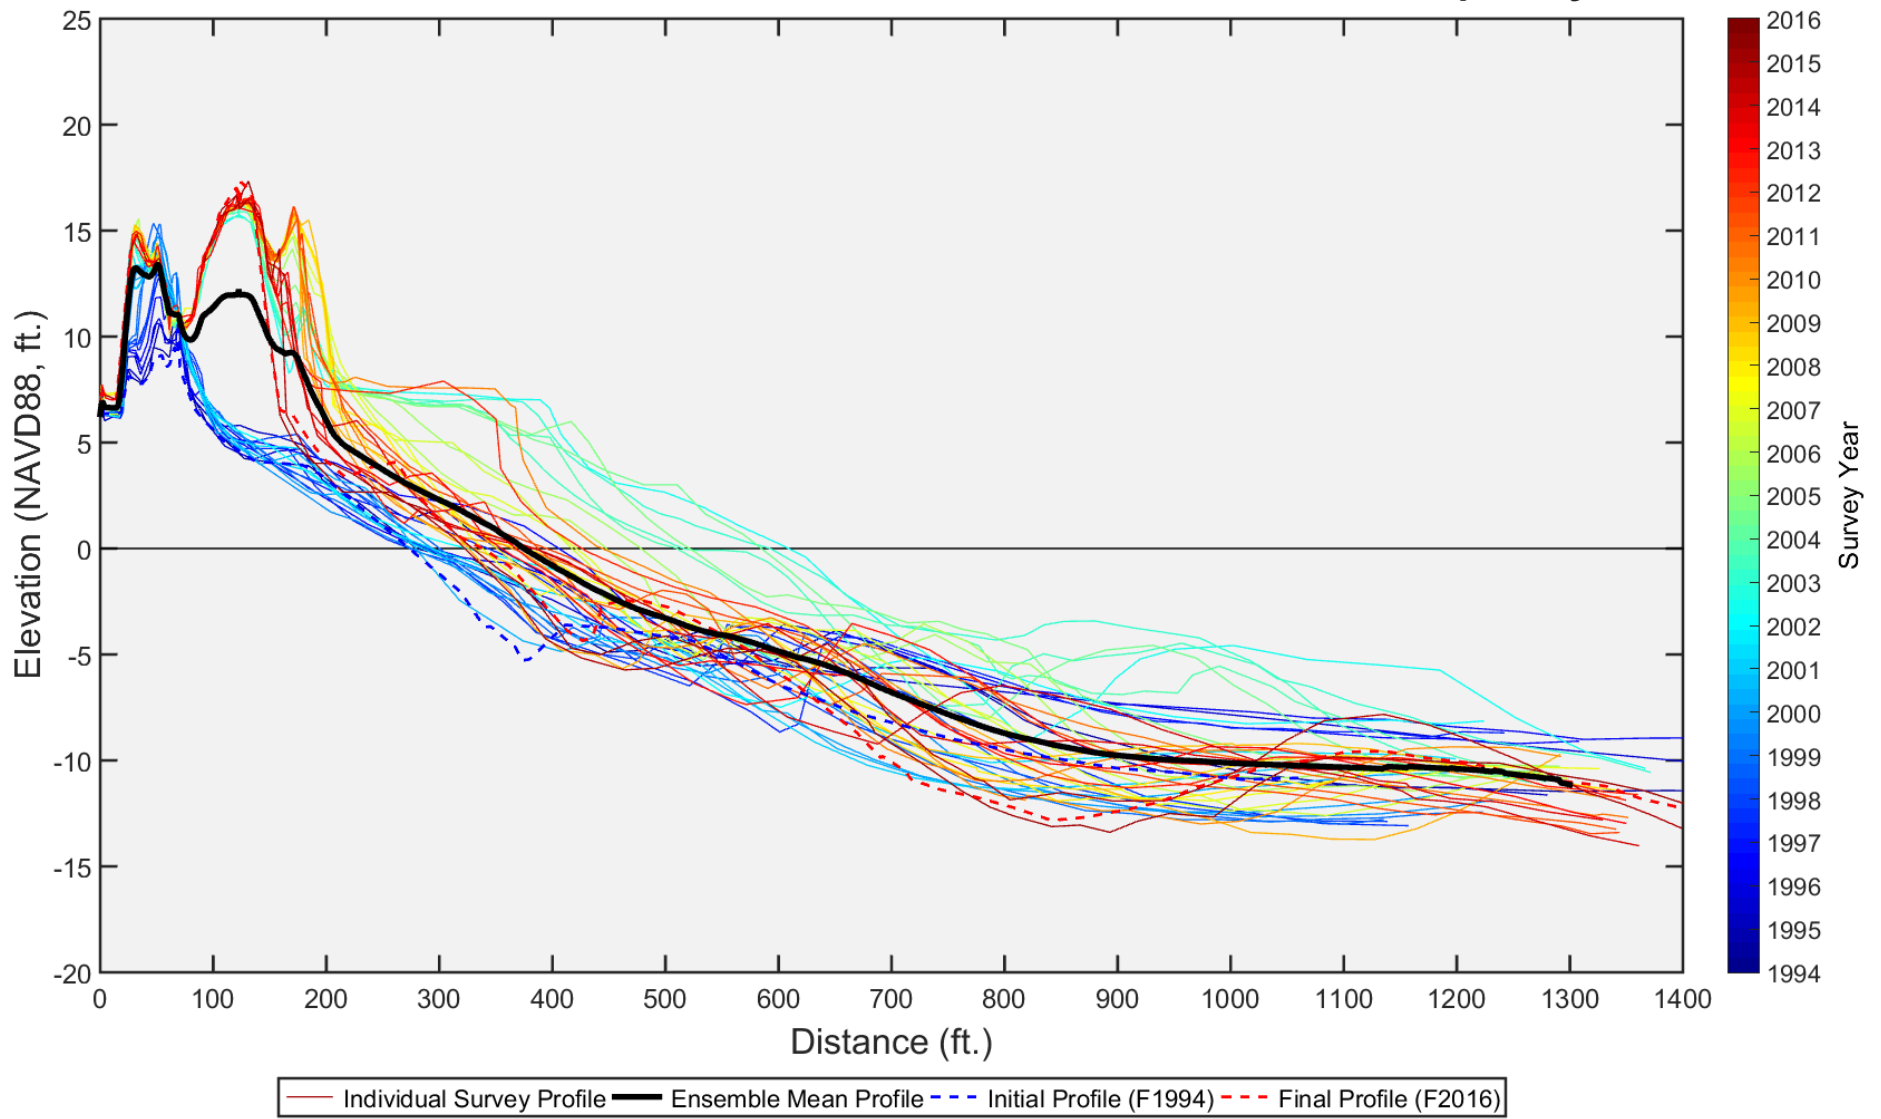
Figure 558. The USACE fill project substantially enhanced the dune and developed a wider beach, but the extensive profiles from the early 2000's (light green lines) failed to maintain their seaward positions for any length of time.

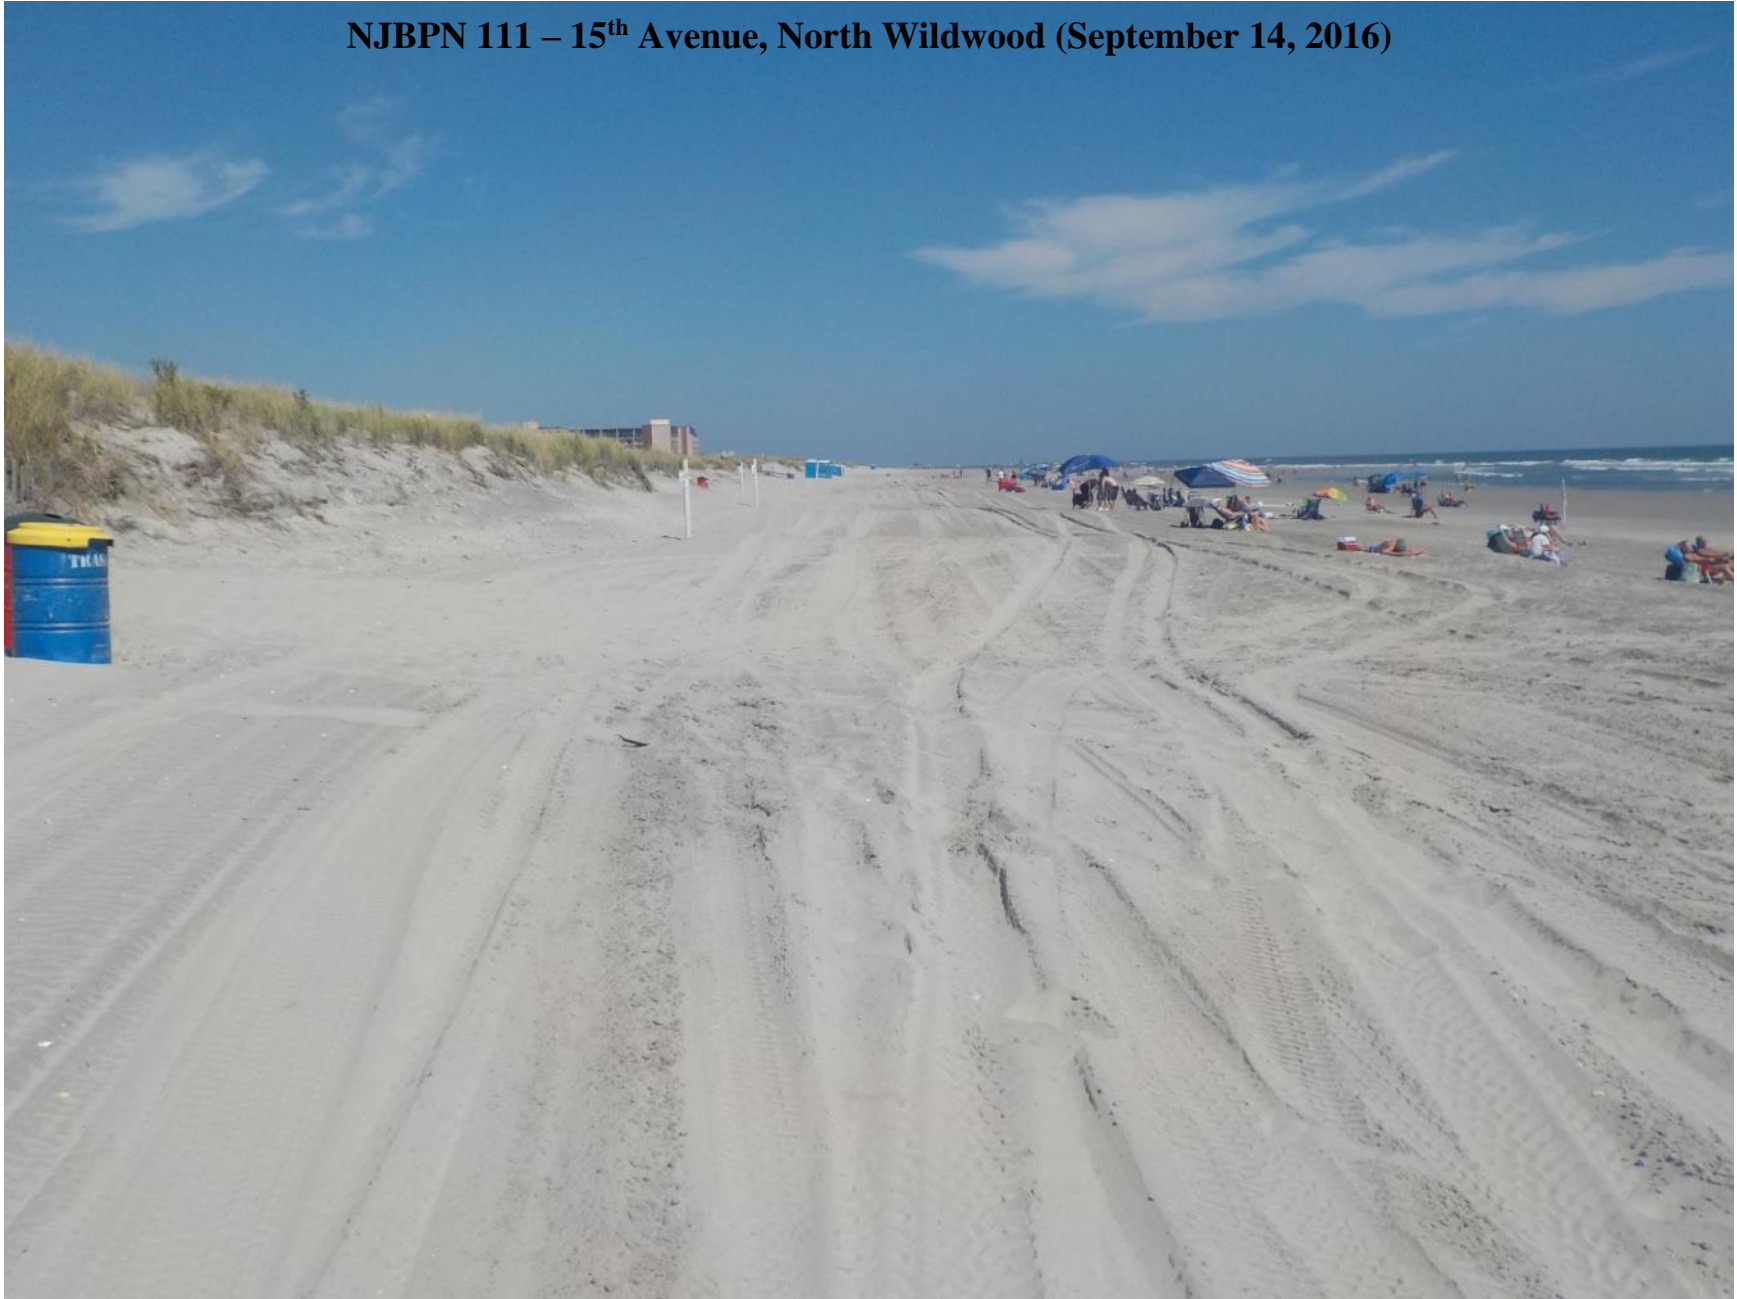
Figure 560. The North Wildwood beach is narrow from here north and subject to rapid erosion due to its proximity to Hereford Inlet and its orientation. North Wildwood has benefited from the largest sand backpass effort to date in New Jersey, which has moved sand from the Wildwood beaches back to the northern beaches.

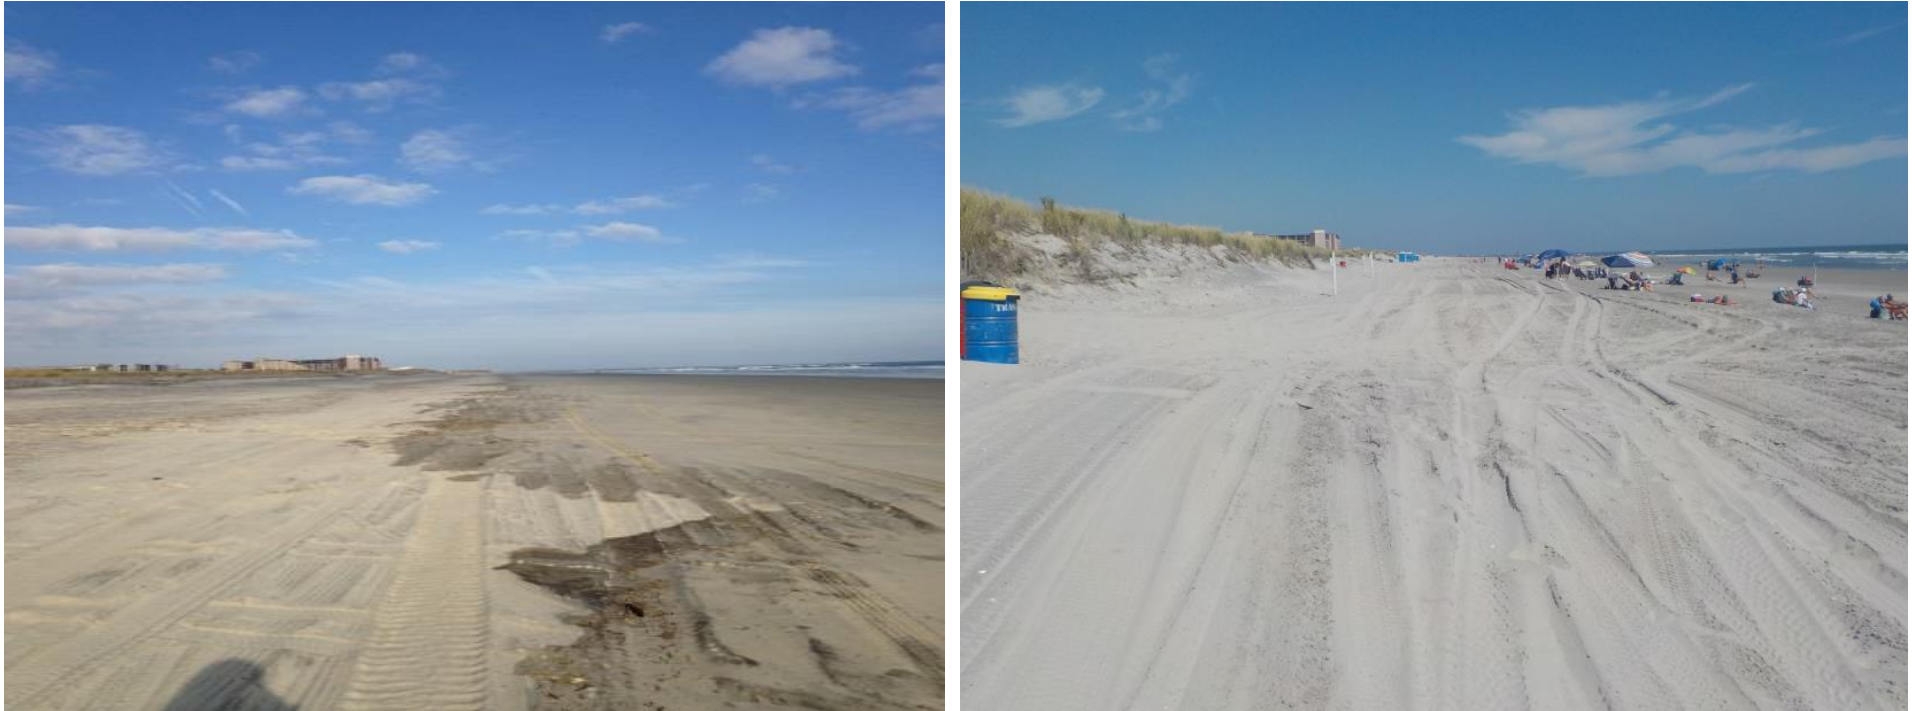
NJBPN 111 – 15th Avenue, North Wildwood

Figure 561a & 561b. The 15th Avenue site is influenced by the dynamics associated with Hereford Inlet. A NJ State sponsored 2009 beach fill temporarily interrupted a decade of erosion here. Photo on the left was taken December 9, 2015 at the limit of wave run-up. The right photo, taken on September 14, 2016, shows a narrower beach as a result of several northeast storms. During the spring of 2016, 151,000 cubic yards of sand were hauled north from the stormwater discharge lines on the beach in Wildwood to augment the beach to the north. Sand back-passing efforts resumed in late winter into the spring of 2017 with 200,000 cubic yards transported.

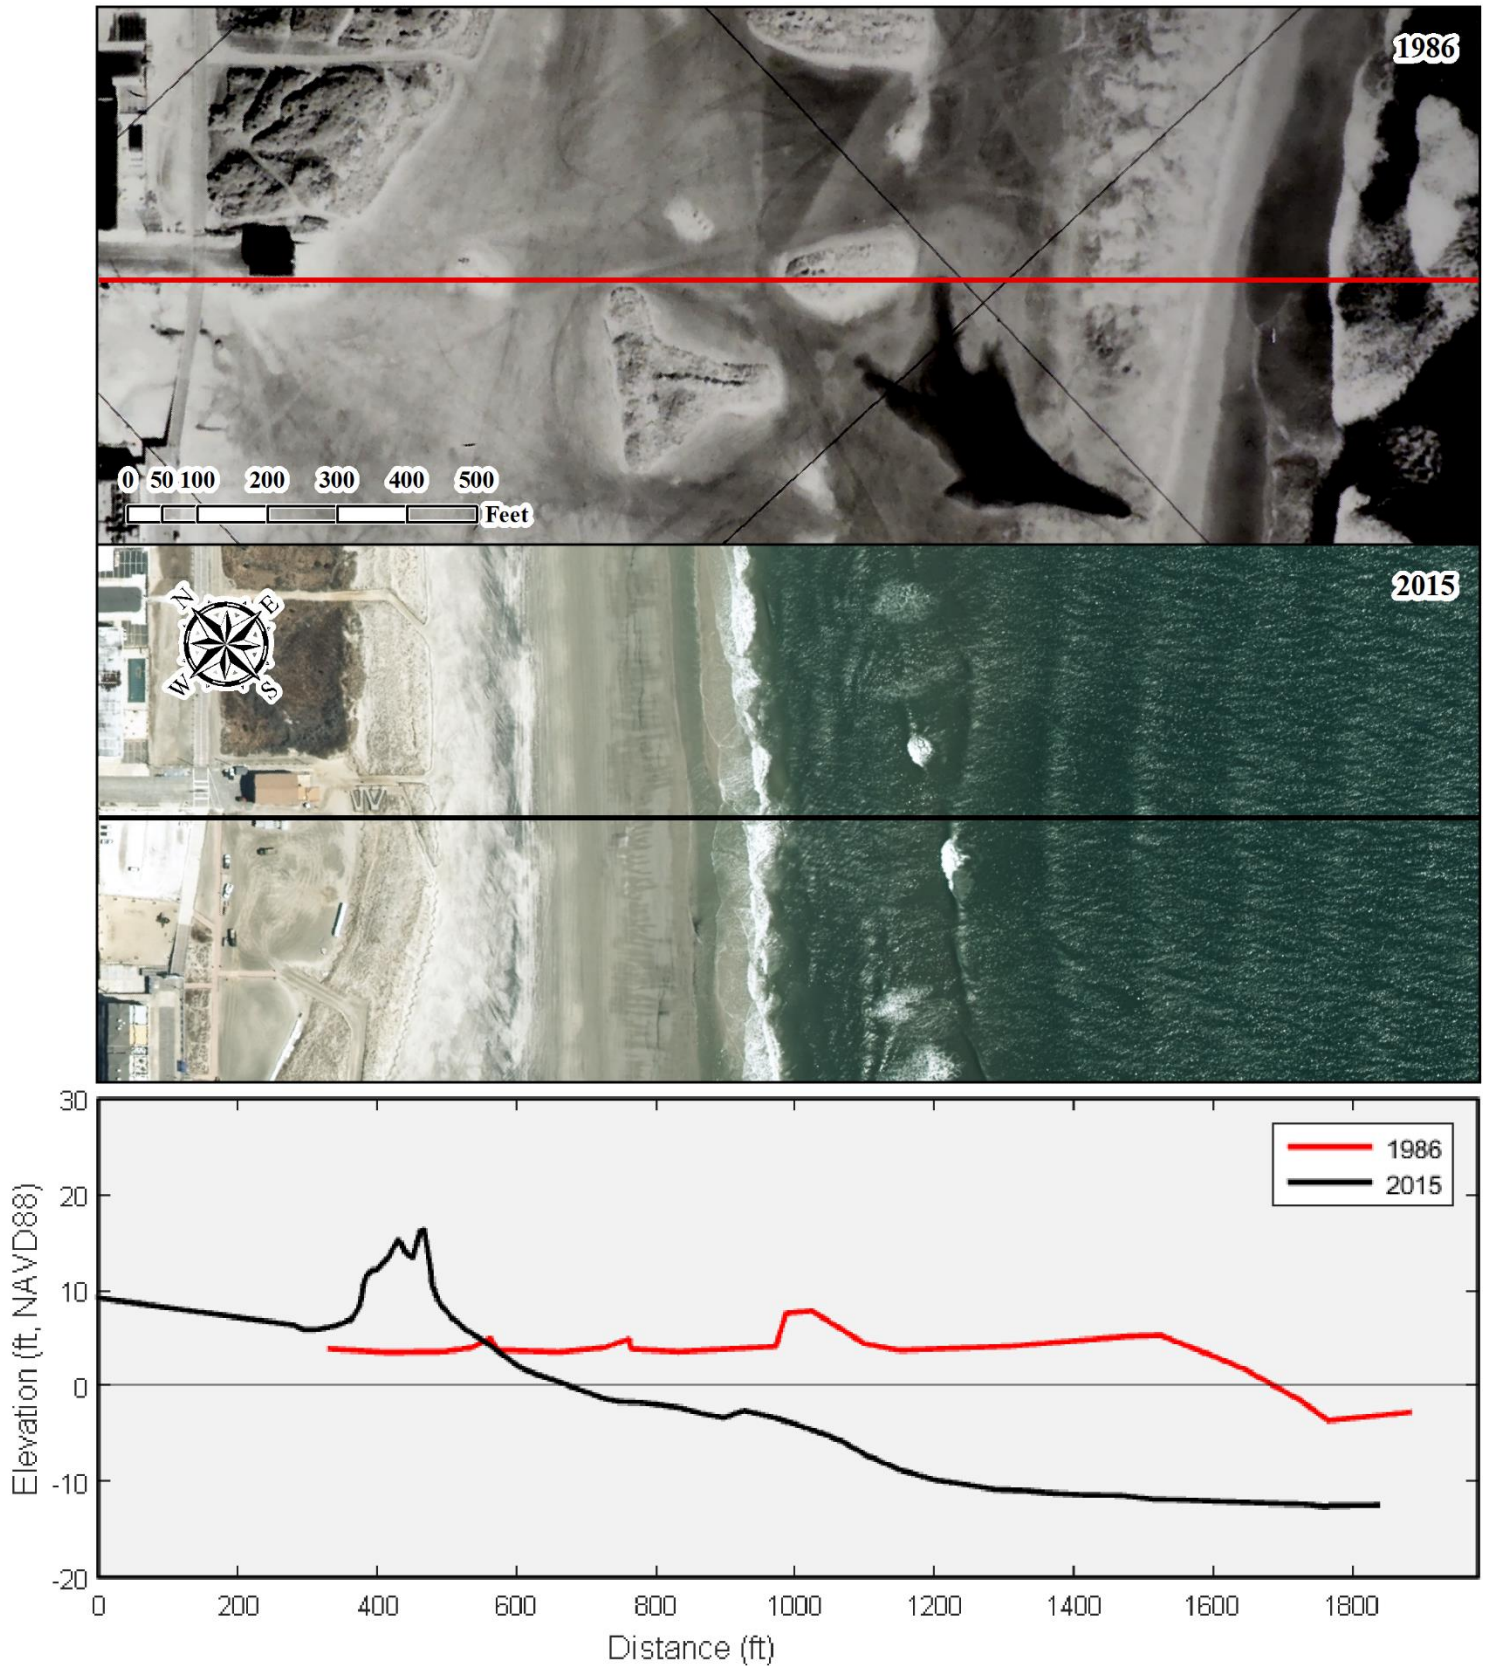
Figure 565. This location has suffered New Jersey’s worst shoreline retreat during the monitoring interval with 1,057 ft of shoreline loss since 1986. Even though the NJ State intercession in 2009 provided 1.45 million cubic yards of restoration sand to the North Wildwood beachfront, this site was never able to rebound. One of the “island dunes” can be seen in the 1986 aerial photograph and on the 1986 profile line, beginning near the 1000 foot Distance location
