An Analysis of Thirty Years' Study of Sand Redistribution and Shoreline Changes in New Jersey's Four Coastal Counties Raritan Bay, the Atlantic Ocean Coast, and Delaware Bay Fall 1986 Through Fall 2016

VOLUME 4 of 4 CAPE MAY COUNTY & APPENDIX

Prepared for:
New Jersey Department of Environmental Protection
Division of Construction and Engineering
1510 Hooper Avenue, Toms River, New Jersey 08753

Prepared by:
The Stockton University Coastal Research Center
30 Wilson Avenue, Port Republic, NJ 08241

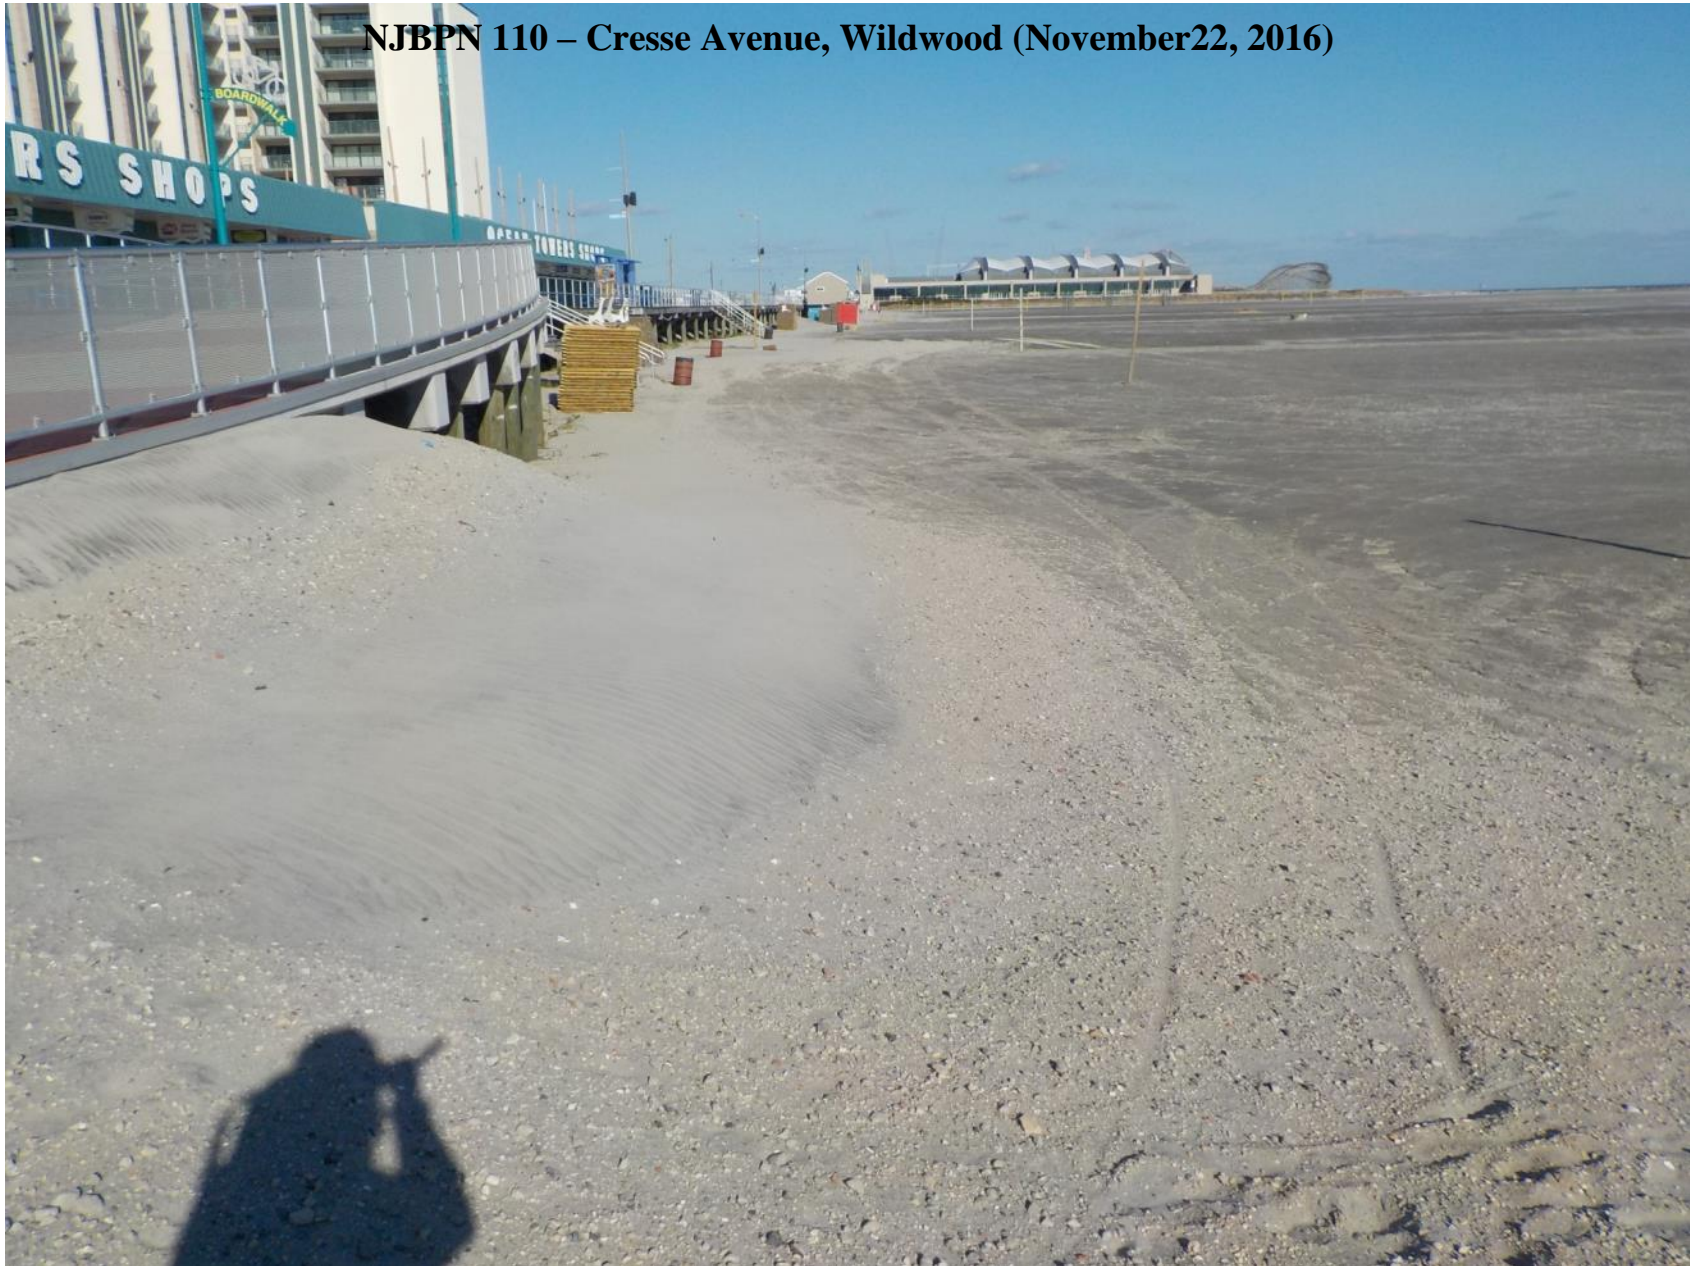
NJBPN 110 – Cresse Avenue, Wildwood (November 22, 2016)

Figure 566. View to the north along the eastern edge of the Wildwood Boardwalk at Cresse Avenue. The wide beach, notorious in Wildwood, shows as a vast gray plain with the amusement piers in the distance along with the new convention center.

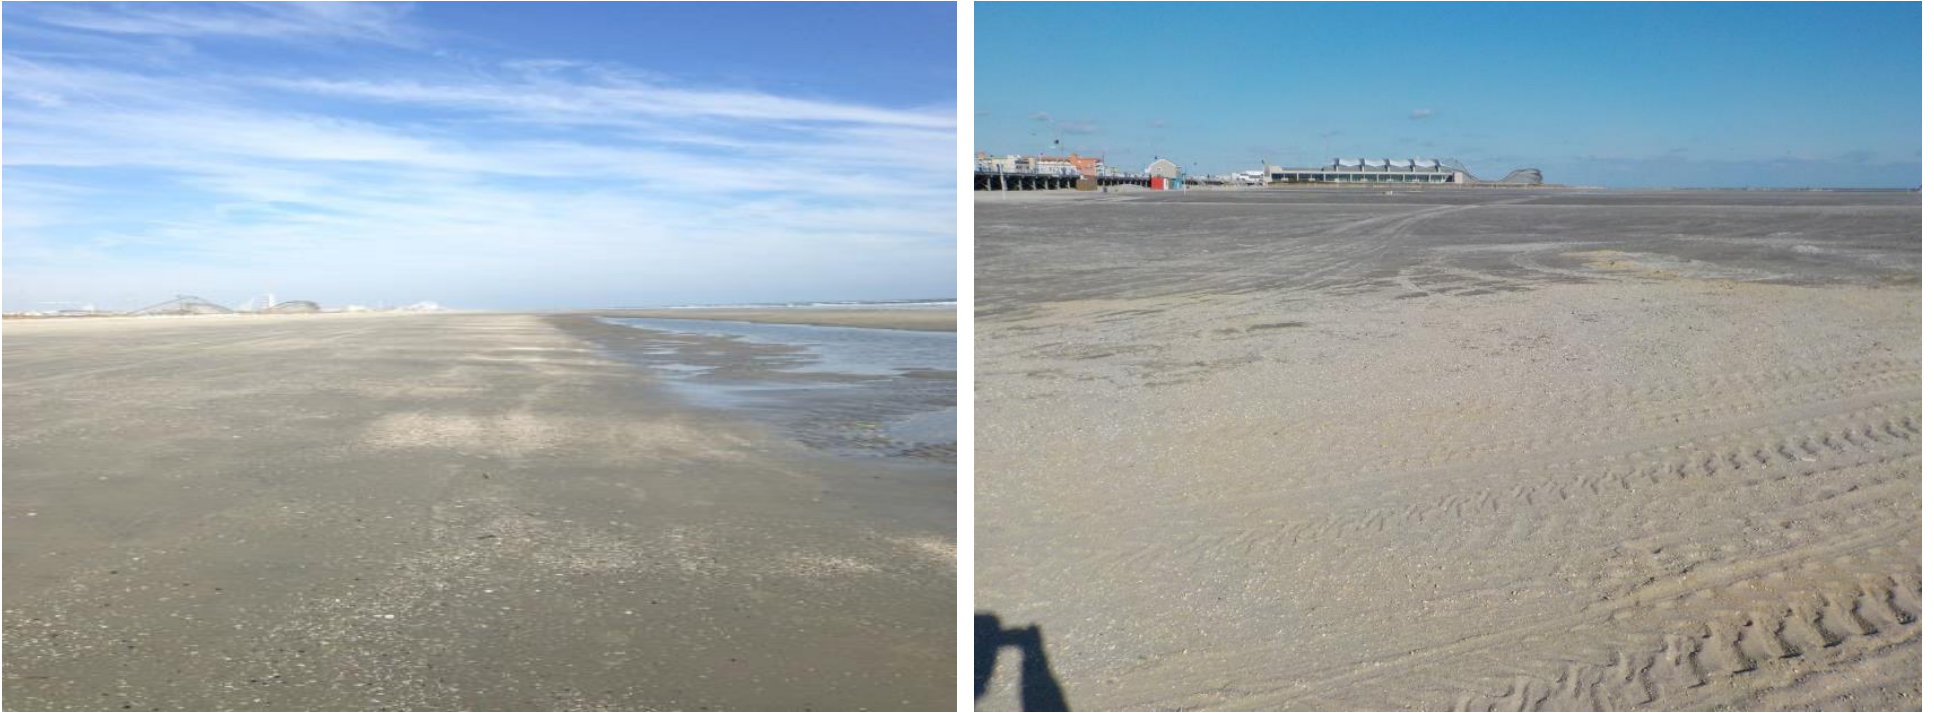
NJBPN 110 – Cresse Avenue, Wildwood

Figure 567a & 567b. The Cresse Avenue site has been accumulating sand volume since 1992. Sand lost from North Wildwood migrates south adding to the beach width each year. The left photo, taken on December 9, 2015, shows the expansive view, an additional 43 ft wider than in 2014. The right photo taken November 22, 2016 repeats the expansive view of the beach, this time 16 ft wider than in 2015.

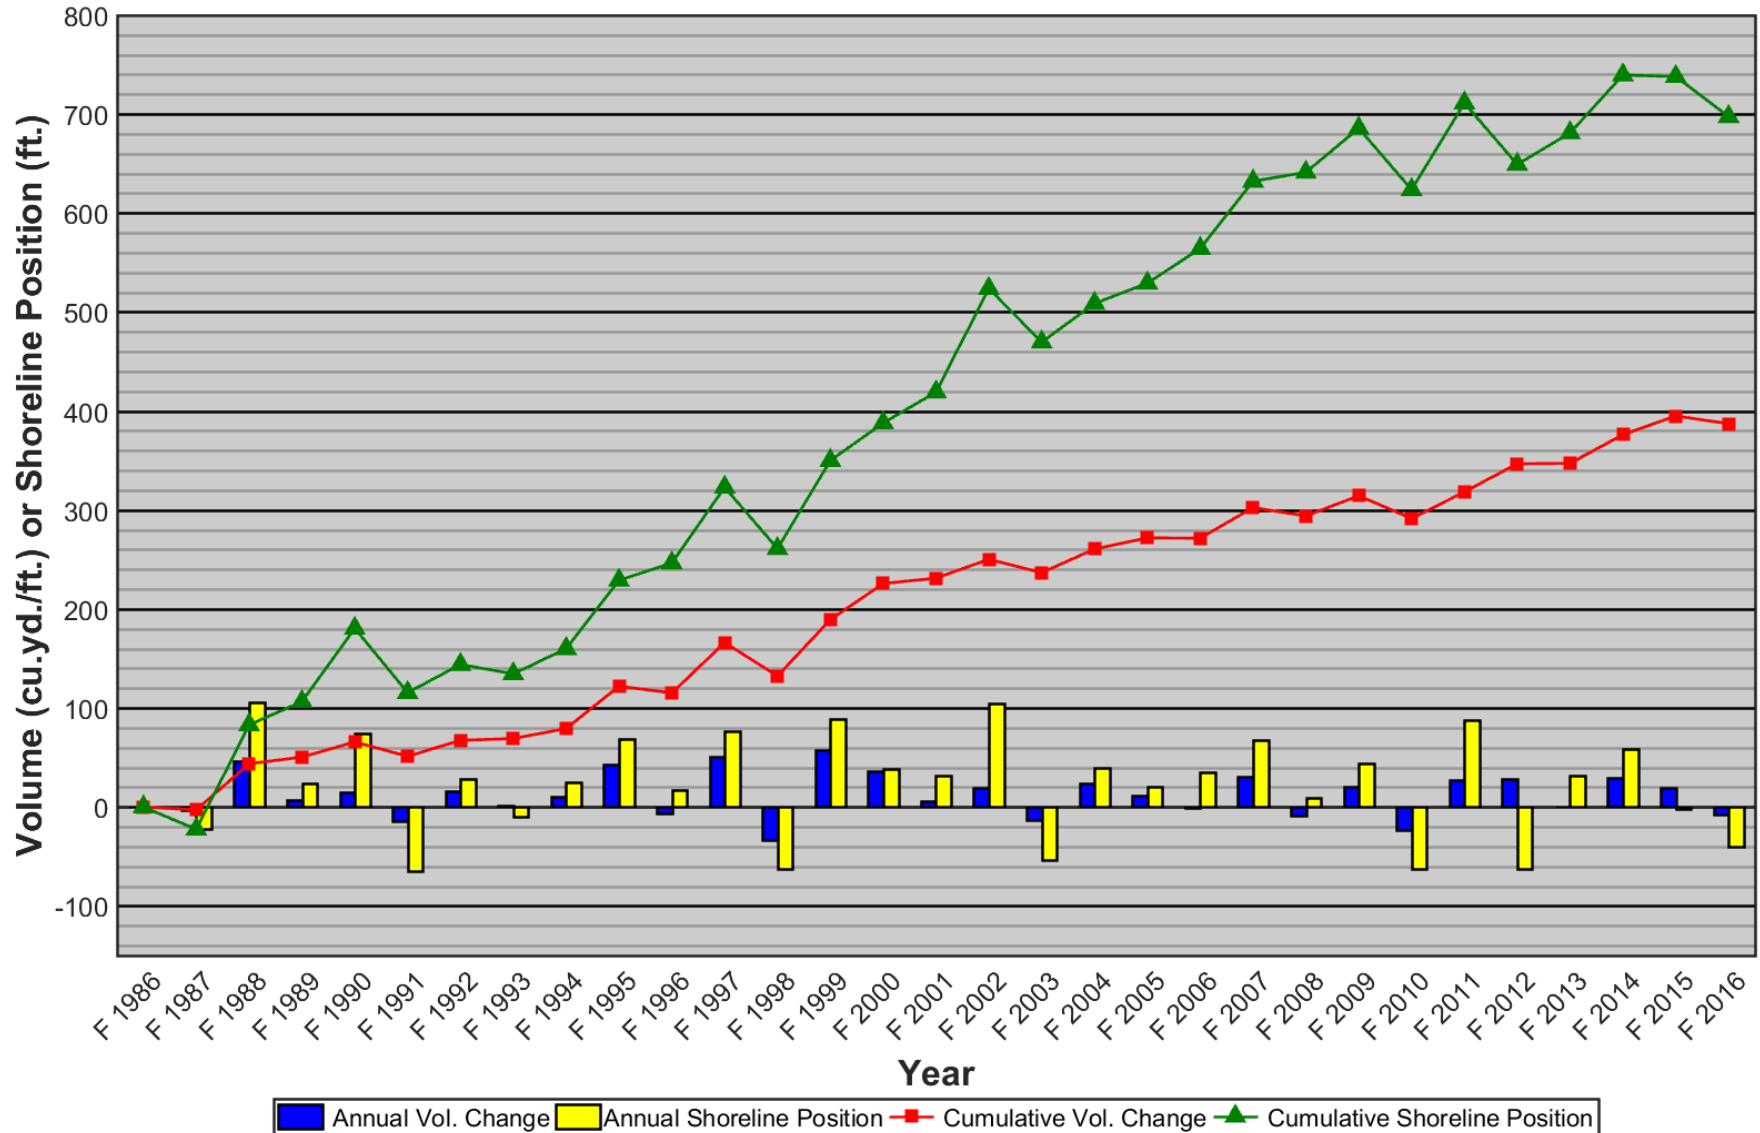
Figure 569. A partial answer to where all the North Wildwood sand went is found at the Cresse Avenue site at the border between Wildwood and Wildwood Crest. Only the series of northeast storms produced negative sand volume and shoreline change data. Minor losses did occur in the future, but the trend was strongly positive. The beach sand volume increased by 383 yds³/ft. and the shoreline advanced by 700 feet, which is one of the largest, naturally occurring shoreline adjustments at all NJ sites.

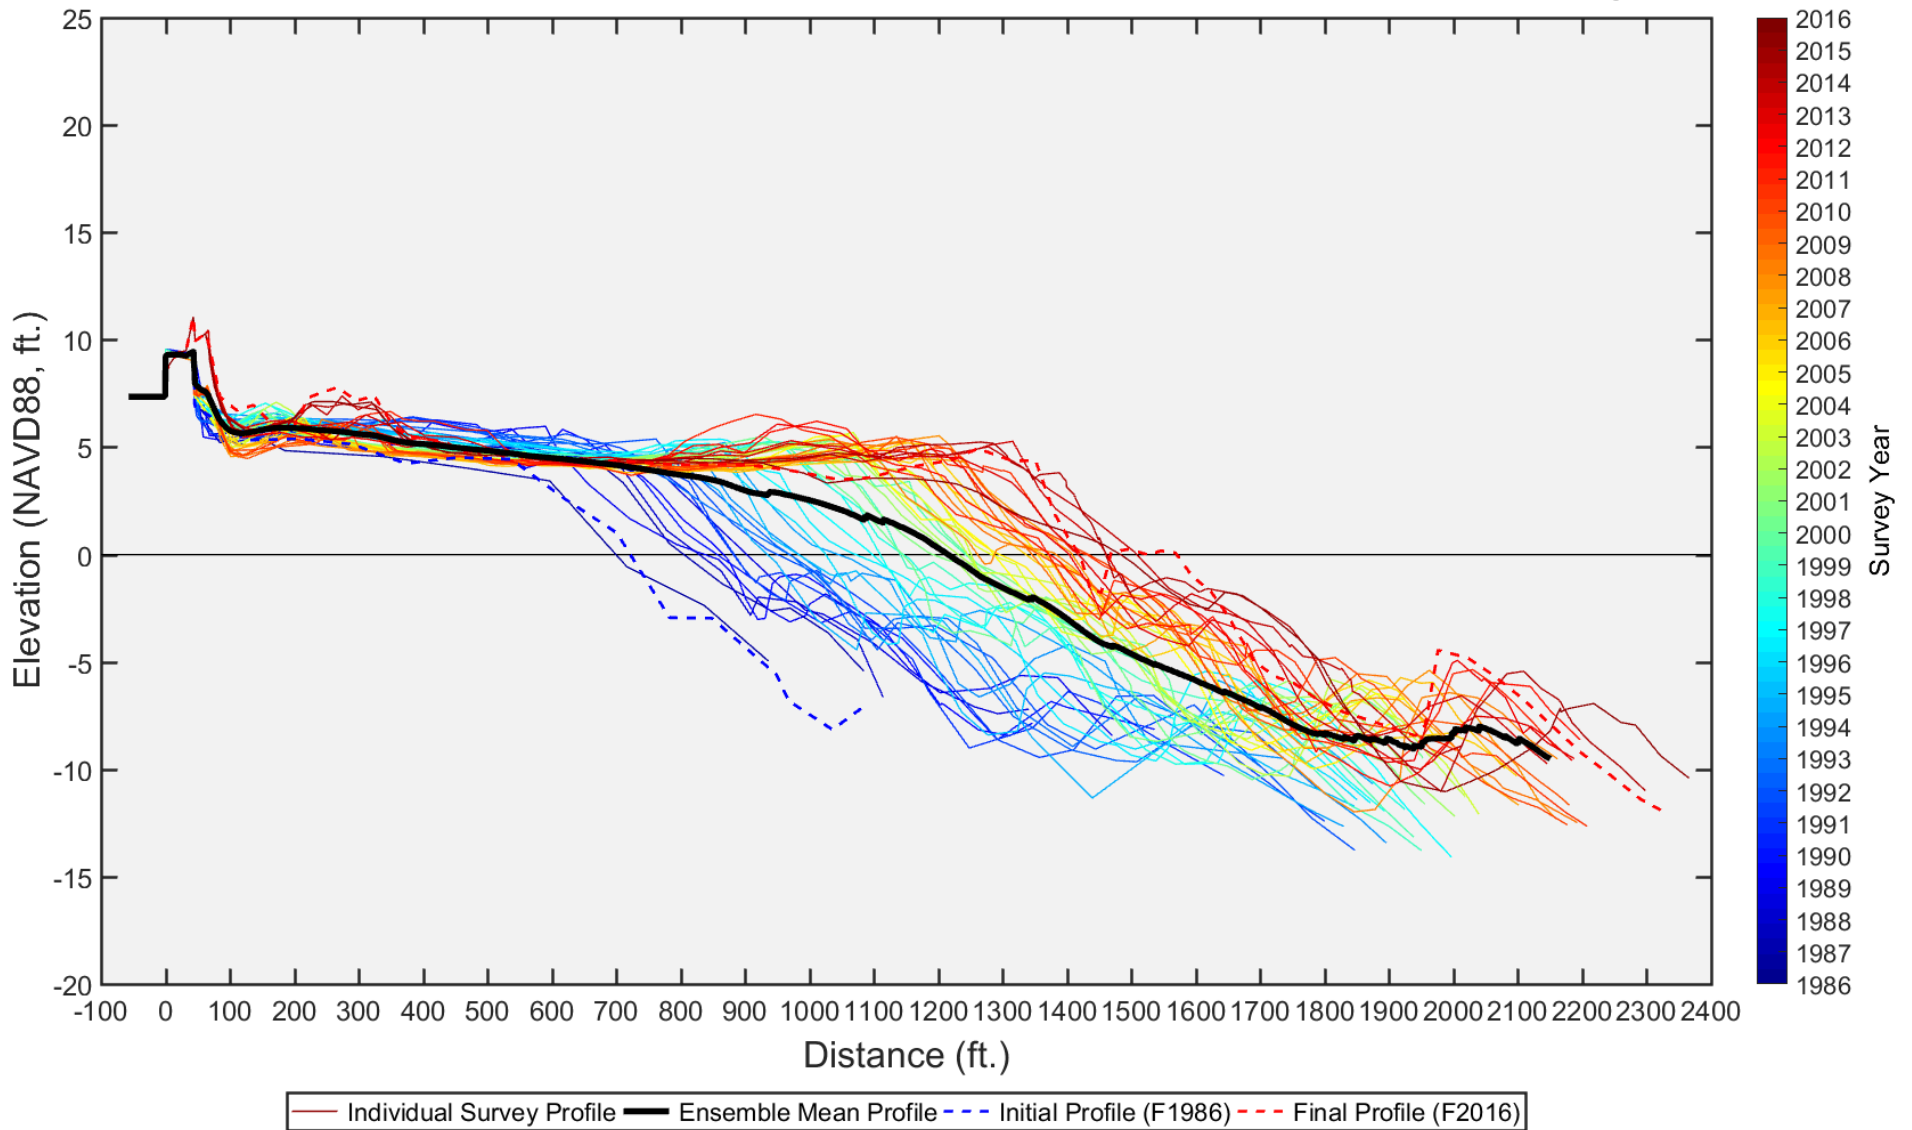
Figure 570. The gain in beach width with time is reflected in the progressive color change from blue to red in the seaward direction at this site. The contrast between the initial survey in 1986 (blue dashed line) and the 2016 survey (red dashed line) is clear evidence that sand moves south from North Wildwood depositing along the Wildwood City beach.

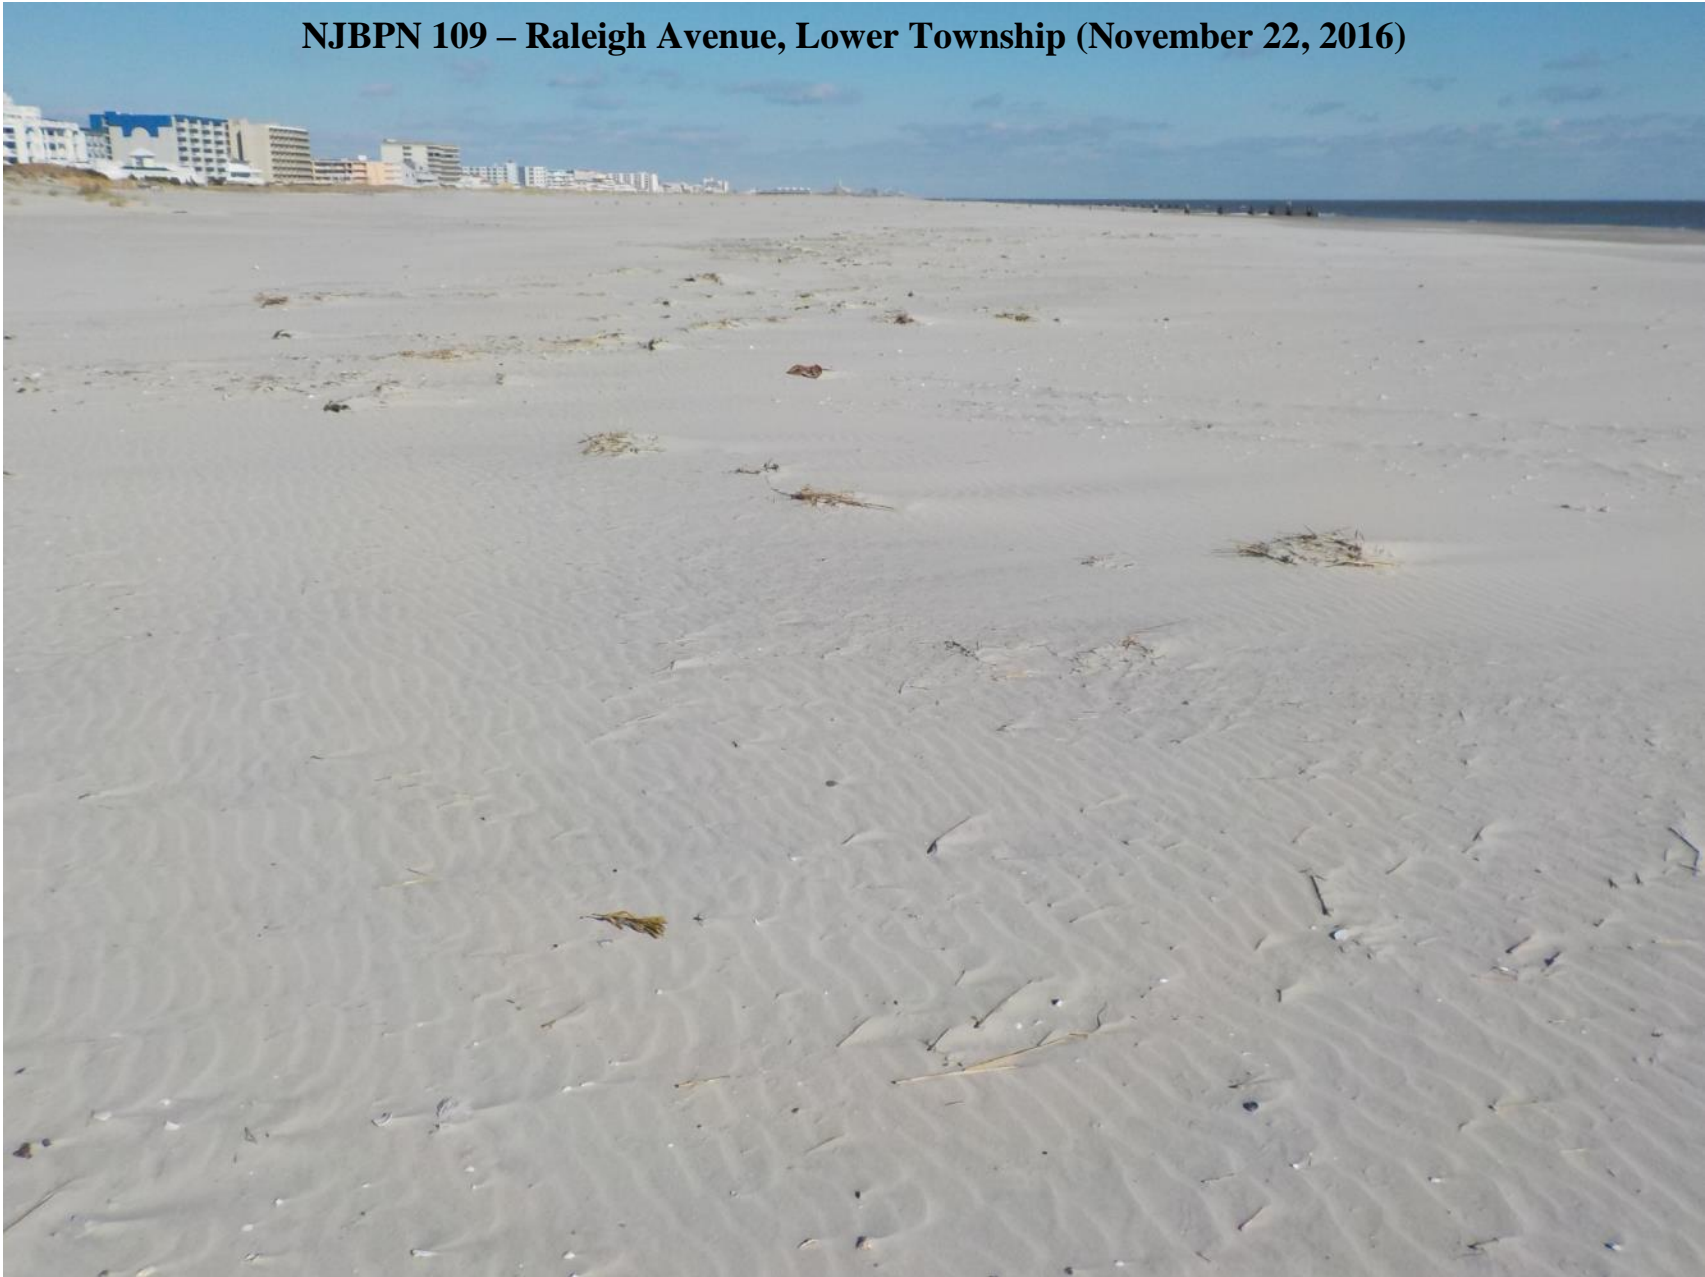
NJBPN 109 – Raleigh Avenue, Lower Township (November 22, 2016)

Figure 572. As evident from this mid-beach view looking north from Raleigh Avenue in Lower Township, the wider beaches continue north through Wildwood Crest. This site is located adjacent to the beginning of the Two Mile Beach Unit Wildlife Refuge lands. This is the southern limit of the proposed USACE back passing project sand source.

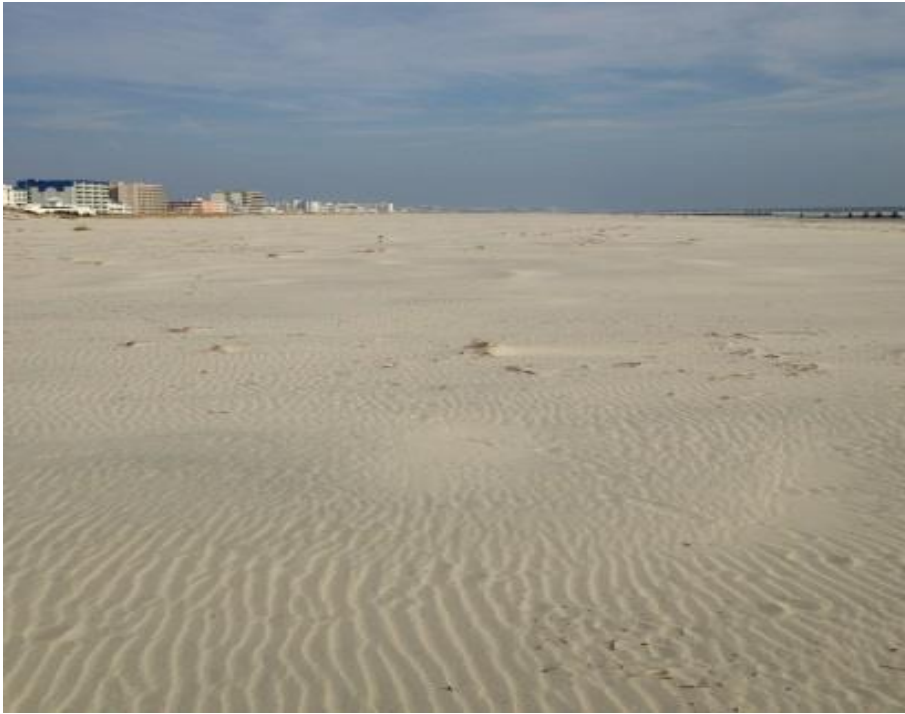
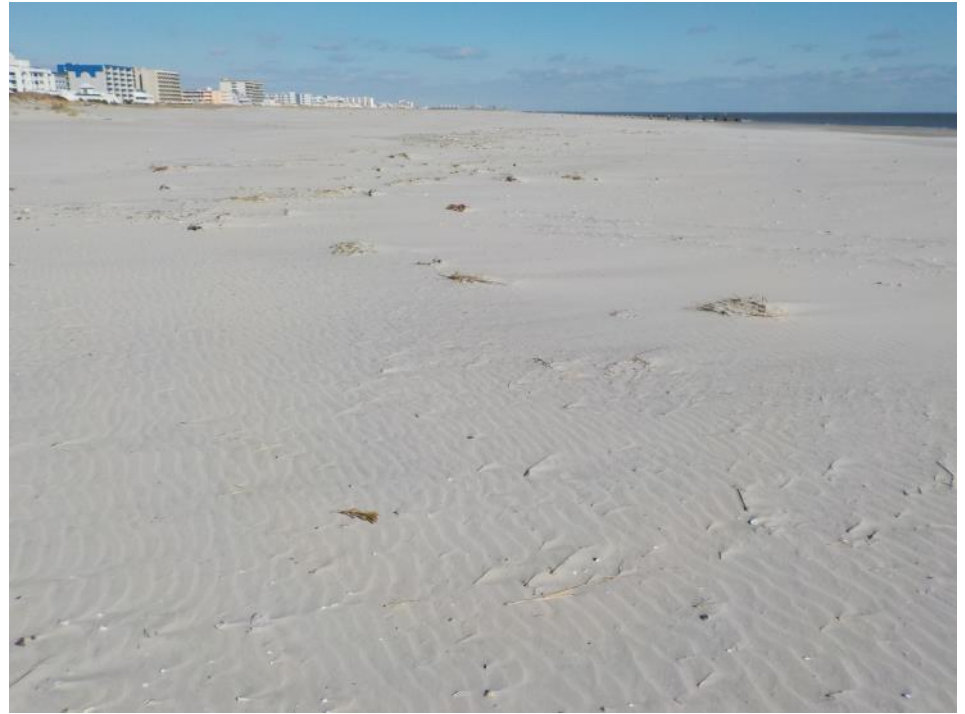
NJBPN 109 – Raleigh Avenue, Lower Township

Figure 573a & 573b. The left photo, taken on December 9, 2015, shows the central zone of the beach and gives a good view of the width. A similar view on November 22, 2016 shows little change, especially in terms of the large scale presented here.

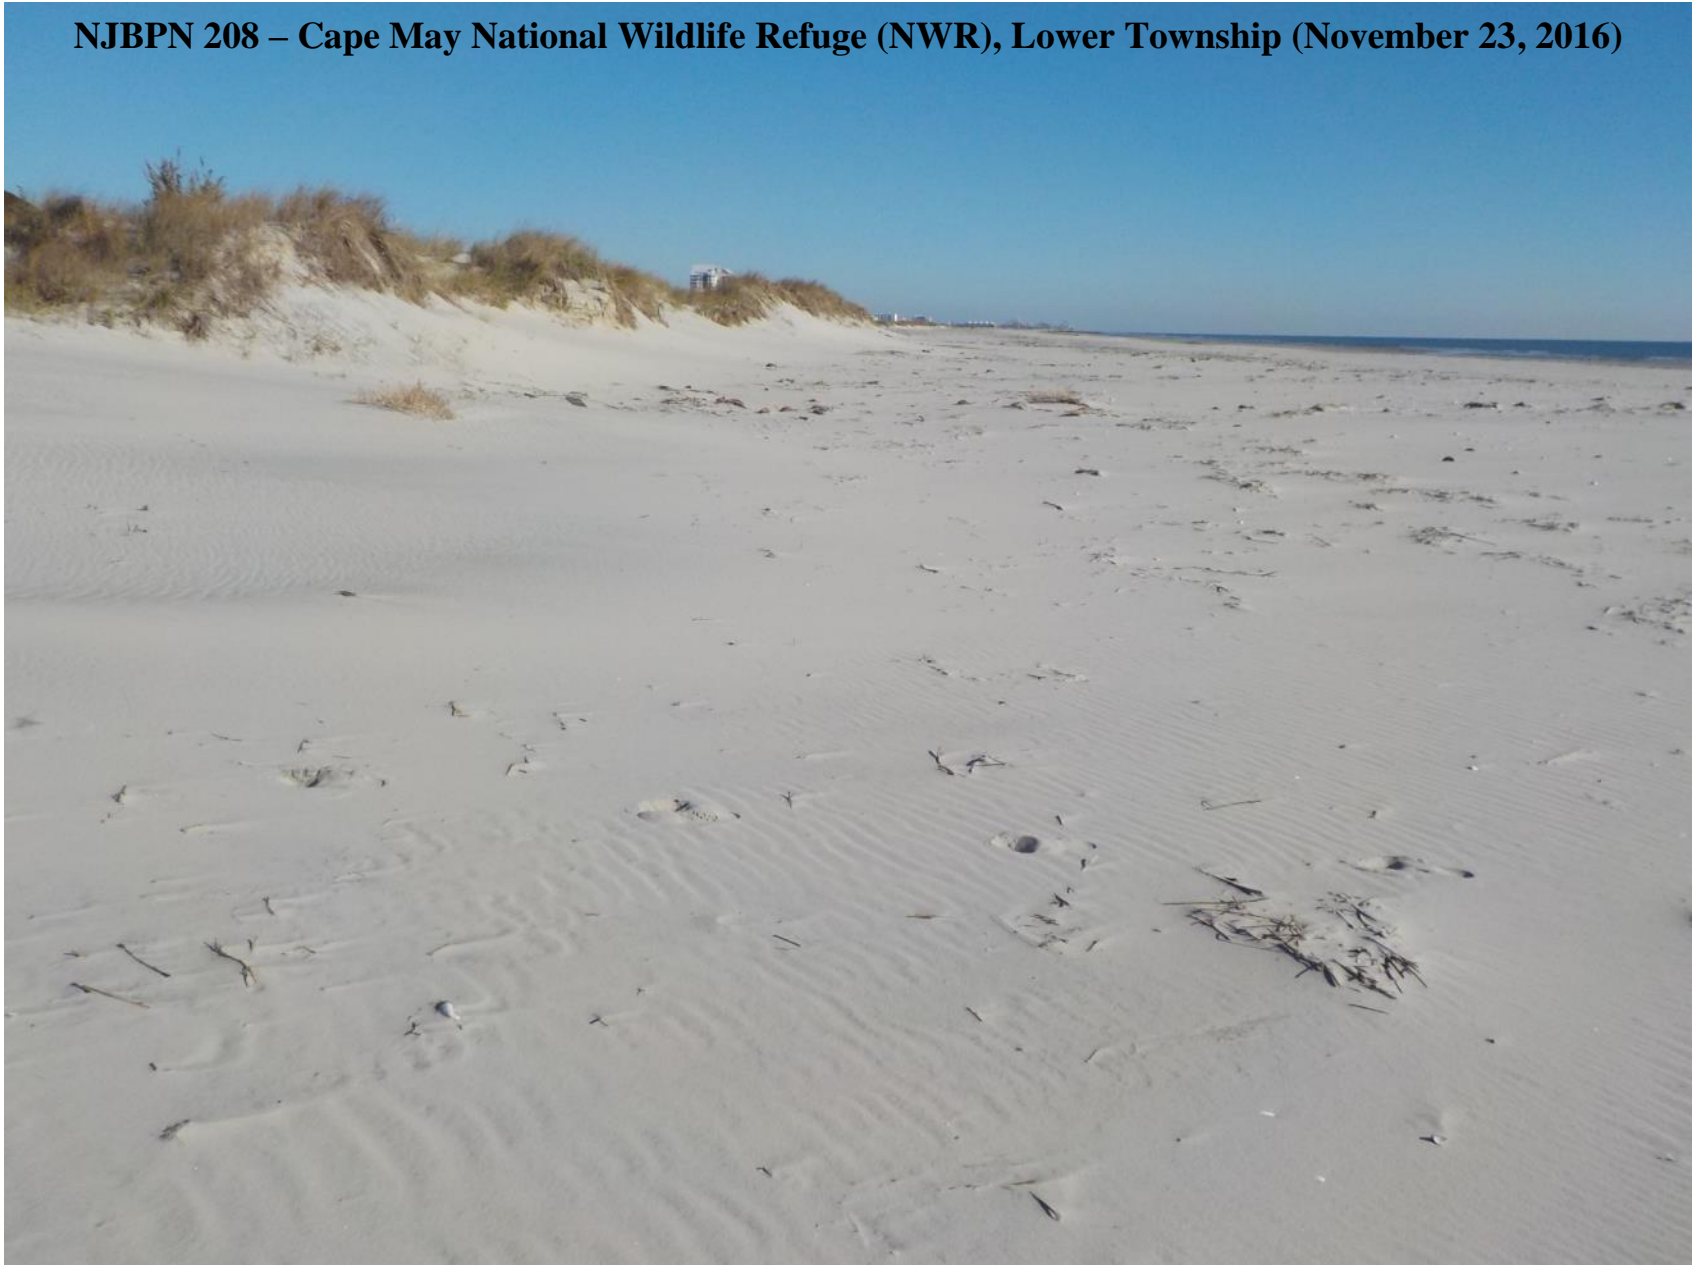
NJBPN 208 – Cape May National Wildlife Refuge (NWR), Lower Township (November 23, 2016)

Figure 578. View is looking north along the wildlife refuge beach near the dune toe toward Lower Township. The beach width is retained by the Cold Springs Inlet jetty built in 1908 to 1911 for the US Navy site now used by the US Coast Guard.

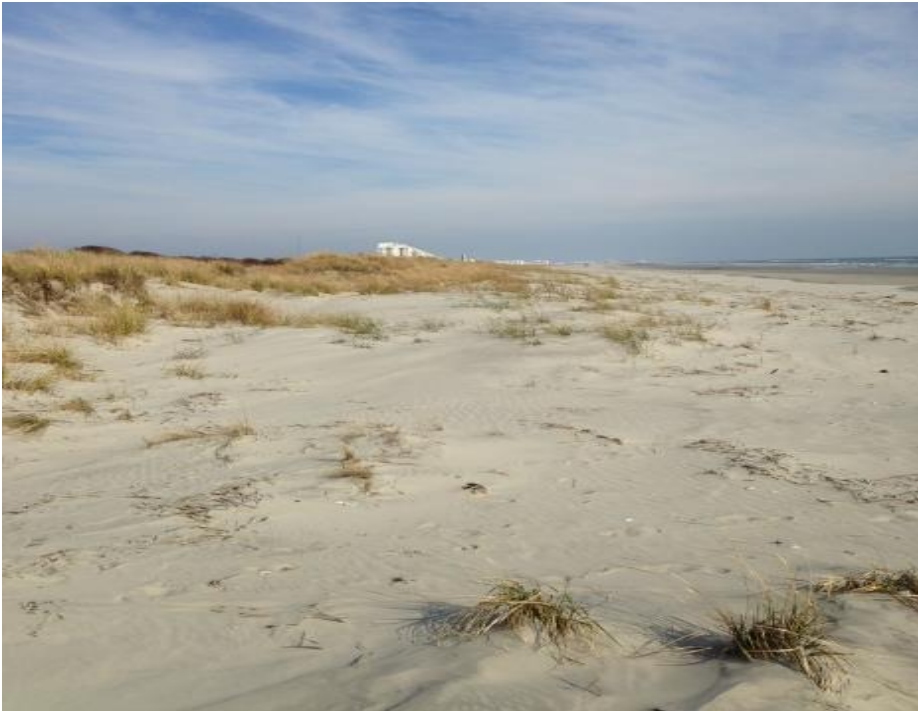
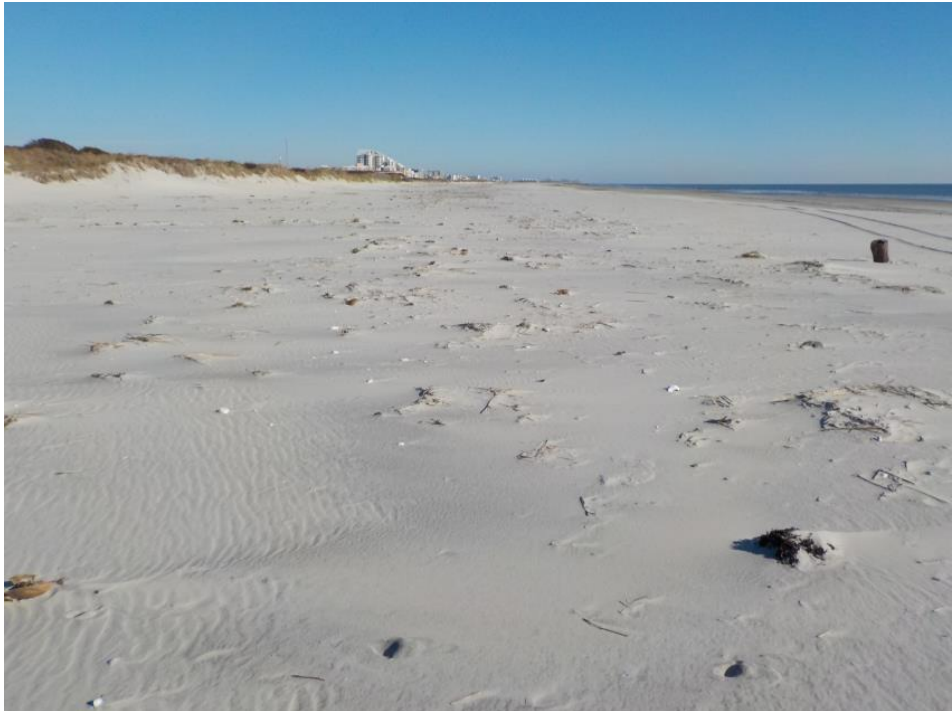
NJBPN 114 – Cape May NWR, Lower Township

Figure 579a & 579b. The left photo was taken December 9, 2015 and is a view across the dunes and gentle shoreward gradient developed on the wide beach. The right photo was taken on November 23, 2016 and shows continued sand accumulation.

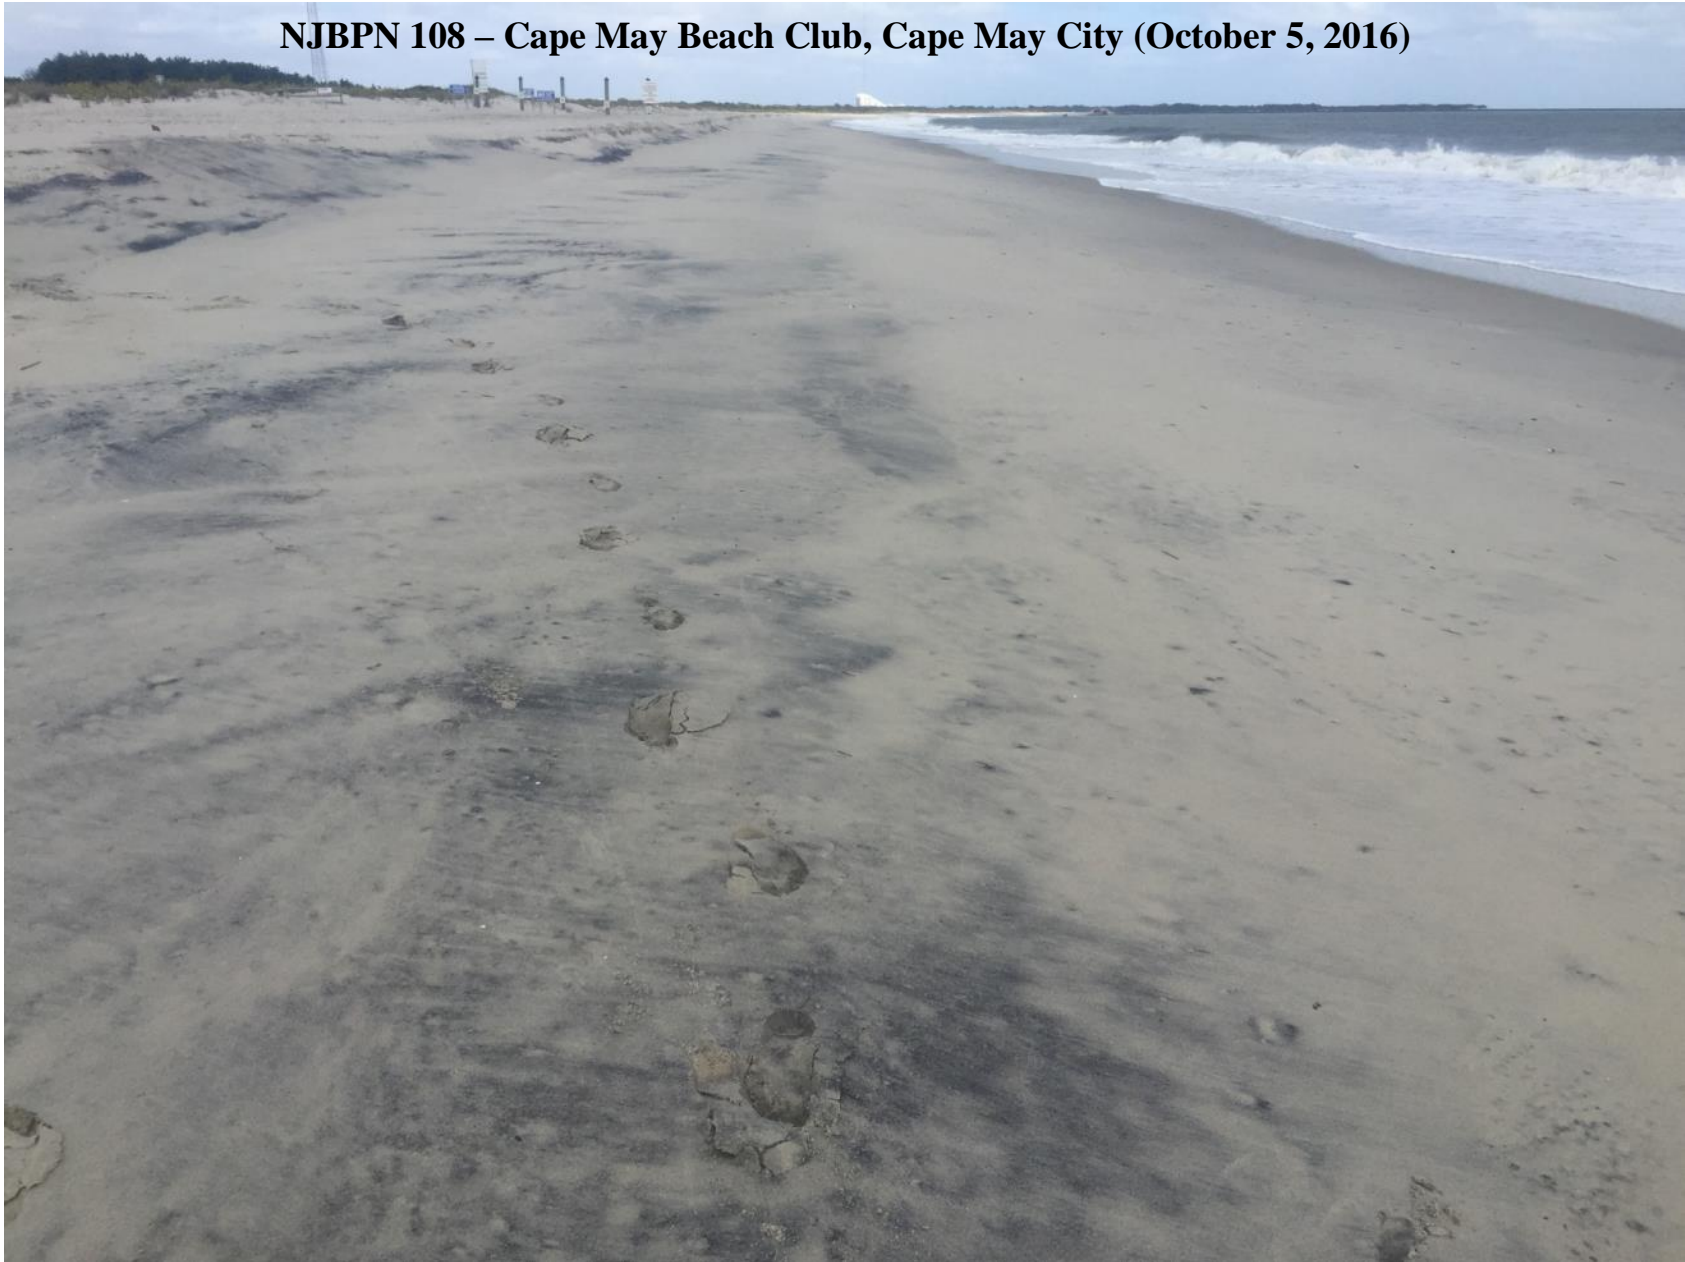
NJBPN 108 – Cape May Beach Club, Cape May City (October 5, 2016)

Figure 584. The Cape May Beach Club property lies between the City of Cape May and the US Coast Guard beach to the south of the Cold Springs Inlet. This site has a steep beach slope with minimal dunes because the club wants direct, level access from the facility to the shoreline.

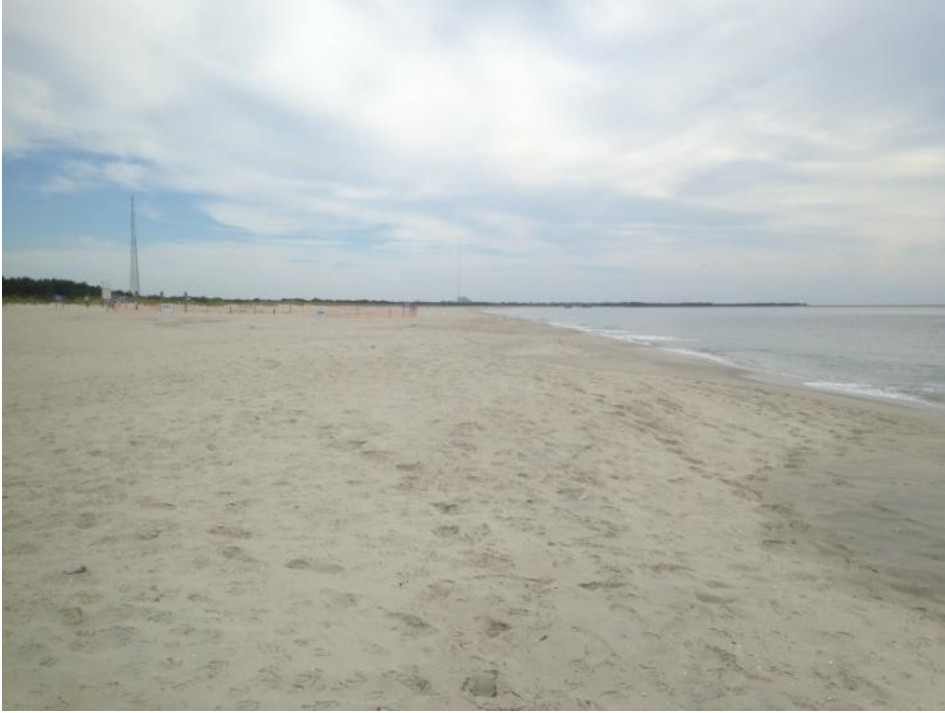
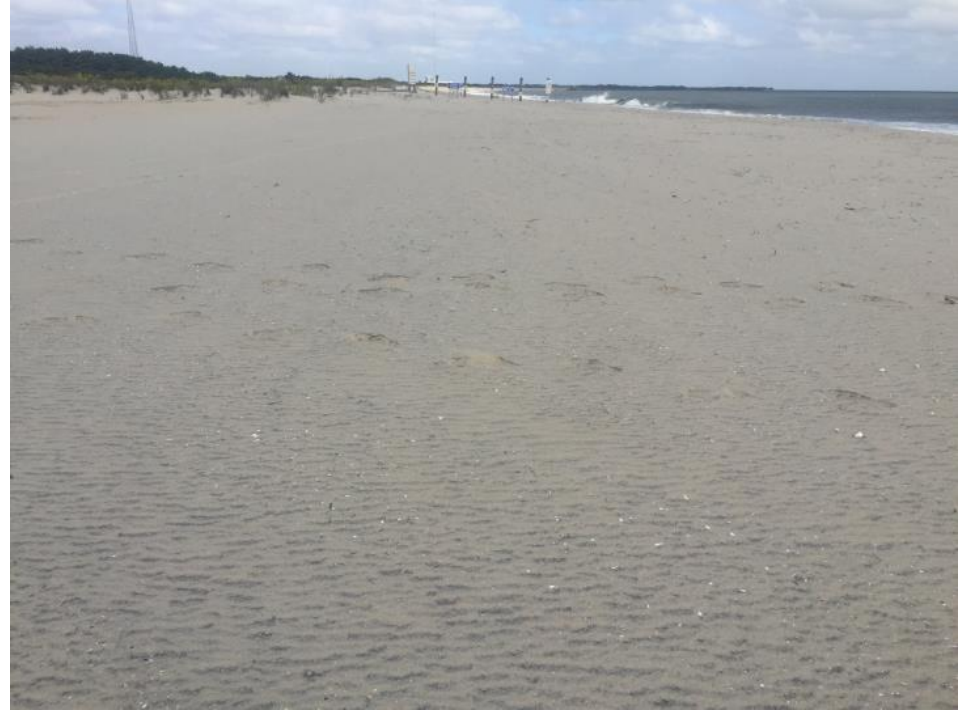
NJBPN 108 – Cape May Beach Club, Cape May City

Figure 585a & 585b. The left photo was taken September 17, 2015. The right photo was taken on October 5, 2016. The two photos show relative consistency in beach configuration and elevation with modest variation in width.

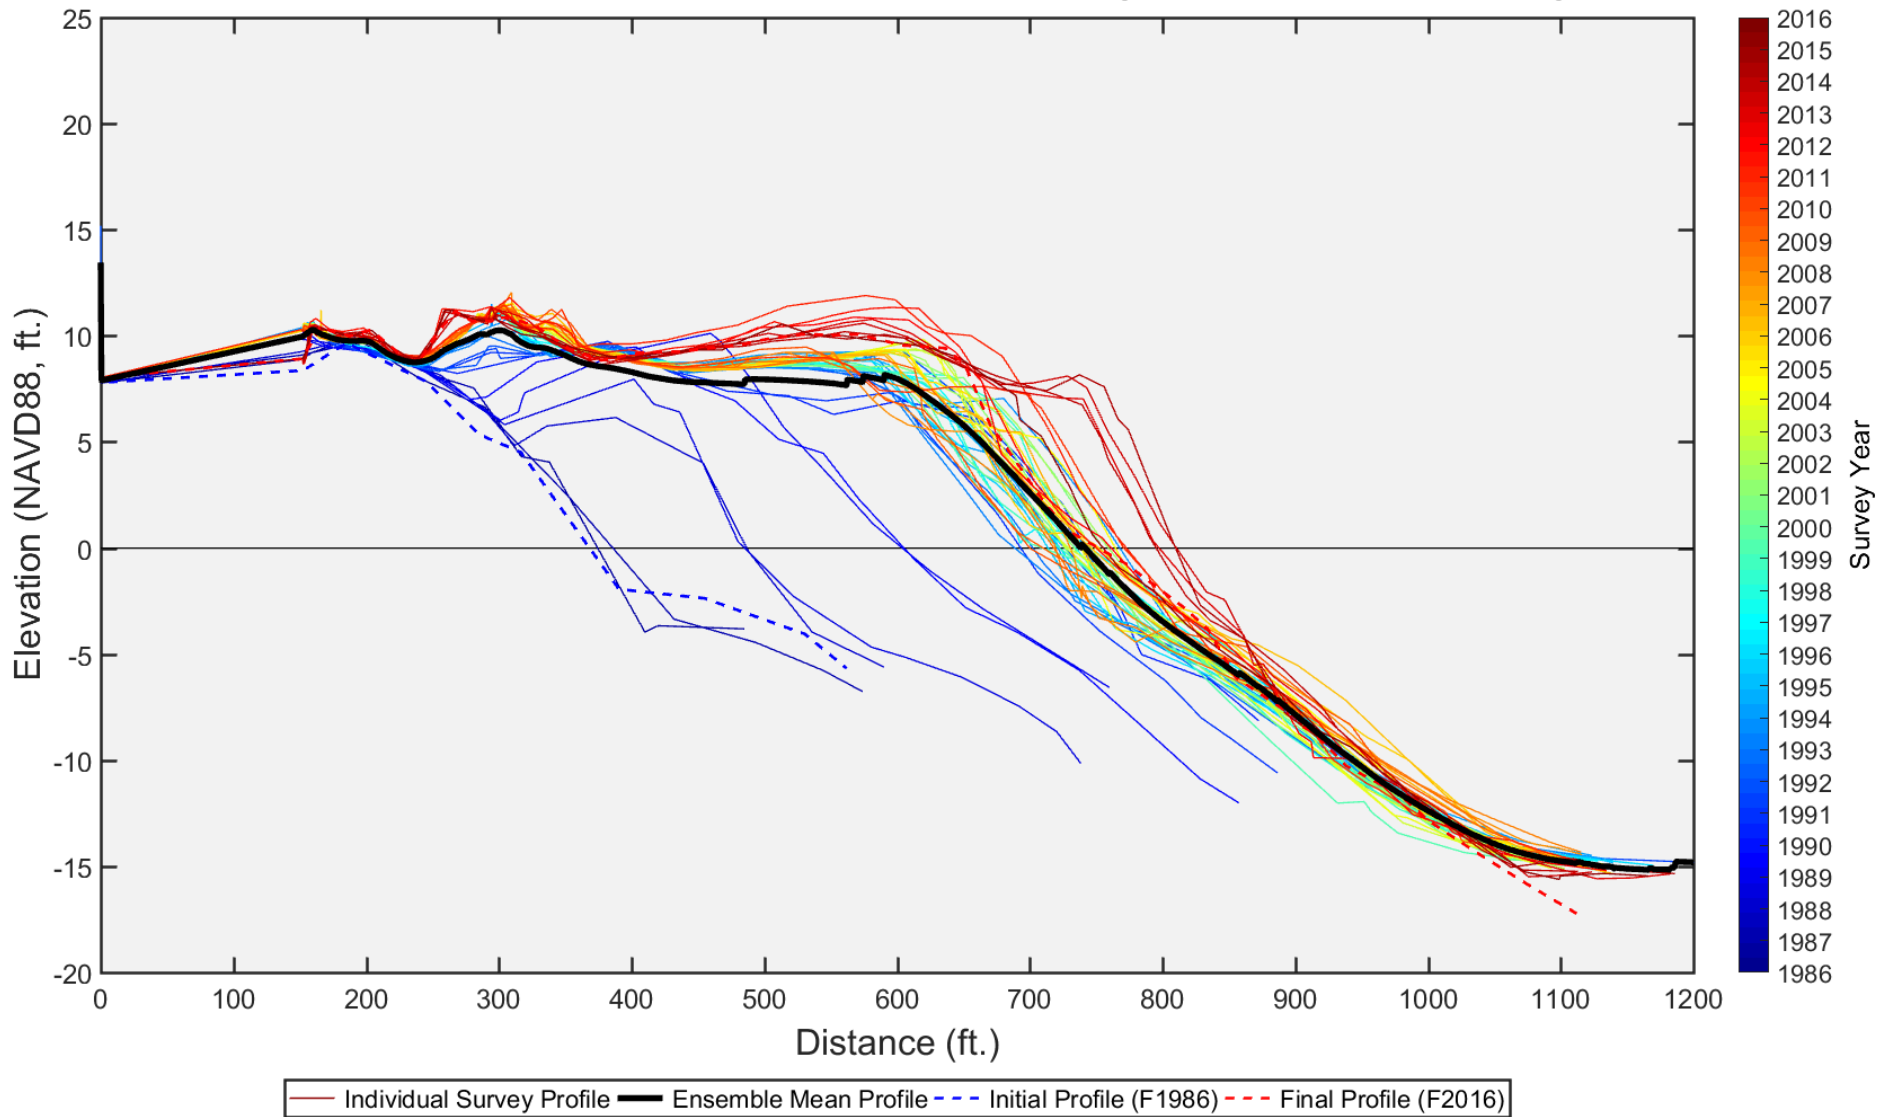
Figure 588. The enhancement is clearly observed in this figure, which shows progressive beach fills moving the beach berm and shoreline seaward while increasing the sand volume. Profiles from the early 1990's onward cluster around a shoreline position of 750 ft with a relatively small envelope of change over time. The more recent profiles show an increase in berm elevation from the mean profile, but very small variation from the mean in the offshore region.
