An Analysis of Thirty Years' Study of Sand Redistribution and Shoreline Changes in New Jersey's Four Coastal Counties Raritan Bay, the Atlantic Ocean Coast, and Delaware Bay Fall 1986 Through Fall 2016

VOLUME 4 of 4 CAPE MAY COUNTY & APPENDIX

Prepared for:
New Jersey Department of Environmental Protection
Division of Construction and Engineering
1510 Hooper Avenue, Toms River, New Jersey 08753

Prepared by:
The Stockton University Coastal Research Center
30 Wilson Avenue, Port Republic, NJ 08241

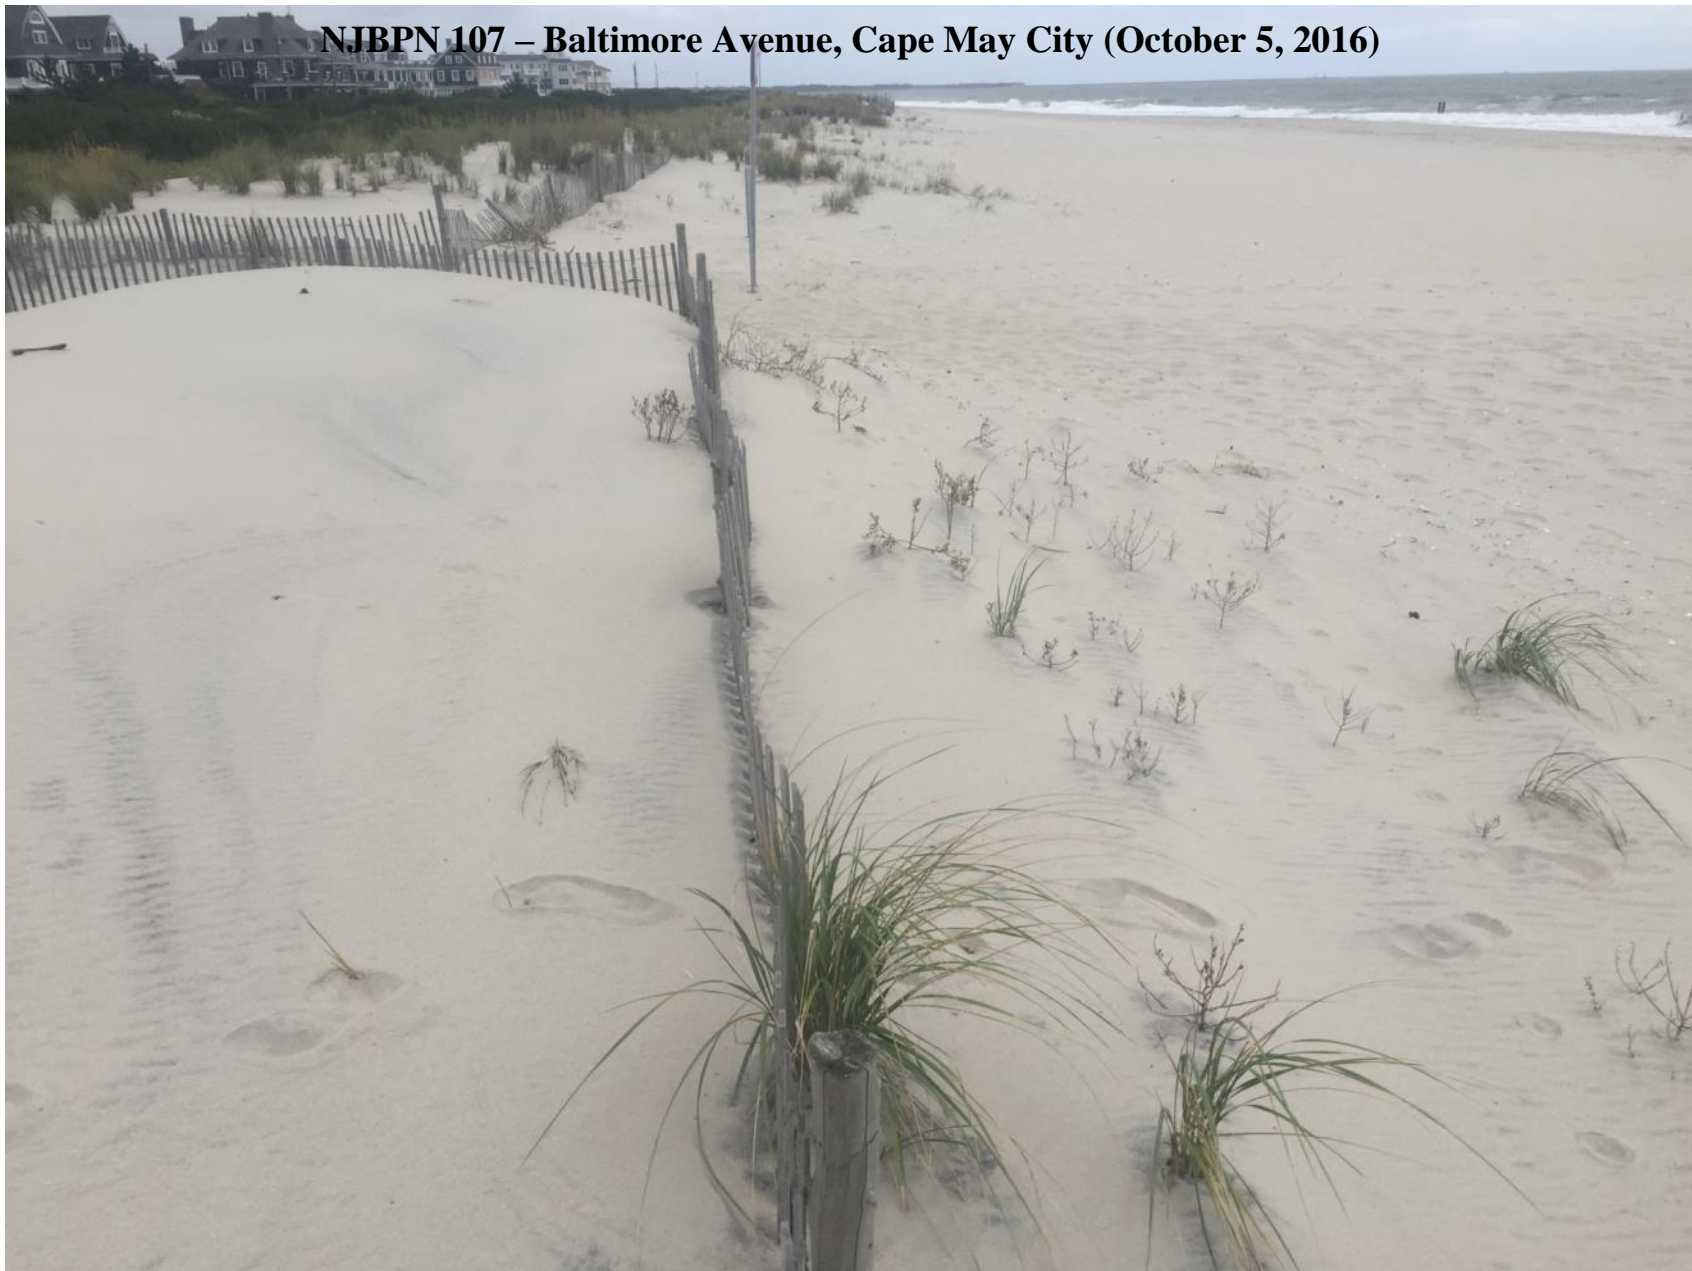
Figure 590. At Baltimore Avenue, the earliest of surveys went into the water at the base of the rocks, now located far to the left of the grass and adjacent to the road in the picture above. Sand nourishment projects have restored an excellent beach that provides abundant recreational space for beach patrons. The wide beach and dune system has also enhanced shore protection for oceanfront development and infrastructure.

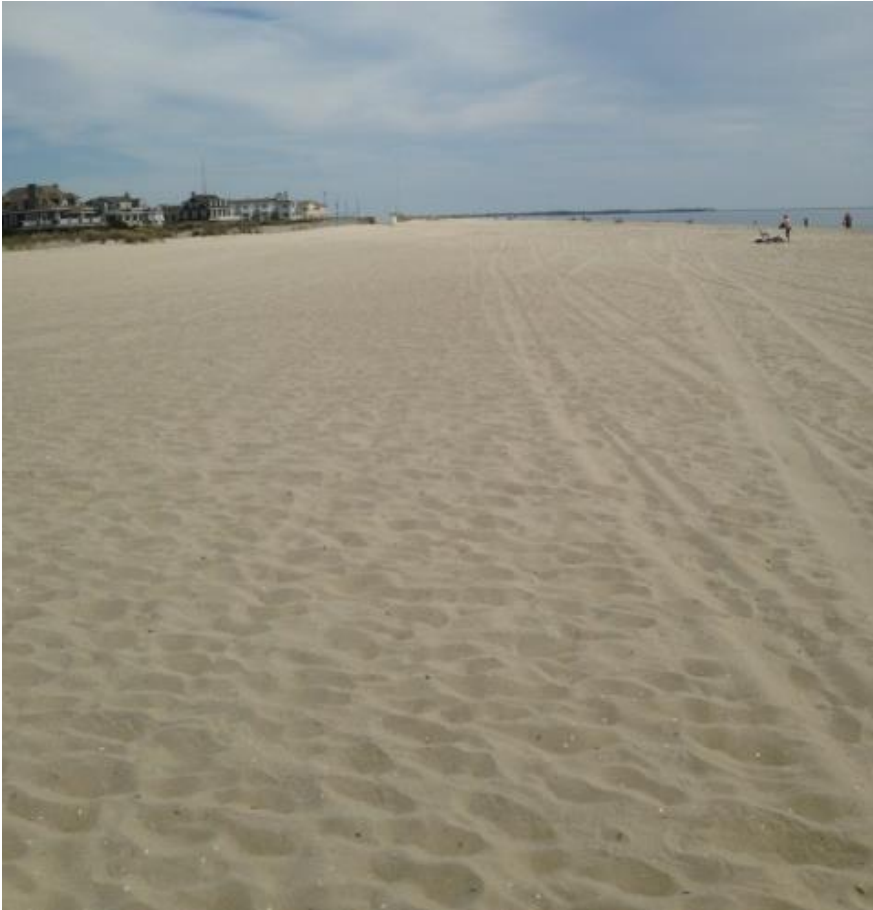
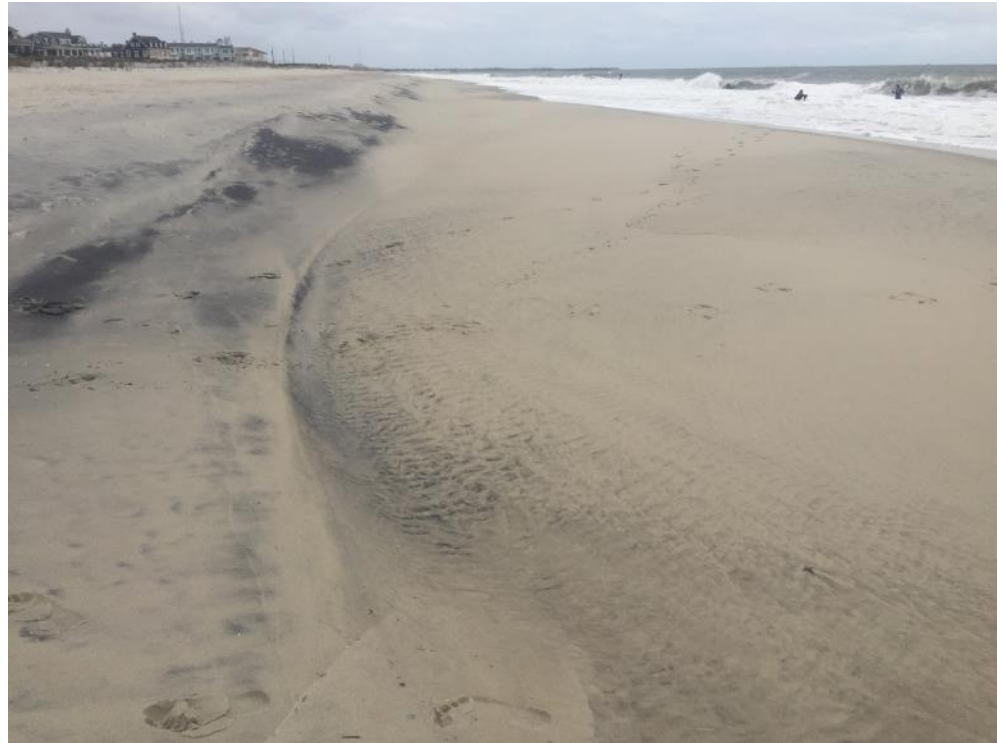
NJBPN 107 – Baltimore Avenue, Cape May City

Figure 591a & 591b. The left photo was taken on September 17, 2015. The right photograph was taken October 5, 2016 with substantial surf scouring the beach face. Prior to 1989, the spot the photographer was standing at would have been 300 ft from the shoreline in about 15 ft of water.

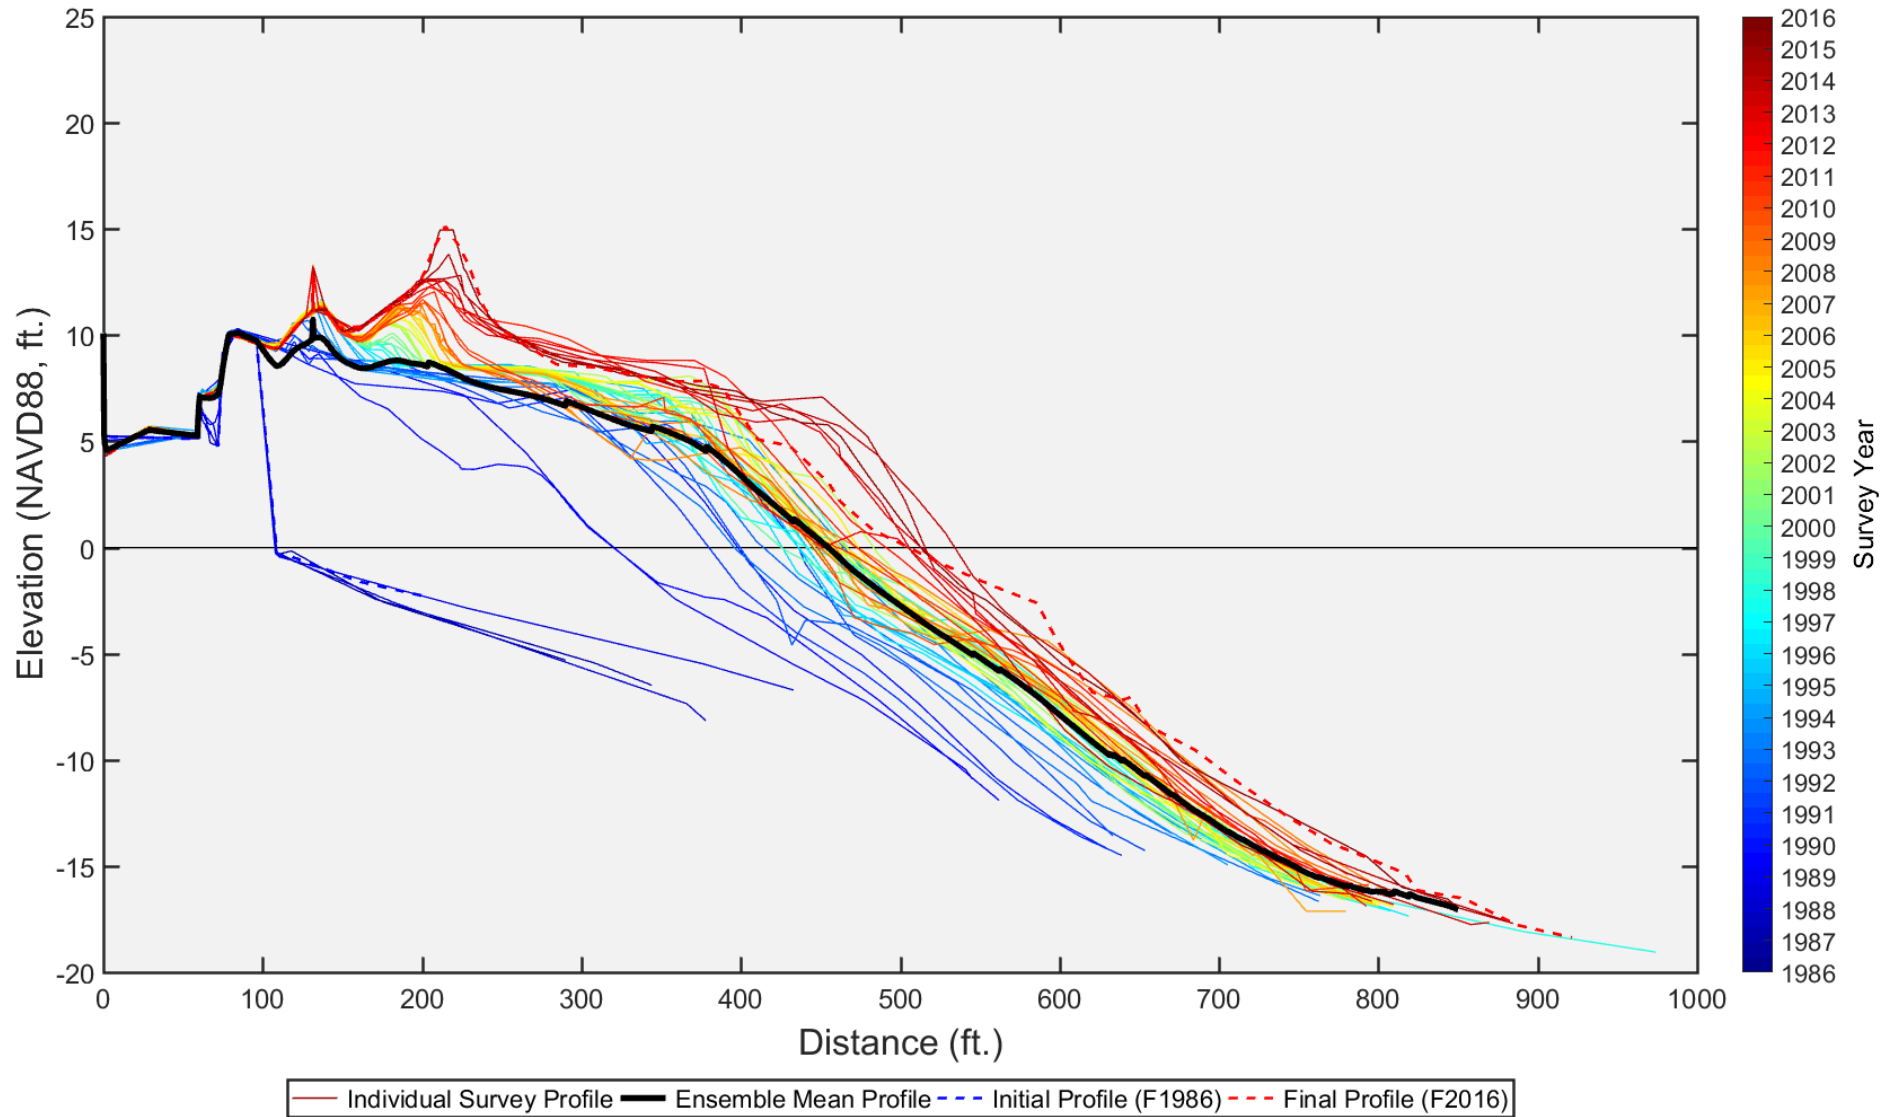
Figure 594. The initial survey involved sliding off the algae covered rocks between breaking waves into the water and trusting there was a sand bottom there somewhere. Three surveys later, the federal beach was in place and advances continued, along with dune development, up to conditions present as of 2016. The economic benefits of this new beach for Cape May City was unsurpassed for all of the variety of tourist destination enterprises in operation within city limits.

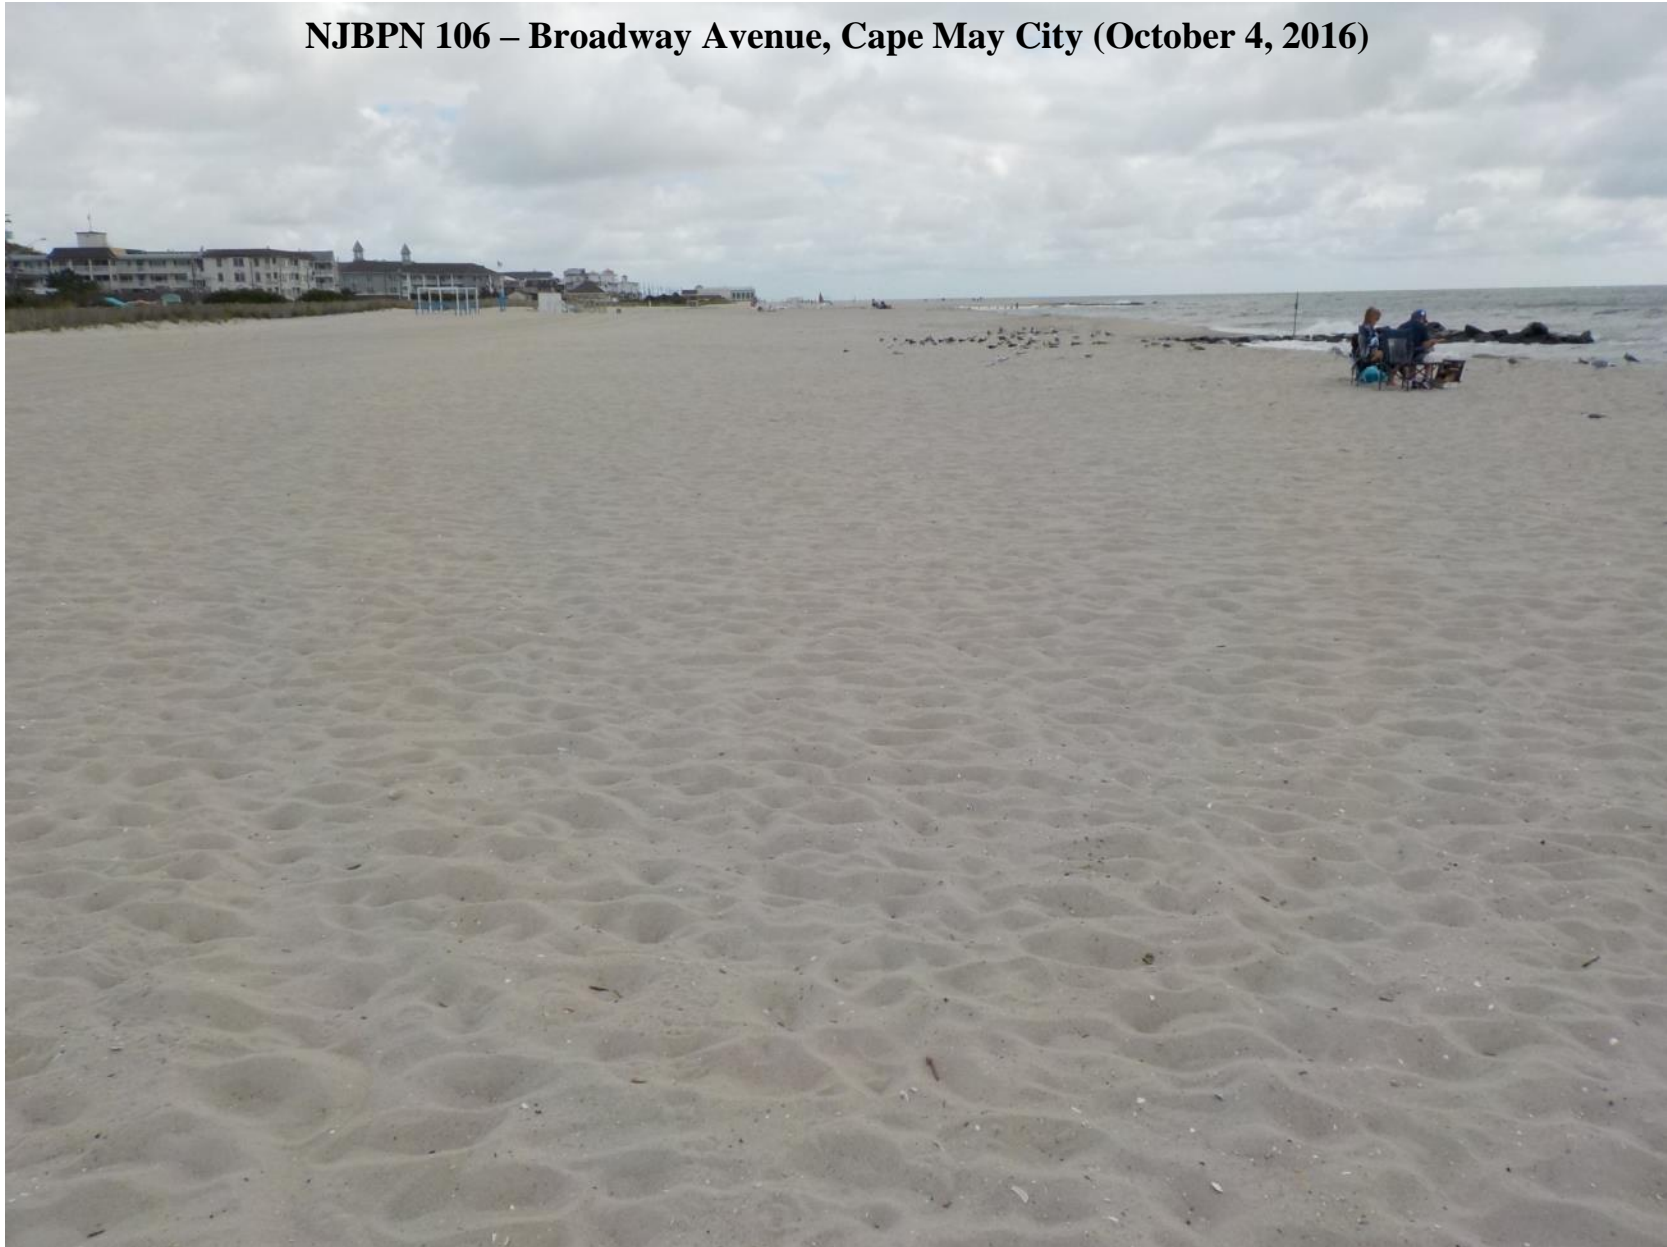
NJBPN 106 – Broadway Avenue, Cape May City (October 4, 2016)

Figure 596. Broadway beach in Cape May City is one of the busiest recreational areas in the municipality. This beach lies at the southern extent of sand nourishment with a terminal groin holding the majority of fill from leaving into the Nature Conservancy to the south. Prevailing currents and waves also transfer sand around the groin, enhancing the shoreline south into Cape May Point.

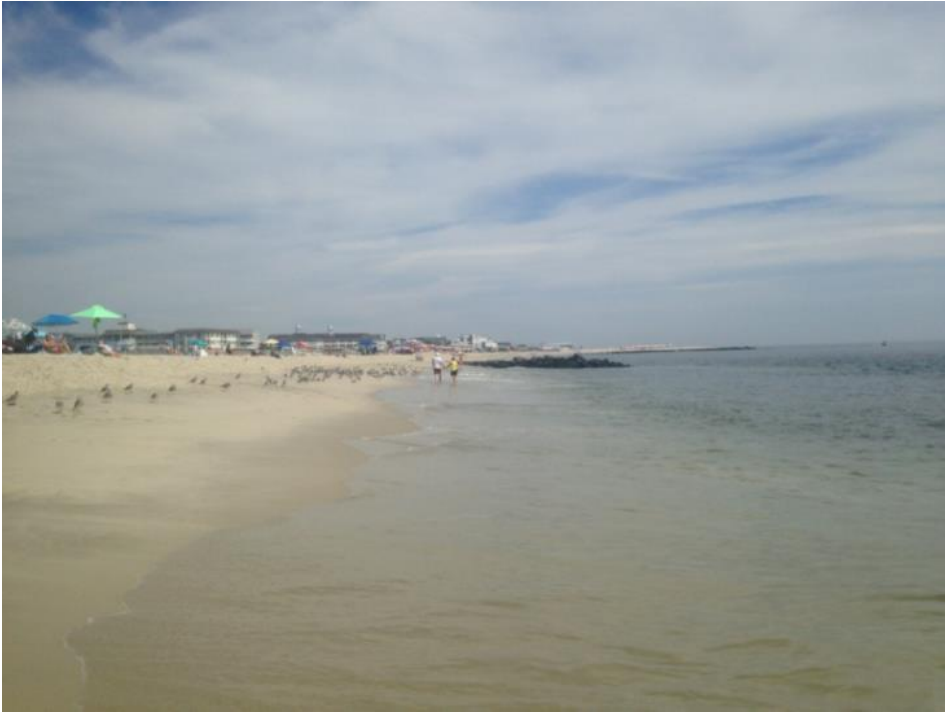
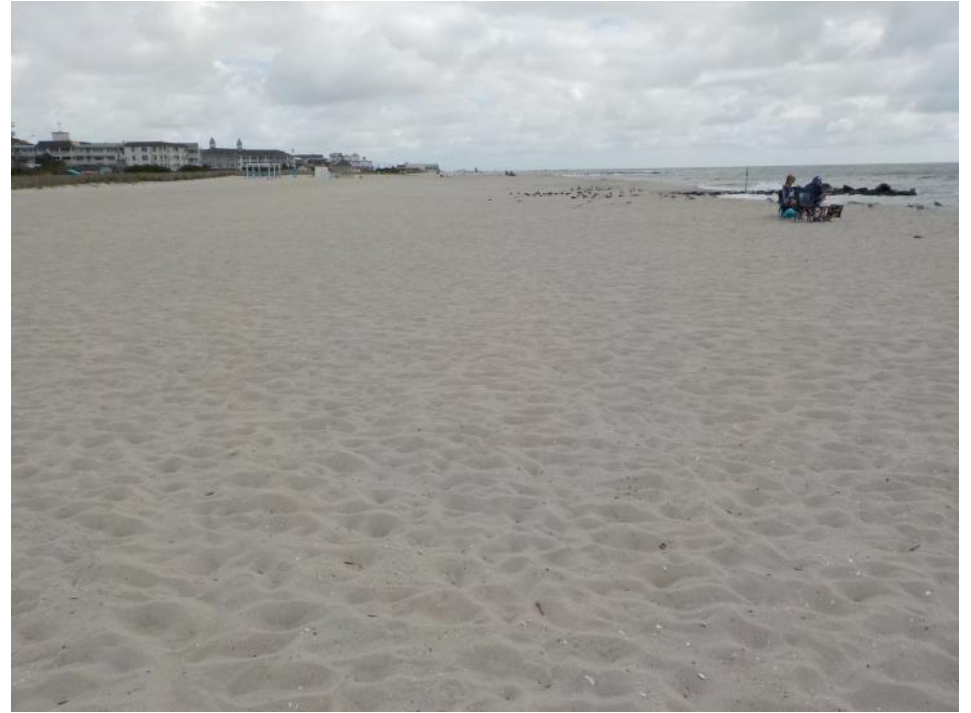
NJBPN 106 – Broadway Avenue, Cape May City

Figure 597a & 597b. The left photo was taken on September 17, 2015. The right photo was taken on October 4, 2016 and shows a stable beach relative to the rock groin in the distance.

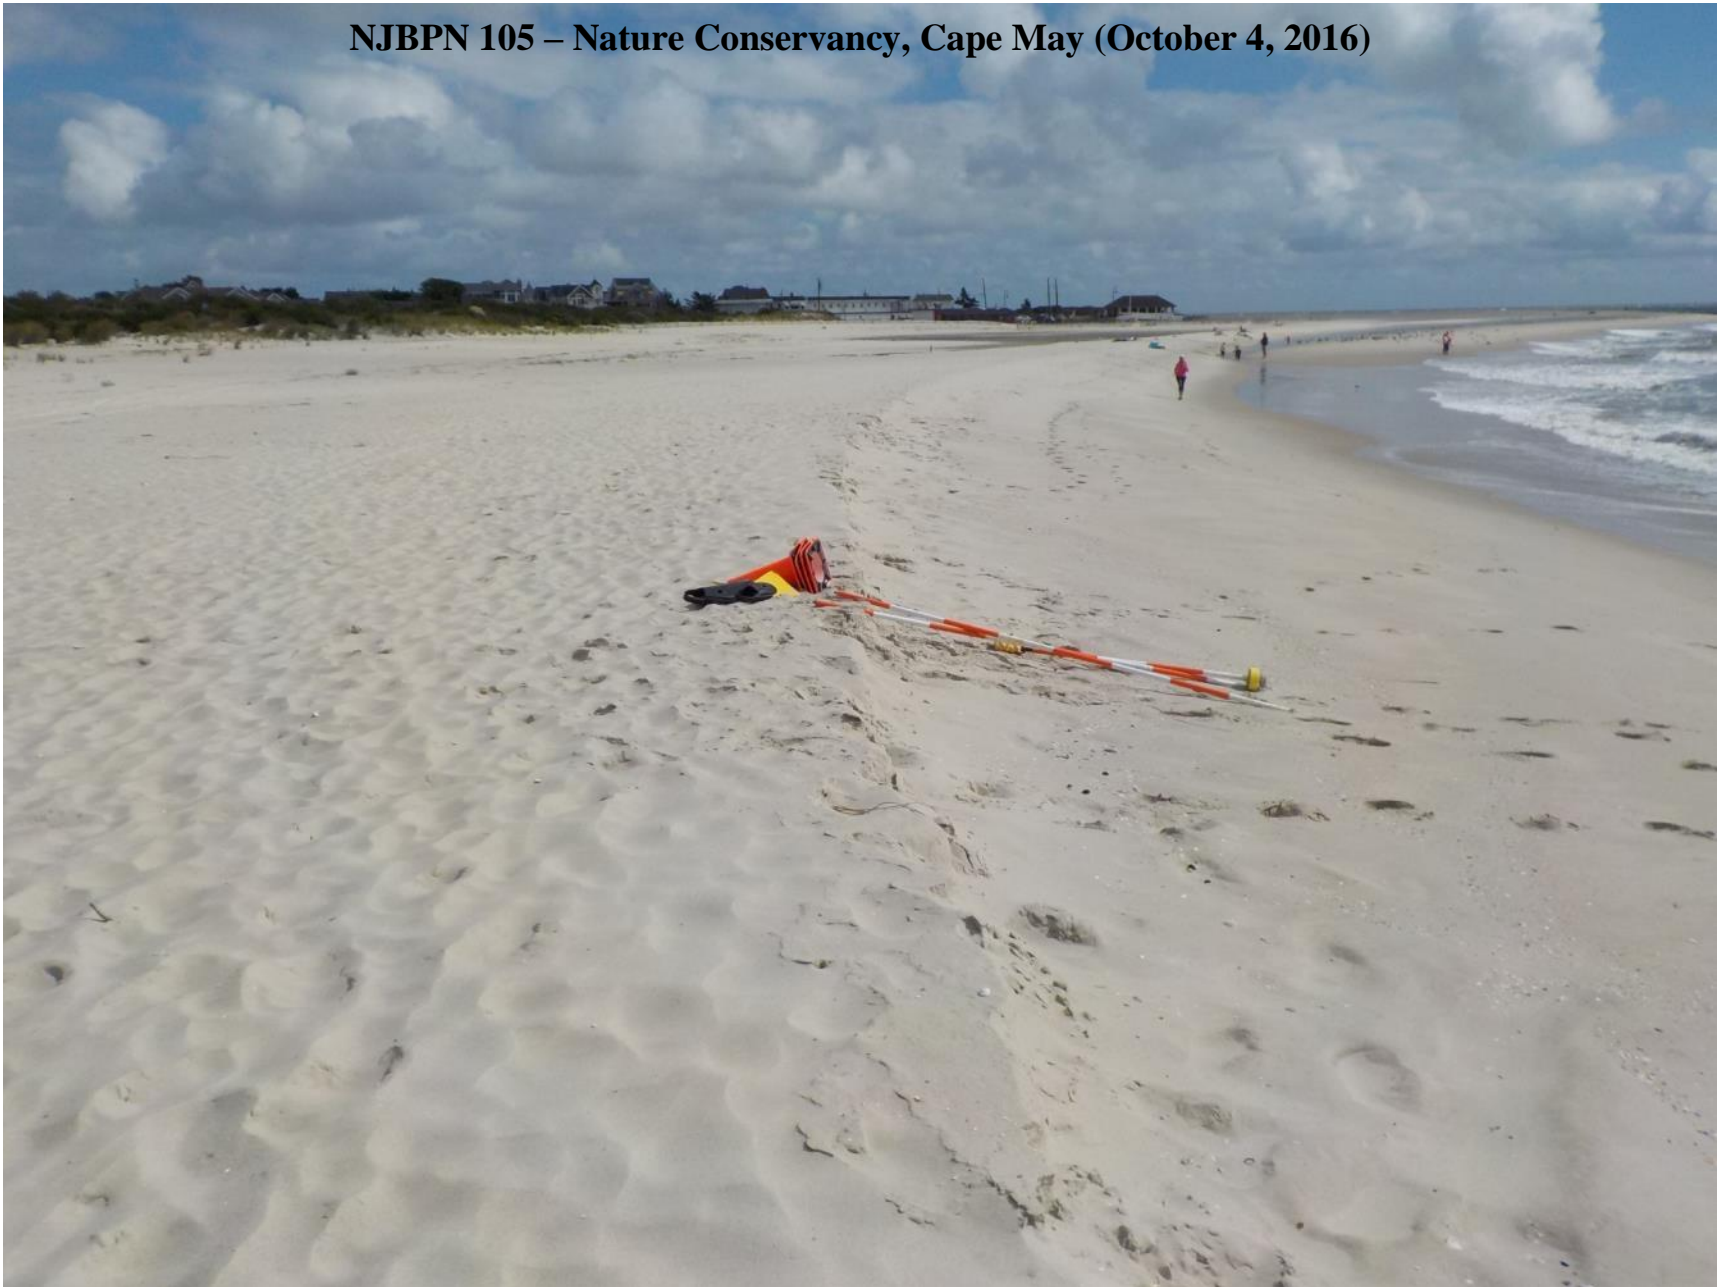
NJBPN 105 – Nature Conservancy, Cape May (October 4, 2016)

Figure 602. The berm with a small scarp cut at the level of the high tide shows a curved beach leading back to the Cape May City terminal groin. The dune at the far left was once the shoreline in 1986 and all of the added width shown here is due to natural sand transfer from the Cape May project around the terminal groin.

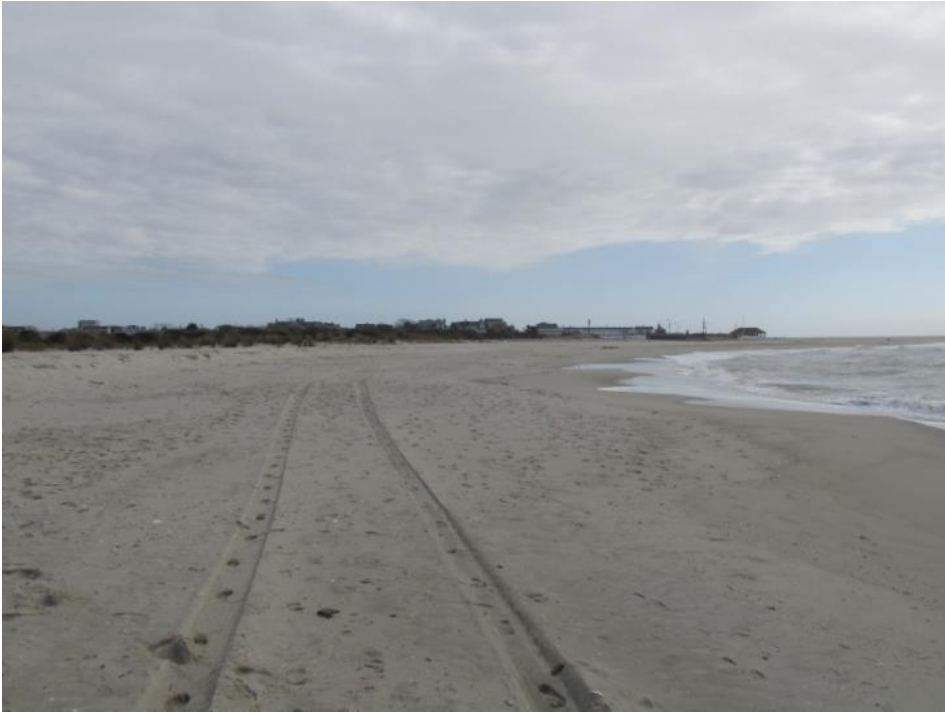
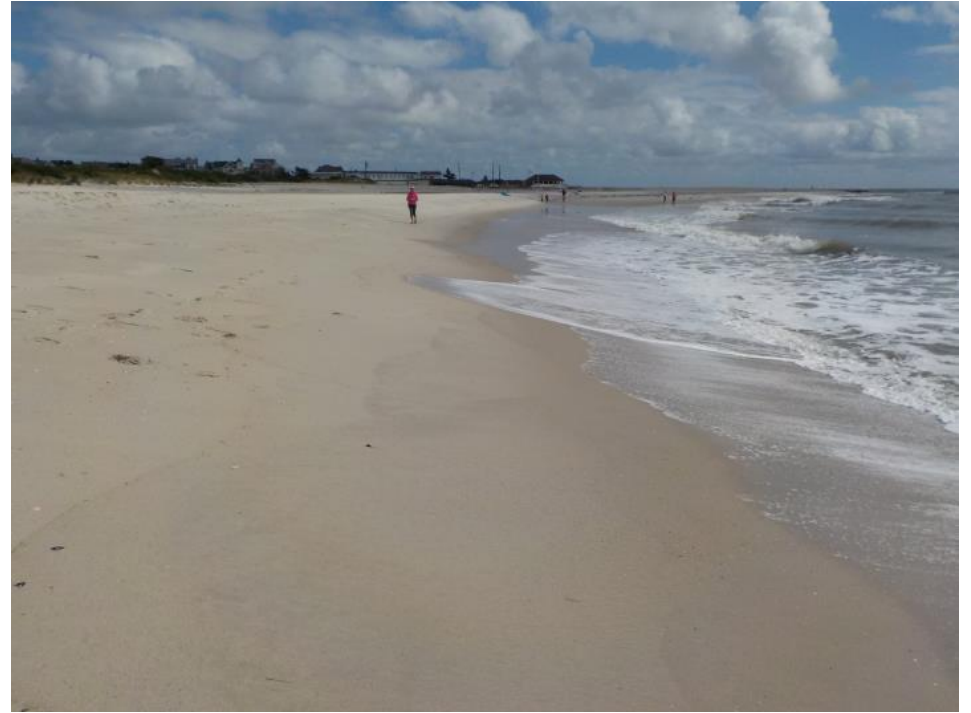
NJBPN 105 – Nature Conservancy, Cape May

Figure 603a & 603b. The left photo was taken November 18, 2015. The right photo was taken on October 4, 2016 and shows a steeper beach face and the deposition of new sand at the base of the groin bordering the development in the distance.

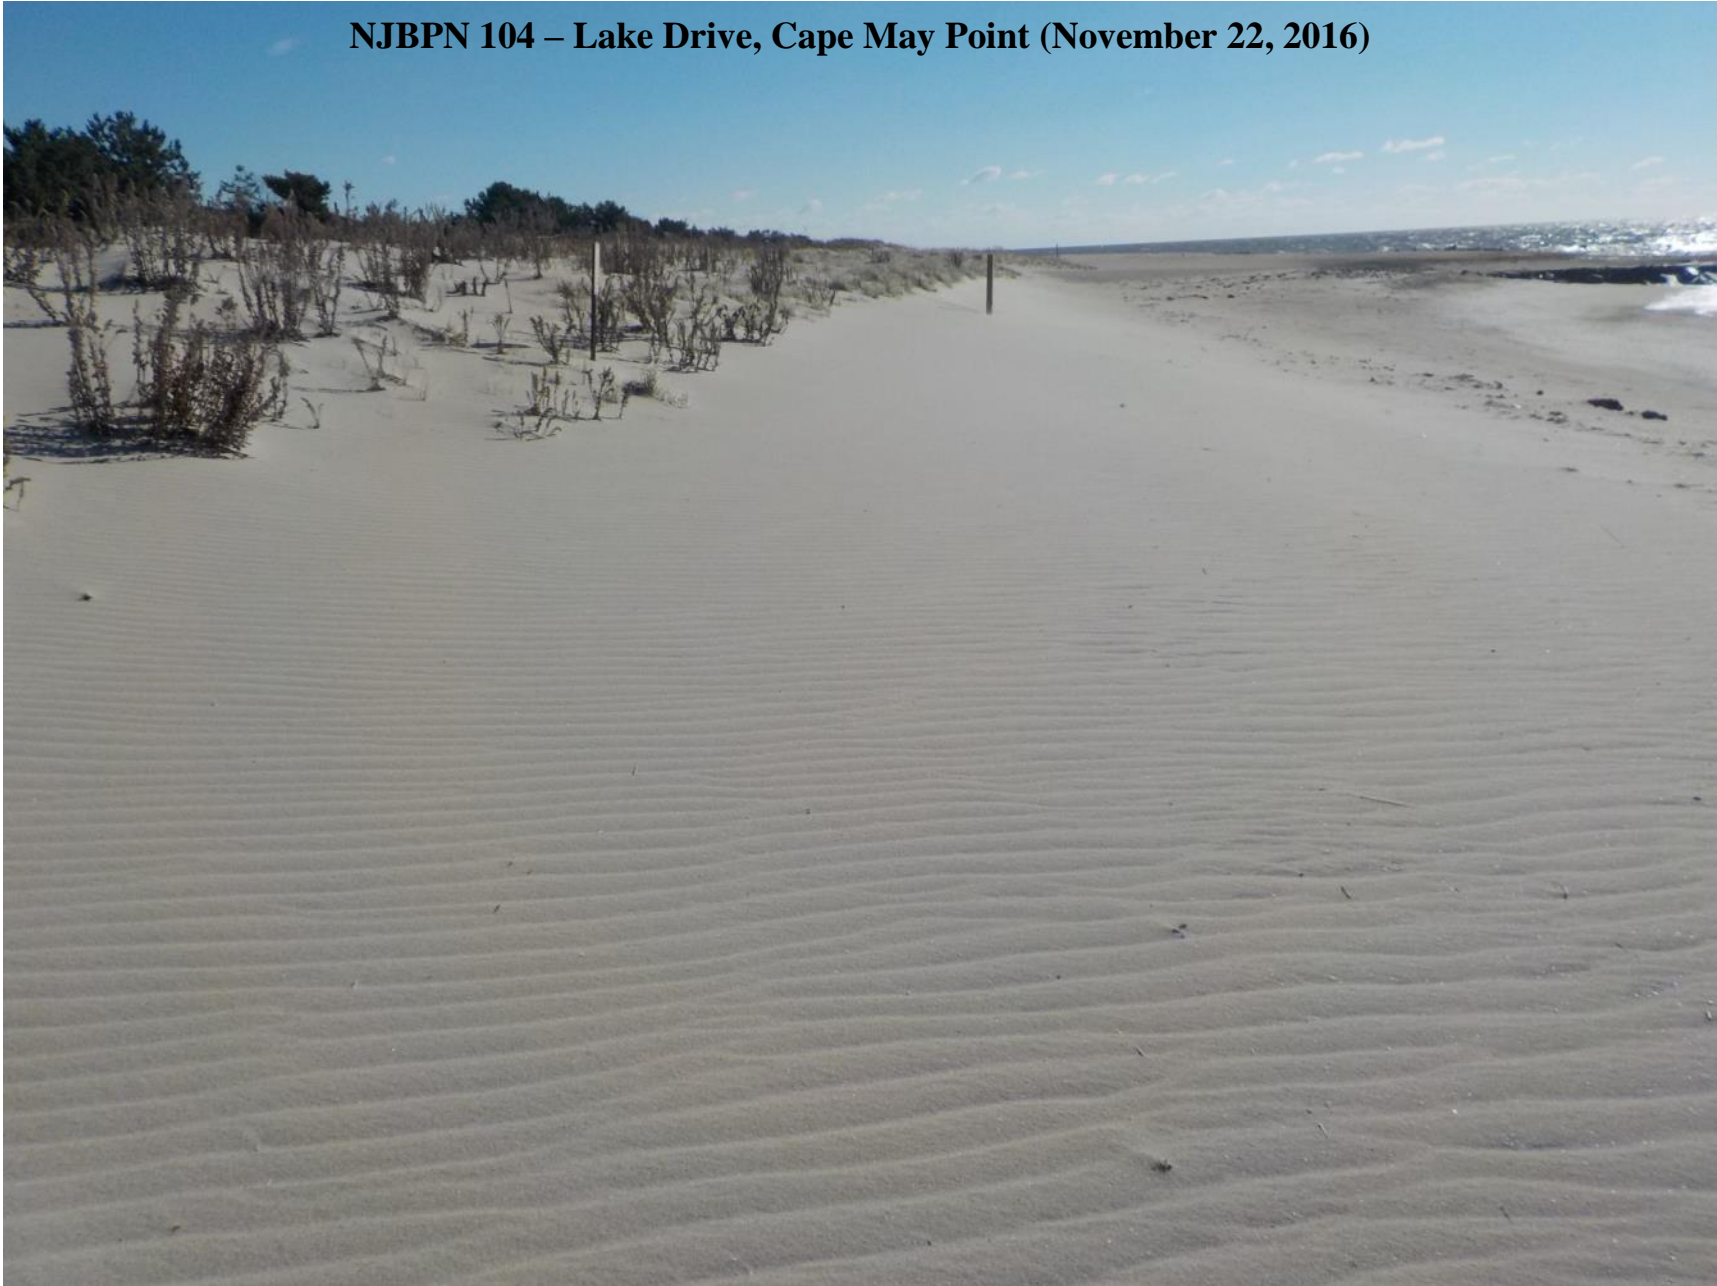
NJBPN 104 – Lake Drive, Cape May Point (November 22, 2016)

Figure 608. The Cape May Point beach at Lake Drive was the last segment between Cape May City and Cape May Point to receive sand from a USACE project in 2005. Retreat rates have been slower than in the past as a direct result of the sand influx into this system.

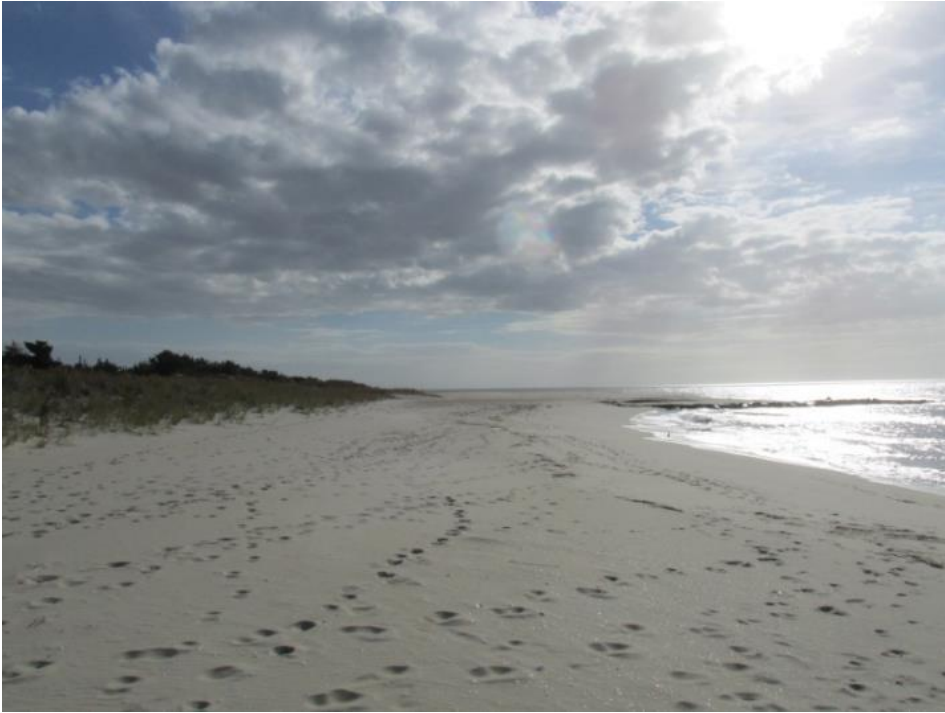
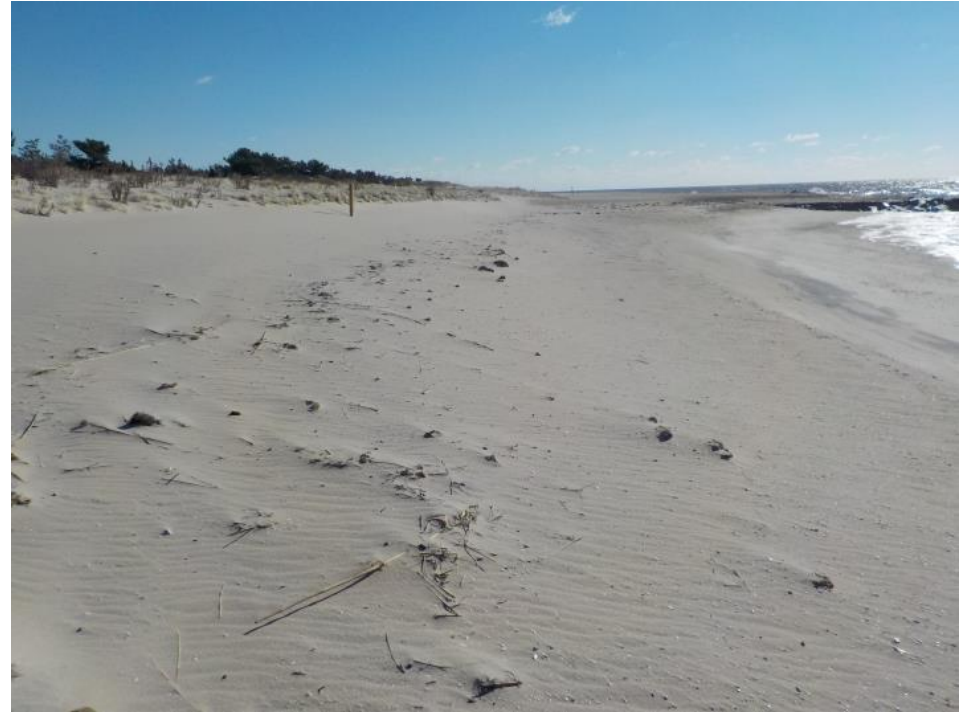
NJBPN 104 – Lake Drive, Cape May Point

Figure 609a & 609b. The left photo was taken on November 18, 2015. The right photo was taken on November 22, 2016, one year later. Sand accumulated on the upper beach but the beach face slope had eroded and retreated by 2016.

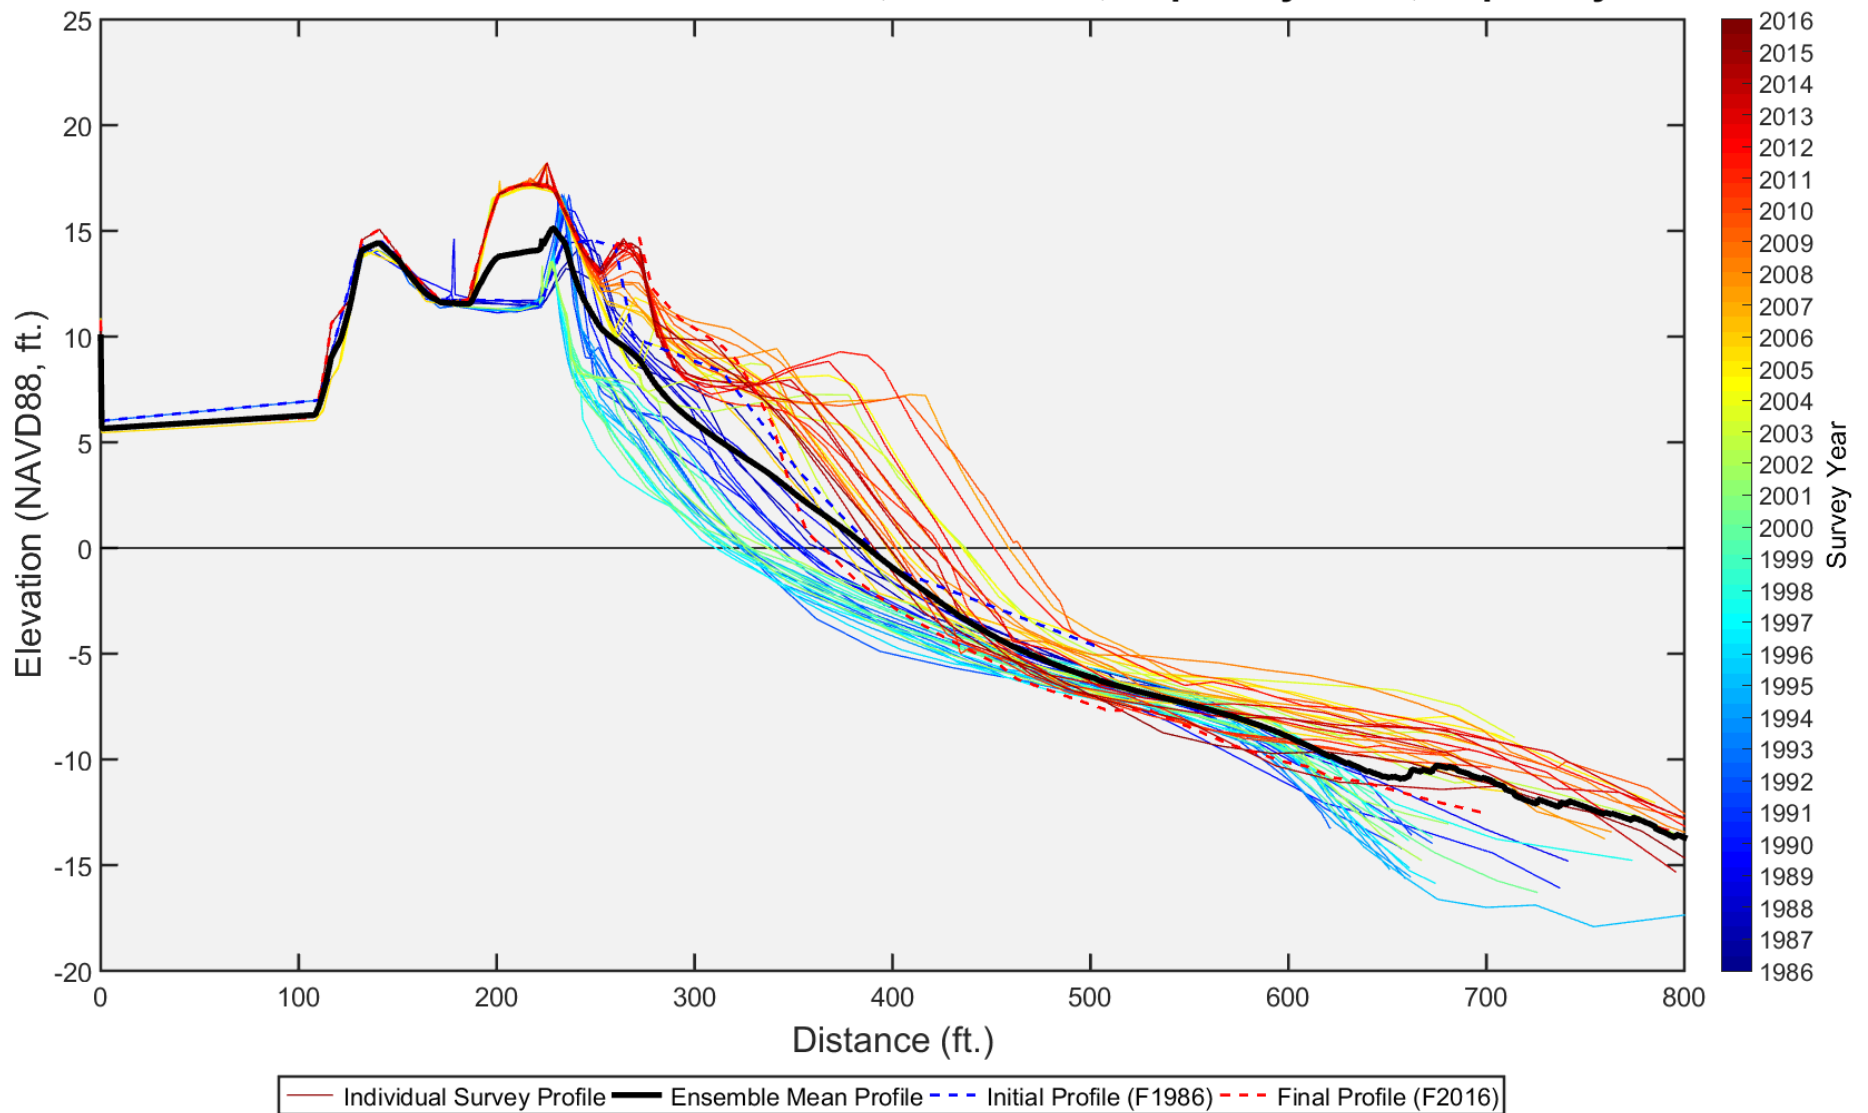
Figure 612. The two distinct color groupings of profiles plots represent pre-federal (blue/green lines) and post-federal project (yellow/red lines) conditions. Dune development has always been encouraged by the borough and they have been successful. The USACE project established a larger primary dune with subsequent fencing adding foredune growth through aeolian processes. The project enhanced the beach berm width and height feeding the nearshore with additional sand. By 2016 conditions had begun to regress as the shoreline retreated landward and the nearshore slope deepened.

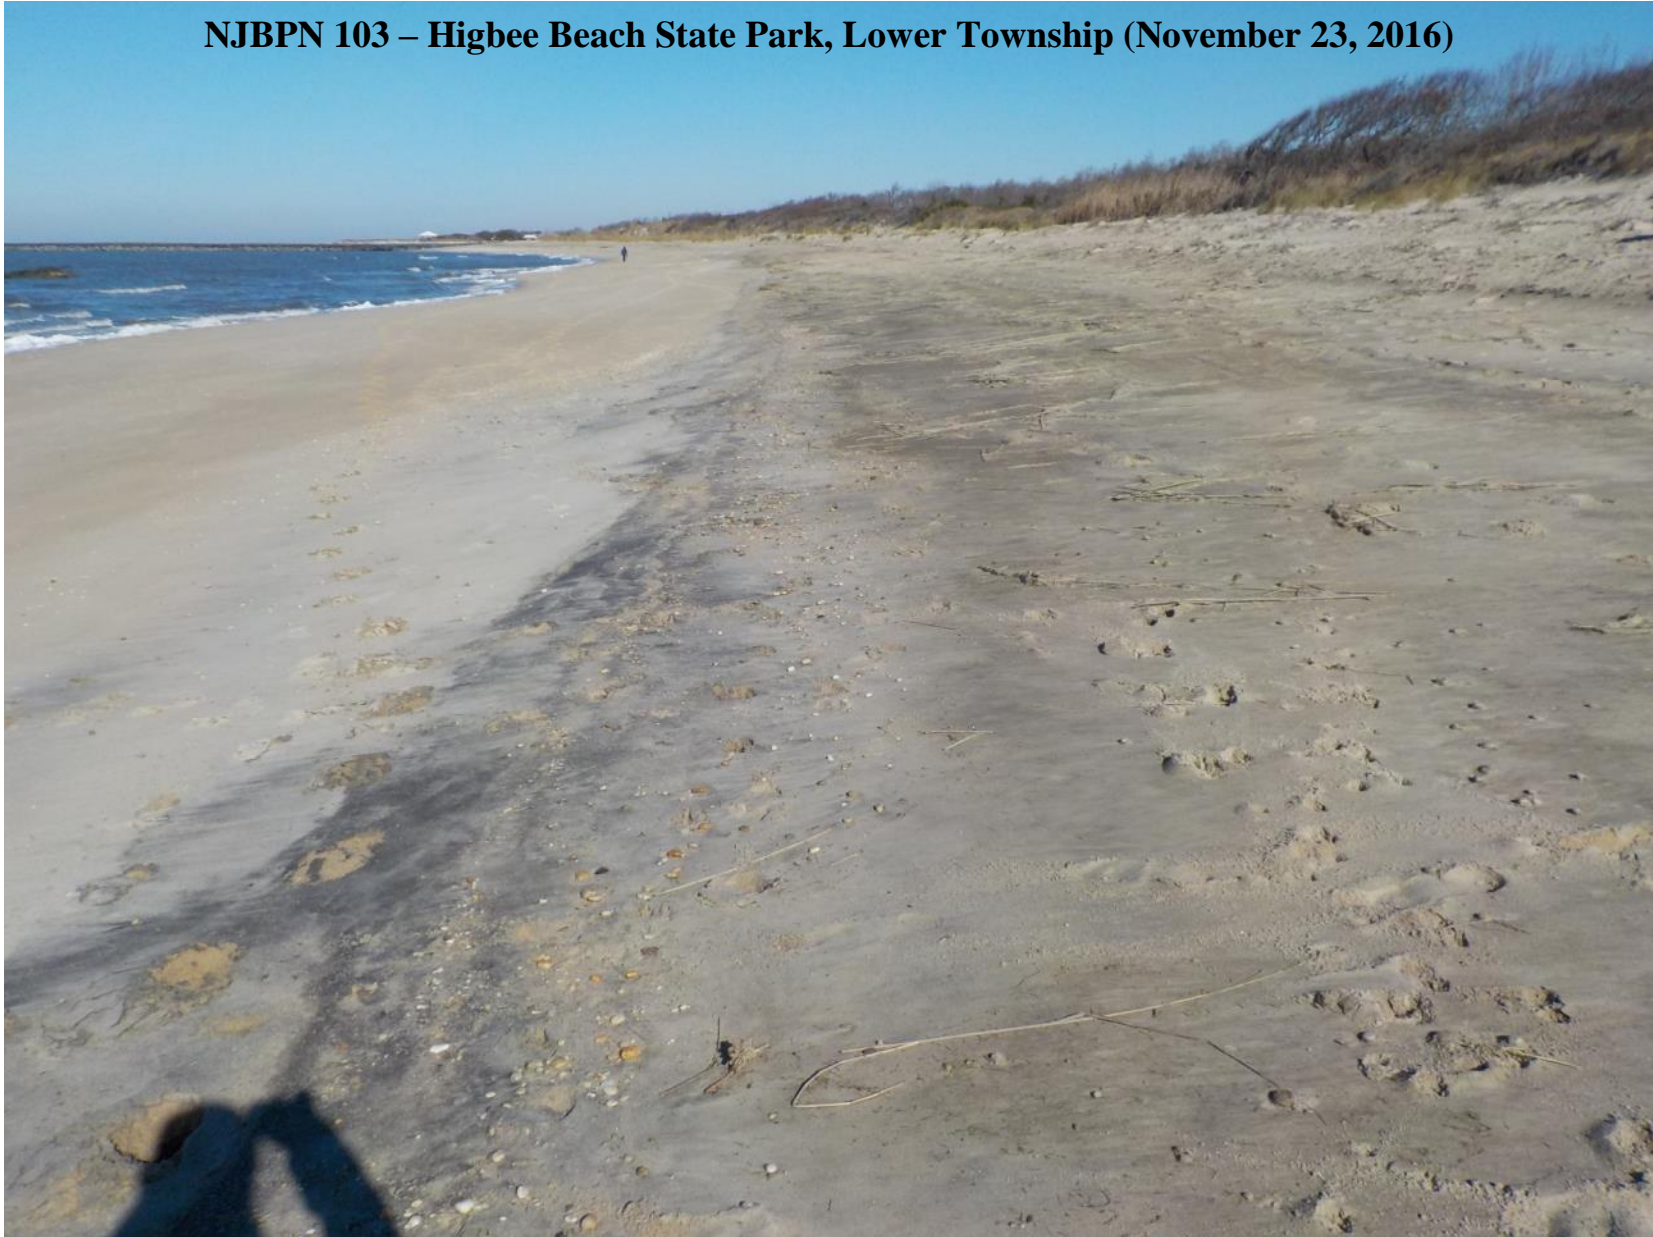
NJBPN 103 – Higbee Beach State Park, Lower Township (November 23, 2016)

Figure 614. Higbee beach is a wildlife/recreation area under the NJ Park Service with an extensive uplands dune field, which was once the site of a magnesite ($MgCl$) smelting operation and a sand mining effort. The beach is narrower in this region as the shoreline transitions into Delaware Bay. This site has been retreating slowly as the bluff erodes feeding some sand into the beach. The Cape May Canal jetty is in the distance.

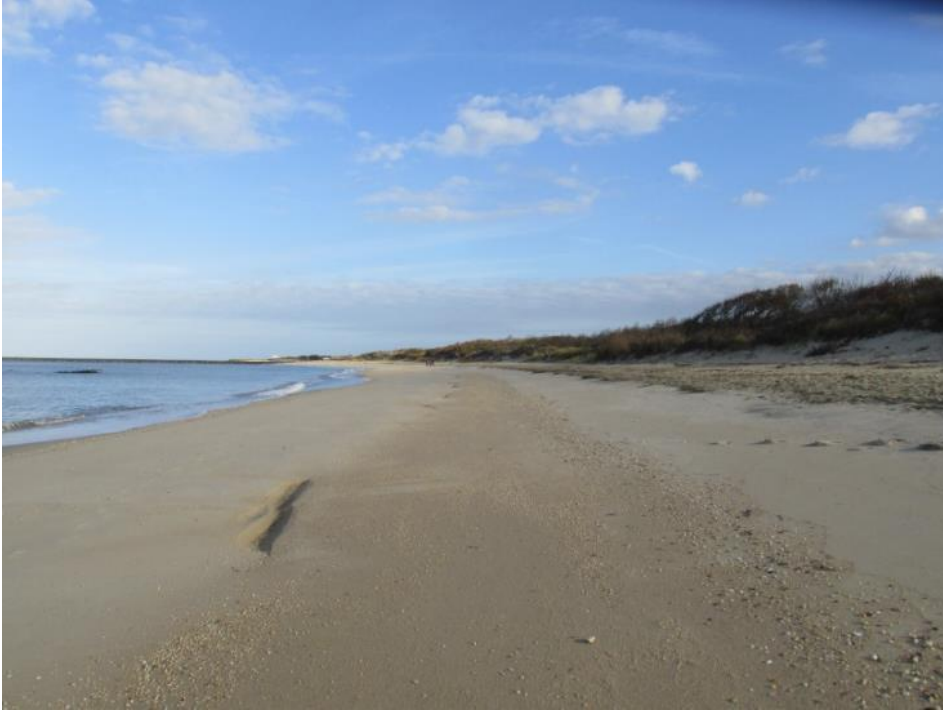
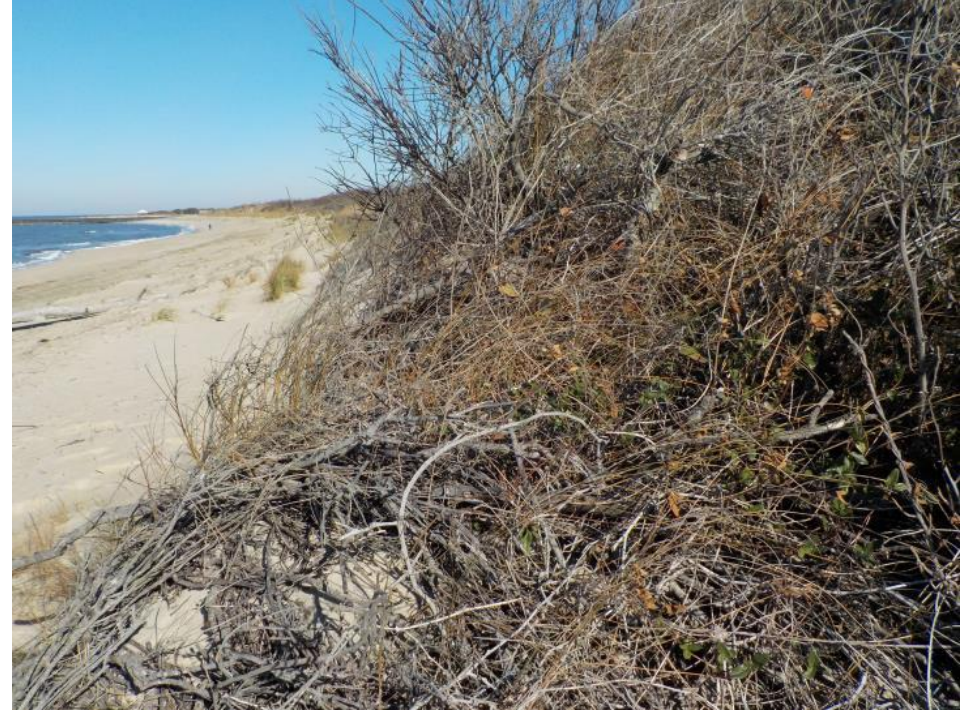
NJBPN 104 – Higbee Beach State Park, Lower Township

Figure 615a & 615b. The left photo was taken November 18, 2015. The right photo, taken November 23, 2016, shows the bluff vegetation at the edge of the scarp and a look up the beach toward the Cape May Canal.
