An Analysis of Thirty Years' Study of Sand Redistribution and Shoreline Changes in New Jersey's Four Coastal Counties Raritan Bay, the Atlantic Ocean Coast, and Delaware Bay Fall 1986 Through Fall 2016

VOLUME 4 of 4 CAPE MAY COUNTY & APPENDIX

Prepared for:
New Jersey Department of Environmental Protection
Division of Construction and Engineering
1510 Hooper Avenue, Toms River, New Jersey 08753

Prepared by:
The Stockton University Coastal Research Center
30 Wilson Avenue, Port Republic, NJ 08241

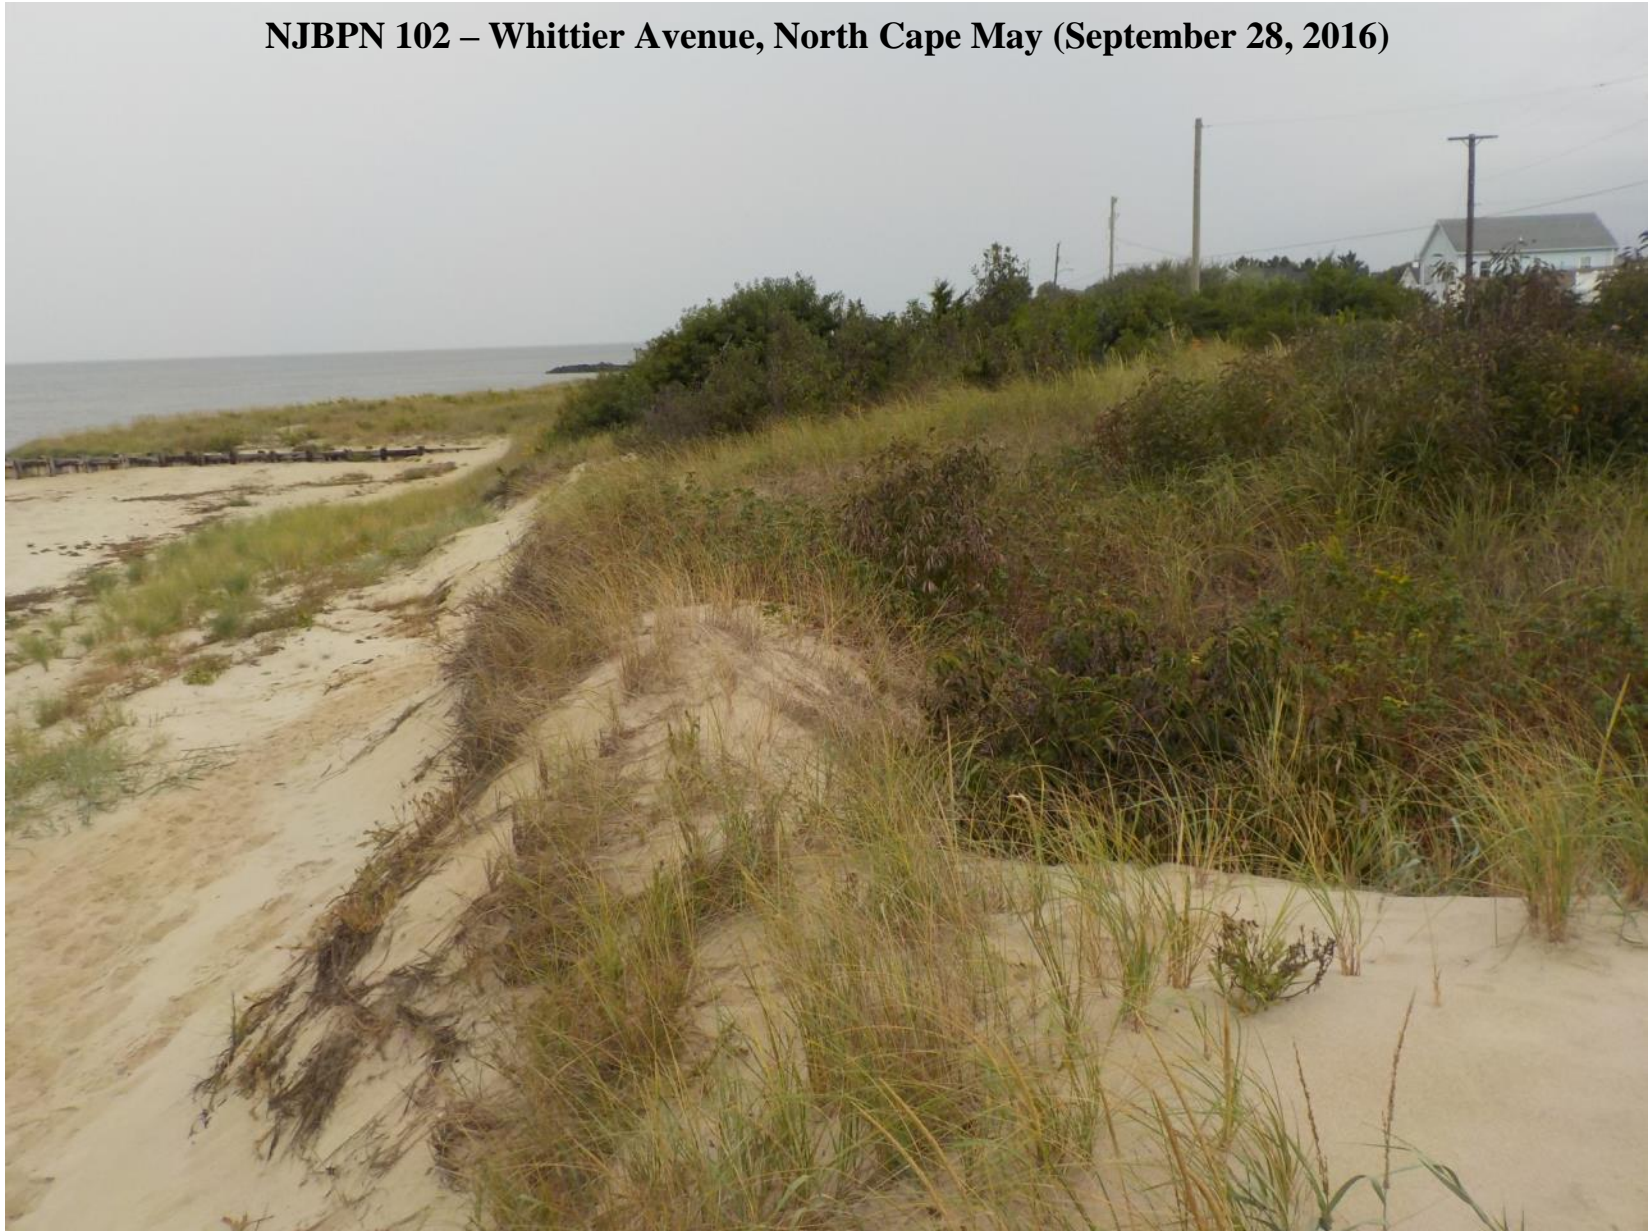
NJBPN 102 – Whittier Avenue, North Cape May (September 28, 2016)

Figure 620. This view to the north along the Delaware Bay shoreline shows the massive dune developed above the seaward edge of the Cape May bluff at this site, along with the smaller hard structures (groins) put in to slow sand transport. The dune and beach system is substantial for the bayshore and remains relatively stable.

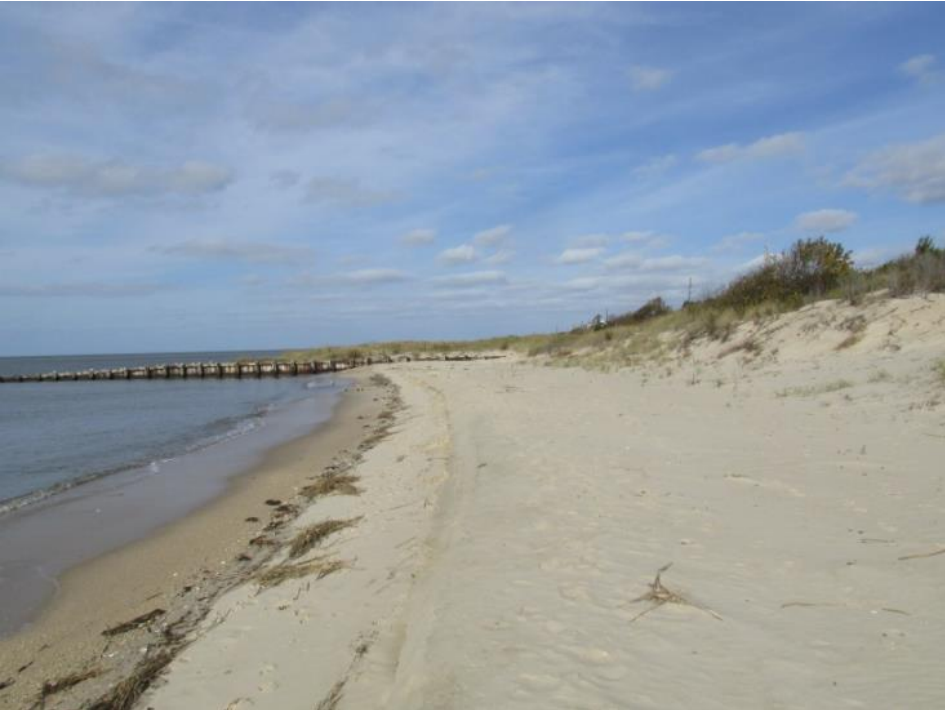
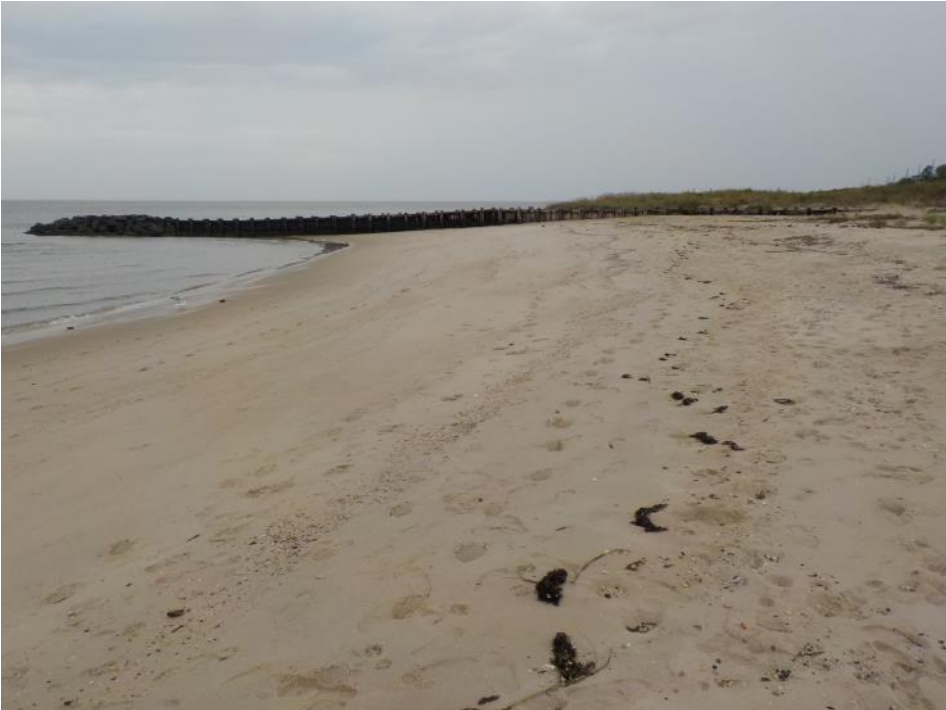
NJBPN 102 – Whittier Avenue, North Cape May

Figure 621a & 621b. The left photo was taken on November 17, 2015. The right photo, taken on September 28, 2016, shows a slightly wider beach in comparison to the timber groin.

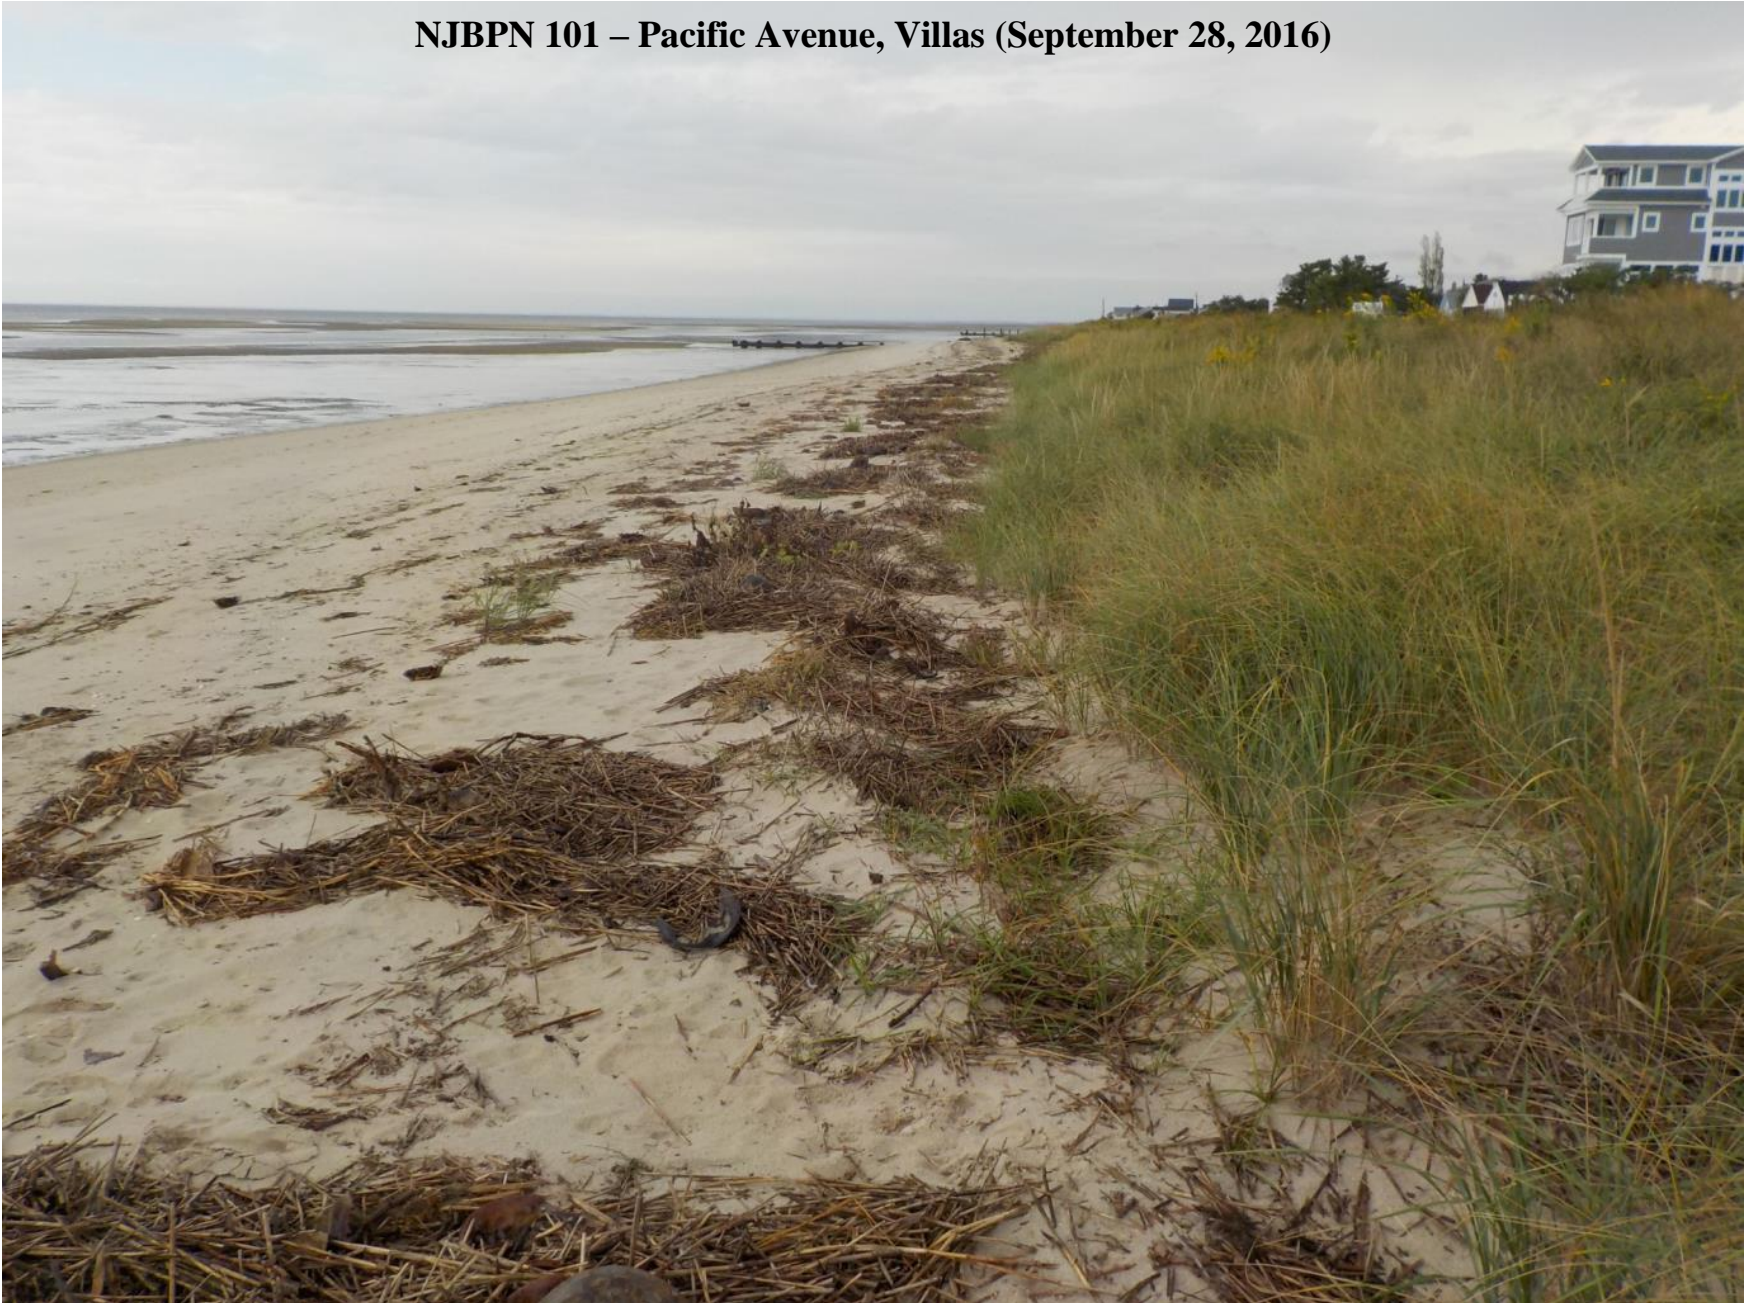
NJBPN 101 – Pacific Avenue, Villas (September 28, 2016)

Figure 626. Farther north along the Delaware Bay shore, the beach narrows and the dune is lower in elevation. Offshore a vast low tide terrace exists due to long-term shoreline retreat.

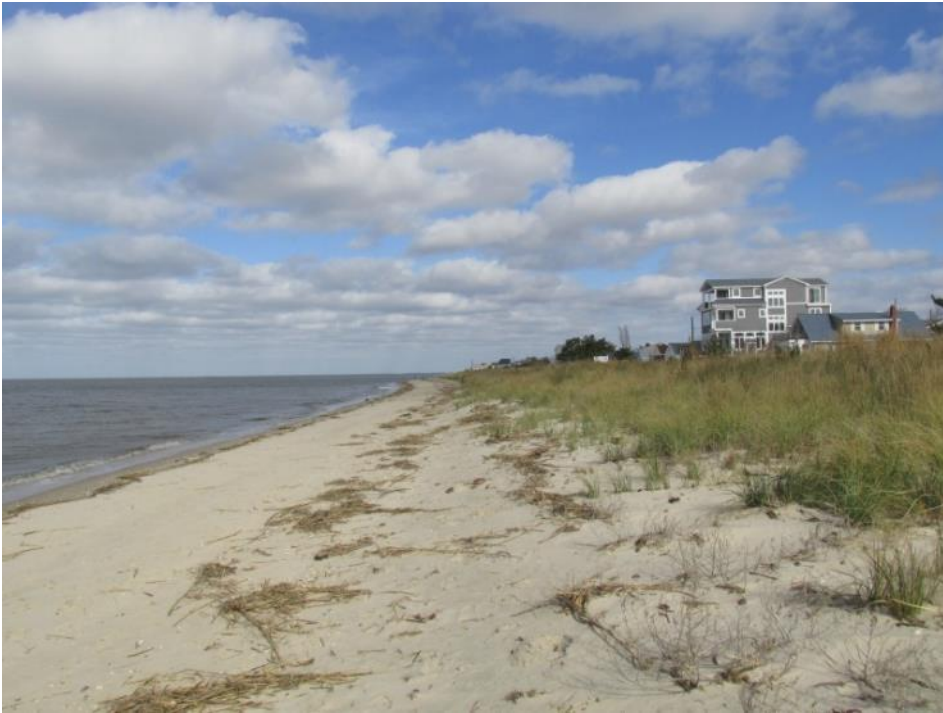
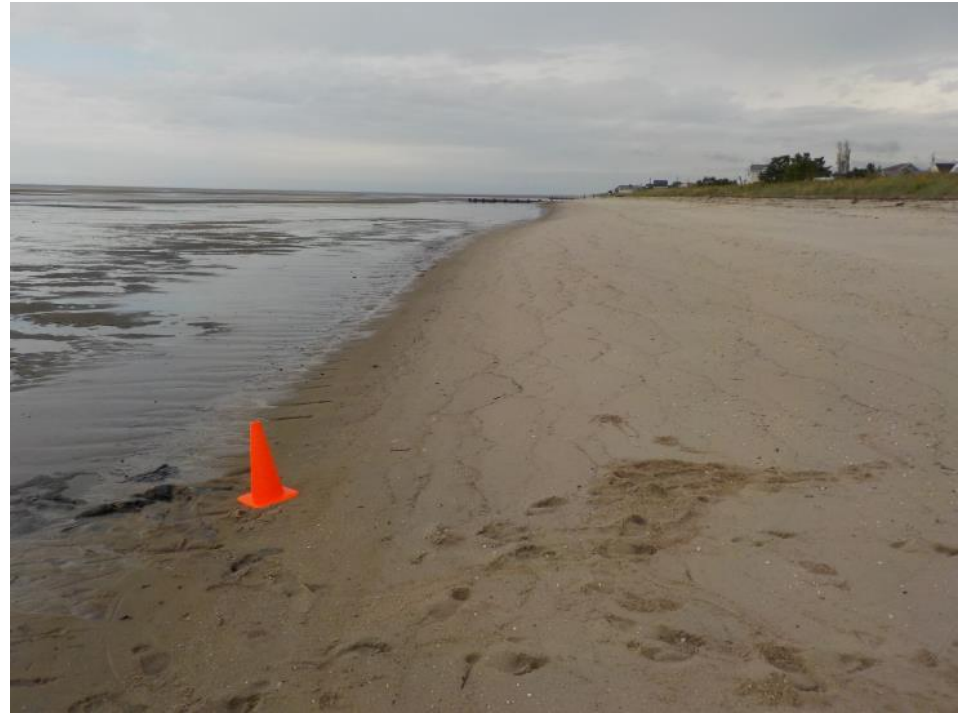
NJBPN 101 – Pacific Avenue, Villas

Figure 627a & 627b. The left view was taken November 17, 2015. The photo on the right was taken on September 28, 2016. Minimal change occurred at Pacific Avenue with some dune grass growth toward the bay. The sediments on the low tide terrace appear to alternate between mud flats and thin sand ridges, as can be seen to the left of the orange cone in the right hand photo.

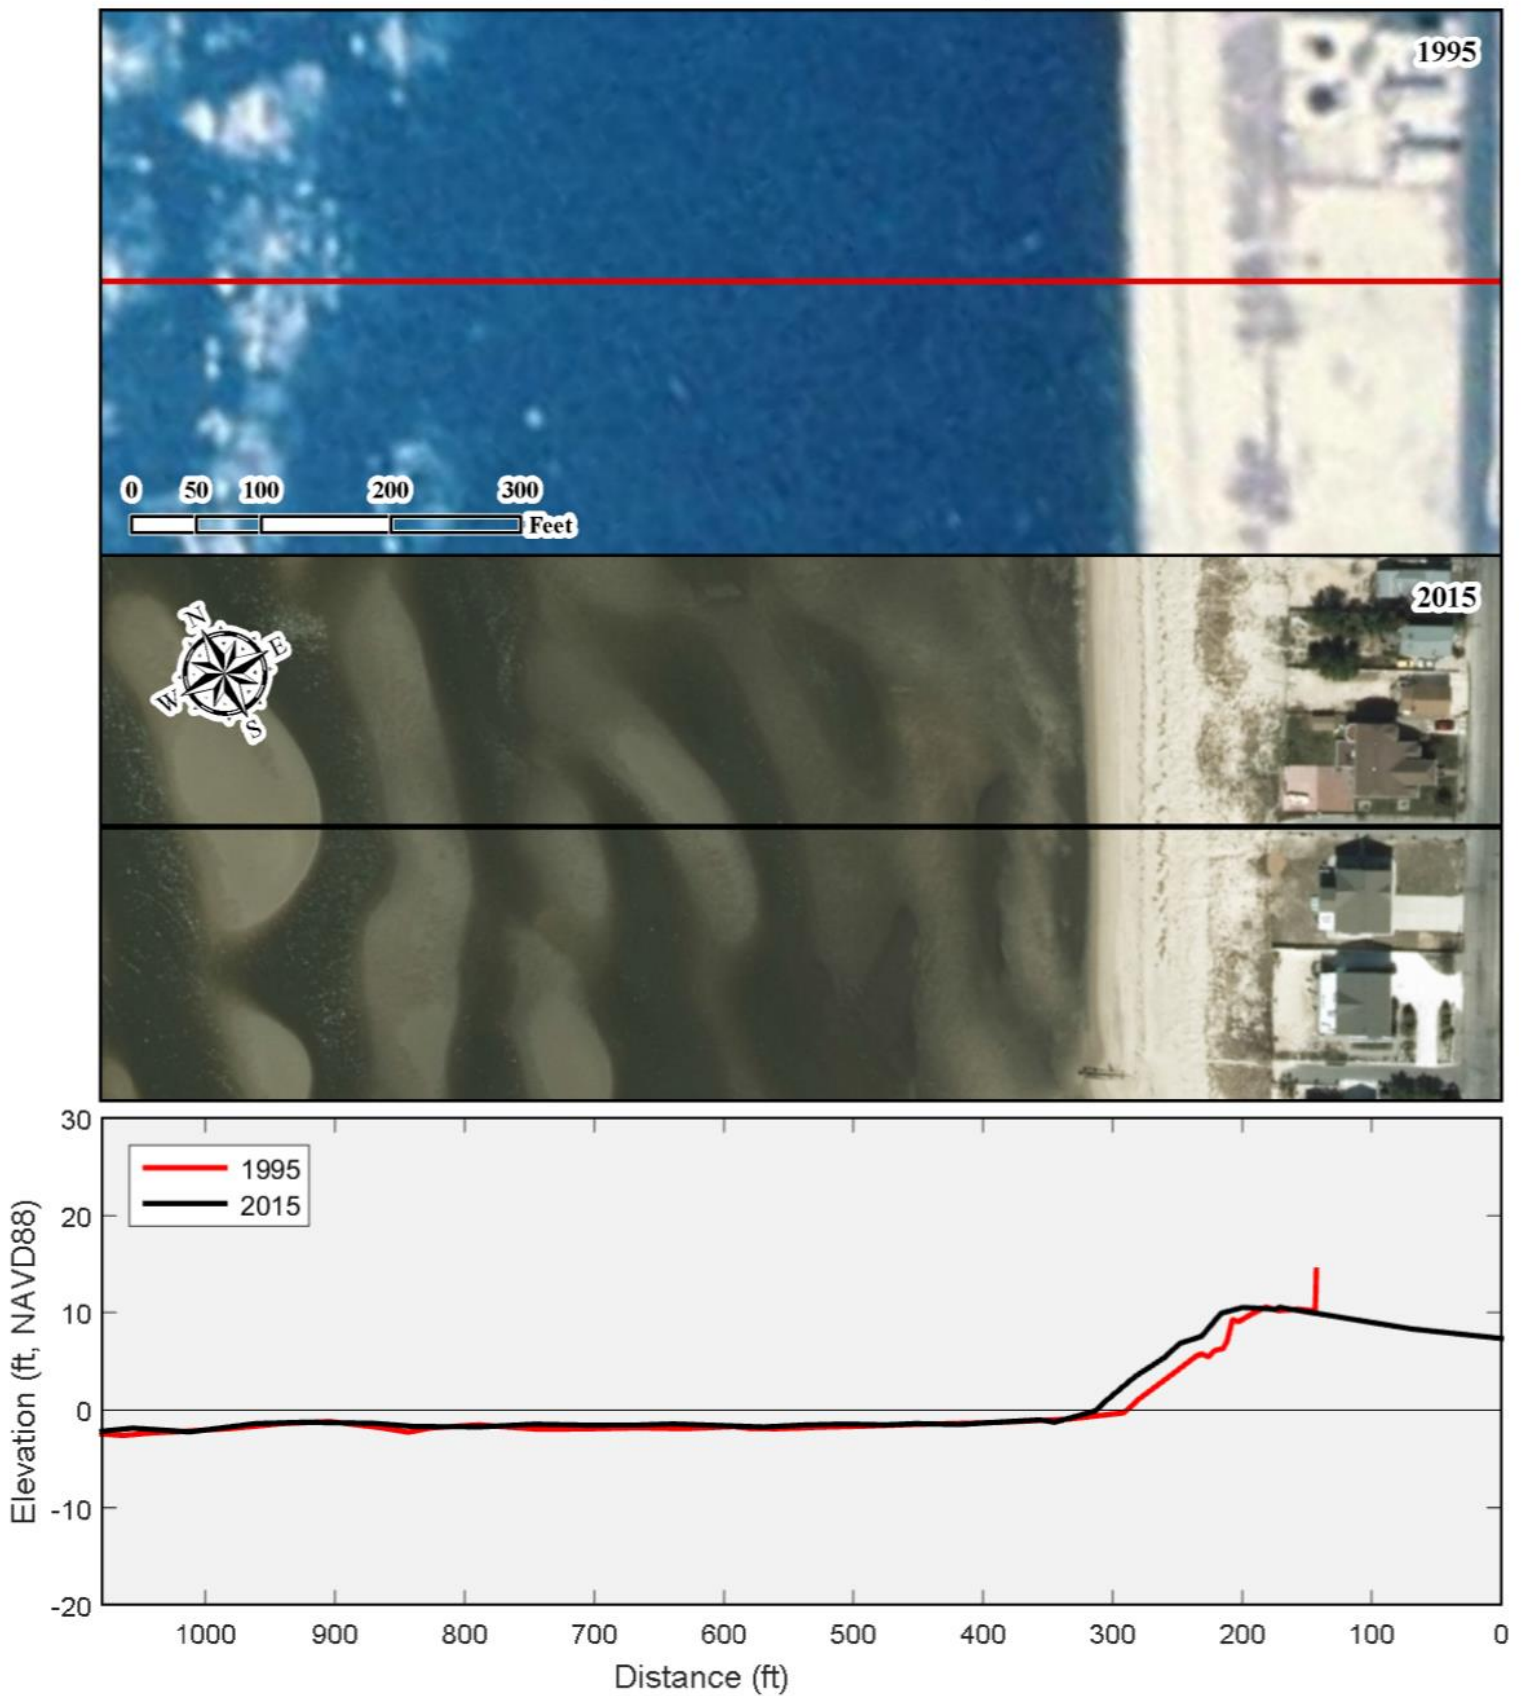
Figure 631. Site 101 shows modest beach expansion with very little difference offshore on the low tide terrace between 1995 and 2015.

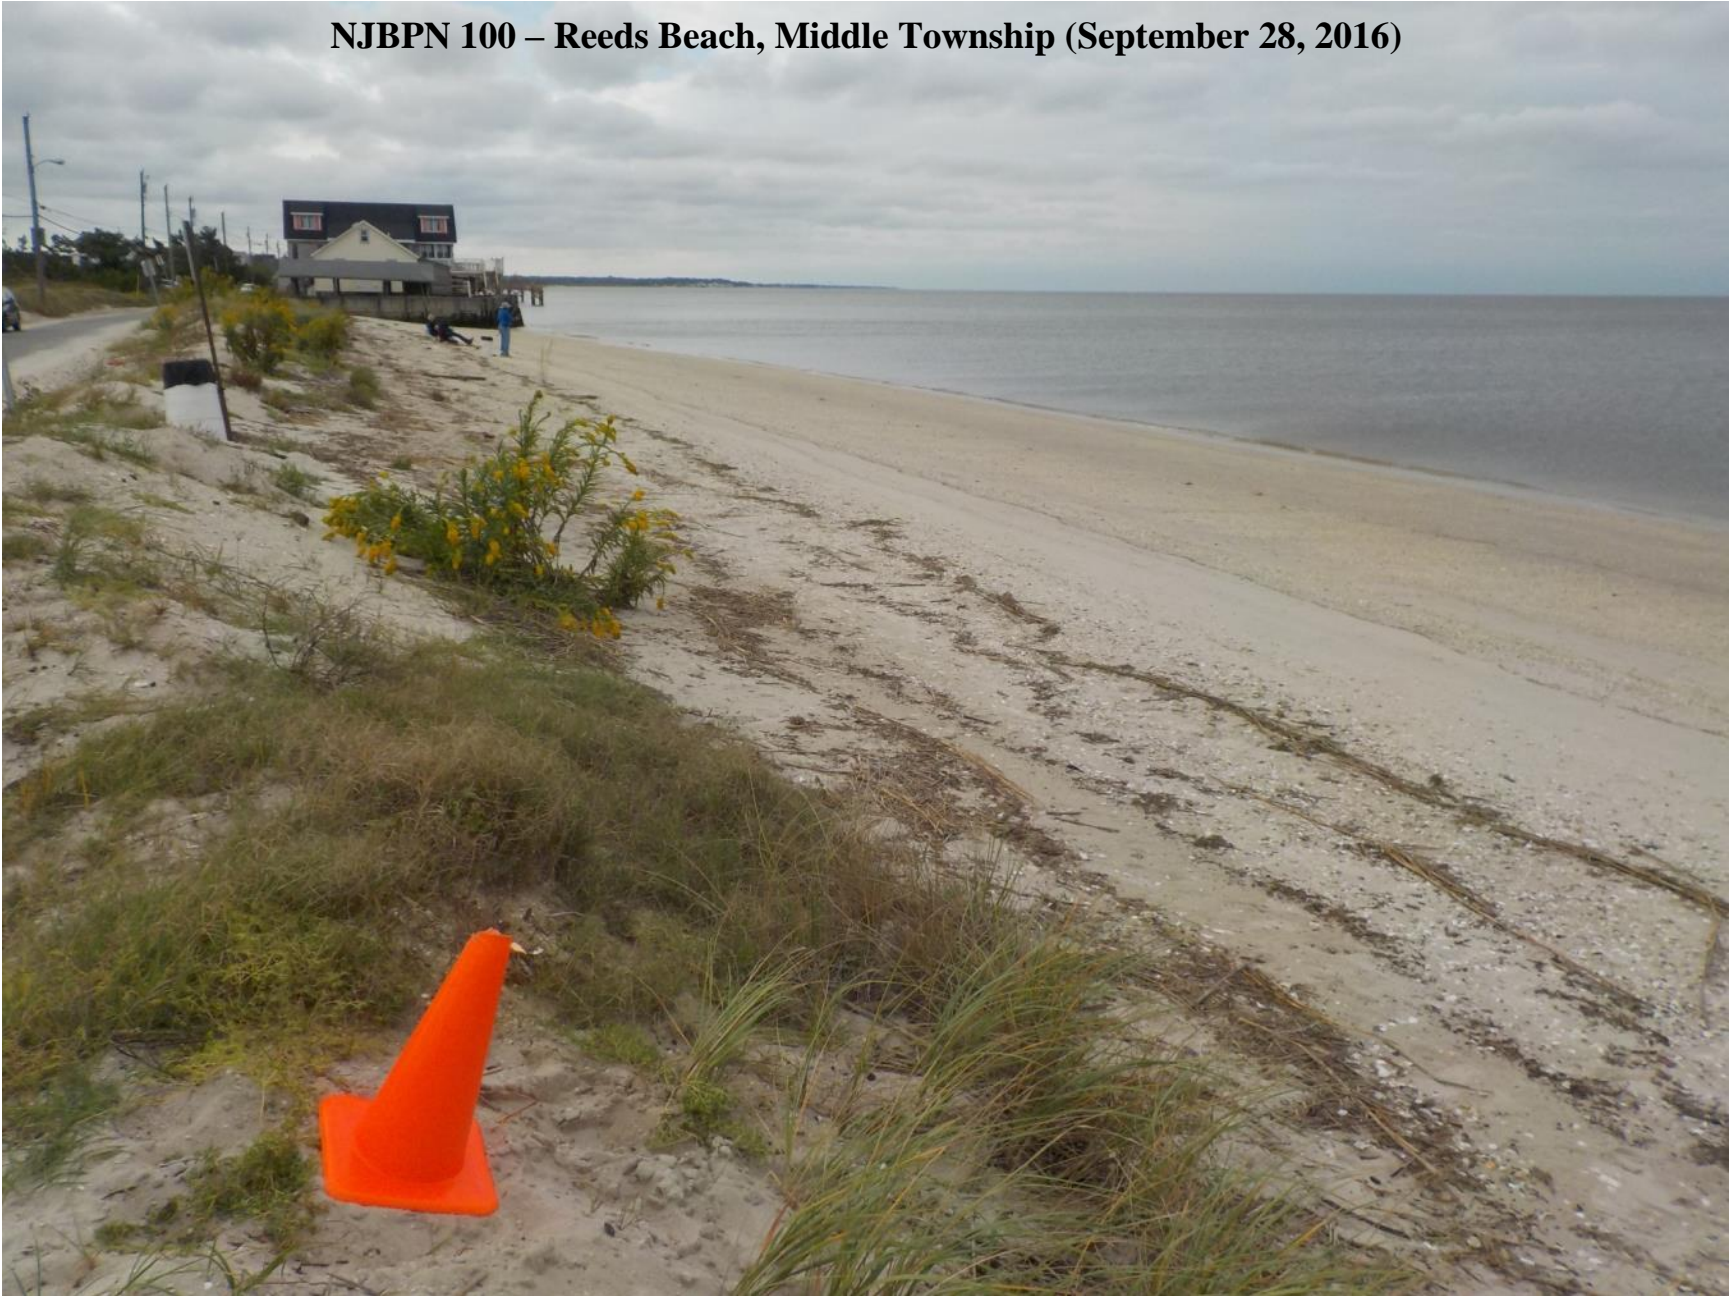
NJBPN 100 – Reeds Beach, Middle Township (September 28, 2016)

Figure 632. Reeds Beach is located on the northwest shoreline of Cape May County. The dune is small and maintained by removing sand from the road, while the beach is narrow and easily flooded in storms. Westerly wind-generated waves on Delaware Bay are particularly troublesome for this part of the county shoreline.

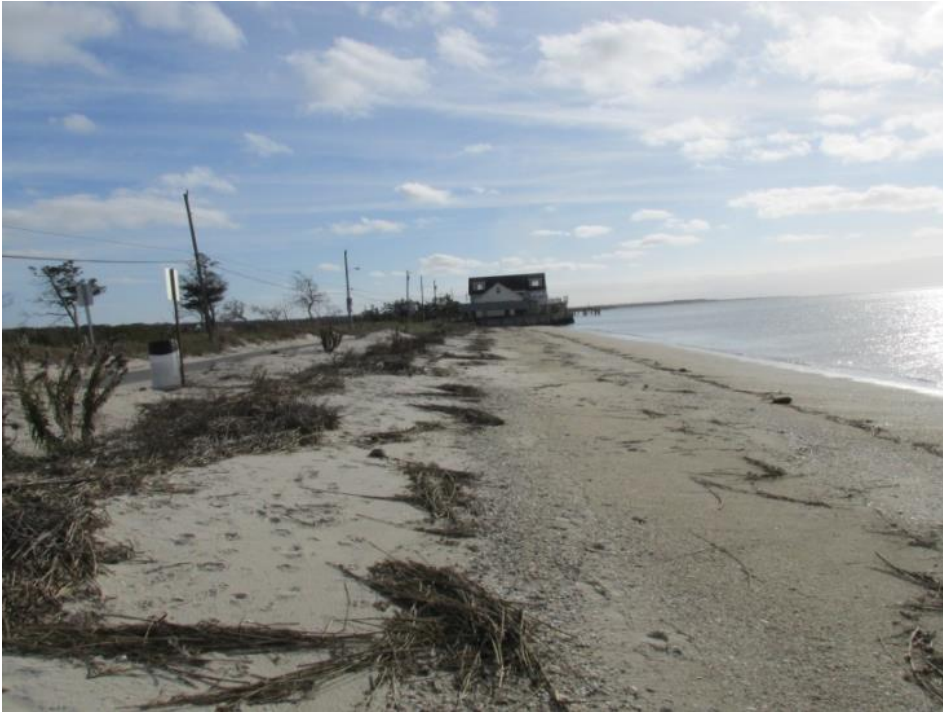
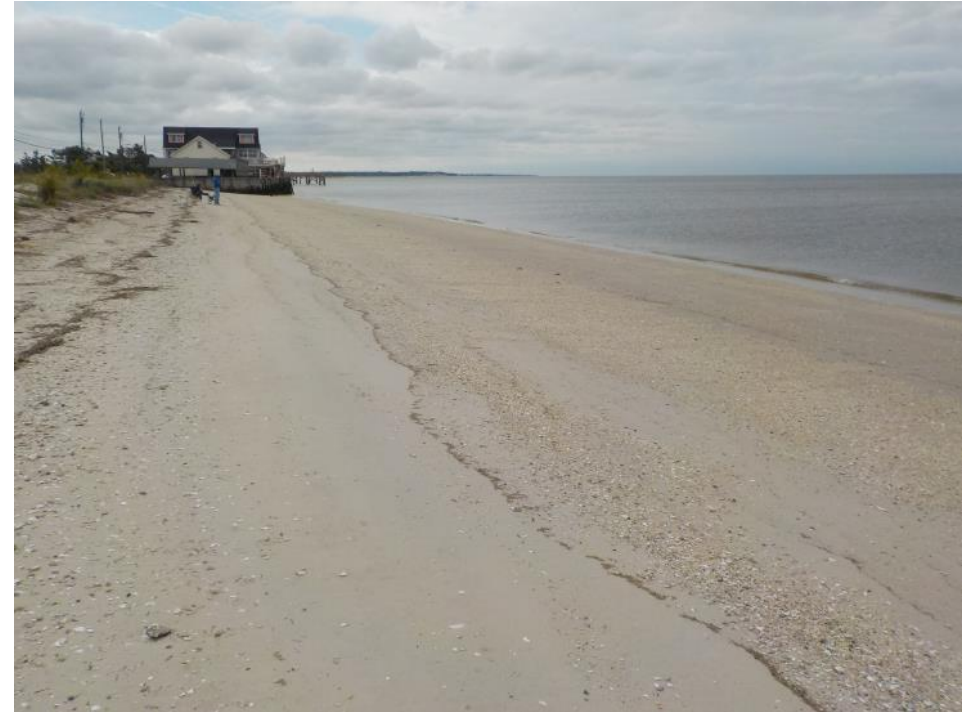
Figure 633a & 633b. The left photograph was taken on November 17, 2015. The right photo was taken on September 28, 2016. The left view shows the road and dune landward of the road and the new ridge of sand placed on the upper beach to hold back minor wave/storm events. The right view shows the beach slope to the low tide terrace with the recent swash line on the sand.

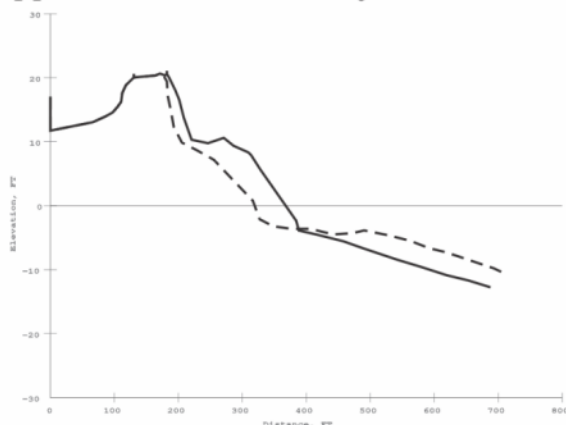
The pair of profiles to the left show typical seasonal beach profile changes. The dashed line profile develops during a winter season, where wave conditions move material offshore. The solid line profile is generated during a summer season, where wave conditions move sand onshore, building a well developed berm and wider beach and adding to the dune. The winter wave conditions shift this beach material to the offshore region of the profile.
