# New Jersey Beach Profile Network

## Monmouth County

Raritan Bay and Sandy Hook  
to Manasquan Inlet

**NJBPN Profile #'s  
187 - 256**

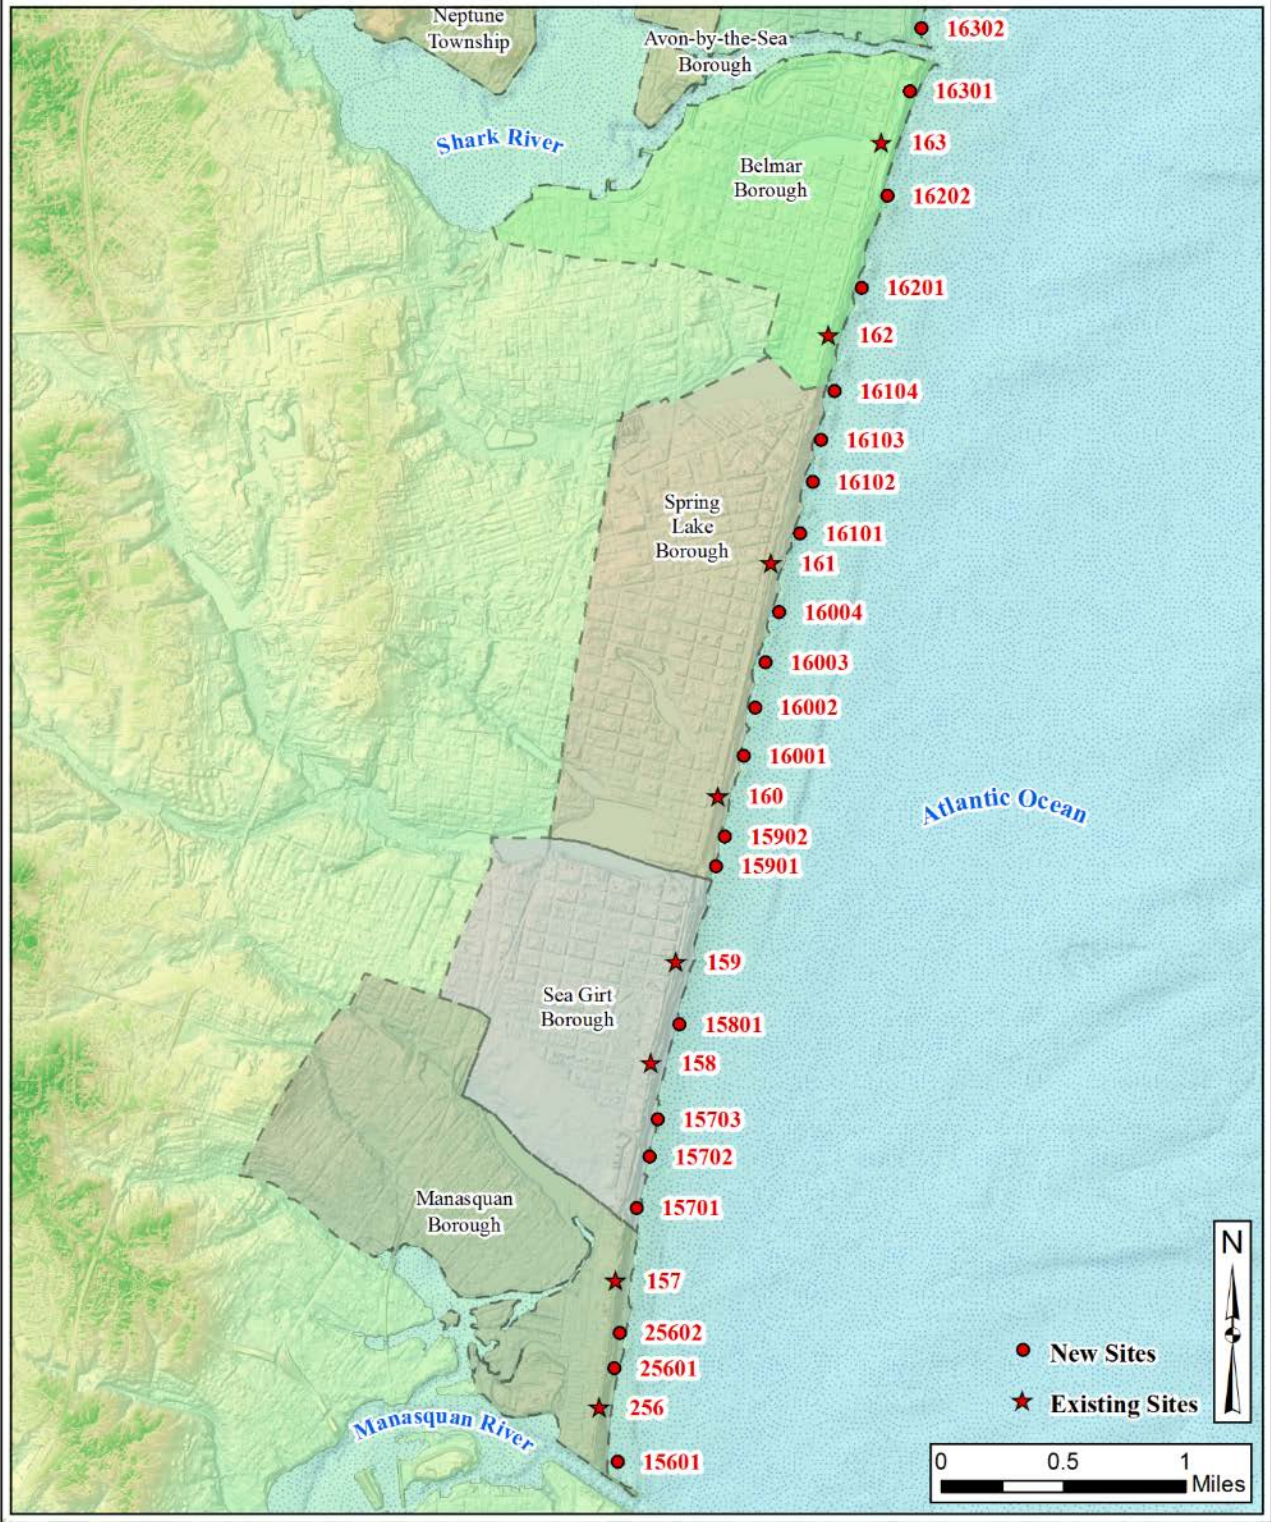
Figure 1d. The fourth reach extends to the Manasquan Inlet, the southern limit of the Monmouth County oceanfront and the NY Corps District project jurisdiction.

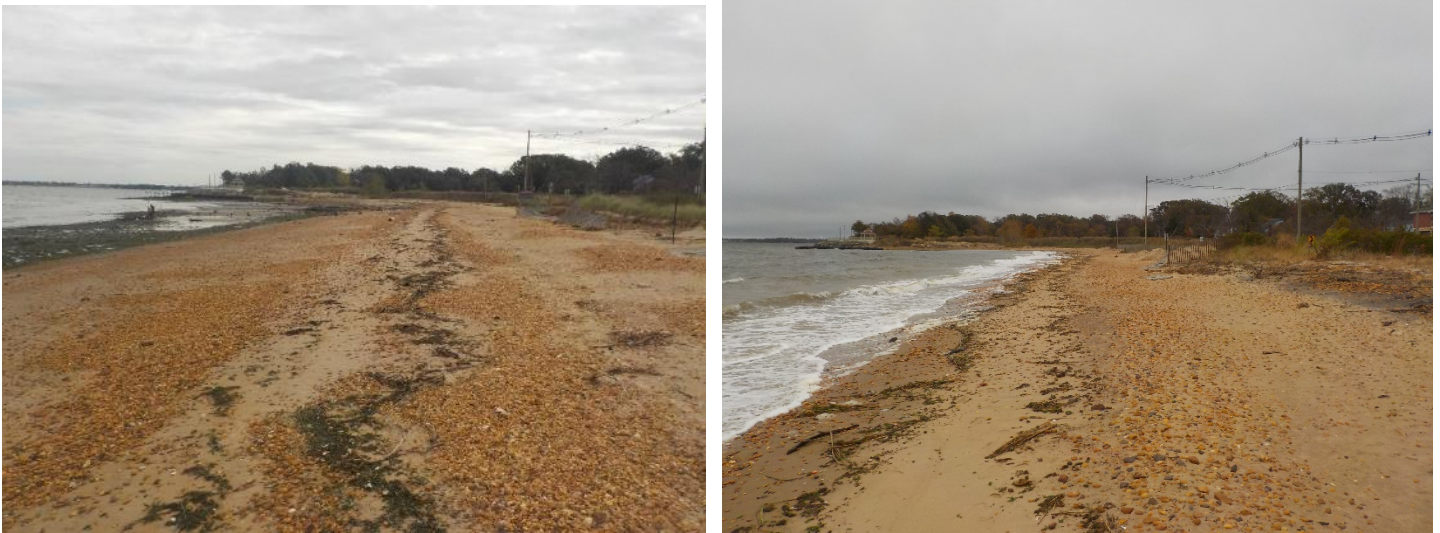
**NJBPN 187 – Beach Park, Cliffwood Beach**

This is the westernmost NJBPN site located on Raritan Bay. The photograph on the left shows the shoreline on October 5, 2018 at a particularly low tide revealing the fine sand composing the Raritan Bay floor. The right picture was taken October 11, 2019 and shows a higher tide stage, but a very similar beach and dune profile.

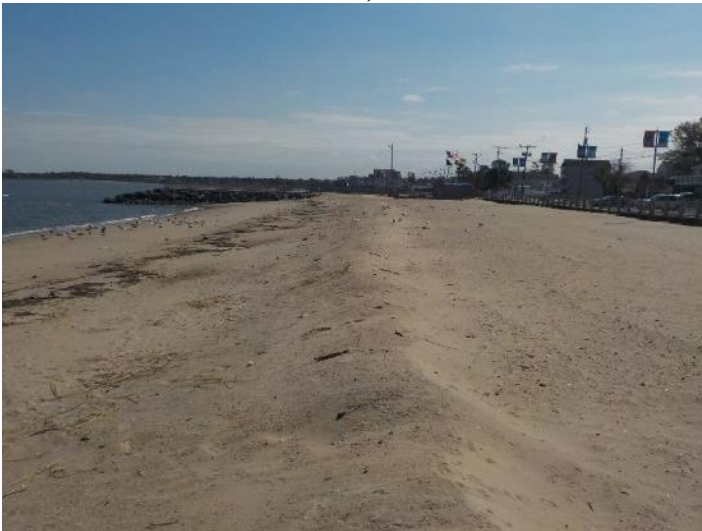
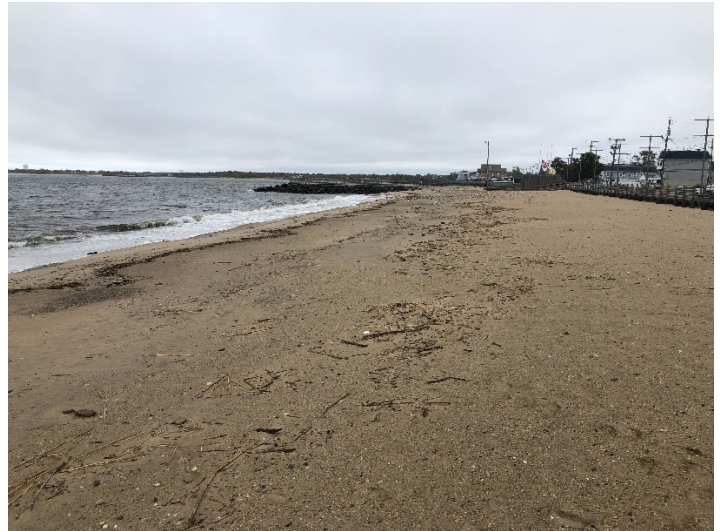
**NJBPN 286 – Beach Street, Union Beach**

This site was moved to the public bathing beach in 2009. The photograph on the left shows the shoreline on October 5, 2018 with a ridge of sand pushed up as added storm protection. The photo on the right shows the beach width and berm on October 24, 2019 with a beach slope created by the bay wave action.

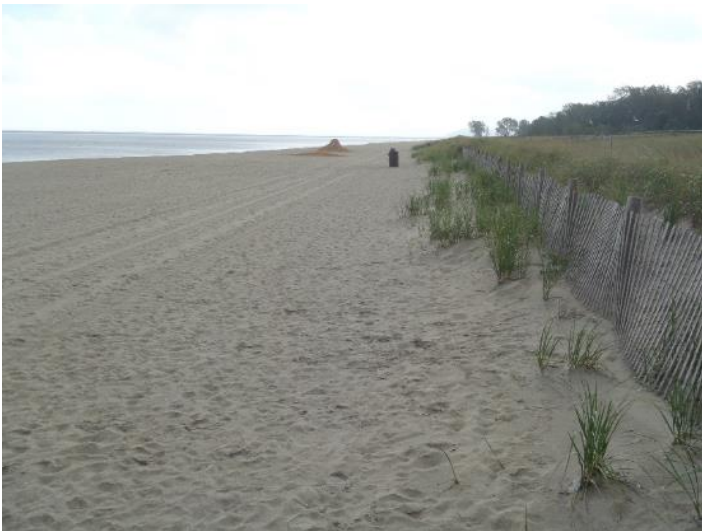
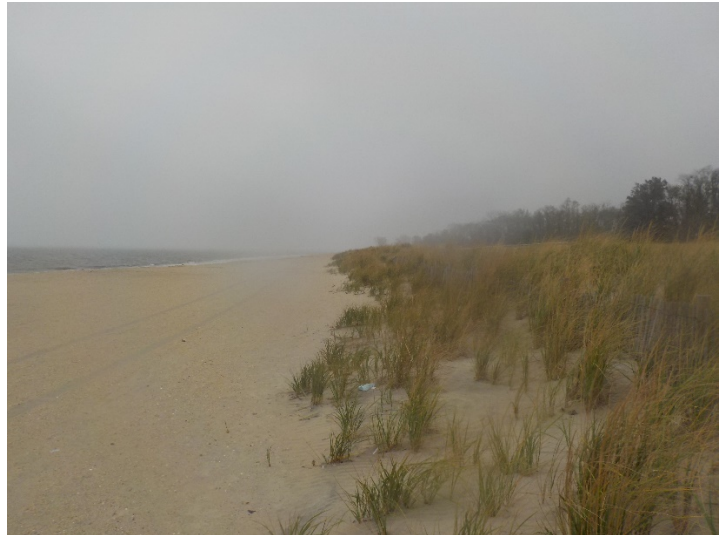
**NJBPN 185 – Bay Shore Waterfront Park, Port Monmouth**

This site was greatly enhanced during 2014 by the NY USACE. The September 18, 2018 view on the left along the beach to the east shows the established profile and sand fence. The right picture was taken October 22, 2019 showing dune grass progressing out onto the upper dry beach beyond the fence.

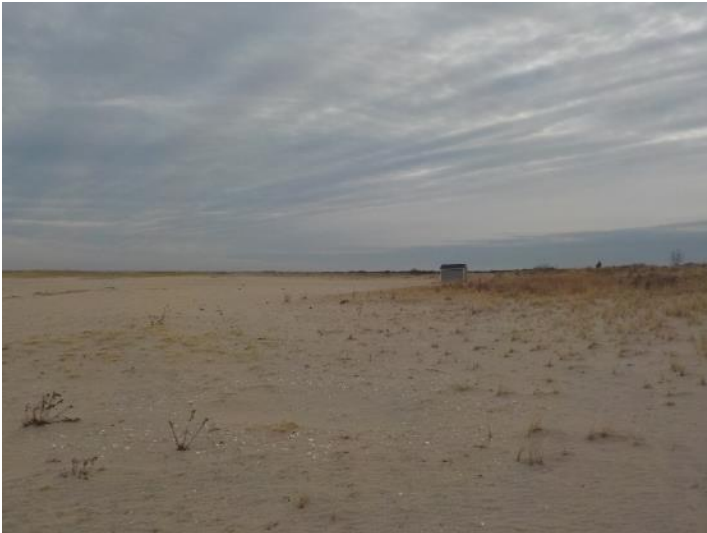
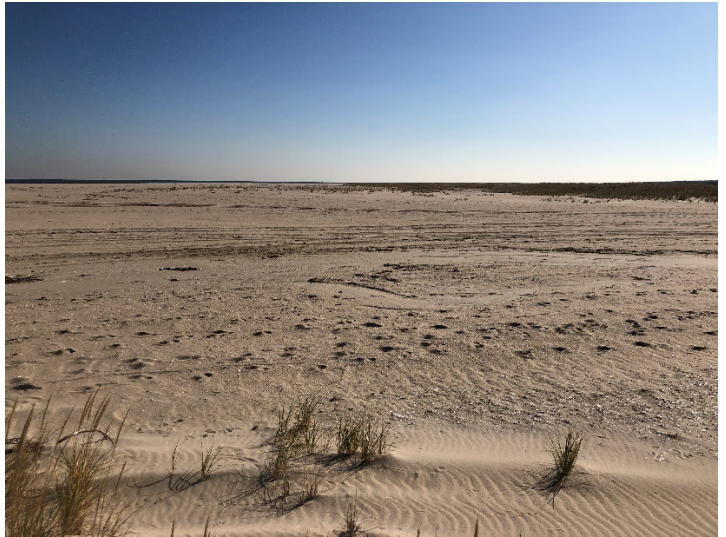
**NJBPN 385 - North Beach, Sandy Hook National Seashore**

This Sandy Hook location was established in December 2016. The expanse of beach with the view to the left December 11, 2018 is looking south along the dune toe. A similar view taking November 22, 2019 shows the extensive expanse of dry sand making up the northern end of the Sandy Hook spit.

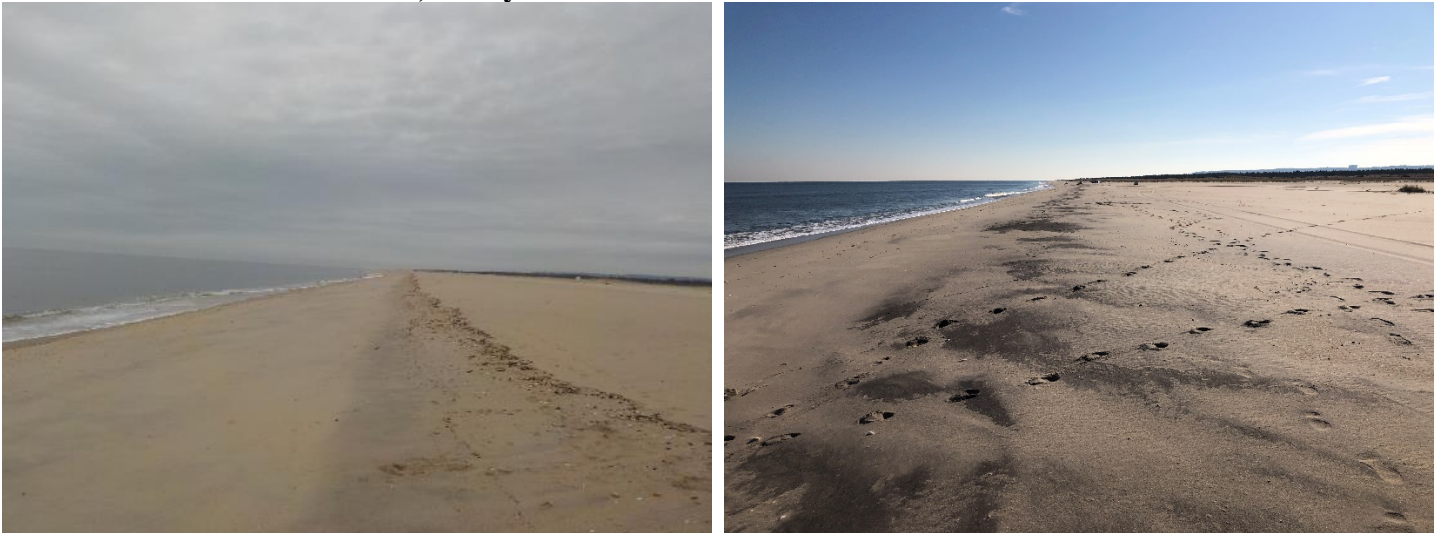
**NJBPN 285 – Gunnison Beach, Sandy Hook National Seashore**

The photograph on the left shows the December 20, 2018 beach looking south along a sharp berm ridge with exceedingly fine plant debris placed on the high tide line by very low energy surf. On November 22, 2019 the berm presented a more common ridge with alternating patches of dark minerals separated by the swash. The expanse of beach to the right is enormous.

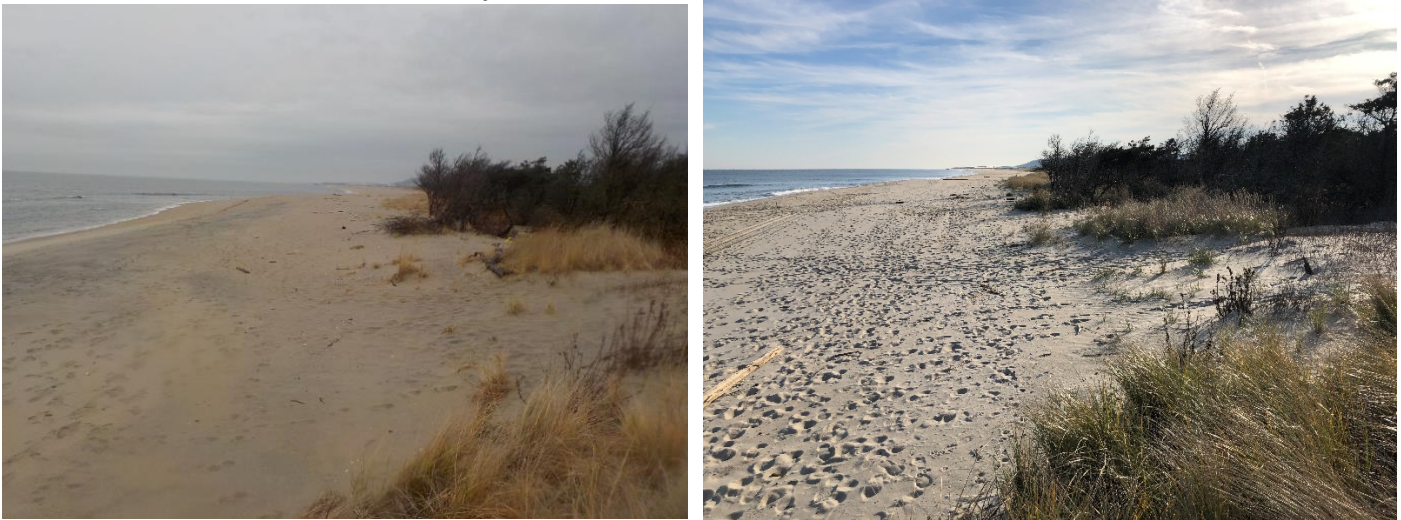
**NJBPN 28401 - Area F Road, Sandy Hook National Sea Shore**

The left view from December 20, 2018 is to the south along the dune crest shows vegetation on the dunes near the beach. The right-side photograph was taken November 22, 2019 with the beach at nearly the same slope and width and few changes in the dunes.

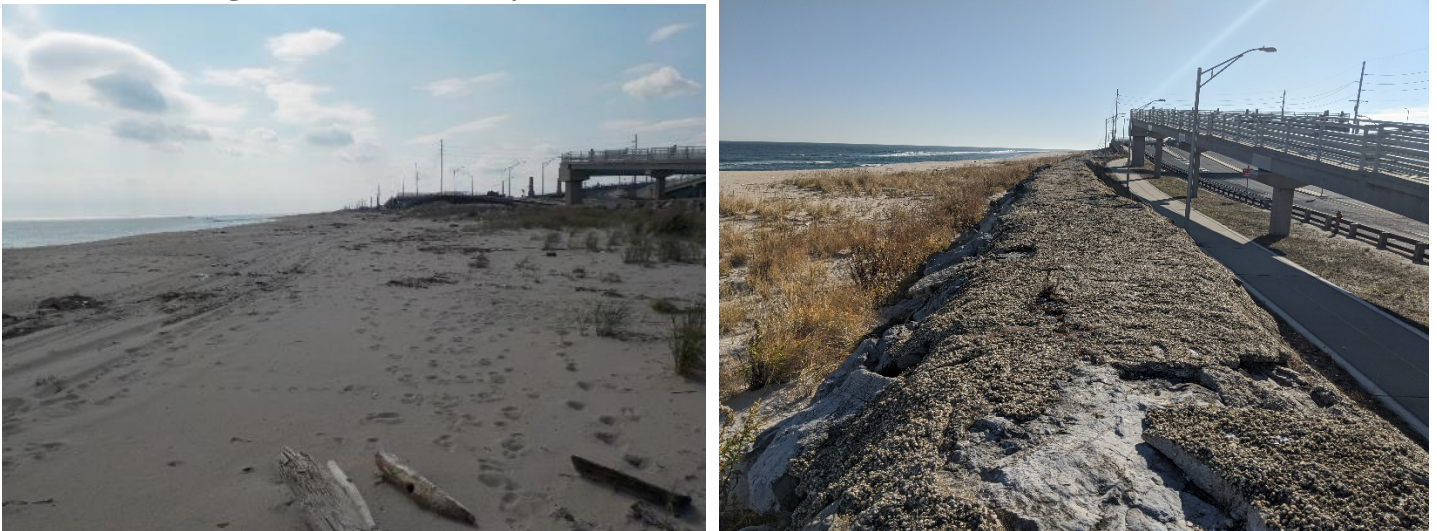
**NJBPN 184 – Highlands Beach, Sandy Hook National Seashore**

This southern Sandy Hook site is located near the entrance to the park. The left view was taken Oct. 1, 2018. The beach and bar system were separated by over 100 feet. As of November 26, 2019 the view south from the rock seawall shows the dune system and the beach and offshore bar system.

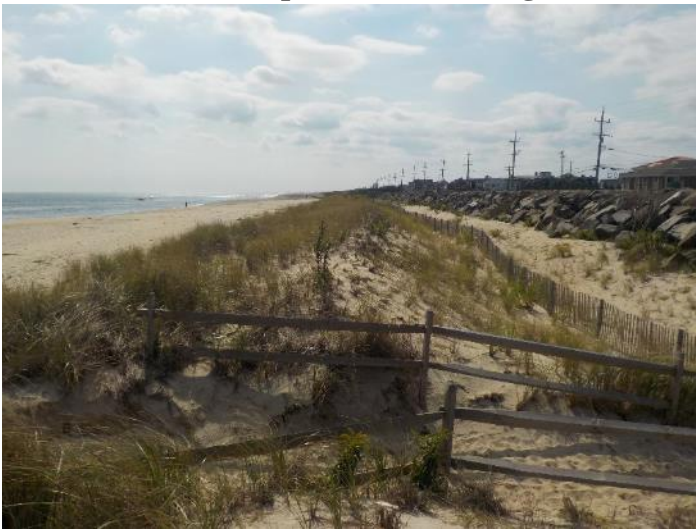
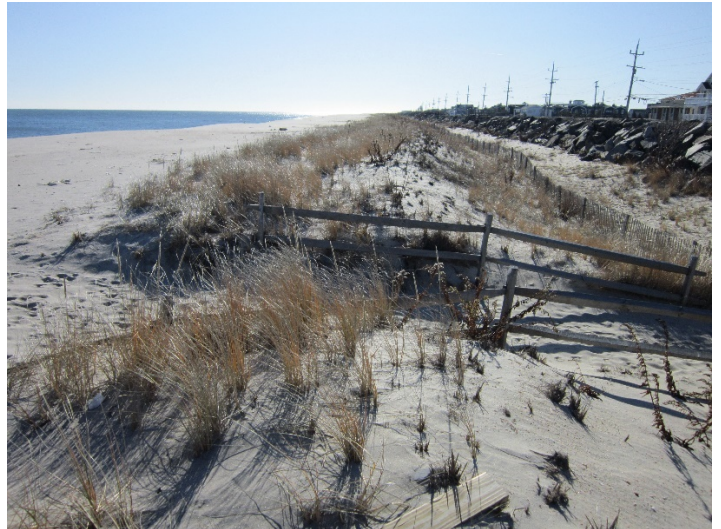
NJBPN 183 – Via Ripa Street, Sea Bright

This site is near the northern limit of the initial Federal shore protection project. The left photo shows the seawall and the line of dunes looking south on Oct. 1, 2018, while the right photo (Dec. 20, 2019) shows the beach from the dune crest.

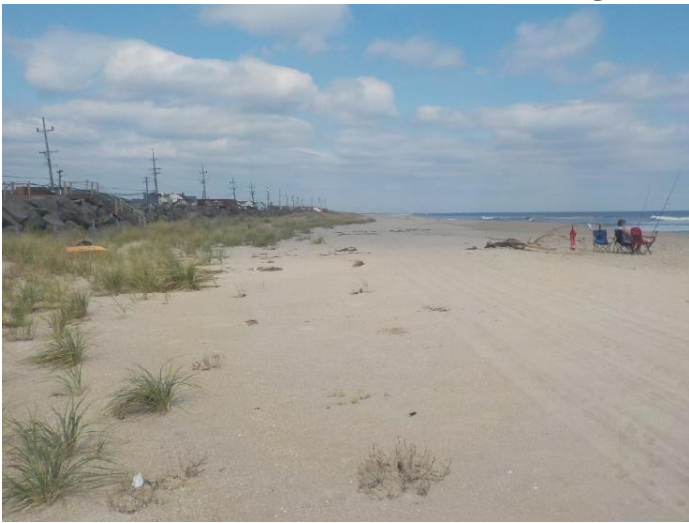
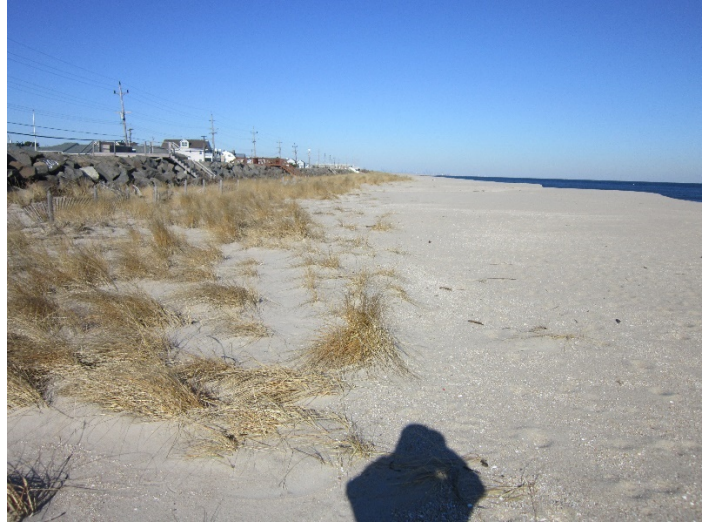
**NJBPN 28202 - 300 Ocean Avenue, Sea Bright**

This new site has beach grass established along the toe of the rock seawall, but no extensive dune exists yet (Oct. 1, 2018). The right hand photograph was taken Dec. 20, 2019 at the seaward edge of the dune grass and appears to show minor growth.

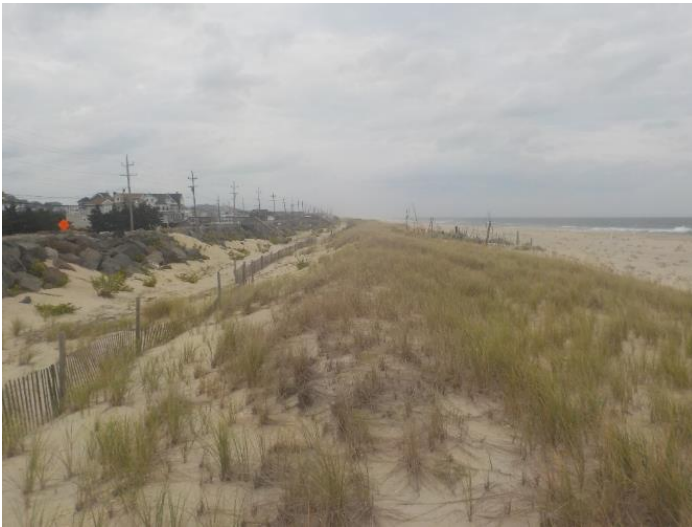
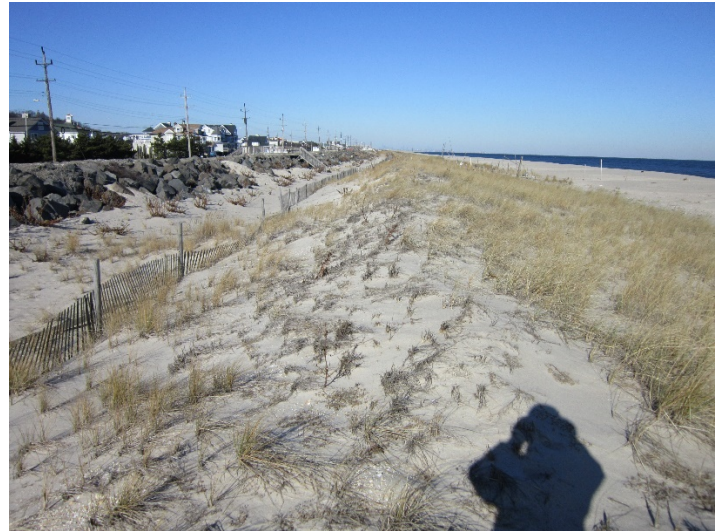
**NJBPN 28201 - 436 Ocean Avenue, Sea Bright**

A short distance south, this location has a substantial dune developed seaward of the seawall with a wider beach and dune grass extending onto the sand flats near the dune (Oct. 3, 2018). By December 20, 2019 (on right) the grass remained consistent with minimal change to the beach.

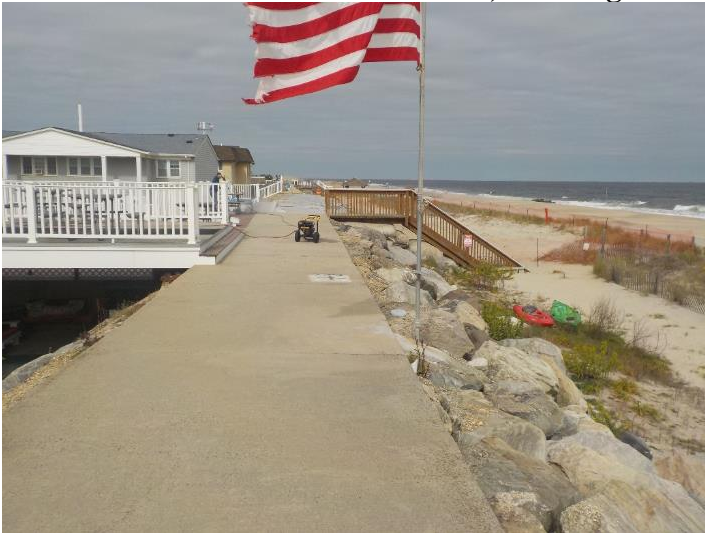
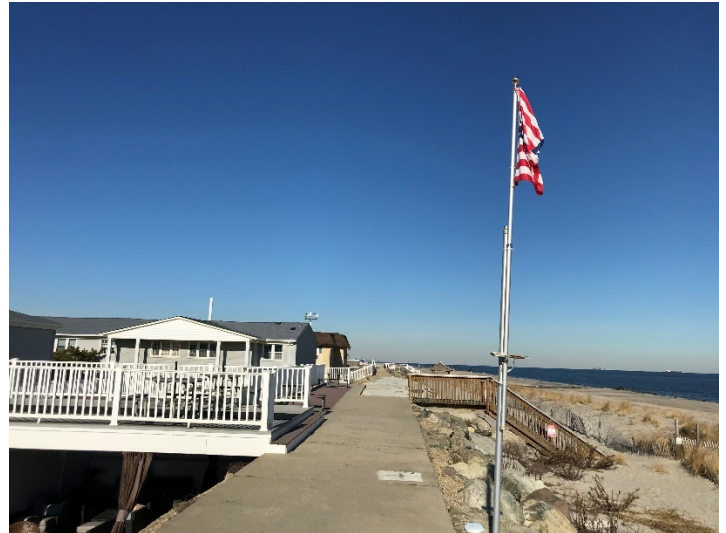
**NJBPN 18003 - 1201 Ocean Avenue, Sea Bright**

This site starts at the rock seawall with a small dune present on the landward beach's first 100 feet of width (Oct. 5, 2018 on left). The Jan. 30, 2020 view on the right shows little change in the dune, but a narrower beach.

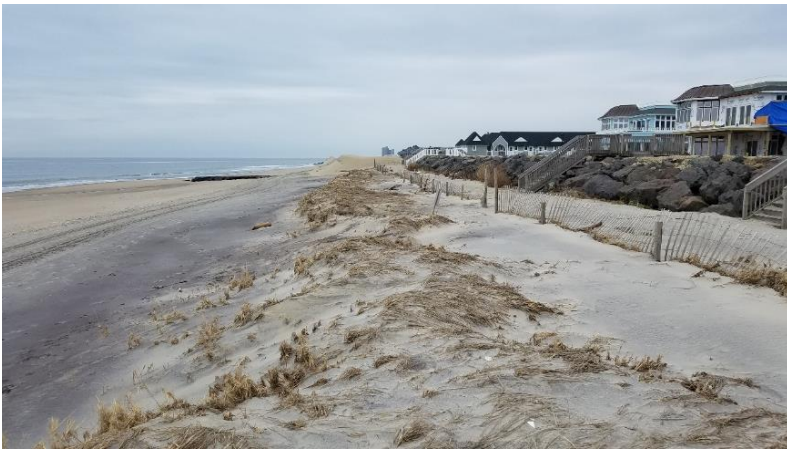
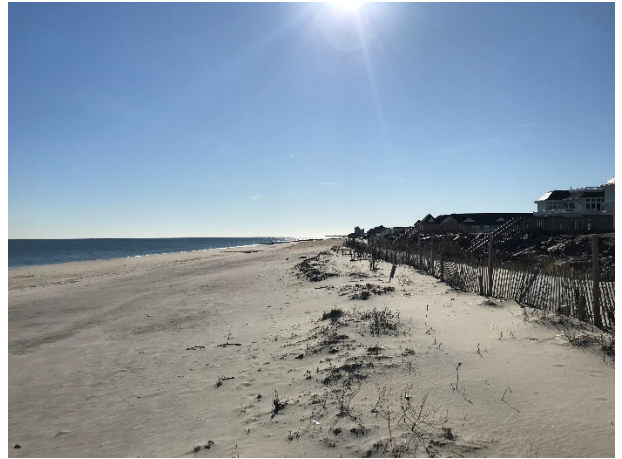
**NJBPN 18002 - 15 Tradewinds Ln., Sea Bright**

The dune at this location has developed along the single row of fencing. The beach width here has declined since Jan. 2018. The December 2018 view shows minimal beach seaward of the dune. By Jan. 30, 2020 some dune vegetation loss is evident, but sand has blown over the dune toward the rock wall.

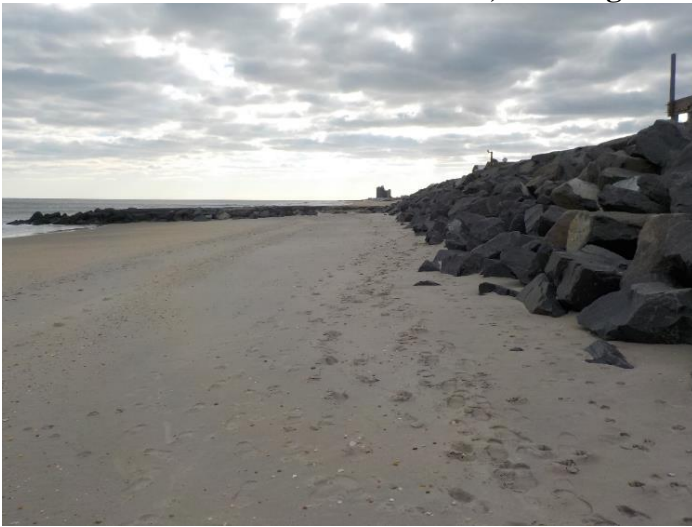
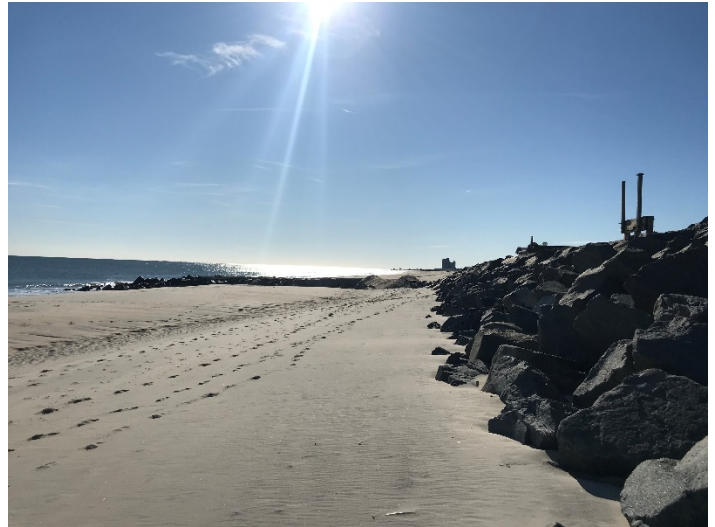
**NJBPN 18001 - 1485 Ocean Avenue, Sea Bright**

This site starts at a bulkhead and rocks considerably seaward of Ocean Avenue because the structures have been built seaward of the highway. There are no dunes, a fairly narrow beach that is losing sand (left view Jan. 9, 2019). As of Jan. 30, 2020, the beach shows that waves regularly reach the rocks while a new ridge of sand has just built onto the shoreline at the low tide line.

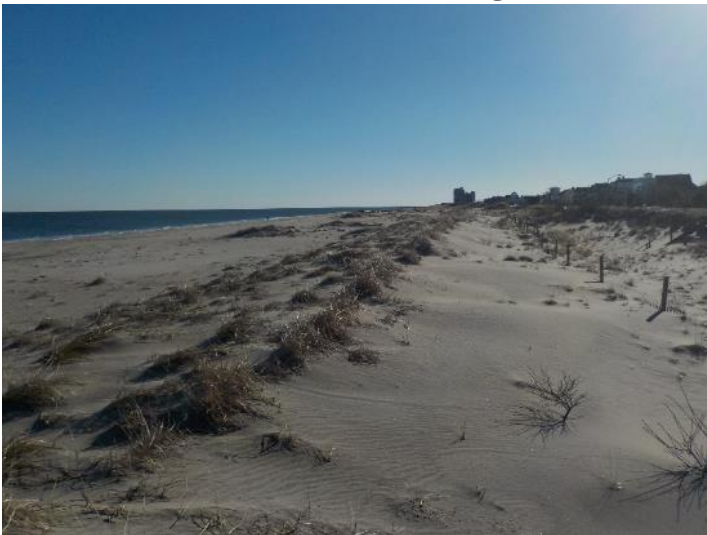
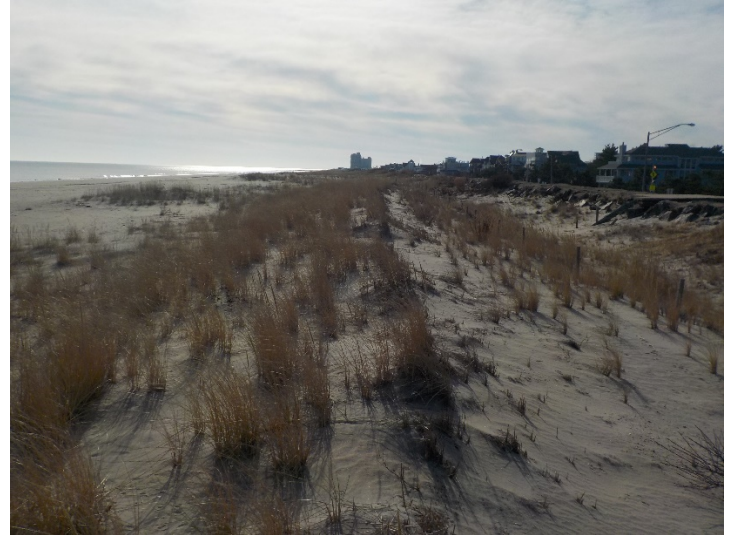
**NJBPN 180 – Sunset Court, Sea Bright**

The view on the left taken Dec. 18, 2018 shows the sand build-up on the dune at the seaward slope (on left). By December 22, 2019 the fence area filled in with new grass and growth was extensive on the dune.

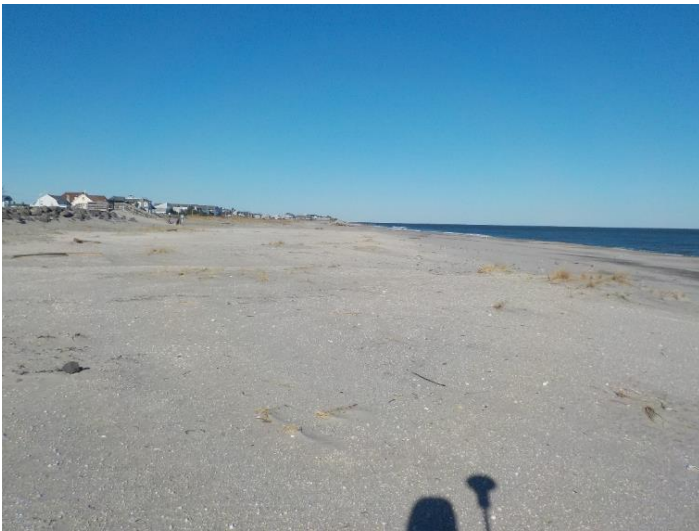
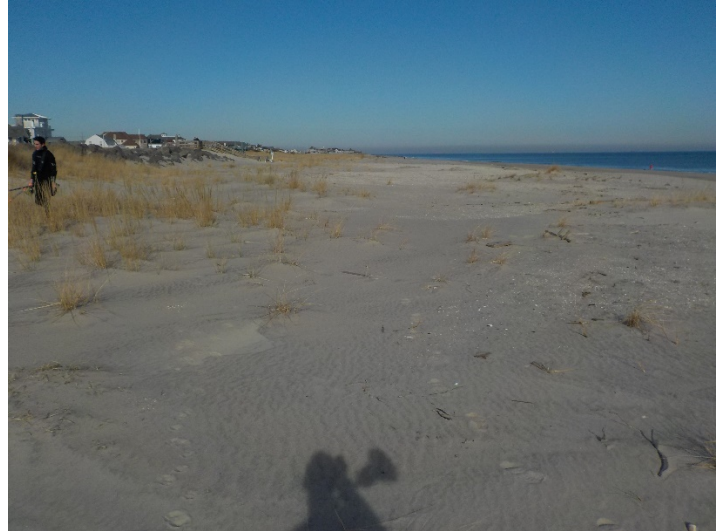
**NJBPN 17901 - 122 Ocean Avenue, Monmouth Beach**

The left view from December 18, 2018 shows sand blown up into the seaward face of the seawall filling in among the rocks, but no dune is present. The right side view was taken Dec. 23, 2019 and shows extensive grass growth with dune mounds appearing on the beach.

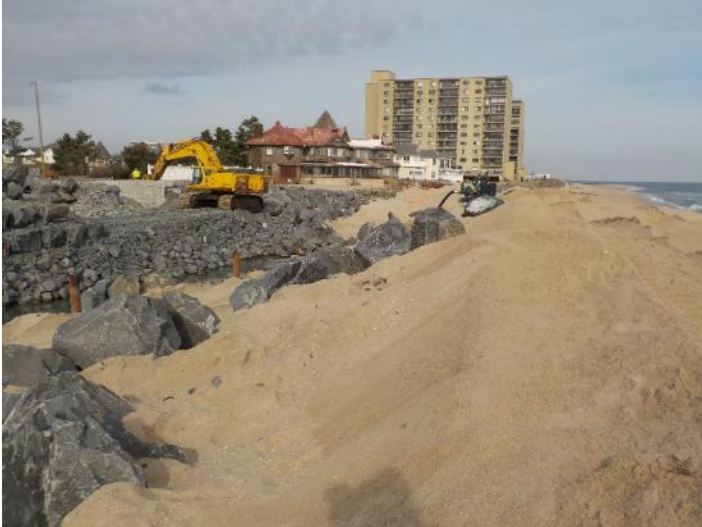
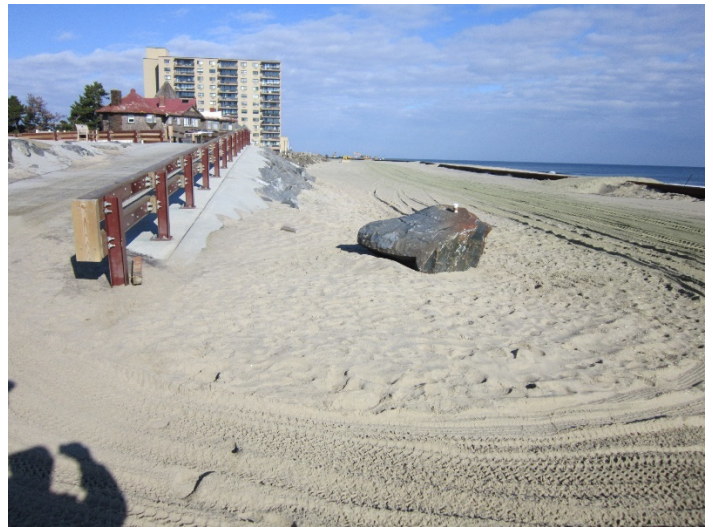
**NJBPN 178 – Monmouth Beach Club, Monmouth Beach**

The left photo taken January 2, 2019 and shows the extensive seawall construction going on at the site establishing the rock barrier to the interior. As of December 23, 2019 the rock wall was complete and the sand pipeline was in place on the beach.

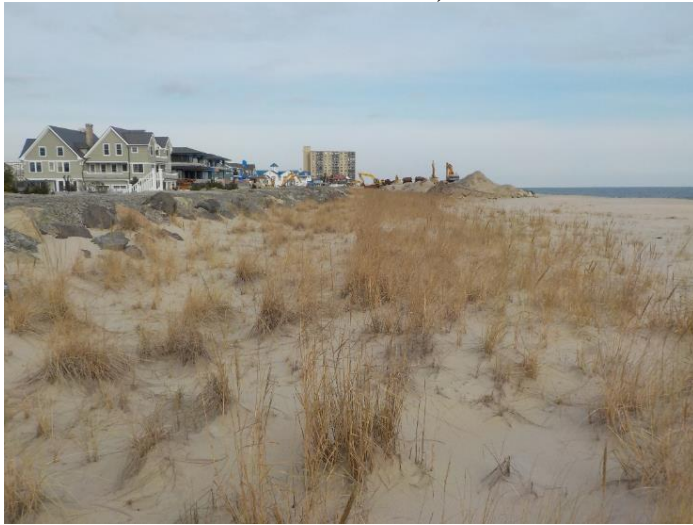
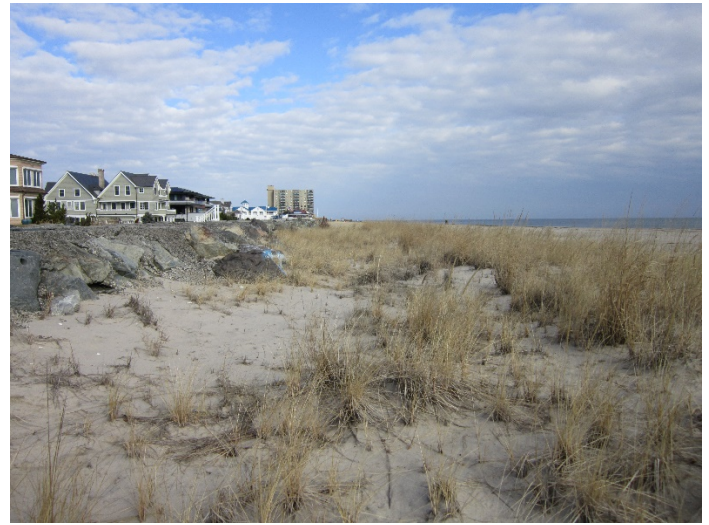
**NJBPN 17701 - 9 Ocean Avenue, Monmouth Beach**

This location has the seawall as the ultimate backstop, with a 270-foot wide beach seaward as of January 2, 2019. As of December 23, 2019, some added vegetation is evident with most of the construction activity to the north completed.

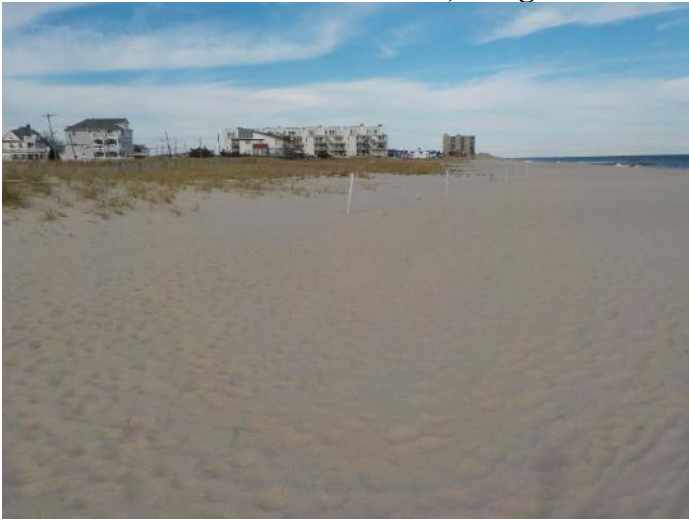
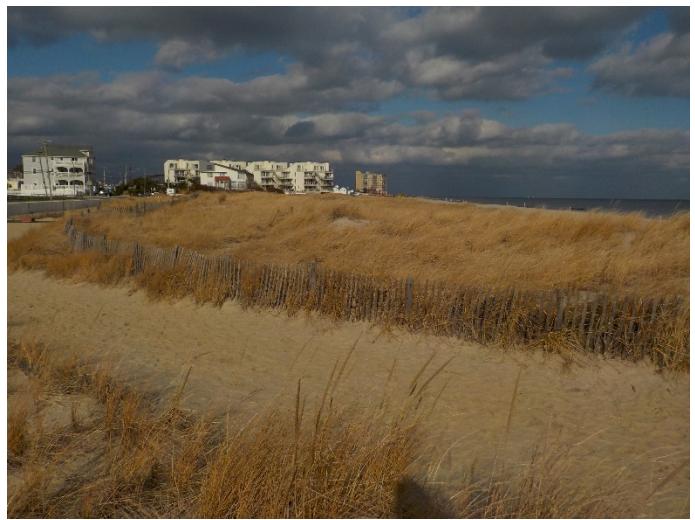
**NJBPN 177 – 404 Ocean Avenue, Long Branch**

The left photo was taken November 14, 2018 looking north along the dune toe. The right view along the foredune crest shows lush grass growth in the dunes, but the beach is obscured (Dec. 18, 2019).

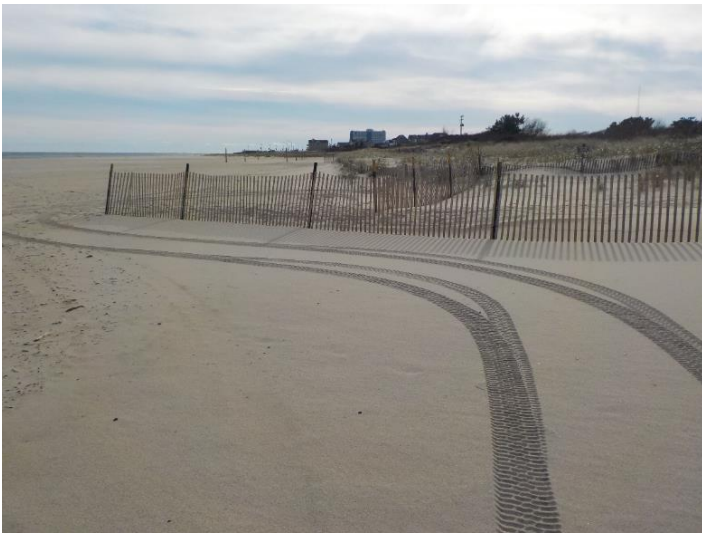
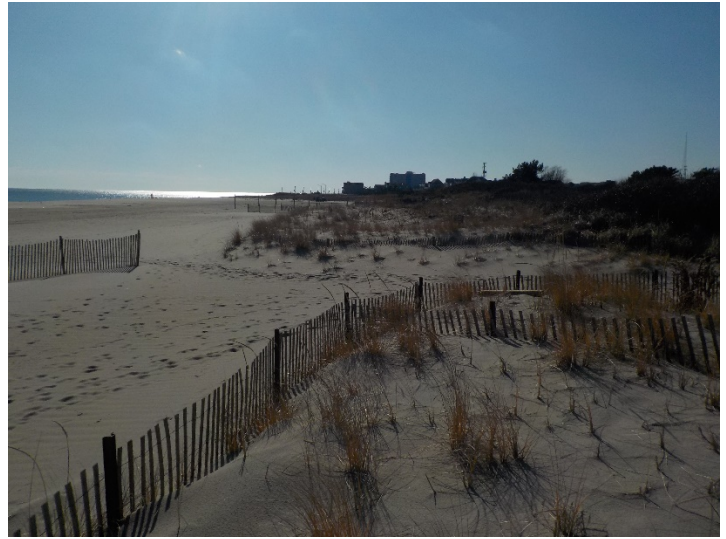
**NJBPN 17601 – 300 Ocean Avenue North, Long Branch**

The right view was taken Nov. 14, 2018 and shows the access pathway and the dunes with a wide beach. As of December 18, 2019 the grass had improved and fencing had been rearranged.

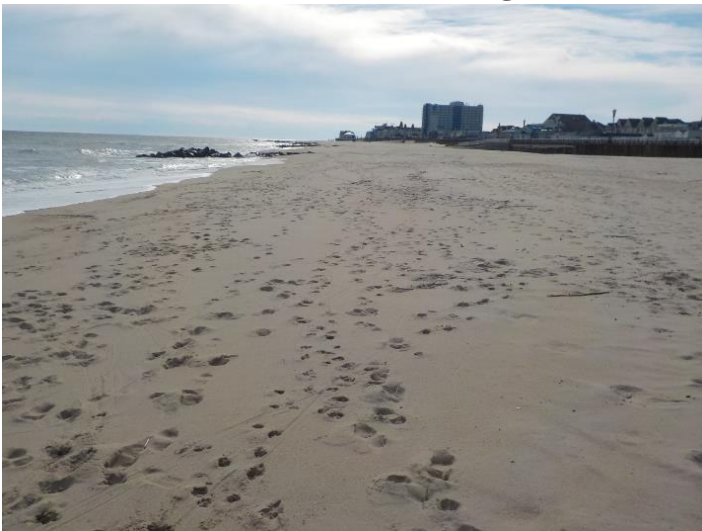
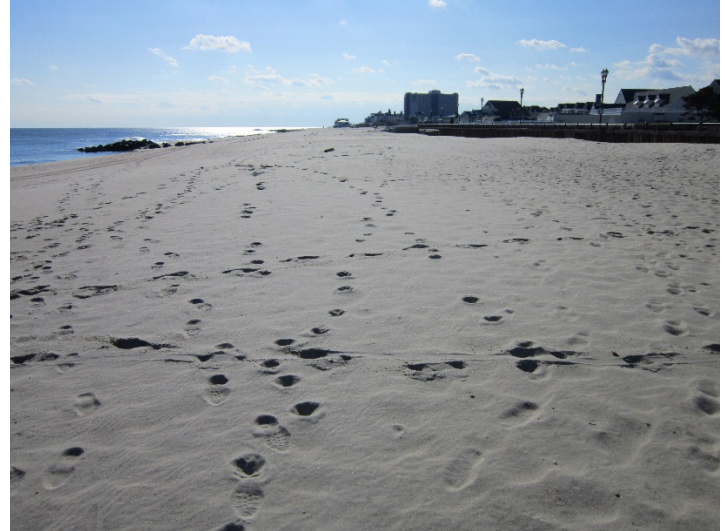
**NJBPN 17501 – Ocean Terrace, Long Branch**

This location is at the very northern end of the old steel sheet pile wall at the Long Branch uplands bluff edge. There is no dune established here, but sand is ramped up against the wall (left view Nov. 14, 2018). On the right is a December 18, 2019 view in essentially the same location on the profile showing less of the groin in the distance exposed in the water, but few changes elsewhere.

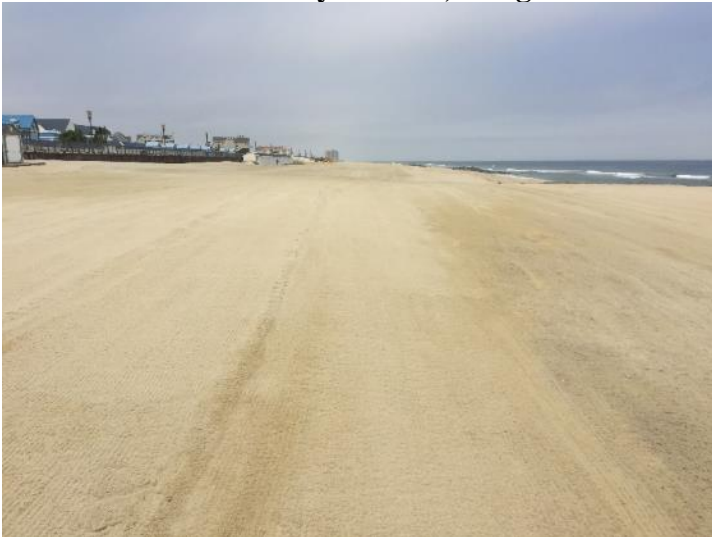
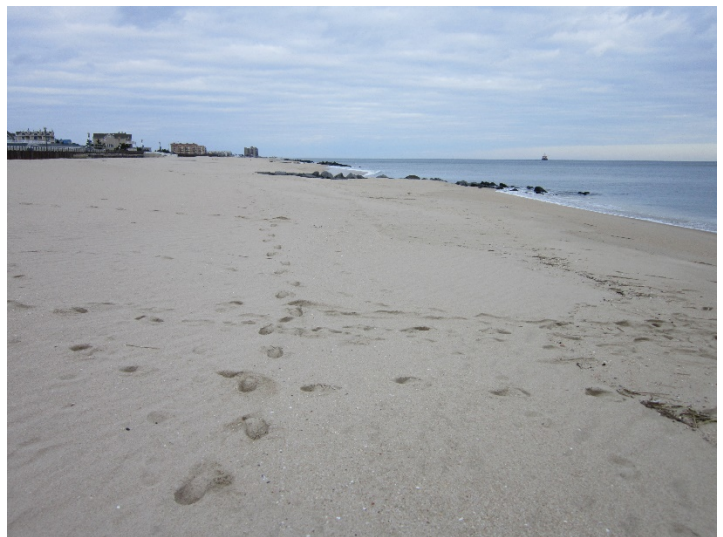
**NJBPN 175 – Broadway Avenue, Long Branch**

The left photograph taken November 14, 2018 shows the berm in a robust condition. As of January 5, 2020 the beach was flatter with a few of the groin rocks exposed.

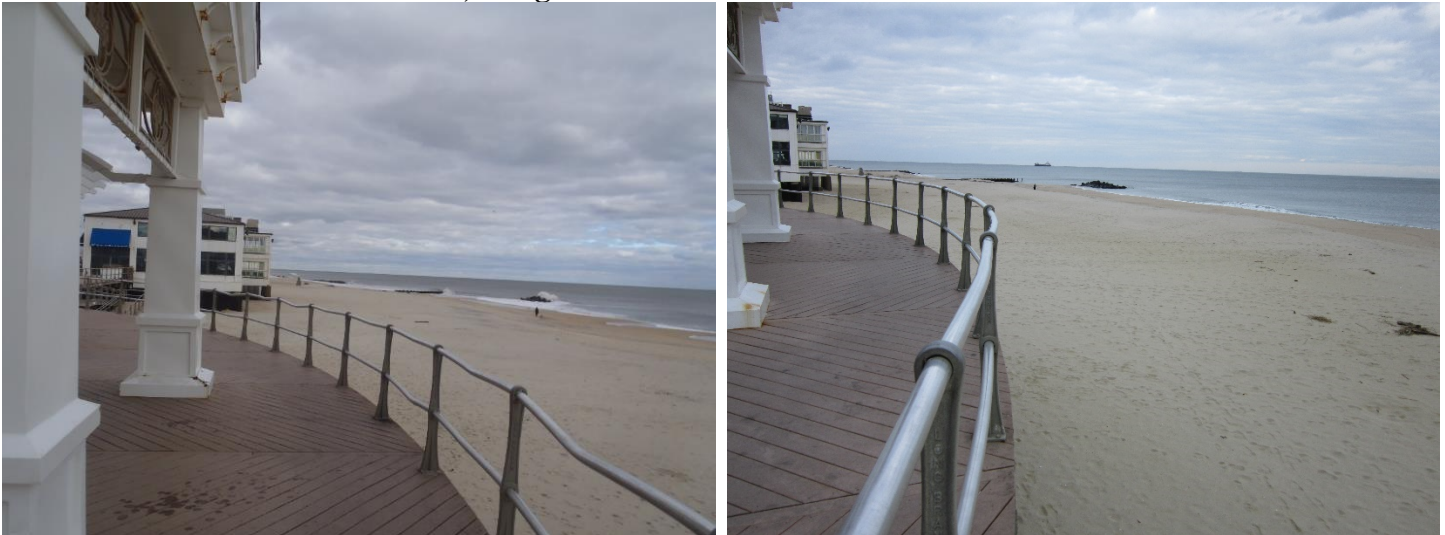
**NJBPN 17402 – 45 Ocean Avenue, Long Branch**

The beach narrows to 150 feet without any bar system present by the fall (Nov. 27, 2018 on left). The beach remained relatively the same as of Jan. 6, 2020 if the distant groin rock exposure is compared (on right).

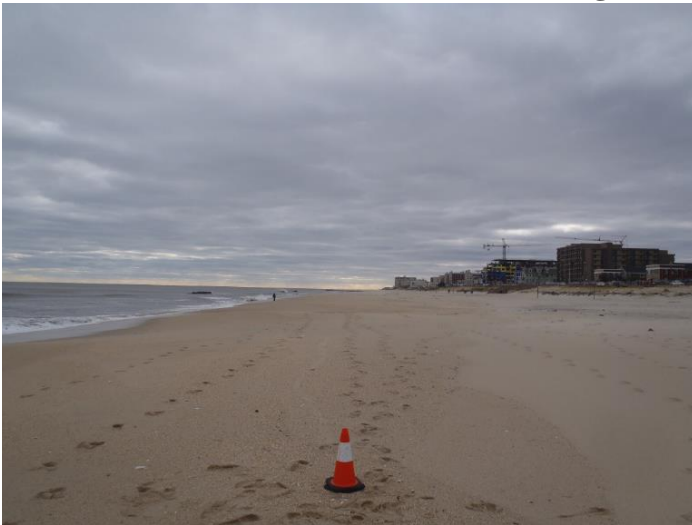
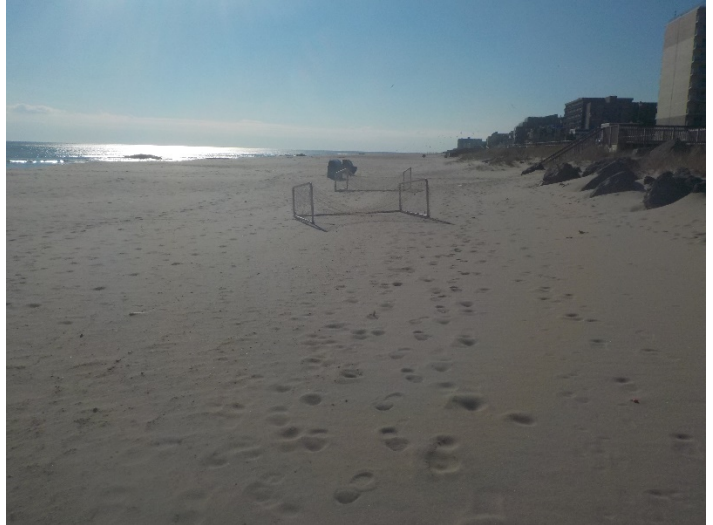
**NJBPN 17401 – North Morris Avenue, Long Branch**

The left view is from Nov. 27, 2018 and shows the sand ramped up against the rock revetment protecting the beach bluff. The right view from Jan. 6, 2020 shows that grass did develop between rocks in that wind deposited sand.

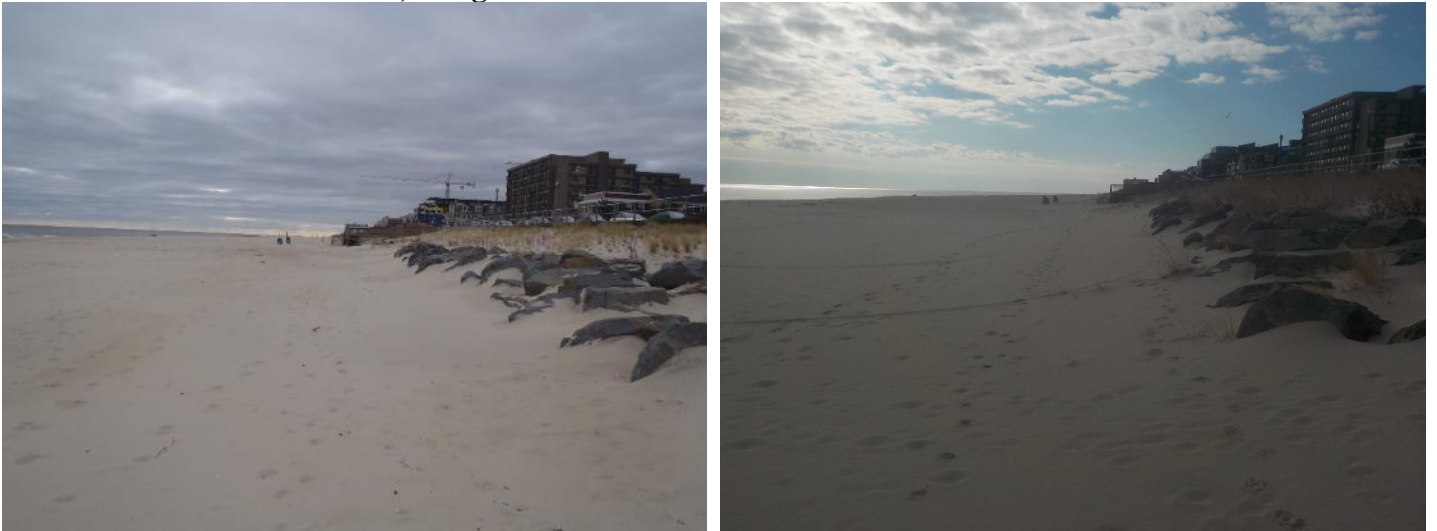
**NJBPN 174 – Morris Avenue, Long Branch**

The left-side view, taken November 18, 2018 shows some grass growth above the rock toe on the beach as wind deposition placed sand up the bluff face. As of Jan. 6, 2020, the grass progressed, but does not appear to be extending onto the dry beach surface (right).

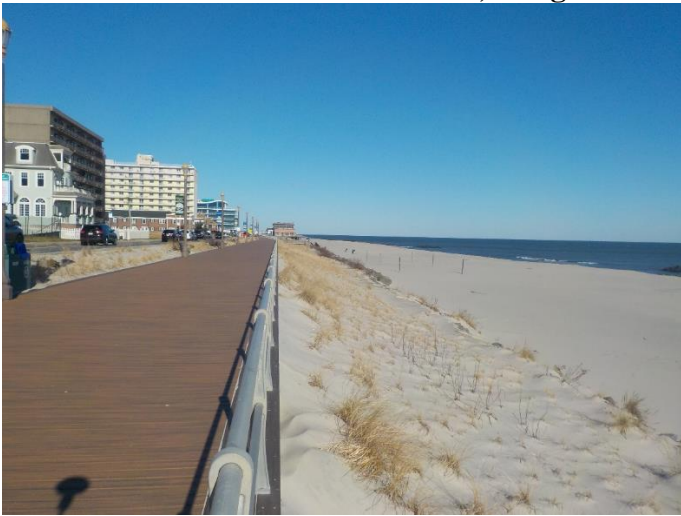
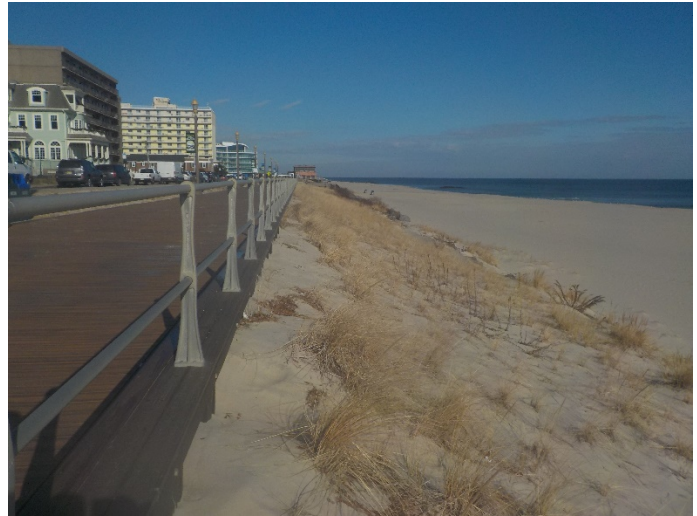
**NJBPN 17303 – 276 Ocean Avenue, Long Branch**

South of Morris Avenue the rock revetment continues with a 240-foot wide beach and no dune system (Dec. 18, 2019). On the right on Jan. 6, 2020, the grass was a bit more pronounced among the rocks, but the beach was still devoid of vegetation.
