# New Jersey Beach Profile Network

## Monmouth County

Raritan Bay and Sandy Hook  
to Manasquan Inlet

**NJBPN Profile #'s  
187 - 256**

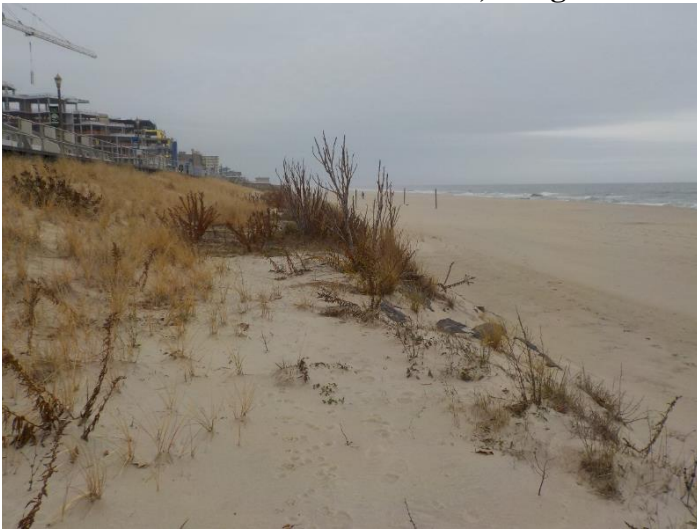
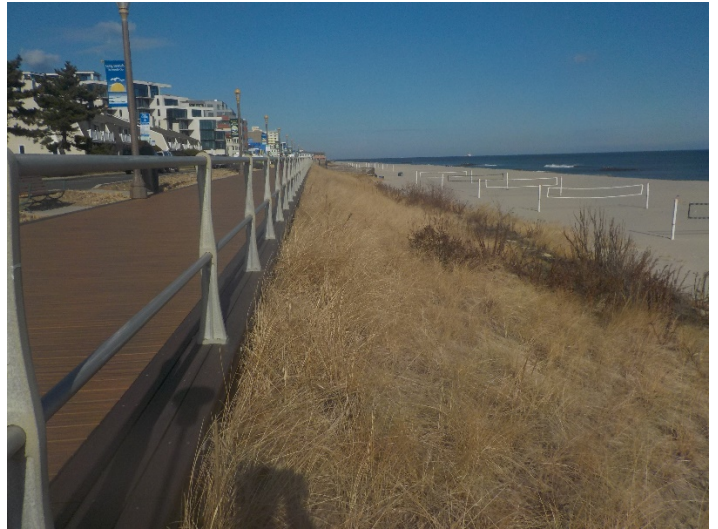
**NJBPN 17302 – 378 Ocean Avenue, Long Branch**

The bluff revetment is the first element in the survey with a 230-foot wide beach to the berm. On the left as of Dec. 14, 2018 the wind had virtually covered the revetment rocks in a sand layer producing vegetation. As of Jan. 6, 2020, that vegetation had developed further. No dune exists at the foot of the revetment, but the beach width remained constant.

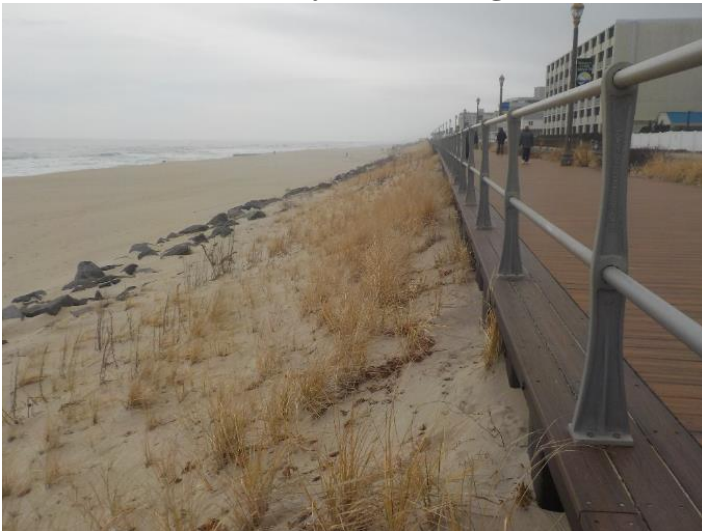
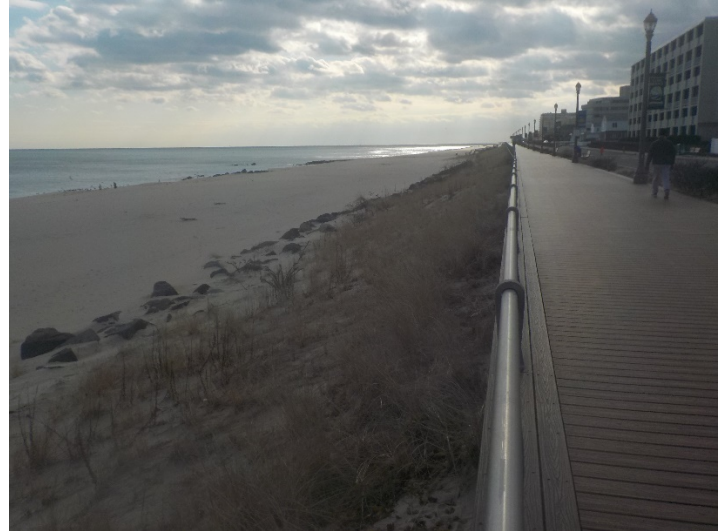
**NJBPN 17301 – Wooley Court, Long Branch**

The rock revetment on the left was photographed Dec. 14, 2018. On the right by Jan. 6, 2020, more grass is present among the rocks, exposed at the toe, but covered up-slope. The beach width remained constant.

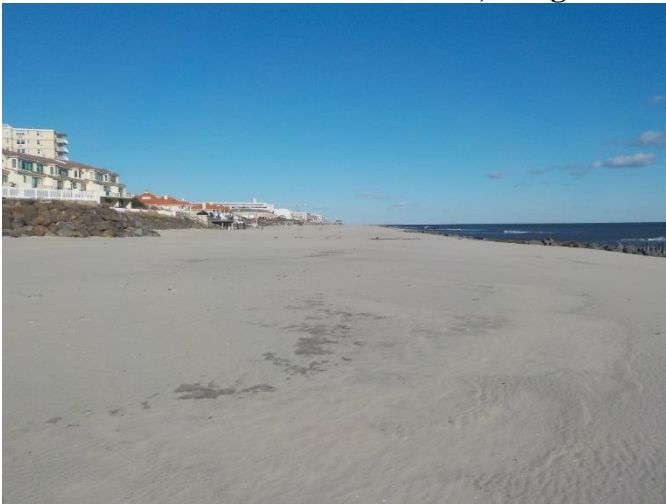
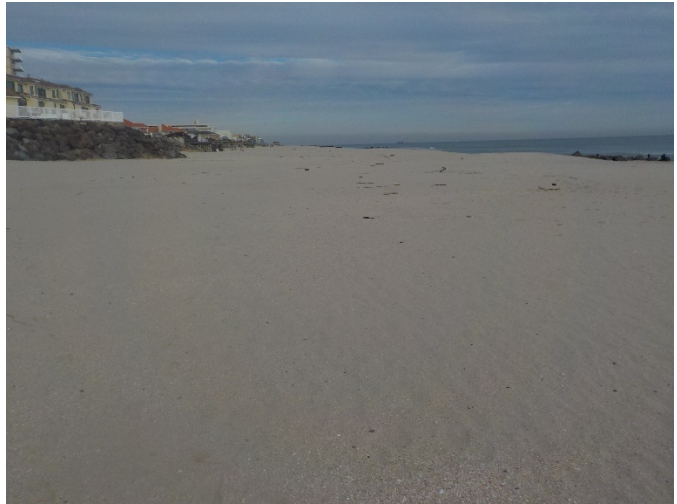
**NJBPN 27201 – 717 Ocean Avenue, Long Branch**

Located in the northern limit for the Phase III USACE beach restoration project, this location was photographed on Dec. 18, 2018 showing the rocks protecting the structures and the dry beach. As of Jan. 7, 2020 the beach was a bit wider, but no further deposition was seen at the rocks with developing dunes.

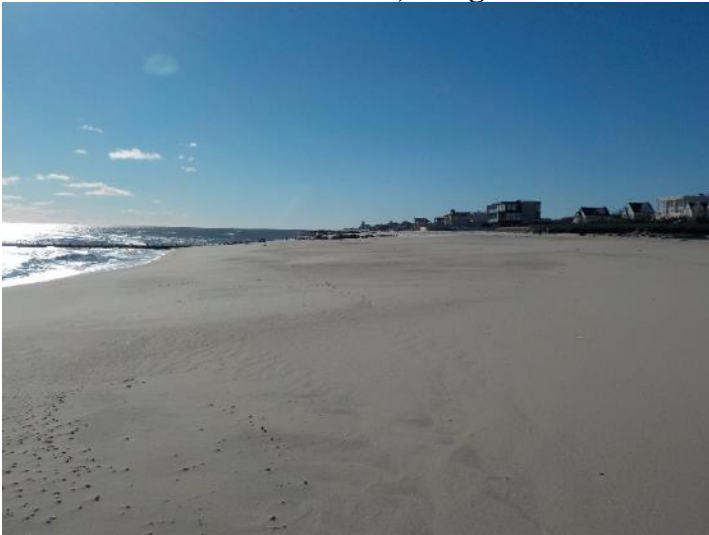
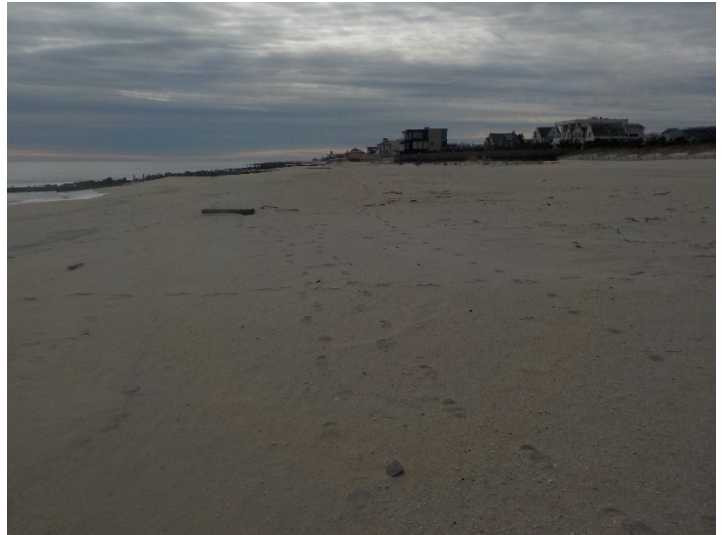
**NJBPN 272 – 805 Ocean Ave, Long Branch**

This site, established in 2010, is located on the northeastern edge of Lake Takanassee. The view to the left, taken December 18, 2018, shows retreat at the berm with rocks showing on the south groin. As of Jan. 7, 2020, more rocks have appeared along the rock groin indicating shoreline retreat.

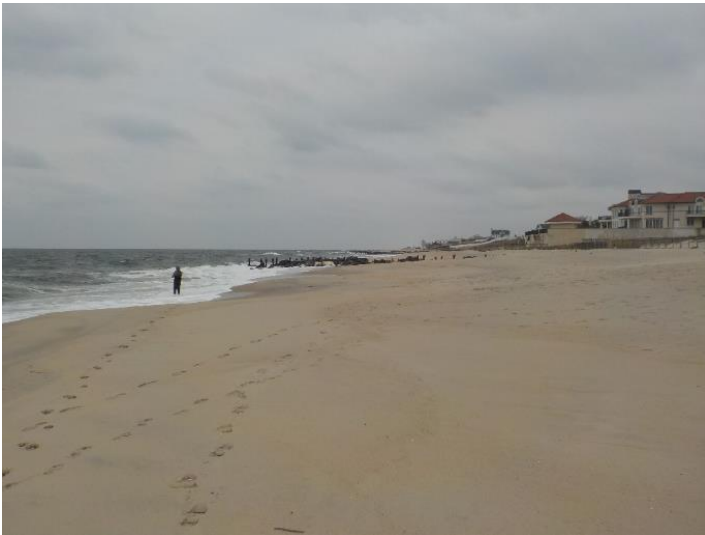
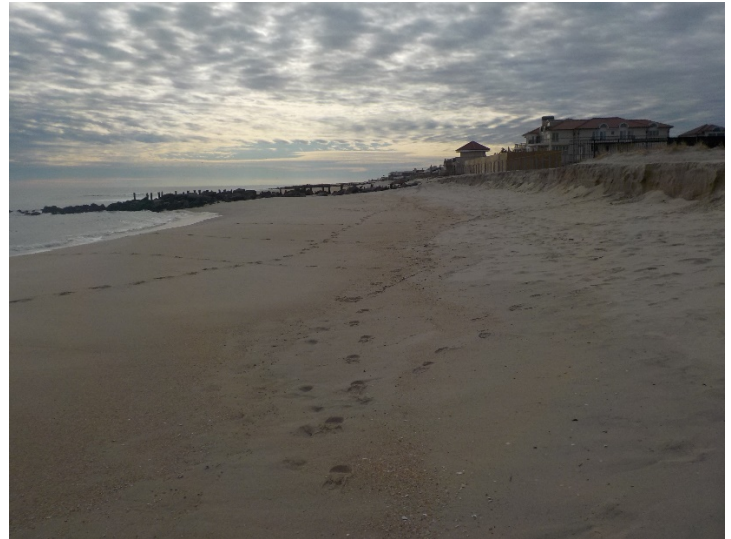
**NJBPN 17101 – Plaza Court, Long Branch**

This site is located south of Lake Takanassee positioned south of the lake’s freshwater exit flume structure. The left picture from De. 13, 2018 shows the rock groin exposed a year following project completion. By Jan. 7, 2020, erosion has taken a serious toll on the beach width with a scarp present and much more of the groin visible.

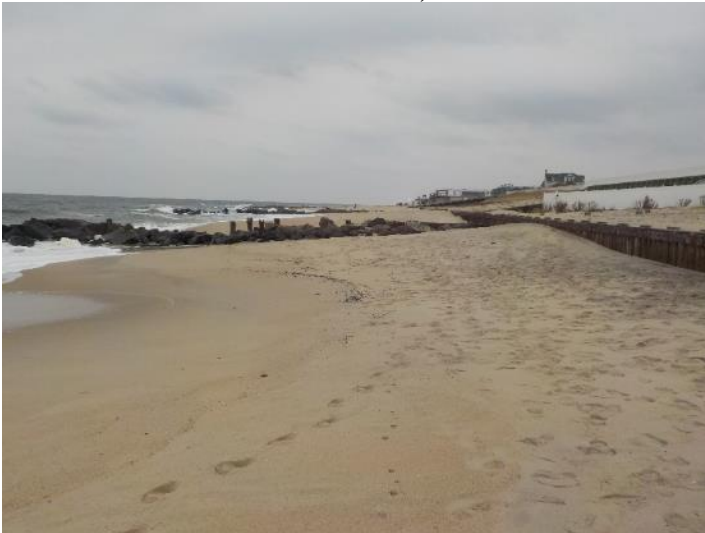
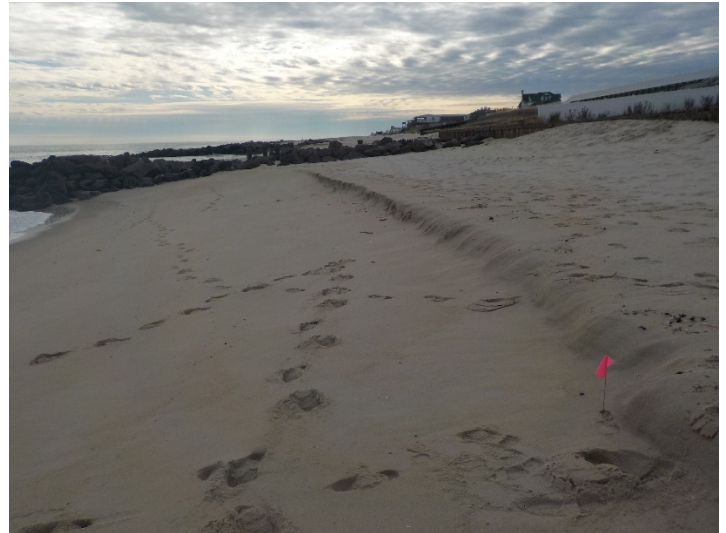
**NJBPN 171 – Pullman Avenue, Elberon**

This site is located on the highest point along the bluff shoreline. By December 13, 2018 the four pilings and a rock that barely were visible in 2017 are now fully exposed on the left view. As of Jan 7, 2020 further erosion has fully exposed the rock groin and pushed the beach berm nearly to the main shore-parallel bulkhead.

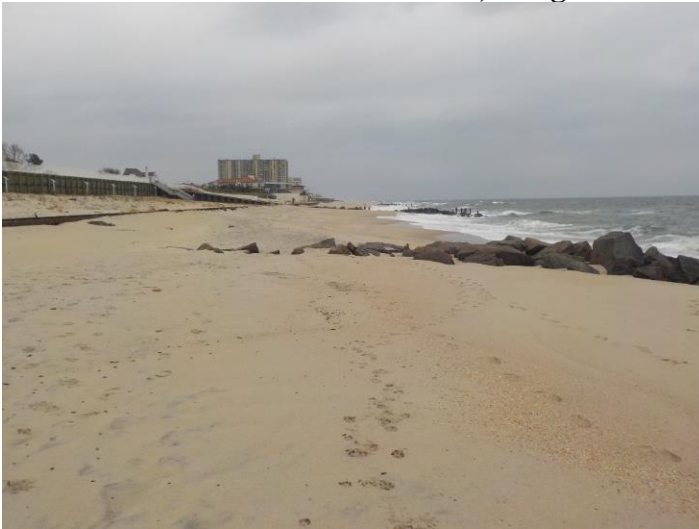
**NJBPN 17005 – 981 Ocean Avenue, Long Branch**

Located in the Elberon groin field, this location was completed during 2016 and suffered retreat producing exposed rocks by Dec. 13, 2018. By Jan. 7, 2020 the beach was lower in elevation with the old timber bulkhead clearly visible on upper beach.

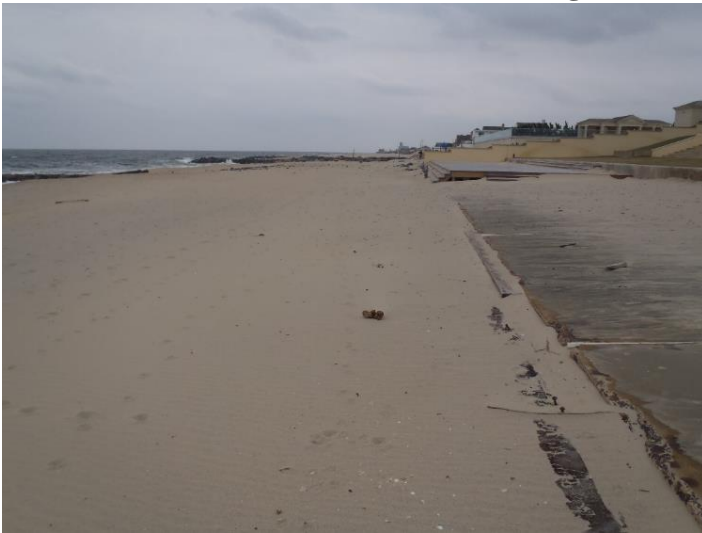
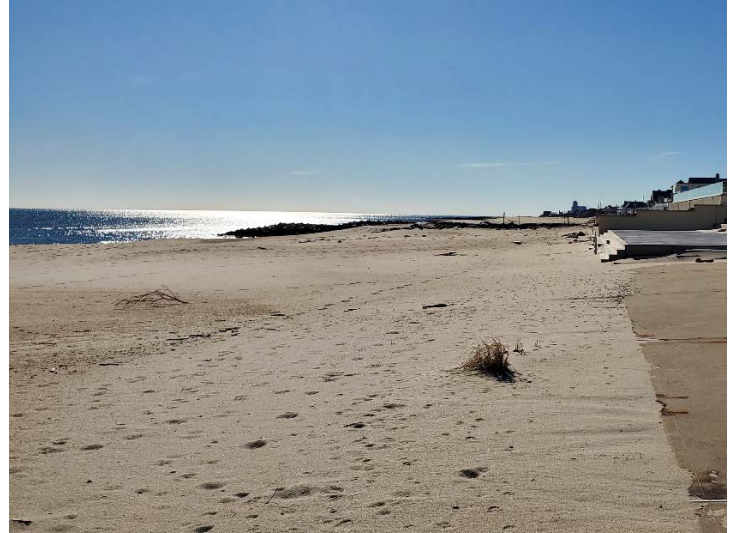
**NJBPN 17004 – 1115 Ocean Avenue, Long Branch**

This location is also within the Elberon groin field. The left view was on Dec. 13, 2018 and shows some rock exposure in the distance to the south. As of Jan. 9, 2020 the same perspective on the right shows about the same elevation to the beach at the structures landward with some additional rock groin exposure.

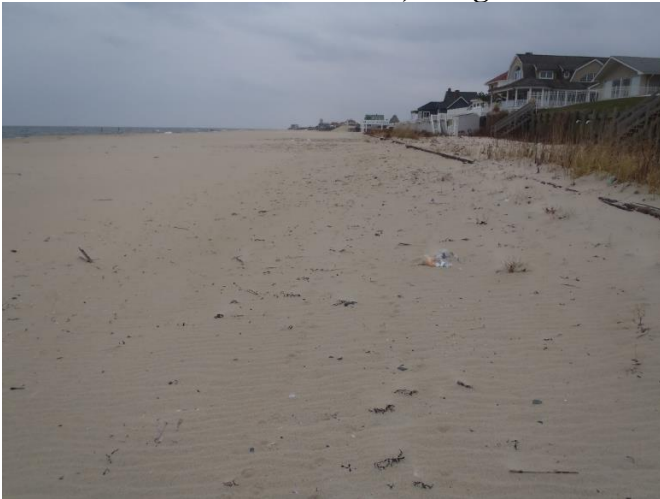
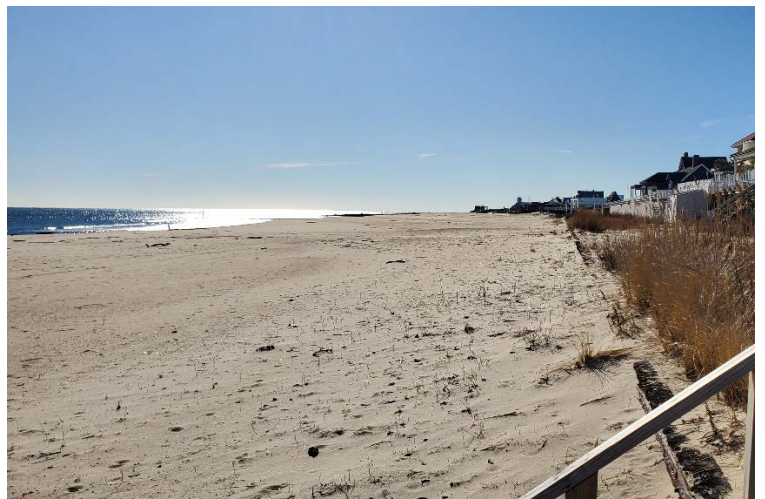
**NJBPN 17003 – Ocean Court, Long Branch**

The left view was taken Dec. 13, 2018 and shows a wide beach with little dune development. The right view shows a similar beach configuration as of Jan. 9, 2020 with few changes.

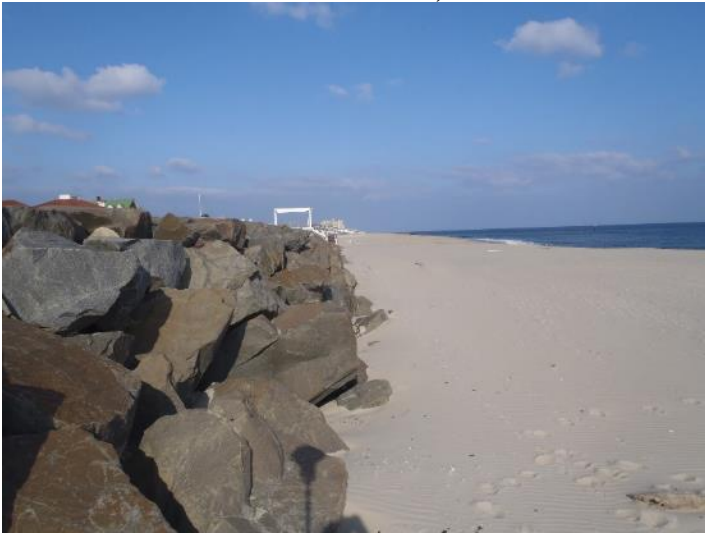
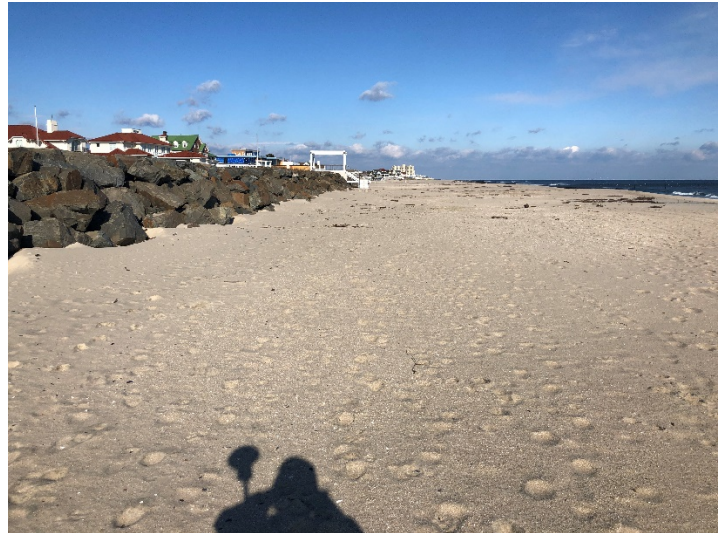
**NJBPN 170 – Roosevelt Avenue, Deal**

By December 11, 2017 the project was complete. The left view was taken a year later on Dec. 12, 2018 with some sand added at the base of the rocks by the wind. As of Jan. 8, 2020, the situation had changed very little at the rock revetment but with modest retreat of the beachface position.

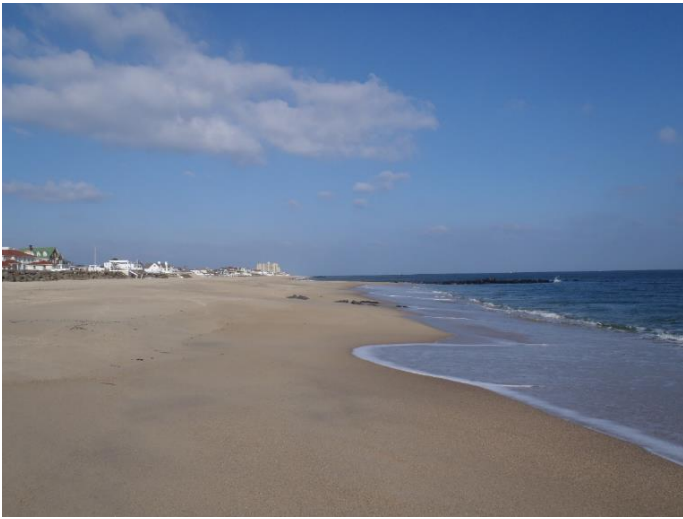
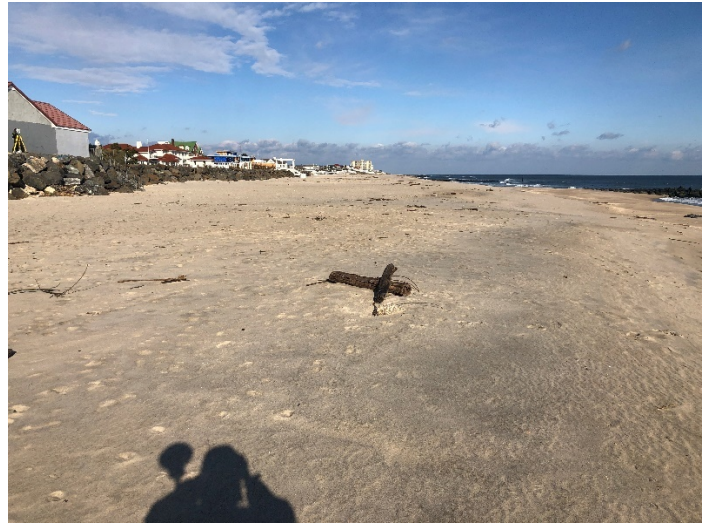
**NJBPN 16905 – South Roosevelt Avenue, Deal**

This new site is just south of Roosevelt Avenue in Deal. The beach on Dec. 12, 2018 was just exposing the rocks in the groin to the north. As of Jan. 8, 2020, the beach width was practically the same with some sand deposited at the toe of the rock by the wind.

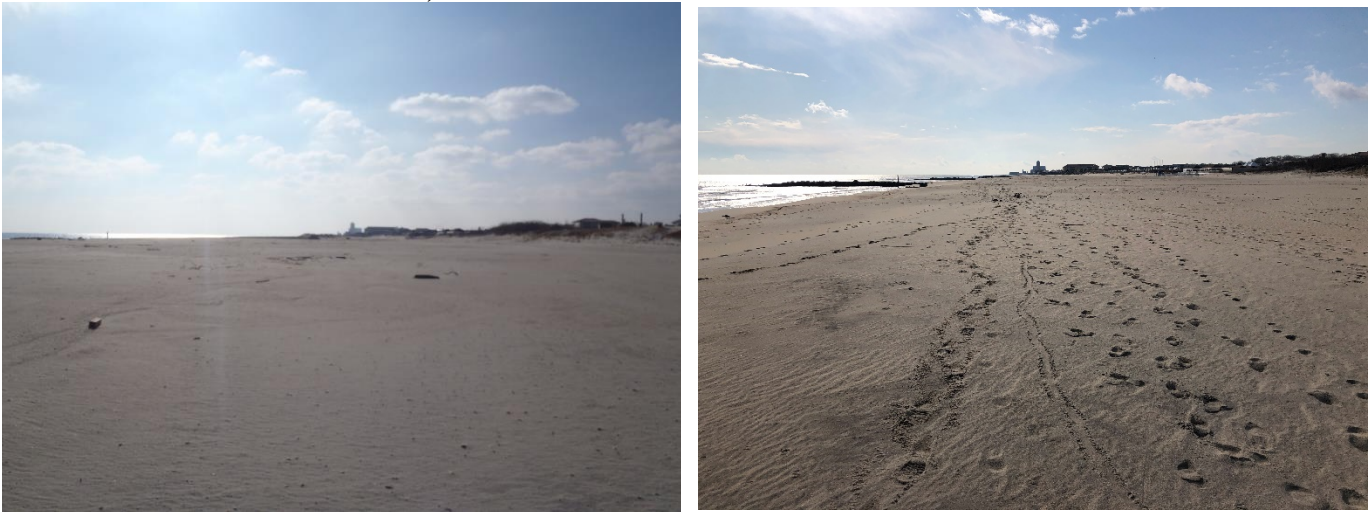
**NJBPN 16904 – 71 Ocean Avenue, Deal**

Located south of Poplar Brook, this site on December 12, 2018 remained essentially at the design width. As of Jan. 8, 2020 some beachface retreat has occurred (right view) with a beach still far wider than pre-project.

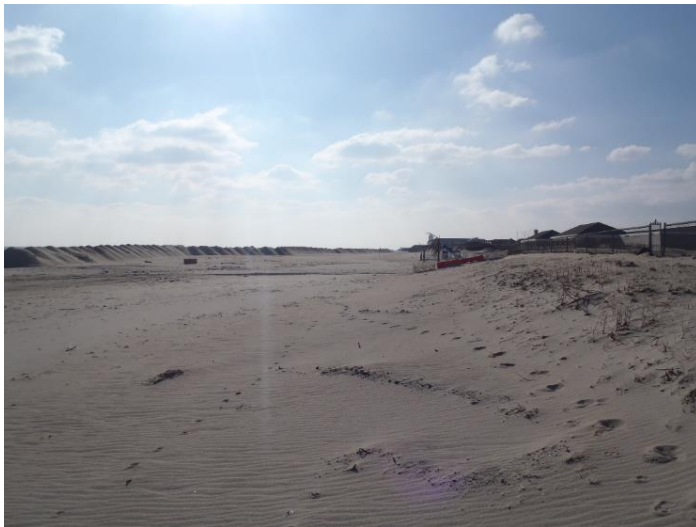
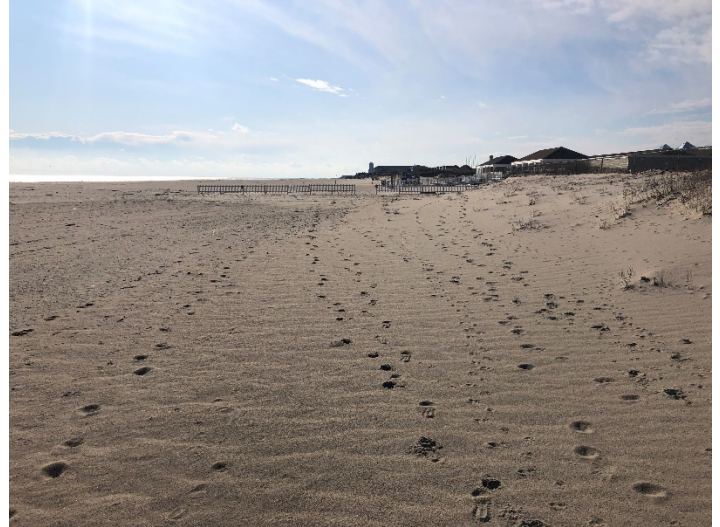
**NJBPN 16903 – Ocean Lane, Deal**

This site is in proximity to Phillips Avenue bathing pavillion, severely damaged by Hurricane Sandy. The Dec. 12, 2018 view on the left shows the toe of the dunes where wind deposition has added material. The right side shows the beach as of Jan. 8, 2020 with more wind deposition.

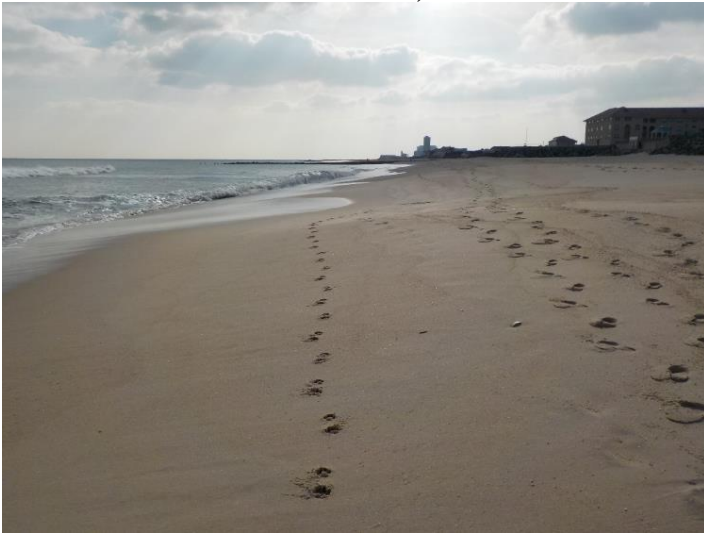
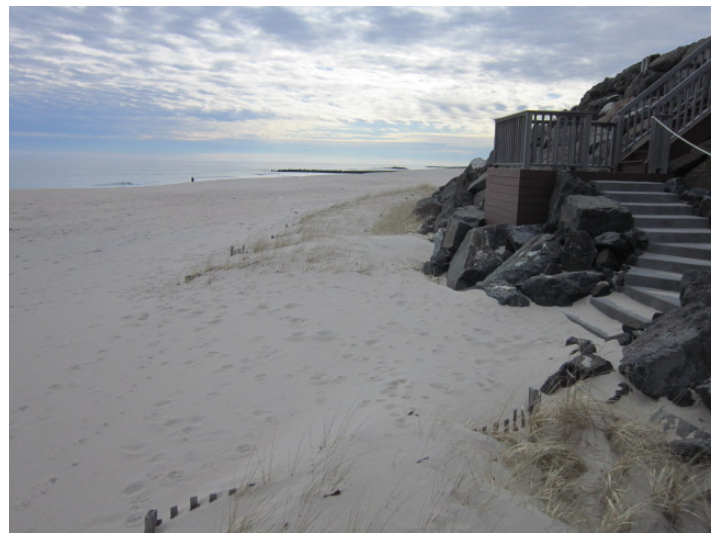
**NJBPN 16901 – Wallace Road, Deal**

This site is located on the boundary between the bathing complex and private homes which extend south of the location. The Dec. 12, 2018 view south on the left was taken at the beachface while the Jan. 7, 2020 view was shot at the toe of the rock revetments built post-Sandy at the site with some wind deposition generating an incipient dune (right view). The 4-foot high fence has been buried.

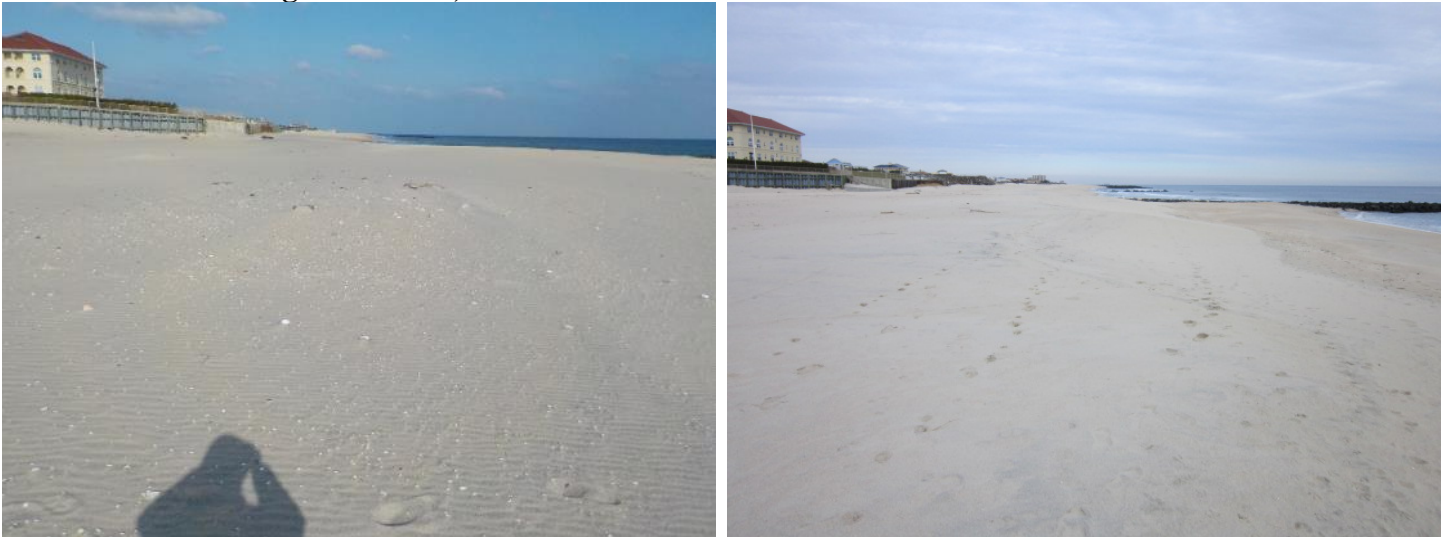
**NJBPN 169 – Darlington Avenue, Deal**

The Darlington site has maintained the as-built width quite well. Completed early during Phase III, there is a wide beach with a berm extending 340 feet beyond the bluff. The December 12, 2018 view shows the beach width quite well (left side) and the Jan. 7, 2020 view on the right shows the berm and beachface at the outer part of the dry sand beach.

The Darlington Avenue site is about a mile north into Deal from Allenhurst and was picked because there was a pocket beach centered at Darlington Avenue extending several blocks in either direction. The sediment bluff once exposed 25 years ago was armored by individual property owners over time with timber bulkhead “seawalls”. The beach varied little over time. Individual owners repaired the extensive damage to their bluff protection once again concealing the sedimentary deposits from inspection. This site did gain sand as the federal project got underway with 241.39 yds<sup>3</sup>/ft. added during the spring to fall 2015 interval. The net change was a sand volume gain of 231.44 yds<sup>3</sup>/ft. accompanied by a 350-foot shoreline advance. The recent study interval produced a 10.06 yds<sup>3</sup>/ft. sand volume loss accompanied with a 31-foot shoreline retreat. These changes were confined to the retreat in the beachface between surveys 58 and 59. The bluff and upper dry beach changed very little. A small bar appeared offshore in the Jan. 2020 survey.

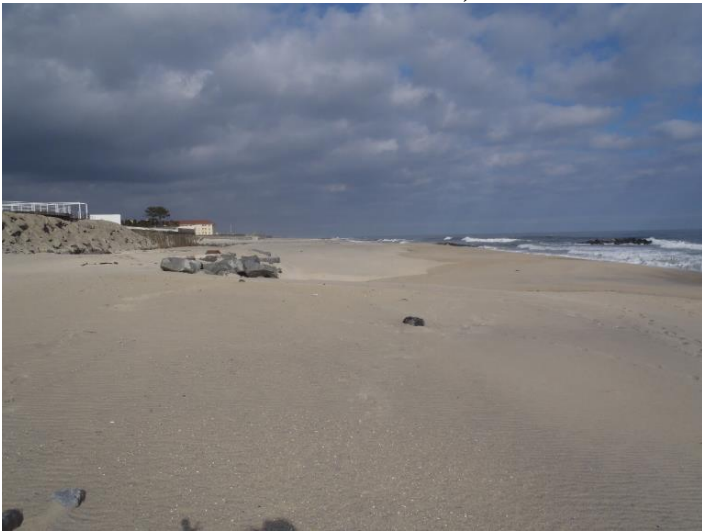
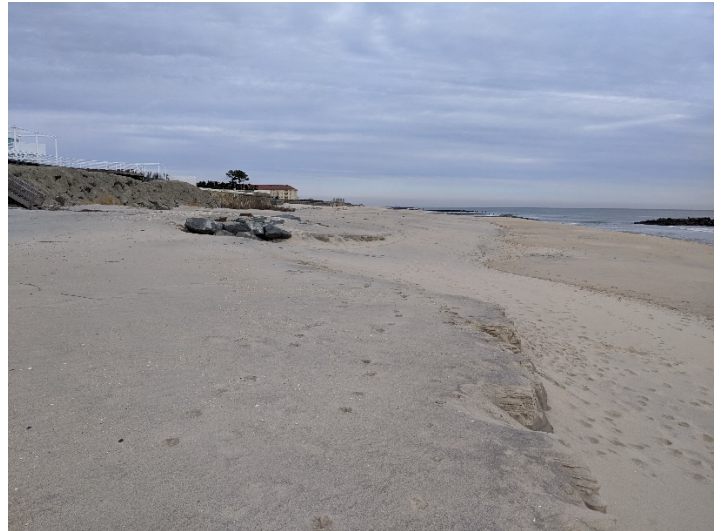
**NJBPN 16802 – Monmouth Drive, Deal**

This site fronts a private home at the bluff. No dune exists and the beach measured 150 feet wide on Dec. 11, 2018 on left. As of Jan. 7, 2020, the beach developed a scarp near the rock revetment with sand deposited as a repair berm seaward of the scarp on the right side view.

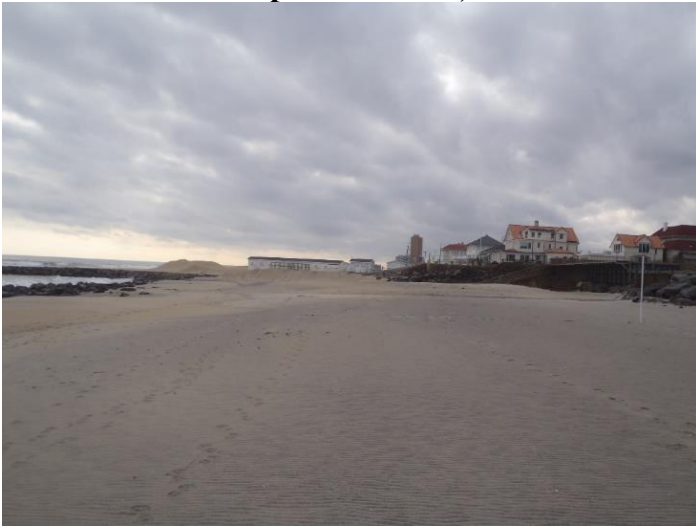
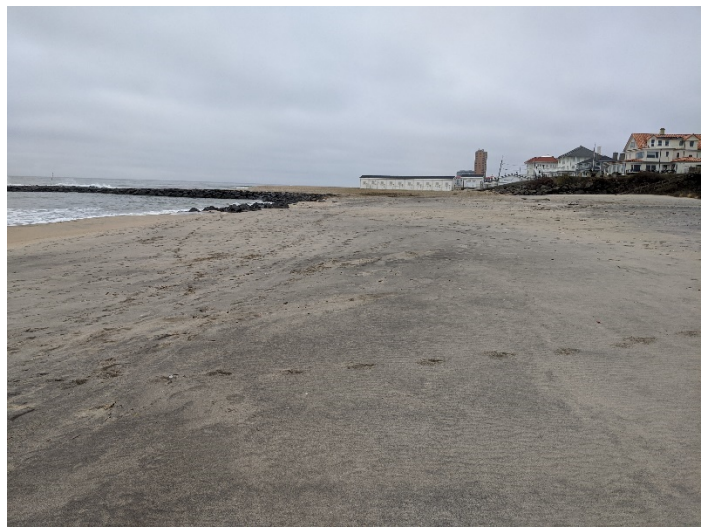
**NJBPN 16801 – Neptune Avenue, Deal**

This is the southernmost site in Deal with the bluff protected by armor stone. This beach sits just north of a massive rock structure designed to hold sand in Allenhurst years ago. The sediment may not reside here terribly long, but the past two years show some stability. The left view was taken Dec. 11, 2018 and the right side was taken Jan. 3, 2020.

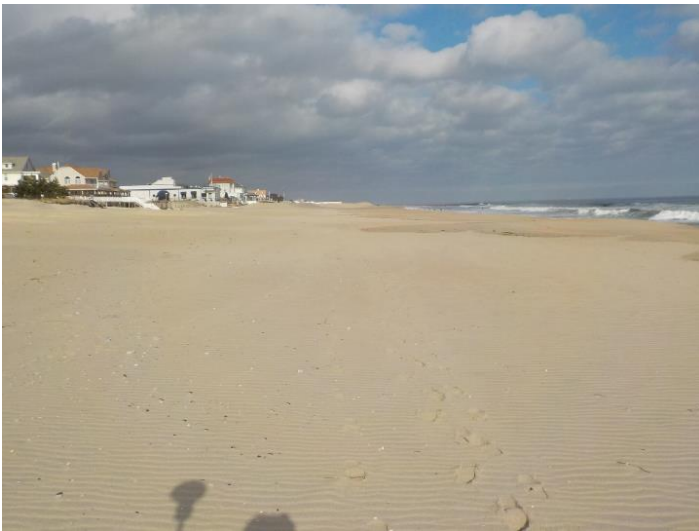
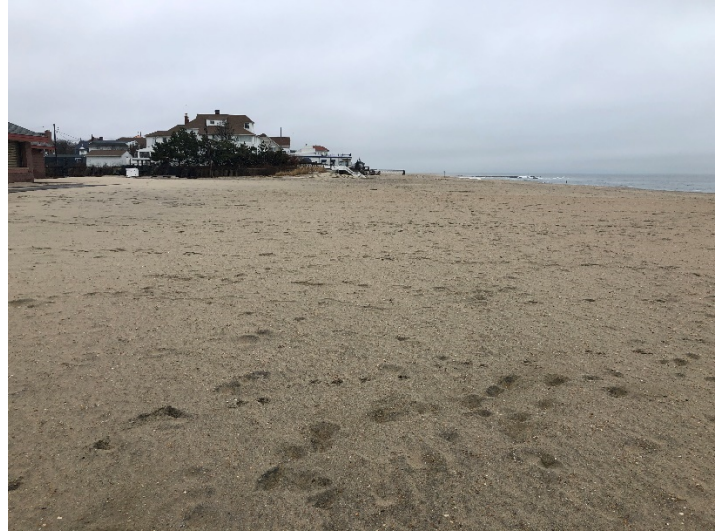
**NJBPN 26703 – Euclid Avenue, Loch Arbor**

This site is located on the public half of the Loch Arbor shoreline. The Dec. 12, 2018 view on the left shows the beach width in comparison with the Jan. 30, 2020 view on the right taken approximately in the same location on the transect.

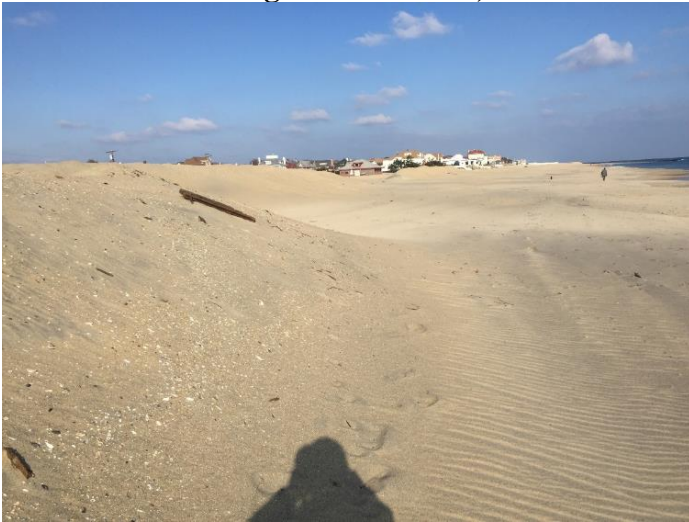
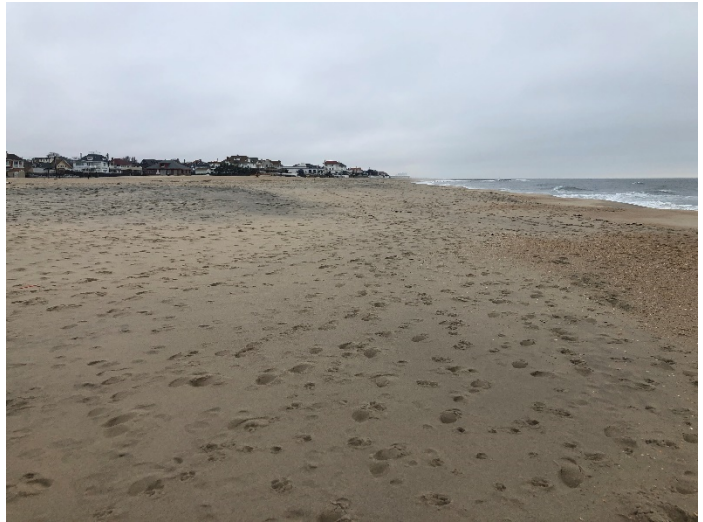
**NJBPN 26702 – Edgemont Avenue, Loch Arbor**

This site is located on the private half of the Loch Arbor shoreline, adjacent to the Deal Lake exit flume. The left view taken Dec. 12, 2018 shows the beach with a series of ridges pushed up as added storm protection. The Jan. 30, 2020 view on the right shows the natural beach slope without sand pushed up.

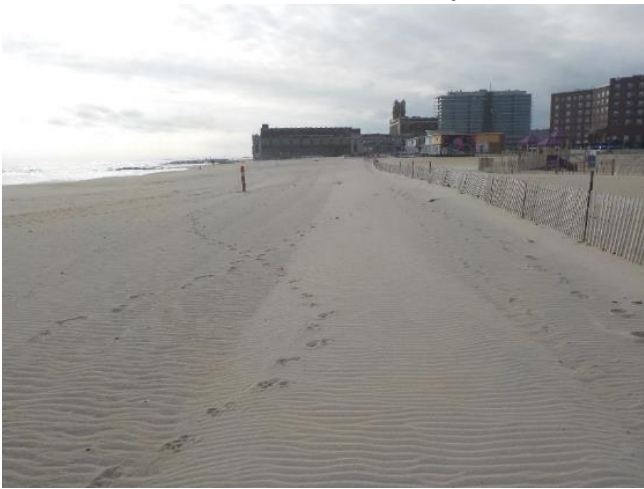
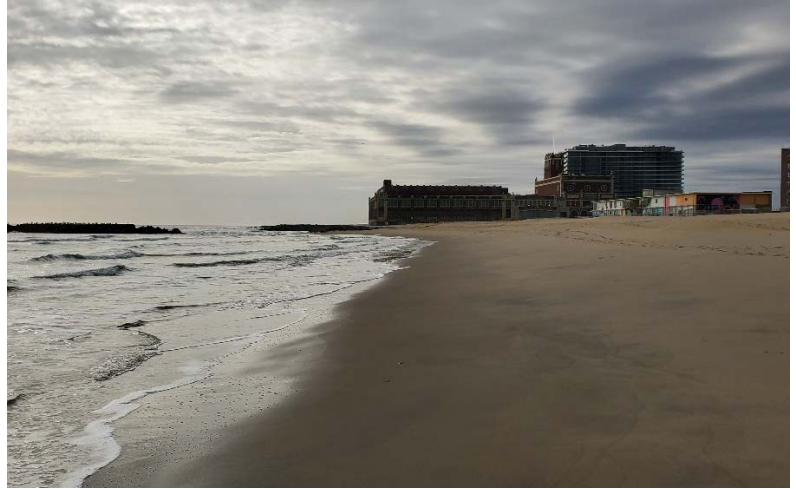
**NJBPN 267 – 7th Avenue, Asbury Park**

This site is the northernmost location in the Phase II part of the Monmouth County project. The left photo was taken Dec. 11, 2018 and shows the sand fence placed primarily to restrict access to the boardwalk reconstruction. The beachface view on Jan. 11, 2020 shows the rock groins with greater exposure indicating shoreline retreat.

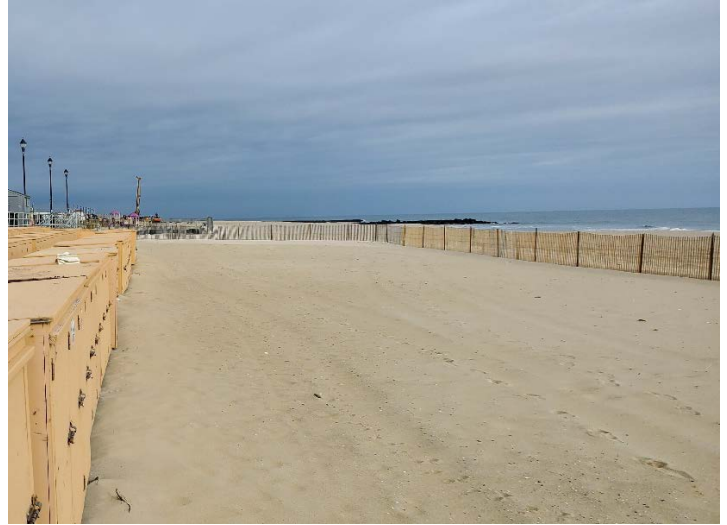
**NJBPN 16701 – Sunset Avenue, Asbury Park**

The Dec. 5, 2018 view on the left shows the beach and fencing designed to restrict access to construction. The Jan. 10, 2020 view on the right shows the storage boxes completed next to the boardwalk with the beach essentially the same.

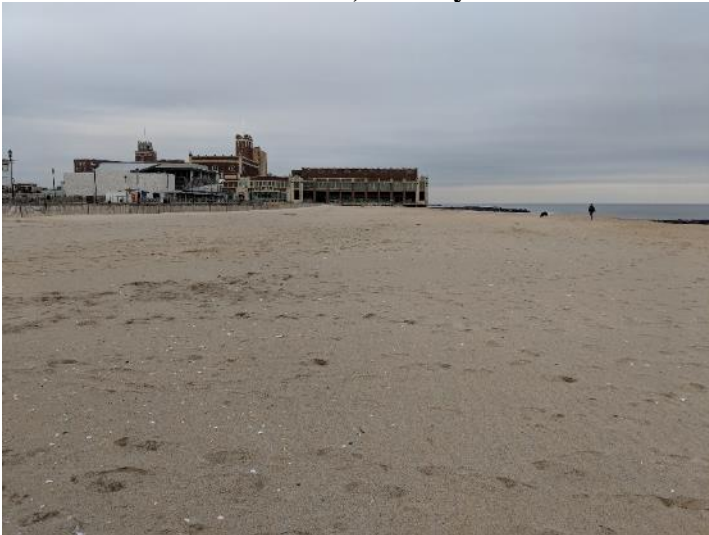
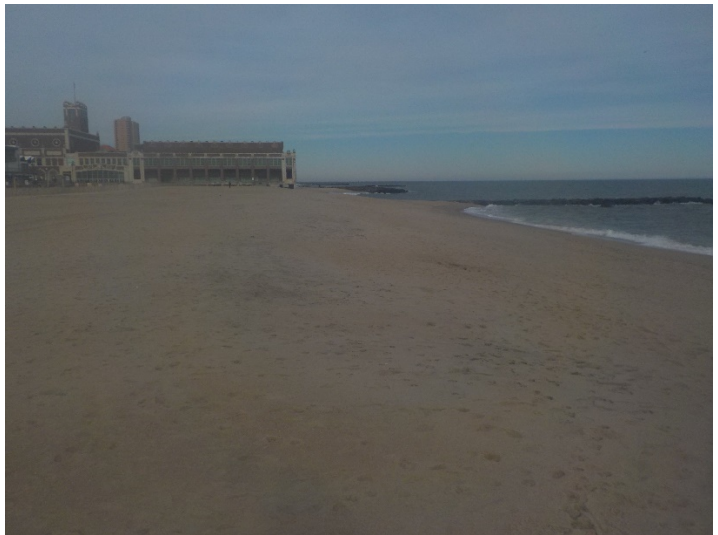
**NJBPN 167 – 3rd Avenue, Asbury Park**

The left view was taken November 30, 2018 on the dry beach looking north. The Jan. 11, 2020 view was at the berm crest showing the exposed groins and the relative beach with compared to the Asbury Park convention center building.

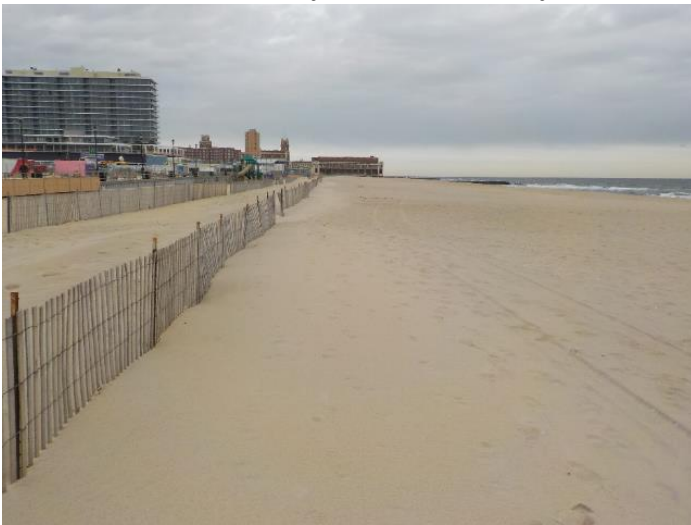
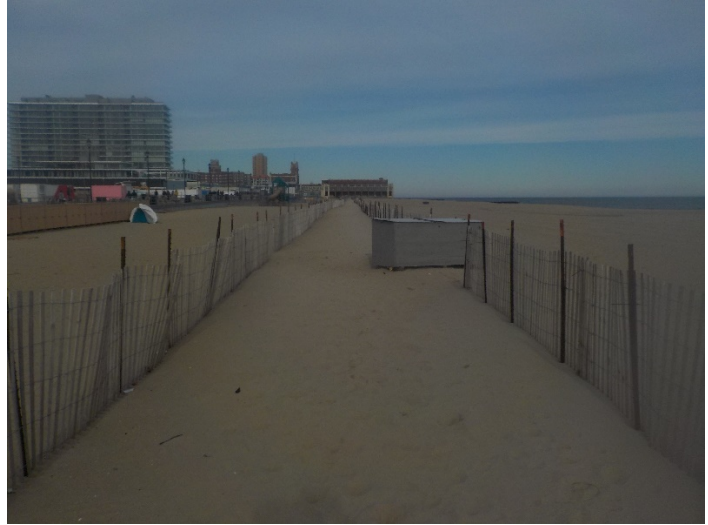
**NJBPN 16602 – Asbury Avenue, Asbury Park**

The left view was taken seaward of a double row of sand fence on Dec. 5, 2018. The same view to the north was shot on Jan 2, 2020 between the rows of fence. Sand does collect here, but in minor amounts.

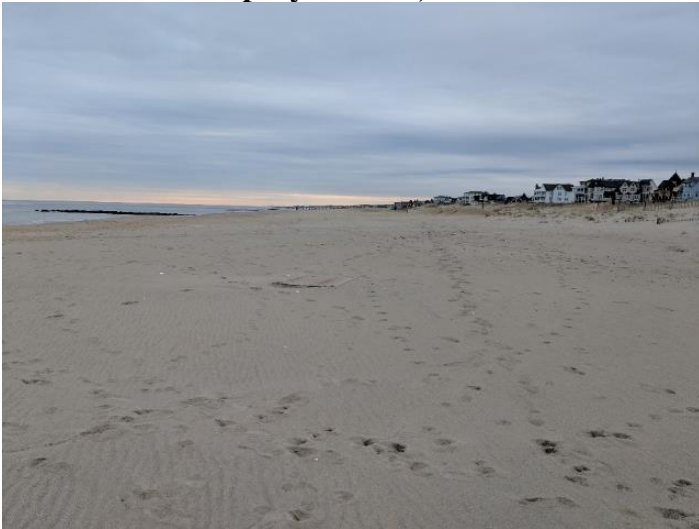
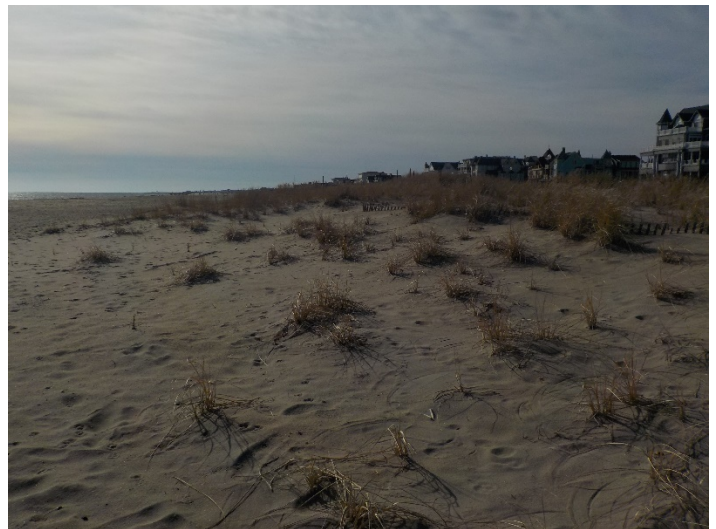
**NJBPN 16601 – Spray Avenue, Ocean Grove**

The view on the left is from Nov. 30, 2018 and shows the entire beach width. The Jan 2, 2020 view on the left shows the dune toe with grass plants extending onto the foredune slope as conditions continue to improve in Ocean Grove dunes.

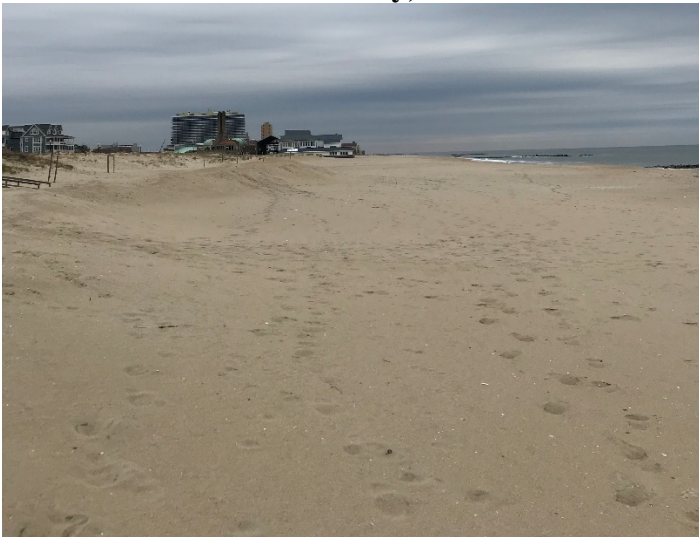
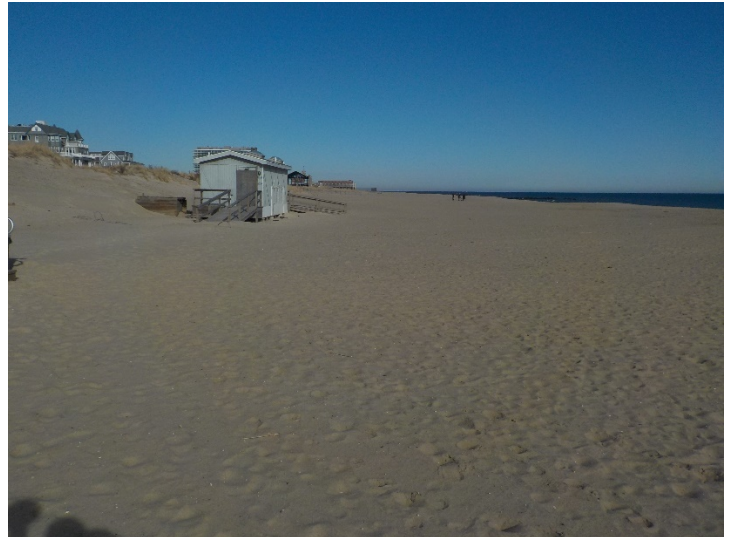
**NJBPN 166 – Ocean Pathway, Ocean Grove**

The Nov. 30, 2018 view to the left shows the sand ridge pushed up that year for added storm protection. The Jan. 2, 2020 view on the right shows the new service building put on the seaward dune toe and the dry beach width present at the time.

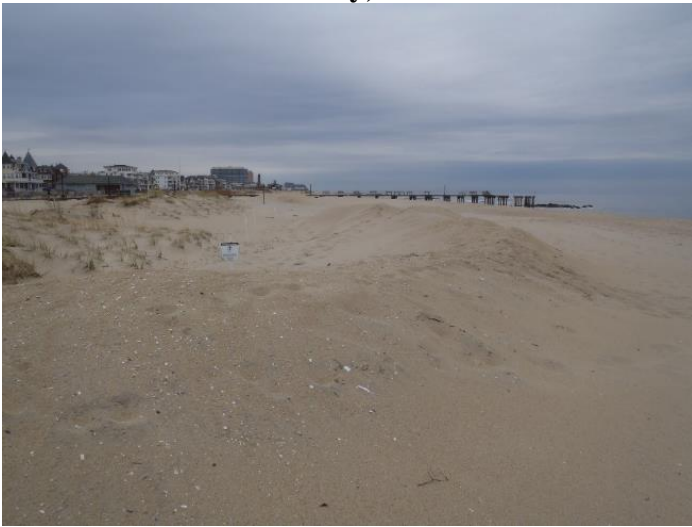
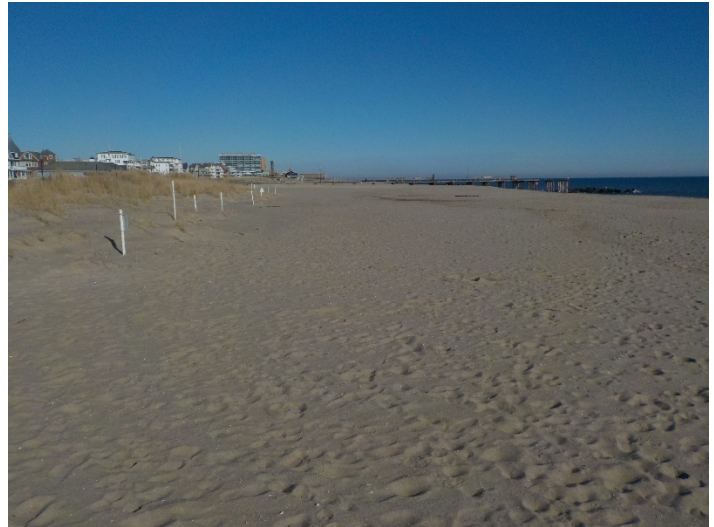
**NJBPN 16502 – Broadway, Ocean Grove**

The Nov. 30, 2018 view on the left shows the dune slope with a sand ridge added that year for storm protection. The right view from Jan. 2, 2020 shows the beach width and seaward dune slope without pushed up material.

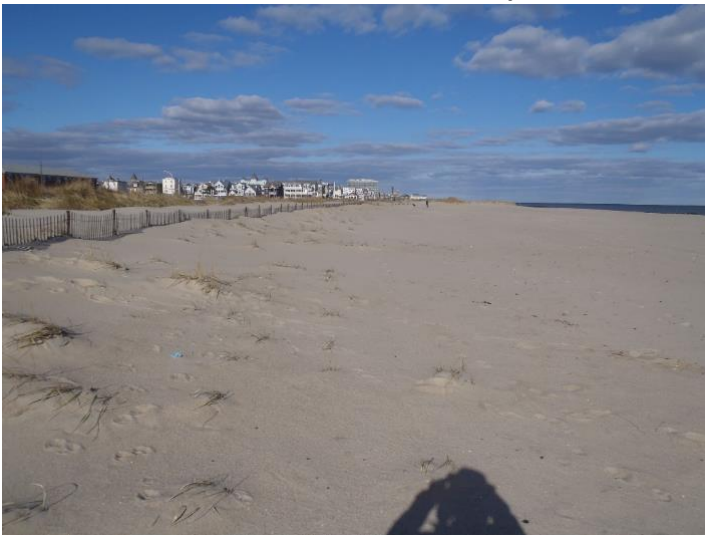
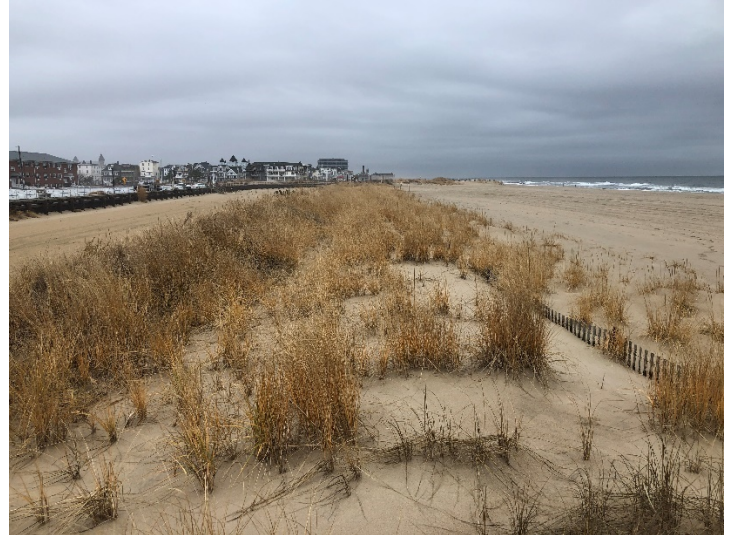
**NJBPN 16501 – Cliff Avenue, Bradley Beach**

The Nov. 29, 2018 view on the left is to the north seaward at the foredune toe on the beach, while the Dec. 12, 2019 view on the right was taken at the dune crest looking north showing the open space landward of the dunes and the beach width seaward.

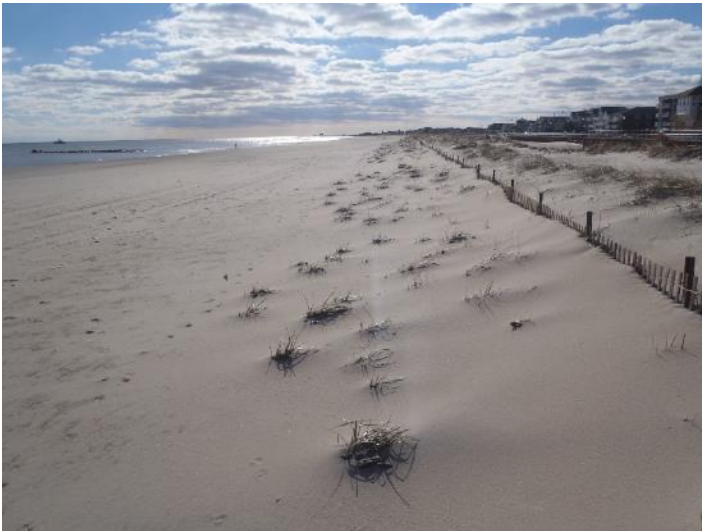
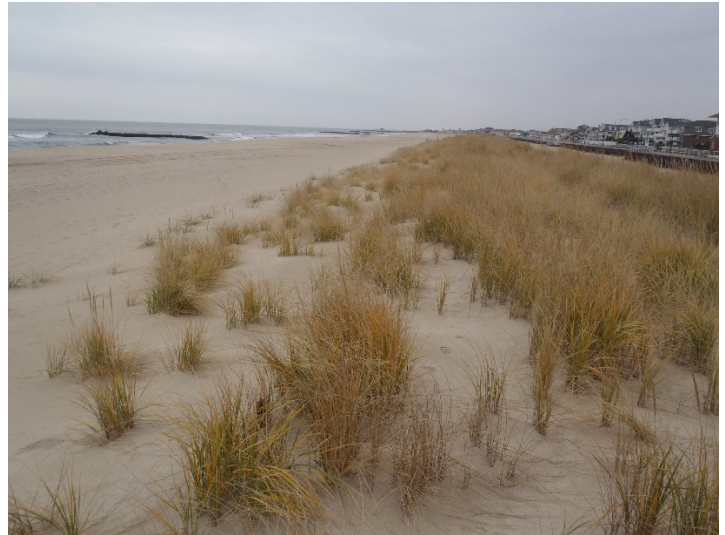
**NJBPN 165 – McCabe Avenue, Bradley Beach**

The November 29, 2018 view to the south shows the beach width (left photo) and dune crest with added sand deposited on the grass plants. The right view Nov. 22, 2019 shows the dunes and the dry beach with conditions appearing to be stable.
